**River Axe, Wookey, Somerset**

**Wild Trout Trust report on a walkover survey carried out on 19 October 2020**

**Written by Theo Pike: [tpike@wildtrout.org](mailto:tpike@wildtrout.org)**

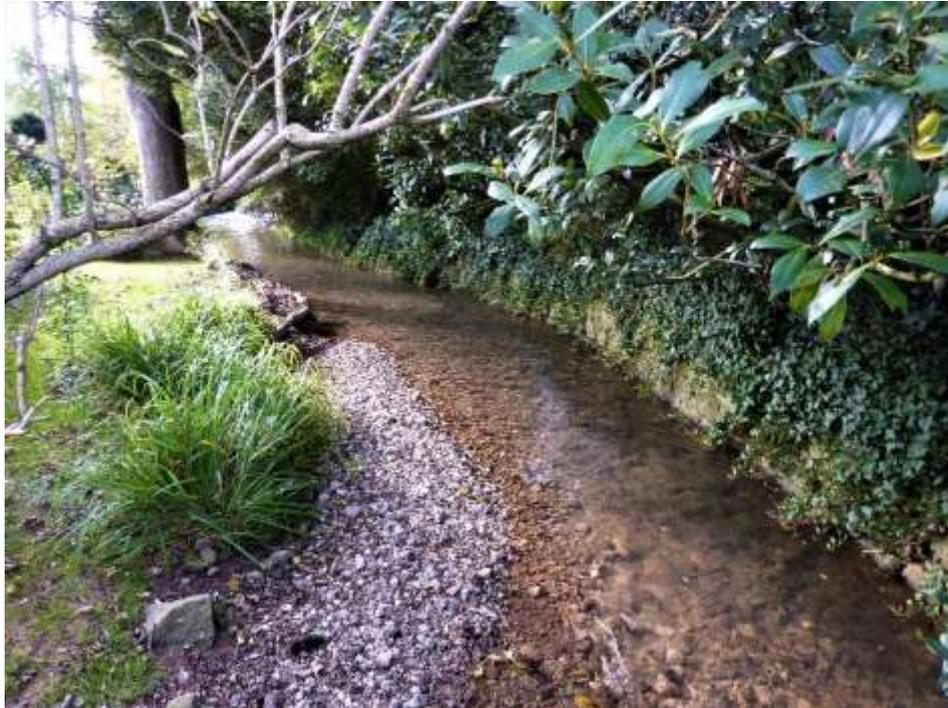
*Figure 4: Looking downstream from Vicarage Road, the River Axe flows through residential gardens*

The main stem of the River Axe enters the village of Wookey under the Vicarage Road bridge and immediately disappears from public view into private gardens, from ST 52049 45717 to ST 51935 45680 (approx.).

Throughout this area, it would be worth engaging with local residents to highlight these potential issues and communicate the benefits of 'river-friendly gardening': solving misconnections, and promoting use of water butts, rain gardens, and permeable paving, as well as softening banks and improving in-channel habitat along individual lengths of stream.

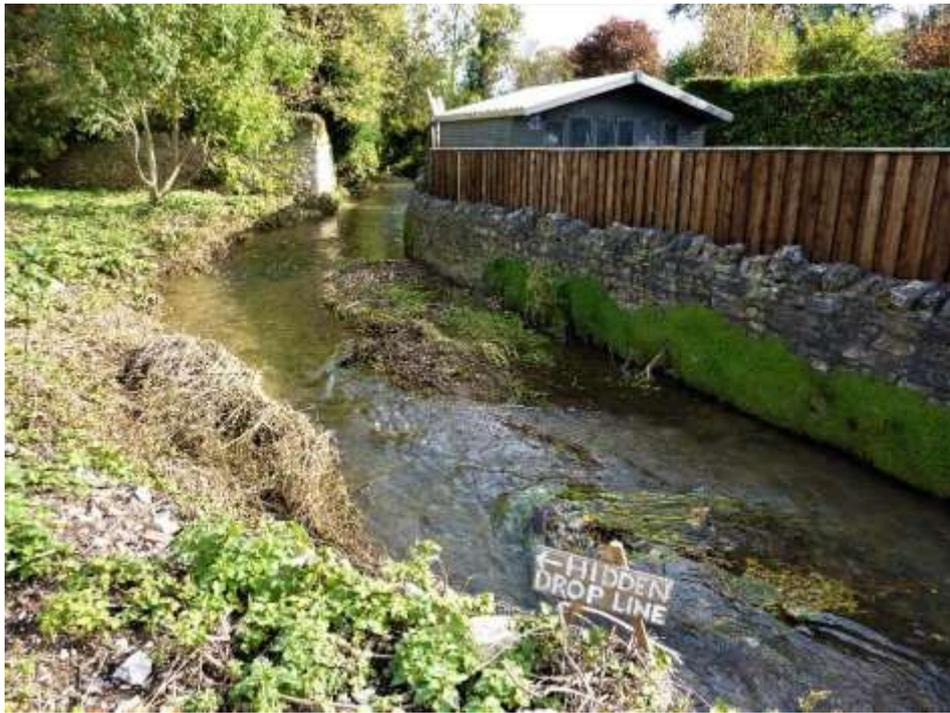
*Figure 5: The view upstream from Vicarage Lane*

Historic maps suggest that the river was once wider at this point – perhaps the site of an older ford. Since then, the channel has been dramatically narrowed and armoured with gabion baskets near the bridge, and broken concrete and hard core on the RB further upstream. Indeed the adjacent land on the RB is now an unsightly area of very poor habitat value: marked as 'private land' on a makeshift fence, it is dominated by areas of burned concrete and other rubbish, and may be a source of pollution for the river.

It would be worth engaging with the landowner to improve the ecological and aesthetic value of this area, perhaps by replacing the rubble with a soft riparian fringe of native vegetation, for the benefit of insects, birds and fish.

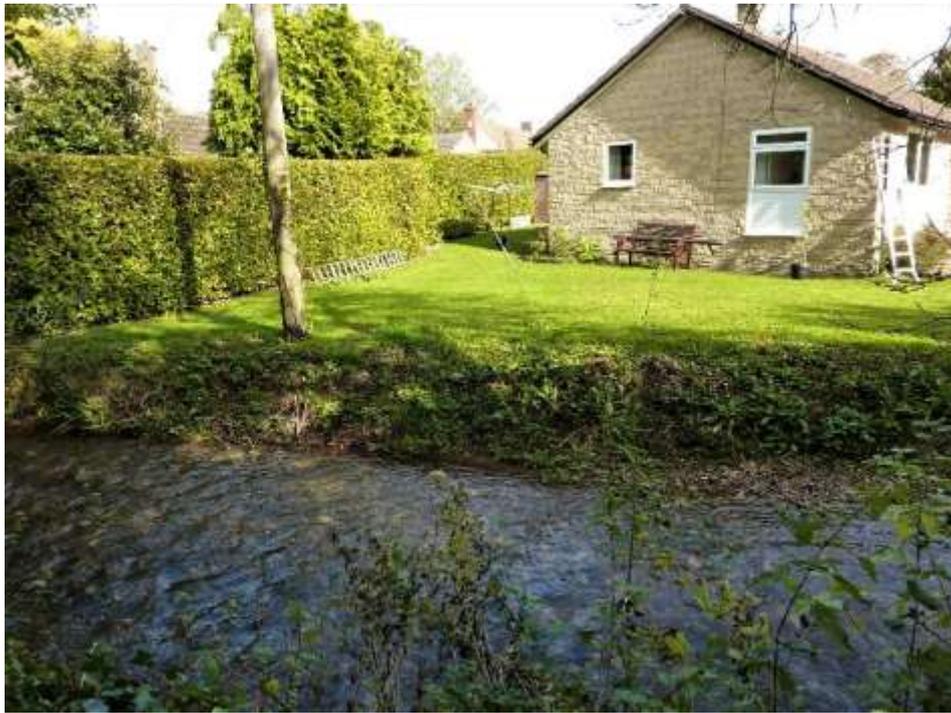
*Figure 6: A recently regraded garden bank, where a 'shaggy' trailing marginal fringe should now be allowed to develop*

As previously discussed, engaging with the local community to retain and develop such soft, 'shaggy' fringes of native vegetation, and encourage more 'river-friendly' gardening practices, would be highly beneficial.

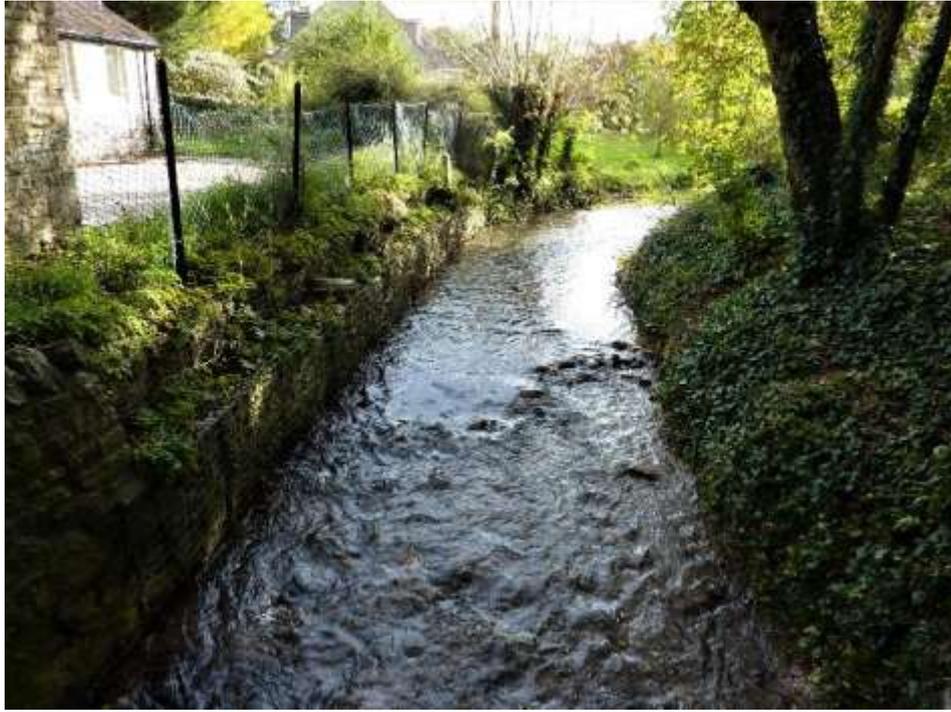
*Figure 7: Looking upstream from the church footbridge, this stretch of the Axe is overshadowed and uniform, lacking habitat features*

Tree management in this area is recommended, to reduce heavy overshadowing, allow more light into the river corridor, and create a 'mosaic' of dappled light and shade. Arisings from these tree works should be introduced to the river as flow deflectors and other Large Woody Material (LWM) structures – increasing flow complexity and localised scour and deposition, and creating a wide range of micro-habitats for different species. Increased light levels will also allow a more diverse riparian fringe to become established: this should be left shaggy and trailing to provide as much roughness and habitat complexity as possible.

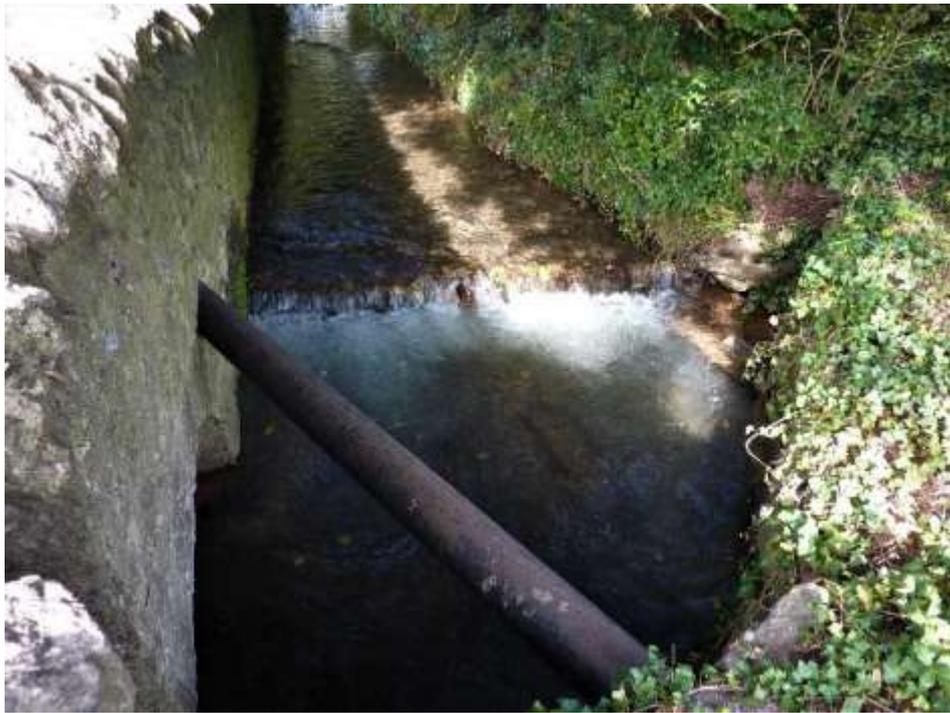
*Figure 8: The straightened channel and small weir alongside Preywater Road: this weir is likely to be a barrier to small fish, while the shallow, uniform channel just upstream offers little habitat for larger adult trout*

As above, tree works are recommended to create a patchwork of dappled light and shade, with enough light to allow new riparian plants to flourish, and arisings recycled as flow deflectors to increase hydrological roughness and habitat complexity. The aim should be to achieve a more sinuous flow within the existing constraints of the channel, restoring processes of localised scour and deposition, and creating varying habitat pockets for a wide range of species.

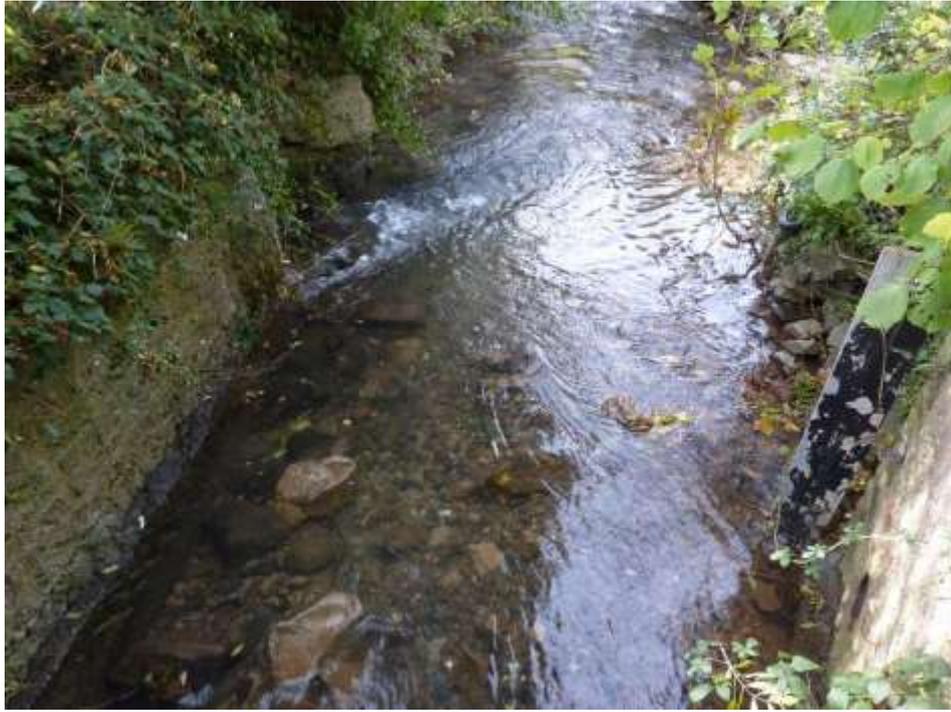
*Figure 9: Boulders and gravel on the downstream side of the Preywater Road bridge*

A few metres downstream, a flow of water enters the channel from a pipe on the LB: this is believed to be the outfall of the minor channel from the mill stream which is culverted from ST 51632 45572 (see below). Adult trout were observed in this area, moving around the boulders, and in and out of the shadow of the bridge.

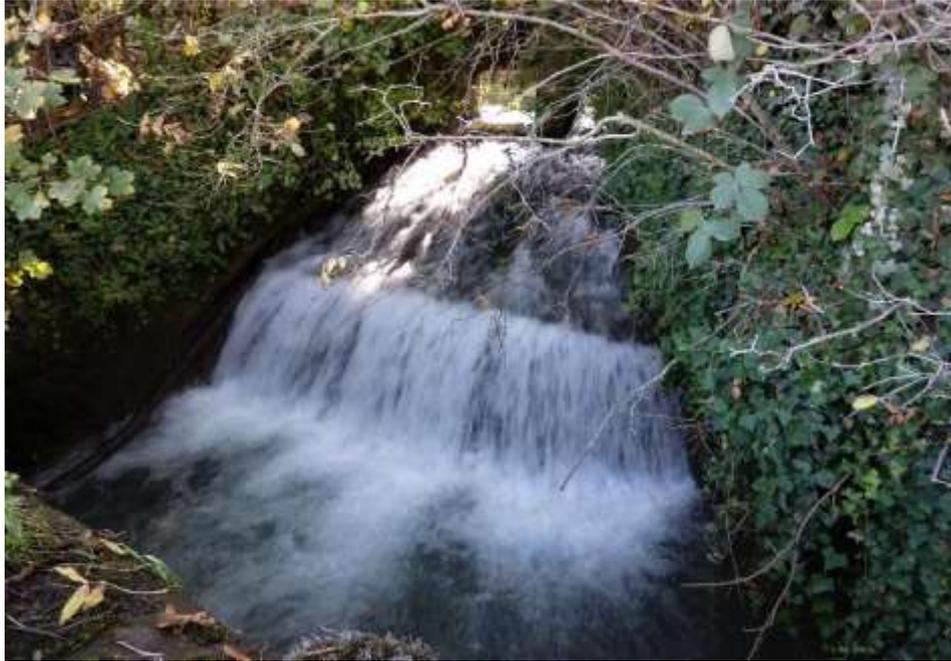
*Figure 10: An impassable stepped cascade at Burcott Mill*

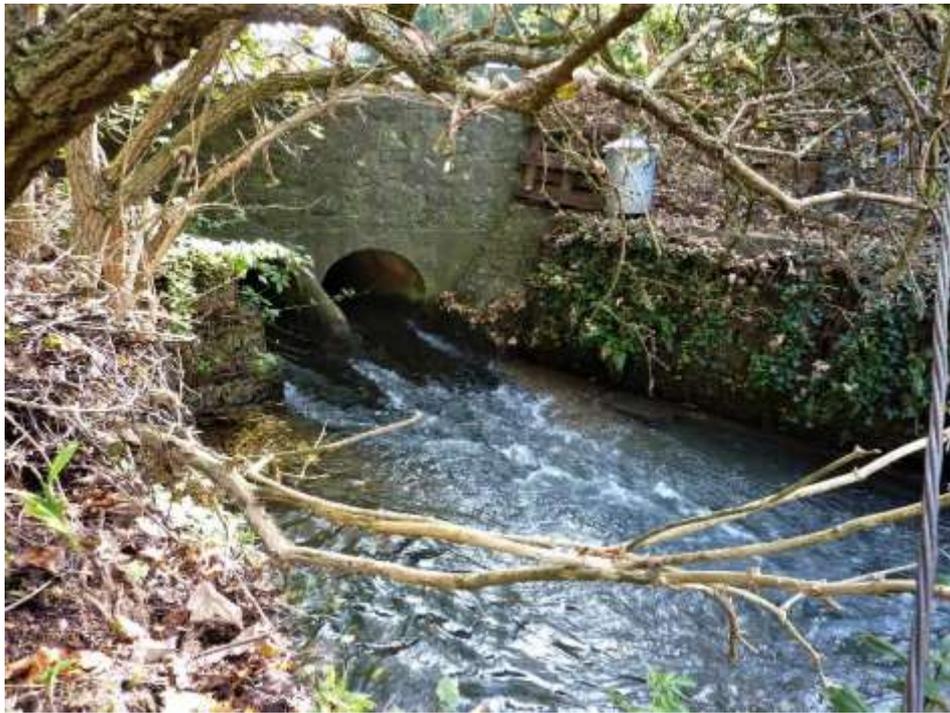
*Figure 11: Fluming of flow through the culvert under the B3139 Wells Road*

Flow from the mill pond overflow reappears from an ornamental stone double pipe culvert, and enters a pool whose banks are reinforced with stone gabion baskets, and a very low stilling weir at the tail. Perhaps related to intermittent activity at the mill, the flow from the culvert seemed to be highly variable, with water levels in the pool fluctuating by as much as 4 – 6 inches in just a few minutes. At times of low flow, several adult trout could be seen in the pool, clearly showing signs of panic when water levels dropped enough to remove the security of deeper water and a broken water surface. (Figure 11 above shows high flow, Figure 12 below shows low flow for comparison).

At either flow, the culvert pipes are a barrier to fish passage, and consideration should be given to replacing them with a single-span, partially sunken box culvert.

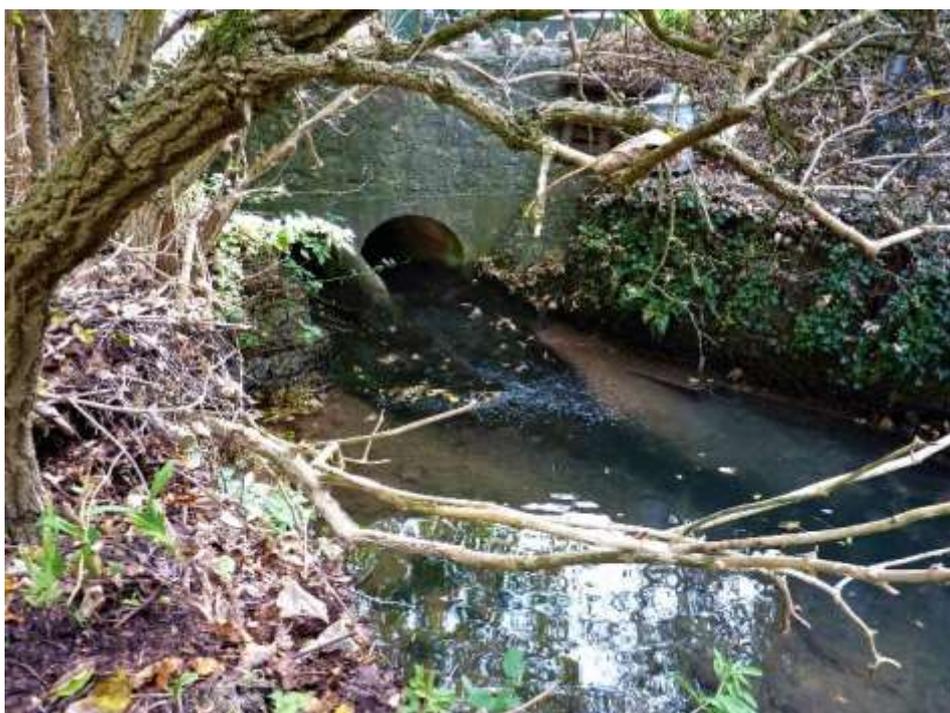
*Figure 12: Low flows from the same culvert*

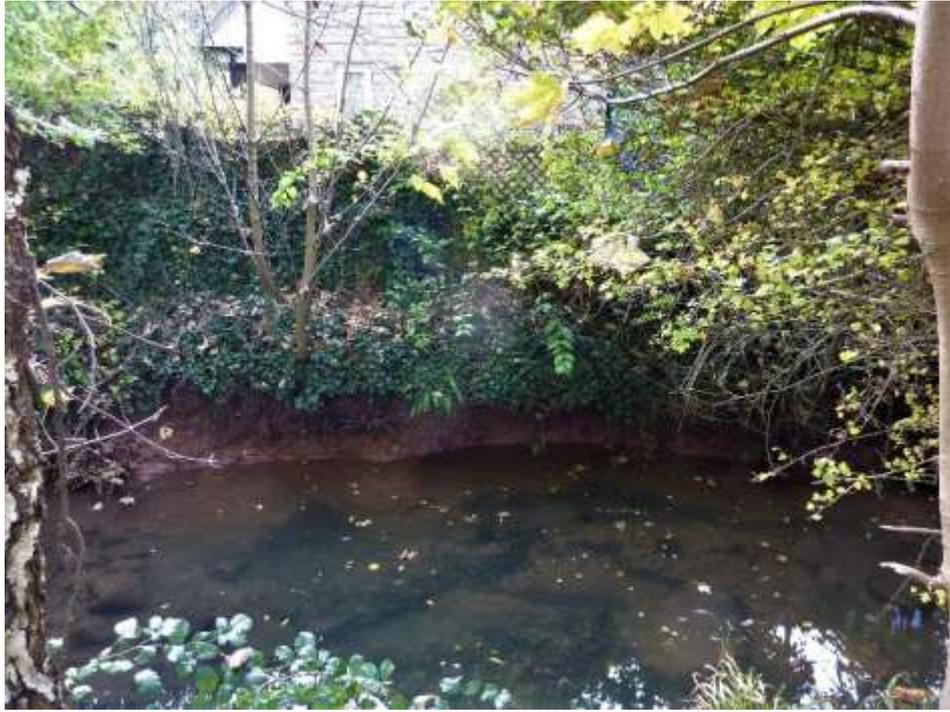
*Figure 13: A deeply scoured pool, with slight undercutting by erosion on the LB*

Downstream from the stilling weir, the mill stream has scoured another deeper pool, where trout were also observed. The LB is no longer reinforced with stone gabion baskets, so the energy of the stream has been released in this area, and some undercutting by a back eddy was noted, potentially starting to undermine the private garden above. (The properties on the LB, between the mill stream and the B3139, may in fact be built on a previous course of the mill stream, as shown in the 1884 map in Figure 2).

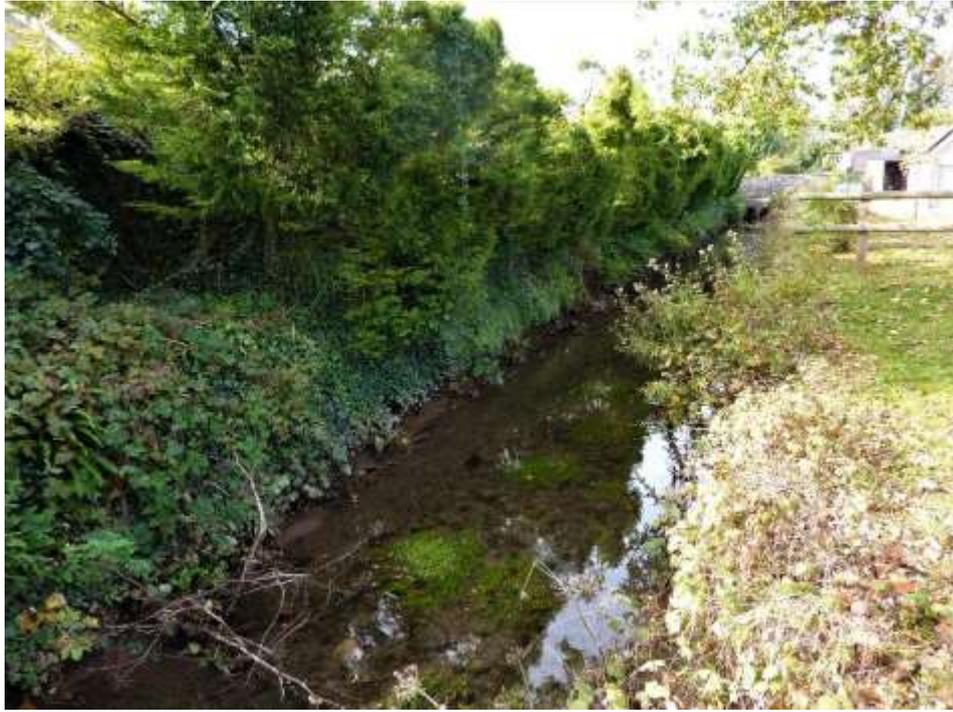
*Figure 14: Straight and shallow, this stretch of channel offers very little habitat value, but could be transformed through the addition of in-channel structure*

Proceeding downstream, the straight channel now becomes extremely shallow and featureless, with a flat bed of unsorted sediment and individual cobbles (possibly eroded and deposited from the deeper pools upstream), and overshading from a non-native conifer hedge on the LB. Some very small 'humps' of fine sediment seem to have formed around stands of starwort, but these are periodically exposed to the air as the water levels rise and fall. By contrast to the pools above, no fish were observed in this area.

Improvements to this stretch could include creating a sinuous inset low flow channel to focus available flows, with alternating flow deflectors to create and maintain deeper areas of scour and sediment sortation, and vegetated berms for 'shaggy', soft edges. Such measures would provide aesthetic benefits for local residents, as well as vastly improved habitat for insects, birds and fish (including trout at all life stages).

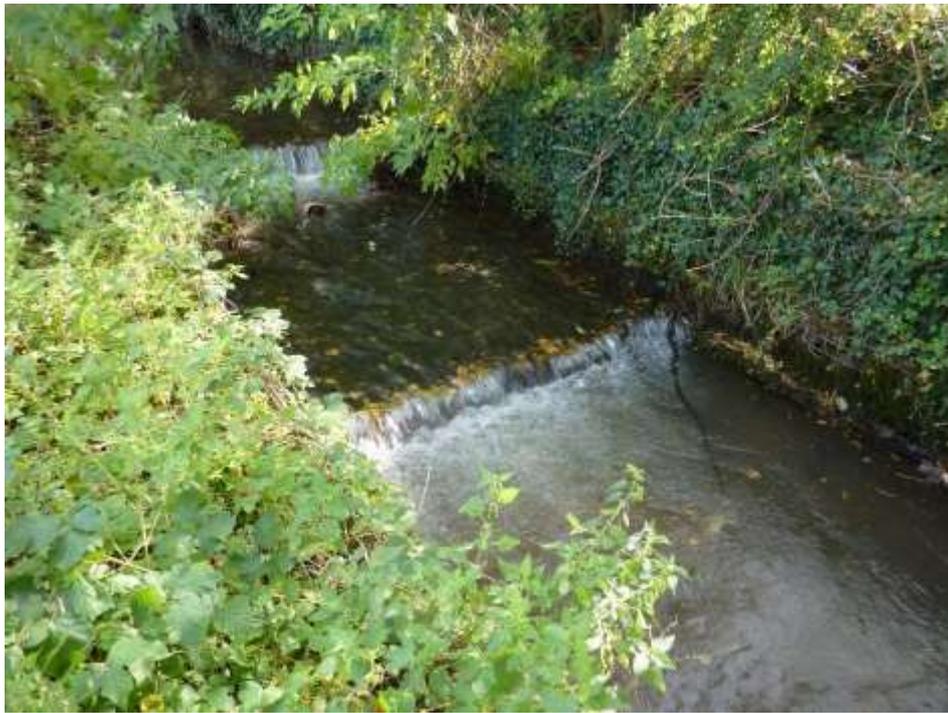
*Figure 15: A redundant stepped gabion weir in the former moat*

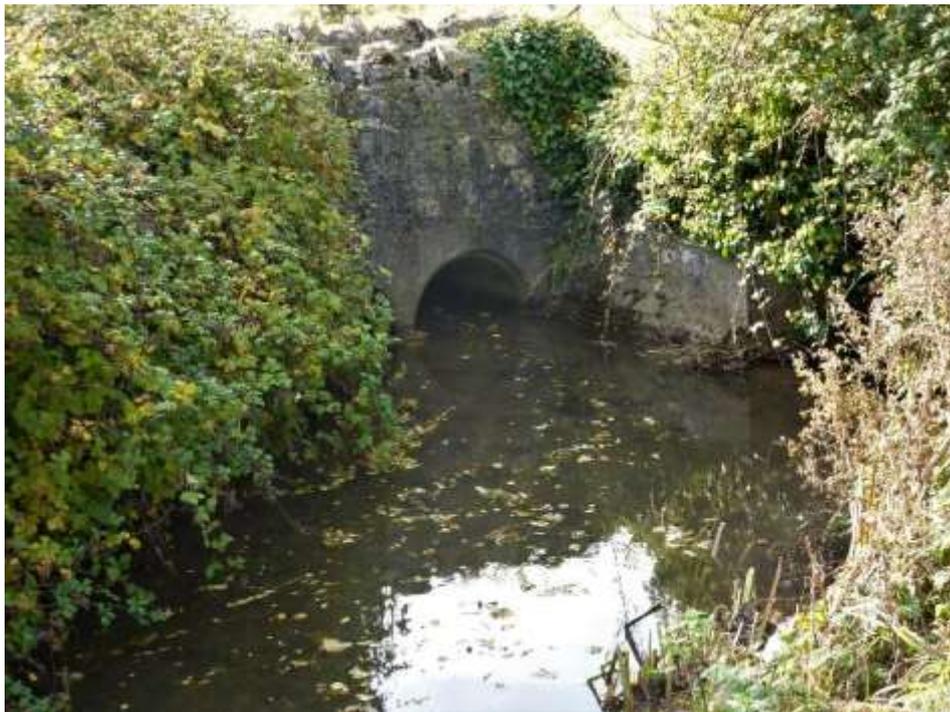
*Figure 16: A small impoundment at the western end of the former moat*

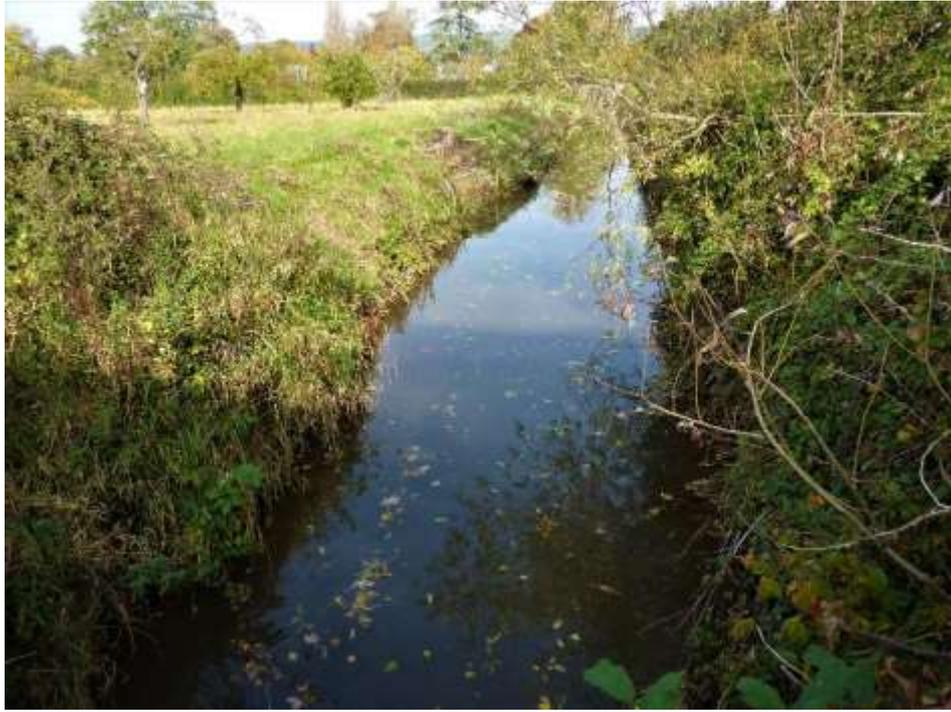
*Figure 17: Looking upstream from the B3139*

Habitat value in this stretch could be improved by adding LWM to increase roughness and add habitat complexity. Small trees could also be hinged down from the LB hedge. Instead of strimming down to the waterline on the RB, a more relaxed mowing regime would allow a beneficial 'shaggy', trailing marginal fringe to become established.

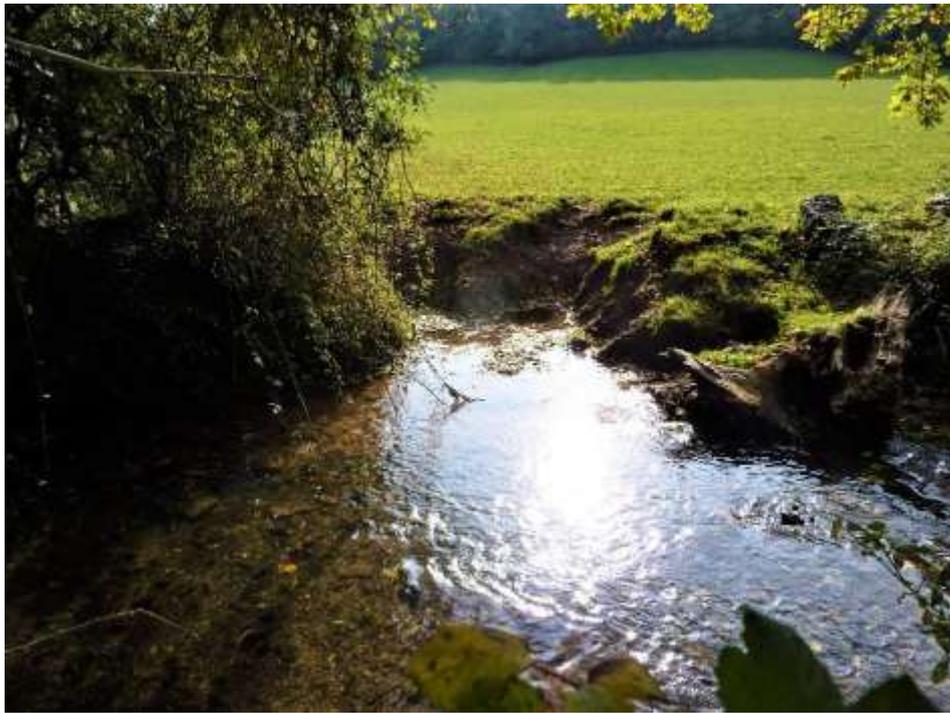
*Figure 18: A source of sediment as a result of poaching by livestock*
