Advisory Visit

Colne Brook, Iver, Buckinghamshire

August 2018

Undertaken by Rob Mungovan

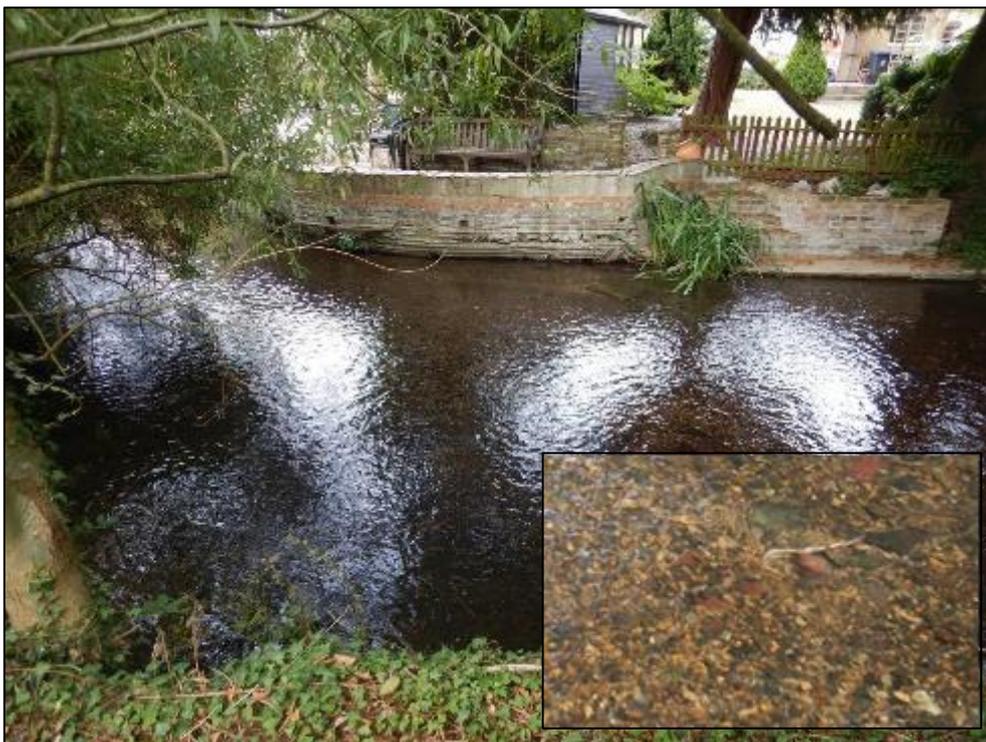
The visit commenced downstream of the Thorney Mill Road bridge. Here the channel was $\sim 5\text{m}$ wide with a gravel bed consisting of well-graded particles but the substrate was black suggesting that it had been stable and partially compacted for many years (pic 1). The gravel was relatively easy to dislodge by foot and contained a high sand component. The sand limits the value of the gravel as a spawning substrate for brown trout. However, for many coarse fish species the gravel is considered adequate.

The water depth varied from $\sim 0.05\text{m}$ to $\sim 0.2\text{m}$ and was characterised by a glide habitat. Water crowfoot was present but was limited in size due to shade. There was minimal habitat due to the shade and hard edge surfaces. Only one yellow flag iris was present together with a limited amount of trailing willow branches. The RB was a garden with a hard concrete edge providing access down to the river. The RB provided no habitat value to the river.

Pic 1 – The riverbed downstream of Thorney Mill Road bridge was dominated by coarse gravel which was partially compacted with little depth variation. The inset shows the gravel to be cleaner than it first appears.

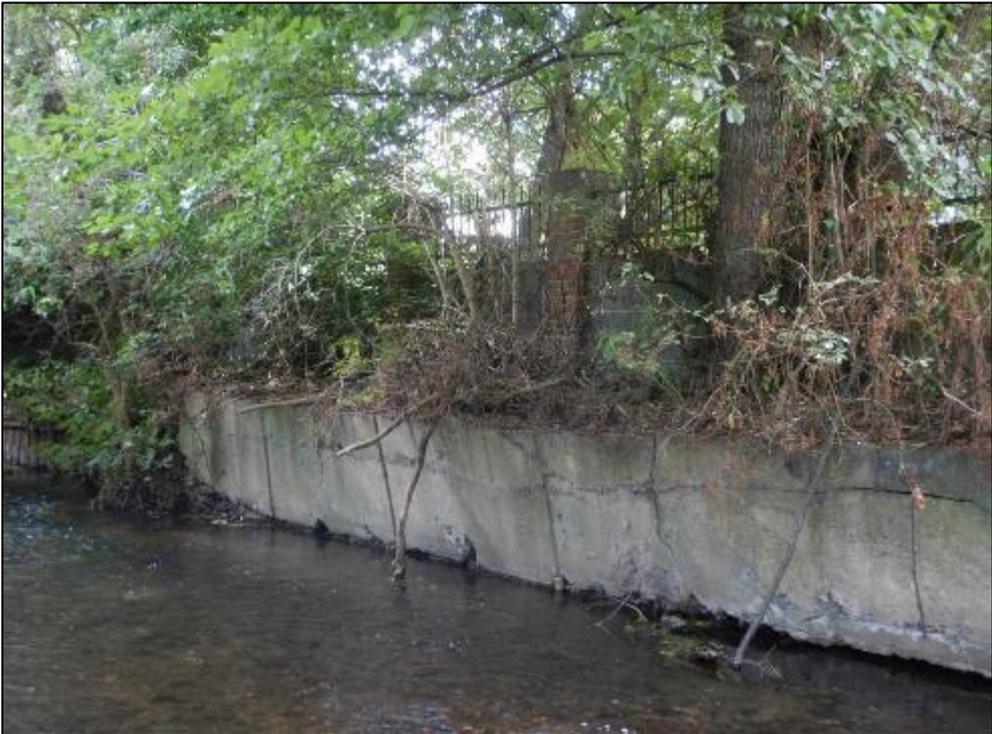
However, connection to the river is prevented by a high wall and railings (pics 2 & 3). The community green space would be greatly enhanced with a natural river frontage.

Pic 2 – The concrete retaining wall is left from the house that once stood behind the wall and railings.

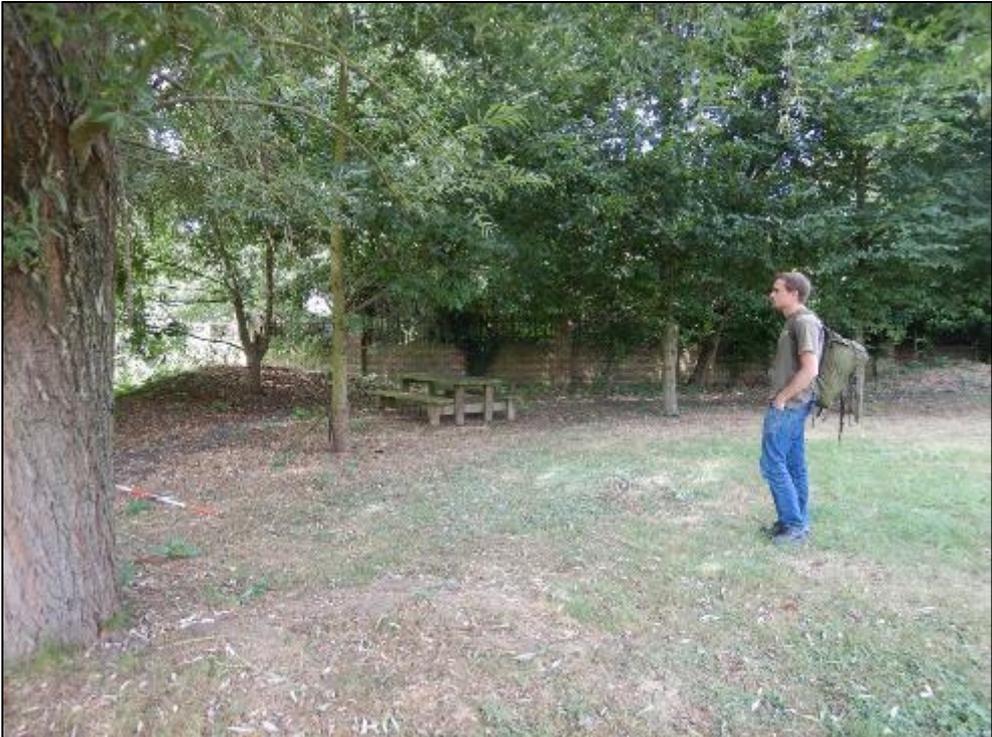
Pic 3 – The community green space could be enhanced if it had a visual connection to the river.

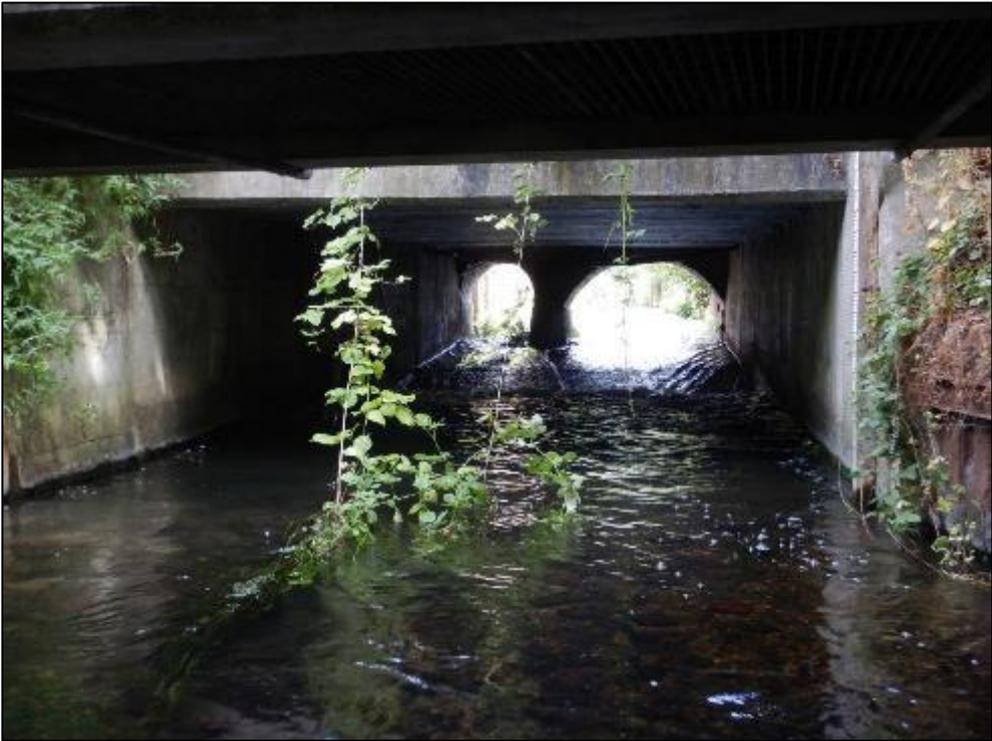
Moving upstream, the double culvert bridge that supports the Thorney Mill Road is encountered. The drop beneath the bridge is estimated to be $\sim 0.8\text{m}$ and results in water rapidly flowing down a smooth concrete flume for a length of $\sim 1.2\text{m}$ (pic 4). The resulting rapid shallow-water prevents most fish from swimming up and through the culverts (it may be possible for

adult trout to traverse the structure in higher flow conditions). Consequently the bridge is programmed to have a series of baffles attached to it to aid fish passage and natural recolonization of the Colne Brook.

Pic 4 – The double culvert and ramp arrangement that forms the Thorney Mill Road bridge.

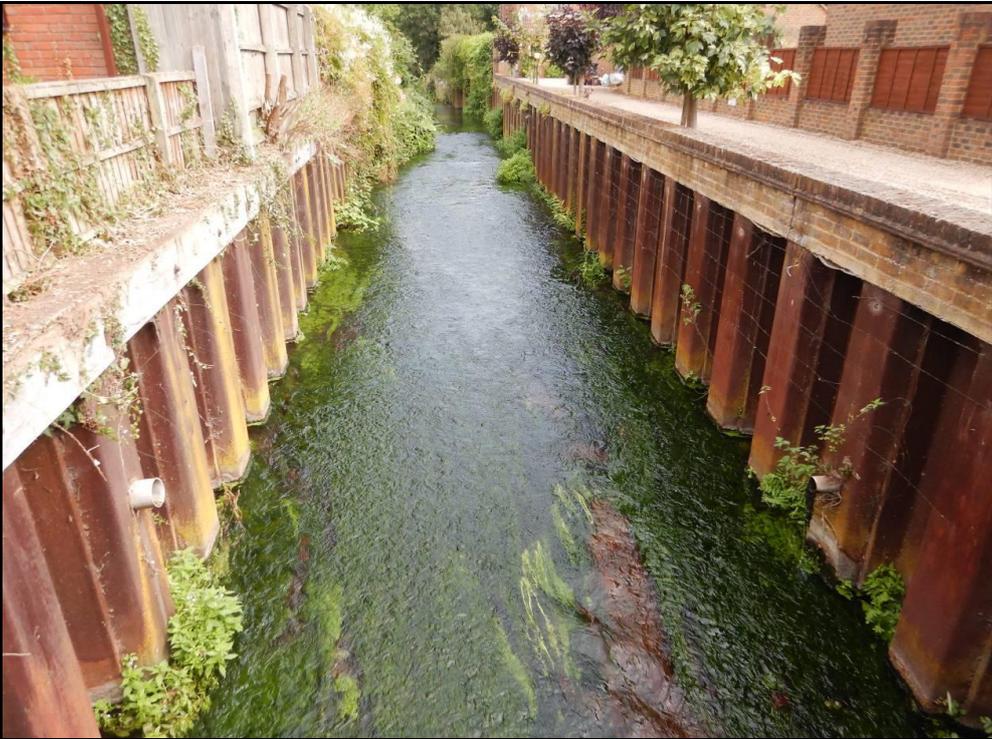
Pic 5 – The Colne Brook looking upstream from the Thorney Mill Road bridge. The sheet steel piling supports houses which are situated close to the top-of-bank.

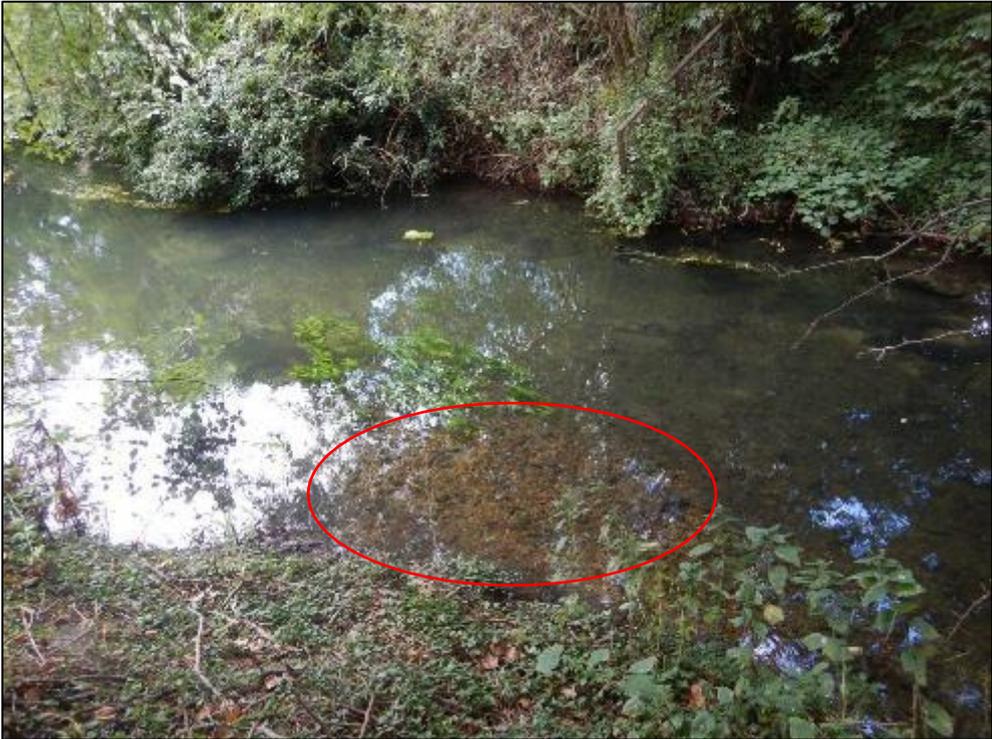
of occurrences where the bed was still raised with gravel present. It is believed that these discrete spots are in fact the original riverbed having been missed during past dredging (pic 6). These original bed occurrences could become important geomorphological features in planning river restoration as they provide spot levels for the riverbed pre-dredging.

Pic 6 – At a few locations a raised gravel bed was observed and is thought to be the remnants of the original river bed pre-dredging (red oval).

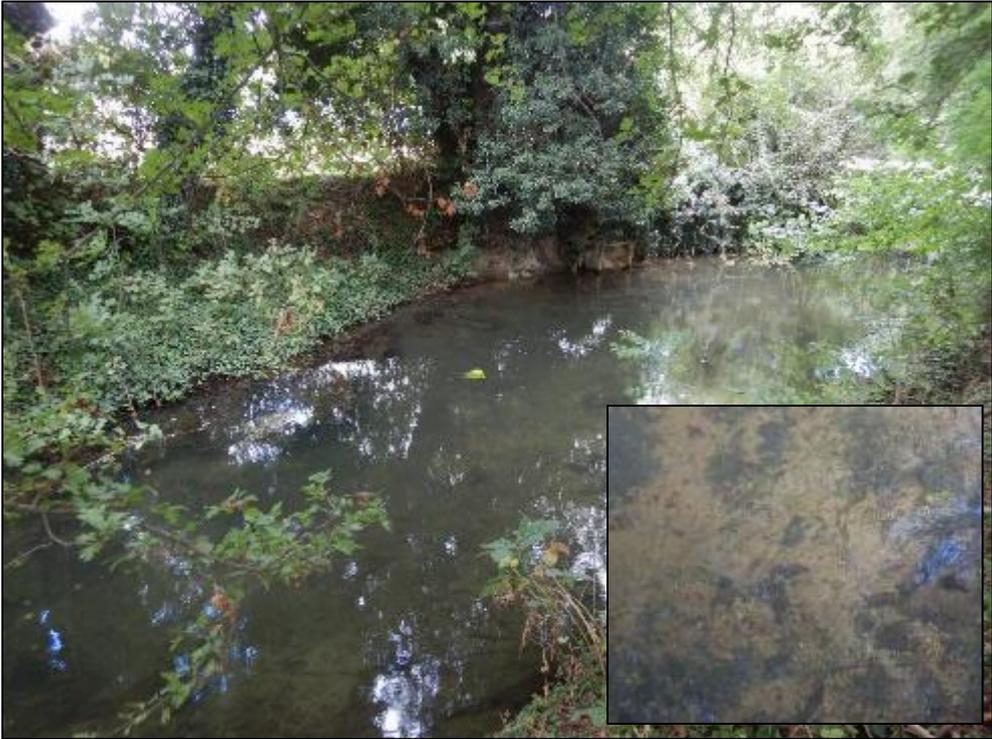
Pic 7 – Where the river has been deepened it is now dominated by fine sediments with the clay bed being revealed at some locations (inset).

Moving upstream into the golf course the bed is deeper with only minimal deposits of gravel. The gravel has certainly been removed through dredging and has not been replaced due to poor coarse sediment transfer. The bed is dominated by fine sediment with outcrops of clay and/or chalk (pic 7).

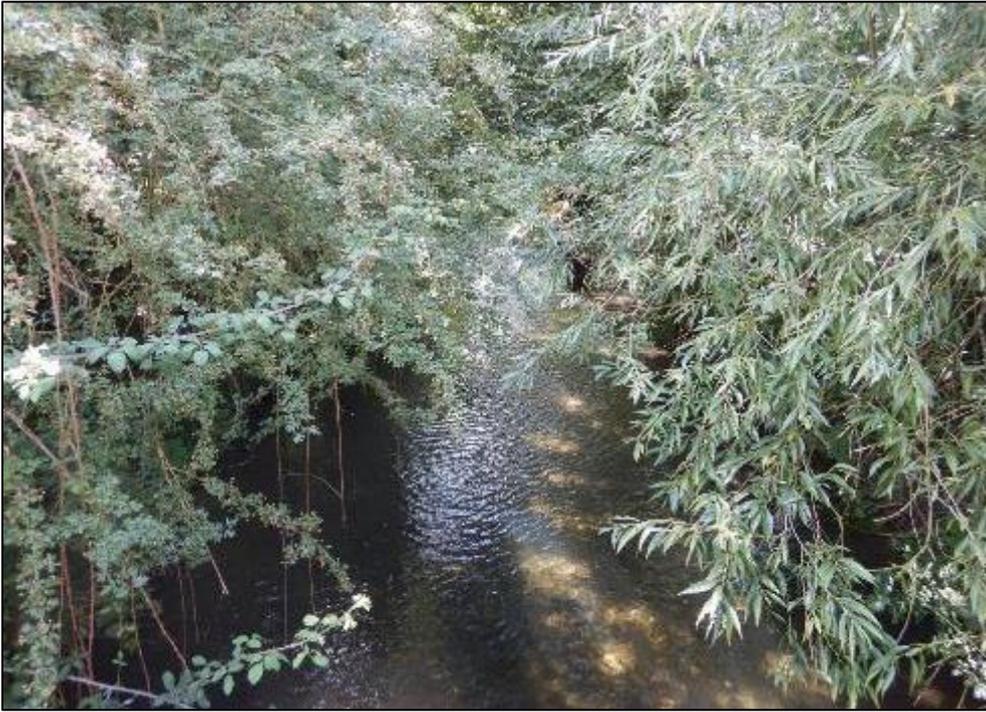
Once more the river became almost totally enclosed by tree canopy, providing an interesting contrast to the open reaches, and with trailing branches to water level (pic 8) represents potentially good brown trout habitat (closer inspection of depth and flow was not possible). Where the canopy is broken, dense aquatic vegetation of unbranched bur reed and yellow water lilies grew.

Pic 8 – The occurrence of trees trailing down to water level should be encouraged.

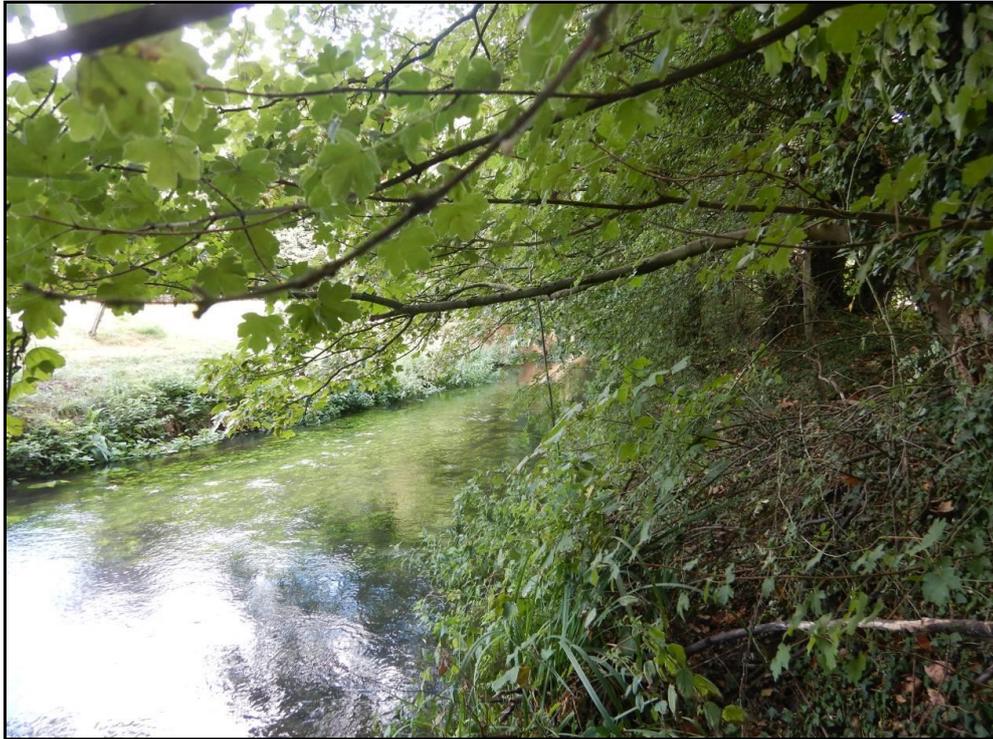
Pic 9 – Where access to the river could be gained through the dense tree and scrub cover there was an attractive swift flowing river but habitats for wild brown trout could be improved.

The river would benefit from habitat enhancement and management. For example, the tree cover was at a high level with few branches trailing down to water level. Trailing branches are particularly important as overhead cover for a wide range of fish, especially trout, creating micro-pocket water and increasing the number of lies within a river. The branches also present opportunities for invertebrates to fall into the channel where they become food for fish. Branches that extend into the water may provide a means for some aquatic invertebrates to return beneath the water in order to lay their eggs. As trees have matured and stabilised the banks at some locations their roots provide excellent cover for invertebrates and small fish, with elm and alder being particularly notable at this site.

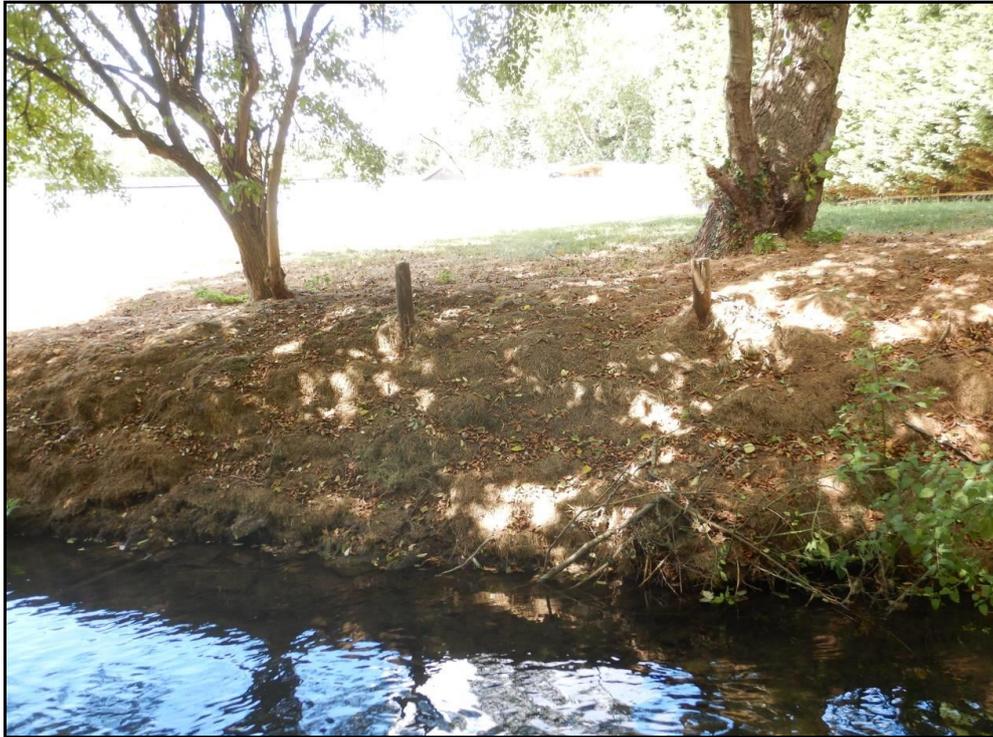
The management of the golf course requires extensive grass cutting. At one location the grass cuttings have been dumped on the bank-top resulting in their gradual fall to the river. The introduction of grass cuttings to the river is detrimental as it will add nutrients to the water. The grass dump should be moved away from the river.

Pic 10 – The dumping of waste grass cuttings presents a pollution threat to the river. The activity should be stopped and the waste removed from the edge of the river.

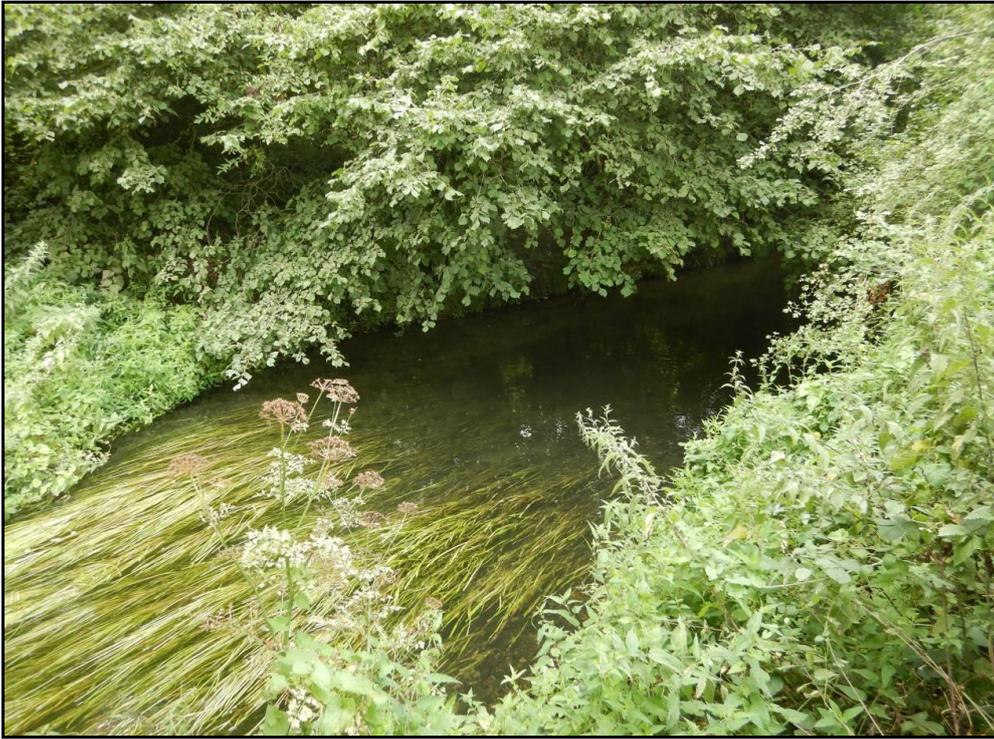
Pic 11 – Slower and deeper glides were becoming dominated by unbranched bur reed with the controlling influence of shade clearly visible.

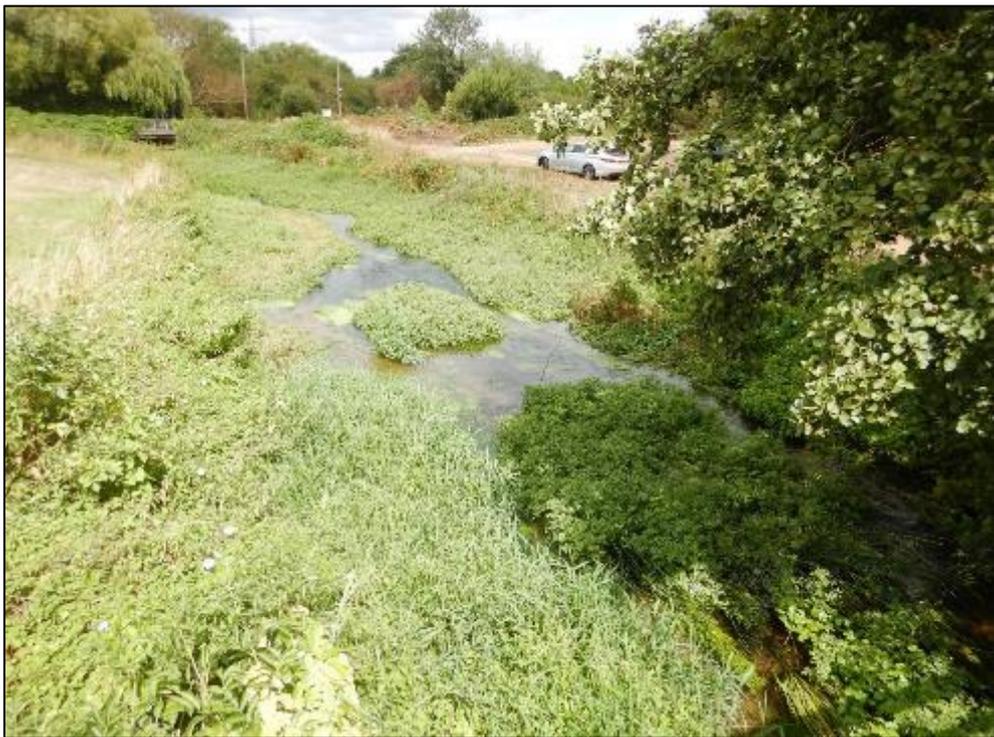
Pic 12 – The Colne Brook showing the chalk river form that is expected of it; low gently shelving margins, abundant marginal cover, a shallow depth with variation and diversity of vegetation growth.

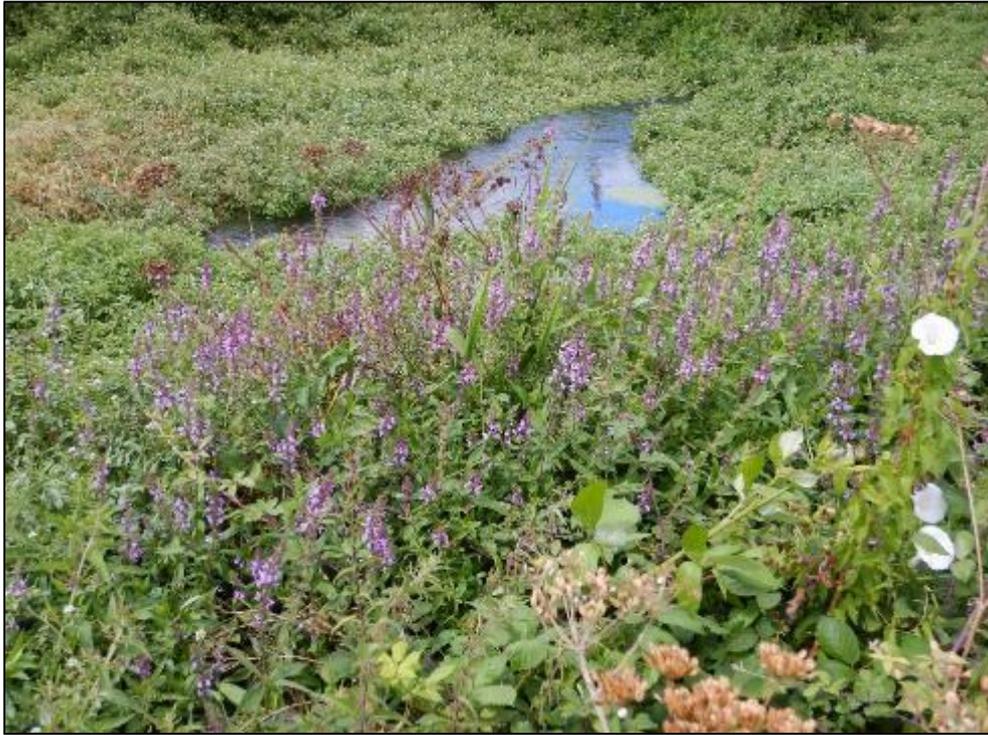
Pic 13 – A gentle transition from the top of bank to water allows a greater diversity of plants. This picture shows an attractive stand of marsh woundwort.

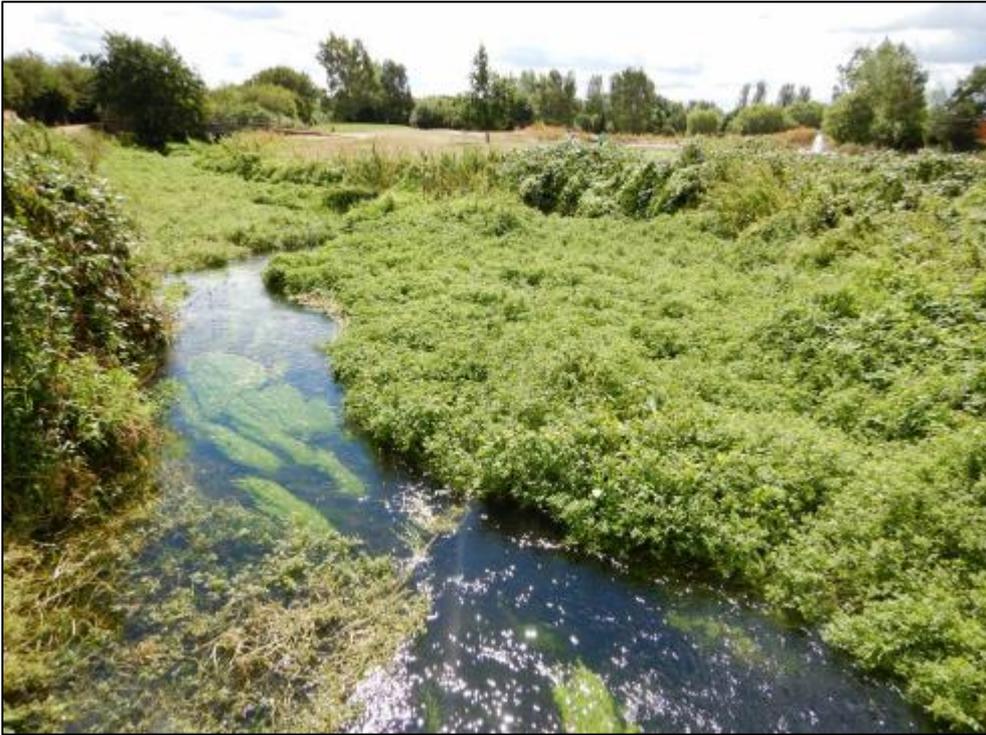
The shallow open reach is being naturally narrowed by its marginal vegetation (pic 14). In addition to providing extensive cover, the narrowing increases the water velocity which aids fine sediment transfer thus enabling a degree of self-cleansing as vegetation dies-back in the autumn and water velocity increases as the river level drops (following the flush-out of vegetation). The ability of chalk rivers to cleanse themselves of summer vegetation and fine sediment build-up is important if spawning substrate is to be revealed ahead of the winter spawning period.

Pic 14 – Watercress provides channel narrowing which in addition to increasing marginal cover cleanses the bed of fine sediment sustaining conditions for typical chalk rivers plants of starwort and water crowfoot.

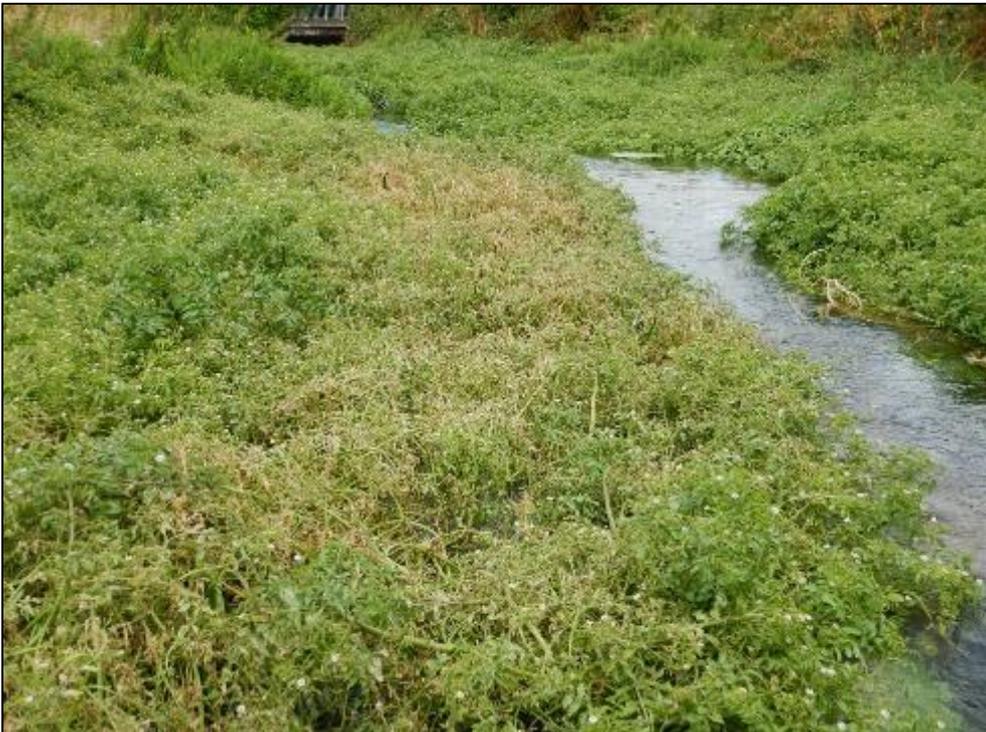
It was noted that the watercress was dying-back (note the brown colouration of plants (pic 15)). The cause is believed to be either the mustard or flea beetle which commonly feed upon watercress and other plants of the Cruciferae family. This occurrence has been seen before and is not considered a cause for alarm.

Pic 15 – Die back of watercress due to insect infestation.

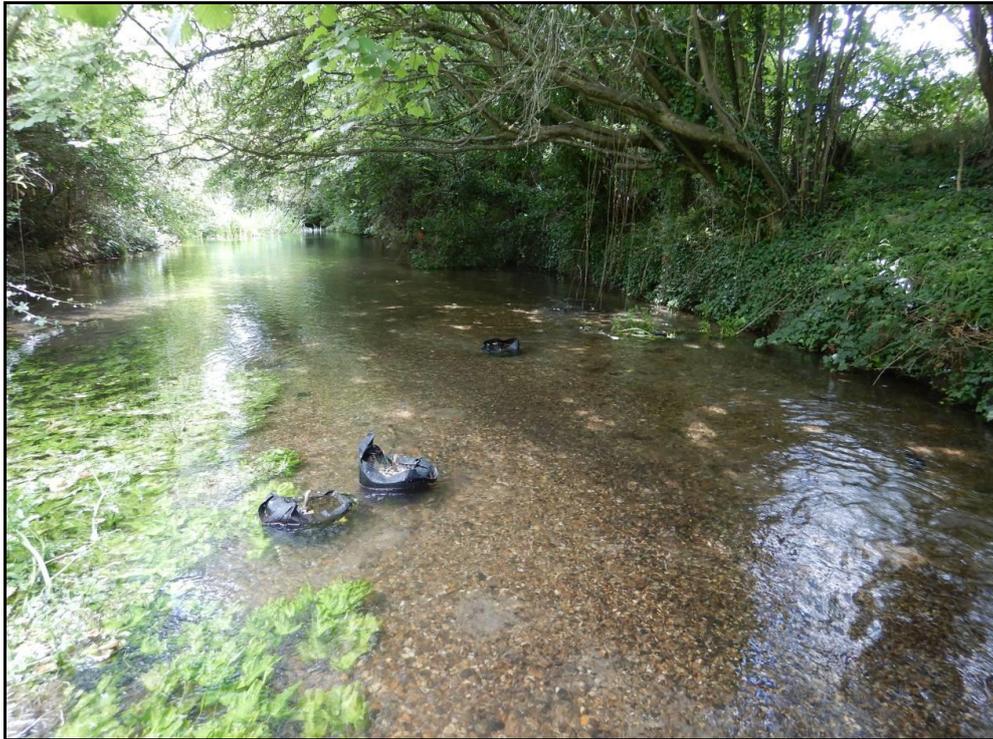
Pic 16 – Tree cover over shallow reaches suppresses the growth of both marginal and aquatic vegetation. The tree on the RB is suitable for hinging into the river.

Shaded shallow reaches were wide and exhibited little in the way of flow diversity or bed depth variation. Such areas would benefit from a reduction of shade in order to establish marginal vegetation which would initiate natural channel narrowing and flow diversity, similar to pic 12.

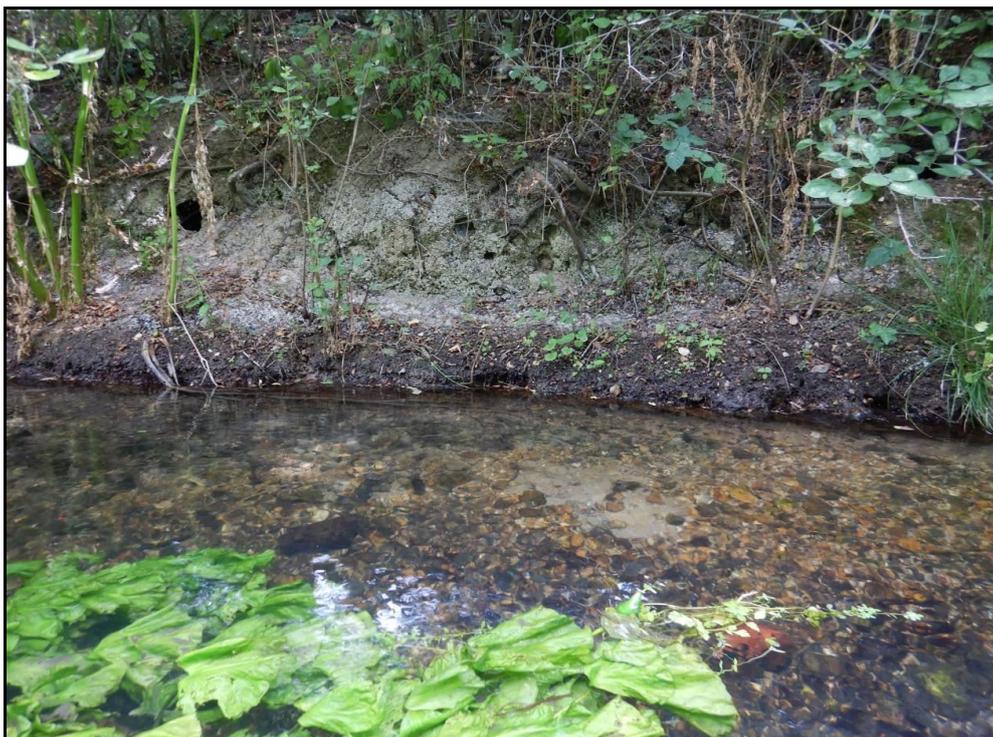
Pic 17 – The banks of some of the most densely shaded reaches were devoid of marginal growth. The banks were largely bare earth which is susceptible to erosion by rain and frost action resulting in the addition of fine sediment to the river.

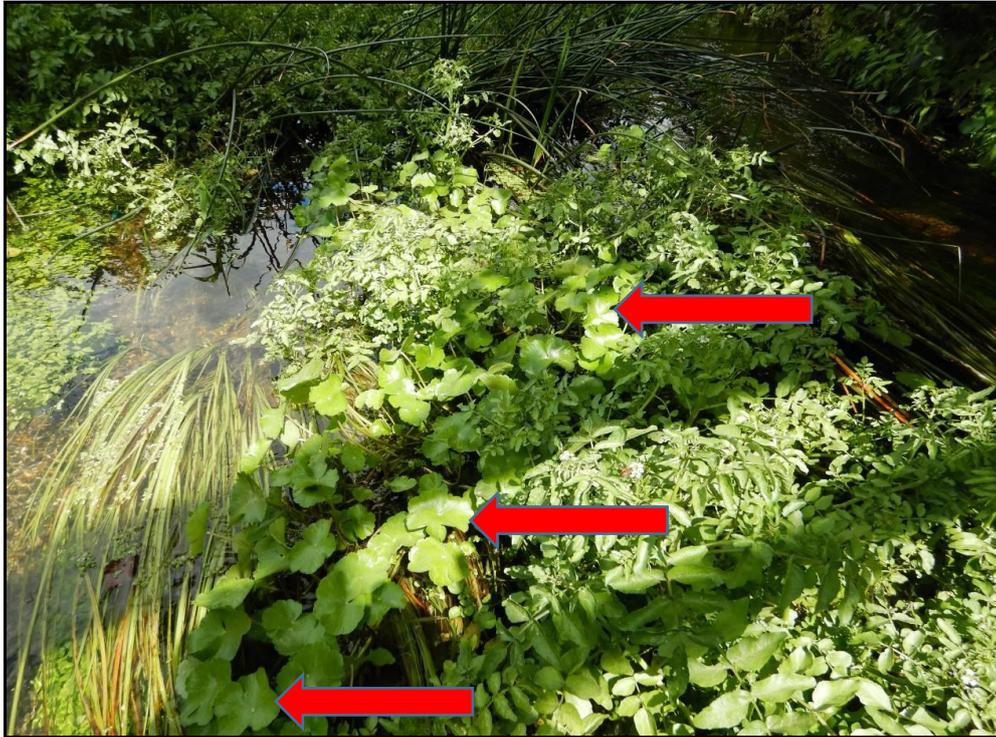
Pic 18 – Floating penny wort (red arrows) an invasive non-native species is growing amongst the native flora of the river.

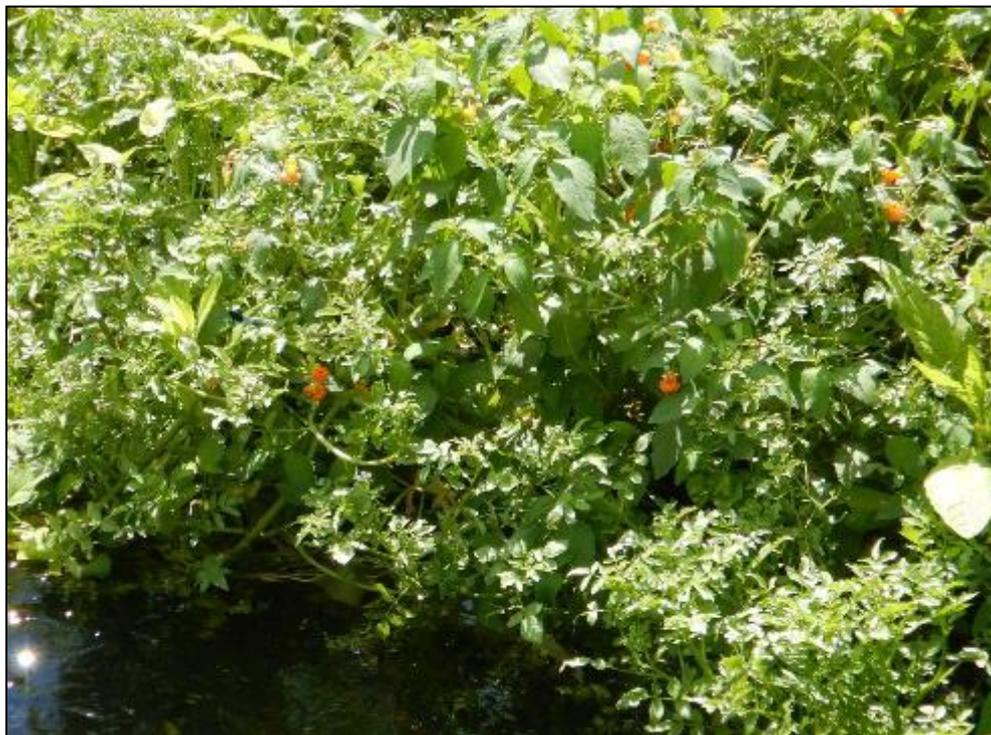
Pic 19 – Orange balsam (*Impatiens capensis*), an invasive non-native species, was present throughout much of the open reaches.

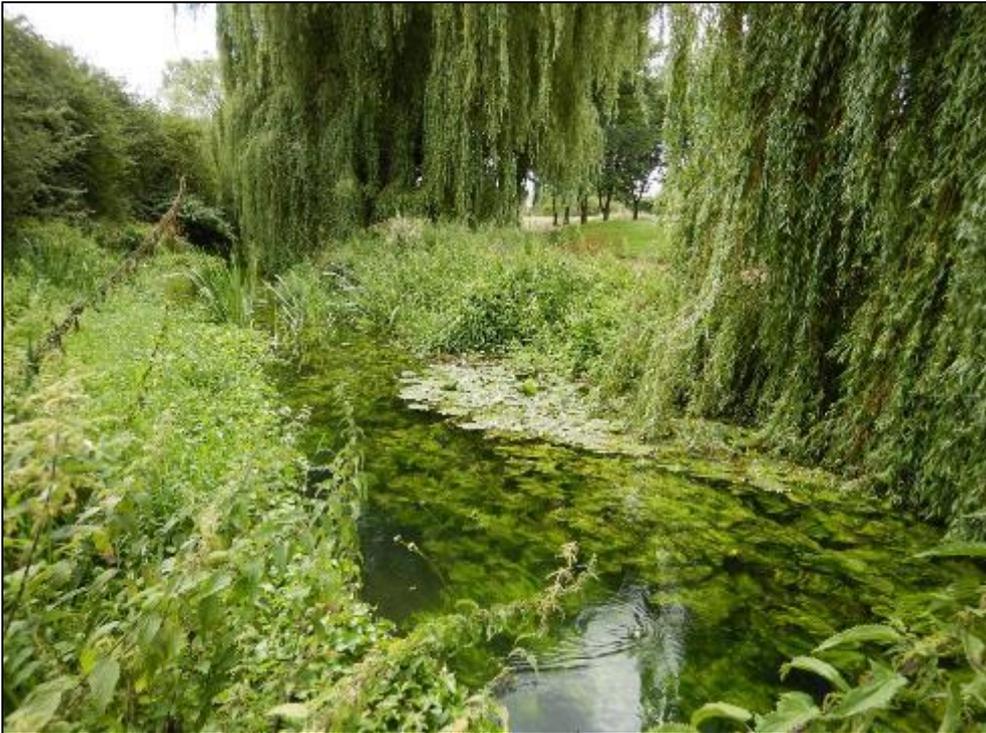
The upper most reach of the golf course has been deepened by dredging to a depth of $\sim 1.2\text{m}$ and is consequently invaded by yellow water lilies and

branched bur reed which grow in silt conditions with little bed scour to prevent their dominance (pic 20).

Pic 20 – The river has again been deepened through dredging. Note the dominance of yellow water lily.

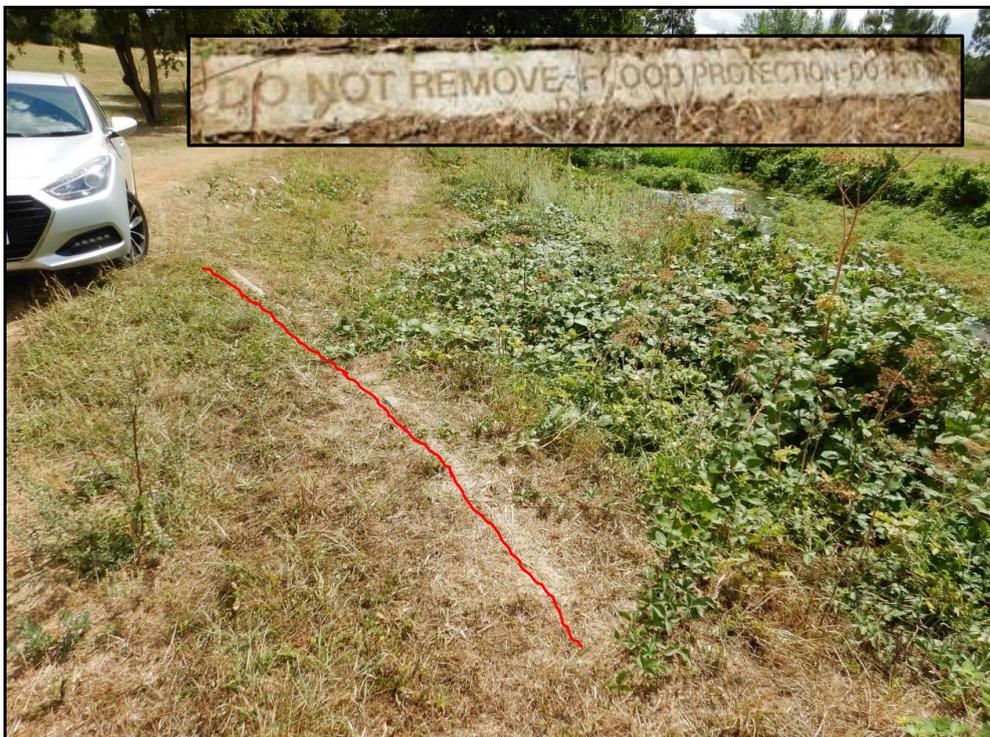
At the upper most extent of the golf course a raised marker line was noted in the ground reading “Do not remove - flood protection”. Prior to any work that may increase flood risk the gravity of this warning must be understood.

Pic 21 – Flood protection warning sign in the ground (red line).

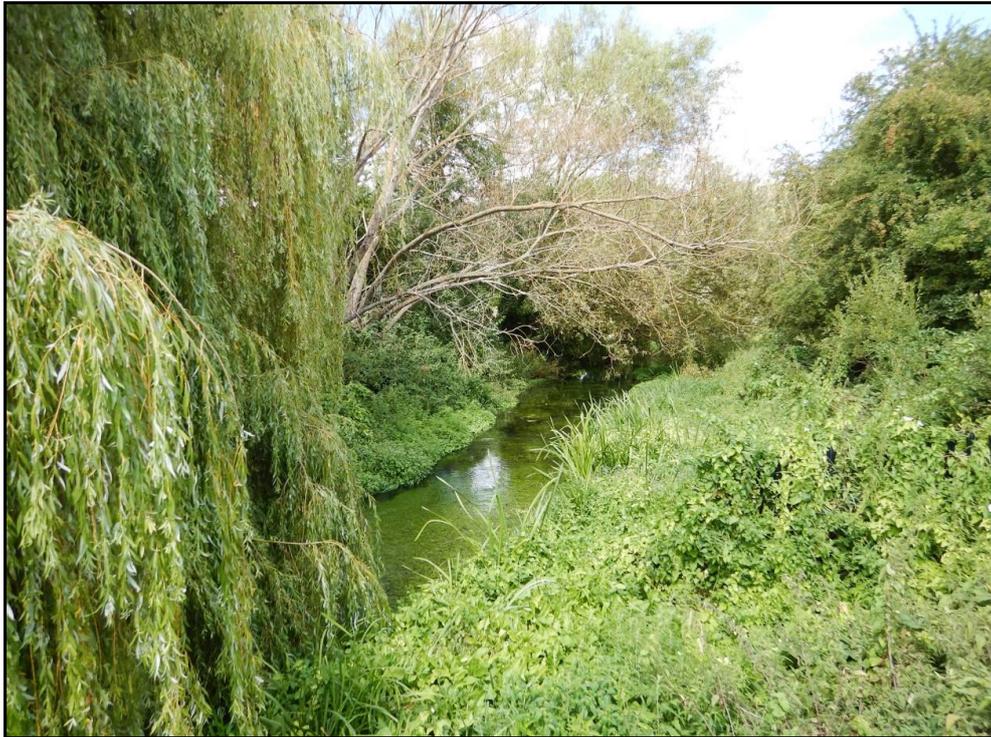
On the approach to the WWTW a number of dead and dying willows were observed (pic 22). It is believed that these trees are dying as a result of

honey fungus and no action is recommended. These trees will become a future source of LWM.

Pic 22 – A willow tree (one of many) believed to have honey fungus.

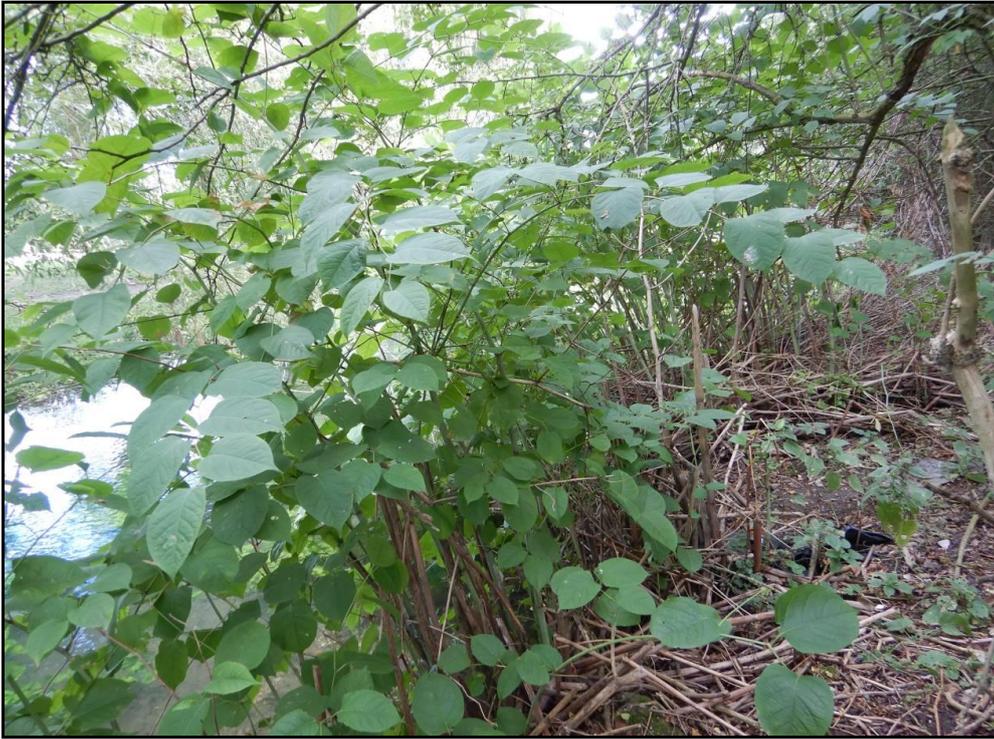
Japanese knotweed was observed at two locations. The largest stand was immediately adjacent to the river and was being prevented from spreading by the dense shade cast by hawthorn trees (pic 23). As an invasive non-native species, Japanese knotweed presents a serious risk to the Colne Brook. The plant is spread by root propagules and is very adept at colonising riverbanks. Once present, its tall growth enables it to outcompete many native plants. The knotweed then establishes monocultures further reducing low-growing species, such as grasses, which are crucially important for binding the soil. Furthermore, knotweed dies back in the winter leaving riverbanks almost completely devoid of vegetation and prone to erosion by rain and scour. It is prudent to undertake control of knotweed when it is in low numbers before it becomes a problem.

Pic 23 – Japanese knotweed, an invasive non-native species, growing on top of the riverbank.

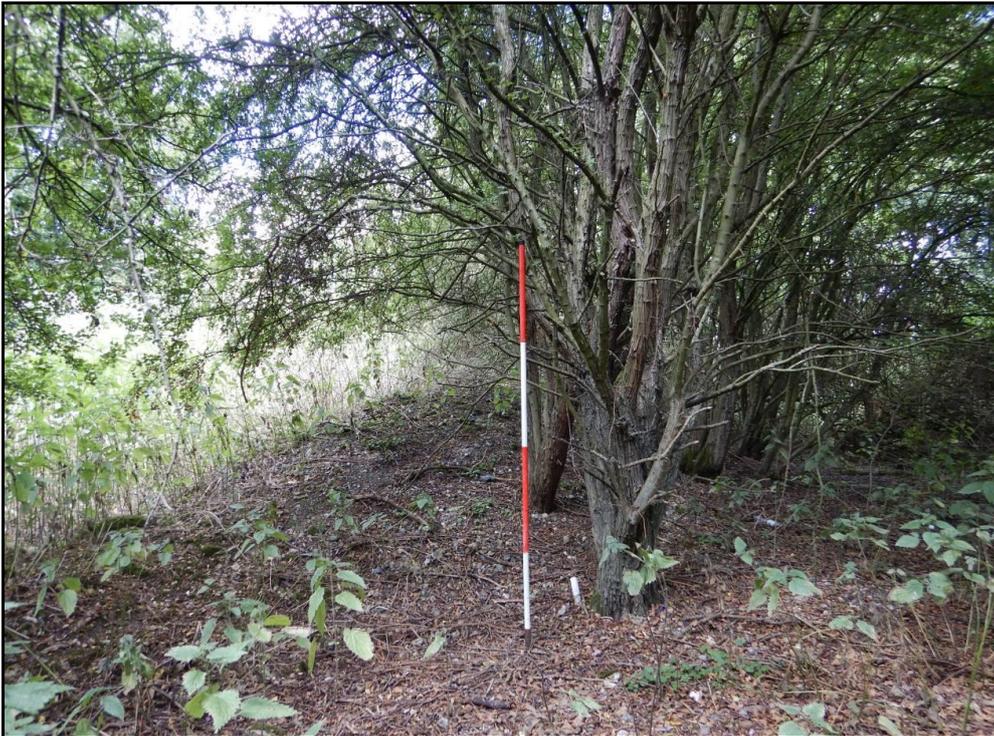
Upstream of the golf course within the wooded area, a large mound of spoil was found (pic 24). The spoil is believed to be former river dredgings. If the dredgings consist of a high proportion of coarse sediment it may be possible to re-use it for riverbed restoration.

Pic 24 – A spoil pile from historic river dredging.

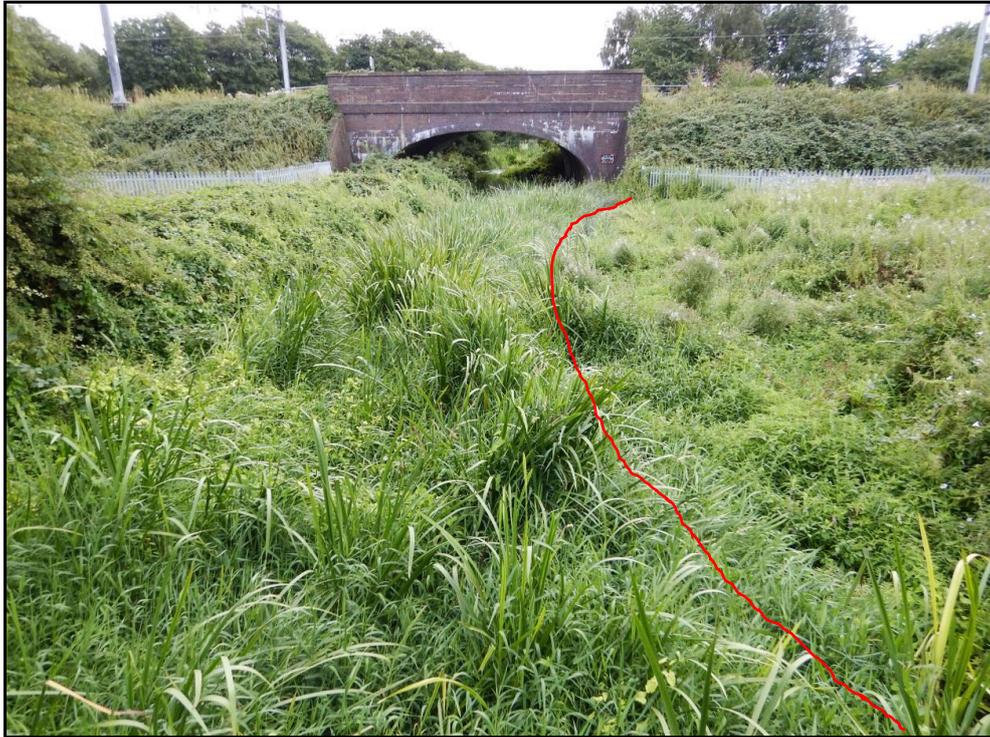
Downstream of the Iver North WWTW the channel is entirely choked with vegetation and very little open water is present. The dense vegetation and tall banks prevent access to investigate bed depths and bank form. However, there does appear to be a slight vegetated berm extending out from the RB (pic 25, see red line). This reach could be further investigated once the vegetation has died back.

Pic 25 – The choked river downstream of the Iver North WWTW.

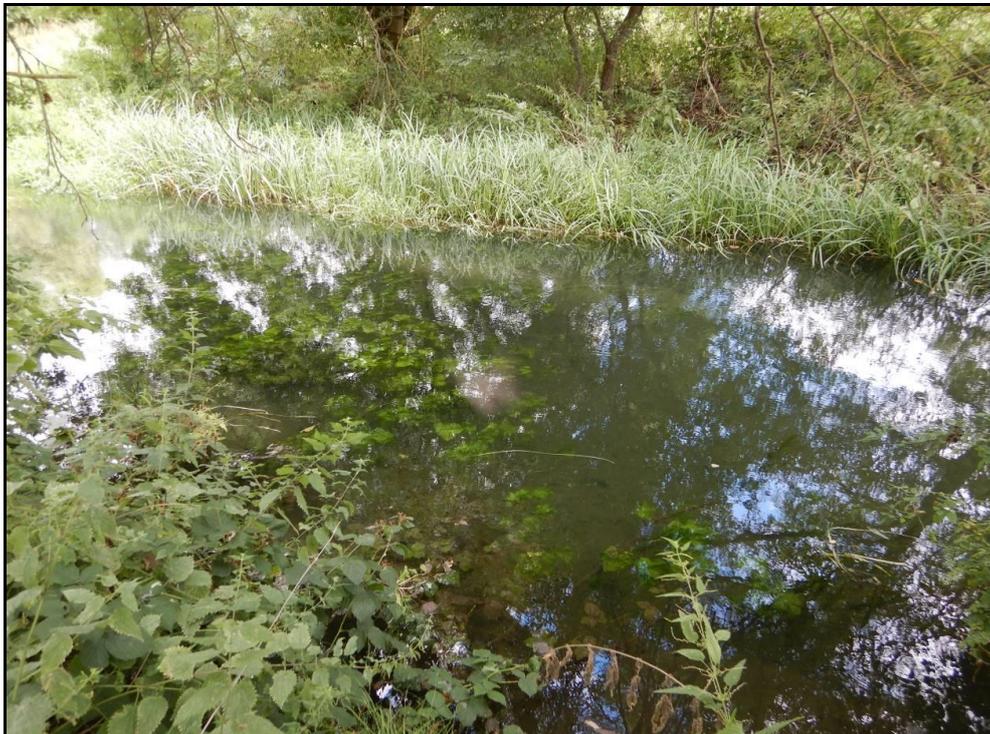
At the end of the reach visited the channel is again over-shaded which suppresses vegetation growth. The outfall from the WWTW was found and gave no cause for concern.

Pic 26 – This picture was taken in a shaded reach immediately above pic 25. Without further investigation it is assumed that the reach below the bridge has a similar bed depth (i.e. is over-deep).

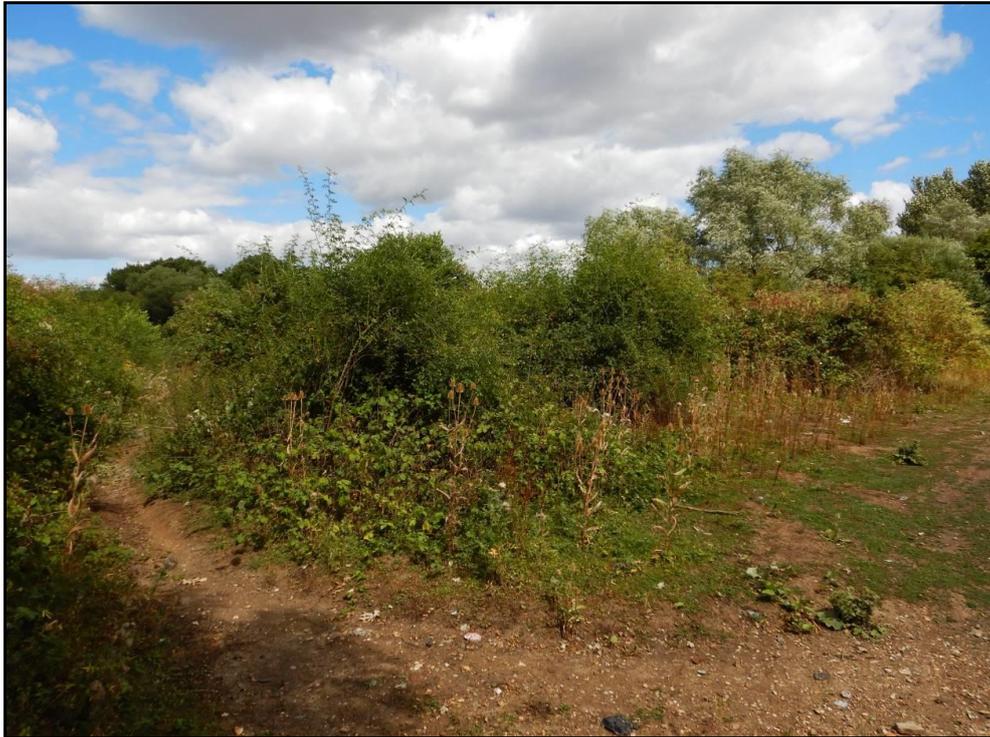
Pic 27 – The land opposite the Iver North WWTW is scrub land, a much undervalued habitat particularly on the edge of urban areas.
