Advisory Visit

Colne Brook, Iver, Buckinghamshire

August 2018

Undertaken by Rob Mungovan

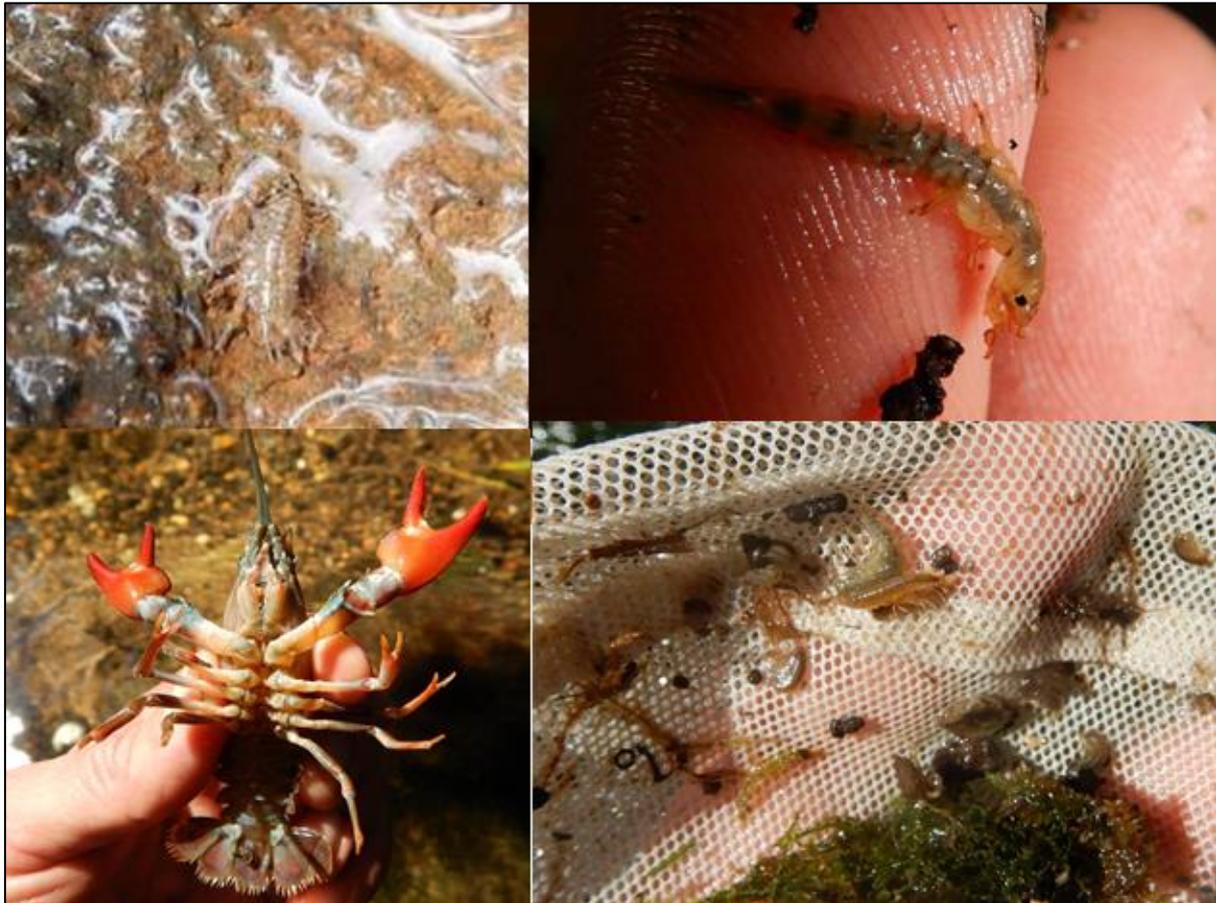
sample contained many more *Gammarus* (100+) which were abundant amongst the organic matter collected at the base of aquatic plants. A greater number of *Agapetus* were caught as well as flatworms and a live river limpet (in addition to empty shells). The overall impression was that this location had more invertebrates but that the range of families represented was still restricted (pic 28).

Pic 28 – Invertebrate sampling revealed a suspected impoverished fauna. Clockwise from top left; Hoglouse – tolerant of poor water quality and found where one would have expected *Gammarus*. Mayfly larvae (*E. danica*) – generally seen as a good water quality indicator, low numbers observed. Signal crayfish – an invasive non-native species which is known to reduce invertebrate numbers and richness, generally considered very disruptive to aquatic ecosystems once present in large numbers. *Gammarus* (freshwater shrimp) – were found in good numbers in rapid water amongst plant matter.
