WILD TROUT TRUST
wildtrout.org

Advisory Visit
River Erme, Devon
October 11, 2021

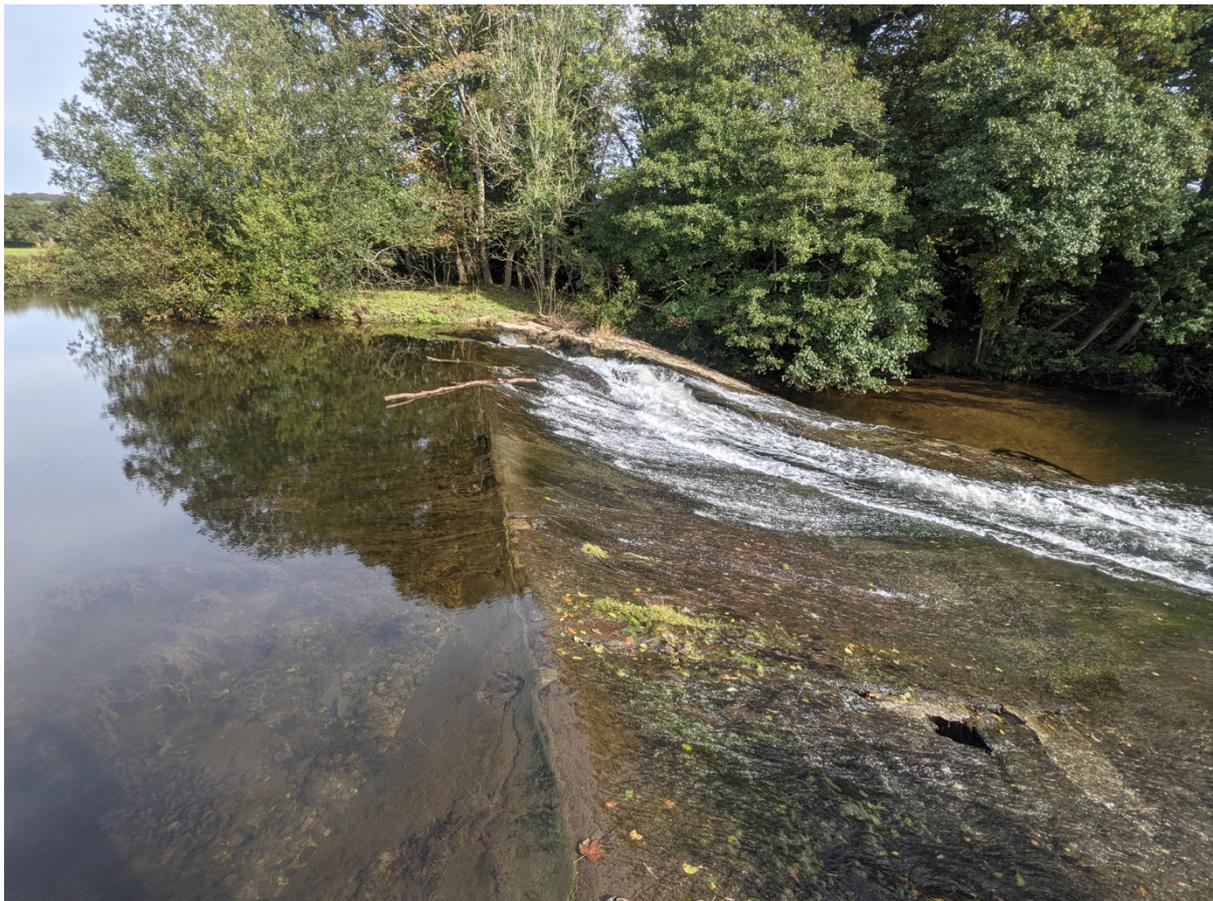
Figure 1 Head weir viewed from the RB. The face of the weir is degrading and will only worsen over time.

At SX 63057 51583, Head Weir is an old Crump weir standing approximately 3.5 metres high (Figure 1), unnaturally forming the u/s limit of the tide. This has stood for centuries and likely provided a navigable water upstream to Sequers (sackers) Bridge. Barges were able to dock and unload on a side channel to the east of Head Weir at high tide, transferring their load to be taken upstream.

The face of the weir is also degrading, with a significant hole visible near the RB. This will snare high flows, increasing forces acting upon it, leading to further deterioration of the structure. Considering the ecological impediment to the river, it is suggested that the detrimental impact of the weir is given serious consideration, and options to redress the issue are implemented.

- Investigations should be made to remove or bypass Head Weir for the benefit of geomorphological processes and downstream migration of salmonids. There will be a significant increase of upstream migration too.

- a. Failed hinges (alder is inconsistent at holding its hinge) can be secured with cable or even lodged.
 - i. See appendix.
4. Weir removal or bypass: The river is attempting to find its way past the Weir on the RB. Allowing this erosion will eventually breach, giving back an unconstrained path to the sea, retaining the weir structure and any heritage value it may have. A more expensive but immediate solution would be to remove the weir but investigations as to the effect of lowered water levels and river bed regrading of the reach below the bridge would be needed.

- a. The cheapest and safest solution would be a gradual approach, either staged reduction (with total removal the ultimate goal) or gradual degradation and bypass.

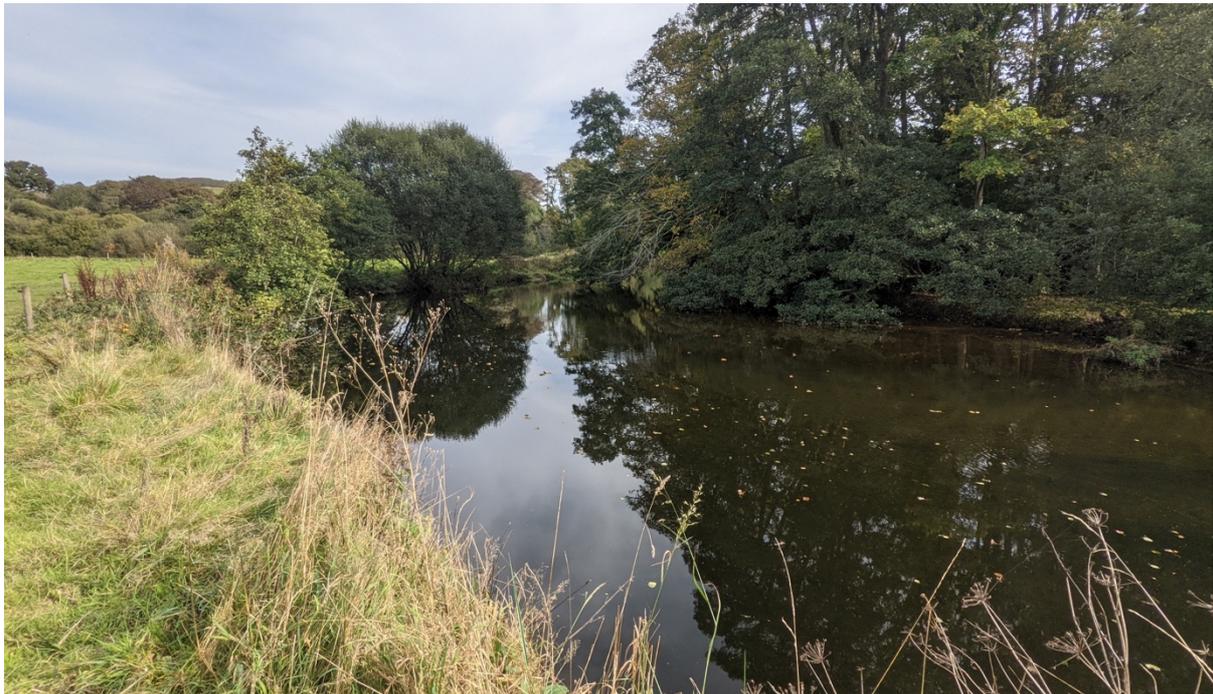
Figure 2 The large pool above the weir showed relatively good habitat considering the impounding effects of the weir but is still far from its potential. Unconstrained flow is the ultimate aim for a river and weir removal, bypass or lowering, would improve the reach considerably. SX 63052 51610

Moving upstream a large deep pool (Figure 2) created by the impoundment sat within a sharp meander. The extra flow energies around the outside (RB) have

created some channel diversity with a variety of structure and gravel sizes. Again, this would have far greater habitat value without the impoundment of the weir and would likely be poorer habitat during periods of low flow, rather than following a spate as witnessed.

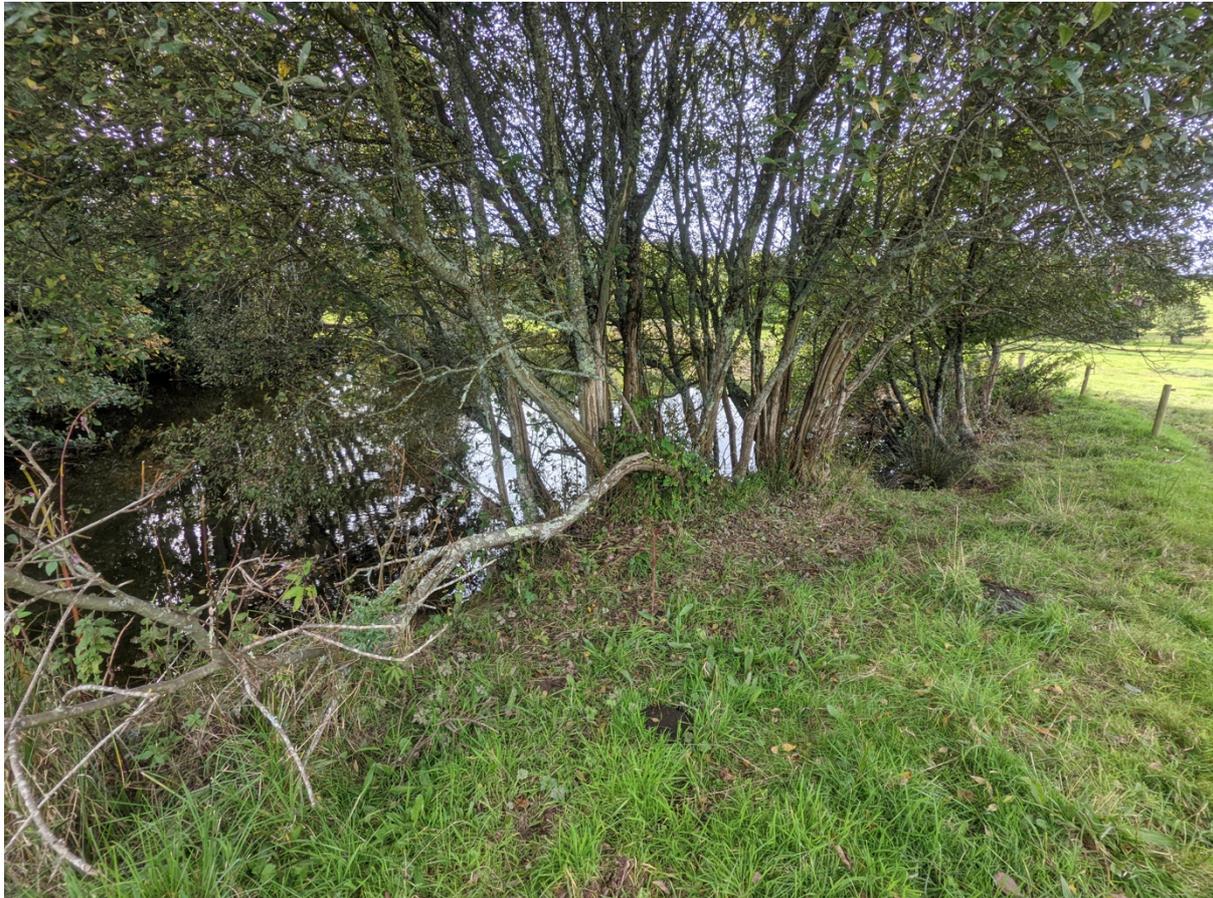
Figure 3 A stand of alder coppice on the RB. Removing will only increase erosion on an already vulnerable bank. Laying some smaller stems (or felling and securing, as alder is inconsistent as a hinged tree) along the bank in a downstream direction, maintaining a number of single 'standards' will bring shade, roughness, refuge and bank protection while creating greater casting room for anglers. SX 63085 51638

A conversation was had about removing a stand of alder (Figure 3) to improve casting room. This would further reduce the minimal vegetation and increase bank erosion as a result.

A compromise would be to hinge (or fell and secure) some, but not all, of the coppice growth along the bank in a downstream direction. The single trees left will grow up, more akin to a standard, and the lain trees will create channel roughness, high flow refuge for fish and improved bank stability. See appendix.

2. Scrape through the bund to allow access to the woodland paleochannel in moderate flows. This will begin to re-sculpt the old channel.
3. Hinging (or fell and secure) alder in a downstream direction along the bank, leaving a few large stems to grow on into 'standards'.

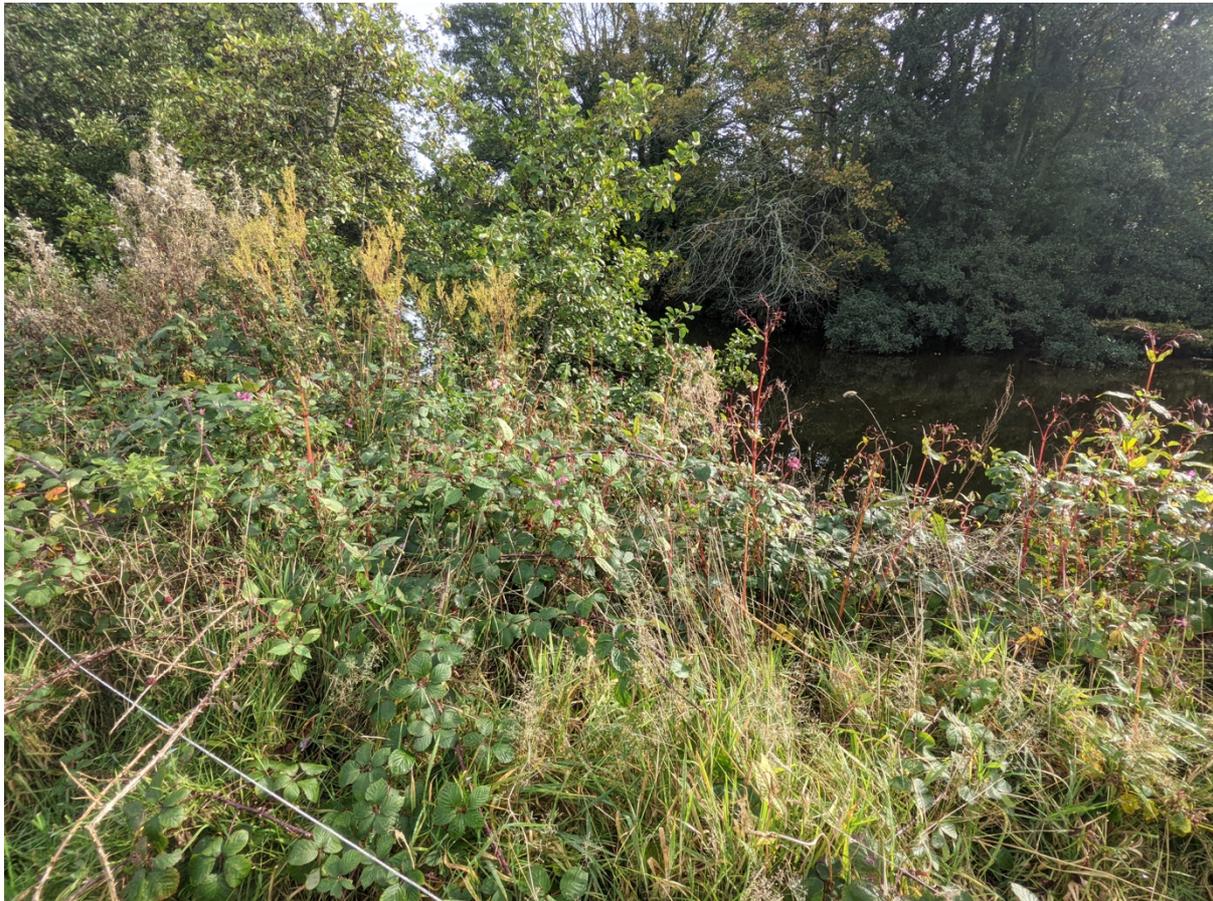
Some stands of Himalayan balsam (Figure 4) were growing. As an invasive plant, it out-competes native vegetation, leaving bare soils when it dies back in the autumn, making the banks even more susceptible to erosion. Though a catchment wide program of eradication is the best ultimate course of action, starting at the upstream limit and working downstream, it is still worth pulling plants as they appear throughout the year.

Figure 4 Himalayan Balsam was evident on the banks of the Erme. A catchment wide program of eradication from the top of the catchment down, is the best course of action, but seasonal removal should not wait until then. Pulling or cutting (cut close to ground level, below the lowest node, before flowering in June. A repeat cut may be needed, and the site revisited after 2 weeks to check for regrowth). SX 63085 51638

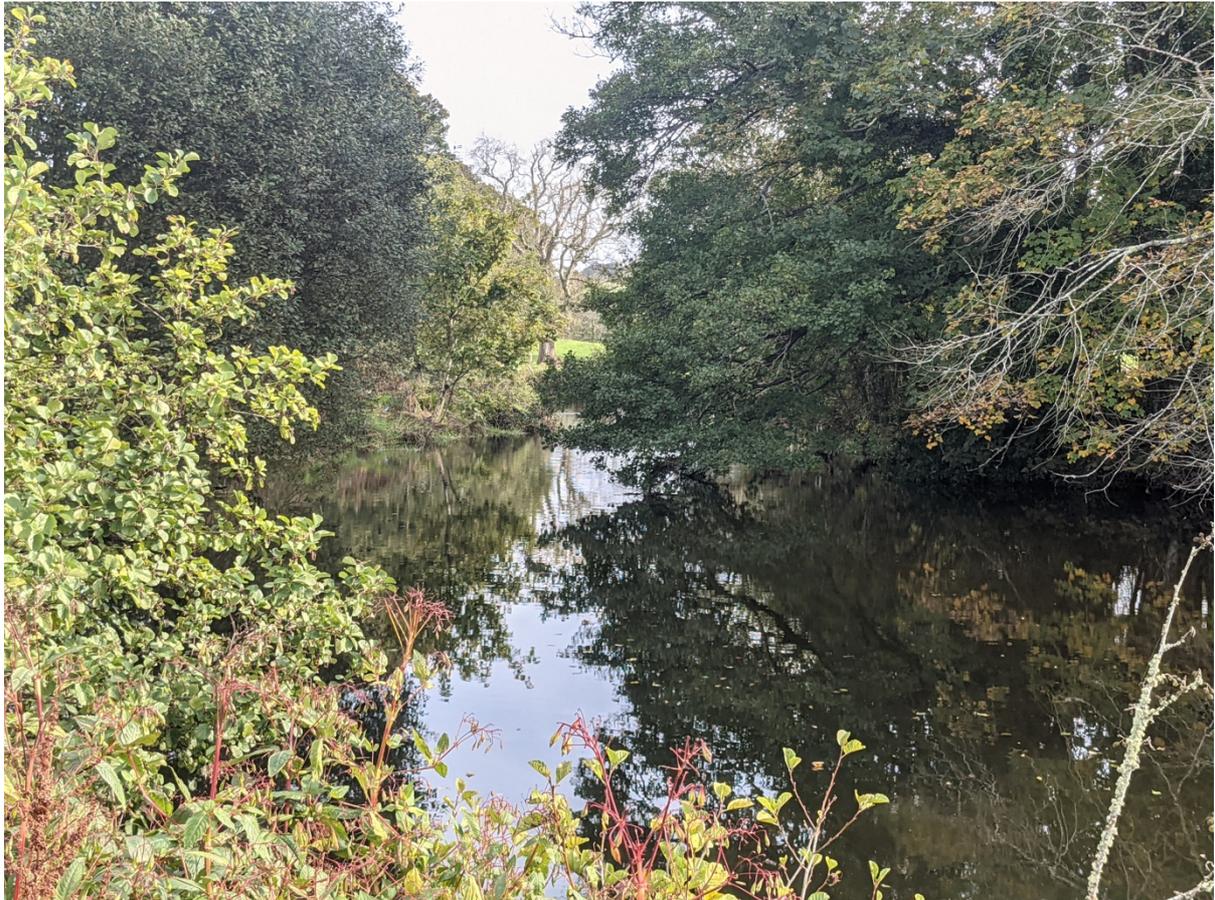
Figure 5 Mixed species of riparian trees stretching out across the river channel. SX 63085 51638

On the LB, stands of alder and sycamore lay across the water's surface (Figure 5). This provides excellent shade for photophobic species like trout and a supply of terrestrial invertebrates falling from the branches for them.

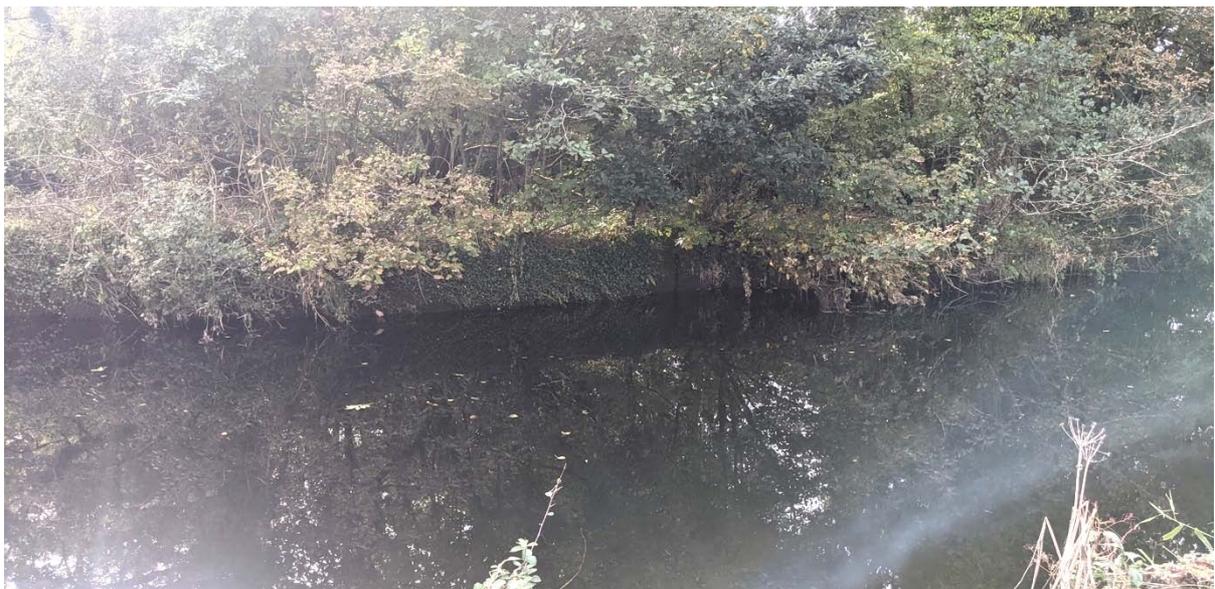
Figure 6 The hard revetment of where the side channel penstock once stood. SX 63085 51638

At SX 63085 51638 the penstock for the barge dock is visible on the LB (Figure 6). The hard construction is deflecting flow downstream unabated. In combination with issues upstream, this is likely exacerbating the RB erosion upstream of the Weir.

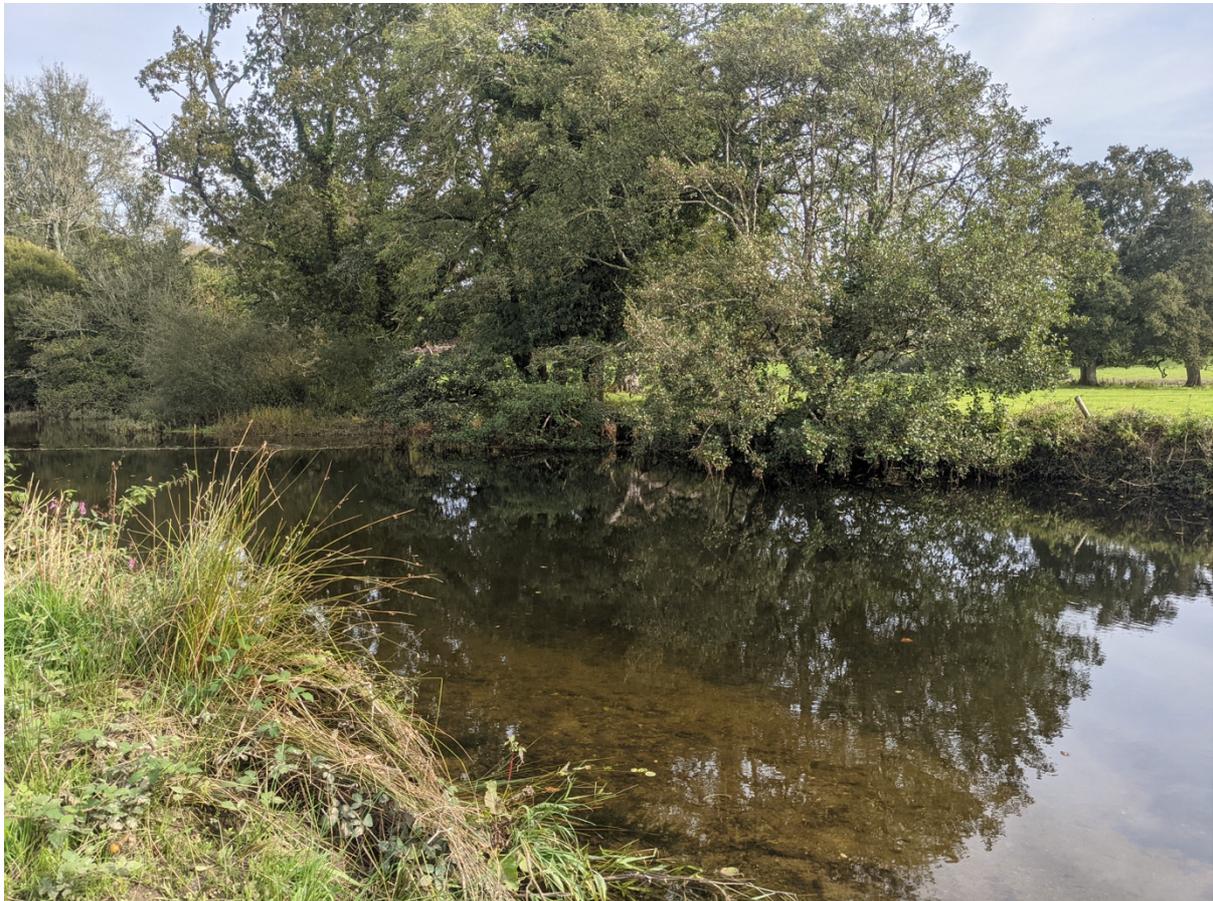
Figure 7 The well vegetated LB (note dilapidated fencing between trees) and the browsed RB. SX 63147 51628

Upstream at SX 63147 51628 similar issues exist with a browsed RB though the well shaded LB is a positive feature (Figure 7). Gaps in the LB tree cover show a dilapidated fence on the bank edge. Repairing or replacing this and moving back greater than 5 metres will help to reduce erosion pressures on the outside of the meander. There is the risk of erosion undermining mature trees creating a cascade of bank losses in the future. Though a natural process, this should not be accelerated through artificially bare banks due to stock browsing.

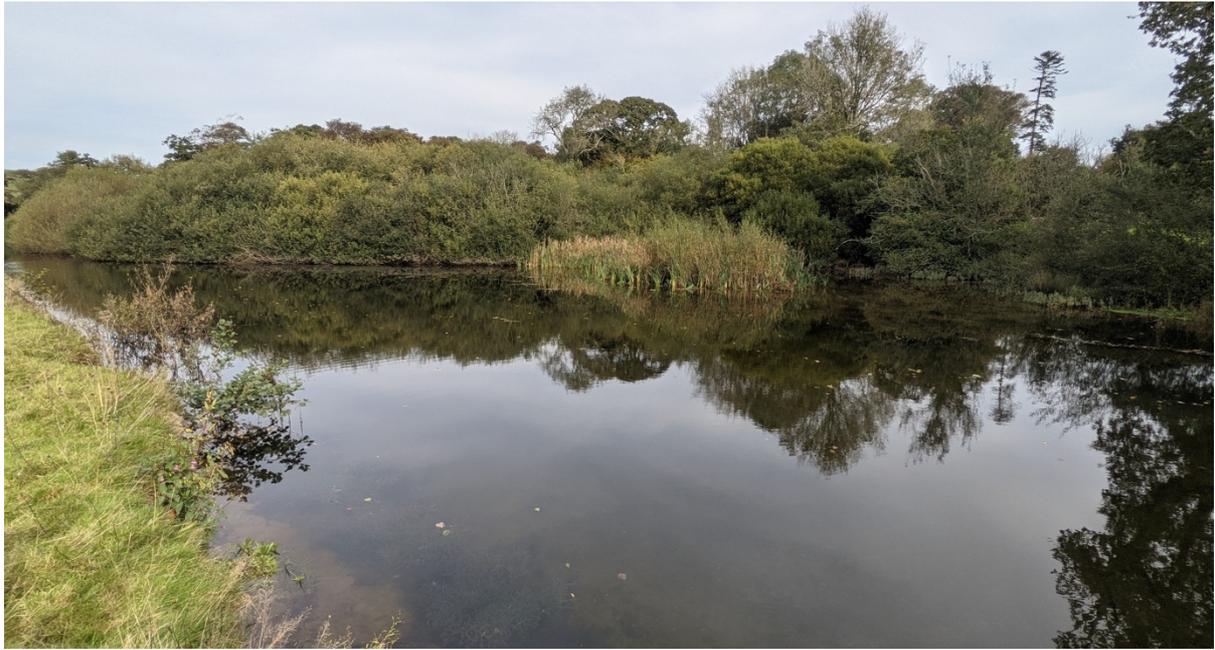
Figure 8 The 'confluence' of the paleochannel and the overly wide current course of the Erme. SX 63171 51656

At SX 63171 51656 the river widens dramatically with the appearance of a confluence though no stream currently enters here (Figure 8). It was later found to be caused by a combination of the paleochannel through the LB woodland and the end of an artificial bund running downstream from the bridge.

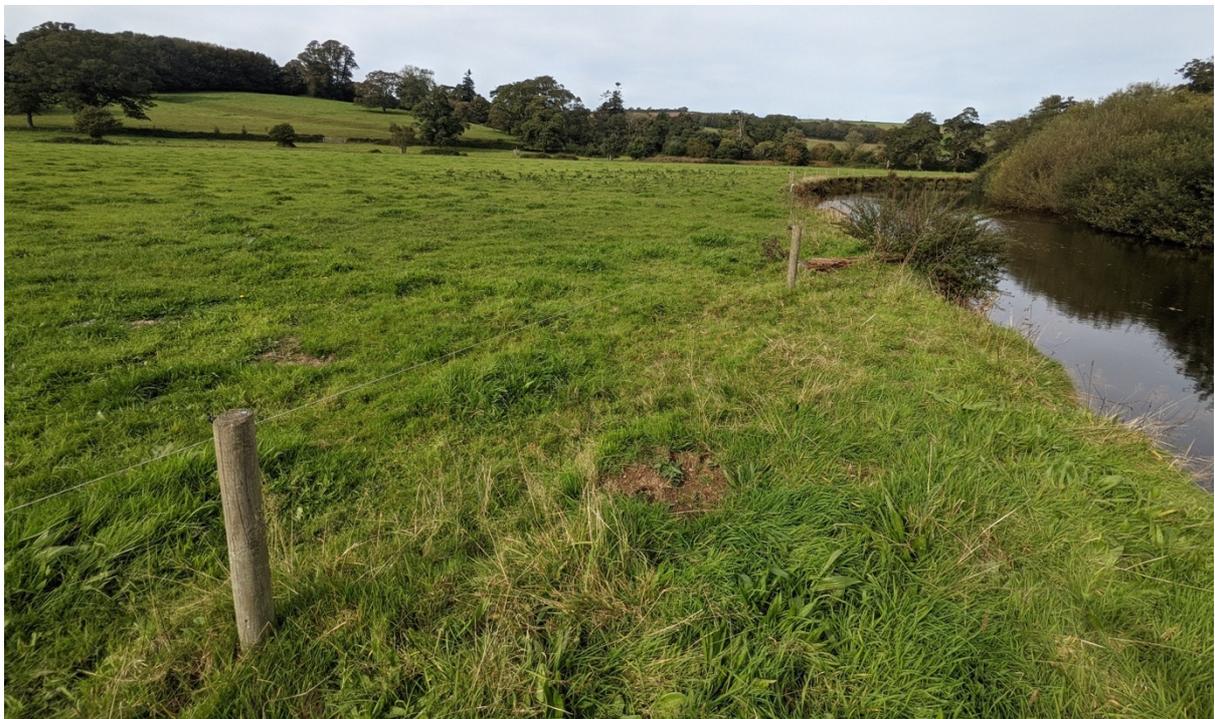
Figure 9 The LB field is heavily browsed, not limited by the strand of electric fencing. This reduction of bankside vegetation is causing increased erosion and a degradation of habitat quality. Better stock fencing situated more than 5 meters back from the river will improve river habitat quality and erosion rates. SX 63140 51721

Single strand electric fencing close to the bank, is only preventing cattle poaching (Figure 9). The banks are browsed as heavily, as the field behind, preventing species diversity and deeper-rooted plants from establishing and holding the soils together.

The sudden increase of erosion (in this case caused by stocking and insufficient fencing) in one place, temporarily upsets this equilibrium, potentially causing knock-on issues elsewhere and reducing habitat quality as a result.

5. Buffer fencing throughout. With the introduction of Environmental Land Management Scheme (ELMS), payments for increased riparian buffers are likely and could partially offset the reduced grazing land. Biodiversity, bank stability and river habitat improvements will add yet more Natural Capital value.

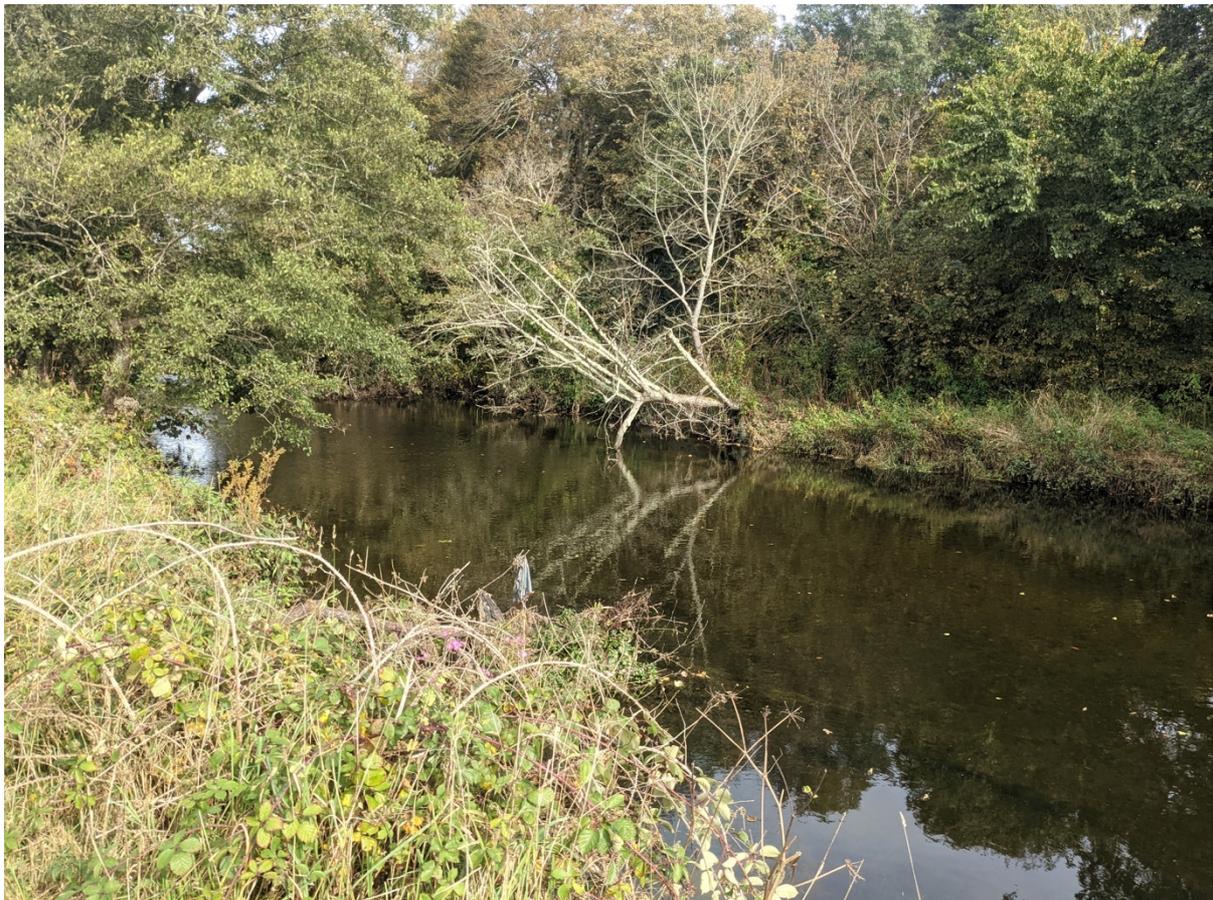
Figure 10 The start of the 'Sanctuary Zone'. Fallen trees have been left in the channel and fish were finally seen. SX 63157 51780

At SX 63157 51780, tree cover on both banks begins to increase with a number of fallen trees left in the channel (Figures 10 and 11). This was described as a sanctuary zone and the only trout of the day were witnessed here. The value of this fallen wood was clear as all fish witnessed swam out from behind these structures, including a large trout of at least 400 millimetres. This benign neglect is to be applauded but volumes of wood in-channel could be increased to build even better habitat.

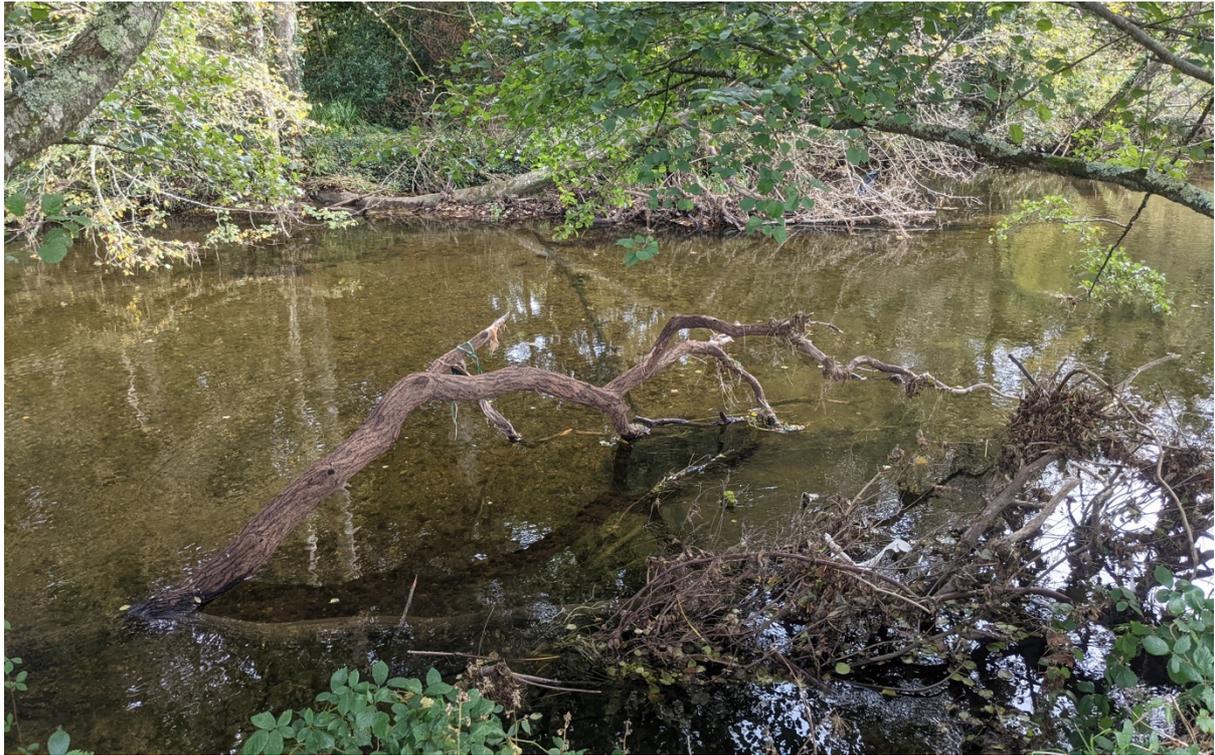
Figure 11 Good wood in the channel on both banks. The overwide and shallow channel here will benefit from increasing the size of such structures and accepting the resulting lateral erosion. SX 63169 51805

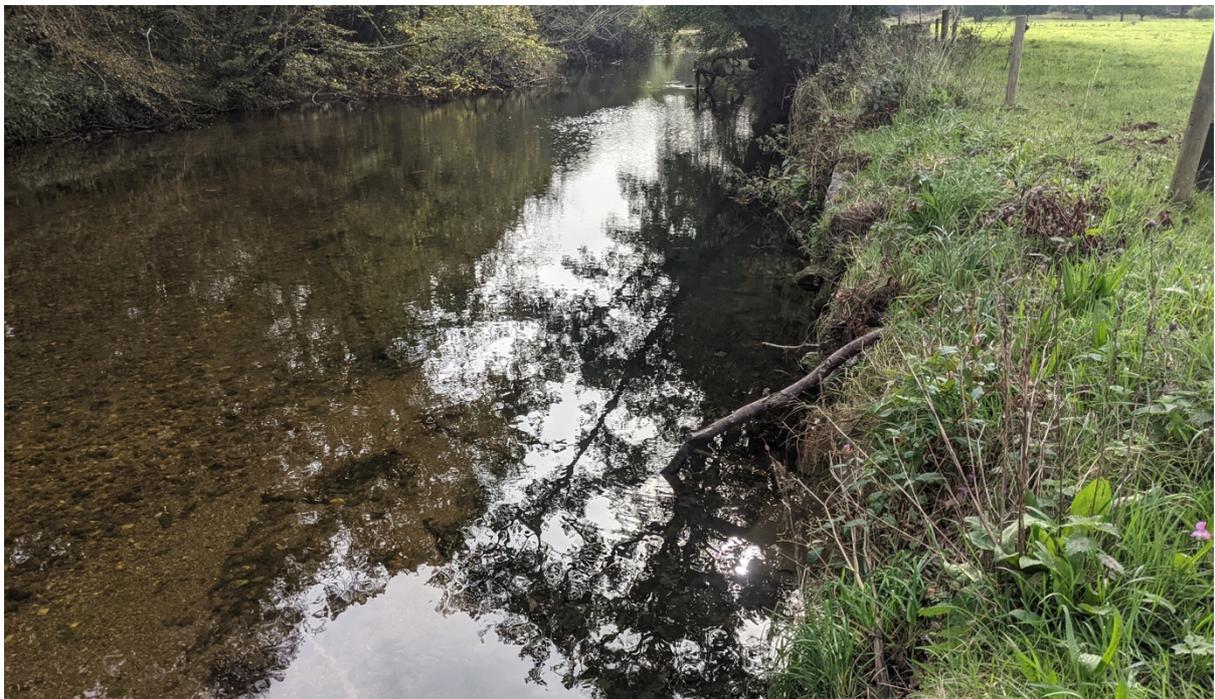
Figure 12 Downstream of Sequers bridge, the channel is straight, overwide and uniformly shallow. The small trailing branches on the LB were holding the only trout witnessed on the survey. Note stone revetment to the RB. SX 63188 51847

The channel form in this area (SX 63188 51847) was unnaturally straight (Figure 11), held back by stone revetment on the RB and a bund on the LB. It was also

overly wide and shallow with uniform bed depth. This 'motorway' of flow is also a contributing factor to the erosion witnessed at SX 63140 51721 as all the energy moves swiftly through this section before hitting the RB.

Allowing some lateral erosion on both banks to build back some meandering would bring a number of benefits;

1. Remove revetment allowing some lateral erosion into the RB, complementing it with a narrowing of the channel on the opposing bank. the latter could be achieved by pulling over young to medium age trees, back filling gaps with coarse woody material from the arisings or other nearby material.

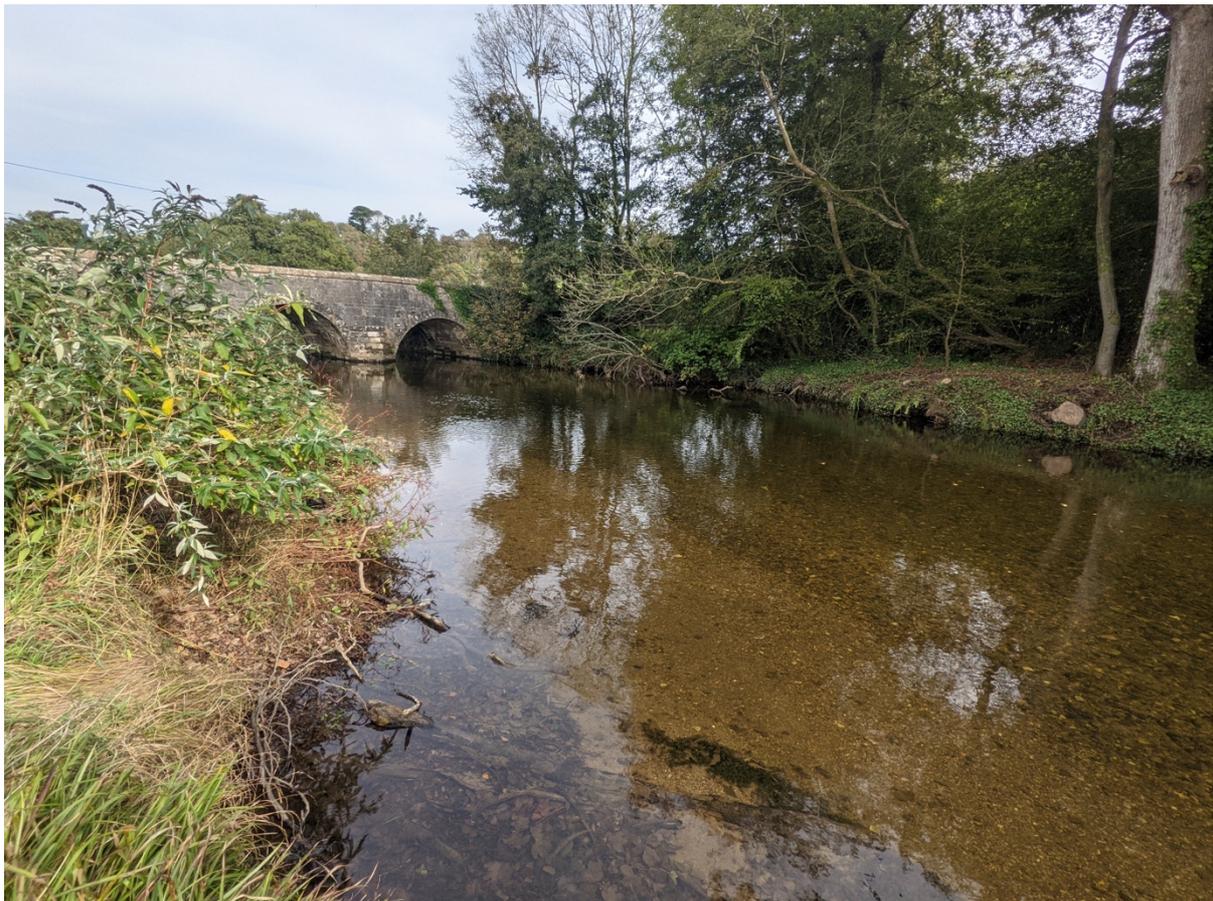
Figure 13 Younger trees on the RB could be pulled over into the channel in a downstream direction. The resulting pinch of the channel will scour out deeper pools, bringing much needed

channel diversity to this reach. Allowing lateral erosion into the LB will bring a more natural, meandering form, in turn reducing erosion forces downstream. SX 63188 51847

To begin with, there are a number of young ash that could be toppled into the channel from the LB (Figure 13). Investigations to scrape back the LB bund and remove the RB revetments should be undertaken to fully realise a restoration in this area.

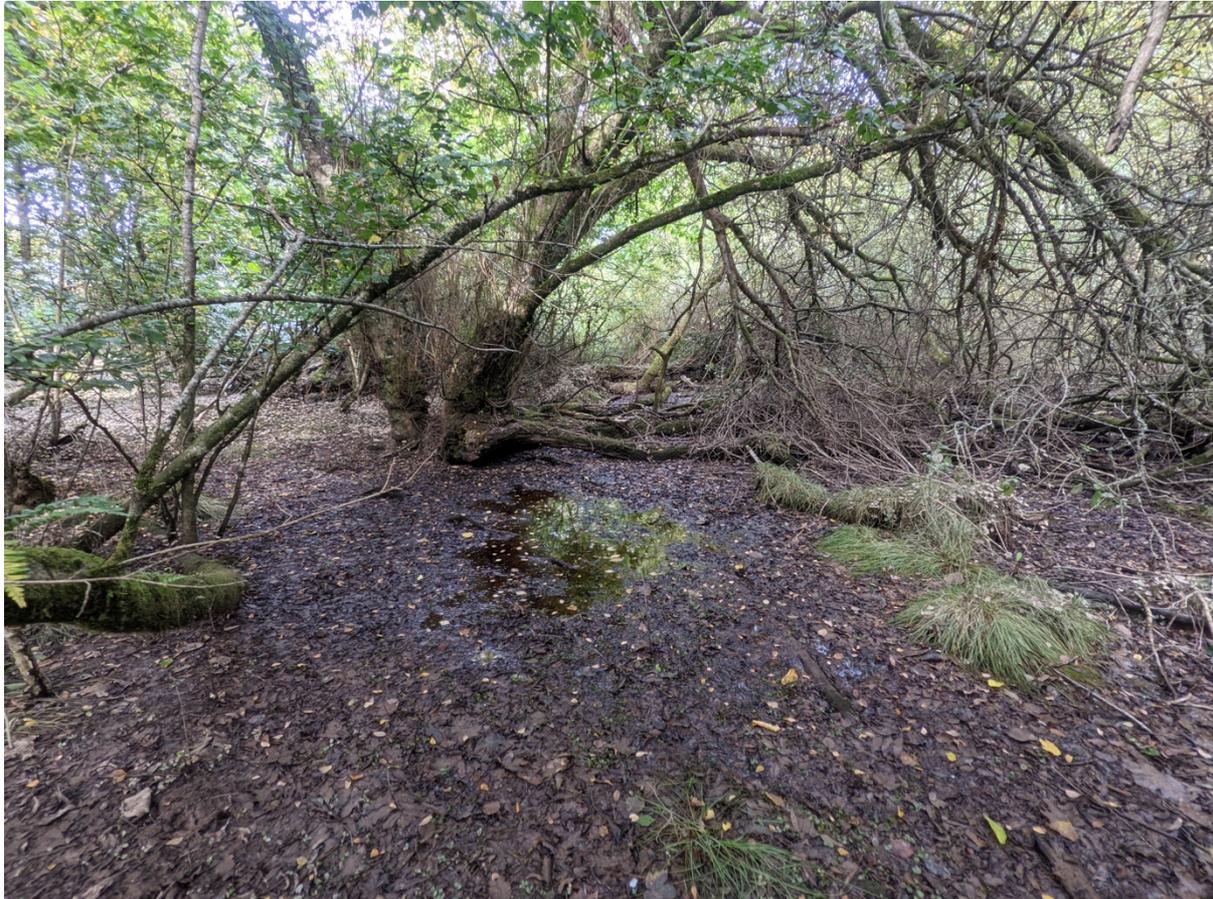
Figure 14 The suspected paleochannel found within the RB woodland. Examinations of LIDAR DTM data and old maps, confirm this assumption. SX 63206 51751

Walking into the woodland to investigate the bund, a clear paleochannel was discovered. A winding channel, holding a little water (Figure 14), courses through to SX 63171 51656. Works to the bridge likely included the downstream straightening and bund, disconnecting this area from flow.

Re-establishing a route through the woods would bring the river instantly to the trees something that is much more immediate than growing new trees next to the river.

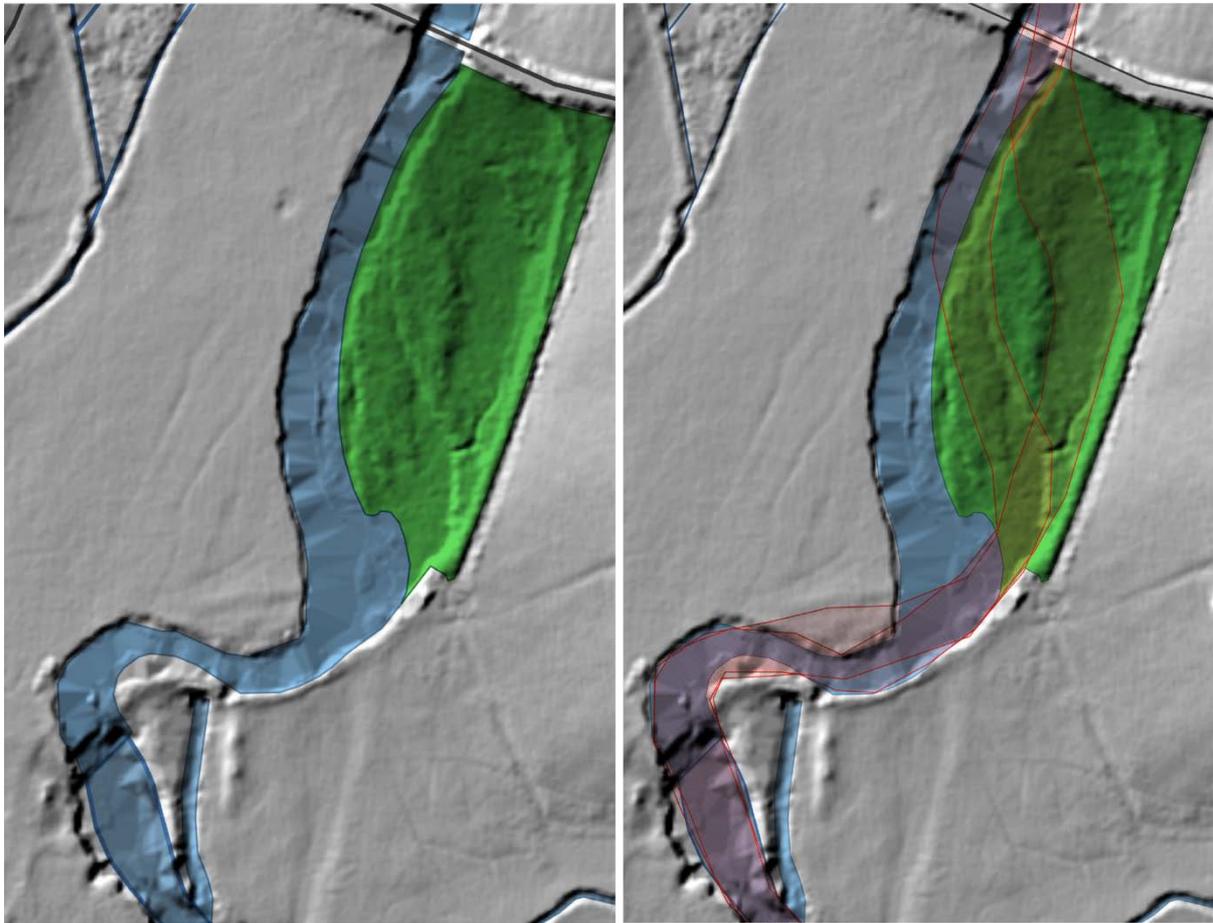
Map 2 (Left) LiDAR Digital Terrain Model and right with likely paleo channels highlighted. Note how the straightening of the reach downstream of the bridge is slowly forcing the river form in a southerly direction into the valuable arable land.

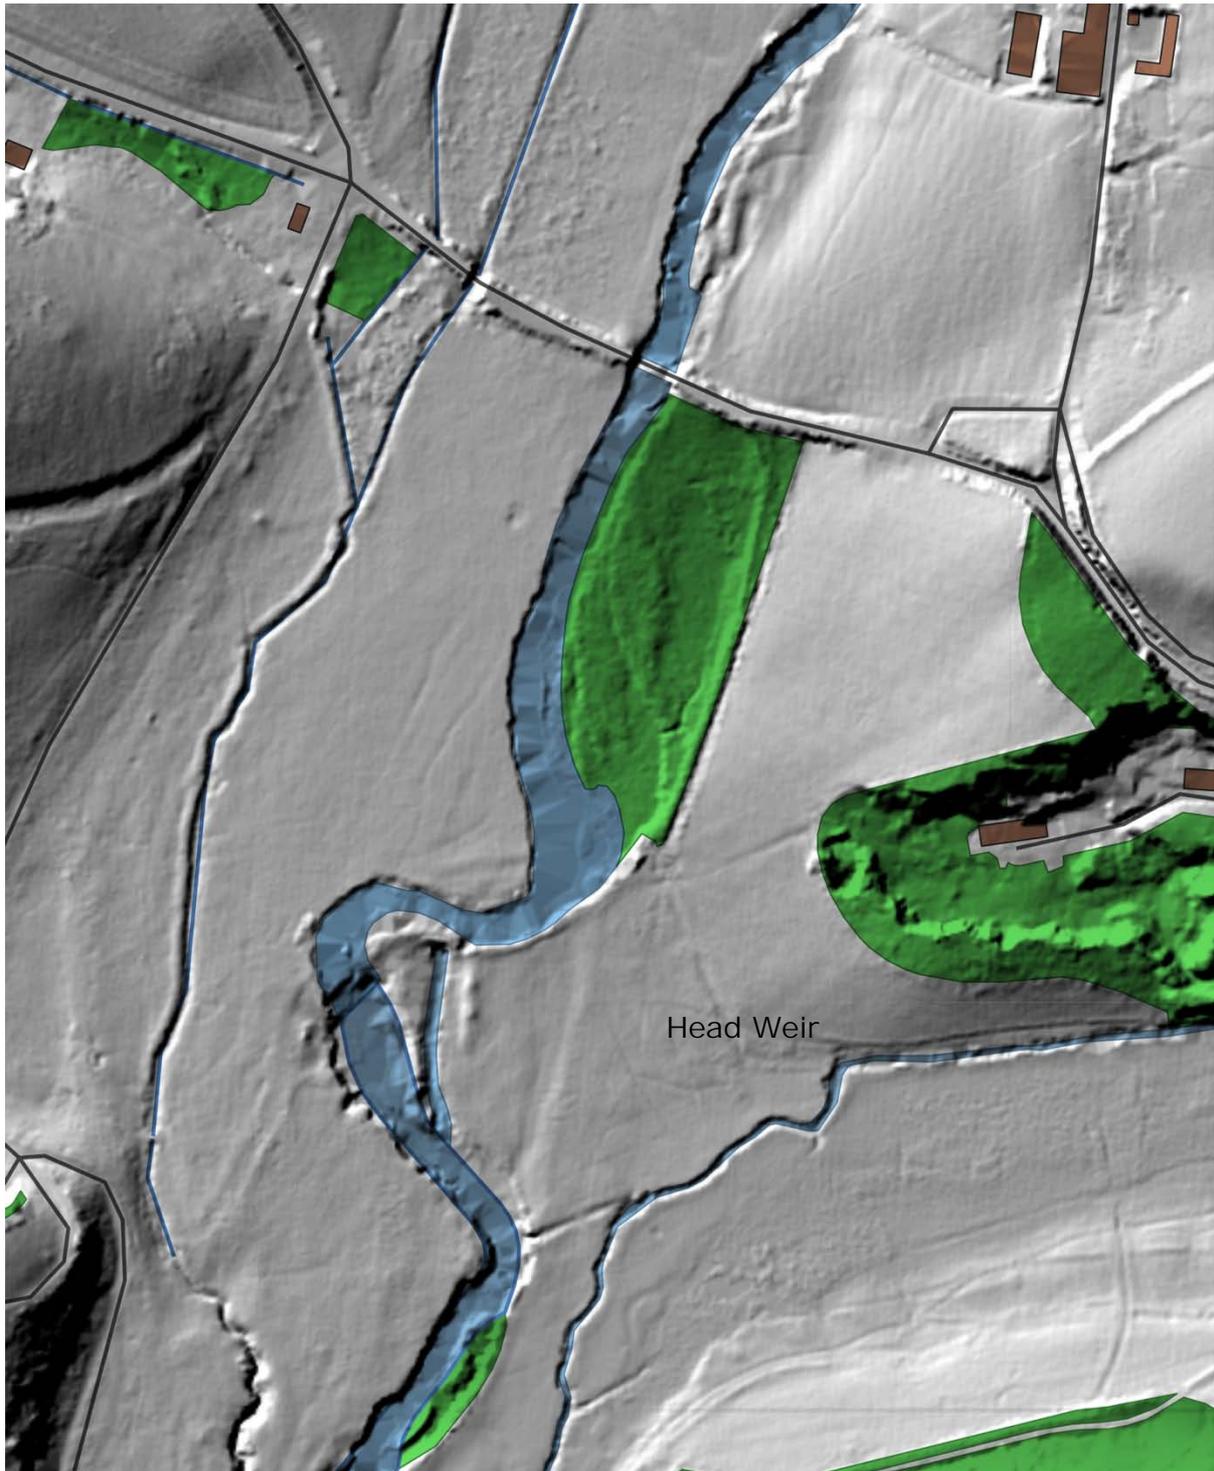
Map 3 LiDAR of the area of the report. Note the deeper, steeper banks of the channel immediately downstream of the weir in comparison to the banks upstream. This is likely due to incision caused by an interrupted gravel supply.

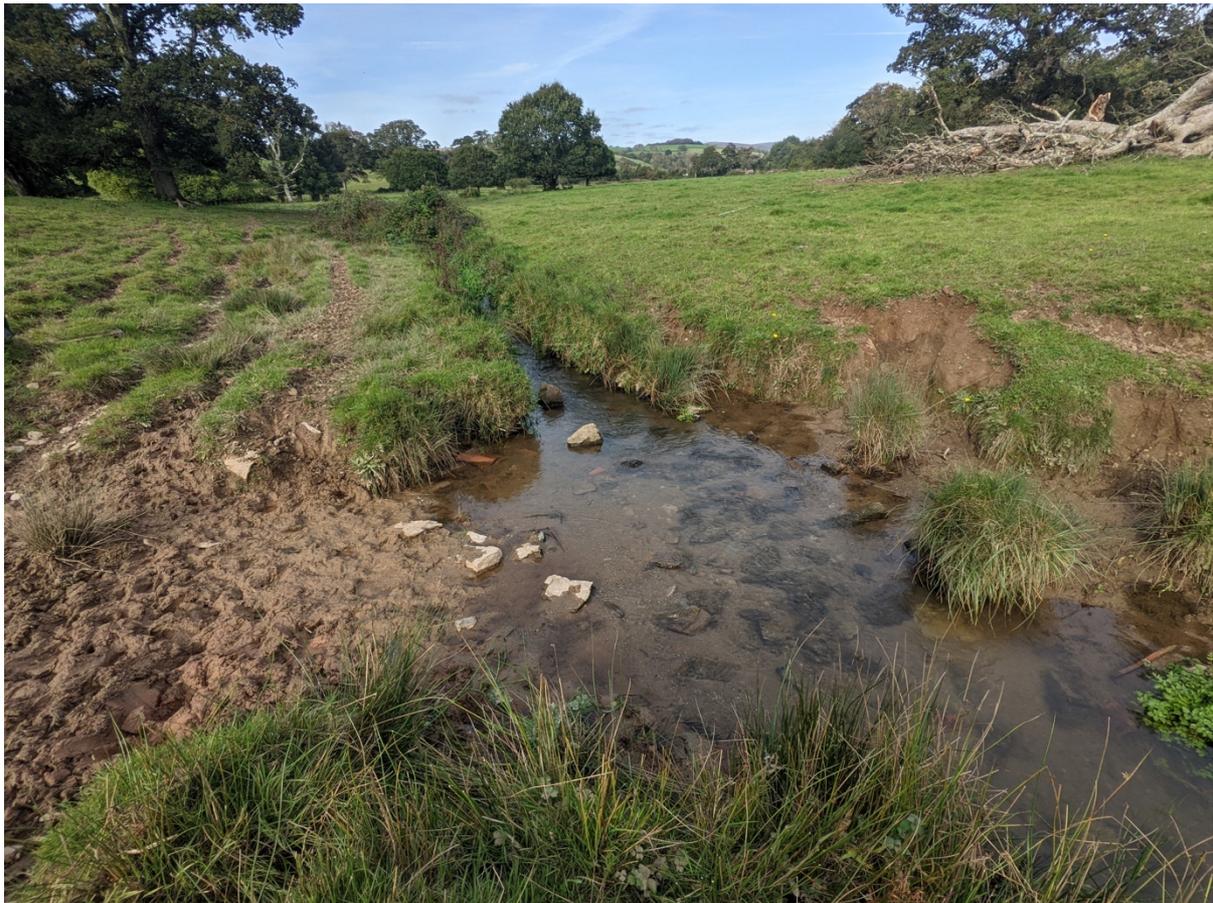
Map 4 A poached area of one of the small streams that run through the estate (SX 62986 51472).

Small streams such as this should not be ignored as they hold significant spawning potential. Clean gravels are required for successful spawning and excessive fine sediment inputs will suffocate eggs preventing such success. Poaching from cattle, being given unrestricted access to the stream, has caused a significant amount of fine sediment to settle on the bed.

Creating a buffer either side of the stream, with appropriate fencing, will prevent stock access and filter other run off. The increased diversity of bankside vegetation would also greatly enhance juvenile salmonid habitat. Cattle drinkers could be installed to organise specific sites for their water, but other solutions such as pasture or solar or mains pumps would be a better and safer investment, particularly if water was held in header tanks and drawn down to troughs when/where necessary.

All the small streams seen were suffering from cattle poaching pressures. Establishing a better formalised watering of livestock will reduce fine sediment issues and contribute to the spawning potential of the catchment.
