Walkover Assessment
Badsey Brook (Warwickshire Avon) catchment
14-15/06/2017

Undertaken by Gareth Pedley

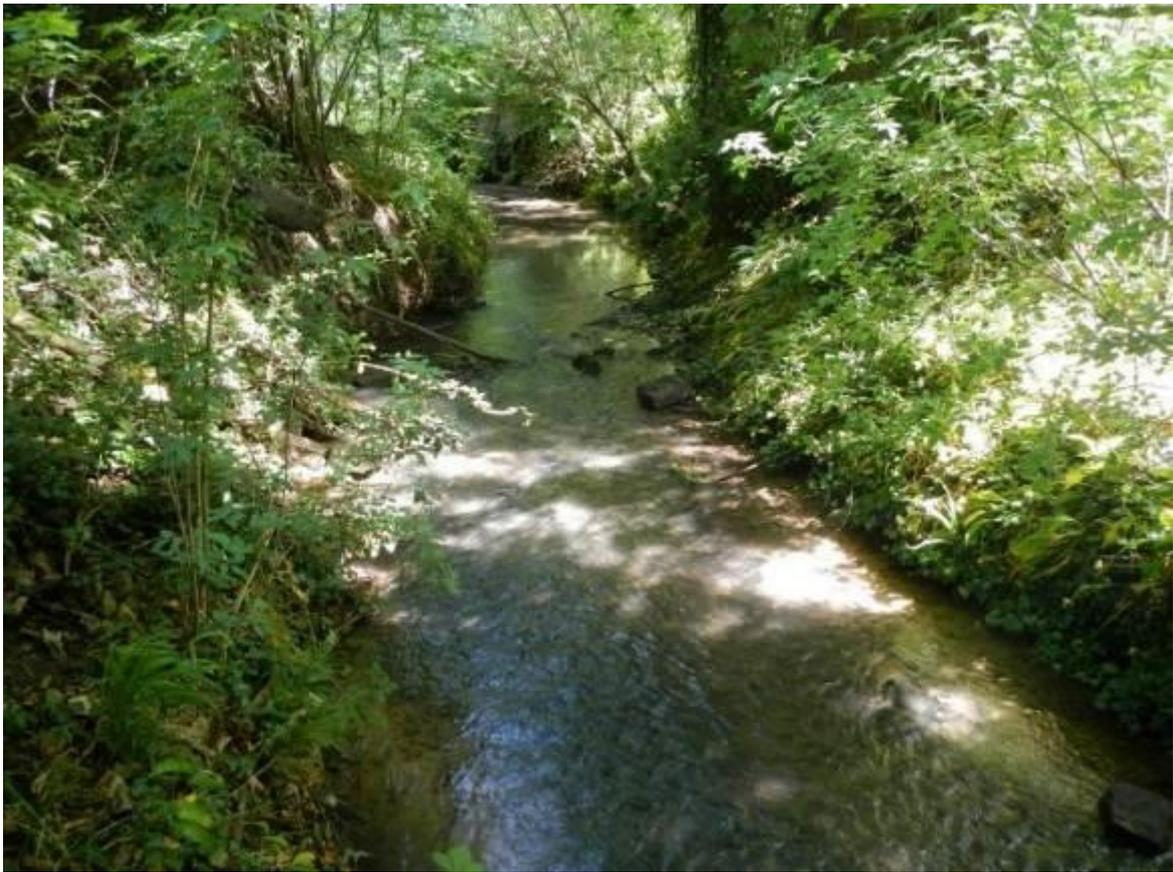
Figure 1. Around the u/s limit inspected on Bunches Brook, potential salmonid spawning and juvenile habitat was observed, despite channel realignment. Areas of the brook and tributaries u/s become more naturally sinuous and appear to provide improved habitat.

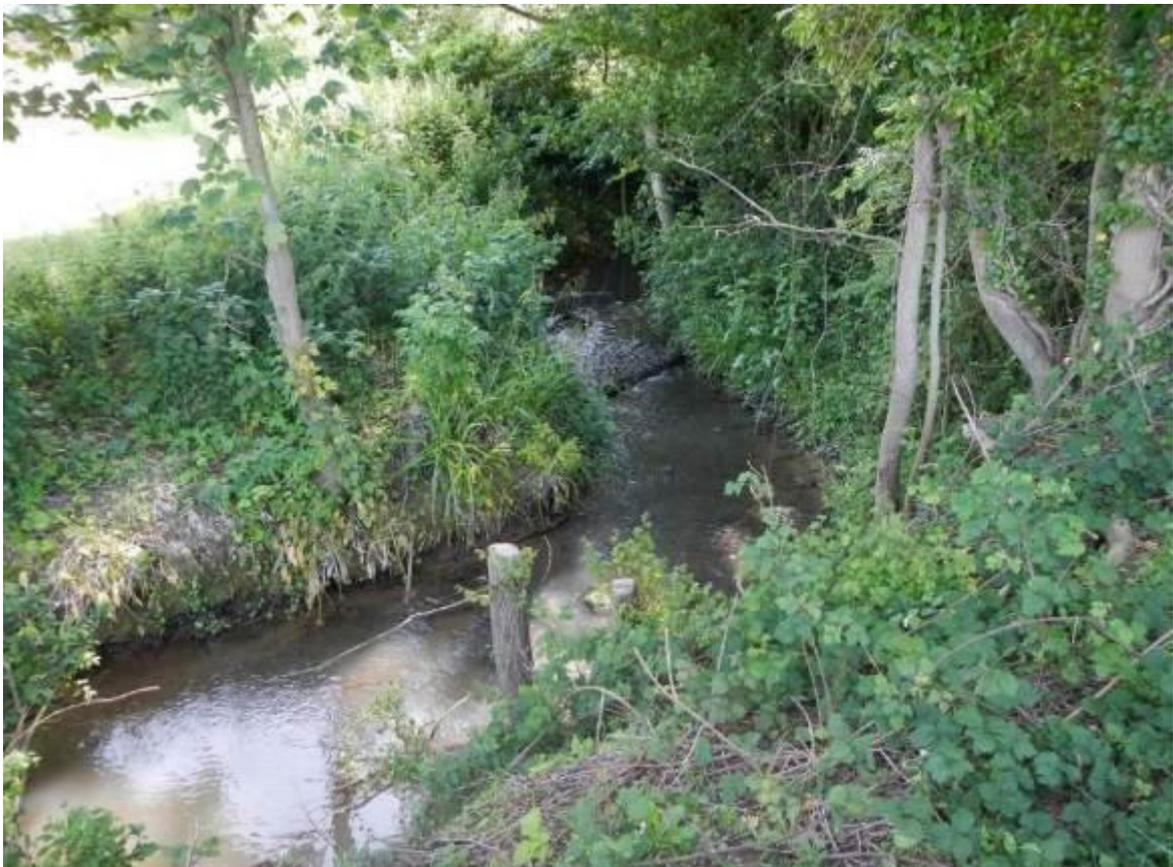
Figure 2. Moving d/s, some deeper water is present on the bends but the section immediately u/s of Broadway Weir is particularly straight, providing poorer quality, more uniform habitat.

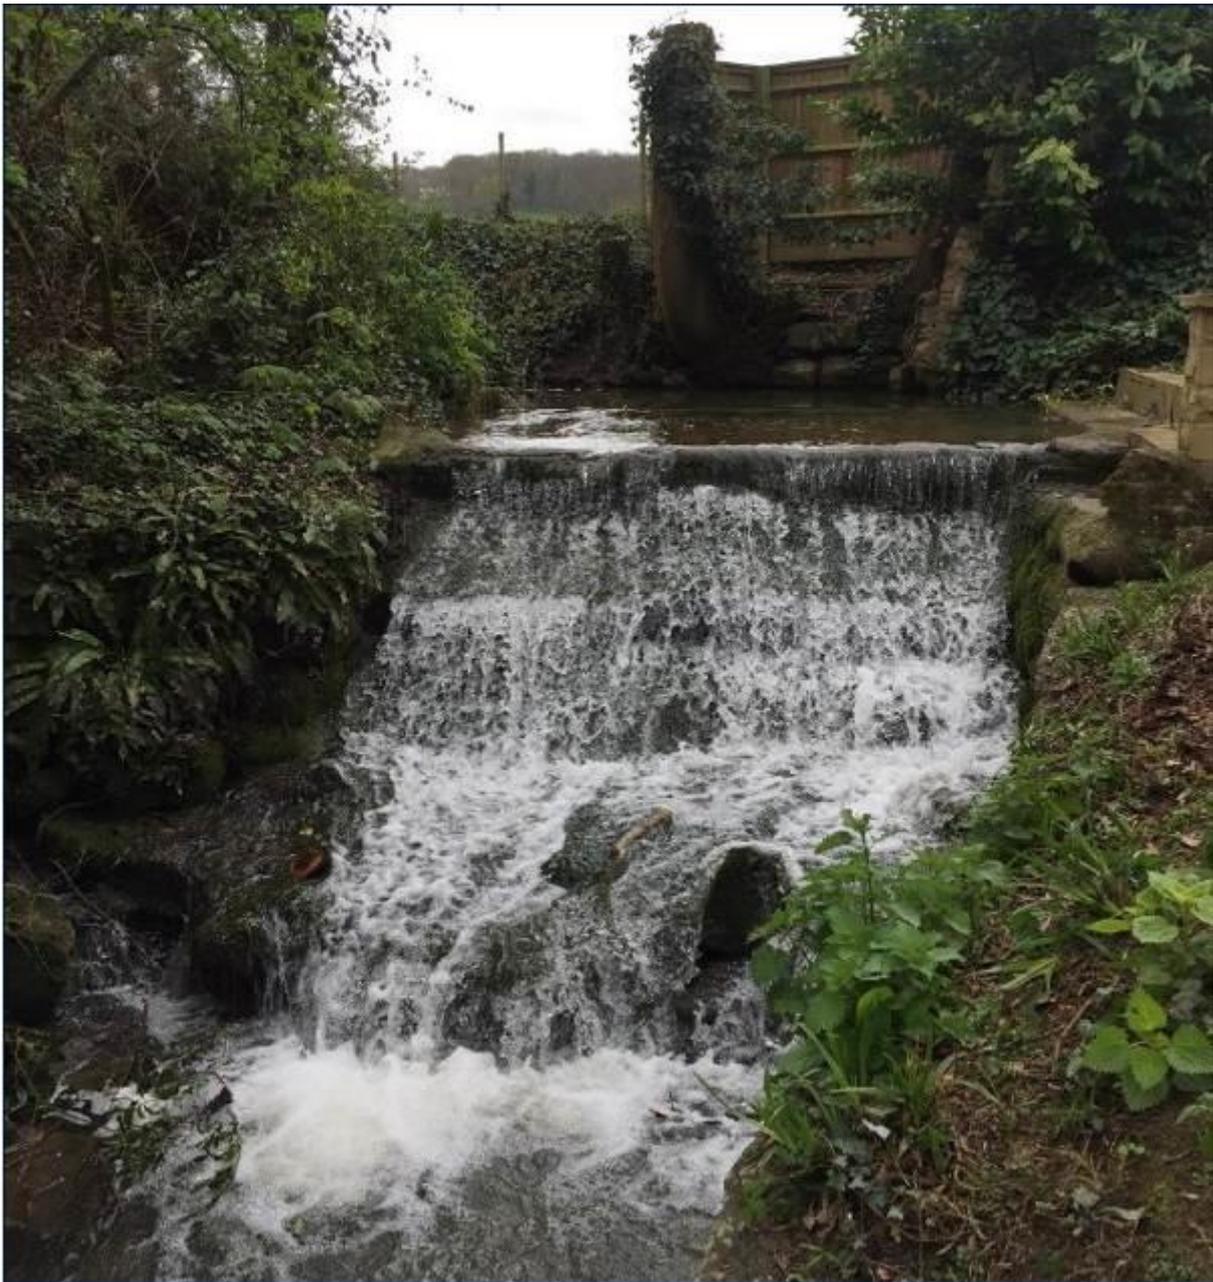
Figure 4. Broadway Weir (SP 09048 37477). The >1.5m high structure is impassable (u/s) to all species in almost all flows, as a result of the shallow water cascade over a steep, stepped face, with an additional vertical lip at the top of the structure.

Weirs like this fragment a catchment, isolating fish populations u/s and disconnecting d/s fish populations from vital habitat u/s (including vital spawning and juvenile areas), making them even more susceptible to impacts from habitat degradation and pollution. They reduce flow and sediment conveyance, artificially elevating the bed and water levels u/s and undoubtedly contributing to out of bank flows. Opportunities to remove these redundant weirs must be seized if habitats and fish populations are to be significantly improved. No fish pass can mitigate the wider ecological and geomorphological impacts of a weir and any attempts to improve fish passage are invariably more complex and expensive than weir removal, with a greater long-term liability. From this point d/s to the road bridge (Fig. 5) the brook flows through private gardens and so was not assessed.

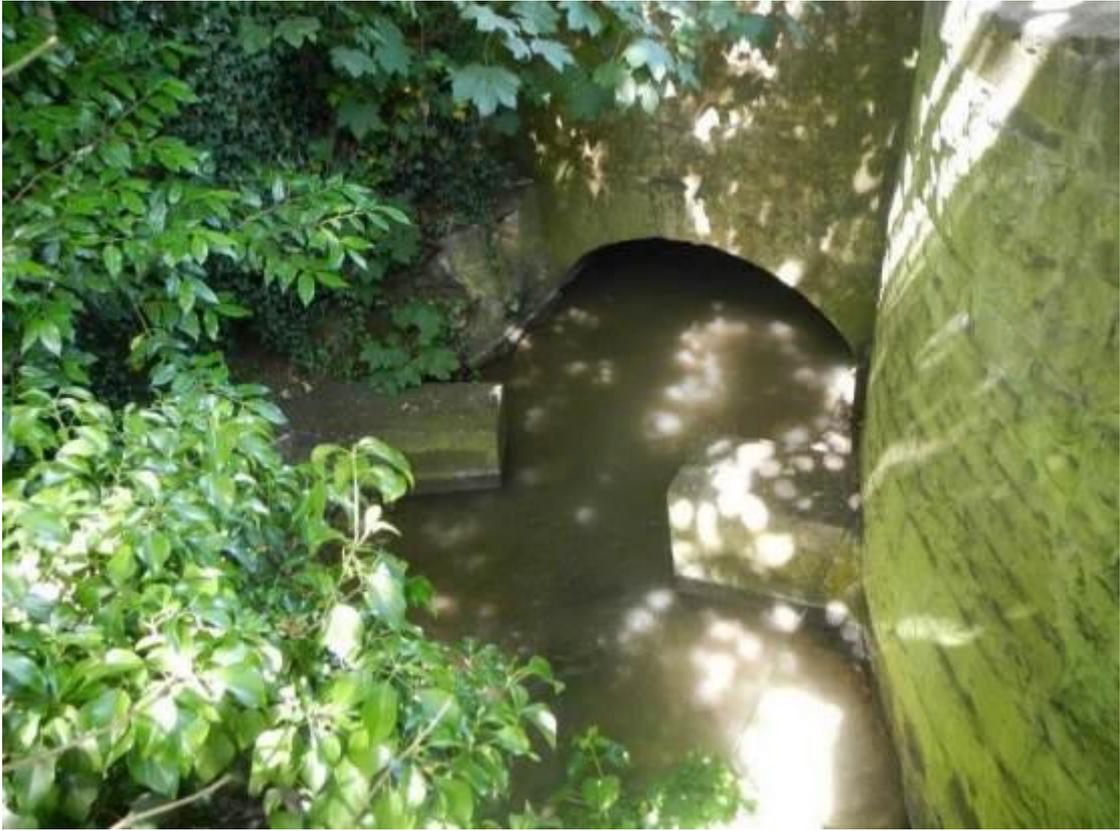
Figure 5. At SP 09014 37599, an undersized bridge d/s of Broadway Weir is suspected to cause much of the flooding around Broadway, precipitating the flood alleviation scheme (also begging the question why the weir u/s and flow-throttle are being addressed to reduce flooding). The brook d/s of this point flows through a narrow buffer of deciduous trees, with gardens on the RB and predominantly arable agriculture on the LB.

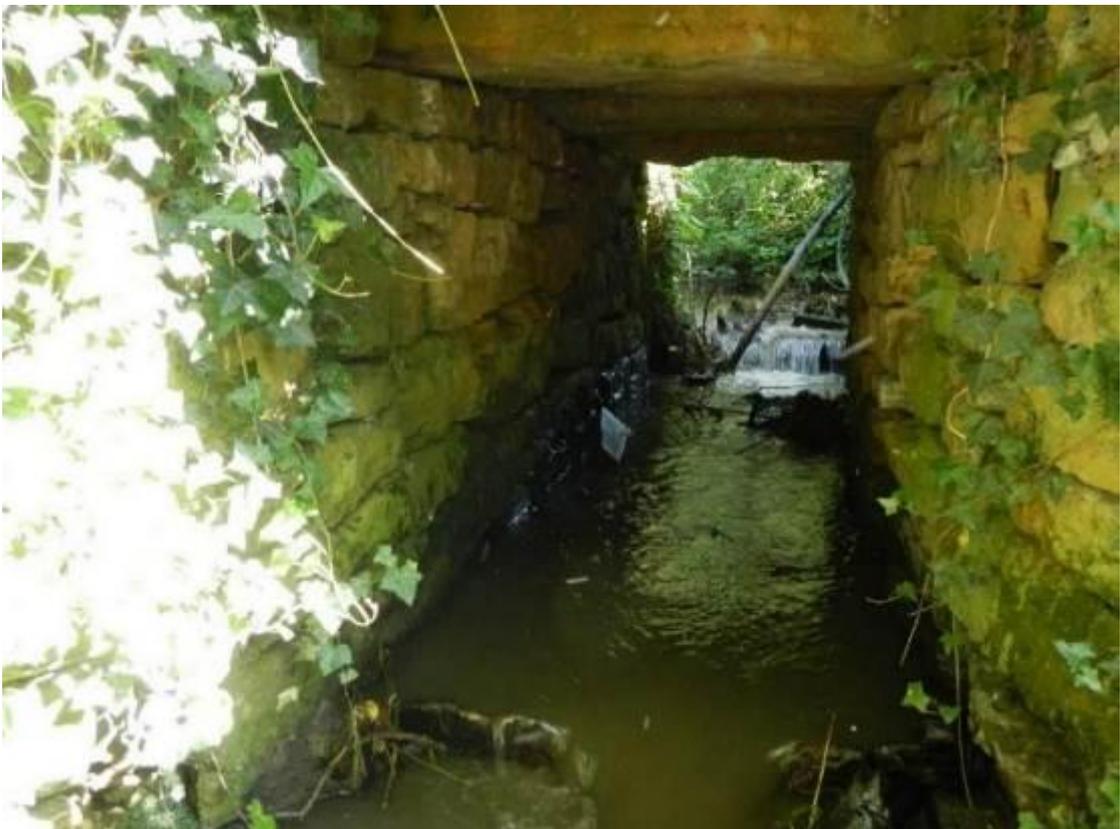
Figure 6. At SP 08750 37749, a stone culvert has been dammed with boards at the u/s end to facilitate an abstraction. This blockage should be removed to assist fish passage and sediment transport. Here the brook flows through a deciduous treed buffer.

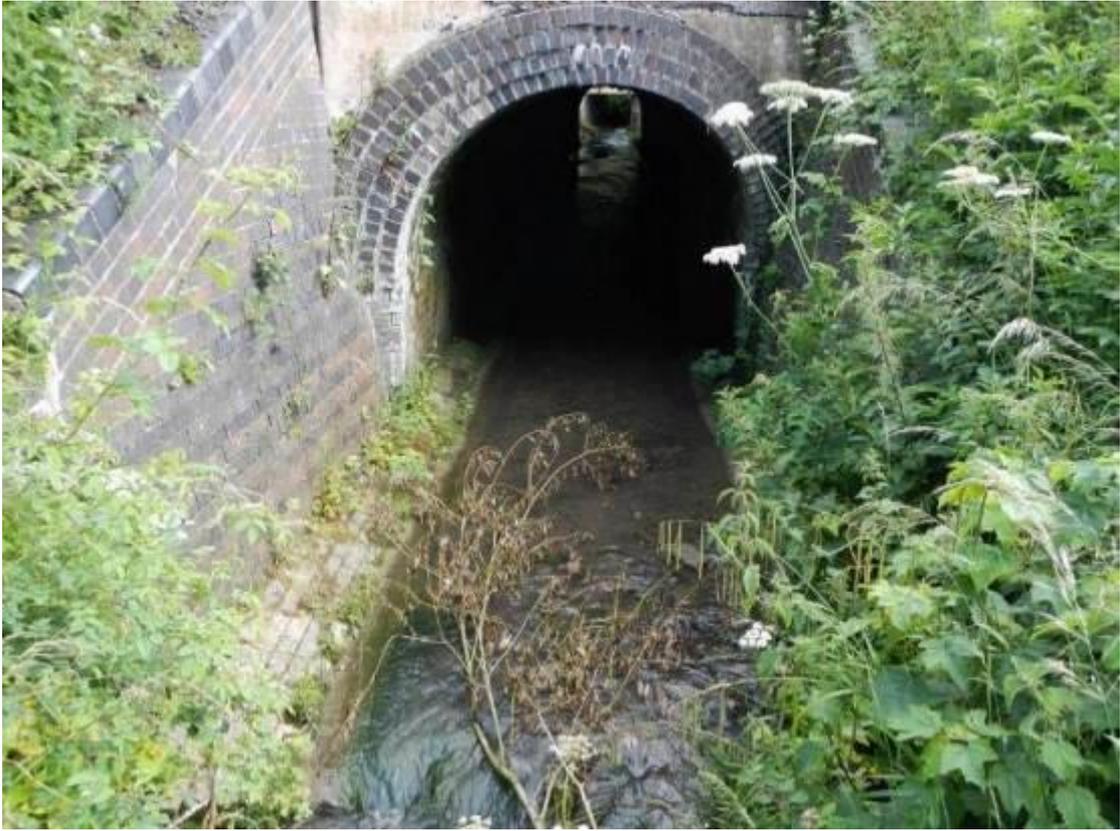
Figure 9. At SP 08545 37973, the culvert under a disused railway creates an extended shallow water section and degrades habitat but poses no major barrier to fish movement or sediment transport. Elevated algal growth was observed.

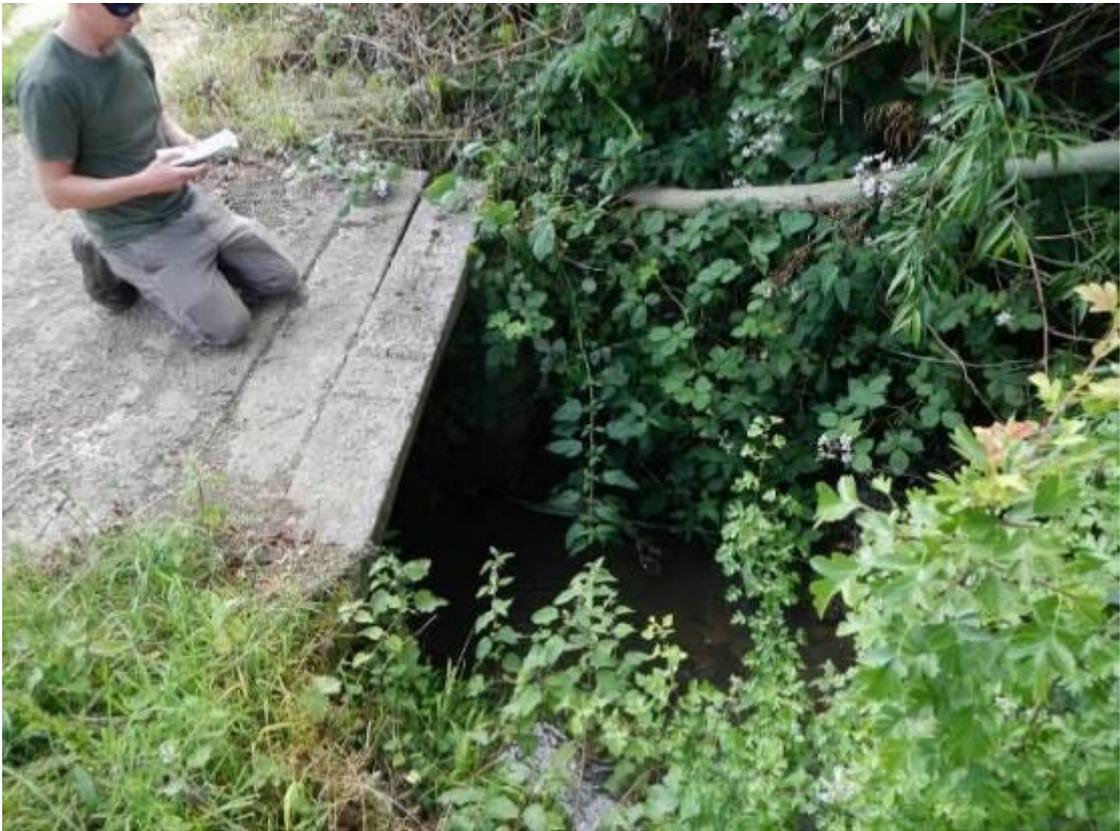
Figure 10. Just d/s of the railway line, another small track crossing poses no issue for fish or sediment movement. Note the irrigation pipe in the background. From this point down, irrigation pipes are a regular occurrence; some appearing disused but others active.

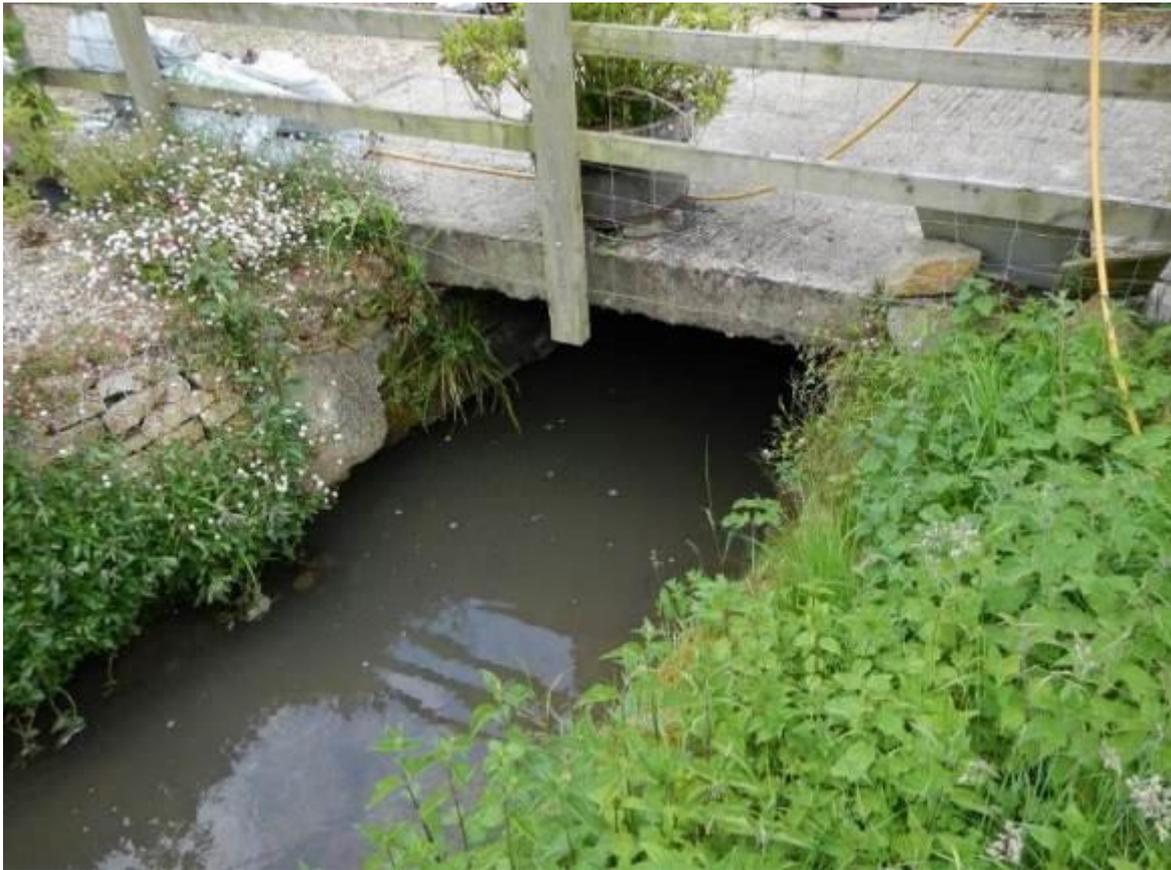
Figure 13. At SP 08200 38202 a clear-span crossing of the brook within a large private garden poses no issue for fish or sediment transport but localised reinforcement of the banks degrades bankside habitats.

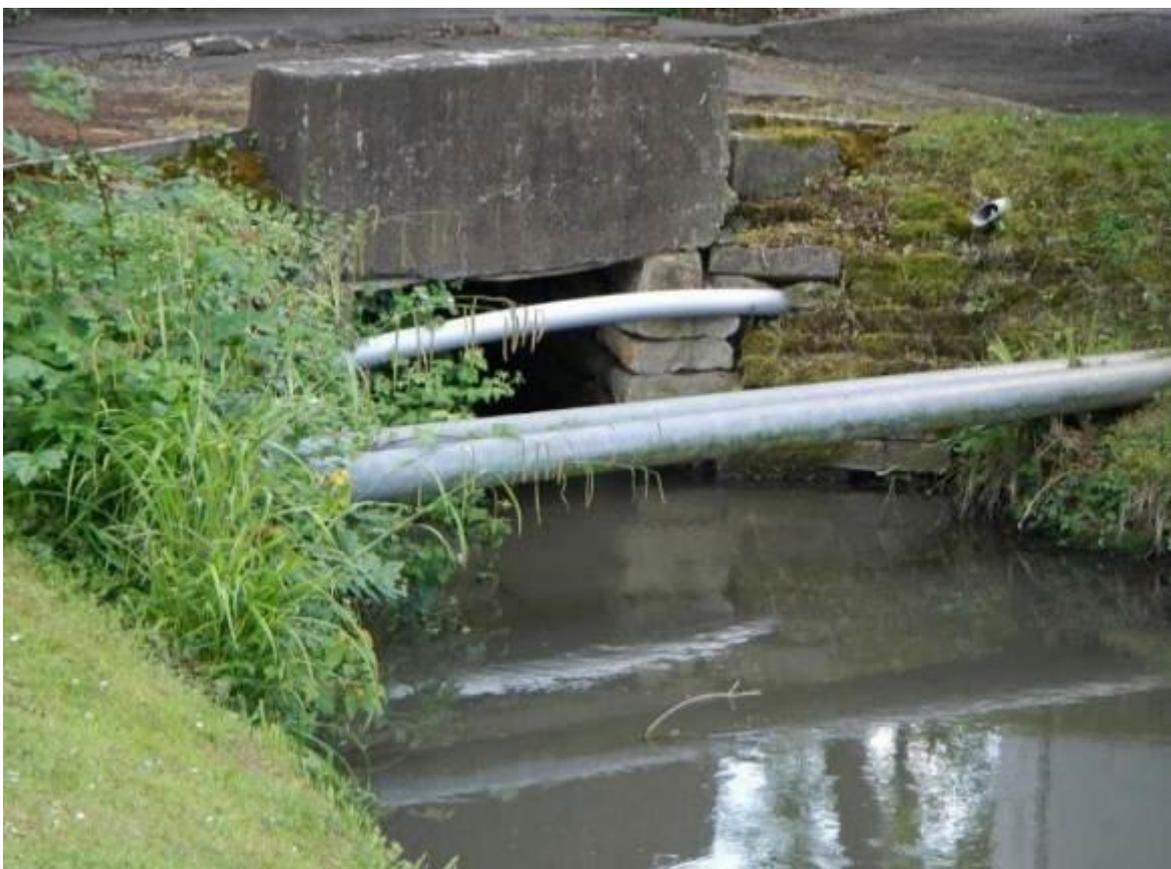
Figure 14. Just u/s of Leedon's Holiday Park a small crossing poses no issue for fish or sediment movement. These deeper-water areas highlight the fine sediment loading.

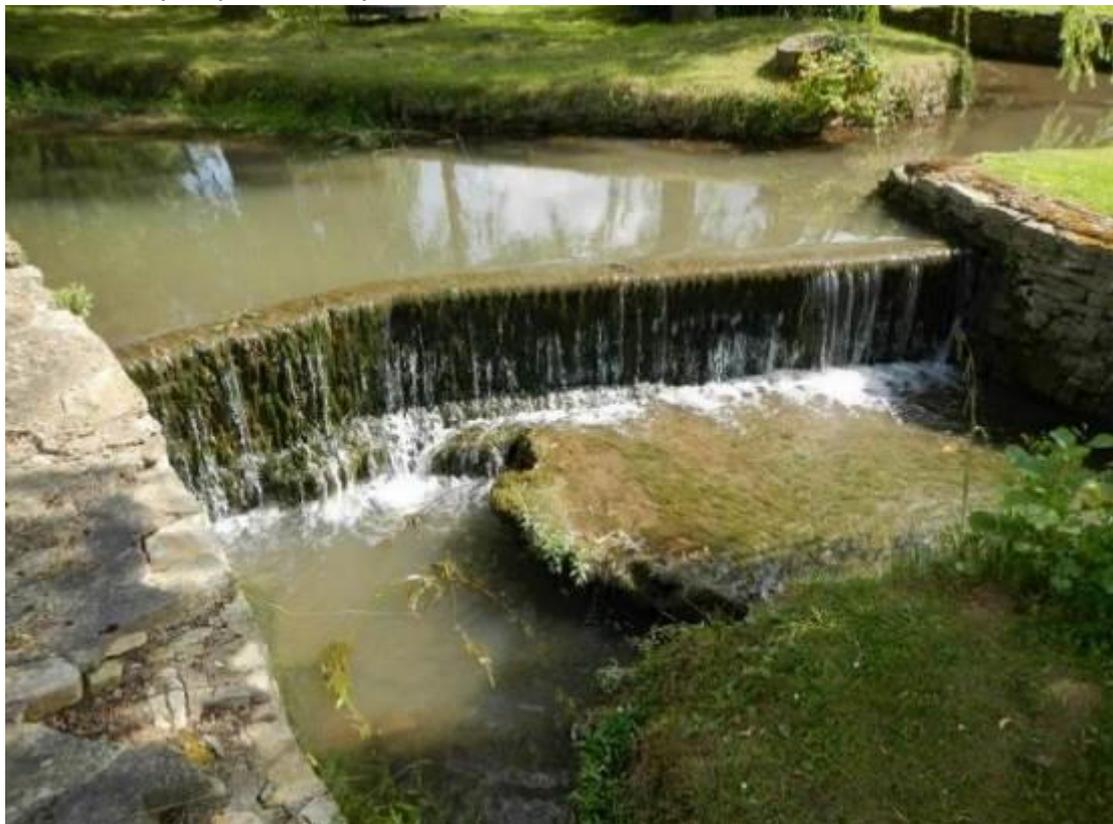
Figure 16. The 1m high, vertical faced structure of Leedon's Holiday Park weir (SP 08155 38380) and lack of depth d/s creates an impassable barrier to fish passage and sediment movement at most flows. Erosion of the bed and banks around the structure has led to undermining and destabilisation of the structure. Rather than repairing the inappropriate obstruction, the area should be re-landscaped to facilitate free fish passage and sediment transport while retaining an aesthetically pleasing appearance.

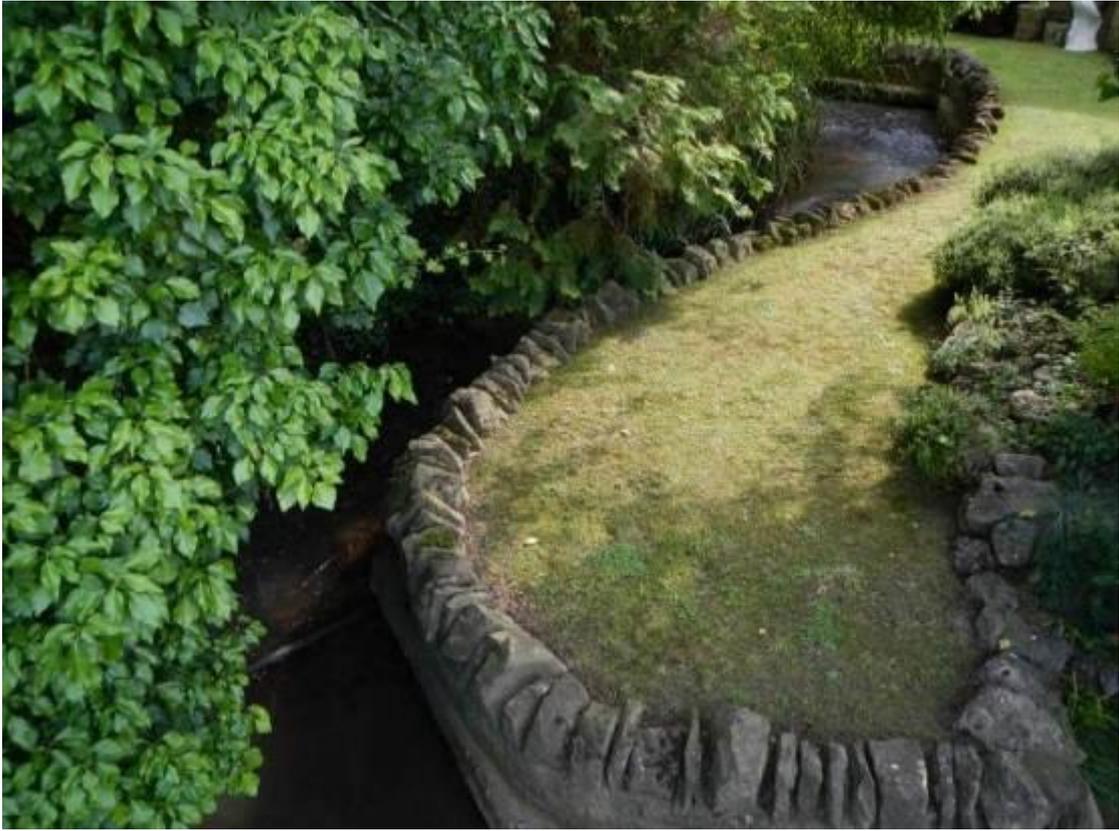
Figure 17. Visible areas of the gardens within Leedon’s Holiday Park revealed significant revetment of the banks.

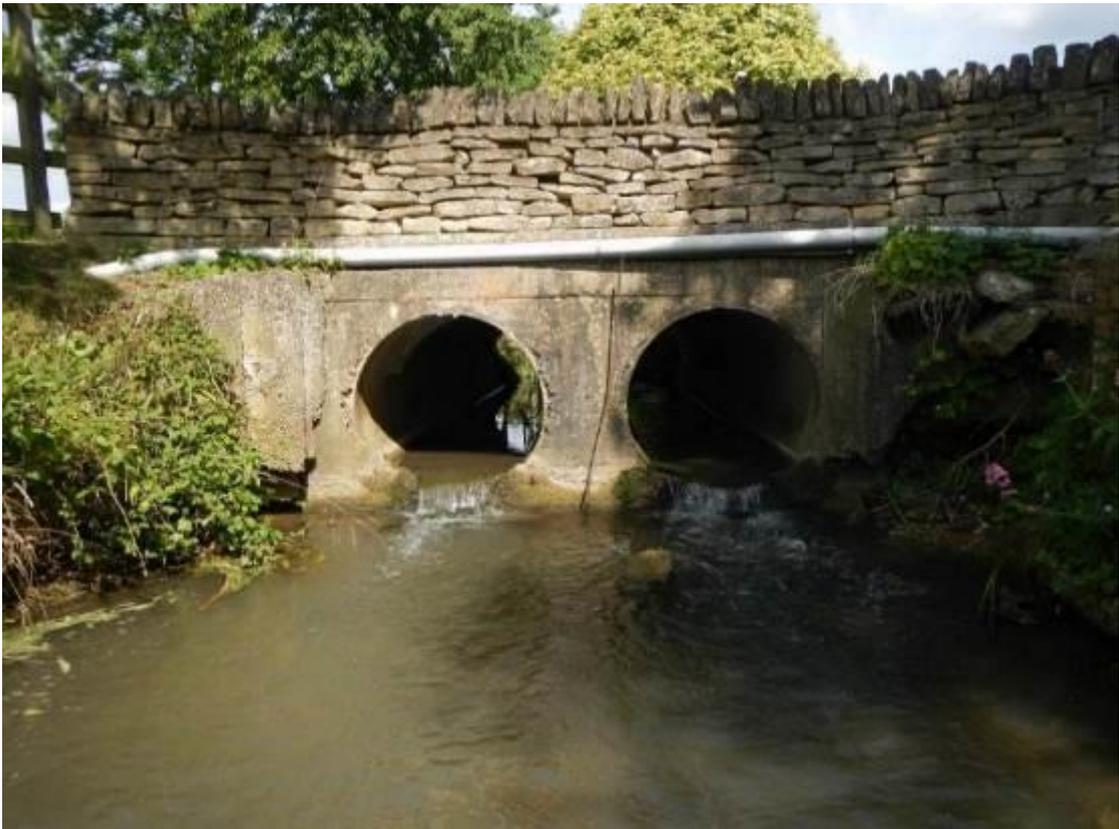
Figure 18. Elevated pipe culvert at the d/s entrance to Leedon’s Holiday Park (SP 07880 38497) creates a small barrier to fish passage through a vertical step, shallow water within and fluming through the pipes. Adult salmonids are likely to ascend in most flows but it poses an obstacle to eels, lamprey and smaller individuals/species. The solution: short-term, a small rock ramp easement; but ideally, replacement with a larger, clear span bridge or sunken culvert which would address potential flow throttle/flood issues.

18	SP 07880 38497	Leedon's Park pipe culvert	A small, informal rock ramp type easement could be installed on the d/s side to alleviate the step, raising the d/s bed slightly above the invert the culvert pipes. Long-term, the structure should be replaced with a single, much larger, partially sunken culvert.	2
21	SP 07709 38490	Small garden weir	This is a low priority but should be removed.	3

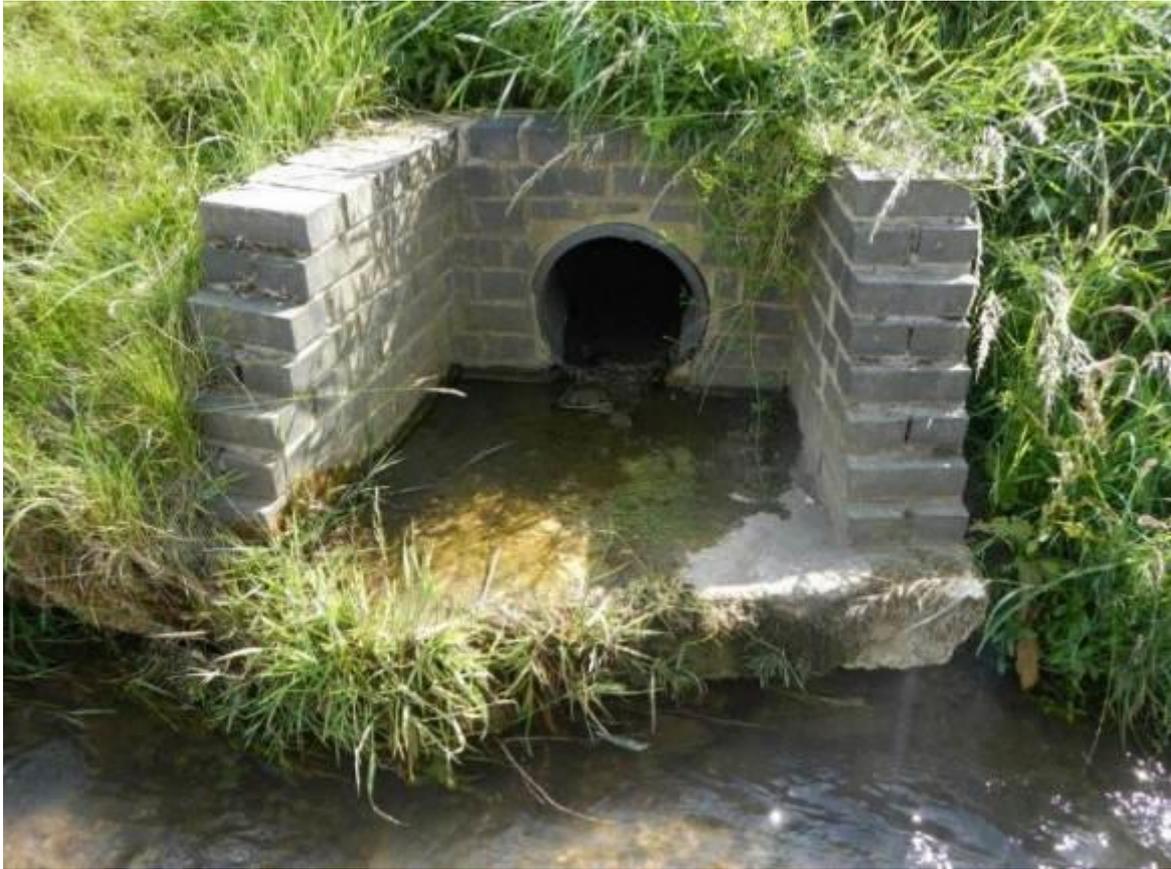
Figure 19. An outfall at SP 07834 38490 appeared to pose no major issues, although a slight increase in algae was observed on the apron. It was initially suspected to be fed by surface water from the park but tufa within the pipe suggests a groundwater component.

Fig	Location	Issue	Proposed action	Priority (1-3)
19	SP 07834 38490	Outfall	Elevated algal growth was noted around the pipe so monitoring/observation of the outfall may be beneficial.	3
23 & 24	SP 07583 38469	Elevated algal growth	Investigate STW discharge to the watercourse further u/s.	2
37, 36 & 39	SP 06454 39104	Discharge	Investigate suspected septic tank issues. Also manure midden adjacent to watercourse. (Fig 39 – suspected impact)	1
47	SP 06289 40213	Discharge	Investigate suspected septic tank issues.	1
54	SP 06266 40622	Herbicide	Investigate herbicide use next to watercourse	2
105	SP 06586 44069	Discharge	Investigate suspected septic tank/misconnection issues	1
113	SP 06453 44836	Discharge	Investigate pipe discharge for excess nutrients and chemicals.	1
115, 116 & 117	SP 06435 44857	Discharge	Investigate pipe discharge for excess nutrients and chemicals.	1
119	SP 06329 44900	Discharge	Investigate pipe discharge for excess nutrients and chemicals.	1

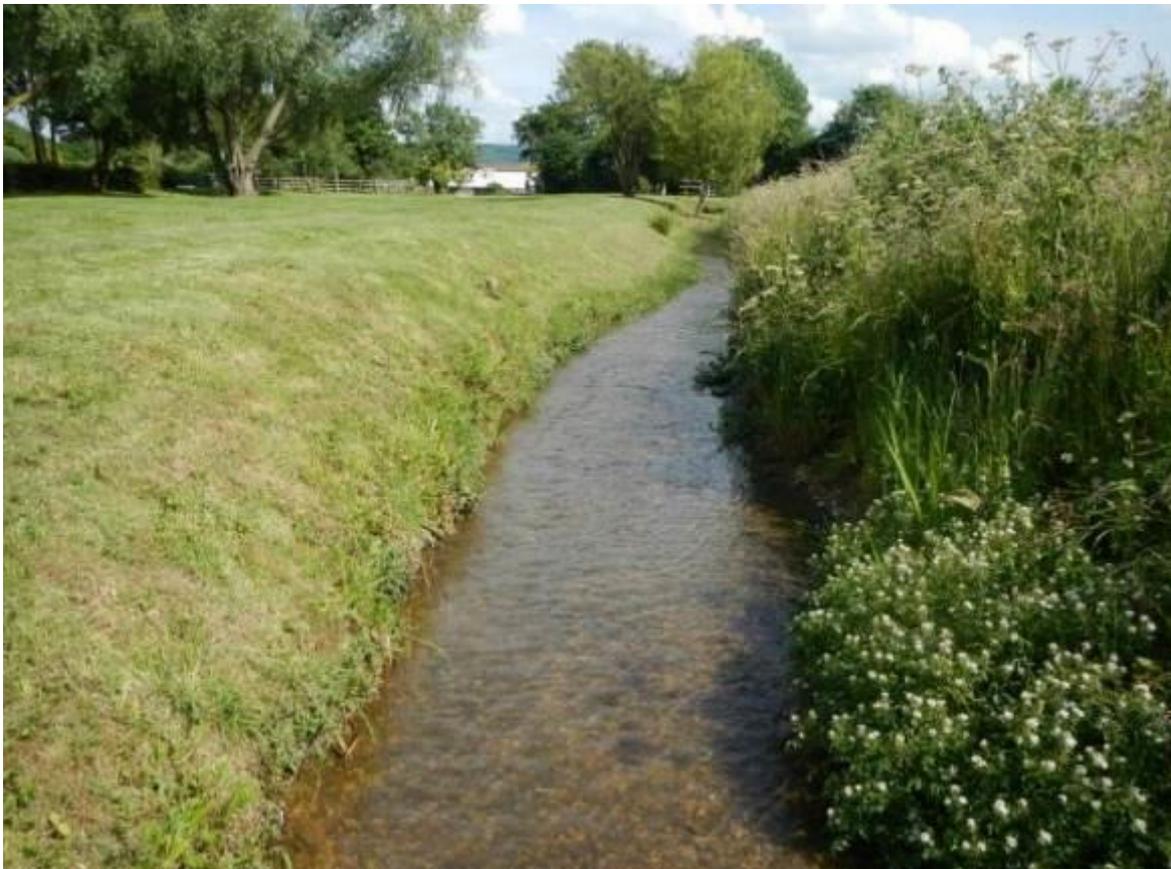
Figure 20. Immediately d/s of the Holiday Park the LB habitat is good but maintenance of the RB degrades marginal habitat. The substrate quality is also good but the straightened channel offers limited habitat diversity or fish holding capacity. Possible restoration site.

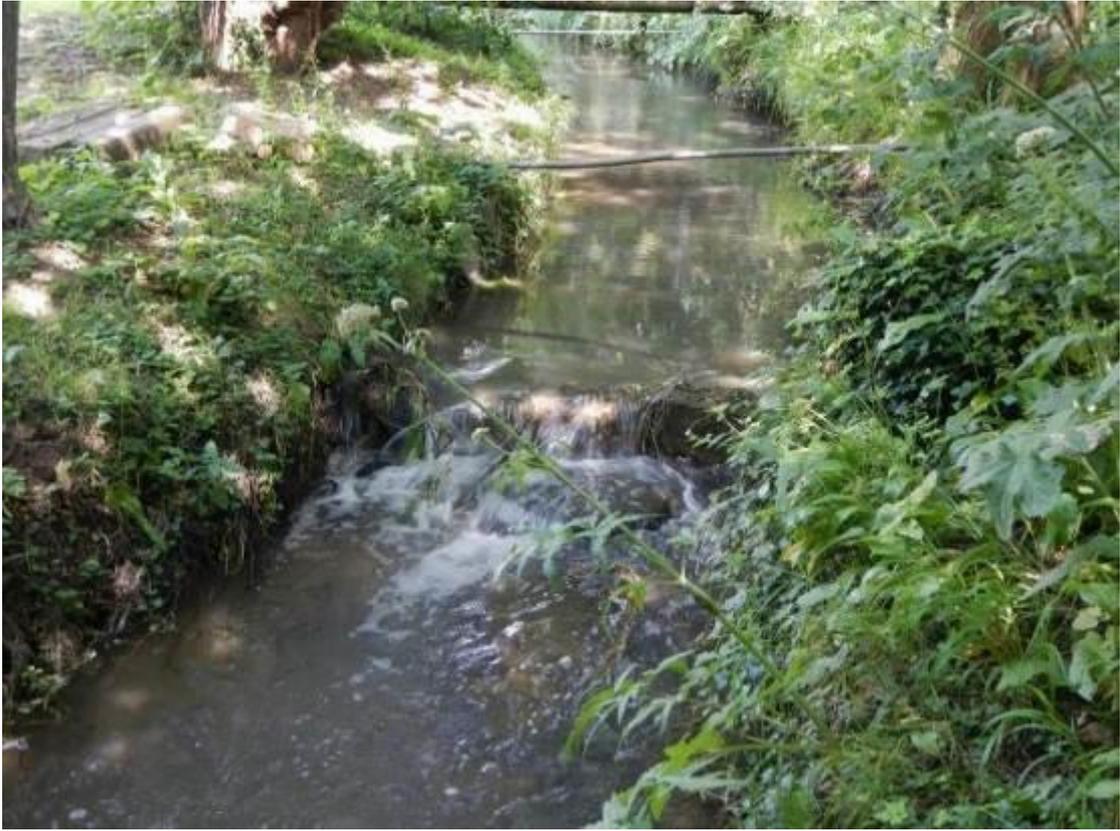
Figure 21. At SP 07709 38490 a low-level weir within a private garden creates an impoundment, interrupts sediment transport and a small obstruction to fish passage. Much of the channel in this area is straightened and shallow. The garden to the RB and rough ground to the LB may offer potential for river restoration.

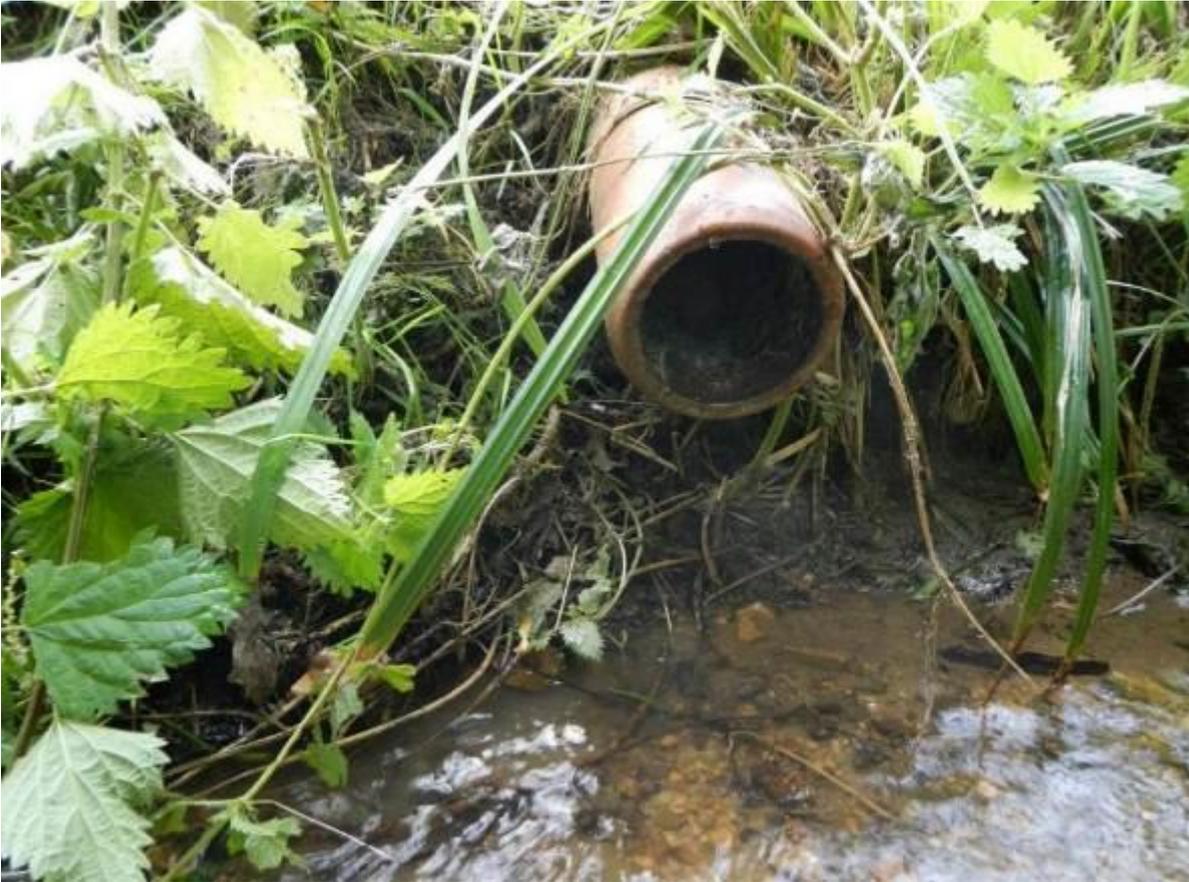
Figure 27. A pipe observed at SP 07383 38571 poses no obvious impact upon the brook.

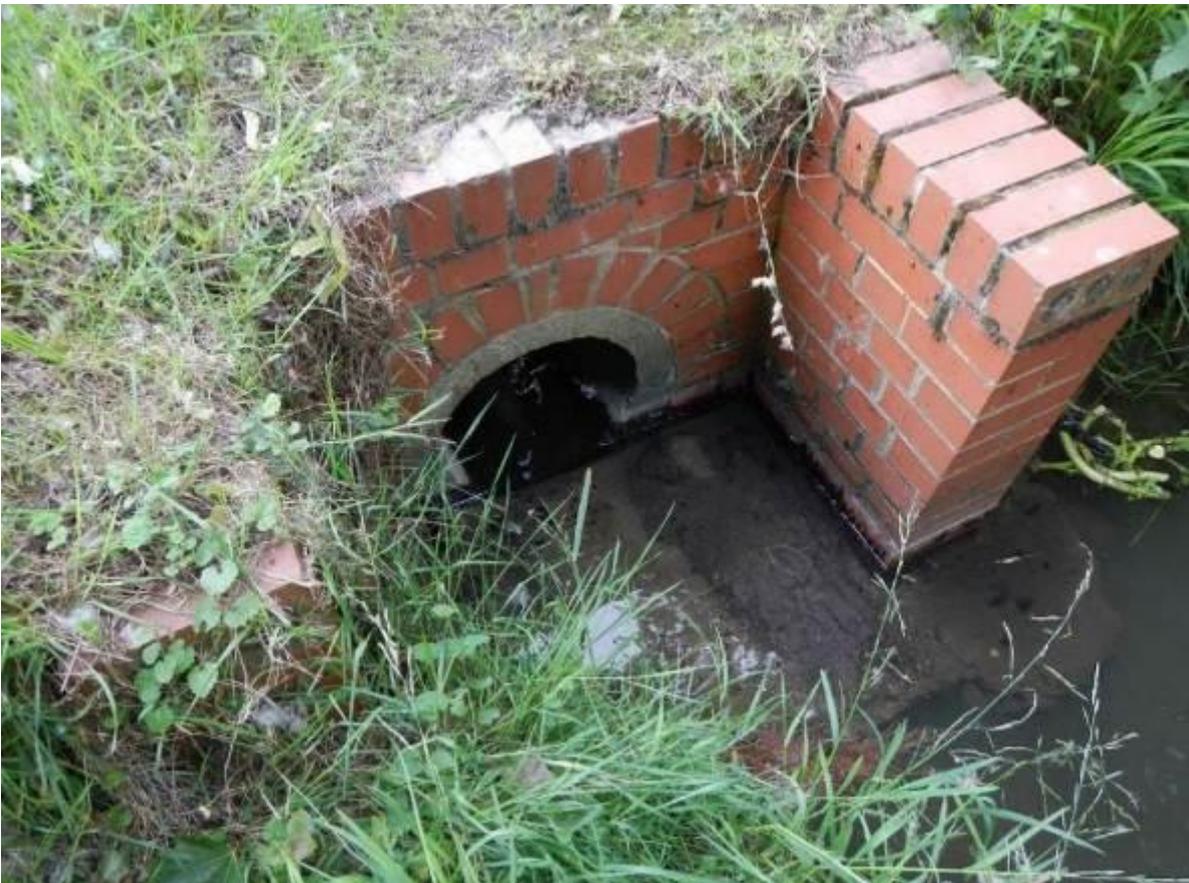
Figure 28. A small outfall just d/s was flowing at the time of the visit; the volume and clarity of water, and substrate supplied, suggest that this may actually be a small tributary that has been piped beneath the village.

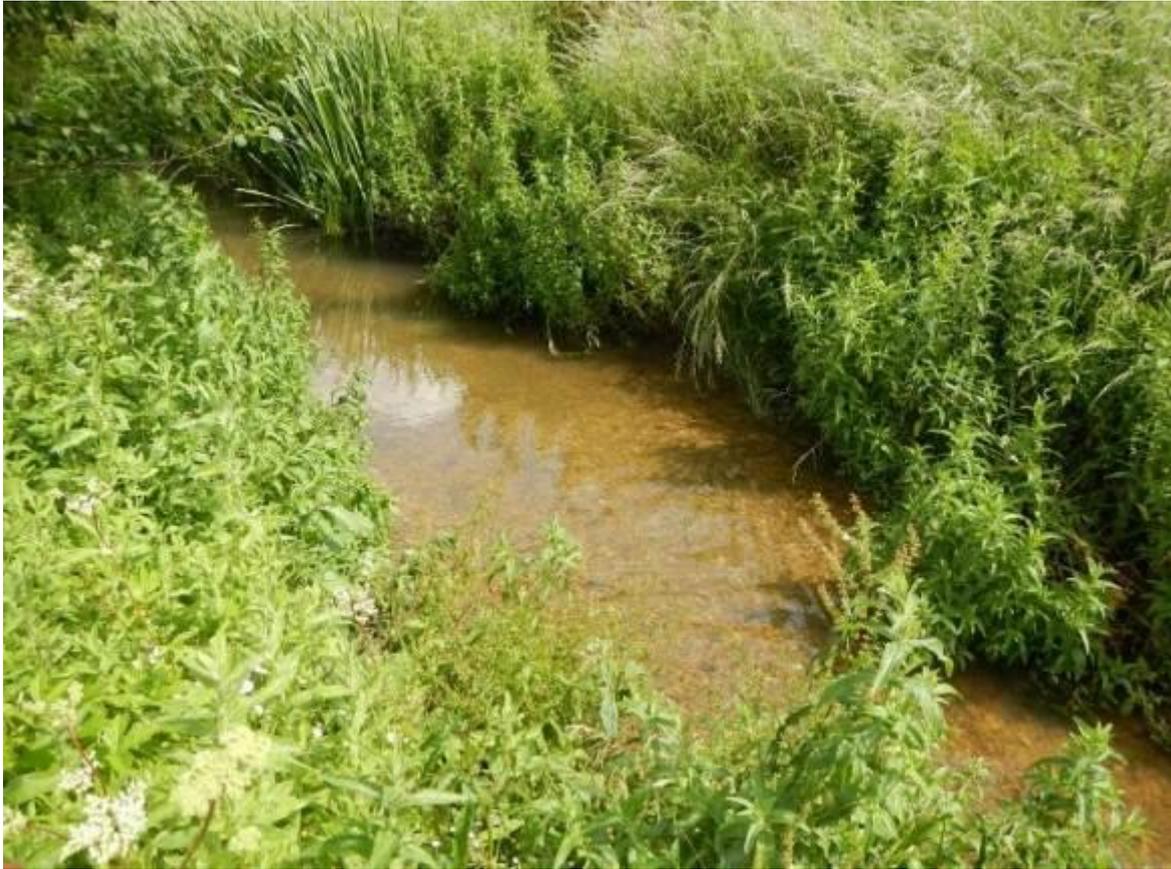
Figure 29. Greater width and depth variation around the mid-point of the village and a good buffer of diverse marginal and emergent vegetation improve habitat quality. Note the bright, algae-free substrate suggesting that inputs/algae observed u/s are localised issues, and also the further improved water clarity.

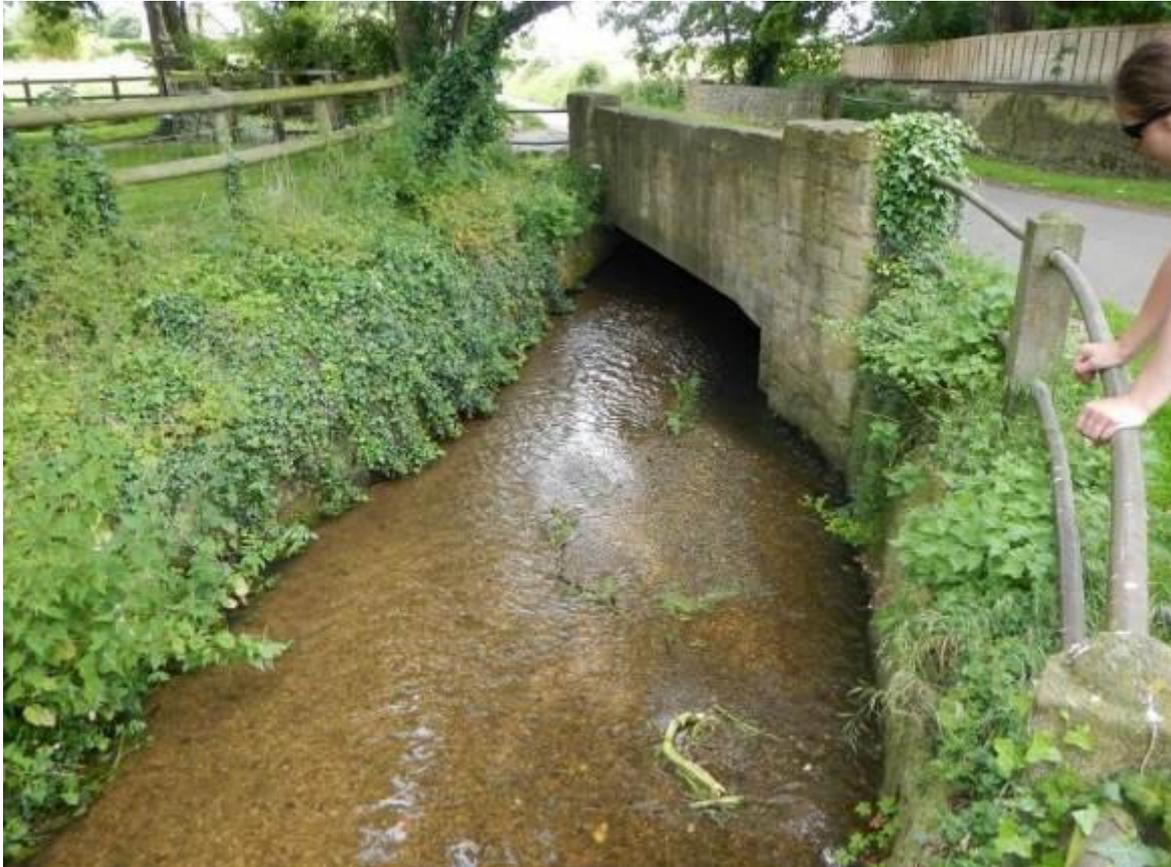
Figure 30. The clear-span/sunken culvert road crossing at SP 07148 38726 poses no major issues.

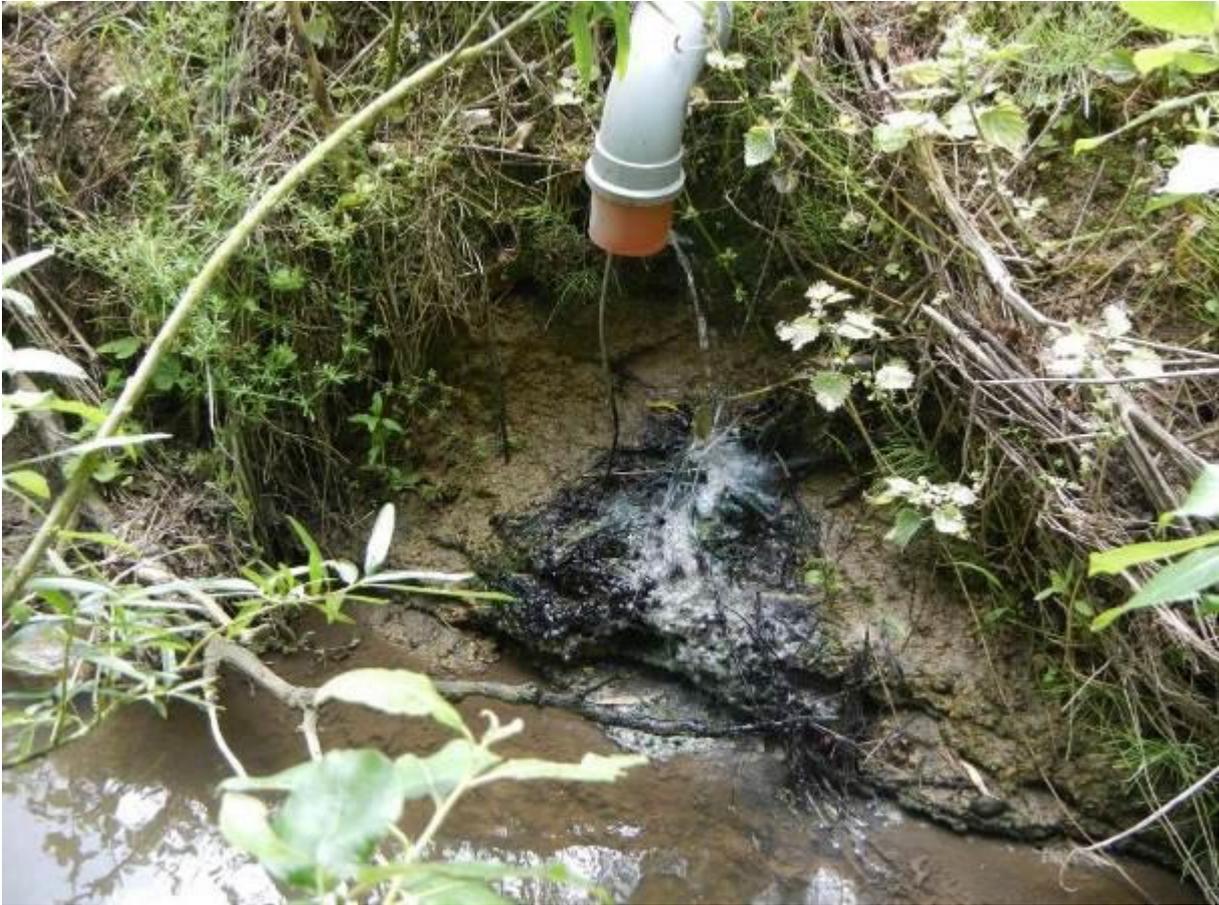
Figure 37. At SP 06454 39104, the putrid smelling outfall of what appeared to be a poorly maintained septic tank was observed.
