Walkover Assessment
Badsey Brook (Warwickshire Avon) catchment
14-15/06/2017

Undertaken by Gareth Pedley

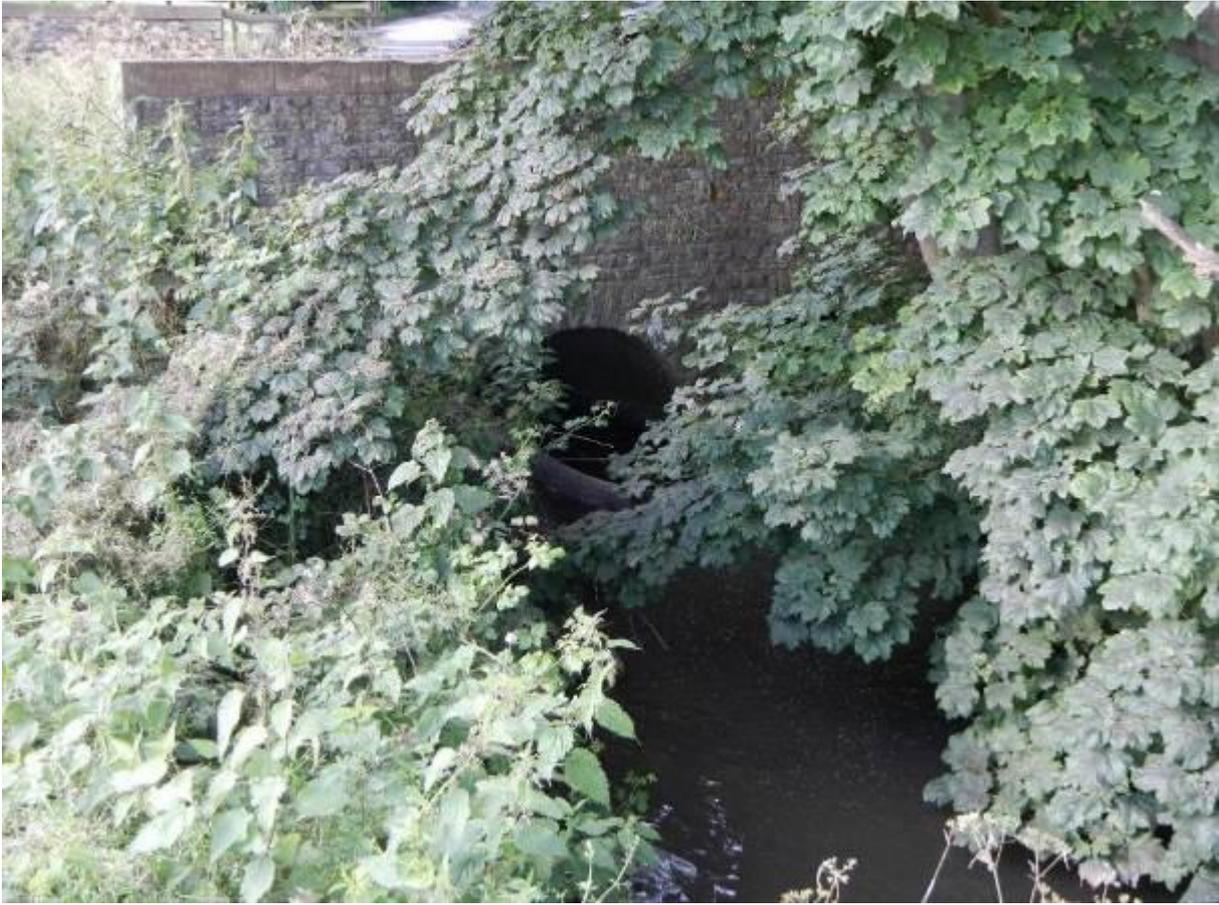
Figure 38. The Horton Road crossing at SP 06451 39119 poses no particular issues.

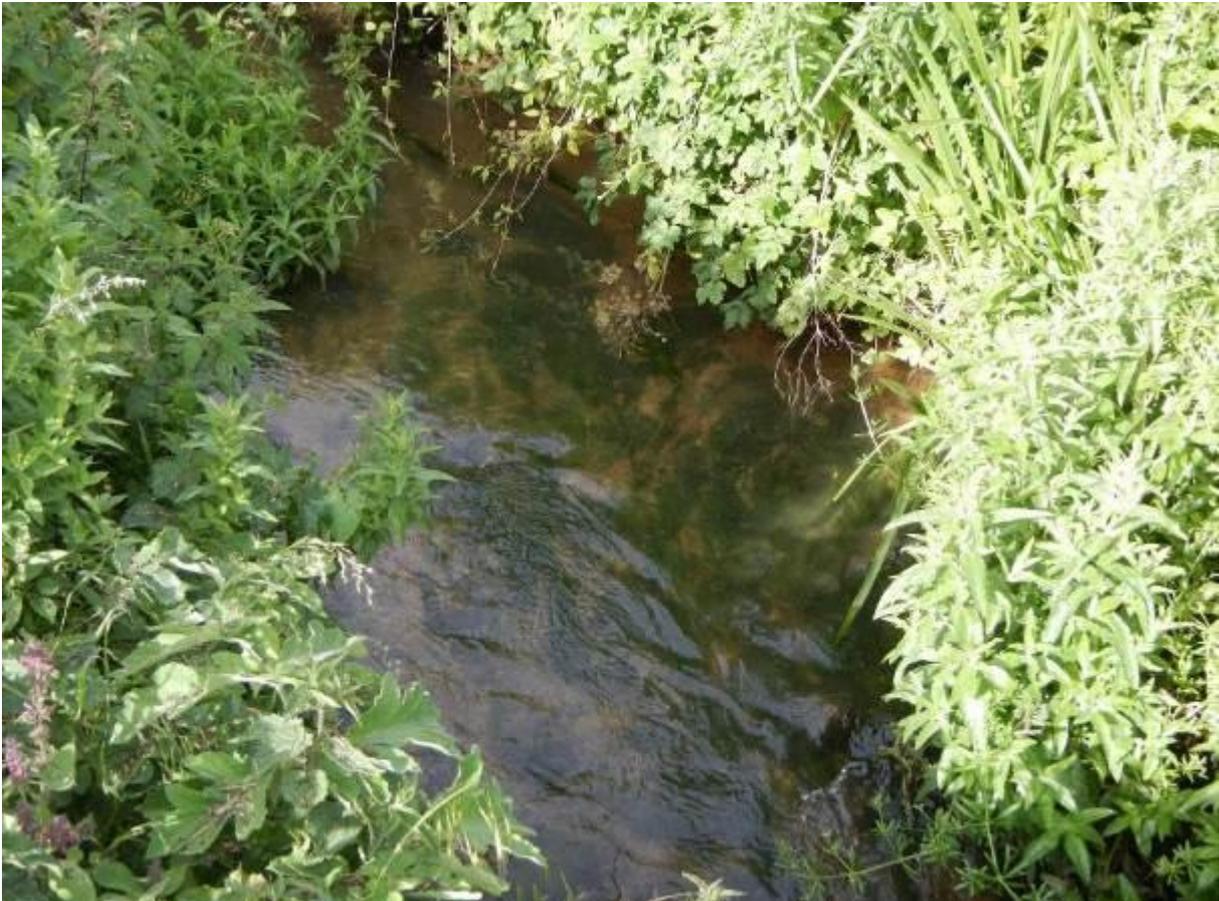
Figure 39. From d/s of Horton Road, and just a short distance d/s of the midden and suspected septic tank discharge, significantly elevated algal growth was noted on the river bed, for some distance d/s.

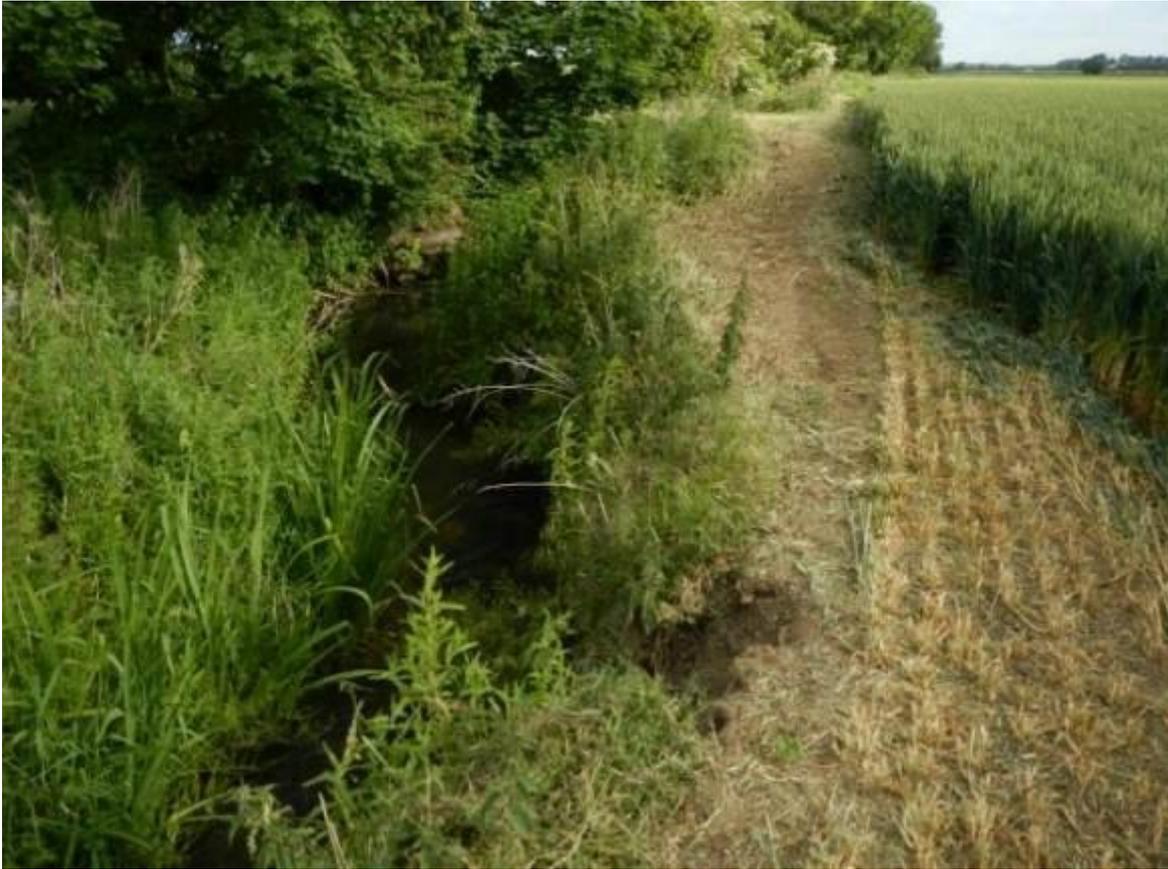
Figure 40. The channel d/s of Horton Road is notably straightened and incised, with only a minimal buffer strip (potentially contributing to eutrophication of the brook). Consequently, as the channel naturally adjusts, it is encroaching on the cultivated land; indeed, the buffer has been lost in at least one location (SP 06460 39192).

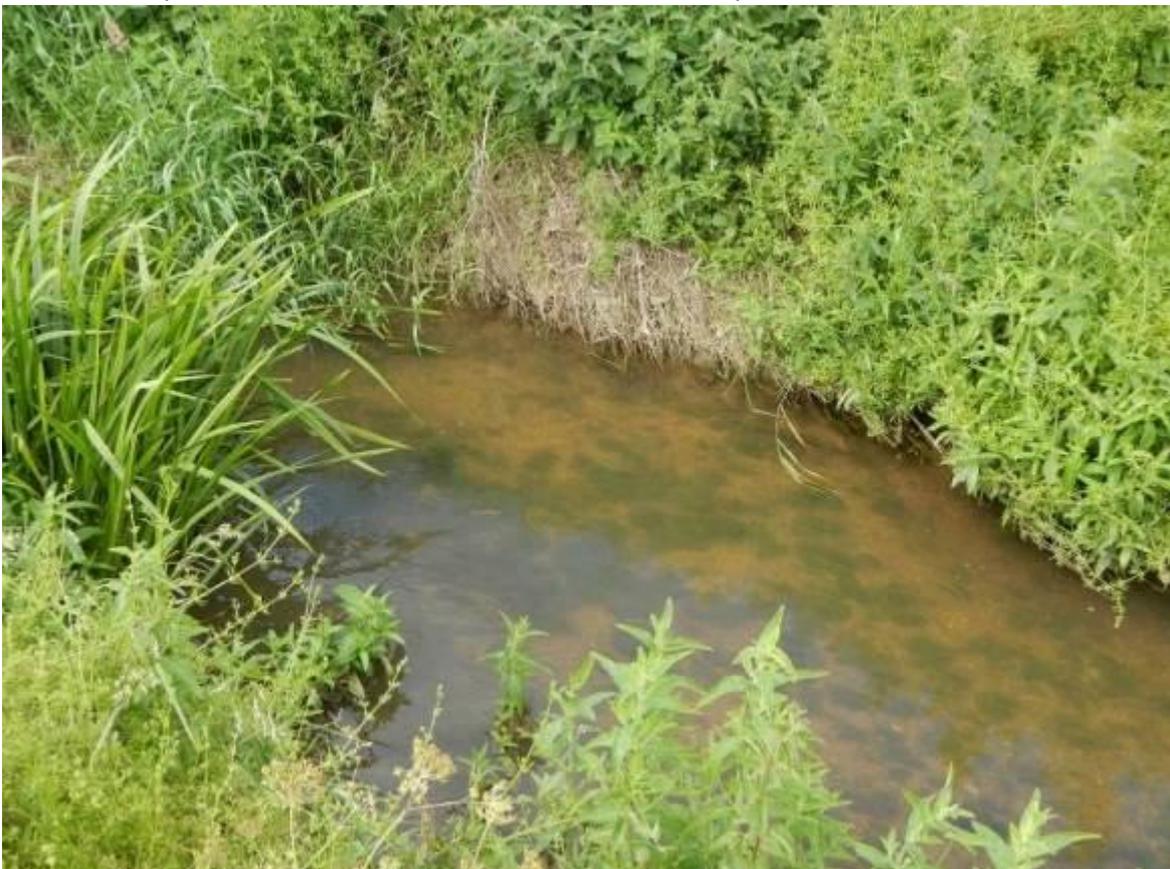
Figure 43. The impact of eutrophication on algal growth can be observed for over 1km d/s of Horton Road. Nutrients are also likely to be entering the watercourse from the poorly buffered arable fields adjacent throughout this section. Note the lack of natural substrate resulting from past straightening/dredging.

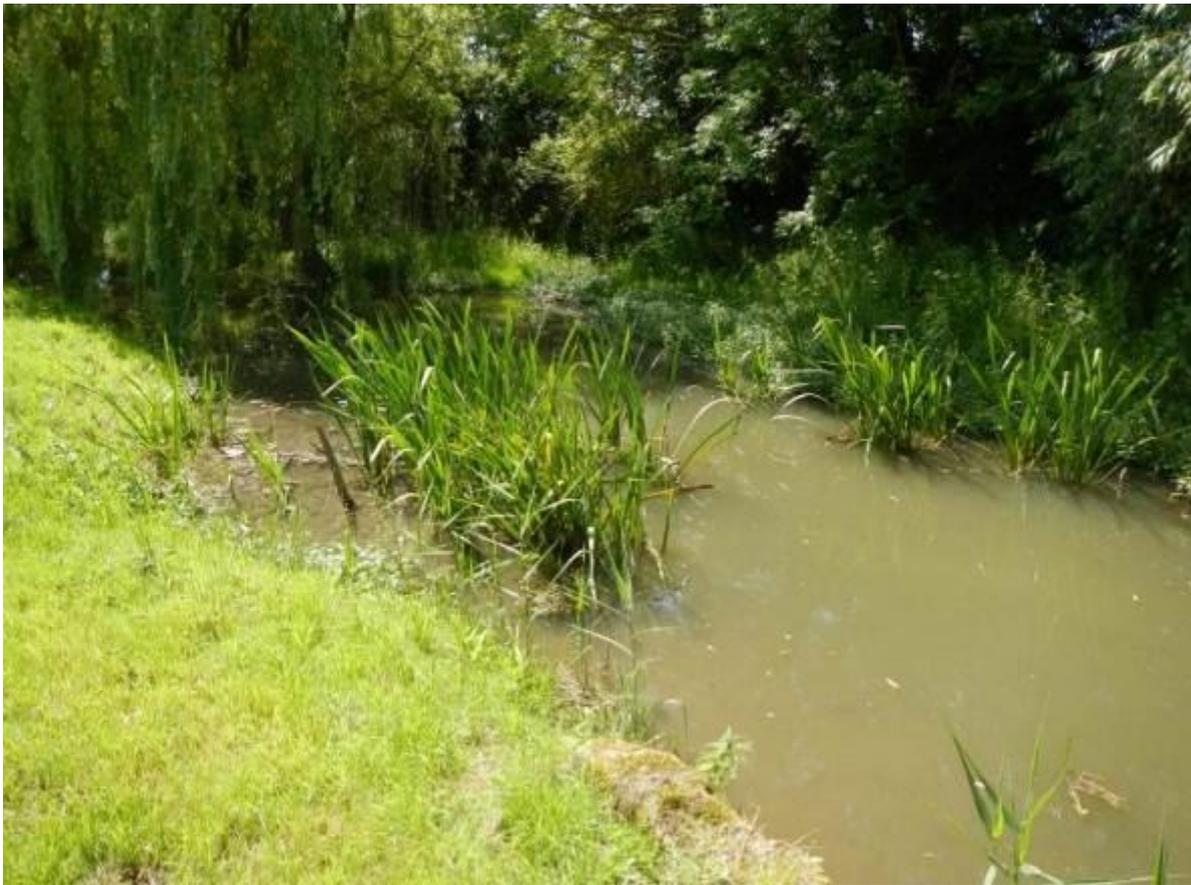
Figure 44. The brook is impounded and habitat is significantly degraded for >100m u/s of Murcot Mill weir (Fig. 45).

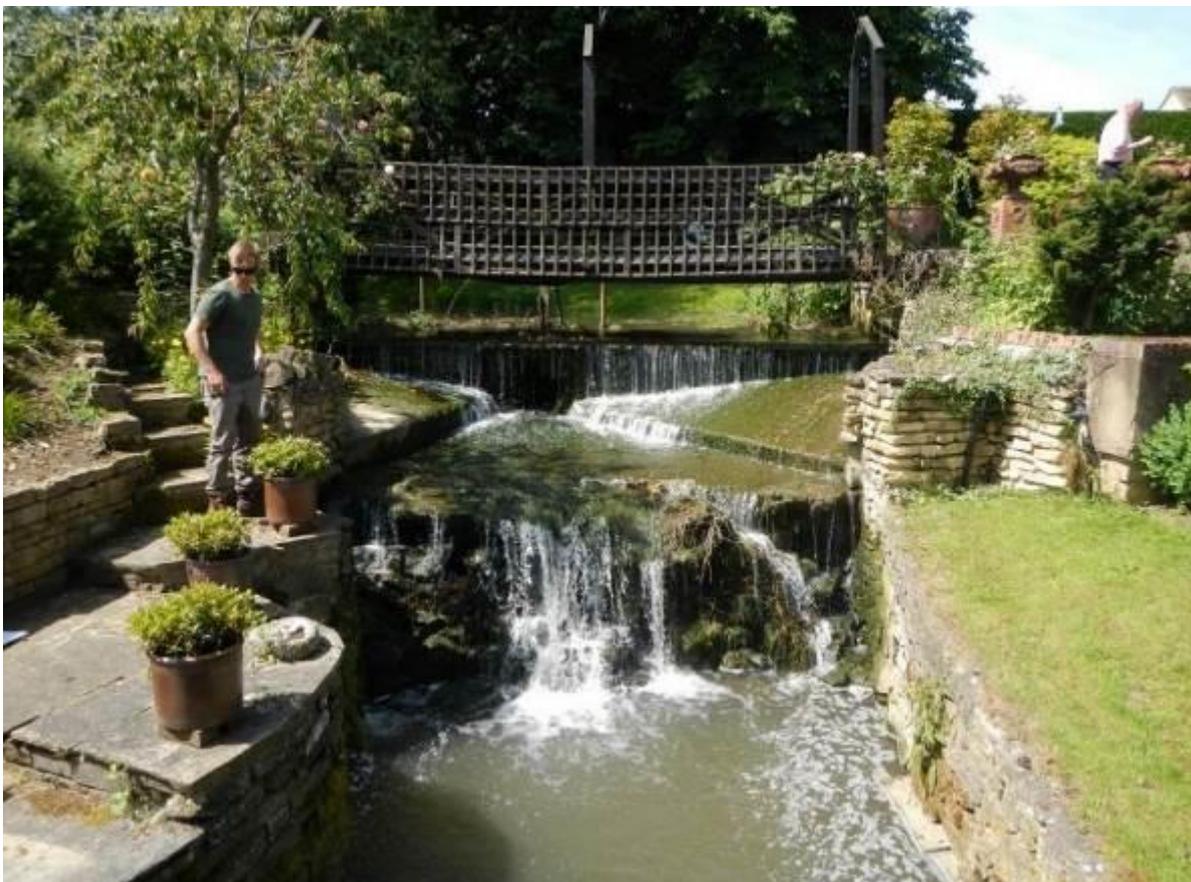
Figure 45. Murcot Mill Weir (SP 06329 40028) - a completely impassable >2m high weir. This weir further fragments the catchment, preventing fish passage into the section u/s, which are both similarly isolated as a result of Broadway and Leedon's Park Weirs.

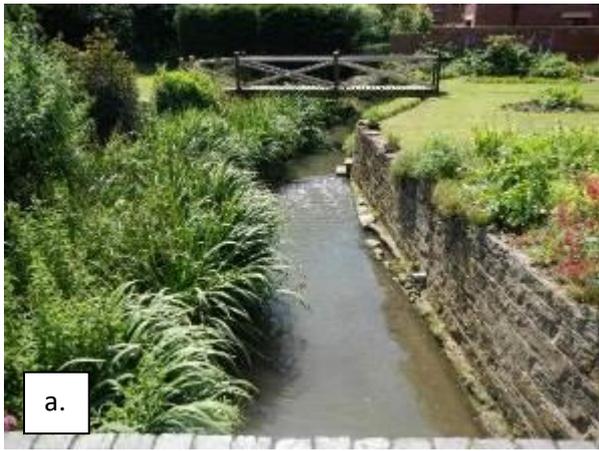
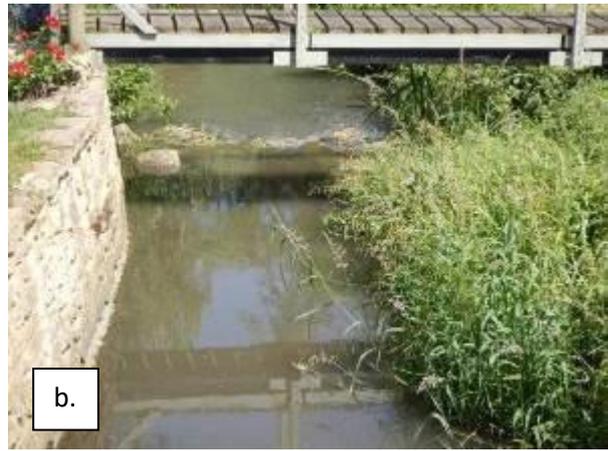
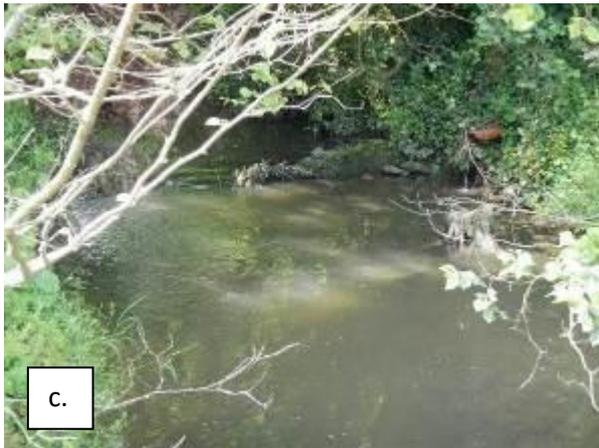
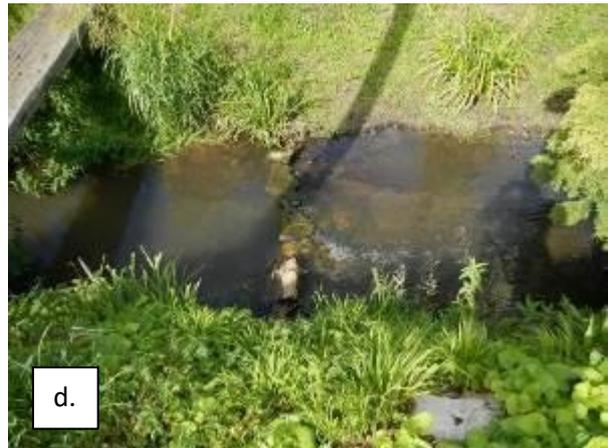
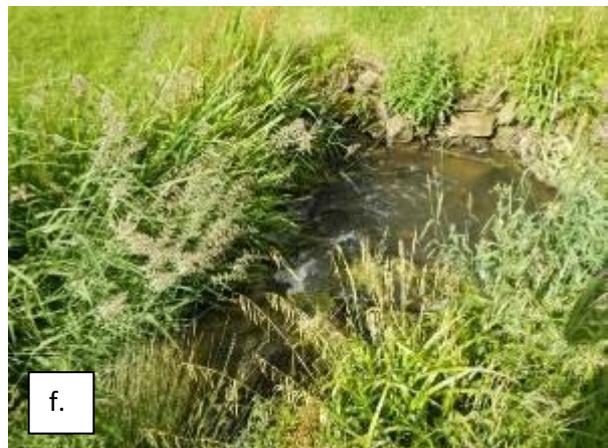
Figure 46a-f. Six small weirs d/s of Murcot Mill (at, SP 06334 40098, SP 06327 40126, SP 06305 40161, SP 06292 40208, SP 06286 40223 and SP 06274 40246, respectively) create minor, passable obstructions, but greatly degrade the habitat quality in the area and, although small, interrupt sediment transport/natural geomorphological processes.

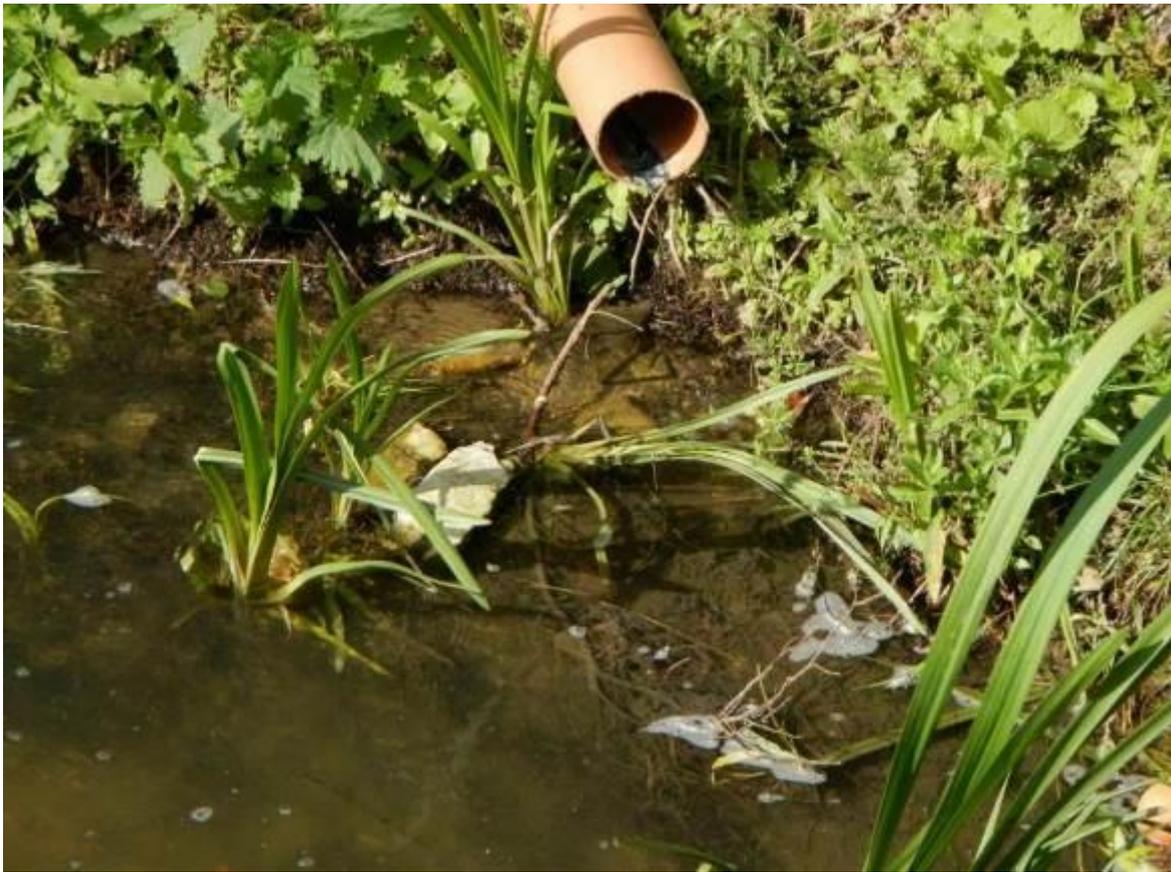
Figure 47. At SP 06289 40213, between the weir depicted in 46d and 46e, another suspected poorly maintained septic tank discharge was observed.

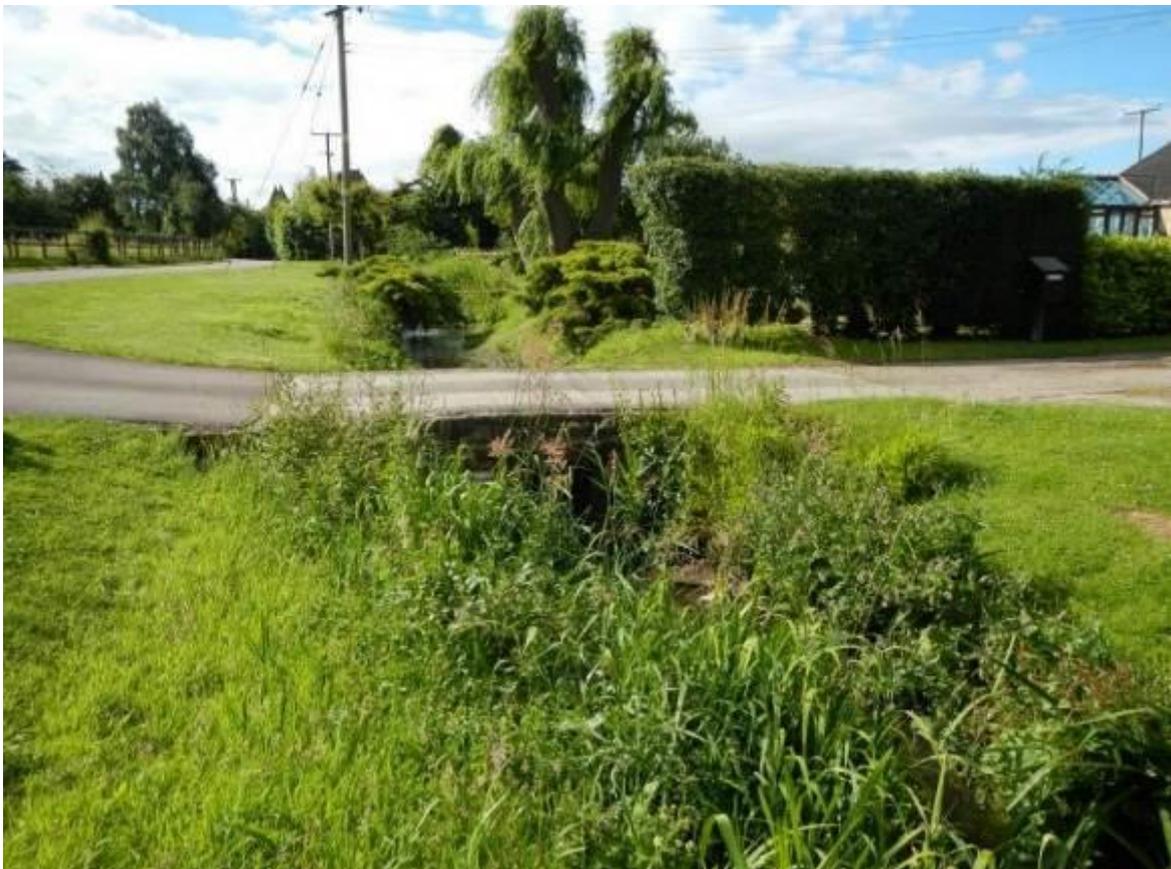
Figure 48. None of the house access crossings pose an issue to the free movement of fish or sediment and, without the weirs, areas in which the vegetation has not been overly maintained could otherwise provide reasonable quality habitat if the channel were allowed to develop.

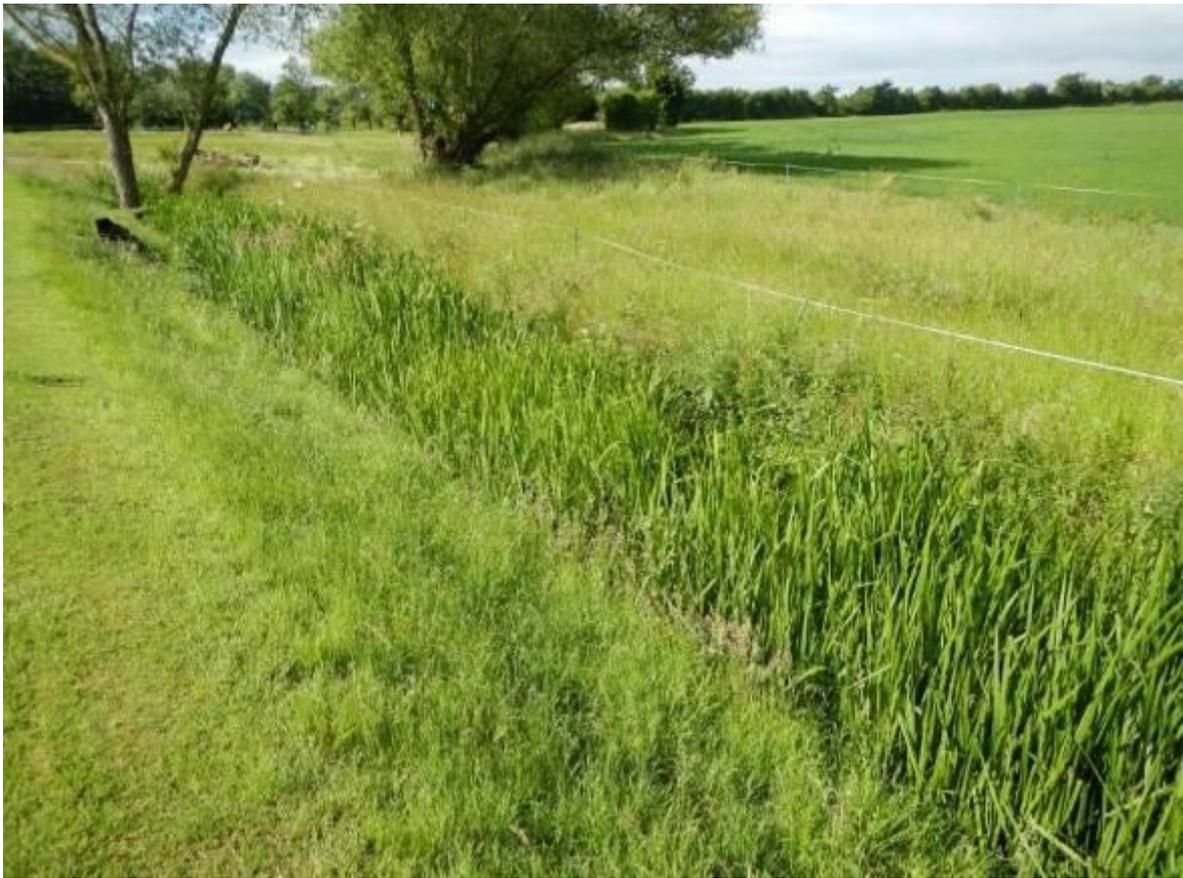
Figure 51. Evidence of ongoing channel maintenance was observed around SP 06241 40407; an over-capacity channel that has led to uniform deposition and encroachment of marginal/emergent plants, and has become weed-choked (actually now greatly reducing conveyance in comparison to a more natural channel, capable of maintaining its capacity).

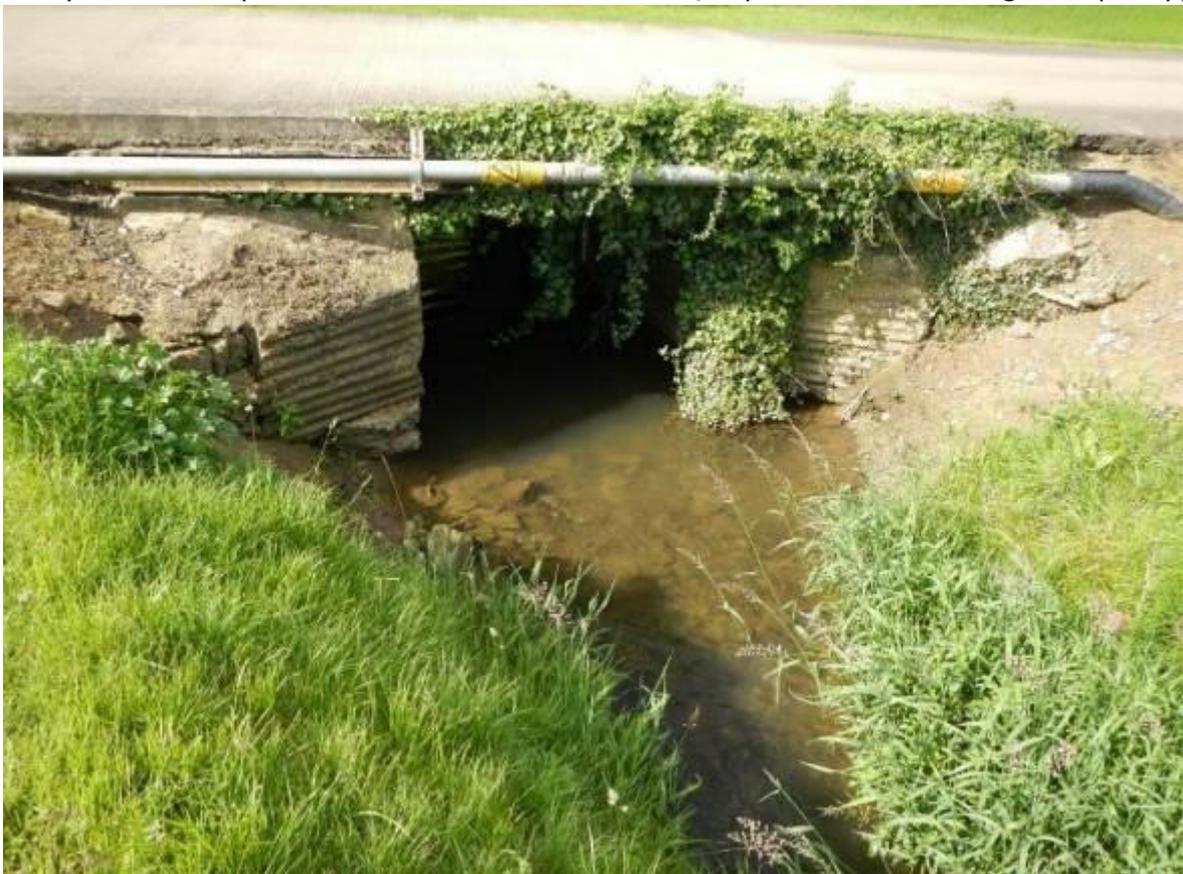
Figure 52. At SP 06253 40460, a clear-span crossing poses no issues to fish or sediment movement.

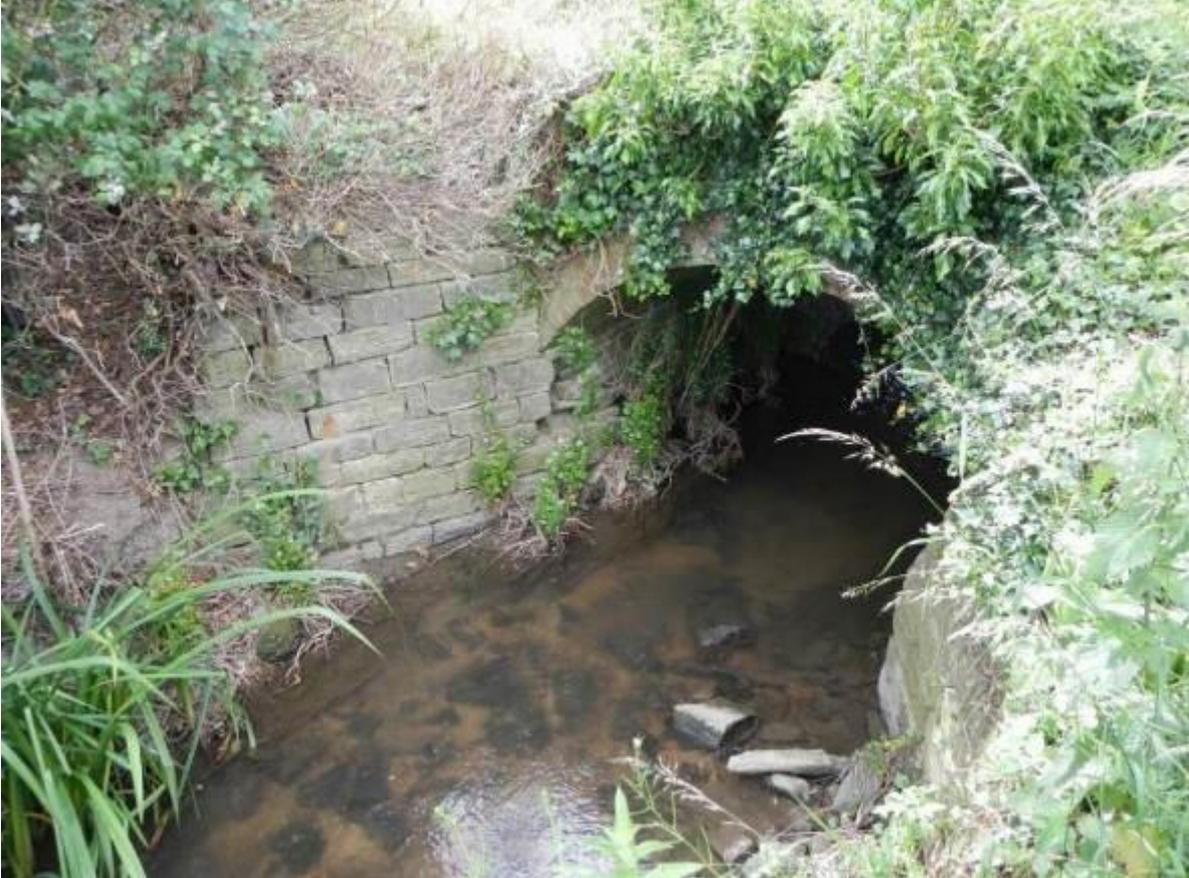
Figure 64. The Mill access track crossing at SP 06513 41193 currently poses no issues but did appear to be degrading.

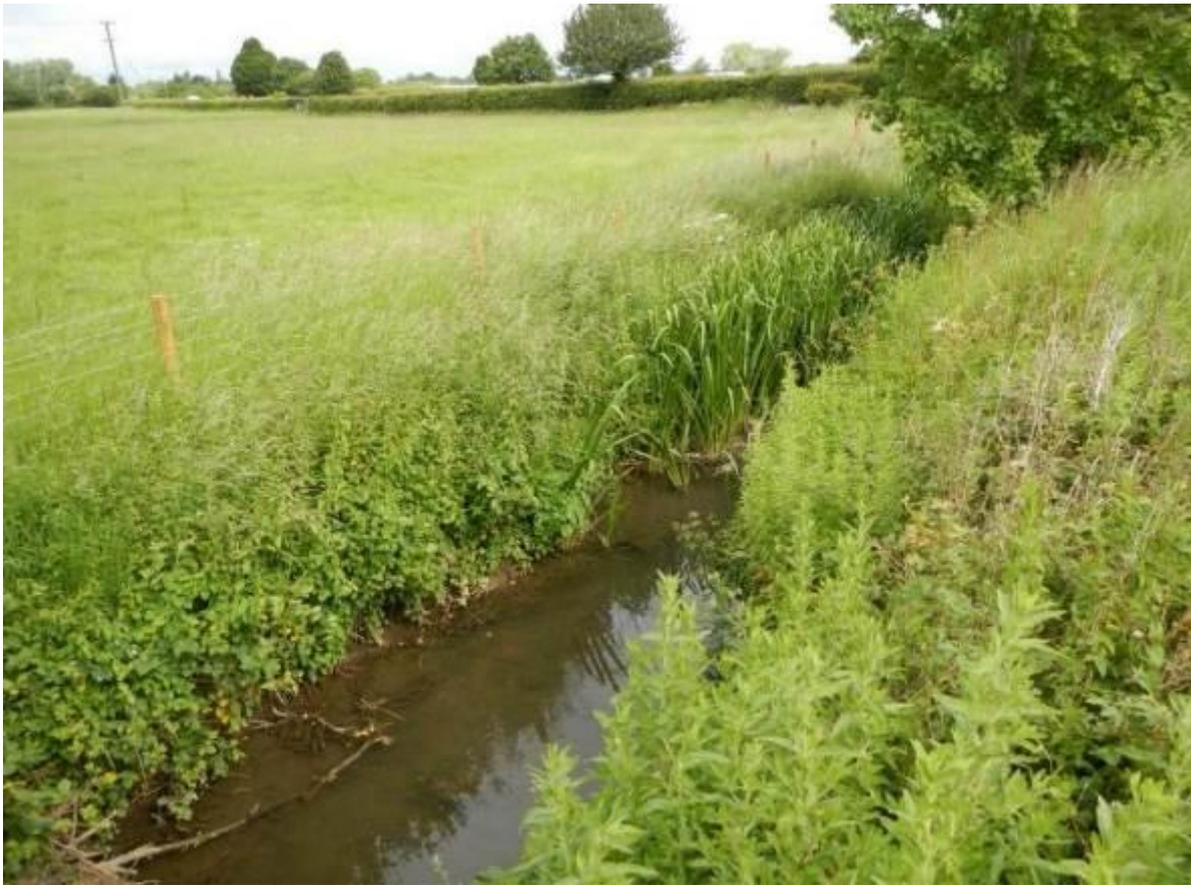
Figure 65. Although buffered, habitat within the over-capacity channel d/s of the mill provides poor quality habitat.

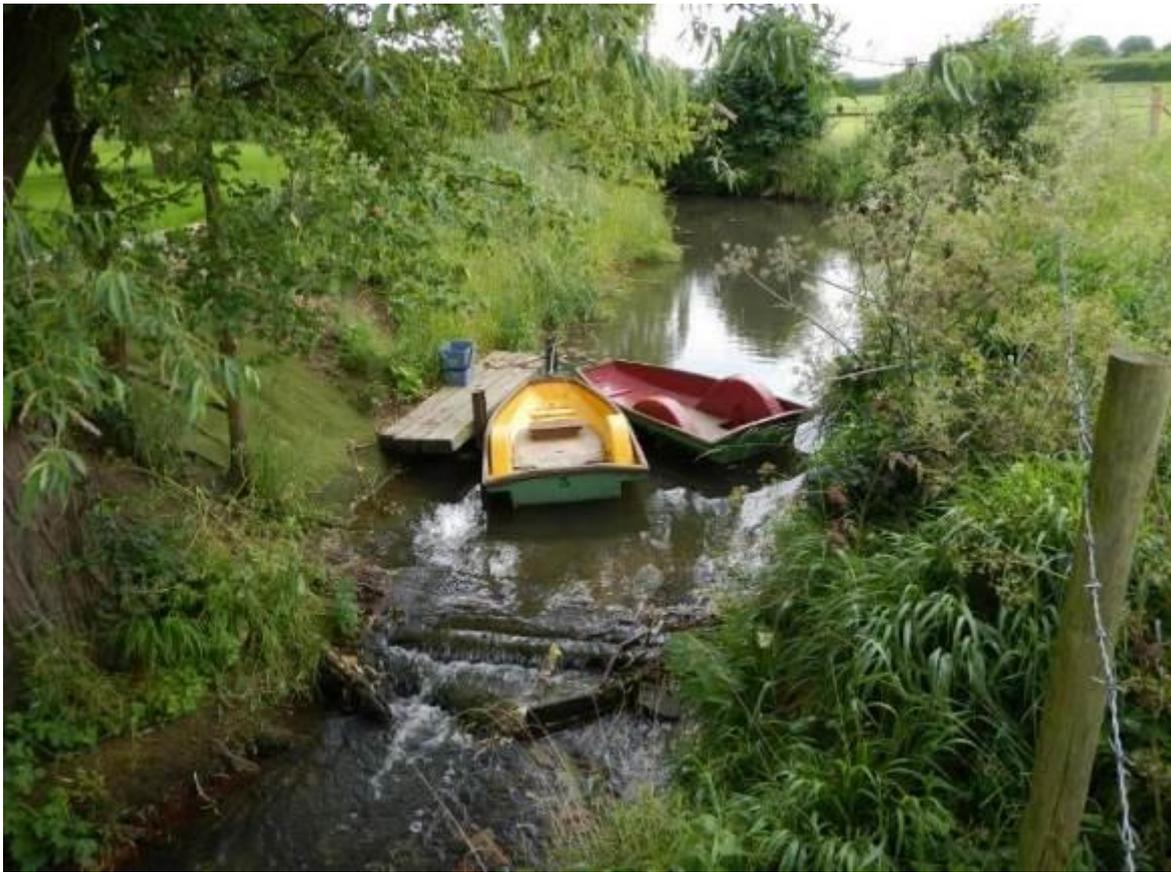
Figure 73. At SP 06584 41768, dredging and widening of the channel combined with a weir creates a small boating pool, greatly degrading the channel. This destruction of habitat should be addressed; it is likely to be unconsented work.

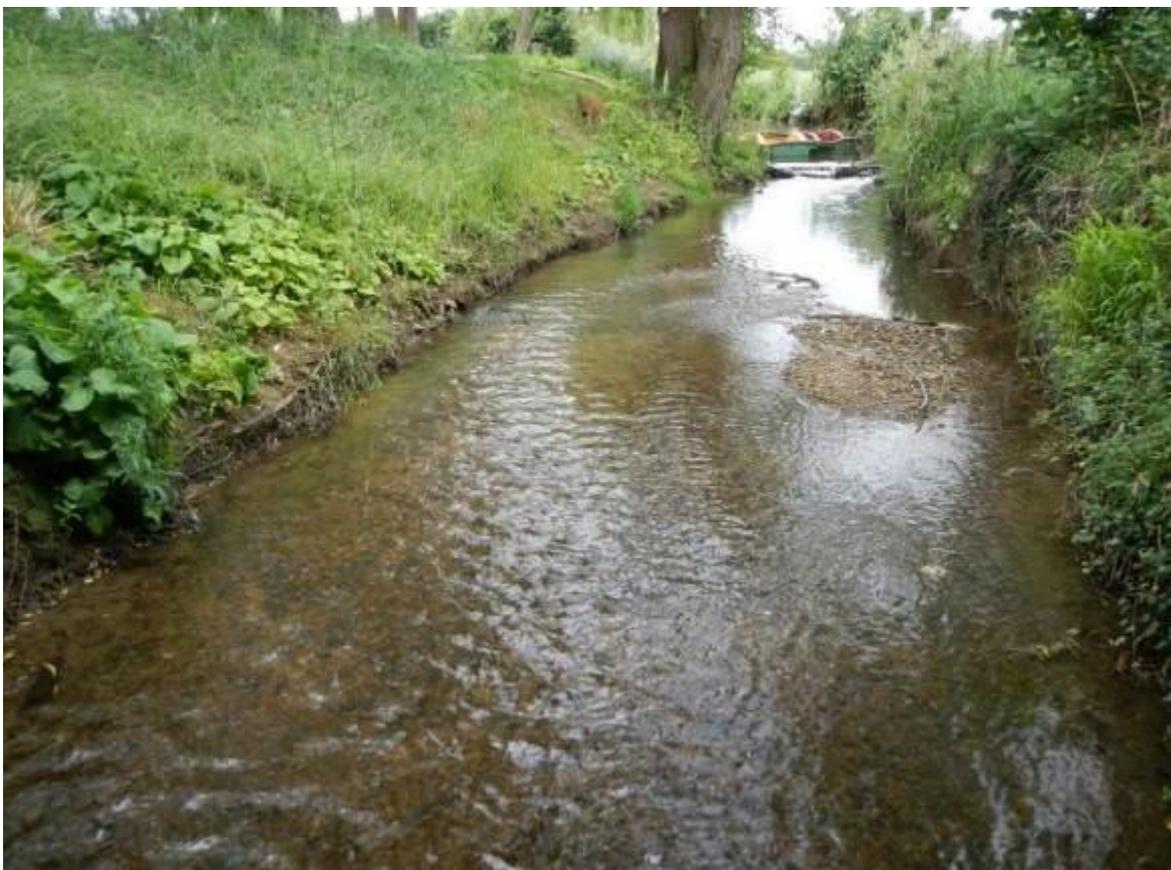
Figure 74. Immediately d/s of the boating area, some improved substrate habitat has been allowed to develop, and provides an example of the kind of features that should be expected in the absence of dredging and straightening.

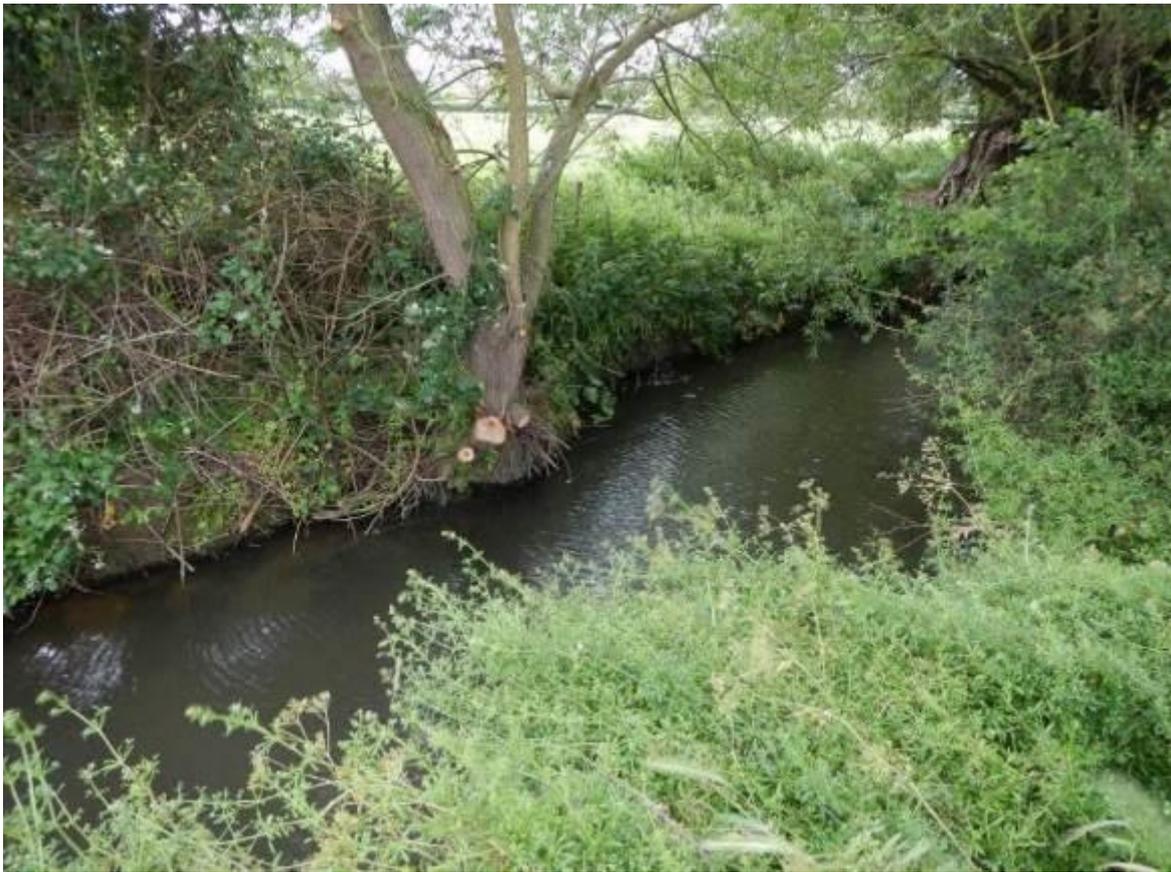
Figure 77. The dredged channel becomes increasingly poor quality habitat as the impoundment of the weir structure around Manor House begins to influence the flow. Tree pruning/maintenance undertaken in this area reduces the availability of low and trailing branch cover and further degrades habitat.

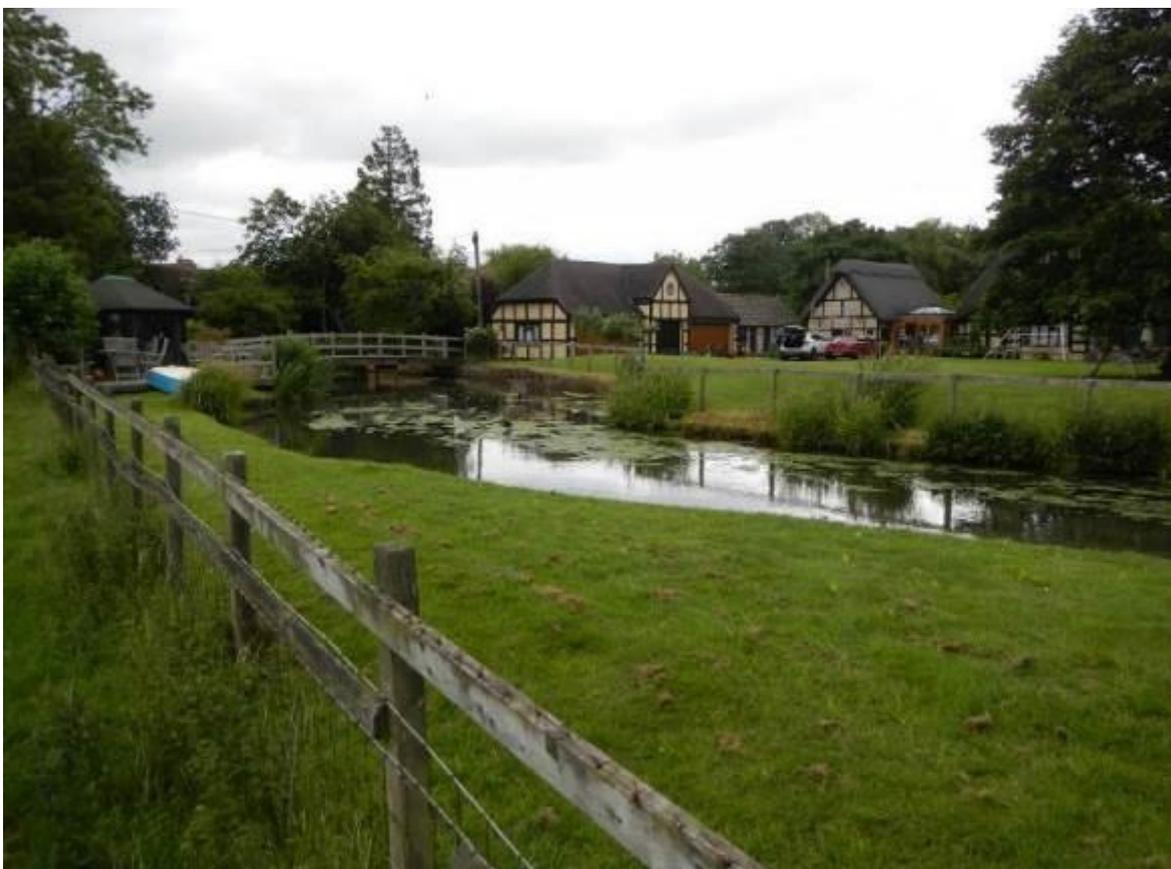
Figure 78. The impoundment u/s of Manor House weir creates an obstruction to d/s fish movement and a sediment sink, preventing substrate movement through the section.

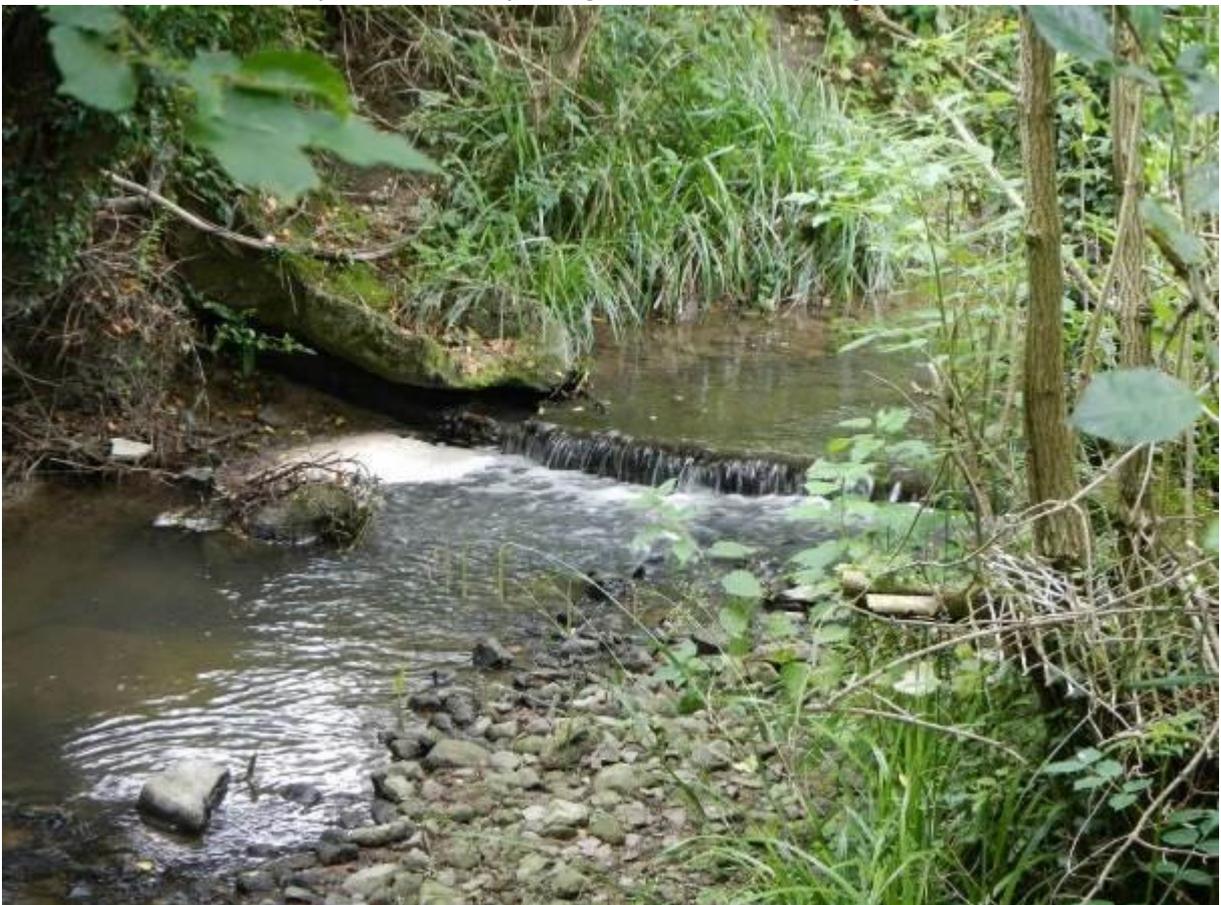
Figure 86. A small weir/armoured bed was observed at SP 06774 42287, possibly associated with services. It poses a minor obstacle and should be set well below bed level.

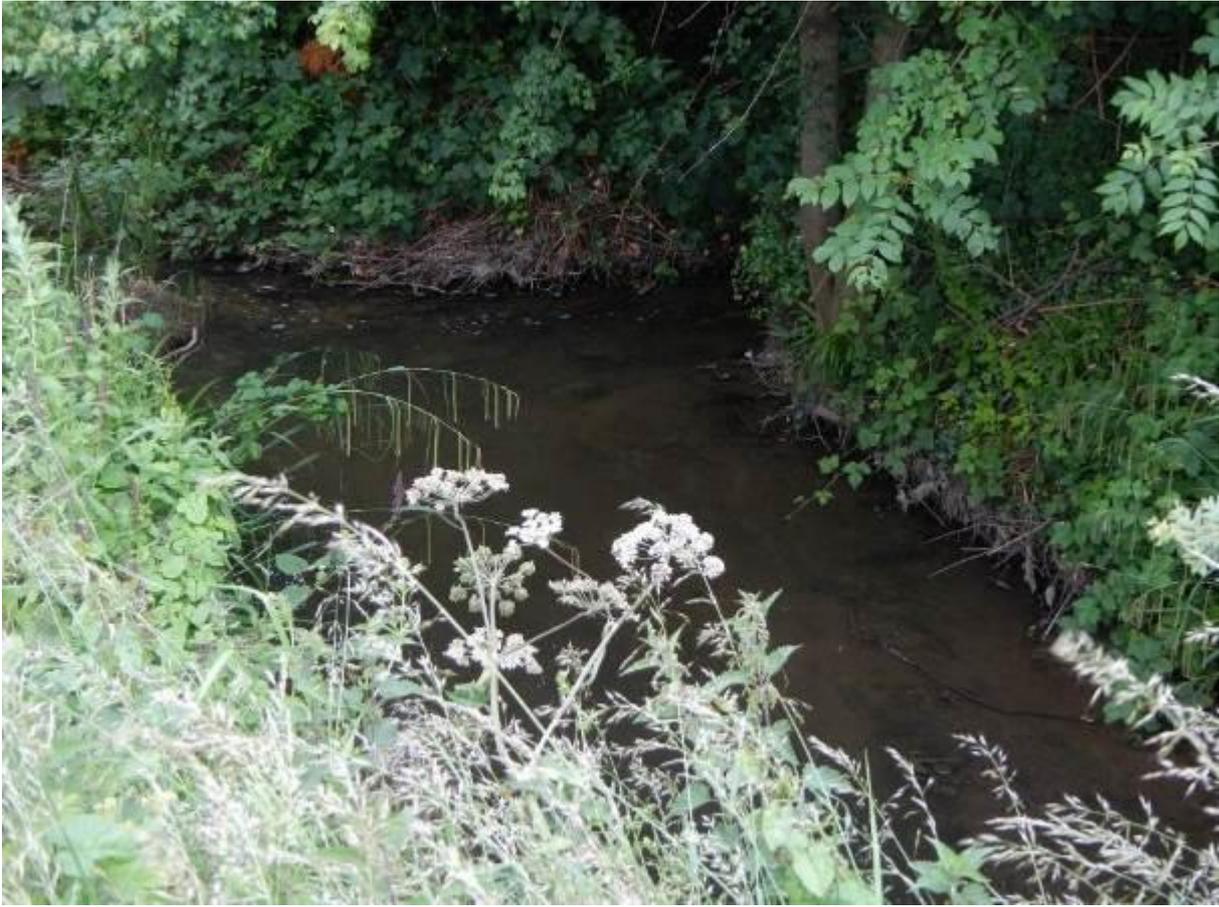
Figure 87. At SP 06891 42411 a tributary joins the brook. The water clarity appeared good and there were no obvious signs of quality issues.

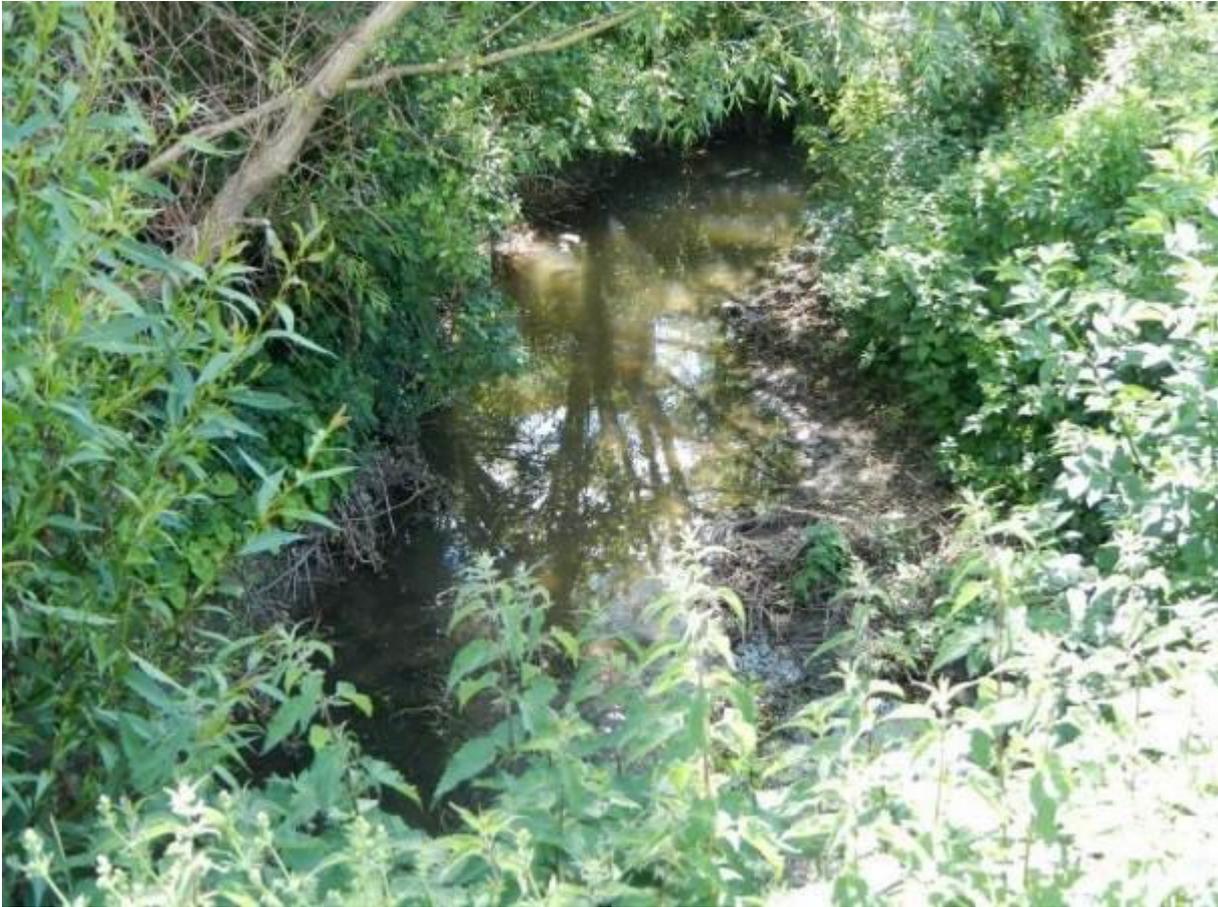
Figure 92. Where bends and depth variation are present, coupled with overhanging and trailing cover, areas of higher quality habitat were observed. Moving d/s, land use on the RB becomes private gardens and market gardening increases on the LB.
