Walkover Assessment
Badsey Brook (Warwickshire Avon) catchment
14-15/06/2017

Undertaken by Gareth Pedley

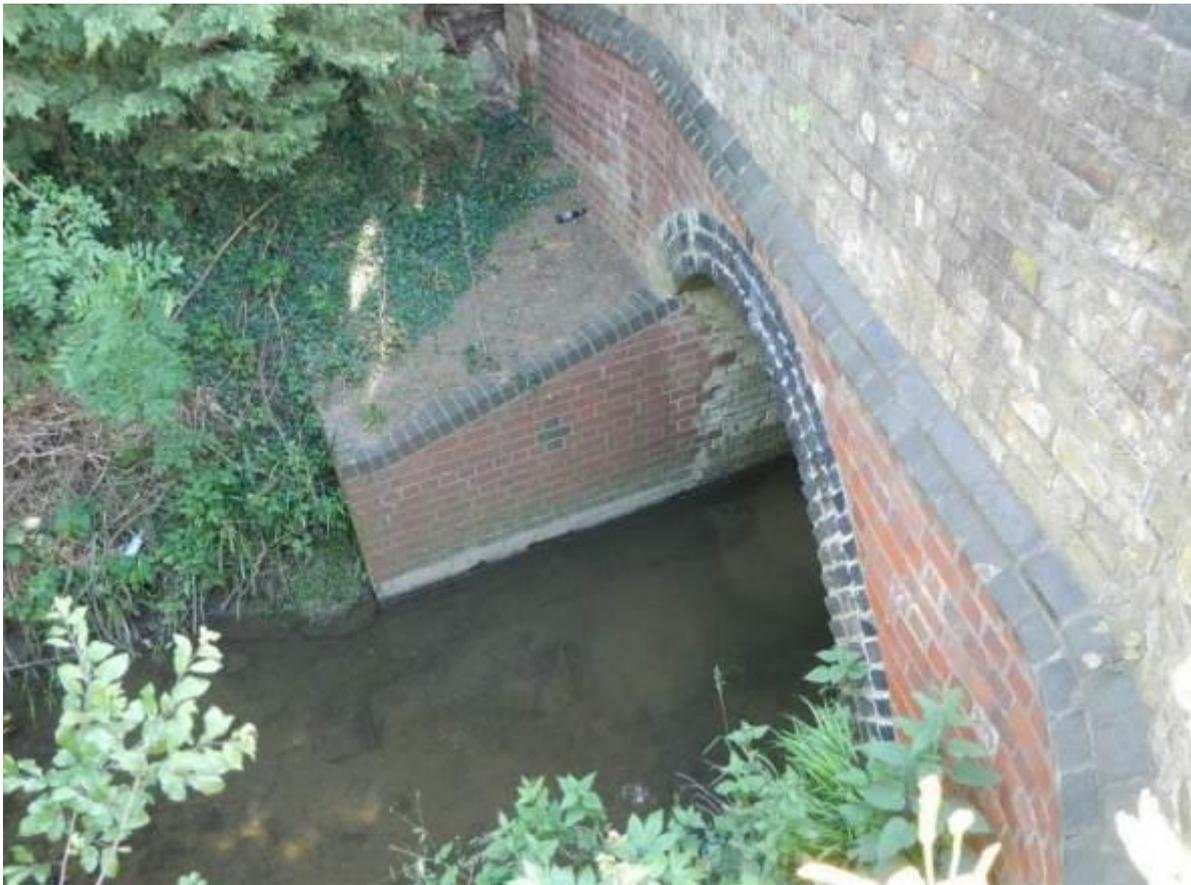
Figure 93. The Badsey Lane crossing (SP 06788 43018) poses no issues for fish or sediment movement.

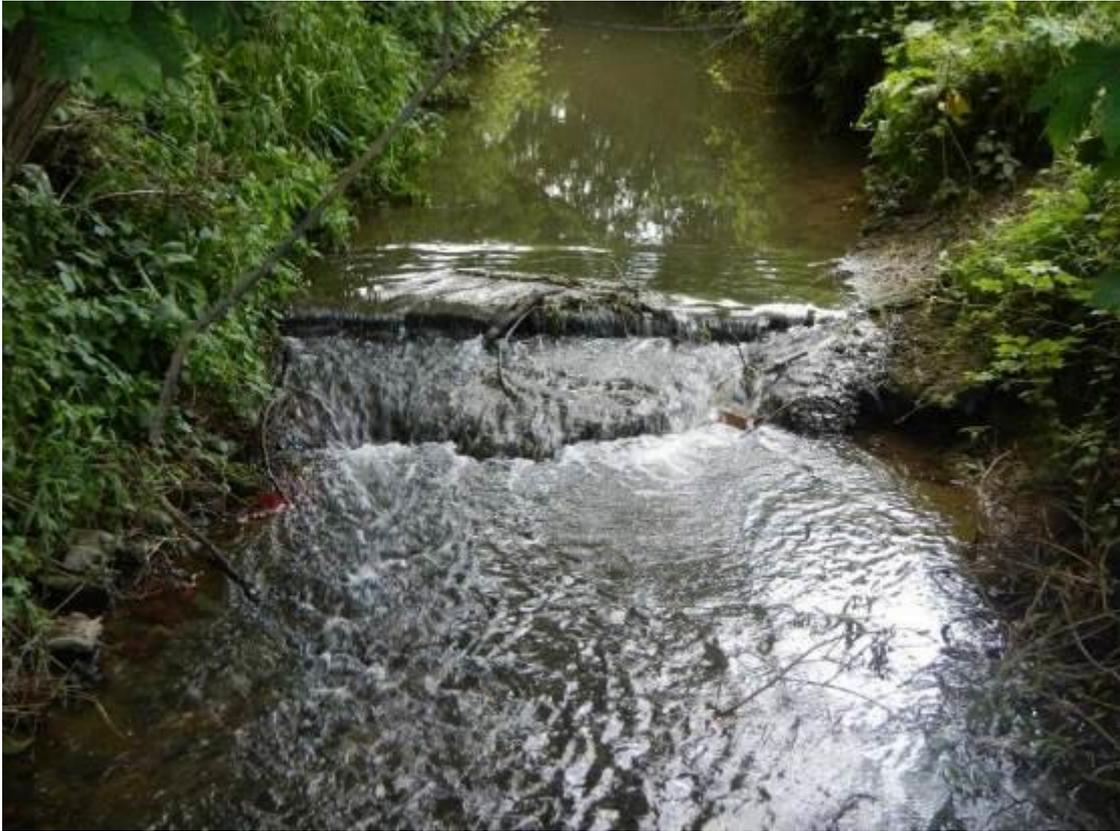
Figure 97. A weir at SP 06788 43374 poses a barrier to fish movement at low flows, impounding the brook u/s and interrupting sediment transport. Large numbers of fish were observed congregating in the riffle below. This suggests that the uniform channel and impounded water u/s, and from a short distance d/s of the weir, do not provide suitable habitat for rheophilic species in low flow, high temperature conditions.

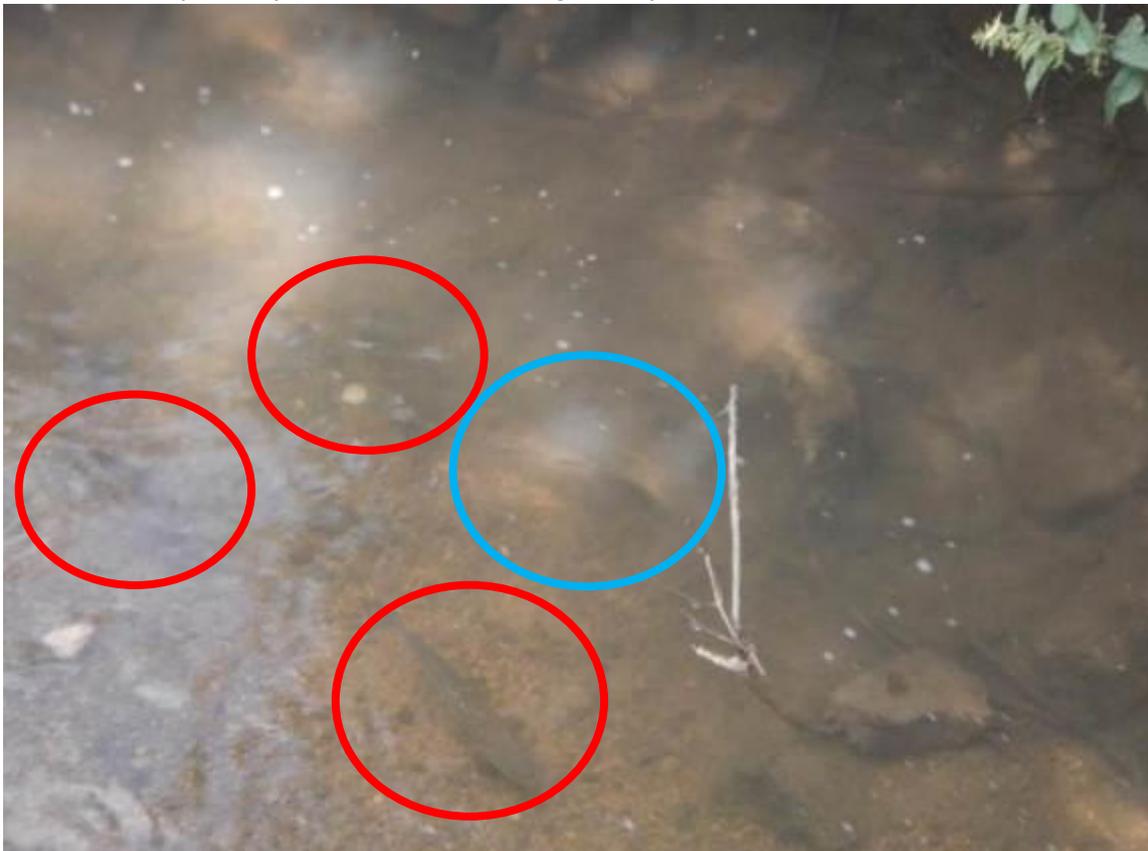
Figure 98. With no access to natural riffle sections u/s or d/s owing to the presence of barriers, chub (red circle) and trout (blue circle) were observed in higher densities immediately d/s of the weir.

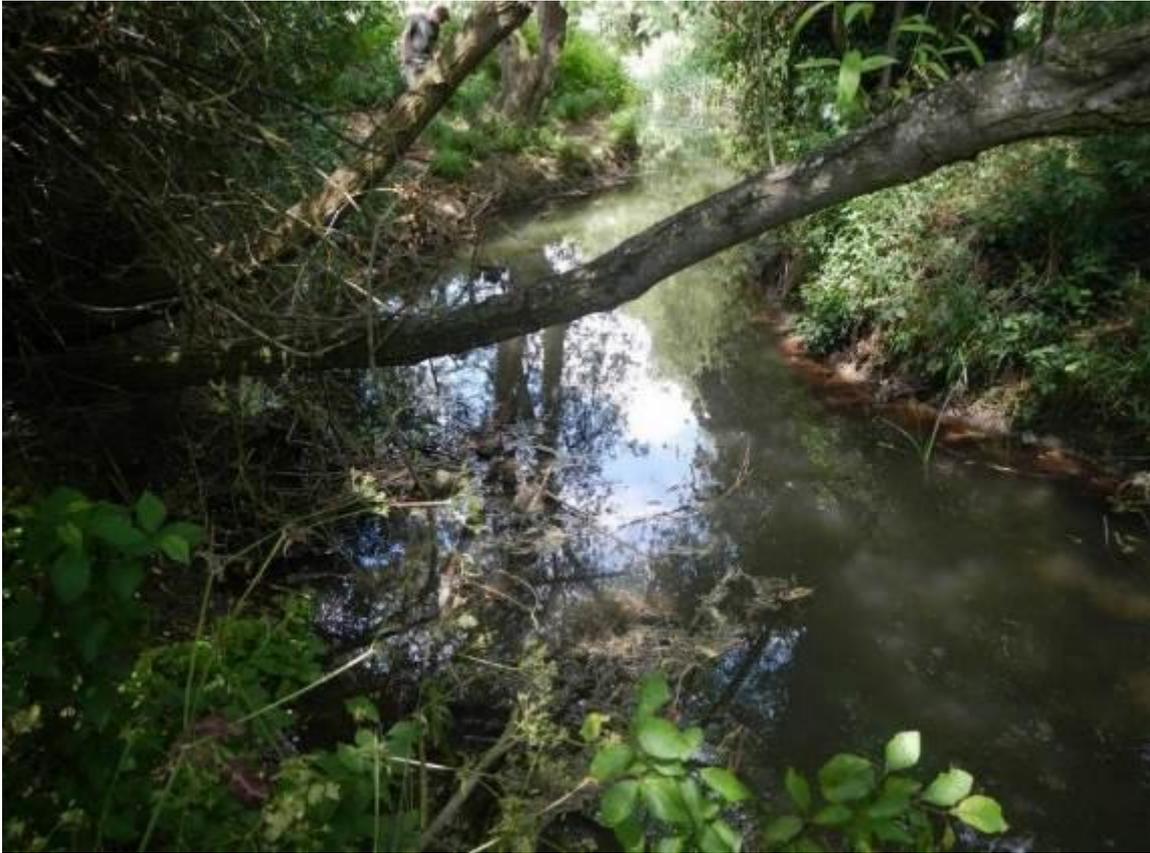
Figure 99. Shade and structure are available in the channel between the weir and the B4035, particularly the wooded section immediately u/s of the road, but in warm conditions this habitat is likely to be unsuitable for many fish species, particularly salmonids. Note the impounding influence of the weir >500m further d/s.

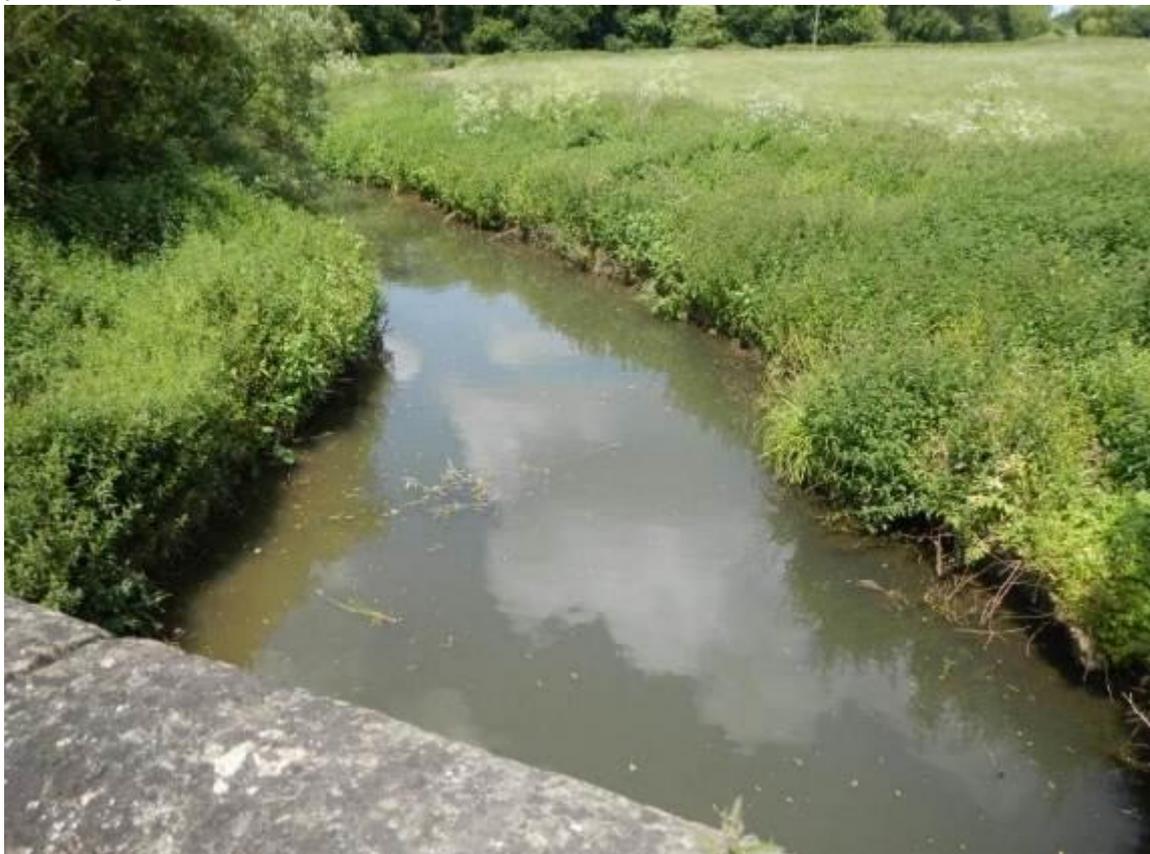
Figure 100. The B4035 road bridge poses no issues for fish or sediment movement but from the bridge, the increasing influence of the weir, and diversion of the channel away from the valley bottom, can be observed.

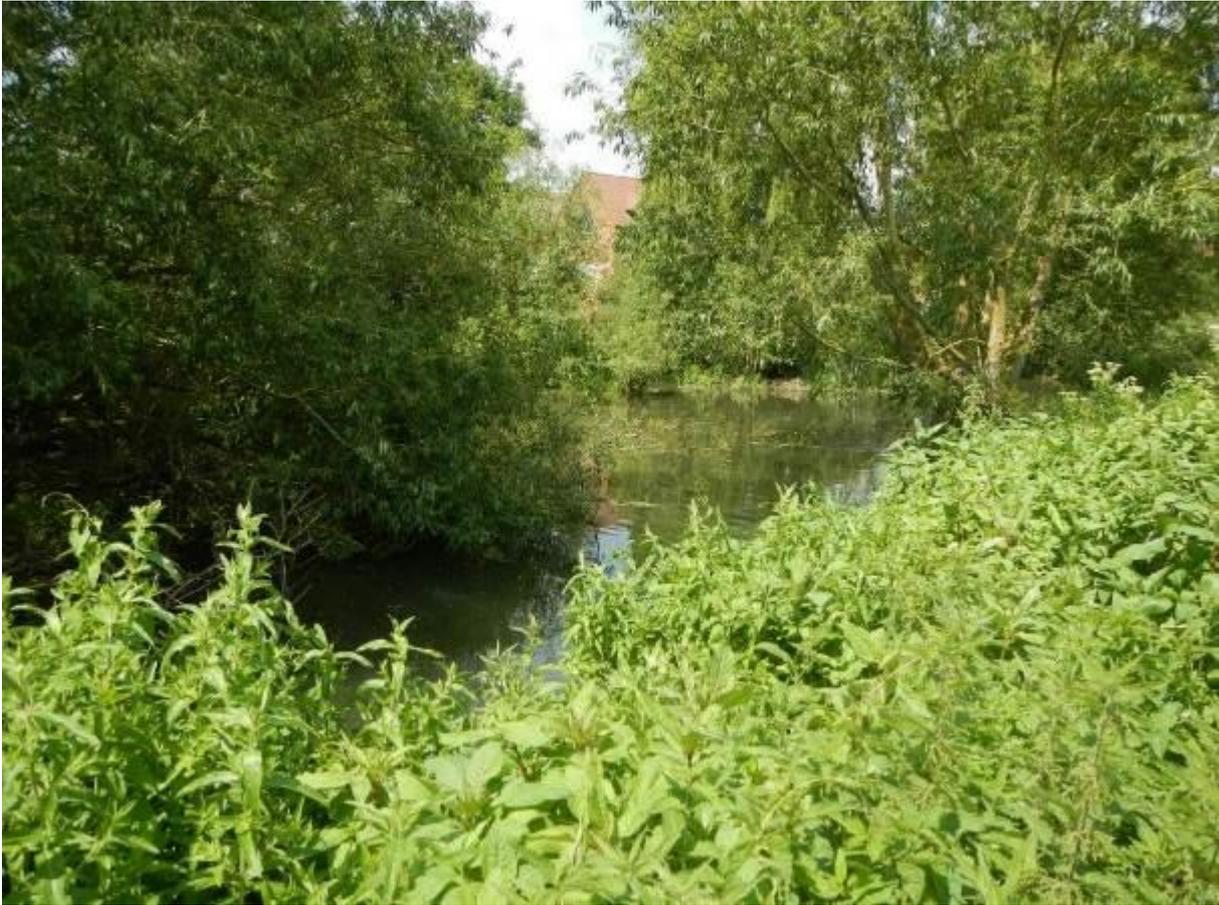
Figure 101. Immediately u/s of the weir, the channel opens out into a large ponded area.

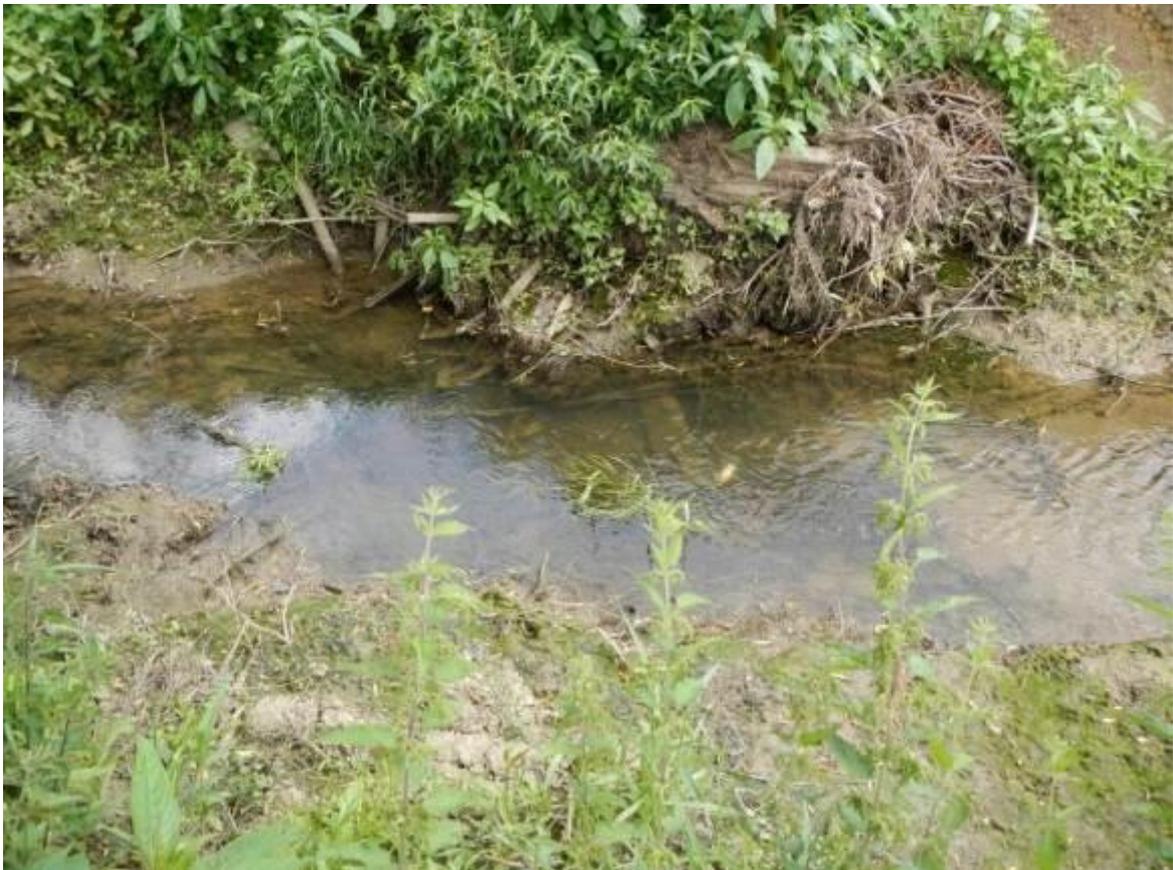
Figure 107. A reasonable sized tributary joins the brook at SP 06687 44326; however, the extent of channel modification and fine sediment loading greatly reduce habitat quality in the section observed. Further investigation of fine sediment inputs would be beneficial.

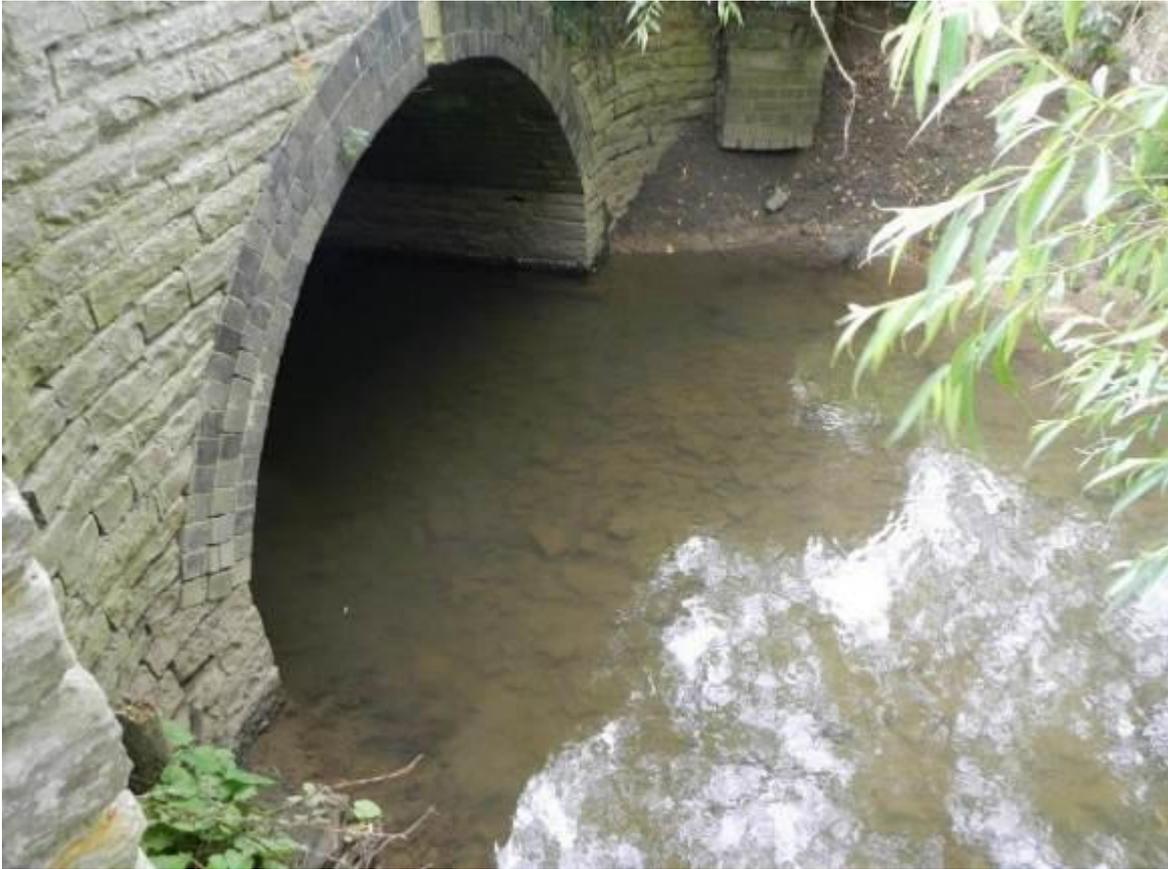
Figure 108. A small bridge at SP 06700 44383 poses no issues for fish or sediment movement. Around this point, the adjacent land use is a mix of arable and pasture with a reasonable buffer afforded in most places.

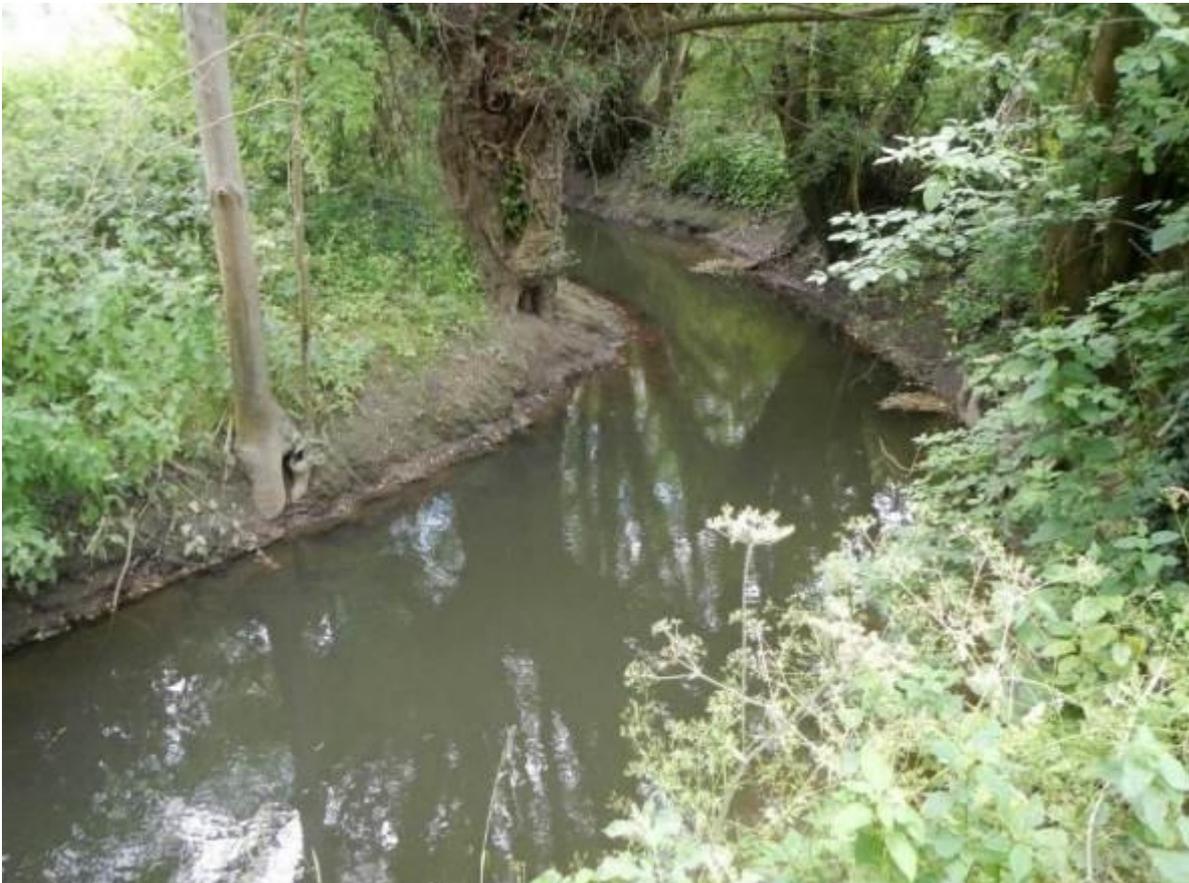
Figure 109. Although supporting a healthy treed buffer, the extent of dredging and channel modification degrades long sections and renders it of little use to salmonids.

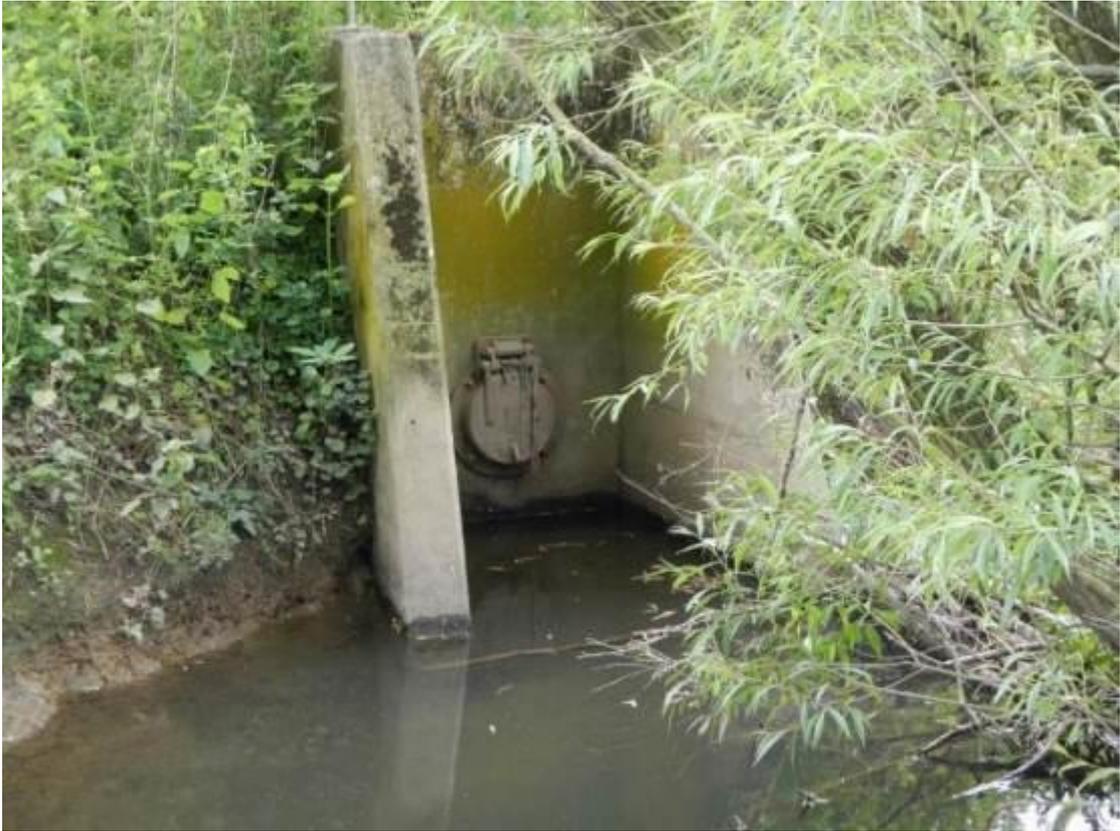
Figure 110. A large STW flap-valve at SP 06664 44612 was not discharging during the visit and no increased signs of enrichment were observed in the immediate vicinity.

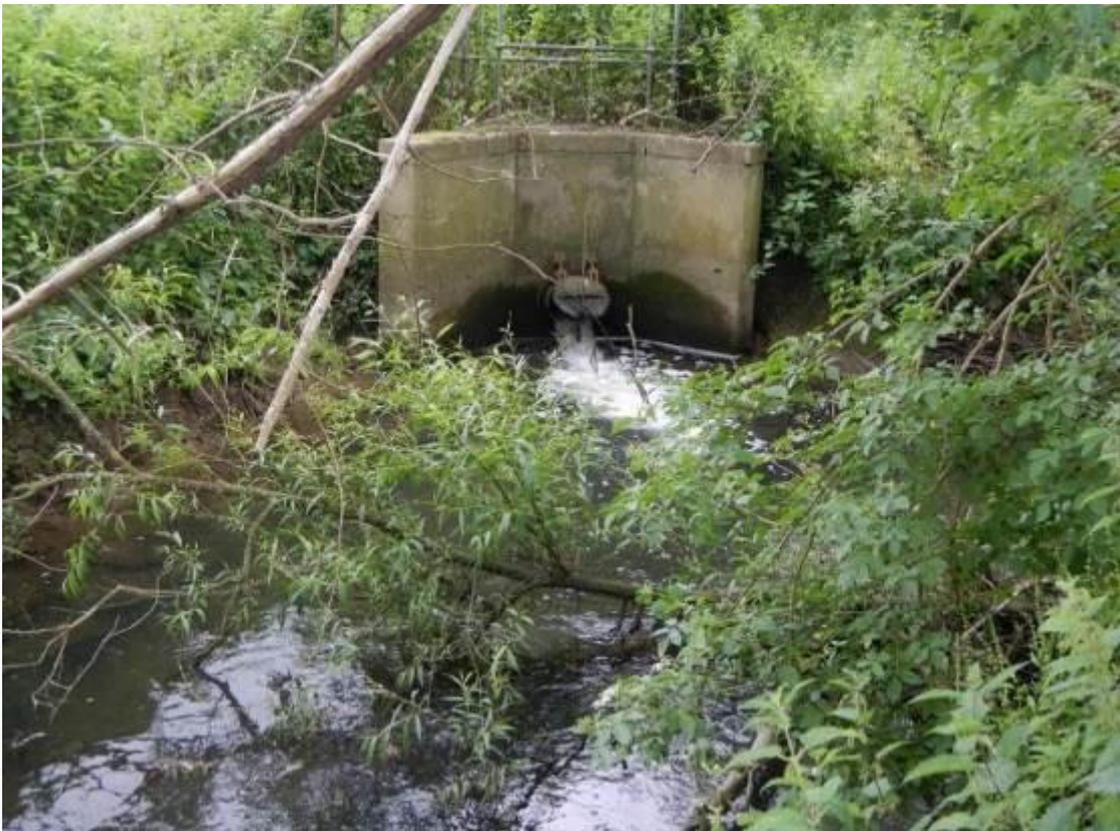
Figure 111. A second large flap-valve at SP 06603 44648 was discharging at the time of the visit and, again, no signs of additional enrichment were observed, other than algal growth on trailing vegetation which was also observed u/s. However, it should be noted that the overcapacity channel and deep water in the vicinity make it hard to identify the usual, obvious signs of enrichment like sewage fungus and excess algal growth on the bed.

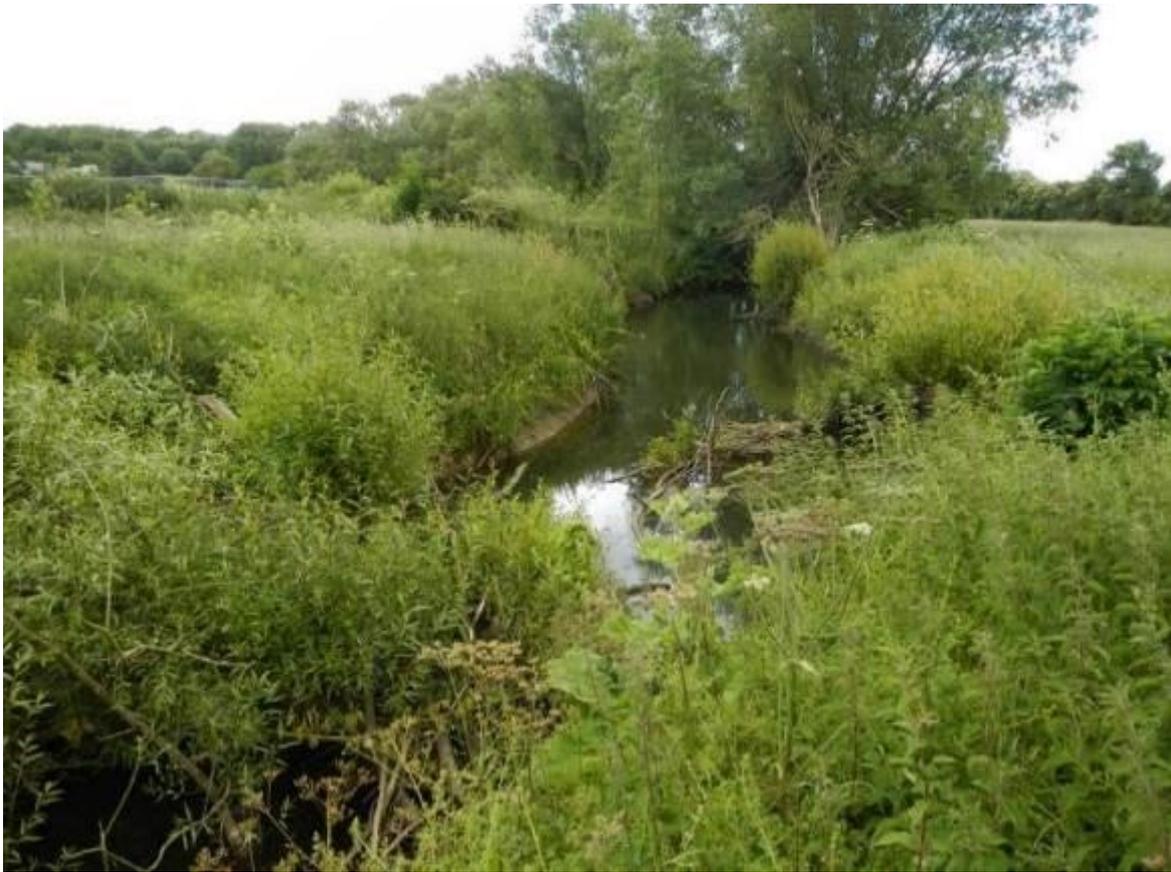
Figure 112. Just d/s of the STW outfalls, recent channel and tree maintenance appeared to have been undertaken, perhaps associated with the overhead powerlines.

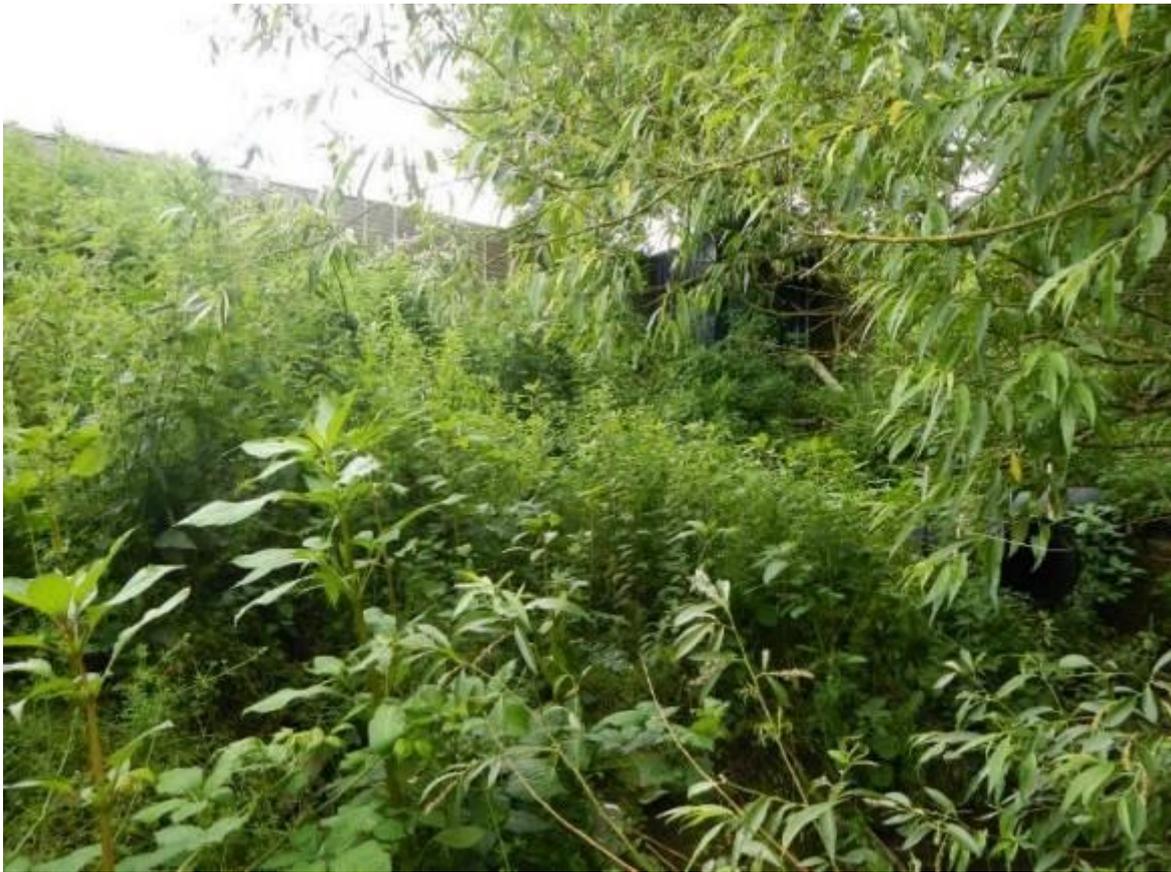
Figure 114. The area around the discharges is screened from the adjacent market gardening/greenhouses area with a series of wooden fence panels. Himalayan Balsam was also observed here, which would form a good starting point for further investigation as to its extent on the catchment.

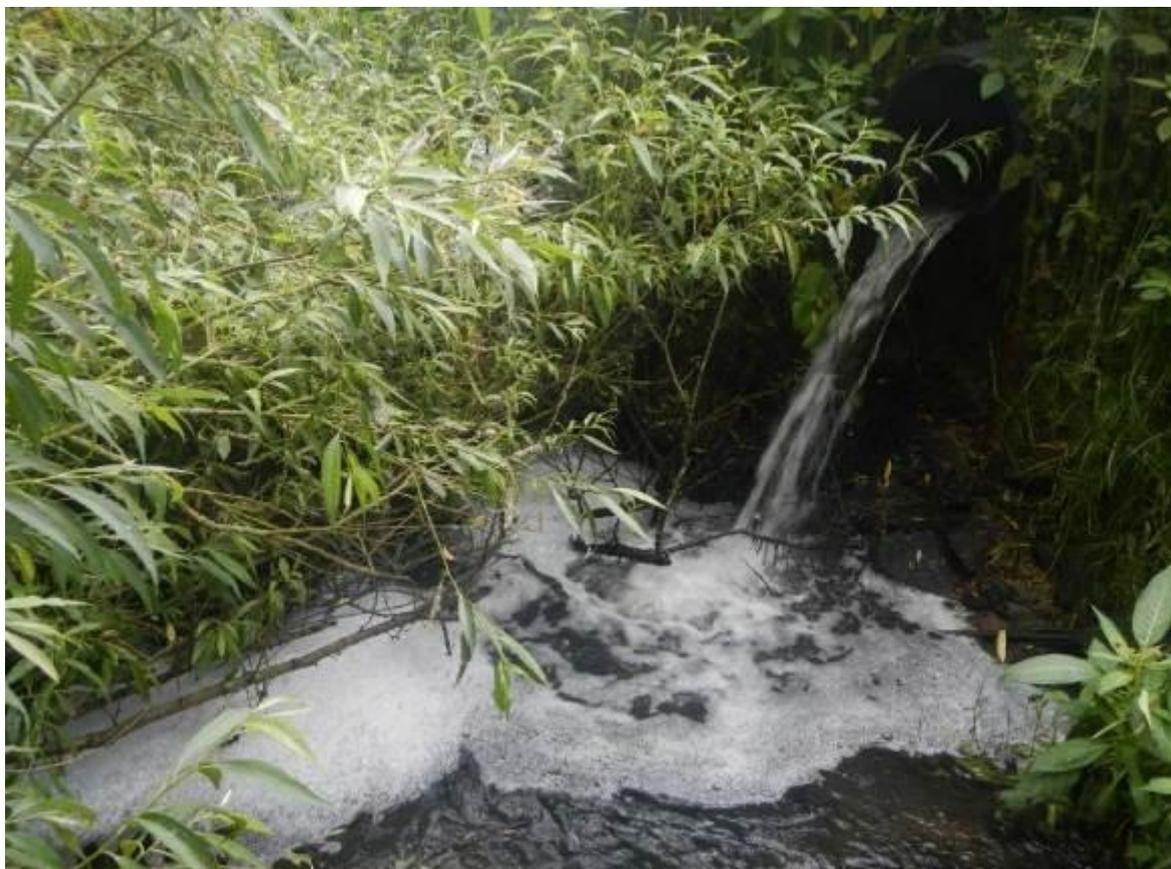
Figure 115. At the next outfall pipe (SP 06435 44857) a distinct chemical odour and water discolouration was observed, along with excess suds.

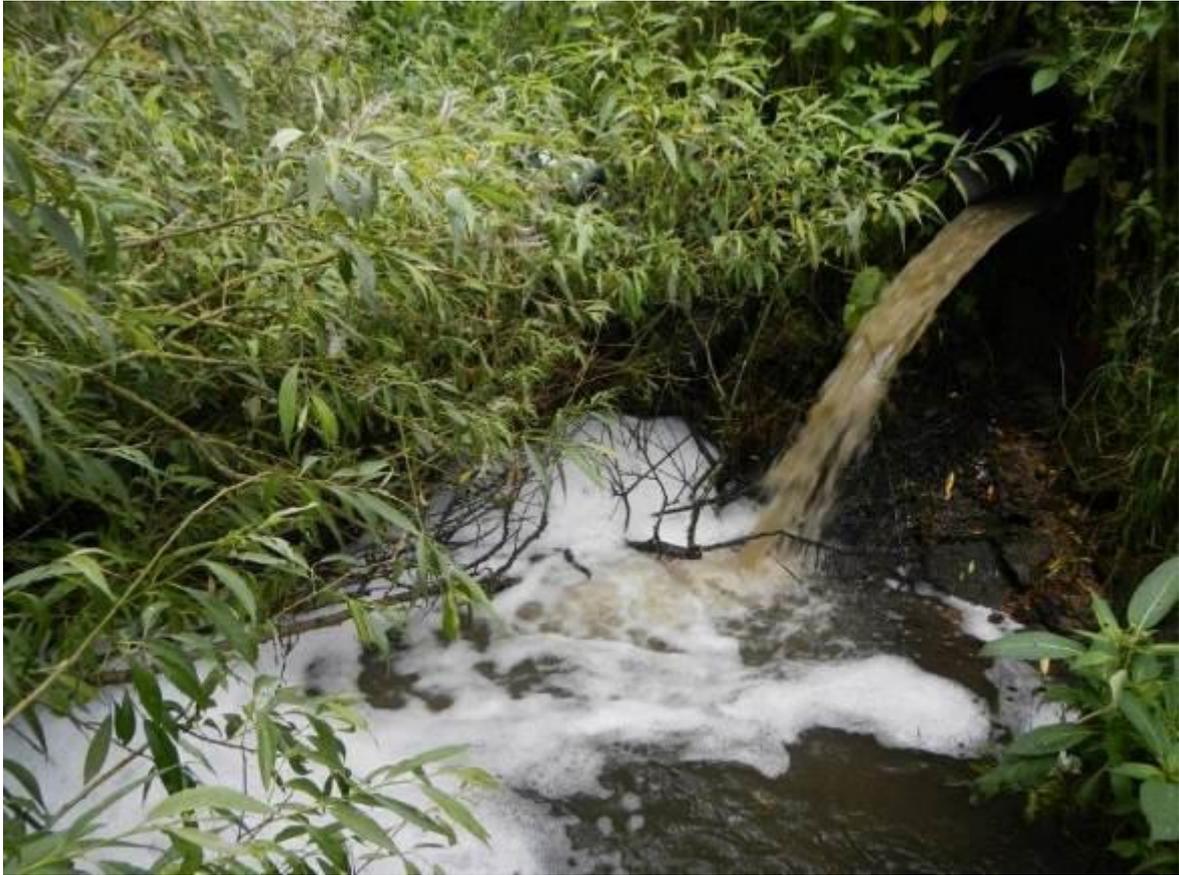
Figure 116. Within a short time, the discharge increased, became much more turbid and the associated chemical odour increased.

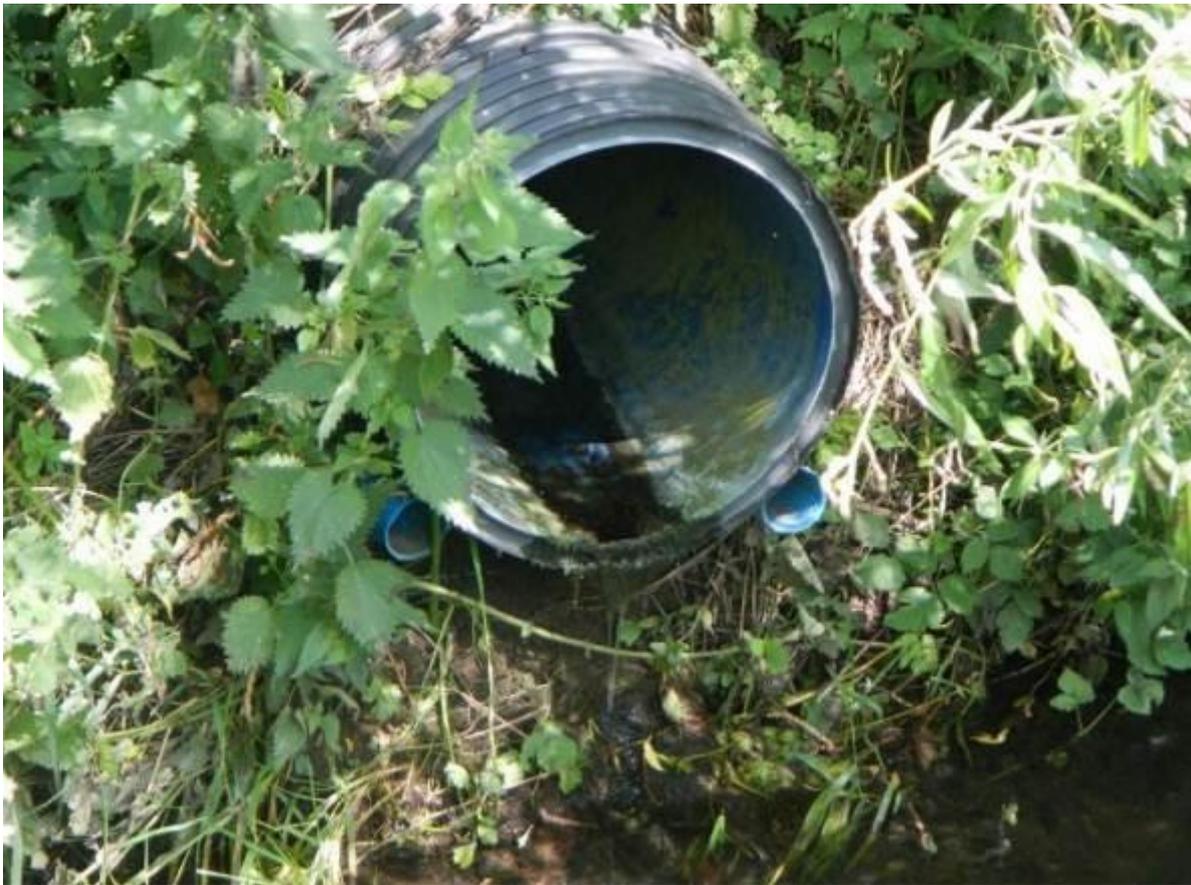
Figure 119. Another pipe was observed at SP 06329 44900.

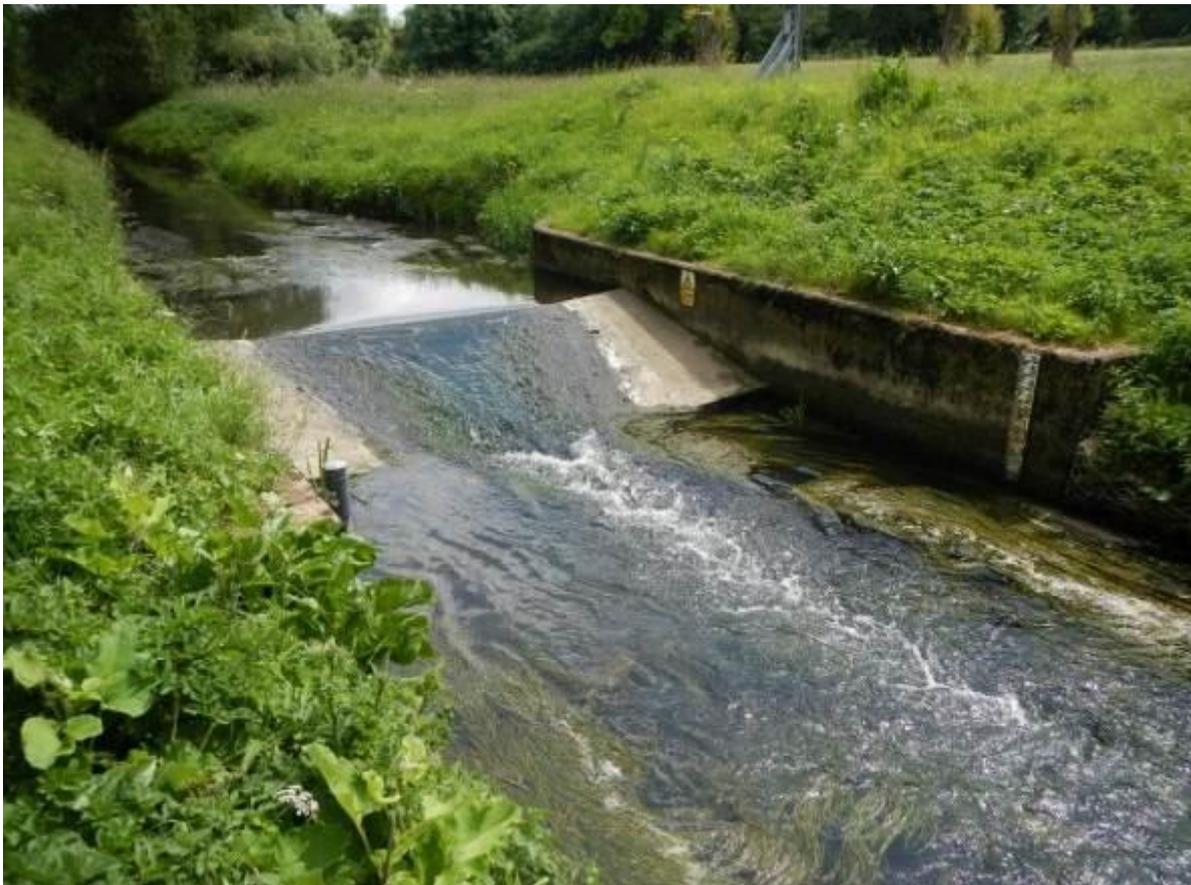
Figure 120. The steep, sheer face of the EA flow gauging weir (SP 06277 44922) and shallow water depth poses a major obstacle for all fish species, particularly eel and lamprey. Excessive growth of weed u/s and d/s of the gauging station are almost certainly a result of the elevated nutrient inputs a short distance u/s.

95	SP 06856 43229	Geotextile	Remove geotextile that is preventing vegetation growth on bank.	2
106	SP 06626 44157	Dredged channel	This work would not be required if the river were restored to its natural course.	3
120	SP 06277 44922	Gauging weir	Ideally this structure should be replaced with more modern, less intrusive flow gauging technology but in the short-term, a fish pass/easements should be installed. Eel passes should already be installed on EA weirs.	1

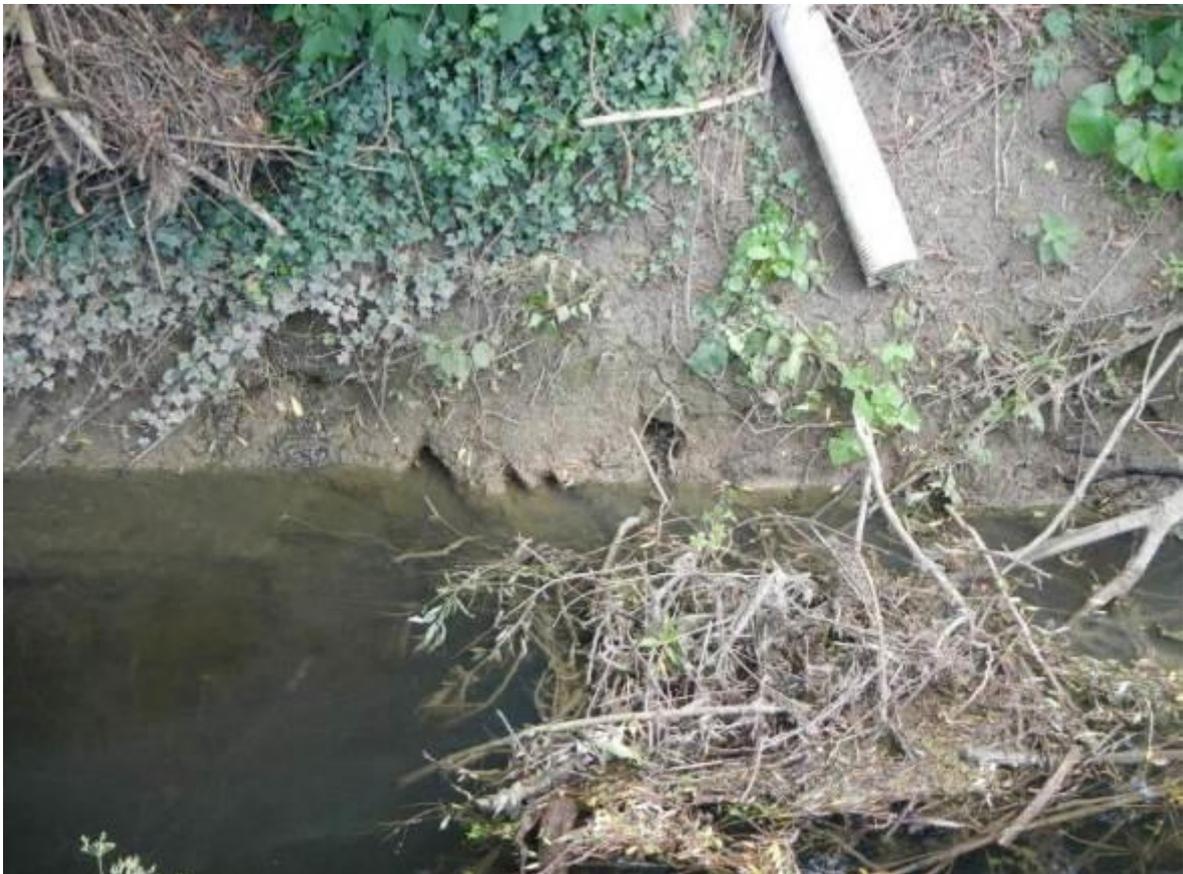
Figure 122. Adjacent to two ponds, seepage was observed through the banks into the brook via what may have been signal crayfish burrows (at SP 06027 45092). Further inspection was not possible as the holes were at the opposite side of a deep channel.

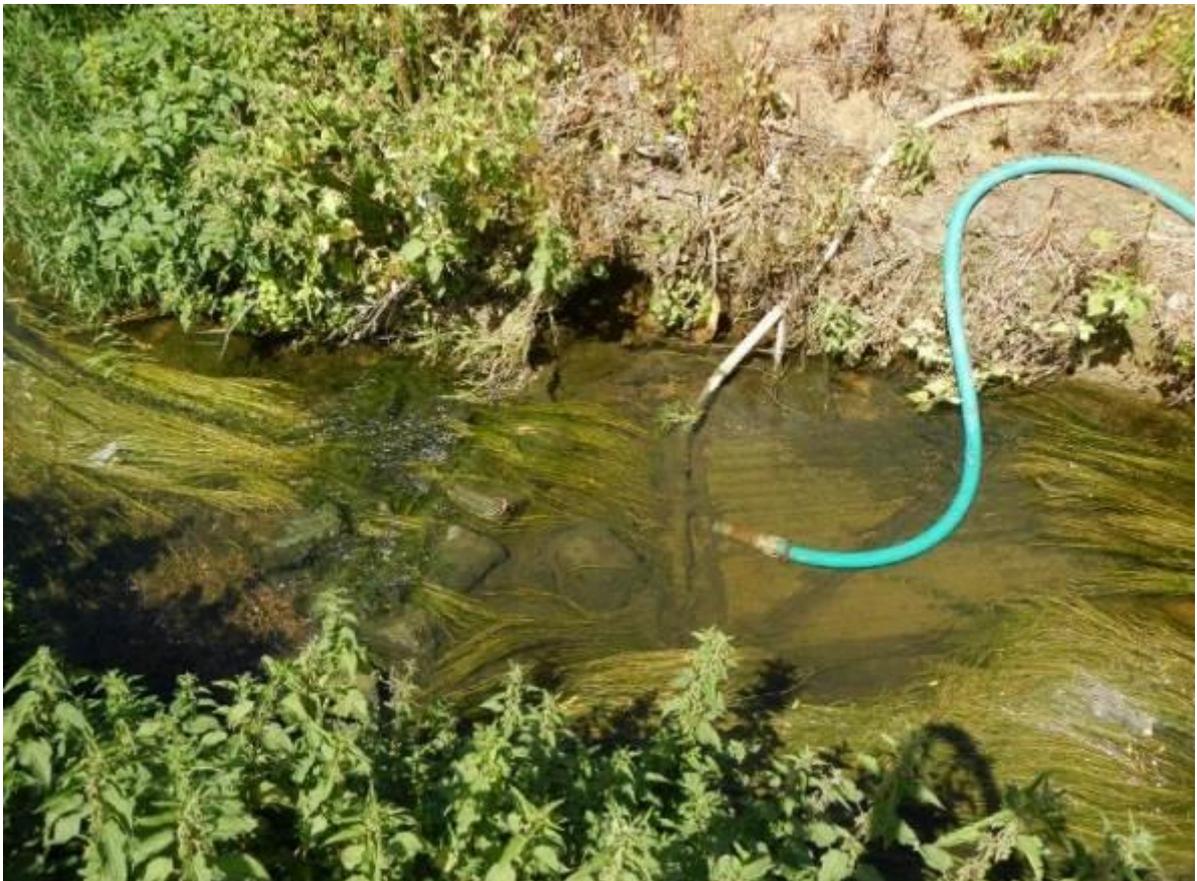
Figure 124. Small abstraction points were noted right along the brook with several in the lower section, like this one at SP 05731 45253. Also note the suspect herbicide usage on the bank/dead vegetation (right of shot).

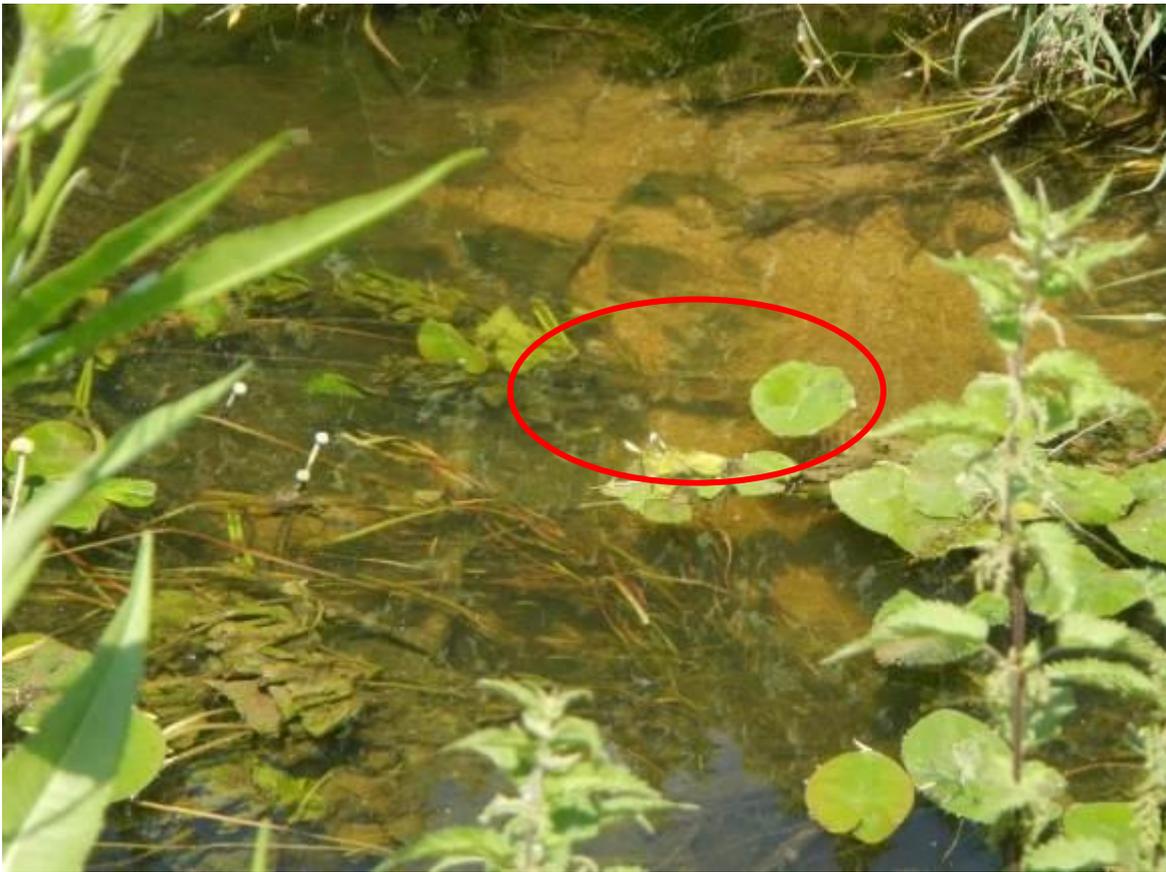
Figure 125. Although the channel is clearly over-capacity, lacking natural coarse substrate and resembling a canal, the occasional trout was observed in areas where vegetation pinches the channel, accelerating flow velocities and providing cover.

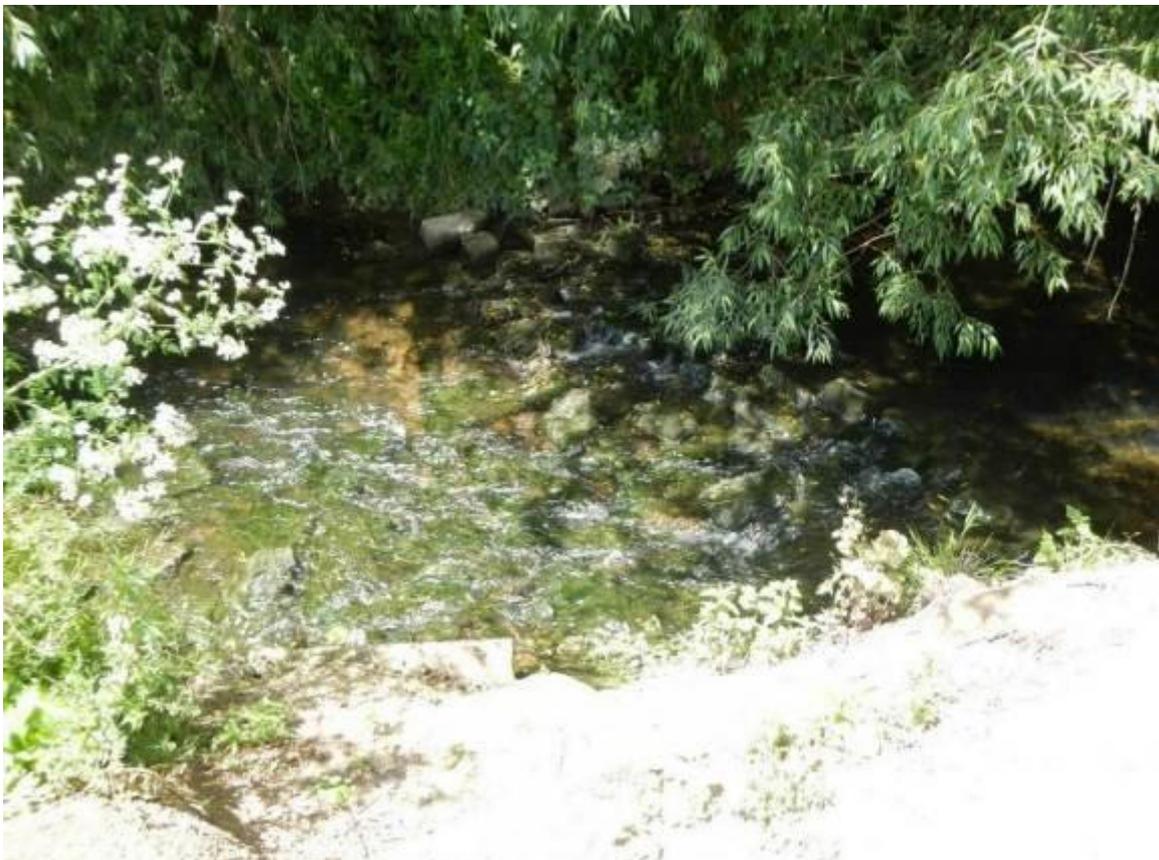
Figure 125. Eutrophication and algal smothering can be observed in shallower, unshaded sections throughout the lower brook, like the remains of an old weir (SP 05587 45344), presumably associated with Faulk Mill. The remains pose no issues now.
