Walkover Assessment
Badsey Brook (Warwickshire Avon) catchment
14-15/06/2017

Undertaken by Gareth Pedley

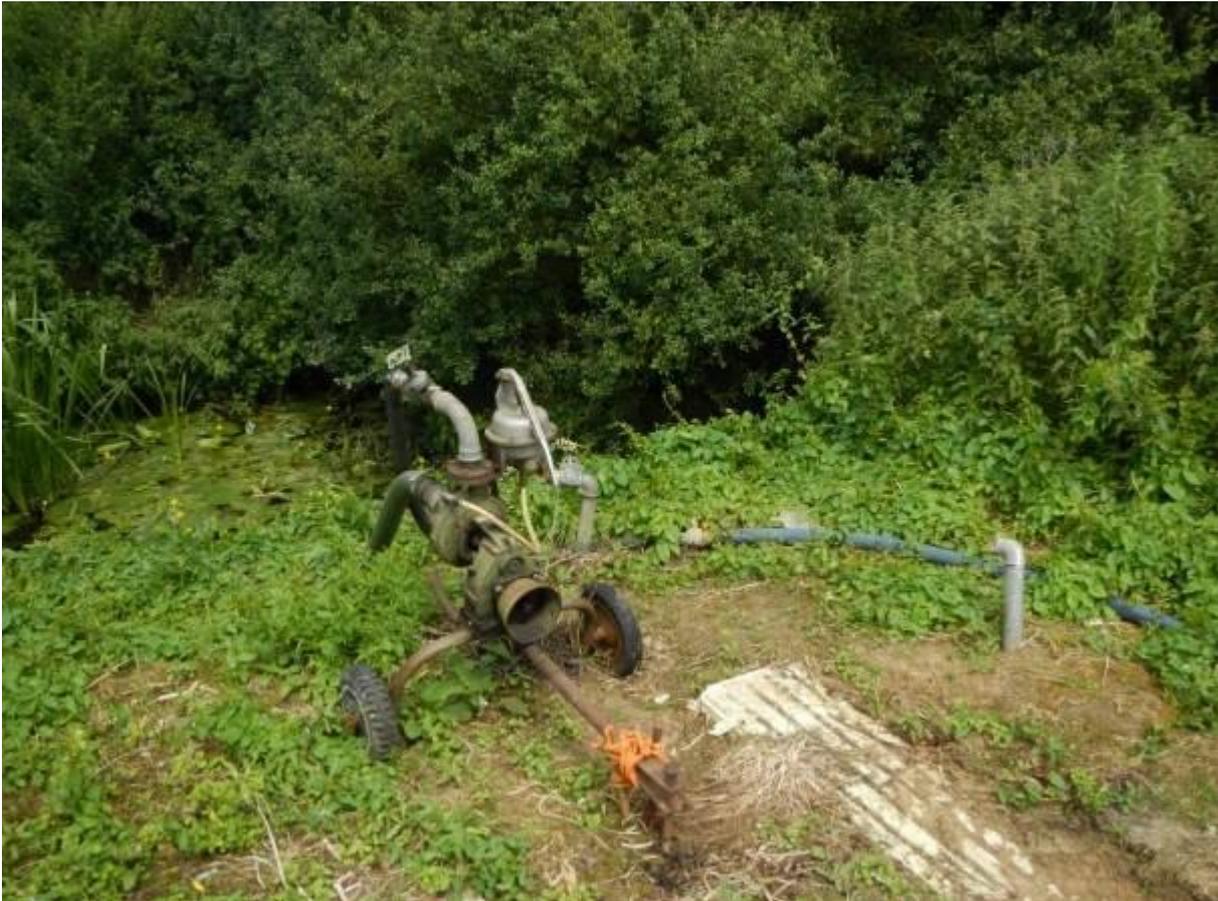
Figure 128. Another apparently active abstraction was observed at SP 05489 45377.
