WILD TROUT TRUST

Bentley Brook (aka Bradbourne Brook)

Derbyshire

February 2024

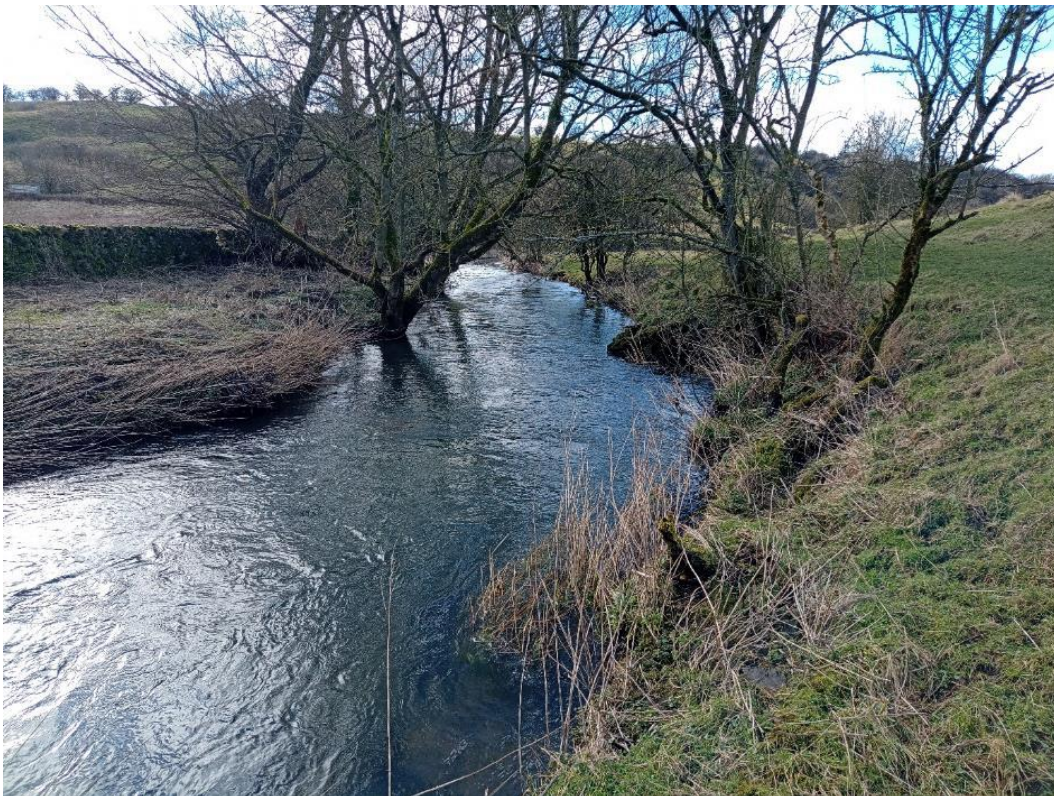
Between the upstream limit and the ford, vegetation cover is relatively sparse. The banks are grazed (more so on the RB) restricting vegetation to short grass and a handful of trees and bushes and their submerged root balls; no tree succession is occurring (Figure 2). A lack of low/submerged cover limits available habitat for trout and restricts their numbers.

Figure 2 Limited cover, few trees and no tree succession due to grazing.

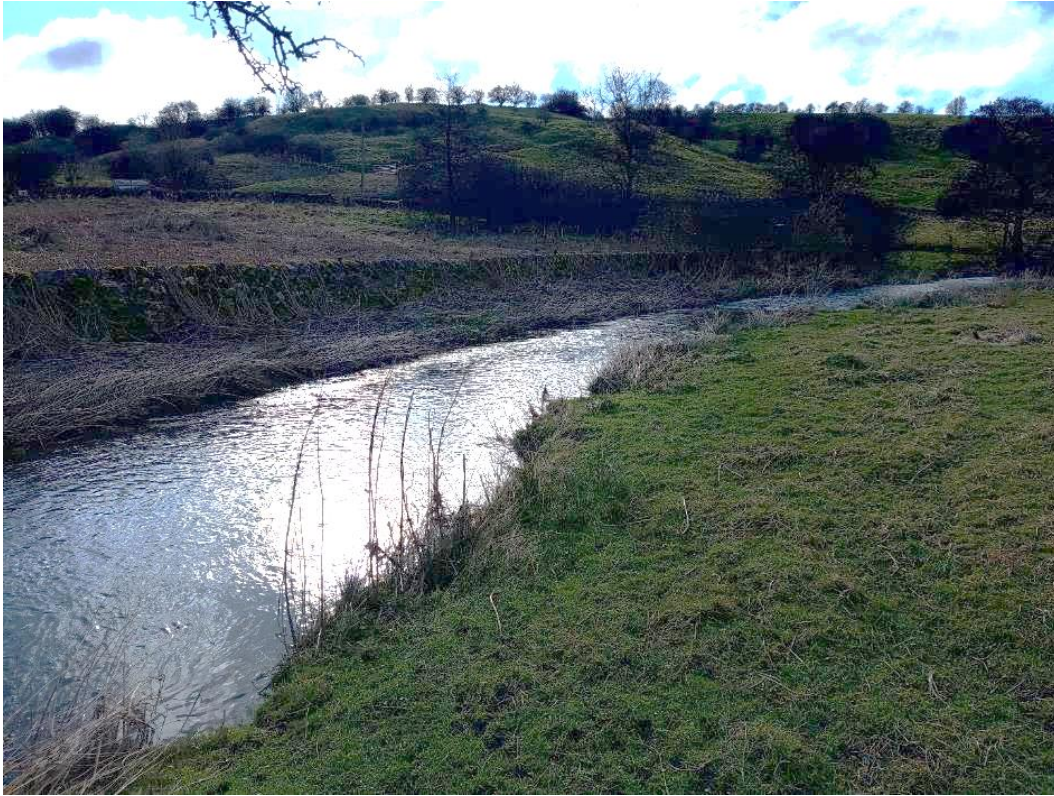
Figure 3 Absence of shade or cover.

Improving riparian cover here would rely on excluding livestock from the river bank. The left bank (Figure 3) appears to be protected from grazing to some degree by the drystone wall, although an absence of self-seeded trees suggests some browsing is preventing trees establishing. It may be possible here to plant some willow whips and/or peg some live willow bundles into the river margins to improve cover. Checking each end of the wall and making sure the river bank is inaccessible to livestock is also recommended, e.g. with a post-and-rail barrier (easily repaired after floods).

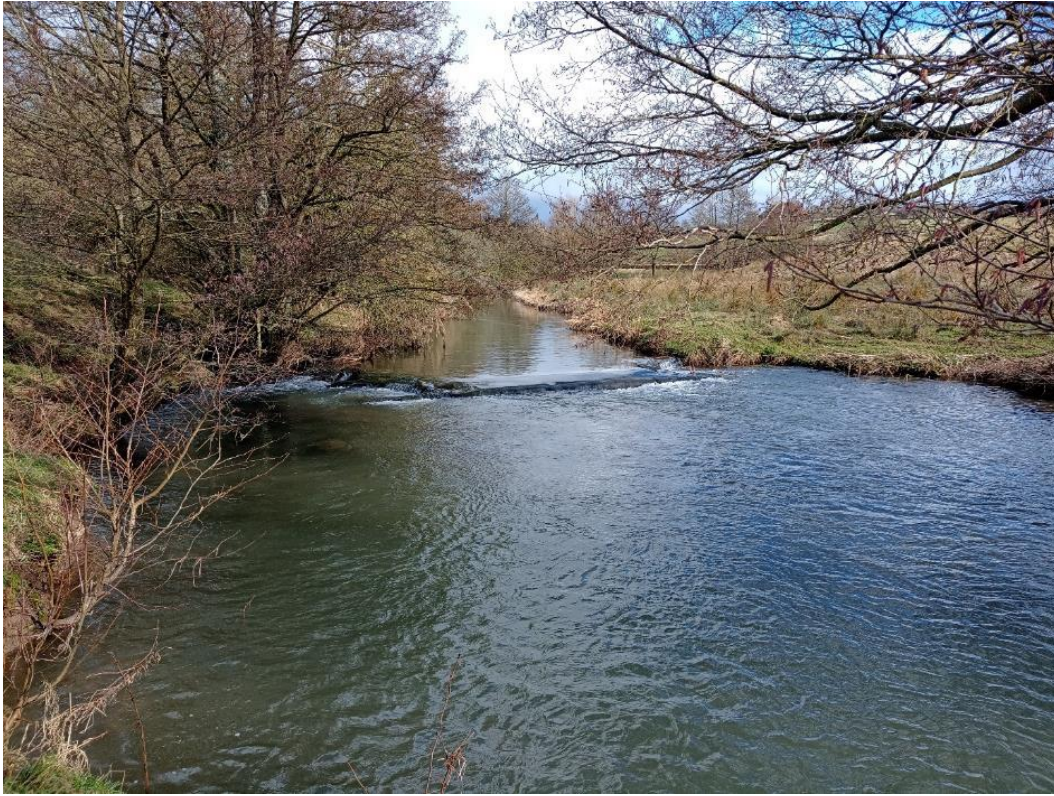
Figure 4 First weir downstream of the ford. Continue to enlarge and deepen the notch close to the true RB (left of shot).

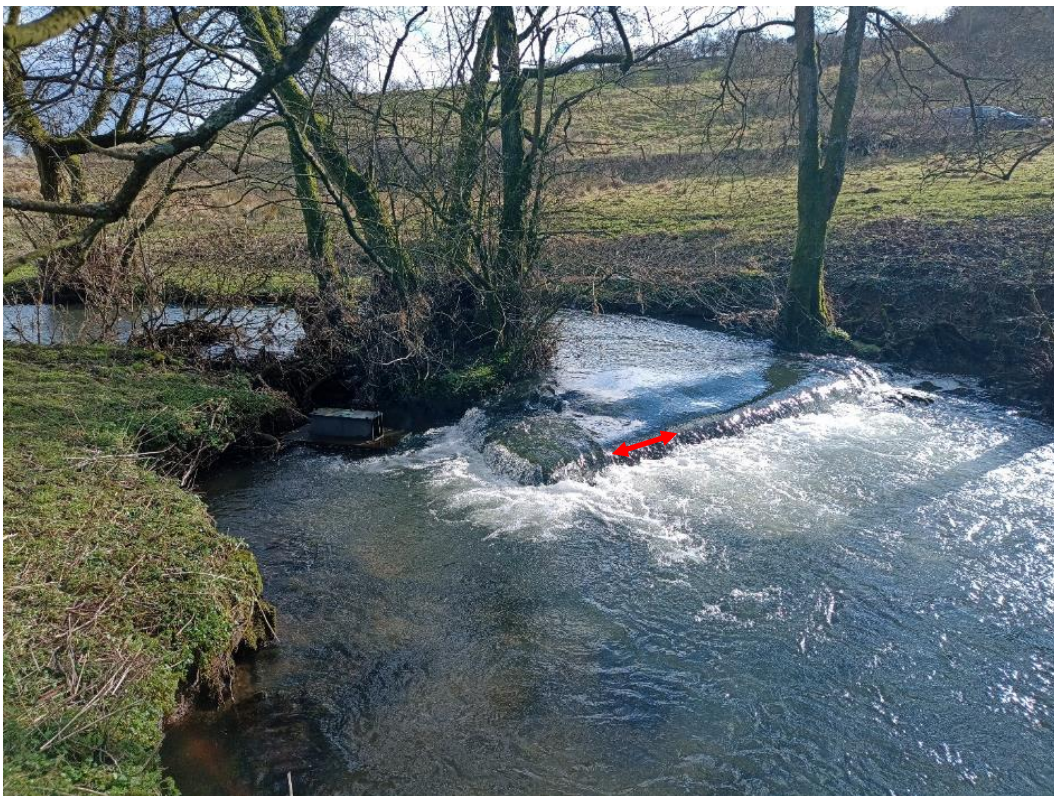
Figure 5 Second weir downstream of the ford. Notch the weir at its lowest point (arrow)

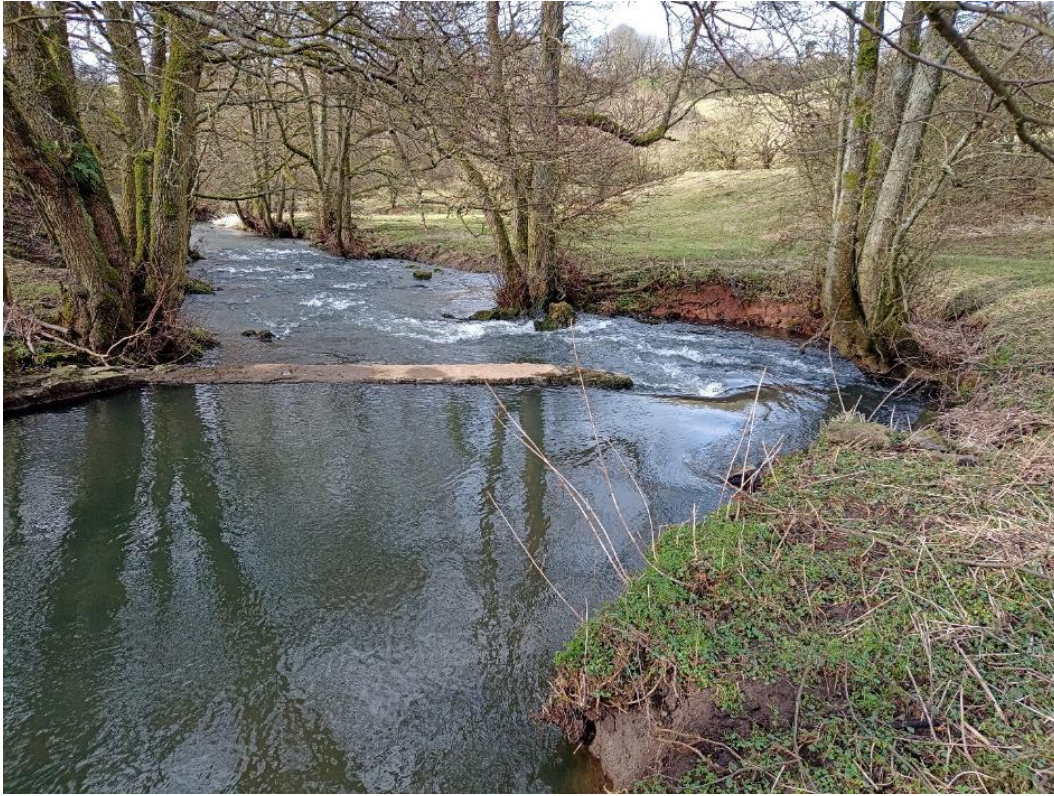
Figure 6 Third weir downstream of the ford. No action required.

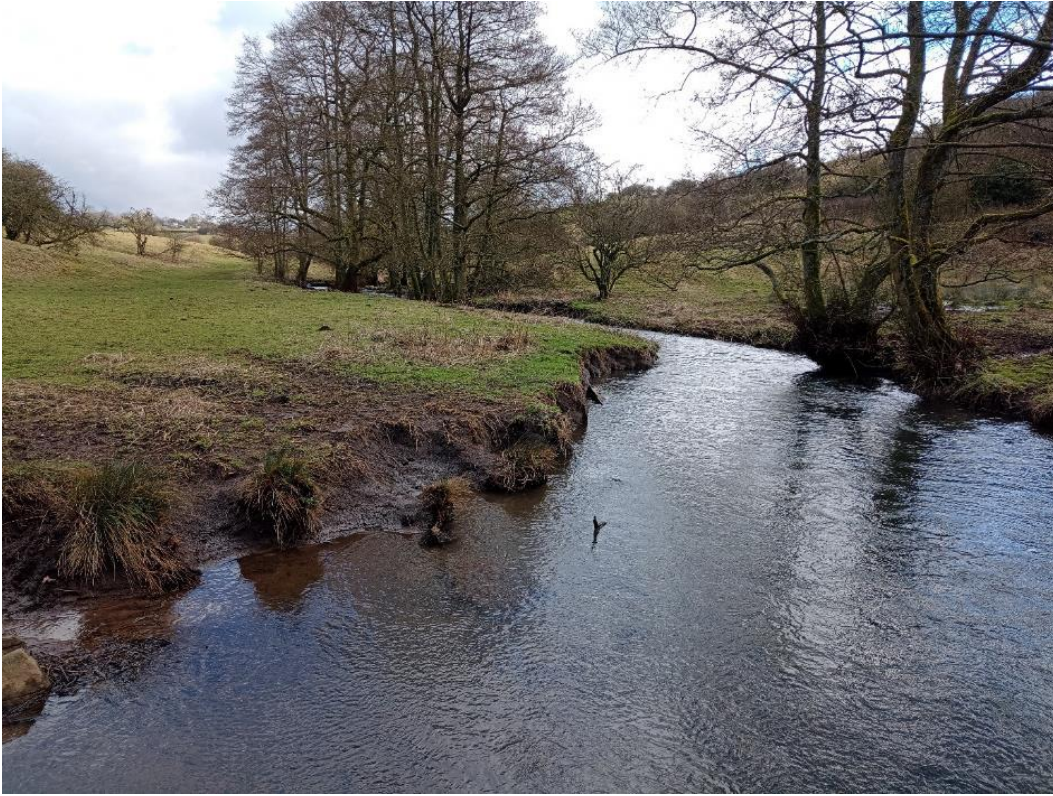
Mature alder trees are present along this section and their submerged root balls provide some cover, but grazing is limiting bankside vegetation to a short grass sward and preventing tree succession, with direct negative consequences for riparian habitat. Towards the field boundary at the downstream end of this section, livestock poaching of the ground around a small RB tributary and gateway is contributing to soil erosion and fine sediment inputs to the brook; the latter restricts fish spawning success by clogging gravels and degrades invertebrate habitat. Reducing livestock levels and/or riparian fencing is required to improve this situation.

Figure 7 Grazing pressure leading to impoverished riparian vegetation, lack of fish cover, reduced bank stability and accelerated erosion.

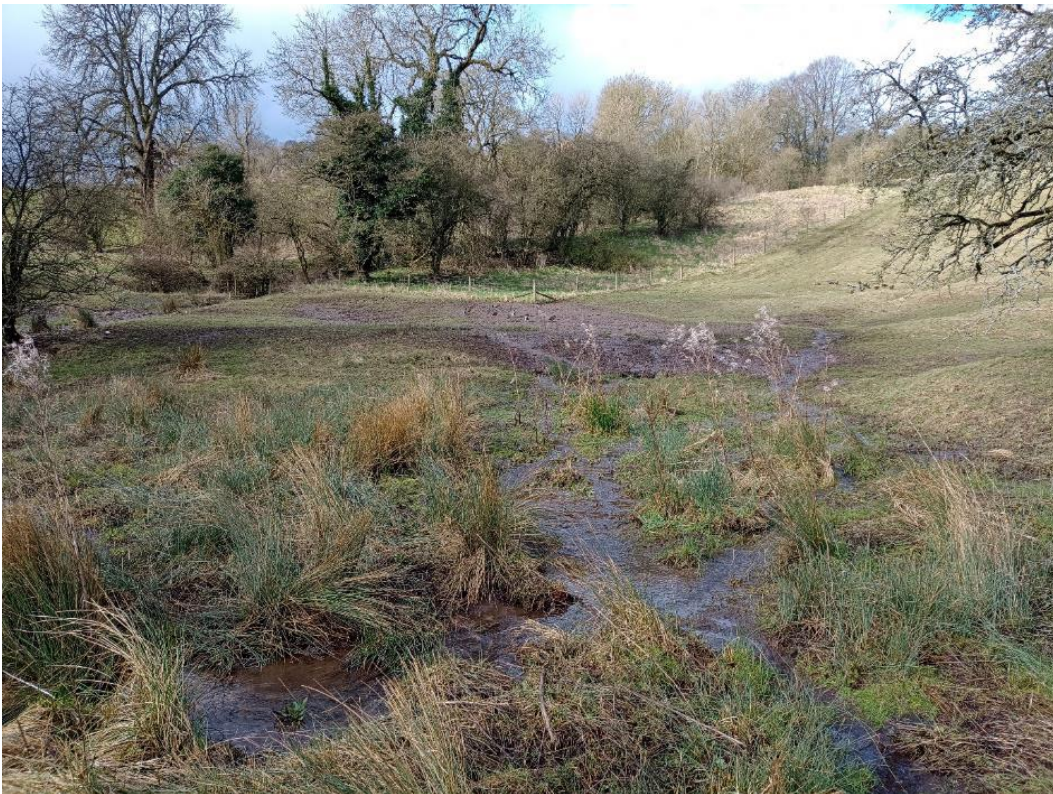
Figure 8 Livestock poaching around a wet flush contributing to fine sediment pollution.

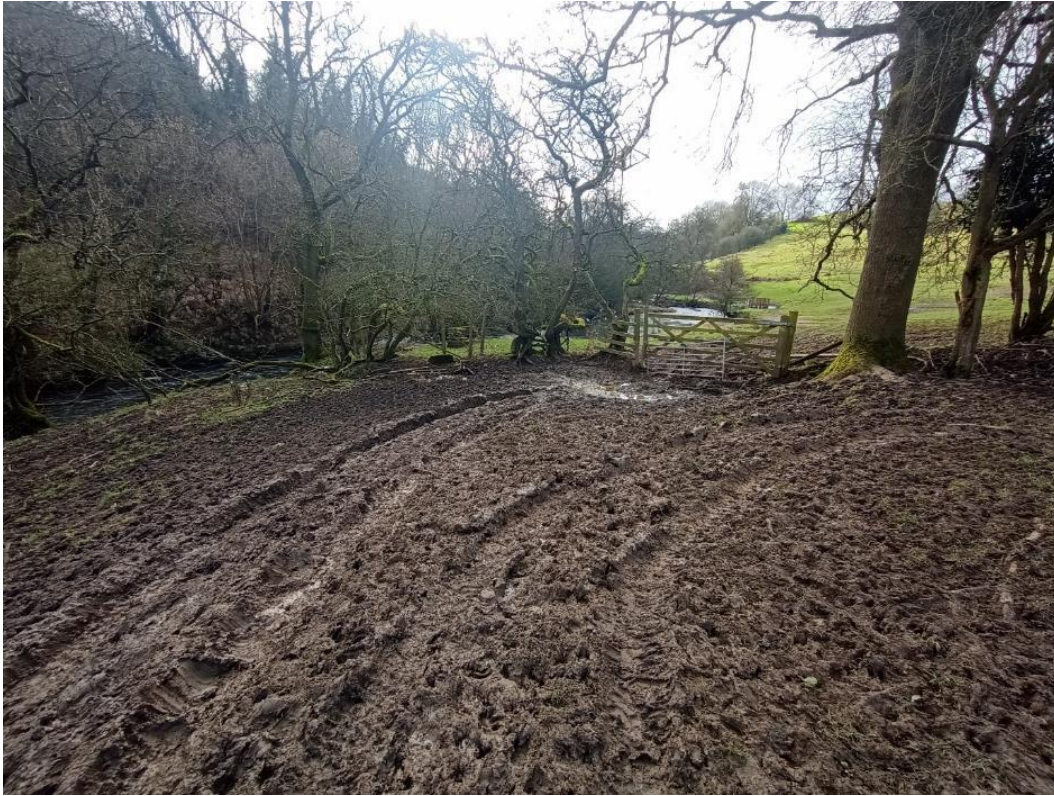
Figure 9 Livestock poaching around a gateway contributing to fine sediment pollution.

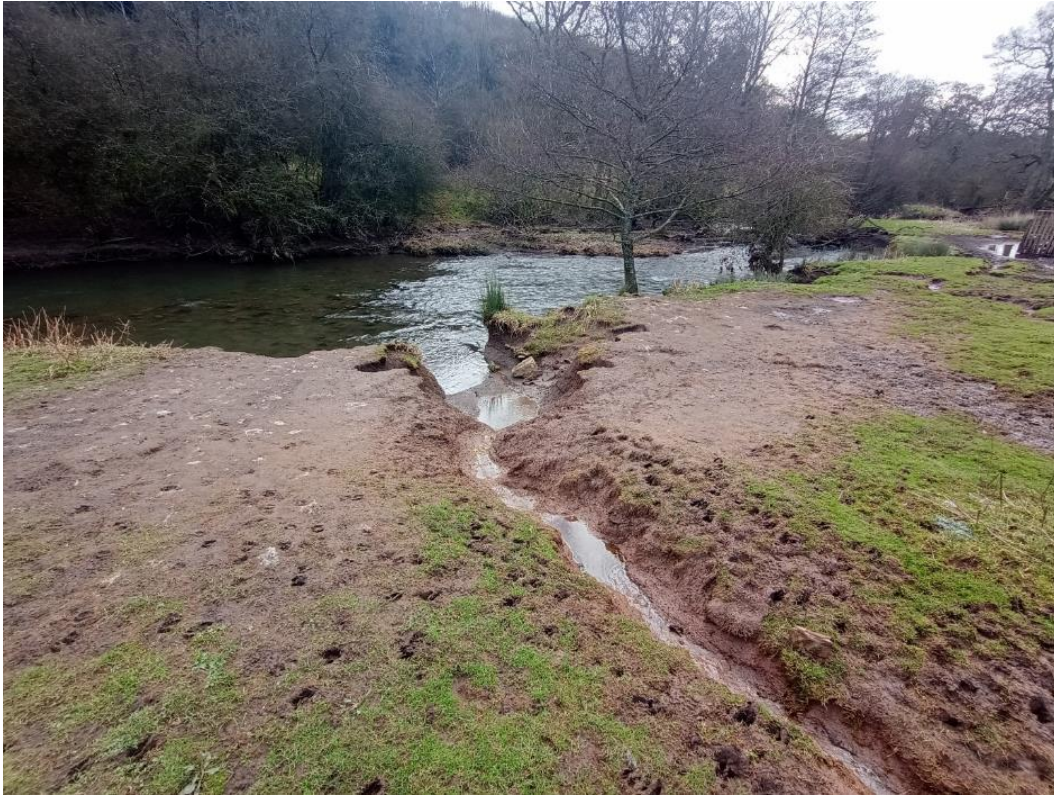
There is a distinct contrast in land use between the LB and RB immediately downstream of the field boundary. The LB is woodland with mature trees providing shade, cover and bank stability. In contrast, the RB is heavily grazed and poached by livestock; reducing livestock levels and/or riparian fencing is required to improve this situation. In addition, ducks are reared here for shooting, exacerbating the overgrazing, bare banks and nutrient input to the watercourse. This has been an ongoing issue for many years which has not been satisfactorily addressed despite liaison by LADFFA with their landlord, the shooting tenant and Environment Agency.

Figure 10 Contrast between wooded RB and overgrazed, eroding LB.

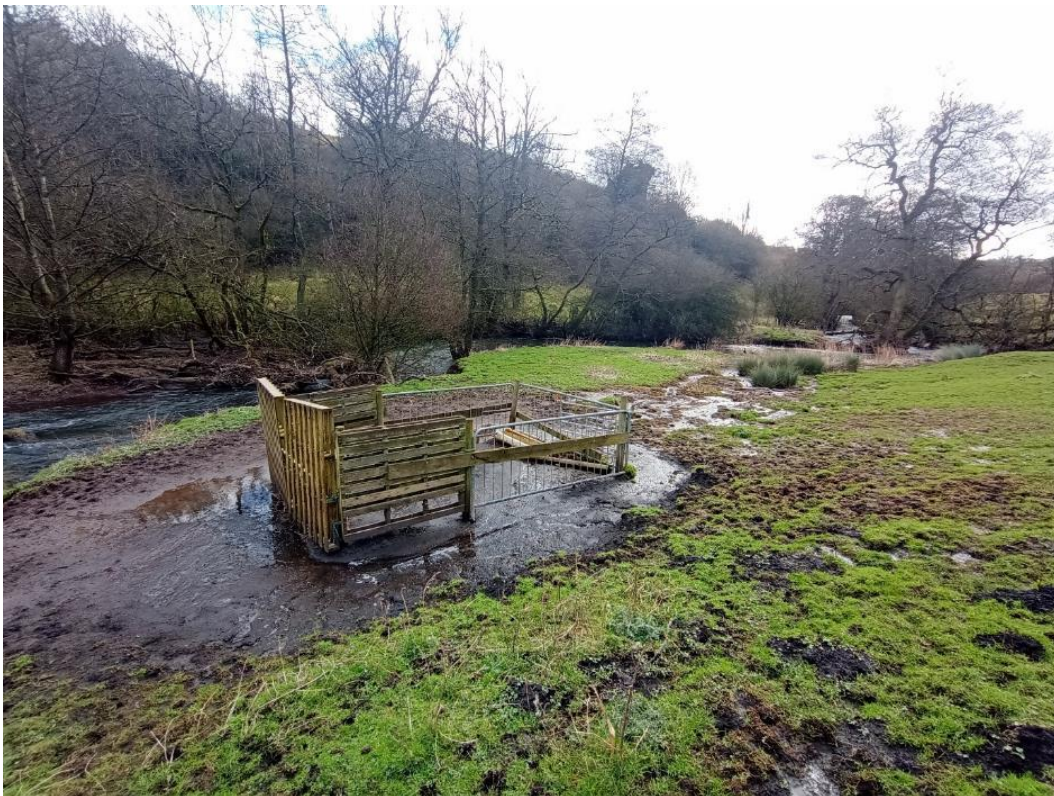
Figure 11 Duck-rearing pen draining directly to the watercourse. Clearly this is an inappropriate location; duck rearing ponds should be offline and well away from watercourses.

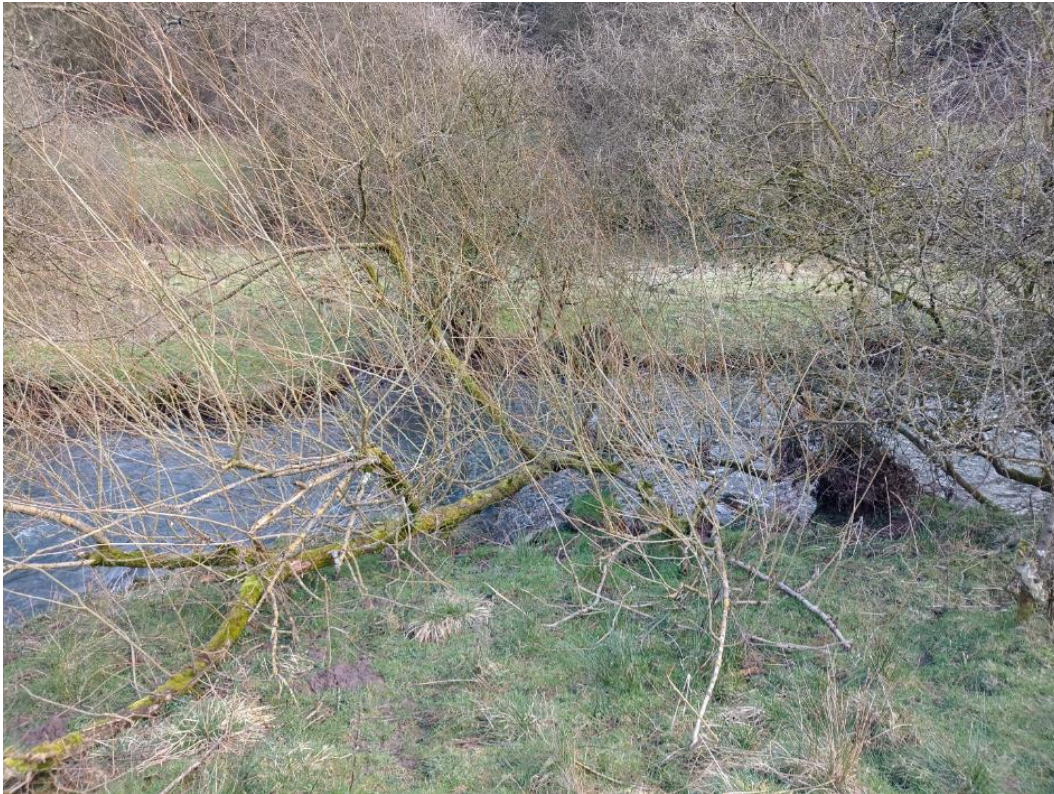
improvement in riparian habitat quality. A fallen willow from the LB creates a good in-stream feature which should be retained.

Figure 12 Retain the fallen willow.

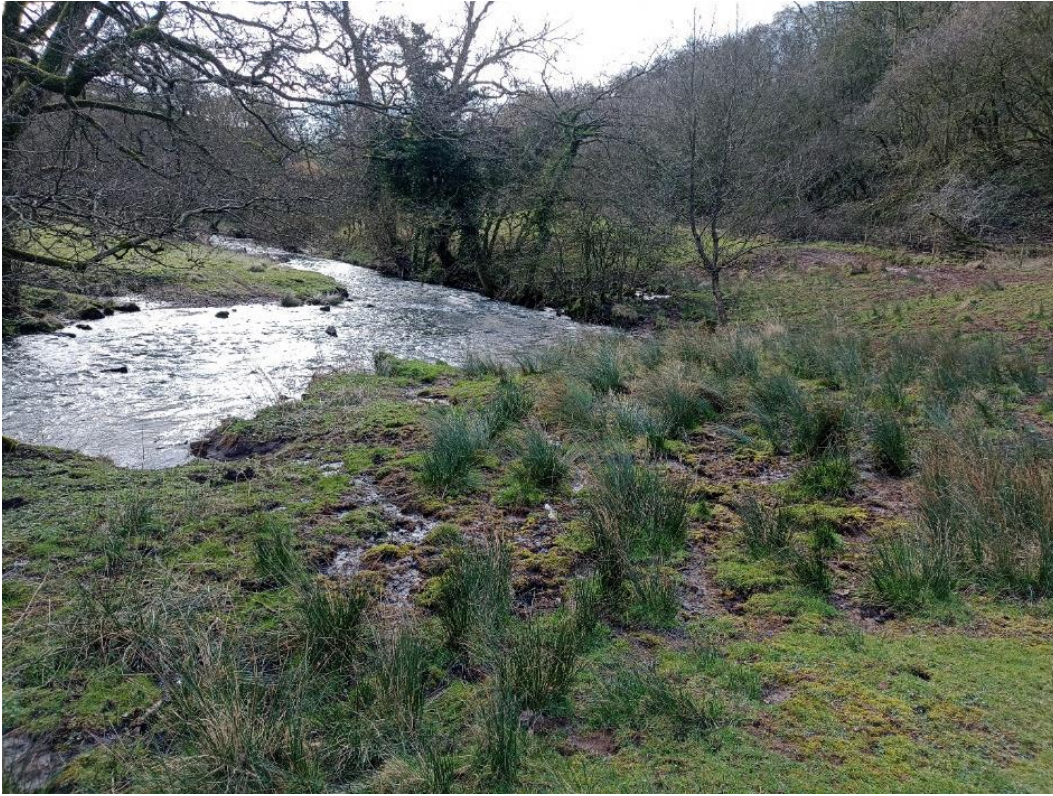
Livestock and grazing impacts are evident again on both banks at the shallow riffle, which appears to be a drinking/crossing point for livestock (Figure 13). A block of woodland on the RB is set back around 10m from the watercourse; it would be beneficial if this were extended to the edge of the river.

Figure 13 Riffle which forms a livestock drinking/crossing point.

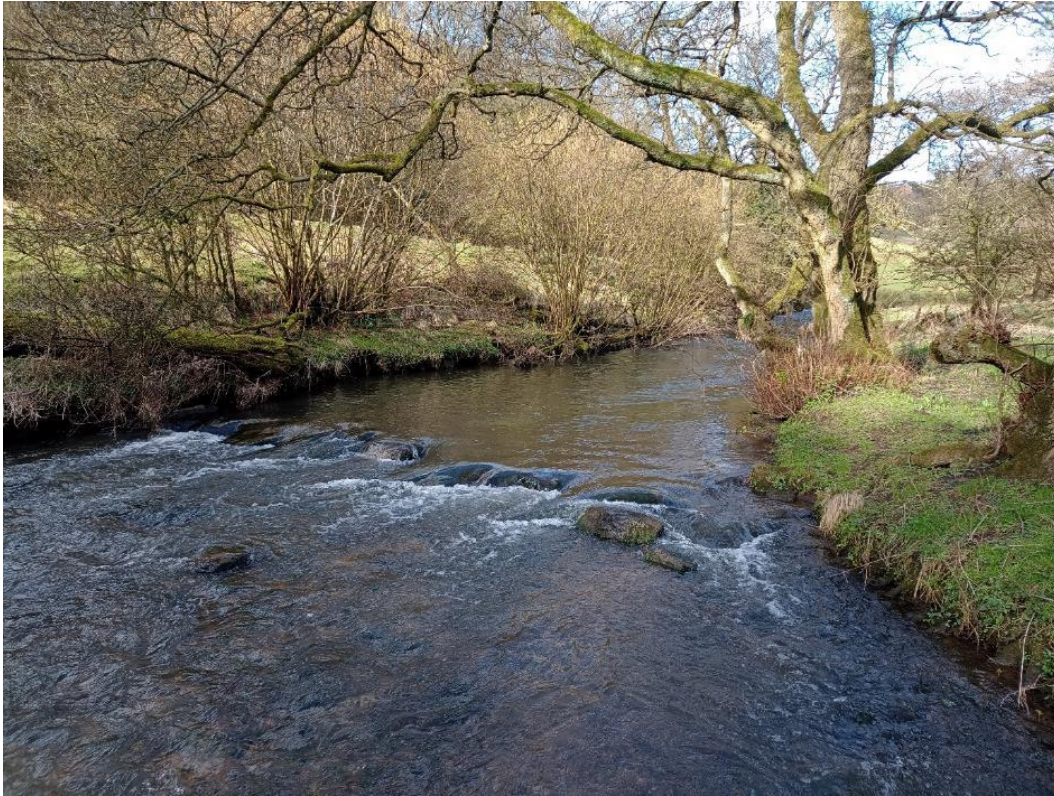
Towards the downstream end of this section is an area where habitat improvement work was carried out previously by WTT in 2015. Figure 14 - Figure 16 show the changes in this area and give an indication of the lifespan of this type of habitat improvement in the Bentley Brook. The coppice re-growth on the RB should be hinged into the brook margins here to create some dense cover; this will improve survival rates of juvenile trout.

Figure 16 Feb 2024 Large trunk has rotted/washed out and marginal cover lost. Re-growth of previously coppiced trees gives scope for further hinging to restore marginal cover.

poaching			woodland block to edge of watercourse.
Previous habitat works (fallen black poplar)	Figure 16	53.061028 , -1.7071643	Hinge coppice re-growth into brook margins.
Lack of cover	Figure 17	53.060335 , -1.7065796	Pinned willow boughs and stakes / whip planting (Appendix 3).
Lack of cover	Figure 18	53.059906 , -1.7062256	Willow hinging and pinning; willow stake planting.
Fallen willow / accumulation of woody material	Figure 19	53.059629 , -1.7060217	Do nothing – retain valuable habitat feature.
Large crack willow	Figure 20	53.058878 , -1.7067298	Do nothing – retain as possible future large woody material. Repair fencing.
Sallow willows near footbridge	Figure 21	53.058252 , -1.7070517	Hinge over into margins to provide low cover. Sparingly harvest material away from river for use in other locations.
Sluice	Figure 23	53.056940 , -1.7069981	Keep sluice free of debris to aid fish passage.

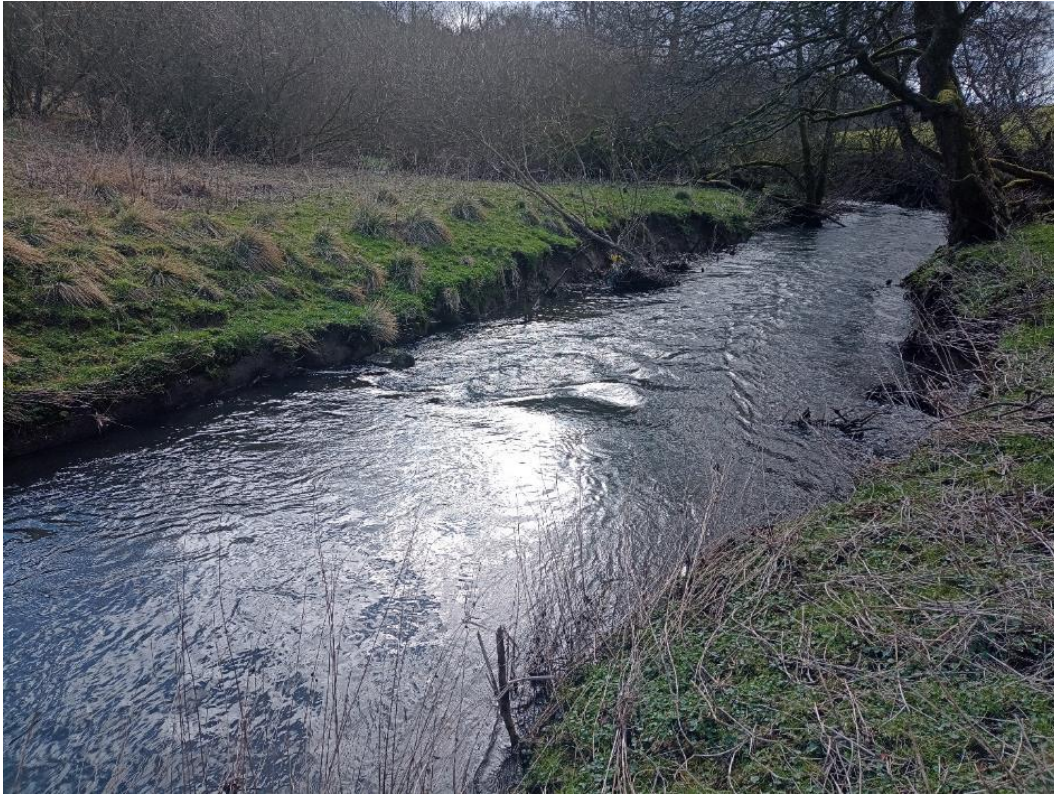
At the downstream end of this section (53.060335 , -1.7065796), LB in particular lacks marginal cover (Figure 17), despite the land use/grazing there being less intensive (a mix of tussocky grass and willow scrub). Previous attempts here (2015) at establishing marginal cover by installing willow bundles have failed, with just the chestnut posts remaining; evidently the scouring force of high flows is too great for this technique here. An alternative would be to try pinning some larger living willow boughs and stakes into the bank face and on top of the bank. There is plenty of material available nearby and it is a quick and easy technique; grazing pressure may be light enough to allow willow to establish, which could then be manipulated to improve marginal cover in the future.

Figure 17 Area where previous willow bundles have failed. Pinning some larger pieces of living willow should be tried here (see recommendations).

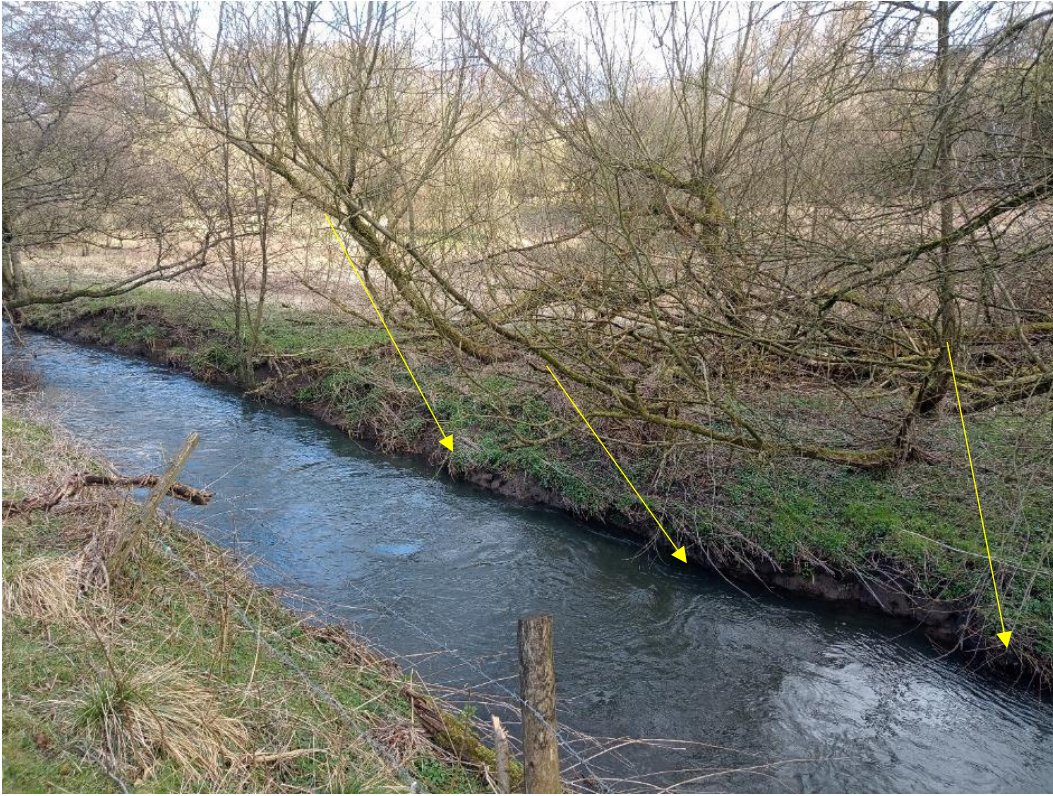
At the upstream end of this section, low cover is similarly lacking and could be improved by hinging and pinning suitable willow boughs along the margins of the brook (Figure 18). The fallen willow (Figure 19) is a long-standing feature (over 15 years) which provides multiple habitat benefits and demonstrates how natural structures can remain stable and provide habitat benefits for many years, compared to the limitations of artificial structures (particularly those created manually). Needless to say, these natural features should be valued and retained.

Figure 18 Hinging willow boughs and pinning them to the banks would improve low cover here.

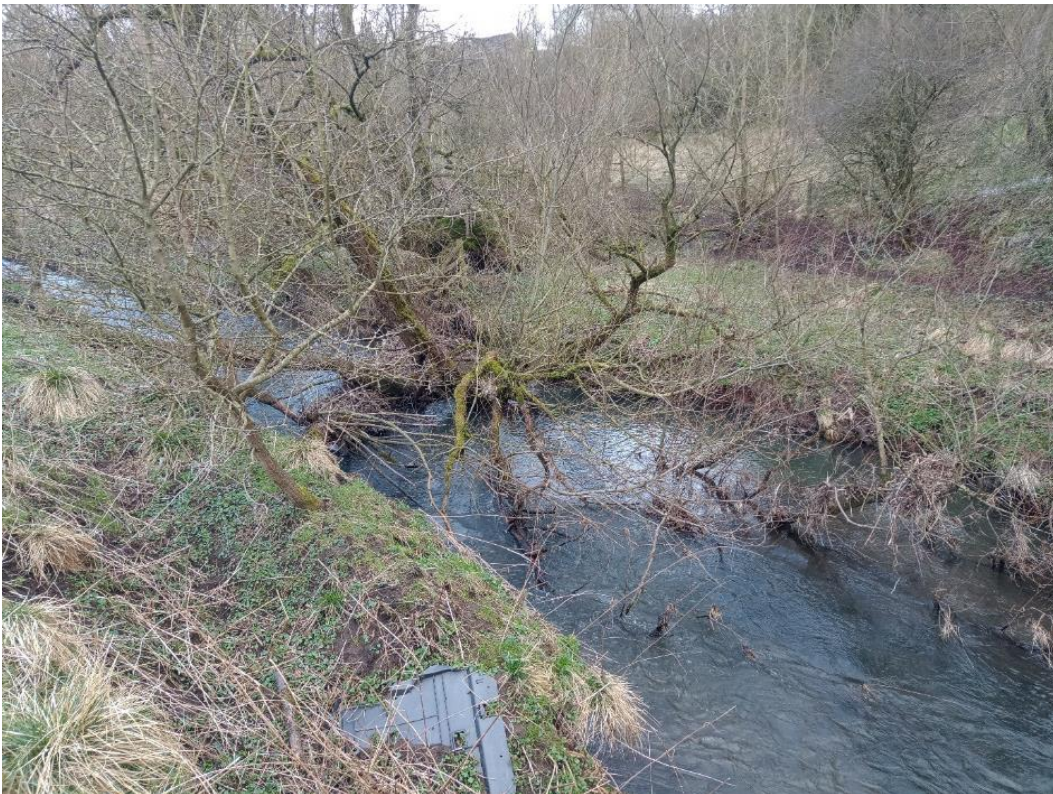
Figure 19 A fallen (but still living) willow creates a fantastic and long-standing habitat feature. It provides excellent refuge habitat for fish allowing them to escape predators such as fish-eating birds and otters. It also scours the riverbed, throwing up well-sorted gravel downstream. The combination of clean gravel and adjacent refuge makes this an ideal (and known) spawning area for trout.

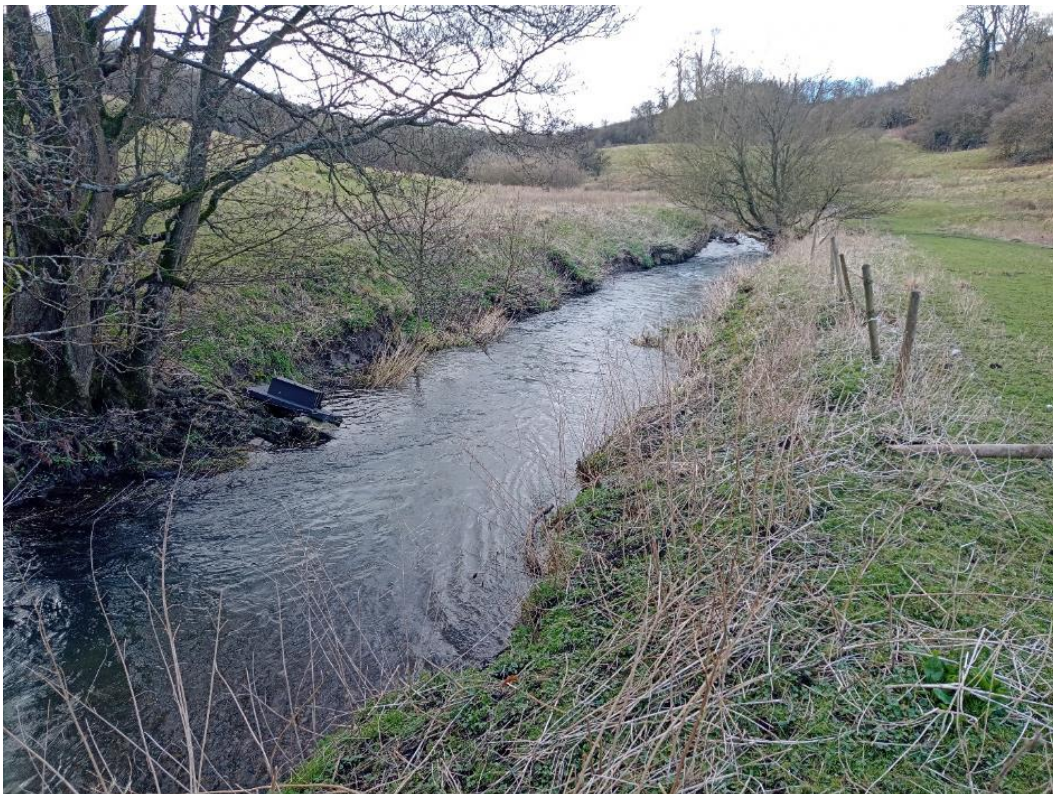
The large willow on the RB (Figure 20) is providing some limited cover with trailing branches. It was discussed whether this should be cut back for angling access, but given the dearth of cover along this section (and hence plentiful access elsewhere), it is recommended this is left unaltered, If allowed to grow unhindered, this tree may form a valuable habitat feature in future like the one in Figure 19.

Figure 20 Open area that would benefit from fence repair and some willow whip planting.

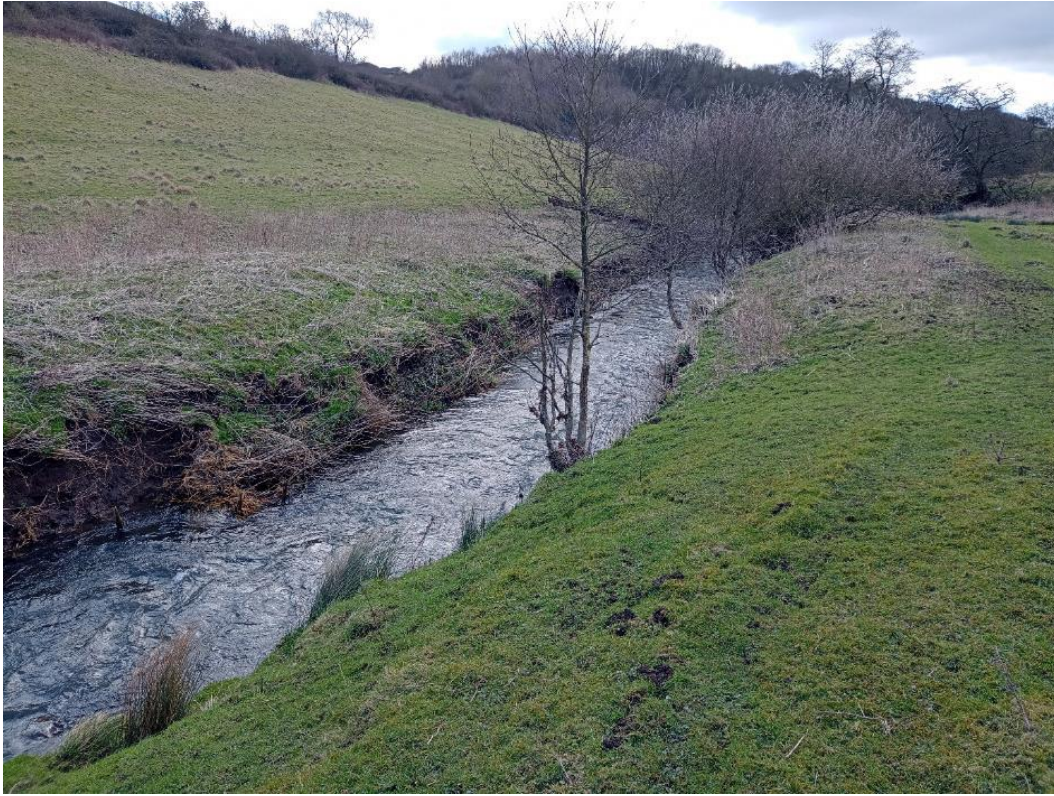
Closer to the footbridge there are several bushy willow trees (sallows) which would lend themselves to hinging into the margins of the brook and provide a source of material for use elsewhere (Figure 21).

Figure 21 Sallows (background) alongside the brook that could be hinged to improve marginal cover and used sparingly as a source of willow whip material.

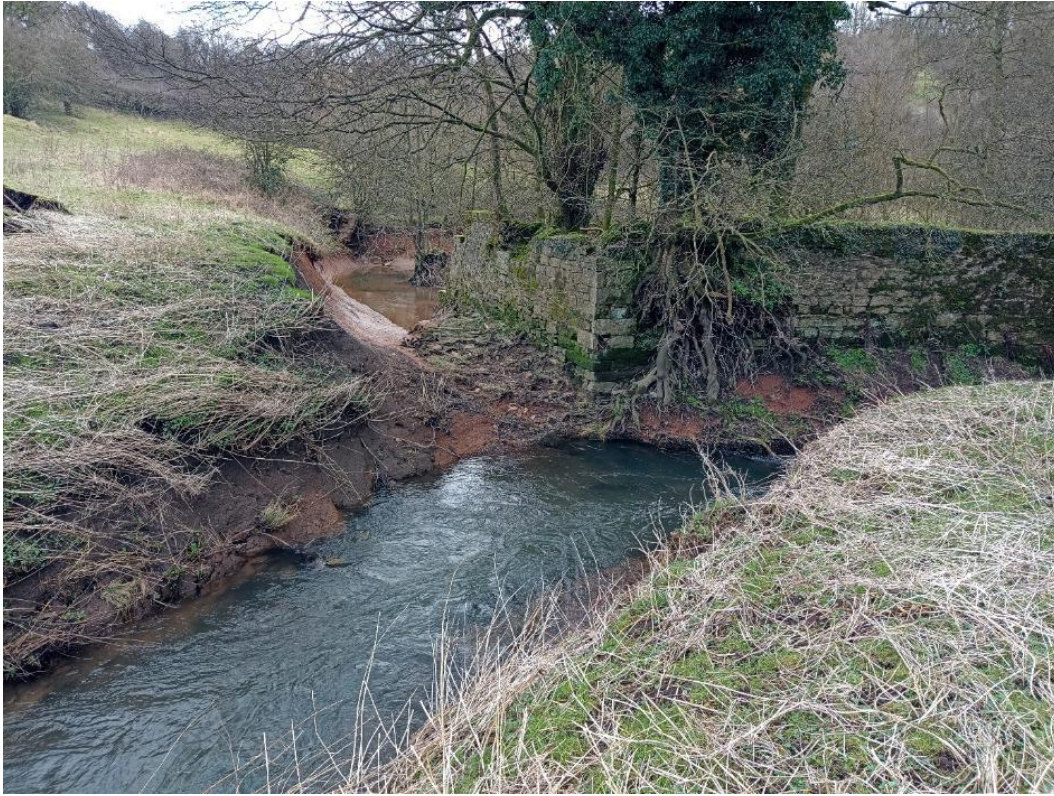
The sluice at the downstream end of this section and bypass channel which connects at high water (Figure 22 and Figure 23) has previously been assessed in detail by WTT for fish passage. The conclusion was the bypass channel has too steep a gradient to be cost-effectively adapted for fish passage, whereas the sluice is passable under low-medium flow conditions as long as it is kept clear of debris.

Figure 22 Side channel around the sluice which runs at higher flows.

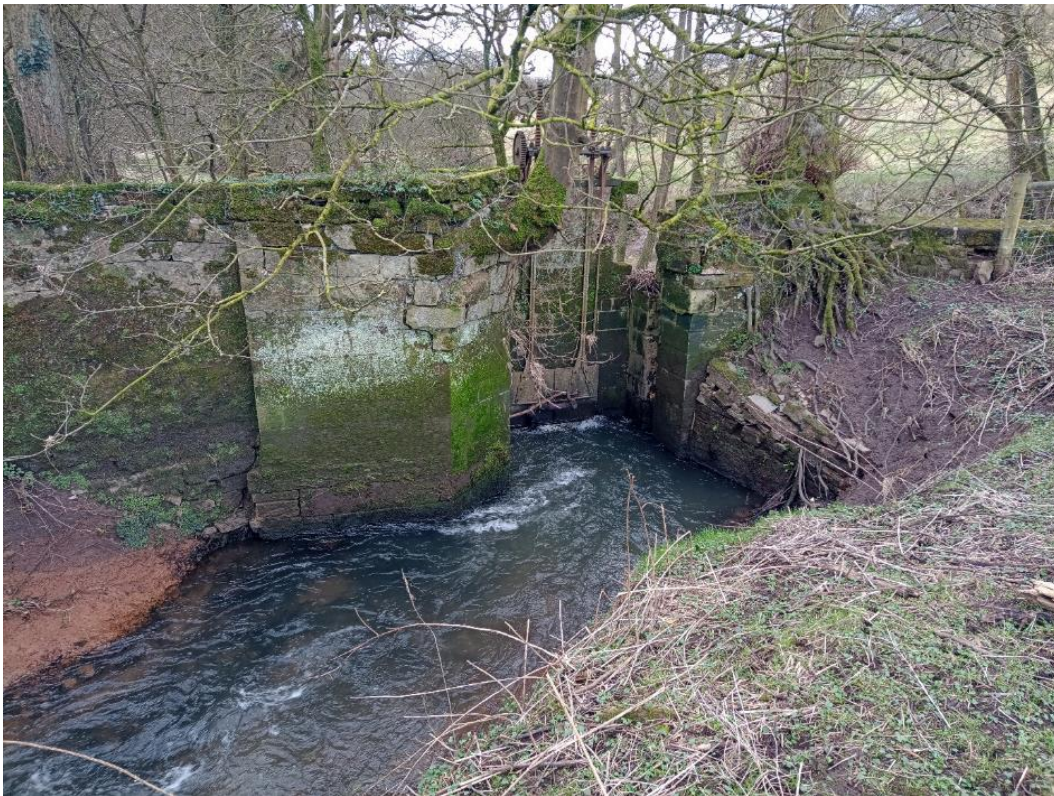
Figure 23 Dilapidated sluice – this is not a barrier to fish passage as long as it is not blocked.

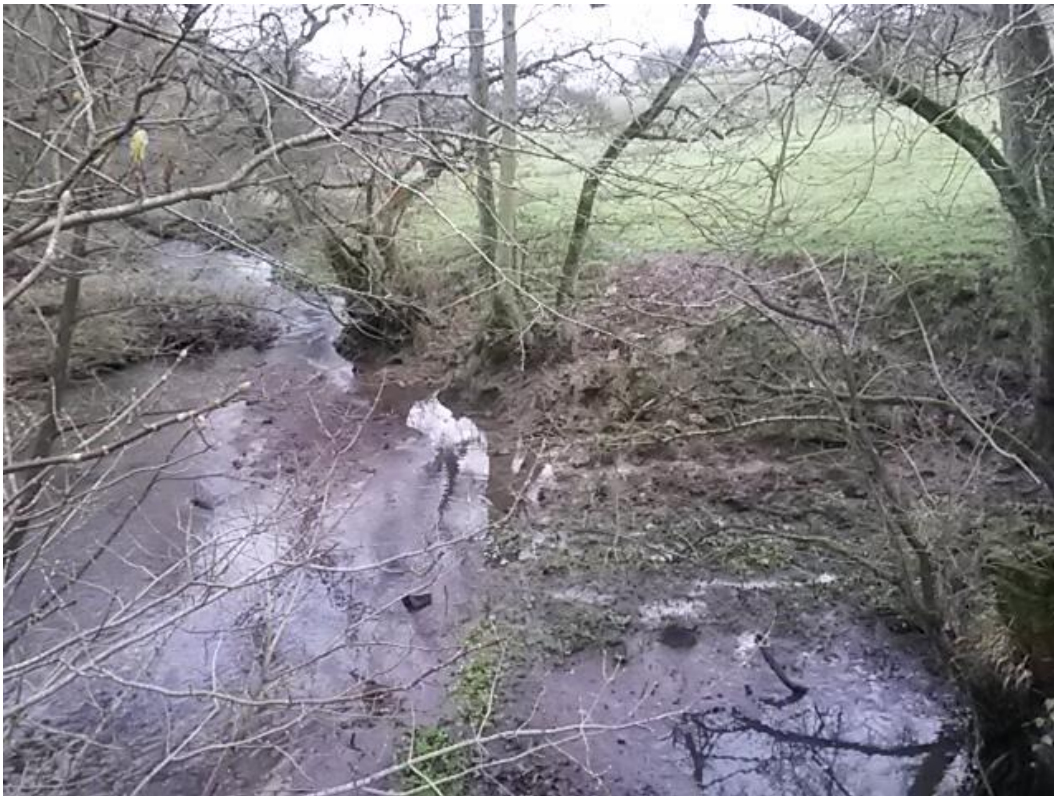
Downstream of the sluice the river channel is very wide with large amounts of deposited fine sediment. This area had been a long-standing problem with livestock access to the river causing poaching of the banks, mobilising fine sediment and preventing the sediment bars from colonising with vegetation (Figure 24). In 2023 the RB of the river was fenced off and alternative livestock watering provided (mains-supplied trough) under a WTT project funded by Environment Agency and a FiPL grant (Farming in Protected Landscapes)(Figure 25). To ensure the benefits continue, it is important LADFFA ensure it remains stockproof.

Figure 24 Area downstream of the sluice in 2014 showing typical livestock damage.

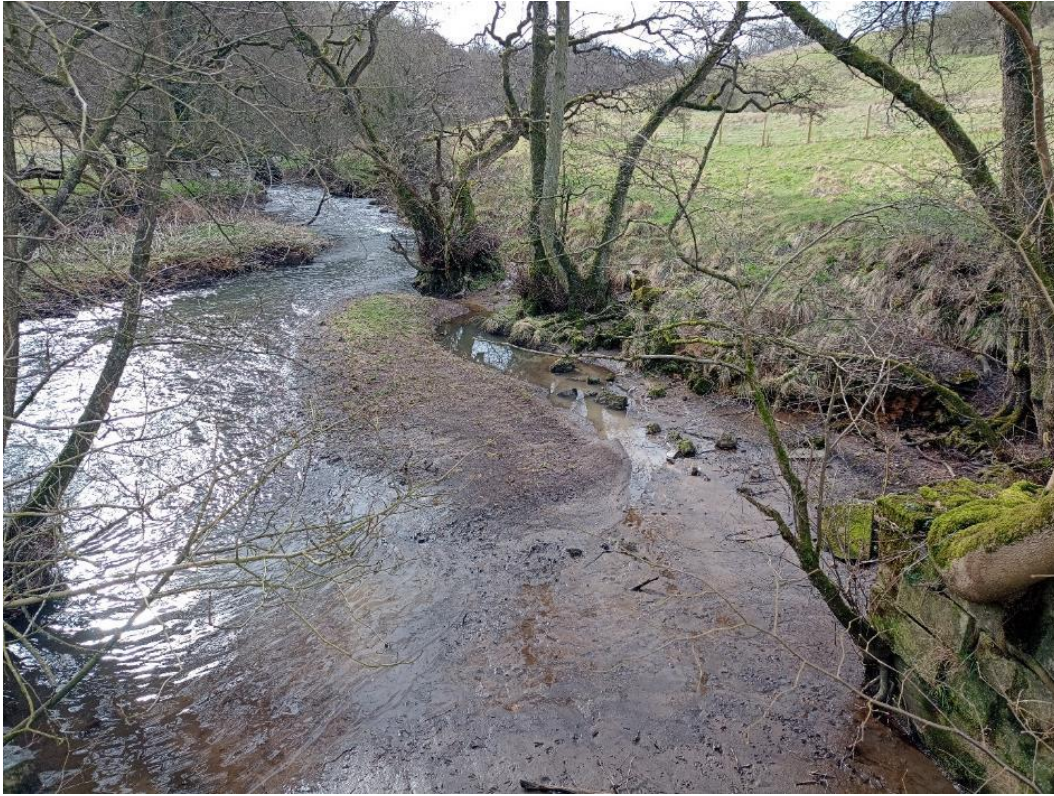
Figure 25 Same area as above, now fenced off from livestock.

Downstream of sluice (newly fenced section)	Figure 25	53.055318 , -1.7078456	Ensure fence remains stockproof.
Notched weir	Figure 26	53.055673 , -1.7077839	Assess extent of bed regrading and scope for further habitat improvement works at low water.

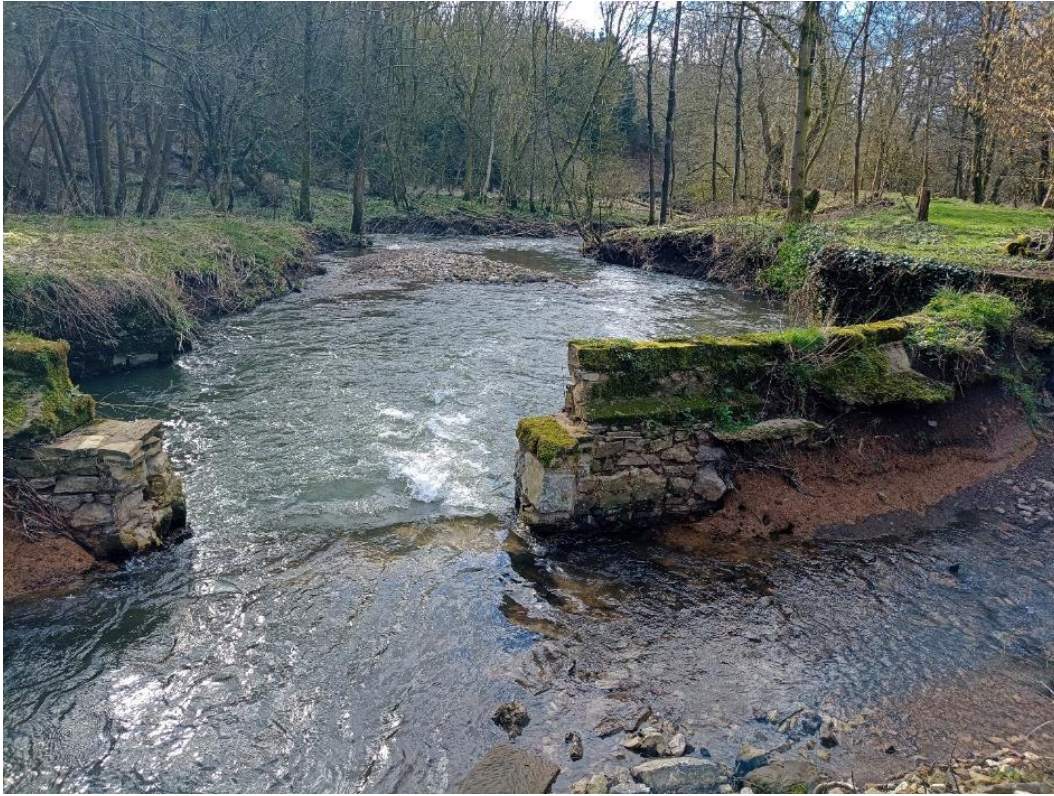
At the downstream boundary, the weir and sluice was modified in summer 2023 in a WTT project to improve fish passage funded by the Environment Agency. A large notch was made in the weir wall, diverting low flows through the notch rather than the sluice and chute on the right hand side of the weirpool (Figure 26 and Figure 27).

Since the notch was created, one of the wettest winters on record has provided ample high flow events which have transported trapped sediments from above the weir, an effect which was anticipated. To some extent this process has been limited by the rock cascade which has been exposed (Figure 28), but this needs to be assessed at lower flows before any decision is taken on whether to modify it. Previously installed habitat improvements have benefited from the rejuvenated flows and LADFFA members report an improved depth profile, far less silty substrate (which formerly dominated here) and some good catches (Figure 29). This will have also greatly improved habitat for many flow-loving invertebrates whose hatches benefit anglers.

Figure 26 Notched weir (downstream view). Note freshly deposited coarse sediment on mid-channel bar.
