WILD TROUT TRUST

Bentley Brook (aka Bradbourne Brook)

Derbyshire

February 2024

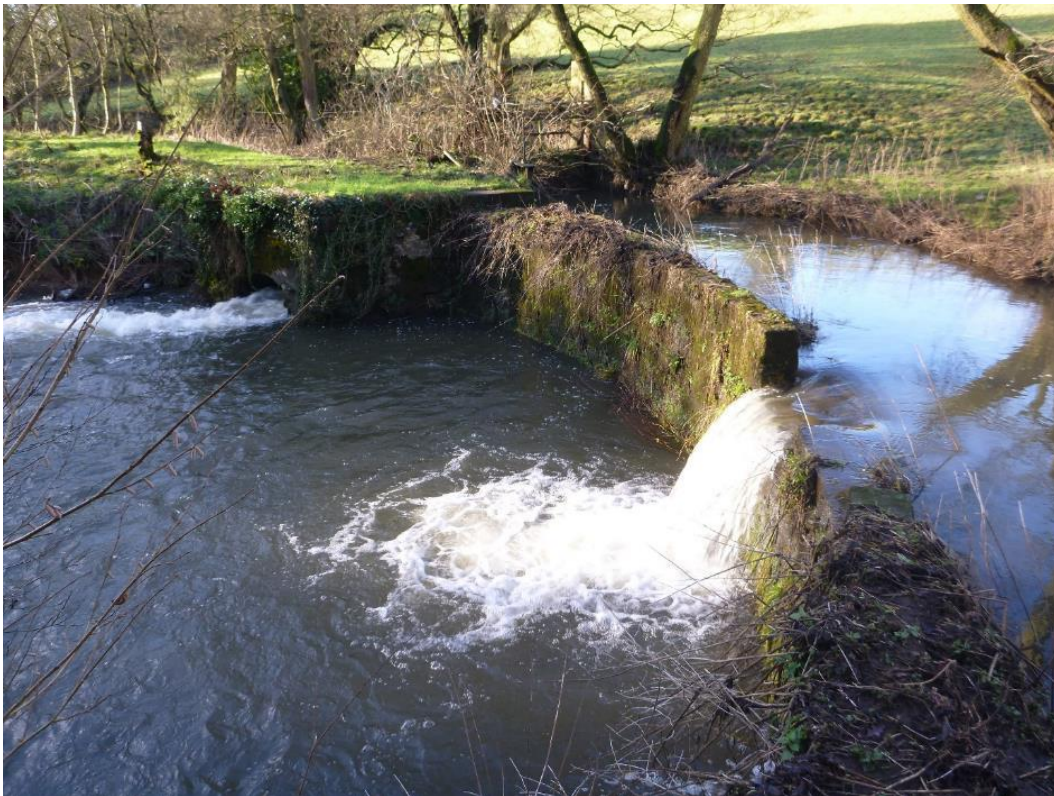
Figure 27 Weir prior to notching (in 2016) during high flow conditions. During low flows, water would pass only through the far sluice at high velocity (preventing fish passage).

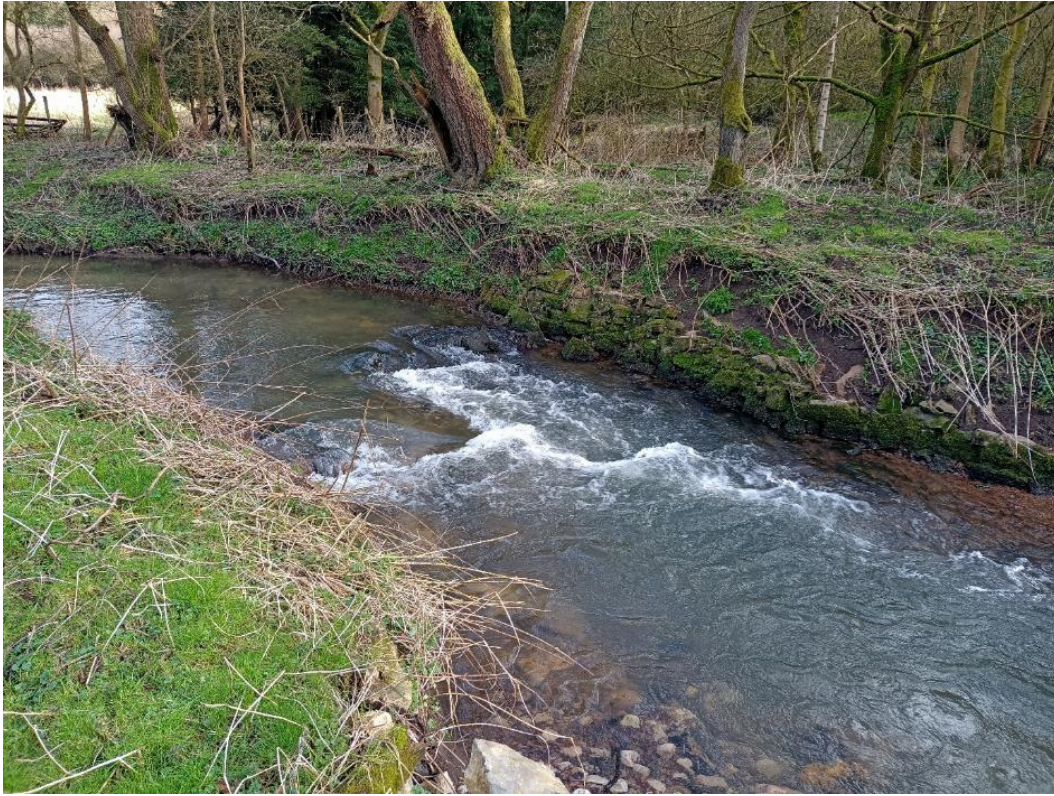
Figure 28 The lowered water levels above the weir have exposed a rough stone cascade, which is acting as a bed level check, slowing the re-grading of the river bed. At this stage (<1 year since weir notching), it is recommended this is not altered and an assessment of bed levels, fish passage and sediment transport is carried out at lower water levels. The structure appears passable to trout at current water levels.

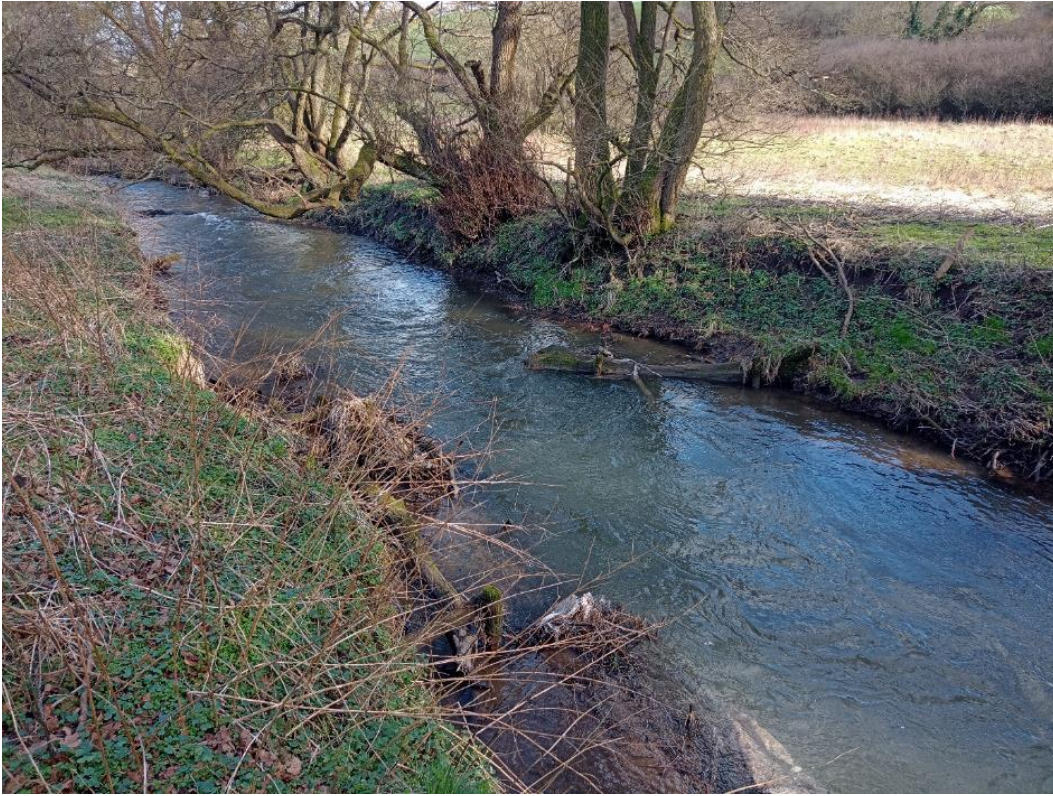
Figure 29 Further upstream from the notched weir, the re-energised flows have allowed previously installed habitat improvements (log deflector, marginal woody cover) to function better. A large amount of accumulated fine sediment has been scoured from this section, increasing depth variability.
