WILD TROUT TRUST  
wildtrout.org

Advisory Visit  
River Camel and tribs, Cornwall  
February 24 & March 22, 2022

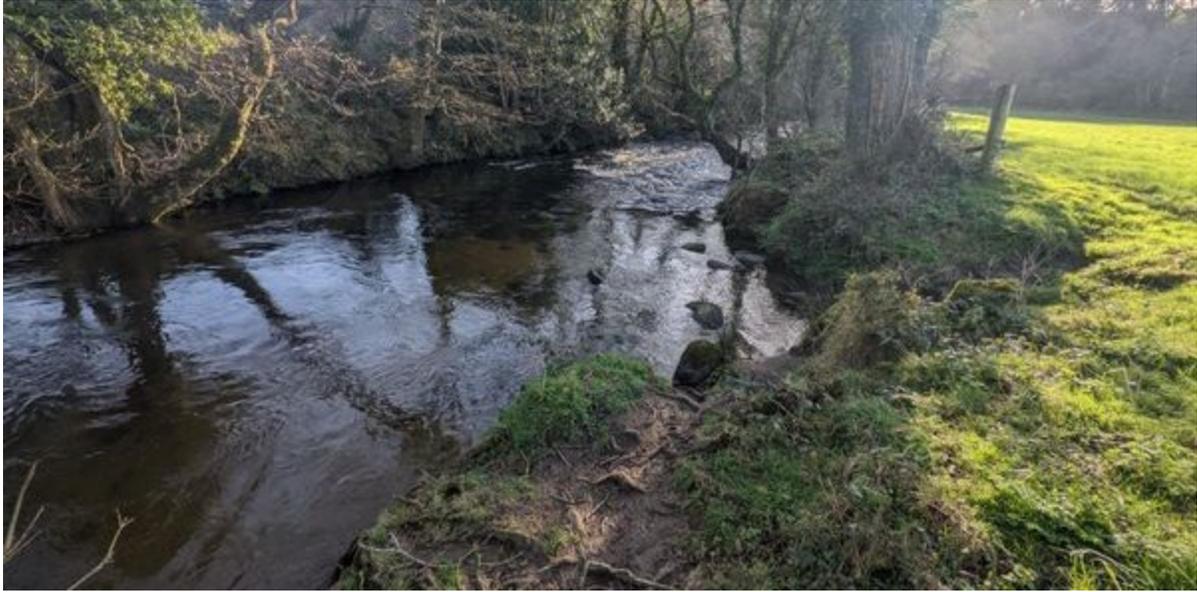
Figure 1 The first potential spawning area on the De Lank. Large trout potentially sea trout, could use this area for redds. -4.7025988 50.5307196

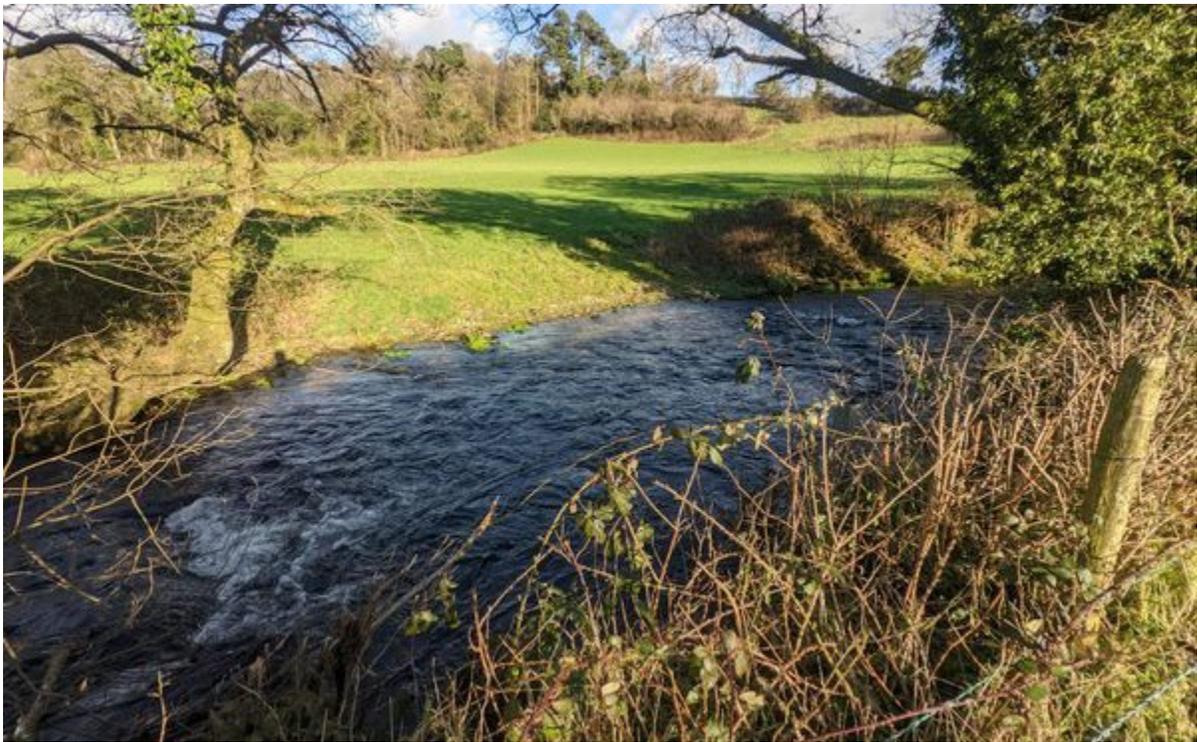
Figure 2 A little used stock ford. Fine sediment supply did not appear to be an issue at the time of visit, however this will increase with wetter weather and greater use. A better entry on either bank with cobble standing should be a minimum alteration though diverting stock over a clear span bridge would be preferable where possible. Examples of better stock fords are included in the Appendix. -4.7027093 50.53105

- The use of stock fords on the lower river should be reconsidered and, if absolutely necessary, should be protected with hard-standing to lessen their impact on the river. Coarse, crushed concrete entries on both banks will reduce erosion from stock and limit fine sediment pathways (see appendix).

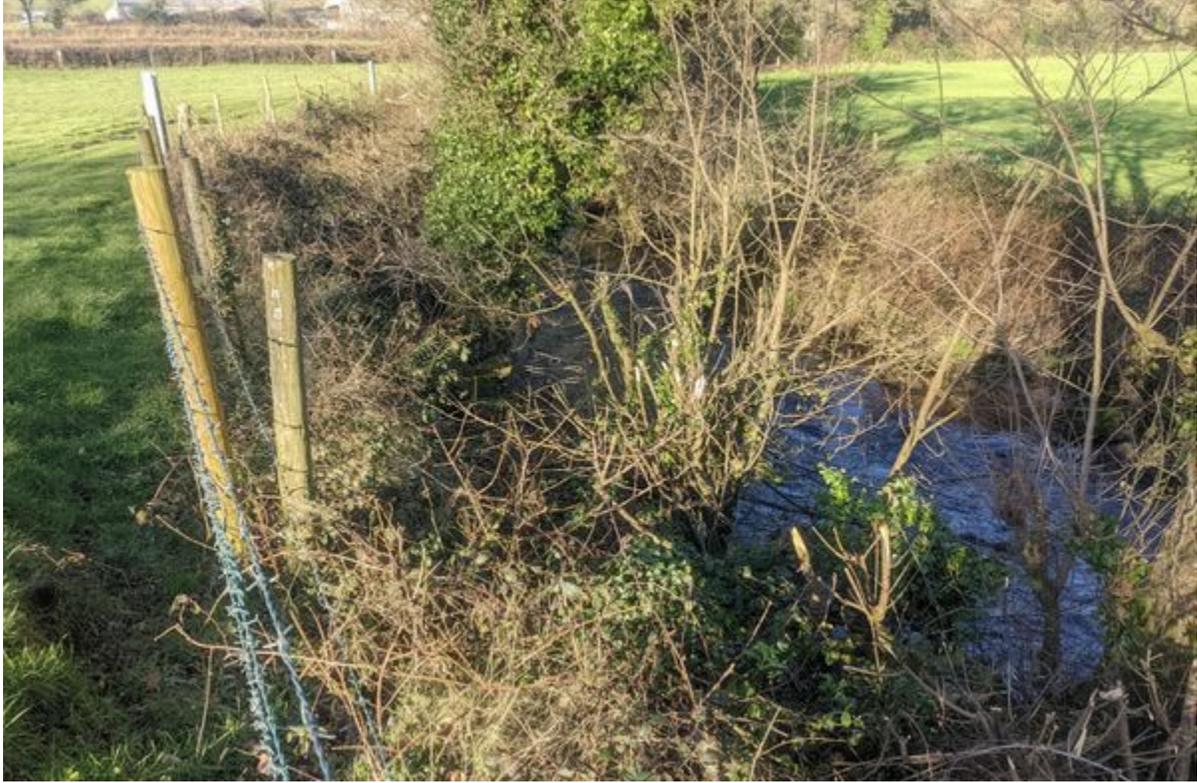
Figure 3 Stock fencing within 1m of the river bank is not providing a sufficient riparian strip to maintain bank stability. Fencing further back, allowing the buffer to establish with deep rooting plants is recommended to reduce erosion and land loss. -4.7031638 50.53161

- Riparian fencing could be improved on the lower reaches, setting it further back from the bank to establish a wider buffer and denser mix of shrub and trees. This would ideally be undertaken now, but could be part of a future programme as the fencing is replaced.

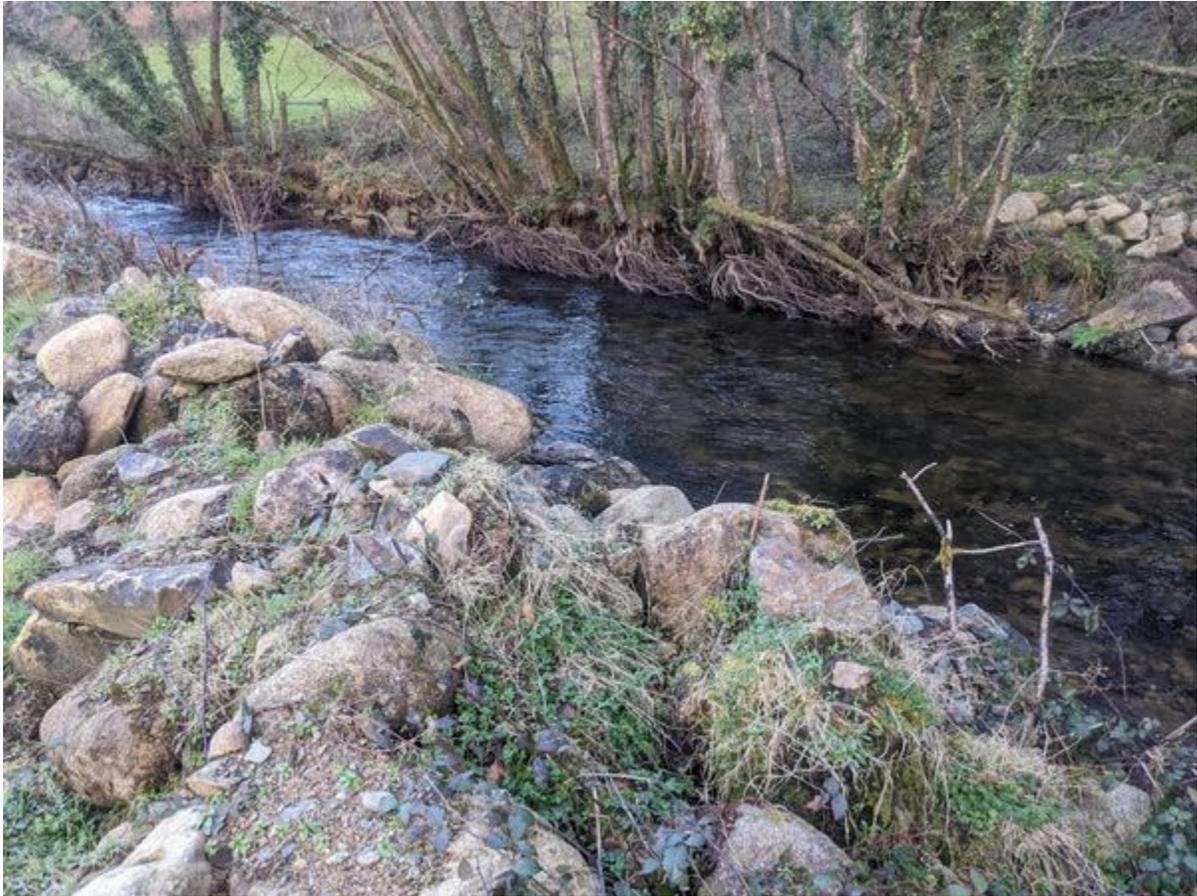
Figure 4 The site of a former boulder weir, removed by Westcountry Rivers Trust and landowner. Note roots exposed from lowered water levels. The RB should be encouraged to establish a denser fringe of trees; the discarded boulders are likely preventing this and should be moved elsewhere if at all feasible. Some larger boulders could be placed randomly in the channel to increase the flow diversity in what is a uniform bed. -4.699093 50.5321787

- The boulders on the right bank of the former weir site are limiting regrowth and should be moved. Some could be reinstalled within the channel to build back some flow diversity.

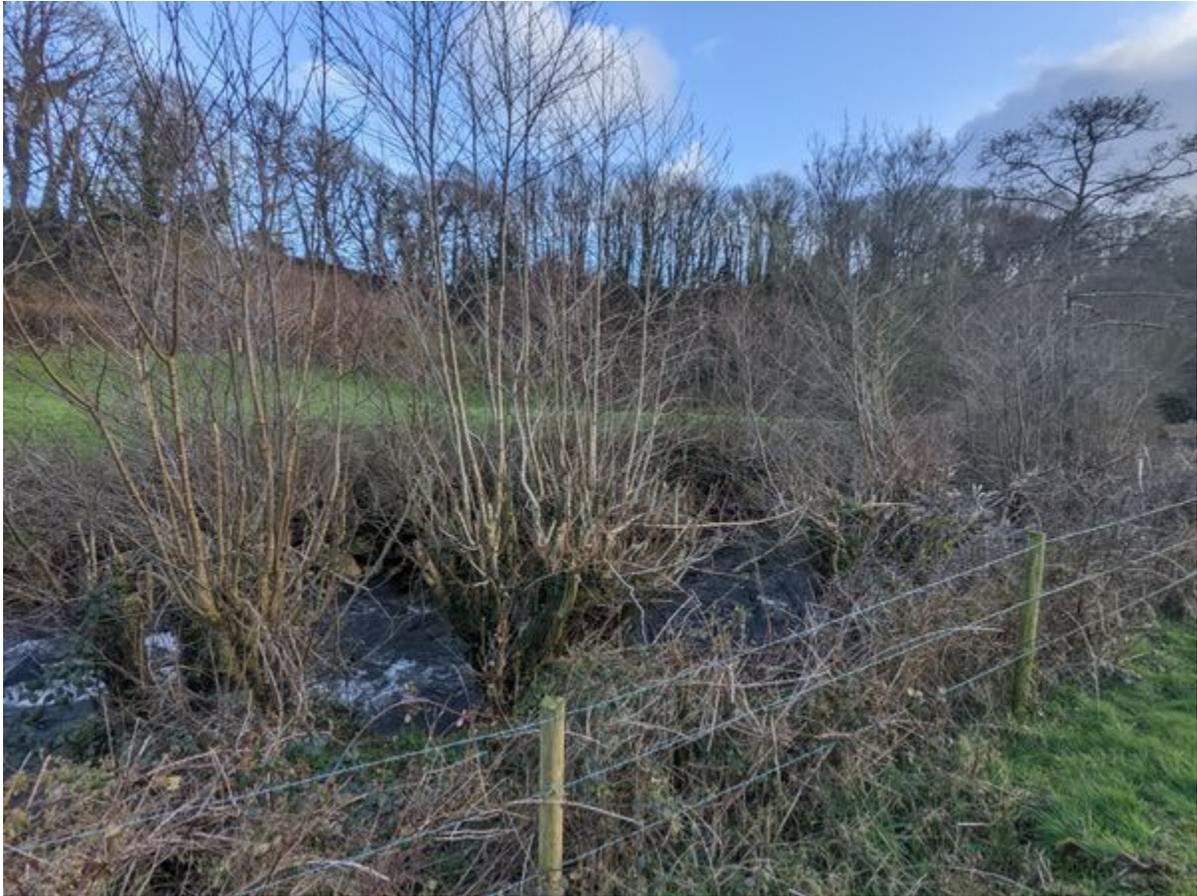
Figure 5 Flailed riparian trees. It is understandable that this is the most efficient way to manage tree growth. However, the uniform and severe result does little for biodiversity and is likely stunting root growth, as evidenced by the pockets of erosion witnessed between trees. -4.698795 50.5329938

- The flailing of the riparian trees is limiting their habitat potential and causing some bank erosion. The practice also encourages vertical growth, leaving the river without trailing branches, shade or cover for fish. Some hinging of limbs could remedy the erosion and habitat issues.

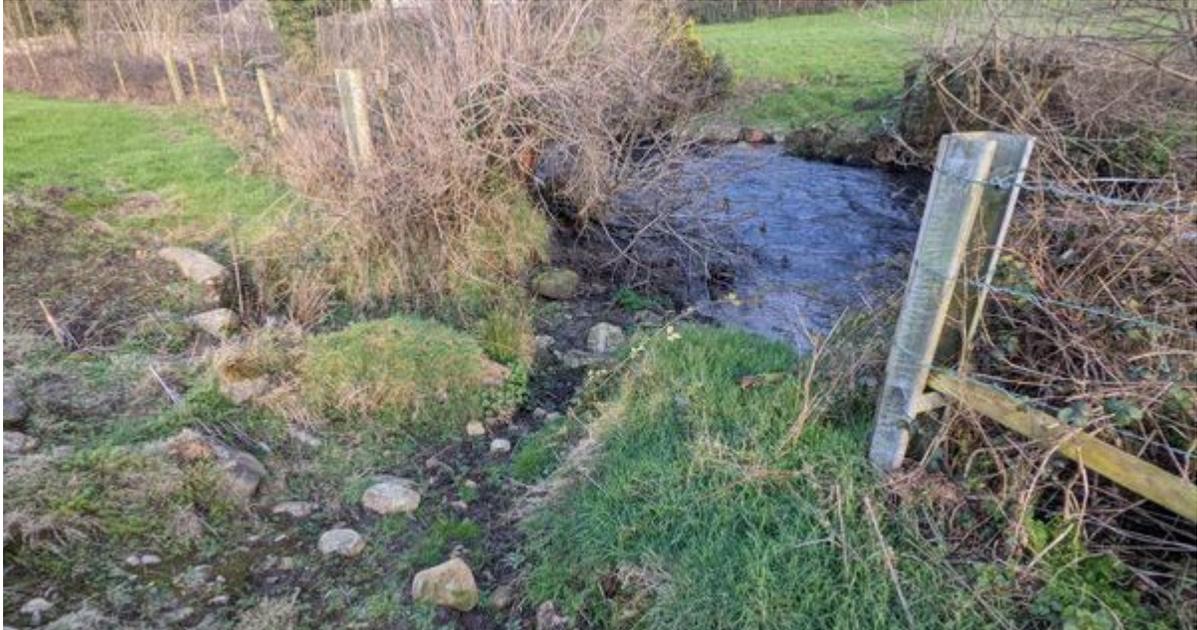
Figure 6 Another little used stock ford. This was a better fenced example, though fine sediment pathways are visible and so diverting stock is the primary recommendation as before. -4.6987607 50.532981

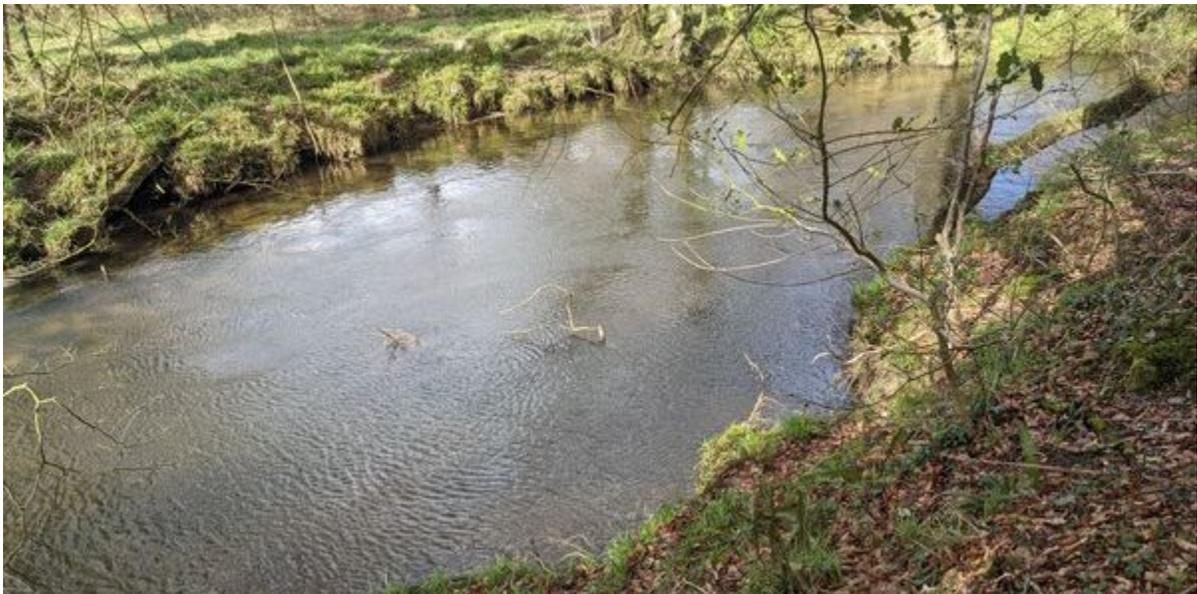
Figure 7 A deep corner pool with large fish holding potential. Solar gain (the amount of solar energy that the body of water receives) could be reduced with better shading, riparian tree planting on the RB would eventually facilitate this and provide future material to hinge into the channel. -4.697455 50.534653

- Tree planting alongside deeper pools to limit future solar gain would be beneficial though this is only a concern in a few places.
- Continue to preserve the un-managed riparian trees and windfall.

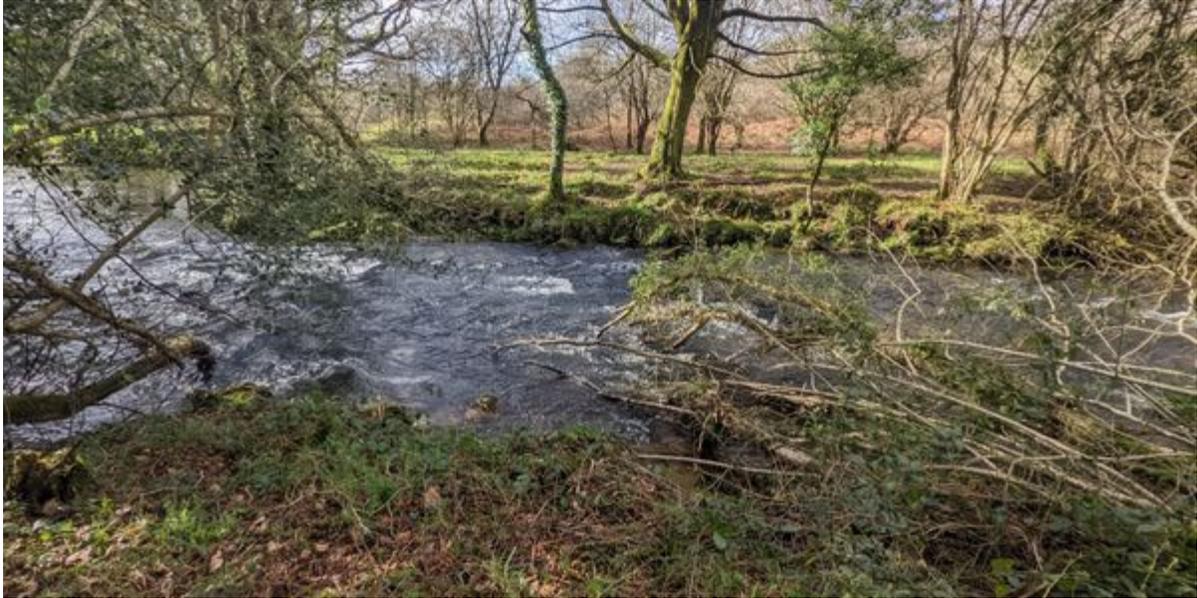
Figure 8 Windblown hazel making a good addition to in-channel diversity. Such fallen material provides refuge and flow diversity for many age classes of salmonids. -4.69744595 50.53538274

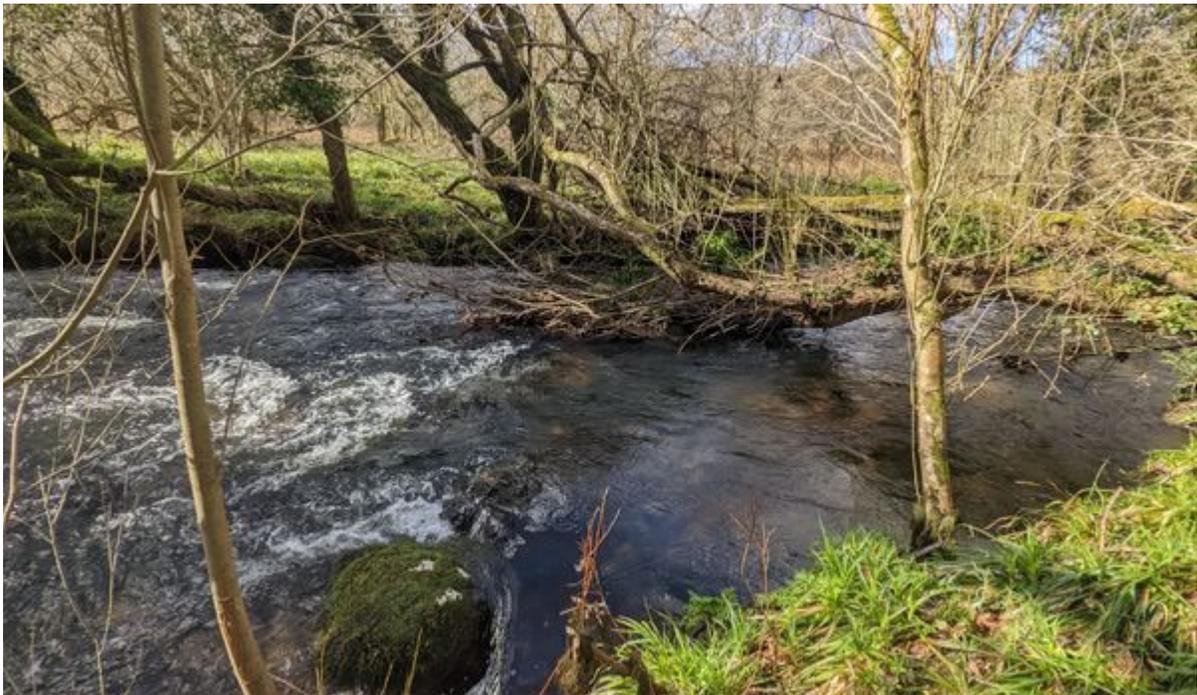
Figure 9 A windblown, bridged tree creates a terrestrial habitat corridor and increased channel diversity where it touches the bed. In high flows, such natural structures reduce flow energies whilst leaving low-flows unfettered. -4.6973444 50.5354265

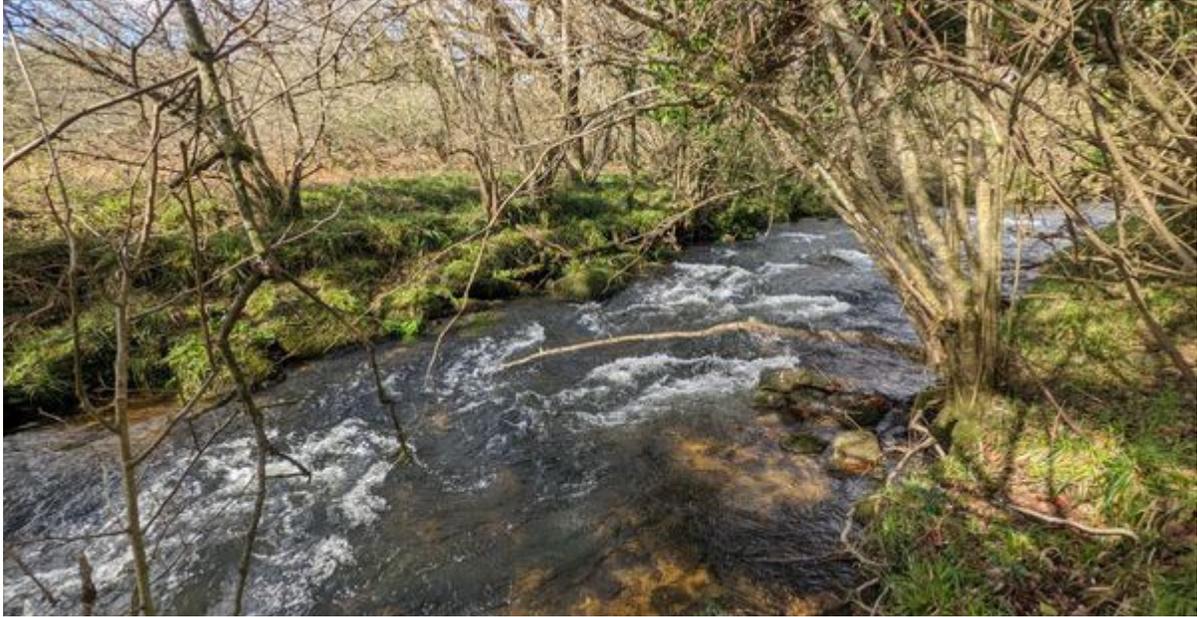
Figure 10 Many bankside multi-stem trees provide good hinging potential. Hinging all but the largest stem into the channel margin will increase diversity and habitat, with the remaining stem growing upward into a standard-like tree. -4.6974022 50.5356991

- Some previously coppiced, bankside trees could be hinged into the channel to increase coarse woody material and add structural & habitat diversity.
- Support efforts by WRT to create free passage through the quarry.

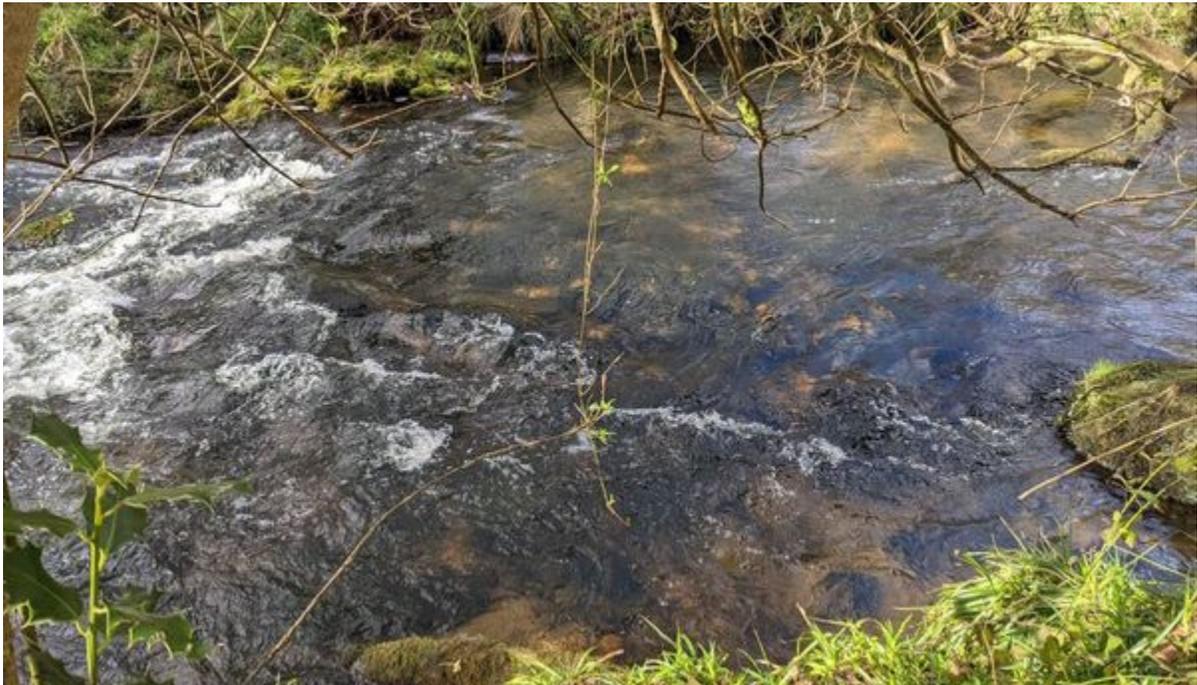
Figure 11 Potential spawning area, the up-kick of gravels at the tail of the pool could support many redds; however, the depleted range of gravel sizes may limit spawning to resident trout and small sea trout only. -4.6973412 50.5359481

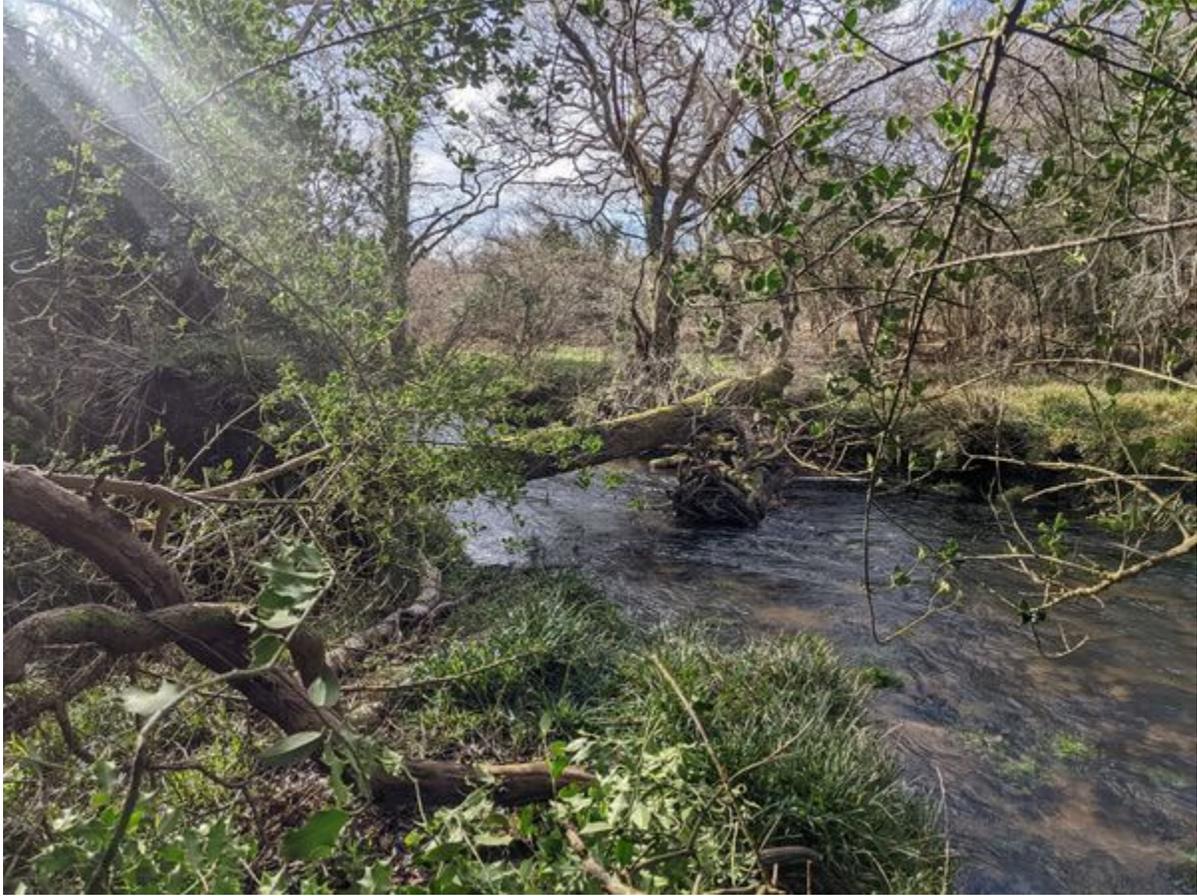
Figure 12 Another big tree bridge and accumulated trunk. The habitat value of such structures should be retained. -4.6972314 50.536083

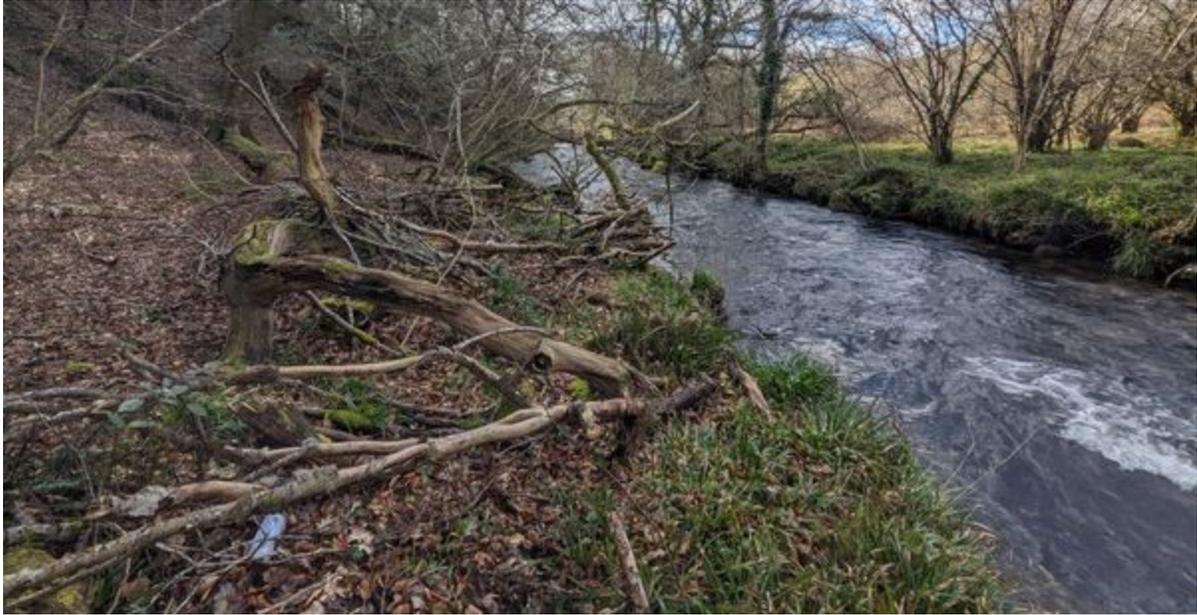
Figure 13 Despite the generally steep LB valley side, this area had good storage capacity as evidenced by trapped flotsam. Felling and lodging trees from both banks as an NFM structure would have capacity to back up in high flows. - 4.6962916 50.5367708#

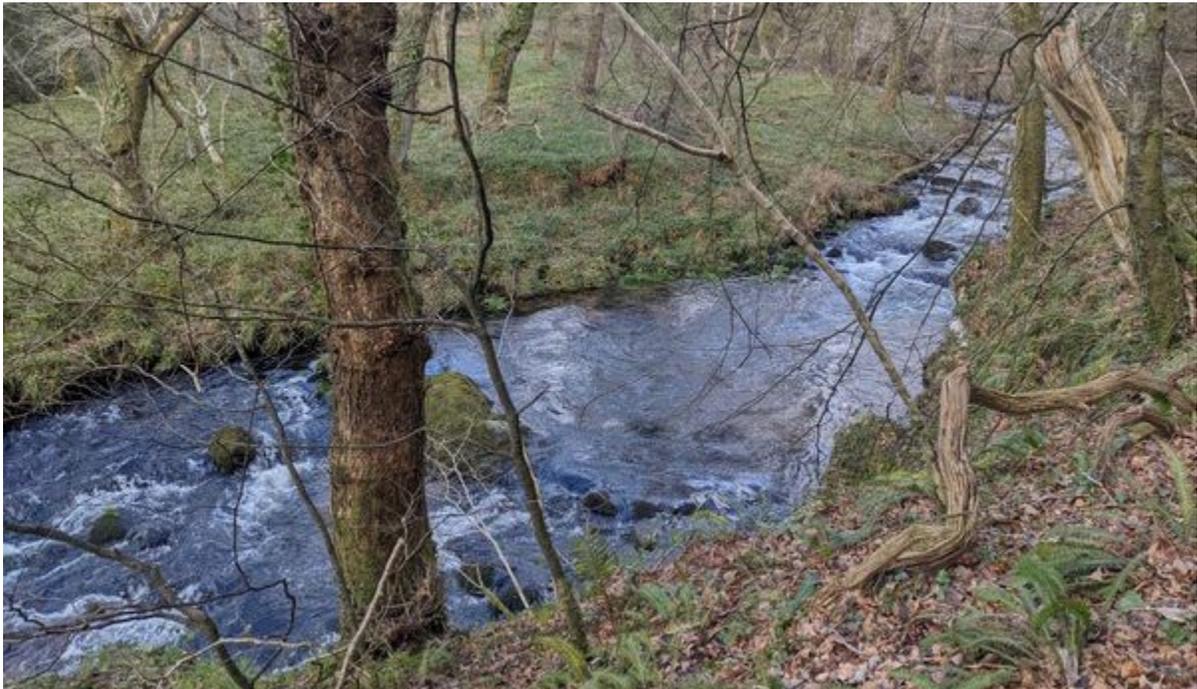
Figure 14 The channel pushes hard against the LB of the floodplain. In combination with an incised stream, floodplain connectivity on the RB is limited, increasing stream energy. -4.6960314 50.5370663

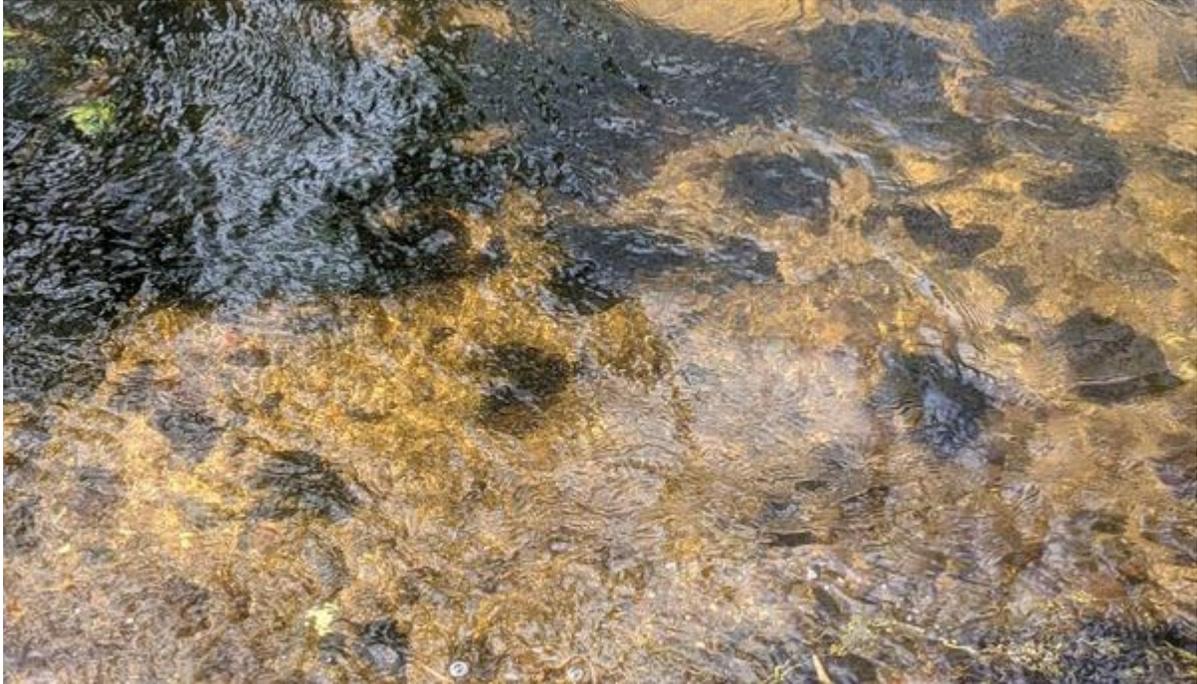
Figure 15 Good, clean trout spawning gravels but lacking larger sizes needed for migratory fish. -4.6954989 50.5379531

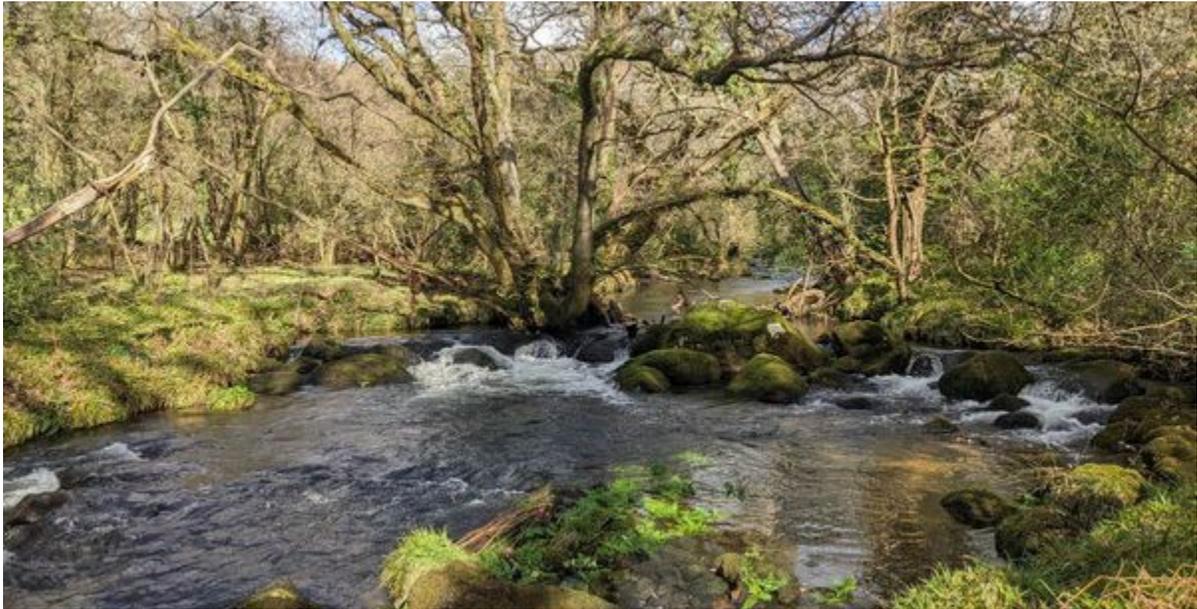
Figure 16 A tree fall many years ago, has pushed the channel to the LB. Lateral erosion caused by windfall is a natural process and the channel diversity downstream has increased as a result. This is to be encouraged. -4.6952639 50.5380944

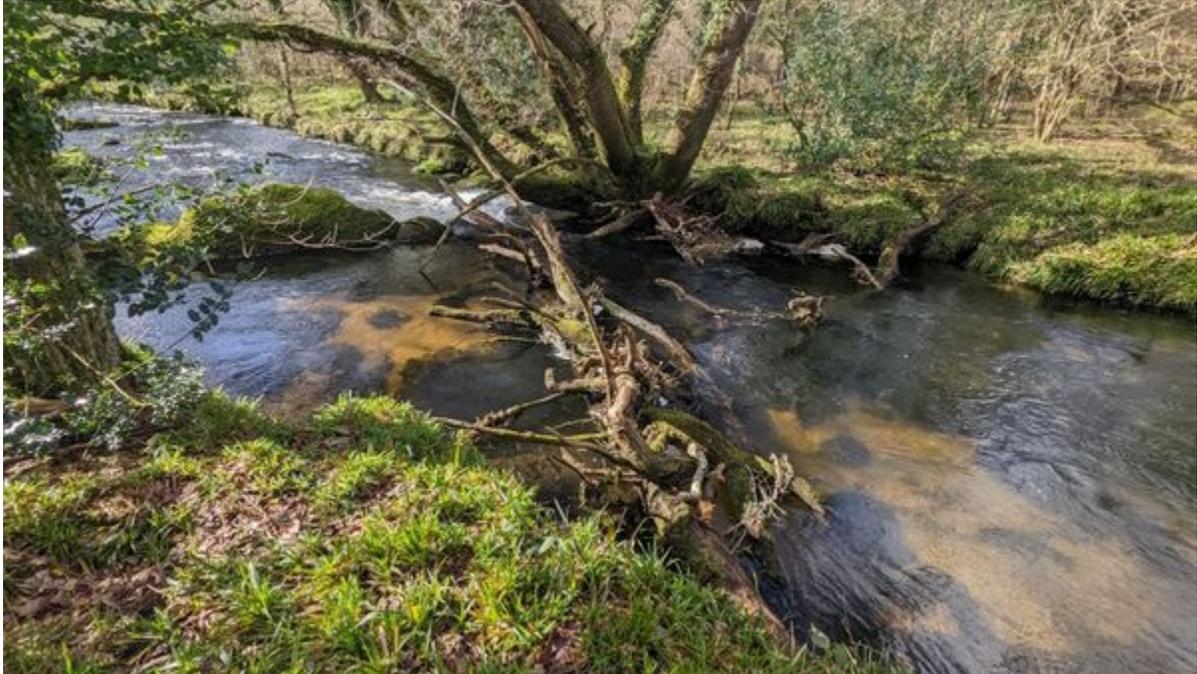
Figure 17 The tree from the previous photo has caught fallen woody debris, creating scour and refuge. A 20cm trout was seen within this structure. -4.6950081 50.538246

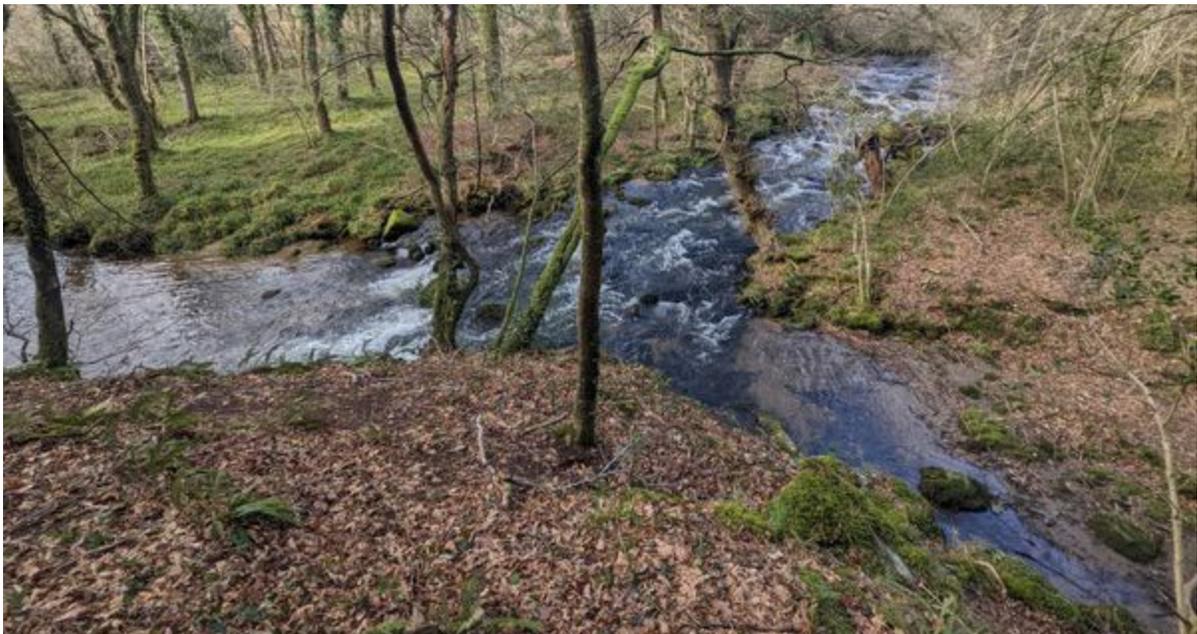
Figure 18 A tributary enters the main river from the LB. The variety of coarser gravel was evident, showing just how much of an impact the quarry is having. Though small, it is not unreasonable to expect sea trout to spawn within the lower reaches of this tributary. -4.6942253 50.5386637

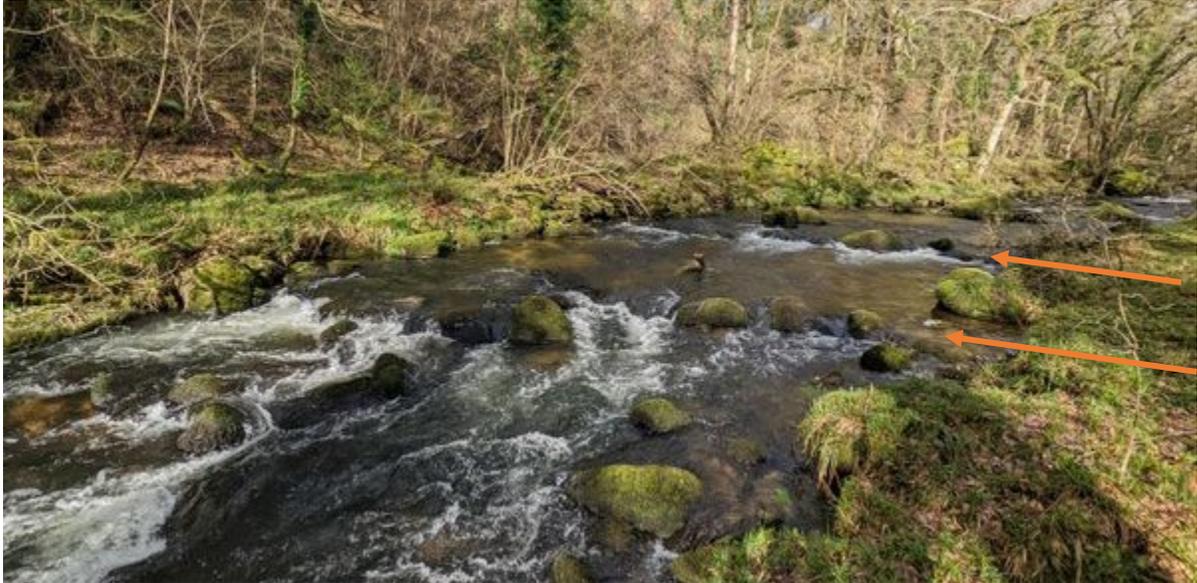
Figure 19 An unnatural looking pair of boulder weirs (orange arrows). There was no obvious reason as to their function, but the regularity and perpendicular stance suggests they were man-made. Manipulation to naturalize their formation could provide better river function, but is not a high priority. -4.692676 50.539886

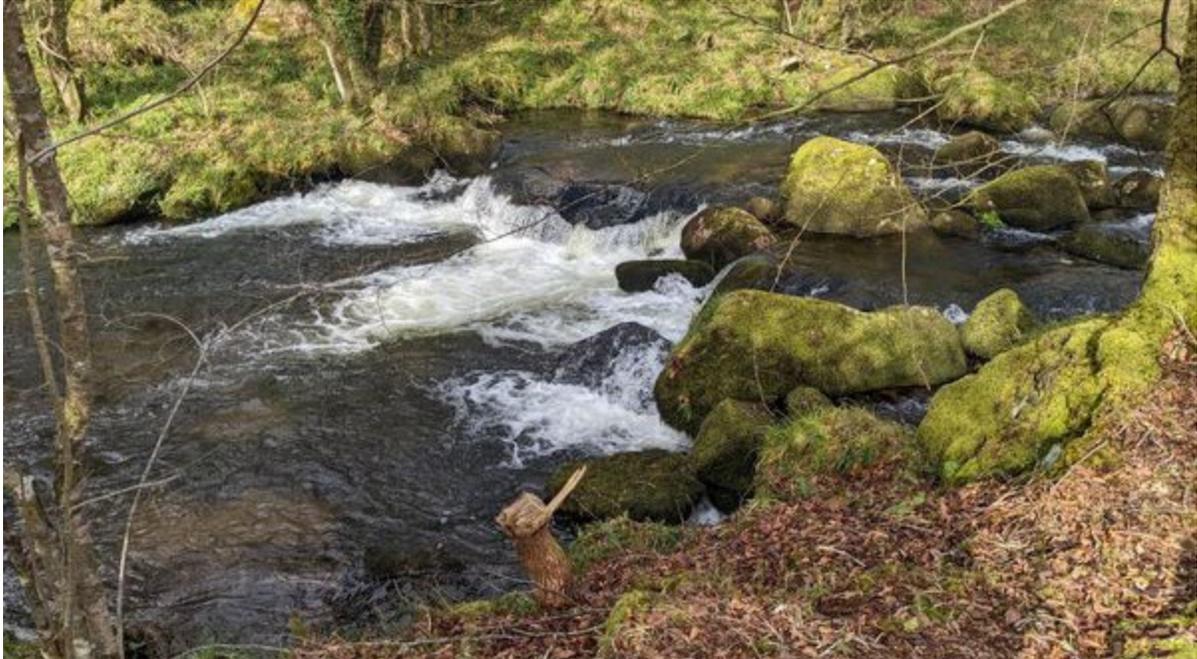
Figure 21 Another tough, natural ascent for anything other than sea trout. Approximately 90cm head. -4.6891292 50.541537

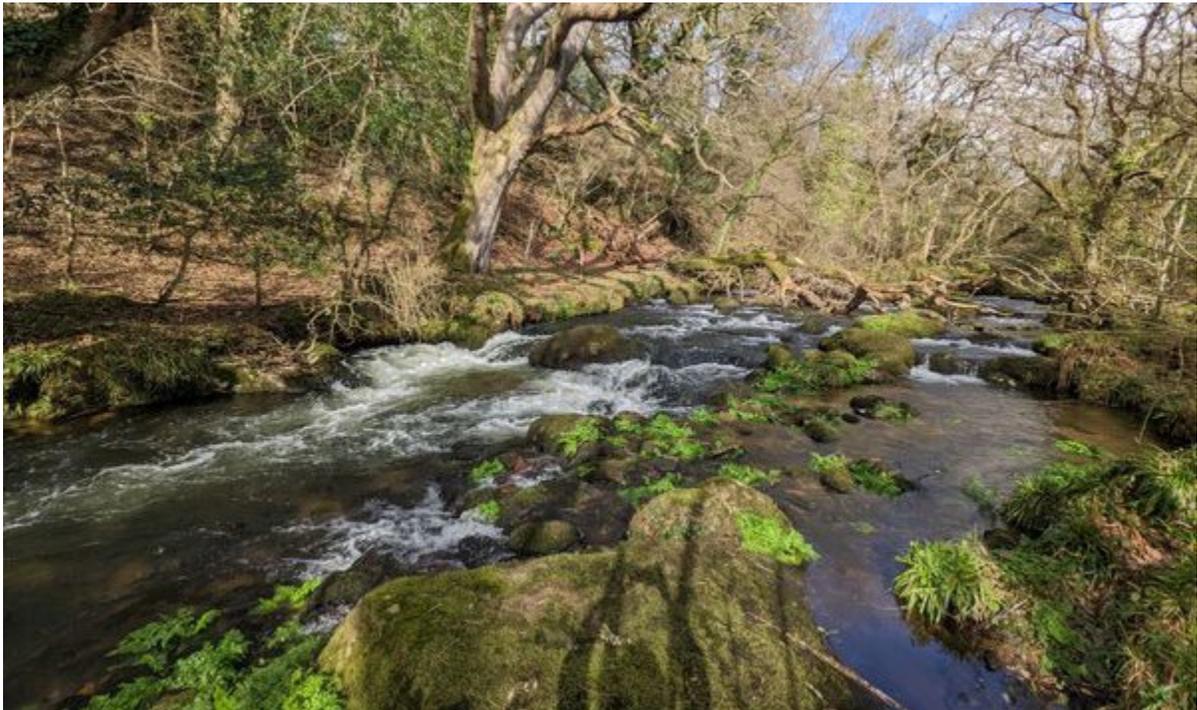
Figure 22 The gradient begins to increase with stream energies moving all but the largest boulders. More fallen trees in channel provide good habitat. -4.6878209 50.5418454

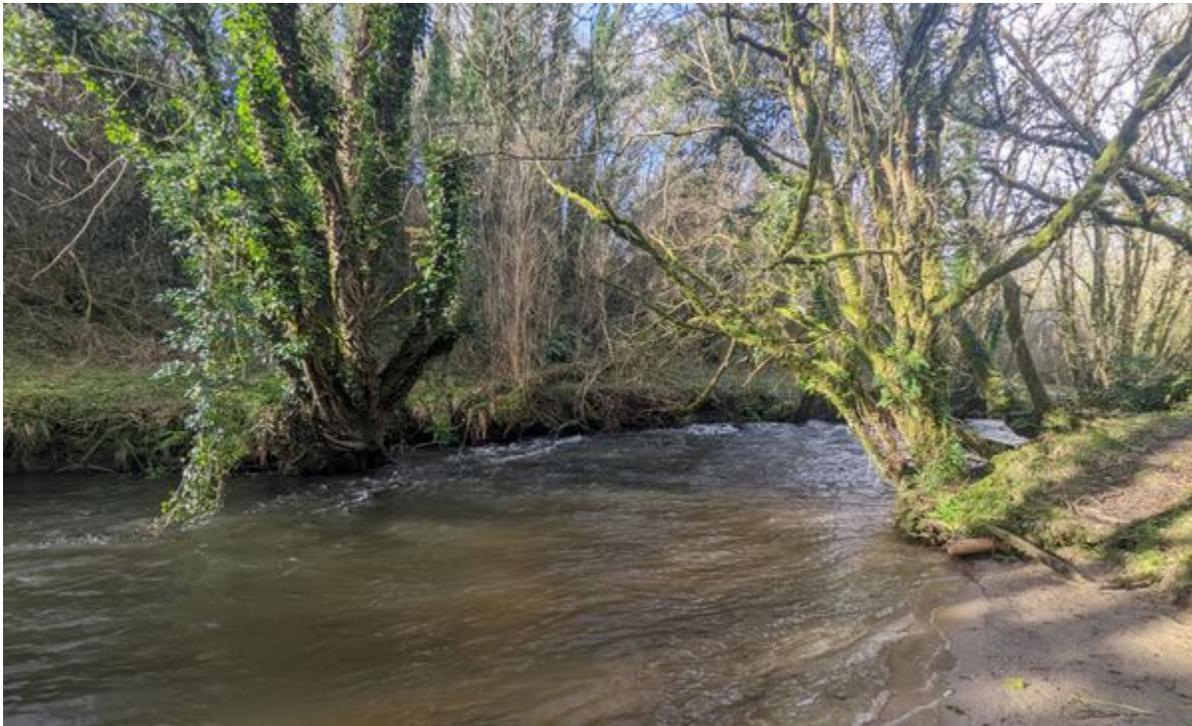
Figure 23 Old coppiced alders overhang the river. Though not the easiest species to [hinge](#), the majority of this material could be felled and/or [lodged](#) to build better in-channel habitat. Where lodging is impossible, some could be cabled to stumps.  
-4.7075246 50.5360806-4.7075246 50.5360806

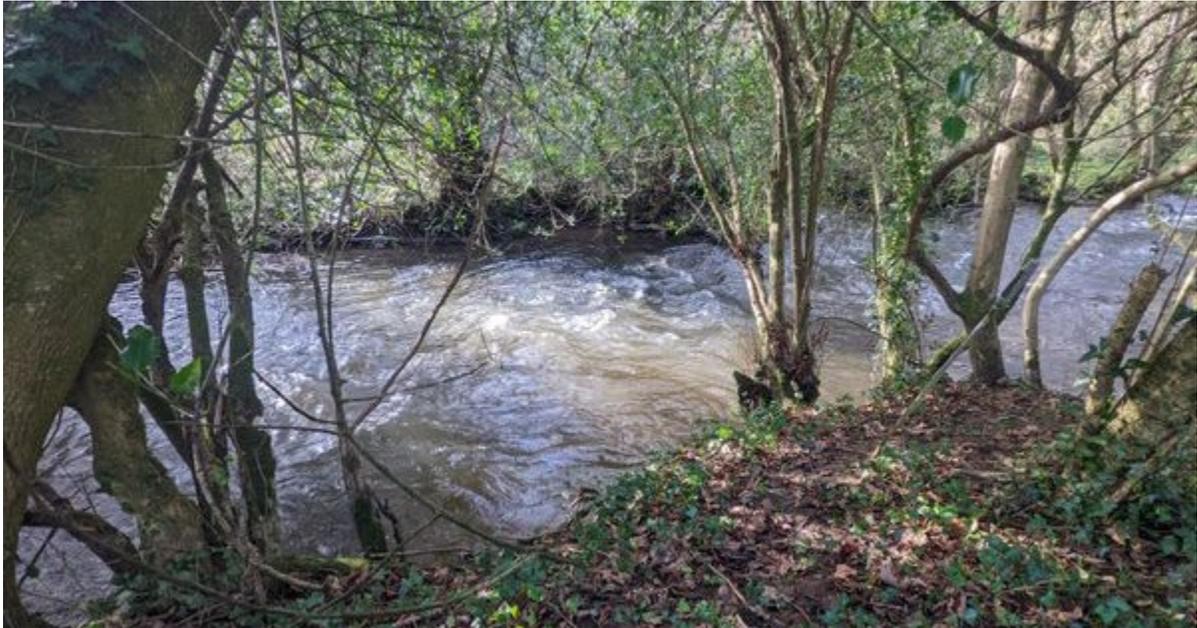
Figure 24 More old coppice that could be hinged into the channel margin.  
-4.7077971 50.5348167

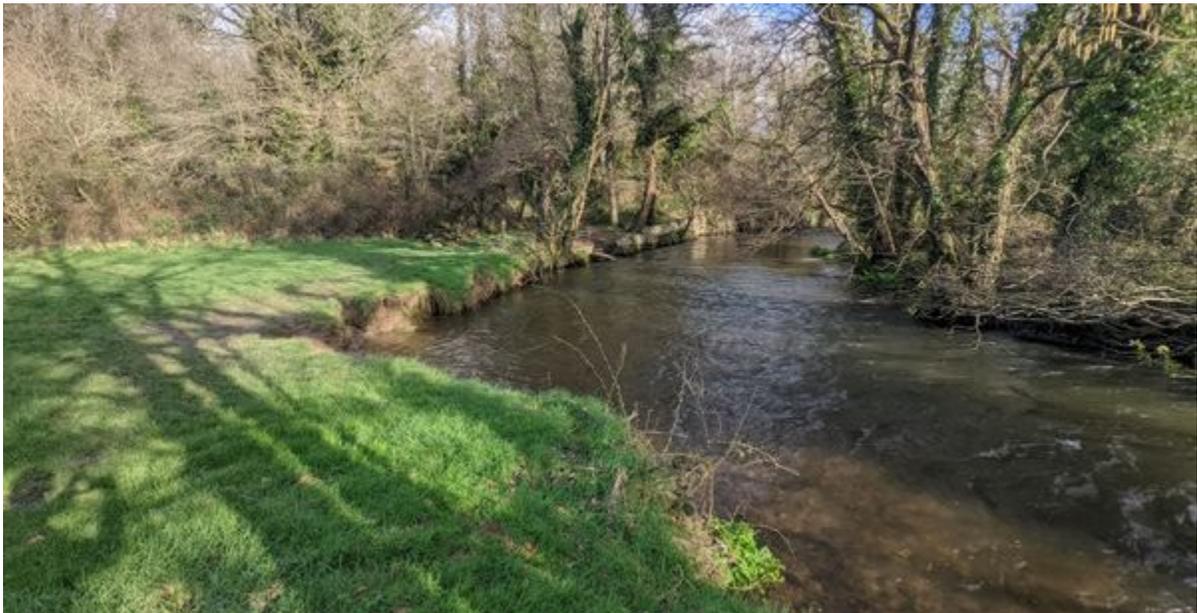
Figure 25 A point of erosion in a municipal area next to the Camel Trail. Dogs entering the river are a likely cause, exacerbated by the total lack of trees and cropped grass. Tree planting of thorny hedgerow species could be established with a view to being laid along the bank in the future. If stock are given access, fencing to exclude them from the riverbank would help planting efforts and reduce

poaching. Formalized dog runs within a better structured riparian fringe will limit the damage. -4.70714, 50.5345

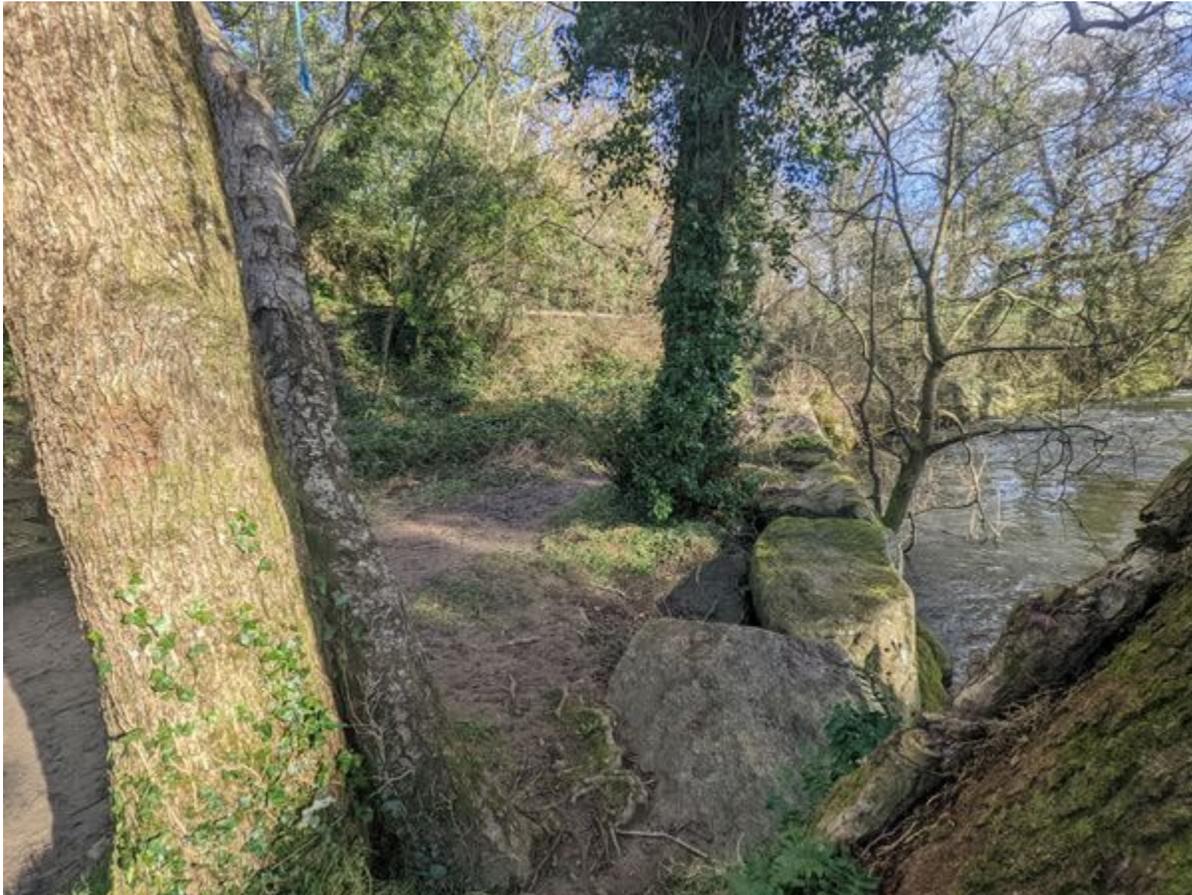
Figure 26 A stone revetment protects the Camel Trail (seen directly above, centre frame). Though important to protect this public asset, the engineered nature of this revetment is increasing erosive forces downstream (and to an extent directly upstream) and providing little habitat value. Green engineering, with strategically fallen trees, tied into the bank, would improve this and neighbouring sections. - 4.7067545 50.5345447
