WILD TROUT TRUST  
wildtrout.org

Advisory Visit  
River Camel and tribs, Cornwall  
February 24 & March 22, 2022

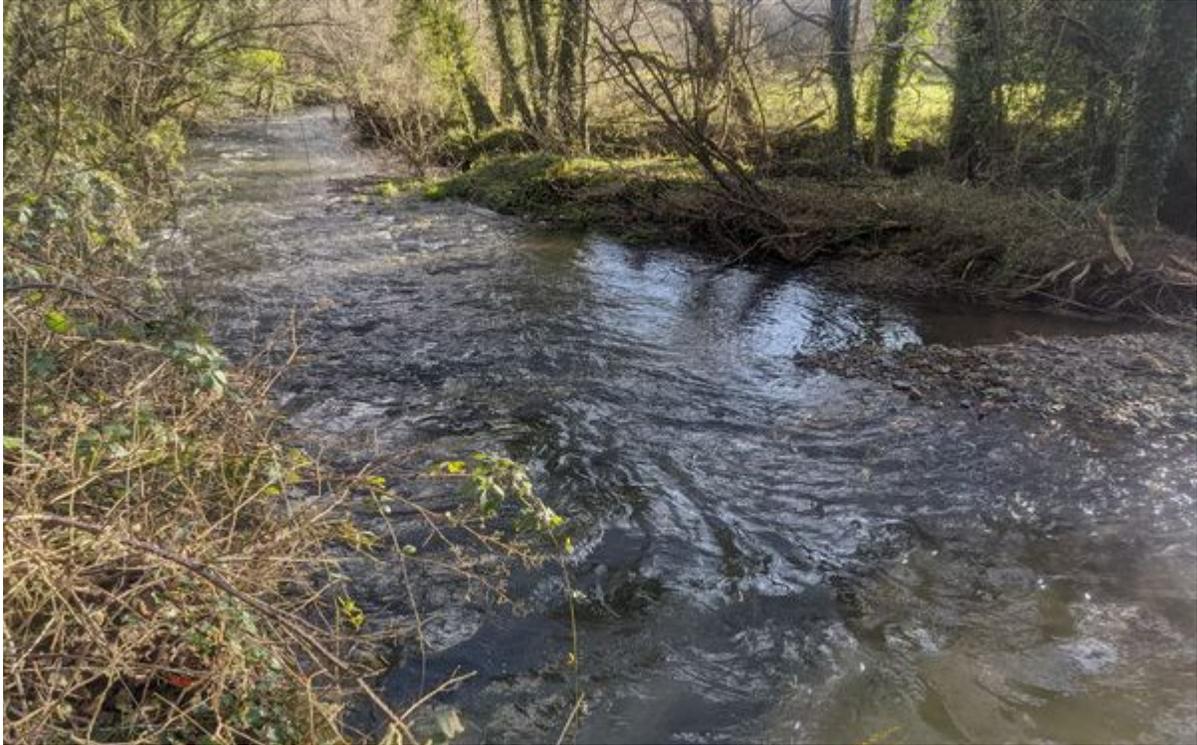
Figure 27 A good riffle, providing juvenile salmonid habitat. Light levels to promote primary production were good, but could accept some holes in the canopy to improve the habitat. -4.7065799 50.5344671

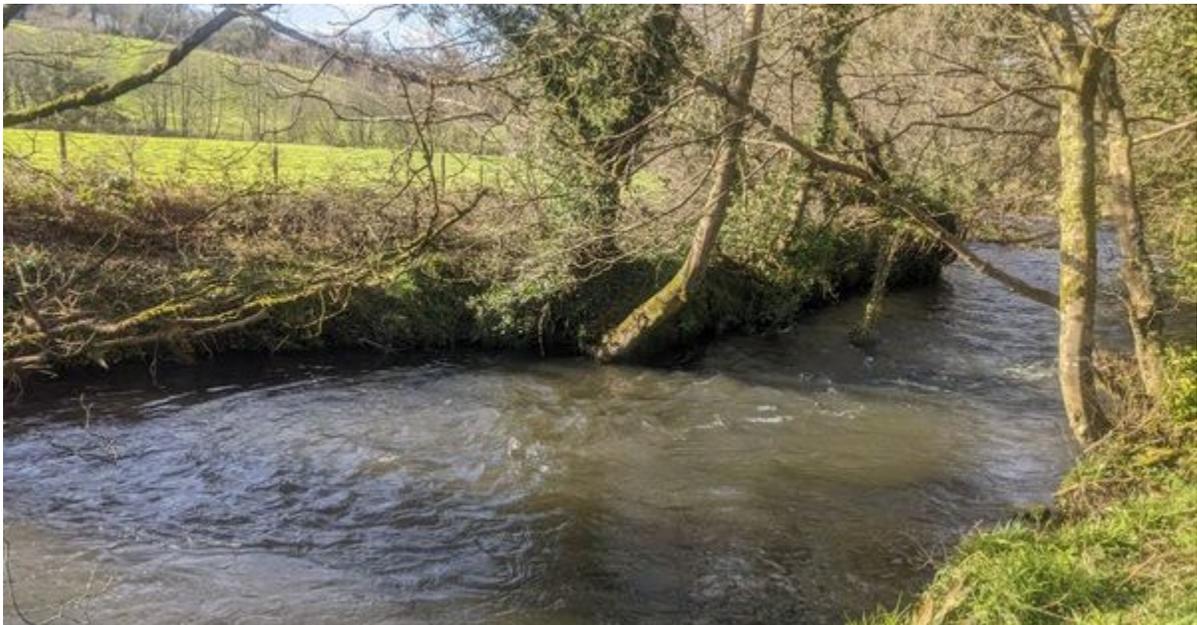
Figure 28 The RB had an approximately 4m wide buffer, complete with good riparian fringe of overhanging plants and trailing limbs. -4.7062301 50.5339232

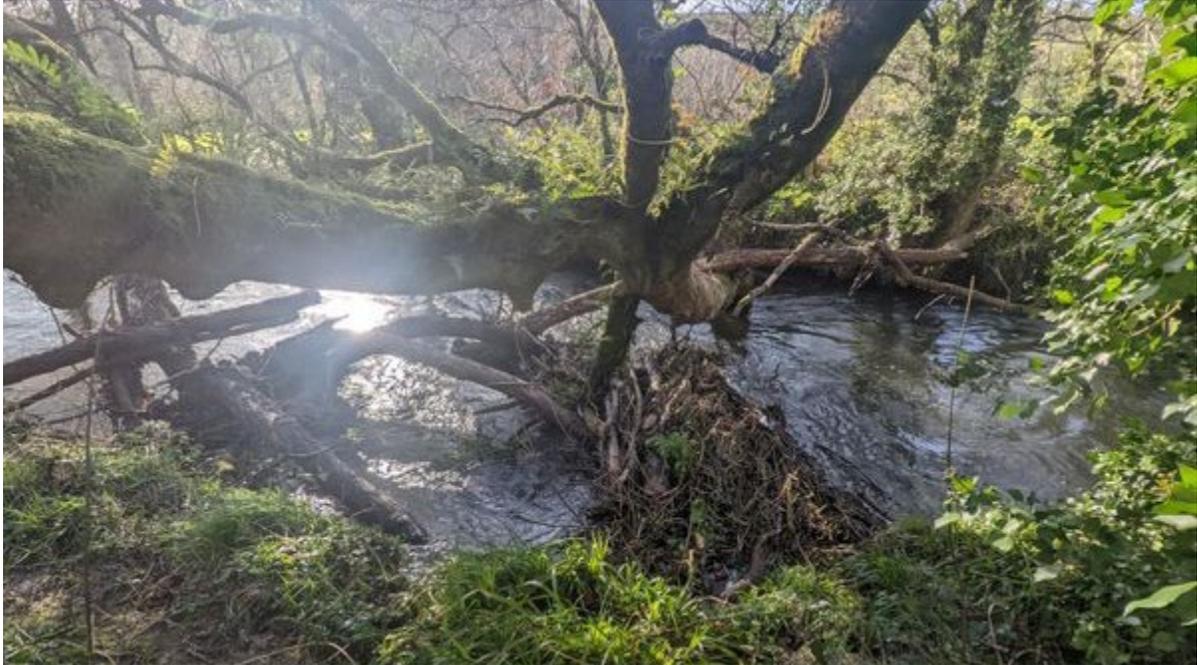
Figure 29 A natural log-jam could establish here, but is currently clear and providing benefit in channel. There is room for the river to circumnavigate the obstruction, by eroding a new route if needed, but the landowner would need to accept the limited land loss. -4.70616 50.53388

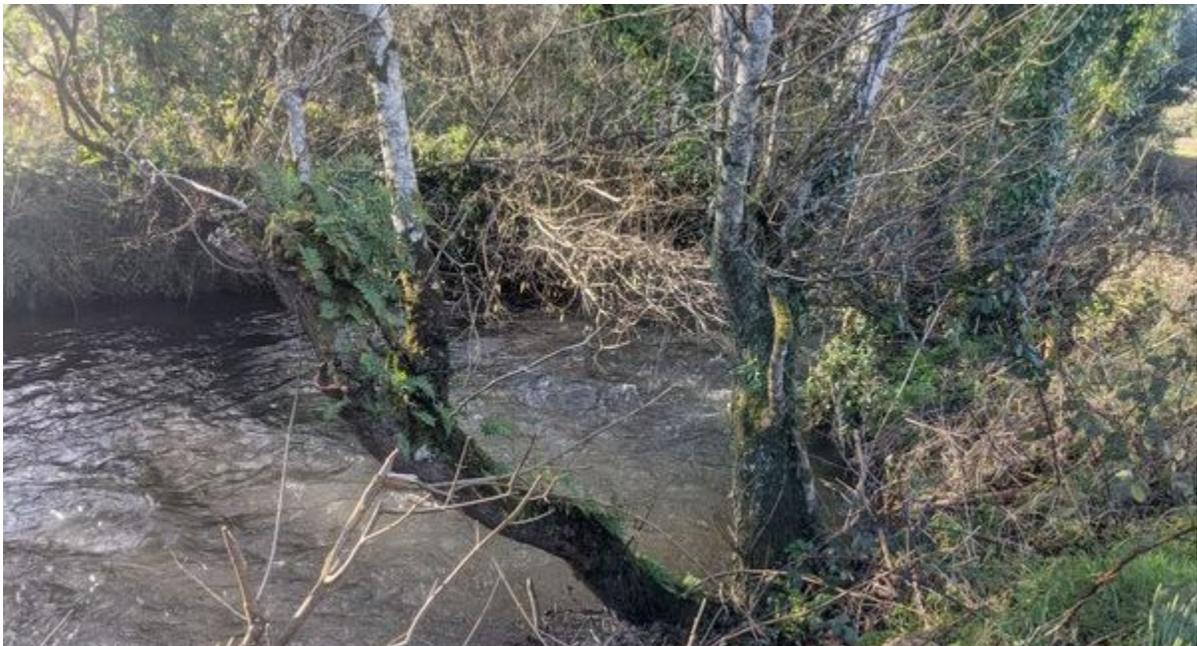
Figure 30 Fallen trailing limbs in channel. This presents good habitat for salmonids and should be left; the process could be replicated by coppicing and trailing limbs in the water. -4.7045047 50.5314007

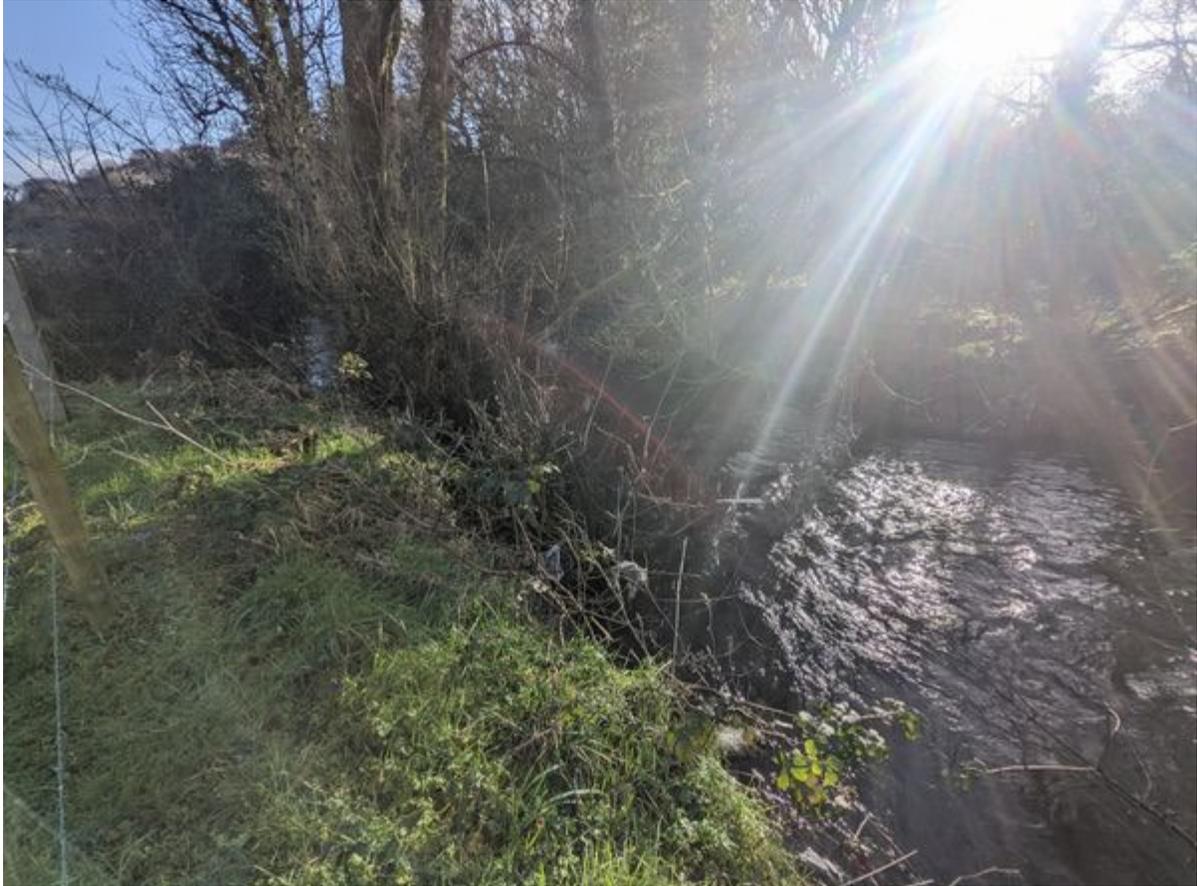
Figure 31 A multi-stem ash is about to wash out. The upstream trees have been regularly flailed and may be the cause of the undermining of this mature coppice stool. The buffer fencing is 1m only in this area and will also contribute to reduced bank stability. -4.70439 50.53142

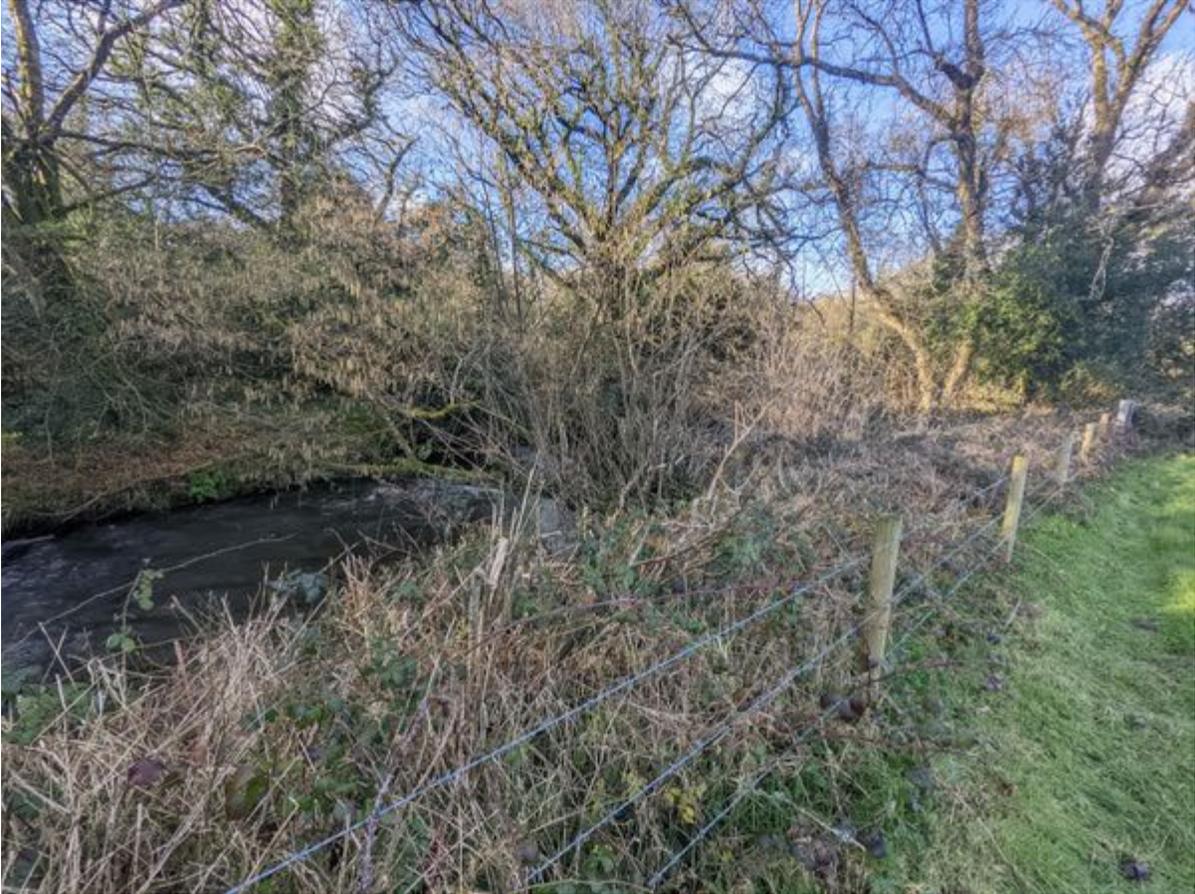
Figure 32 A mixed thorn, riparian fringe has been flailed. This reduces the terrestrial habitat quality and prevents better marginal aquatic habitat from establishing. As small, slow growing species, the wind loading (mentioned by the owner as the reason for flailing) would be low and the habitat value of leaving it unmaintained would be great. On a northly aspect such as this, the increasing light levels will be minimal, but as a general practice it will introduce large amounts of solar gain to the stream, detrimentally increasing water temperatures. -4.70434 50.53124

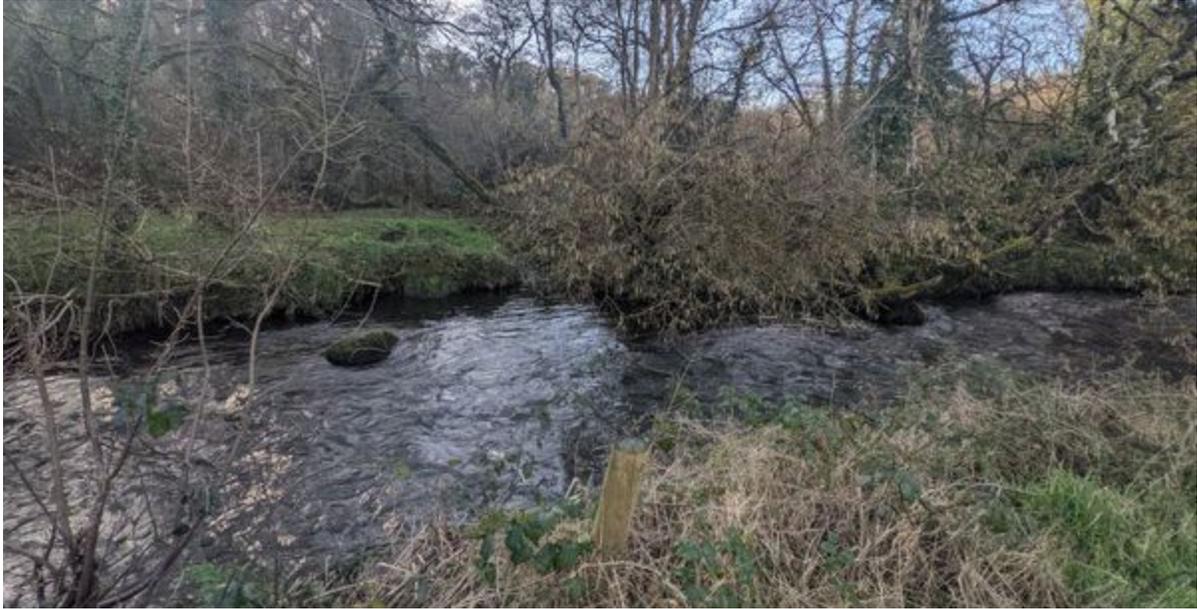
Figure 32 More overhanging and trailing trees on the RB. An opposing complement on the LB would be of benefit to the river. -4.7045195 50.5304834

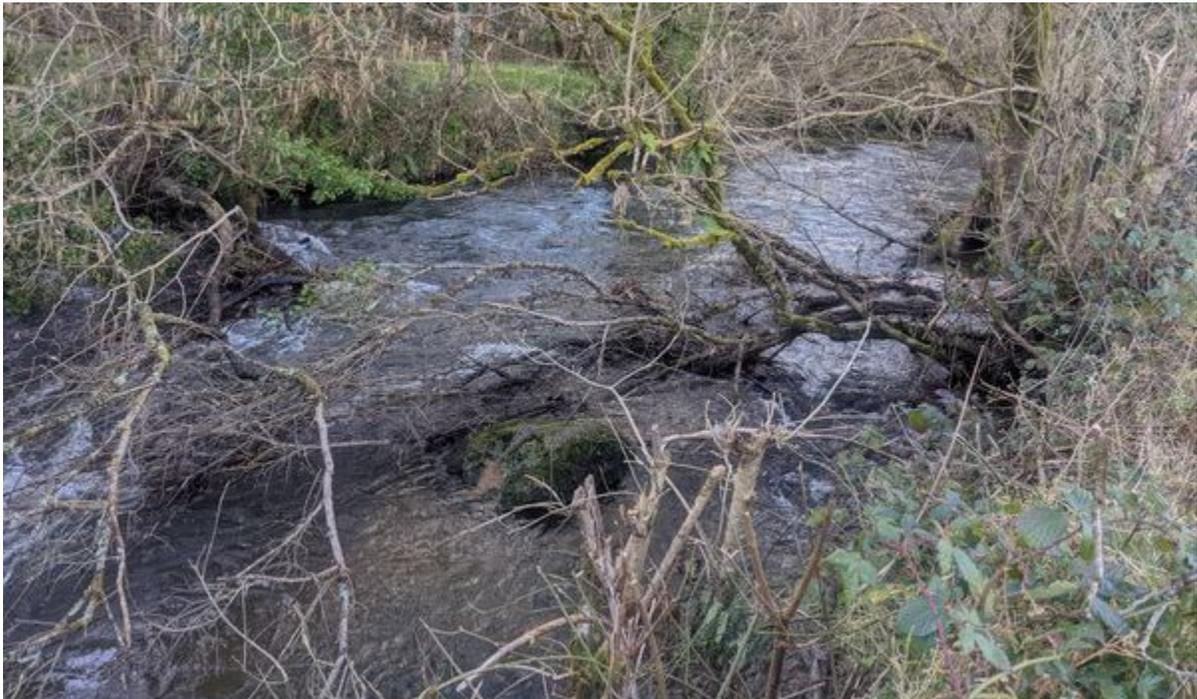
Figure 33 Small trees lay in the channel providing scour, refuge and habitat diversity. They should be left and allowed to settle into position following spates. -4.704327 50.5303269

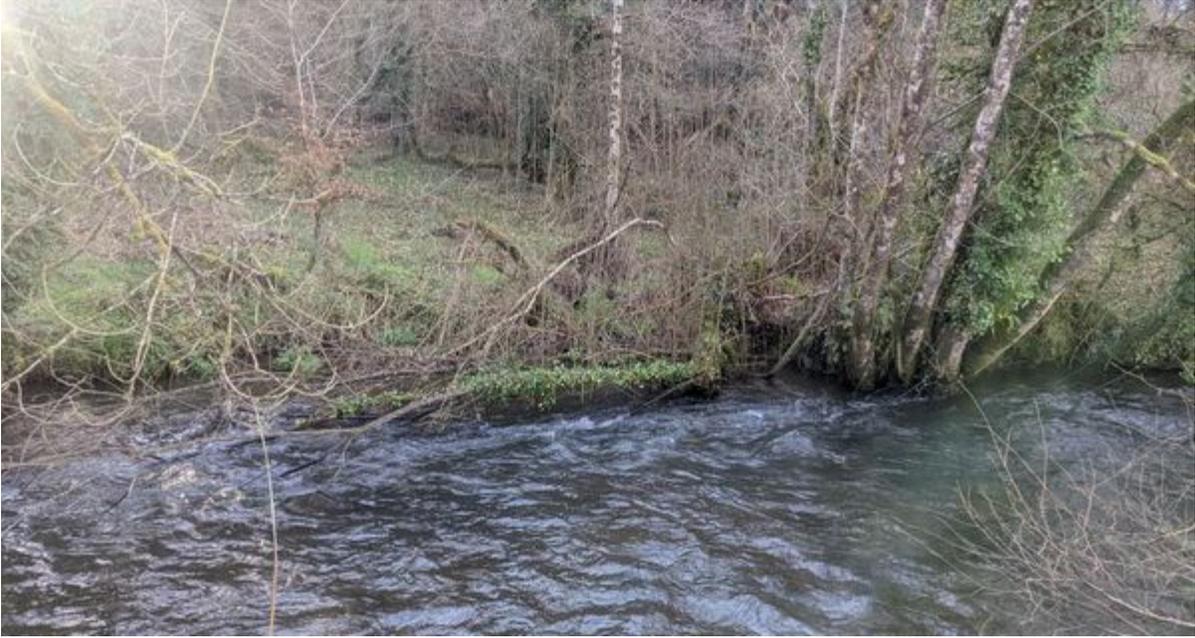
Figure 34 An overhanging, fallen tree on the RB. Around 2 years of vertical growth have sprouted, indicating good root connection, stability and vigour. -4.7042682 50.5298775

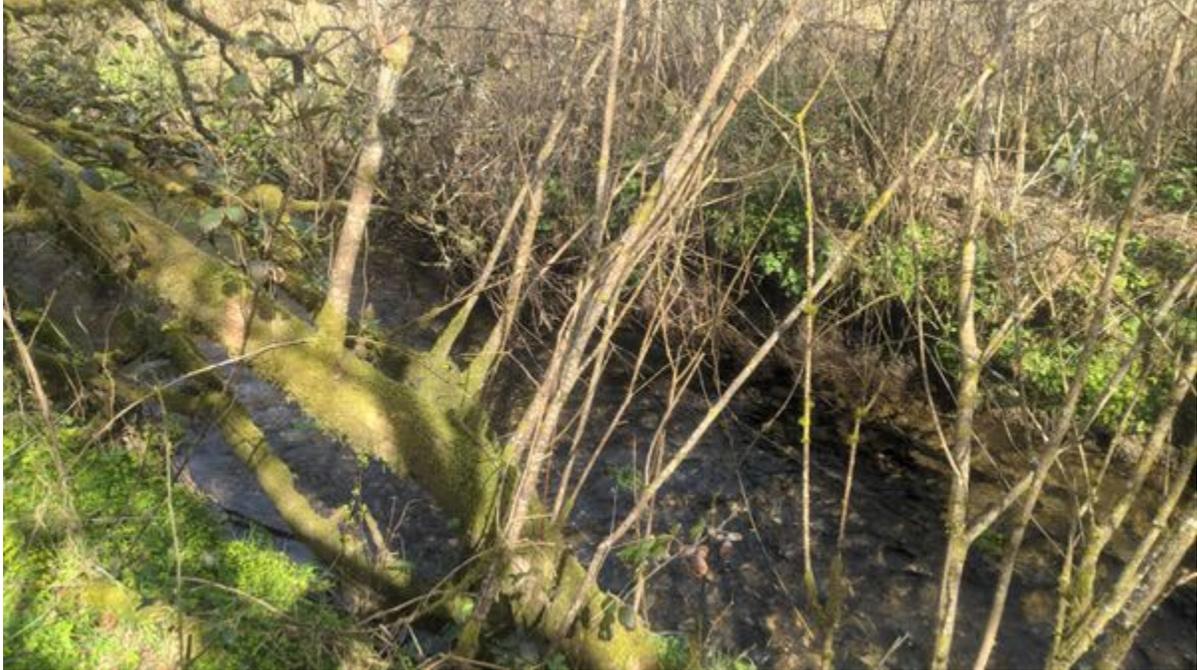
Figure 35 The upper reaches were pleasantly unmaintained on both banks. The stream exhibited incision, with banks disproportionately high for the channel width. -4.6731315 50.6460435

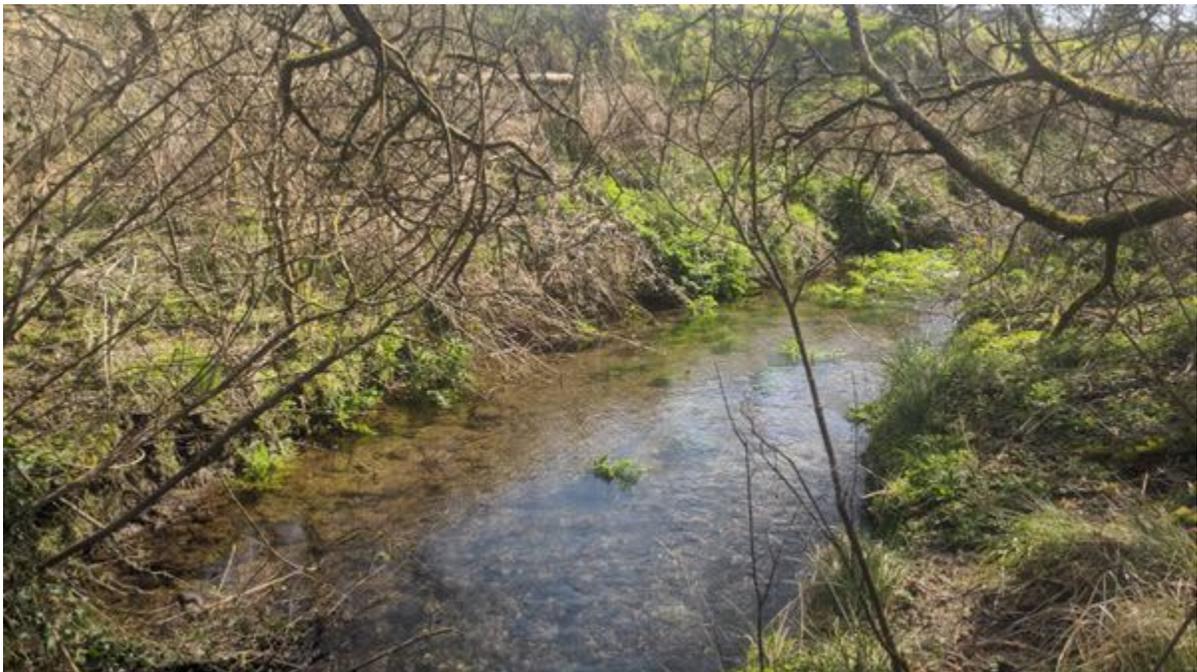
Figure 36 In places, tree cover was reduced and the resulting increase of light was promoting the growth of hemlock in the stream. A stock fence on the LB was sited too close to the bank and so was not preventing livestock from browsing valuable new growth. -4.6731201 50.6460294

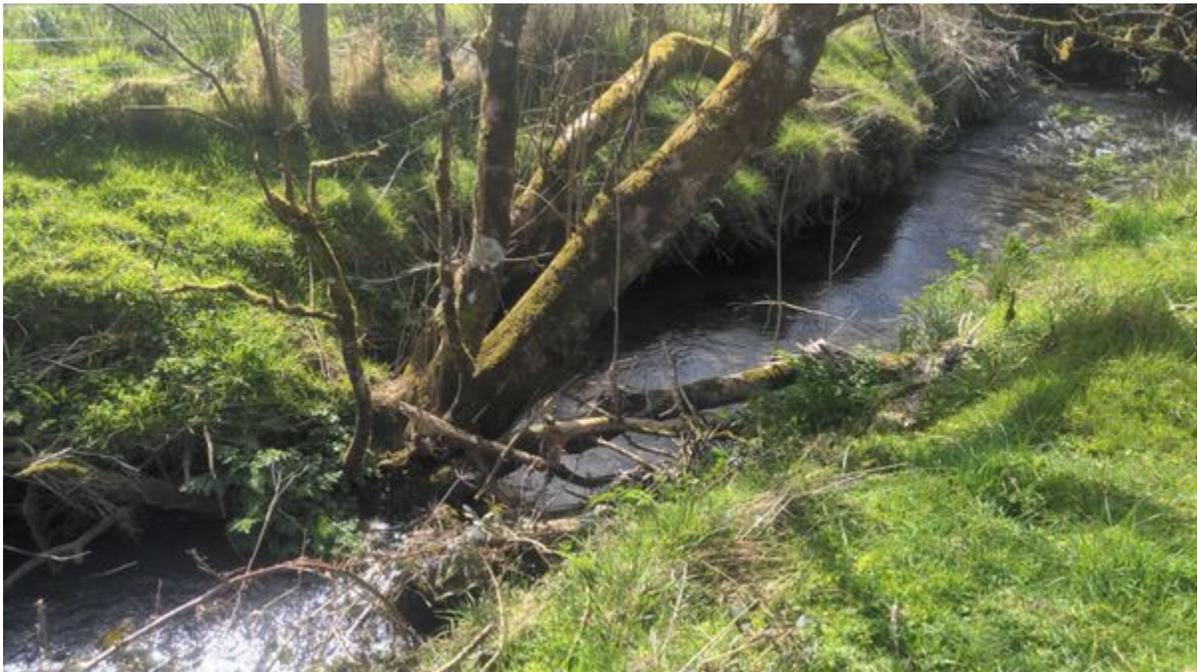
Figure 38 A slumped tree providing a pinch point in the channel. The deep pool downstream and the focused flow through the pinch provides an excellent lie for adult trout. -4.6731534 50.6458918

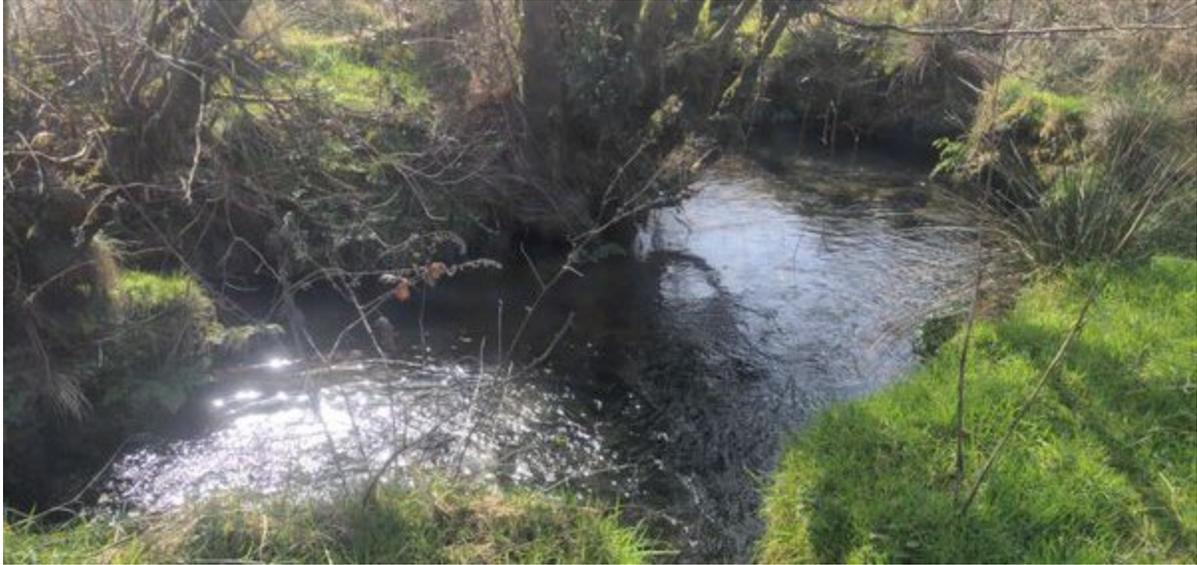
Figure 39 Significant incision is evident. Disconnection from the floodplain only increases the bank-full energies and hence greater bed erosion. The planform of the stream is not particularly unnatural so coarse sediment supply is a likely cause, due either to an obstruction upstream such as a weir or channel dredging or straightening downstream that is drawing sediment from further up to replace what is lost. Nothing witnessed on this reach appears to be the direct cause so investigations on neighbouring properties may yield a likely cause. -4.6733382 50.6458542

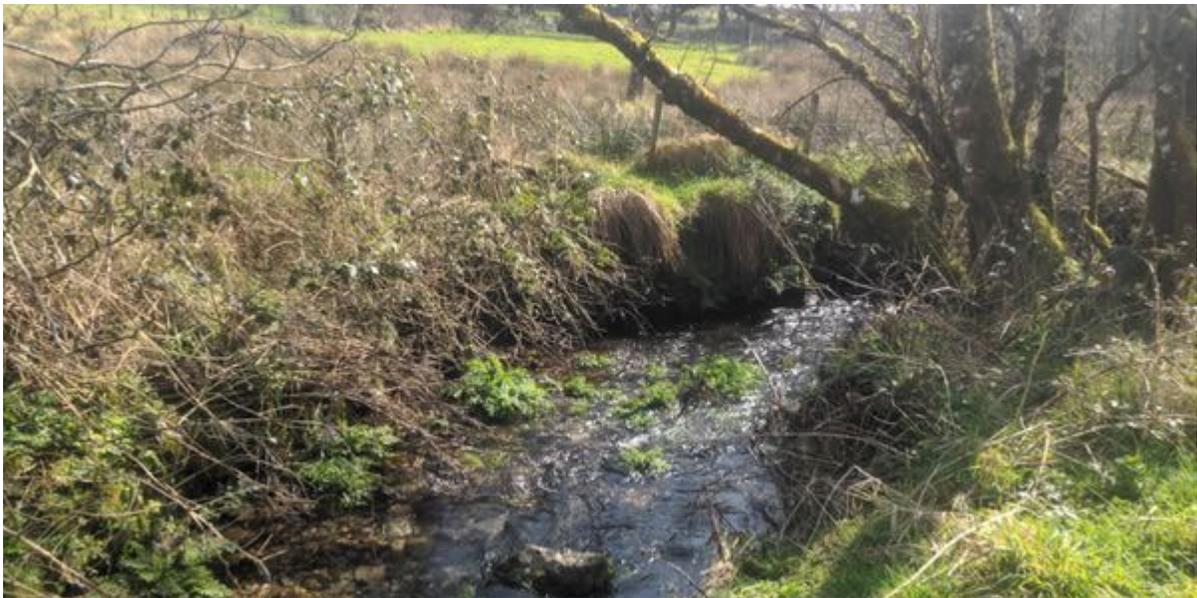
Figure 40 Stockfencing on the LB is too close to the watercourse, however stock density appears to be light or occasional. Regardless, establishing a better riparian buffer will reduce run-off and create better bankside biodiversity and riparian habitat. -4.6734793 50.6457647

- Improved stock fencing on the LB will enable better riparian fringes to establish, reducing run-off and increasing bankside and in-channel habitat diversity.
- Some tree planting could be implemented to increase shade and bind the banks together with deeper roots.
- The three weirs witnessed would be redundant in a better designed river. Removal and reengineering of the scrapes would have all of the current benefits whilst improving the stream.

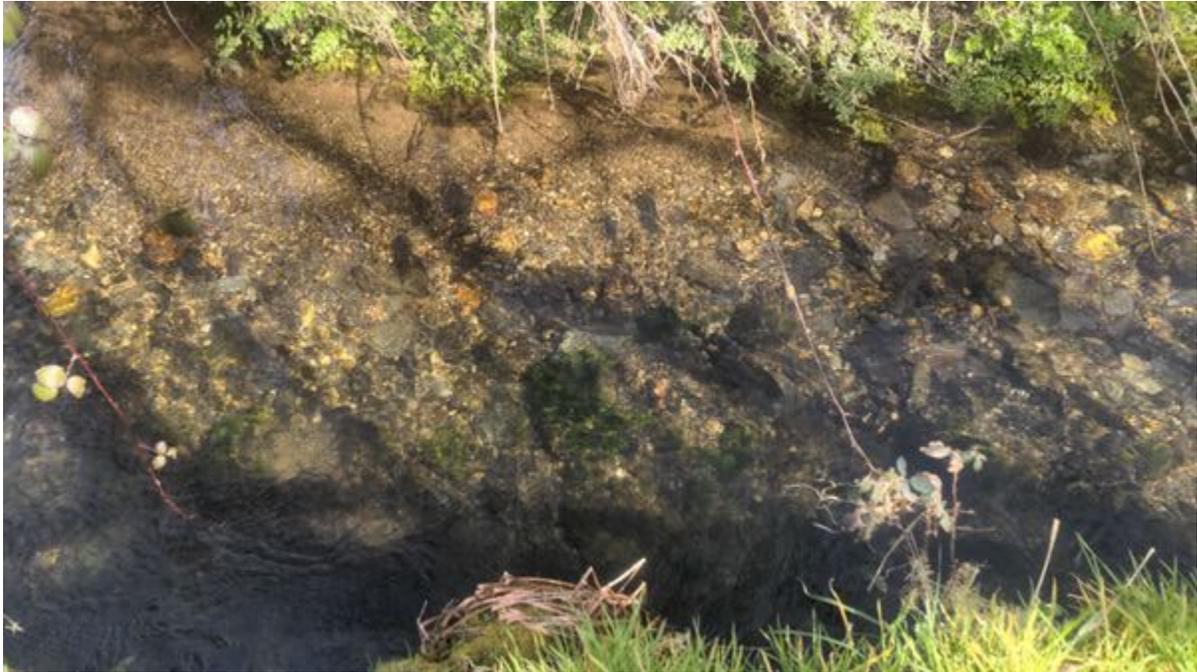
Figure 41 A good range of gravels were seen, however they may be missing 5 - 10cm range. A Wolman Count analysis could confirm this, but investigations upstream to find any man-made obstructions may get to the point faster. -4.6734481 50.6458539

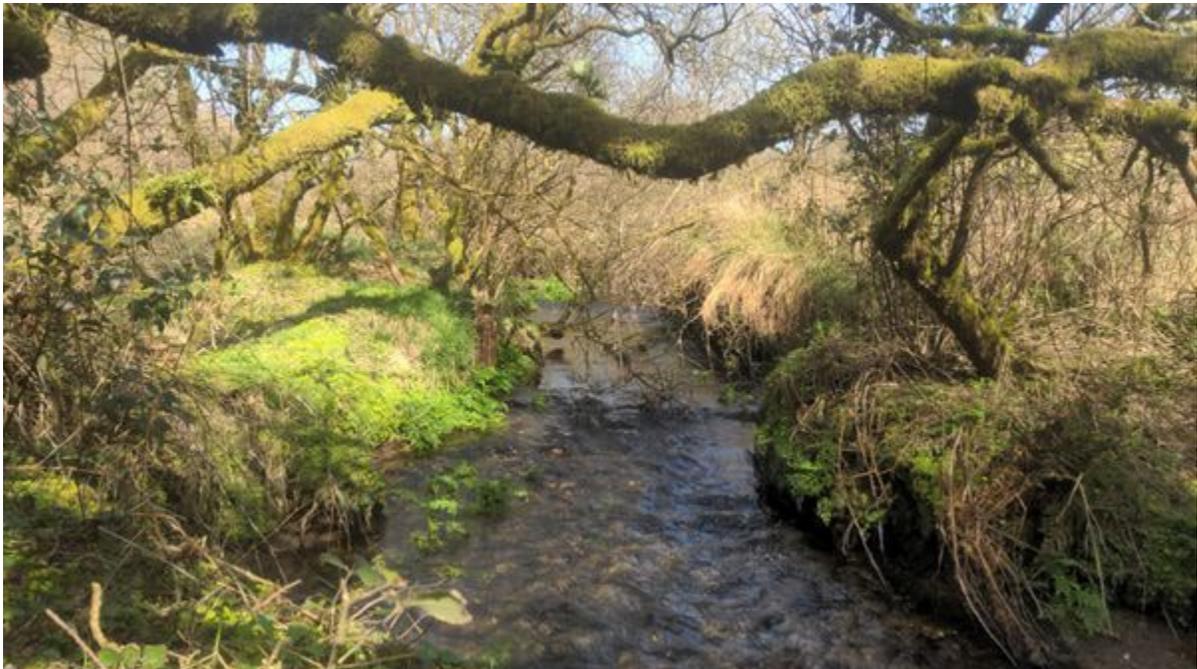
Figure 42 Good cover and trailing branches in the section are encouraging, but it could be improved with a more diverse and deeper rooting riparian fringe of mixed species. -4.6735369 50.6455351

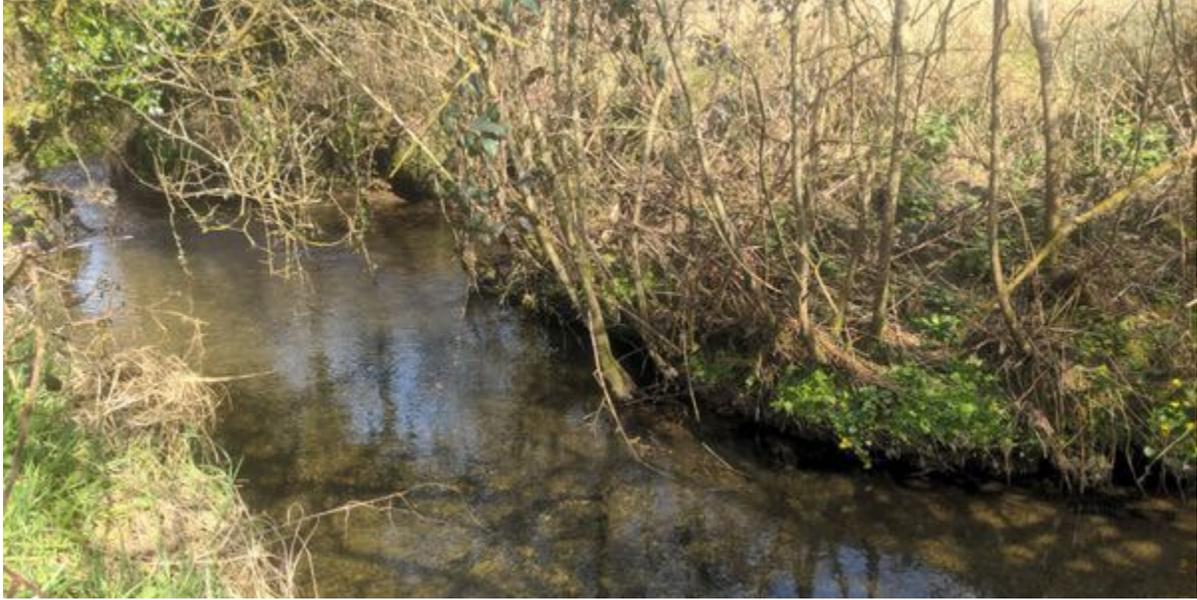
Figure 43 The LB had a number of young saplings and coppice growth that could be hinged into the margins to increase habitat and provide hydraulic roughness. The channel was a little uniform in depth and the addition of fine and coarse woody material will help to scour out a more variable depth and clean the gravels seen. - 4.6735018 50.6454254

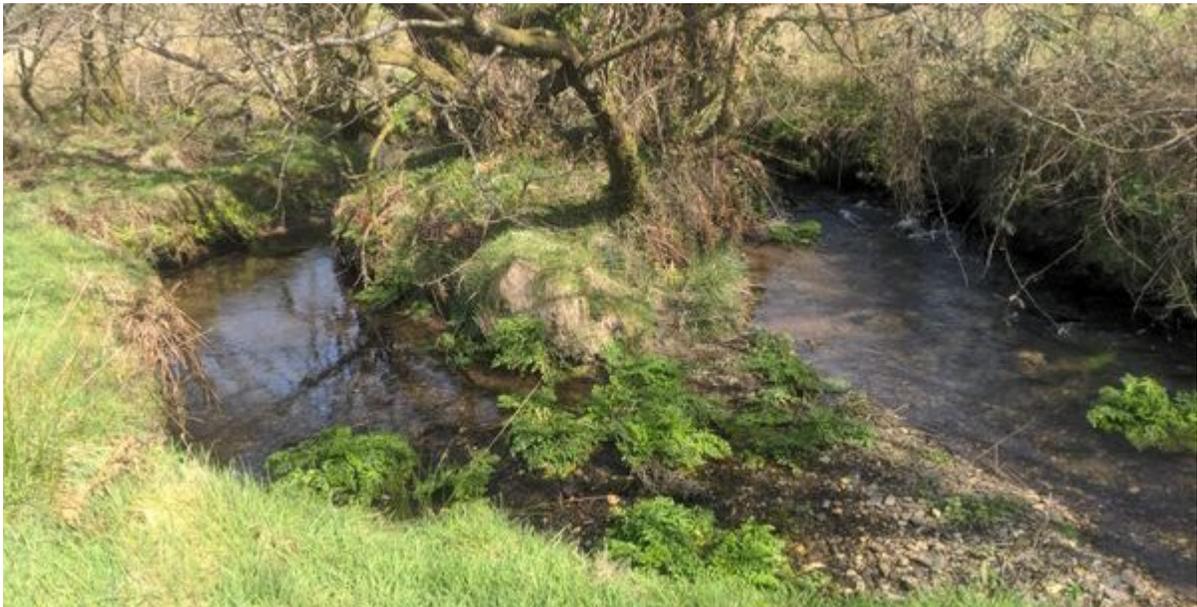
Figure 44 The stream has diverted around a tree, leaving a back channel. This extra channel capacity could be used in conjunction with a downstream NFM structure. In high flows the capacity could hold a reasonable volume of water to be released slowly as the river falls. The added capacity and lower bank height have accreted a better range of gravels, suggesting the incised sections are pushing through material too fast.-4.6732835 50.6452451

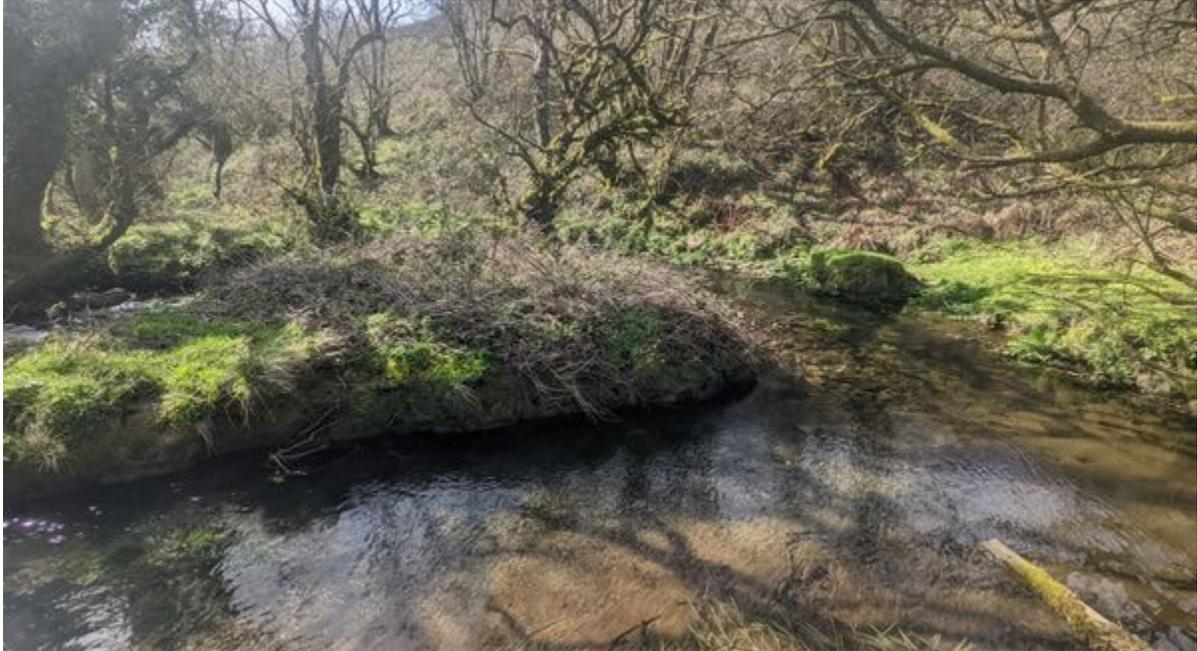
Figure 45 As evidence of the natural, dynamic planform, a sharp meander is only a few seasons away from forming an oxbow. This freedom of movement for rivers is essential for good river function. -4.673634 50.6450141

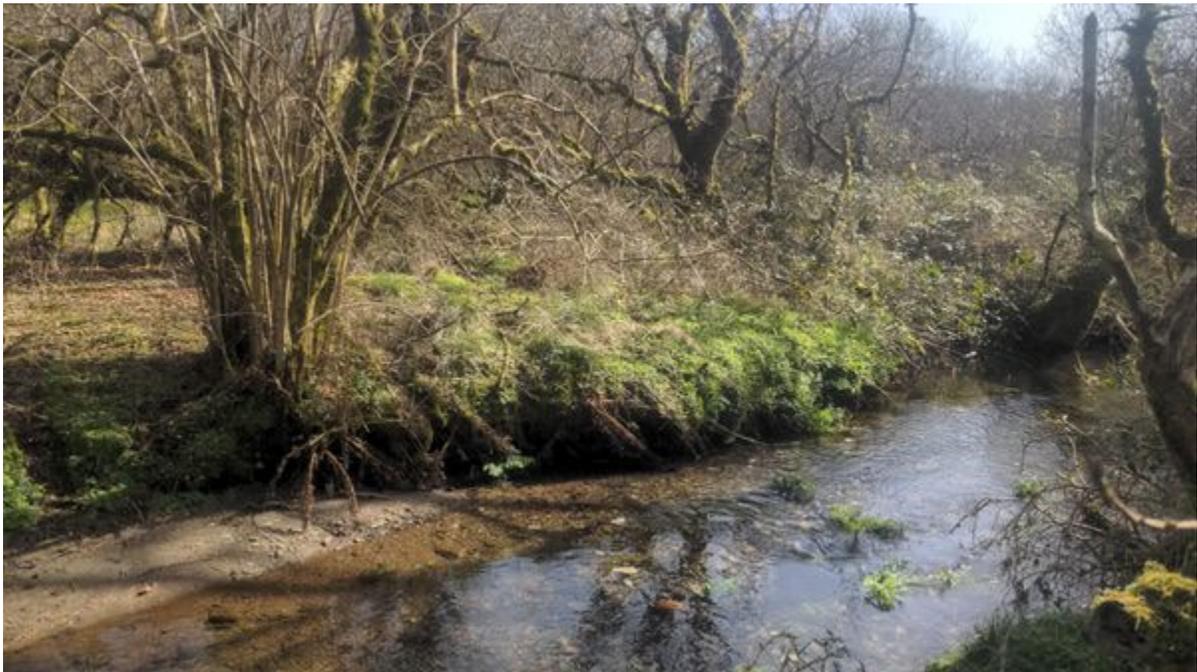
Figure 46 More hingeable material on the LB with a good shaggy margin. - 4.6738781 50.6442839

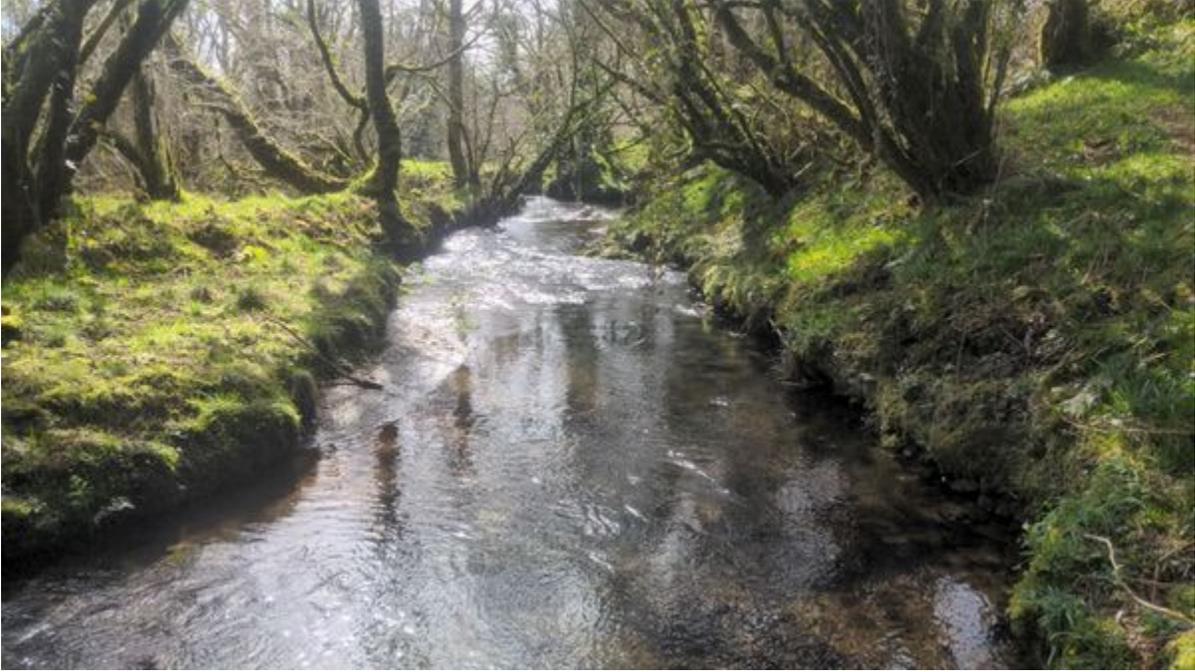
Figure 47 As the shade level increases, the stands of hemlock are thin and sparse. Shading regimes are good for hemlock control and suppressing river temperatures, essential as the climate warms. -4.674251 50.6441681

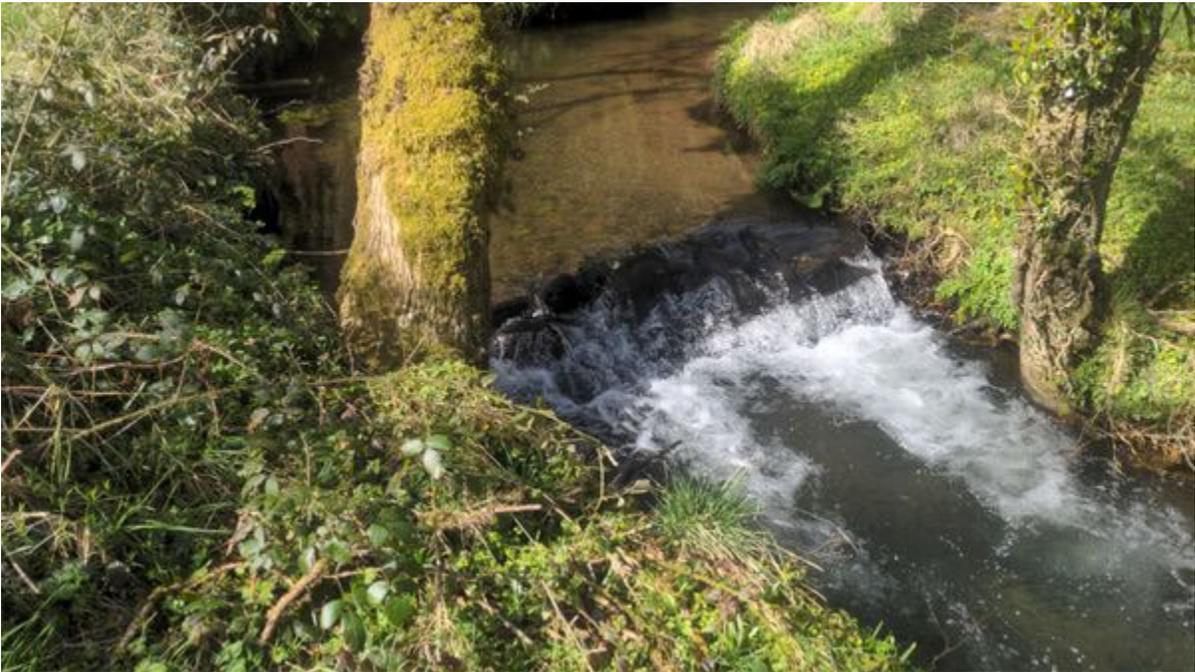
Figure 48 The first weir seen within the reach, evidently created to provide the offtake for a wetland scrape immediately downstream on the RB. It is definitely an obstruction for small species and as a man-made structure it should be removed. -4.6743736 50.6437812

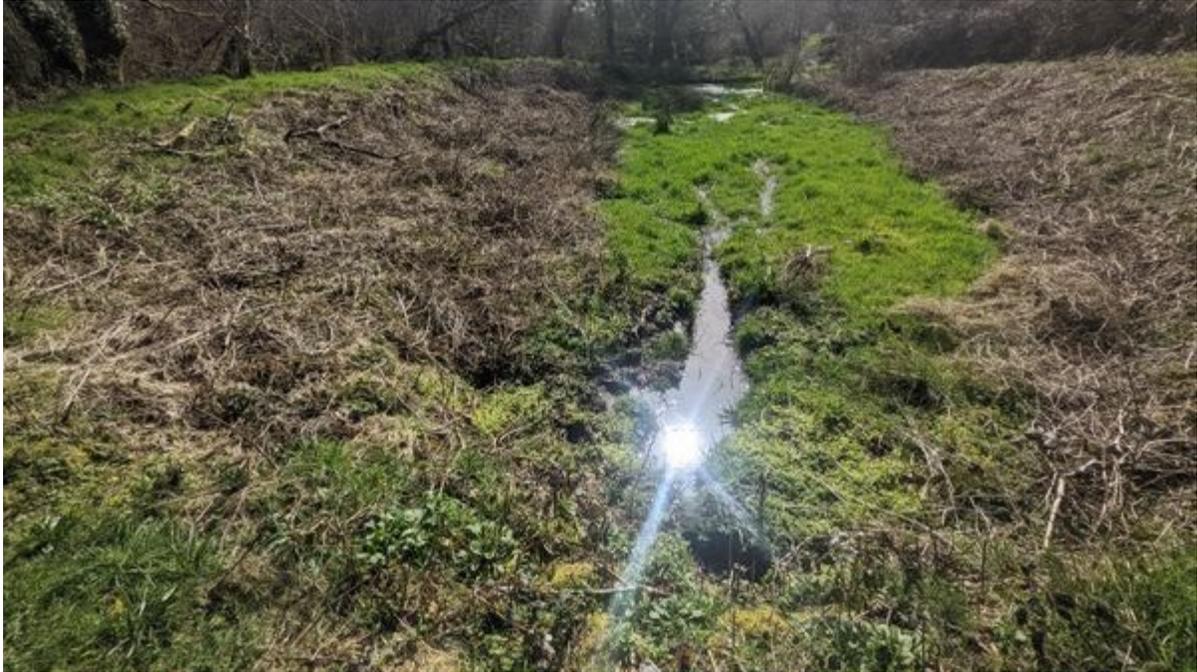
Figure 49 The wetland on the RB, apparently the sight of a historic trout farm, is providing some aquatic habitat; however, it is at the cost of the river Camel. The arisings of the scrape's construction have been formed into a bund (seen on the left of frame) that is preventing the stream from accessing what was once its floodplain. Removing the weir and bund will allow the river to periodically fill this scrape and create a better, more natural wetland feature whilst slowing the flow, without the current detriment to the river. -4.6743164 50.6437541

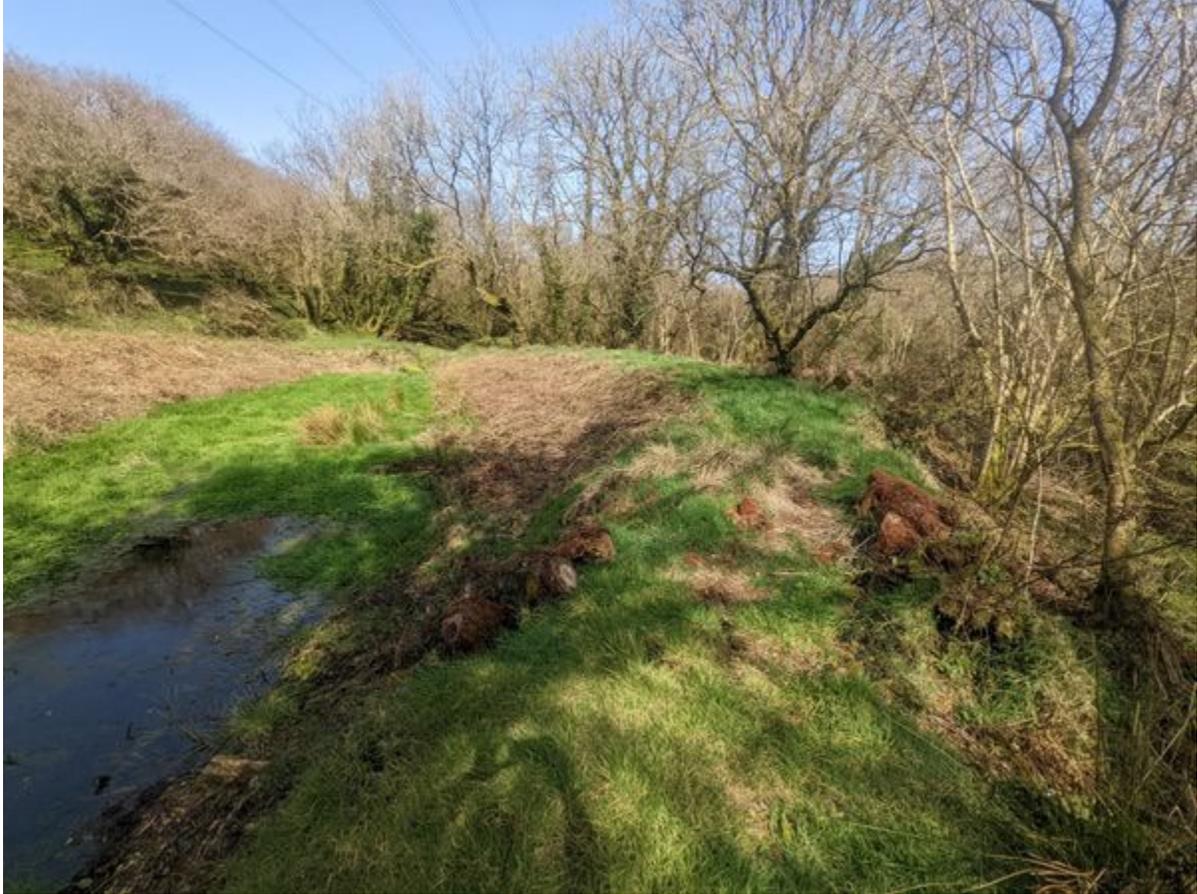
Figure 50 The ~90cm bund seen looking upstream with the river on the right of frame. This artificially increases the already incised bank height and the bankfull flow energy as a result. -4.6743378 50.6436185

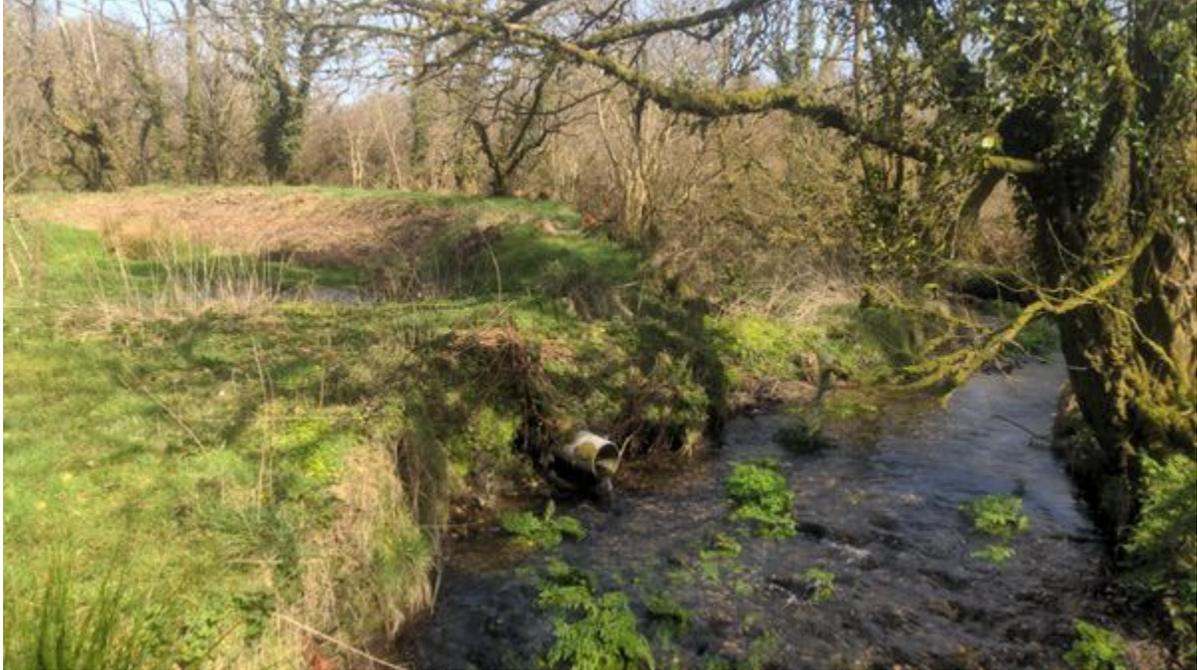
Figure 51 The outfall from the wetland feature. Throttling this will hold more water within the scrape. Better still would be to allow natural drainage. -4.6745856 50.6434267
