WILD TROUT TRUST  
wildtrout.org

Advisory Visit  
River Camel and tribs, Cornwall  
February 24 & March 22, 2022

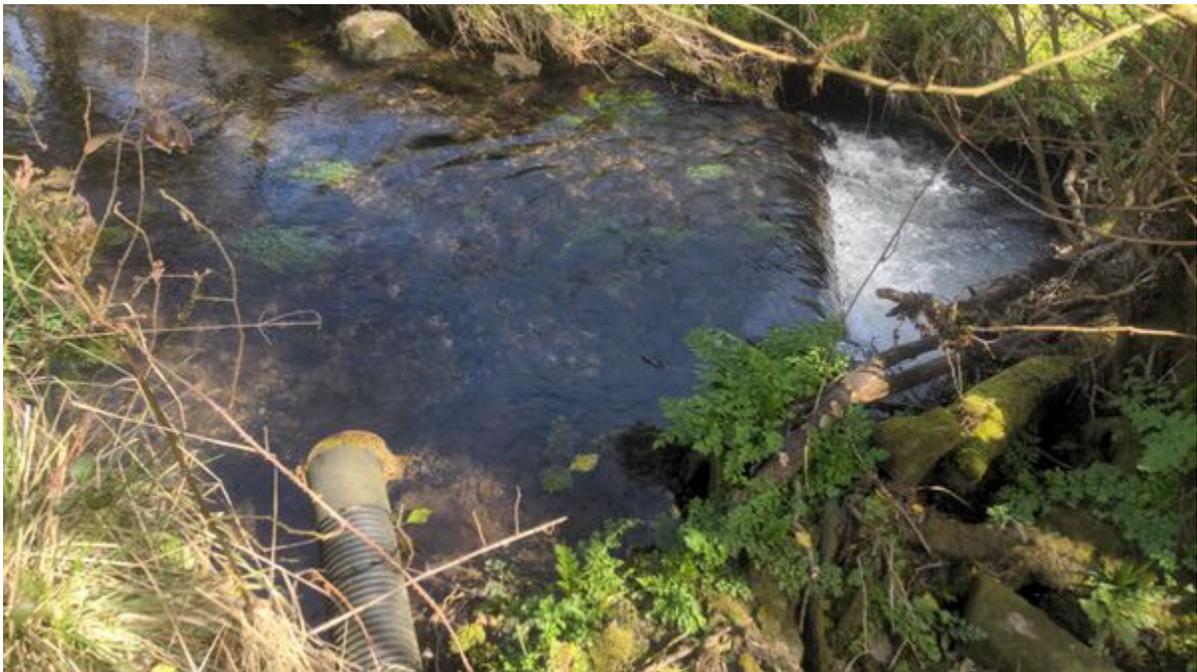
Figure 52 The second weir witnessed. This was a more designed arrangement but still a barrier to some fish. Again, this serves to feed an artificial wetland downstream and could be removed. -4.6746289 50.6431215

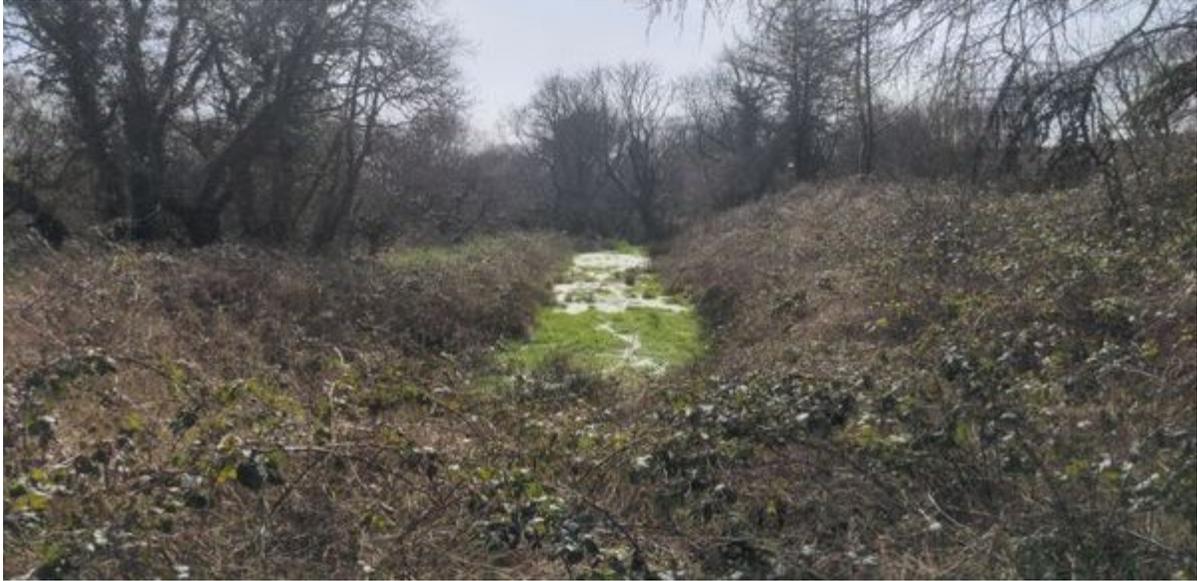
Figure 53 A similar image to the wetland upstream (Figure 50). Robbing a river of sediment and habitat connectivity to provide an artificial wetland feature is not enhancing biodiversity. It is far better to restore habitats to as near natural a state as possible. -4.6745939 50.6432073

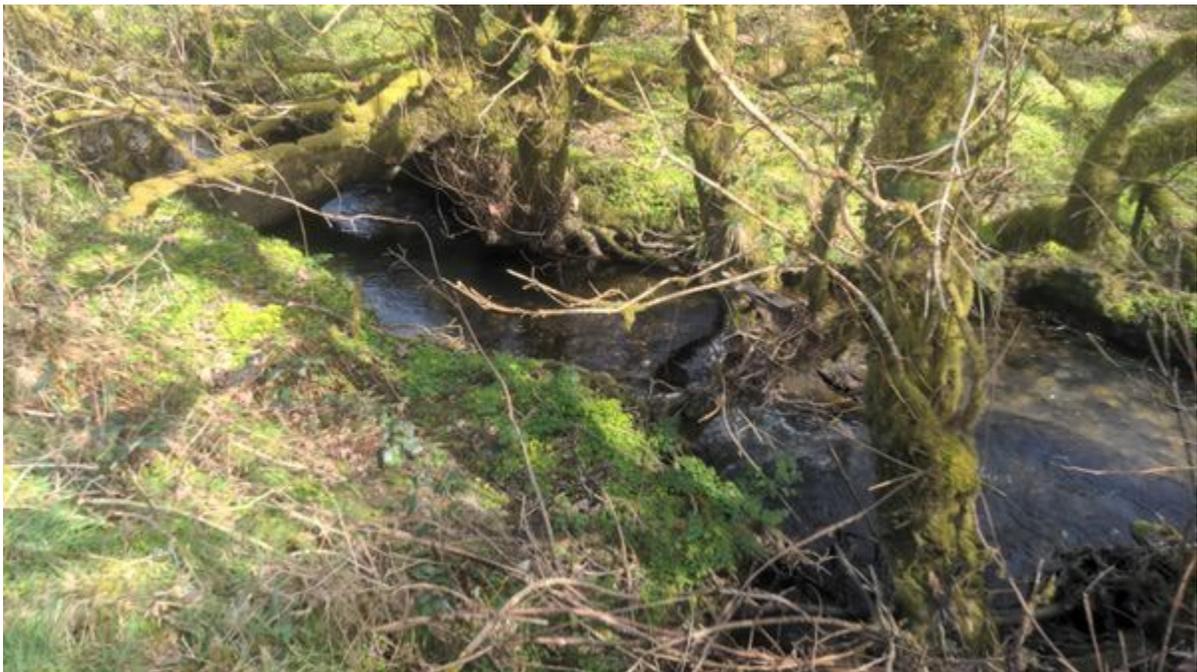
Figure 54 Fallen trees bridge the stream, something to leave and encourage. - 4.6747463 50.642689

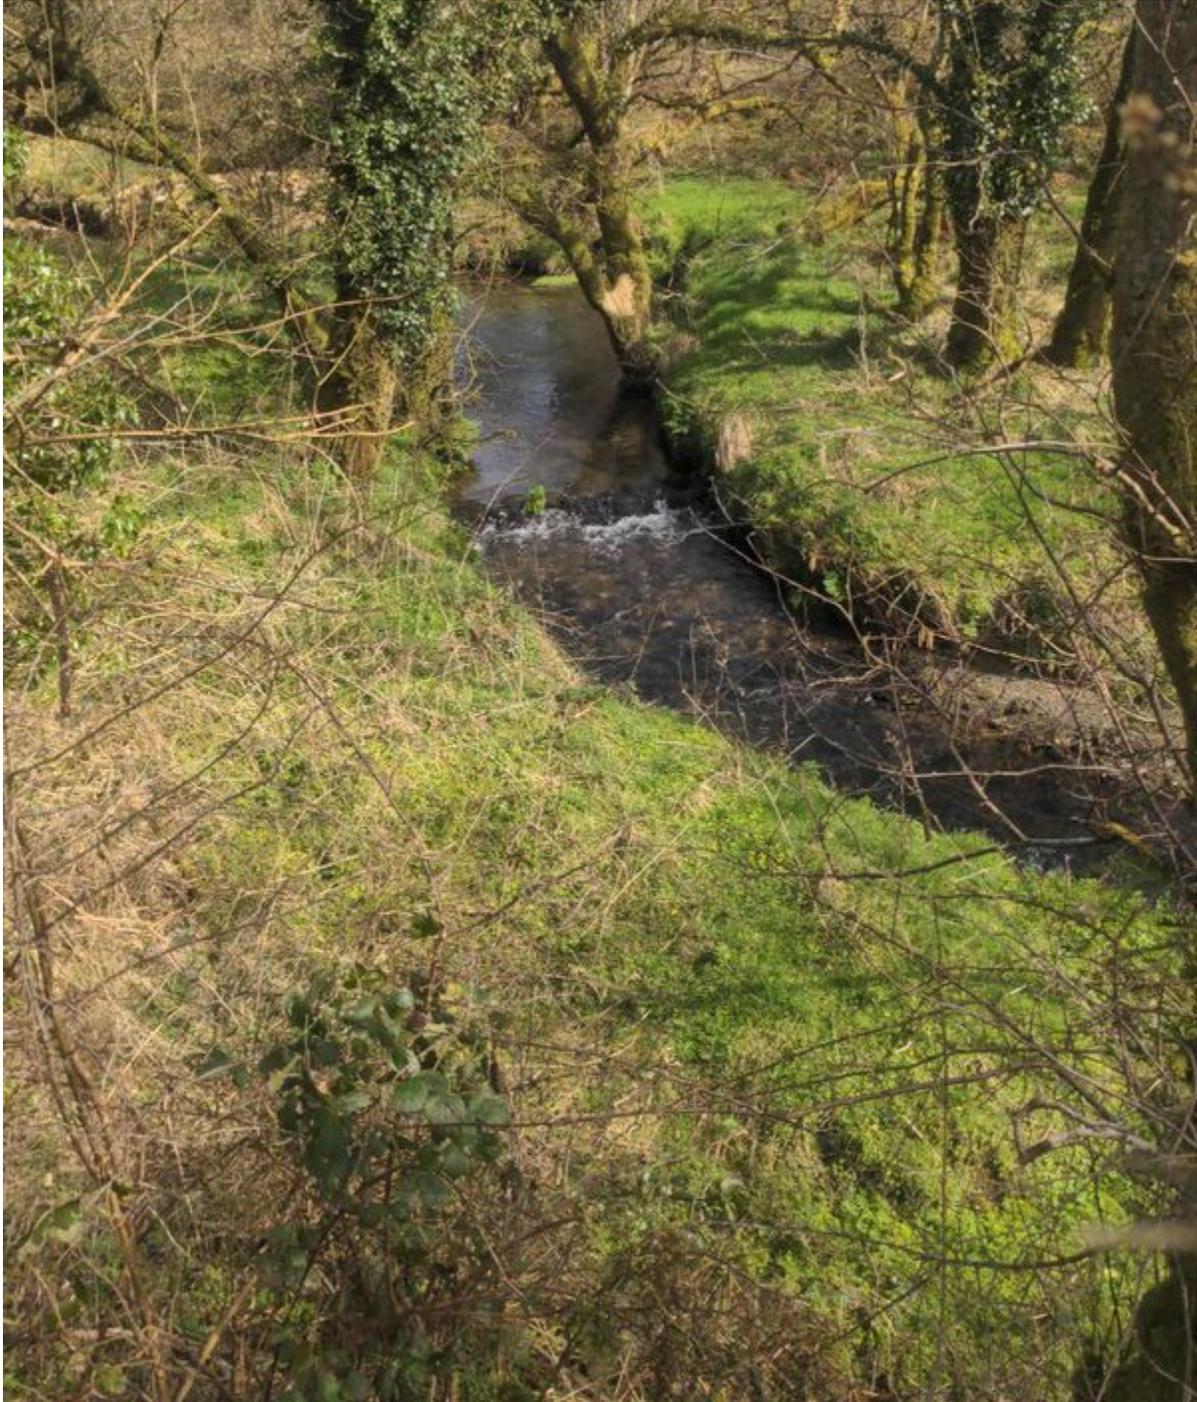
Figure 55 Another unnecessary small weir. The featureless impounded reach above is entirely the result of this structure and would be greatly improved by its removal.  
-4.6752573 50.6423714

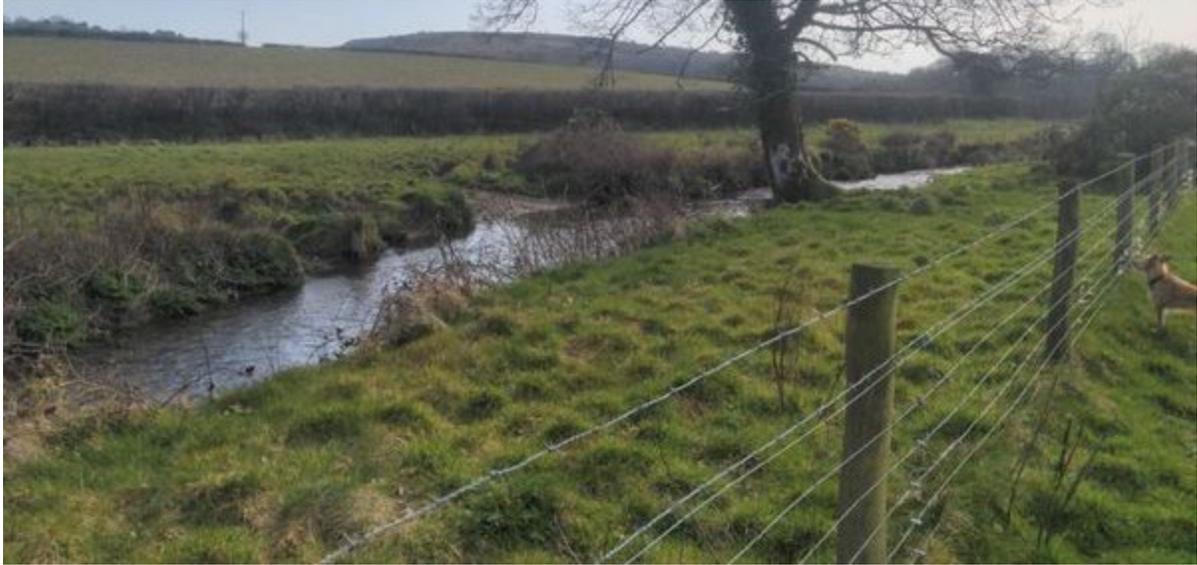
Figure 56 RB has good stock fencing, forming what could be an excellent buffer strip, but it is still grazed. Though occasional grazing within buffers is advised, the aim is to establish a rough and diverse fringe to the field. LB should also be excluded from livestock. There is some evidence of poaching on the LB and this could be the cause of the browsed buffer strip, with cattle fording the river. - 4.6892498 50.5977827

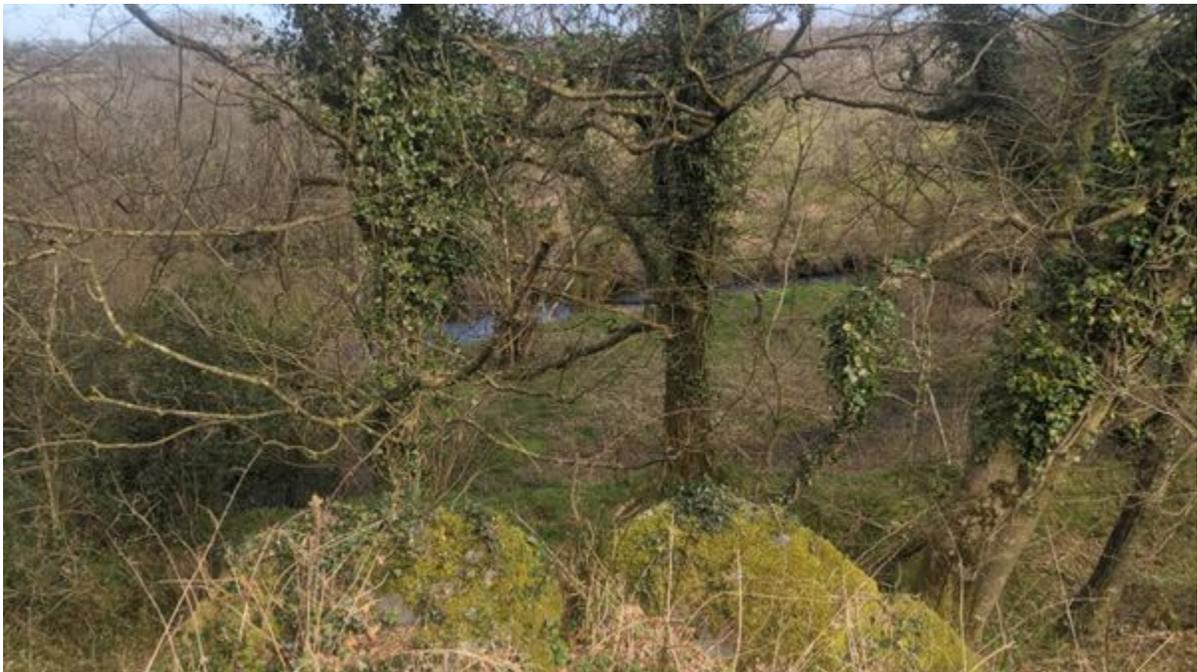
Figure 61 The river finally turns back into its floodplain. -4.6914617 50.5943445
