Advisory Visit

R Wharfe & tributaries, Bolton Abbey Estate, Sept 2019

Prof J Grey: jgrey@wildtrout.org

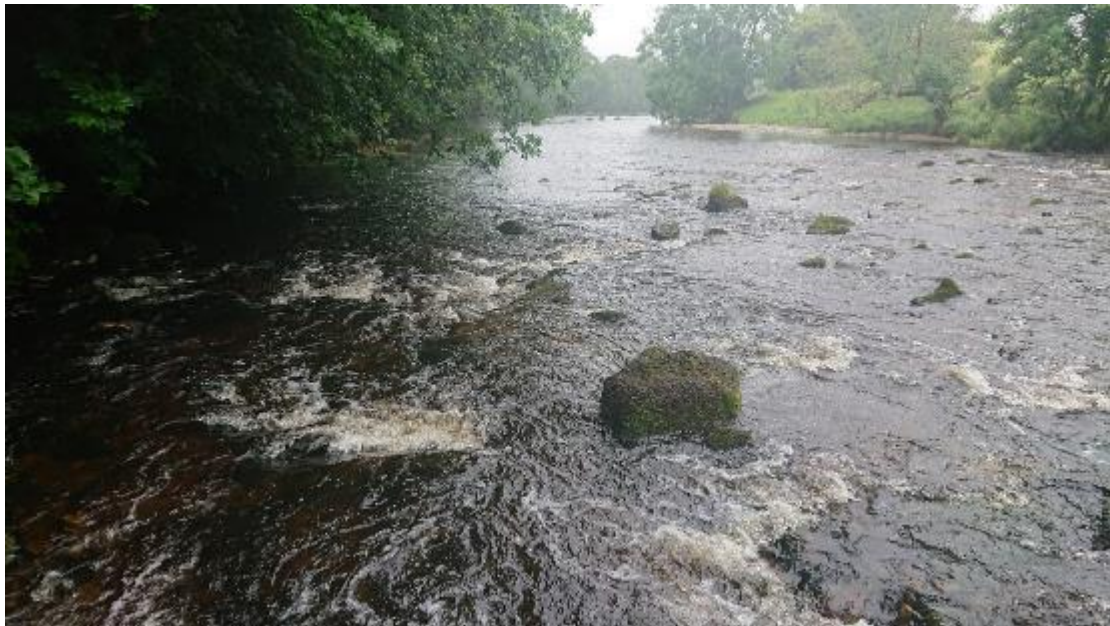
Fig 1. Looking d/s from the stepping-stones at Drebley, the upper extent of the walkover.

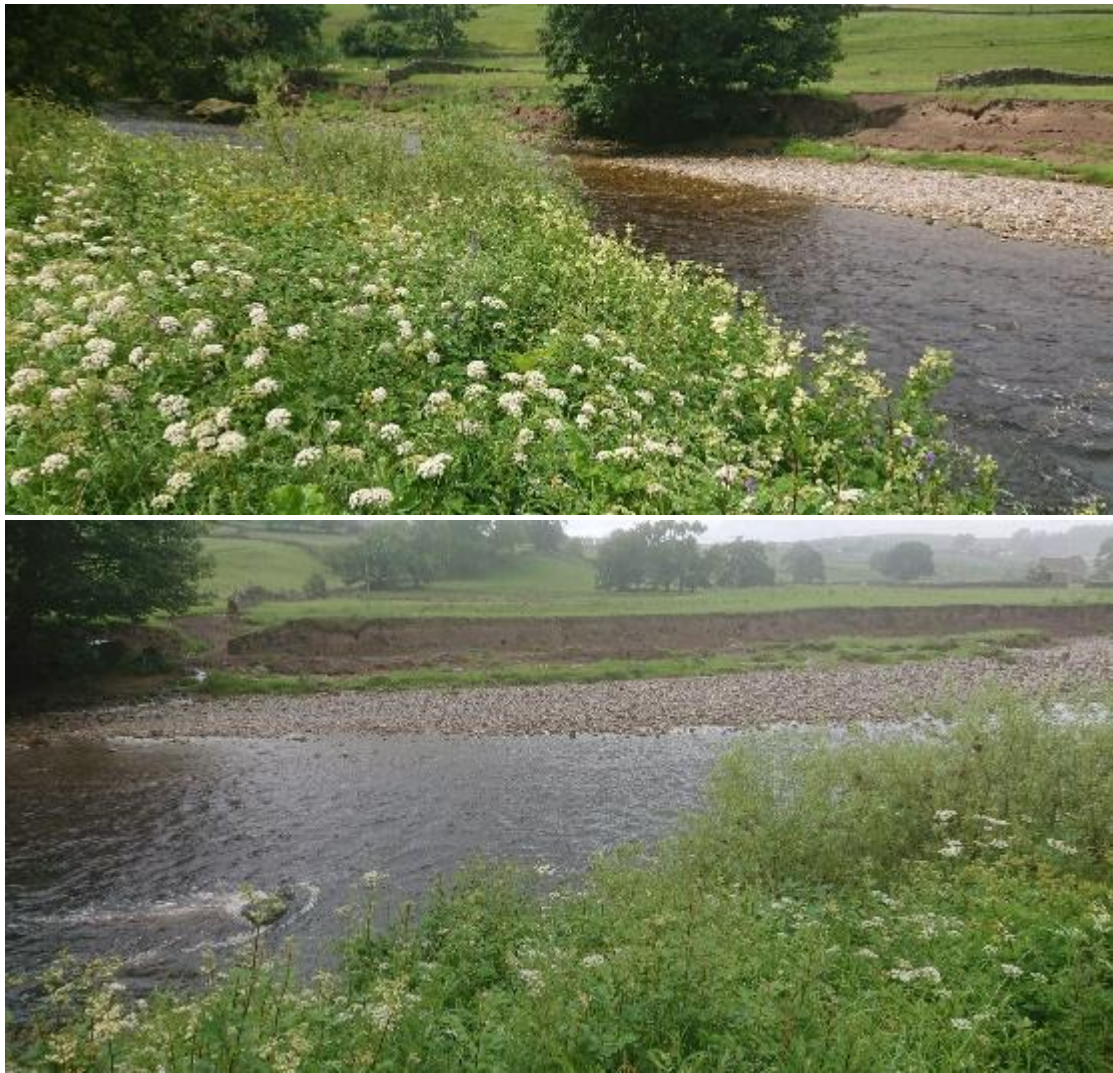
In stark contrast, the RB was open to livestock and grazed to a short sward of grass turf (Fig 2). Where grass is cropped and shoot material removed regularly, photosynthetic energy is invested in regenerating shoot rather than root material. As a consequence, there is no root matrix holding the soil together in grazed pasture. Exposed vertical banks hint at lateral erosion via block failure, as spate flow erodes the base of the 'cliff' and slabs collapse into the channel. These can be seen in Fig 2 (& Fig 3) and might eventually lead to reprofiling of the bank to a more natural gradient if stock were removed. However, with continued access, that stock will maintain the deposition bar free from colonising plants by browsing and trampling, and further maintain the weakened integrity of the bank face by traversing across and rubbing against the soil.

The channel was probably 10-15m wider than it should be (in Fig 2) simply because of straightening and unrestricted livestock access. The exact same situation could be observed for 200m of the LB as soon as the livestock fencing ceased (Fig 3; below Wood Spring).

Fig 2. Compare and contrast the riparian flora and related extent of erosion on the two banks: the LB well vegetated with a diverse native herbage and rich resource for pollinators; the RB overgrazed to a short sward and eroding laterally as a result of block failure and stock accessing the toe of the bank.

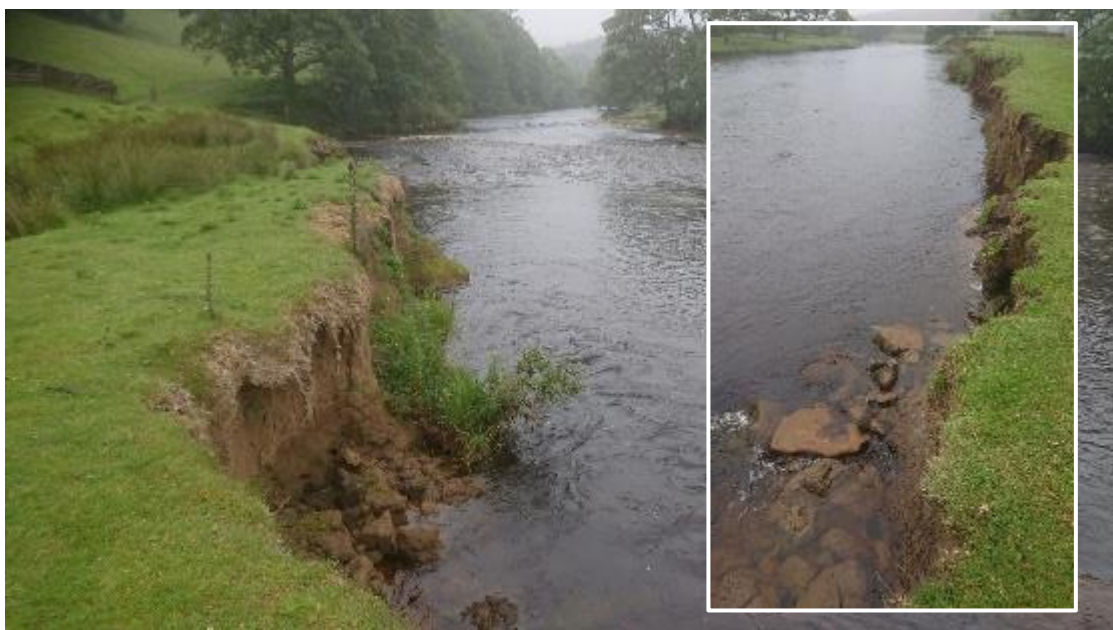
Fig 3. Block failure of the LB above Barden Bridge. Overgrazing has created a short sward of grass with no diverse root structure to physically bind the soils together and present greater resilience to spate flows.

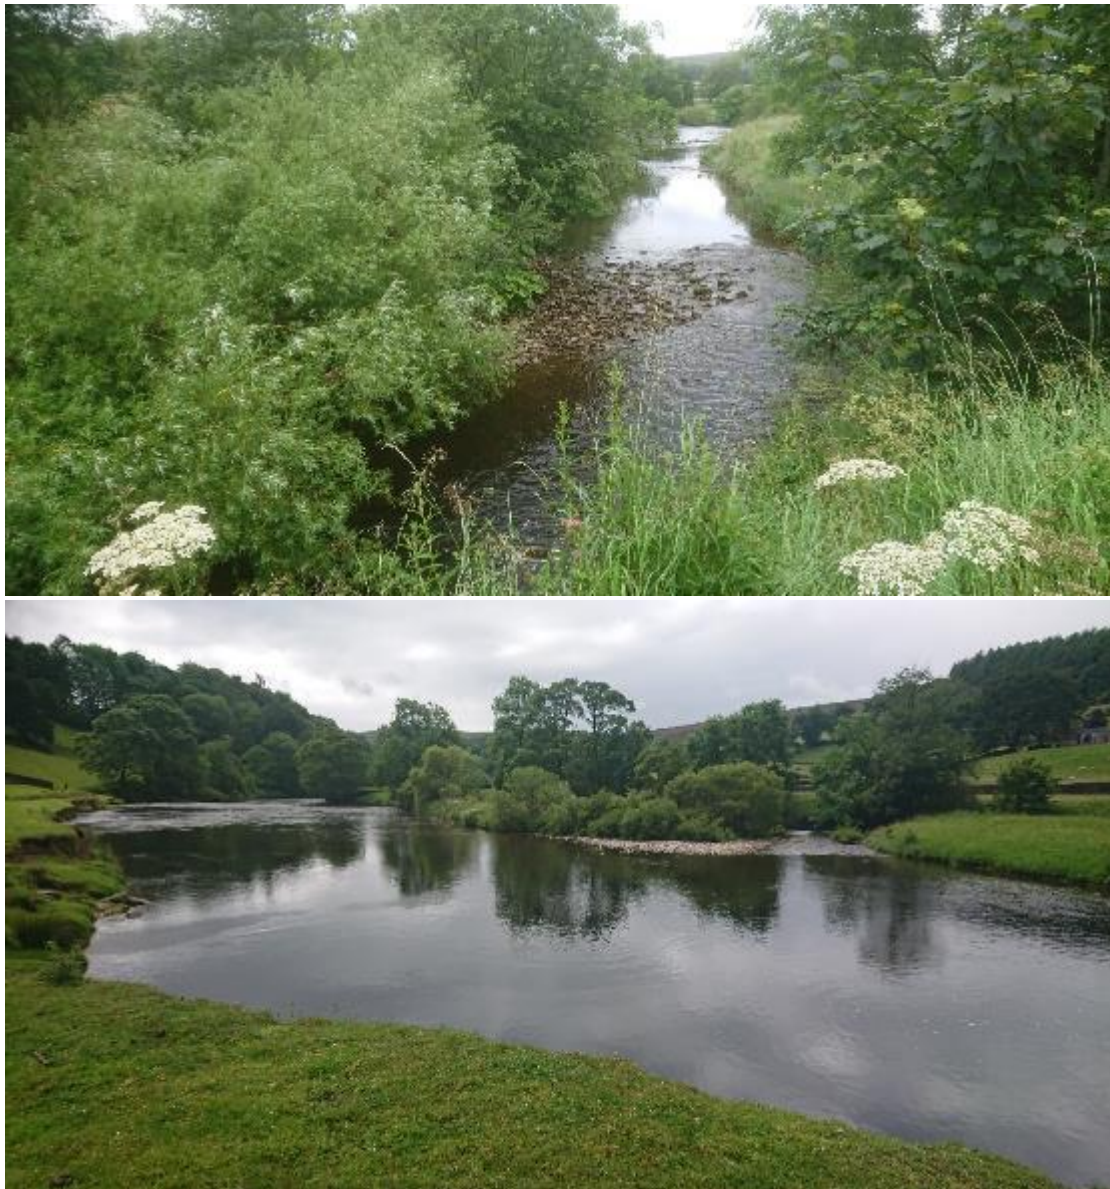
Fig 4. Two examples of where an island has formed, and the resultant side channels provide excellent cover and refugia for juvenile fish from flow and predation pressures in the main channel. Upper: at SE 05456 58472; and lower at SE 05264 57908. The latter is particularly valuable given the highly exposed and uniform characteristics of the main channel caused by the lateral erosion of the overgrazed LB.

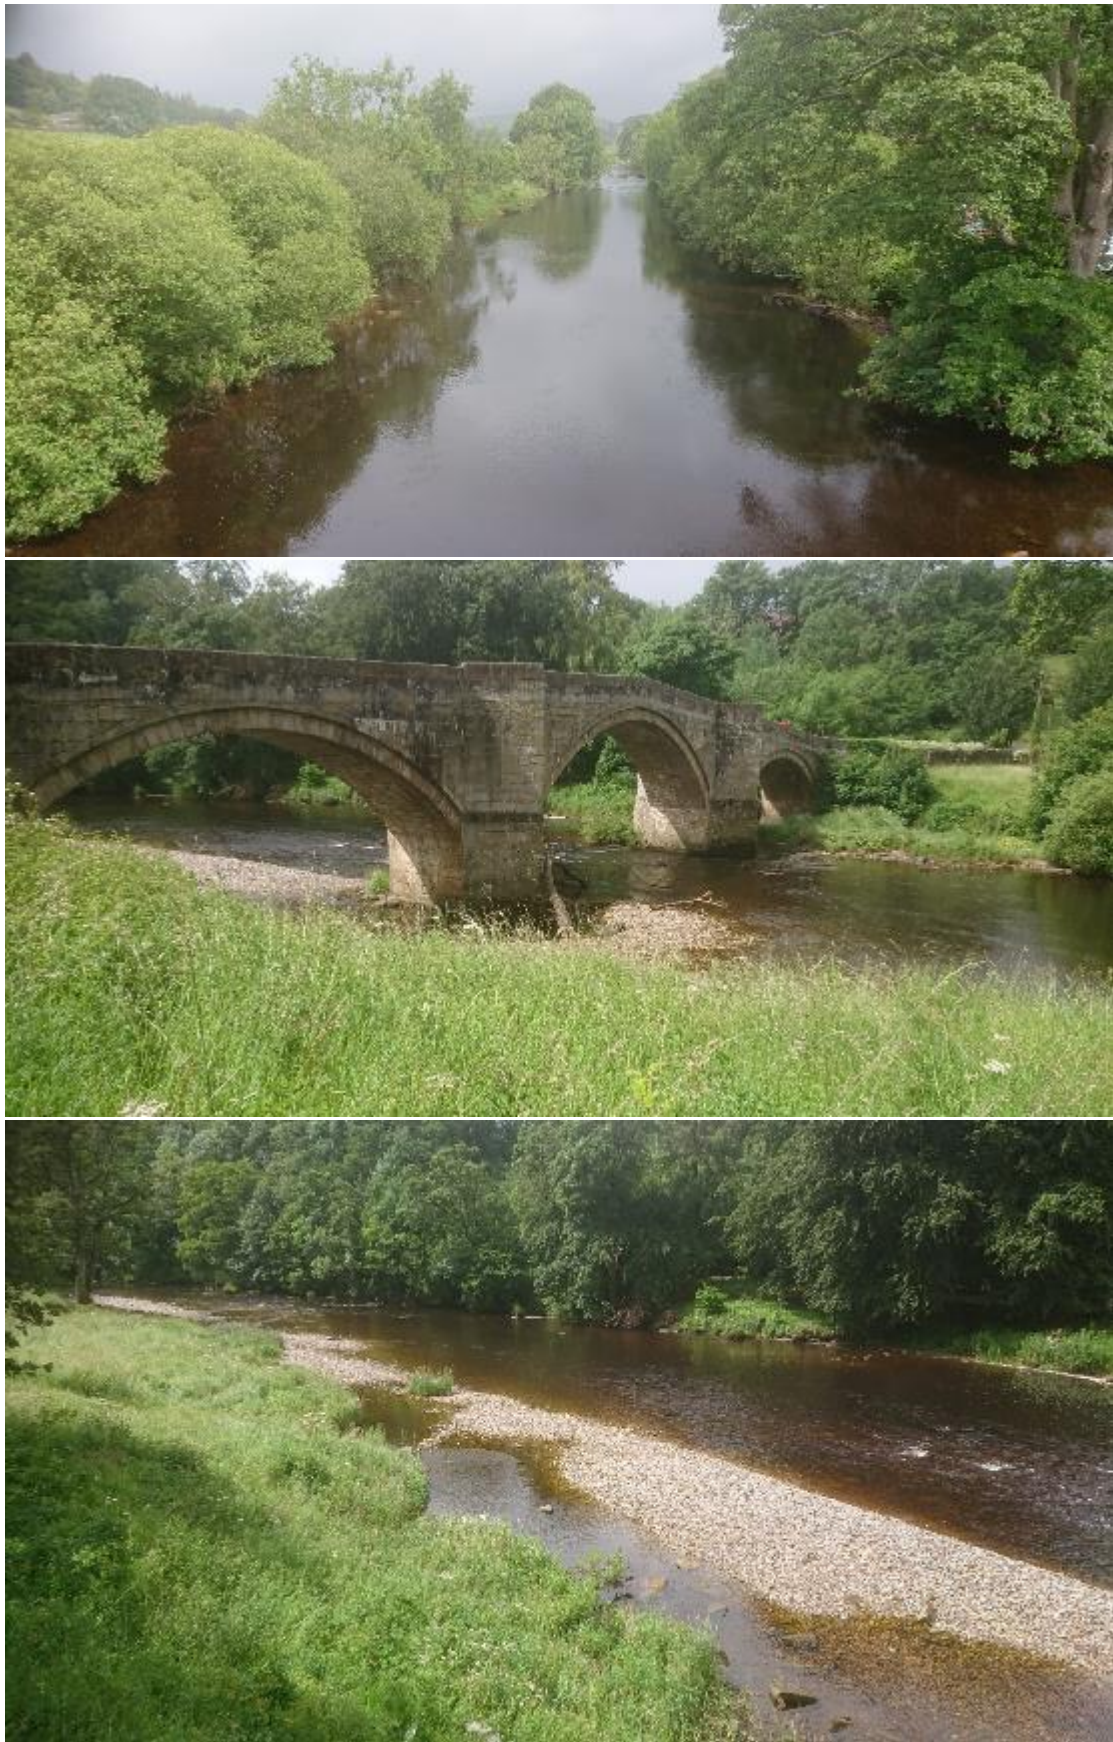
Fig 5. Characteristics around Barden Bridge. Upper: looking u/s from the bridge at the straightened, impounded section – a saving grace being the extensive overhanging tree cover on each bank. Mid & Lower: the pinching effect of the bridge parapets and extensive deposition bars d/s narrow (and speed the flow within) the main channel, and create shallow backwaters against the LB; important nursery areas for fry.

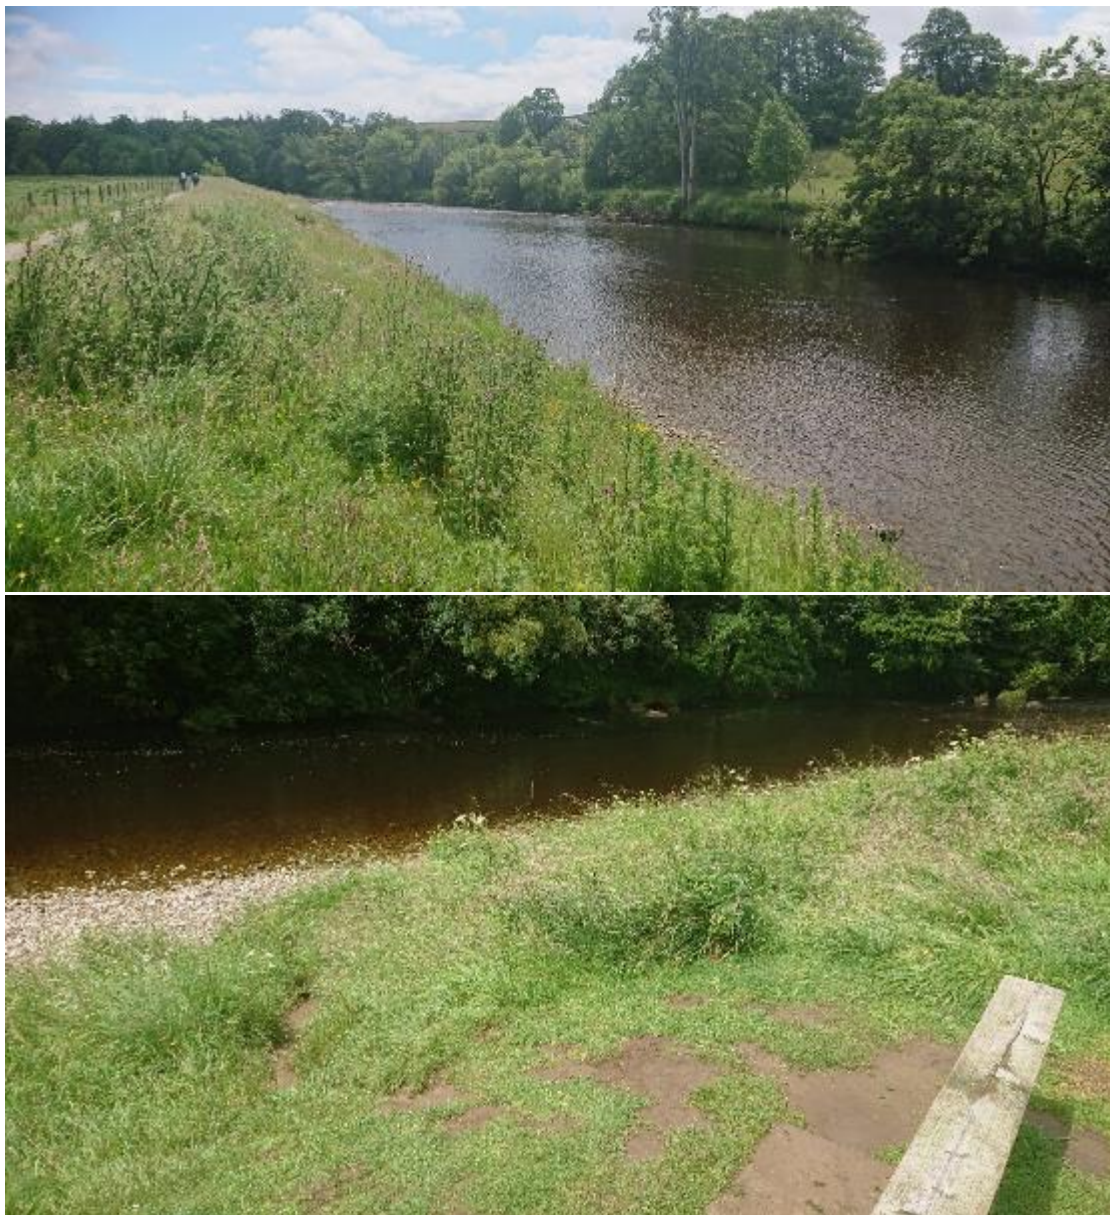
Fig 6. The long, sweeping, relatively uniform section between Barden Bridge and the aqueduct (Fig 7), typical of a realigned watercourse with boulder revetment to prevent the channel meandering. Paleo-channels can be seen on either side of the current artificial course from aerial imagery. Desire lines, footfall around focal features like benches and deposition bars ('beaches') create potential weak spots in the bank line via trampling of the soil and vegetation.

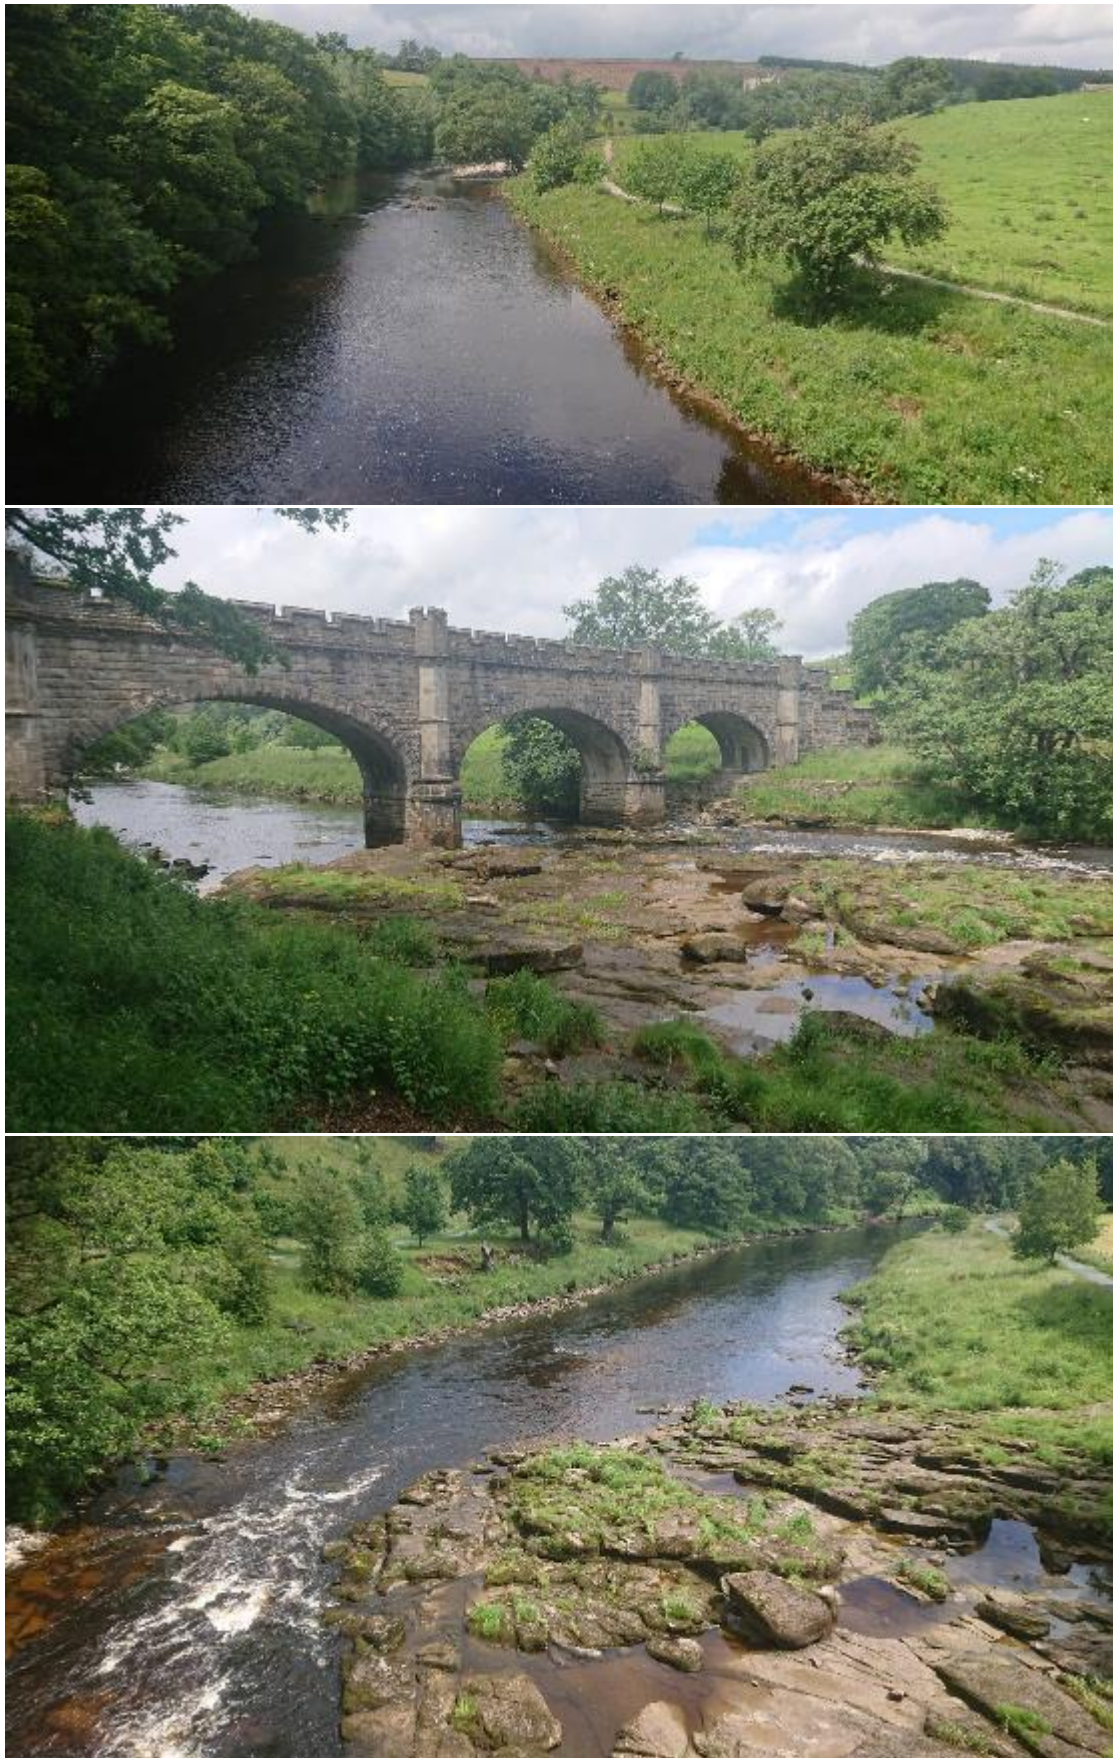
Fig 7. A seam of bedrock has been used to facilitate crossing of the aqueduct. This natural pinch diversified the channel characteristics briefly before it returned to the same uniform proportions (as in Fig 6) under the constraint of boulder revetment banks within 50m d/s.

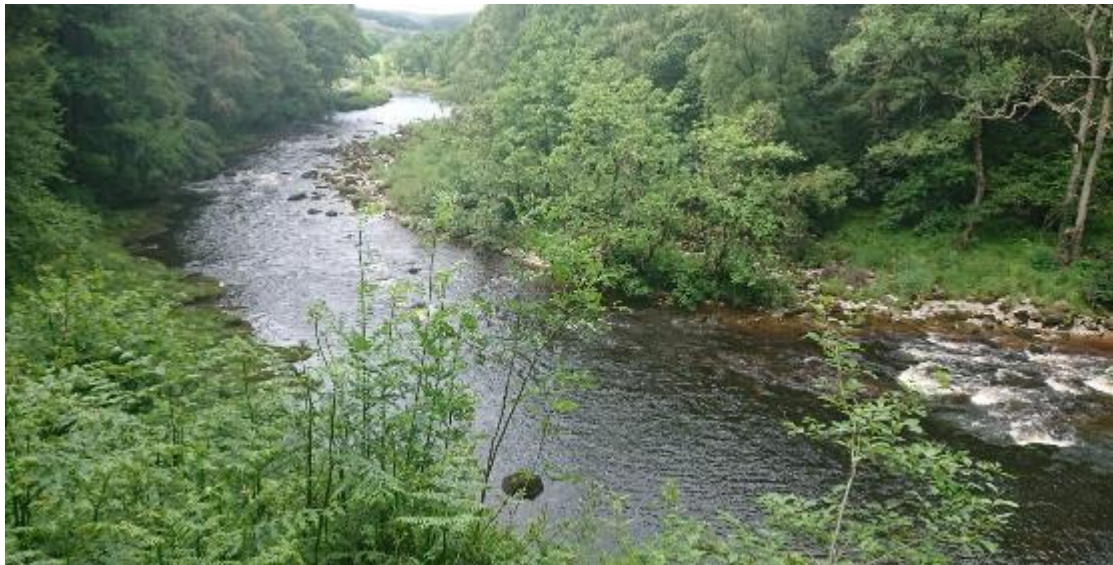
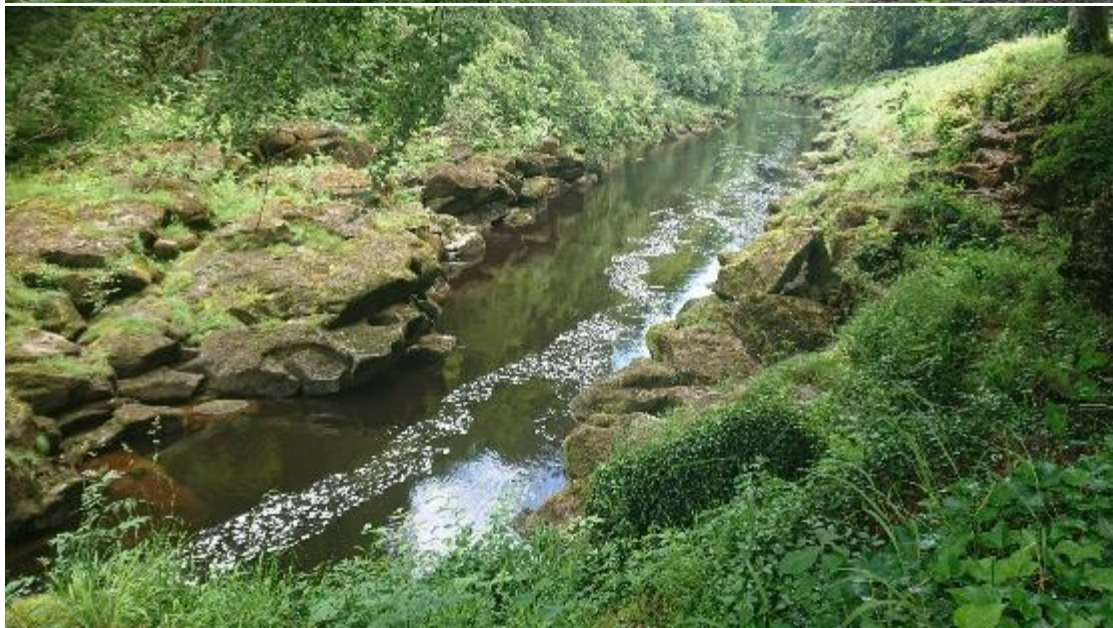
Fig 8. The narrowing of the valley instigated a few natural twists and turns through The Strid, and with no requirement for revetment on either bank, the channel presented very diverse morphology and high quality habitat.

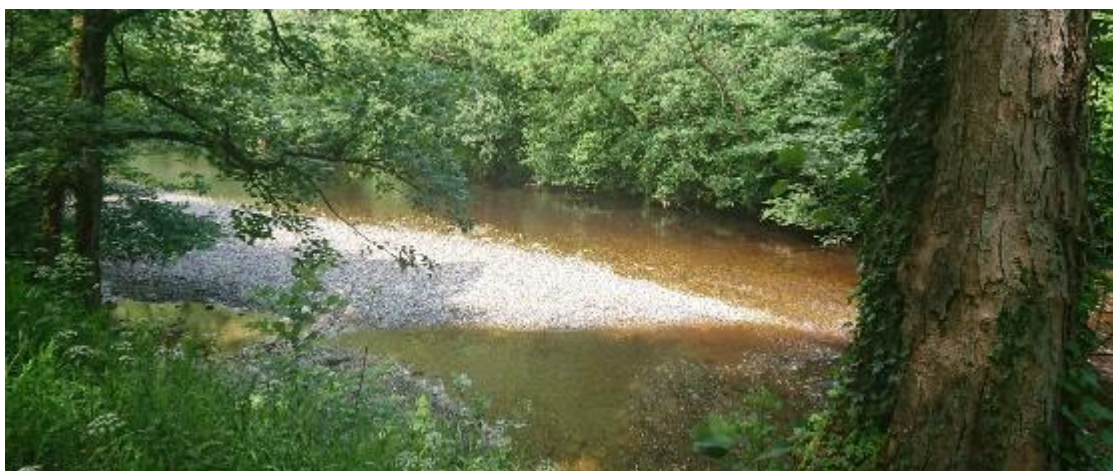
Fig 9. The development of a natural deposition bar within Strid Wood created a run of deeper water to the LB under the cover of overhanging branches (perfect feeding lies for larger fish) whilst also forming an adjacent shallow, slackwater pool to the RB (important for juvenile fish).

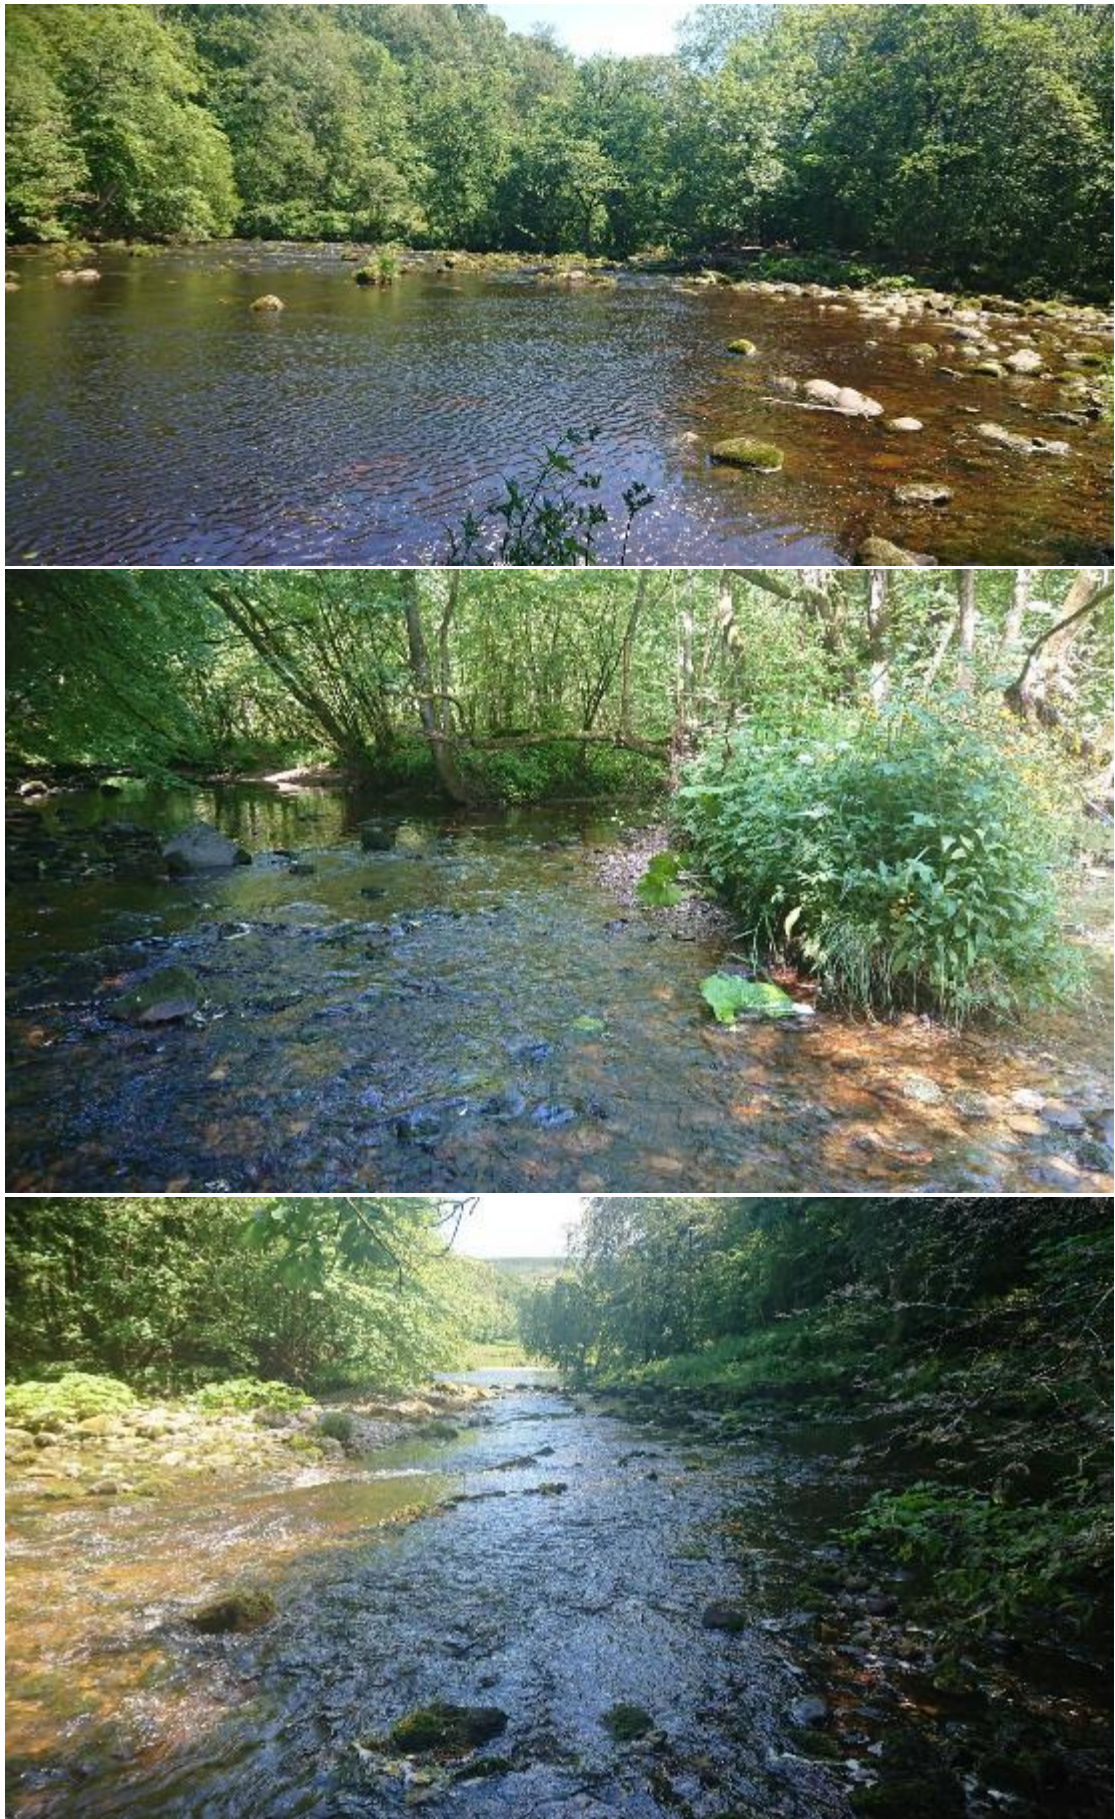
Fig 10. Channel diversity amongst the Lud Stream Islands; plenty of pocket water, shade and retention of gravel.

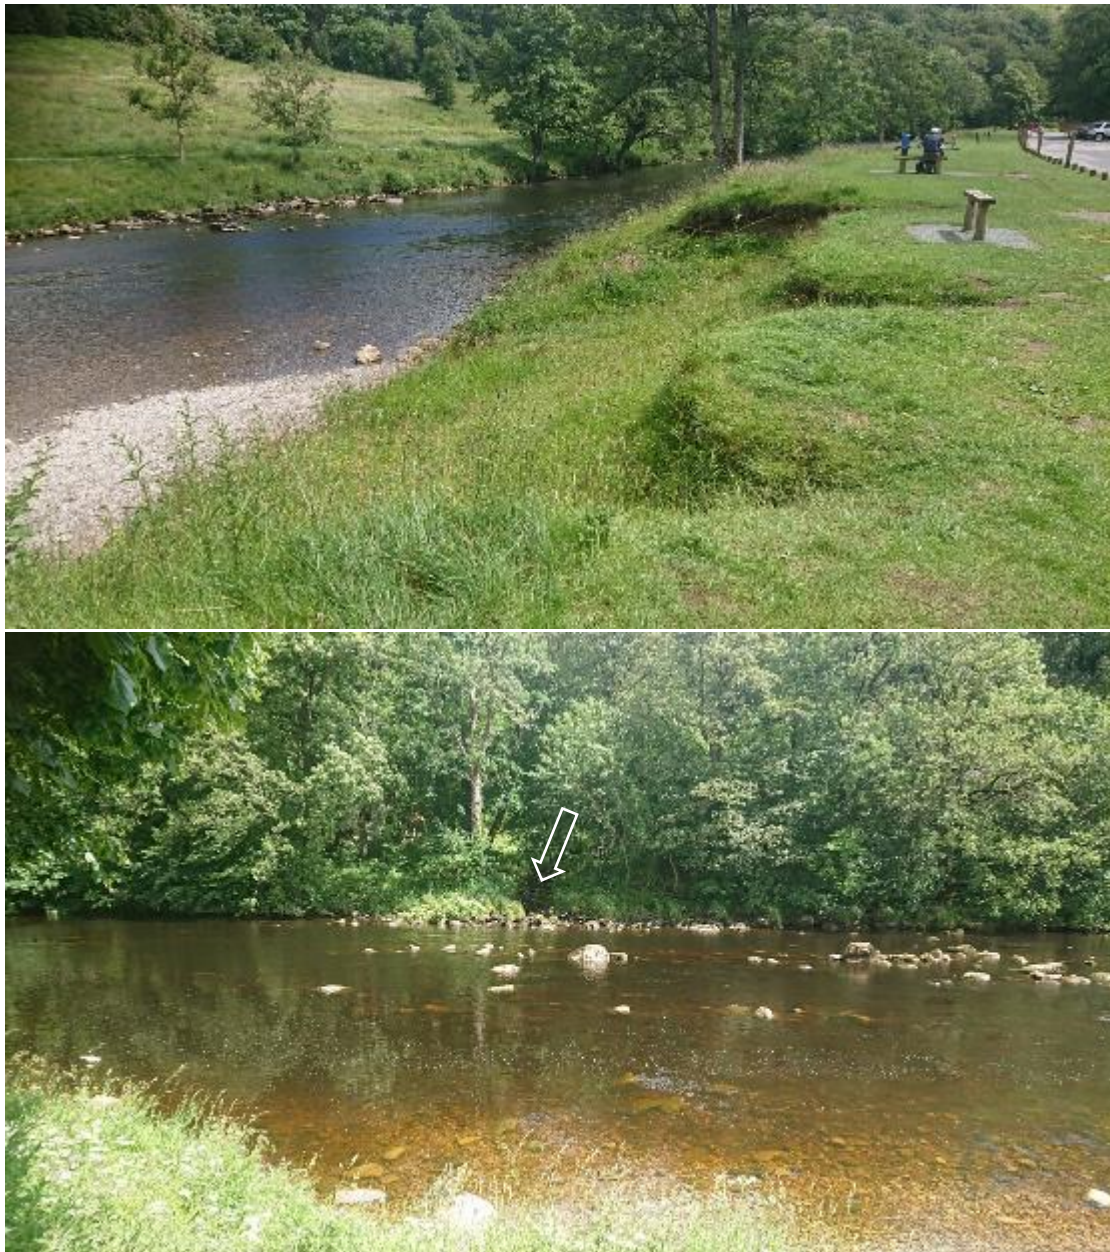
From the Pavilion car park almost down to Bolton Bridge, the RB was heavily impacted, assumed formerly by agriculture and latterly by human access for tourism and leisure (Fig 11). Grazing or mowing affected much of the bank tops although the slope to the water's edge was generally wilder and, in some places, left unkempt. Trees were more notable by their scarcity. The LB was more natural woodland, primarily because of gradient, at least to the Abbey environs. From there, the LB also flattened out and livestock access had caused considerable erosion and lack of floral diversity.

Fig 11. A return to more formalised banking and uniformity of channel characteristics, and footfall pressures d/s of Wooden Bridge at the Pavilion and Sand Holme Brow. Lower: the white arrow depicts the confluence of Pickles Gill Beck on a more secluded stretch of the LB.

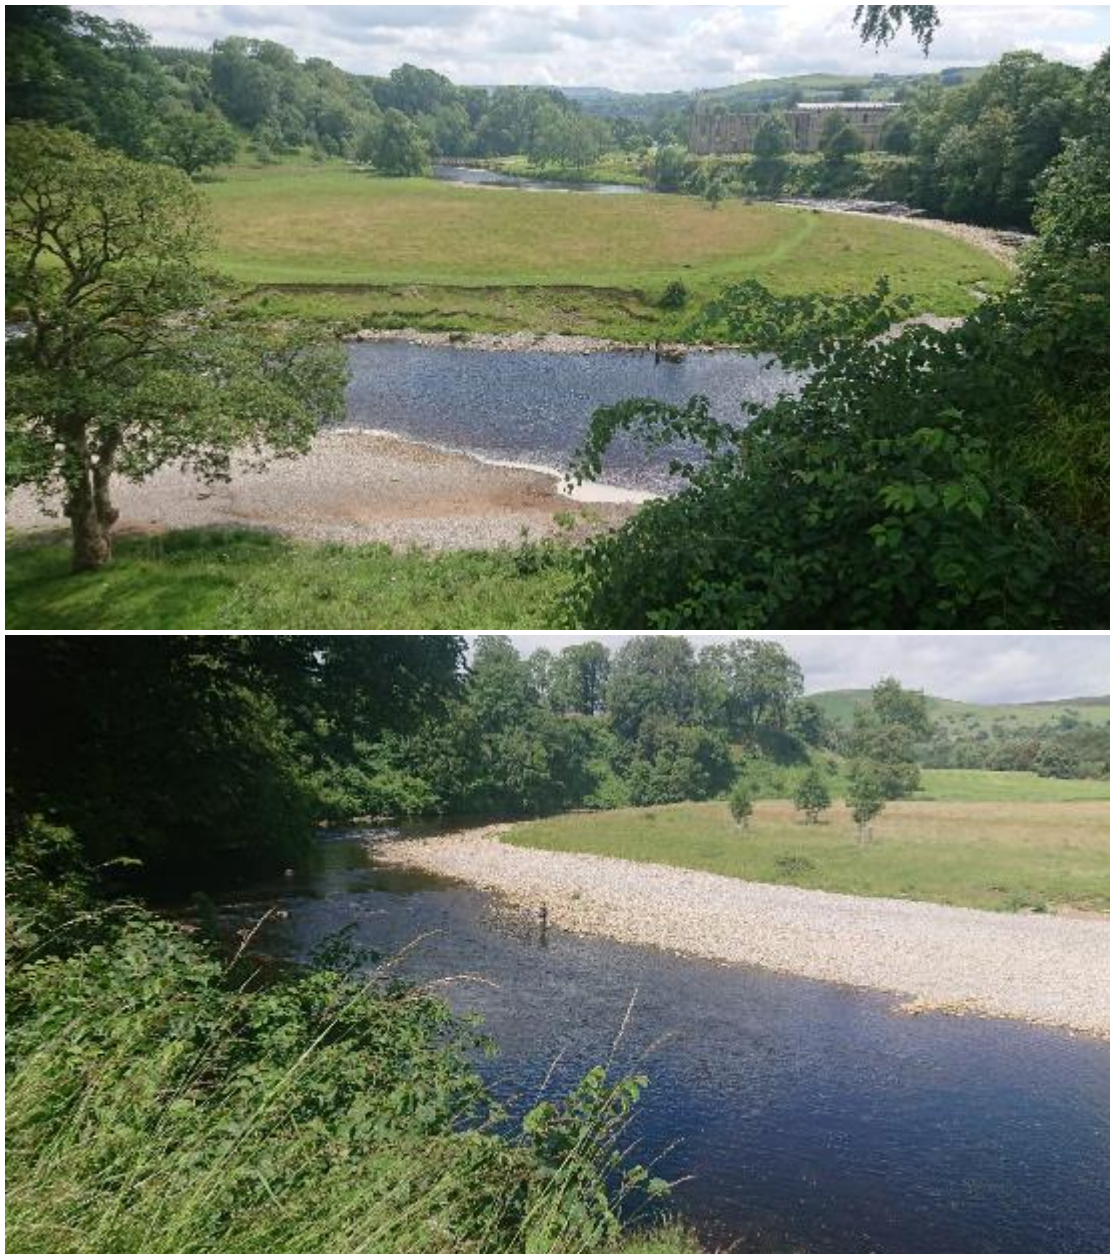
Fig 12. One of the few meanders retained although now 'fixed in aspic' via revetment immediately u/s from Bolton Abbey. These bends are tighter than the long sweeping examples u/s & d/s, and impart more natural channel morphology as a consequence.

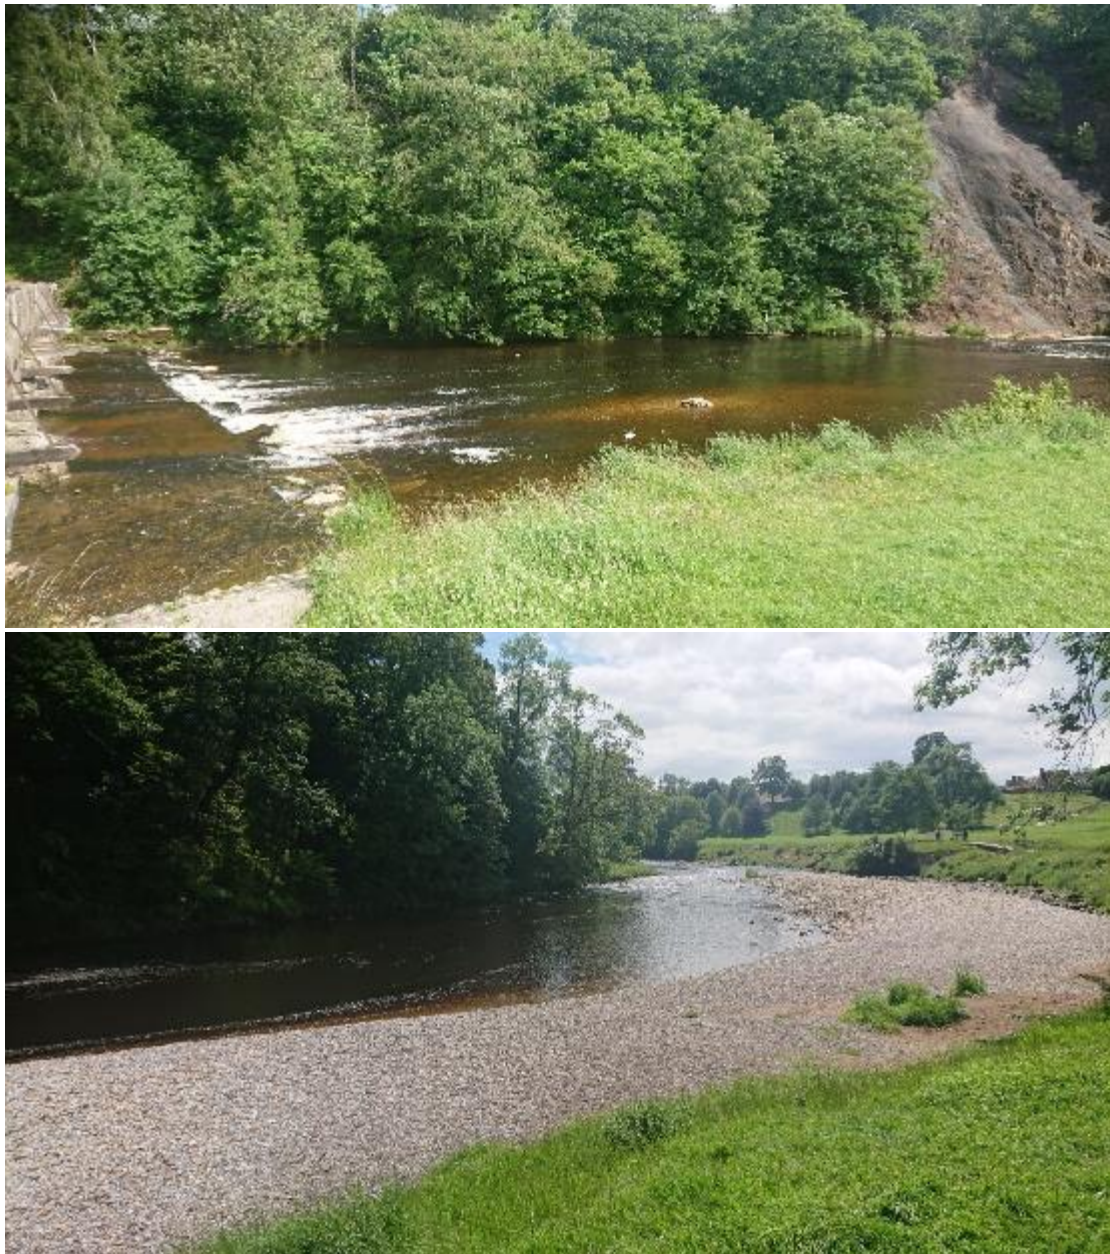
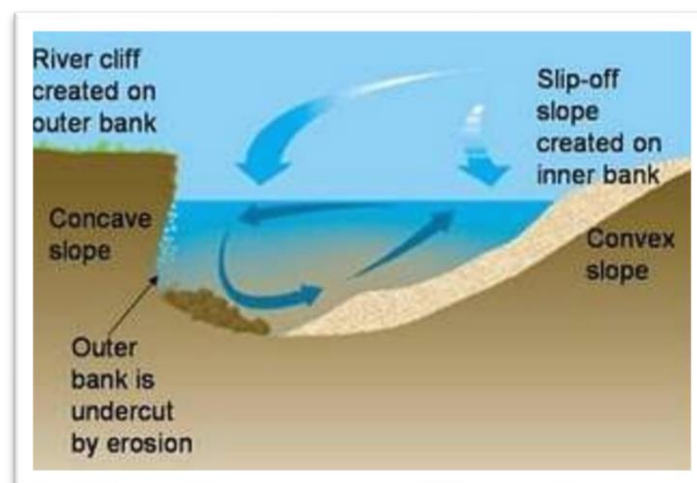
Fig 13. Upper: the weir, wooden footbridge and stepping-stone footings combined to reduce free fish passage at the Abbey. Lower: d/s of the footbridge, the channel was essentially pinned to the left hand side of the valley (in part by the angle of the weir). As a consequence, there was considerable erosion of the exceedingly steep LB (visible in the upper panel) and deposition of substrate to the RB from the helicoidal flow (see schematic).

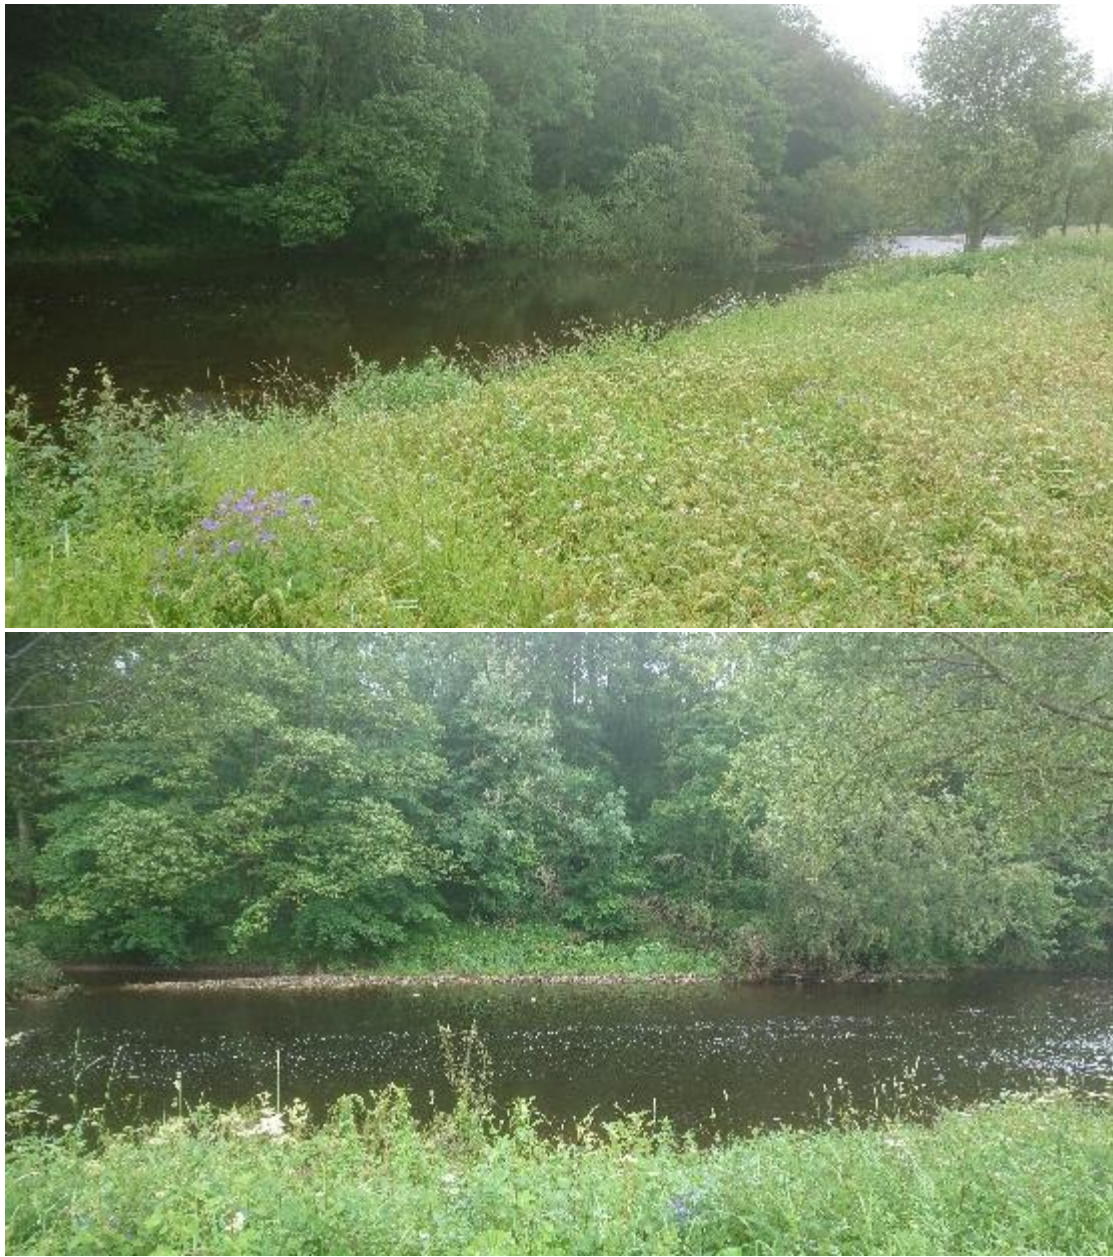
Fig 14. Although still straightened, the riparian zone on both banks downstream of the A59 at Bolton Bridge was much more natural and with less evidence of management although trees were sparse on the LB; several leaning and fallen trees from the RB were *in situ* and providing excellent habitat.

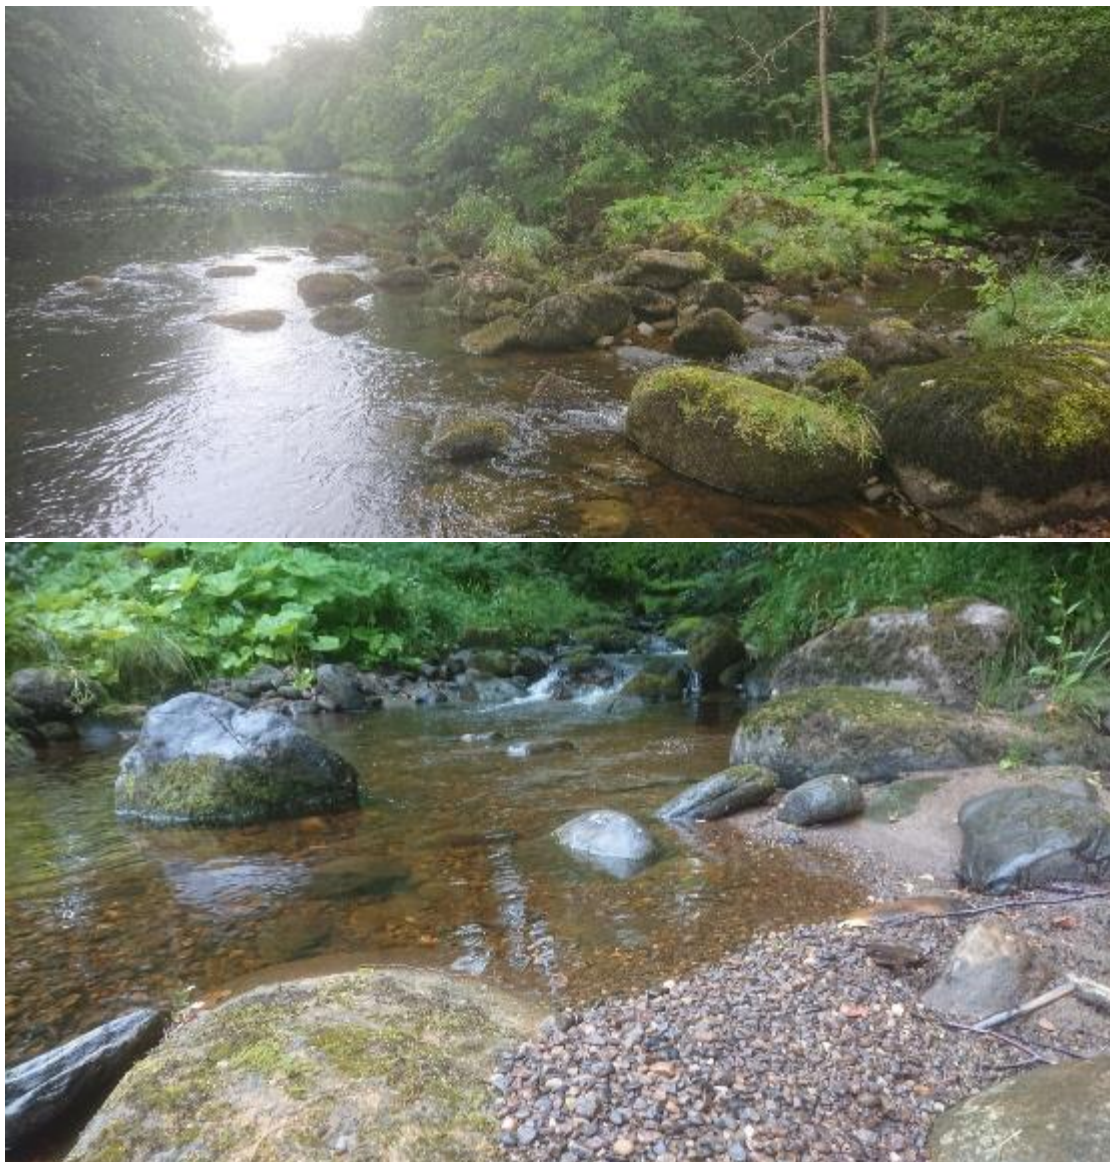
Posforth Gill Beck was examined from its confluence for a distance of ~450m. Natural waterfalls prevent further use of the beck by fish. Boulder revetment of the Wharfe bank had been almost wholly reclaimed by nature at the confluence; the walling had been broken up, and natural regeneration and succession of native trees provided good shade and plentiful leaf litter input. The mouths of small tributaries can become very shallow due to the deposition of sediment when they meet a mainstem river in spate flow. However, larger boulders at the mouth of this beck constrained it and scoured a deeper path, thereby maintaining access for fish even at low flows. Deposits of clean gravel in the lower reaches indicated the potential contribution and supply of quality spawning substrate both within the beck and into the Wharfe (Fig 15).

Fig 15. Upper: the confluence of Posforth Gill Beck and the mainstem Wharfe was relatively shallow but boulder strewn thereby focussing flows and maintaining access for fish. Lower: deposits of gravel indicate Posforth is a source of suitable spawning substrate and macroinvertebrate habitat.
