Advisory Visit

R Wharfe & tributaries, Bolton Abbey Estate, Sept 2019

Prof J Grey: jgrey@wildtrout.org

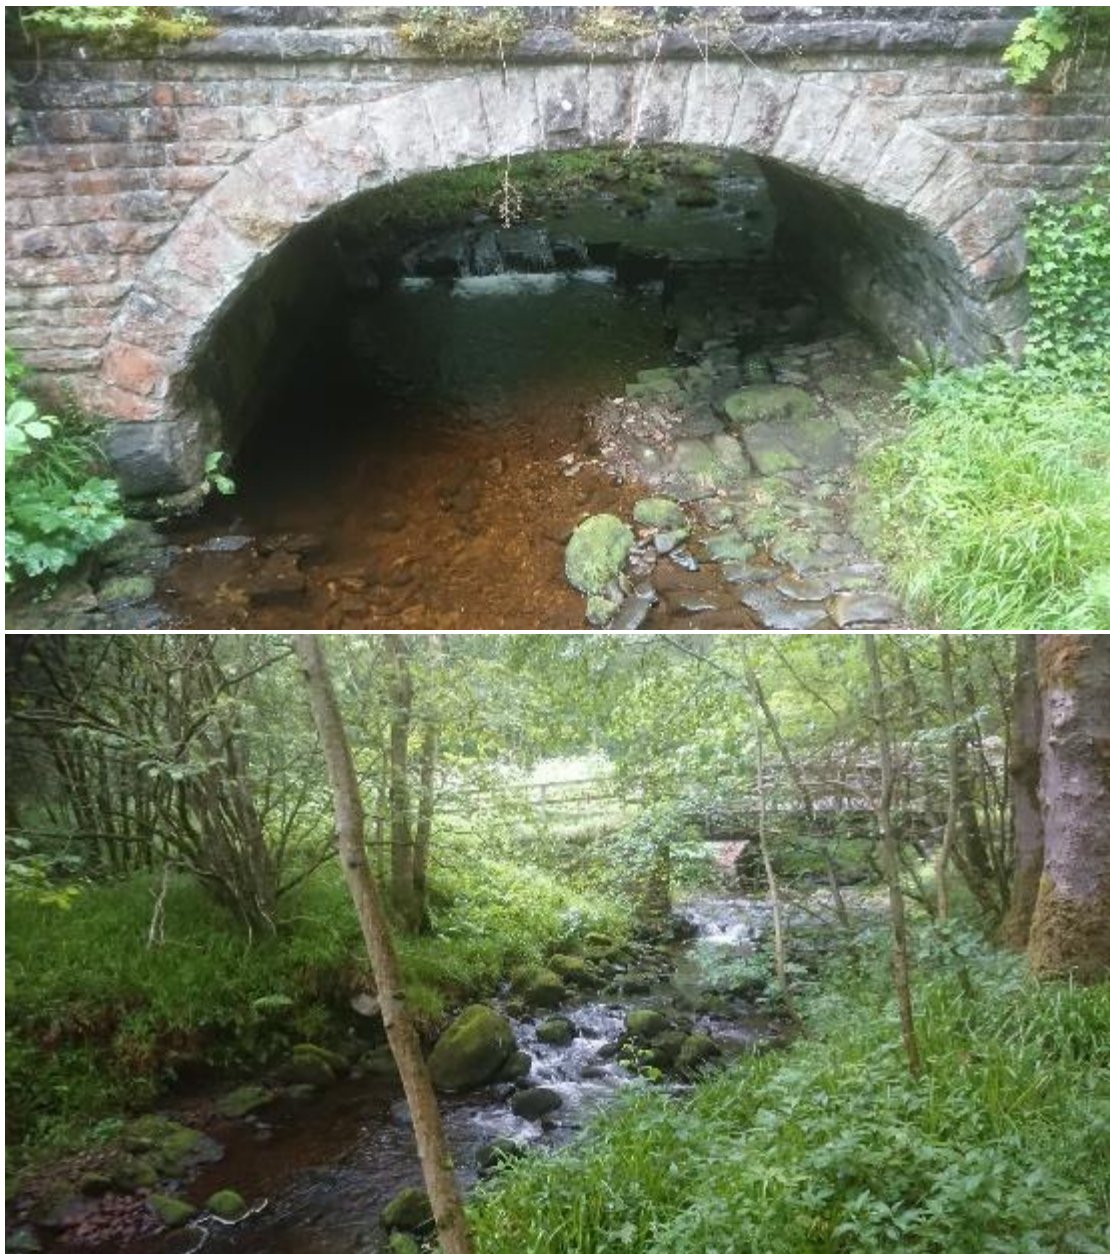
Fig 16. Two bridges adjacent to each other carry the road and the footpath over Posforth Gill Beck. Approximately 60% of the dressed stone culvert beneath the road bridge has been washed away, improving fish passage and holding capacity of the beck at the bridge.

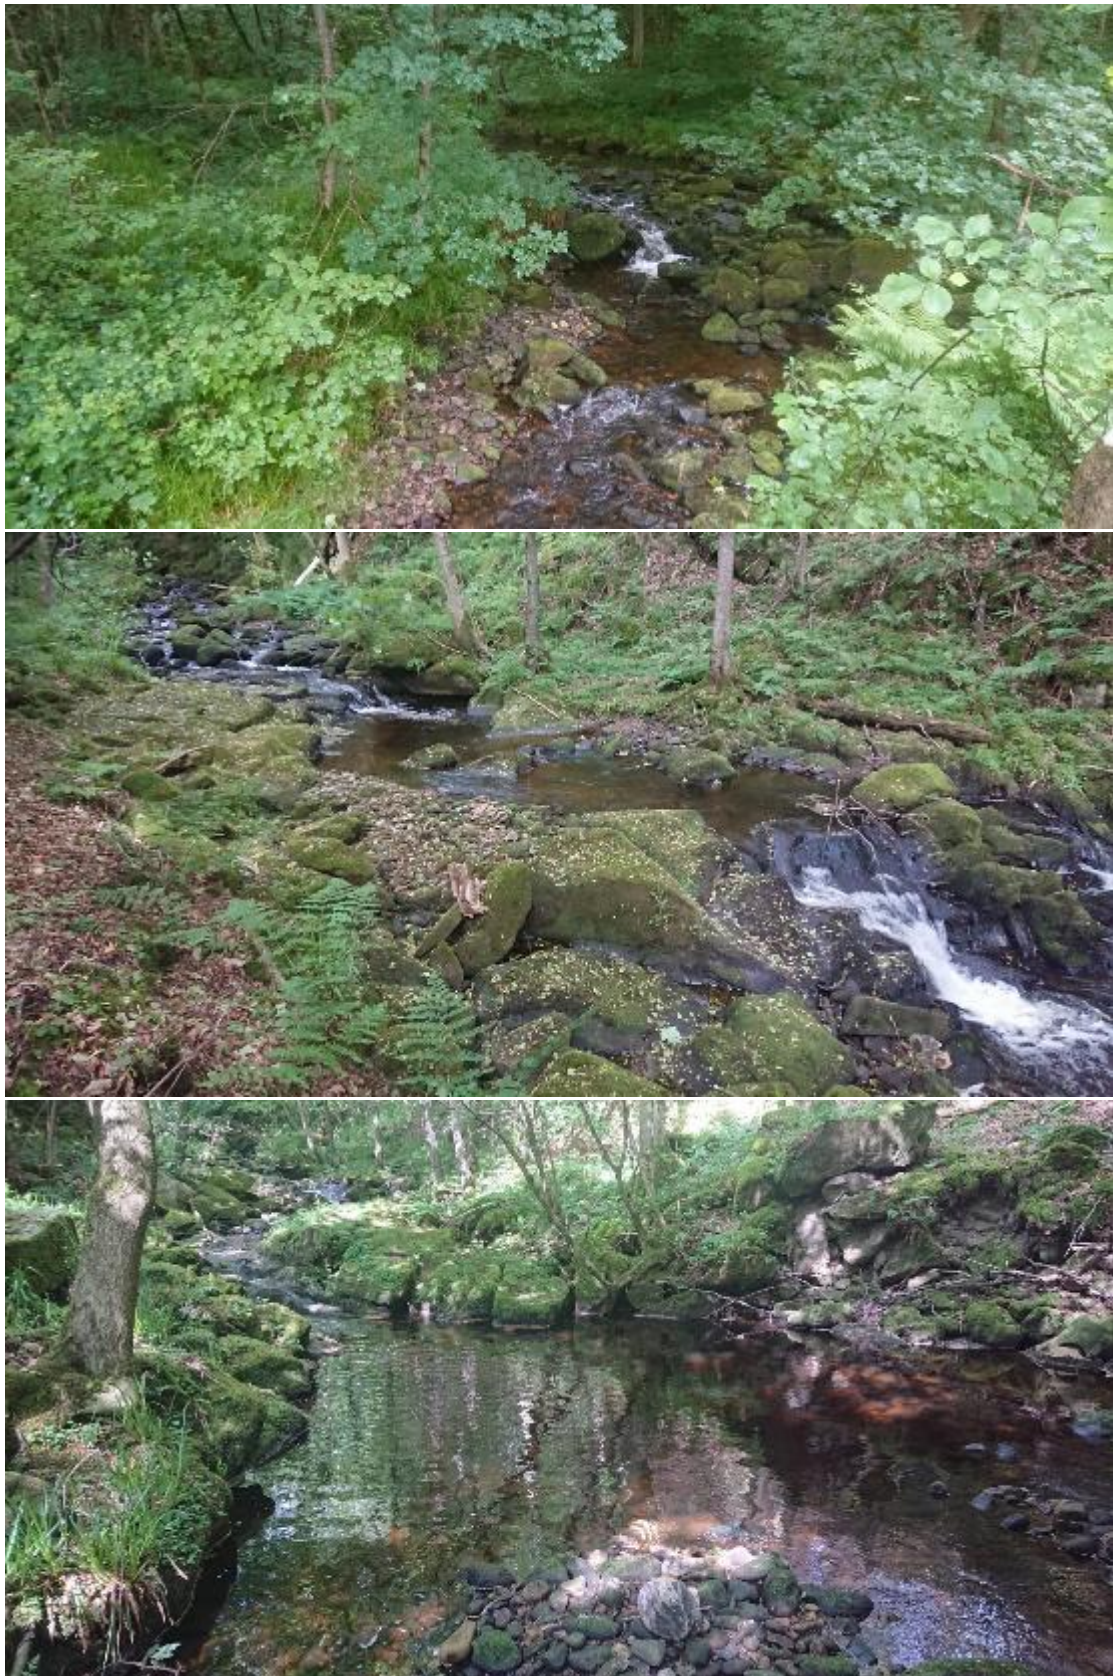
Fig 17. U/s of the road bridge, the beck was naturally constrained within a narrow and steep valley and hence habitat was dominated by pool and cascade between bedrock and boulders. The riparian fringe was native wet woodland. Note the ramp of smaller cobble and some gravel at the d/s end of the pool in the lower image – this is where trout will try to create redds.

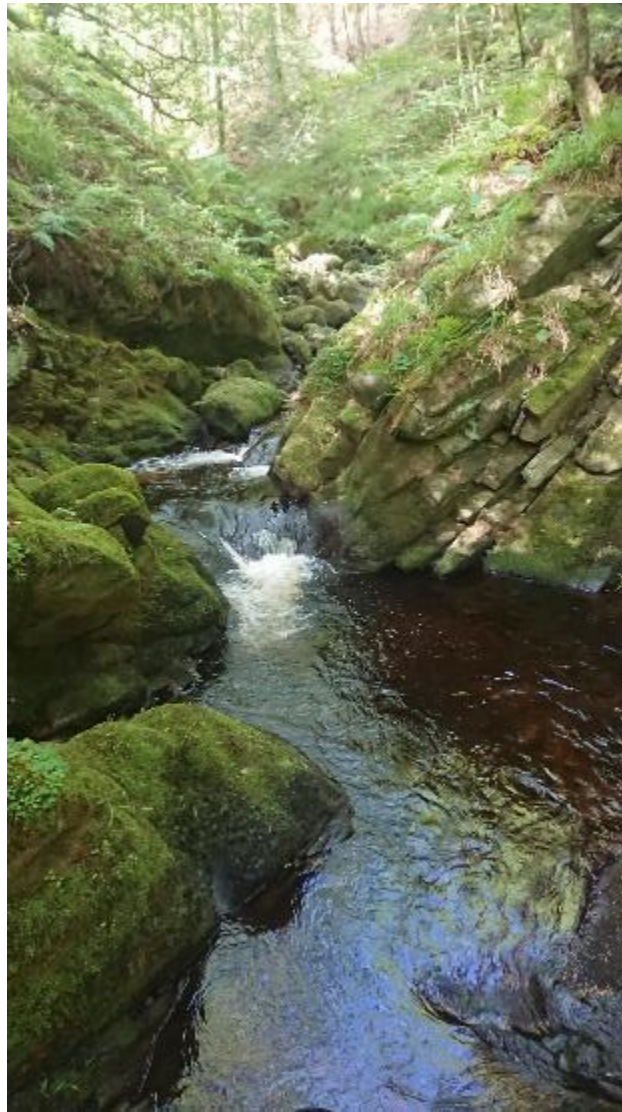
Fig 18. Typical pool and cascade features, ideal parr habitat, on the approach to a natural waterfall, the barrier to u/s movement on Posforth Gill Beck.

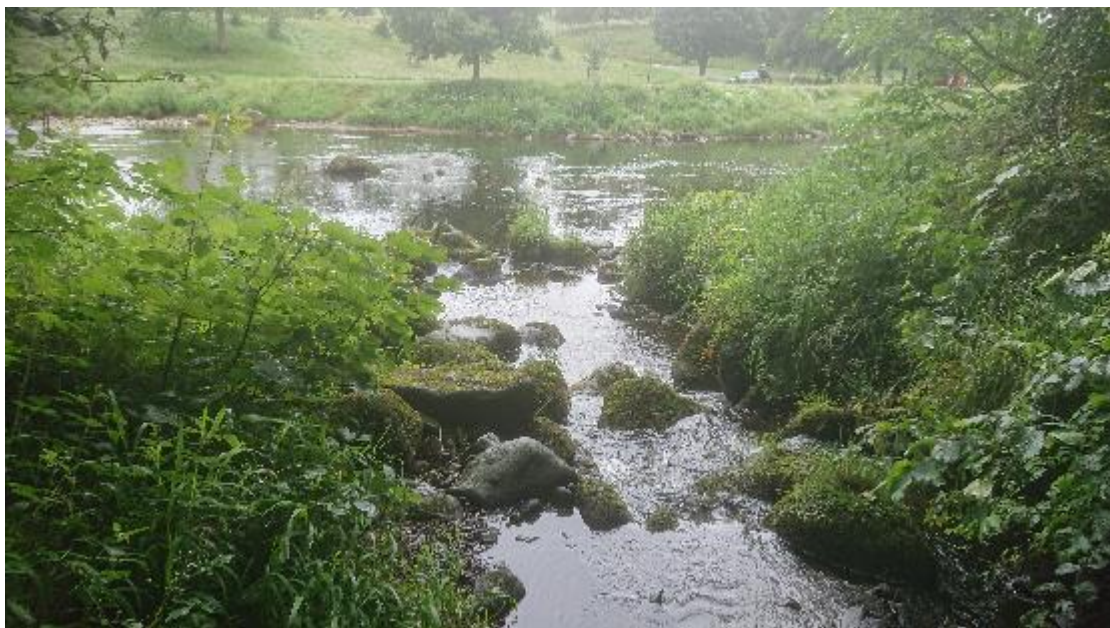
Fig 19. The confluence of Pickles Gill Beck, entering the Wharfe from the LB at SE 07982 54981.

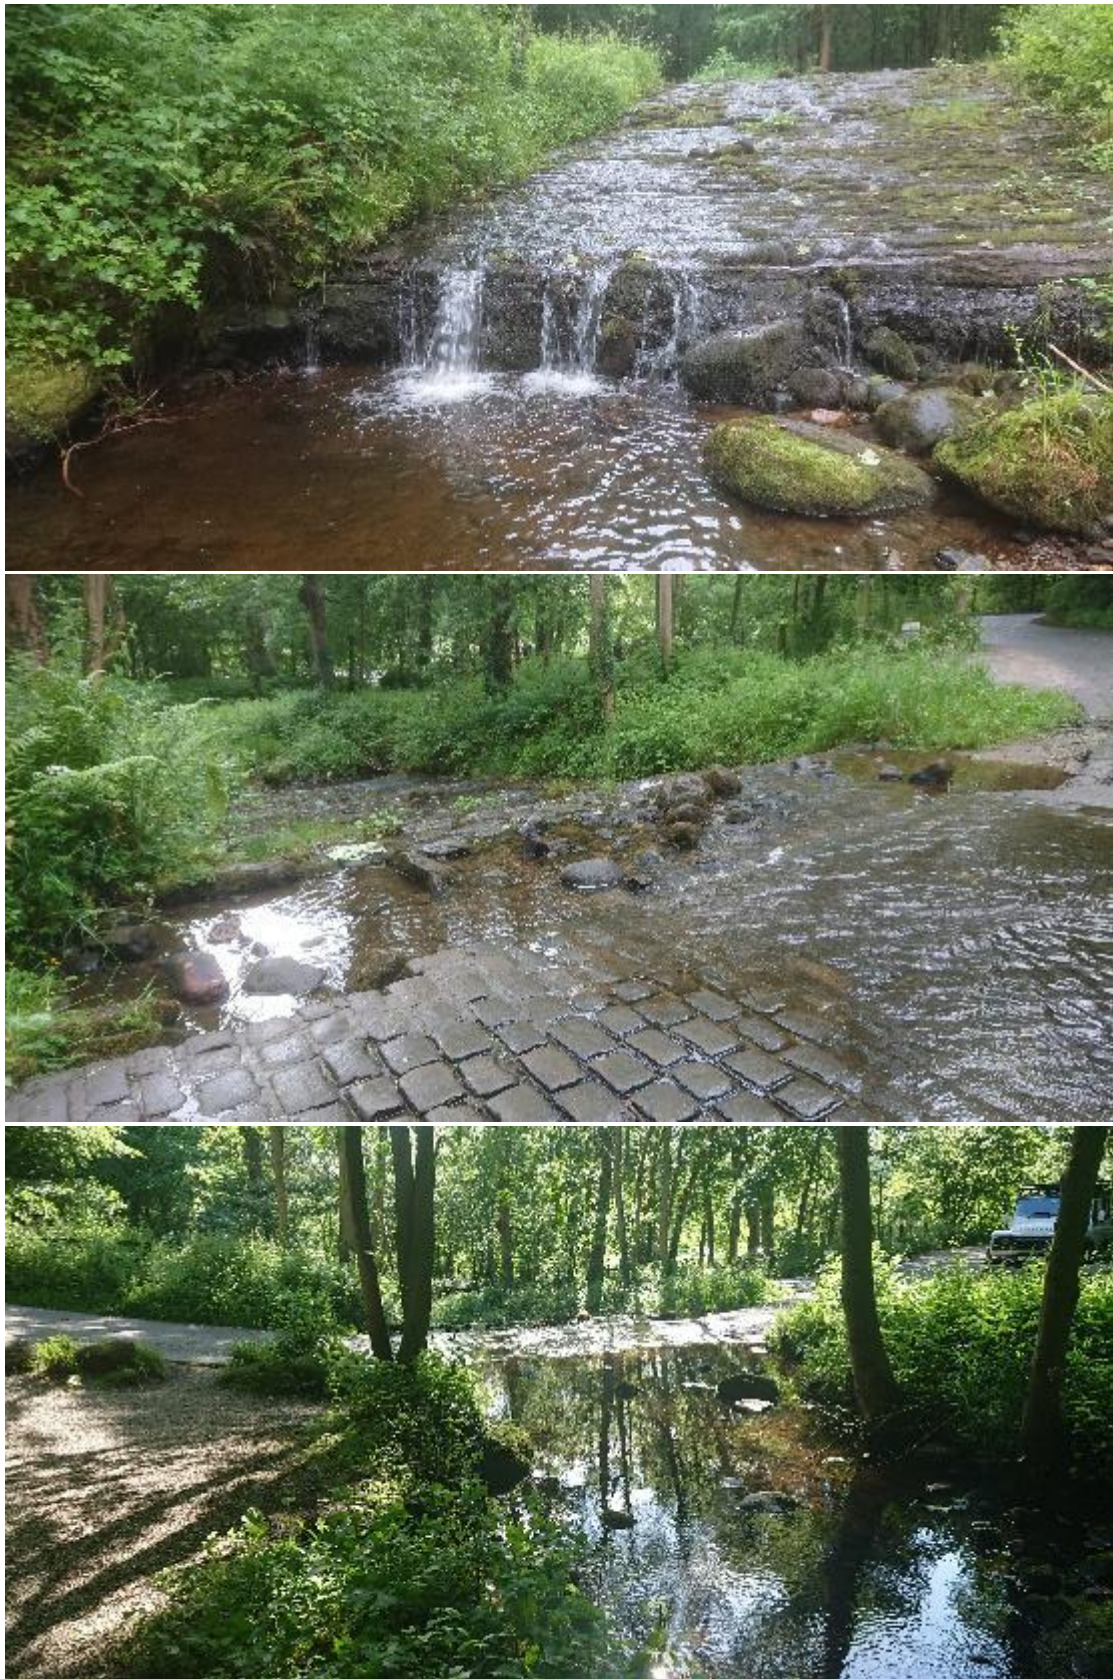
Only the very lowest 400m of Pickles Gill Beck were examined because of the considerable issues observed. Within 50m of the confluence was a dressed stone / cobbled and perched ramp of significant gradient which supported the road and ford above (Fig 19 & 20). Anecdotal evidence of fish waiting at the bottom to ascend is clear evidence of the impact such a structure will have on fish passage; it only being passable for very narrow windows of time, potentially not coinciding with fish spawning migrations. Resident fish would have no chance to ascend under the 'normal' flow conditions observed. This was a great pity because the reach through the woodland u/s had great potential.

Fig 20. The approach (upper) to the cobbled ford (middle) and the impounded section immediately u/s of the road (lower) presented a series of significant obstacles to fish passage within 50m of the confluence.

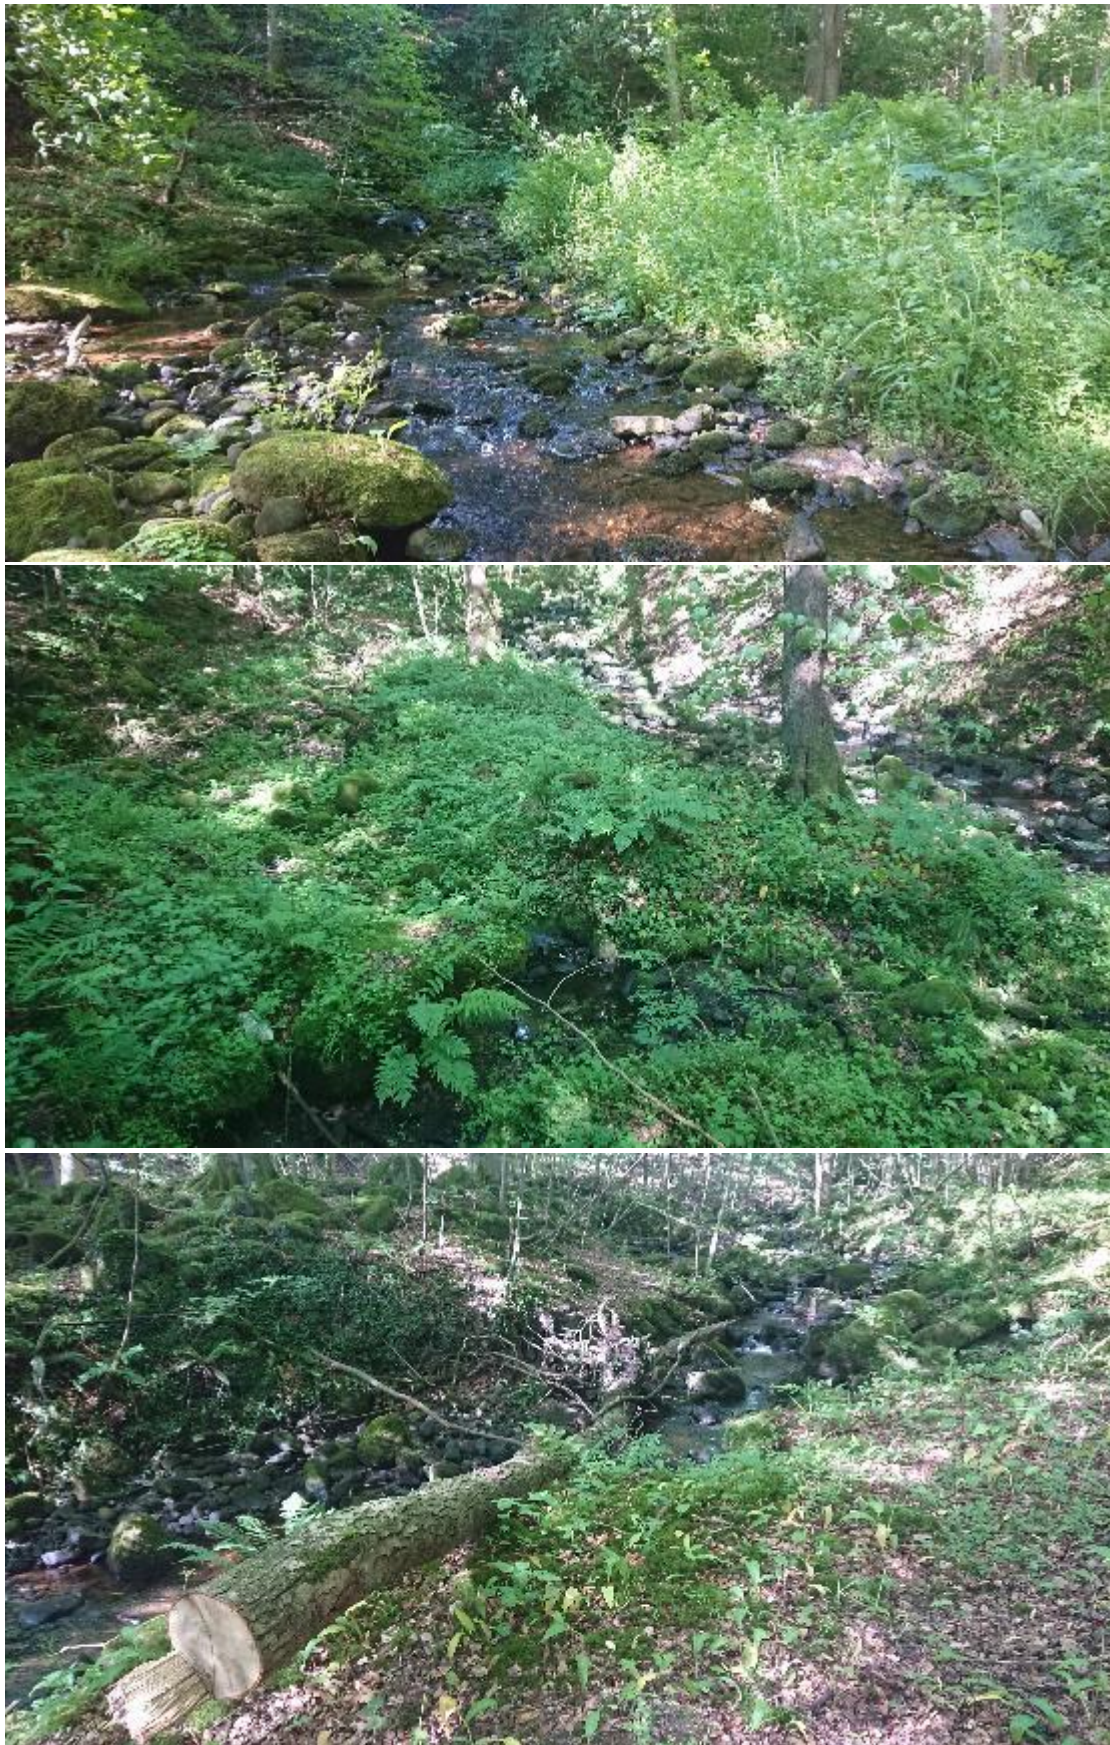
Fig 21. There was evidence of meandering across the valley in the lower gradient section above the ford and old paleo-channels or spate flow side channels (e.g. middle panel). The native understory was well developed and some woody material was found in the channel. The cut trunk (lower) was assumed to be for access for gamekeeping / shooting interests, rather than 'tidying up'. There should be more trunks and limbs like this in channel to improve the instream habitat and to help 'slow-the-flow'.

The channel form was quite natural beyond the impounding influence of the ford and clearly dynamic within the woodland, as evidenced by recent paleo-channels and retention of fallen wood (Fig 21). The substrate was varied in size and there was plenty of gravel but, perhaps more than any other tributary observed, there was a considerable amount of fine silt smothering the bed (Fig 22). Aerial images reveal that the upper reaches of the beck were exposed to livestock access in the relatively long but narrow valley.

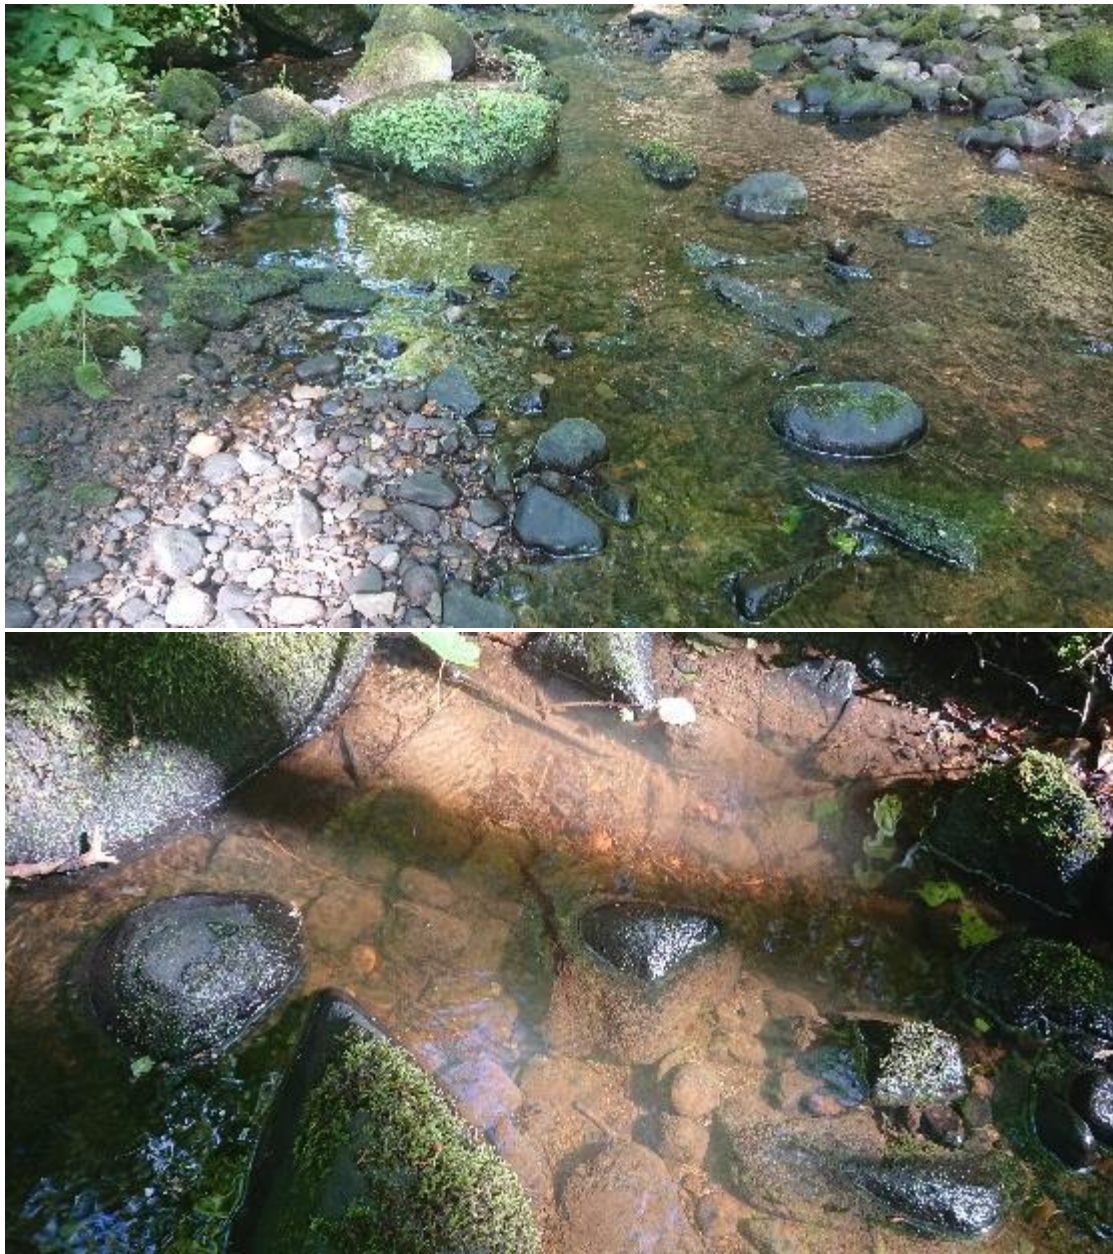
Fig 22. Although the size fractions within gravel deposits were suitable for spawning substrate and demonstrated ample supply (upper), there was also a notable fine fraction smothering and filling the interstices (lower) which points to issues of sediment ingress further u/s.

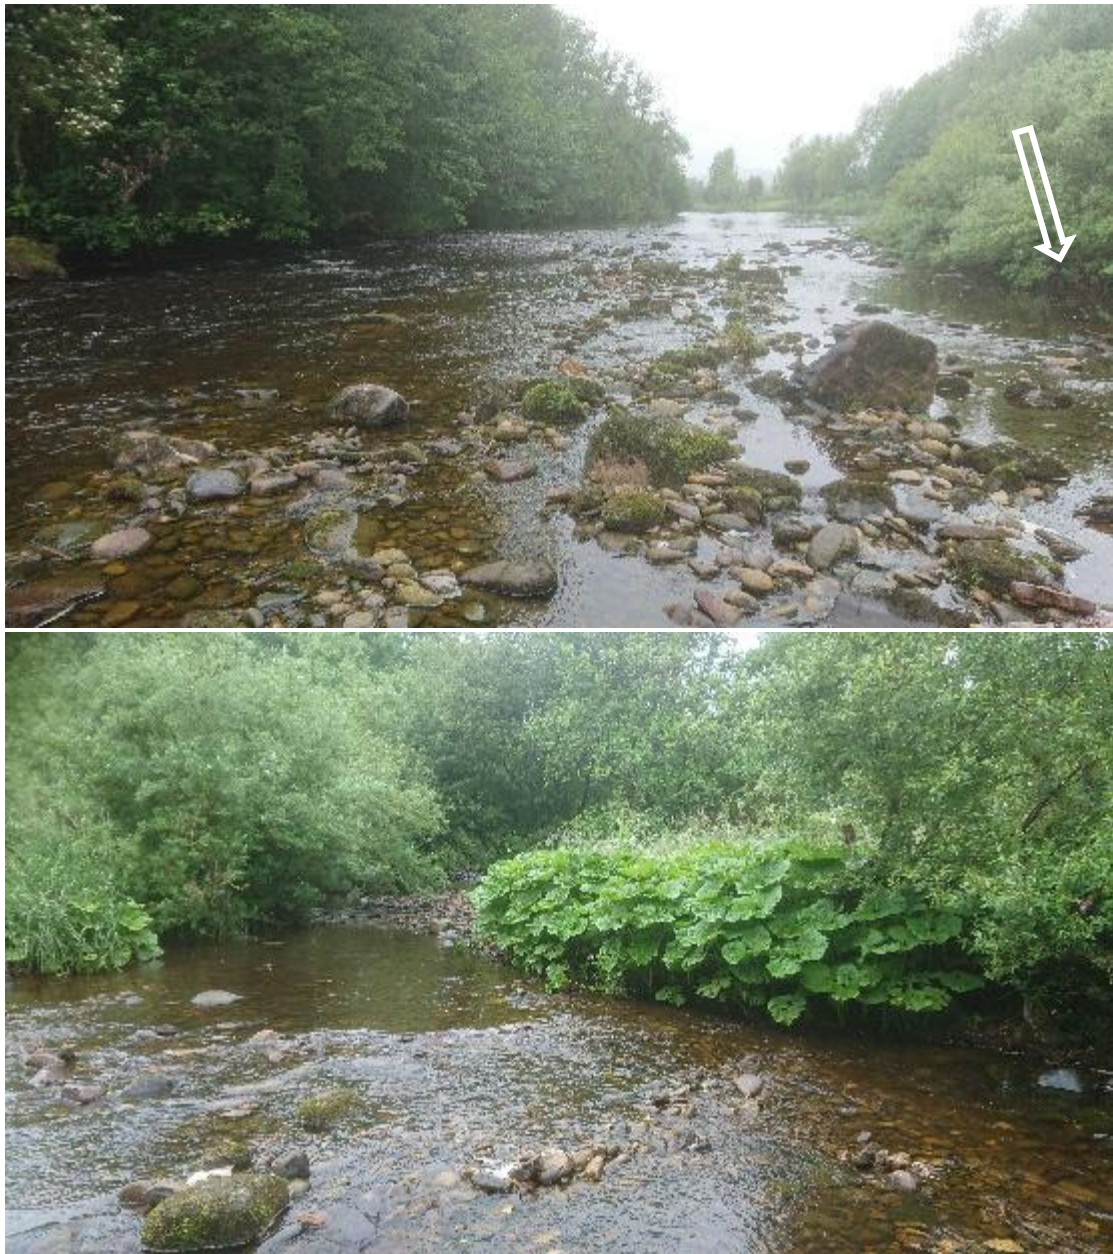
Fig 23. The confluence of Kex Beck entering the mainstem Wharfe from the LB (white arrow). A boulder, cobble and gravel deposit bar along the LB has been partly colonised and stabilised by emergent vegetation such as butterbur and scrubby goat willow which help to retain depth at the mouth and provide important low cover for fish moving in either direction (lower panel).

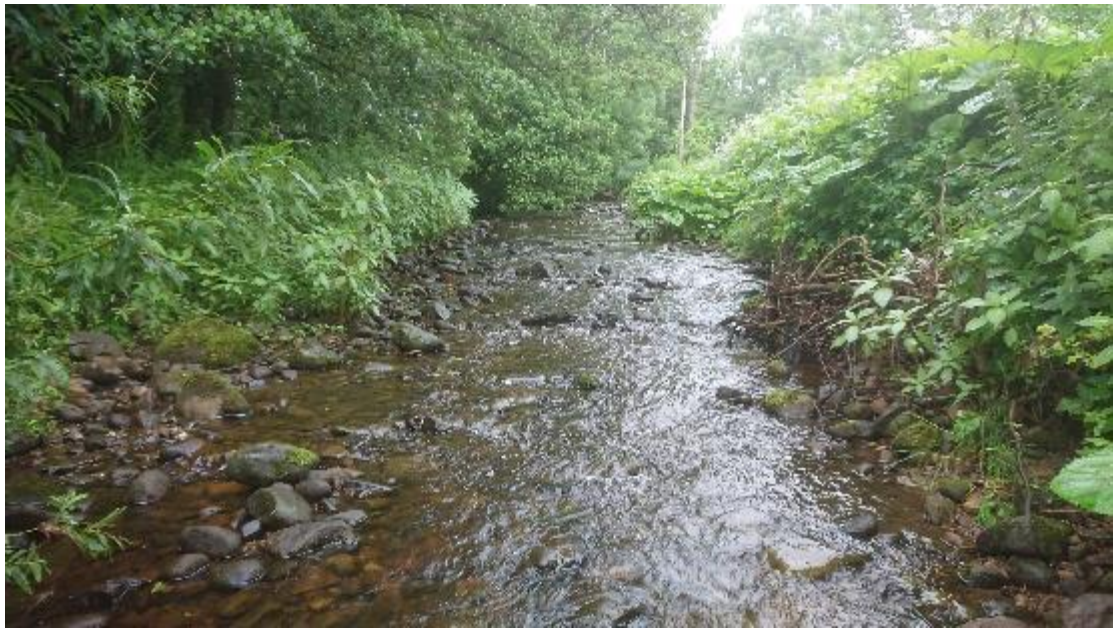
Fig 24. The lowest reach of ~180m has been straightened and dredged so the channel has taken on a trapezoidal shape with little sorting of substrate and hence uniformity of habitat. Himalayan balsam was prevalent on both banks.

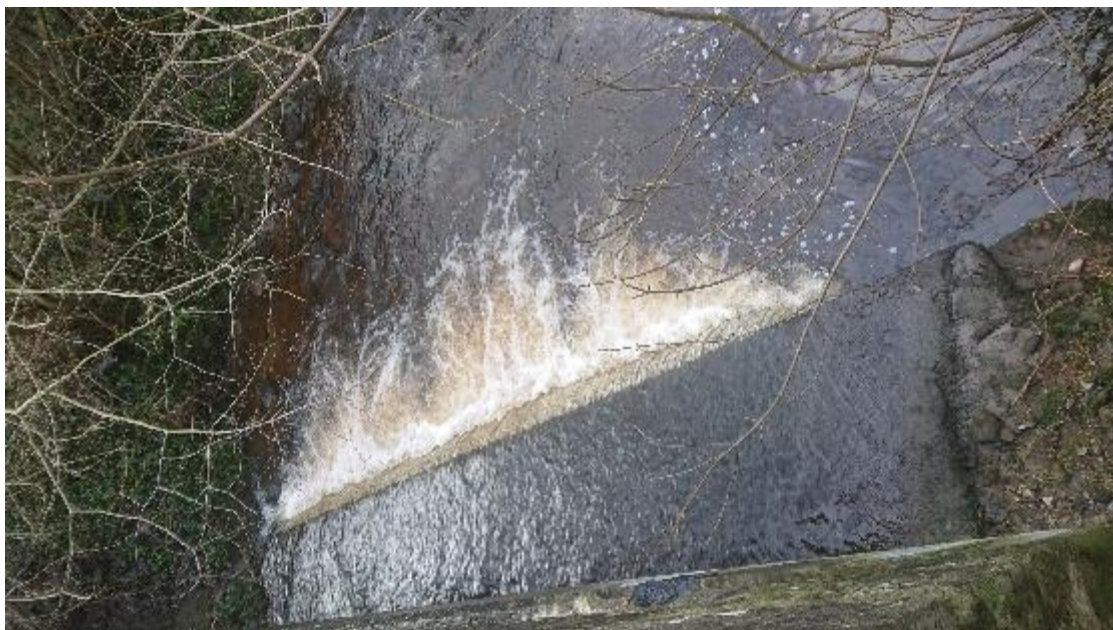
Fig 25. The bridge footings at Beamsley were perched; the combination of a weir and a shallow fluming flow across the culvert presented an obstruction to free fish passage and sediment transport.

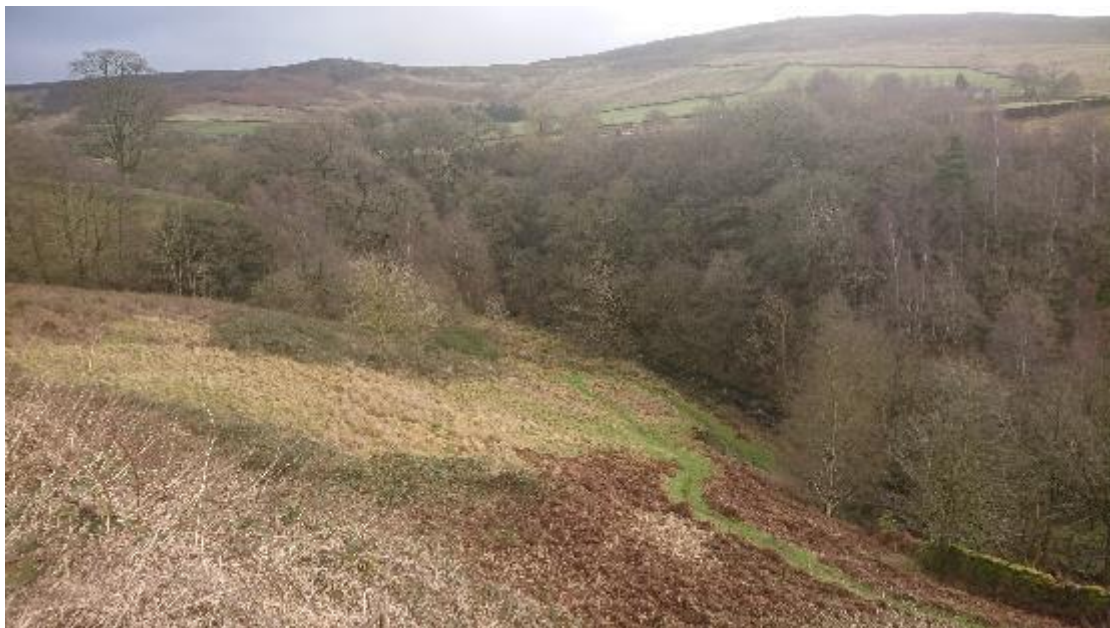
Fig 26. The valley of Kex Beck is naturally narrow and steep and with a reasonably well protected riparian fringe in the mid-lower reaches which comprised native deciduous woodland.

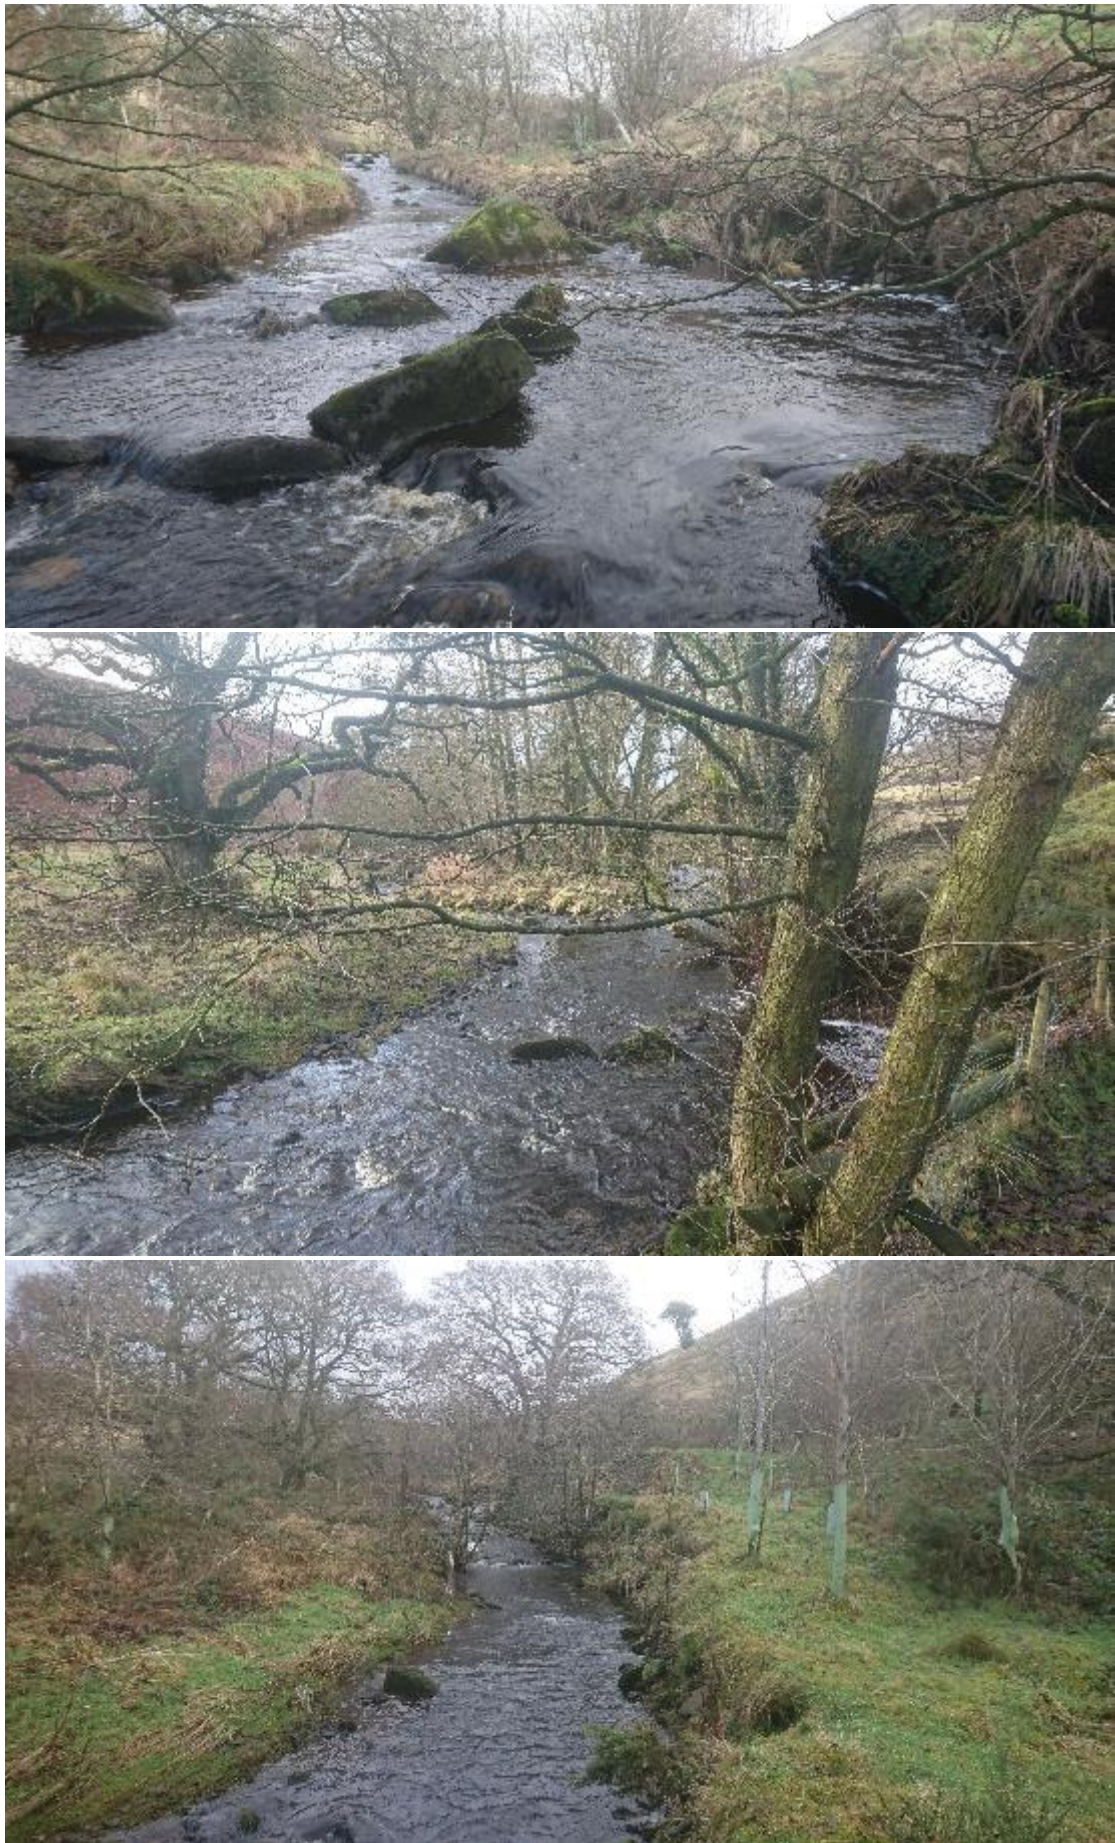
Fig 27. Numerous large boulders, bed rock seams and mature alder growing from the bank toe provided physical structure to richly diversify the channel morphology. Further planting with other species was evident and had clearly been carried out some time ago.

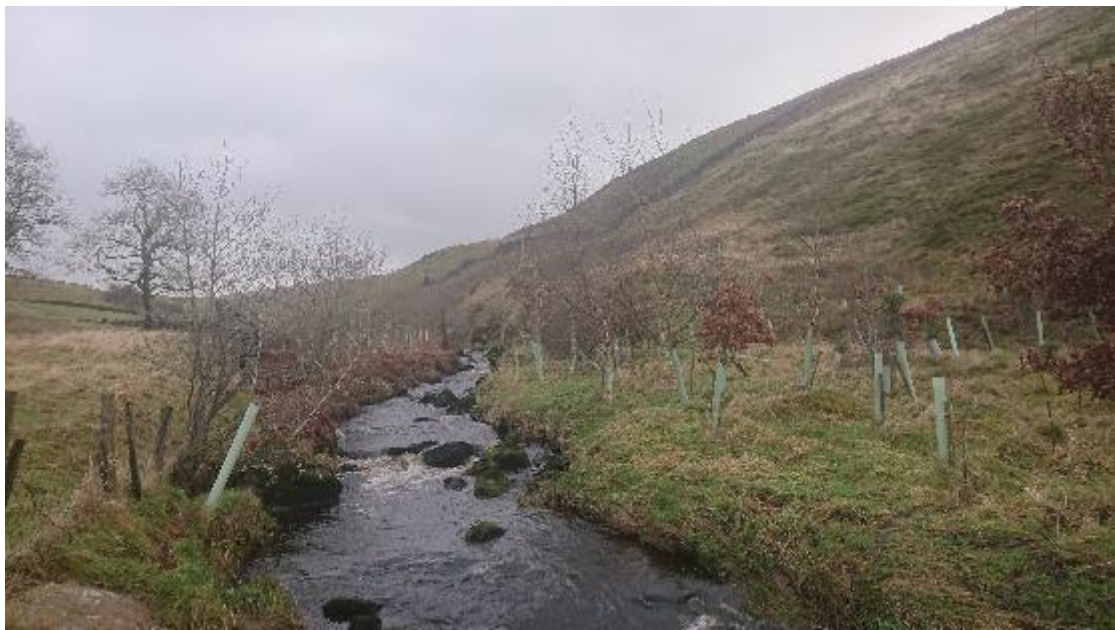
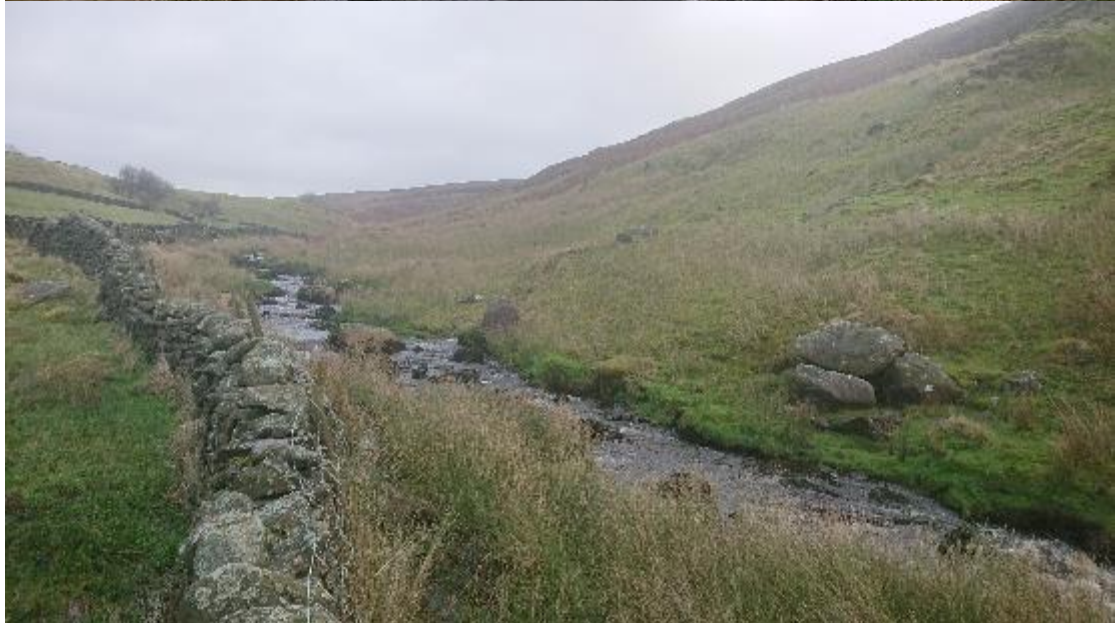
Although the woodland was petering out, a considerable amount of planting had been undertaken with a variety of native species to extend its reach and some of this was well established. Lengths of fencing and walling were in place, but it was not clear that these were entirely effective at removing all grazing pressure on the banks and should be reviewed for repair / replacement. Superficially then, the habitat looked in very good condition for trout and their macroinvertebrate prey but there was still a considerable amount of fine silt infiltrating and impacting the gravel beds, pointing to issues of ingress further u/s from the open, grazed pasture and moorland (Fig 28).

Fig 28. Clearly there have been moves to extend the woodland fringe further up the valley. Beyond that (lower panel), riparian cover was restricted to rough grass and rushes. Note the steep gradient, especially on the LB.

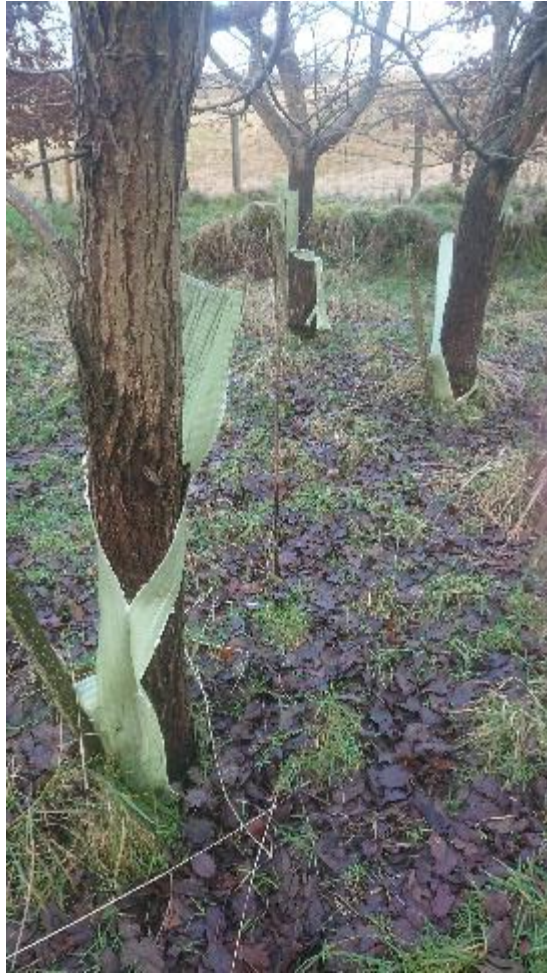
Fig 29. Plastic tubes should have been long removed from this site and recycled or reused.

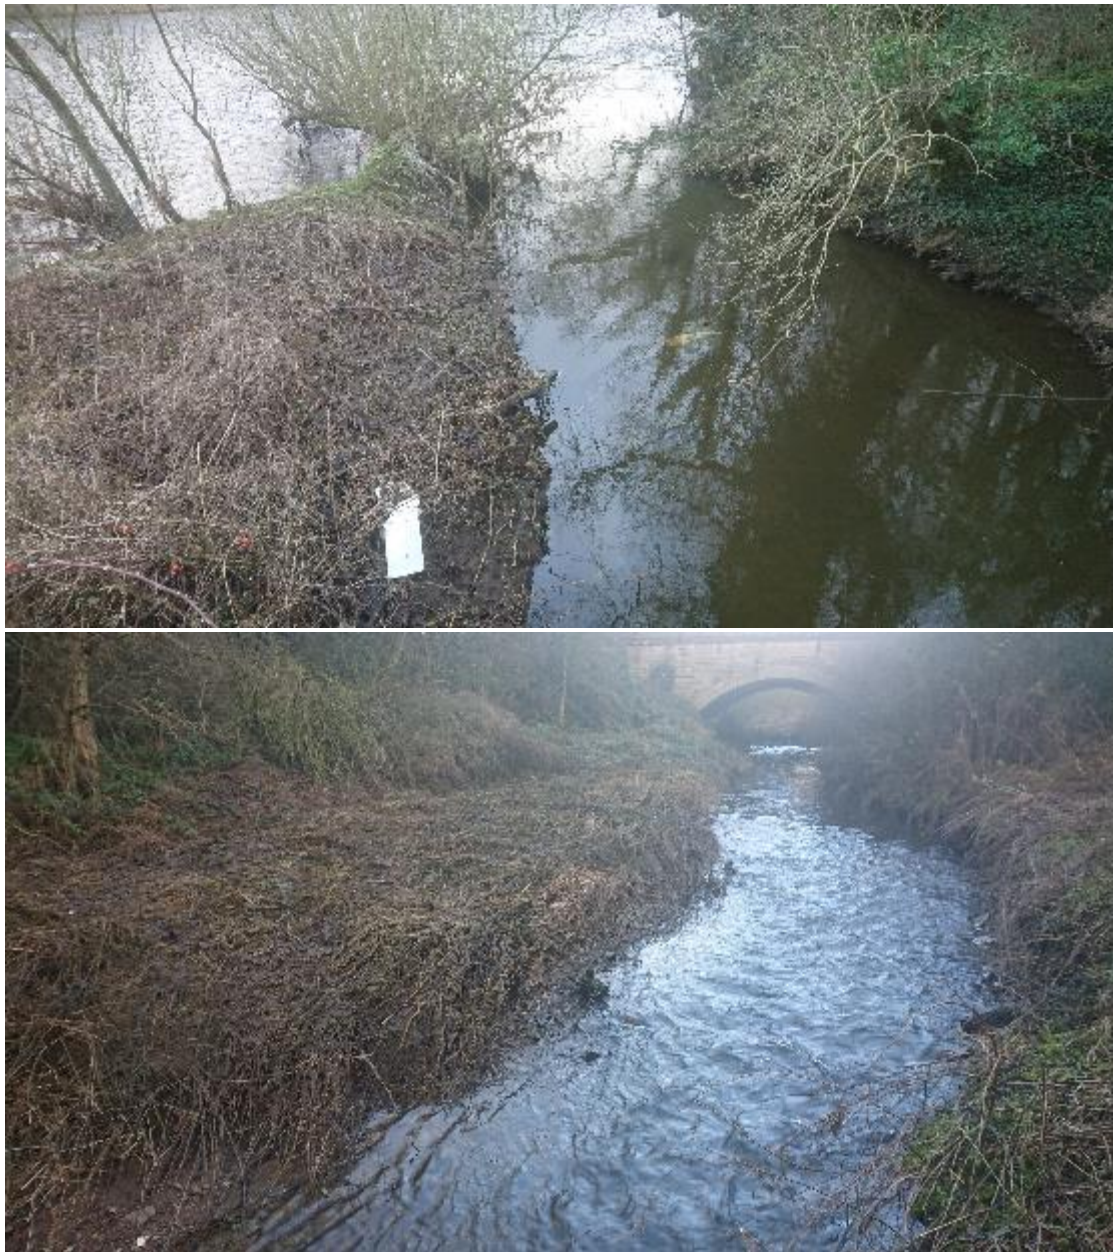
Fig 30. Upper: the confluence with the Wharfe was sufficiently deep and with adequate cover, allowing for safe fish passage in both directions, even at summer low flow. Lower: within 100m of the confluence, the beck passed under the A59 bridge which was clear span and presented no issues. The riparian flora was dominated by willow wet woodland.

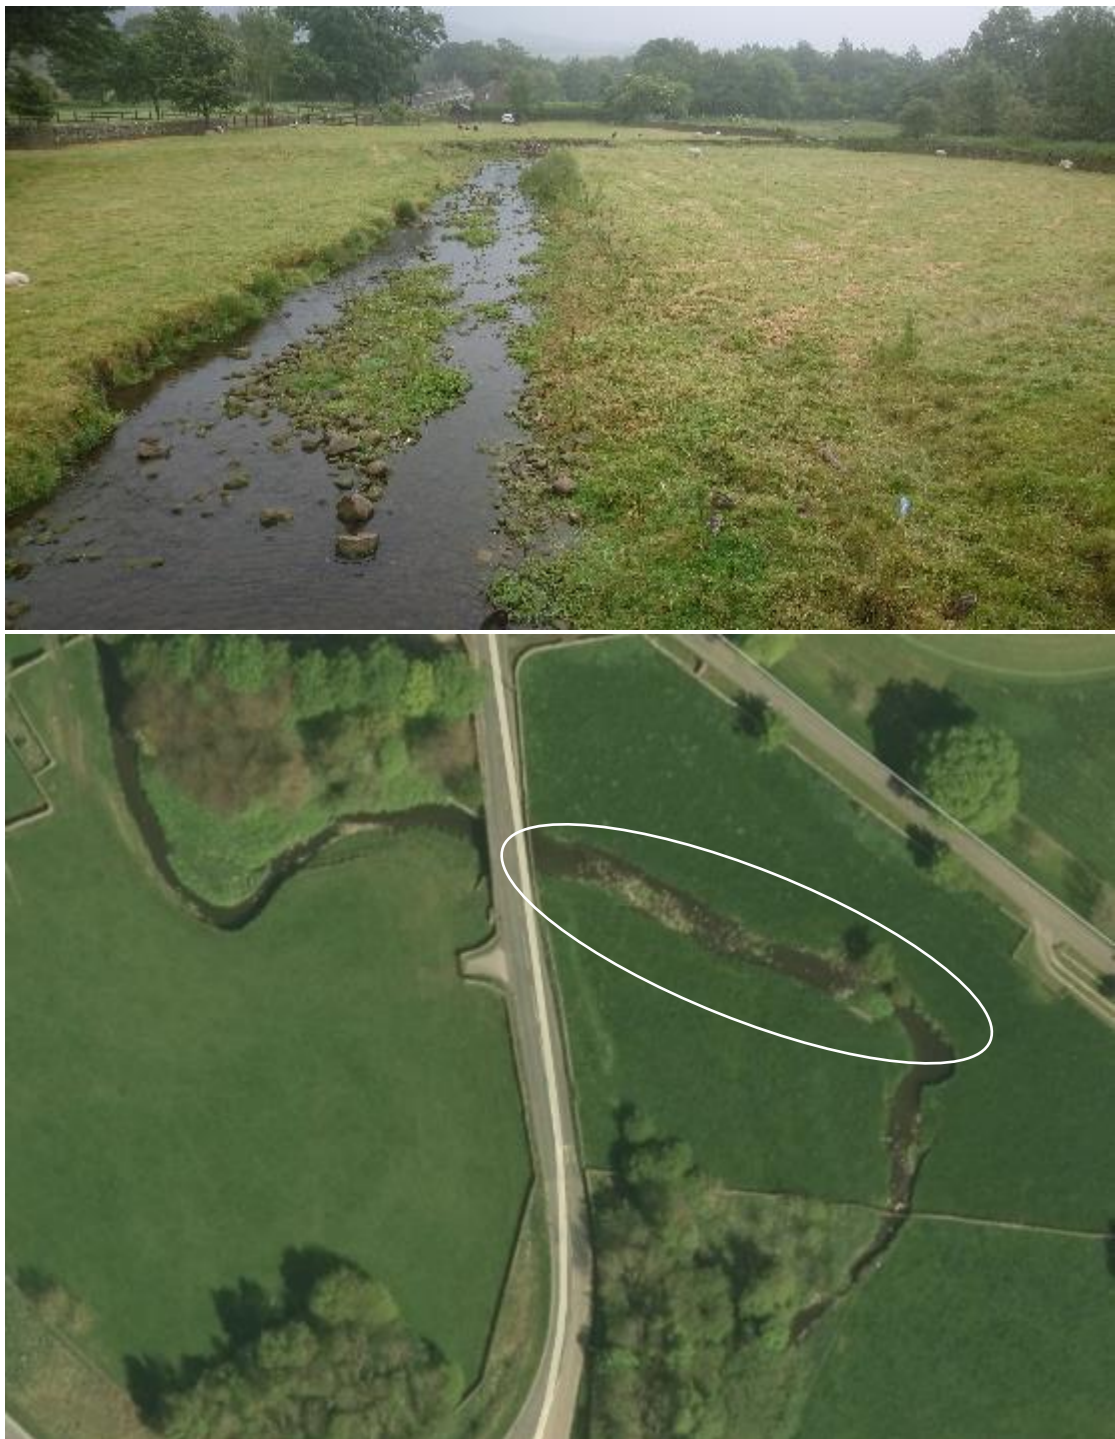
Some of the worst impacts of exposure to livestock resulting in heavily degraded habitat were observed close to the Devonshire Arms complex (eg Fig 31). In combination with straightening, the channel was much wider and uniform than it should be and bereft of any bankside vegetation to provide cover or shade. Deposition and subsequent colonisation of sediment within the channel hinted at the beck trying to re-establish a natural dynamic equilibrium. This is one of the first parts of the Estate to be viewed by visitors arriving from the south, and it would be relatively simple to achieve some improvements.

Fig 31. Upper: Looking d/s from the B6160 bridge at Hambleton Beck flowing through the penultimate field before its confluence with the Wharfe. The channel was over-capacity, of relatively uniform dimensions, and almost devoid of instream habitat diversity and bankside cover. Compare the channel dimensions u/s & d/s (lower panel) where the channel was better protected from livestock; white ellipse depicts the reach in the upper panel. Note the three small trees in the aerial image have since disappeared.

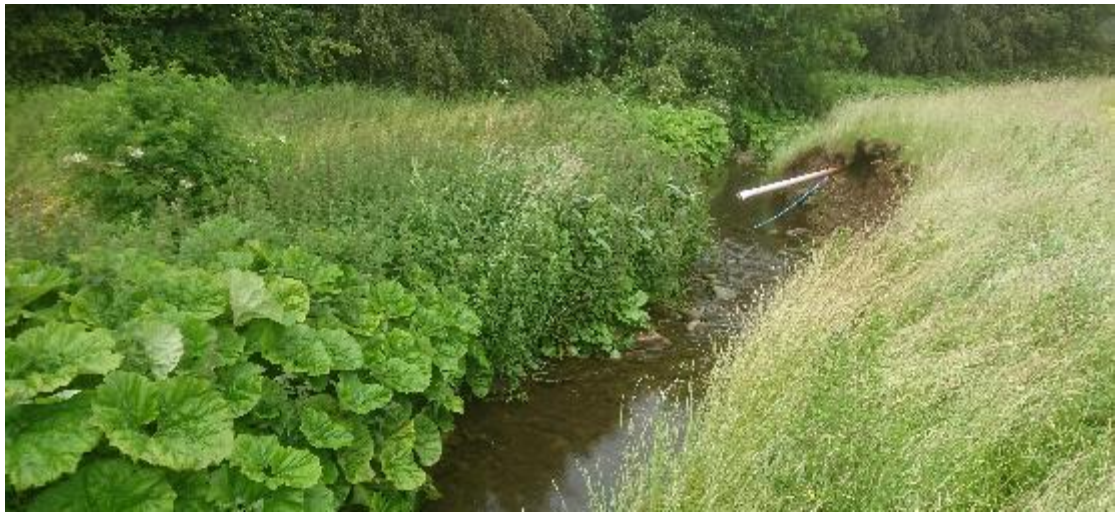
Fig 32. U/s of the B6160 bridge, the channel appeared heavily incised (see text) and a field drain in the RB indicated how the channel has migrated laterally in recent years.
