Advisory Visit

R Wharfe & tributaries, Bolton Abbey Estate, Sept 2019

Prof J Grey: jgrey@wildtrout.org

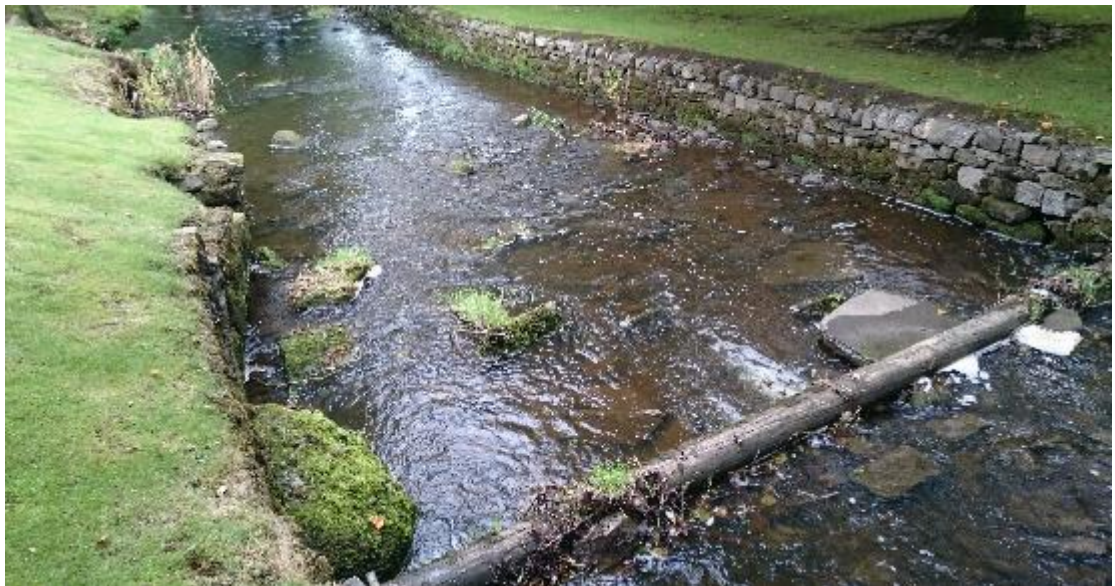
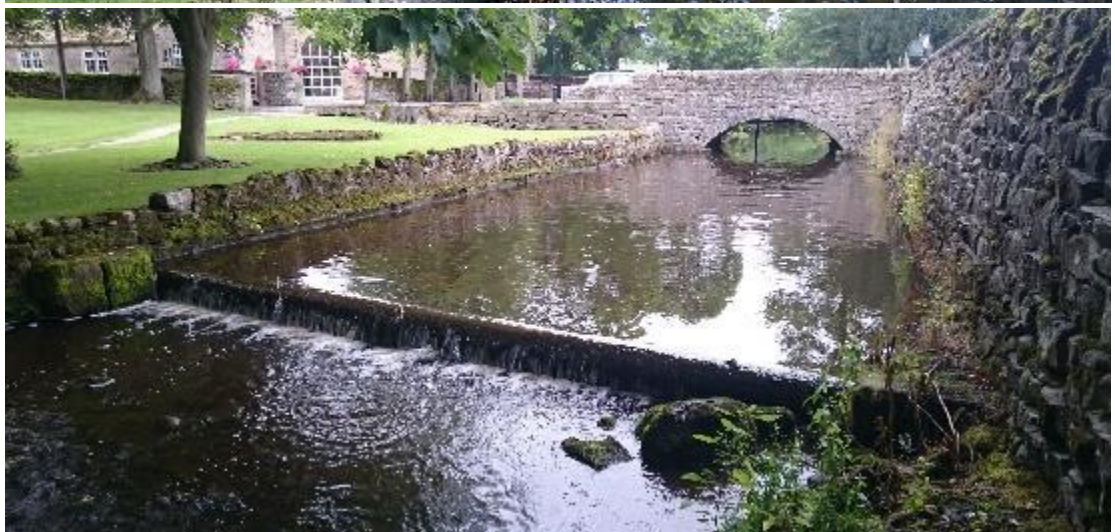
Fig 33. The formalised channel within the Devonshire Arms complex was maintained by walling and a series of log weirs ~5x wider than the beck would naturally be. These structures have negatively impacted upon habitat and fish passage.

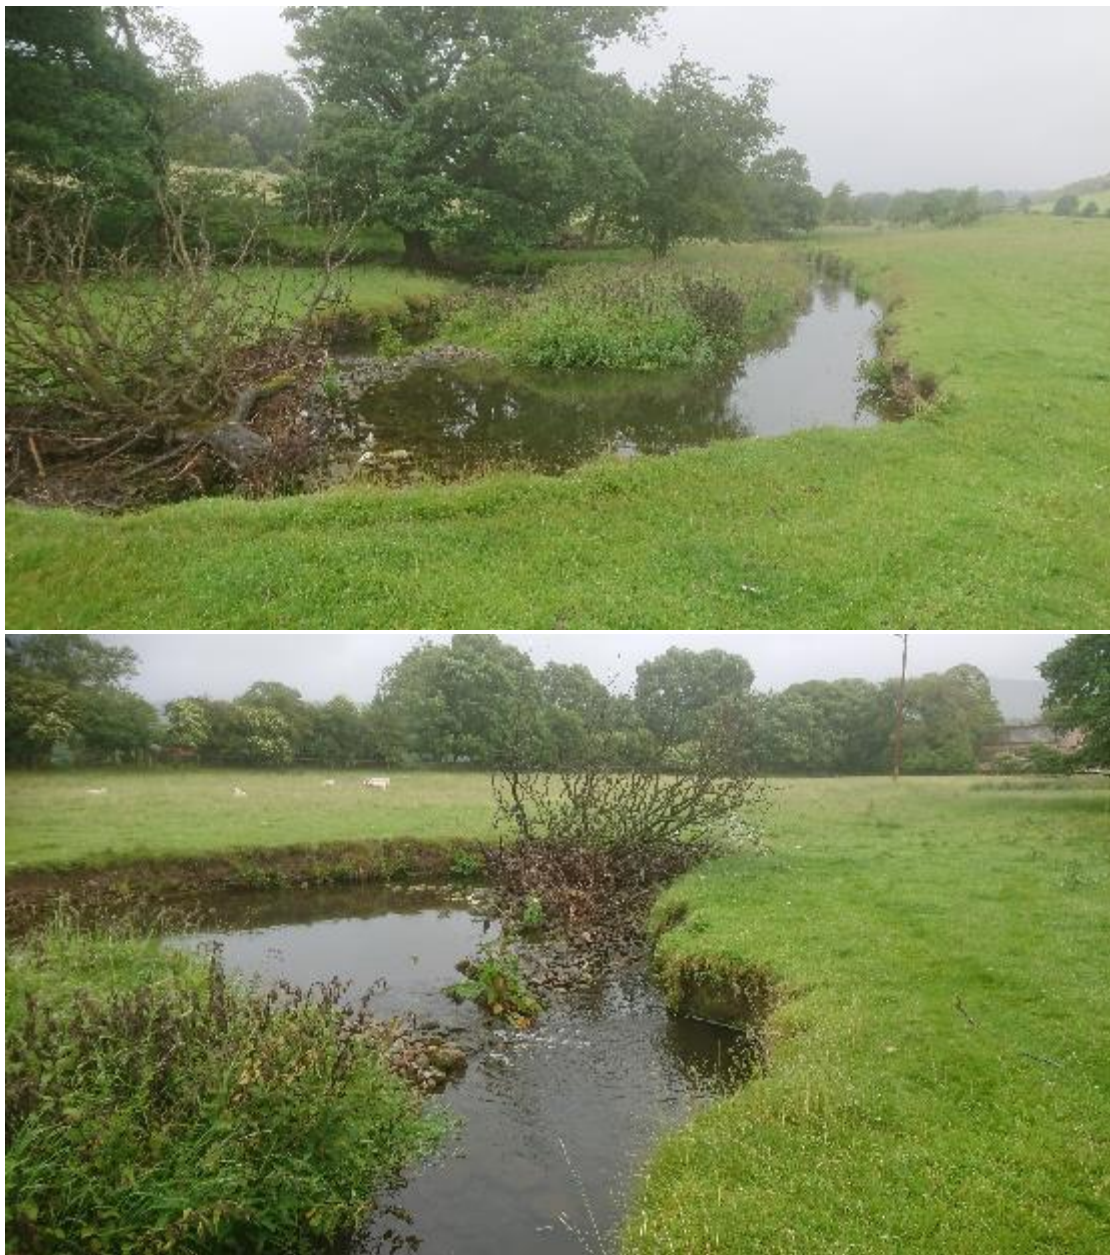
Fig 34. In the field above the Devonshire Arms complex (at SE 06818 53233), the beck was trying to return to a natural meandering path. The short, grazed grass offered little resistance to lateral erosion, and the reach would benefit from livestock fencing being extended from the exemplary reach u/s (Fig 35).

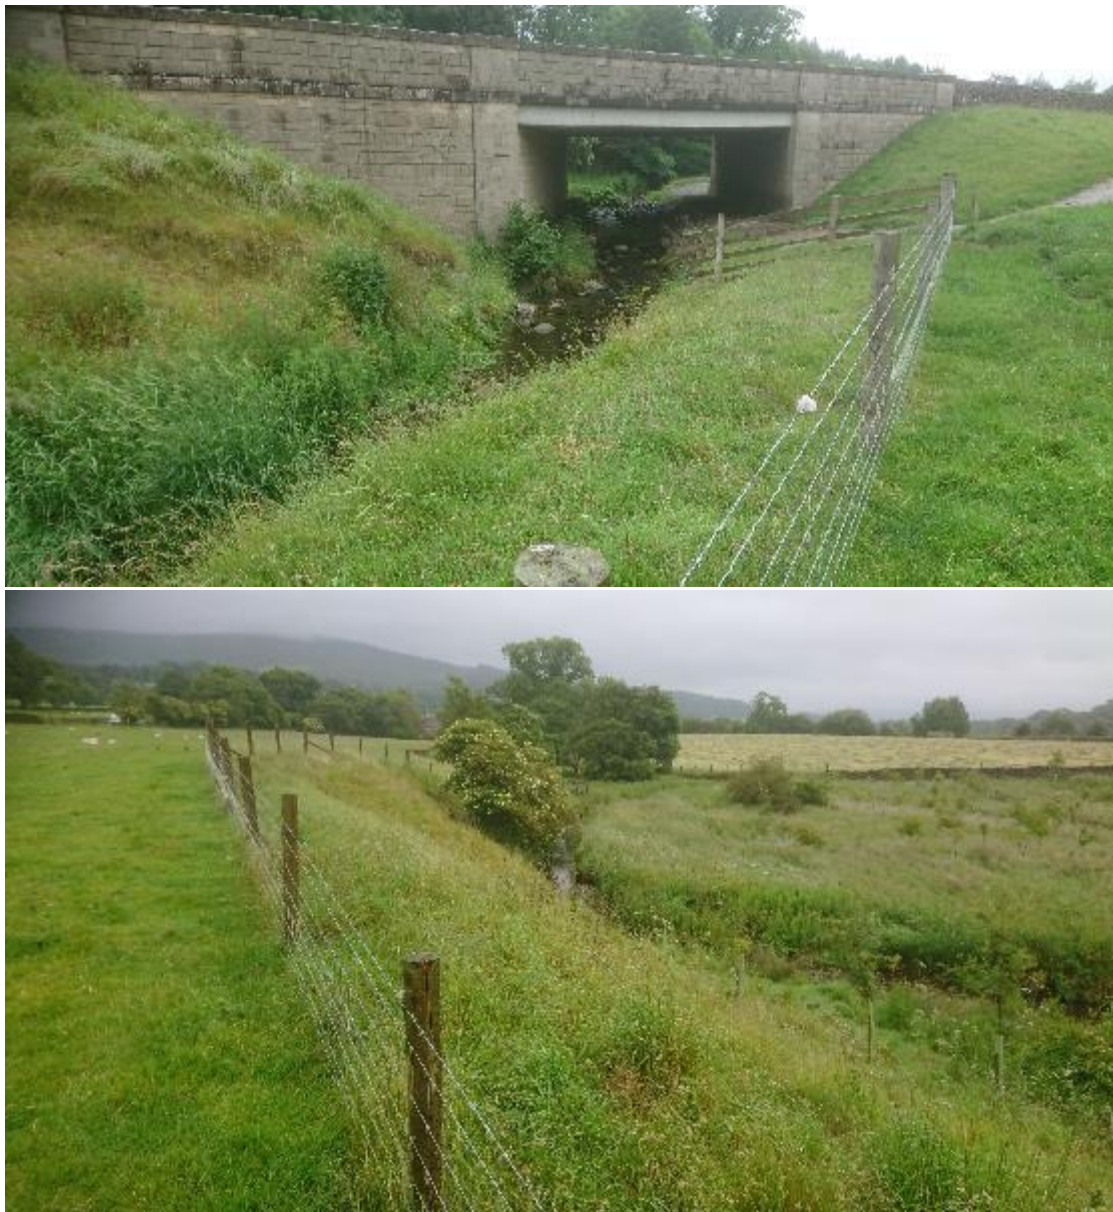
Fig 35. A relatively recently fenced-off reach of 250m up to the A59 bridge (SE 06510 53291) with some supplementary tree planting. The biodiversity benefits were clear to see with tall herbage and grasses to the bank toe providing shading and cover, and the channel width regaining more natural proportions.

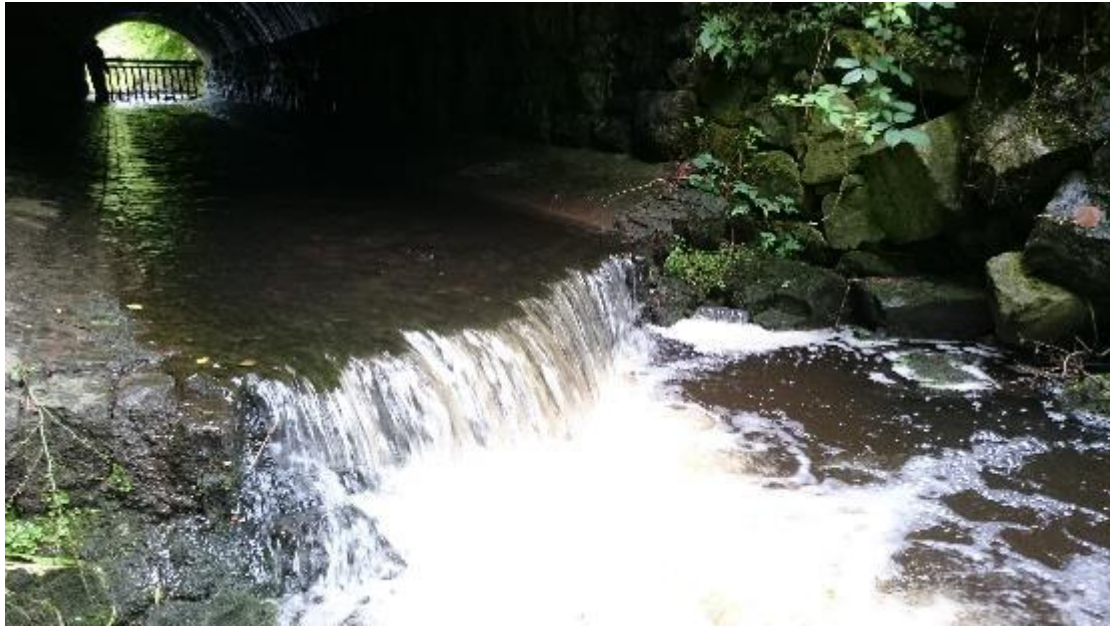
The next location observed was a culverted section near to Bolton Abbey Railway Station which introduced various issues for fish passage: perching at the d/s end requiring a leap onto a long, shallow culvert subject to fluming flow, and then a water gate at the u/s end which will be prone to blockages and damage during spate events (Fig 36).

Fig 36. At SE 06154 53396, the beck was culverted for ~25m through a dressed stone tunnel. Various issues impacting upon fish passage were identified with this structure: perching at the d/s end; shallow depth throughout; and a water-gate at the u/s end.

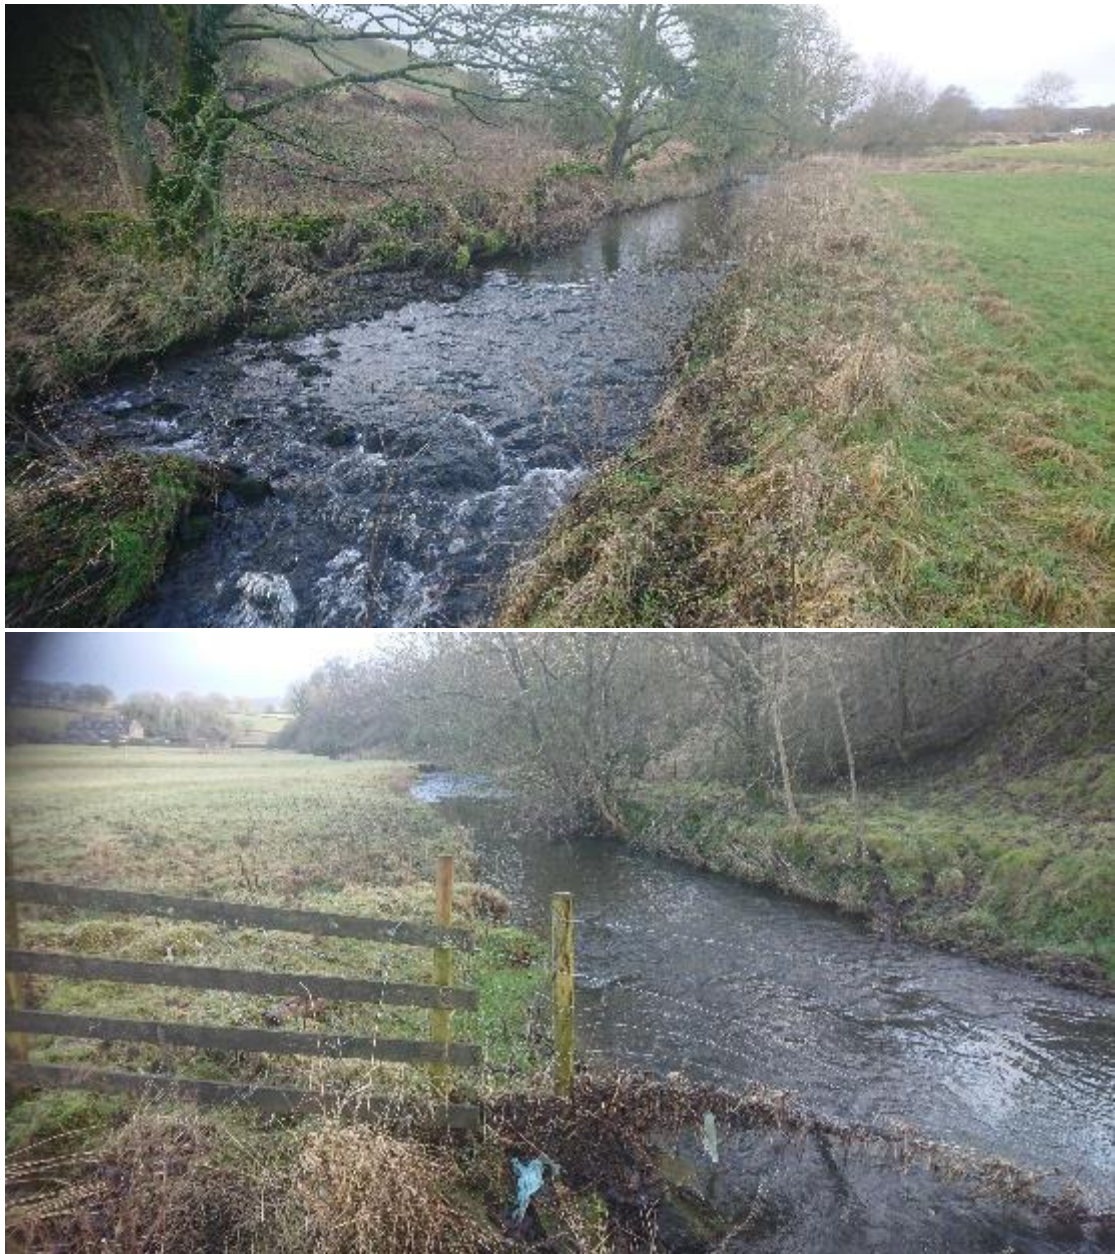
Above Hambleton Farm, the channel was in better condition although had been historically realigned to run parallel to the railway line (to the RB; Fig 37). The straighter sections were relatively featureless and of constant proportions, but several delightful meanders were encountered and more were evident from aerial imagery (Fig 38). Unfettered livestock access in the fields immediately adjacent to the farm was clearly leading to erosion of the banks and the riparian zone of the LB was like a bowling green. The RB was generally more natural, although still relatively few self-set trees indicating that even a reduced grazing regime was impacting upon the regeneration of the riparian flora.

Fig 37. Looking u/s & d/s (upper & lower, respectively) from SE 05306 53380 at a realigned section to pin the beck parallel to the railway line and maintain a coherent parcel of flatter land for improved grazing. As a consequence, the channel was straight and of relatively uniform dimensions. The riparian flora of the RB was in better condition (less livestock impacts) although under low flow conditions, sheep had still crossed in the lower field.

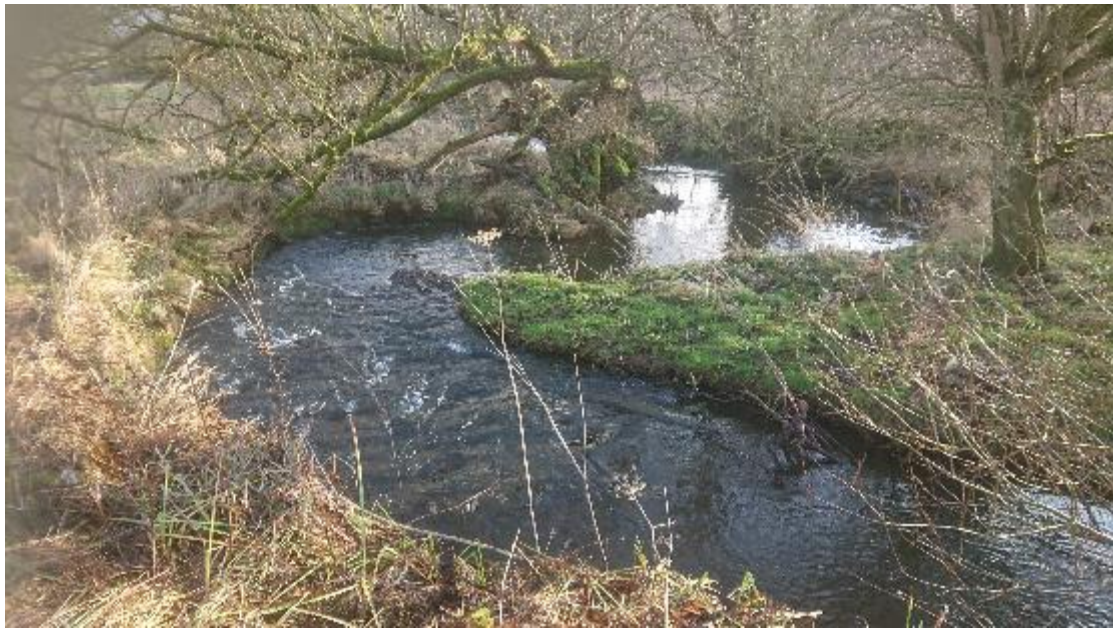
Fig 38. In several locations, the beck had been allowed to meander and there were deeper pools, here with beneficial cover, for larger fish as a result.

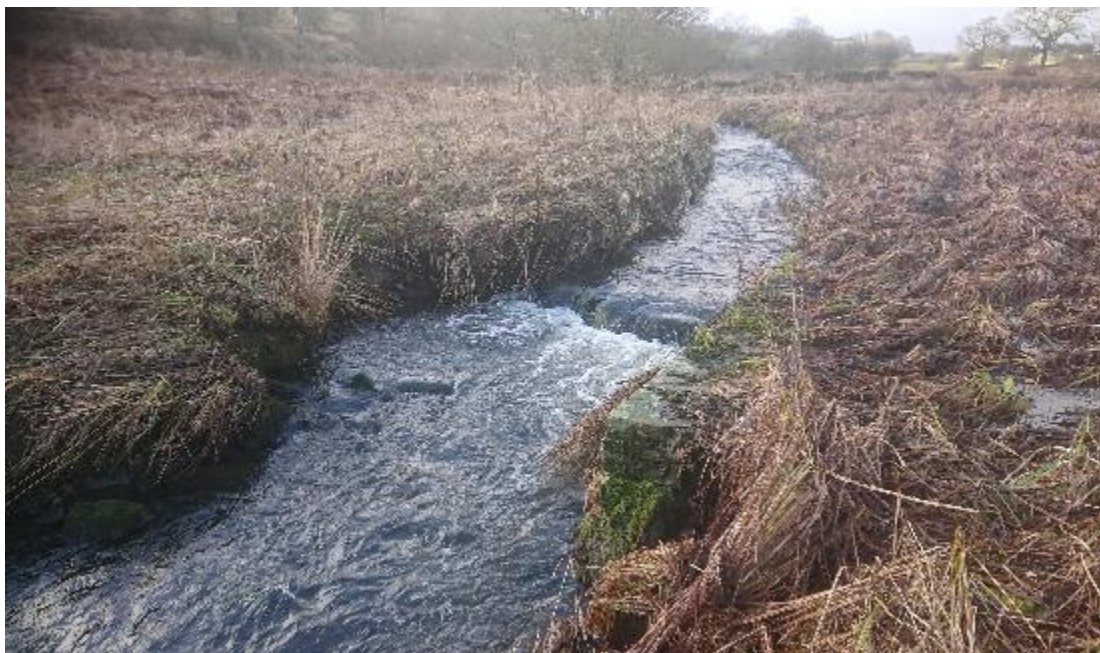
The most u/s point visited (SE 05066 53340; Fig 39), was in a marshy area dominated by sedges and perhaps grazed very occasionally. Shaggy vegetation trailing into the water provided good overhead cover to fish, but the sediments were clearly impacted by infiltration of fine silts pointing to ingress upstream. Consultation of aerial imagery indicated that although the beck meandered naturally in the fields u/s, sheep have access to both banks and there was no tree cover. A wastewater treatment site was observed ~600m u/s.

Fig 39. Numerous springs made both banks extremely wet at the highest location examined (SE 05066 53340) where some sort of pipe crossing caused a small interruption to fish passage and sediment transport. The trailing shaggy vegetation provided good cover. A lack of self-set trees in this area suggested occasional grazing use.

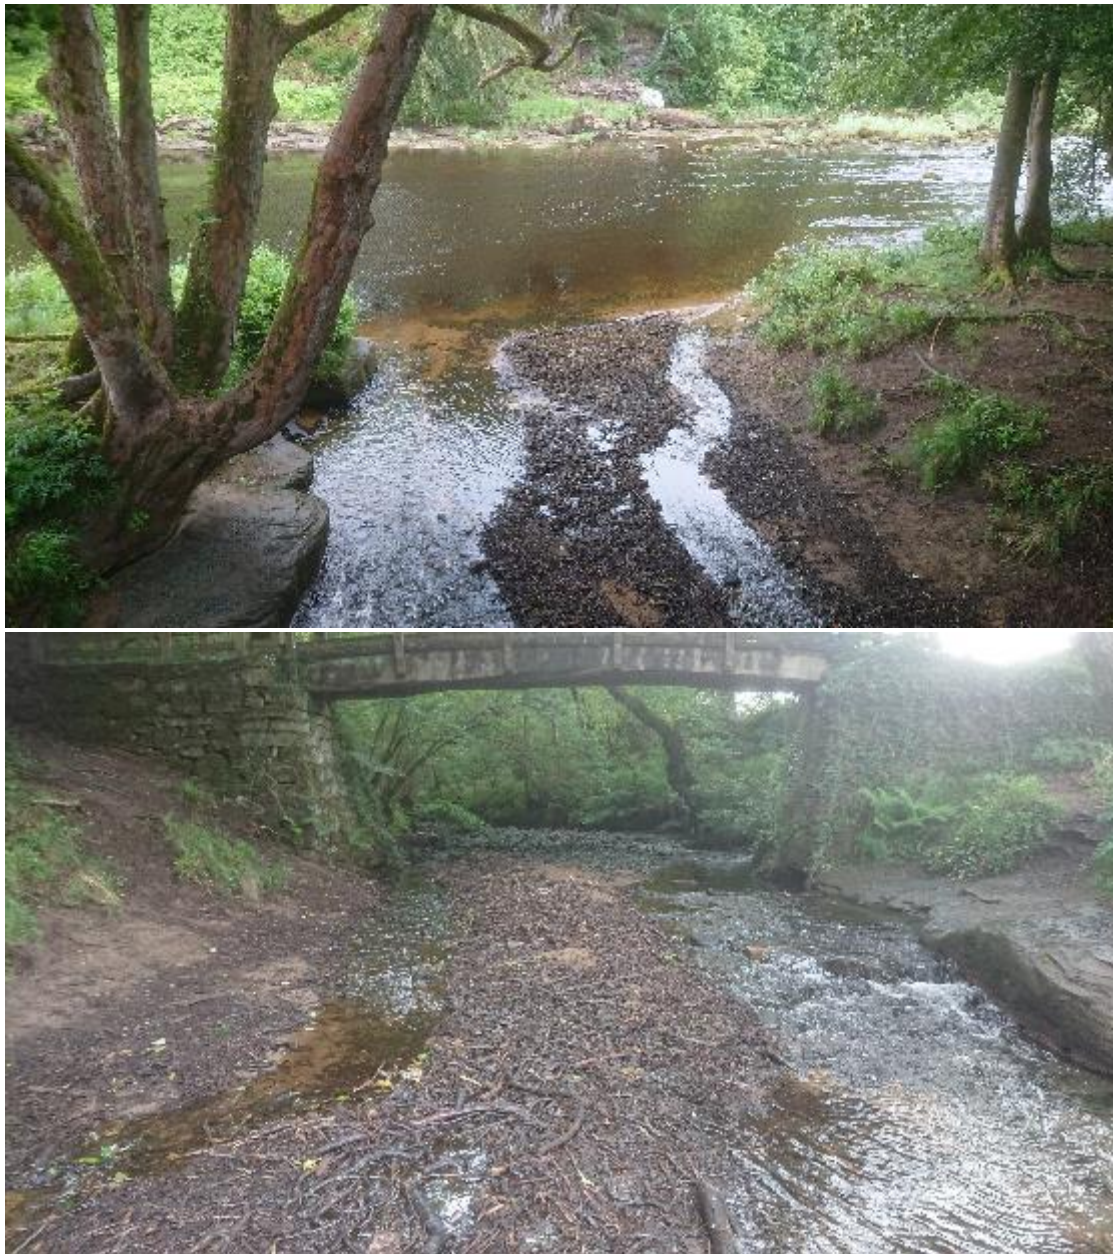
Fig 40. The confluence of Barden Beck and the Wharfe is clearly a focal point for footfall from walkers and dogs, and the banks are degraded as a result. Upper: looking d/s from the footbridge. Lower: looking u/s from the confluence to the footbridge. Note the delta of fines and debris caused by deposition when the spate flow from Barden Beck meets the considerably larger volume of spate flow in the Wharfe.

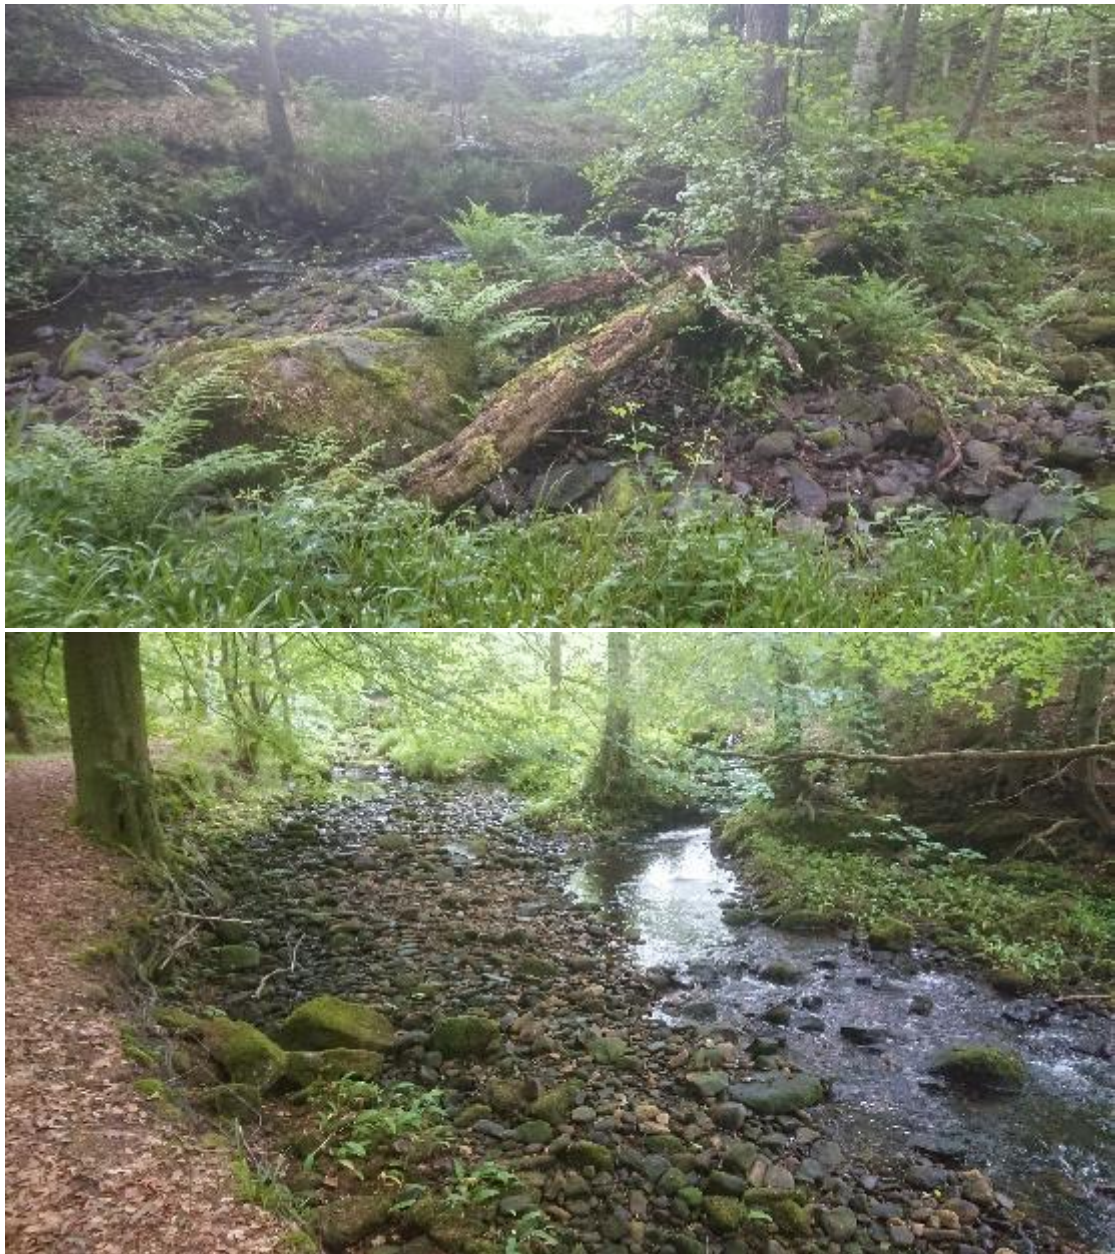
Fig 41. The lower reaches of Barden Beck flow through mixed deciduous woodland and where natural wood fall has been allowed to accumulate, it has diversified the channel morphology.

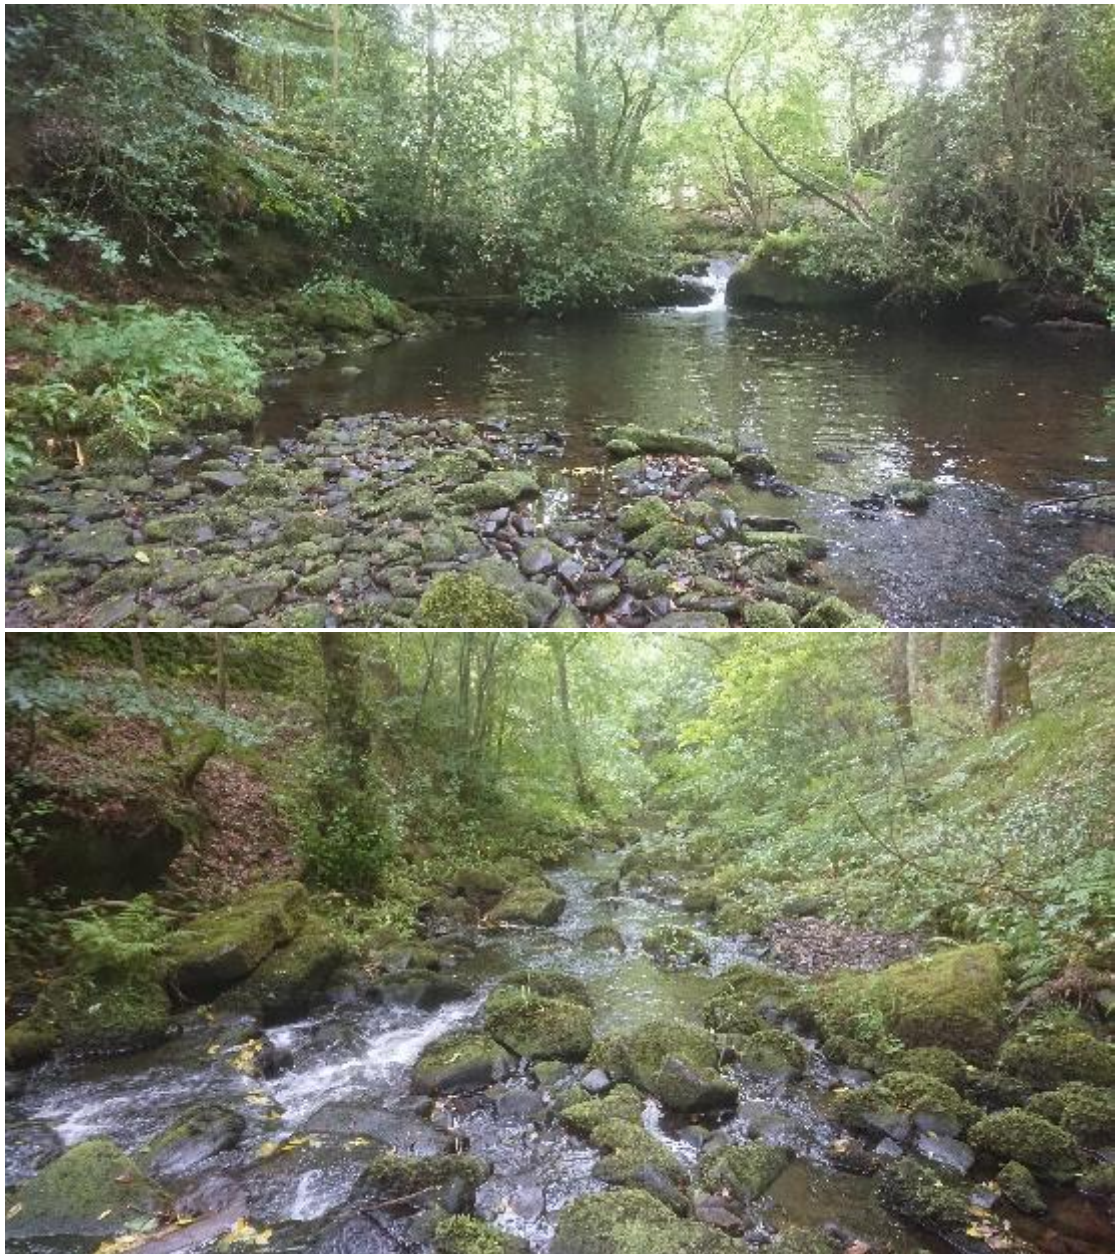
Fig 42. The naturally steeper and narrower part of Barden Beck approaching Barden Beck Bridge (B6160) was characterised by pools and cascades with larger boulders dominant within channel.

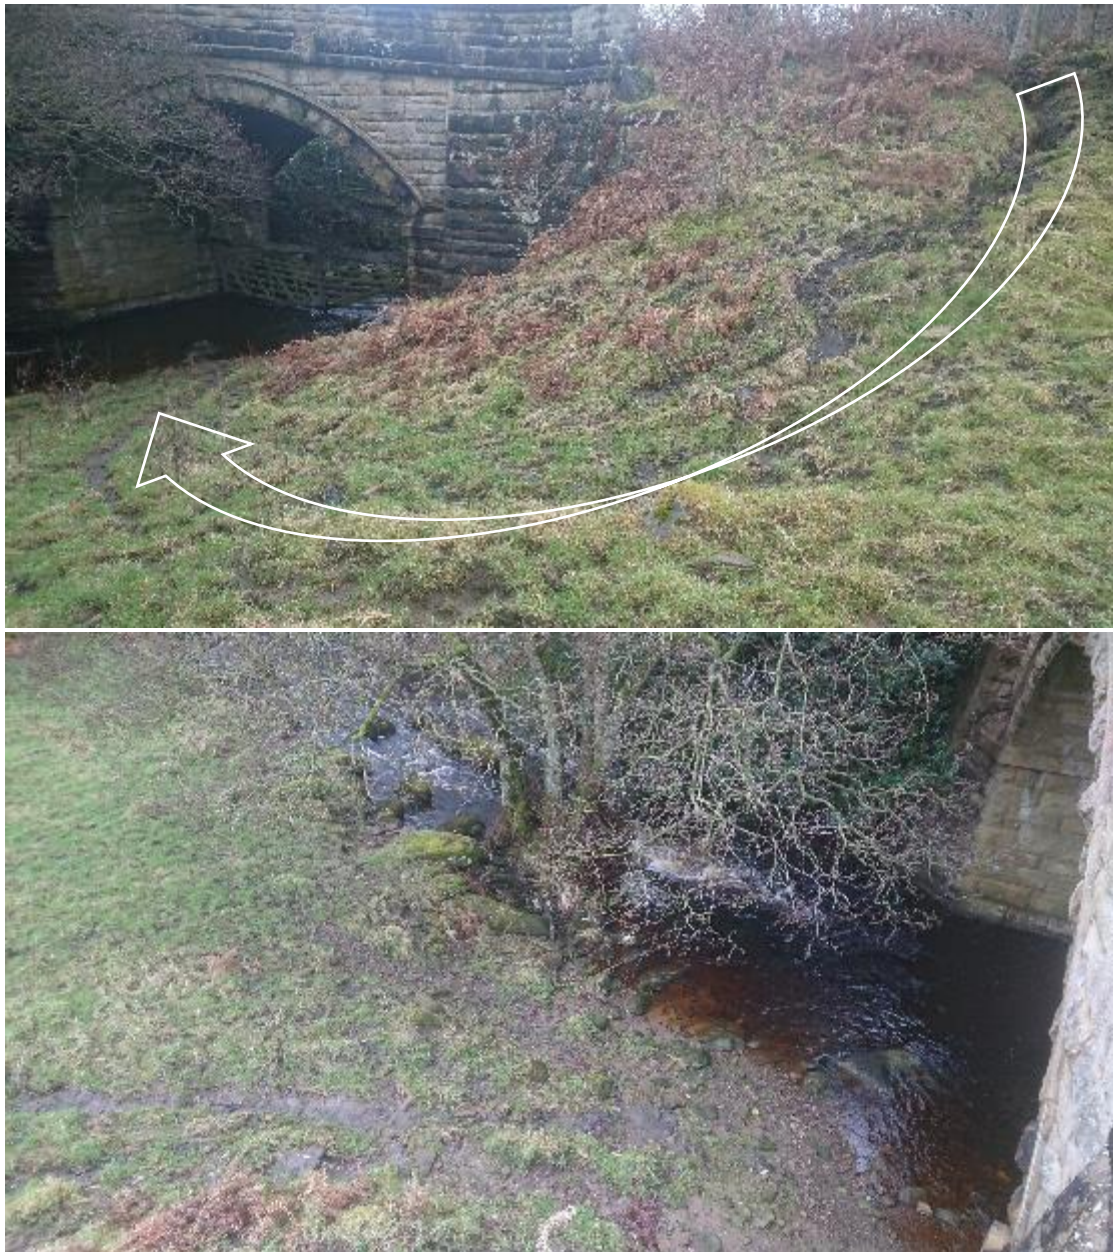
Fig 43. Evidence of road run-off guttering from Barden Beck Bridge and discharging into the beck. The route of the overland flow (highlighted by the white arrow) also joins a desire line for stock accessing the water and thus further contributes to introducing fine sediment into the beck from the poached and trampled bank (lower panel).

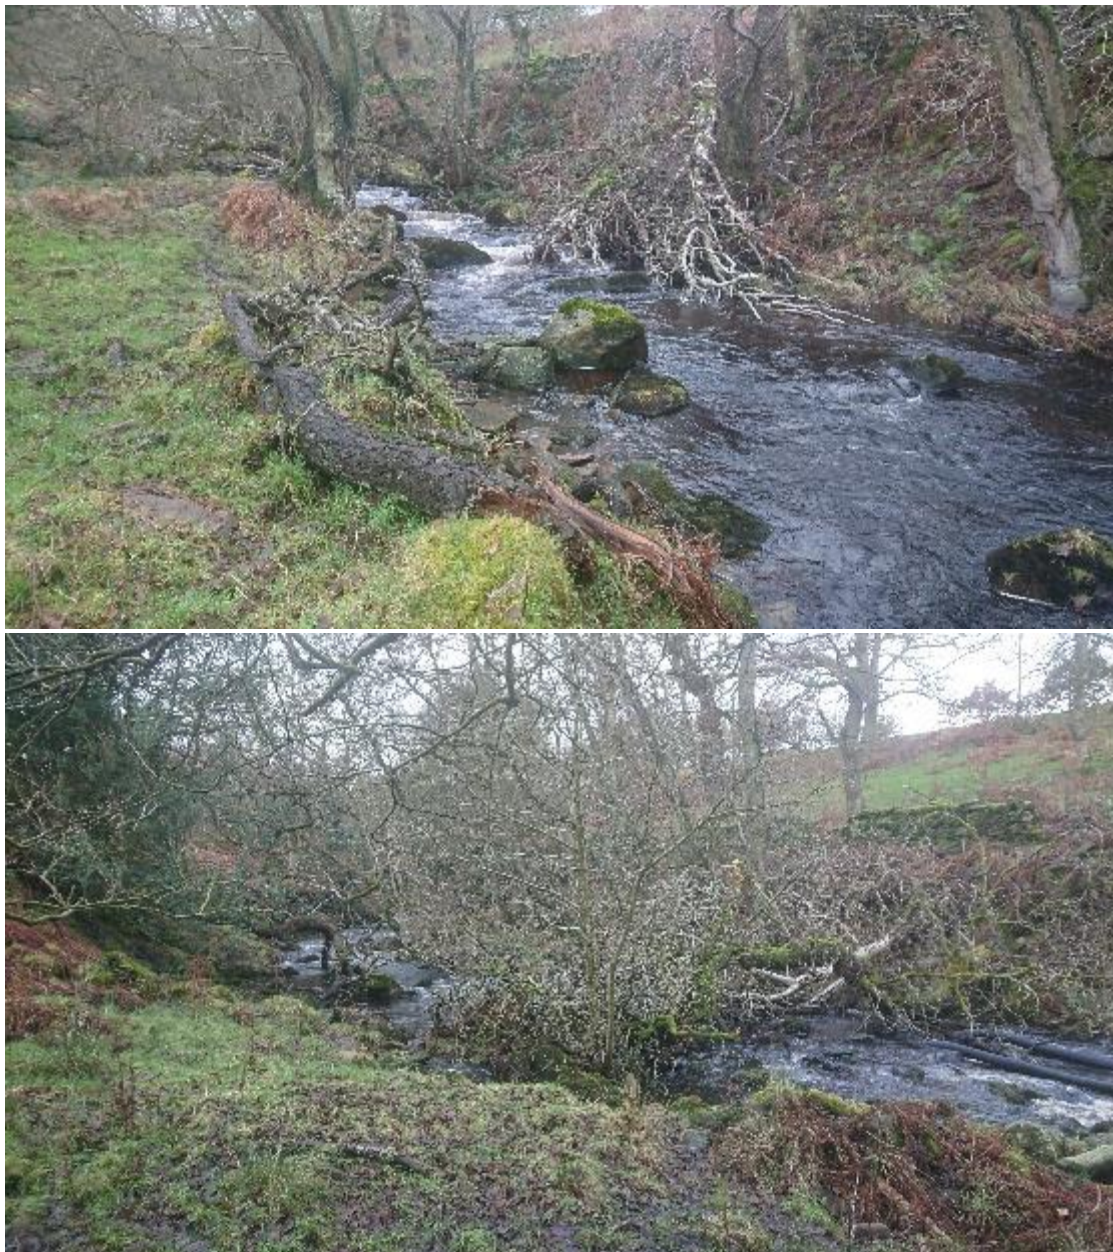
Fig 44. Immediately u/s from Barden Beck bridge were some excellent natural examples of large woody material lodged in the channel and providing multiple benefits.

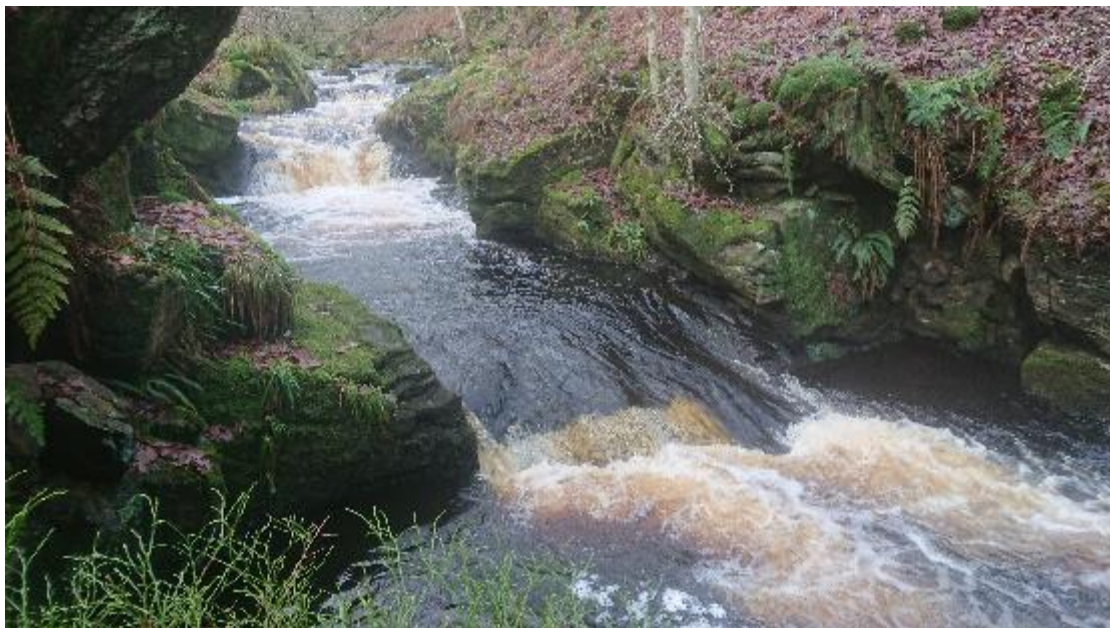
Fig 45. Fish passage is not without its natural challenges on Barden Beck but uneven fissures through the bedrock seams generally provide focal flow channels for fish.

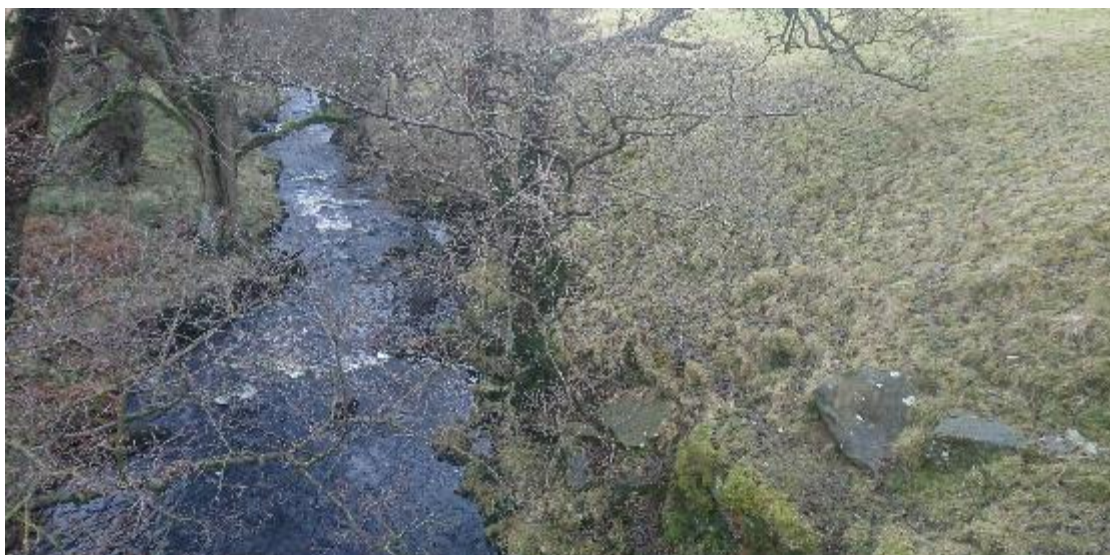
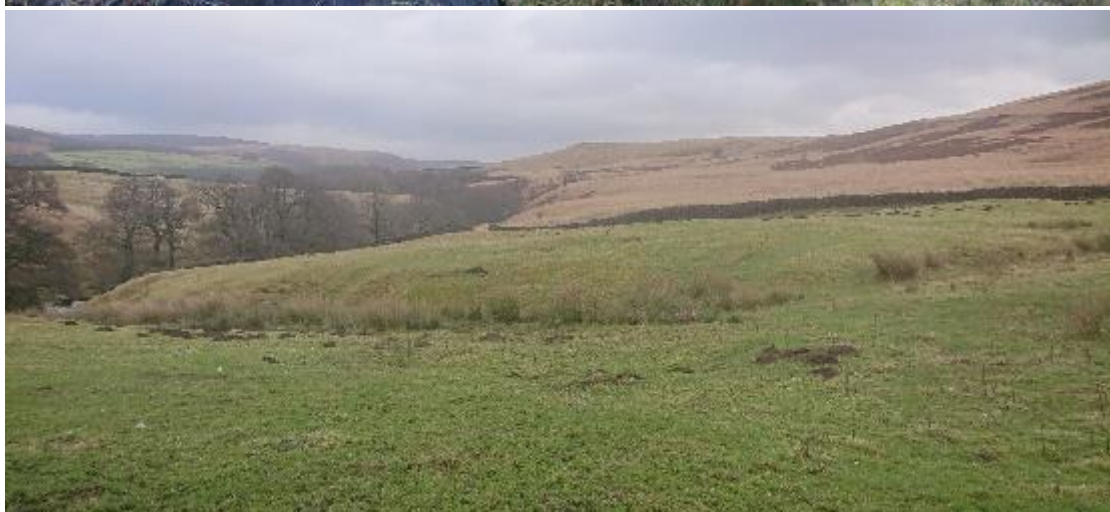
Fig 46. Images taken from Broad Park Bridge (SE 04737 56244). The narrow riparian fringe of mostly mature alders in stark contrast to the improved pasture surrounding, and indeed, beneath the trees. There was a distinct paucity of self-set trees to resupply the riparian zone once the mature alders are eventually lost.

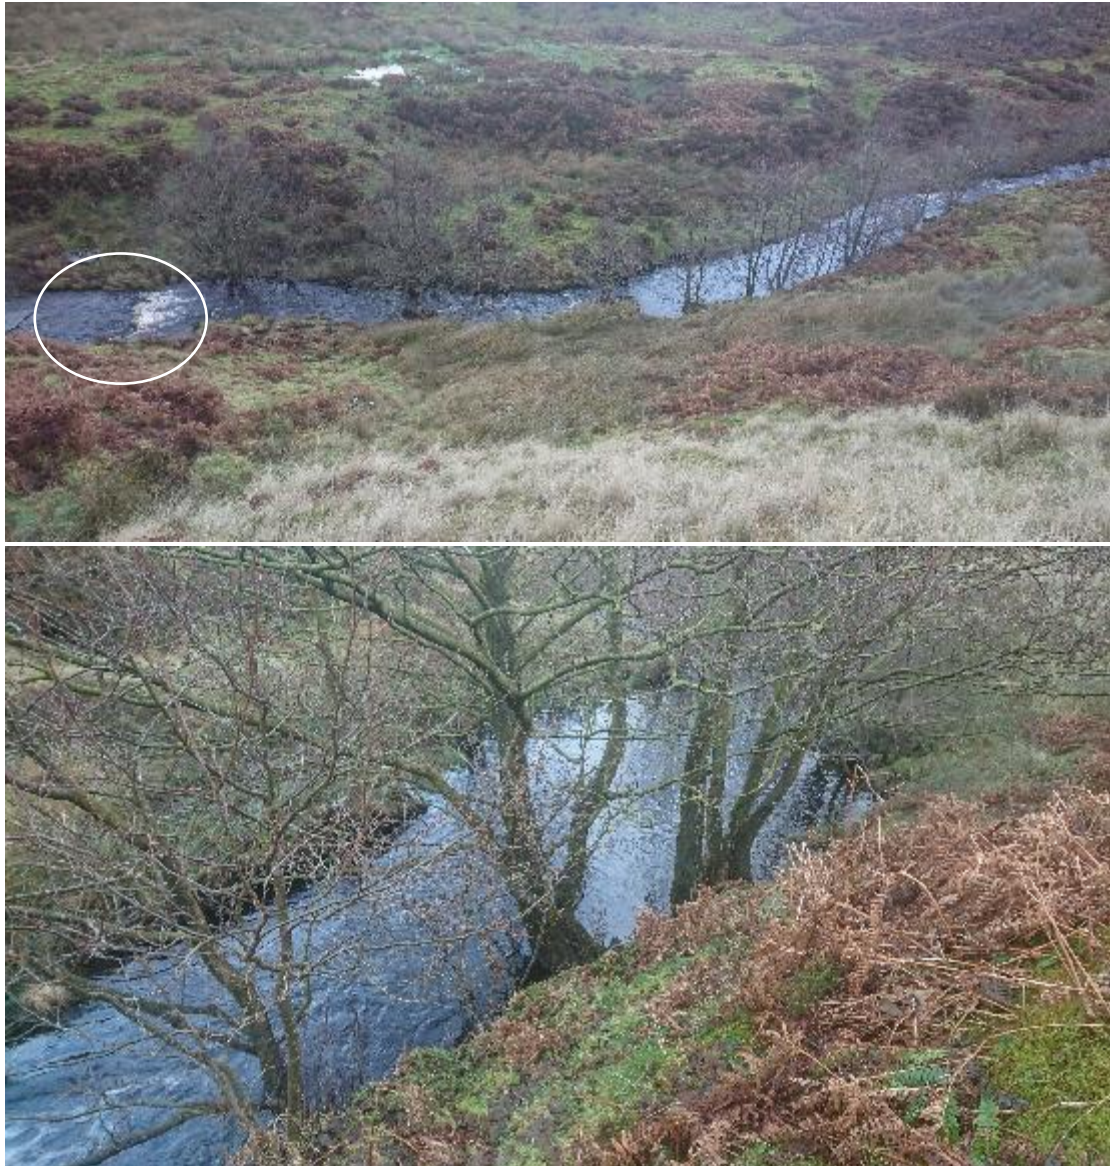
Fig 47. The alder fringe began to thin out by SE 04390 56310 and only those trees growing from the bank toe had managed to escape browsing pressure. There was an old ford and/or pipe crossing associated with reservoir infrastructure, highlighted in the white ellipse.

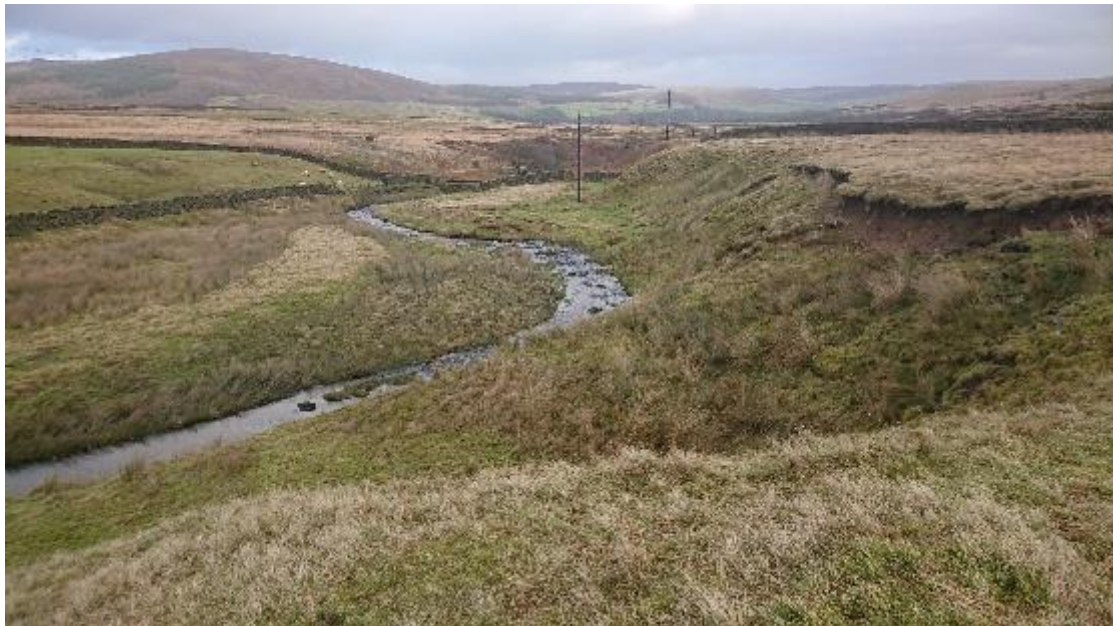
Nearer to the reservoir and the associated farmstead, the pasture had been improved again, and the impact of a more intense grazing regime was evident: no trees, a wider more uniform channel, and erosion scars on the steepest slopes caused by sheep traversing, rubbing and laying up in the lee of the overhang for protection from the elements (Fig 48). The spillway was impassable and hence marked the u/s extent of the survey (Fig 49).

Fig 48. The upper reaches of Barden Beck were essentially devoid of any tree cover and, with unlimited livestock access, there was clear evidence of erosion of the fragile soils.

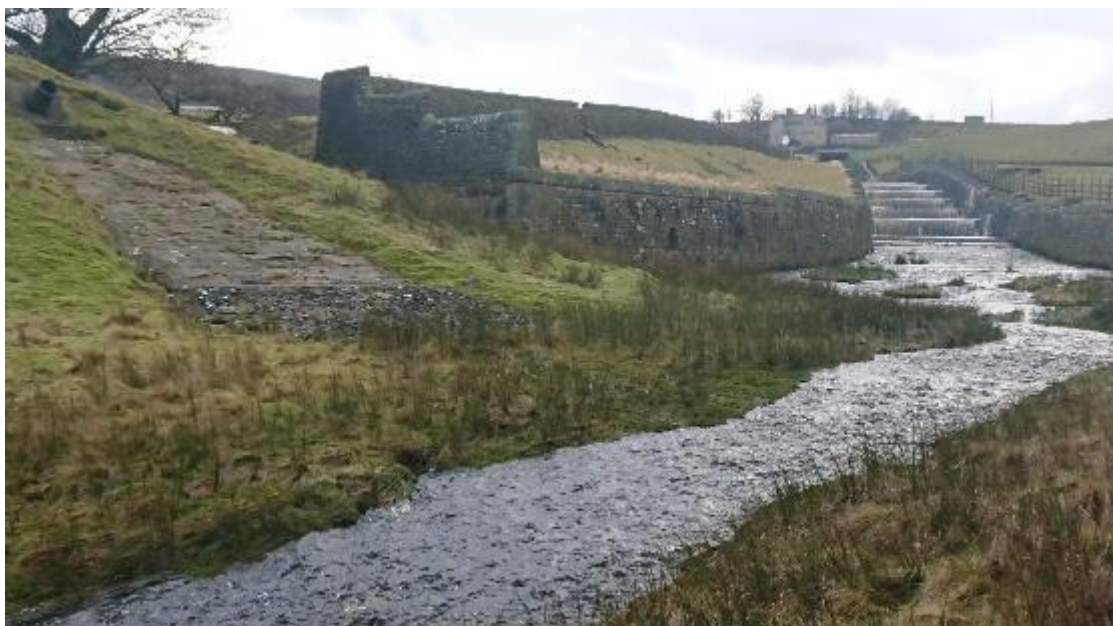
Fig 49. The impassable spillway and infrastructure below Lower Barden Reservoir marked the u/s extent of the survey.

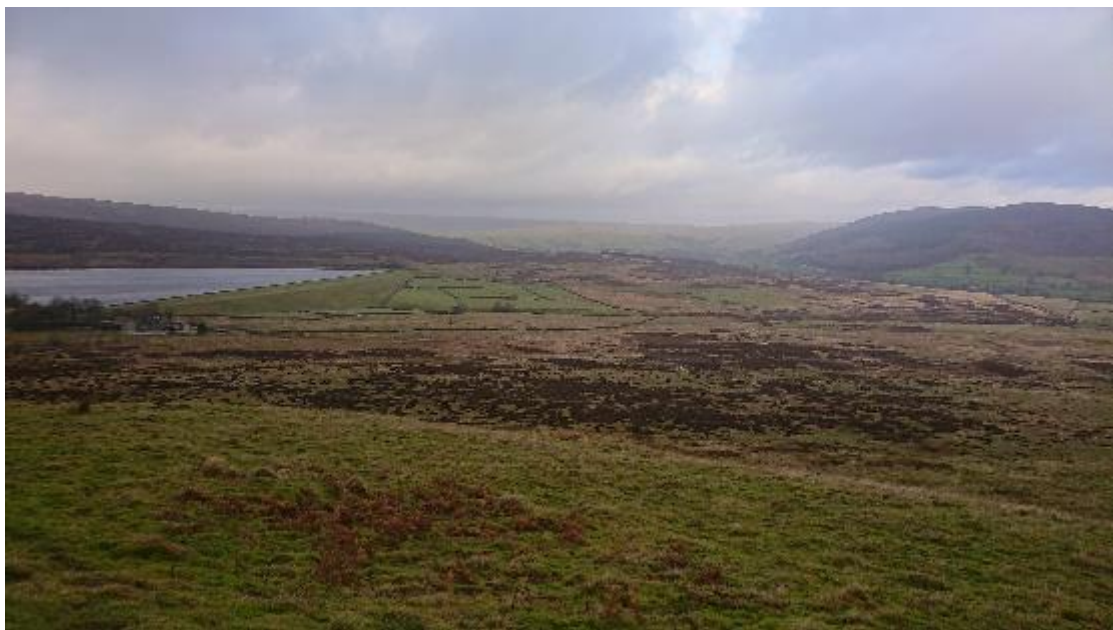
Fig 50. An overview of the 'upper' sub-catchment of Barden Beck available to trout (i.e. that below Lower Barden Reservoir).

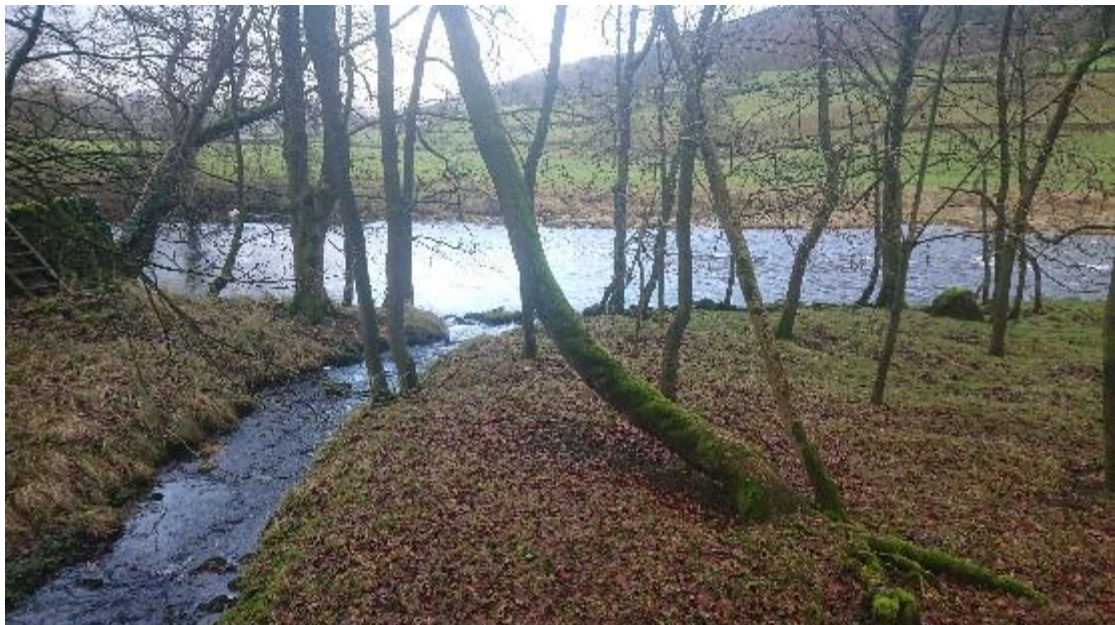
Gill Beck was only examined on the d/s side of Gill Beck Bridge as several impassable cascades over bedrock shelves were noted. Despite only ~350m of beck being accessible to trout from the Wharfe, the quality of habitat and protected nature of the lower reaches warrant further investigation of this watercourse. The upper catchment, a narrow relatively short valley, was dominated by heather moorland relatively. Nelly Park Wood was part plantation and part mixed deciduous. If efforts can be made to slow the flow of water through the 1km of woodland u/s of the bridge, then the lowest reach could be very high-quality spawning and juvenile habitat indeed. The confluence appeared perched, presenting a cascade entrance / exit into the Wharfe and should be addressed (Fig 51).

Fig 51. The confluence of Gill Beck with the Wharfe at SE 05225 58020 was perched and probably of limited access under low flow conditions.
