Advisory Visit

R Wharfe & tributaries, Bolton Abbey Estate, Sept 2019

Prof J Grey: jgrey@wildtrout.org

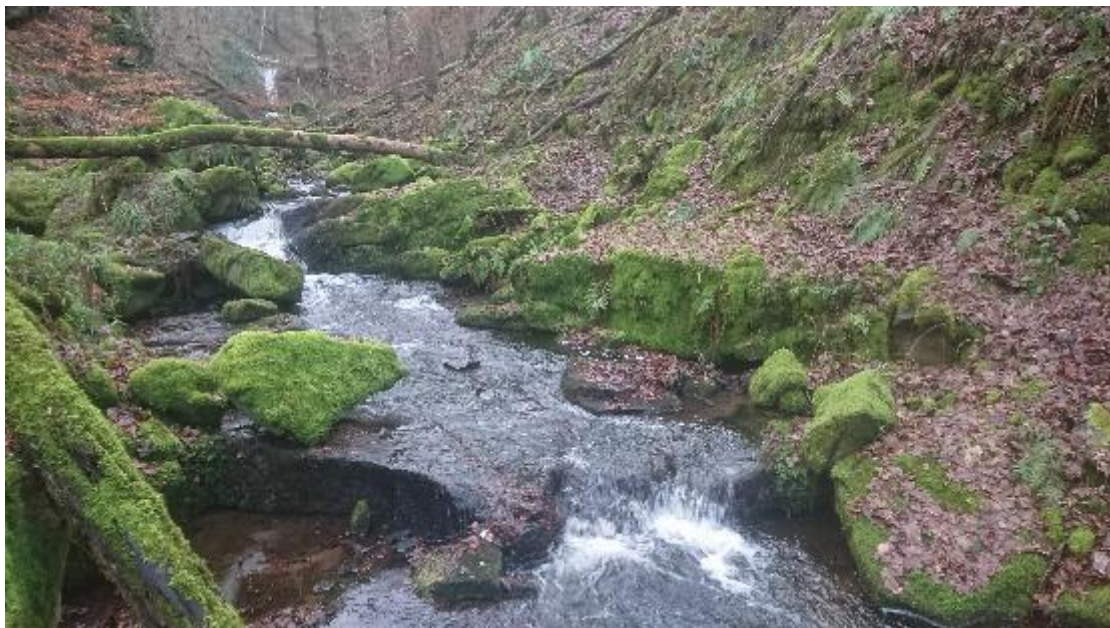
Fig 52. Some natural wood fall was noted but much more could be introduced in this low-risk area. The cascade just visible toward the top left of the image is a ~15m near vertical natural barrier to fish movement, ~350m from the confluence.

gaps and thereby encouraging new low understory growth near to the channel while leaving the felled trunks strewn around the channel to mimic natural wood fall and introduce channel diversity (Figs 52 & 53). Keeping more wood in the channel helps to retain and sort the smaller gravel fractions required for spawning, and also further retain leaf litter which underpins much of the macroinvertebrate production. Gill Beck would thus appear a low risk / high reward site for some management interventions (see Recommendations).
