# WILD TROUT TRUST

**Project Proposal**

**Borrow Beck, R Lune**

**Prof J Grey ([jgrey@wildtrout.org](mailto:jgrey@wildtrout.org)), May 2025**

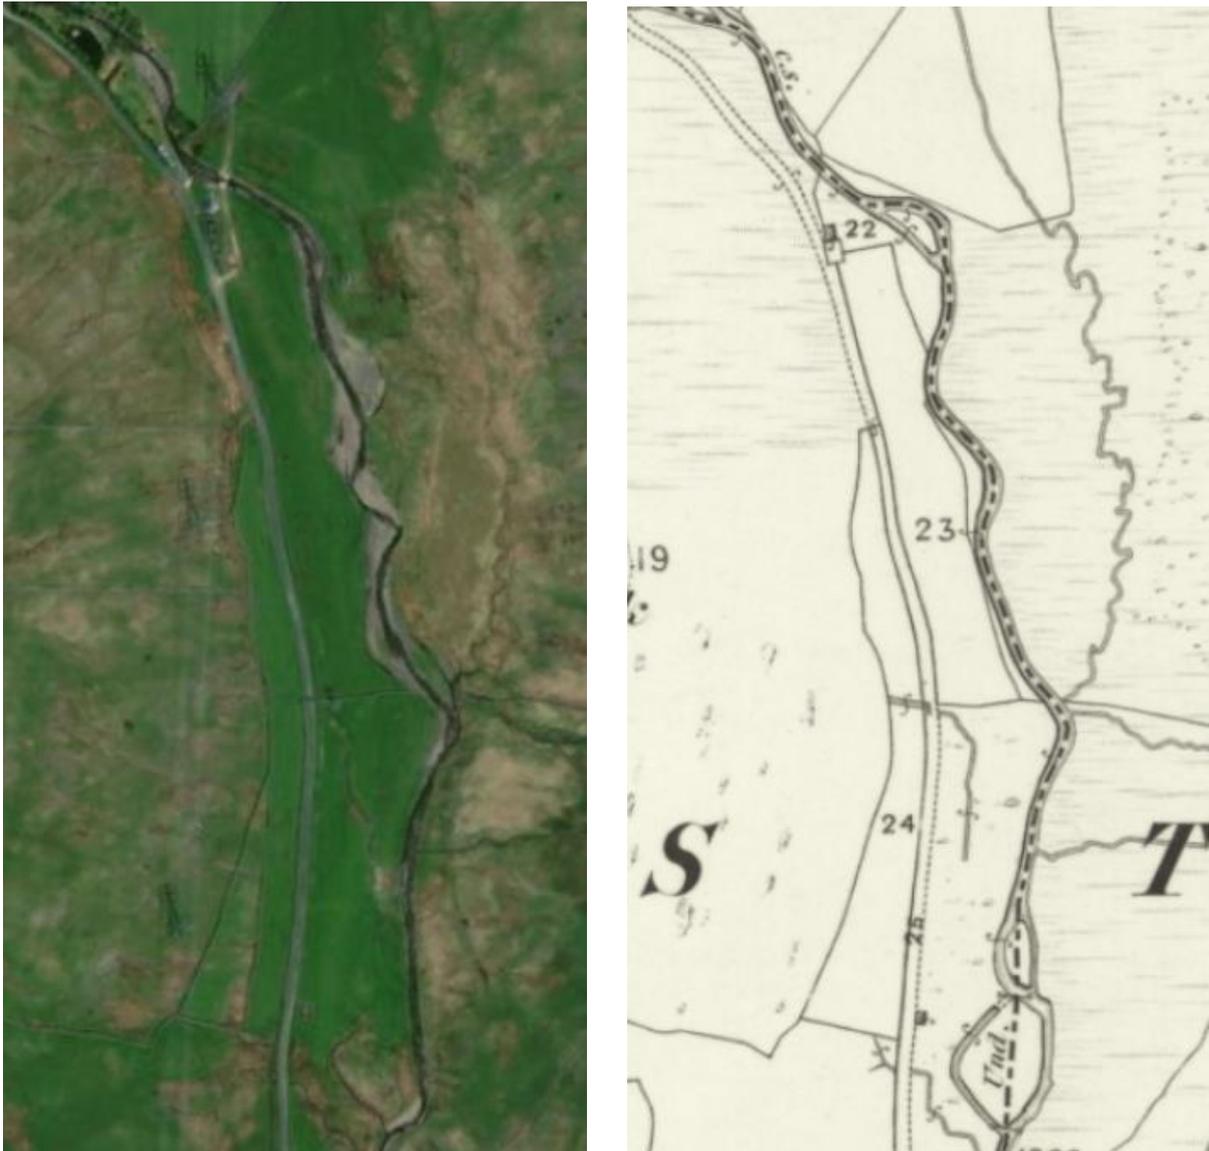
Comparison to the first 1830s Ordnance Survey maps (available via the National Library of Scotland) indicated that the channel had already been straightened and realigned to the side of the floodplain – see maps below. There was evidence of recent modifications to the northernmost section where the extant channel was straighter, but also some evolution of the extant channel in the mid reaches to a more sinuous course. The LiDAR data hint at a much more dynamic channel, both spatially and temporally, with multiple paleochannels across the entire floodplain – see Fig 6 later.

Map from 1830s Ordnance Survey (RH panel) as compared to the extant satellite view of the channel.

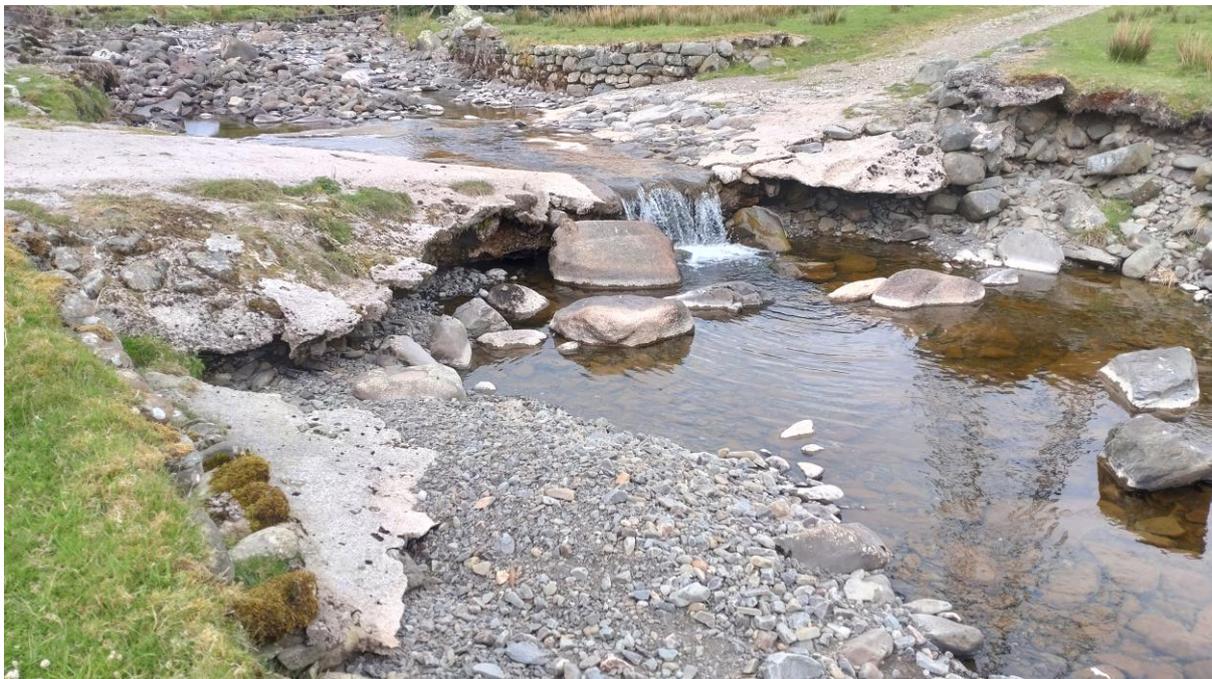
The u/s limit of examination of the main channel was effectively at a ford crossing point which was in a very poor state of repair. It appeared to have been bolstered with concrete additions at several points in its history. As observed (Fig 1), it was significantly undermined and will no doubt fail again shortly. It presented a barrier to fish passage for the majority of flow conditions, with a headloss of  $\sim 0.7\text{m}$  and a shallow skim of fluming flow across the concrete, and restricting access to  $>5\text{km}$  of potential habitat u/s.

**Fig 1. A ford (u/s limit, NY 55172 05422), which was in a very poor state of repair and undermined, presented a substantial barrier to free fish passage and natural sediment transport.**

- Ideally, the structure should be removed if there is no requirement for it, especially considering there was a clear-span bridge  $\sim 225\text{m}$  u/s.
- Full removal would reinstate free fish passage and sediment transport, as well as helping to renaturalise the channel with no on-costs or maintenance.
- A possible though sub-optimal fish passage solution could be to re-purpose large boulders from bank revetment d/s to create a rock-ramp but this would be extremely difficult to engineer in such a way to resist becoming unstable, being outflanked, or simply the finer material washed out from it. The three are not mutually exclusive and hence it is a poor option as compared to full removal.

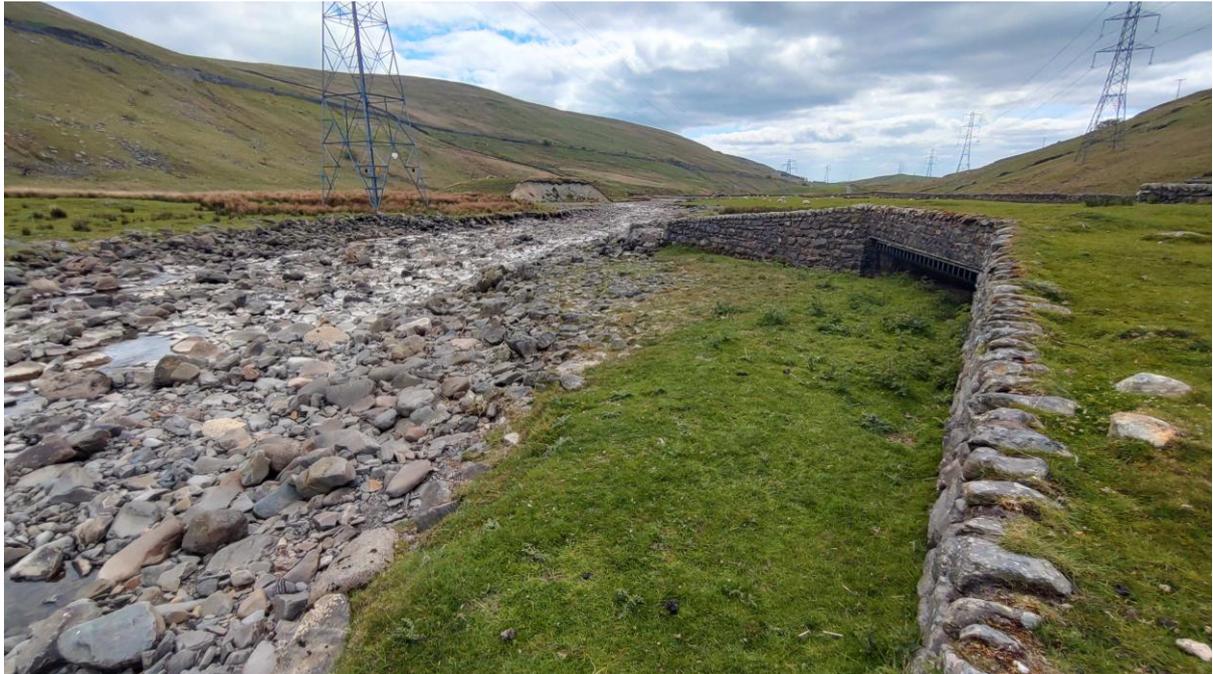
Around 65m d/s of the ford (at NY 55222 05375), there was an offtake situated on the RB (Fig 2). Presumably, this was a United Utilities asset but should be assessed as to whether it is still required / functional. Almost opposite, there was evidence of concrete & revetment within the channel to the LB, potentially in an attempt to steer and maintain the channel away from the footings of the nearby pylons. A full service check of the area would be required before any works commenced.

**Fig 2. Assumed United Utilities offtake at NY 55222 05375 and proximity of high voltage powerlines.**

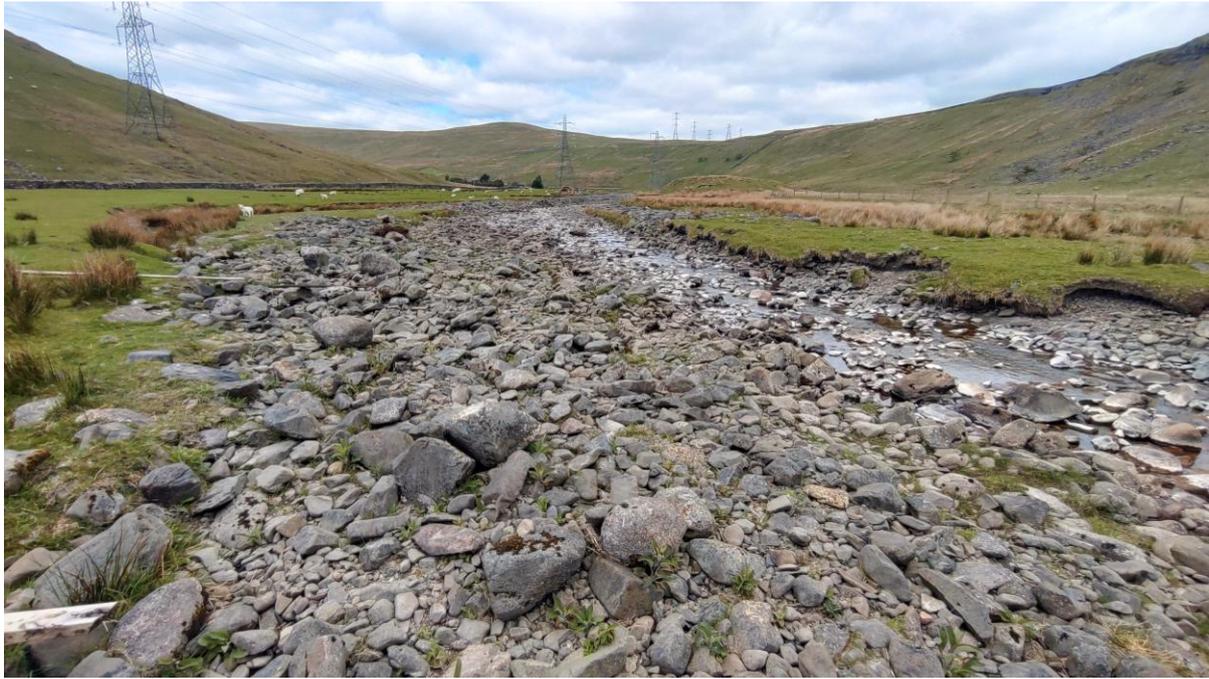
**Fig 3. Looking u/s from NY 55299 05070 at the over-capacity channel, exposed boulders and heavily grazed sward.**

At the time of the visit, after a prolonged dry spring, the water level was extremely low within the over-capacity channel which comprised mostly large cobble and boulder substrate (Figs 2&3). Livestock grazing had reduced the riparian vegetation to an extremely short sward and was hampering colonisation and consequent stabilisation of deposition bars. Hence, the channel was extremely exposed and at severe risk of warming. Evidence of historical and more recent dredging of substrate to bolster existing boulder revetment and realigned embankments and maintain the straightened course has reduced the channel to a trapezoidal gutter in cross-sectional profile and the substrate was homogeneously distributed as a consequence – see Fig 4.

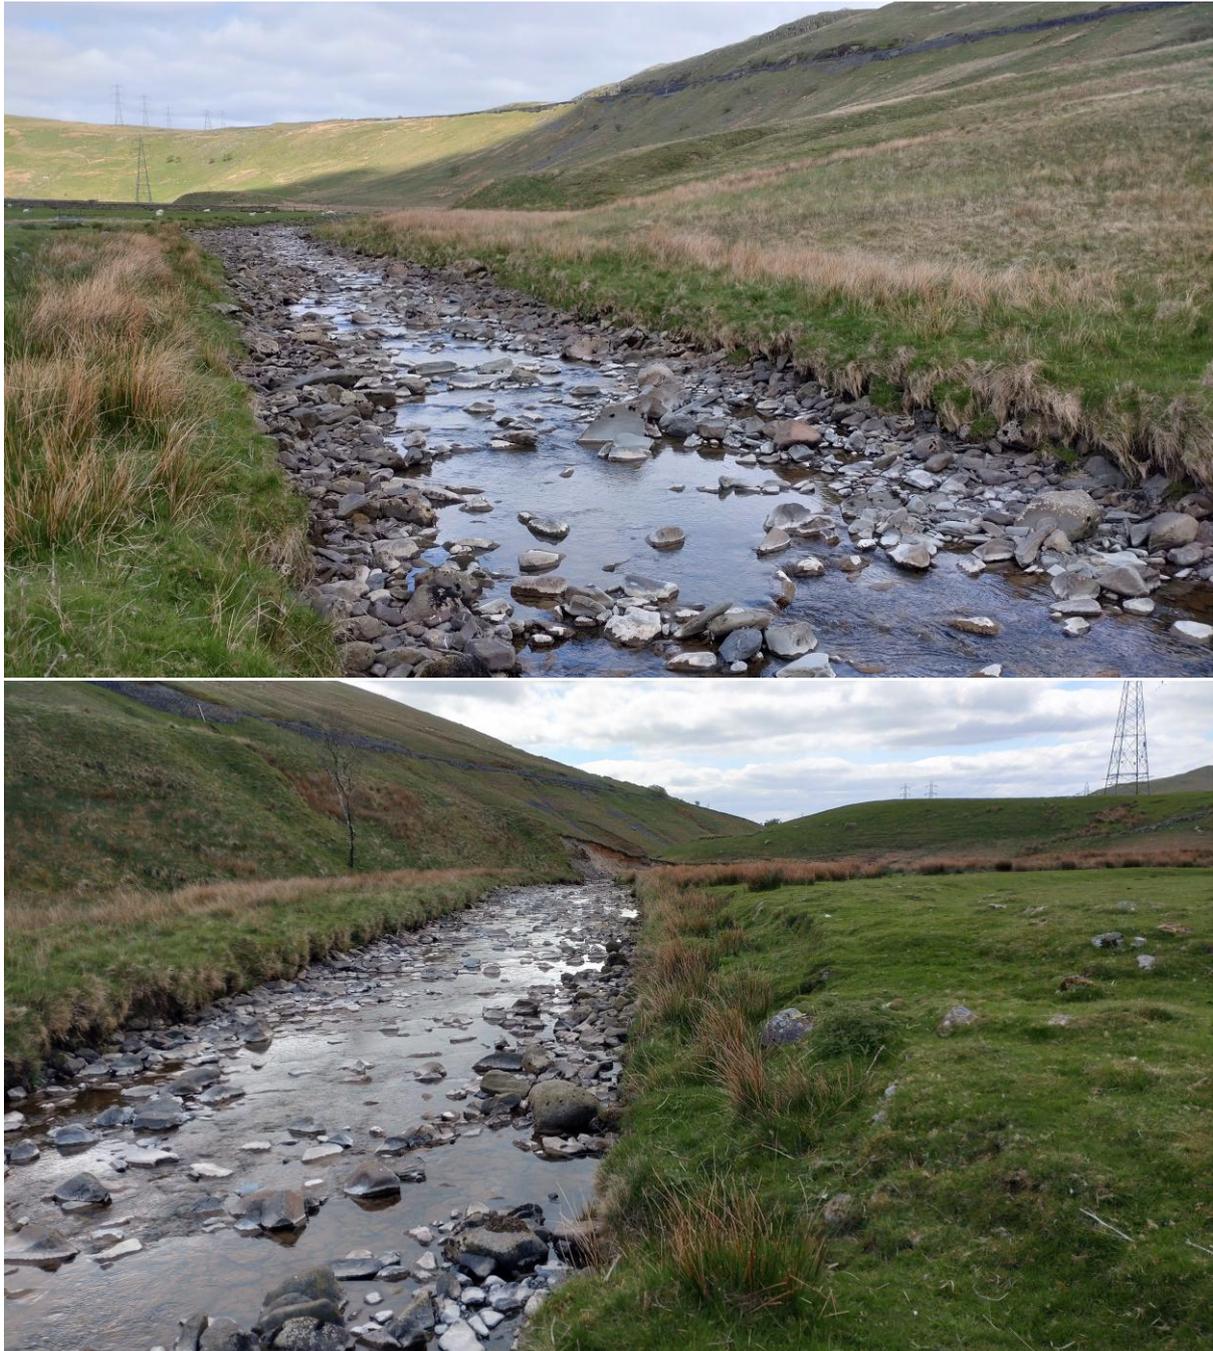
**Fig 4. U/s & d/s from NY 55298 04886, the realigned, straightened channel pinned to the eastern side of the valley was extremely exposed and provided little habitat heterogeneity.**

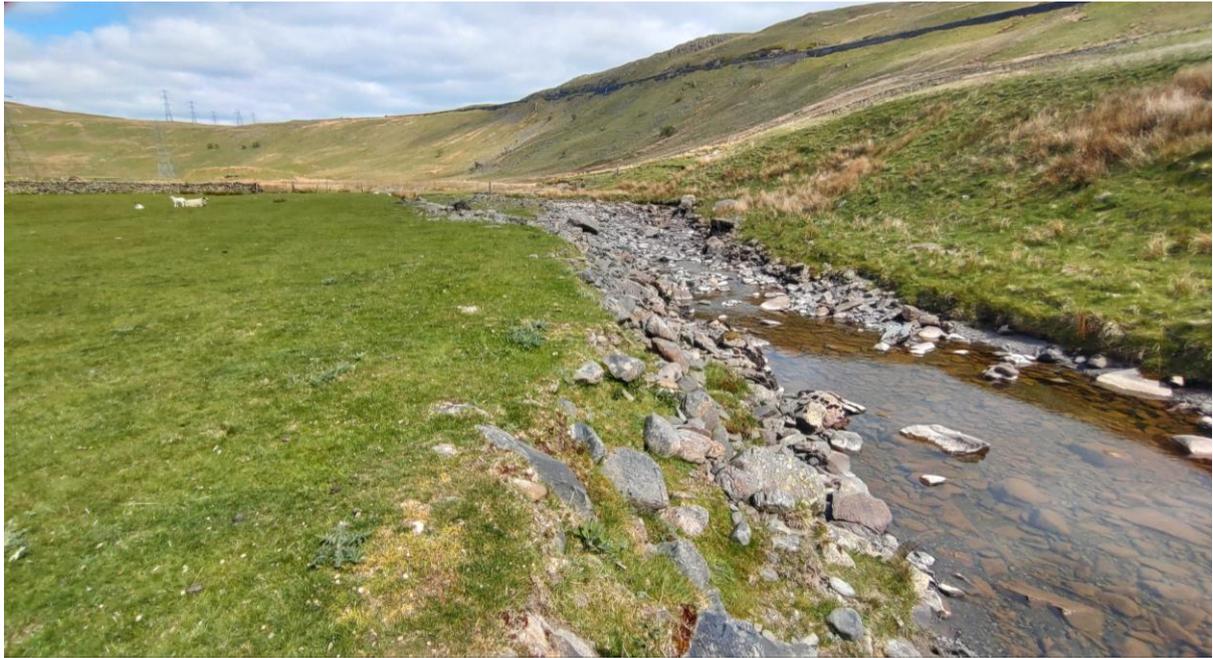
In particular, around NY 55311 05004 just to the south (d/s) of the main field boundary, there was a substantial length of boulder revetment keeping the channel pinned to the LHS of the floodplain – see Fig 5. Reference to LiDAR-derived models of the terrain (Fig 6) demonstrate exactly how spatially and temporally dynamic the channel should be within the reach under consideration.

**Fig 5. Looking u/s from NY 55311 05004 where the channel had been realigned to the eastern side of the floodplain and pinned there by large boulder revetment in the RB.**

- The simplest, least disruptive and probably most natural approach would be to remove the ‘shackles’ of the boulder revetment, especially to the RB, thereby reconnecting the channel to the floodplain – see Fig 6.
- Much of the stone and boulder observed within the revetment and embankments was clearly fluvial in origin and would have been dredged from the channel at the time of realignment.

- Returning that boulder and cobble to the channel, either as a dispersed matrix to subtly bed-raise or in more defined clusters to accentuate sinuosity would be essential to aid restoration of natural function and floodplain reconnection.
- Another option might be to remove the cross-valley walling (NY 55269 05063), returning the stone to the channel, but leaving the footings to impede spate flow – see Fig 6.
- Combined with replacing sheep with cattle (and shifting to a low-density, conservation-style grazing regime), should allow for a much more diverse riparian flora to develop and help to colonise deposition bars, increasing hydraulic roughness, physical habitat diversity, biodiversity, and resilience.
- There should be ample stone material within the revetment to bolster defences around any pylon legs if required.

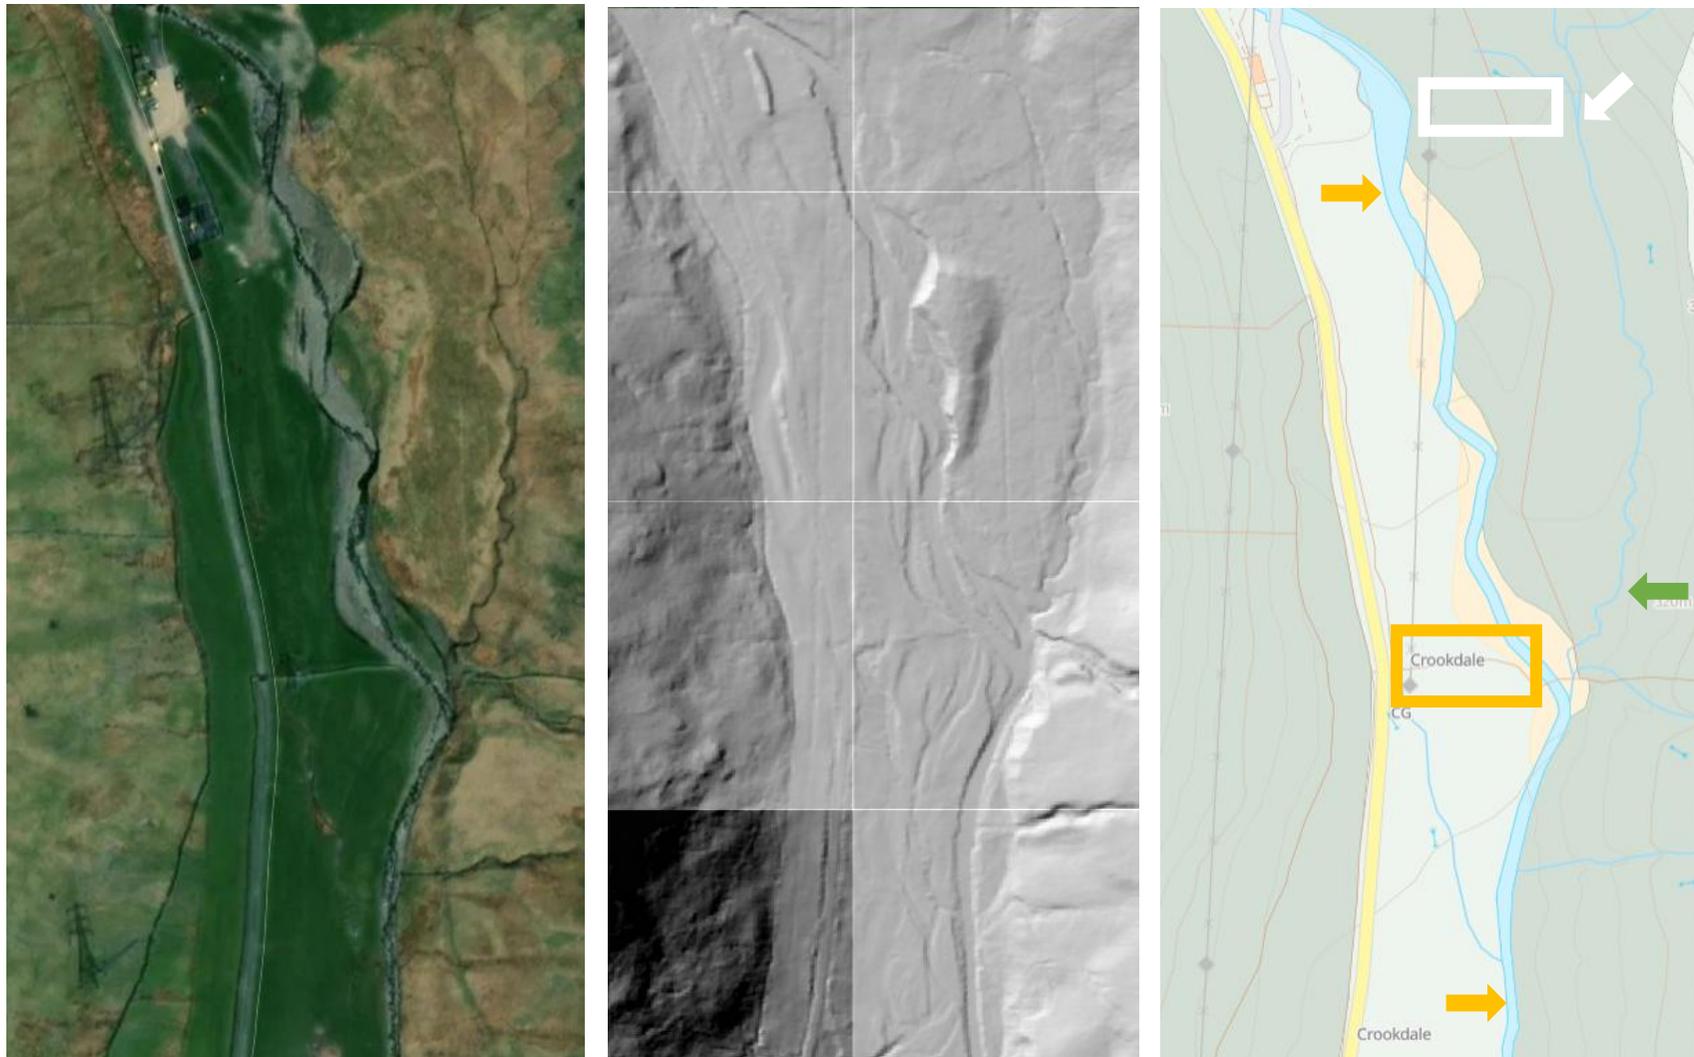
**Fig 6. Satellite, LiDAR & Magic representation of the reach of Crookdale Beck (Borrow Beck). Orange arrows delineate the length of RB from which boulder revetment could be removed. Orange rectangle denotes cross valley walling which should be removed except that section to protect the pylon. White arrow marks the start of drainage channels within the wetland to the east which could be blocked repeatedly or potentially just once near to the green arrow. White rectangle denotes potential for a shallow reconnection between the extant channel and the wetland to accommodate spate flow.**

- With a more detailed topographic survey and some exploratory excavations, it may be possible to identify paleochannel connection between the extant channel and the wetland – see white rectangle on Fig 6.
- If a paleochannel connection is found, then there is potential to create a shallow channel between the two which would accommodate spate flow from the Crookdale Beck into the wetland during extreme events.
- Otherwise, within the wetland, any formalised drainage channels should be blocked.
- A low impact approach, rather than running plant through sensitive wetland habitat, might be to identify key pinch points towards the southern end (green arrow on Fig 6) where a low bund could be introduced to drown out all the drainage network u/s.

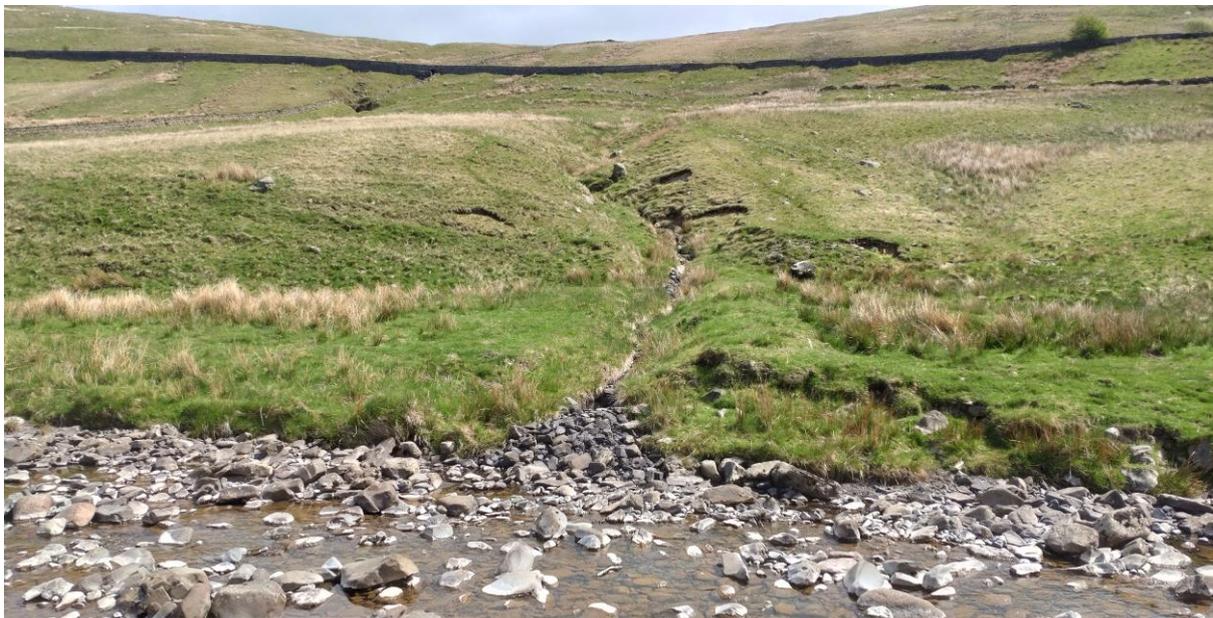
Naturally steep channels of smaller tributaries flowing from the eastern side of the valley were clearly highly erosive in nature, as evidenced by the coarse substrate at the confluence – see Fig 7. There was also evidence of slippage, likely exacerbated by livestock: grazing reducing sward diversity and depth of root matrix within the soils; and the direct physical impact of trampling / traversing.

**Fig 7. Naturally steep tributary entering the mainstem at NY 55303 04954 exhibiting evidence of land slippage because of poor root structure in the heavily grazed sward.**

- Changes to the livestock regime should see a rapid change in the riparian structure.
- Augmented planting of these ghylls with scrubby tree species would further accelerate recovery.

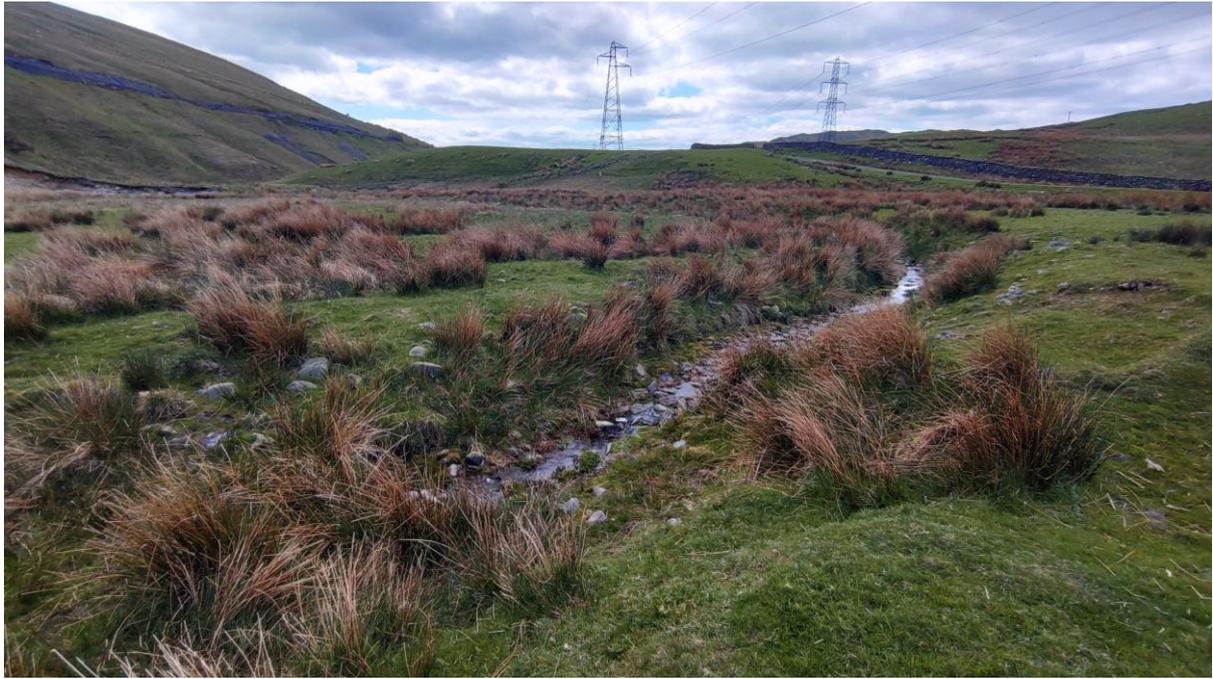
To the southern end of the reach, and to the west of the main channel, there was a spring or diverted tributary that may once have been a paleochannel but has since been dredged into a narrow, uniform drain (Fig 8).

**Fig 8. To the southern end of the site at NY 55245 04817, a spring or small tributary adjacent to the road had been dredged to increase drainage.**

- It should be a relatively simple task to return stone into the drain from the dredging spoil banks on either side to rewet the entire area, either via a stage-zero approach, or to block the drain channel at irregular intervals and potentially reprofile the banks in between to form a series of shallow ephemeral pools which should increase the biodiversity potential immediately.
