**WILD TROUT TRUST**  
wildtrout.org

**Advisory Visit**

**Brailsford / Spinneyford Brook, Derbyshire**

**January 2026**

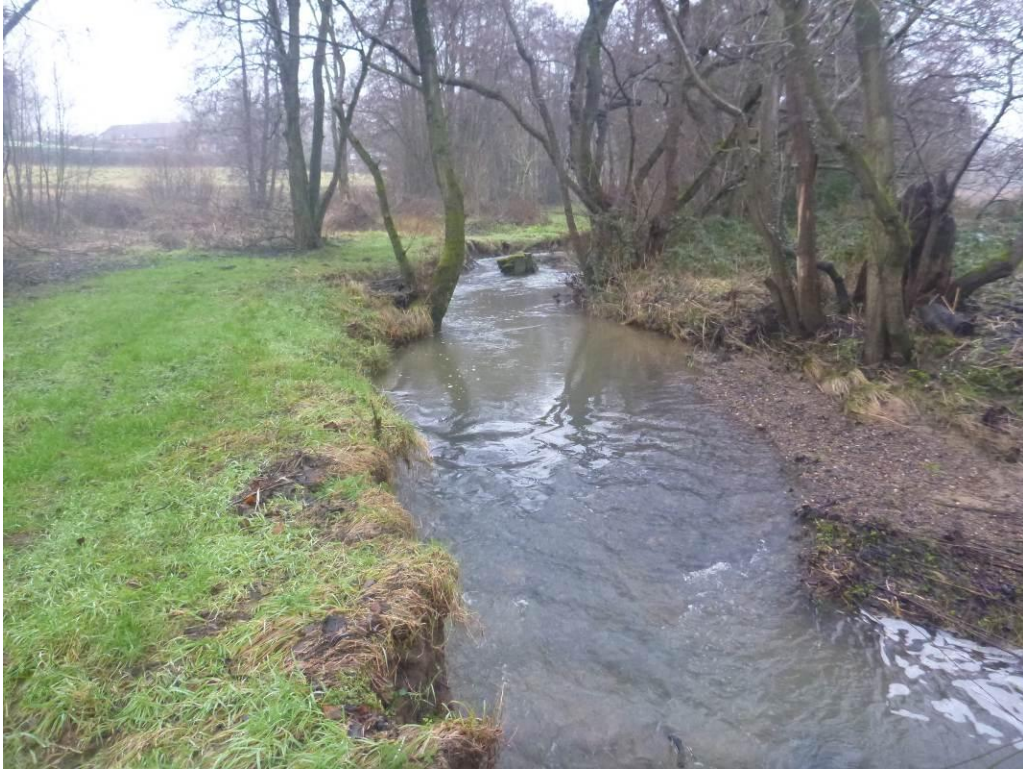
**Photo 1 Good natural habitat features including pool-riffle sequence, gravel sidebars and mature tree root systems. The right bank (left of shot) is trimmed to control Himalayan balsam. Leaving an untrimmed marginal strip alongside the river (and hand-pulling balsam from it) is recommended. This would improve bank stability by increasing the vegetation's root depth profile and also provide opportunity for some tree succession (e.g. self-seeded alders) which is generally lacking.**

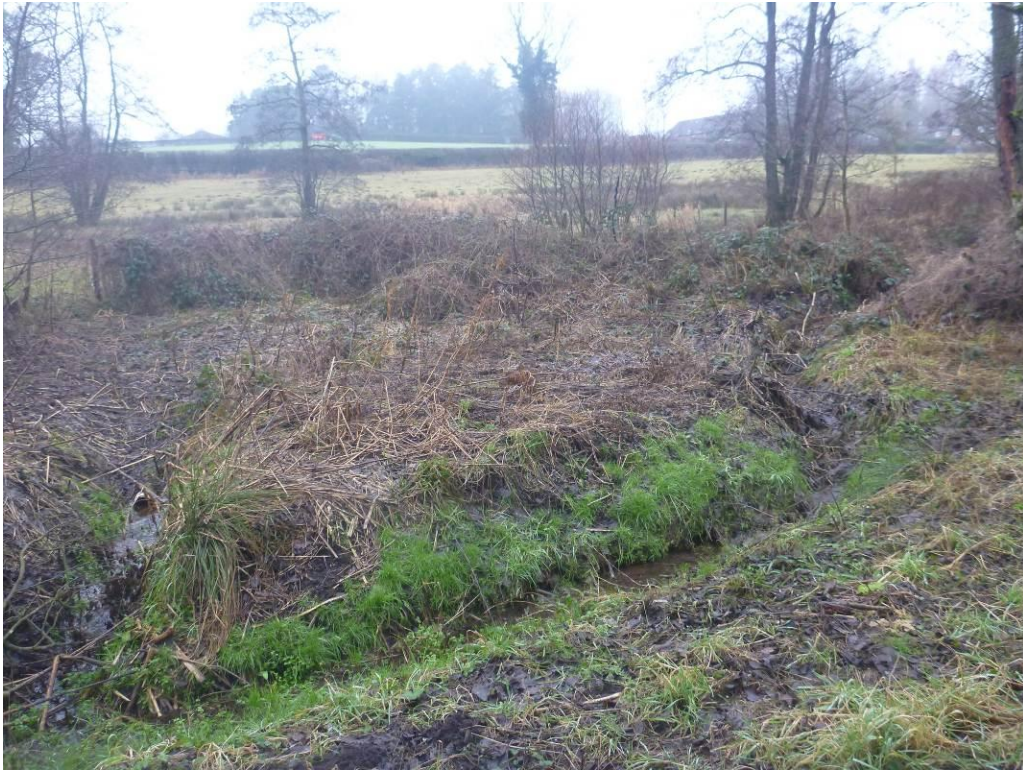
**Photo 2 Land on the west bank – a wide buffer strip between the river and a wet meadow is excellent practice to protect water quality and riparian habitat. Drainage ditches are present within the buffer strip which could be ‘soft blocked’ with woody dams to enhance wetland habitats and slow runoff. This area is identified as a Local Wildlife Site (Brailsford Brook Marsh, lowland swamp habitat) in the Derbyshire Local Nature Recovery Strategy, alongside adjacent areas of lowland fen (Mill Farm Wet Meadows LWS).**

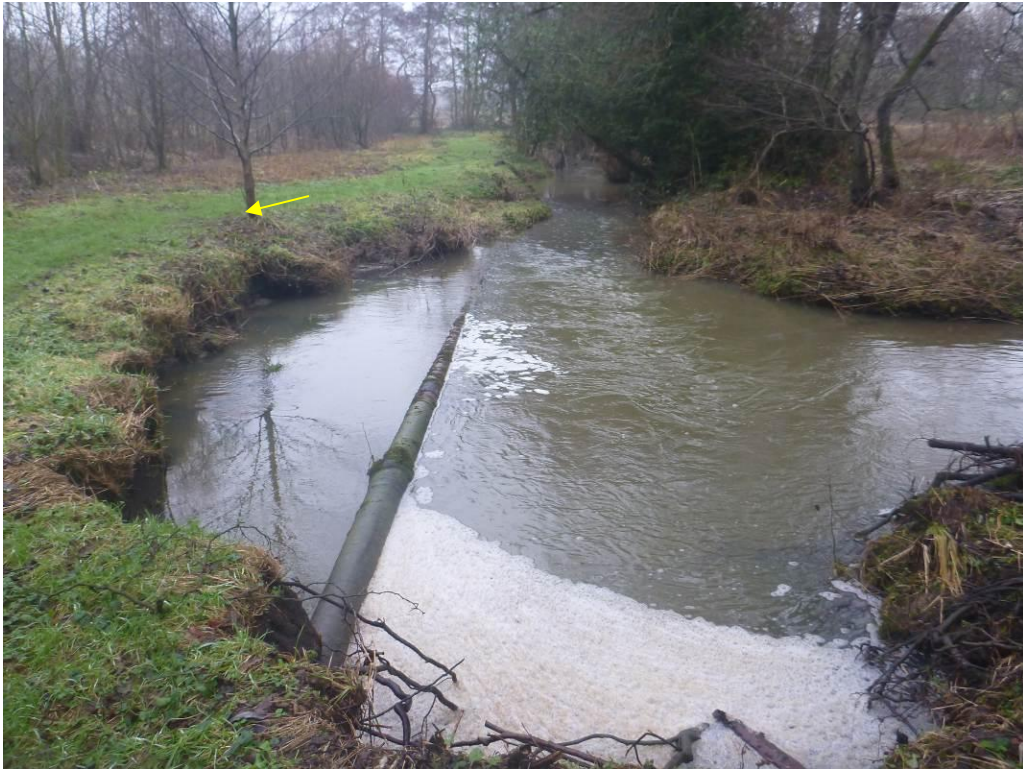
**Photo 3 The 'Pipe Pool' in January 2026 compared with a decade ago (Photo 4). Note the single tree on the right bank (arrow) compared with the growth in the background. A change in management of the marginal strip would allow managed natural tree regeneration and reduce the rate of bank erosion.**

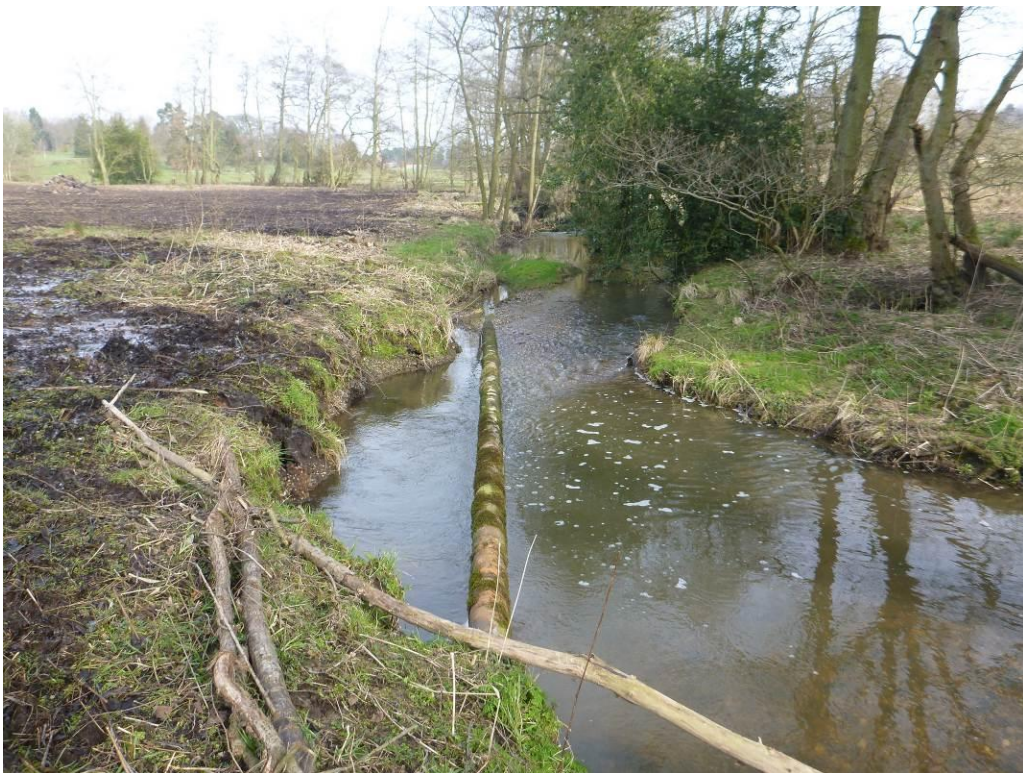
**Photo 4 The 'Pipe Pool' in February 2016.**

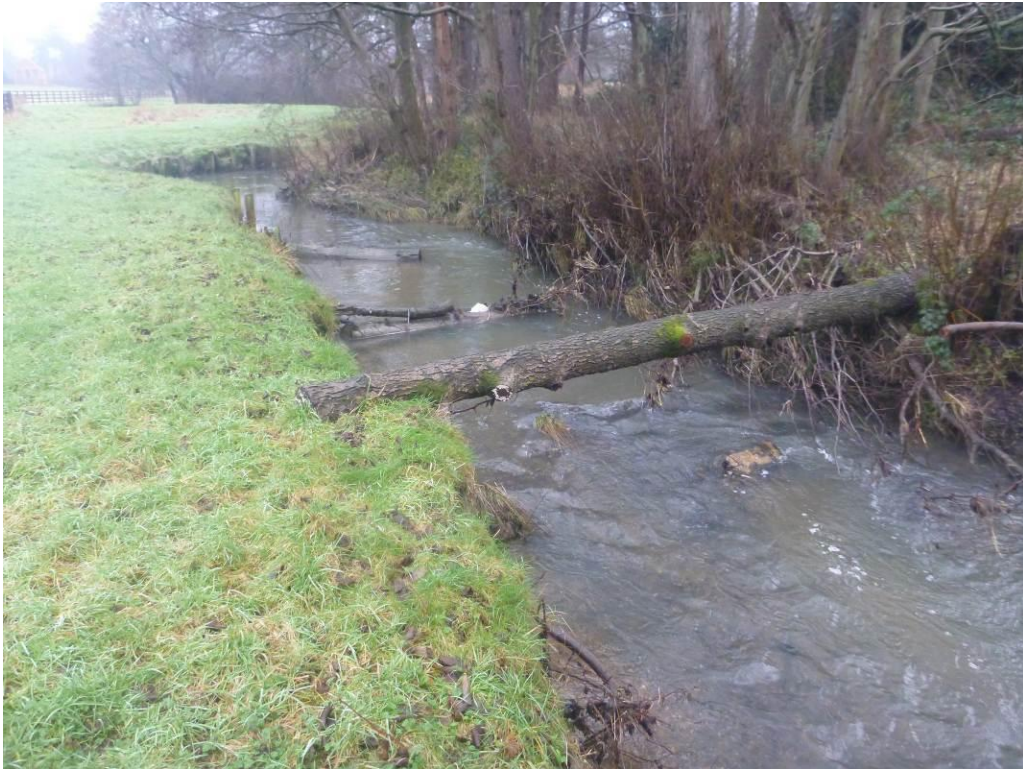
Some cross-channel logs and flow deflectors have been installed ([Photo 5](#)) which need to be on a larger scale to have the desired effect. The cross-channel log is set too high to cause effective undershot scour, but is probably too small to withstand washout if set lower. The numerous alders on the left bank provide opportunities to introduce LWM structures on a larger scale.

**Photo 5 Introduced structures need to be on a larger scale to have the desired habitat effects.**

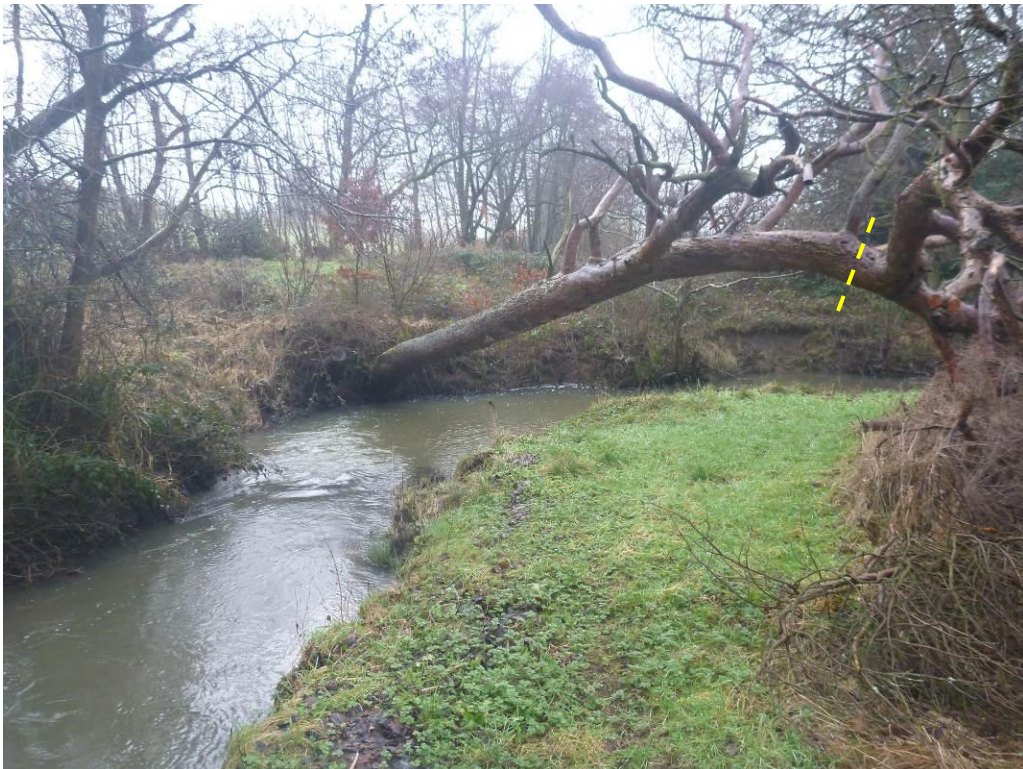
**Photo 6 An opportunity to create a good habitat feature: cut the trunk as indicated, lowering the main trunk across the stream. Lodge the crown upstream of the cross-channel trunk. Alternatively, the whole tree could be winched around upstream into the channel.**

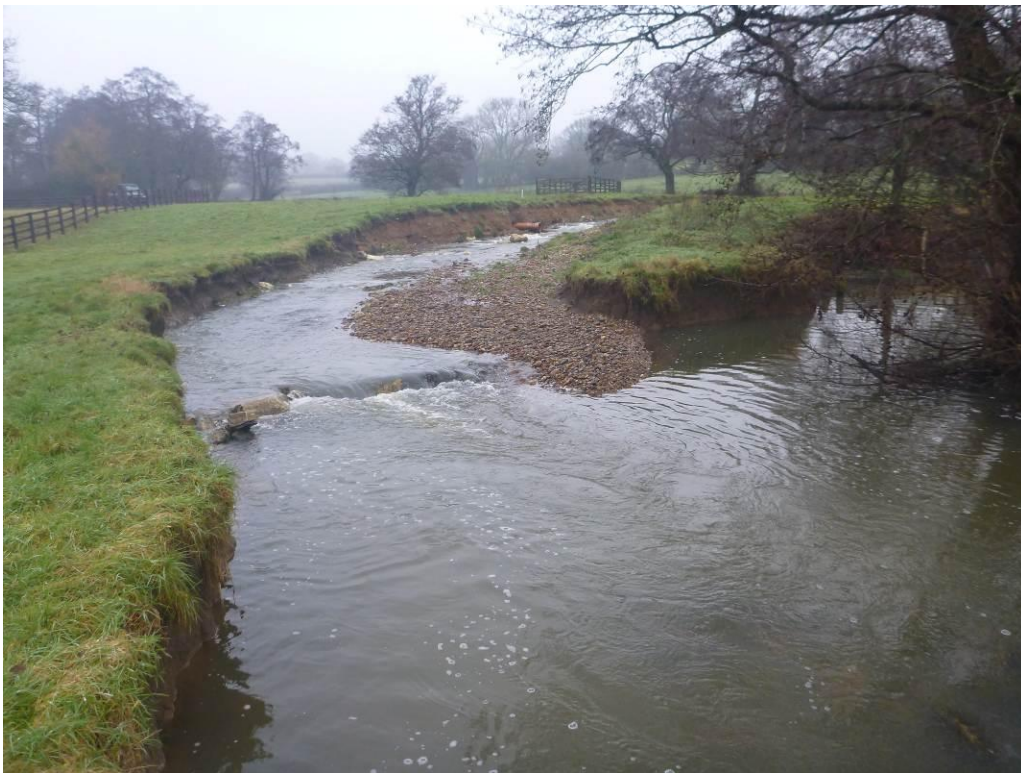
At the upstream end of the reach is a recently (2024) constructed rock ramp which is the transition from the higher Longmeadow river restoration site to the downstream river level ([Photo 11](#)). This structure replaced a concrete side weir in the mill leat which is fed by the upstream water level, which itself was the subject of an unsuccessful fish passage improvement in 2018 (pinned boulders on steep weir apron/rock ramp).

**Photo 11** Rock ramp and former leat overflow channel (right), now a backwater.

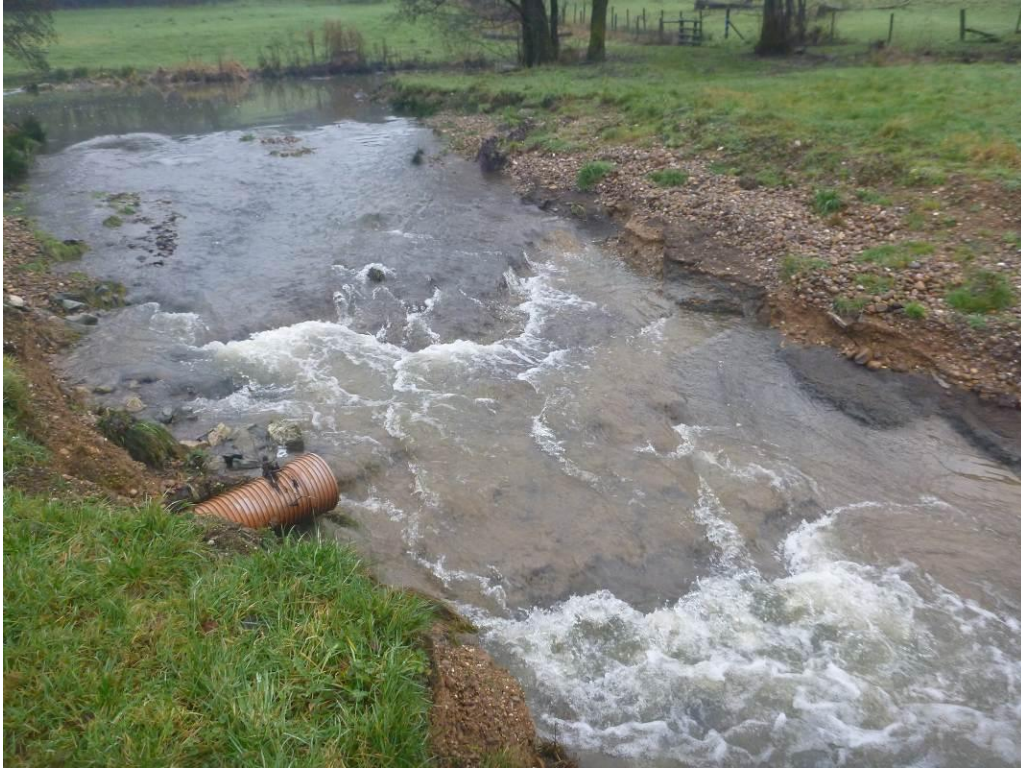
The rock ramp consists of low, rough boulder weirs with infill of angular cobble and coarse gravel in-between, which is a great improvement for fish passage compared with the previous situation. However, much of the infill has been displaced during flood conditions, leaving areas of underlying clay exposed on the bed and banks ([Photo 12](#)).

The difference in bed height across this structure is a legacy of historic changes to the watercourse for milling and there is uncertainty over the true natural course of the stream. Adjacent ground levels have also been raised in recent years through the landscaping of spoil from nearby construction works, thus the rock ramp channel is cutting through an artificial bund.

**Photo 12 Upstream end of rock ramp showing loss of introduced bed material (bare clay).**

There are essentially two options for countering the erosion at this location. Firstly, to increase the length (and thereby reduce the gradient and energy) of the channel; secondly, to further engineer the existing structure to be more resistant to erosion. The first option would have to take a course into the field on the right bank. The second option could still be vulnerable to erosion, but incorporating some living willow may help stabilise and retain bed material (Photo 13).

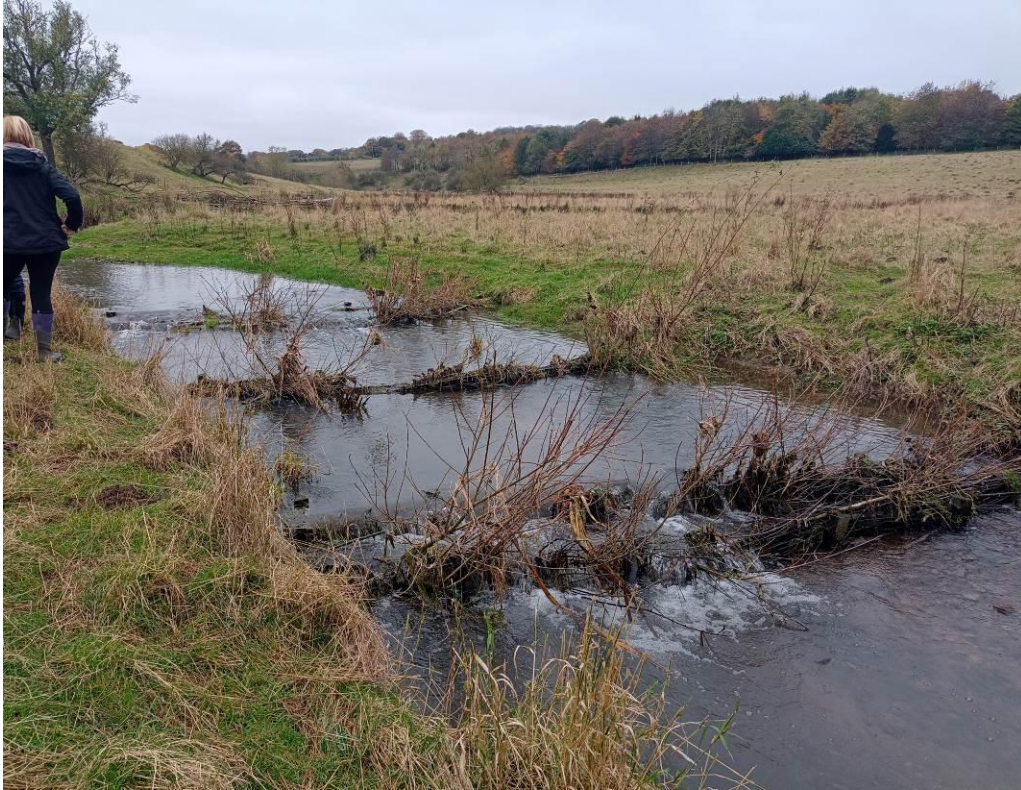
**Photo 13 Example of the use of living willow ‘weirs’ to stabilise introduced bed substrate at the transition in levels between a restored river/floodplain (upstream) into the incised, historically modified channel downstream (upper River Witham, Lincolnshire).**

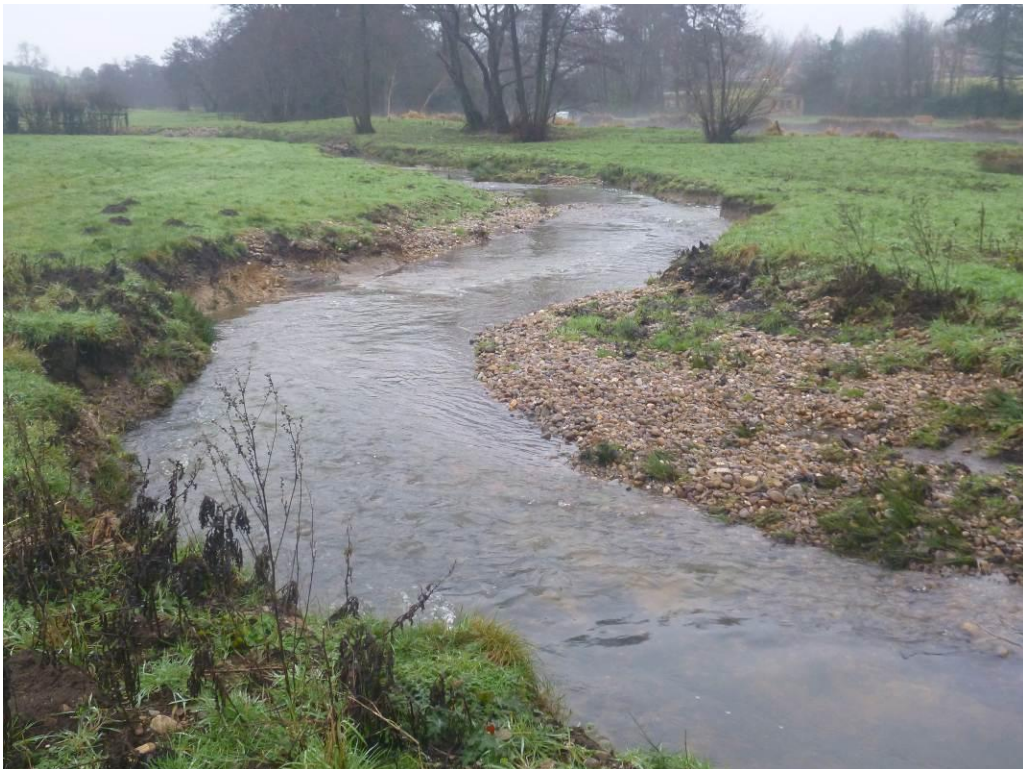
**Photo 15 The upstream limit of the Longmeadow restoration site, where the brook regains its natural gradient.**

Some introduced gravel has been transported from the upstream end of the restoration site (Photo 15) and it appears this is not being replaced, probably because of the interruption of natural sediment transport by the series of weirs up to the hatchery pond offtake (Photo 16 - Photo 19). The introduction of gravel between the upstream end of the restoration (Photo 15) and the first weir above (Photo 16) is recommended to compensate for this. The gravel should be of a size range and shape that occurs naturally within the brook.

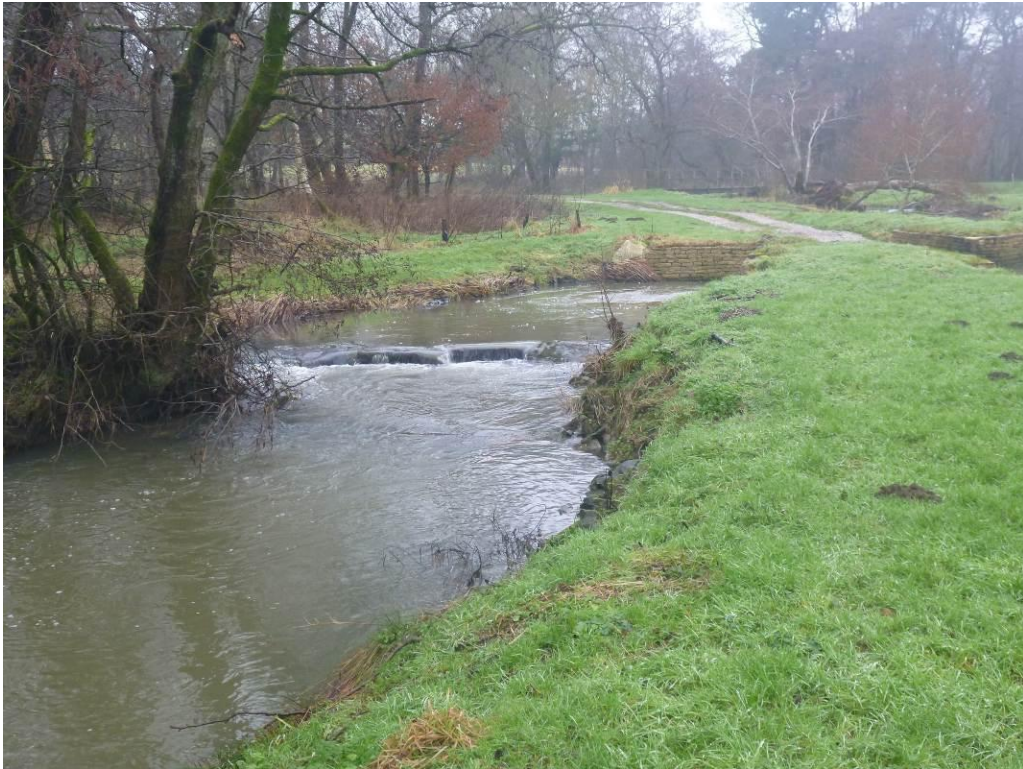
**Photo 16 Weir upstream of Photo 15**

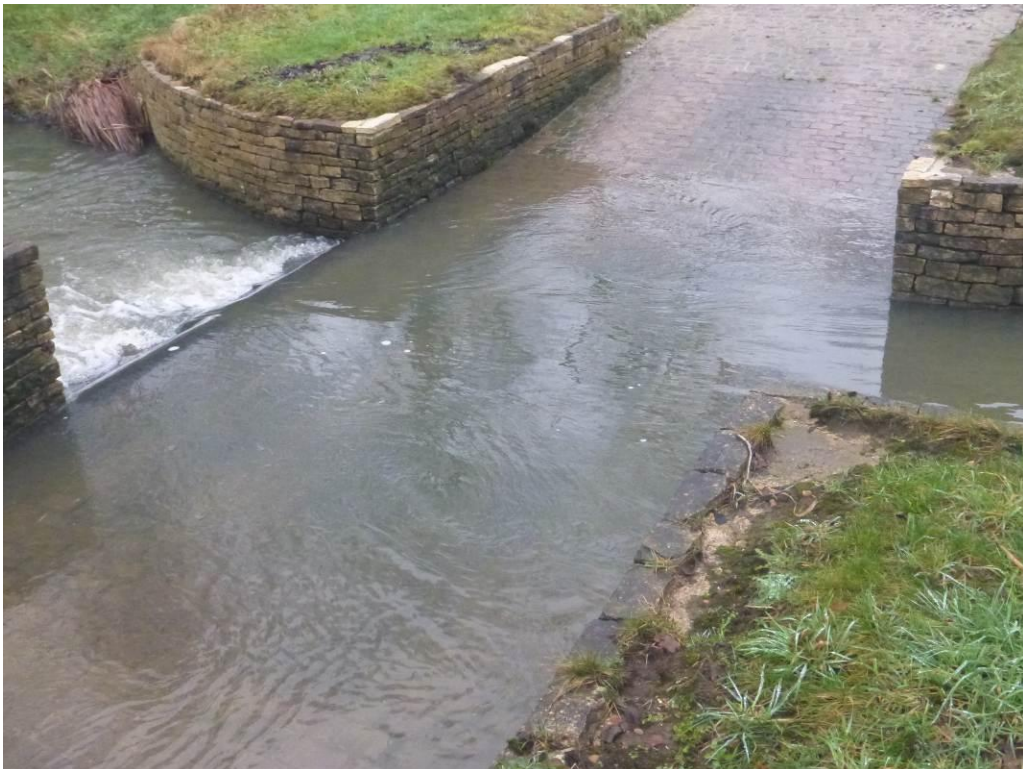
**Photo 17 (52.983966,-1.6383241) Ford: passable in certain conditions, but an obstruction to fish dispersal and migration. Ideally this would be replaced with a clear span bridge or appropriately oversized sunken culvert, alleviating the issue for fish movement and also improving access.**

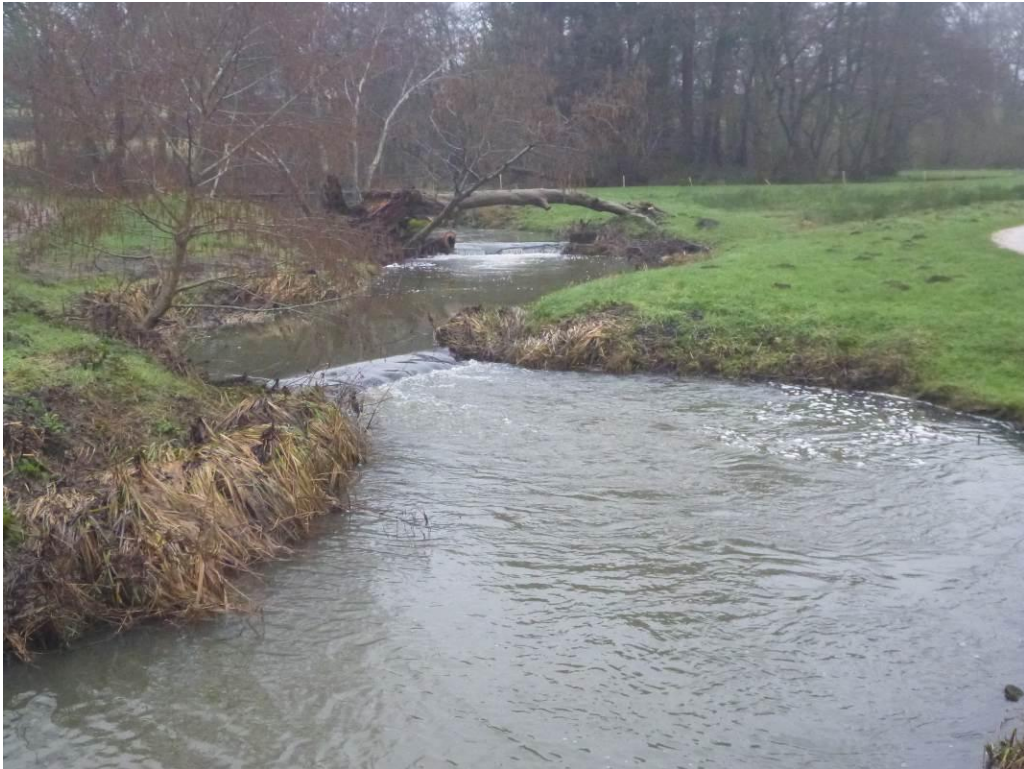
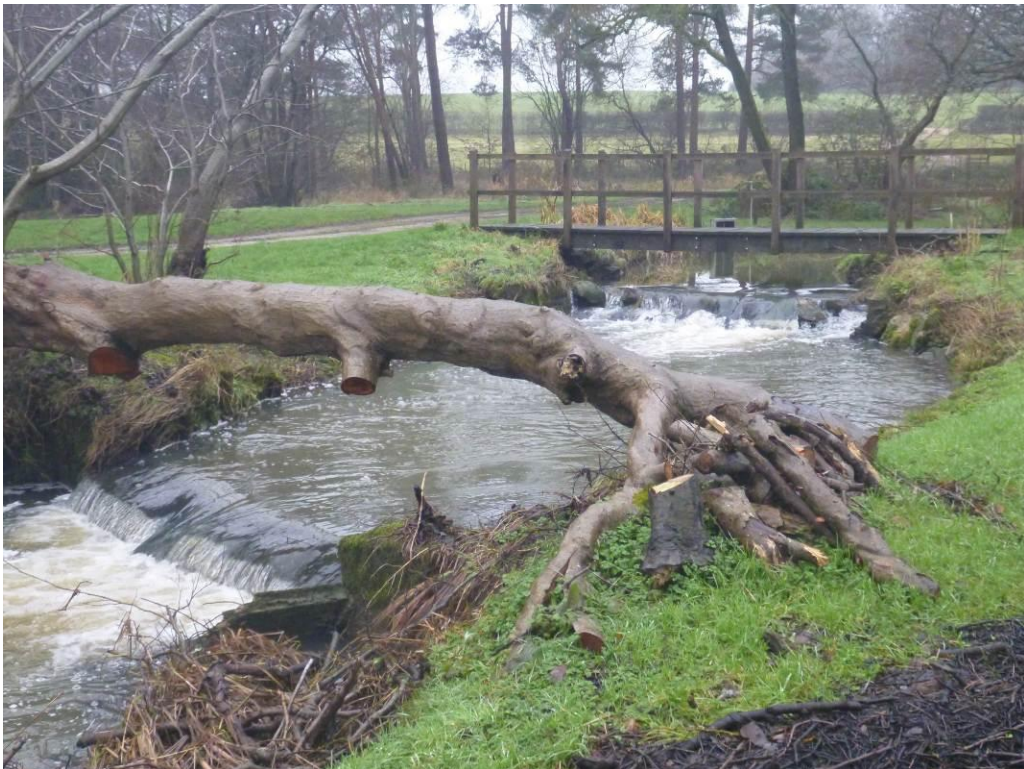
**Photo 18 Weirs leading up to hatchery ponds offtake**

**Photo 19 Weirs leading up to hatchery ponds offtake**

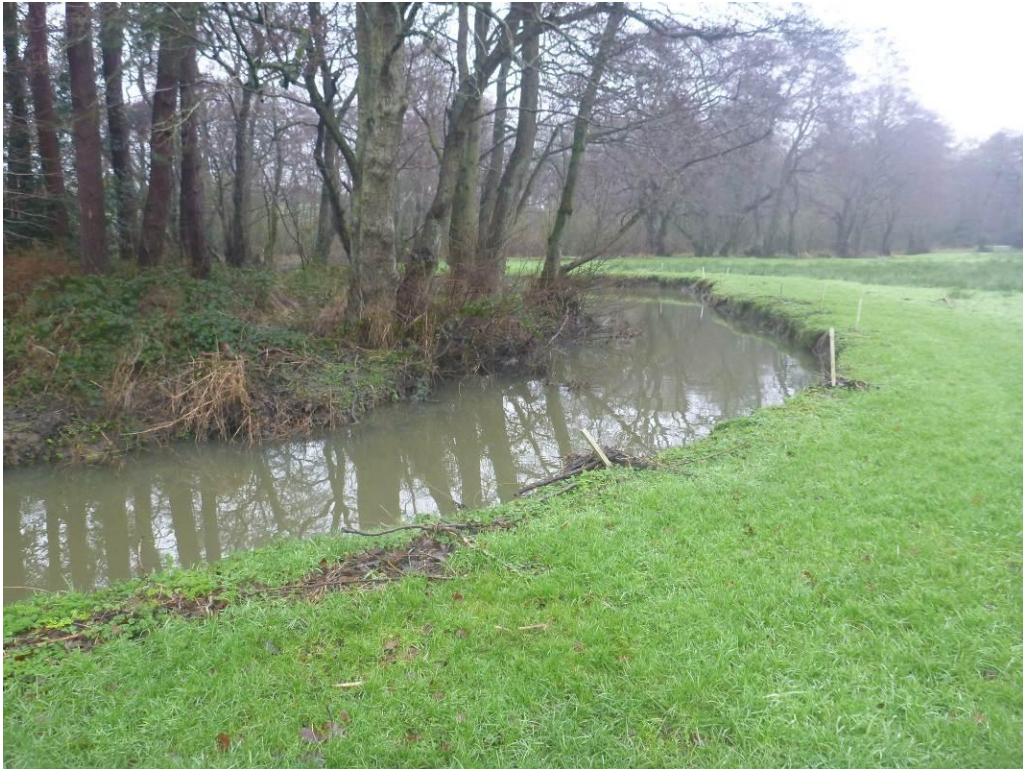
Above the hatchery ponds the brook is impounded for c.150m (Photo 20). The deep water and vertical clay banks here provide favourable conditions for dense concentrations of signal crayfish in galleries of underwater burrows in the banks; large numbers are trapped and removed from this location. Where the impoundment runs out there is substantial deposition of gravel, indicating the sink effect of the impounded reach on natural sediment transport, as noted above (Photo 21).

**Photo 20 Impounded reach upstream of hatchery ponds offtake. A hotspot for signal crayfish and degraded habitat for flow-loving species like trout.**

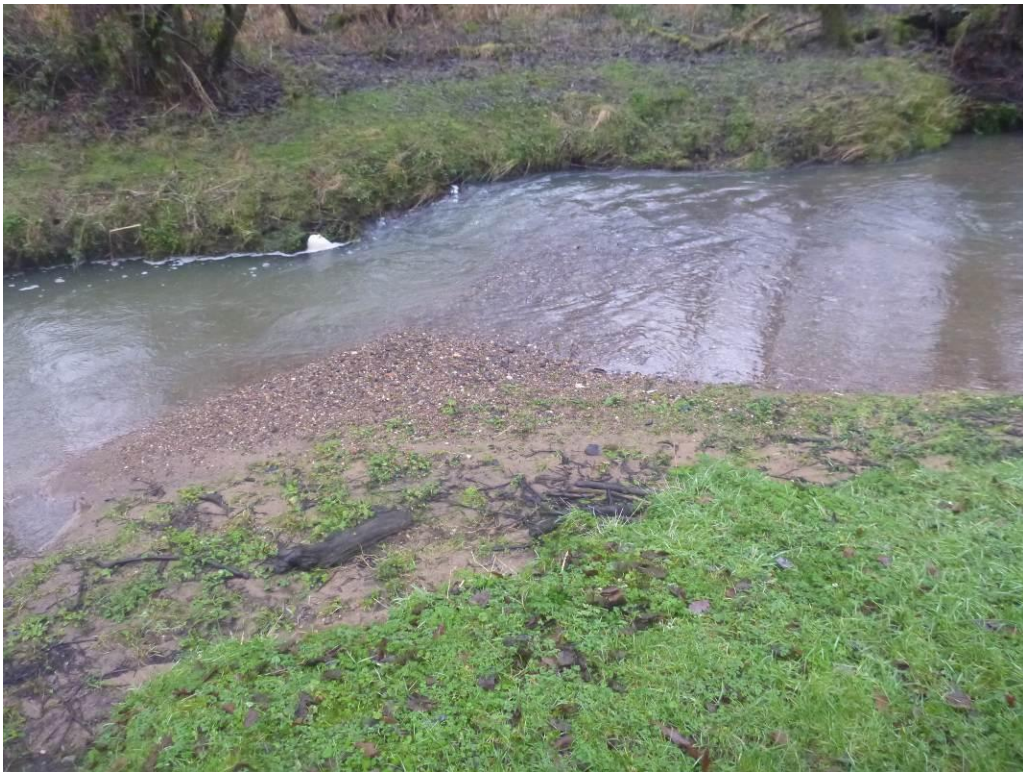
**Photo 21 Gravel deposition at the upstream extent of the impoundment in Photo 20.**

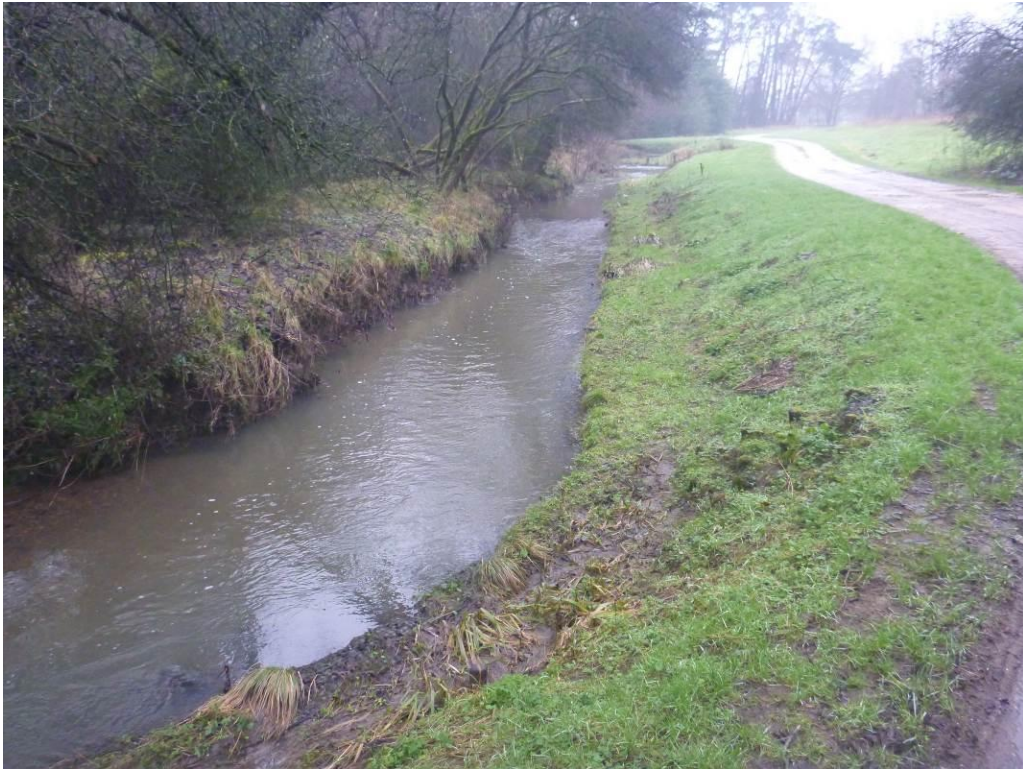
**Photo 22 Hard bank protection (rock rolls at the toe) has stabilised erosion alongside the track, but the issue stems from the historical realignment of the brook from its likely natural course into the straightened channel, which also lacks natural habitat features.**

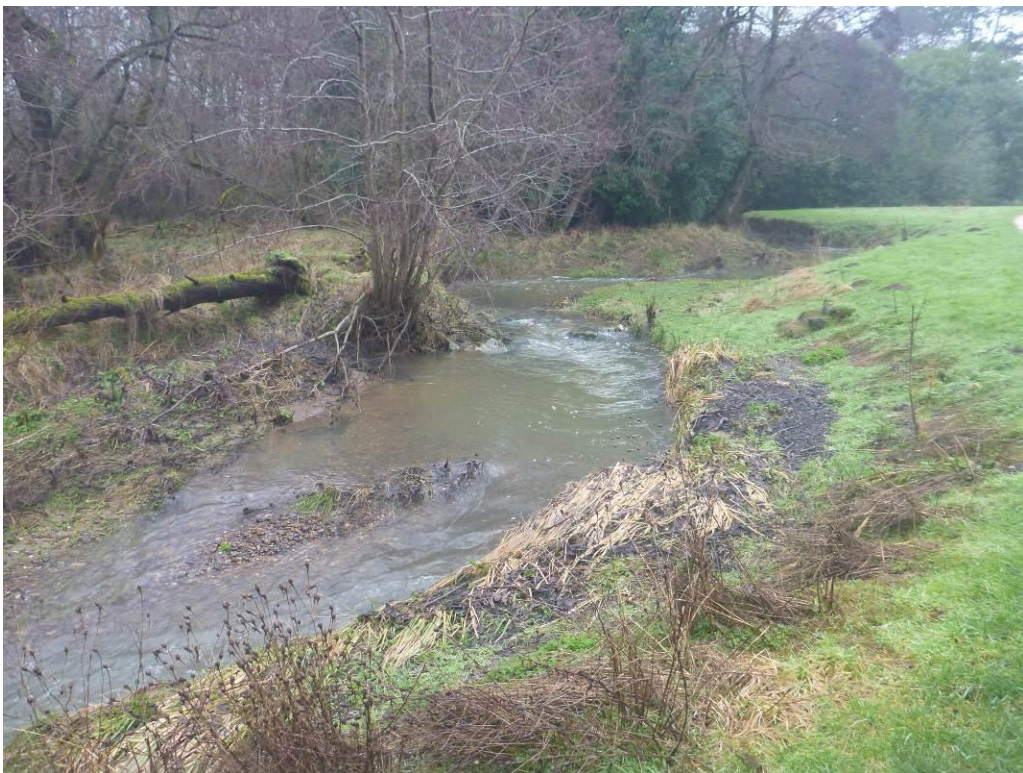
**Photo 23 Weir removal and left bank reprofiling (right of shot) have greatly improved this area, leading to development of gravel features. Note the improved morphology where the channel has greater sinuosity and more varied dimensions.**

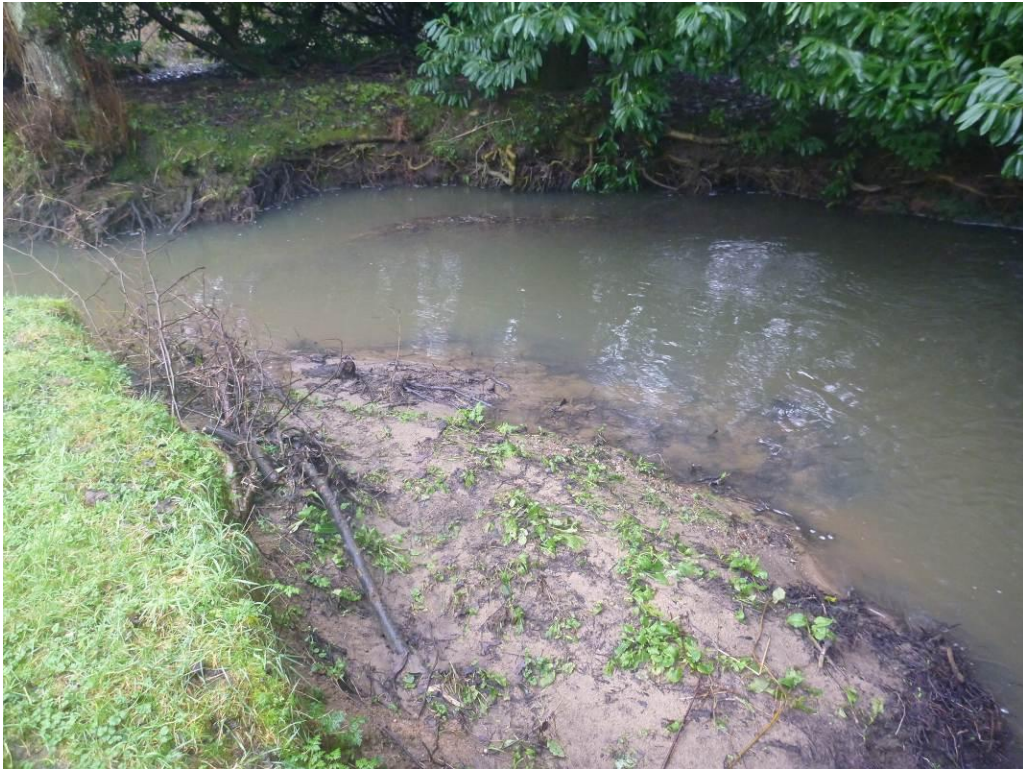
**Photo 24 Deposition of fine sediment within a brushwood mattress on the inside of the bend in Photo 25. This, along with the turbid water, highlights an issue with fine sediment inputs further upstream.**

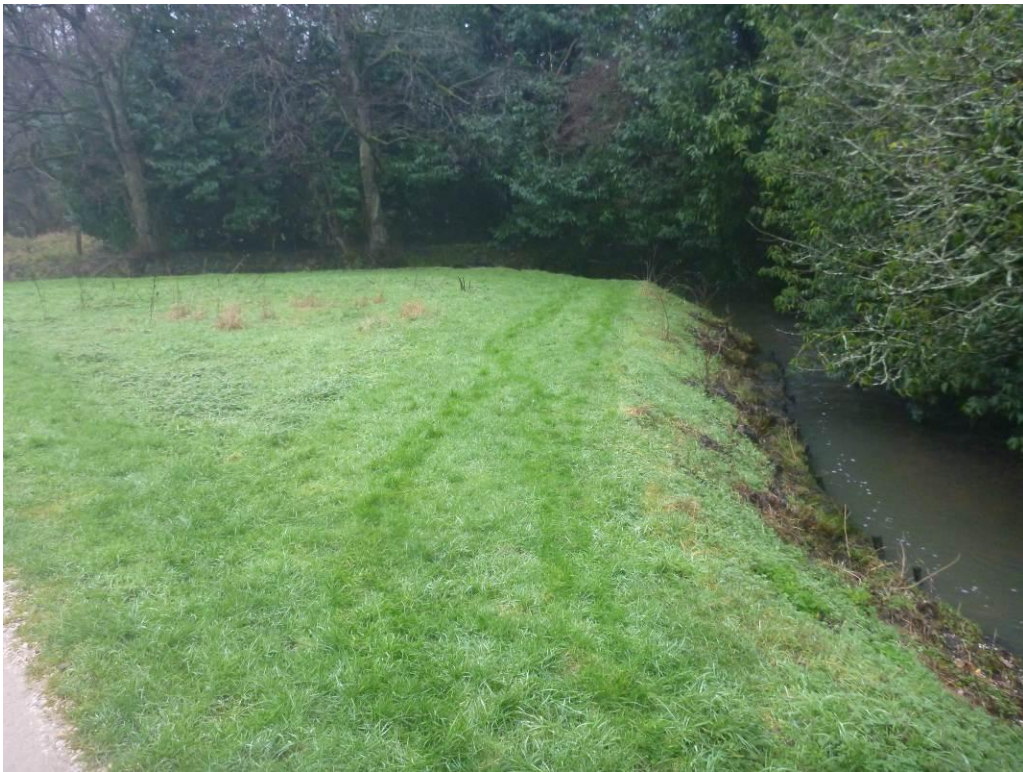
**Photo 25 Reprofiling the inside of the bend here is recommended to create a similar profile to Photo 23.**

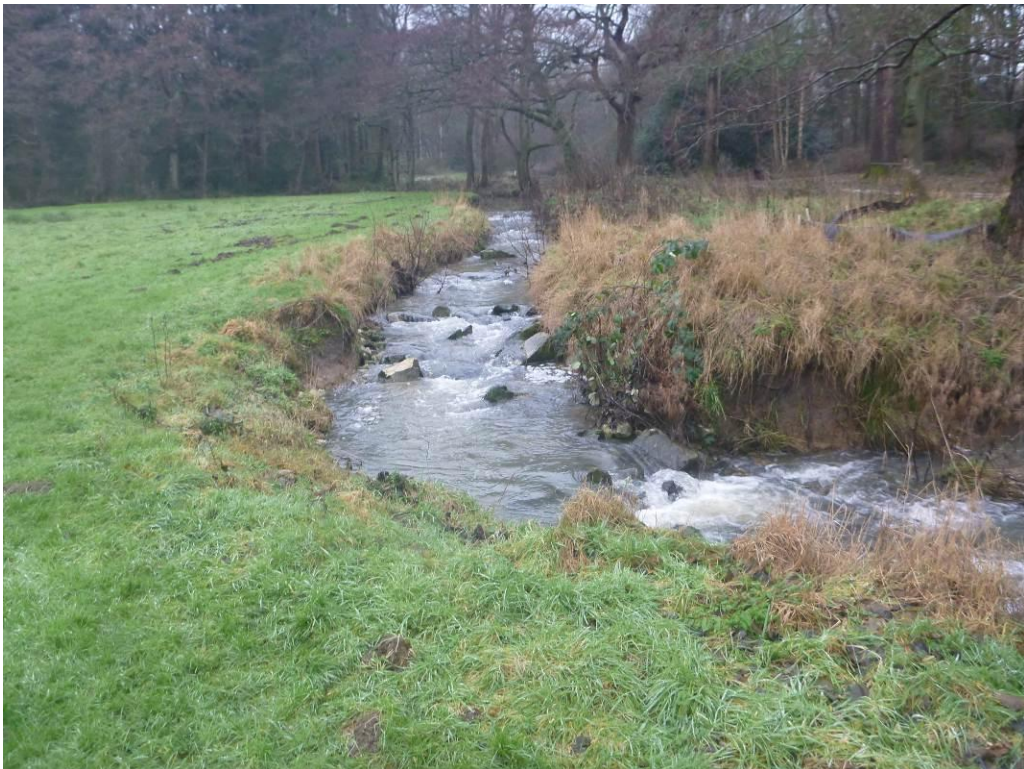
**Photo 27 Rock ramp maintaining water levels for the Sandy's Lake offtake.**

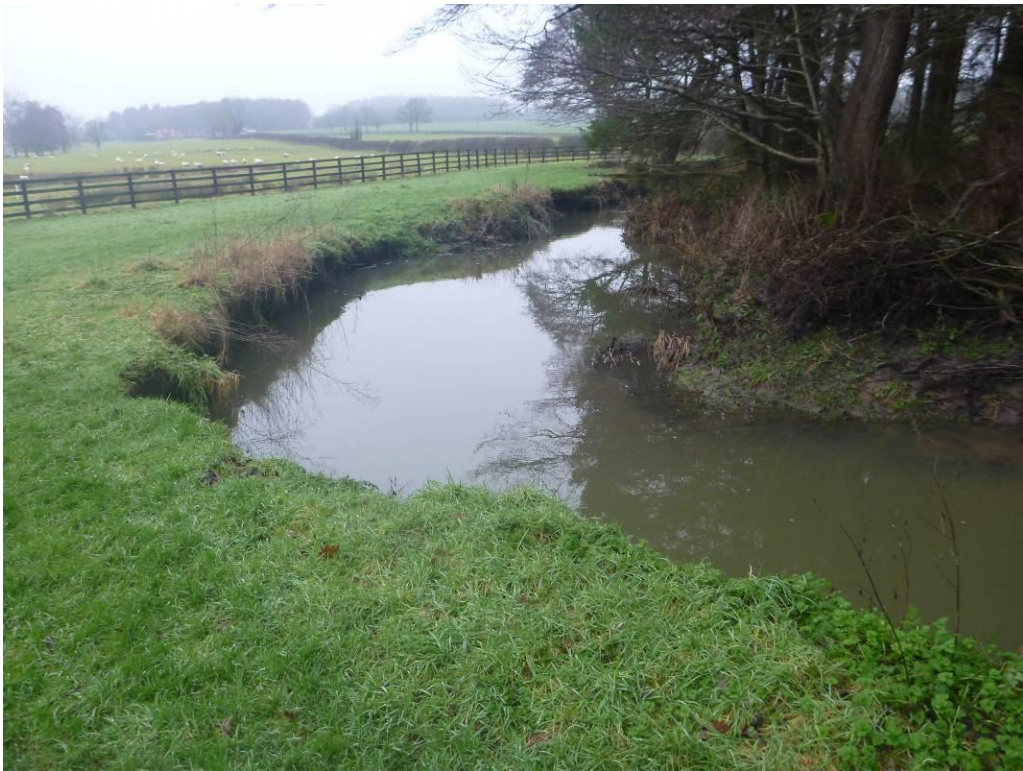
**Photo 28 Impounded reach above rock ramp in Photo 27.**

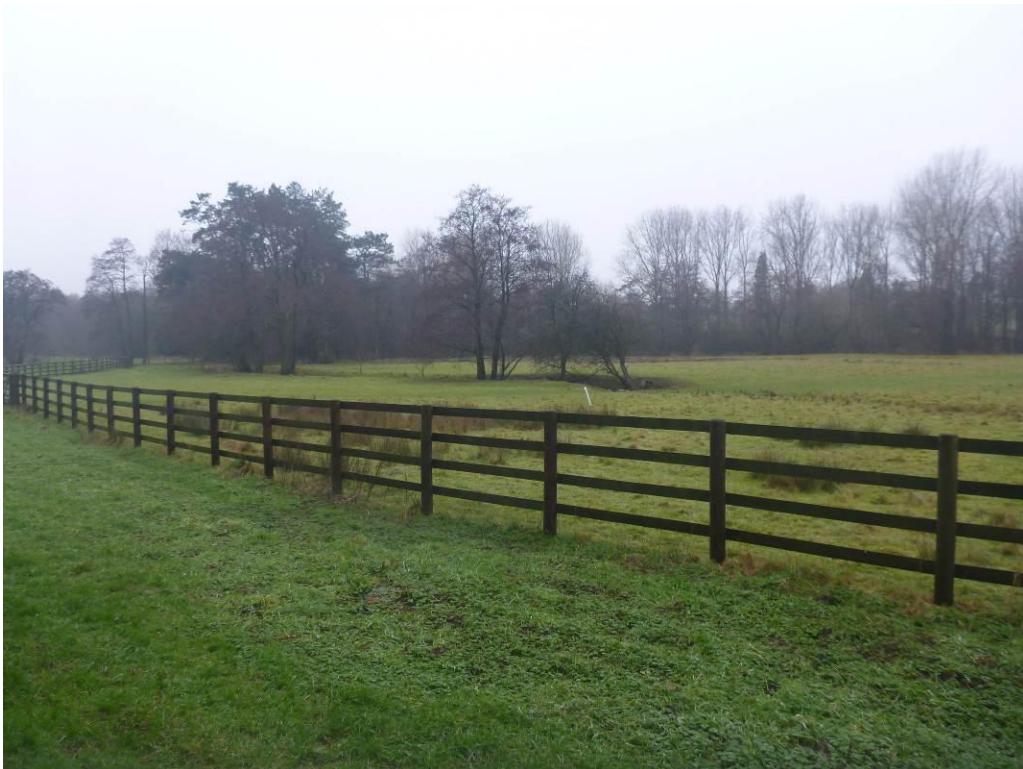
**Photo 29 Land on the right bank downstream of Blue Bridge that may have once been a former course of the brook.**

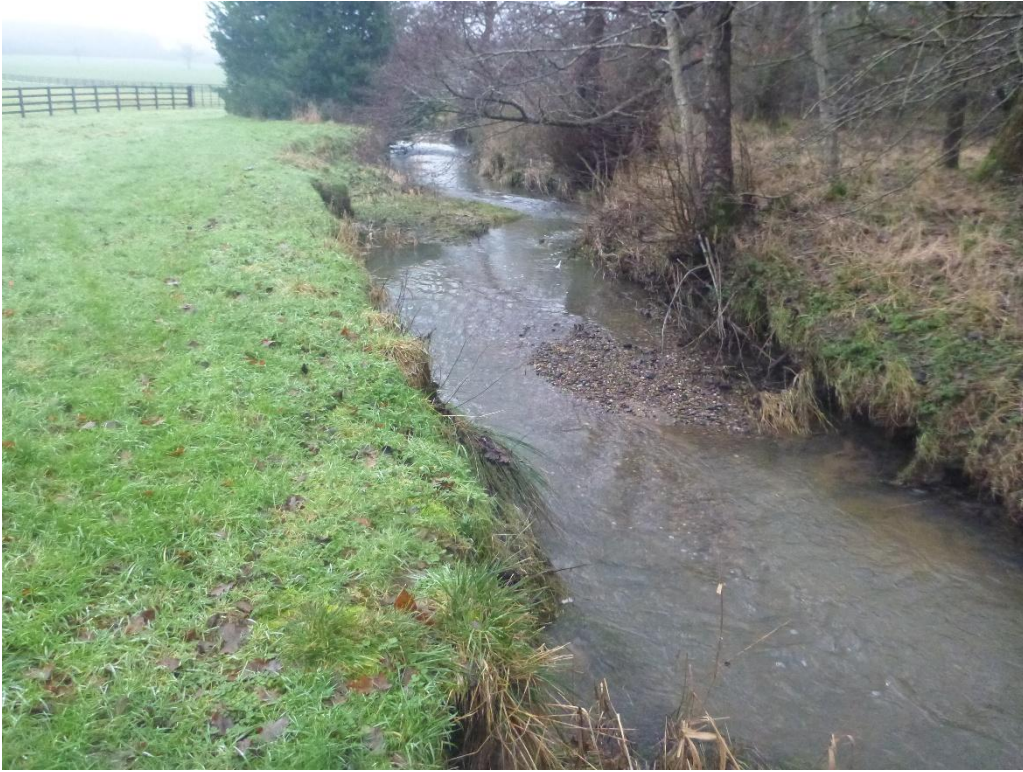
Beyond the Sandy's impoundment, better instream habitat has developed where some small weirs were removed around a decade ago ([Photo 30](#)), but this is quickly succeeded by a series of three boulder weirs which replaced the concrete beam types ([Photo 31](#)). These structures, along with the one immediately upstream of Blue Bridge ([Photo 33](#)) were retained as a precautionary measure to avoid the risk of scour to the bridge. With hindsight, the retention of these weirs was over cautious; there has been no major scour or erosion resulting from weir removal elsewhere. Their removal, particularly in conjunction with re-meandering the brook channel, would greatly improve habitat.

**Photo 30 Some better instream habitat where weirs were removed around a decade ago, above the impounded section in Photo 28.**

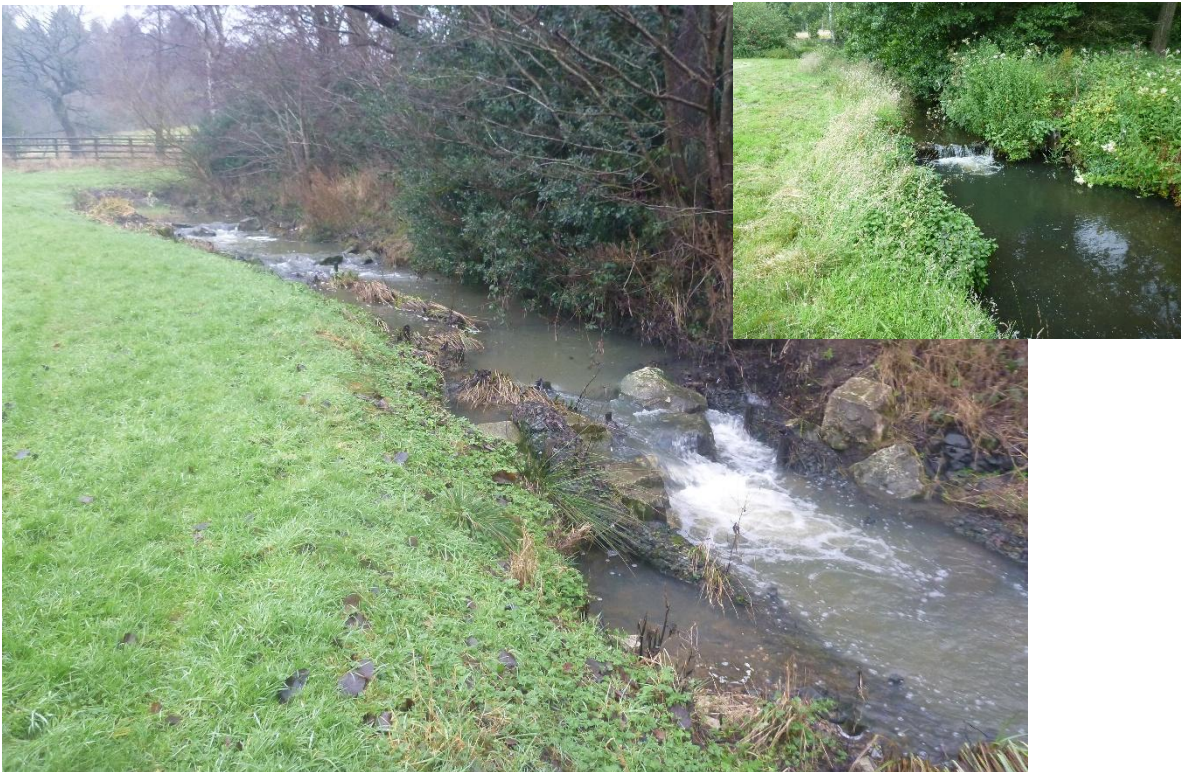
**Photo 31 Boulder weirs and the type of structure they replaced (inset).**

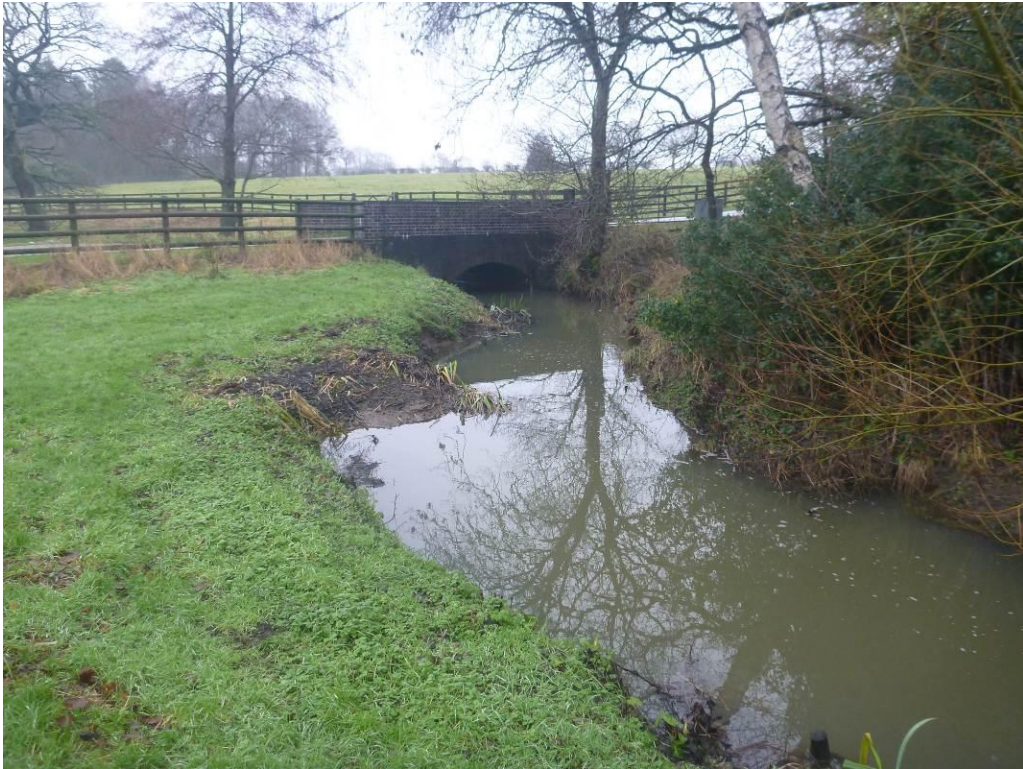
**Photo 32 Impounded reach above weirs in Photo 31 towards Blue Bridge.**
