**WILD TROUT TRUST**  
wildtrout.org

**Advisory Visit**

**Brailsford / Spinneyford Brook, Derbyshire**

**January 2026**

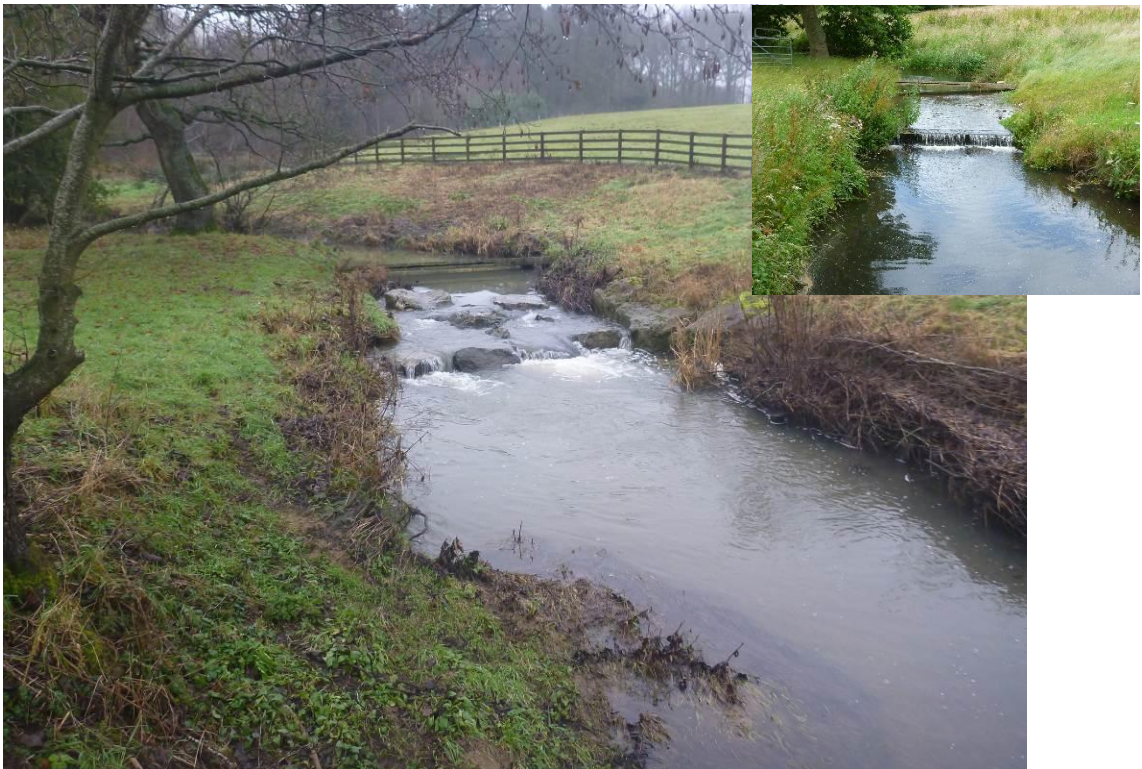
**Photo 33 (52.989597,-1.6358706) Boulder weir immediately upstream of Blue Bridge, and structure it replaced (inset).**

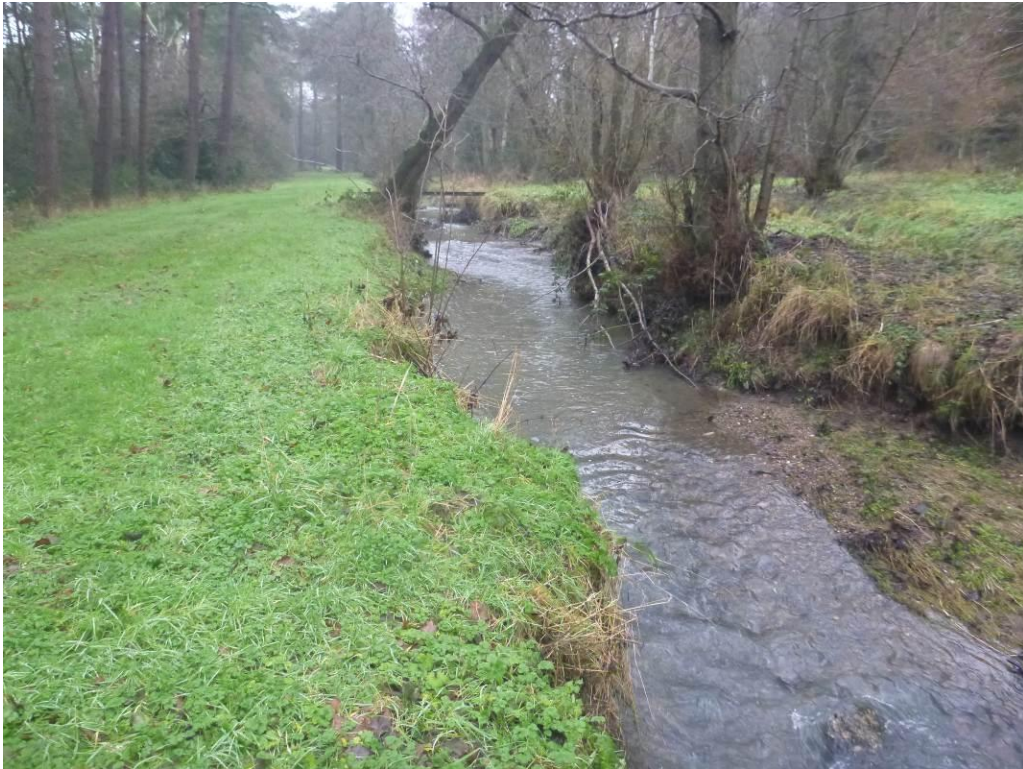
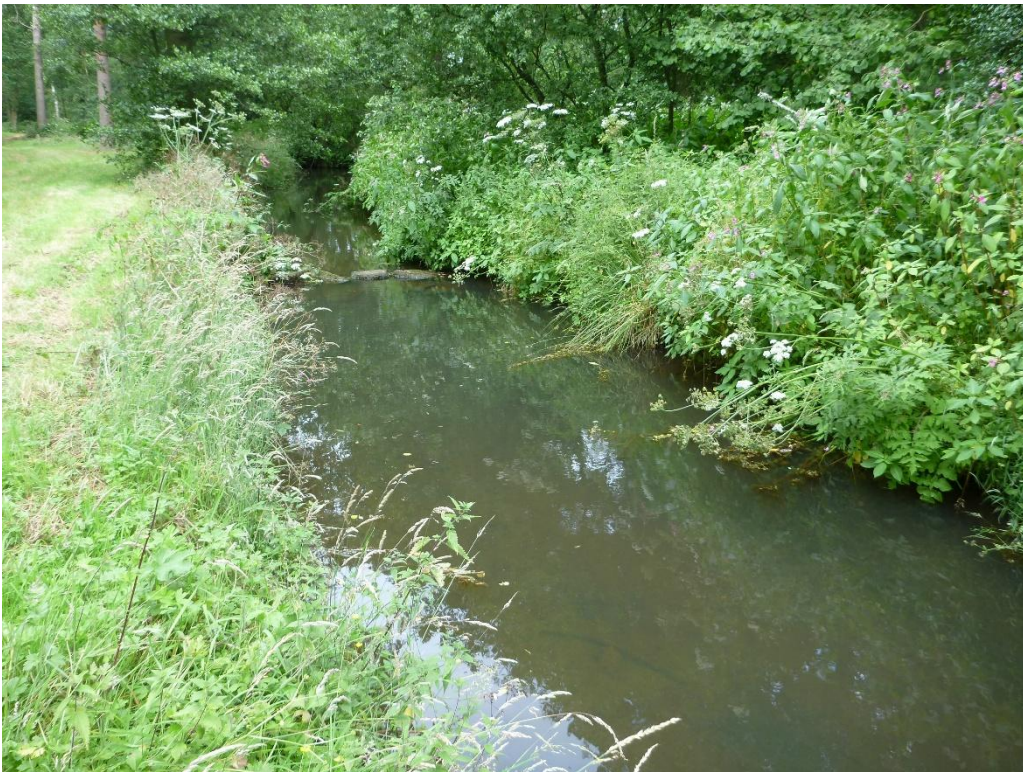
**Photo 35**

**Photo 34 (52.990879, -1.6354474) Artificially straight section from which a number of weirs were removed a decade ago, and below in 2015.**

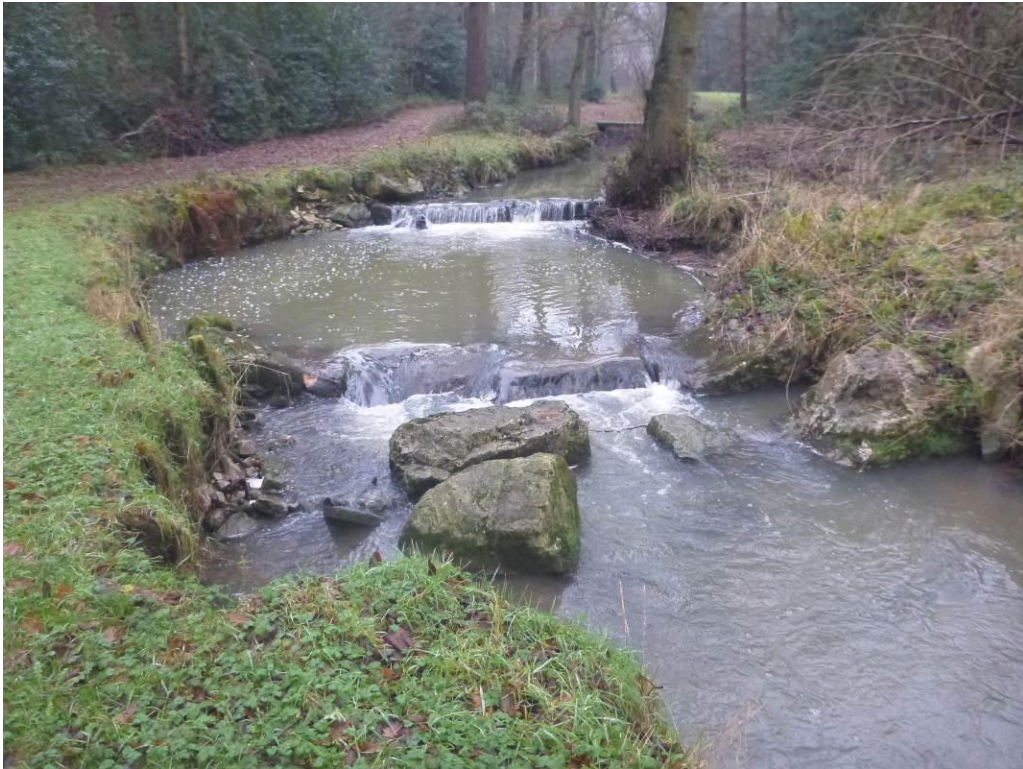
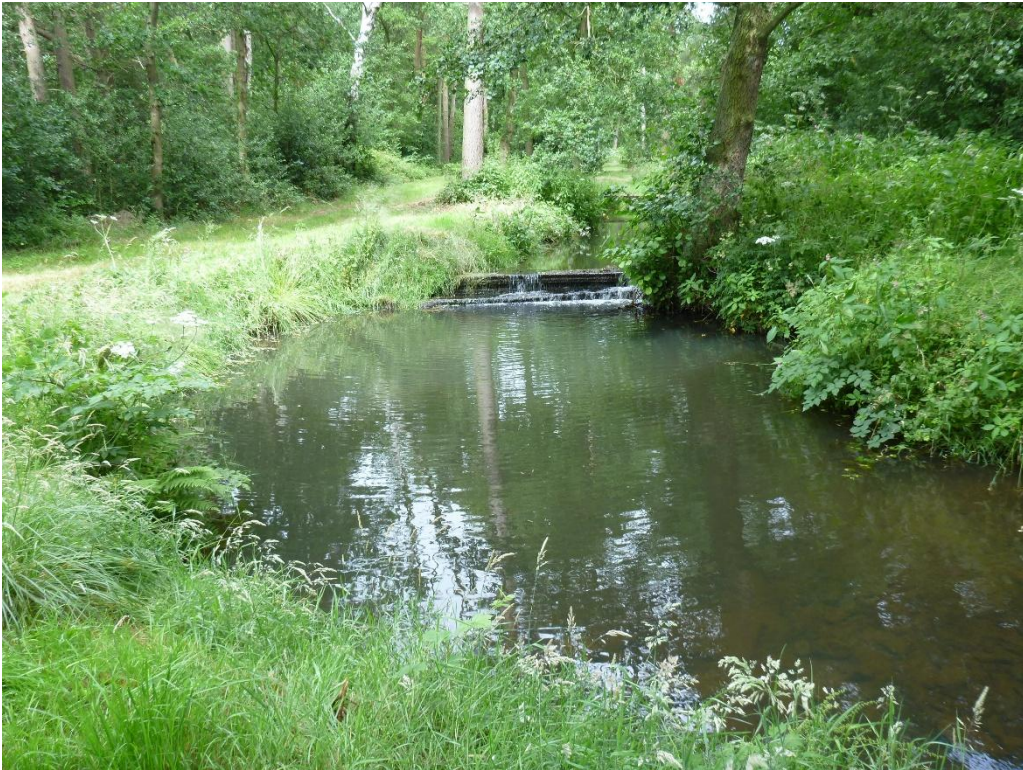
**Photo 37**

Photo 36 and Photo 37 show a weir now and a decade ago when many others were removed. This illustrates the issues caused by not removing all possible weirs; removal of just some weirs makes the remaining ones worse in terms of greater head loss and poorer fish passage, and attempts to improve this (notching, pre-barrages) are not working and/or impacting habitat quality. Another example is illustrated in Photo 41 - Photo 44. Given former concerns over headcutting and channel stability proved unfounded, re-visiting the removal of the remaining weirs is recommended, alongside the introduction of multiple, large-scale LWM structures, bank reprofiling and (if possible) re-meandering.

**Photo 36 (52.991435, -1.635491) A retained weir and subsequently constructed boulder pre-barrage (foreground), and the same area in 2015 below.**

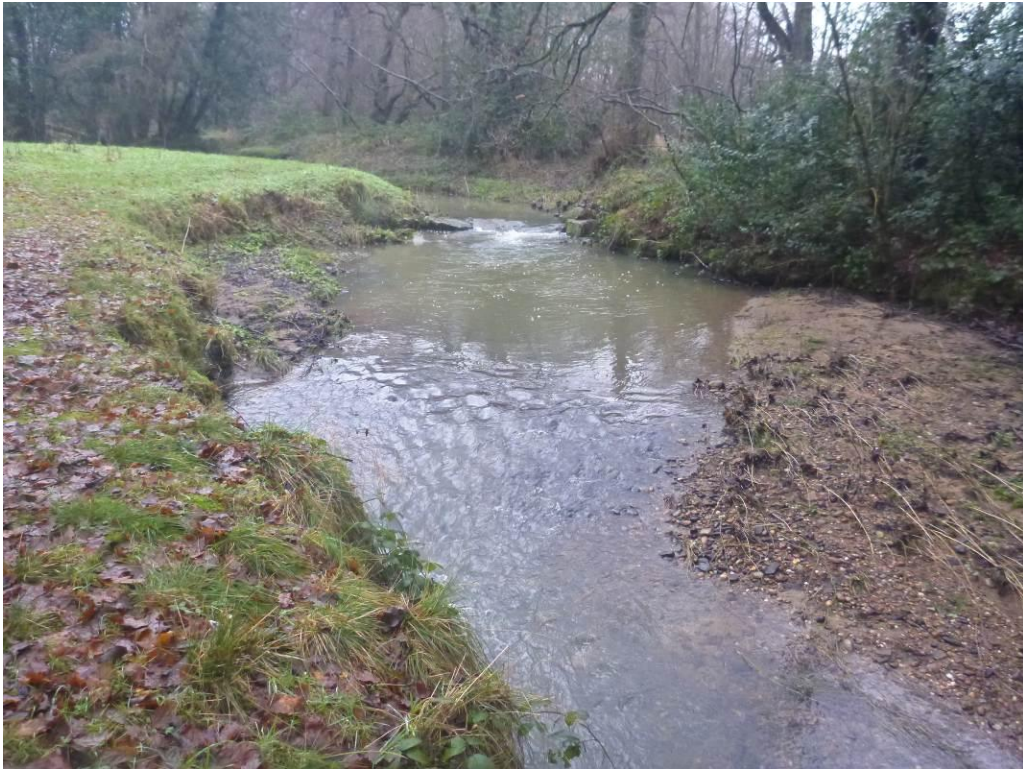
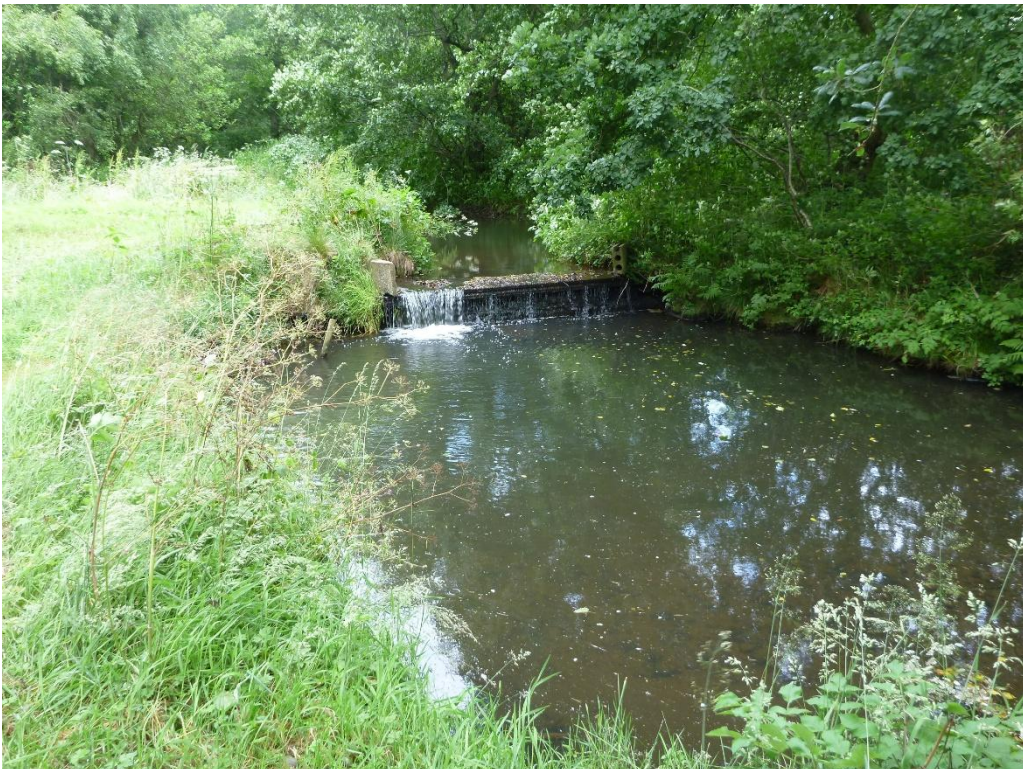
**Photo 39**

**Photo 38 (52.991990, -1.635546) Partially removed weir and the same area in 2015 below.**

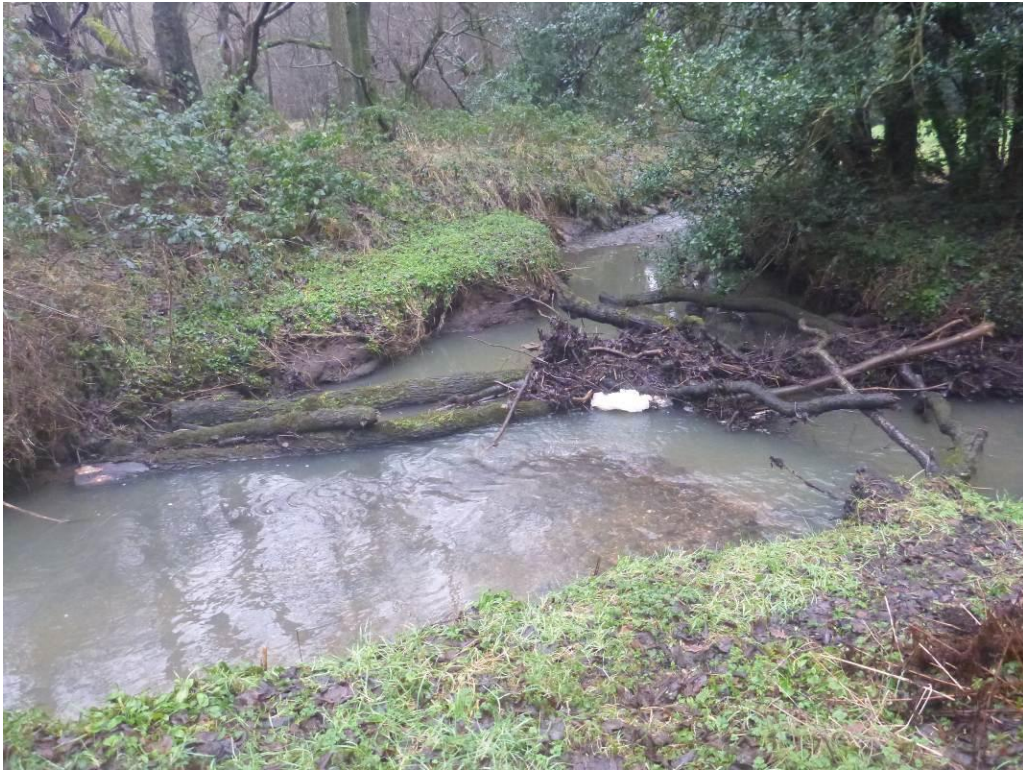
**Photo 40 (52.992360, -1.635636) Introduced LWM forming a nice feature with bed scour at a point where the channel bifurcates.**

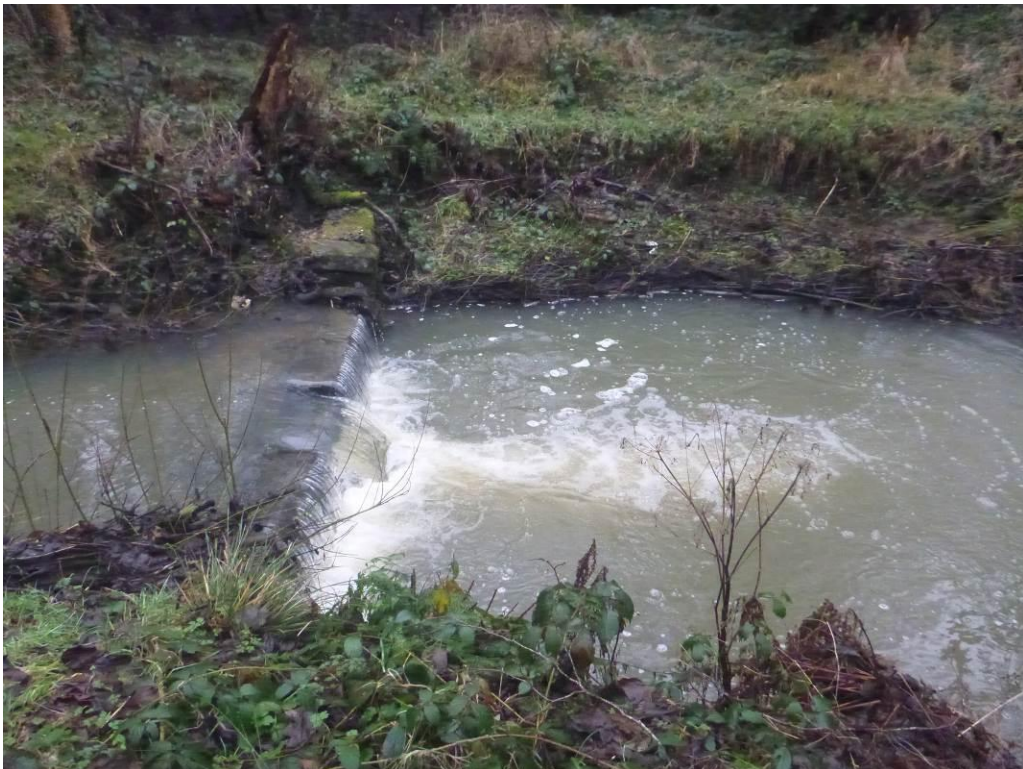
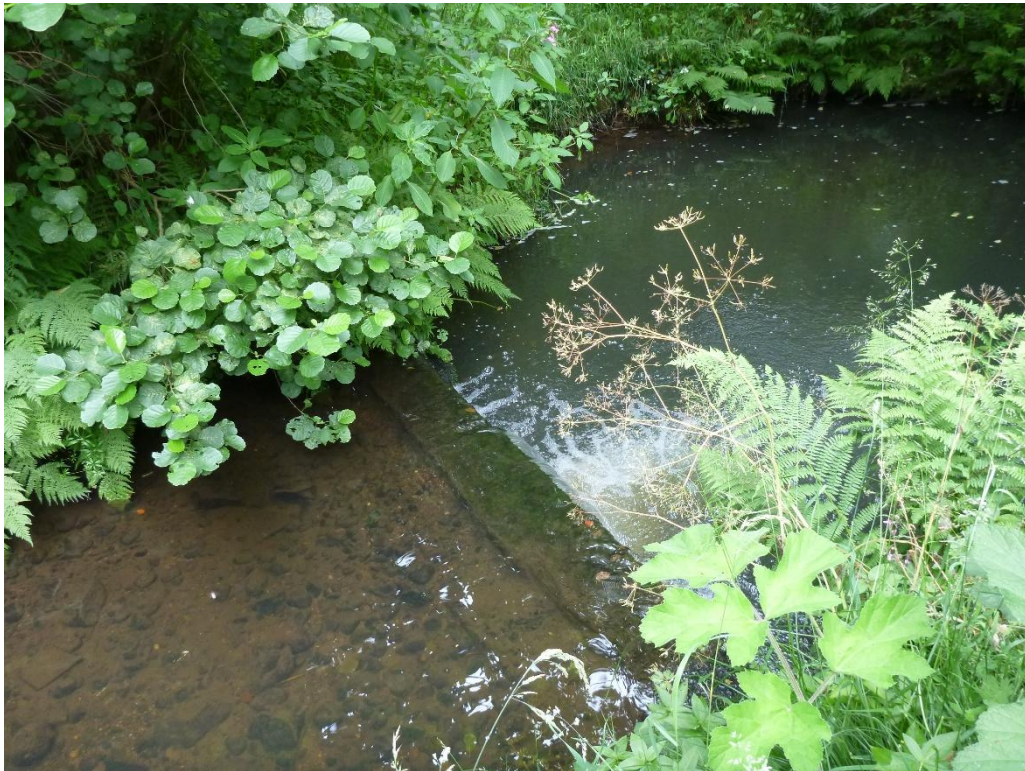
**Photo 42**

**Photo 41 (52.992452, -1.635620) Notched weir and same structure below in 2015 (Photo 42).**

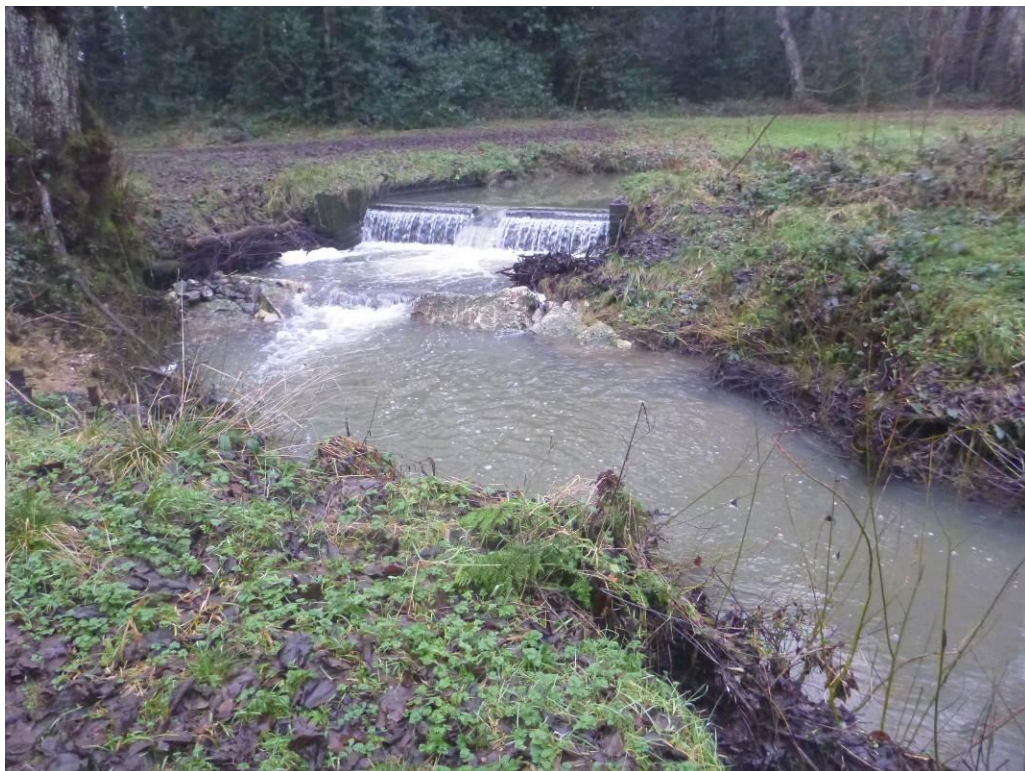
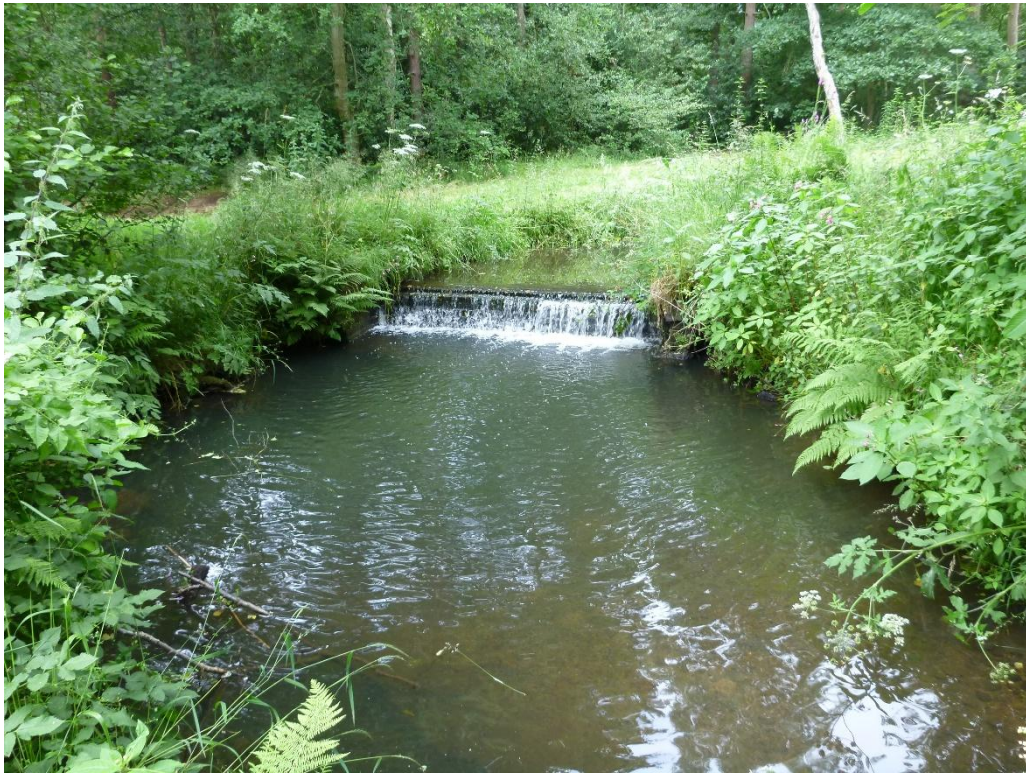
**Photo 44**

**Photo 43 (52.992460, -1.635787) Notched weir and pre-barrage, and same structure below in 2015 (Photo 44).**

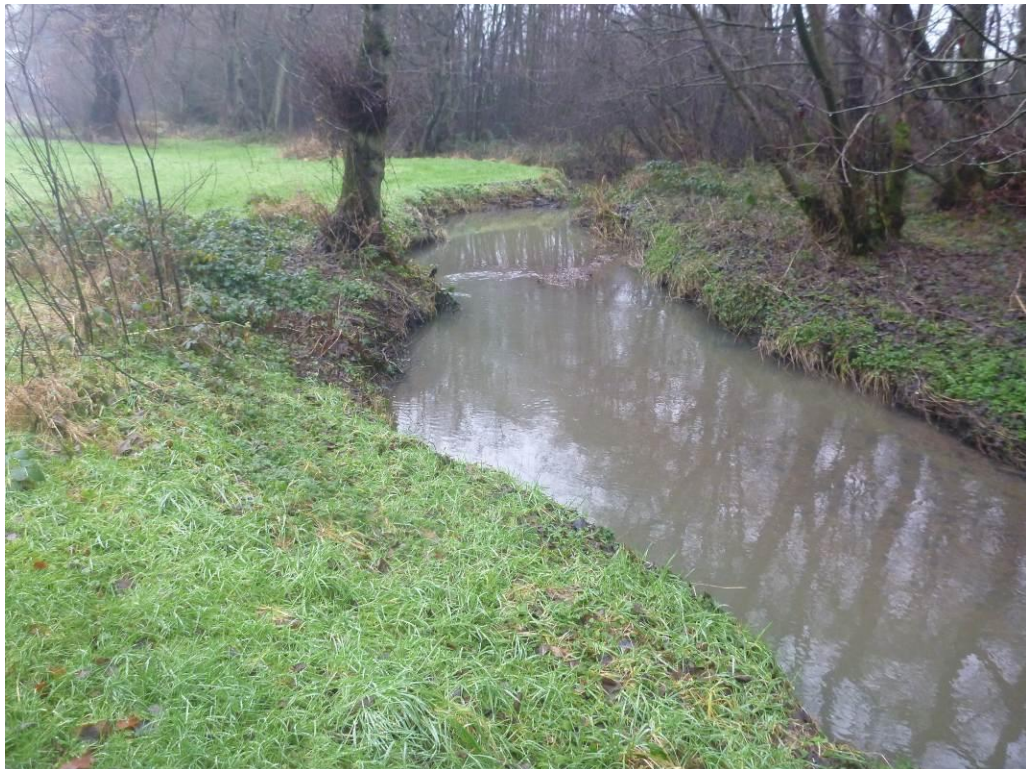
**Photo 45 (52.992893, -1.635654) Impounded section upstream of weir in Photo 43...**

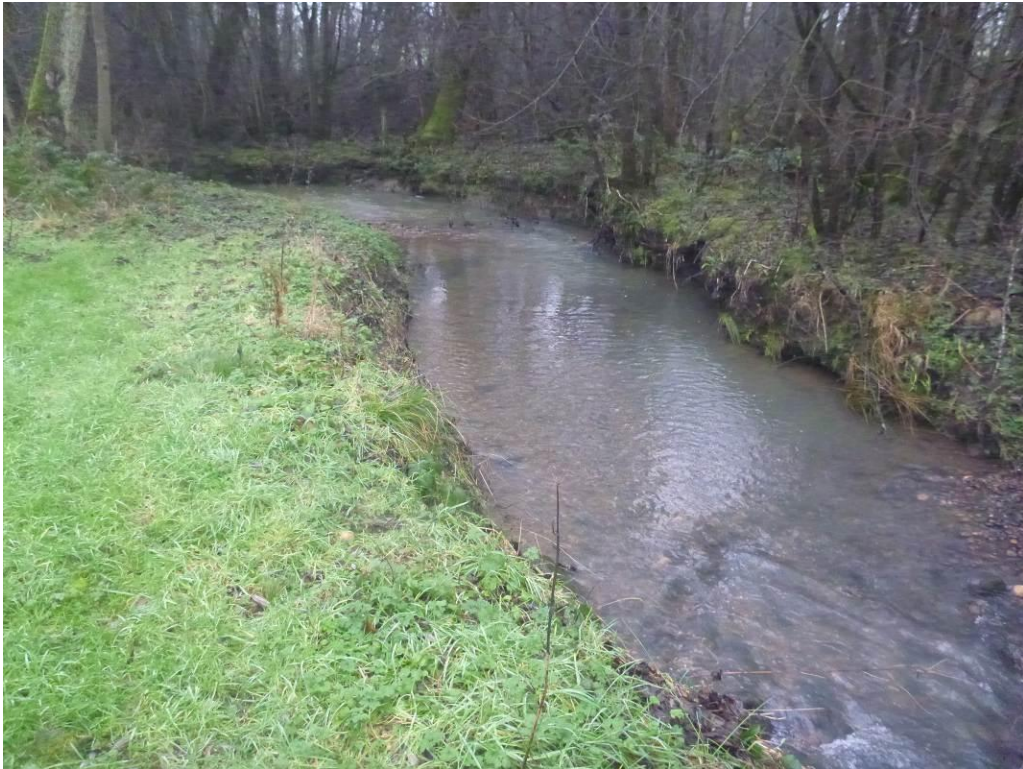
**Photo 46...and a little further upstream where small weirs were removed post-2015....**

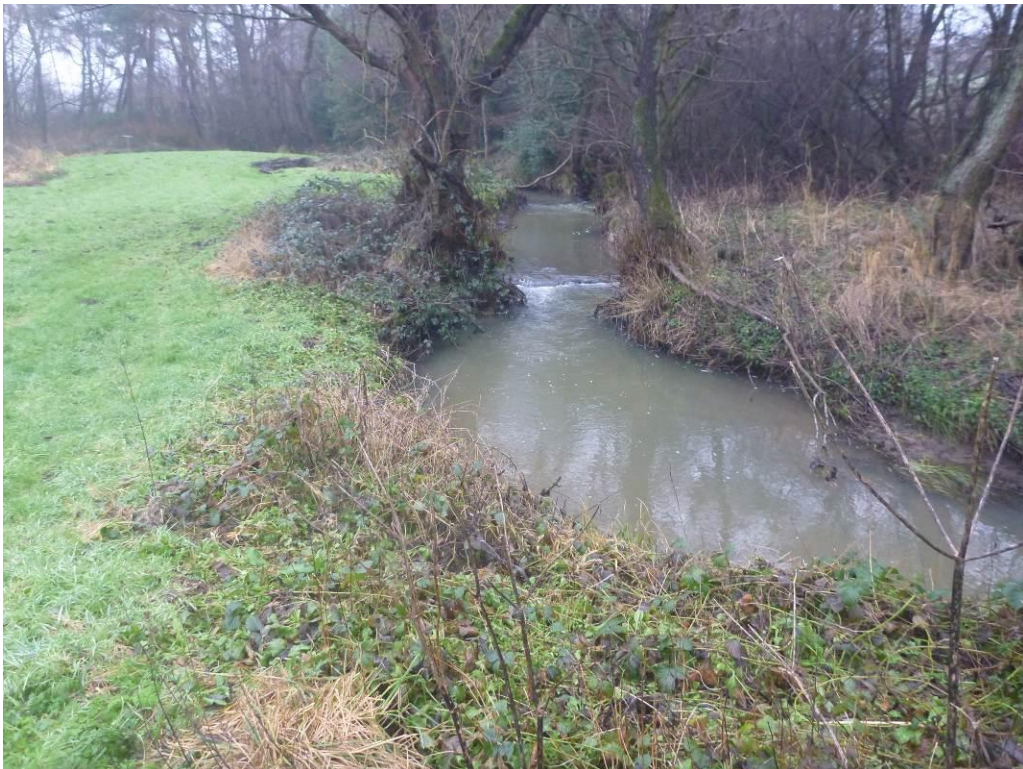
**Photo 47...but some small weirs remain alongside Secret Lake.**

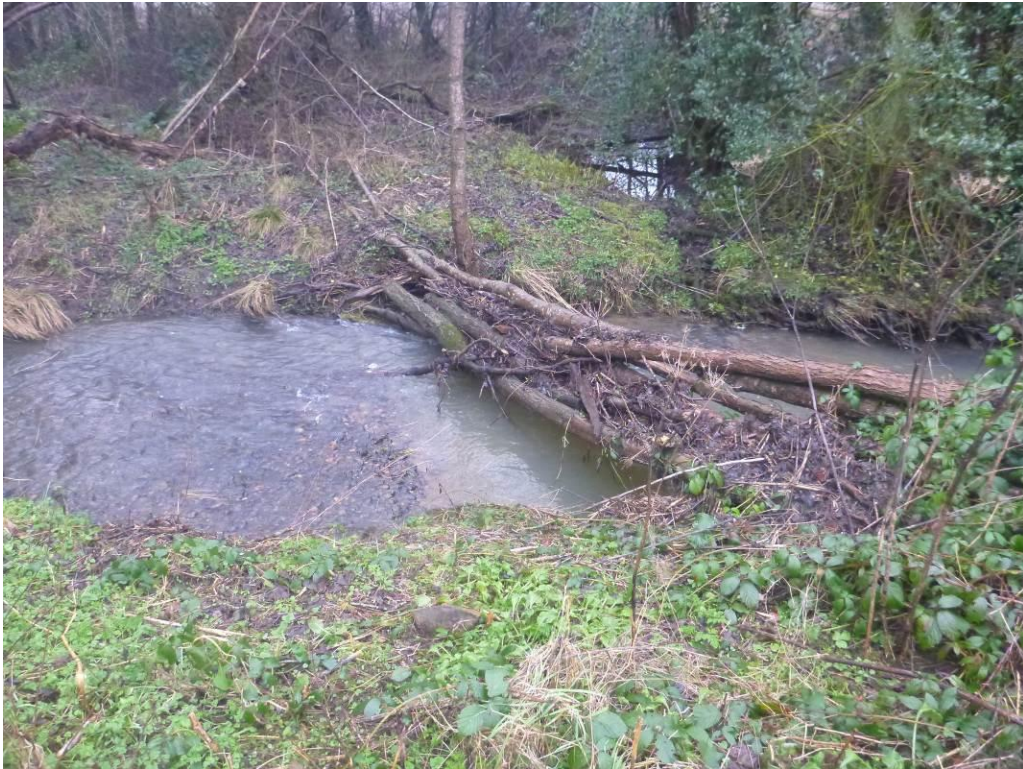
**Photo 48 Introduced lodged LWM forming an excellent cross-channel feature, driving bed scour, depth variation and substrate sorting.**

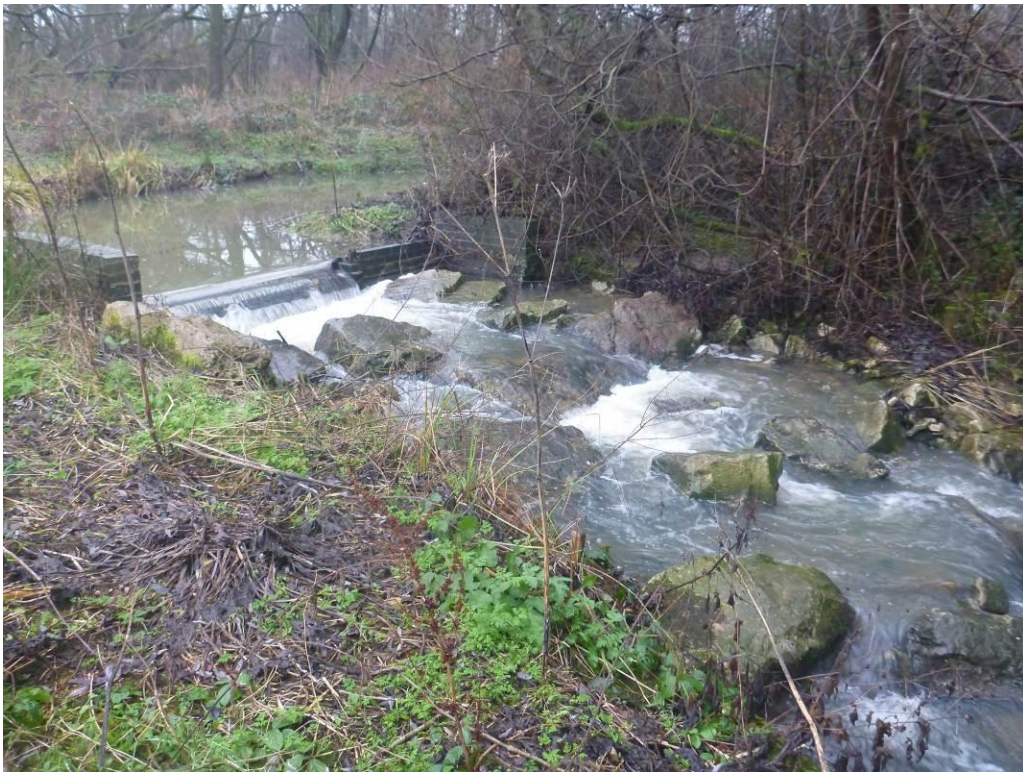
The rock ramp at Secret Lake offtake does not reach the crest level of the weir here, impeding fish passage (Photo 49). The simplest solution is to remove brick courses from the weir if this doesn't compromise the lake inflow (now controlled by a new penstock). Otherwise, the top of the rock ramp should be built up to drown out the weir crest.

**Photo 49 (52.994224, -1.635426) Rock ramp installed downstream of the weir maintaining water levels for Secret Lake offtake.**

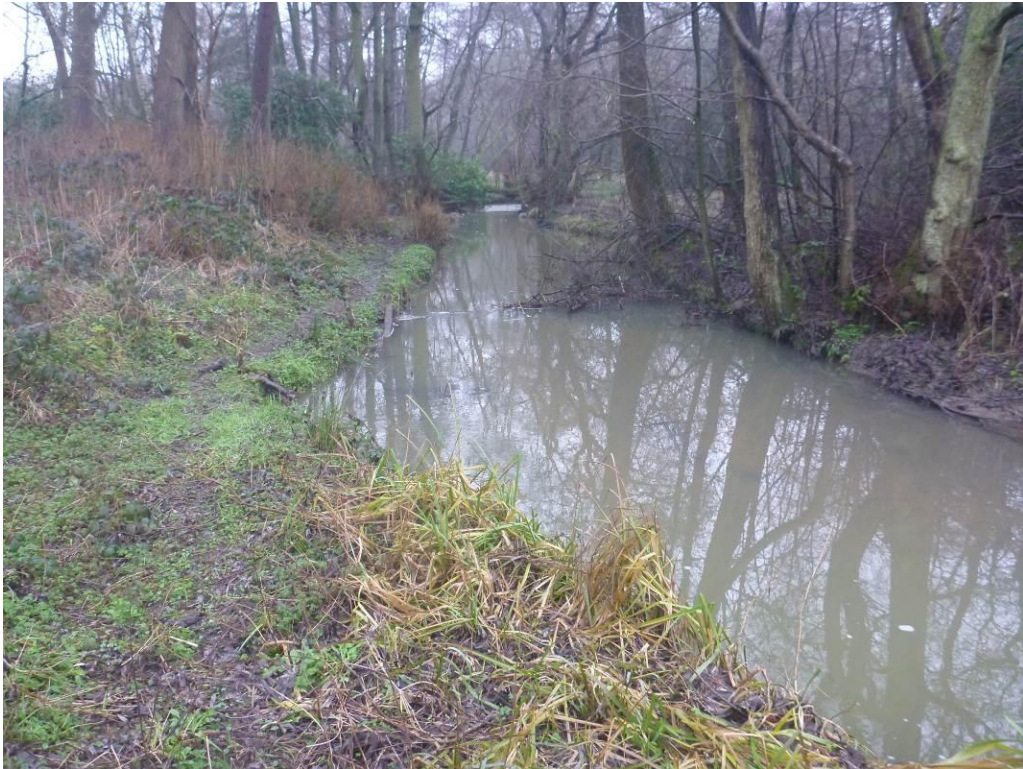
Beyond the impounded reach above Secret Lake (Photo 50), the brook has generally good in-stream habitat which is compromised by the presence of multiple low weirs. The weirs are in various states of repair, of similar construction (hollow concrete panels) to those found elsewhere on the Estate and now largely removed (Photo 52 - Photo 53). The brook is bordered by high quality riparian habitats as recognised above (Photo 51) and crossed by a public footpath which includes wooden walkways and a footbridge.

**Photo 50 Impounded length above Secret Lake offtake, low weir visible in background.**

It is recommended that the weirs are removed to reinstate natural river processes and realise the potential for excellent in-stream habitat here. This must be done with proper regard to the Local Wildlife Site (LWS) and its irreplaceable habitats, and it is recommended that a method statement is developed in consultation with interested parties – Derbyshire County Council is responsible for both the Local Nature Recovery Strategy (LNRS) and issuing the Ordinary Watercourse Consent which is required for weir removals. Derbyshire Wildlife Trust are a partner in the LNRS and would be a good starting point for consultation.

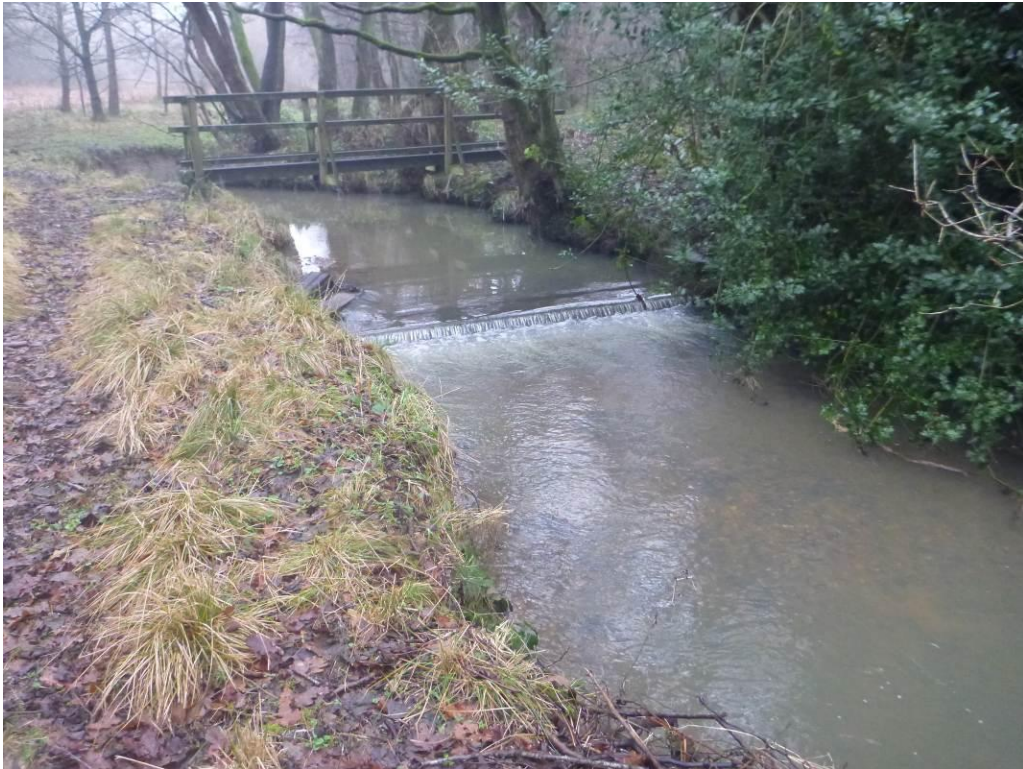
**Photo 52 Public footpath bridge and one of numerous weirs.**

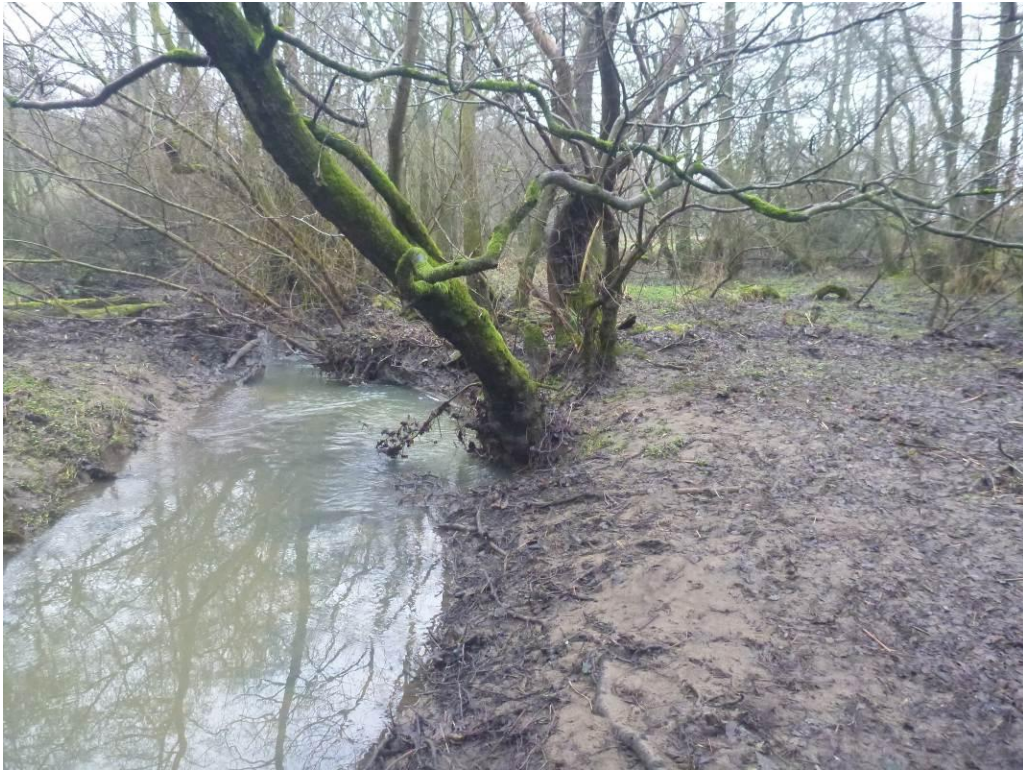
**Photo 56 View downstream from above the feature in Photo 55, showing flood flow pathway to the right and deposition of fine sediment on the floodplain.**

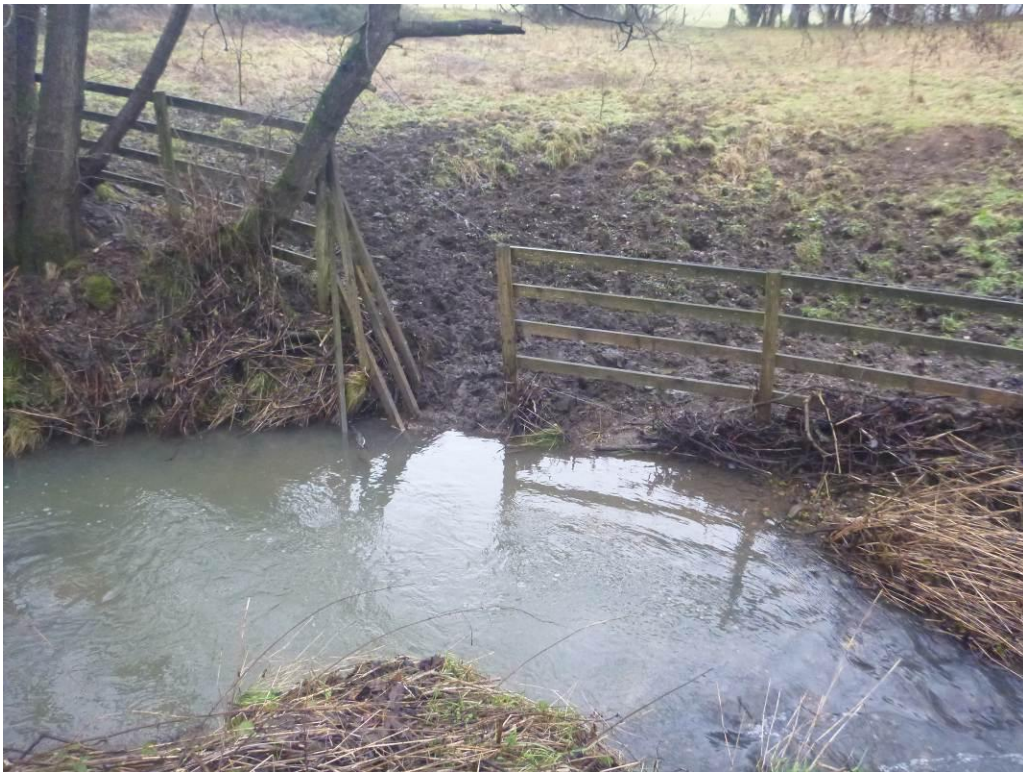
Just downstream of the lake, livestock poaching is occurring on the left bank and should be addressed to prevent ingress of fine sediment to the watercourse (Photo 57).

**Photo 57 (52.999580, -1.6330066) Livestock watering point is a source of fine sediment. Repair/set-back the fence and provide alternative watering, e.g pasture pump.**

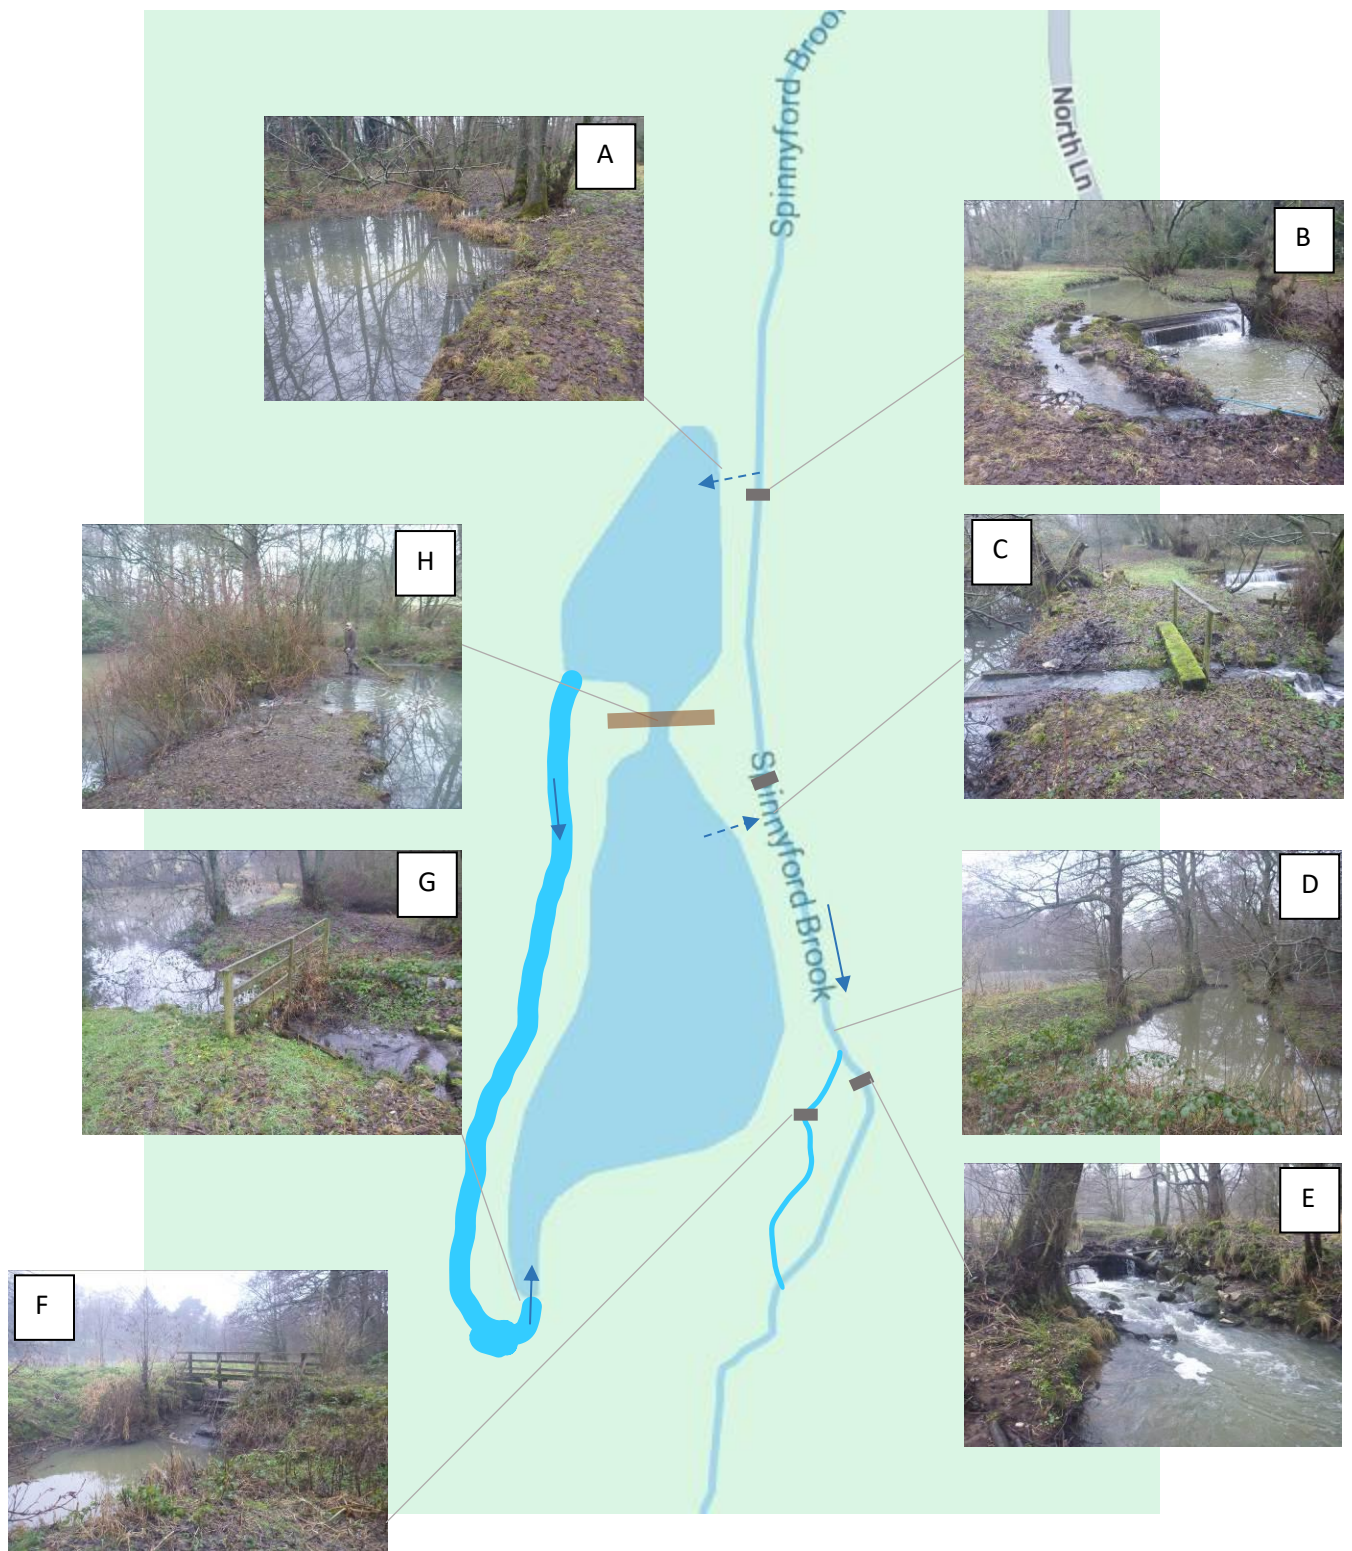
**Figure 1 Thackers Lakes showing flow paths. (A) piped inflow above weir (flow dependent on river level); (B) weir maintaining inflow level; (C) lake outflow (level dependent); (D) brook alongside lake; (E) weir at bifurcation of brook; (F) weir and footbridge; (G) inflow to main lake from top lake; (H) bund between lakes (overtopping at time of visit).**

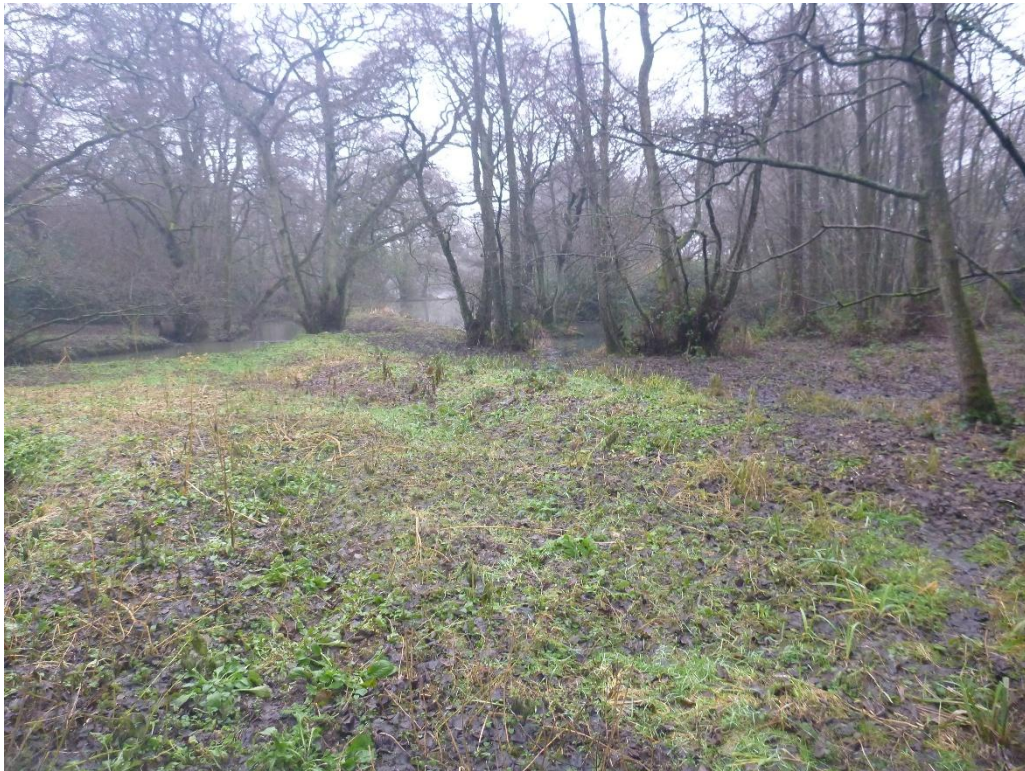
**Photo 62** Downstream view from above Thackers Lake (right), brook channel to the left. Bund in the foreground suggests the top lake was formerly more extensive and has silted and reverted to terrestrial habitat.

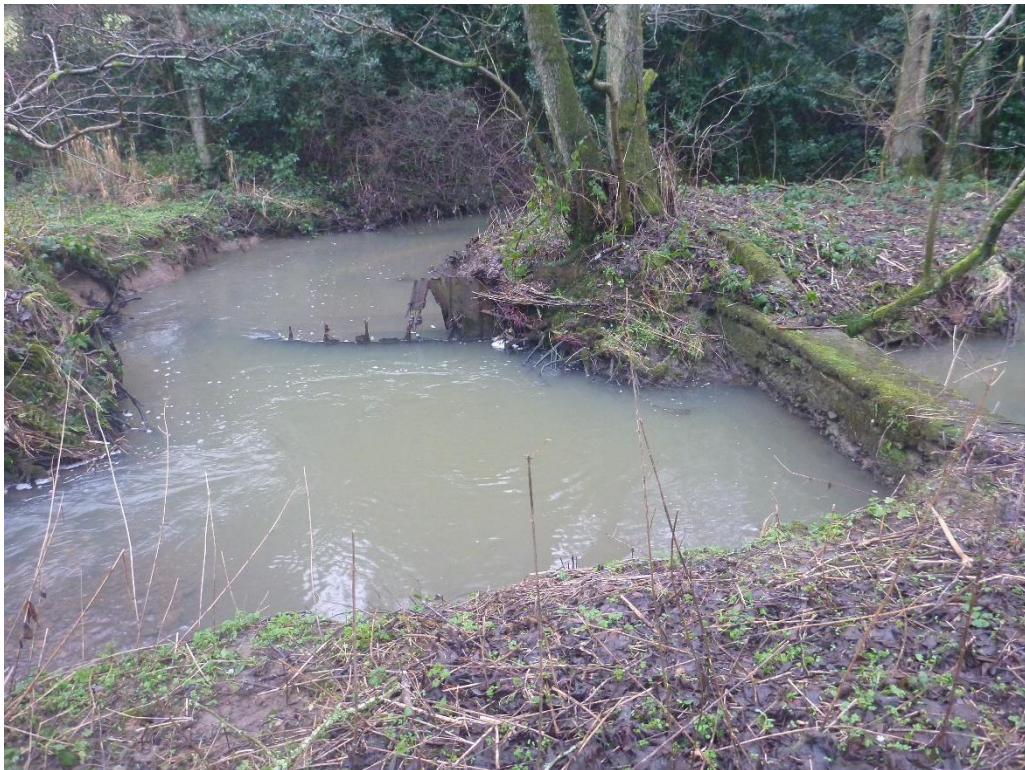
**Photo 63** (53.001672, -1.6333821) Channel bifurcation with weir (right) and remains of sheet piling (left).

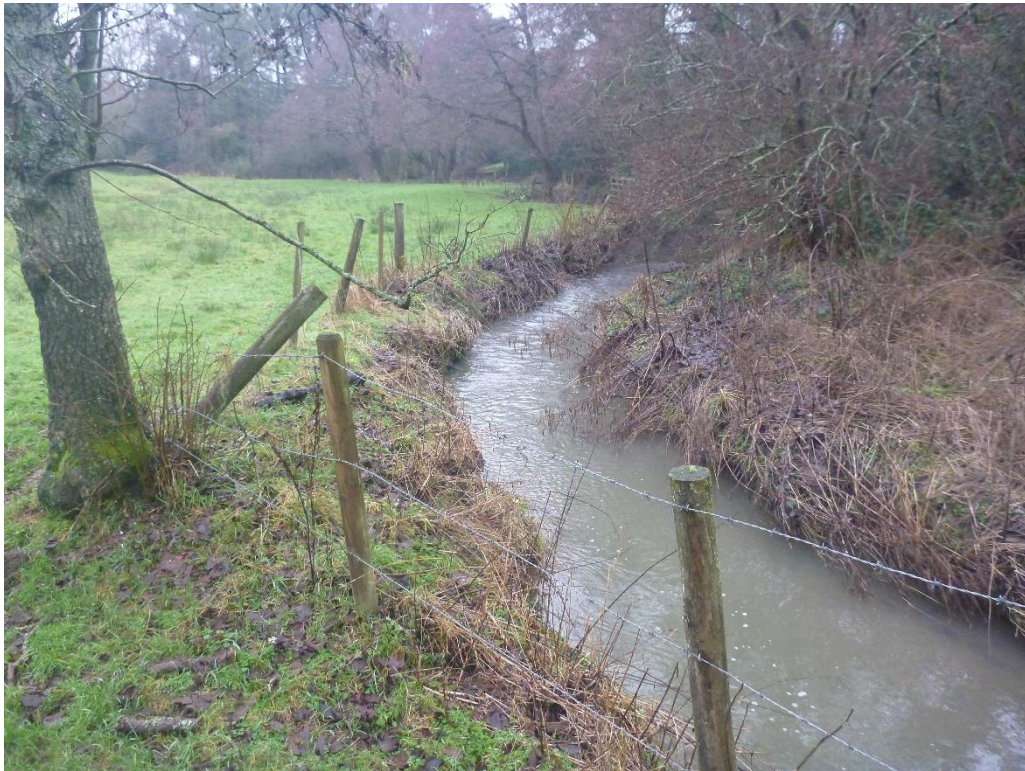
**Photo 64 Brook and final field towards the upstream boundary. Historic maps show the channel was realigned to its present course from a route in the field to the west (left of shot), which is clearly visible on LiDAR maps (below).**
