WILD TROUT TRUST

Advisory Visit

Duerley Beck (Ure)

for Ure Dales Landscape Recovery, 2025

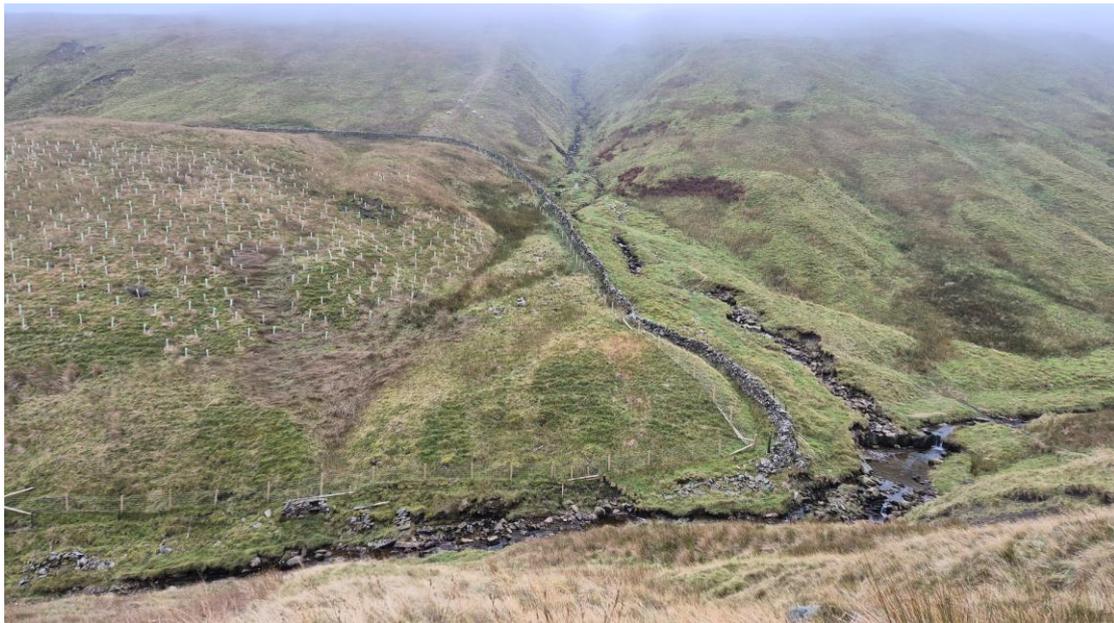
Fig 1: 54.260058 , -2.2282318. Most u/s point viewed on the system, where Parpin Gill joins with Bank Gill (right of shot) to form Duerley Beck. The southern boundary wall running adjacent to Parpin Gill demarcates the extent of a recent and extensive tree planting scheme across West Duerley Pasture.

- While this scale of tree planting is fantastic to see and will bring multiple benefits to Natural Flood Management and biodiversity in time, the new sheep-proof fence does little to benefit the beck directly. The beck remains exposed, eg to warming, and

prone to further riparian degradation by concentrating stock impacts in a narrower strip between the fence and the RB toe. See Fig 2, also.

- When examined closely, the formal 'tube-planting' actually stops 25-50m up-slope for the majority of the scheme, so even when fully mature, those trees will have negligible impact in terms of shade, shelter / cover, nor indeed woody material input, to the channel.

- Maximum impact would be achieved by encapsulating the beck within a livestock exclusion zone to reduce trampling, grazing and browsing pressure. Farming benefits include reduced loss of stock into the channel, especially during spate flow, and easier checking / gathering. A functional riparian zone acts as a buffer between the land and the water, increasing resilience to erosion, increasing hydraulic roughness, speeding up the natural recovery of channel proportions through colonisation and stabilisation of deposition bars, mitigating for climate change, and increasing physical diversity which begets biological diversity.

- Given the proximity of bedrock seams near to the confluence between Parpin and Bank gills, it should be possible to devise a watergate that could tie in to fencing of the LB for the full extent (ie down to the new watergate; Fig 12) at an appropriate distance set-back from the channel edge – ideally a workable contour line accounting for the bluffs etc d/s.

- A fully protected riparian strip to both banks would allow for augmented planting closer to the channel for more direct benefits to be realised sooner.

- There did not appear to be any tubes located within the rushy ghylls inside the fenced area, but such wet flashes could be peppered with willow whips, either harvested locally from goat willow further down the valley, or potentially used as reintroduction sites for rarer species like eared, purple or bay willow.

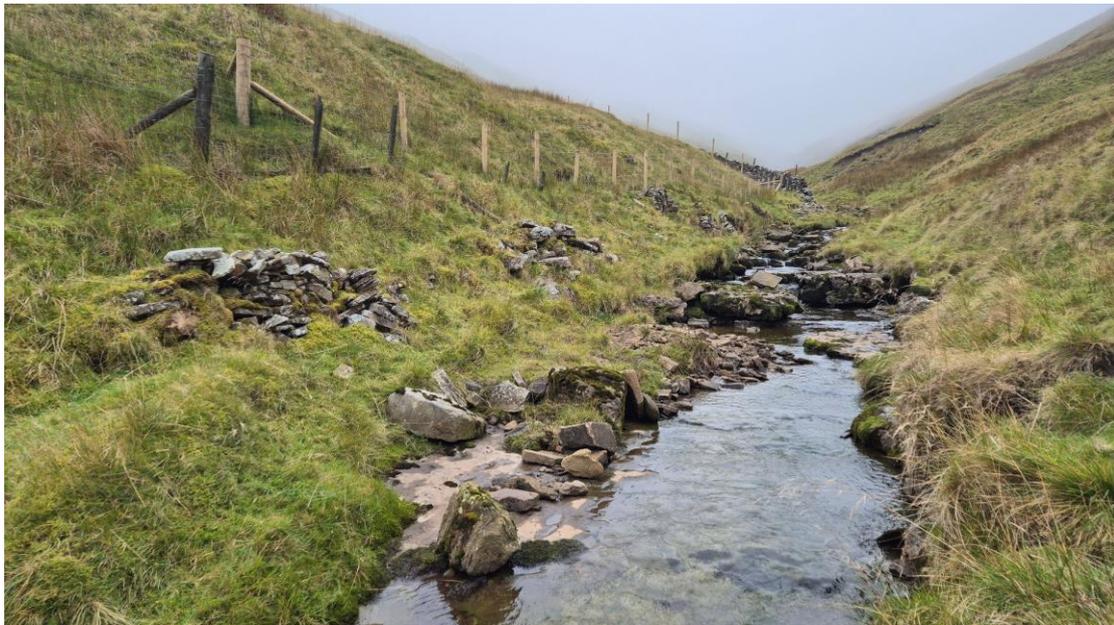
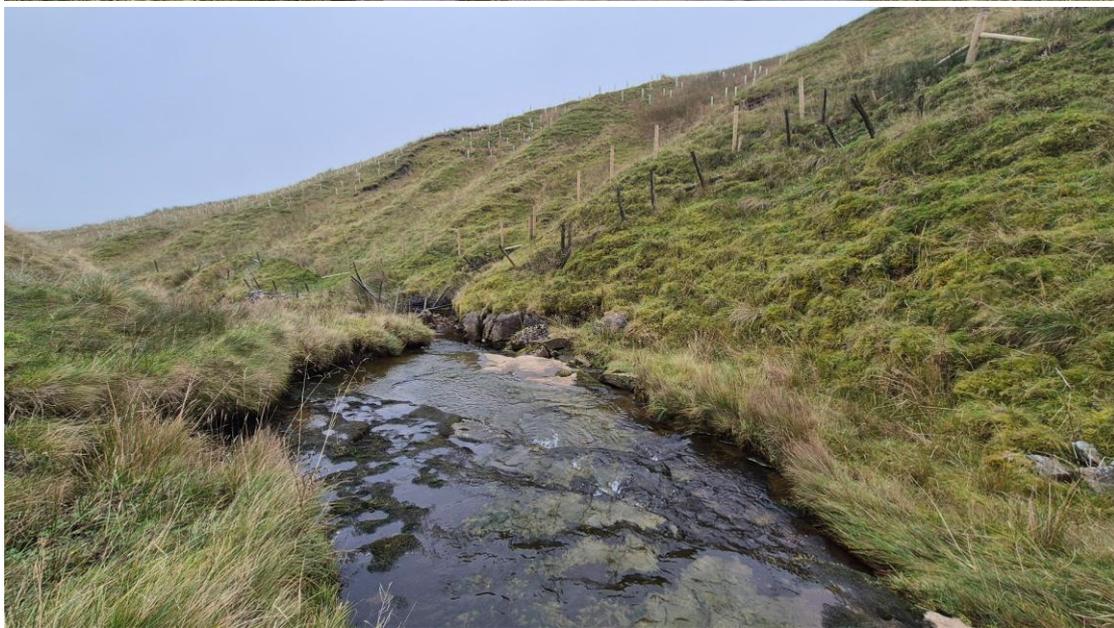
Fig 2: 54.260488 , -2.2274197 environs. Further images from beck level highlighting how the new and old fence can inadvertently focus livestock impact within a narrower strip, and also how far the planted trees are from the channel.

- See proposal at Fig 1 for full riparian zone restoration.

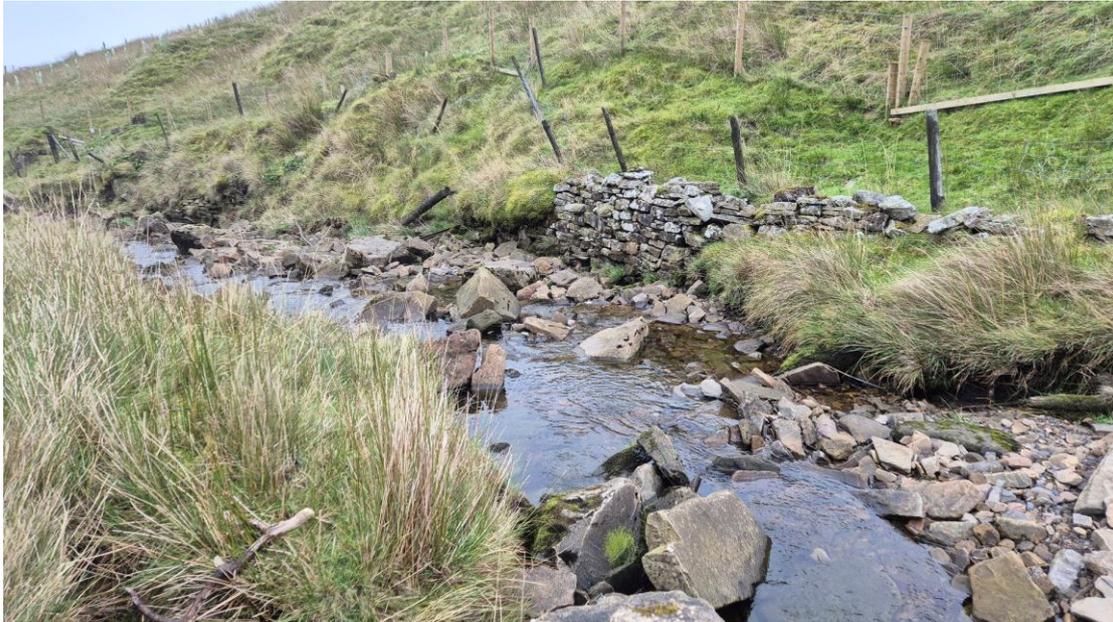
Fig 3: 54.260488 , -2.2274197 environs. Short section of walling which is no longer a functional boundary.

- It is most likely that such walls would have been created from stone taken from the adjacent channel, thereby contributing to incision.
- The legacy of a hard edge to the channel remains, potentially preventing natural processes of erosion and resupply of sediment to the channel.

- Wherever possible, such stone should be returned to the channel and allowed to redistribute naturally under spate conditions.

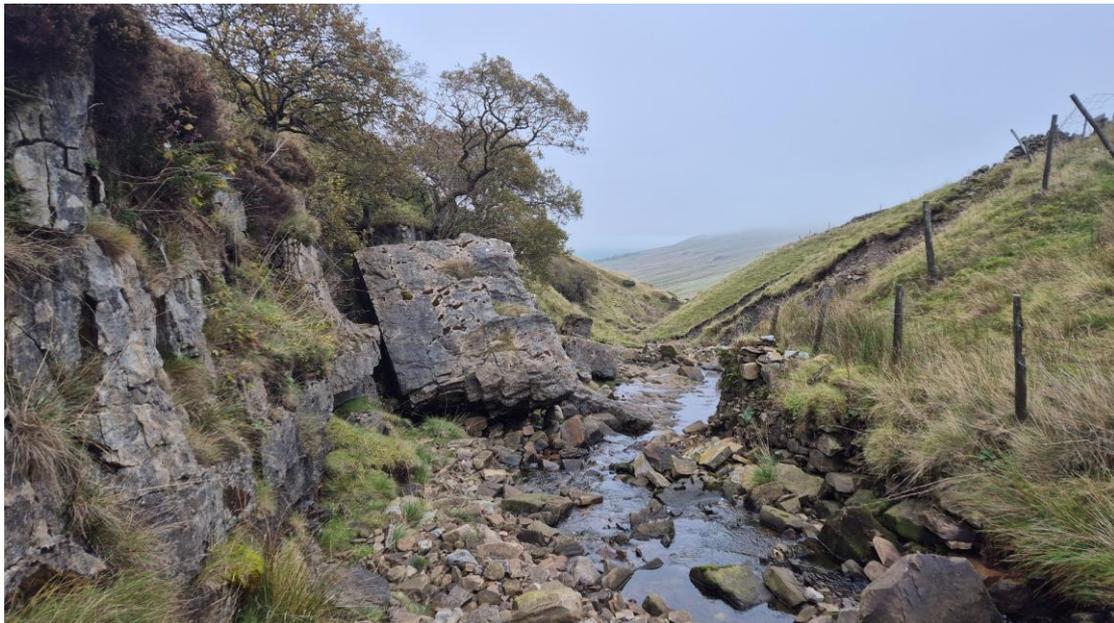
Fig 4: 54.261248 , -2.2267047. A more gorge-like section of limestone bedrock dotted with trees, ferns, lichens, mosses and native herbs (to the LB) and the old fence-line almost to the toe of the RB in the foreground.

- It was notable that on the d/s side of the old fence, where livestock had unfettered access to the steep slopes, there were more obvious signs of slippage; also, see Fig 5.

- The diversity of flora increased dramatically within the nooks and crannies of the limestone where sheep could not access.
- Further evidence for complete livestock exclusion to increase both bank resilience and floral diversity.

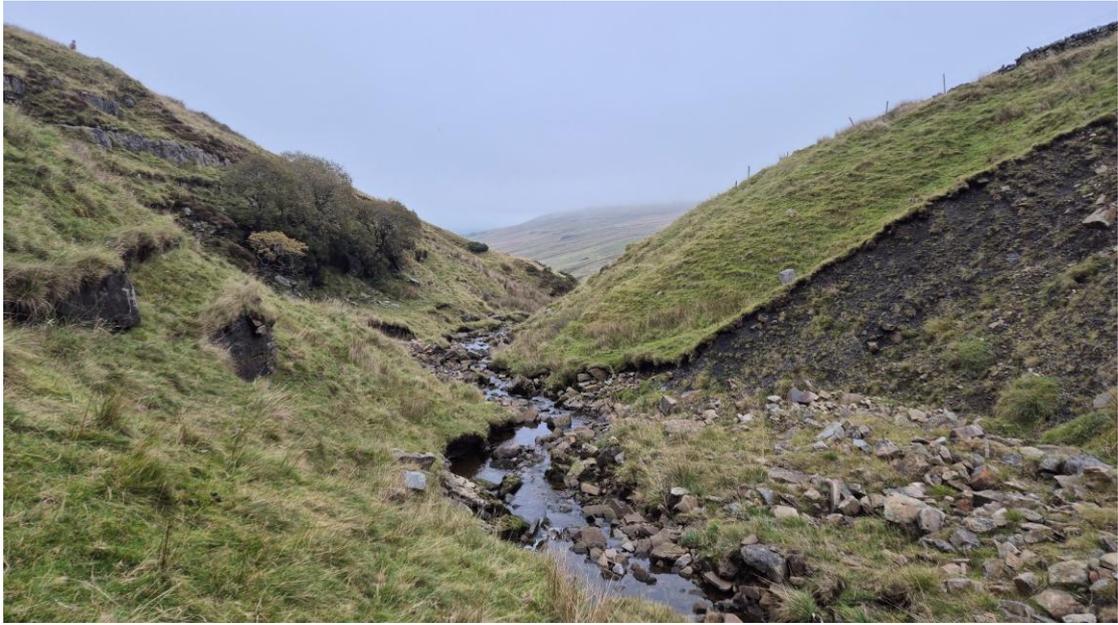
Fig 5: 54.261677 , -2.2262147. A landslip on the RB that had probably been precipitated or exacerbated by livestock impact on the steep slope. The input of stone to the channel had caused some localised meandering, and certainly had created a miniature floodplain of reprofiled material at the base of the slip. However, recolonisation, and hence stabilisation of both the slip and deposited material was being compromised by continued livestock access.

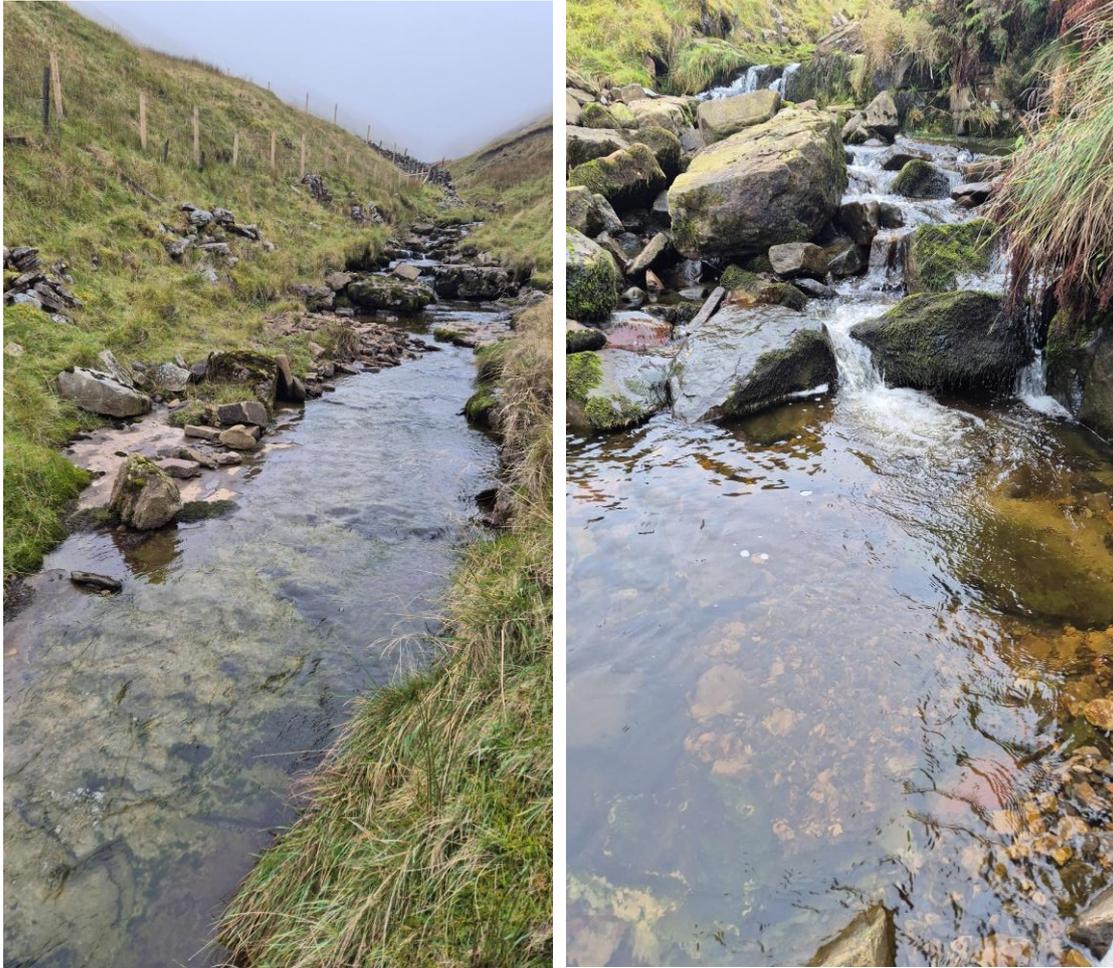
Fig 6: 54.476705 , -1.8037865 environs – water quality appeared good based upon the clarity, colour, and lack of biofilm on the gravel.

Combined with the diversity of substrate sizes, the habitat appeared capable of supporting brown trout and white clawed crayfish, though none were directly observed and there was no evidence of otter spraint or discarded chelae.

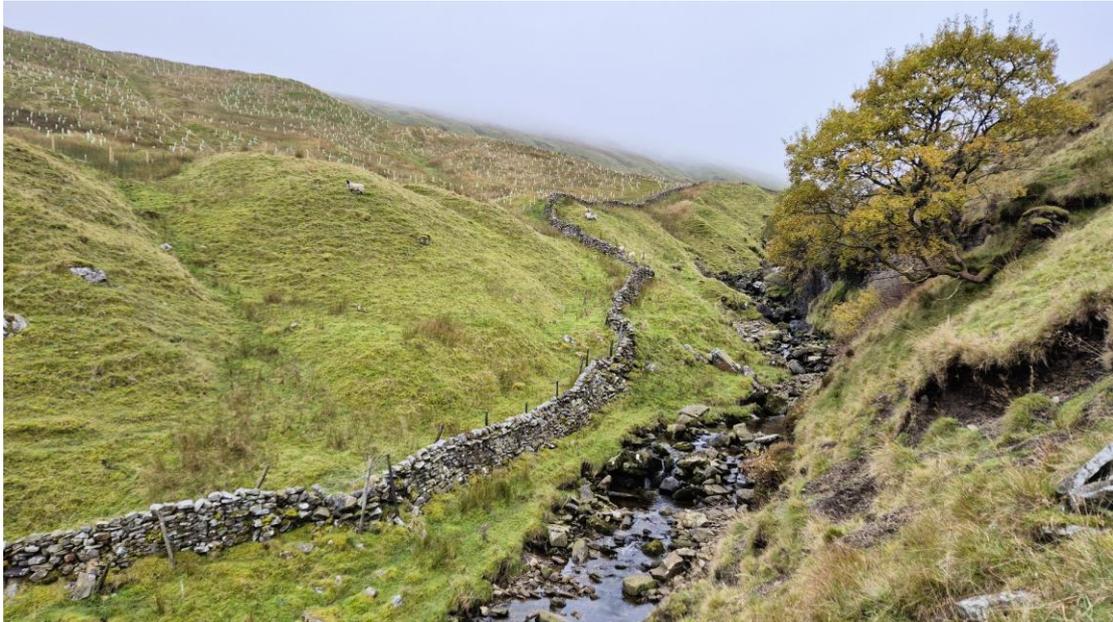
Fig 7: 54.263628 , -2.2239502. Looking u/s, another example of the distance of planting from the beck, the precarious nature of the narrow strip between the wall and the channel on the RB prone to damage from livestock tracking (see also Fig 11), and erosion / slippage on the LB caused by sheep constrained to cross at this point.

- The wall & top-fencing could form the boundary of a riparian buffer on the RB (allowing for grazing of the pasture in between the wall and the planted parcel above) if the LB could be fenced as previously noted.

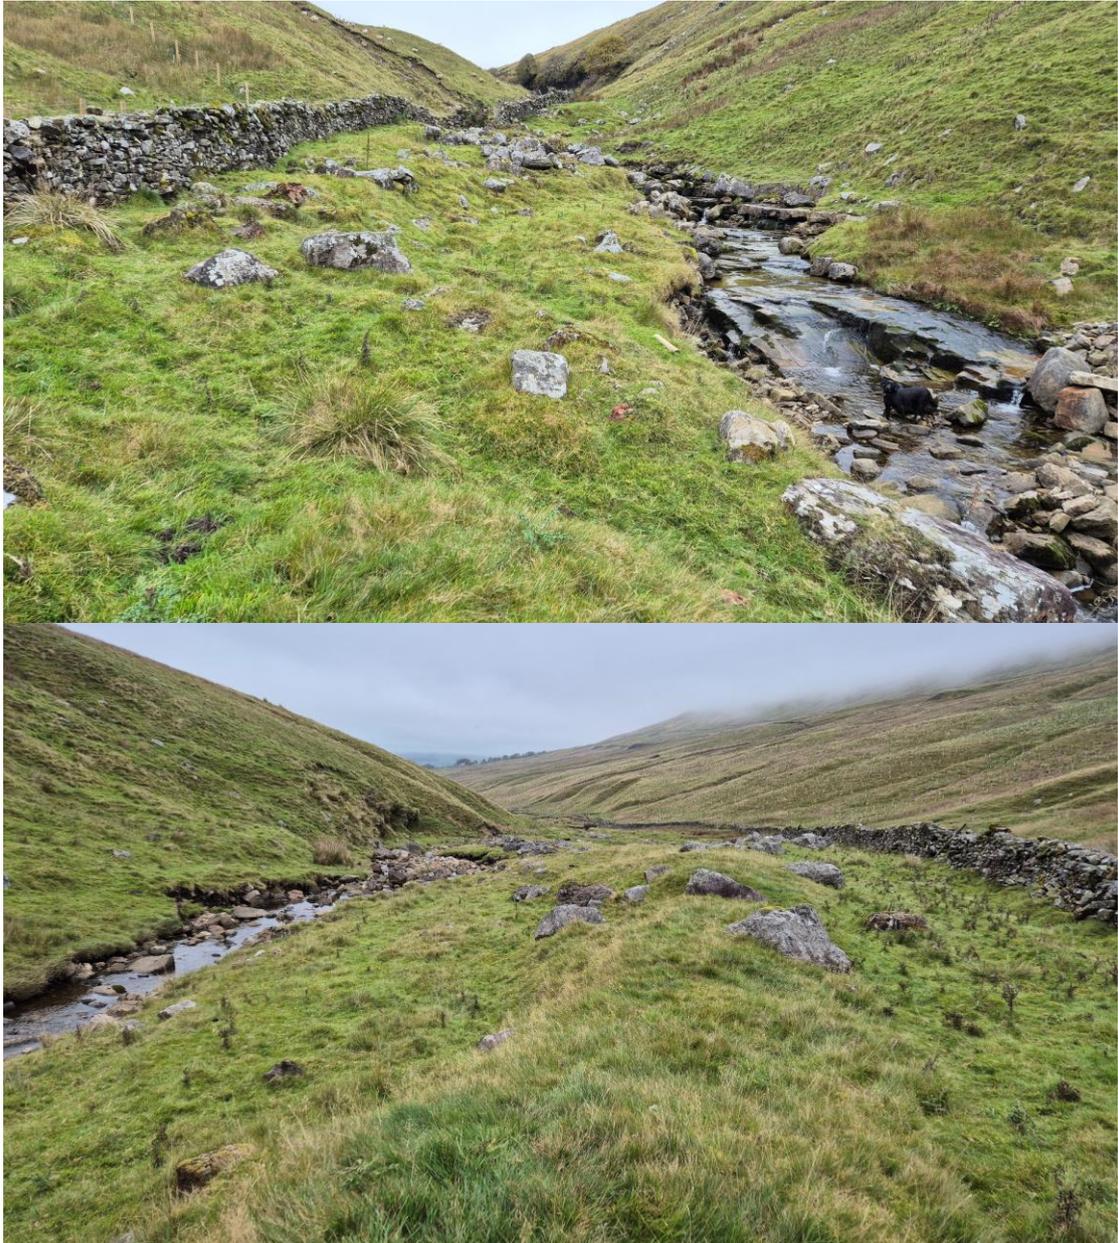
Fig 8: 54.264444 , -2.2224961 environs. From this point in a d/s direction, there were notable piles of limestone boulder which appear to have been dredged from the channel and used as embankment to keep the channel on a straighter, realigned course.

- A straighter channel is shorter, steeper, and more erosive, conveying water d/s more quickly during spates (and thereby increasing flood risk in Hawes) and conversely draining the water away more effectively in summer when retention would be beneficial.

- With appropriate plant, sort through the embankment to separate stone from sod and soil. Return the stone to the channel from whence it came and utilise the sod to re-cover the bare soil.

- Returned stone can be used as:
 - a dispersed matrix to subtly raise the bed level throughout a reach
 - a more densely-structured raised riffle to better connect the channel with the floodplain
 - clusters placed to one side and/or alternate sides of the extant channel to accentuate sinuosity and meanders.
- Wherever a paleochannel has crossed the extant channel, explore opportunities for better reconnection.

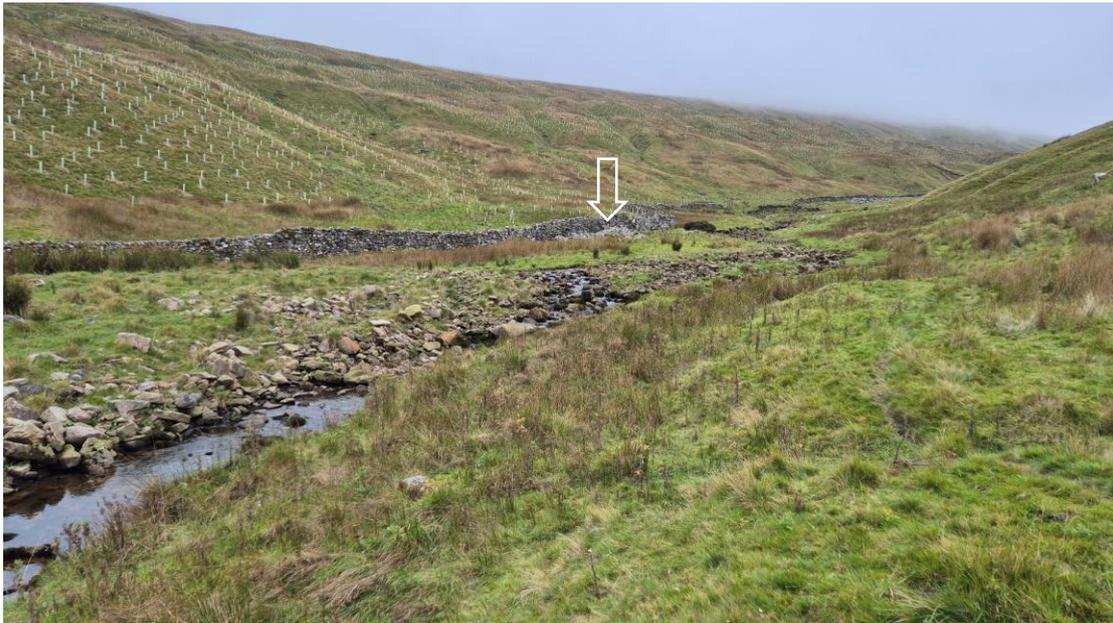
Fig 9: 54.265161 , -2.2217331. Looking u/s at the RB and extent of dredged and embanked material, as well as a pile of limestone boulder placed to the wall side (white arrow).

- Return stone to the channel as above, and let the beck redistribute it naturally over time.

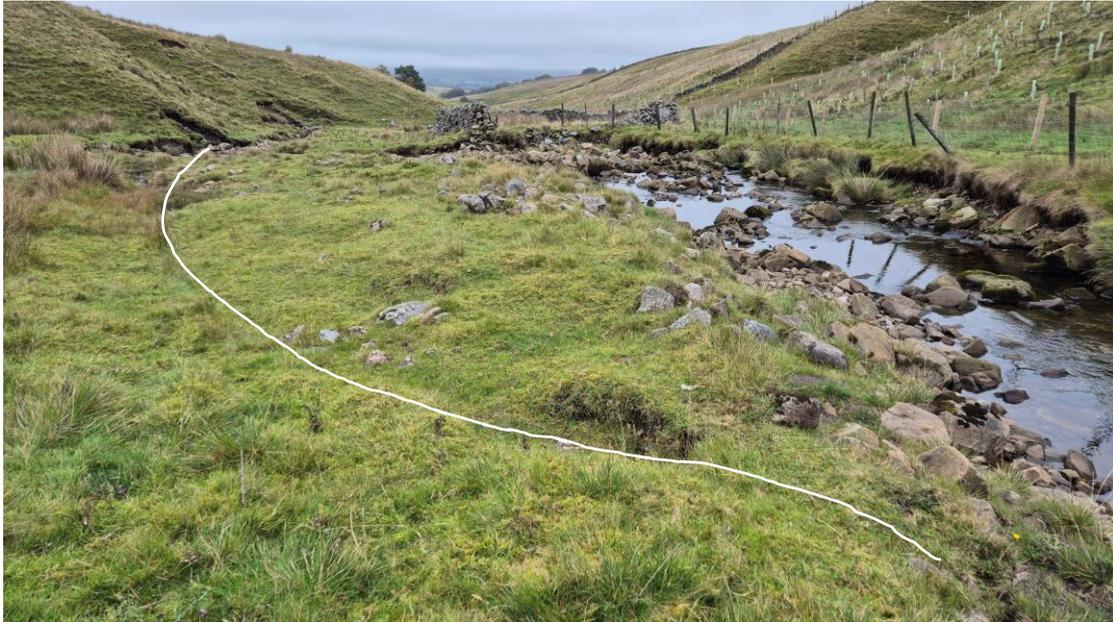
Fig 10: 54.267323 , -2.2200271. A straightened section of beck, embanked with dredged stone to the LB to prevent it returning to the clear paleochannel (highlighted by the white line).

- The straightened course is routed tightly toward the foundations of a former sheep fold and then forced abruptly to the left. Unsurprisingly, the increased conveyance has resulted in accelerated erosion into the RB and will soon undermine the old fence line and foundations.

- Open up access to the paleochannel in the LB (bottom right of image) by removing boulder and returning that and any from the embankment d/s to constrict the extant channel and encourage paleochannel activation.

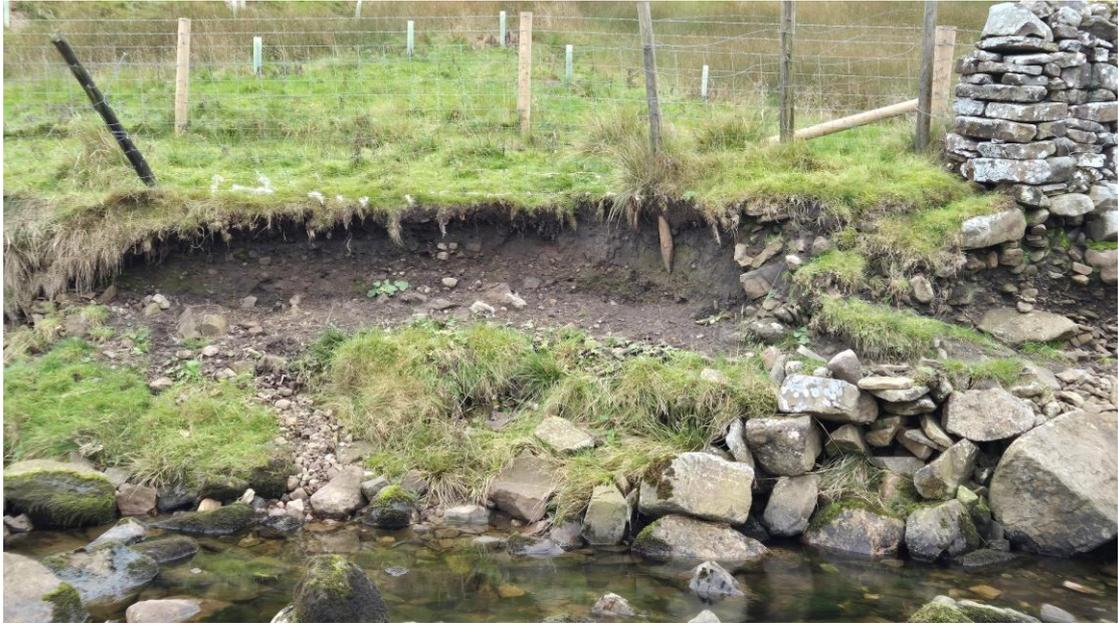
Fig 11: Example of where position of a wall head and stock fence placed too close to the channel have focussed sheep tracking and grazing to the extent that they have accelerated erosion and undermined the fence. Unfortunately, the new fence is not much further back and exemplifies why it is better to completely exclude livestock from these fragile habitats.

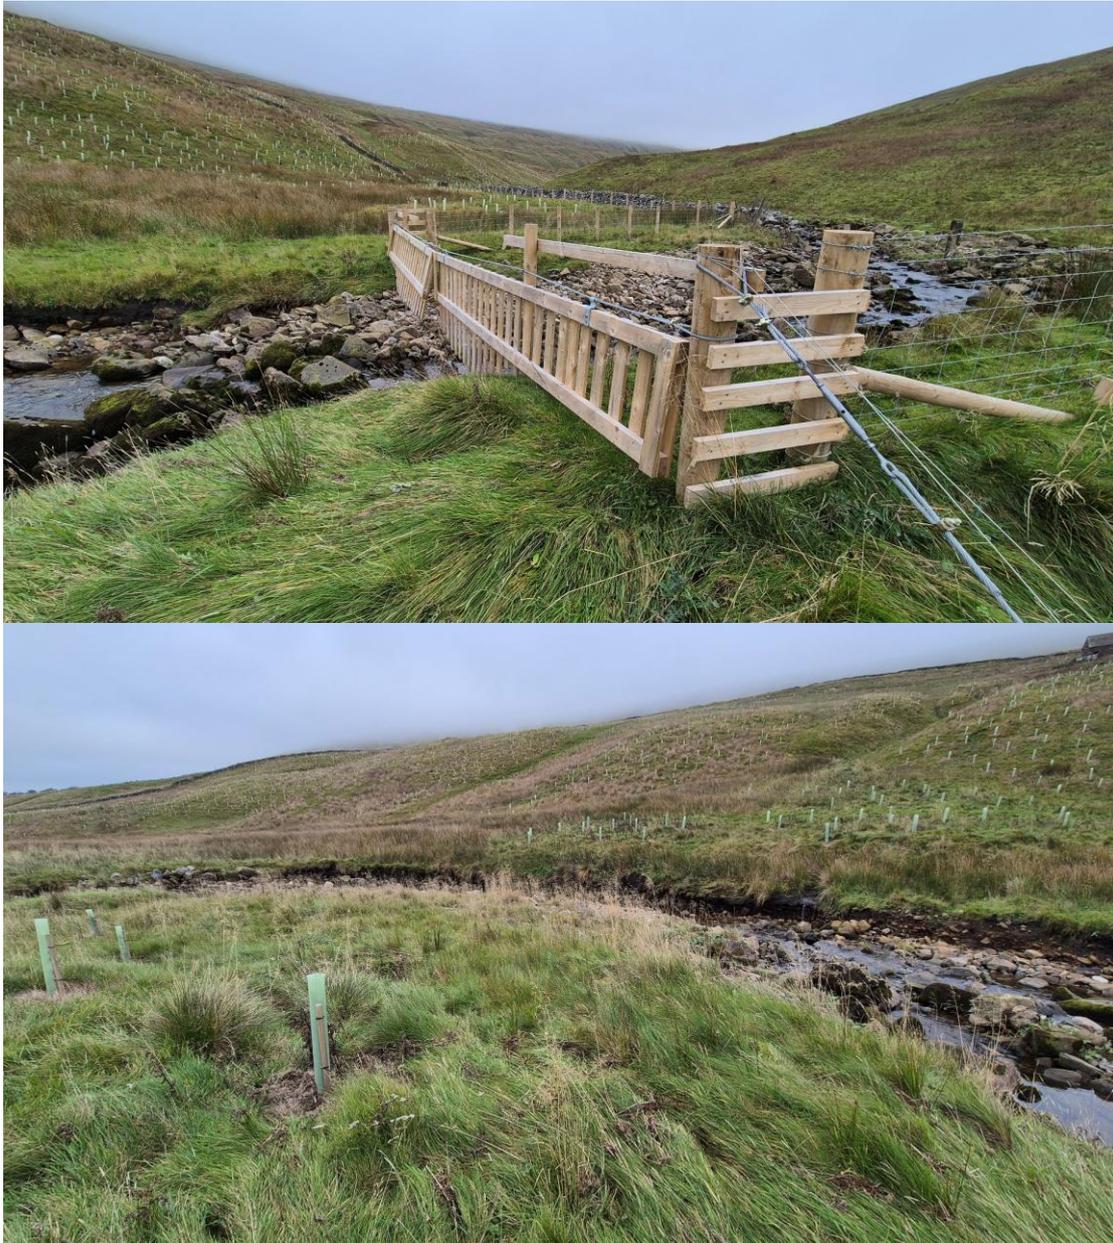
Fig 12: 54.268899 , -2.2196279. Newly constructed watergate to encapsulate a planted parcel to both sides of the channel.

- Whilst seemingly of robust construction, watergates always require ongoing assessment to ensure stock-proofing and maintenance, and the fewer required, the better.
- All the planting with tubes was set well back from the channel edge, and thus, no direct benefits to the channel *per se*.
- It is assumed that the planting was the only conservation intervention for this parcel, and hence it overlooks the fact that the channel was formerly modified and constrained.

- Open up access to paleochannels and judiciously return any embankment stone and defunct boundary walling-stone (see Fig 13) to the channel to encourage paleochannel reactivation.

- Appreciating that it is sometimes essential to use plastic tubes in these harsh environments to kickstart woodland recovery, it is not advisable to do so where spate flow could reach. The wetter ground and bank toes, plus edges of paleochannels, should be peppered with willow and alder whips (without guards) at high density to compensate for potential losses.

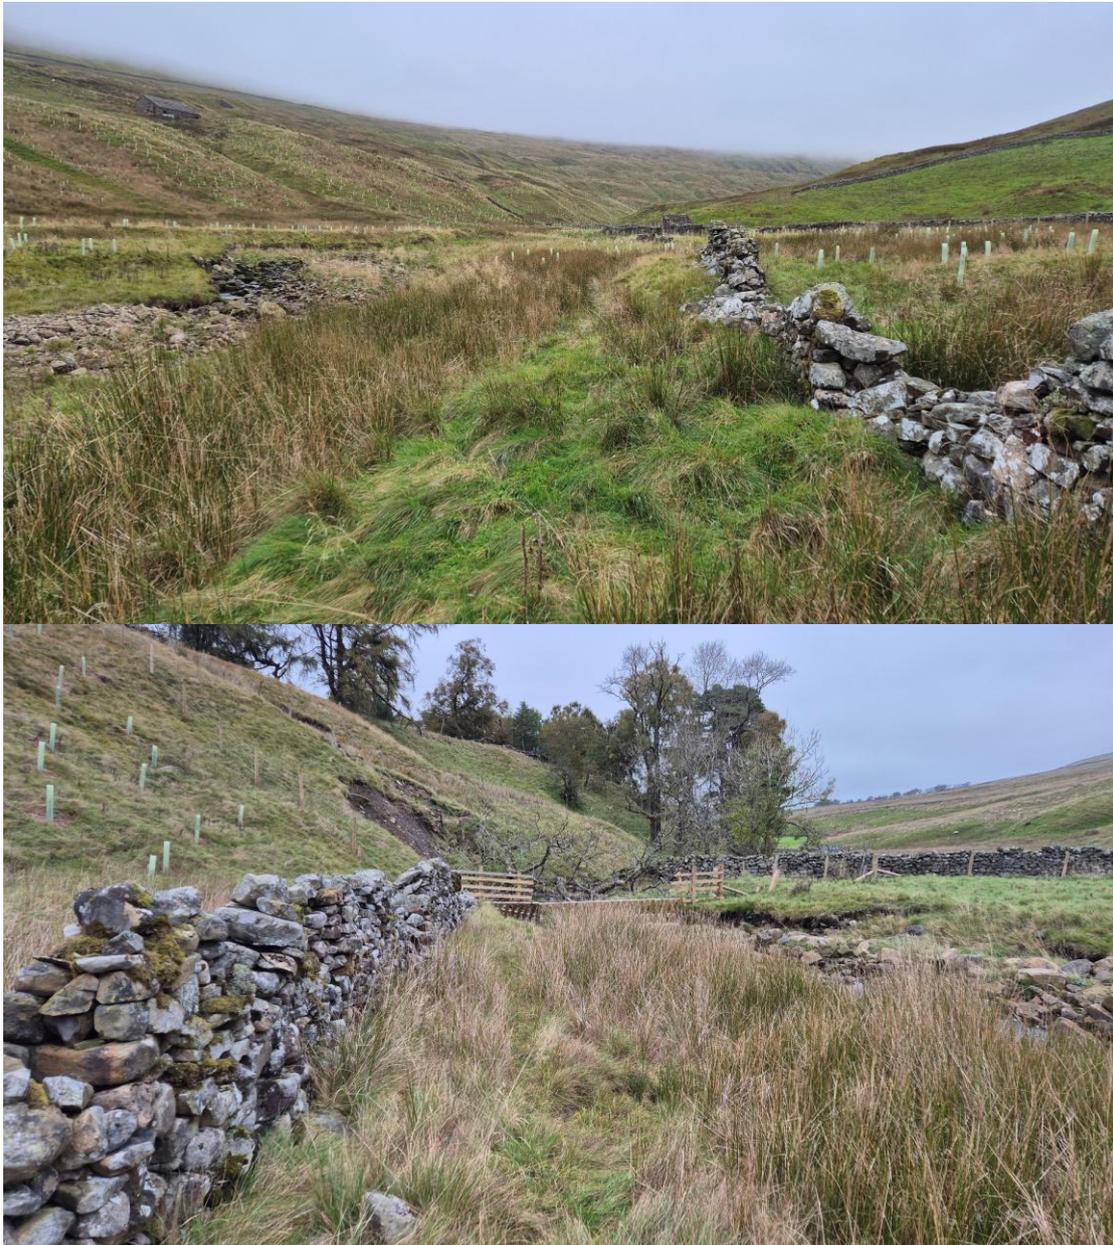
Fig 13: 54.270191 , -2.2197163. Images of the defunct walling, and the stone which should be returned to the channel to counter incision and help reconnect the floodplain.

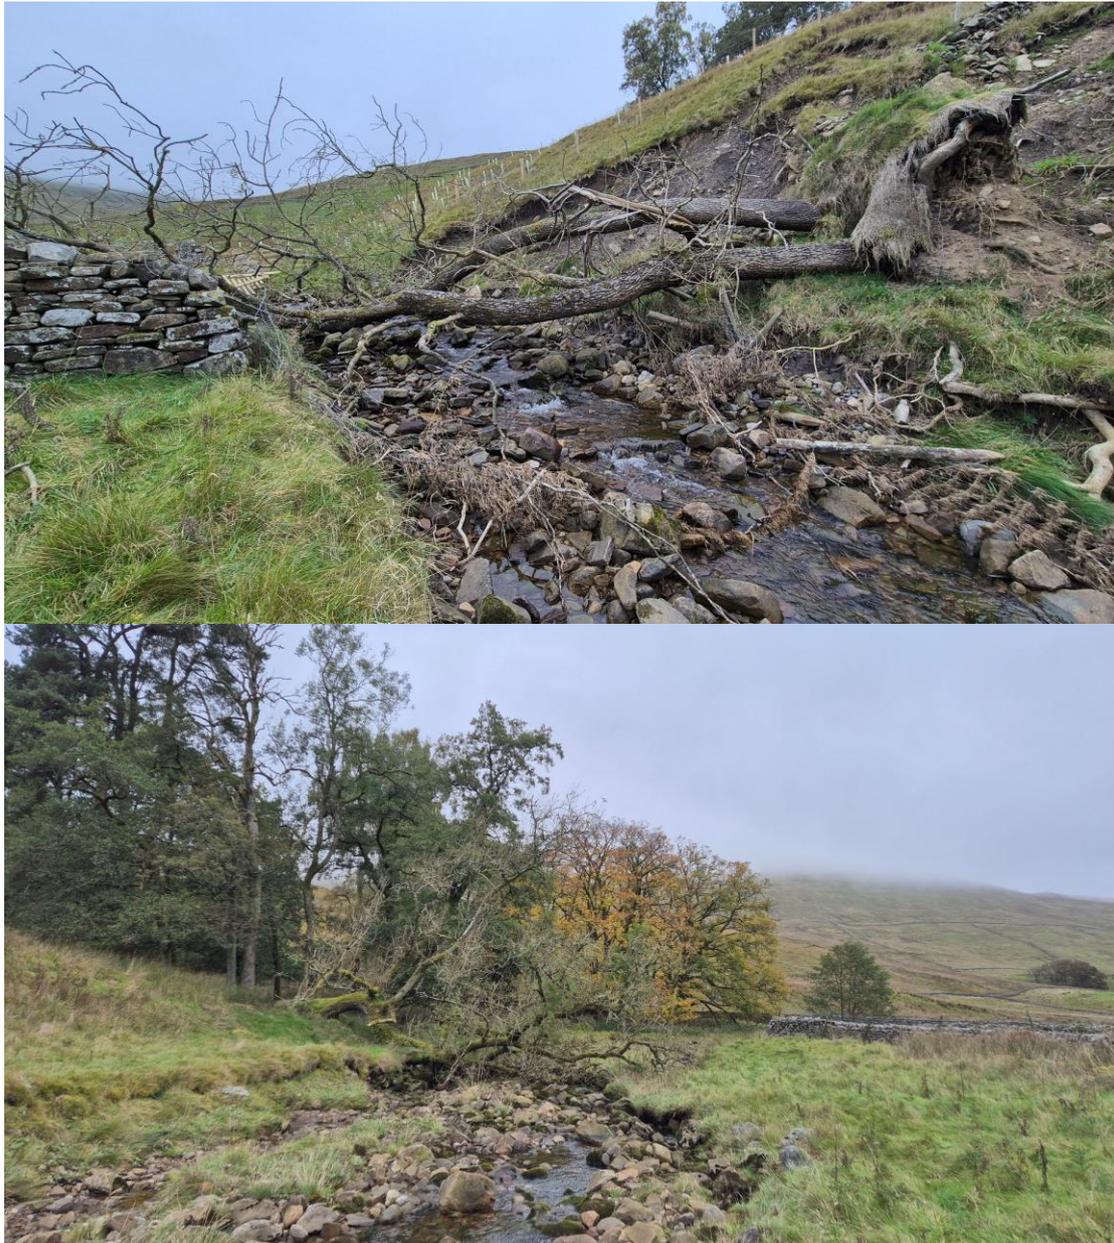
Fig 14: 54.270503 , -2.2196599 to 54.271855 , -2.2192764. Examples from the top and towards the bottom of the next parcel (Tongue Wood), where mature trees had slipped or leaned into the channel and were lodged, creating fantastic habitat by forcing flow over, under and around the complex structure.

- The landslips in the upper image had been caused by pinning the beck to the left side of the valley where livestock tracking across the steeper slope had resulted in instability.
- Tongue Wood had no evidence of natural regeneration despite a good variety of mature trees and apparently intact boundaries, suggesting grazing / browsing in recent history.

- Livestock exclusion and extending augmented planting.

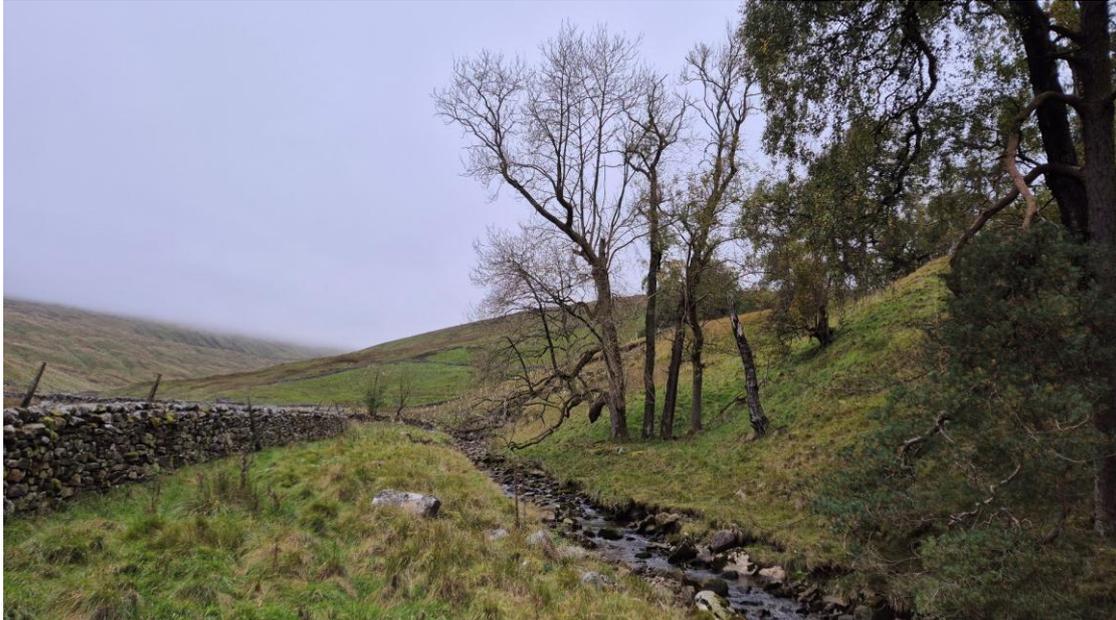
Fig 15: 54.270917 , -2.2193808. Looking u/s at the realigned and straightened reach adjacent to Tongue Wood.

- The pinning and straightening of the channel were causing issues of accelerated erosion at the d/s end (Fig 16).
- Image highlights a lack of natural regeneration, indeed, any trees on the artificial RB.

- Ideally, the boundary wall (left of image) would be set back, completely off the floodplain, allowing the beck to access that floodplain again by removing any revetment and embankment along the RB. Stone should be returned to the channel.
- The diseased ash trees could be proactively pulled over or felled into the channel, retained intact as possible, to slow the flow in the same manner as the example in Fig 14.
- Ensure removal or strict limitation of grazing to allow for natural regeneration or augmented planting.

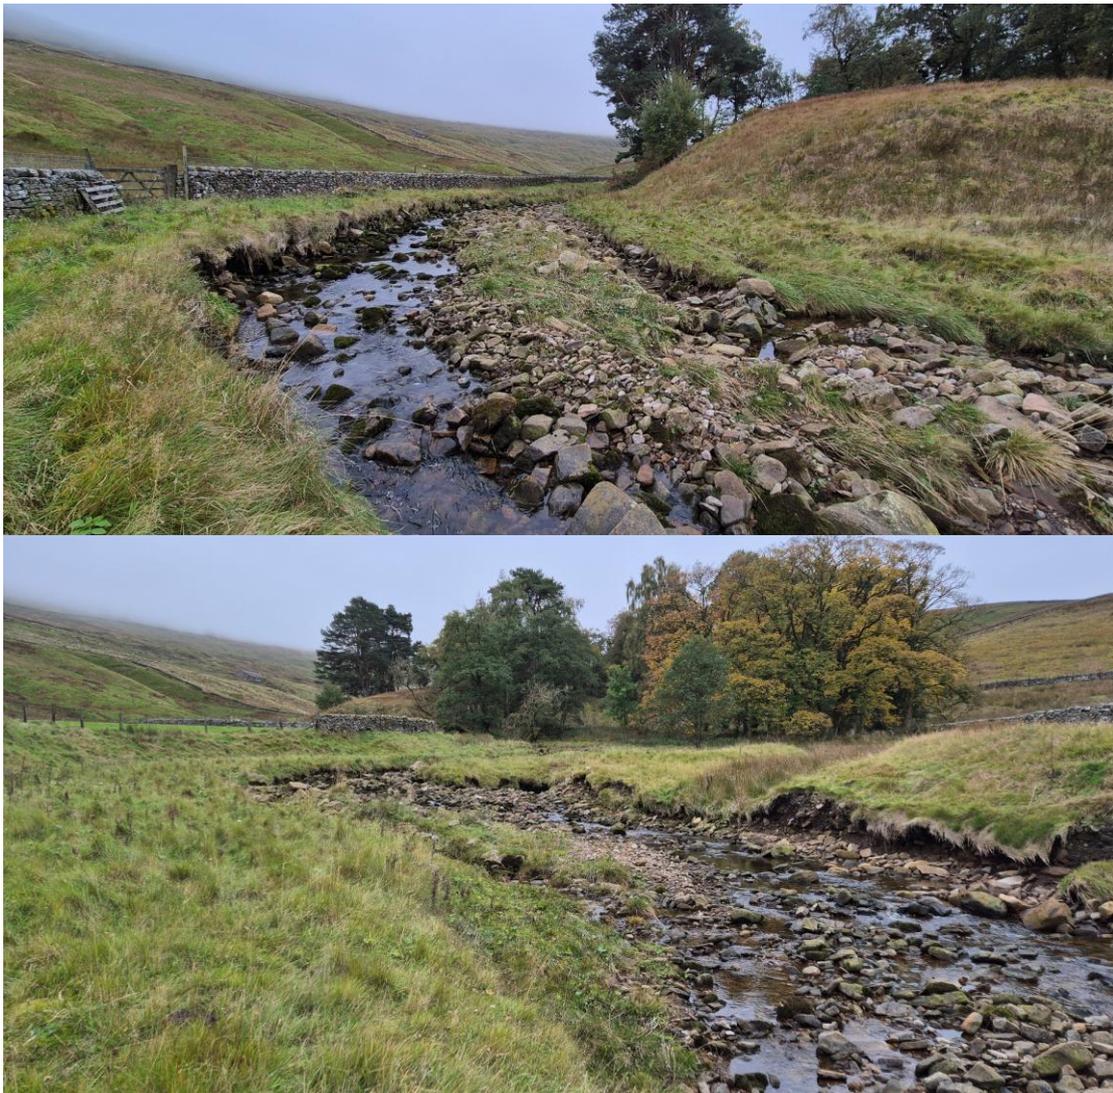
Fig 16: 54.271640 , -2.2187372 and 54.272552 , -2.2192761.

- Upper image – looking u/s at the erosion in the RB caused by the straightening and realignment (Fig 15). It is exacerbated by the fact that the beck is forced further left as another boundary wall cuts perpendicular across the floodplain (behind the photographer).
- Lower image – again looking u/s at what should be a highly dynamic network of braided or anastomosed channels in a relatively low gradient area below Tongue Wood, but realignment, dredging and straightening of the channel further d/s (Figs 17 & 19) has led to incision of the active channel and substantial perching of the paleochannels.

- Return stone from any nearby embankment work to the channel, particularly to encourage better reconnection with paleochannels (and ensuring access into those paleochannels has not been blocked). Any failing / diseased trees from the wood could also be used.

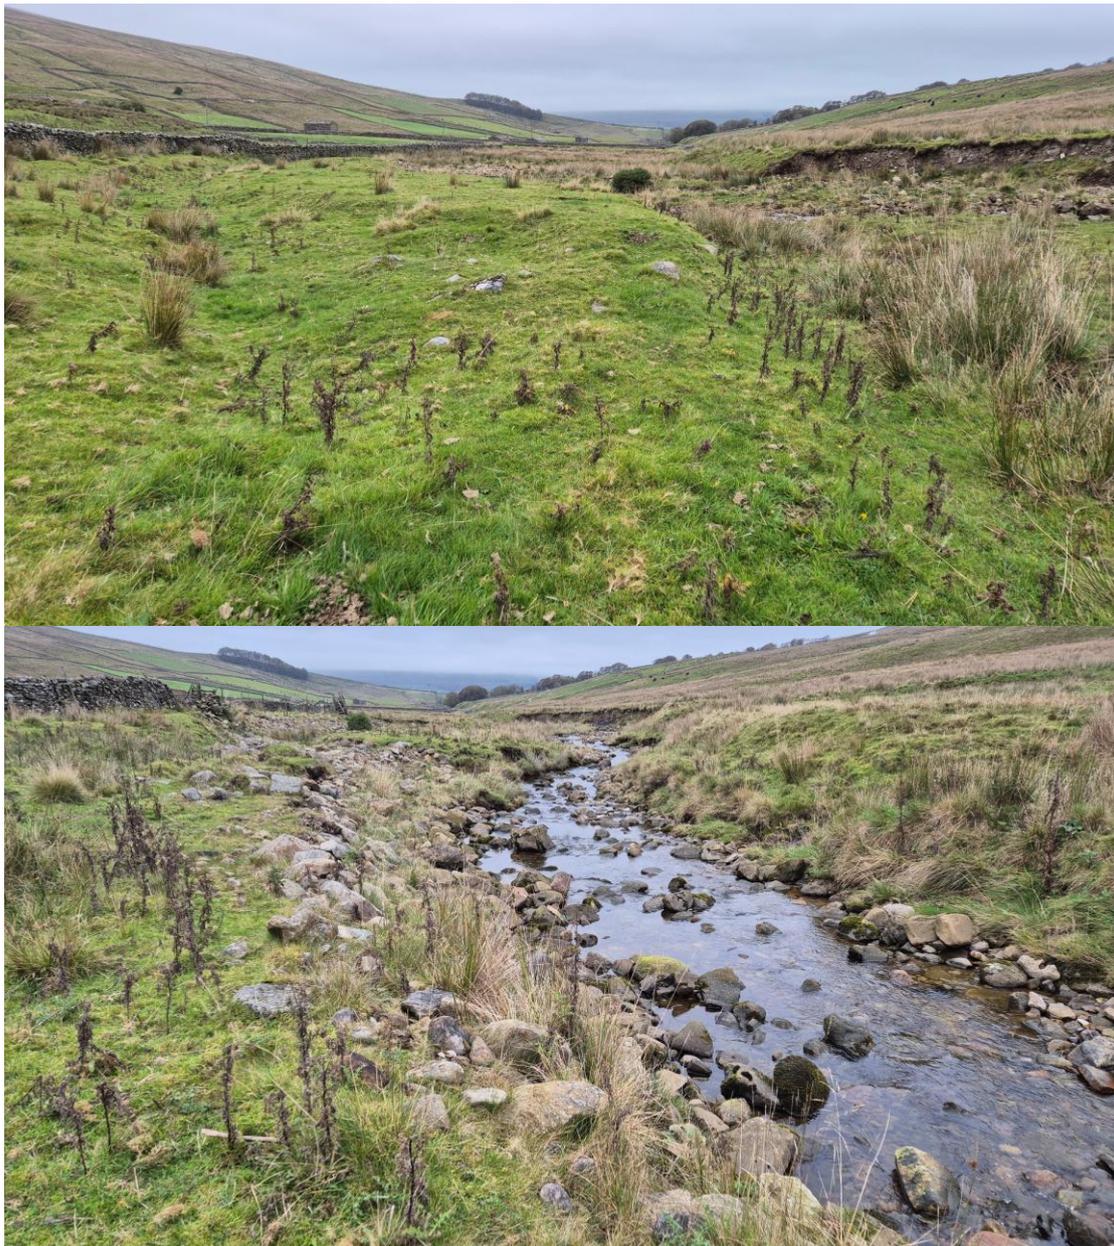
Fig 17: 54.273374 , -2.2193647 environs. Much lower gradient on the approach to the confluence with Little Ing Gill; starting point for pinning of the channel to the right-hand side of the valley for >1km.

- Straightening here, and resulting incision, has led to head-cutting back u/s to impact as far as Tongue Wood environs (Fig 16).
- Spoil from channel realignment has been used to block paleochannel connections and embank the LB. Hence all the energy is constrained within the channel, increasing conveyance and flood risk d/s.
- Heavily grazed, so low floral biodiversity and reduced hydraulic roughness if water does eventually spill onto the floodplain.

- Floodplain reconnection. Reduction or removal of grazing.

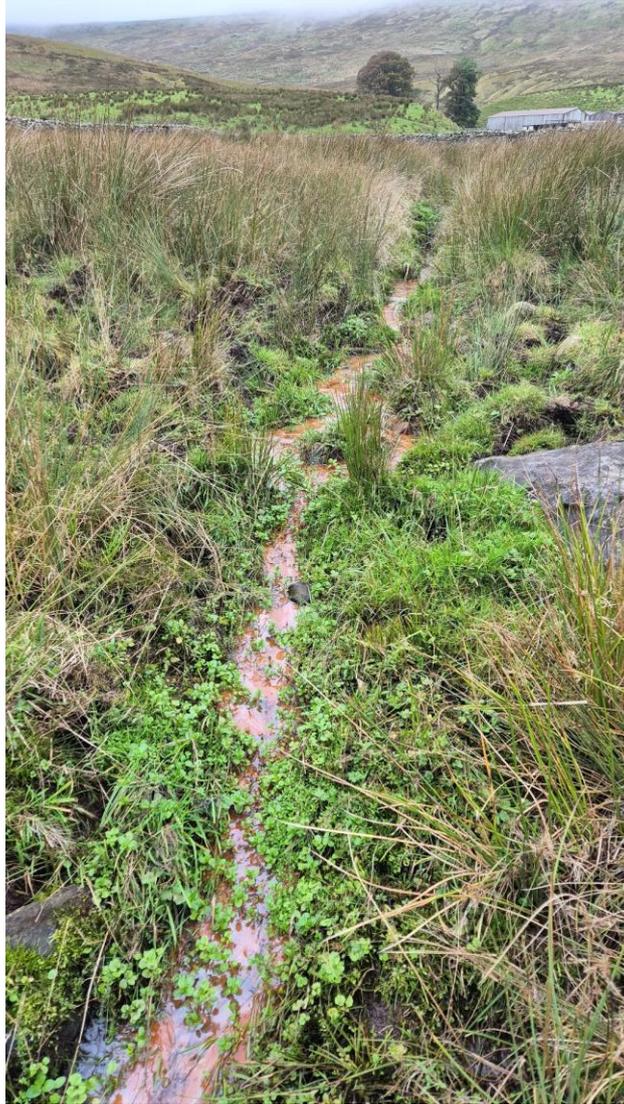
Fig 18: 54.275612 , -2.2184077. Symptomatic of the straightening issues on the main channel, even the smaller tributaries and seeps have been formalised into drains, contributing to accelerated conveyance and flood risk. Iron precipitation, possibly indicative of flow through a farm midden.

Opportunity to block such drains repeatedly to raise water table and re-engage floodplain, slowing the flow for both winter spate and summer retention.

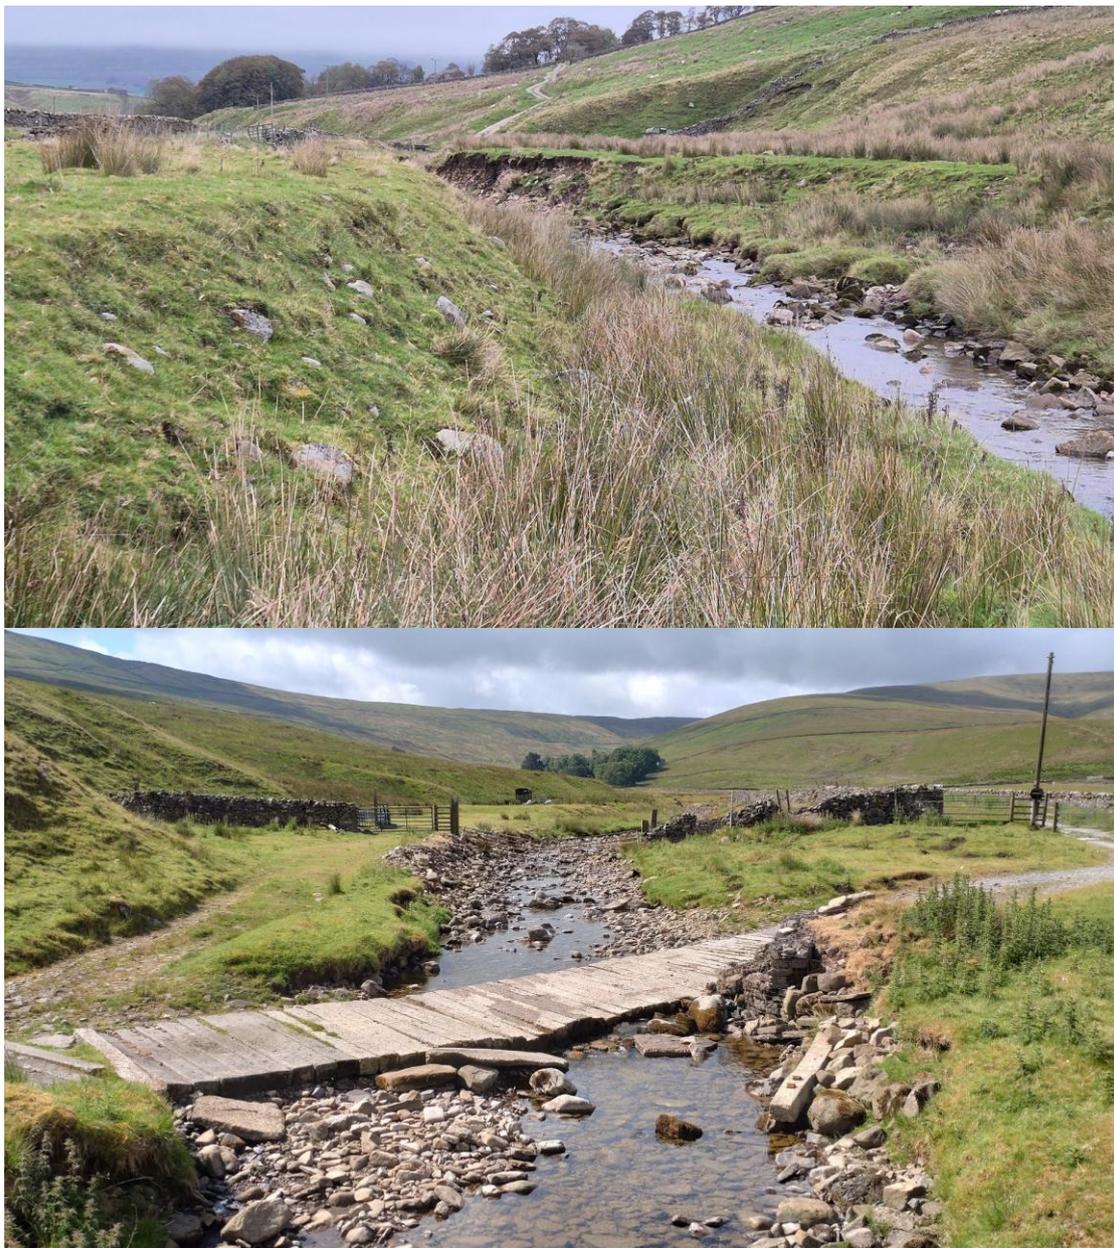
Fig 19: The approach to the ford at 54.277870 , -2.2167615.

- Upper image – highly modified bank profiles to keep the heavily incised channel on a straightened course, and with no opportunity to access floodplain.
- Lower image of ford highlights how constrained the artificial channel is, with multiple crossing points and formalised tracks parallel to each bank, and an obstruction to fish and sediment movement.

- Gold standard would be removal of the obstruction of the ford as there is a clear span bridge d/s (from where the image was captured).
