WILD TROUT TRUST

Advisory Visit

Duerley Beck (Ure)

for Ure Dales Landscape Recovery, 2025

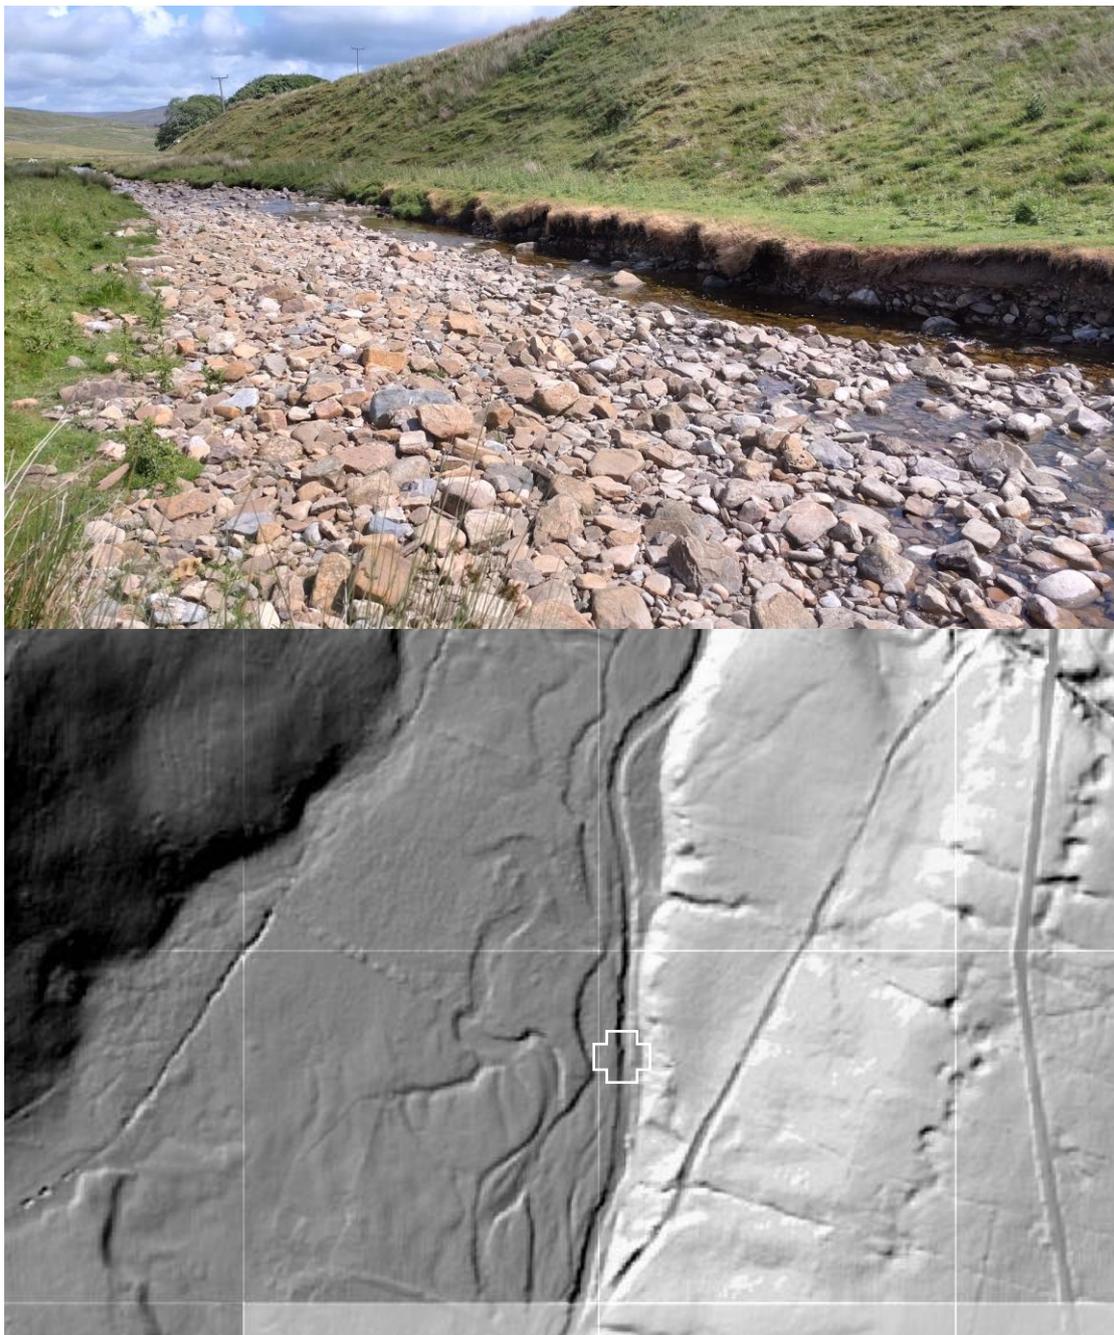
Fig 20: 54.279314 , -2.2162838. Typical section of the beck between Duerley and Sleddale pastures where the gradient is extremely low. The channel is 'overcapacity' – reflecting poorly consolidated banks, high discharges overwinter and copious supply of coarse sediment which is then deposited and low summer flow trickles through the rock and cobble. Lower panel is derived from LiDAR data, where the white cross marks the point of the photo.

- Little chance for the sediments to stabilise and become colonised by plants as they are constantly re-mobilised either by flow or disturbed by livestock.
- Such a thin trickle of water flowing through the coarse substrate, exposed to full sunlight in spring and summer, will be subjected to accelerated warming – extremely poor conditions for cold-adapted aquatic organisms.

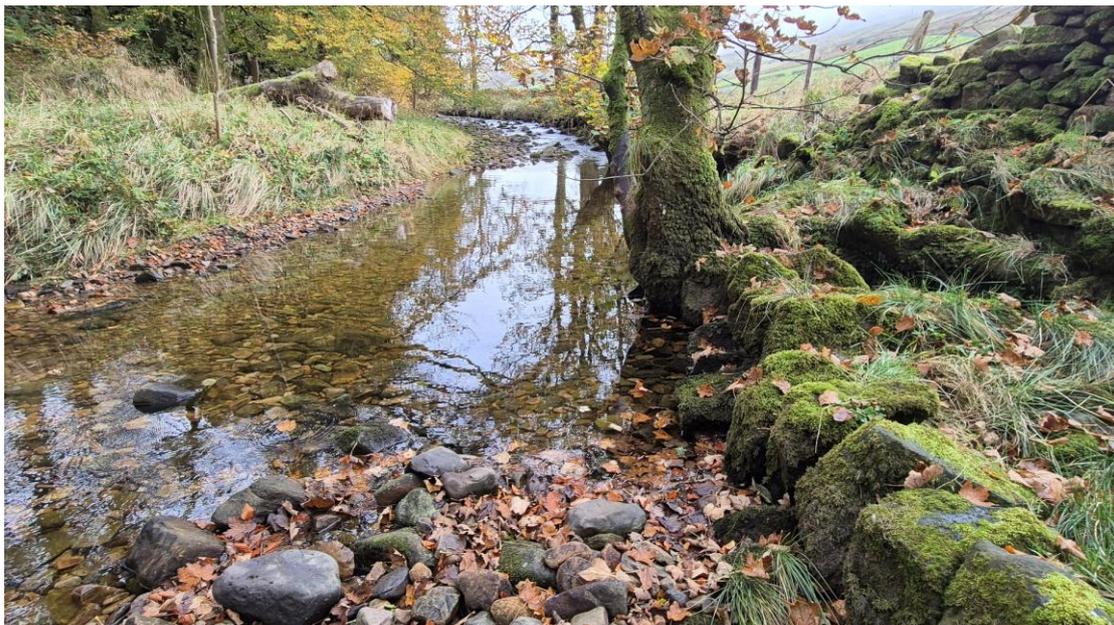
Fig 21: 54.282384 , -2.2150869. Looking u/s, the first albeit short section of mature tree cover along the beck but it was still pinned to the right-side of the valley – note line of boulder revetment at LB toe.

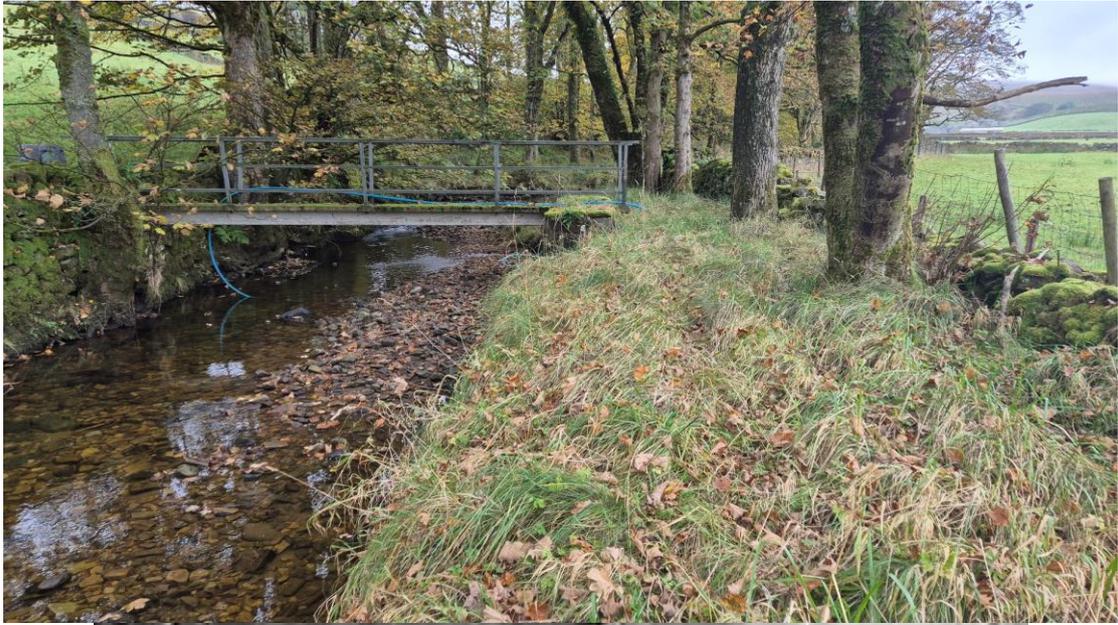
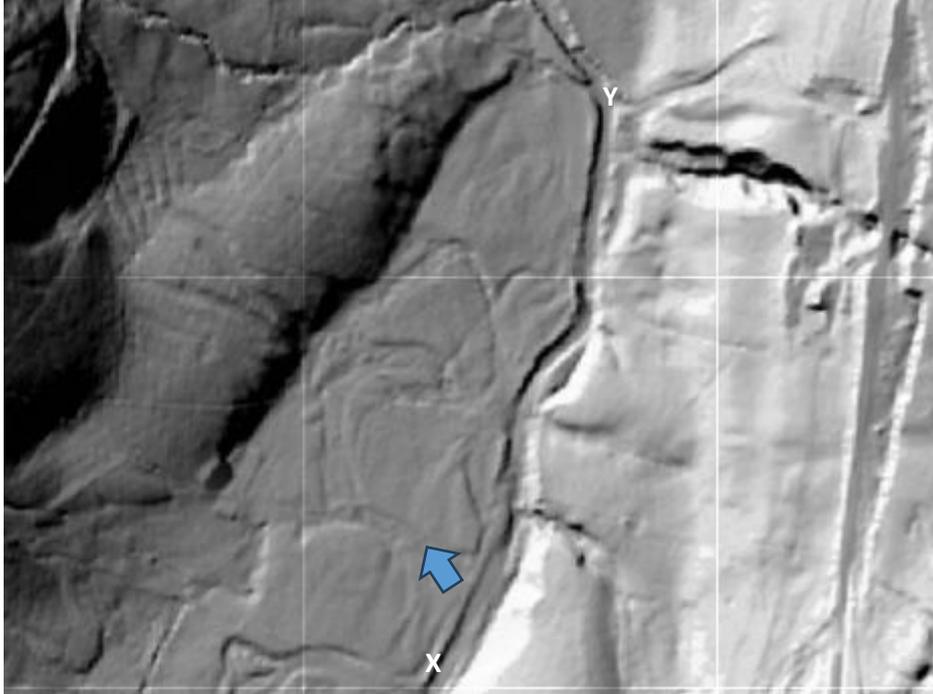
Fig 22: 54.282895 , -2.2146320. The channel tightly constrained between a walled RB and an embanked LB, with a single line avenue of similar-aged trees to either side. LiDAR data show the straightened extant channel, heavily embanked between X (Fig 21) and Y (Fig 23; watergate), and disconnected from a plethora of paleochannels to the west.

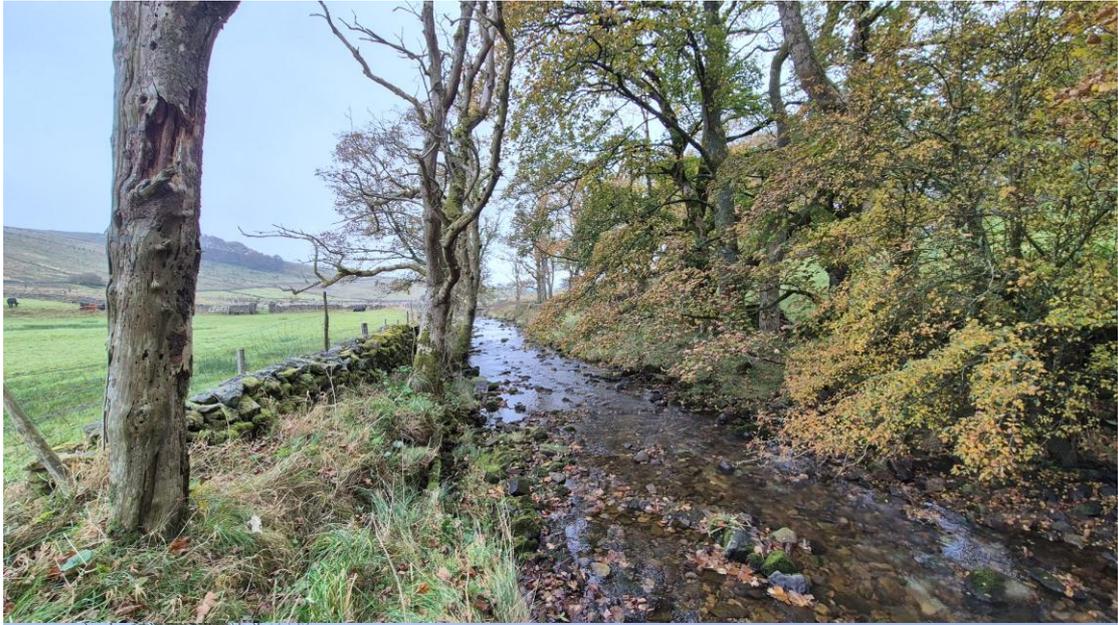
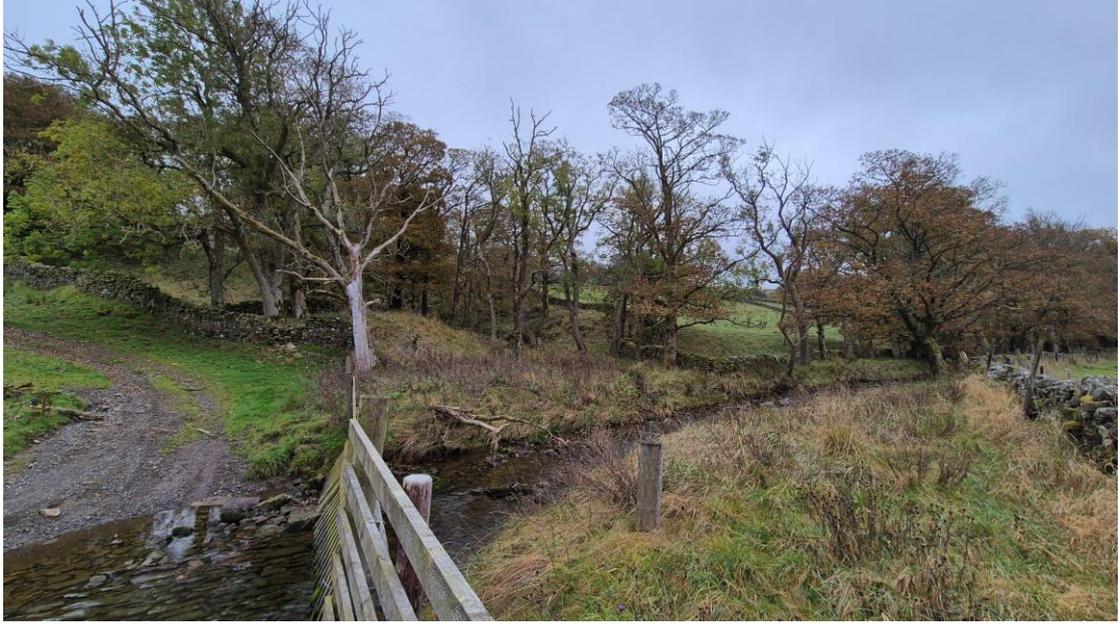
Fig 23: 54.283482 , -2.2144789 environs. The heavily straightened run approaching the watergate (visible in the LiDAR; Y in Fig 22).

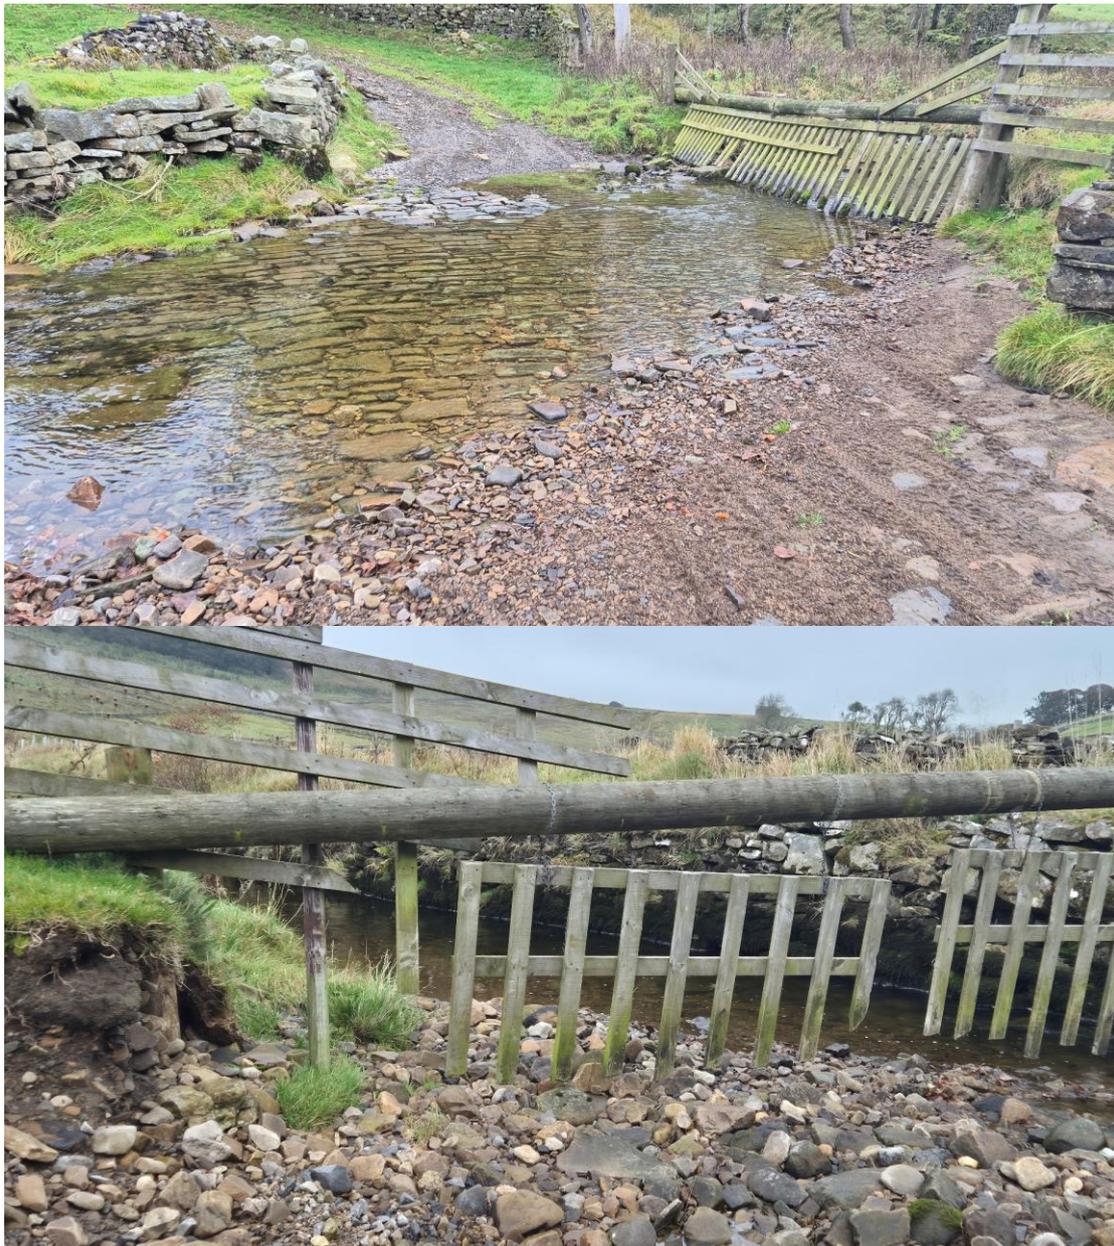
Fig 24: 54.283639 , -2.2145299. From the dressed stone ford with a functional watergate on the u/s side, and one that was being by-passed on the d/s.

- Whilst not ideal for fish passage, the irregular stone construction actually afforded retention of depth and a focal flow, and was not perched, so aside from extremely low summer flow, was unlikely to cause obstruction. Watching brief.
- Livestock accessing the fenced riparian zone d/s through the damaged watergate.

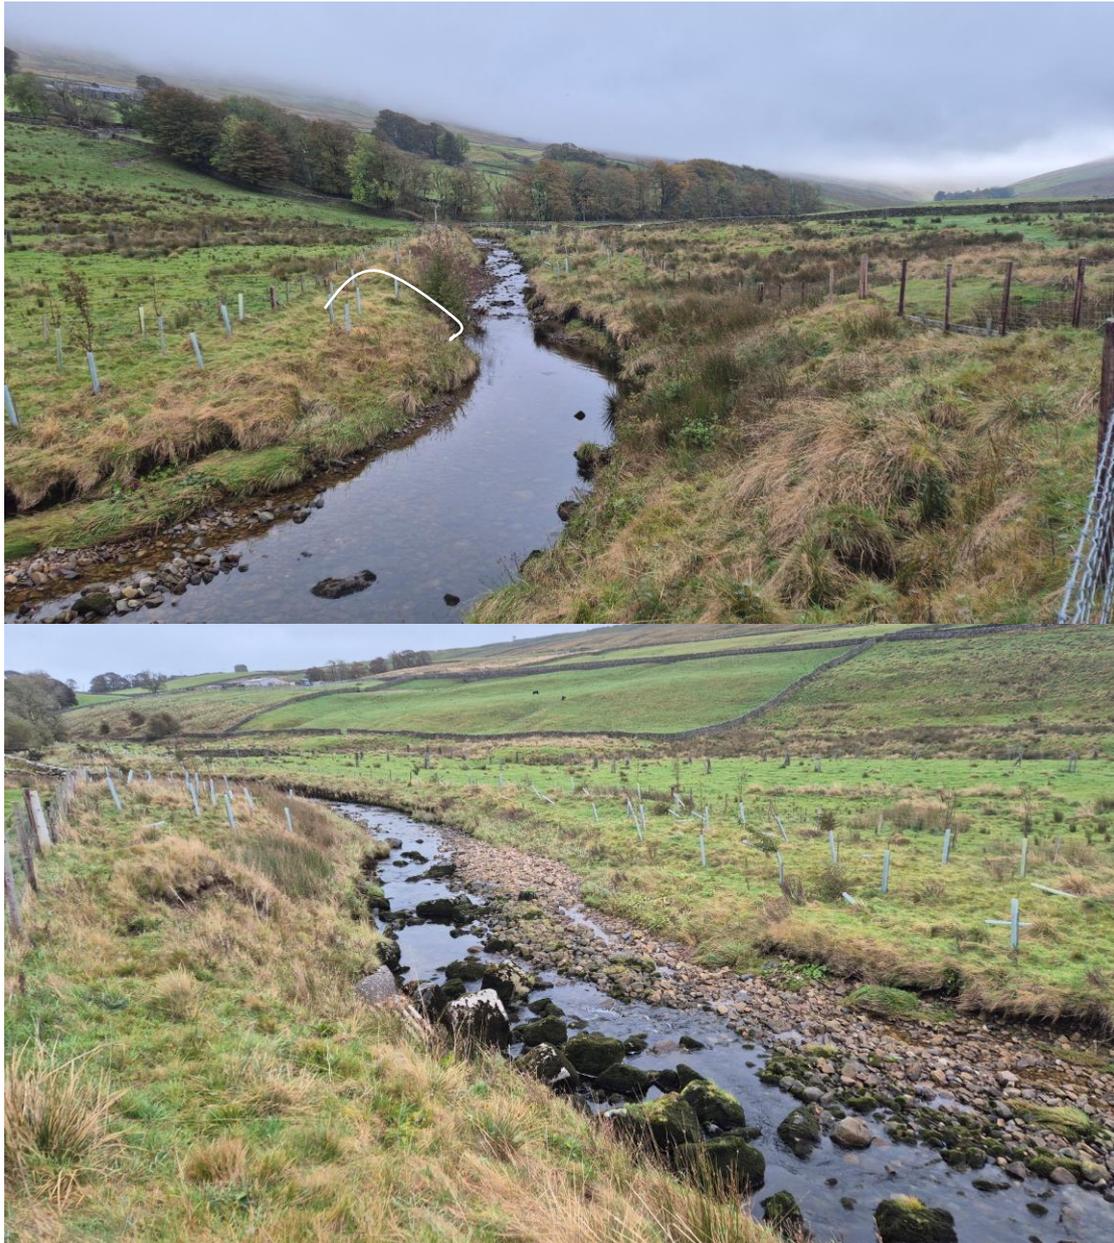
Fig 25: 54.284918 , -2.2155729. From a higher vantage point, looking u/s (upper) at the straightened channel and heavily embanked RB (highlighted by the white line), and d/s (lower) at the failing boulder revetment placed along the LB toe; the latter, presumably in response to erosion caused by the accelerated flow along the straightened reach. The riparian zone was fenced, nominally protecting a modest buffer of ~8m to each bank but there were signs of grazing and damage to tree-guards, probably from stock accessing at the watergate u/s (Fig 24).

- Great to see a riparian strip protected but the benefits of doing so would never achieve full potential because the channel was heavily modified.
- Boulder revetment was simply bouncing energy elsewhere, and hence had failed; much had fallen into the channel.

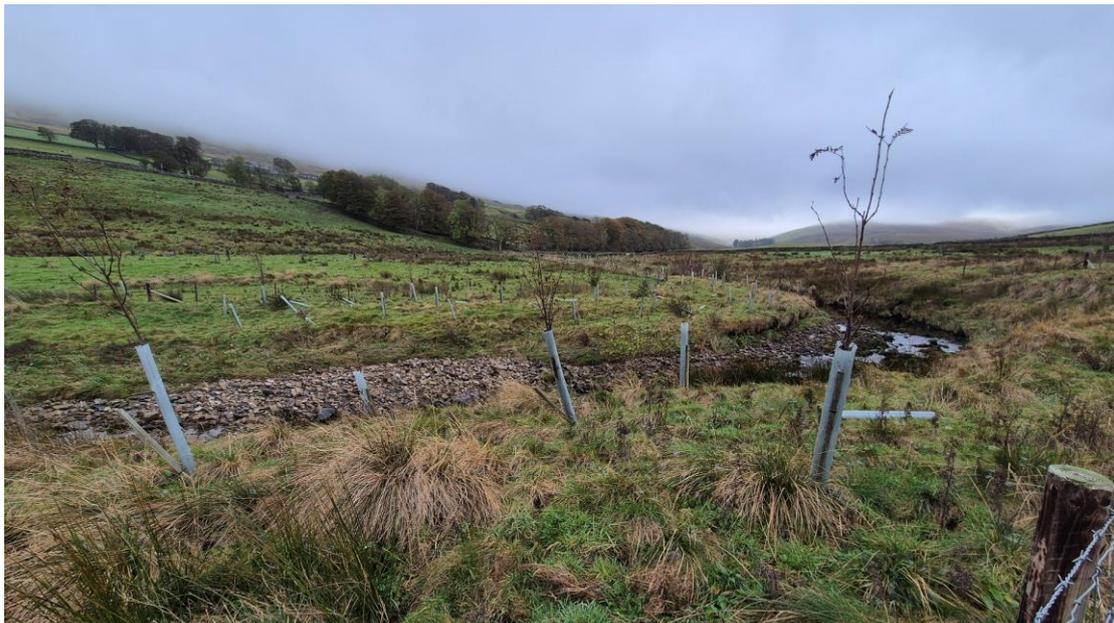
Fig 26. Many of the tree-guards were horizontal or leaning. Those trees that were obvious / thriving seemed to be mostly rowan.

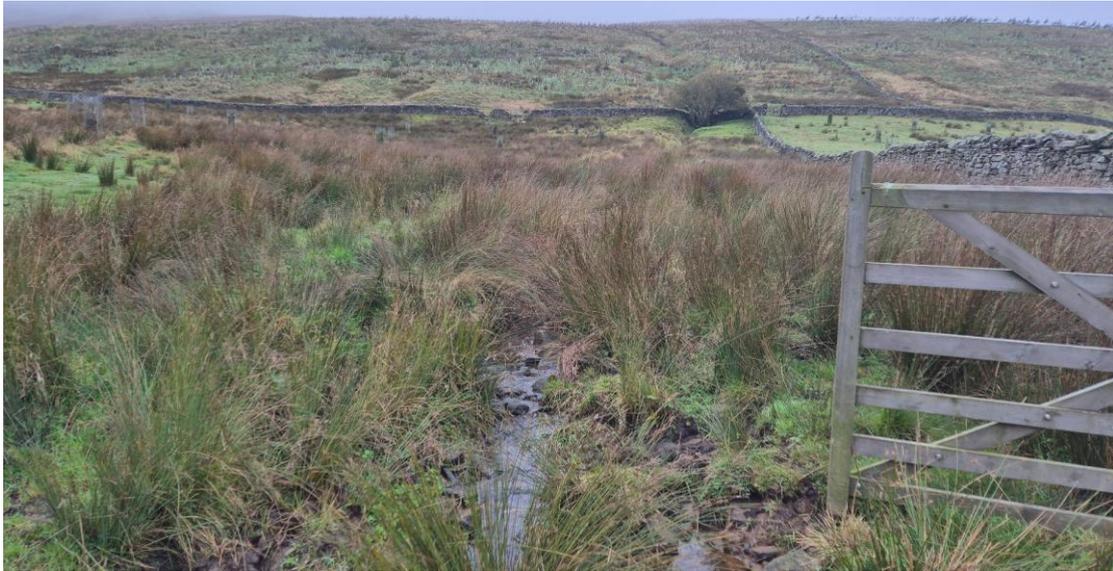
Fig 27: 54.285317 , -2.2151379. Just one example of several sources of overland flow from the west that had been routed into straightened ditches, mostly down the sides of field boundaries.

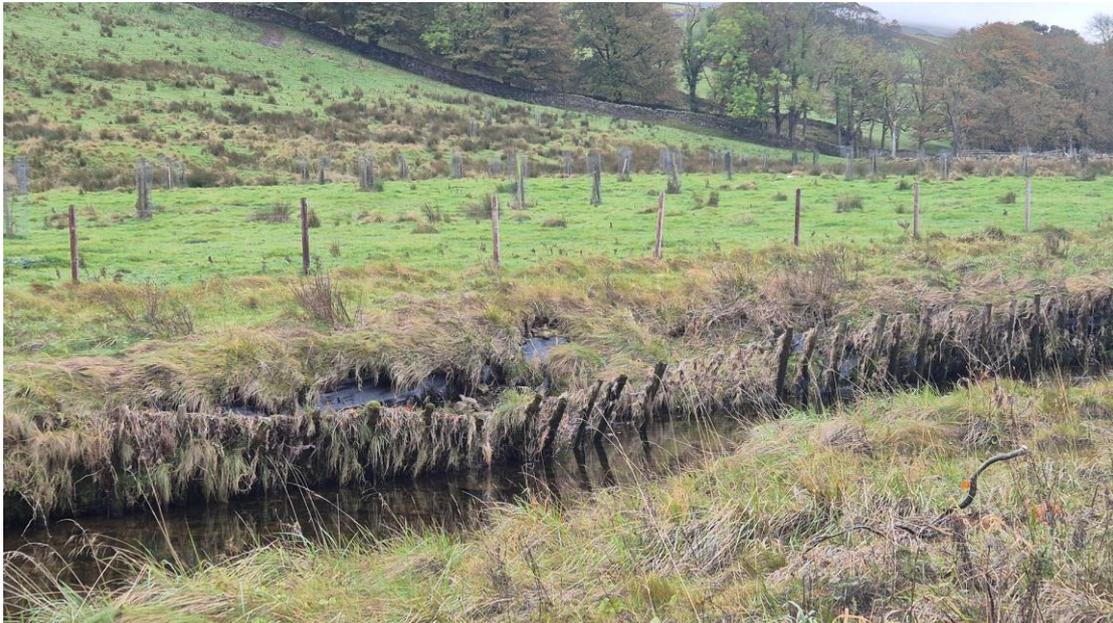
Fig 28: 54.285378 , -2.2145896. A more modern attempt to prevent erosion and return to the natural position within the valley. The bank had been lined with either plastic or a geo-textile, and a series of posts & wire installed at the RB toe.

- Maintaining the straightened course, creating a poor growing media and vertical bank-line, and causing more issues as the intervention fails.

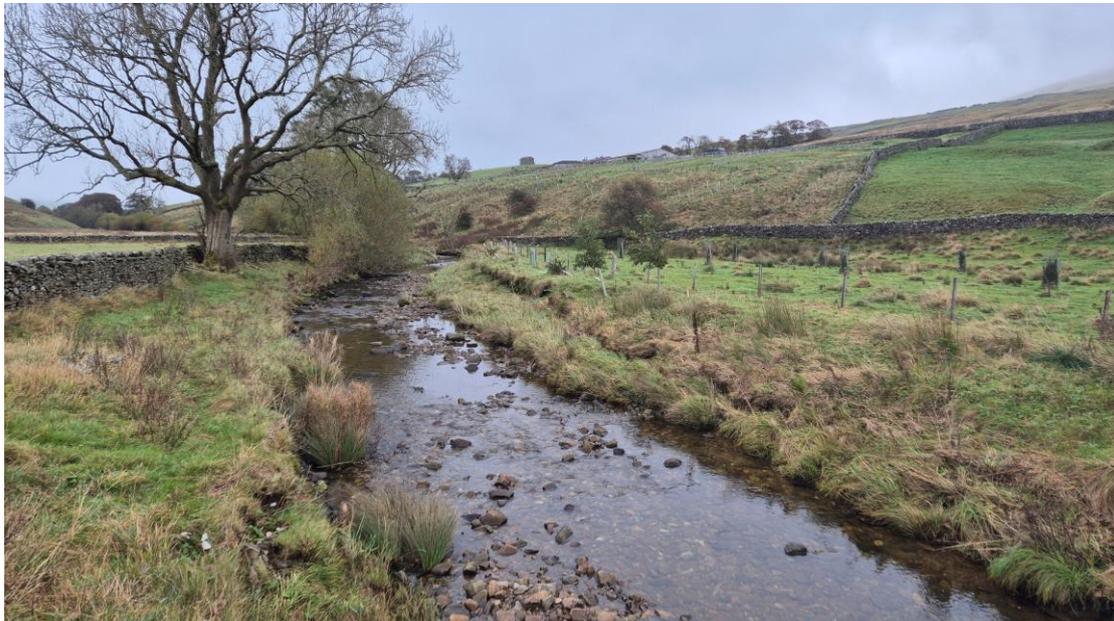
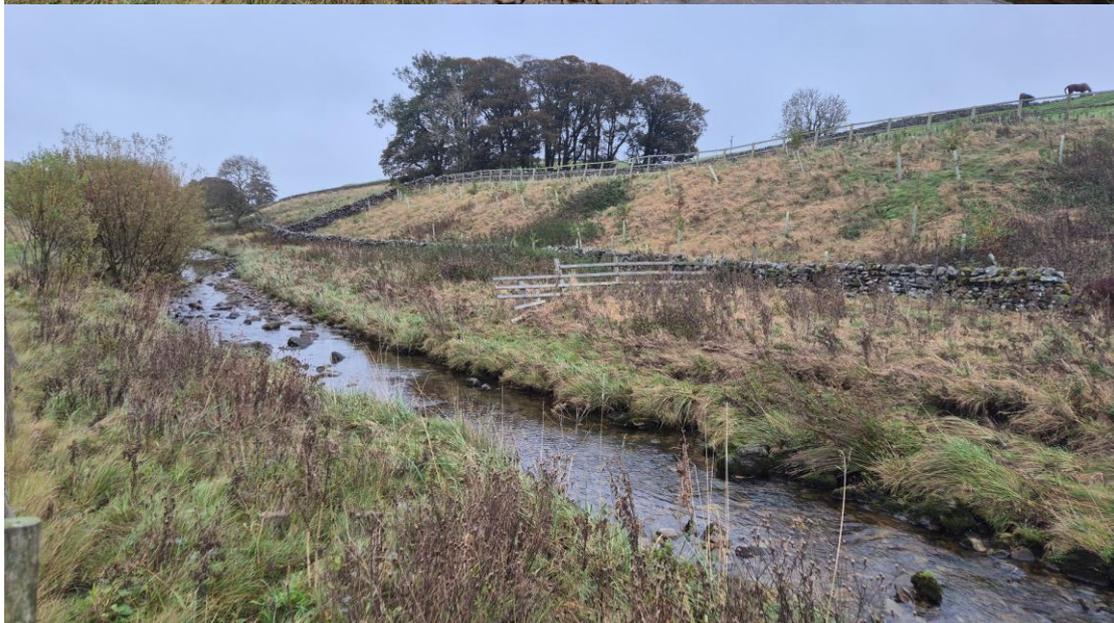
Fig 29: From 54.286183 , -2.2138920 (u/s) to 54.287868 , -2.2118780 (d/s) and another ~100m, the floodplain began to narrow and while both sides of the channel appeared to be fenced or walled to prevent livestock access, there was no evidence of self-set regeneration of trees. The few mature specimens were ash, severely compromised by *Chalara*.

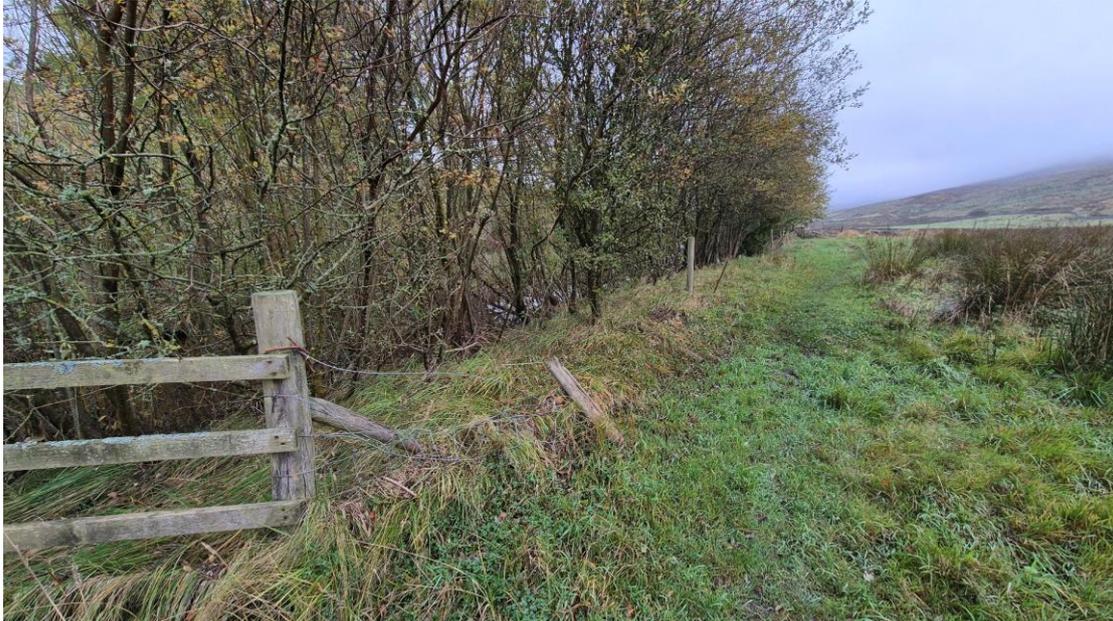
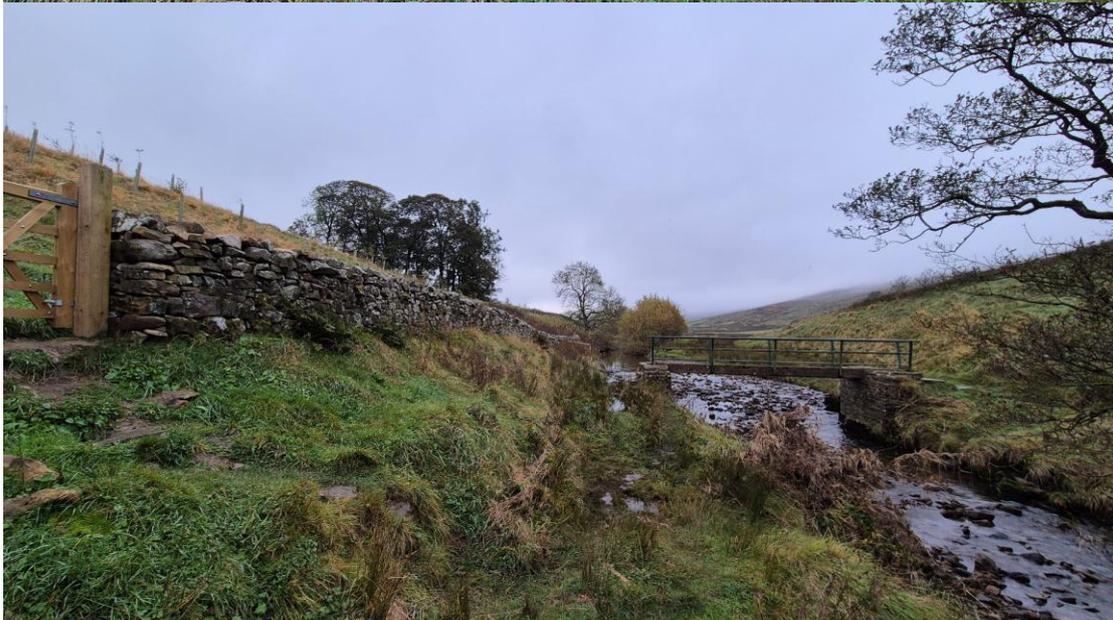
Fig 30: 54.288798 , -2.2111899 and 54.289079 , -2.2109538. The PROW in this area was routed tightly against some dilapidated buffer fencing where a row of willow spp. had been planted, presumably to reduce bank erosion. D/s around the bridge, there was no fence and livestock had complete access.

- Fencing placed too close to bank and probably damaged by stock reaching to browse the willow. Walkers / dogs & livestock still mixed.

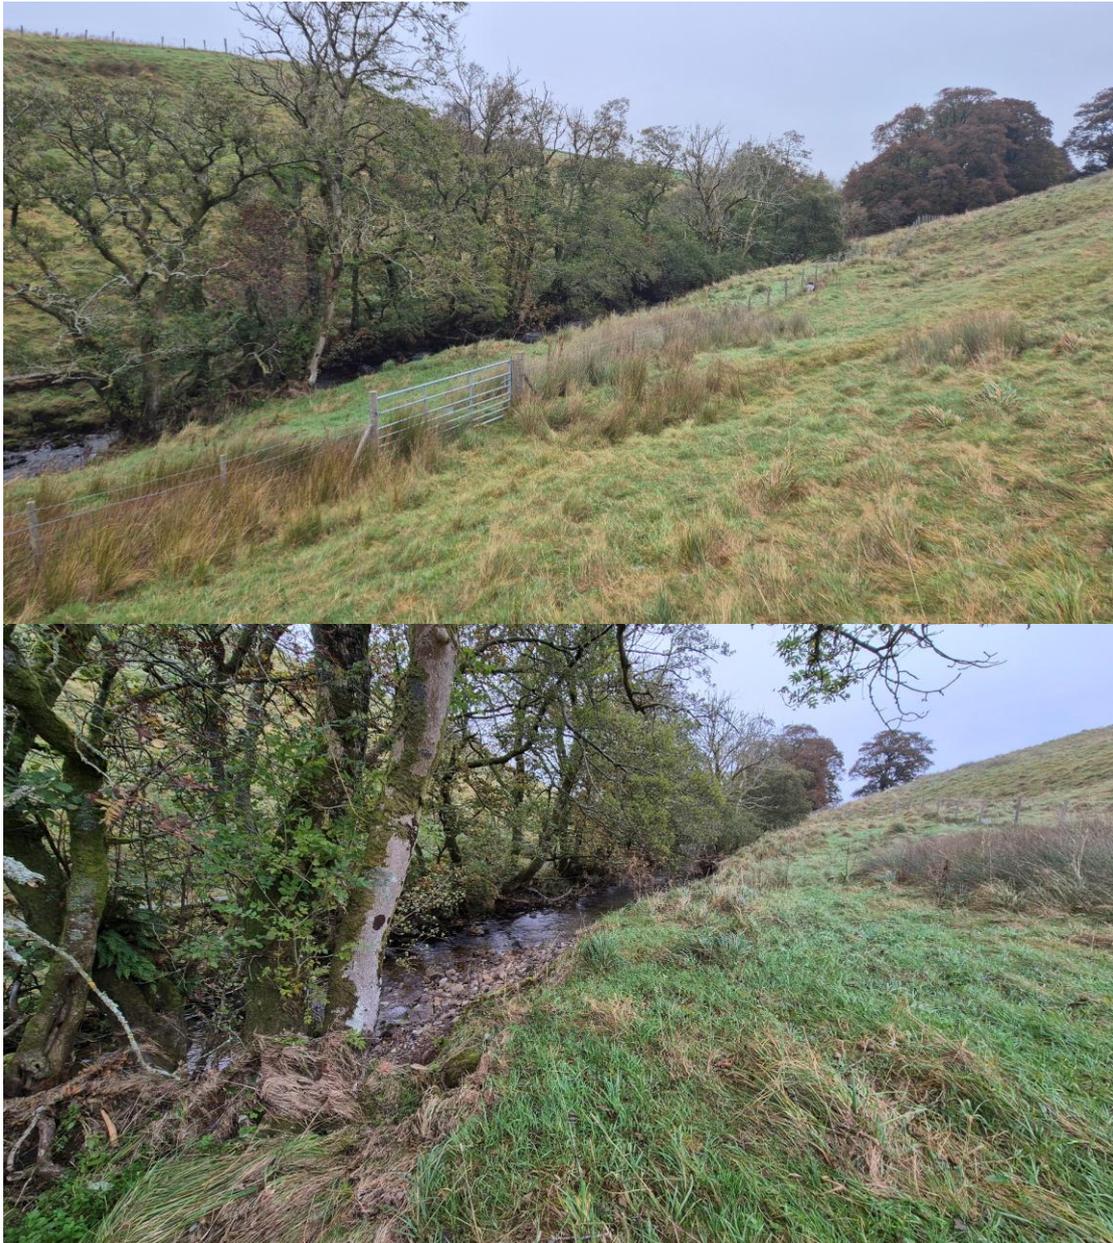
Fig 31: 54.289349 , -2.2105918. Most u/s field at Scaurhead. Buffer fencing was set well back from channel but clearly stock could access the RB from the LB, potentially even via the footbridge (Fig 30).

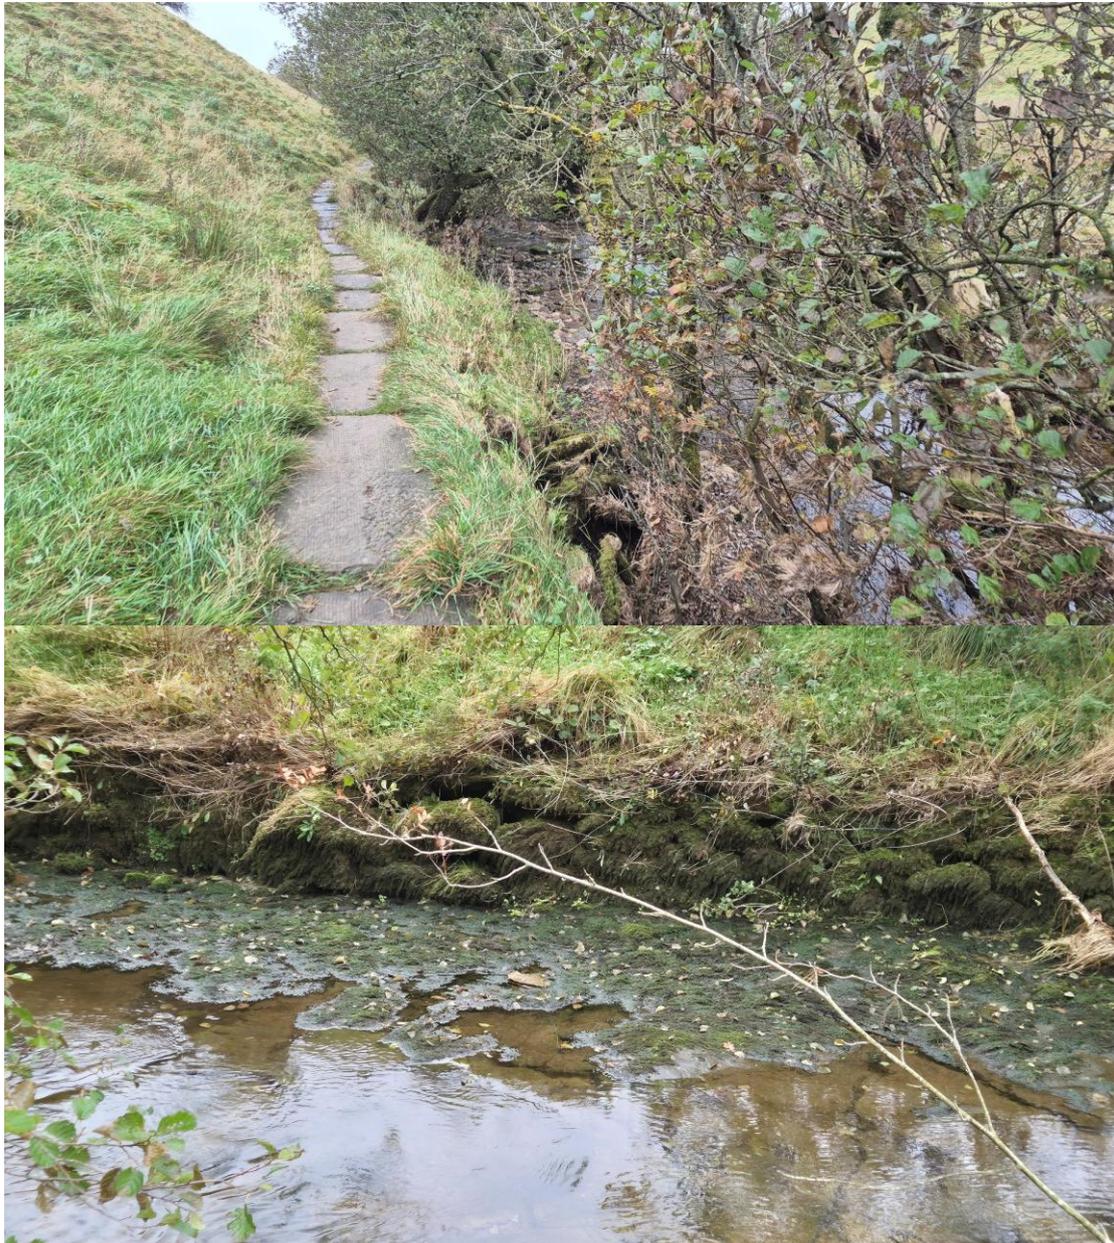
Fig 32: 54.289822 , -2.2104133. On the approach to Aysgill Force, both banks had been heavily modified with walling stone, and the riparian zone to the LB further compromised by stone flags for the PROW.

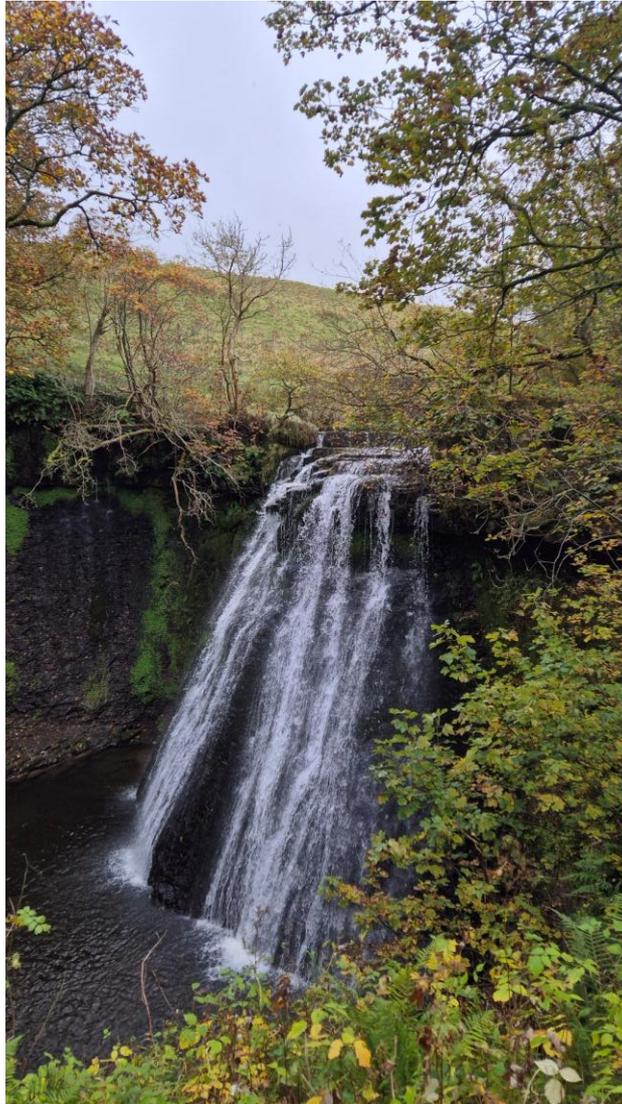
Fig 33: Aysgill Force at 54.290196 , -2.2101097. A natural barrier to fish passage, and the head of a very narrow, very natural gorge, mostly unimpacted by human intervention.

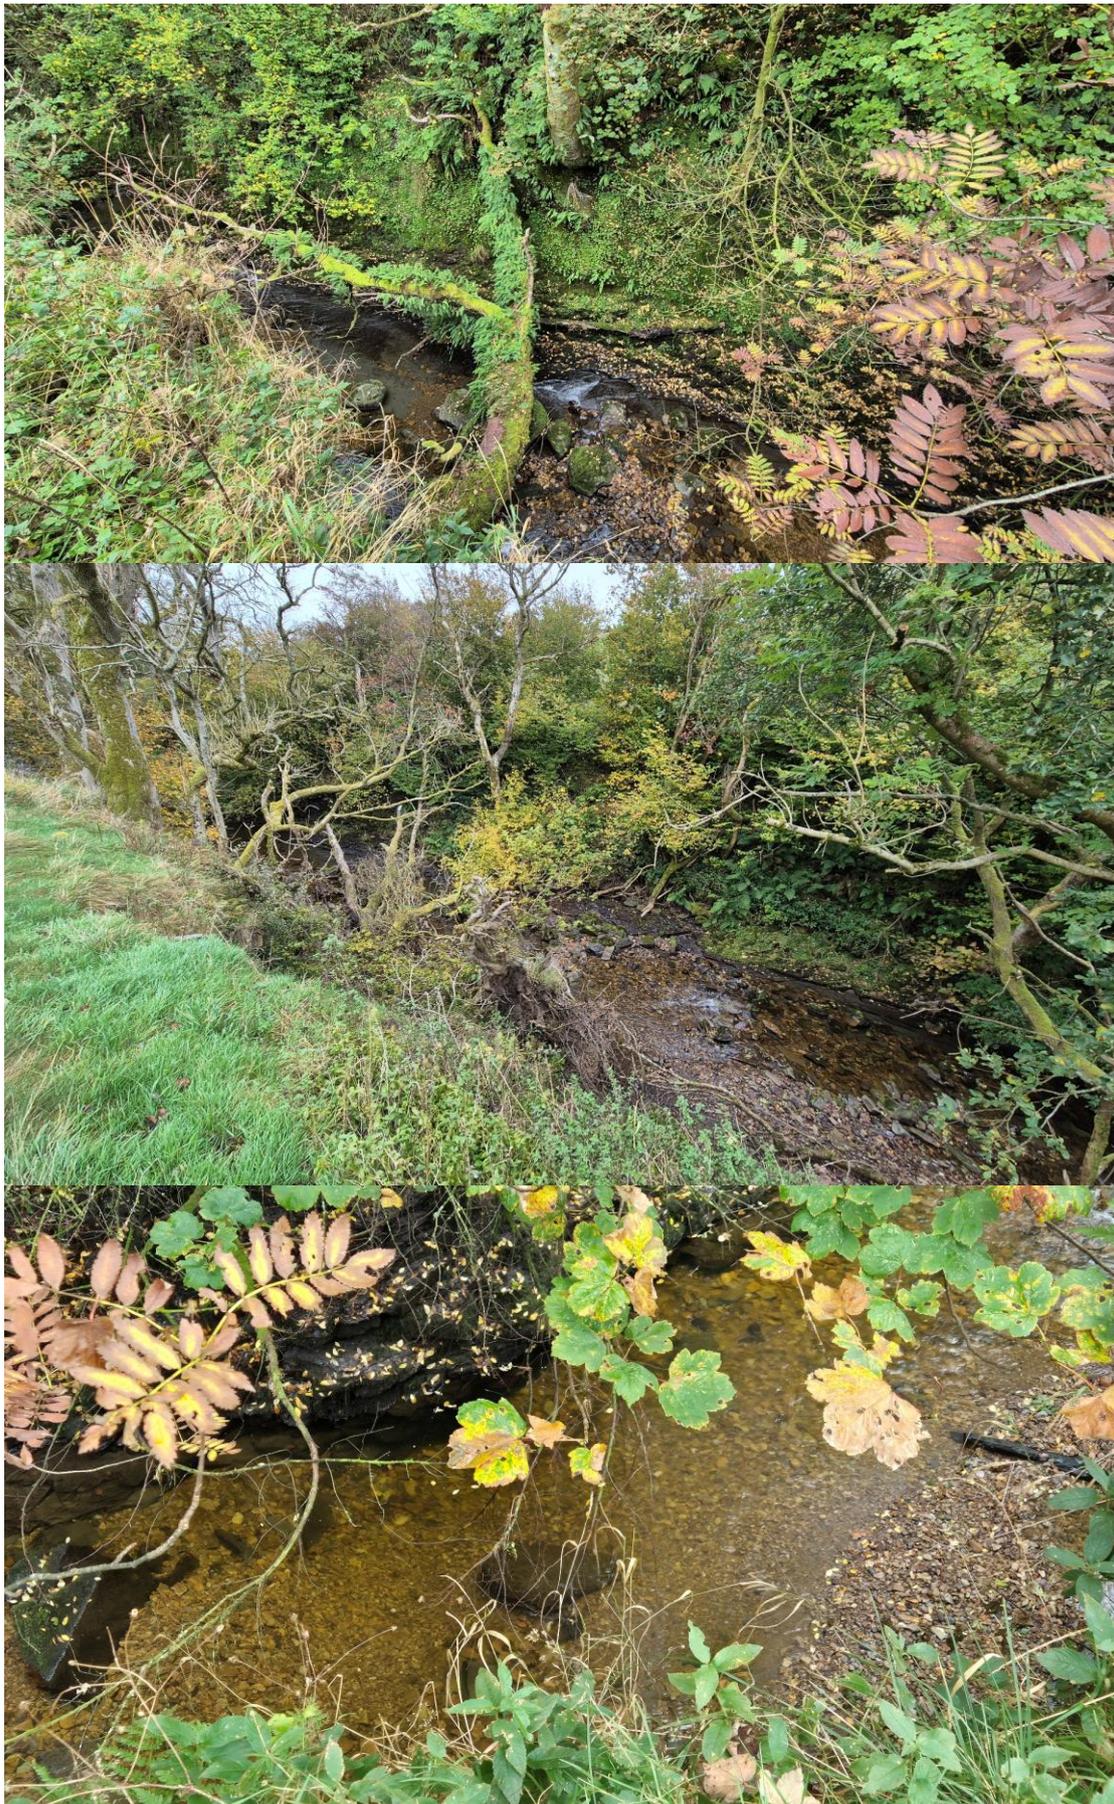
Fig 34: 54.290999 , -2.2091603 environs. Plenty of natural wood fall and retention of gravels within the confines of the gorge.

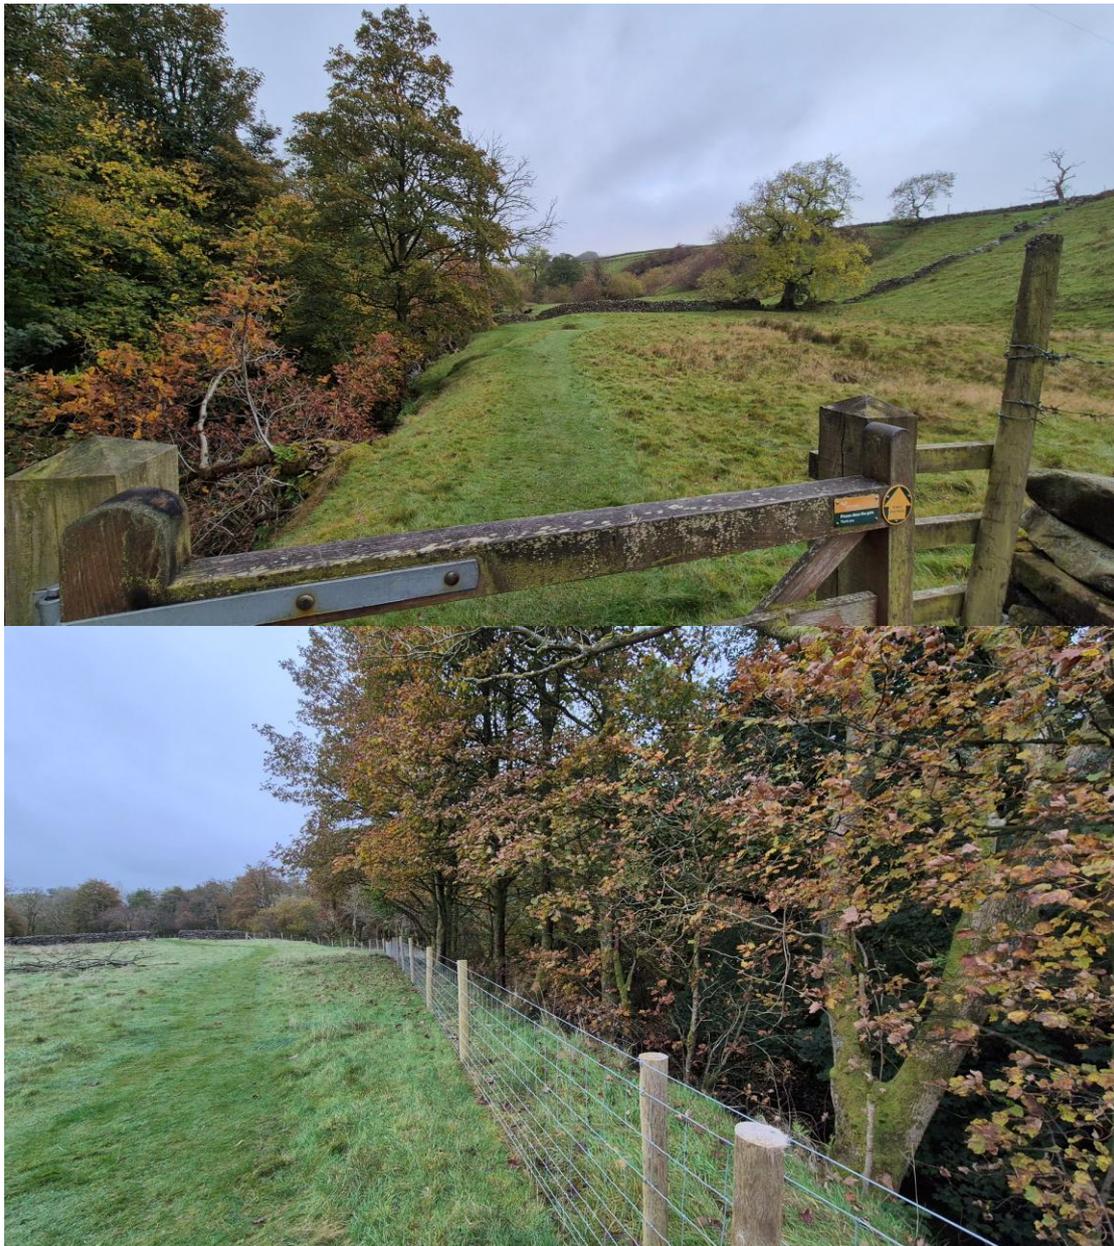
Fig 35: Looking u/s and d/s from 54.293829 , -2.2064288 on the LB at unfenced and fenced sections. The channel was incised at this location, and hard to envisage how the adjacent pasture was so level without historical human intervention. Placing the fence so close to the top of bank does not give much room for anything more than a single line of (mature) trees.

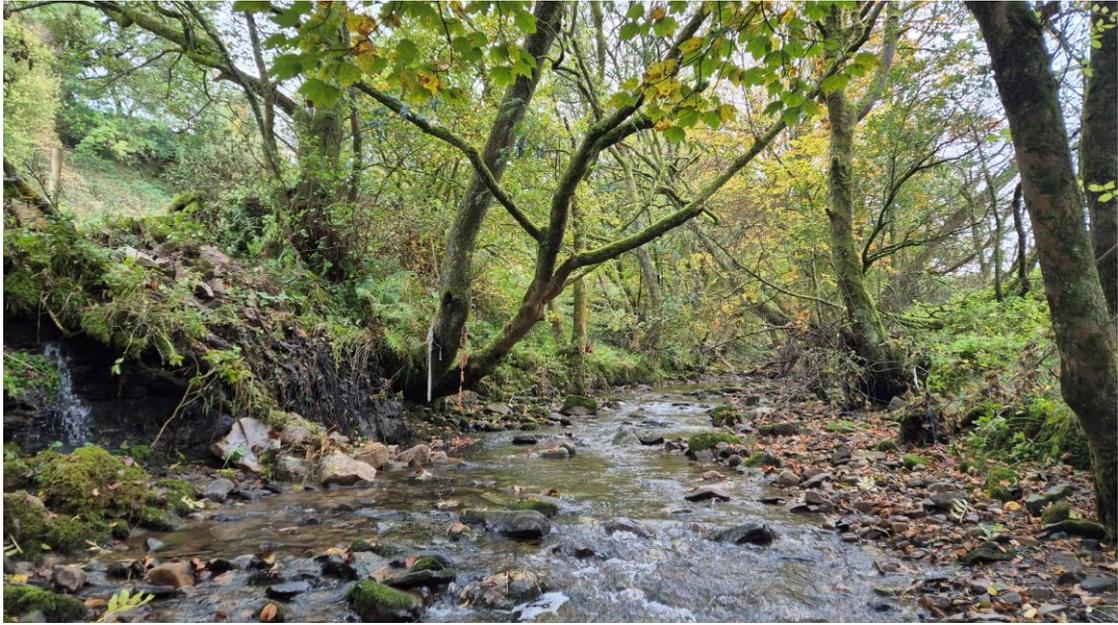
Fig 36: 54.294635 , -2.2048836. Further d/s and the bank profile was still modified but recovering with some mixed deciduous woodland growth. Water from a ditch network and series of scrapes (Fig 37) entered from the RB as a cascade, just visible left of shot, and was clearly a source of fine sediment ingress.

- Felling of failing / diseased trunks and lodging / tethering in the channel to diversify physical habitat.

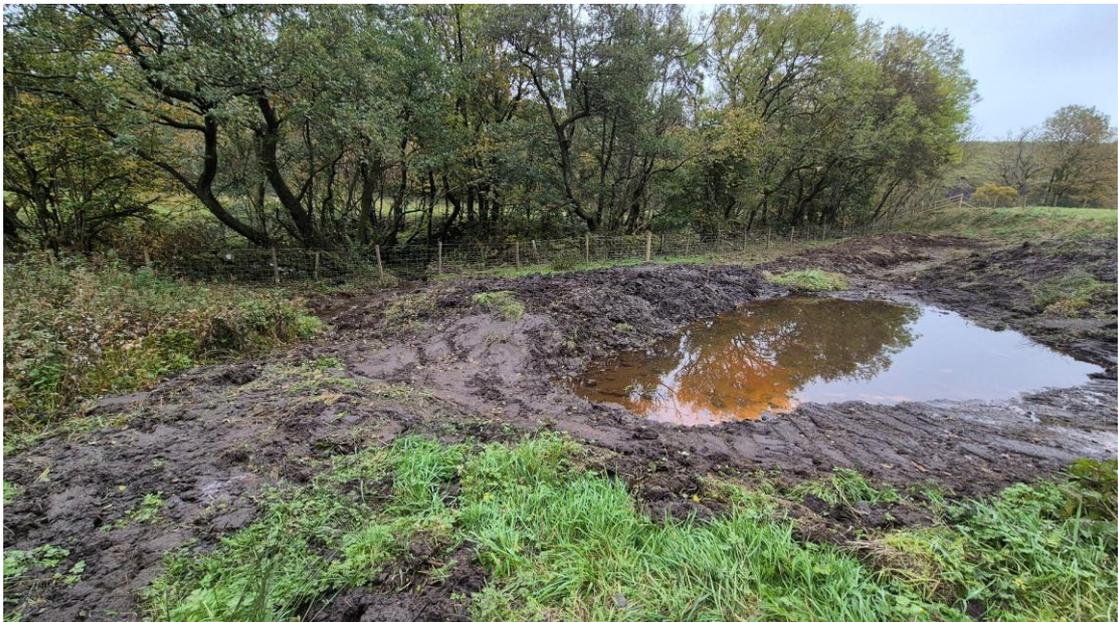
Fig 37: 54.294844 , -2.2045618. Attenuation pools installed by Ousewem – works had only just been completed but it had been left with a surprising amount of bare earth considering the likelihood of rain washing more fines into the beck. Needs returfing or covering with geotextile.

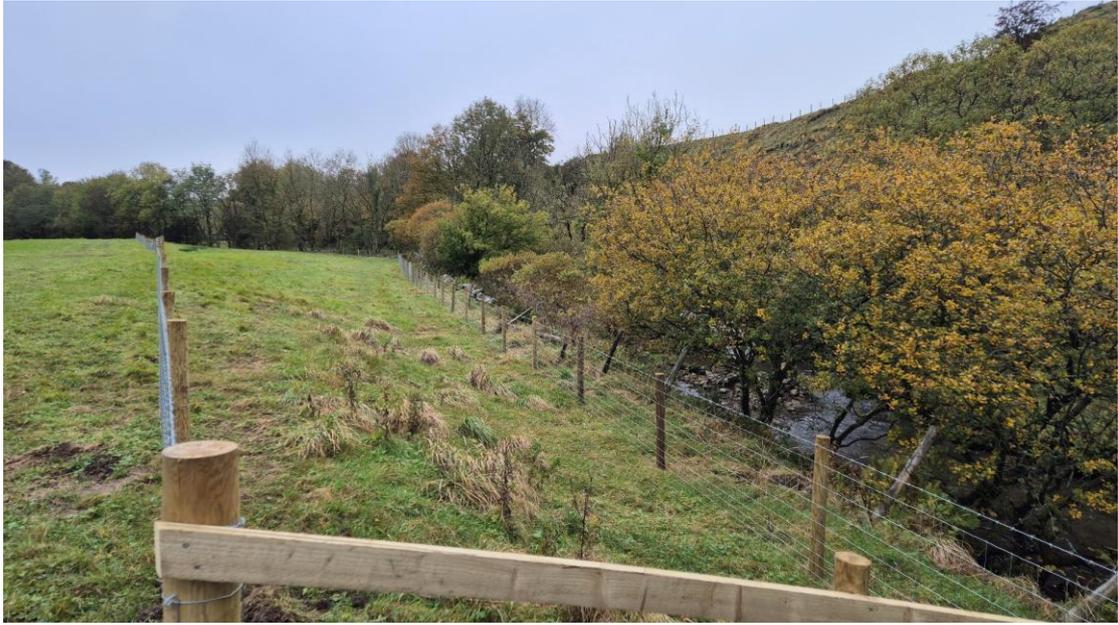
Fig 38: 54.295722 , -2.2031673. Parcel separation, recently completed. Would be ideal for woodland creation.
