WILD TROUT TRUST

Advisory Visit

Duerley Beck (Ure)

for Ure Dales Landscape Recovery, 2025

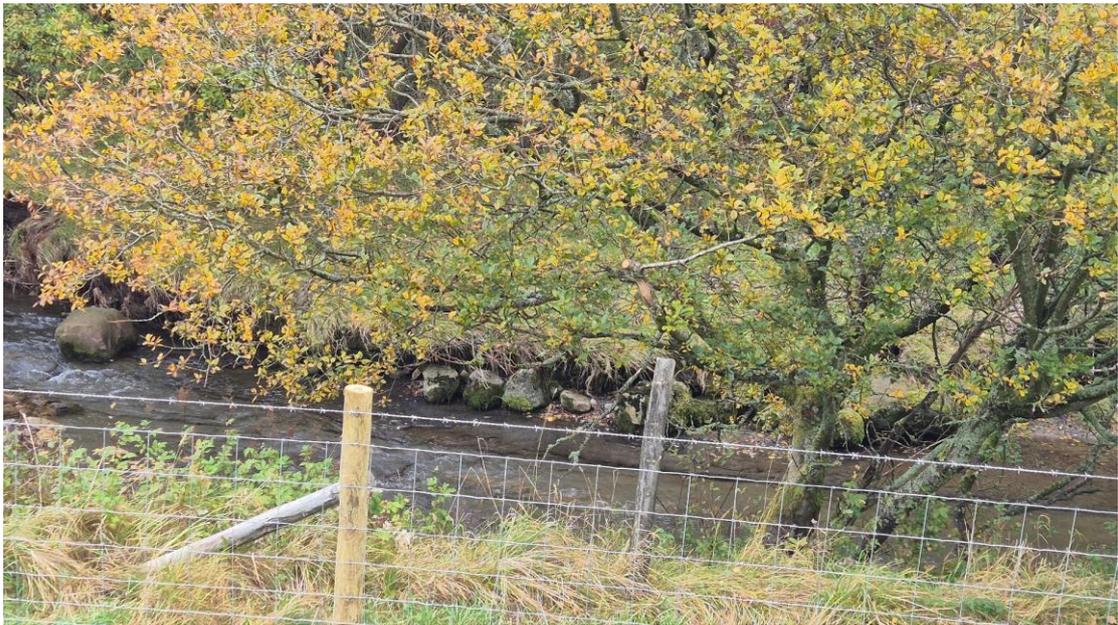
Fig 39: Looking across from 54.295722 , -2.2031673 at the LB below Gill Wood Scar, the channel had been lined with boulders which should be removed and cast into the channel.

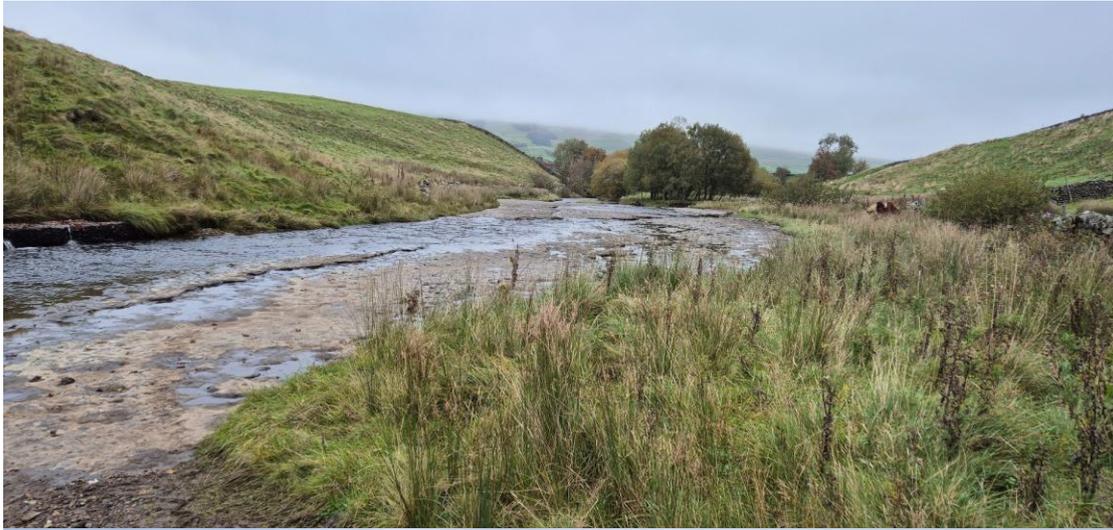
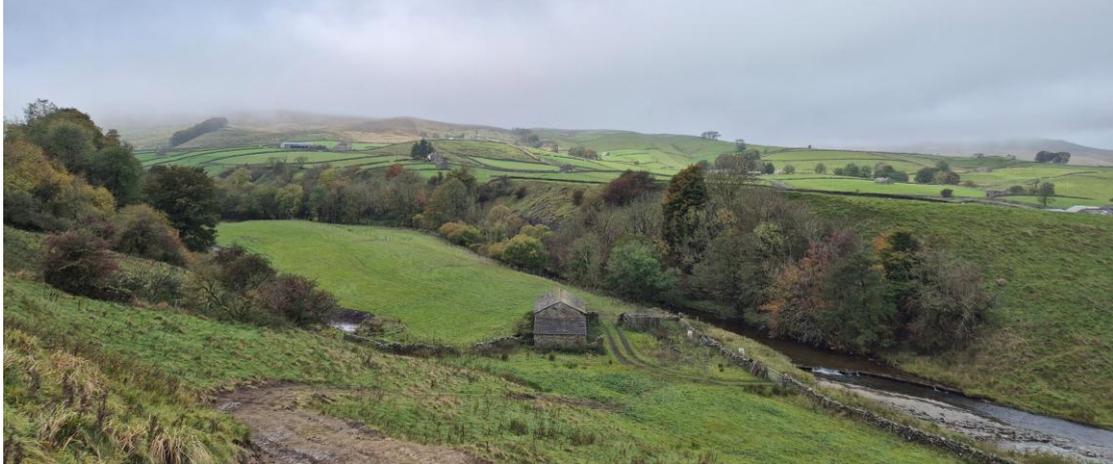
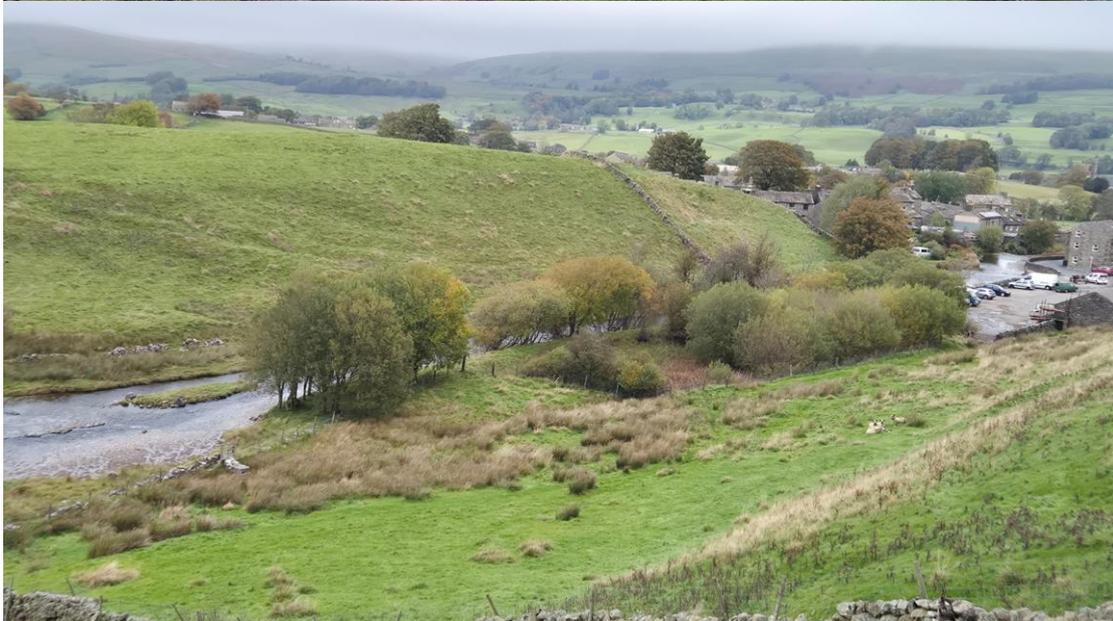
Fig 40: 54.296190 , -2.2020569. Vantage point looking down onto the bedrock seam of Duerley / Gayle Beck on the approach to Gayle.

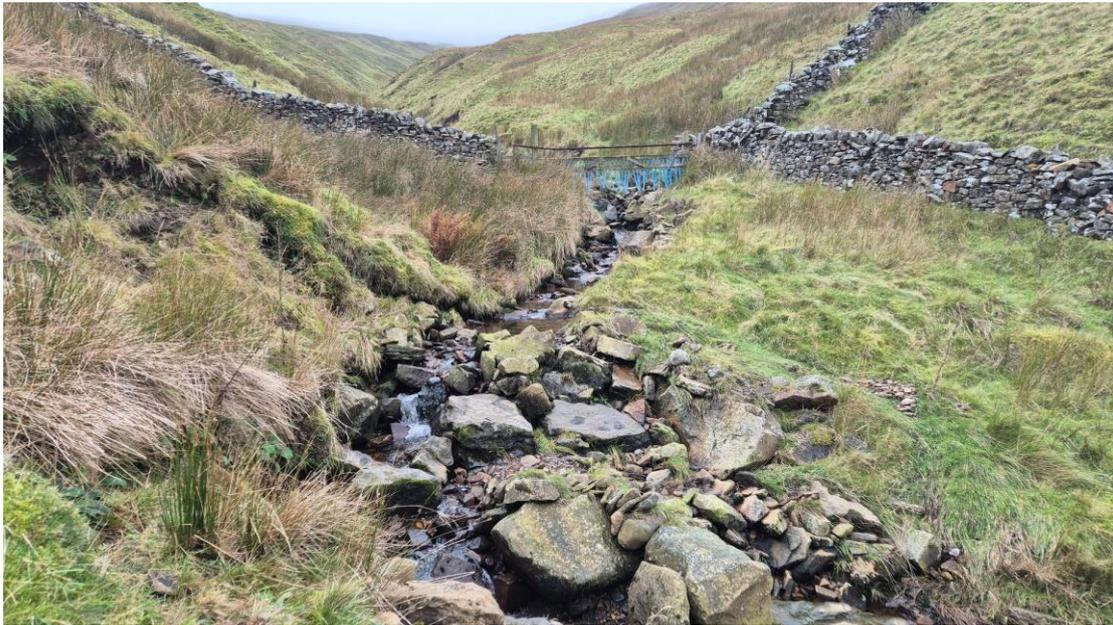
Fig 41: 54.267972 , -2.2334081. Most u/s point of assessment on Little Ing Gill. Innovative watergate construction in remote location! Further u/s, the channel looked mostly natural and less impacted by livestock grazing but would still benefit from establishment of shrubby tree cover in the gills.

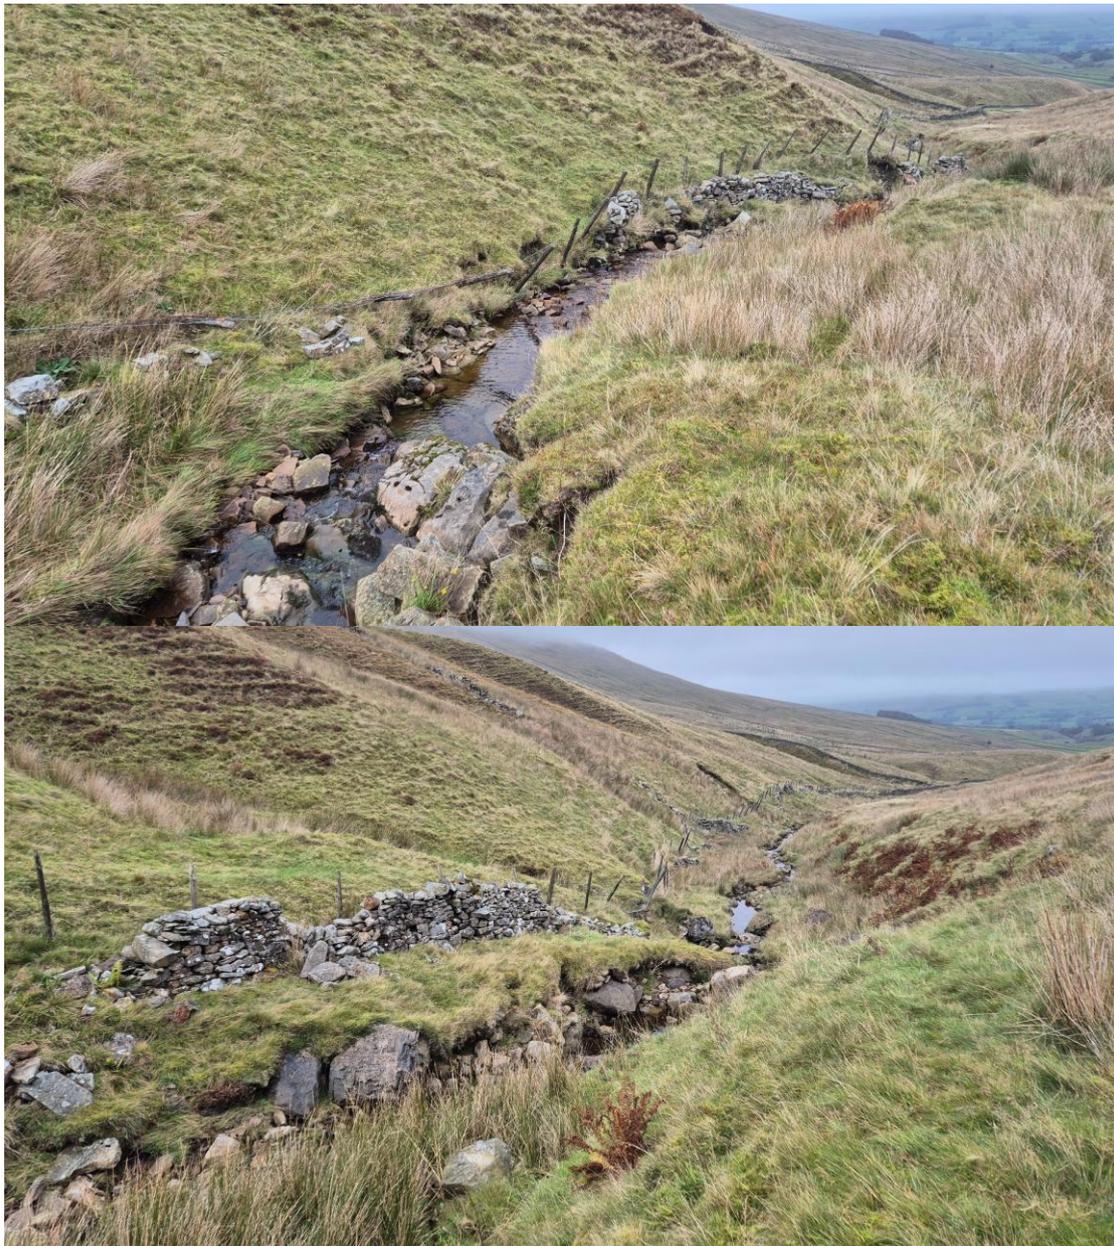
Fig 42: Unfortunately, a boundary wall, then fence, had been placed too close to the channel, and was failing in multiple places.

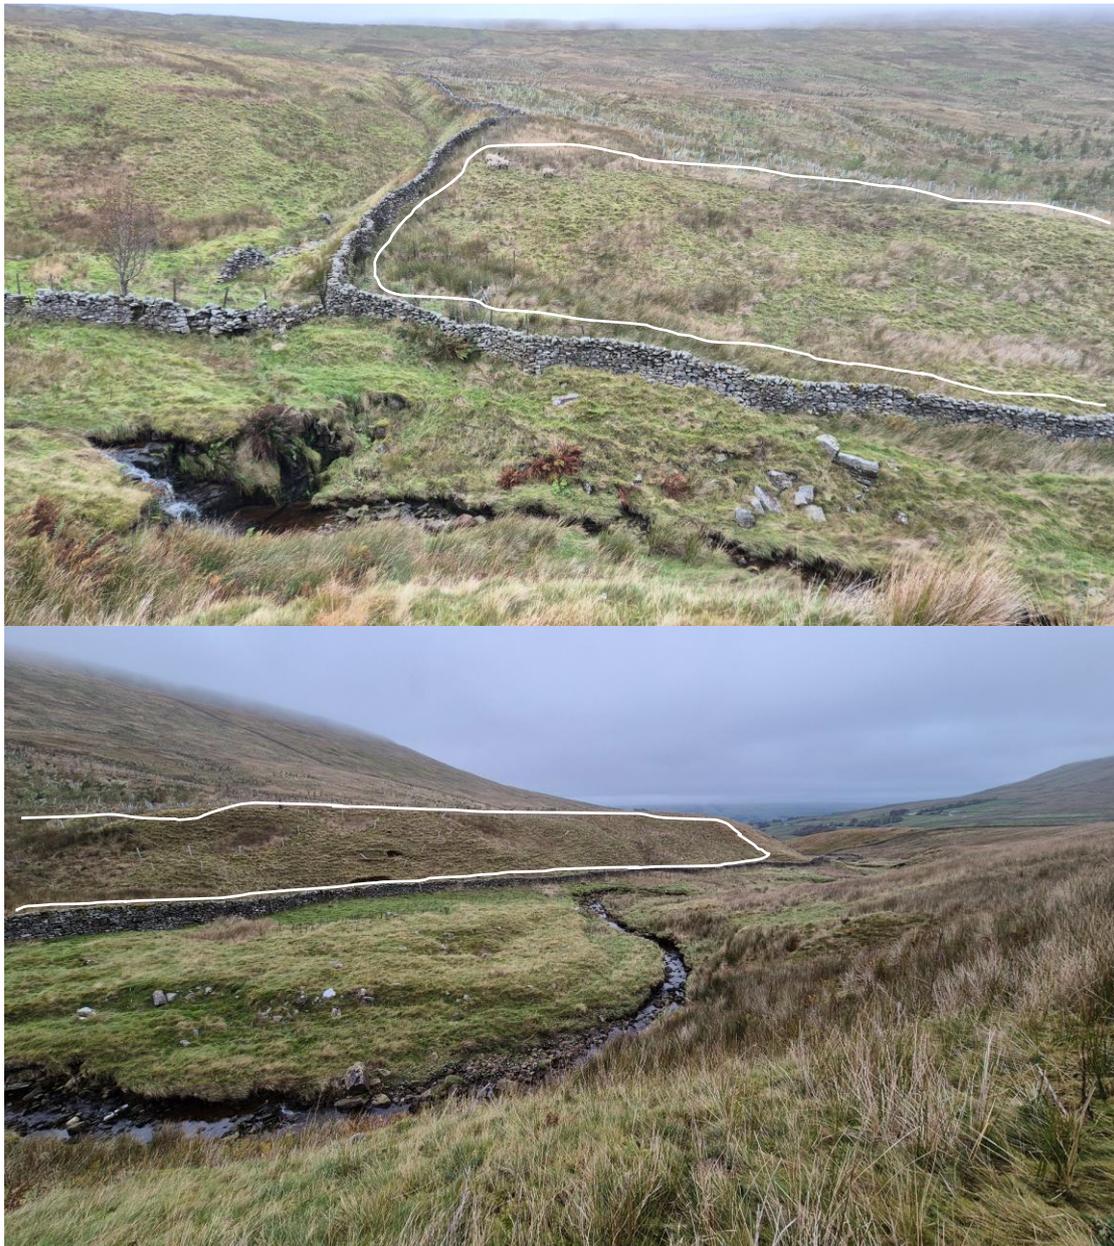
Fig 43: 54.270335 , -2.2313546. Grand-scale tree planting in the parcel set back ~50-100m from the beck, but within the intermediate parcel, highlighted by white line, there had also been an attempt (older?) at much sparser tree planting which seemed to have mostly failed; there were also sheep within the boundary.

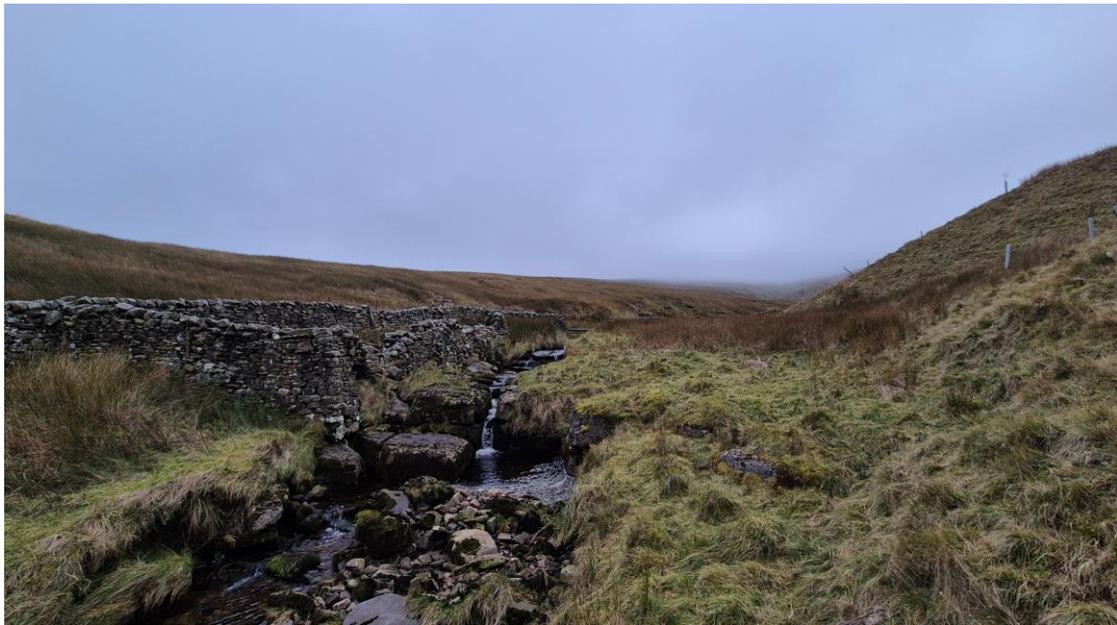
Fig 44: 54.272741 , -2.2277473. Natural pinch in the valley constrained by underlying geology. Note the slope of the parcel to RHS (highlighted in previous figure) with clear grazing impacts and failing tree planting effort.

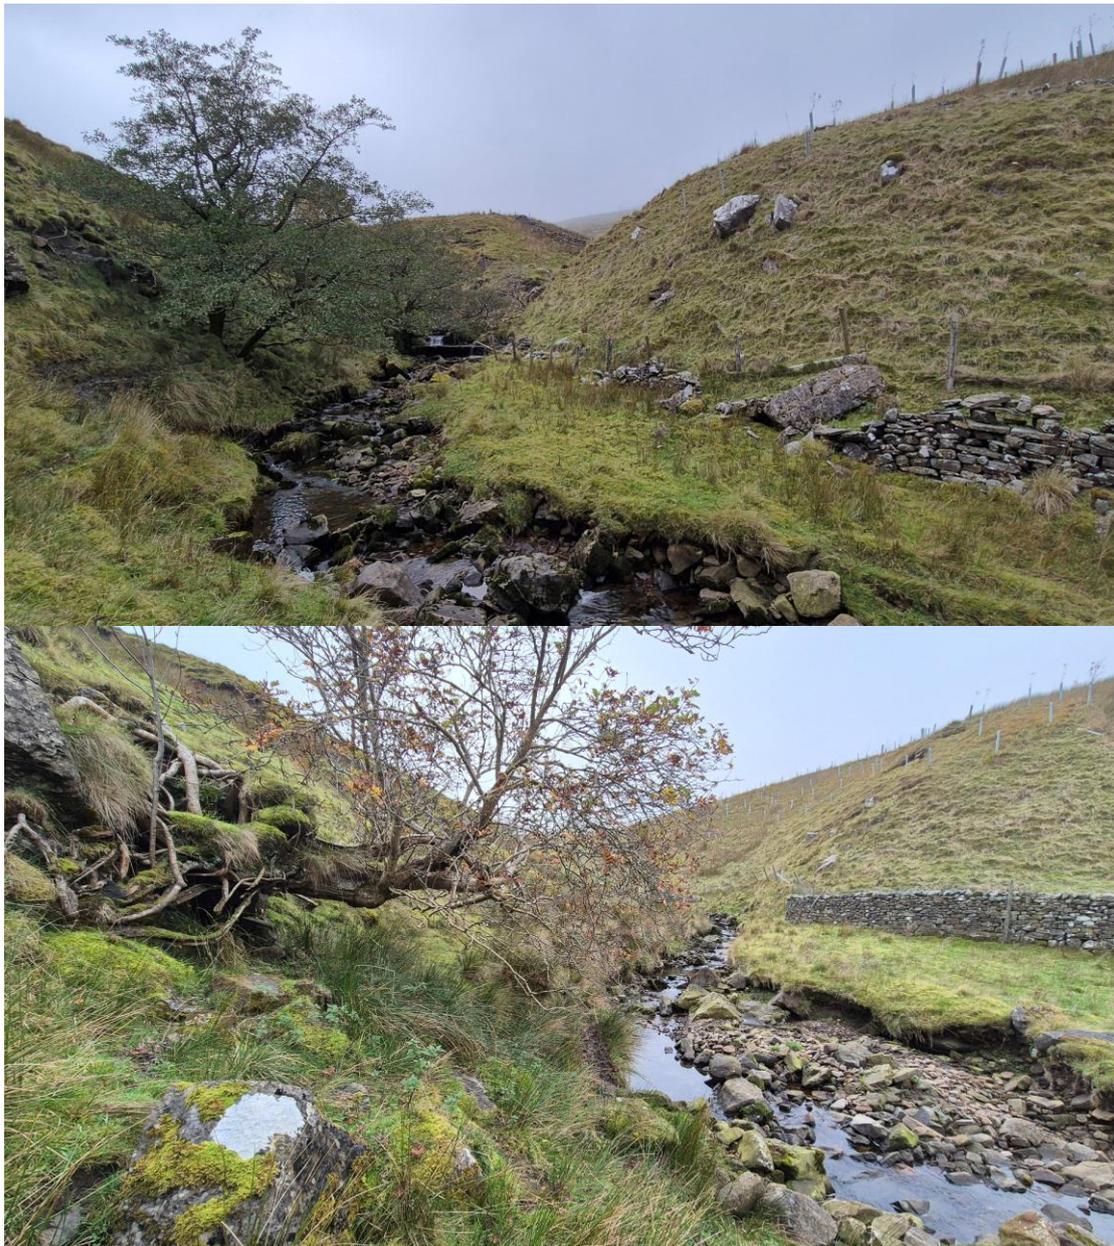
Fig 45: Very narrow section of valley down to 54.274017 , - 2.2266934, again highlighting issues of sheep ingress around the tree planting parcel on the RHS. Mature specimens of rowan and hawthorn indicate what should be in the gill, but any natural regen was being suppressed by sheep.

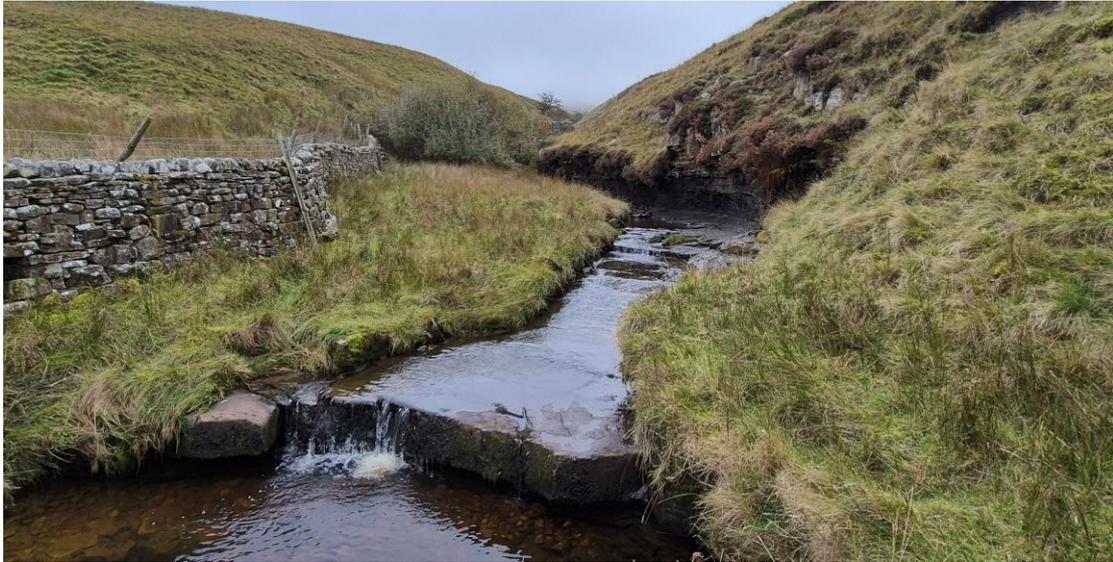
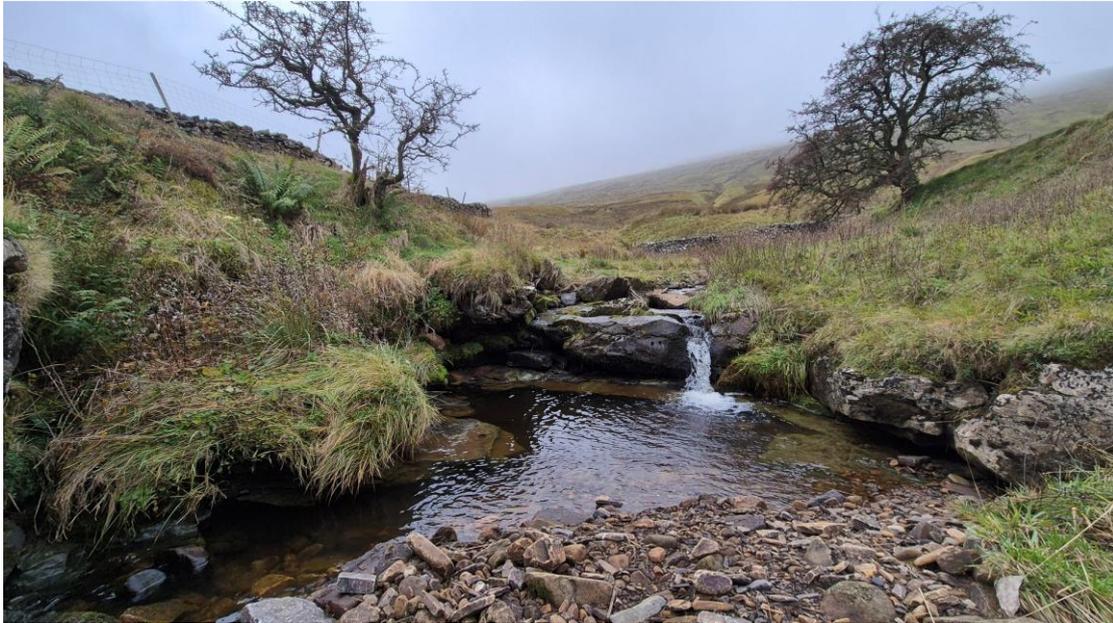
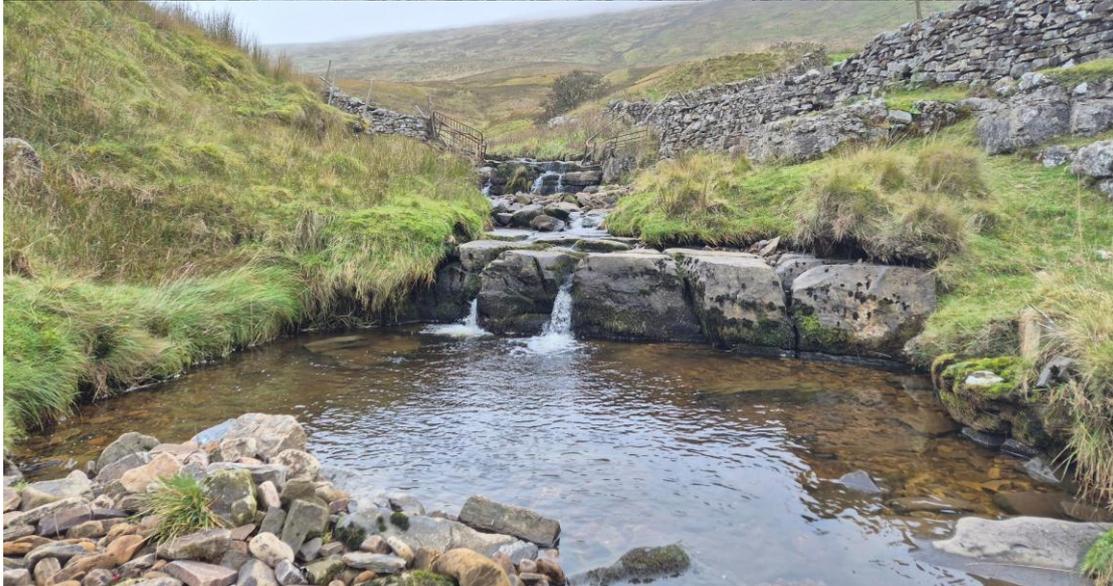
Fig 46: 54.274891 , -2.2259310 and d/s, the gradient and interaction with bedrock seams increased, creating distinct pool-cascade characteristics which would be naturally challenging but not insurmountable for fish passage.
