Walkover Report Erring Burn (River Tyne Catchment)

Undertaken by Gareth Pedley, Wild Trout Trust

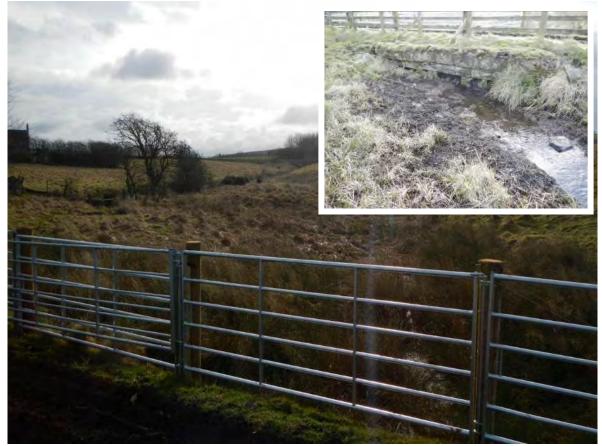
Photo DSCN6010. The burn was walked from NY 99337 74233, which is almost the u/s extent of the Fairspring Burn. At this point, the watercourse is very small originating in a field of rough, boggy, low density grazing land.

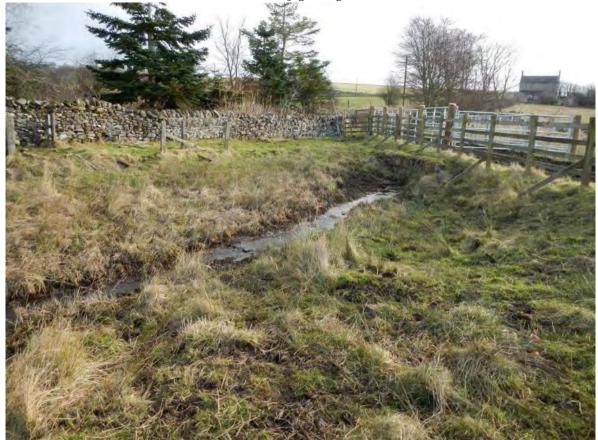
Photo DSCN6011. In the next field d/s, the grazing density/intensity increases and with no buffer strip, poaching becomes an issue.

Issue	Proposed action	Photos	Priority (1-3)
Poaching and livestock access to Fairspring Burn (NY 99337 74233).	Buffer fencing. Possible issues as land is being actively managed to utilise all potential grazing.	DSCN6011, DSCN6012 & DSCN6013	2
Poaching and sediment input from spring in field (NY 99091 74376).	Fence off wet corner of field.	DSCN6015	2
Livestock access and bank erosion on Erring Burn and Mootlaw Burn.	Install buffer fencing.	DSCN6033 & DSCN6034	2
Channel realignment and loss of habitat quality and	Possible options river restoration site, particularly conducive owing to	DSCN6033 & DSCN6034	3

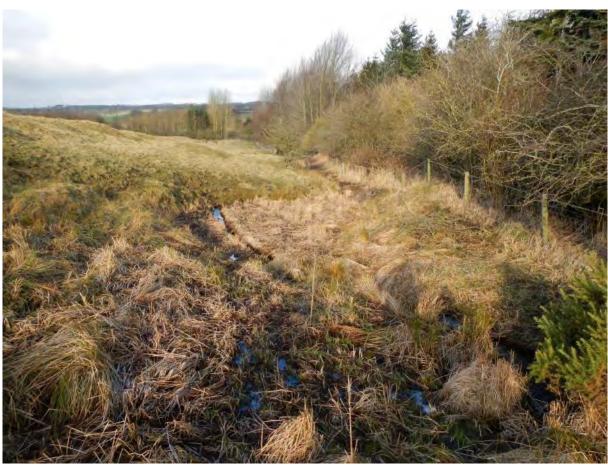
Photo DSCN6012. I deally livestock would be excluded from the watercourse but this may be an issue for the land user that is actively trying to improve grazing on the wet areas of the field. Note the recently topped sedges and other rank grasses.

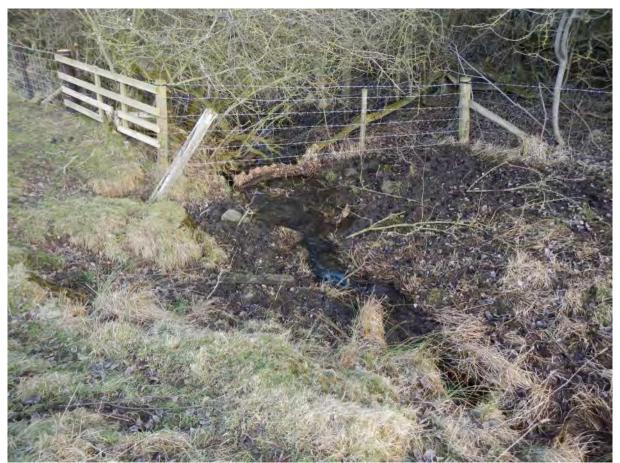
Photo DSCN6013. Poaching was also noted to be an issue at the d/s extent of the field where the burn becomes fenced.

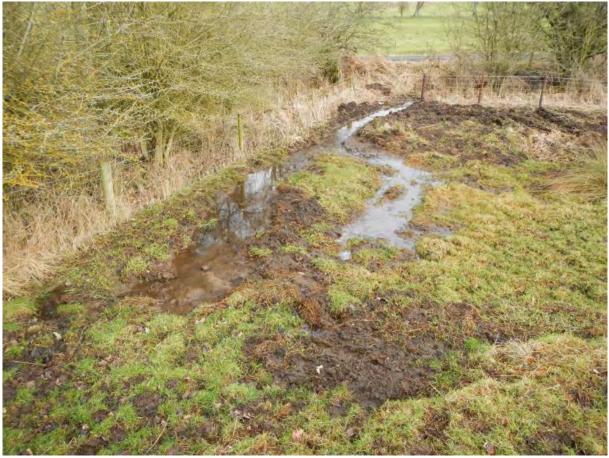
Photo DSCN6015. A small spring creates a wet area in the farthest d/s corner of the field (NY 99091 74375). This area, and the water quality of the burn d/s, would also benefit from stock exclusion.

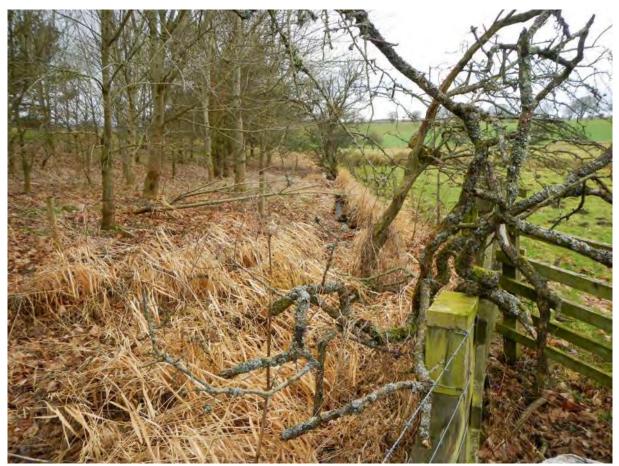
Photo DSCN6018. Much of the channel has been straightened, greatly degrading the habitat but fenced areas at least prevent detrimental livestock access and erosion.

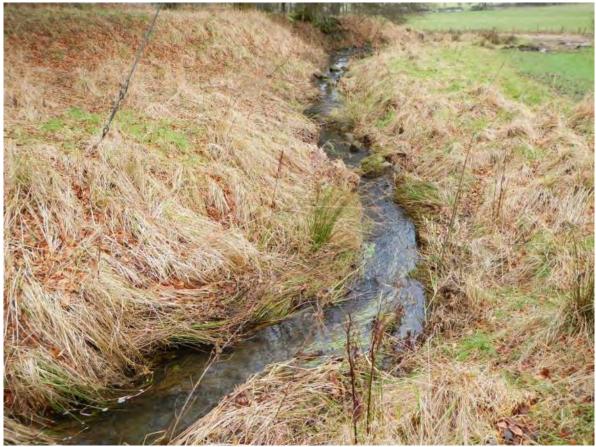
Photo DSCN6031. Where some sinuosity has remained (or recovered) improved habitat can be found and is likely to be capable of supporting juvenile salmonids. However, the quality is still far below that which would be expected within potential salmonid juvenile and spawning areas. A general lack of gravel bars and potential spawning habitat was observed in this area.

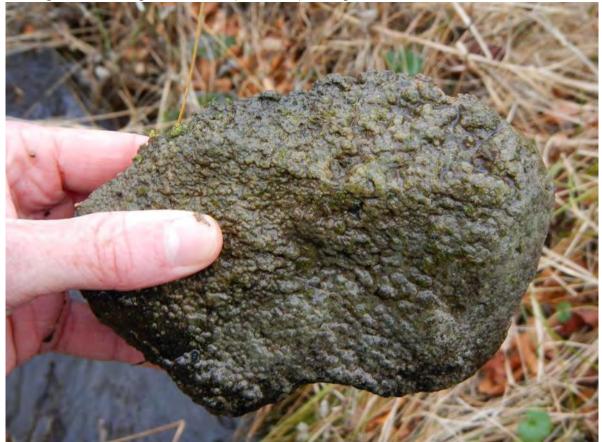
Photo DSCN6021. Tufa (calcium carbonate precipitate) was observed on some of the substrate, signifying a limestone geology, high calcium content within the water and high pH. This is a useful clue that the watercourse is likely to have an increased productivity over other more peaty burns.

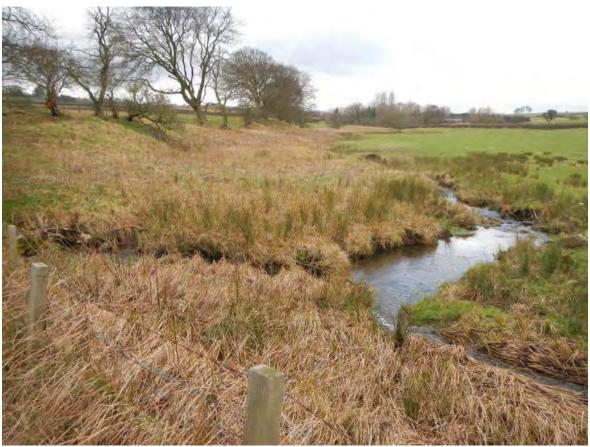
Photo DSCN6033. The confluence of the Fairspring and Eairspring Burns. The resulting Eairspring Burn appears to have been realigned to the left side of the field. Note the improved, grazed nature of the RB land in contrast to the ungrazed LB. Habitat benefits could be gained through a buffer fence along the RB or, ideally, restoration of a natural, sinuous, less incised, self-maintaining channel. The farmer here indicated that he has to periodically re-dredge the channel.

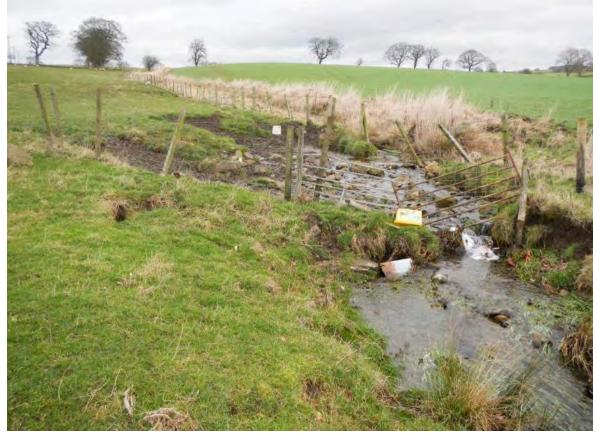
Photo DSCN6034. Mootlaw Burn is similarly straightened and livestock access is resulting in erosion and fine sediment input. Vegetation in the burn again hints at the high productivity of the watercourse.

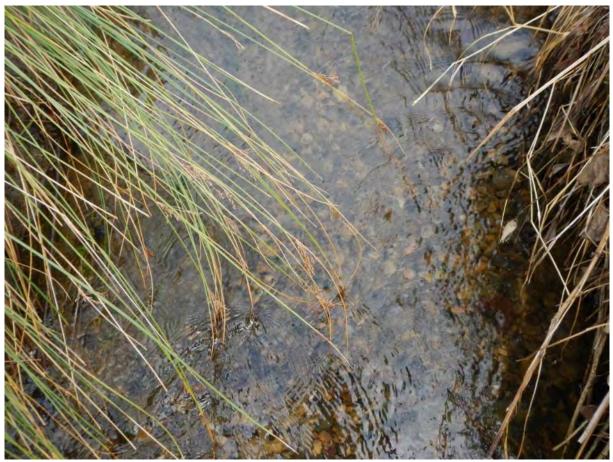
Photo DSCN6036. Occasional patches of gravel with some potential for salmonid spawning and improved invertebrate habitat were observed, but were scarce.

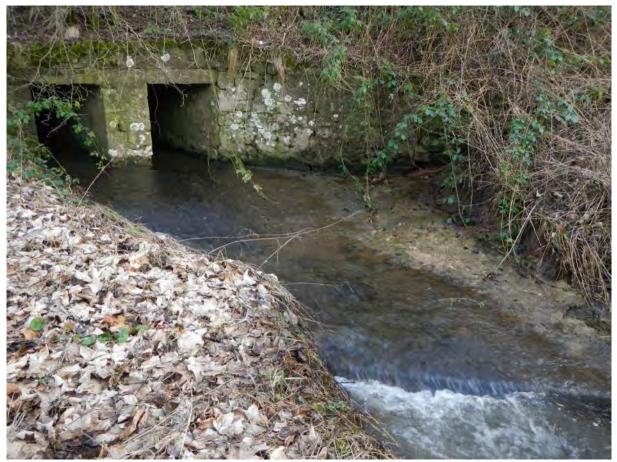
Photo DSCN6040. A concrete apron associated with a road culvert (NY 98453 74436) creates a potential issue for fish passage. This could be easily improved with the installation of baffles that would not only allow access for potential spawning fish but also juveniles wishing to disperse u/s.

increased	the large unused buffer strip along		
requirement for	the LB side of the channel.		
dredging.			
Poor fish passage.	Install baffles on apron and through culvert to increase water depth and reduce velocity.	DSCN6040	1
Major fine sediment input/runoff from adjacent field.	Seek greater buffer and drainage of any runoff to rough, well vegetated ground. Alterations to field tillage direction to reduce runoff.	DSCN6043, DSCN6048 & DSCN6051	1
Impoundment, and minor barrier (NY 98304 74358).	Remove block stones from across the channel.	DSCN6052	2
Weir at Hallington Mill pond (NY 98238 74333).	The weir has collapsed, now only the sediment deposition remains. Ensure that the weir structure is not reinstated.	DSCN6059	1
Pipe/culvert at u/s end of Hallington Mill pond (NY 98196 74400)	Remove pipe to reinstate uninterrupted fish passage. A small, simple and cheap project.	DSCN6057	2
Fine sediment issues on Hallington Burn	Investigate fine sediment inputs on the Hallington Burn catchment.	DSCN6056	2

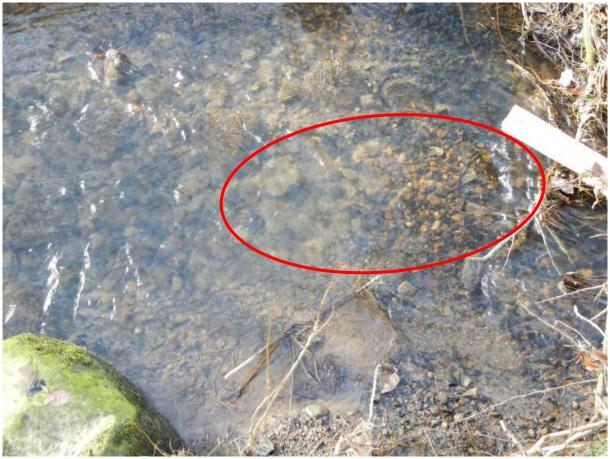
Photo DSCN6042. Interestingly, a suspected redd was observed at the tail of the pool d/s of the culvert. This could signify an obstruction or a lack of habitat u/s. Note the already problematic level of silt/fine sediment.

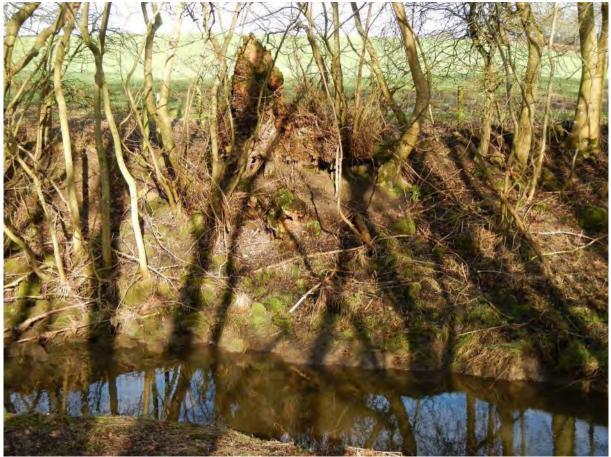
Photo DSCN6043. The field immediately d/s of the bridge (NY 98417 74428) slopes to the watercourse and surface runoff of fine sediment/topsoil was observed to be an issue here, with visible pathways and a major impact upon the substrate composition d/s (Photo DSCN6048).

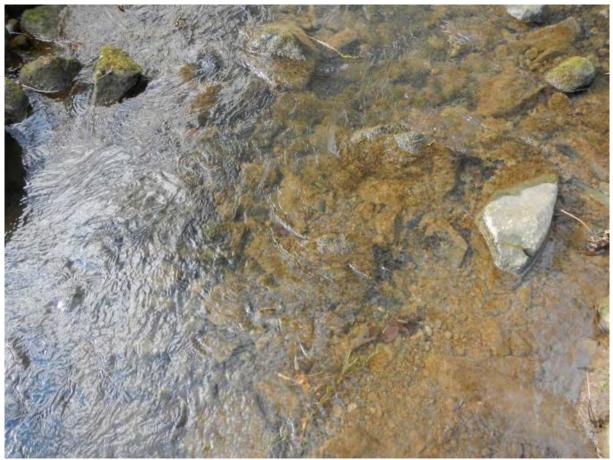
Photo DSCN6048. Fine sediment and excessive algal growth smothering the bed d/s - severely impacted invertebrate habitat.

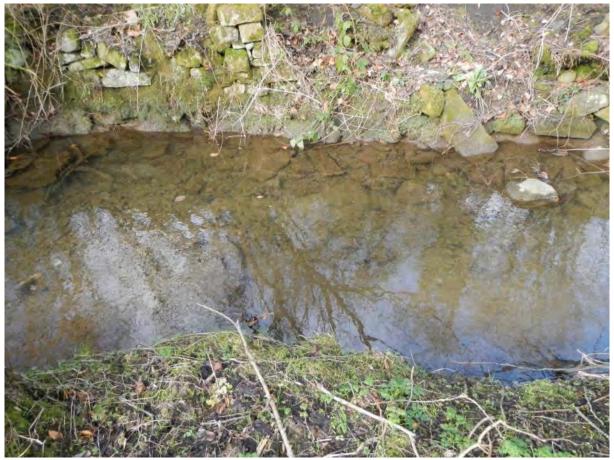
Photo DSCN6051. In pool areas, the fine sediment issue becomes even more evident. Being at the top of the catchment, this is a major issue degrading potential salmonid spawning and juvenile areas and impacting upon all of the watercourse d/s.

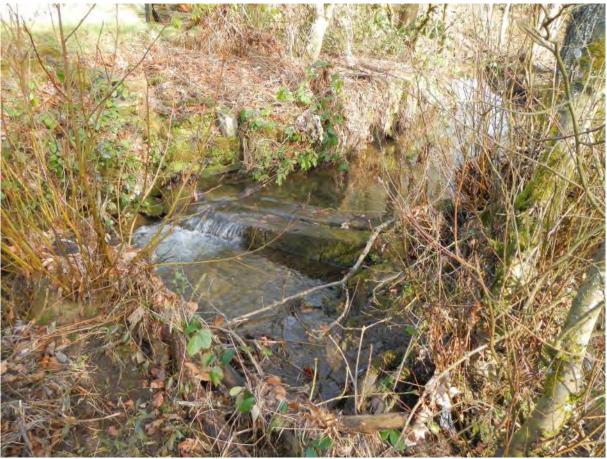
Photo DSCN6052. A small block stone weir/crossing point in front of Hallington Mill (NY 98304 74358) impounds the watercourse u/s and poses a small impediment to fish passage. It may be easy to gain permission to remove such an inconsequential structure.

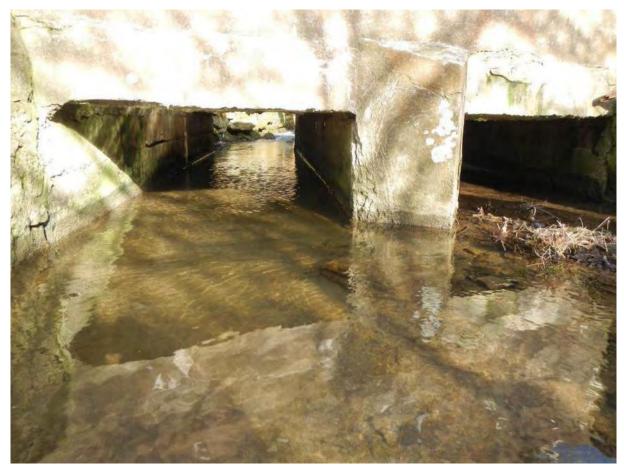
Photo DSCN6053. Relatively unencumbered fish and sediment passage is afforded at the road culvert in front of Halllington Mill.

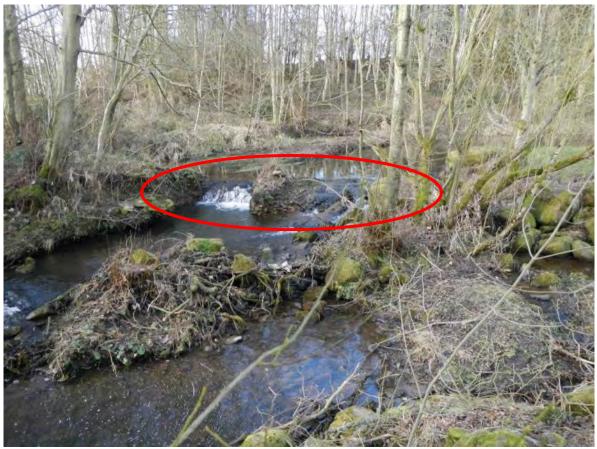
Photo DSCN6059. Hallington Mill is located at the confluence of the Earspring and Hallington Burn, which form the Erring Burn. The old weir on Hallington Burn (the other Erring Burn tributary) associated with Hallington Mill has fortunately washed away (reducing potential flood risk to the property and improving fish passage; however, some of the gravel deposition from the pool tail remains. This will continue to regrade over time, further reducing the barrier.

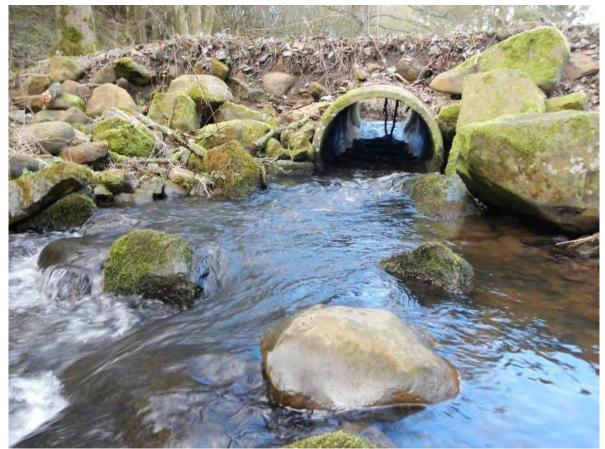
Photo DSCN6057. A pipe/culvert on the Hallington Burn at the u/s end of the mill pond poses some issue for fish passage and should ideally be removed.

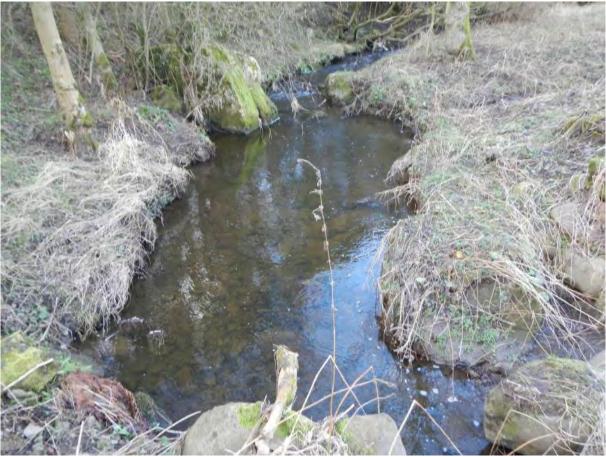
Photo DSCN6056. Some reasonably good habitat was observed in the lower reaches of the Hallington Burn but fine sediment also appeared to be an issue. Further investigation of the burn u/s would be beneficial.

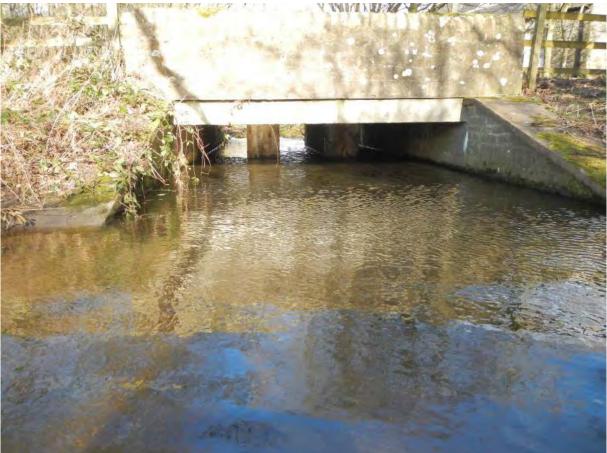
Photo DSCN6061. The road culvert on the Hallington Burn just u/s of the confluence with the Earspring Burn poses no issues for fish or sediment passage; accepting that the over-widened channel immediately d/s may lead to sediment deposition there over time.

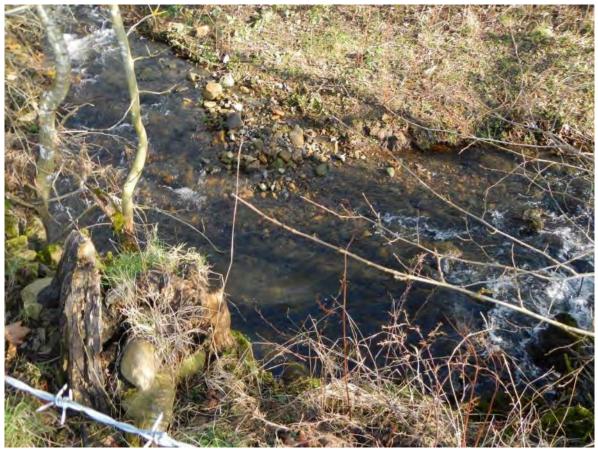
Photo DSCN6063. The lower 50m of the Hallington burn appeared relatively healthy with active gravel transport – probably supplied by the disintegration of the mill weir and liberation of the once impounded sediment.

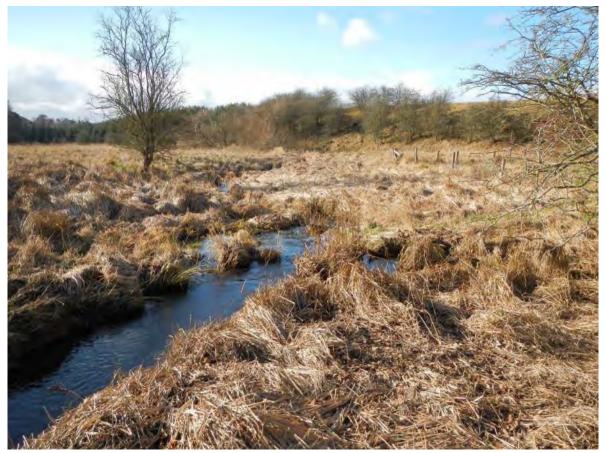
Photo DSCN6067. The field of the Erring Burn, d/s of the Eairspring/Hallington Burn confluence, is very rough, unimproved land and would make a great potential river restoration site, through which the burn could be returned to a more natural, sinuous channel. Alterations to the channel here probably related to a now dilapidated weir a few hundred metres d/s (Photo DSCN6076).

Possible river restoration site in first field d/s of Hallington Mill.	DSCN6067	3
Un-natural channel.	Further possibilities to improve the channel right throughout the section between Hallington Mill (NY 98268 74323) and NY 97103 73286 where although relatively sinuous, past channel maintenance has left straightened sections and degraded habitat – land use offers potential.	DSCN6079, DSCN6091 & DSCN6097	3
Pipes/crossing point (NY 98208 74194).	Remove pipes. A simple, by hand, volunteer workshop task.	DSCN6069	3
Dilapidated weir (NY 98084 74000).	Remove remains of weir or at least remove a section down to river bed level.	DSCN6076	3
Dilapidated weir (NY 97853 73771).	Remove remains of weir or at least remove a section down to river bed level to remove impoundment and improve sediment transport.	DSCN6087	2
Point source runoff (NY 97413 73610).	Seek improved land management.	DSCN6099	2

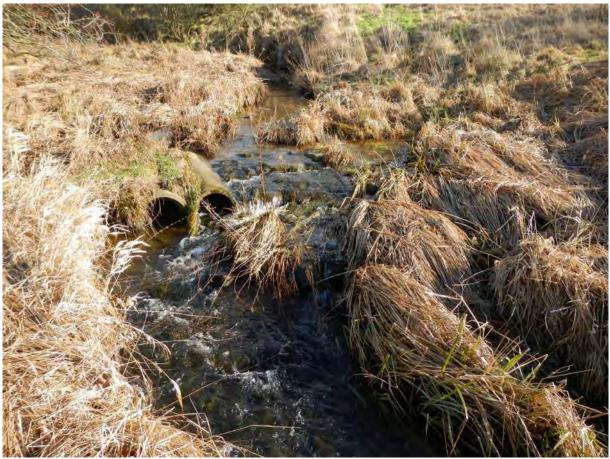
Photo DSCN6069. At NY 98208 74194 a small, disused, degraded pipe crossing could be quickly and easily removed to improve sediment transport and fish passage but poses a very minor impact.

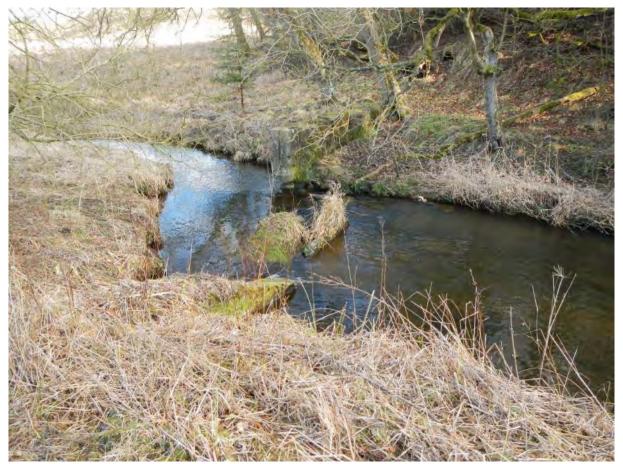
Photo DSCN6076. The dilapidated weir (NY 98084 74000) that historically impounded the reach upstream, through which the burn has managed to form a channel. The weir is no longer a major issue for fish or sediment transport but should ideally be removed (at least the central section).

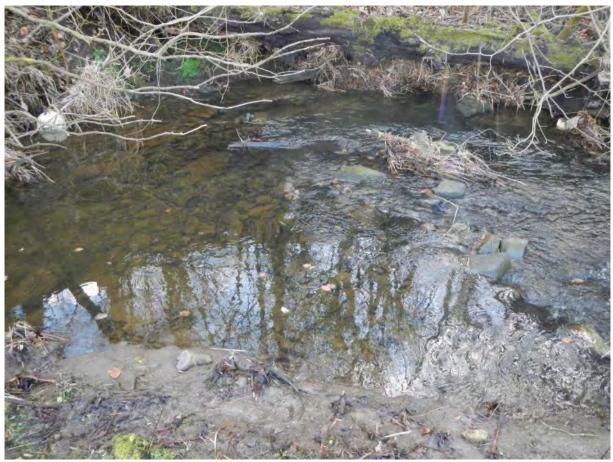
Photo DSCN6077. The channel d/s of the weir begins to take on some more natural characteristics but remains notably impacted by fine sediment.

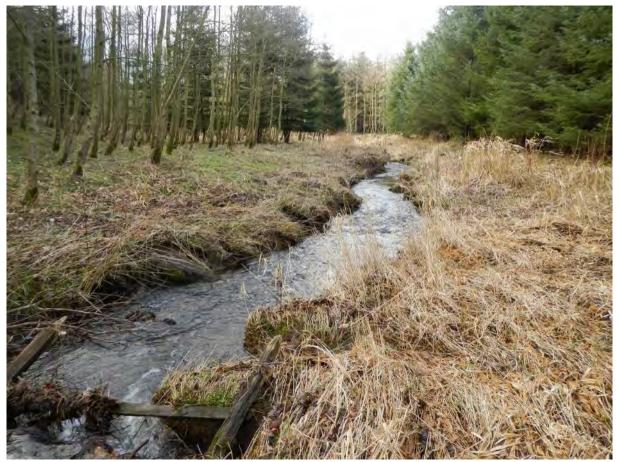
Photo DSCN6079. Sections of the burn still appear to have been realigned, possibly associated with plantations/past land management. From here on, for some distance, the riparian land is rough grass, with some adjacent plantation.

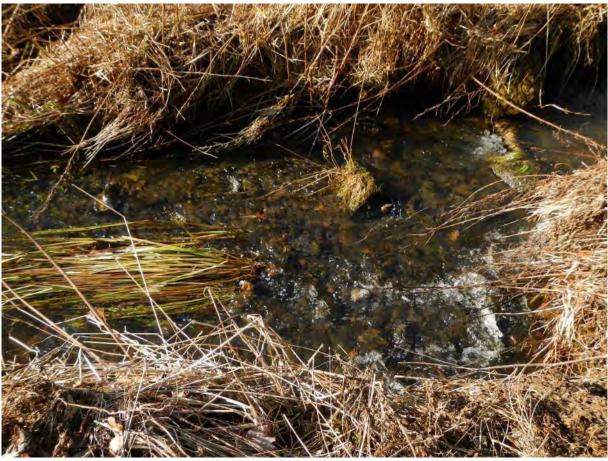
Photo DSCN6084. In most areas, the substrate of the burn is relatively natural, allowing that the uniform width and somewhat incised channel limits the aggradation of finer material, particularly the size-sorted gravels and cobbles required for salmonid spawning.

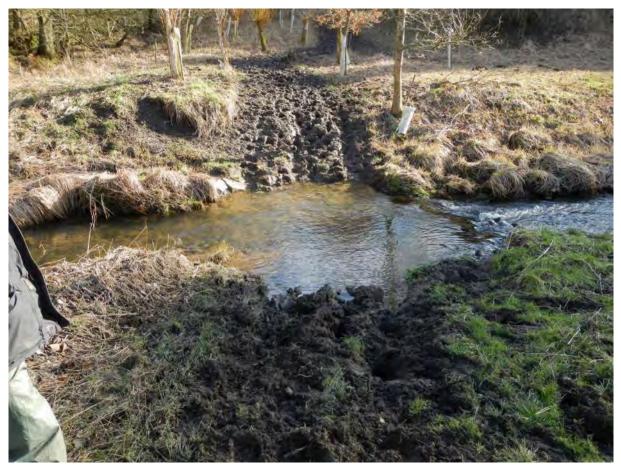
Photo DSCN6085. At NY 97912 73815, a quad bike and horse riding track creates another fine sediment input where the banks have become trodden/poached.

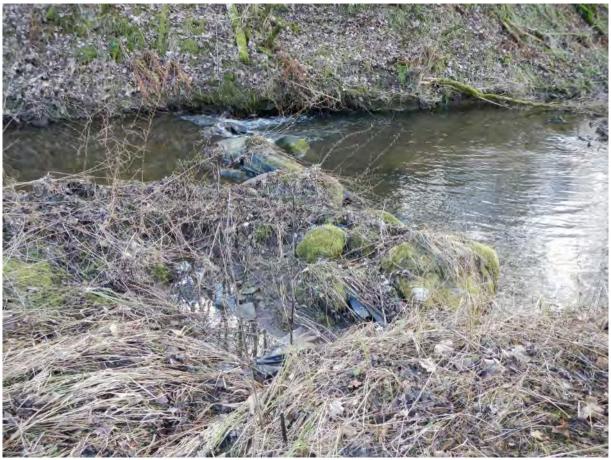
Photo DSCN6087. Channel modification work has clearly been undertaken in this area and another remaining but dilapidated weir (NY 97853 73771) poses a small obstruction. I deally this should be removed.

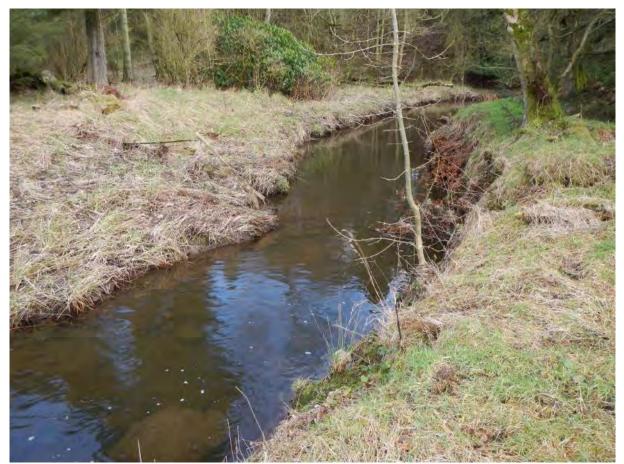
Photo DSCN6091. The channel d/s displays a more variable width and, consequently, depth. But the sediment issues are all too evident in the slower flowing pools.

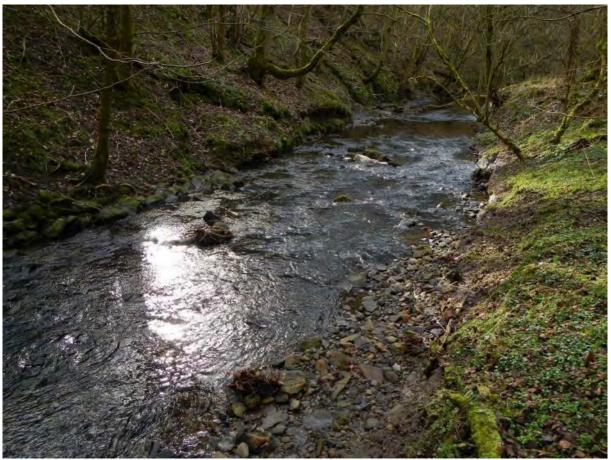
Photo DSCN6092. Shallower, wider riffles provide fry and parr habitat, often lacking elsewhere.

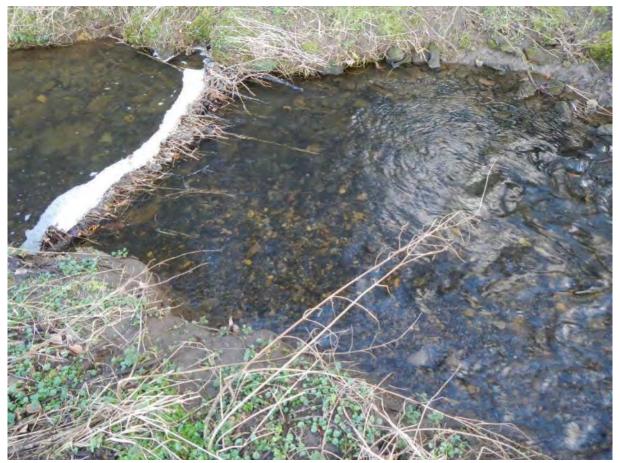
Photo DSCN6095. Some pool and riffle/gravel bar features do provide potential for salmonid spawning

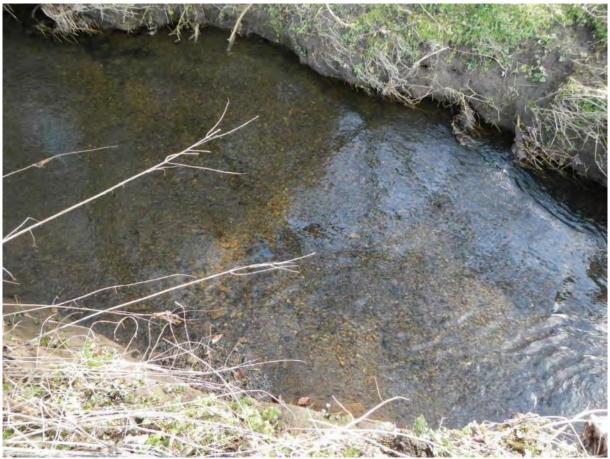
Photo DSCN6096. Where the pools dissipate flow energy sufficiently to provide appropriate spawning habitat for smaller resident trout - the fine sediment component greatly degrades its quality.

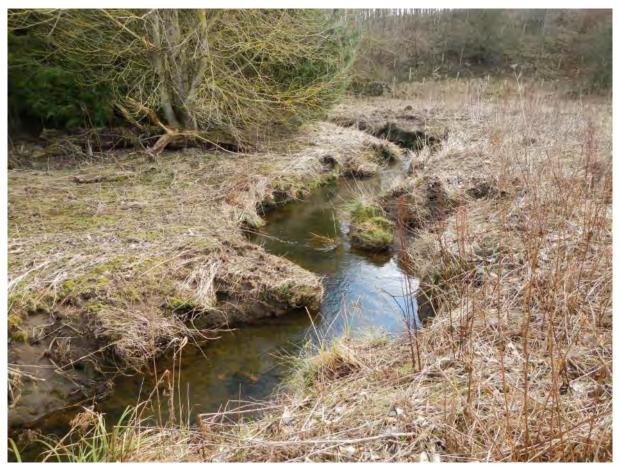
Photo DSCN6097. In some areas the channel displays a degree of sinuosity but appears dredged and over-deepened.

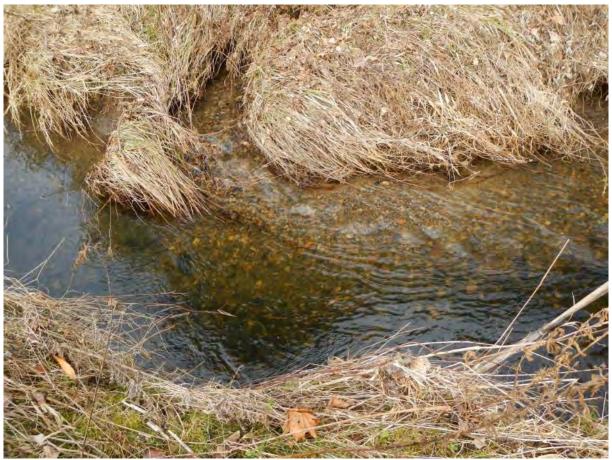
Photo DSCN6098. On some of the bends, a reasonable level of active sediment transport and retention can be observed.

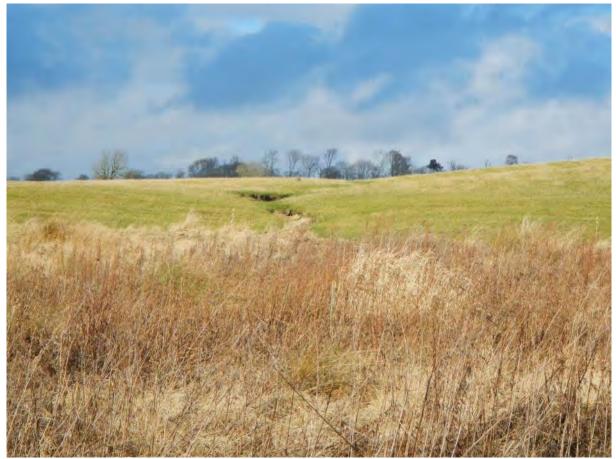
Photo DSCN6099. In most areas, a wide, roughly vegetated buffer protects the burn from arable land use and surface runoff, although several natural gullies/watercourses, field drains and potential conduits for fine sediment-laden water were observed (NY 97413 73610).

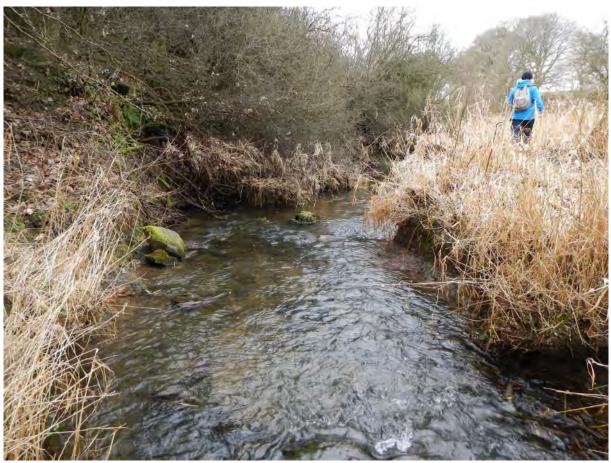
Photo DSCN6103. In the less obviously dredged and modified, less-incised sections, the true character of the burn and its potential as juvenile salmonid habitat begins to emerge.

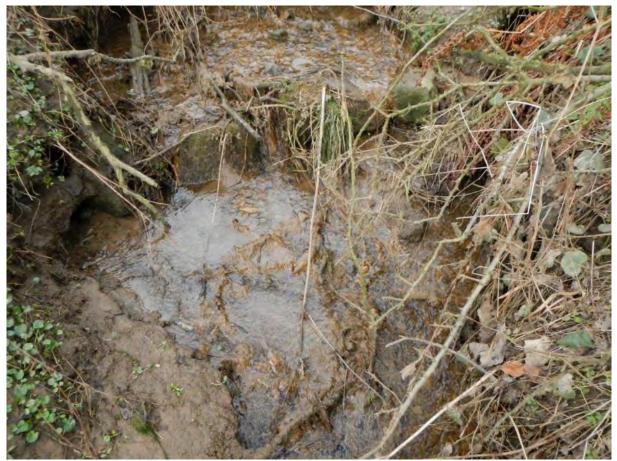
Photo DSCN6109. At NY 96786 73125 a particularly problematic field drain supplies fine sediment and elevated nutrients to the burn.

1		
Point source runoff and elevated nutrient levels (NY	Seek improved land management and larger un-vegetated buffer.	DSCN6109	1
96786 73125).			
Point source runoff and elevated nutrient levels (NY 96521 72988).	Seek improved land management and larger un-vegetated buffer.	DSCN6116	2
Point source runoff on 1 st LB trib d/s of A68 (NY 95966 72516).	Monitor reassess to identify whether the issue at the recent land drain improves. Investigate tributary u/s for further inputs.	DSCN6134	3
Point source runoff on 2 nd LB trib d/s of A68 (NY 95966 72516).	Investigate tributary u/s for further inputs. Suspected source - lack of buffer along LB of trib. Possibly also grazing and straightening u/s (as observed from Aerial photography).	DSCN6143	1
Point source runoff on LB (NY 95119 72255).	Alter direction of tillage. Possible installation of settlement lagoon within buffer.	DSCN6139	2
Major channel realignment around NY 95173 72354.	Possible river restoration site. Reconnection with the floodplain could also improve flood storage.	DSCN6146	3

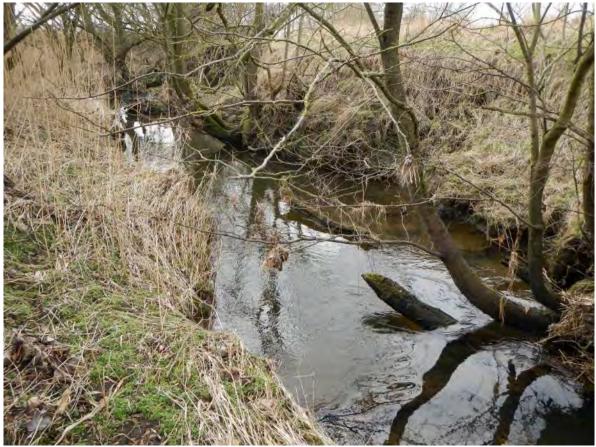
Photo DSCN6114. In the section u/s of the A68, dredging becomes more prominent and the channel is more obviously incised, probably owing to the immediately adjacent arable farming land use. Impoundment from the footings of the A68 culvert also degrades the habitat quality.

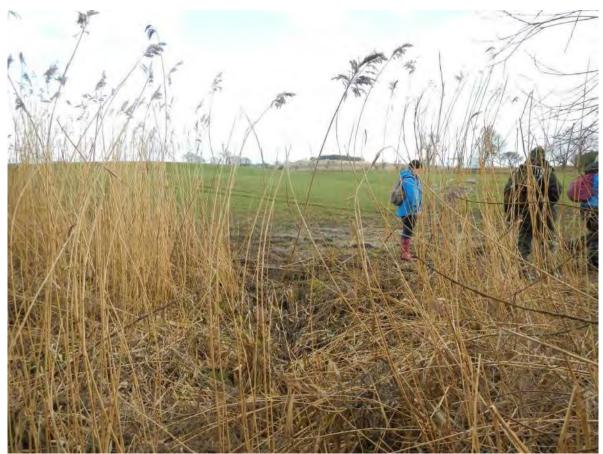
Photo DSCN6116. The immediately adjacent arable farming (minimal buffer strip) in the 800m u/s of the A68 is also leading to notable surface runoff and fine sediment input, further degrading the already impacted salmonid and invertebrate habitat.

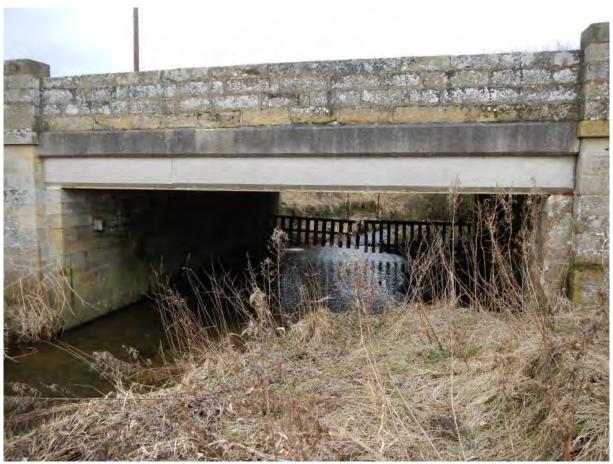
Photo DSCN6122. The A68 road culvert poses no impediment to fish passage or sediment transport.

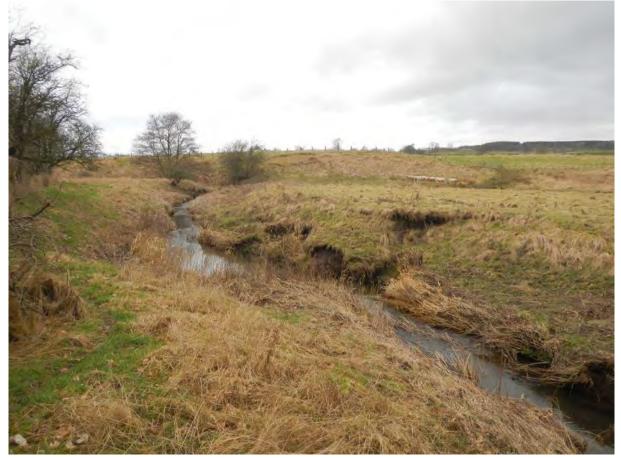
Photo DSCN6130. The LB d/s of the A68 is well buffered with a large area of uncultivated land/plantation extending to the next tributary d/s. Areas of the RB are grazed and correspondingly exhibit greater signs of erosion. The general character of the burn suggests that the history of dredging and realignment continues through this reach.

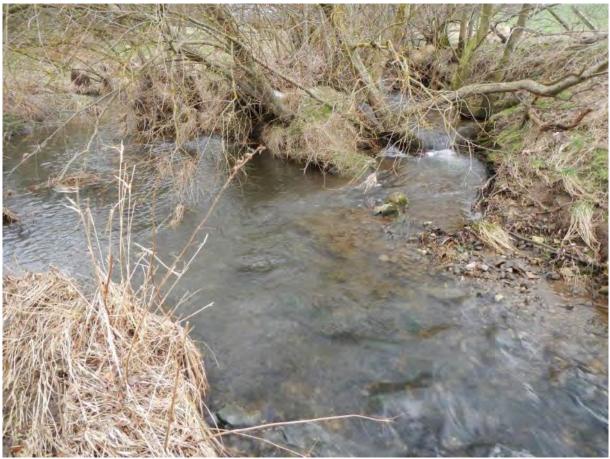
Photo DSCN6133. Although subject to past maintenance, some areas of higher quality habitat were observed, particularly where bankside trees protrude into the channel.

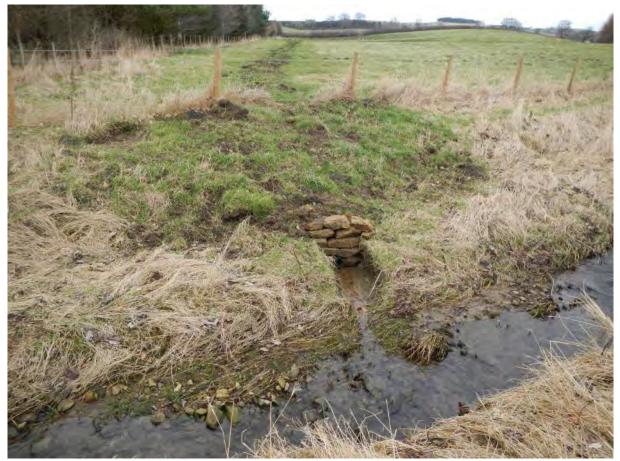
Photo DSCN6134. At the end of the plantation (NY 95966 72516) a LB tributary joins the burn. The tributary is notably straightened and shows further signs of fine sediment input. A recently installed/renovated field drain creates a visible input.

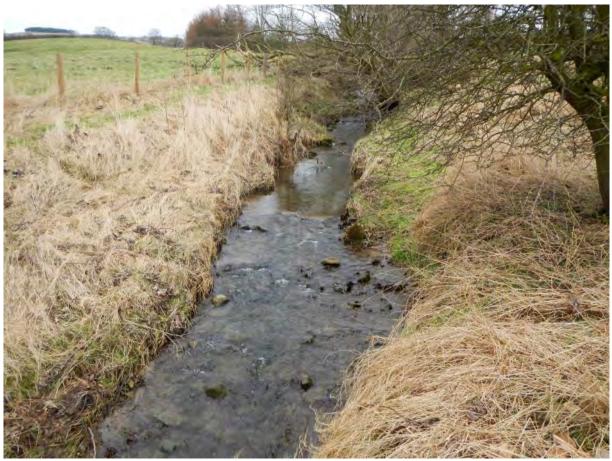
Photo DSCN3135. Although dredged/straightening of the tributary is obvious, the work appears to have been historical and the channel has recovered somewhat, providing some potential spawning and juvenile habitat. The watercourse is also flanked by a beneficial rough grassland buffer.

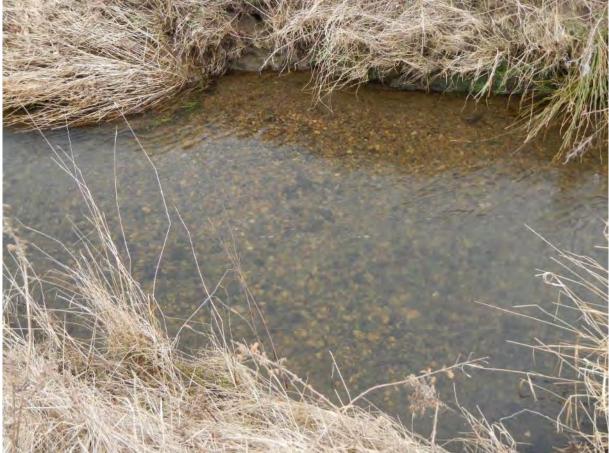
Photo DSCN6137. Areas of the Erring Burn d/s of the tributary also provide some high quality salmonid spawning habitat, demonstrating the potential of the burn before the land drainage impacts.

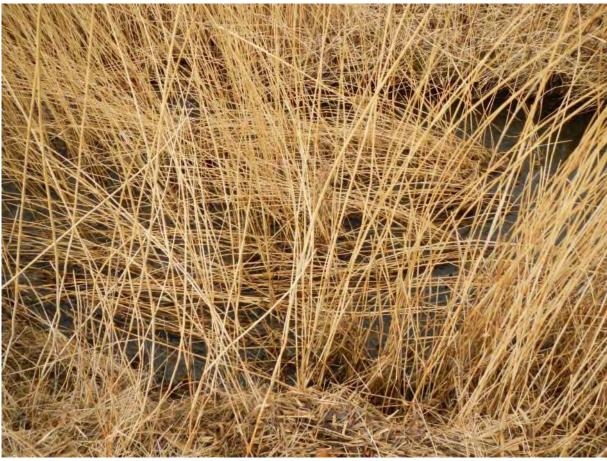
Photo DSCN6138. A further impact of the straightening and dredging of the channel was observed though the significant encroachment of emergent vegetation; a sure sign of impacted geomorphology that is less able to support a self-cleansing channel.

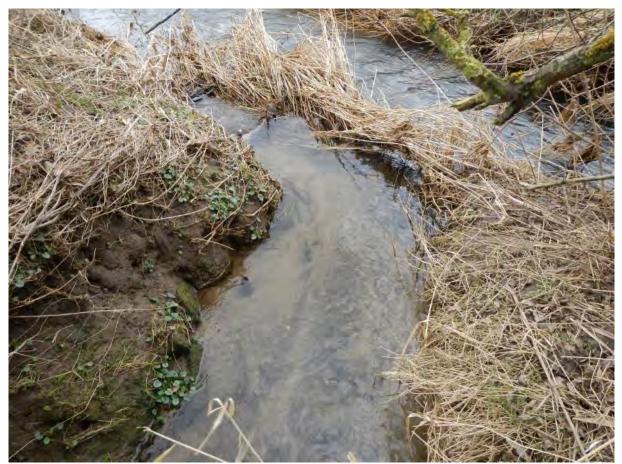
Photo DSCN6143. The next tributary d/s (NY 95418 72380) has minimal buffer along its LB, with low areas/suspected surface runoff from the adjacent field.

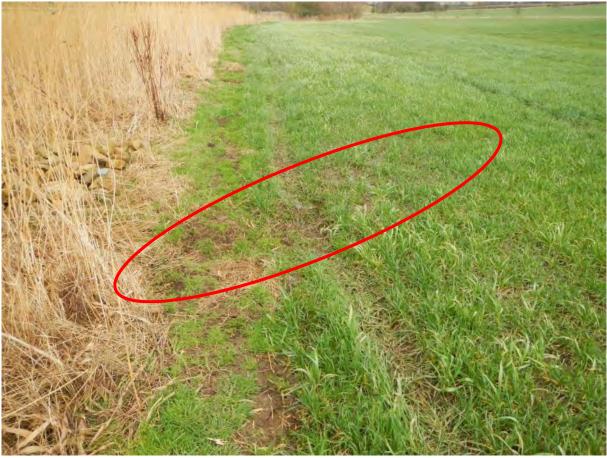
Photo DSCN6139. Although difficult to discern from the photograph, several low points in the arable fields adjacent to the main burn, between the tributary and NY 95119 72255, provide conduits for surface runoff, sediment, and almost certainly nutrients.

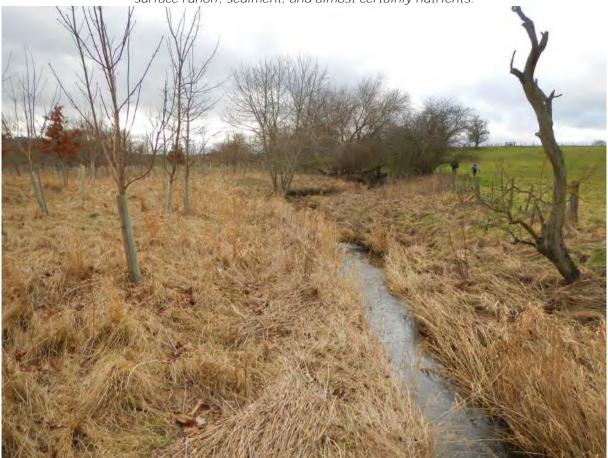
Photo DSCN6141. Where land has been set aside for tree planting, a much greater buffer alleviates the issues with surface runoff and excessive fine sediment input. However, in many areas the channel remains overly uniform in width and depth, lacking meanders and or a natural planform.

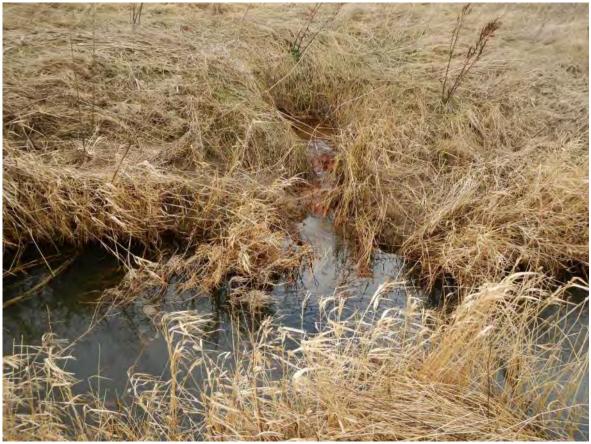
Photo DSCN6145. I ron oxide precipitation was observed in several small springs/drains but the volumes discharged and the extent of the issue are unlikely to have much of an impact upon the burn.

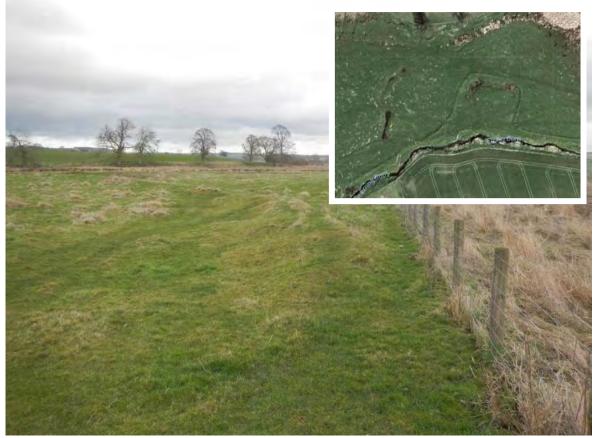
Photo DSCN6146. In several areas of the floodplain (like NY 95173 72354**), the burn's natural** paleo-channel and past maintenance of it (flood banks) can be observed. Note the greater amplitude of the paleo-channel meanders (inset) than those of the current straightened but somewhat naturalising channel. This demonstrates the shortening and steepening of the watercourse that has occurred and the loss of discrete pools and riffles that has resulted.

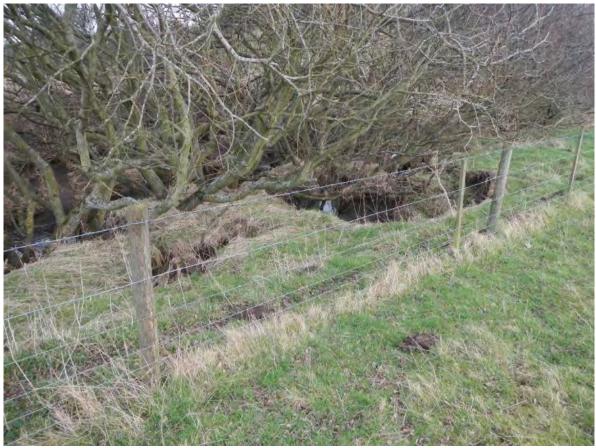
Photo DSCN6149. In some areas, willows have encroached right across the channel, driving lateral scour into the banks. Sheep are also clearly breaching the buffer fence in places (NY 94729 72147).

Livestock access through buffer fence (NY 94729 72147).	This is a general issue, particularly where sheep fencing is plain strand wire. Such fencing requires maintenance.	DSCN6149	3
Un-buffered section on the RB (NY 94620 72065 - NY 94144 72007)	Buffer fence.	DSCN6151	2

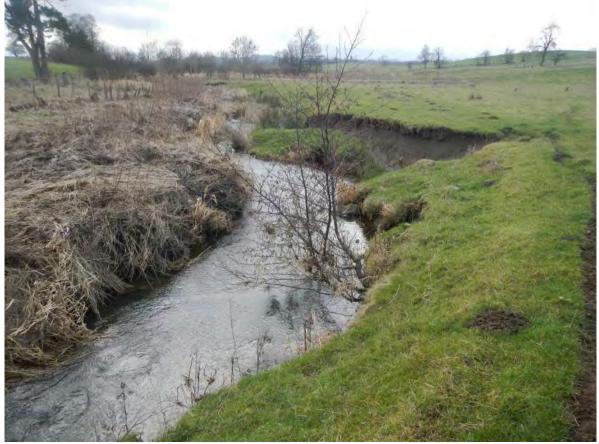
Photo DSCN6151. In the un-buffered section on the RB (NY 94620 72065 - NY 94144 72007), major erosion and bank slumping are occurring. Ironically, this is likely to be accelerating the recovery of the channel diversity somewhat (post dredging). However, the extent of erosion that would be required to reinstate a natural length, shape and quality of channel in most areas would result in significant inputs of bank material.

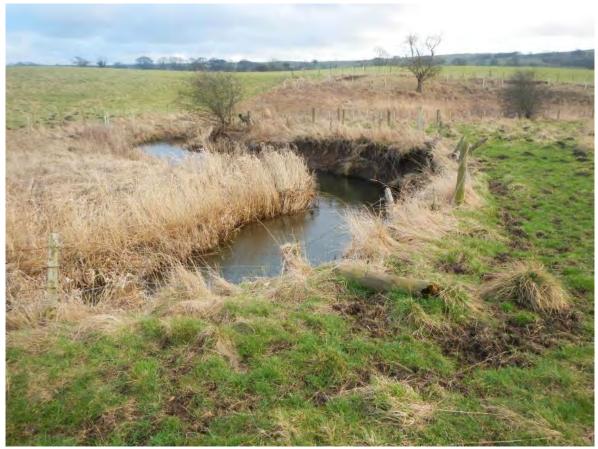
Photo DSCN6156. From the next field d/s (NY 94144 72007) the burn has a reasonable buffer and no major grazing issues, except the first few metres, where lateral erosion has breached the fence.

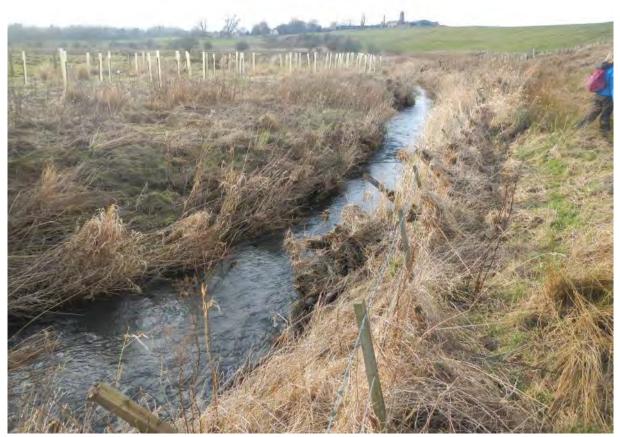
Photo DSCN6160. Some areas display the signs of past straightening and dredging but rough vegetation is consolidating the banks and tree planting has been undertaken on the LB.

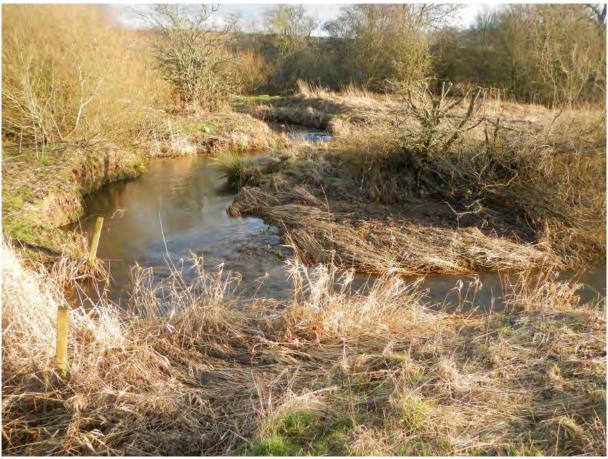
Photo DSCN6164. Towards the Chollerton viaduct, the channel shape and form improves, likely due to a reduction in historical dredging and realignment. Consequently, the channel is more sinuous and less incised, with a much greater occurrence and quality of pool and riffle features.

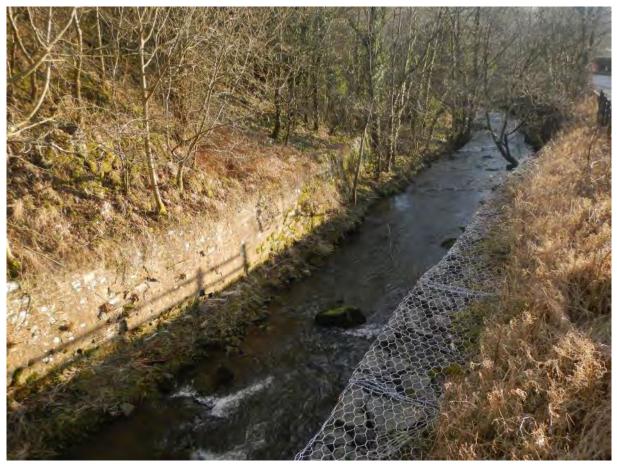
Photo DSCN6166. Immediately d/s of the viaduct the channel is straightened and bank armoured alongside the road. Although impacted, areas of the habitat are suitable for juvenile salmonids.

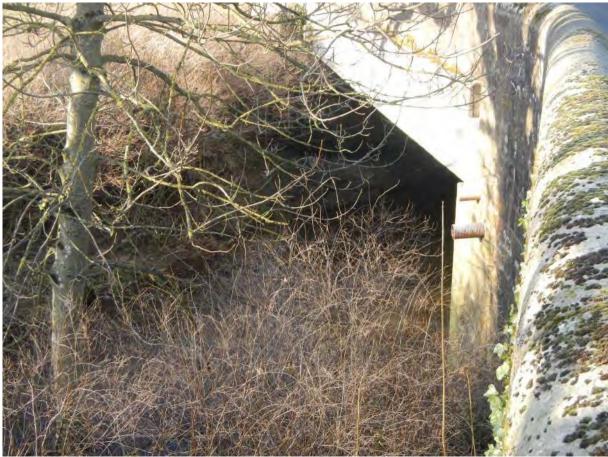
Photo DSCN6170. The Chollerton road crossing is a clear span bridge and poses no issues for fish passage or sediment transport.
