**Advisory Visit to River Beane at Frogmore Hall Park, Herts.**

**June 2026**

**Rob Mungovan**

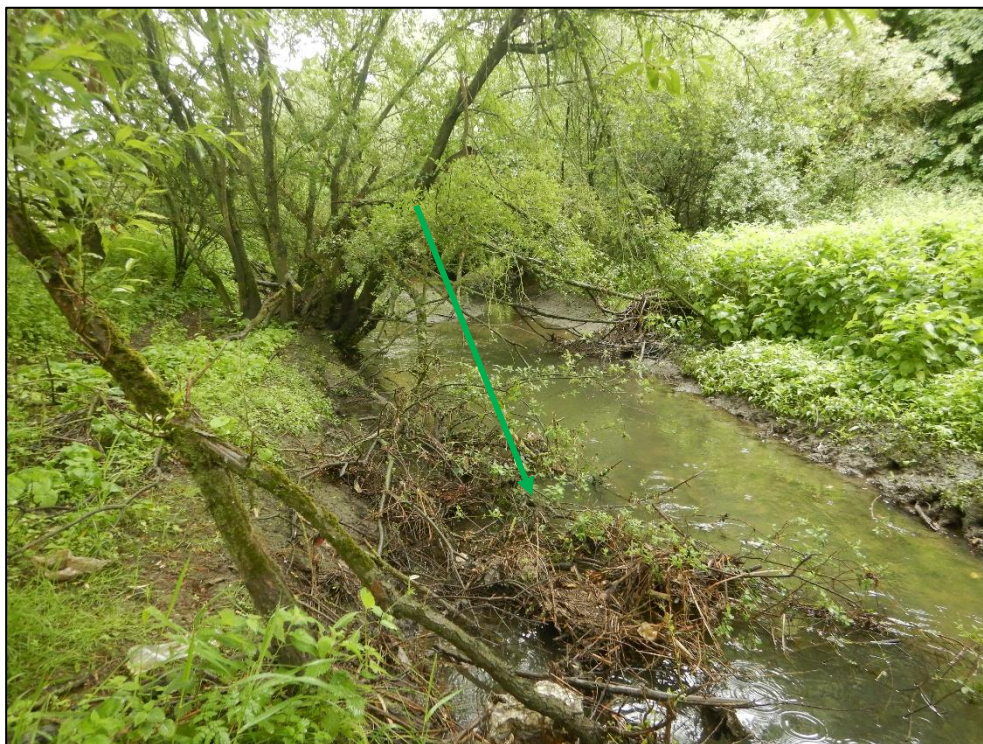
Pic 1 – The small multi-stemmed willow could have limbs hinge-cut to trail downstream to aid retention of woody material in the margins of the River Beane. It would also allow light to the margins to encourage vegetation growth. See example of tree-hinging and felling in Recommendations.

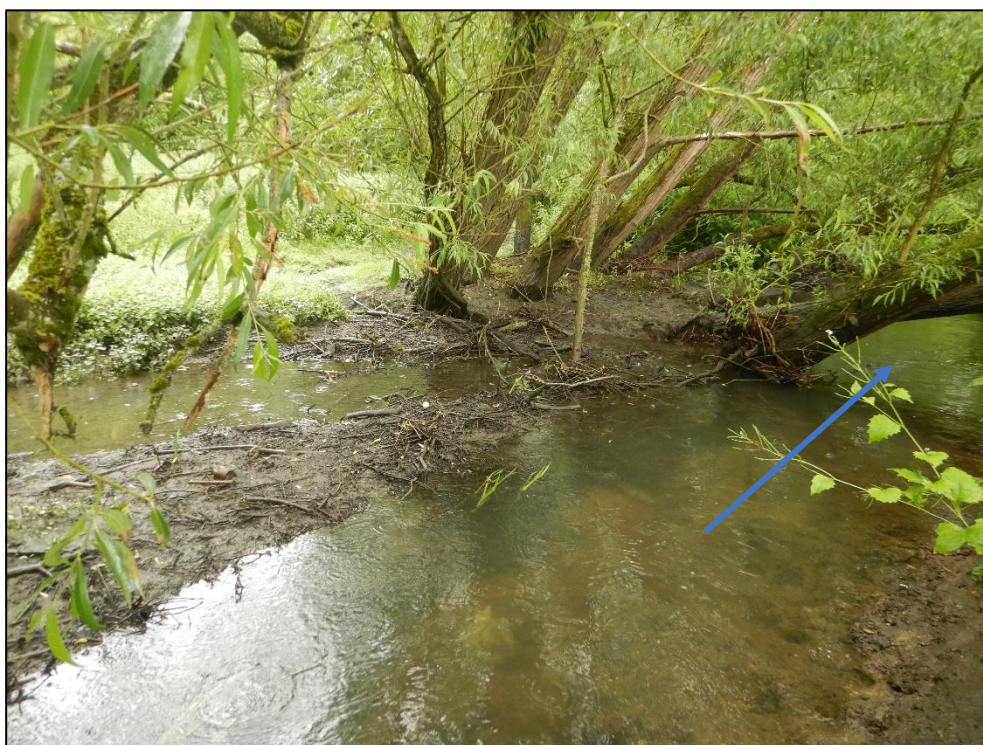
Pic 2 – Willow trees are growing from the river channel, that should not be seen as a problem. The main flow pathway is open (blue arrow), and when the river rises it takes additional flow pathways around some of the low growing trees resulting in water attenuation within the site and slowing of the flow.

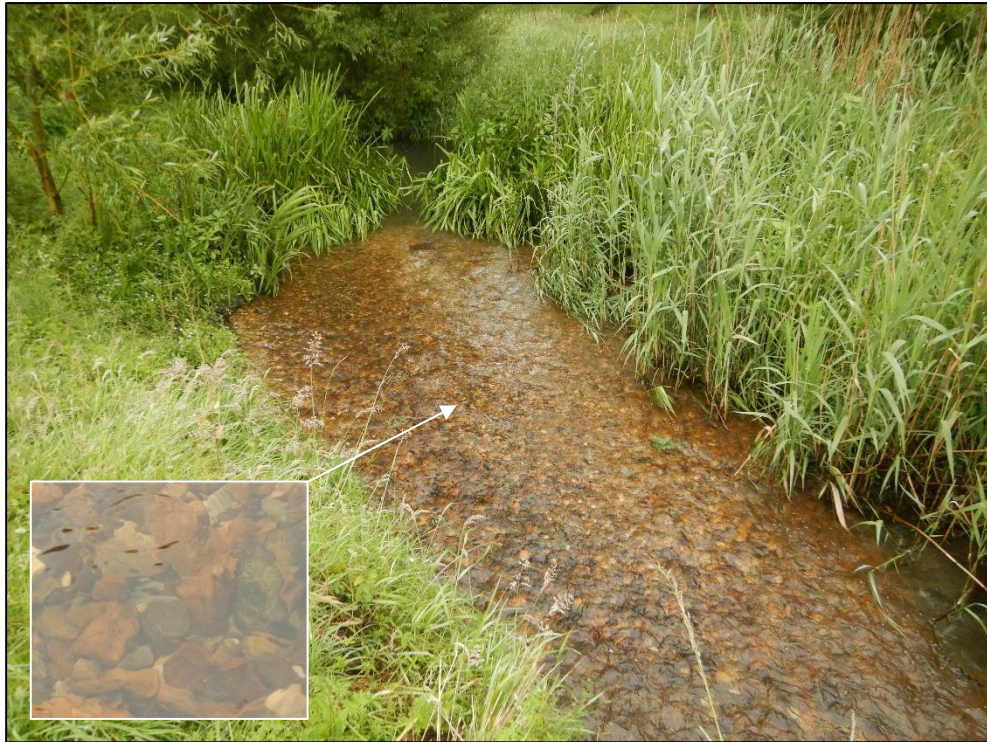
Pic 3 – A previously placed gravel riffle is still functioning and requires no intervention. The stones had collected some fine sediment amongst them, but most flushed out as stones were dislodged. The gravel should support brown trout spawning.

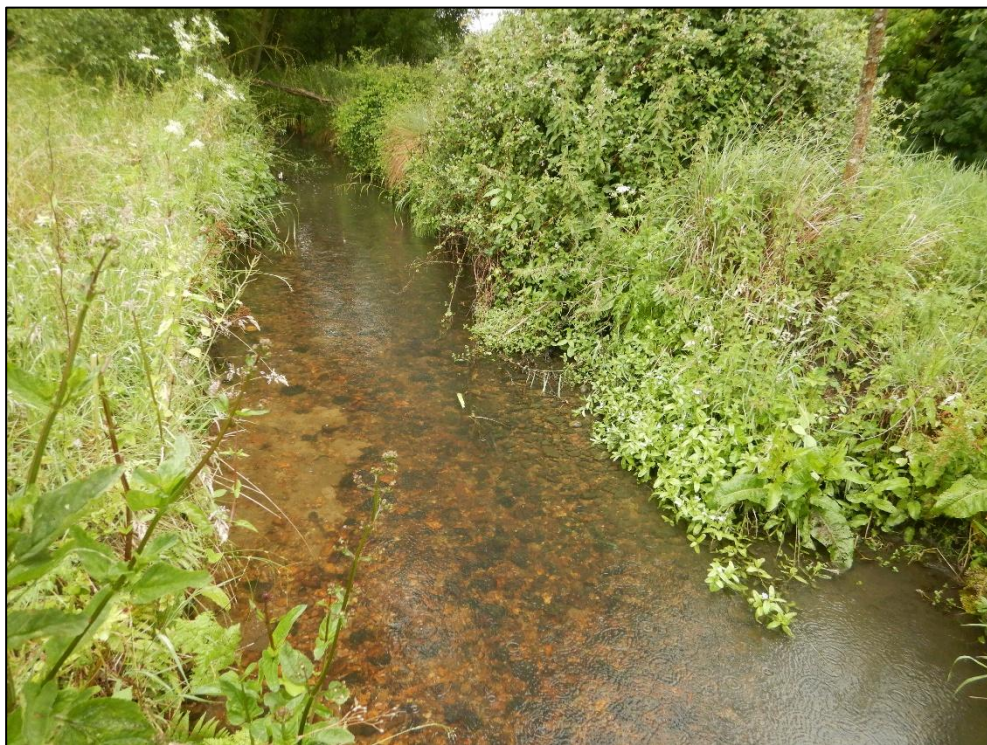
Pic 4 – The gravel bed of the Stevenage Brook is considered natural. It has a greater diversity of particle sizes and had eroded to its clay base. Although the gravel may not be deep enough for trout to cut redds into, the gravel may support spawning by dace, minnow and other lithophilic fish species. Local scour of gravel exposing the clay bed is not a problem, it is the start of pool excavation and bedform variation. However, if the gravel appears too mobile then matters to address it (such a fixed wood) may be appropriate. The trailing vegetation is good for fish and could be enhanced further with pinned wood in the margins. See examples of brash and timber fixing in Recommendations

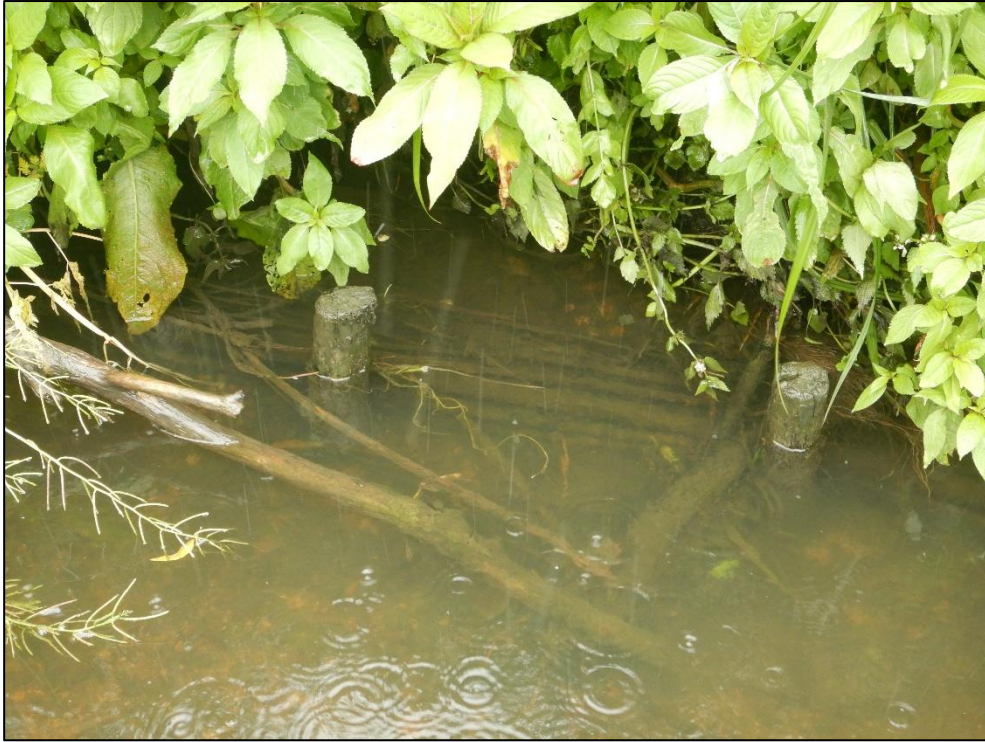
Pic 5 – Some installed faggot bundles in the brook have not entrained fine sediment, and now the wood has degraded a void is left. Where posts can be found, they could be used to hold more wood gathered from nearby shrubs. The silt was probably flushed out due to shading from tall vegetation above, with shade the root structure is weakened. See example of brash and timber fixing in Recommendations.

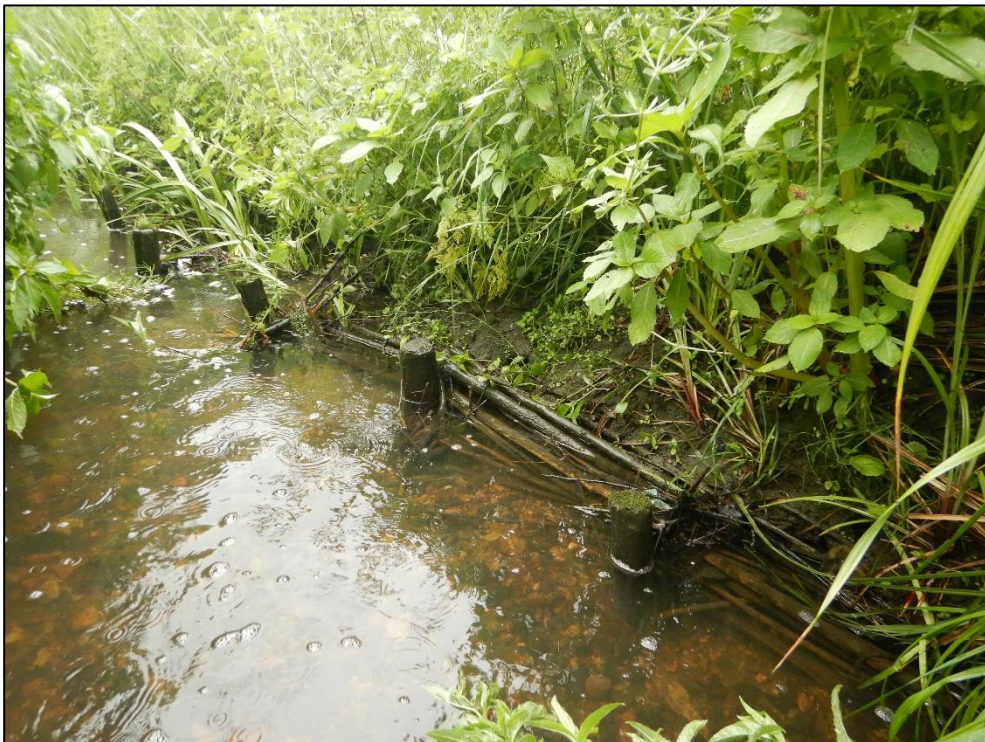
Pic 6 – Some faggot edging has retained fine sediment and provides a rooting substrate for marginal vegetation along the brook. Control of the invasive non-native species, Himalayan balsam, would aid the growth of native plants beneficial to marginal vegetation development. See example of invasive plant species control in Recommendations.

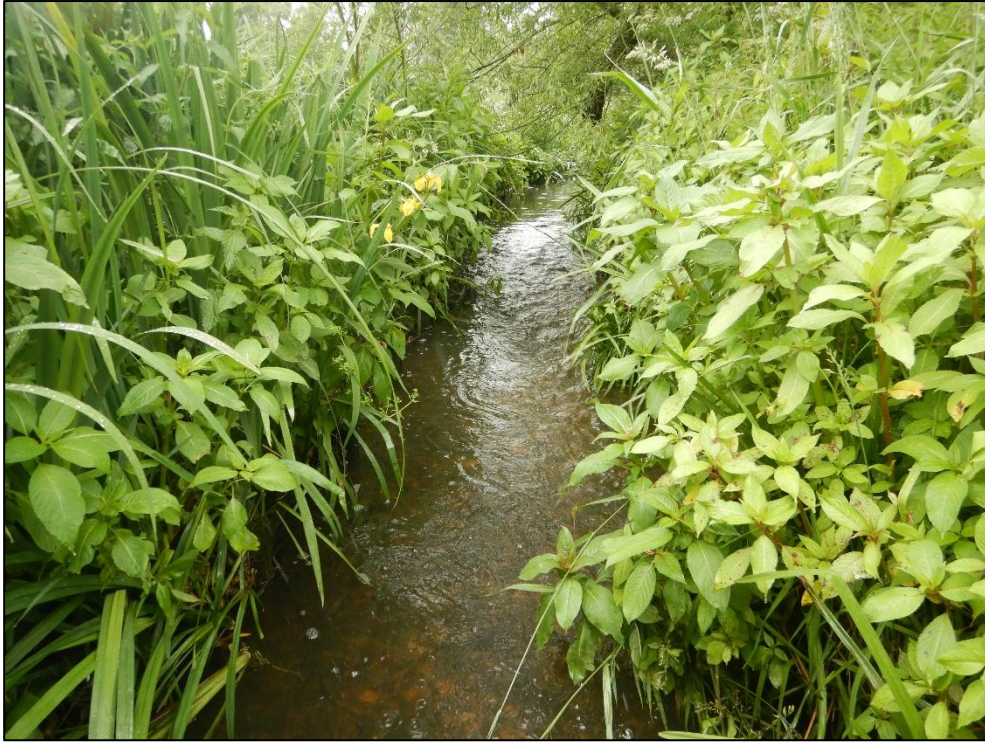
Pic 7 – The Stevenage Brook has good marginal cover where light reaches the channel. The desirable species of yellow flag iris, great willow herb, water mint and lesser pond sedge are present. Less desirable species included Himalayan balsam (should be pulled up to remove it), hemlock (grows tall and dominates) and nettle (can dominate margins but is hard to control when soil enrichment is present).

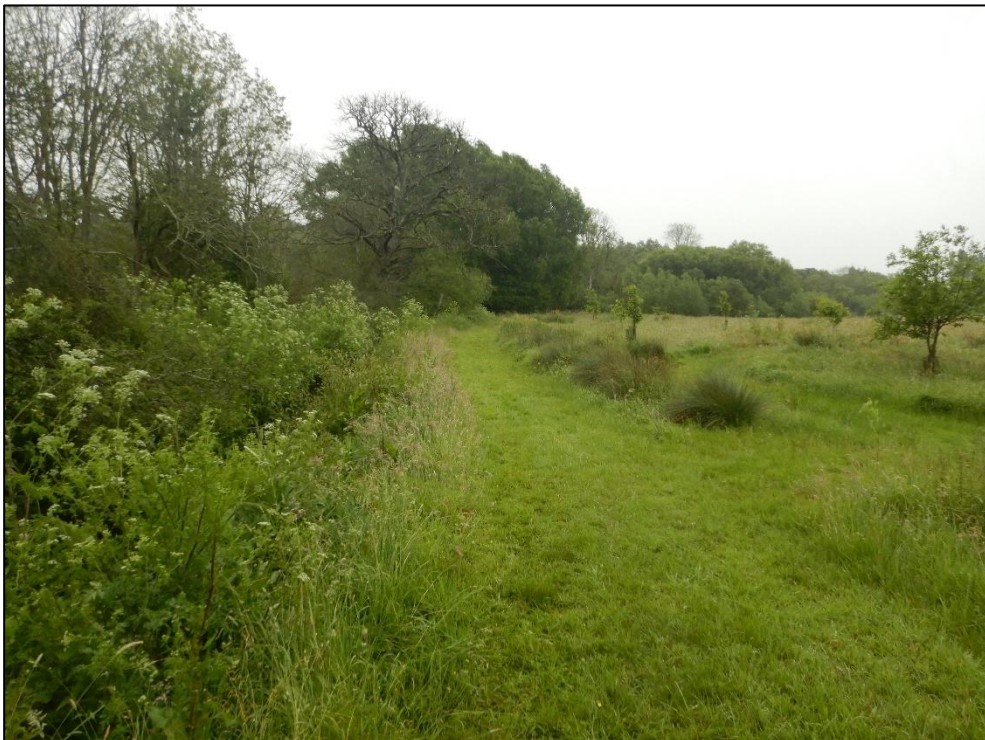
Pic 8 – The Stevenage Brook is too straight as it shown by its course on Map 1. To get the brook functioning better it should be re-meandered across the grassland. Introducing meanders would enable better sediment transport and deposition, facilitating greater depth variation and an increase in biodiversity. Although tree planting has taken place in the grassland, they are of a size that could be dug up and replanted, and should not be viewed as reason to hold back significant habitat restoration. See example of channel realignment in Recommendations.

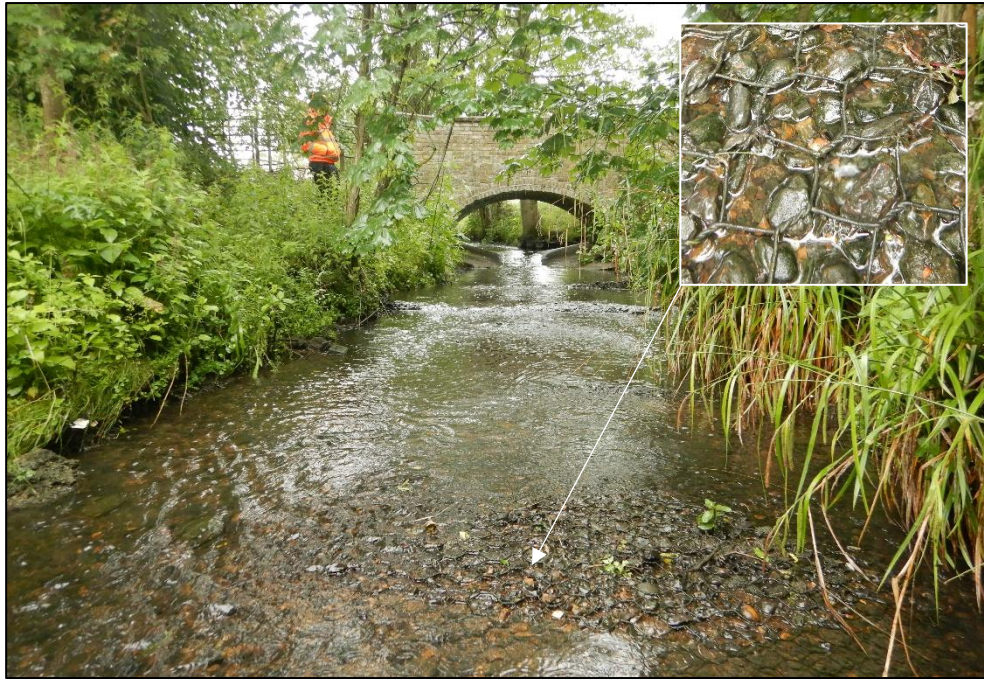
Pic 9 – A rock ramp has been installed to raise the bed level of the Stevenage Brook, allowing fish to swim up and through the bridge. The rock ramp was constructed with stone held by wire mesh, which is now exposed making it vulnerable to damage and possibly hazardous to animals. The original design for the rock ramp should be revisited, if it was meant to be capped with gravel then it should be topped up. If not, then presently there is little cover for fish moving through this reach and the original designer should be asked about measures to improve the approach. Caution should be had at any measure that could potentially damage the mesh holding the stone.

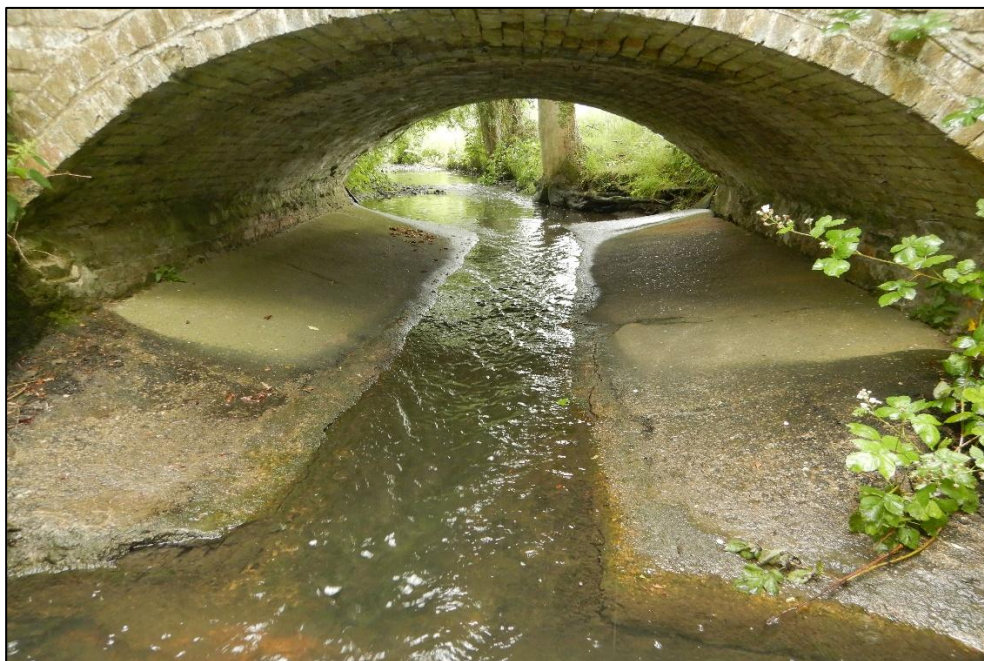
Pic 10 – If fish reach the bridge in low flow, they have very shallow water to swim through because the easement was not finished to the crest height of the obstruction. In high flows the water velocity and smooth bed will make it challenging for most species to traverse. Passage through the bridge could be enhanced by the installation of stones fixed to the base of the bridge to increase its roughness whilst creating small pockets of calmer water to aid resting. Similarly, flow baffles could be attached. See example of fish passage easements in Recommendations.

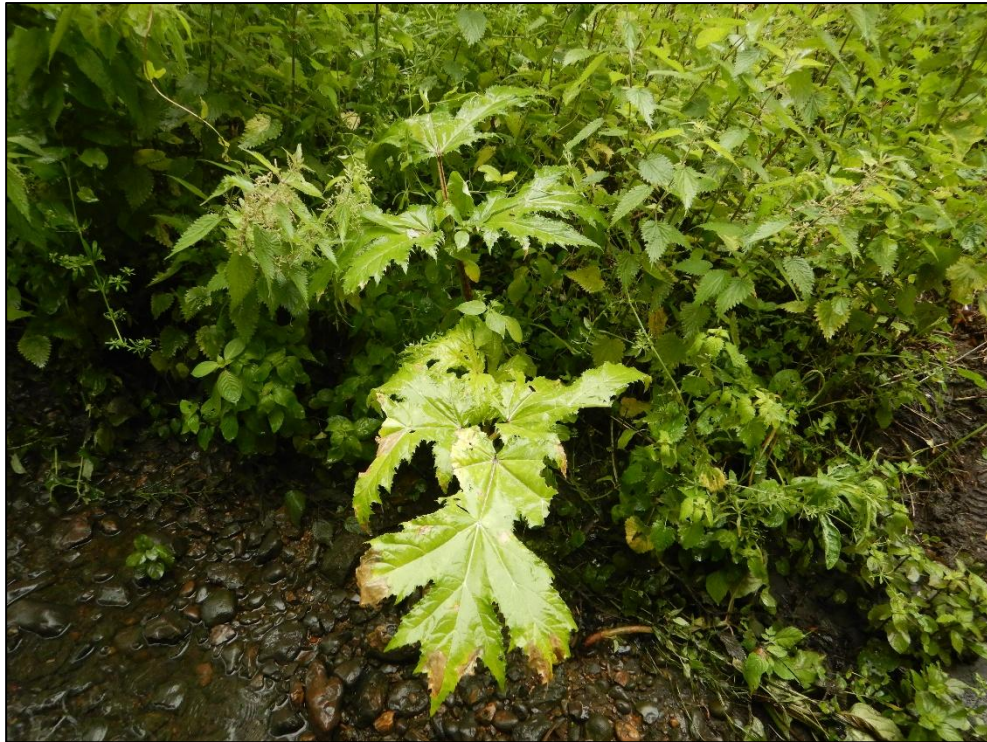
Pic 11 – The invasive non-native species giant hogweed is present on the brook. Friends of the River Beane have been undertaking control using herbicide. That work should continue with full support by Tarmac. If the plant is allowed to dominate it presents a serious threat to health due to its phototoxic sap, in addition to degrading riparian habitat/species diversity. See example of invasive plant species control in Recommendations.

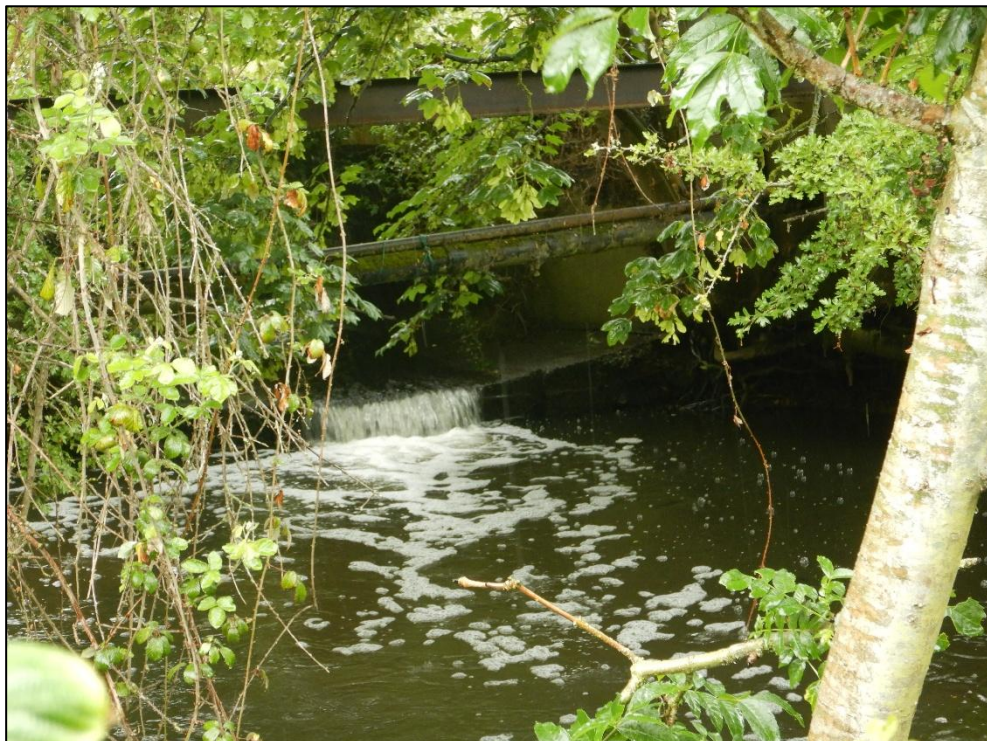
Pic 12 – Approximately 80m upstream from the rock ramp easement another bridge was encountered. The drop from bridge base to water was ~0.15m. It may have been may have been accentuated by the low flow conditions, but it still presents an obstruction to the movement of fish and river substrates. Access through the bridge should be enhanced by the addition of stones set into the base of the bridge, but that does not address the problem that the bridge poses to the river corridor.

The second bridge encountered on the Stevenage Brook has a raised concrete bed, this acts as weir resulting in impounded flow upstream. The impact of impounded flow is shown in the images below. With base of the bridge fully removed the Brook would become more dynamic. The same issue applies to the base of weirs retained in the River Beane.

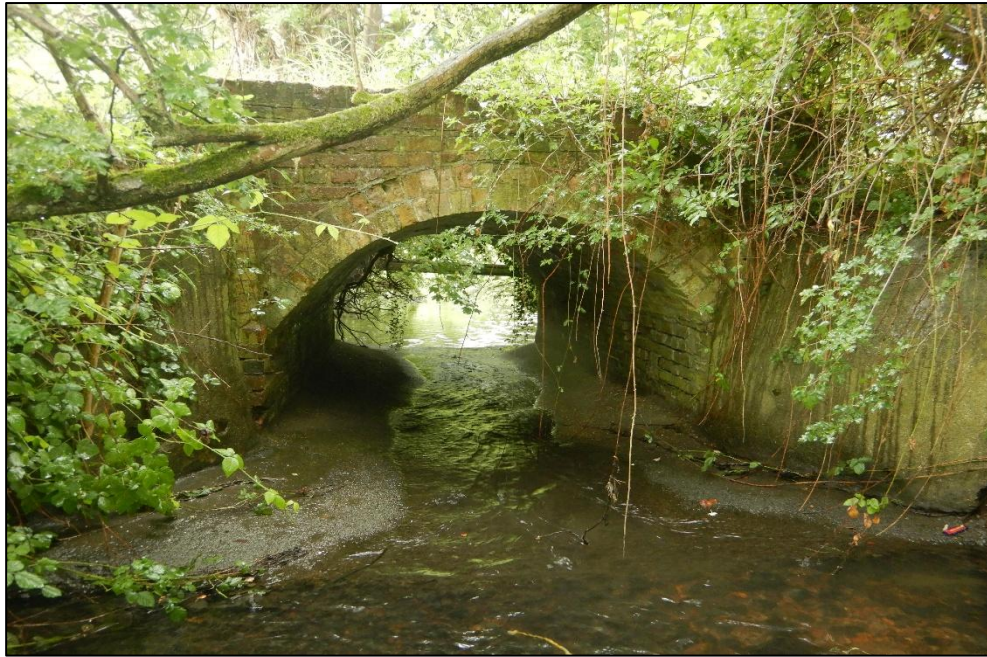
Pic 13 – The same bridge as Pic 12. Given that this bridge is a short distance from the last, and that it had not been accessed for recent meadow management (suggesting concern for its strength), the best option in terms of river restoration would be to remove the bridge. The bridge is causing an impoundment, and with its removal, flow diversity would be restored to the upstream channel, with the potential to mobilise important bed substrates that will aid natural channel processes downstream (such as riffle formation). The upstream channel may even start to naturally meander. The best outcome would be to package the bridge's removal with channel realignment. The bridge impoundment presents similar problems that weirs cause to rivers, see bridge removal in Recommendations.

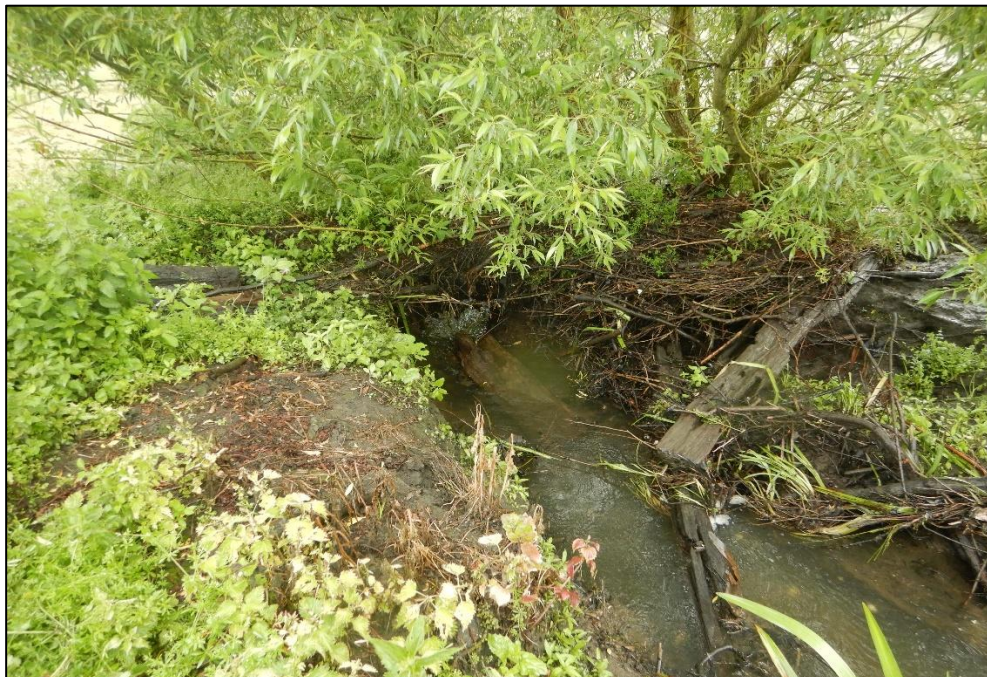
Pic 14 – Recent rainfall led to rising water levels in the brook. This log jam has been partially removed to allow water to move through. Whilst local site conditions are not fully known, it would be better to retain the accumulated material as it focusses the force of water to create scour either upon the bank or bed, resulting in either meandering or pool development. See creating undershot flows and bed scour in Recommendations.

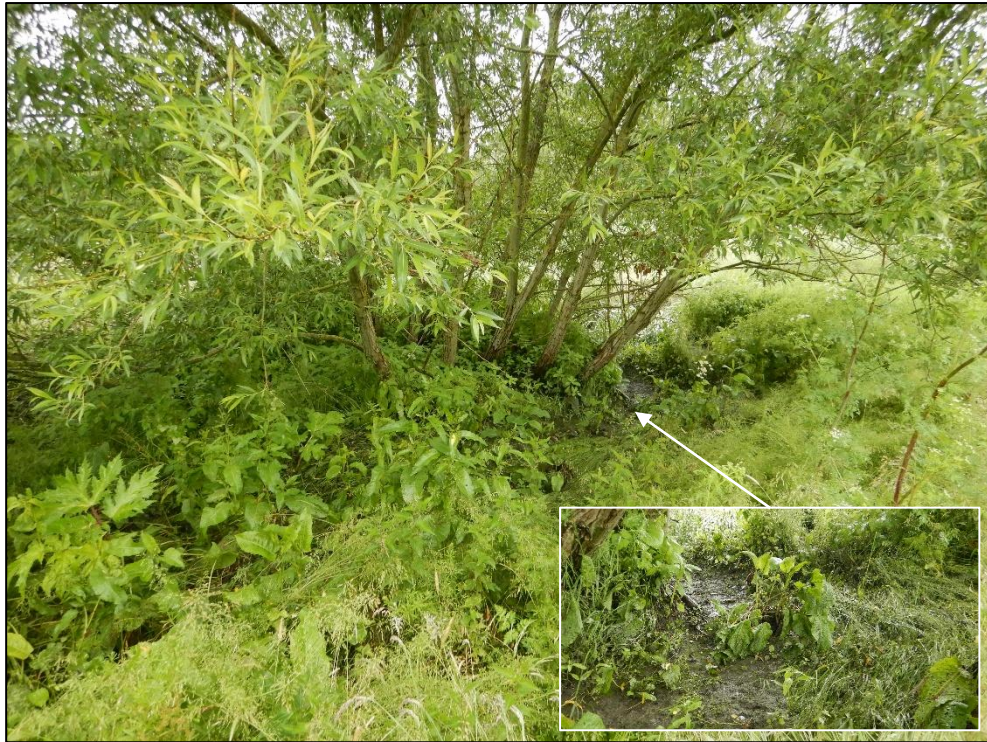
Pic 15 – Only a few metres upstream of the partially cleared log jam, the brook has small willows growing from it. These trees should be retained for their habitat and ability to push high flows out of bank.

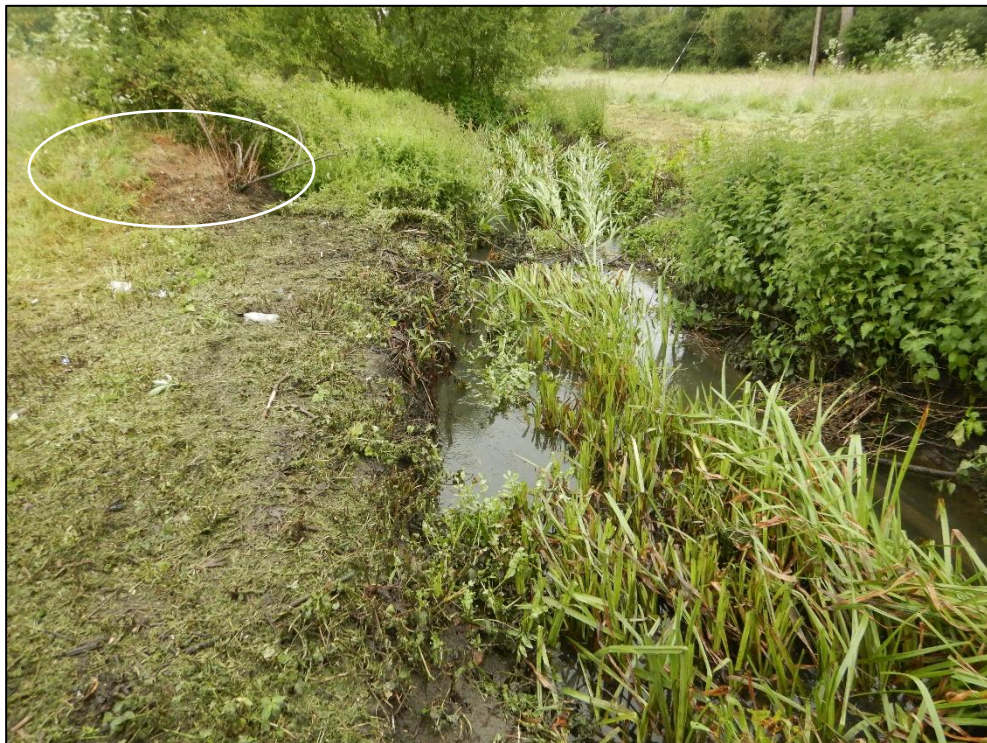
Pic 16 – Recent bank clearance (probably to allow viewing of the brook) has exposed extensive stands of bur reed. Bur reed typically grows in channels dominated by fine sediment with little bed scour, such as dredged channels. Note the pile of deposited material (with evidence of hogweed control by herbicide, white oval). This part of the brook has been over-deepened and will not restore itself unless it is supplied with suitable substate material and is allowed to meander. Rubbish appears to be transported down the brook and should be collected (if not already being done).

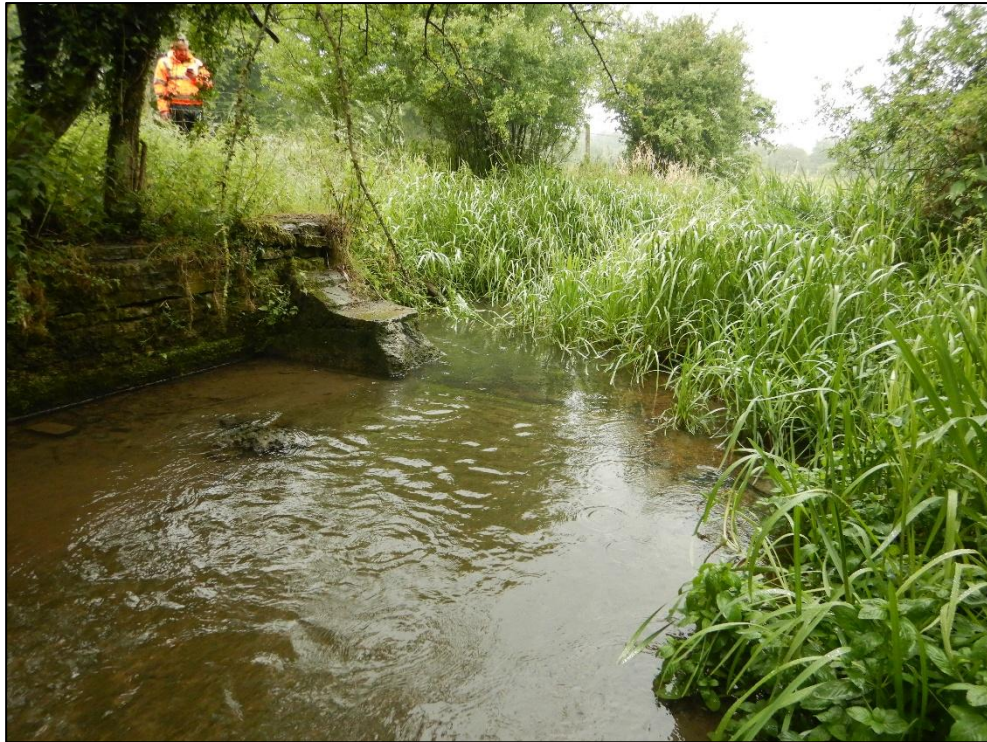
Pic 17 – The base of a former weir has been retained after its partial removal. The effort to remove the barrier is commended but the issue is not resolved until the concrete base of the structure is removed. With ~4m of concrete base in place, downstream sediment transport is interrupted, an impoundment is created and fish passage in low water is not as good as it should be.

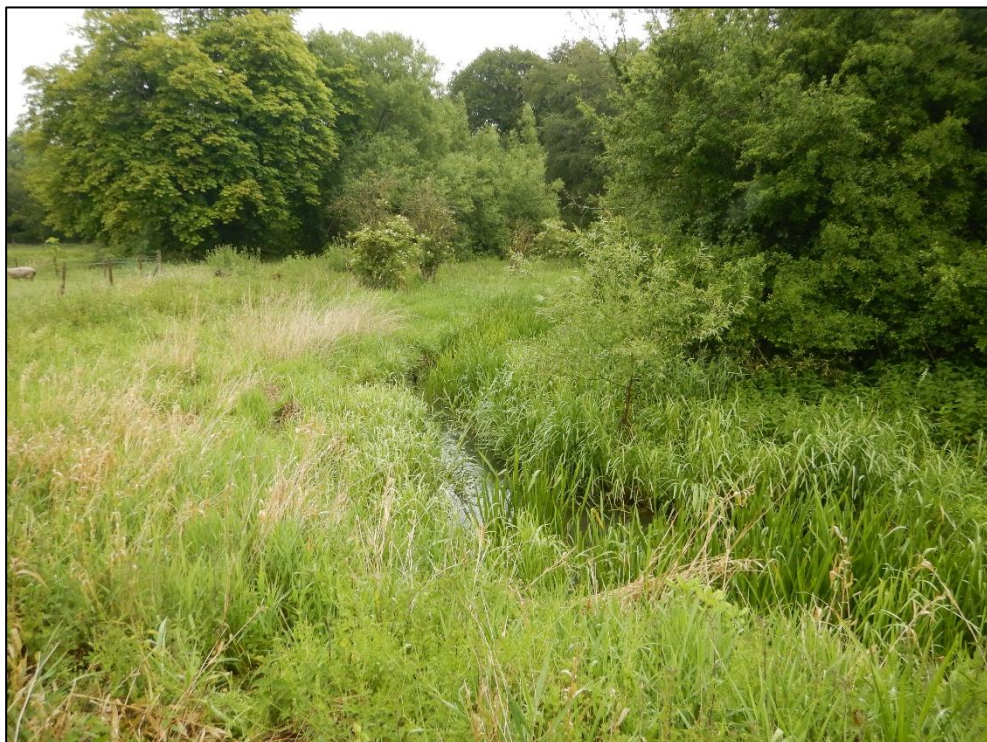
Pic 18 – Upstream of the retained concrete bed, the channel is dominated by reed sweet grass. This may be indicative of the slight impoundment which reduces the river's ability to scour the plant from the channel come winter. It is noted that the low flow conditions may be contributing to the plant's current dominance. Although dominant it should not be viewed as a problem as water is passing through and it provides important habitat, it just lacks open water at present.

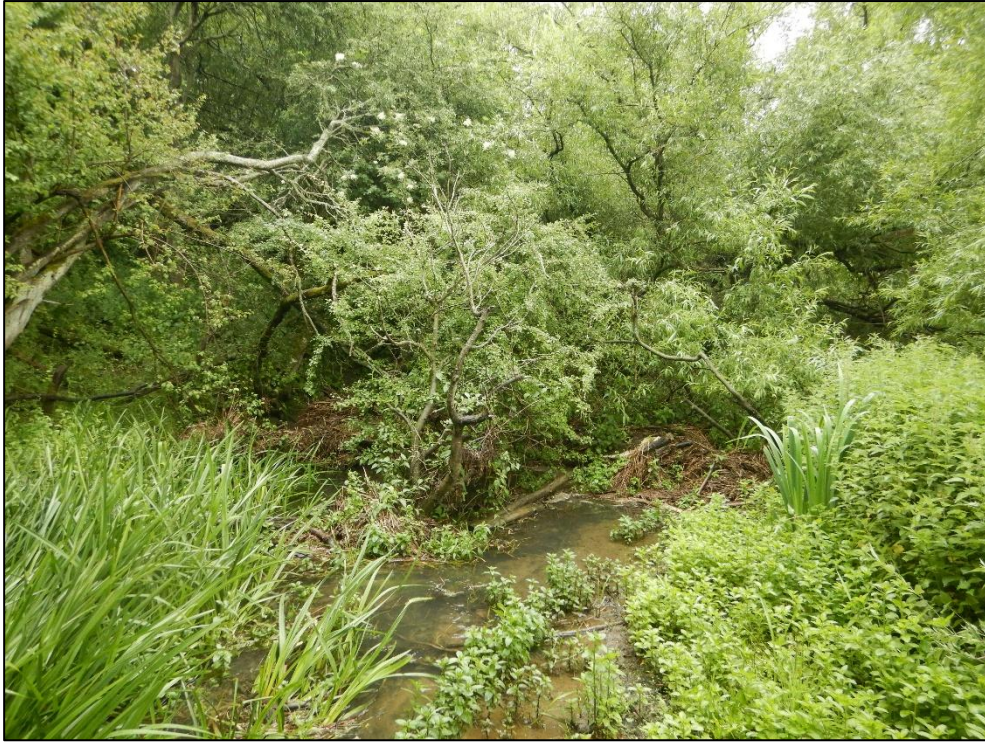
P19 – Fallen trees within the river should not be seen as a problem. The fallen material provides low shade which suppresses emergent vegetation dominance, and the various flow pathways created by the partial blockage aid local scour, sediment sorting and transport. The fallen wood also provides important habitat for a wide range of invertebrates which in turn may feed fish. See example of brash and timber fixing in Recommendations.

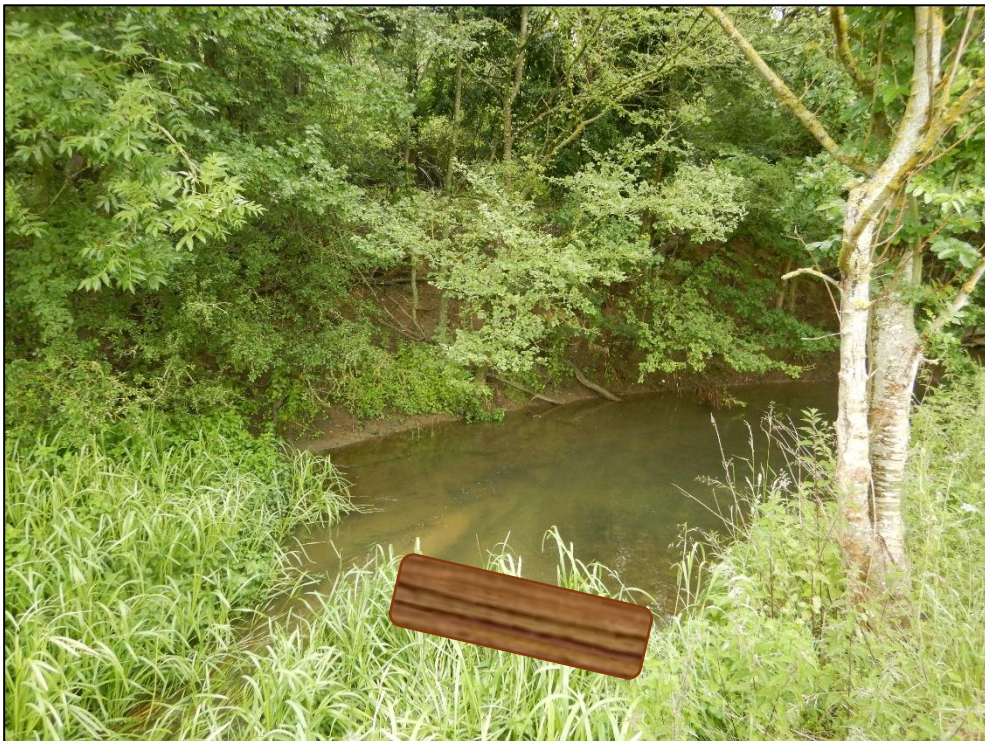
Pic 20 – Beneath the shade of an oak tree a pool receives a defined flow path into it. Flow into the pool could be enhanced by the placement of a large tree trunk flow deflector (~0.5m diameter timber extending to 50% of channel width, note illustration). The pool could be partially excavated to increase its depth and initiate bed scour. The pool was almost completely degraded by the excessive fine sediment load. See example of flow deflectors in Recommendations.

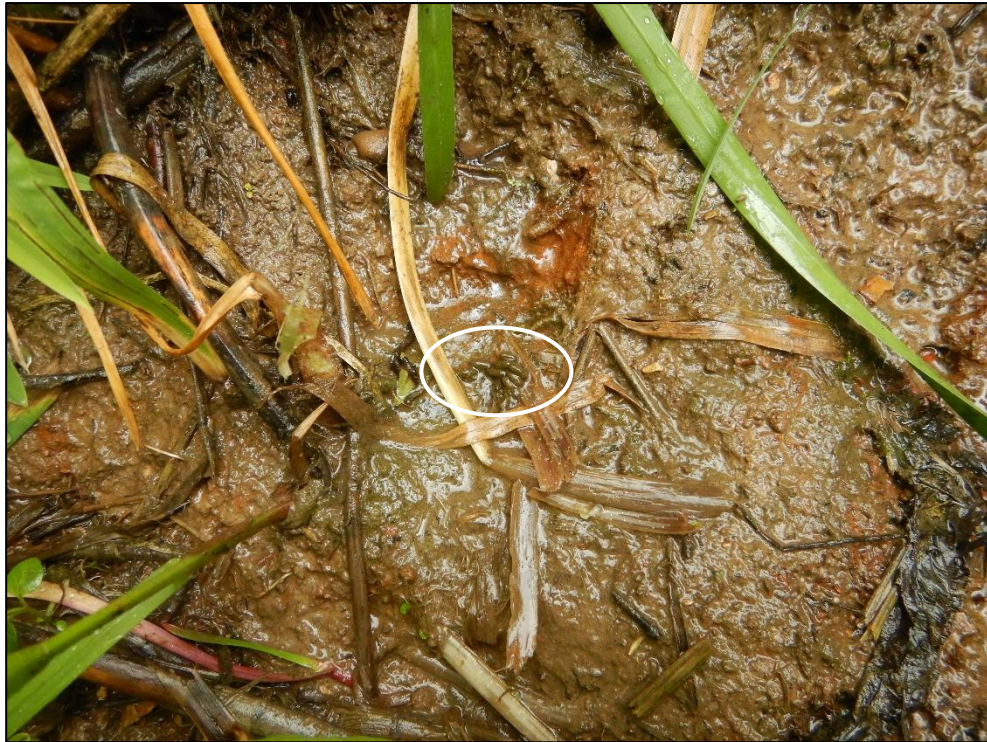
Pic 21 – Water vole latrine with fresh dropping (white oval) and food piles along with runways are present amongst the dense stands of reed sweet grass. The site was not known to support water vole.

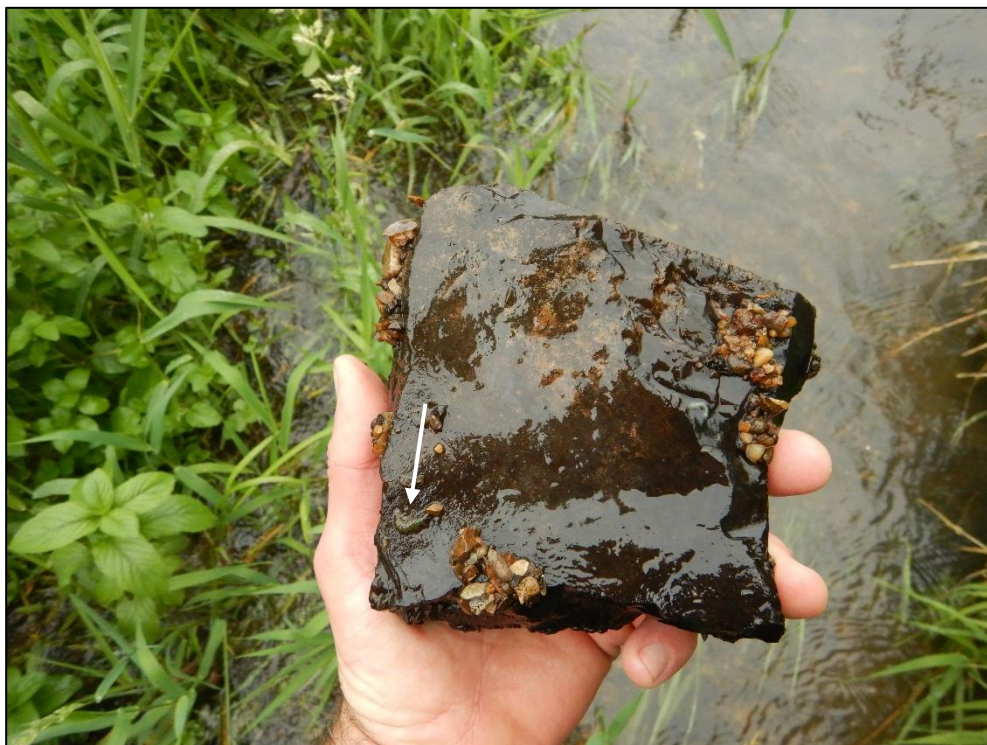
Pic 22 – Whilst searching for bullhead fish, stone turning revealed a good diversity of aquatic invertebrates. Caseless caddis (white arrow) are encouraging to see given the high sediment load. Also present are cased caddis, freshwater shrimp, flatworms and mayfly larvae.

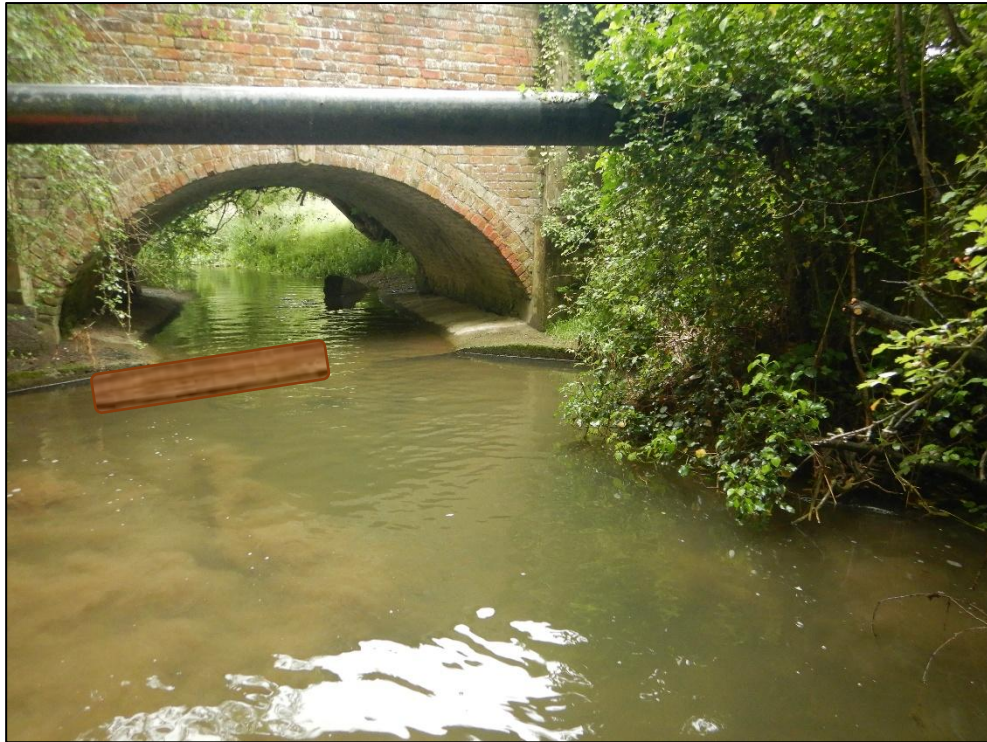
Pic 23 – Access for fish through the bridge is possible at all water levels. The bridges shown in pics 10 & 12 should be like this and could be so with appropriately installed rock ramps, which actually drown the invert of the structure. Note the high fine sediment load disturbed as soon as the pool was entered. It is degrading the habitat. If it were not for the excessive fine sediment this pool would offer good trout holding potential given its low trailing cover. The positioning of a flow deflector (note illustration) could enhance the main flow pathway to the trailing cover.

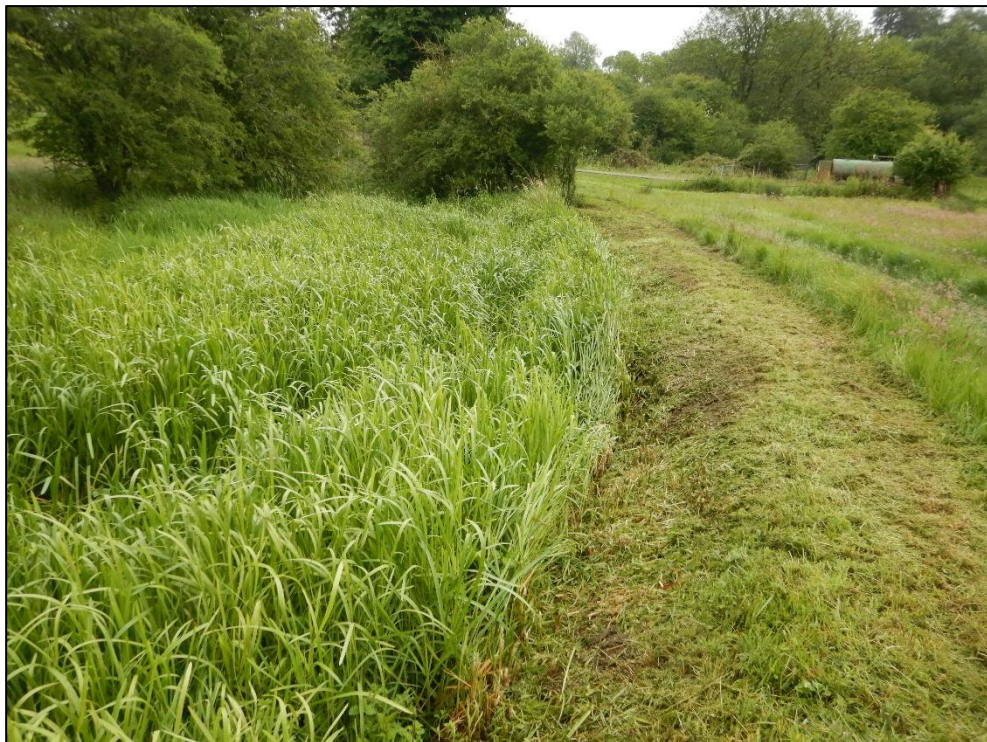
Pic 24 – The bank slope should not be cut, especially where water voles are present. The cutting is to facilitate an electric fence. All grazing animals should be kept back from the top-of-bank to reduce trampling by livestock and retain bank integrity.

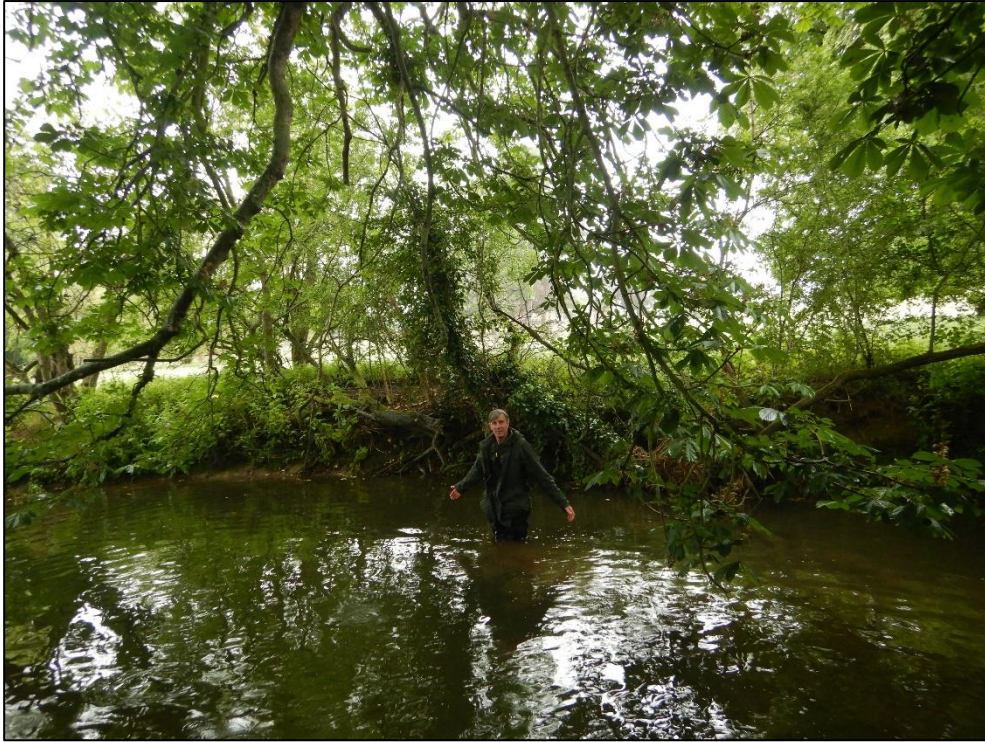
Pic 25 – Another deep pool found beneath the shade of a horse chestnut tree. The depth results from an historic weir now partially removed (pic 26). The ideal situation would be to fully remove the remains of the weir to allow natural sediment transport from upstream. If that cannot be achieved, then the placement of large stones (or the redundant concrete weir-base blocks) or a log flow deflector would create some cleansing flow into the pool to prevent the build-up of excessive volumes of fine sediment.

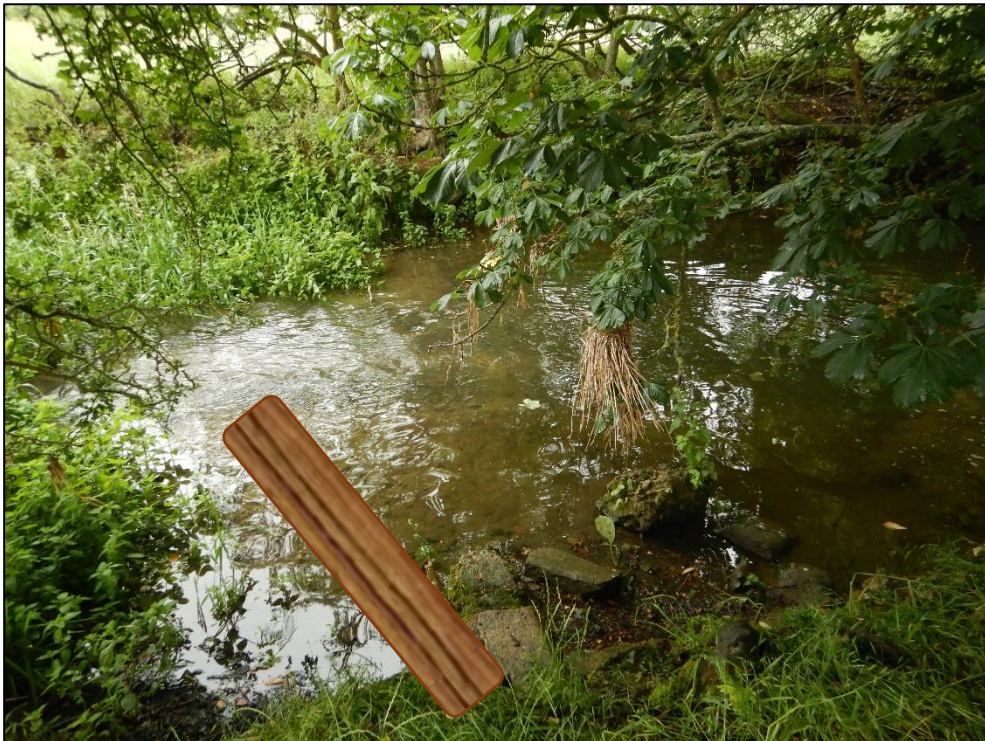
Pic 26 – The remnant weir structure now partially removed. Flow into the pool should be enhanced by flow deflection using the concrete blocks or a large log (note illustration).

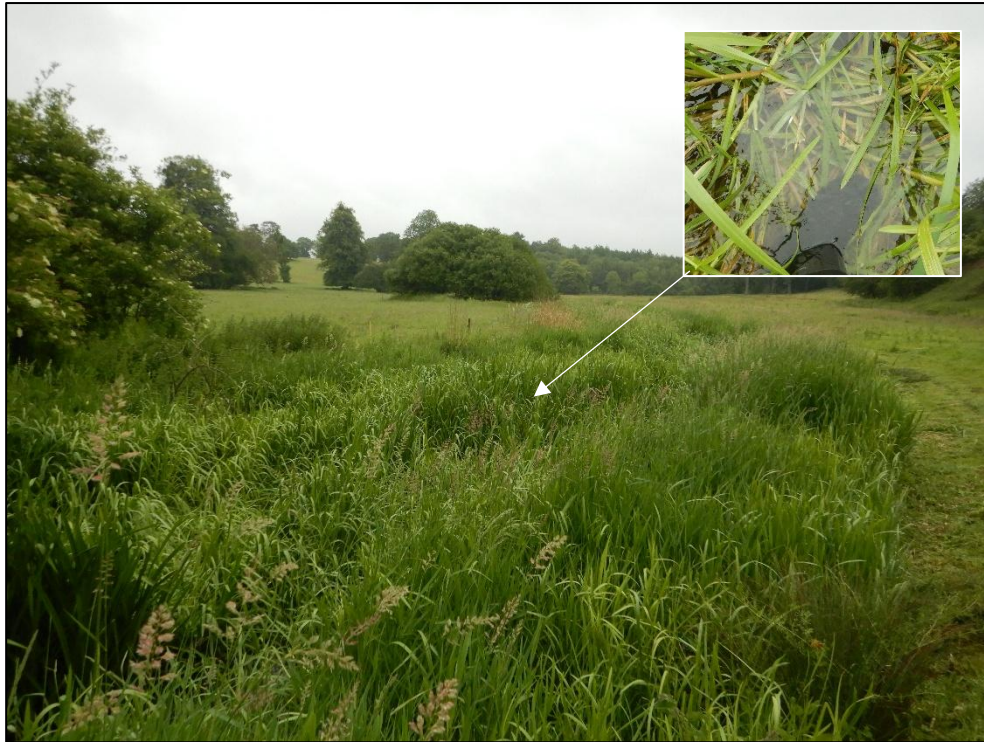
Pic 27 – In the parkland landscape there was little riparian tree cover to suppress the dominance of reed sweet grass. To compound matters, the river here has been widened to create a broadwater in front of Frogmore Hall resulting in a river that has little energy to scour sediment or plants from the bed (inset), and so swamp habitat has developed. See example of tree planting to create shade in Recommendations.
