**Advisory Visit to River Beane at Frogmore Hall Park, Herts.**

**June 2026**

**Rob Mungovan**

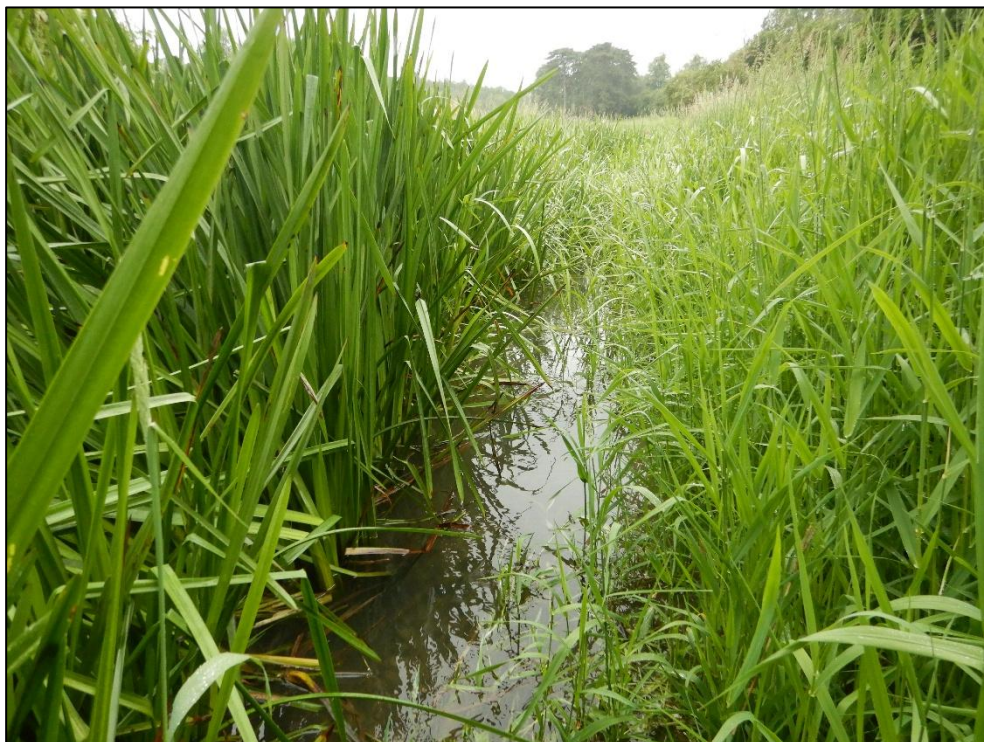
Pic 28 – At the upstream end of the former broadwater (now a swamp of reed sweetgrass) there was evidence of flow entering. This pathway could be enhanced through the installation of large woody material to create bed scouring flow. Large hardwood timbers should be used to ensure their impact is maximised in the long-term. See example of brash and timber fixing in Recommendations.

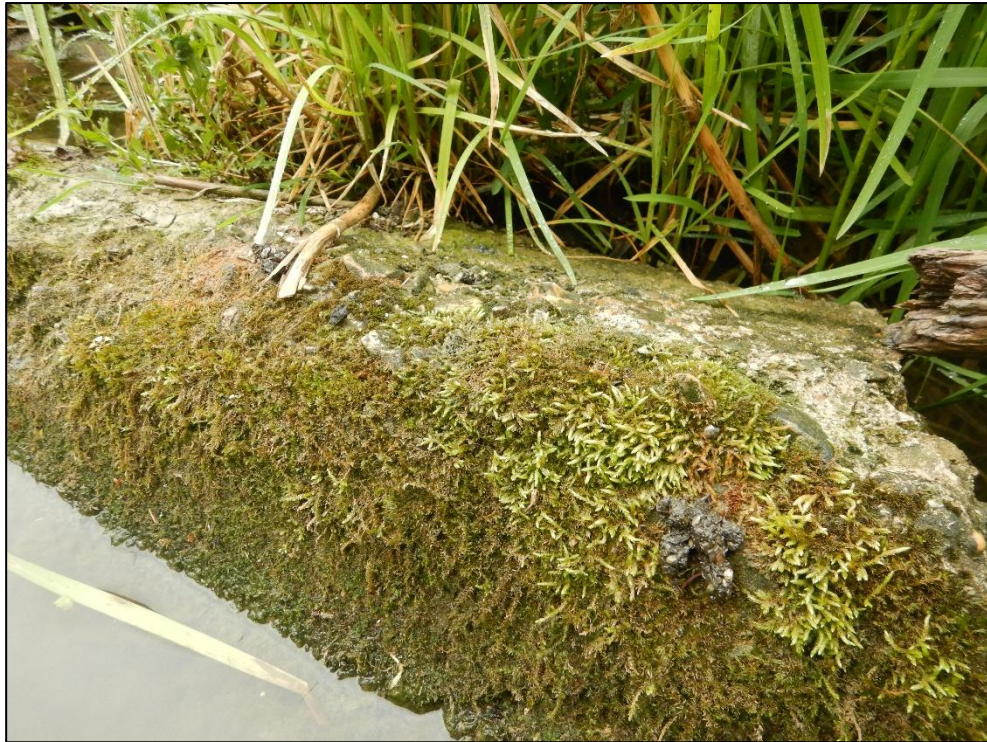
Pic 29 – Fresh otter spraint present on a removed weir structure.

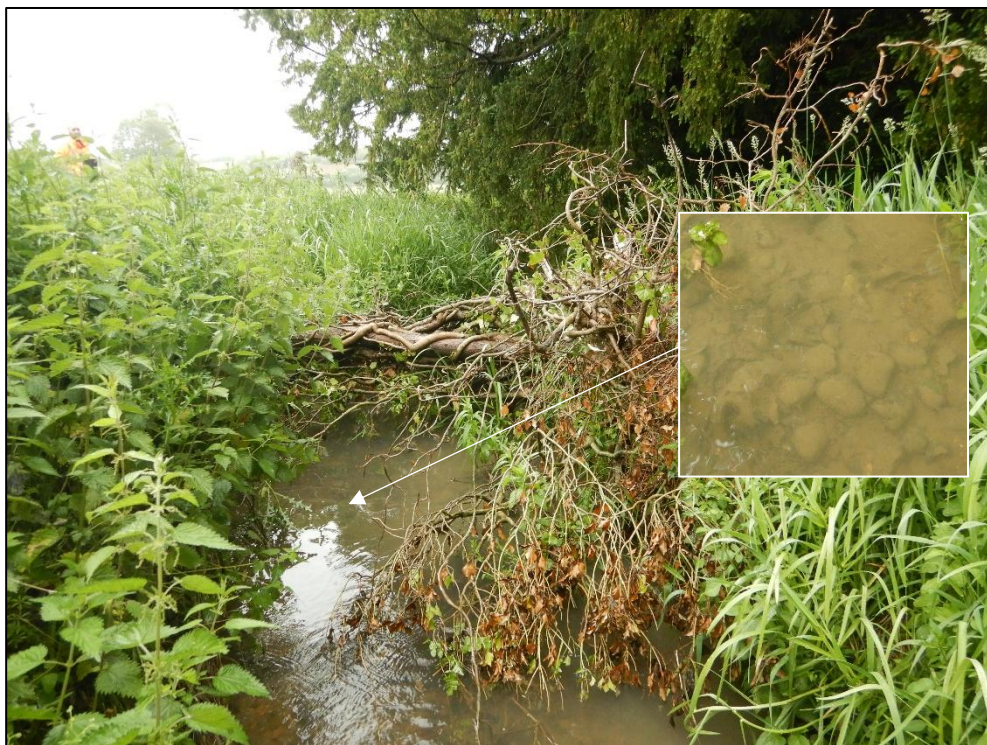
Pic 30 – Only one fallen tree is present in the river. It is small but still useful in terms of flow diversity. It doesn't appear to have held back any significant flood flows, but it is interesting that the channel was clear of reed in its proximity (which may be a consequence of riparian trees casting shade). The riverbed consisted of gravel with a layer of degrading silt (inset).

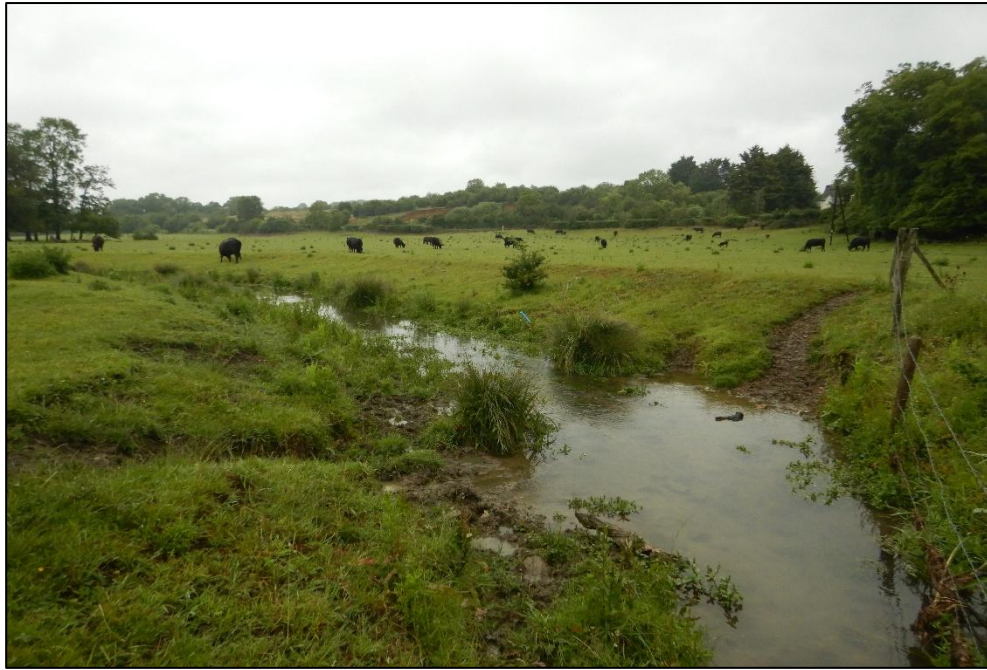
Pic 31 – The cause of the high fine sediment load was apparent as soon as cattle grazing was encountered. The animals have unrestricted access to the river. Fencing and alternative watering is required to prevent the animals from accessing the river and breaking its banks. This reach of river had signs of embankment, presumably to drive a nearby hydraulic ram pump which once supplied water to the Hall. If there is potential for floodplain connection, then the embankment should be removed. See example of riparian fencing in Recommendations.

Fencing to keep animals out of watercourse is essential to reduce the input of fine sediment. Fencing should be set-back a minimum of five metres to allow a natural vegetated buffer zone to evolve.

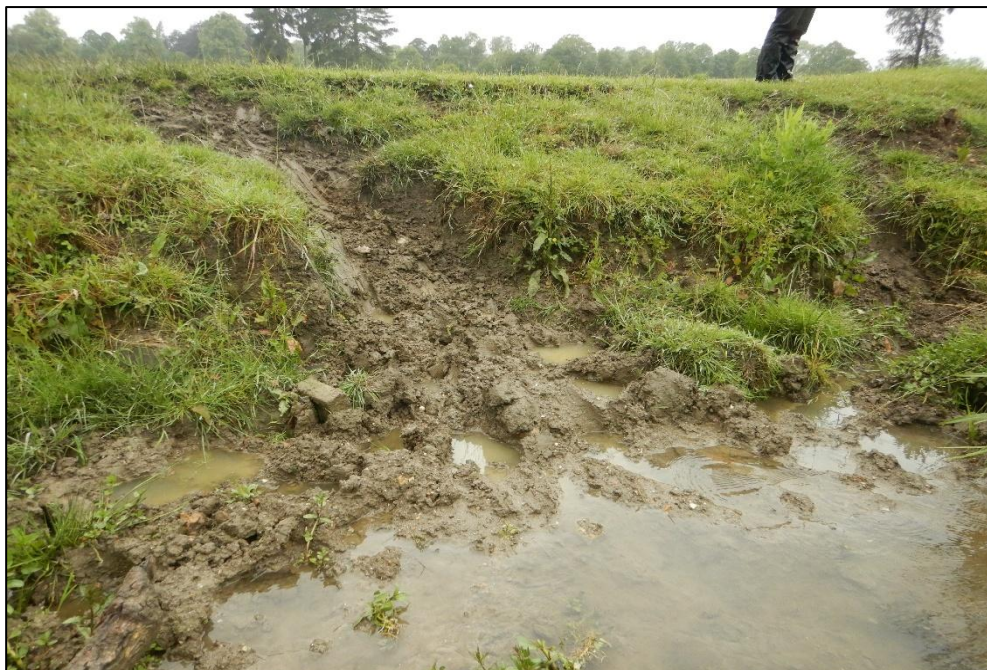
Pic 32 – Cattle cause serious damage to rivers and their banks, especially small low-flow ones. In this case cattle have destroyed water vole habitat by grazing the marginal fringe, that has also removed cover that may have been used by juvenile fish. As the animals cross the river multiple times a day they send large volumes of fine sediment downstream. That fine sediment clogs potential spawning gravels and reduces habitat diversity for aquatic invertebrates. Cattle watering should be provided away from the river using mains fed troughs, pasture or solar pumps. The last resort could be to construct a fenced crossing point, but that would not eliminate the problem of animals defecating in the river as they watered. See examples of cattle watering in Recommendations.

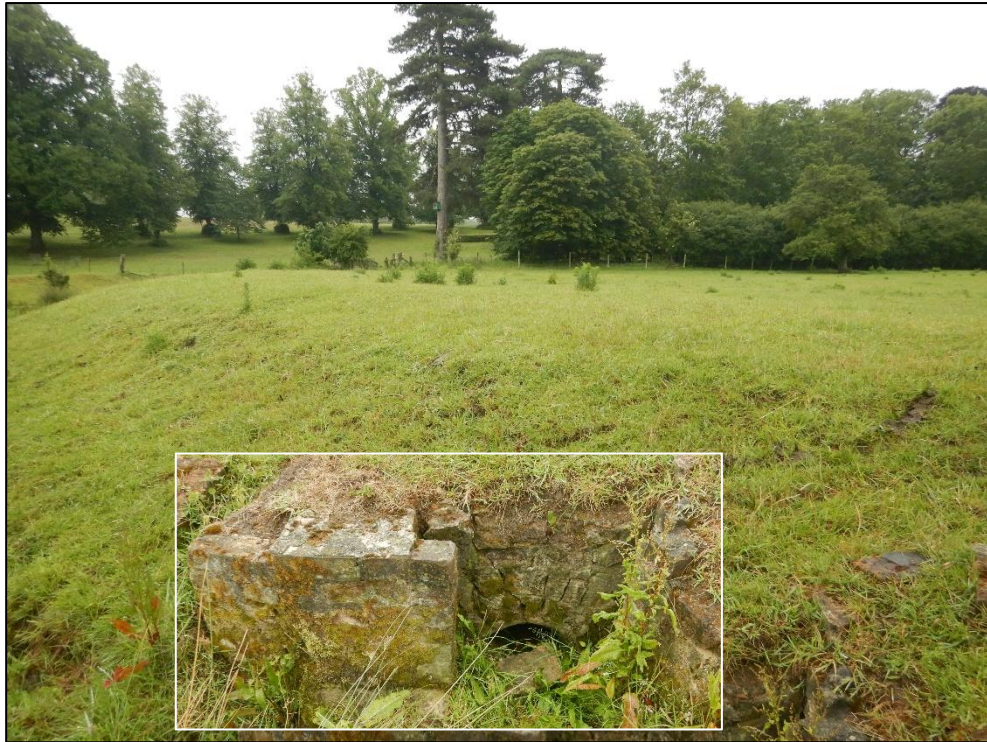
Pic 33 – A defunct sluice off-take from the river was found. It was later stated that it once directed flow to fish rearing ponds when levels in the channel were kept higher. It serves no purpose now but is an interesting reminder of how this chalkstream once had enough water to push flow in multiple directions for a range of purposes. It should be retained for its historical interest.

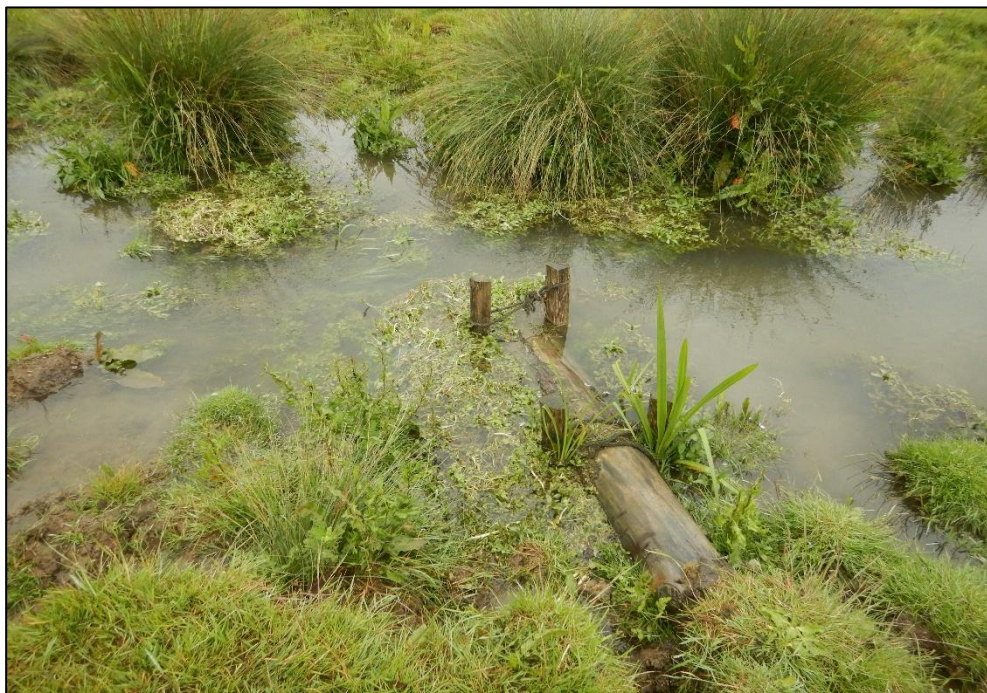
Pic 34 – A flow deflector in the cattle poached reach. It had no effect, mainly due to the constant disturbance caused by cattle and secondly due to the limited gradient of the reach reducing the river's capacity to drive flow against the bed to create scour. It would be more effective to install large tree trunks across the river at differing heights to make use of high flows. If needed gentle excavation of the bed beneath such structures could be done to initiate bed scour.

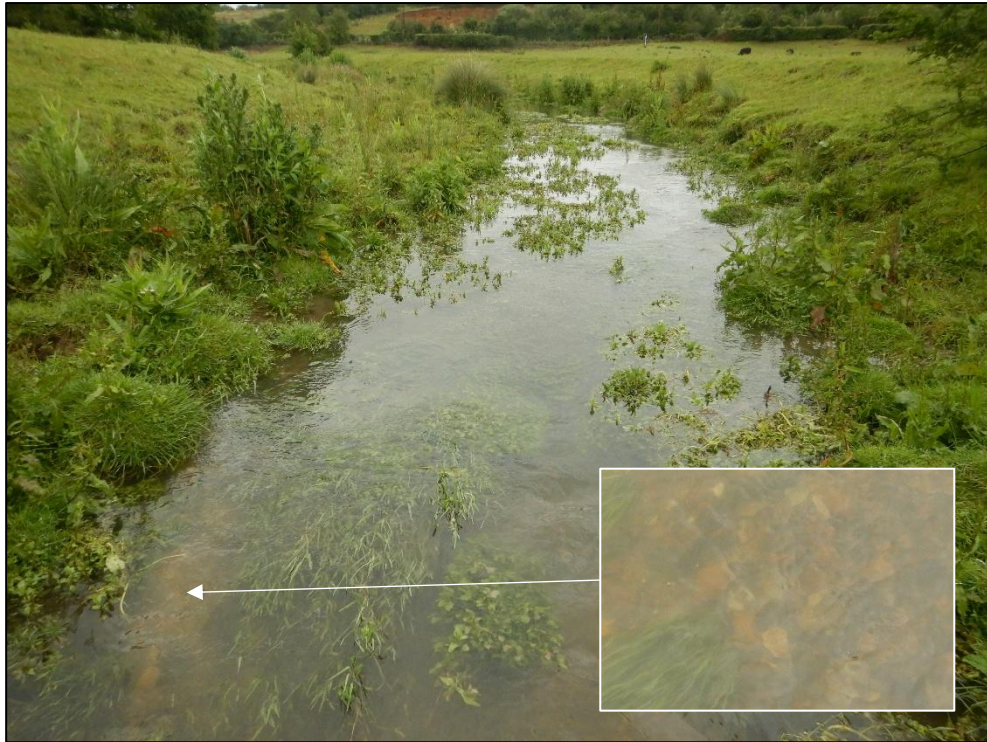
Pic 35 – Upstream of the main cattle activity area the river retained more vegetation but grazing is still apparent (and the animals may have now moved onto this area). Potentially, with cleaner bed substrates, there is more potential for the river to support trout once again. But they would be very vulnerable without the river being fenced.

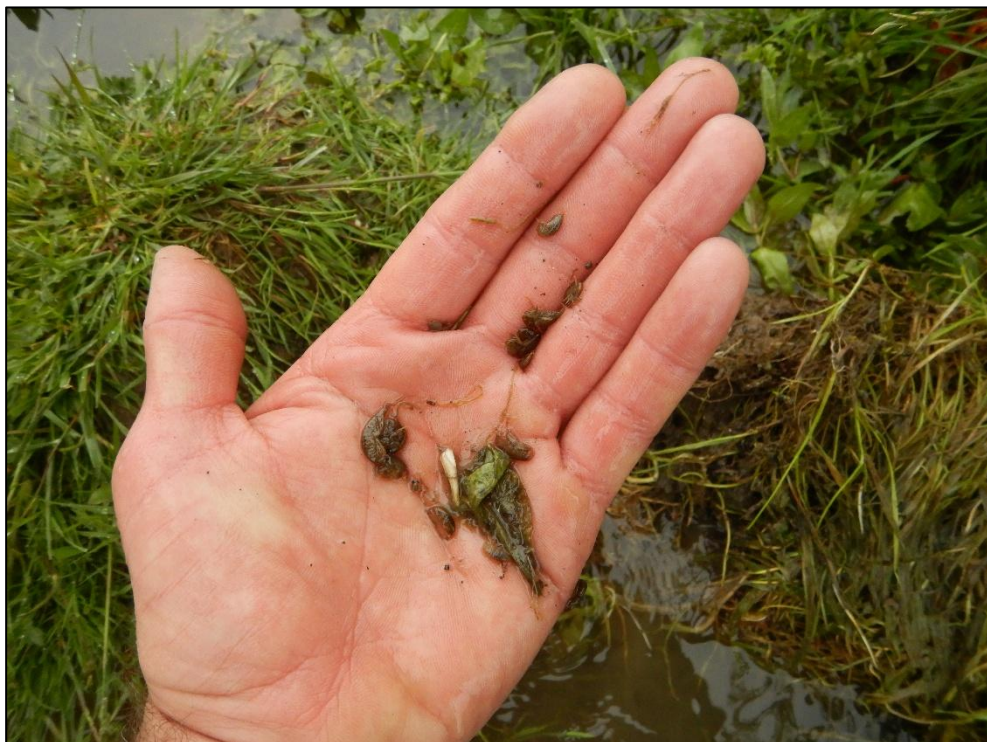
Pic 36 – Further stone turning still did not find any bullhead fish, but it did reveal high number of freshwater shrimp feeding on the accumulated organic matter (a positive). If this reach of river has dried it may be possible that bullhead have not yet been able to re-colonise as they cannot traverse obstructions (like the bridge footings) very well and are considered rather sedentary.

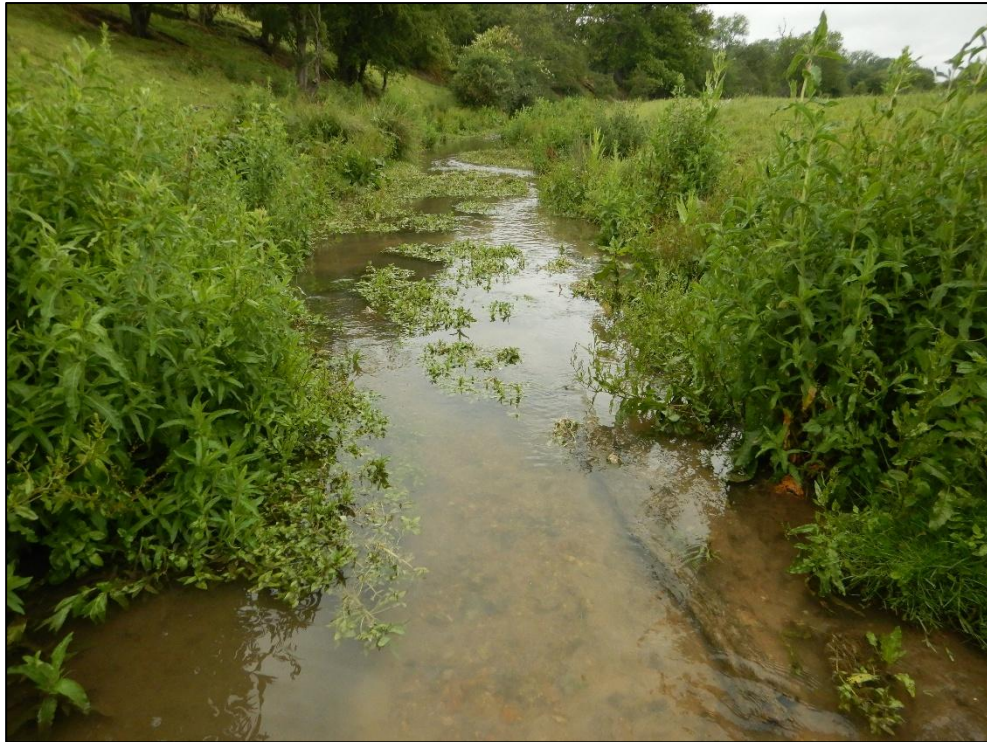
Pic 37 – Where the river has more gradient it flows more swiftly and is able to clean some fine sediment from the bed. Note that cattle have (currently) retained less palatable plants of great willow herb, teasel, rushes and thistles. Grazing of in-channel brooklime has taken place and fine sediment covers what should be clean gravel. Cattle damage is apparent and reduces the reach's potential to support trout.

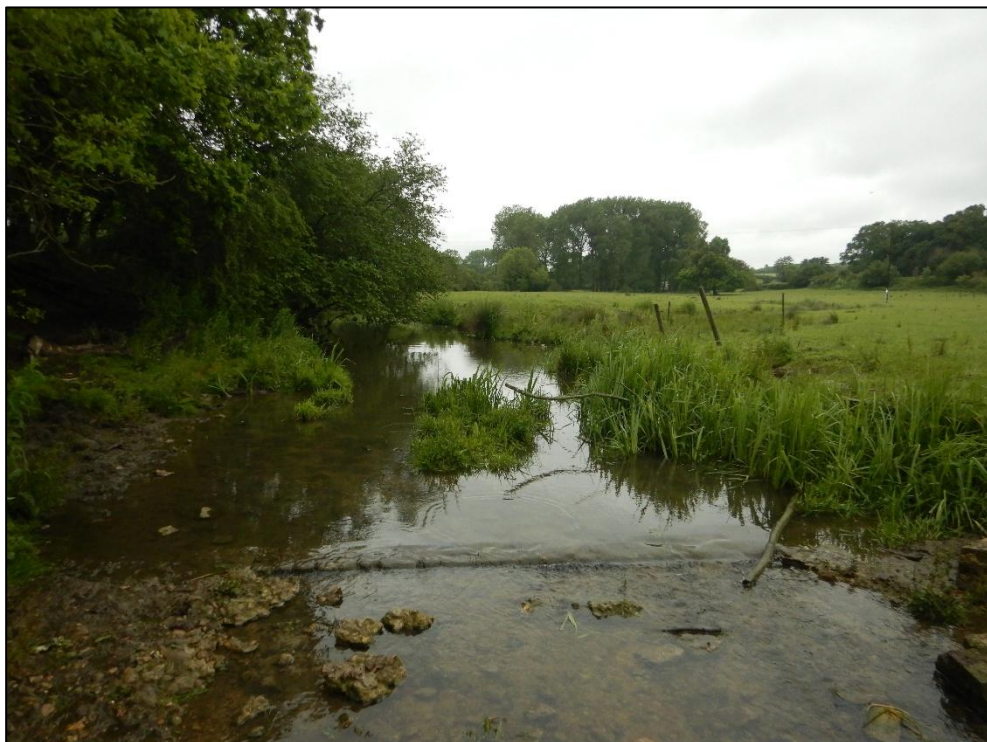
Pic 38 – Once again a weir removal has removed most standing blocks to lower the upstream impoundment of water, but by unnecessarily retaining the foundation a shallow weiring effect is still present. Unless there is a need to retain the upstream pond habitat, the weir's complete removal should be sought as in low flow conditions it still presents a barrier to fish (such as bullhead).

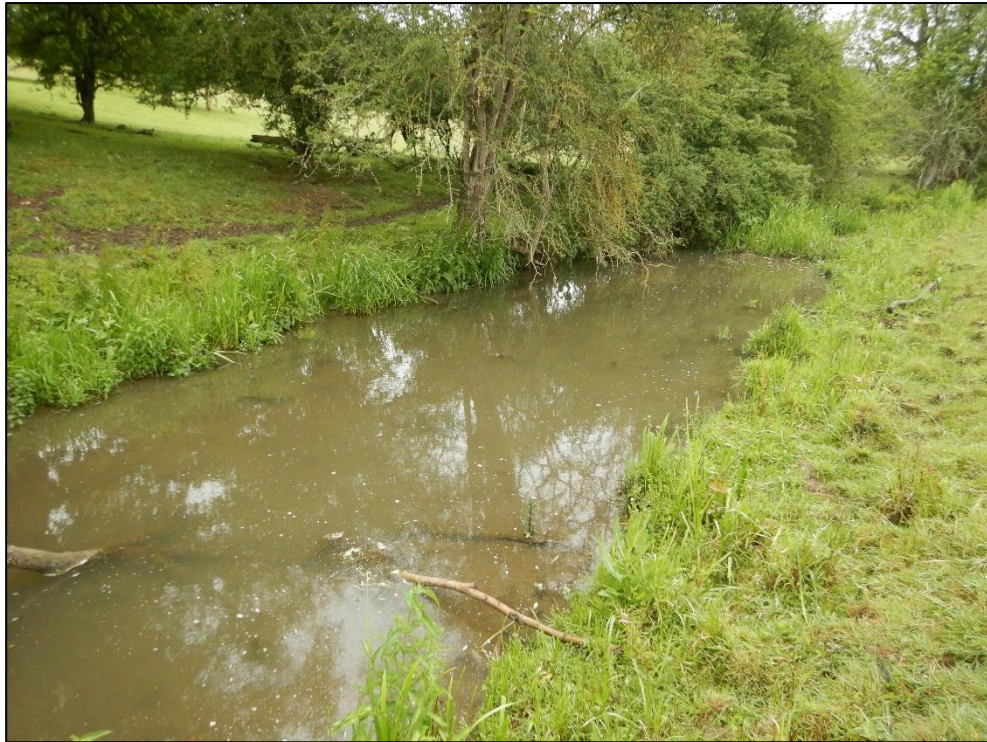
P39 – The ponded river upstream of the partially retained weir is subject to cattle intrusion which significantly degrades the chalkstream habitat. Also note the fine sediment deposition that the impounded, de-energised flow is unable to transport.

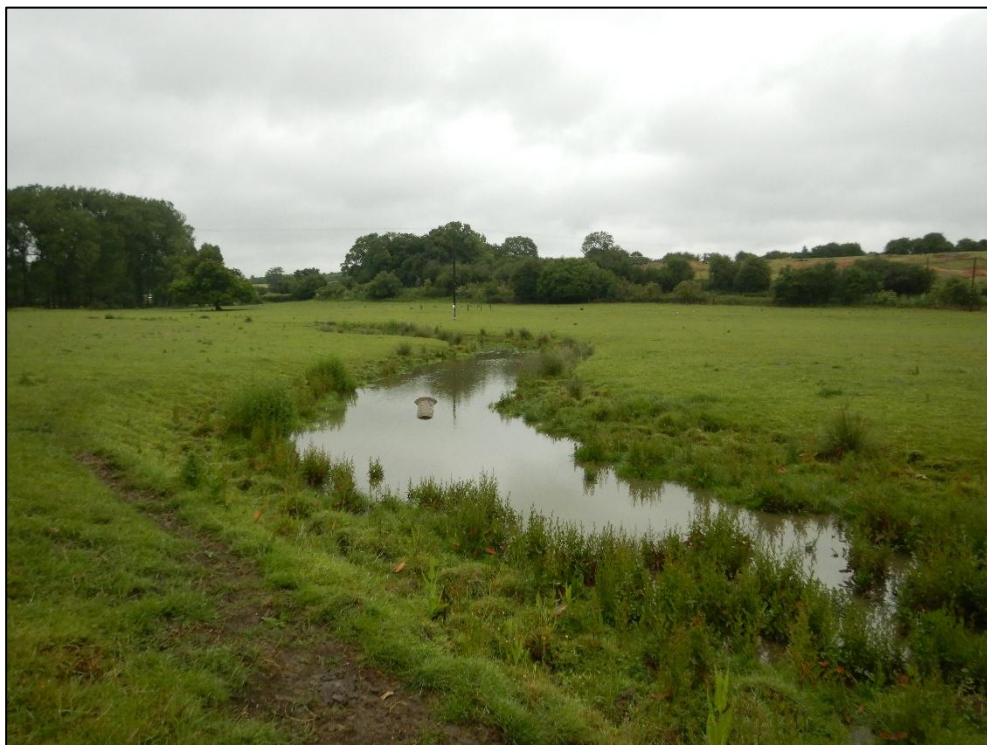
P40 – A tributary channel with a meandering planform is present. Careful observations were made in case it was a defunct river channel (a paleochannel). That is not the case as cool water near its start indicates notable spring flow providing the tributary with its own source (independent from the river). The channel is being degraded by cattle, and it should be fenced. It would be best to fence it with a 5m to 10m buffer to allow dense marginal cover to evolve with tree and scrub cover over the spring head to aid natural cooling.

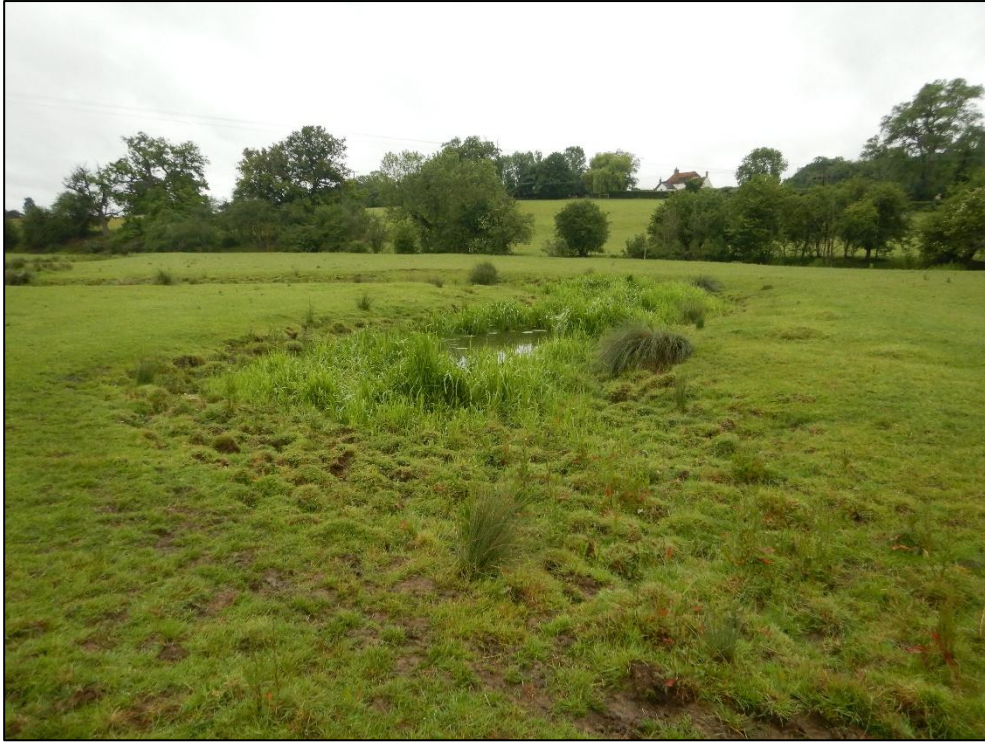
P41 – The tributary rises from a springline in the pasture. The area is currently subject to intense cattle trampling. The area should be fenced to protect it and to allow a vegetated buffer zone to grow.

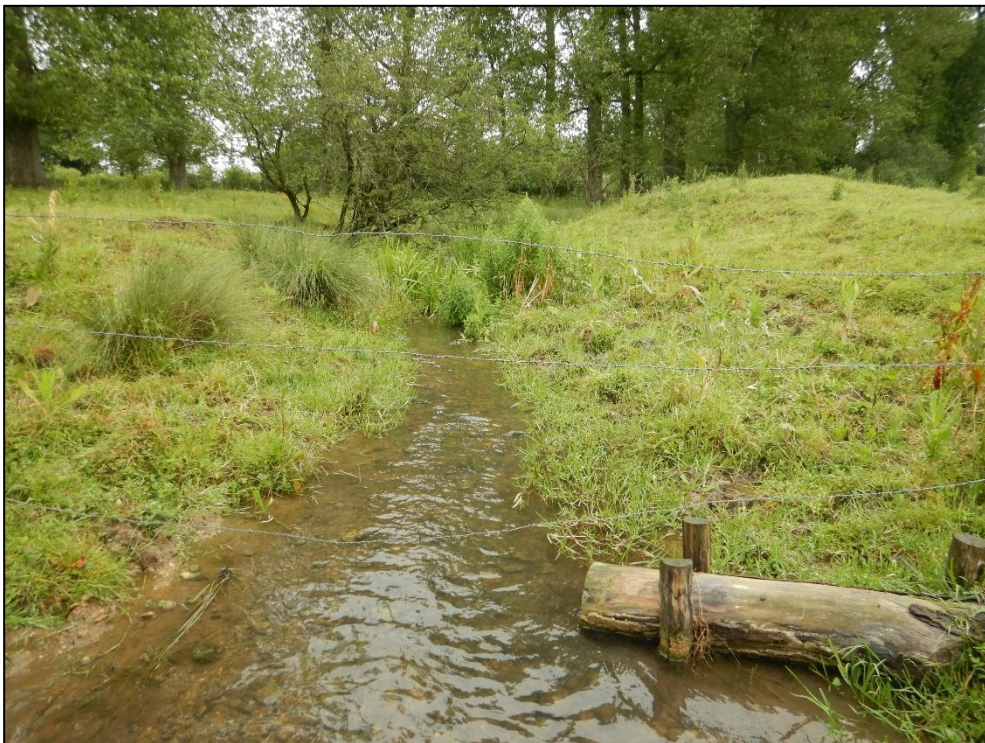
P42 – The upper extent of the site was marked by a barbed wire fence and a single flow deflector. The adjacent site receives only occasional cattle grazing and consequently it is not subject to the same degrading pressures that the survey reach is. The banks are better vegetated with less bare soil and the river is cleaner.
