## WILD TROUT TRUST

### **Advisory Visit**

**Gilling Beck, R. Swale, Gilling West Fly Fishers, April 2021**

**Prof J Grey: [jgrey@wildtrout.org](mailto:jgrey@wildtrout.org)**

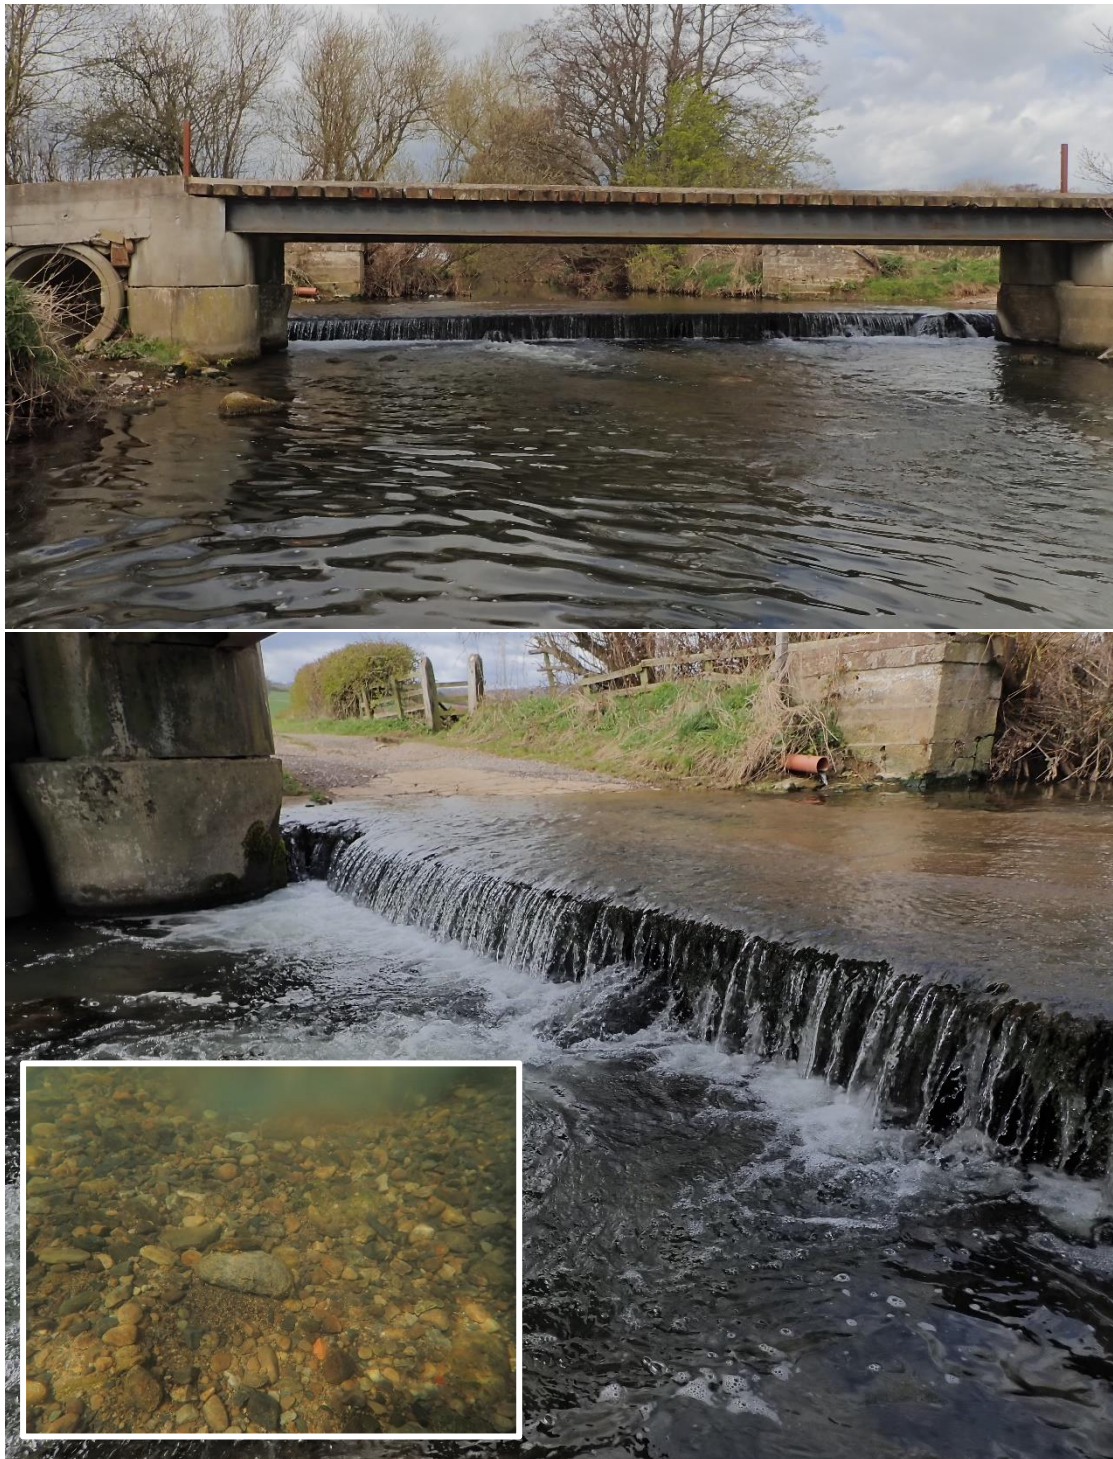
The lower beats were assessed primarily from the RB. The d/s limit was a ford and bridge structure, a complex arrangement of inappropriately sized culvert pipes running through a concrete fillet of the ford (Fig 1). Immediately d/s of the ford, a clear span bridge had been installed, presumably for when the ford was impassable under higher flows. The ford presents a considerable obstacle to fish passage and sediment transport, impounding a reach u/s for ~50m. Several of the culvert pipes were blocked completely or partially by debris, thereby increasing the velocity of water through the remainder and routing more water over the top; obviously, this issue will be an ongoing maintenance problem. The jetting flow within the pipes would be too strong for the majority of the time even for a powerful salmonid to overcome via burst-speed and hence impassable via that route. The perched nature of the ford, a headloss of ~50cm, is a further issue for fish passage. Weaker swimming species would be unable to ascend. Salmonids could theoretically leap that height but the thin skim of water across the ford provides insufficient depth for onward passage for the majority of the time. There were no such issues associated with the clear-span bridge and it would be worth exploring options for removal of the ford.

**Fig 1. The ford at NZ 19597 03780 marks the d/s limit of GWFF water. It was a complex structure comprising multiple parallel culvert pipes of inappropriate diameter ( $\sim 0.5\text{m}$ ) in a concrete fillet. Several of the pipes were blocked and clearly had been for some time, and all the remainder had debris partially blocking the u/s side contributing to the impounded reach which extended for  $\sim 50\text{m}$  u/s. A considerable barrier to fish passage and sediment transport, especially considering the clear span bridge adjacent. Insert highlights where flow energy was concentrated, the gravel could be kept clear of fines.**

Jetting flow through the pipes (which were also slightly perched above the water level d/s) would be impassable for most fish species for most of the time. Similarly, the skim of fluming flow across the concrete fillet would be too shallow.

The ford at the d/s limit has contributed to the fragmentation of the fish community along Skeeby / Gilling Beck, and as there is a bridge adjacent to facilitate crossing, should be considered for removal. It would be worth contacting the local EA fisheries officer and possibly YDRT to investigate removal.

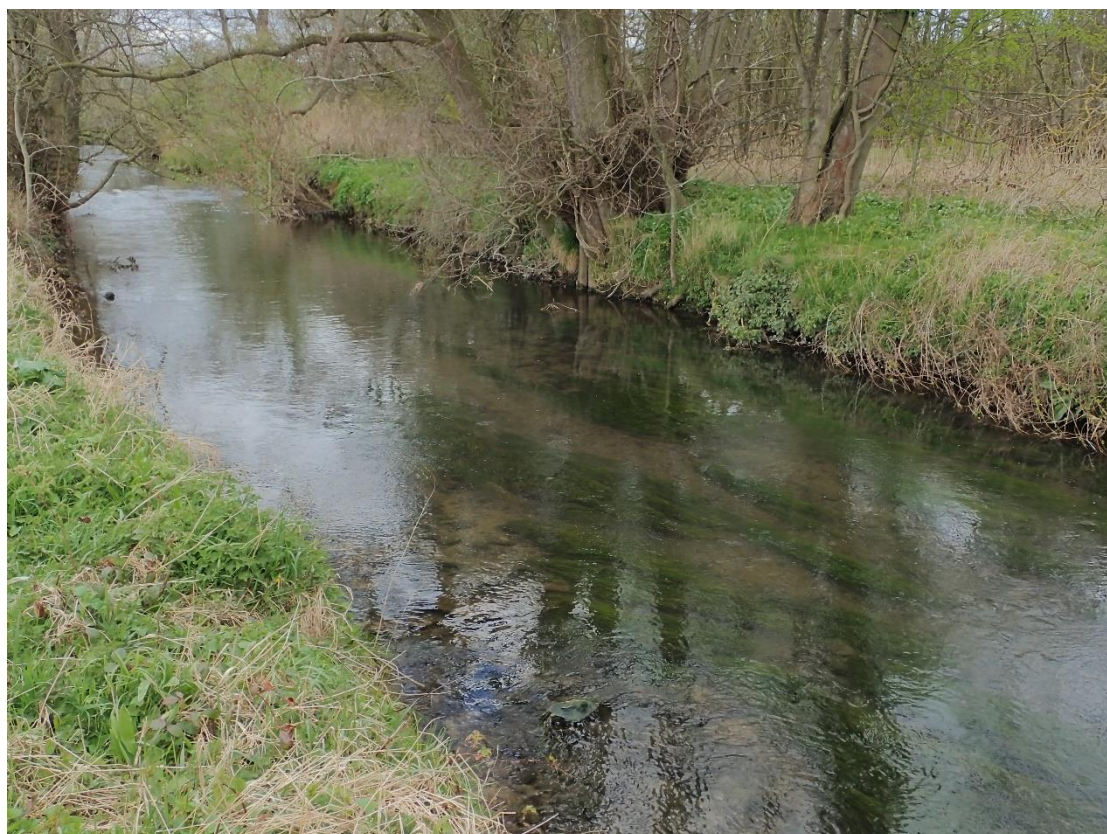
**Fig 2. A slower, deeper glide, typical of the straightened reach at the u/s end of the impounded reach created by the ford (Fig 1). Valuable instream cover was created by dense stands of *Ranunculus* (water crowfoot) but low or trailing overhead cover from tree branches or indeed large woody material retained within channel was scarce.**

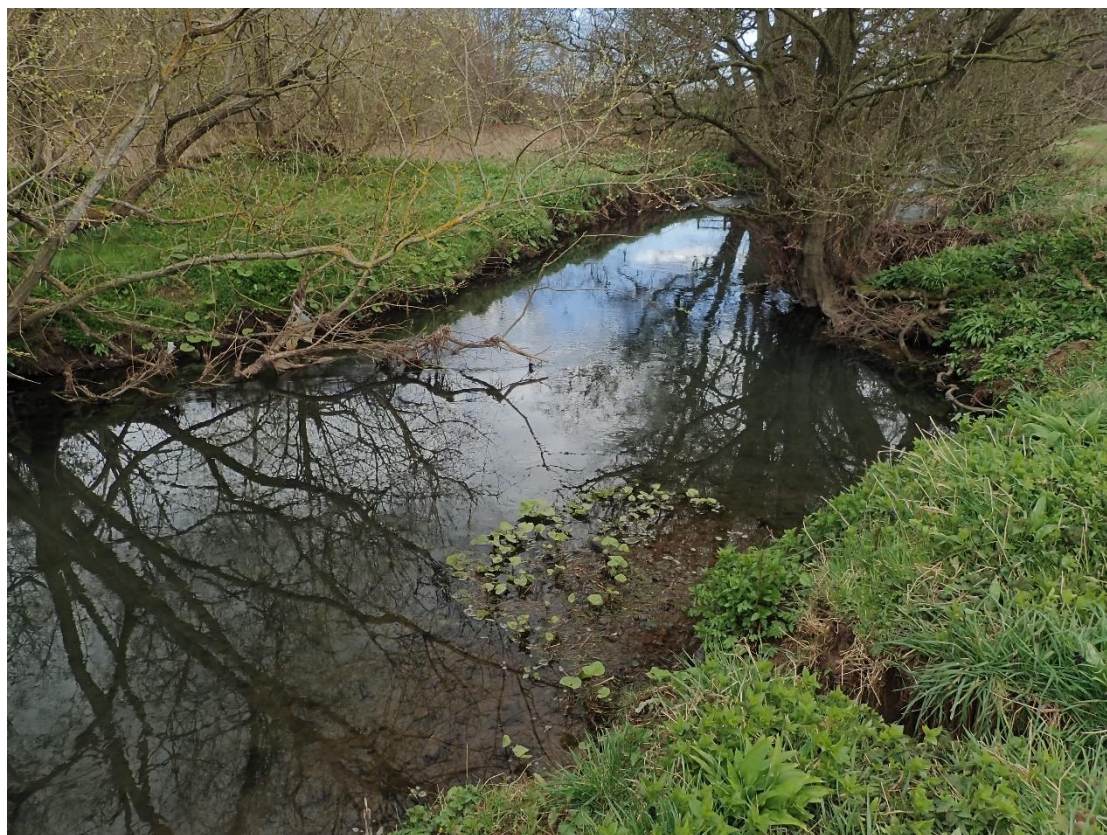
**Fig 3. An example where the formerly trapezoidal and consistently proportioned channel has been modified by structure: a willow limb on the LB has laid naturally into the channel margin, pinching the flow toward the root ball of a mature alder on the RB which has created a deeper scour pool. Finer sediment flowing in from a small channel on the RB has been colonised by butterbur, adding to the pinchpoint.**

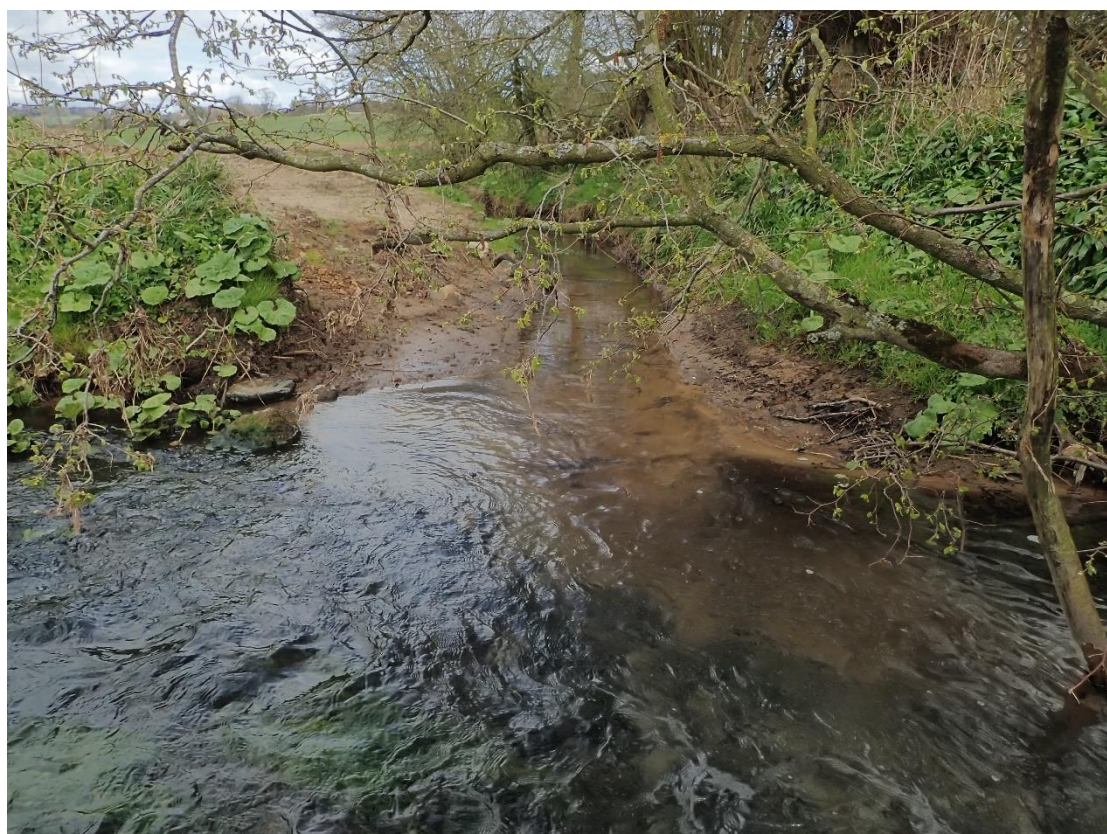
The friable, sandy nature of the catchment soils was evident on both banks, especially where former becks had been converted to and maintained as drains (Fig 4). Fine sediment ingress from such works (a primary reason identified for not achieving good ecological status) was evident at all the confluences. Constant supply of finer sediments clogs the interstices between gravels and cobbles, reducing the viability of that larger substrate as fish spawning and high-quality macroinvertebrate habitat. Reduction of the channel to a consistent trapezoid again robs the beck of the energy to sort sediments and

**Fig 4. Fine sediment ingress was all too obvious. Drainage ditch 'maintenance' on the LB at NZ 19378 04031 had left exposed soil graded to the beck bank; a plume of fine sediment was evident along the toe of the LB d/s on Gilling Beck.**

Diffuse pollution sources from silt / soil ingress were apparent from almost all tributaries (drains) and from field boundaries where ad hoc channels had been cut to drain standing water. It is in the landowner's best interest to keep the soil on their land rather than lose it to the beck. Any particularly problematic sites might be best dealt with via a farm advisory visit with respect to Farming Rules for Water, and these can be arranged via the Dales to Vales River Network. Any works introducing fine sediment pollution to the beck should be reported via the Environment Agency National Incident Reporting Service (**0800 80 70 60**) – ideally, be prepared with a National Grid Reference which can be pinpointed using <https://gridreferencefinder.com/> or similar.

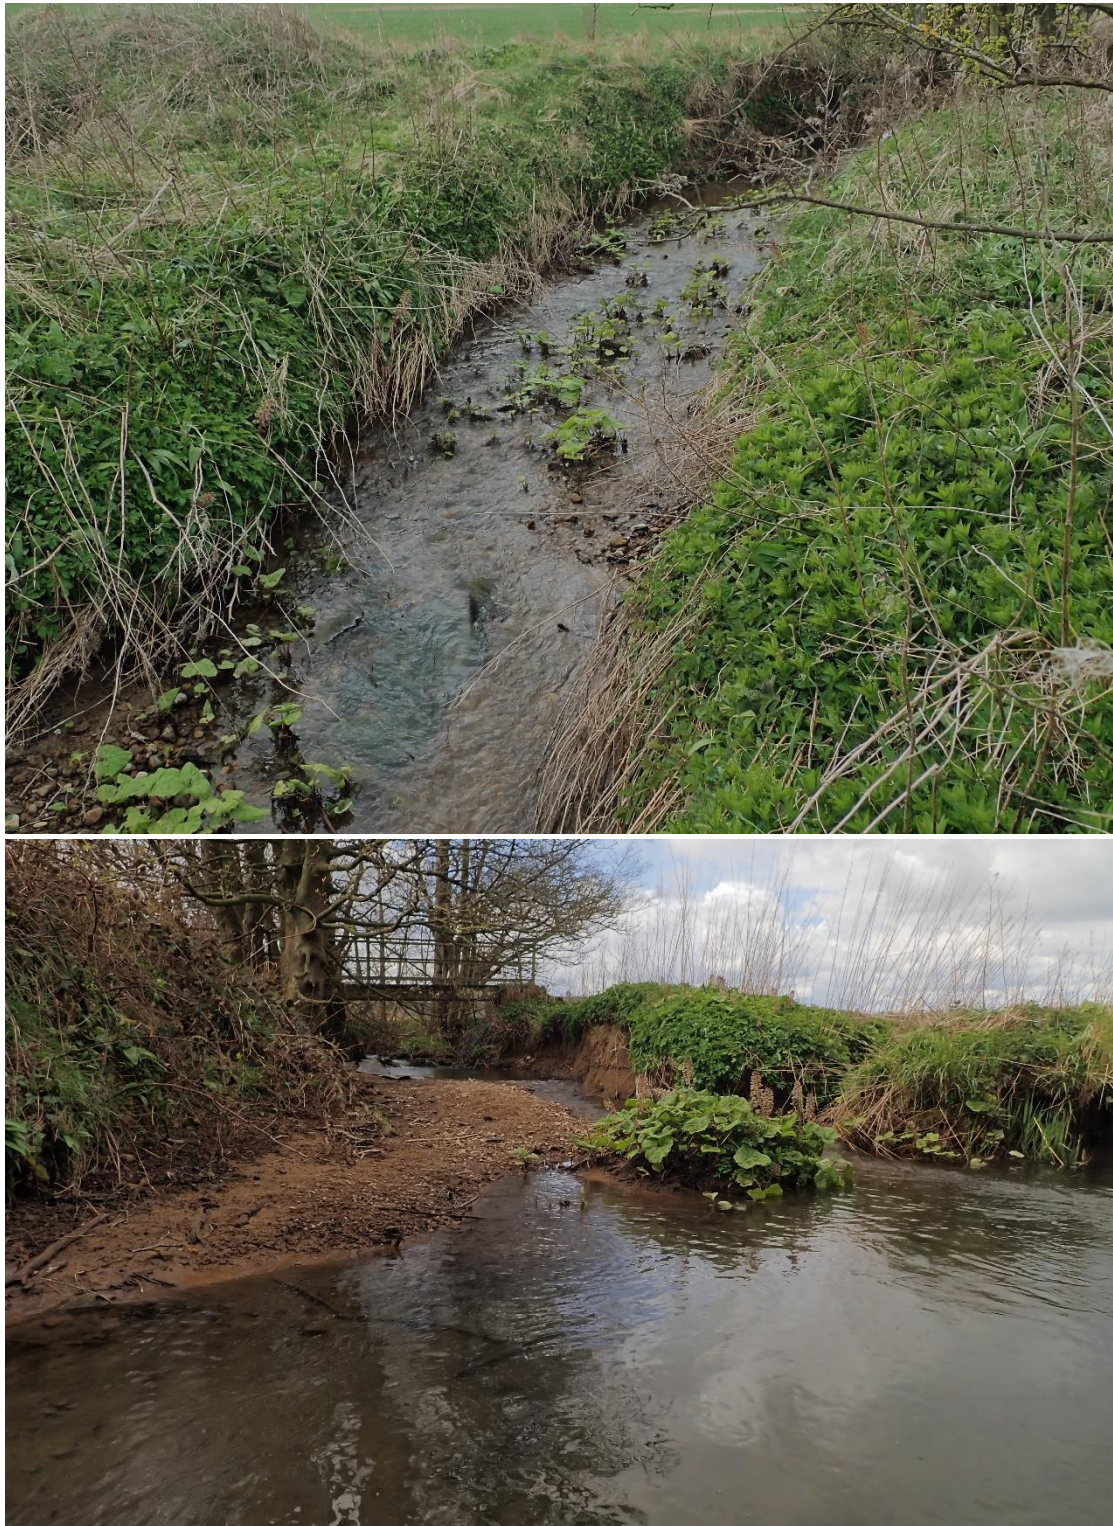
Crayfish Beck entered the main channel from the RB and had also been straightened (Fig 5). However, compared to some of the other 'drains', it appeared to retain limited functionality because of a riparian buffer and colonisation within the channel by butterbur, helping to focus flows and clean up the gravel. It is entirely possible that trout may use these smaller, seemingly inconsequential tributaries for spawning, with fry dropping d/s into the main channel as flow recedes during spring and summer.

**Fig 5. The confluence of Crayfish Beck at NZ 19335 04022 presented no physical issues for fish passage although there was a clear desire line to the water from the footpath indicating potential disturbance. U/s, the beck had been heavily straightened (see Map 3) but had good tree cover, and good gravel deposits sculpted by butterbur colonisation.**

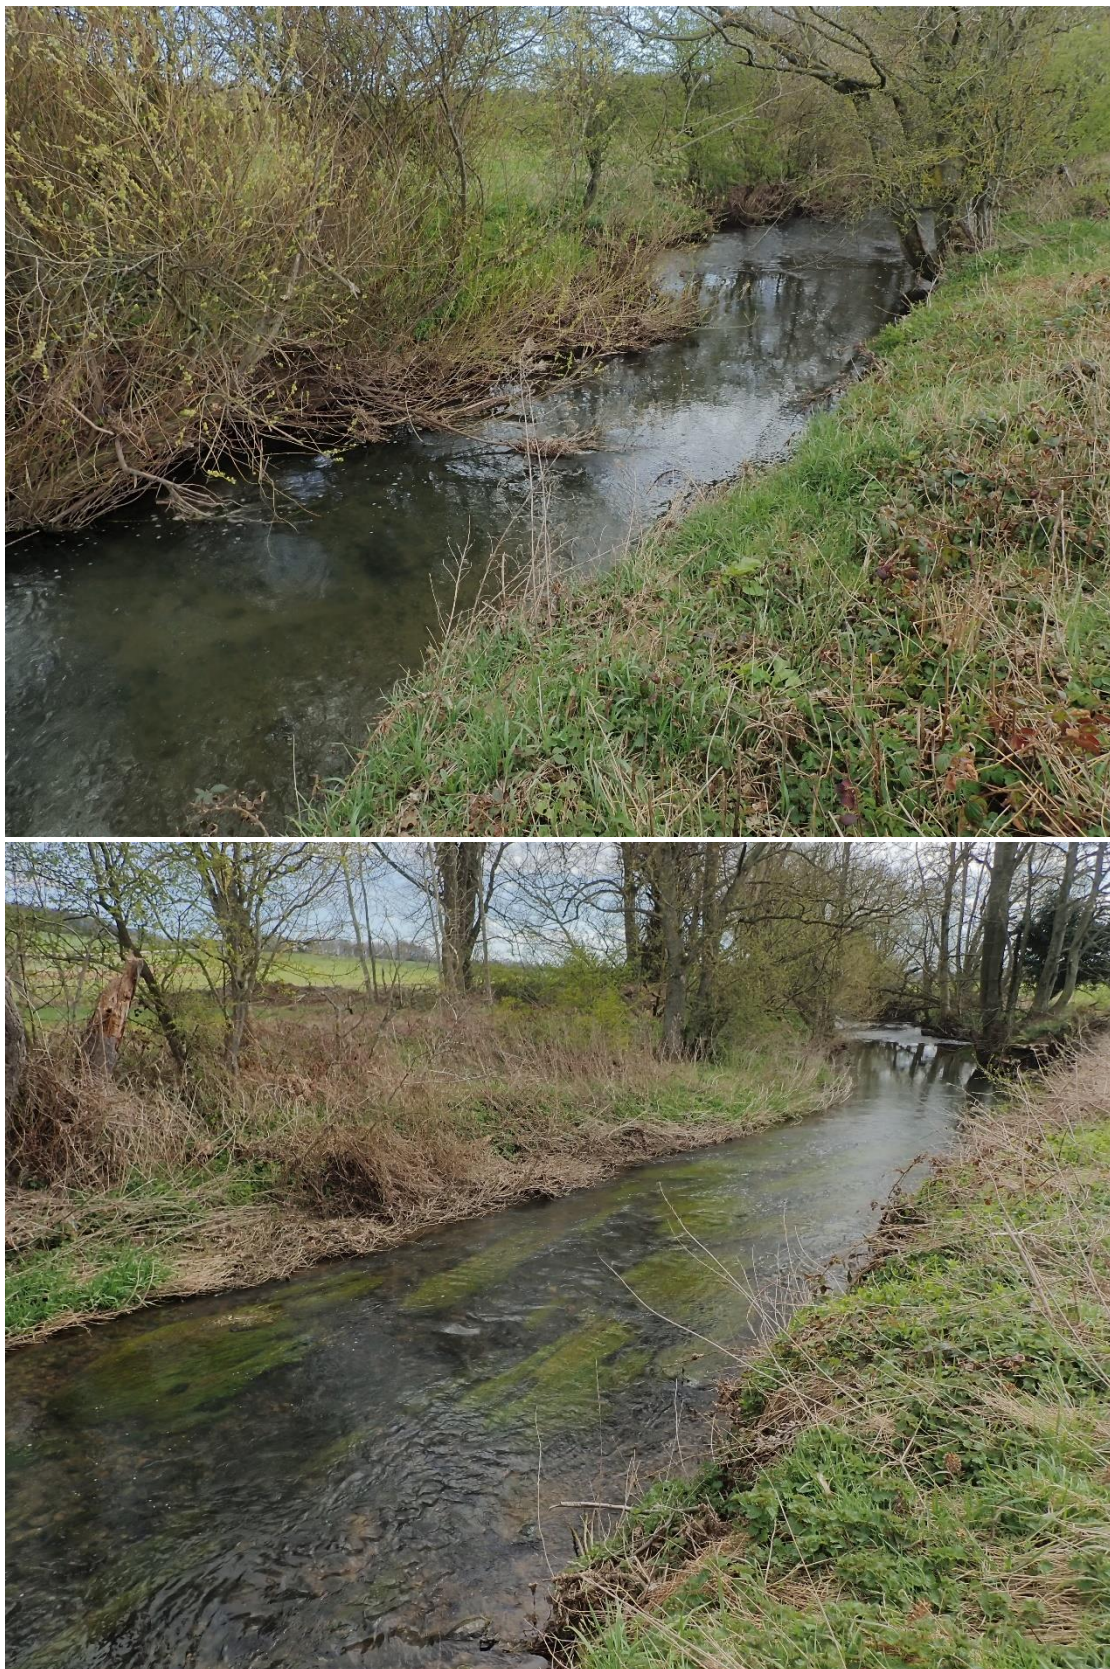
Where the canopy was more open or absent, the water crowfoot took on greater importance in terms of creating habitat diversity (eg Figs 6&7). This plant is known as an ecosystem engineer; its presence modifies the physical and chemical nature of the habitat around it and hence creates niches for biota. Substantial, dense stands of water crowfoot force water around the plant, increasing the velocity of water over the surrounding gravels and helping to maintain them free from silt. Indeed, that silt tends to be accumulated within the water crowfoot stand and in its lee d/s, thereby providing a rooting and nutrient medium for the plant to 'move' into. Stands provide refugia

**Fig 6. More positive natural features combatting the uniformity of the straightened channel: upper – low, bushy cover from willow creating pool habitat beneath; and lower – water crowfoot stands in a riffle, maintaining cleaner gravel in the faster flows between and around the plant.**

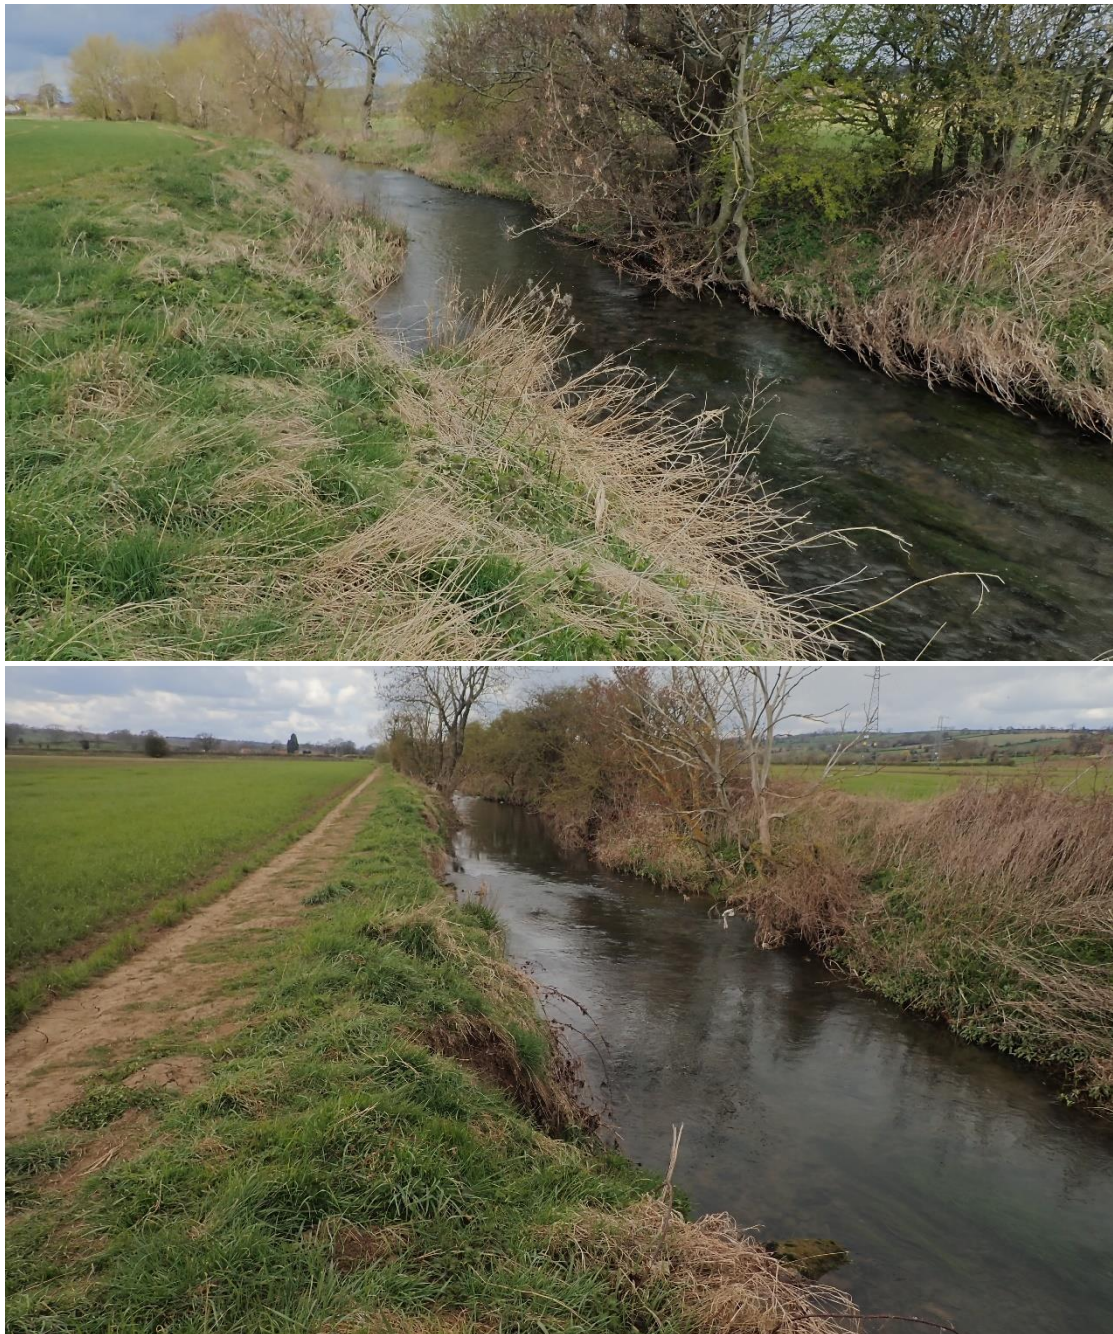
Along more open sections u/s of Crayfish Beck, while the LB remained reasonably buffered from intensive agriculture, the RB was more pressured (Fig 7). The arable field boundaries were <2m from the bank top in places which might have been sufficient if it were not for the popular footpath squashed between the two. Footfall was causing visible detriment to the flora via disturbance and soil compaction, effectively halving the already small buffer zone, and the stability of the banks was deteriorating. Indeed, it was one of the few reaches where there was notable erosion.

**Fig 7. Straightened sections with a reasonably natural and ample 'buffer' zone from the intensive agriculture on the LB. Less cover and space was given on the RB, although it was appreciated that the native grass and herb cover would grow to >1m. More troublesome was the proximity of the field boundary squashing the footpath to the very top of the RB. There was notable erosion of the RB exacerbated by the compaction of the bank and the lack of buffer.**

The condition of the riparian zone would be improved by allowing more space for the flora to flourish, otherwise the banks will continue to fail and productive land lost. Augmented planting of some shrubby tree species (hawthorn, blackthorn, hazel etc) would increase the resilience of the bank via roots binding the soils together, diversify the community and provide further pollinator and leaf litter resource, as well as shade from the southwest side of the channel.

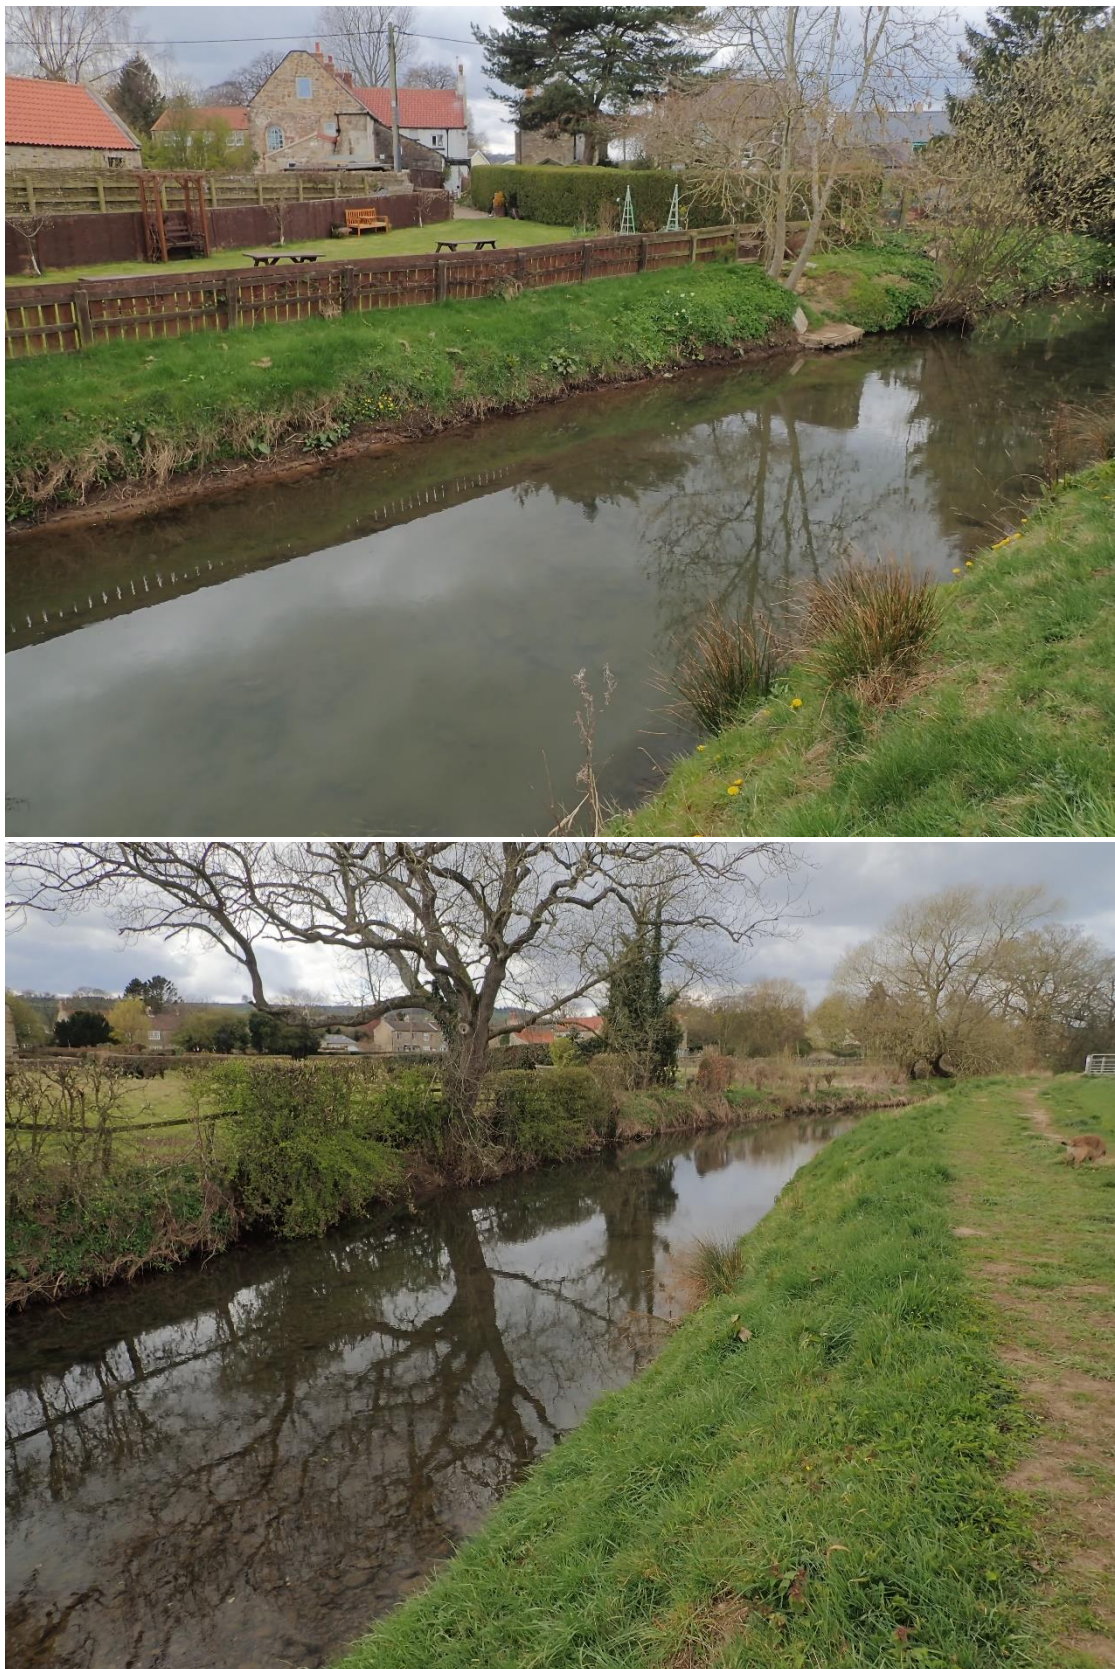
From the d/s edge of the village and through to Gilling Bridge, virtually all habitat had been destroyed by dredging, removal of tree cover and uniform embankments maintained at a relatively short sward of grass to allegedly alleviate flood risk (Figs 8&9). Creation of an over-capacity channel to deal with extreme flood events is evidently self-defeating in such an environment. The channel was inexorably filling up with gravel and cobble that had been transported d/s by the beck to fill the void created. On top of those, under low flows with insufficient energy to transport the finer silts and sands, there was a deep smothering of 'mud' – a barren reach of the beck reduced to a deeper sluggish glide with limited food resource and virtually no cover. One small shoal of grayling was visible at a slight pinch in the channel where a hollow in the bed had been sculpted.

**Fig 8. Complete destruction of any habitat features from dredging of the channel within the village environs, and maintenance of predominantly grass along the artificially reprofiled bank. The 'over-capacity' channel, deep, sluggish and canal-like, was simply infilling with silt and the bed was smothered.**

Far more effective solutions to alleviating flood risk might have been allowing the river to access all the original arches on the bridge, preventing development within the immediate floodplain, and actually allowing for some peak-flow reconnection with the floodplain (here and further upstream). A two-stage channel which maintains more natural proportions and hence functionality under low flows but has sufficient capacity to accommodate greater volumes during spate flow would be a far better solution. Certainly, there was adequate space on the LB under the footpath to lower the bank and set the flood bunding back further into the floodplain.

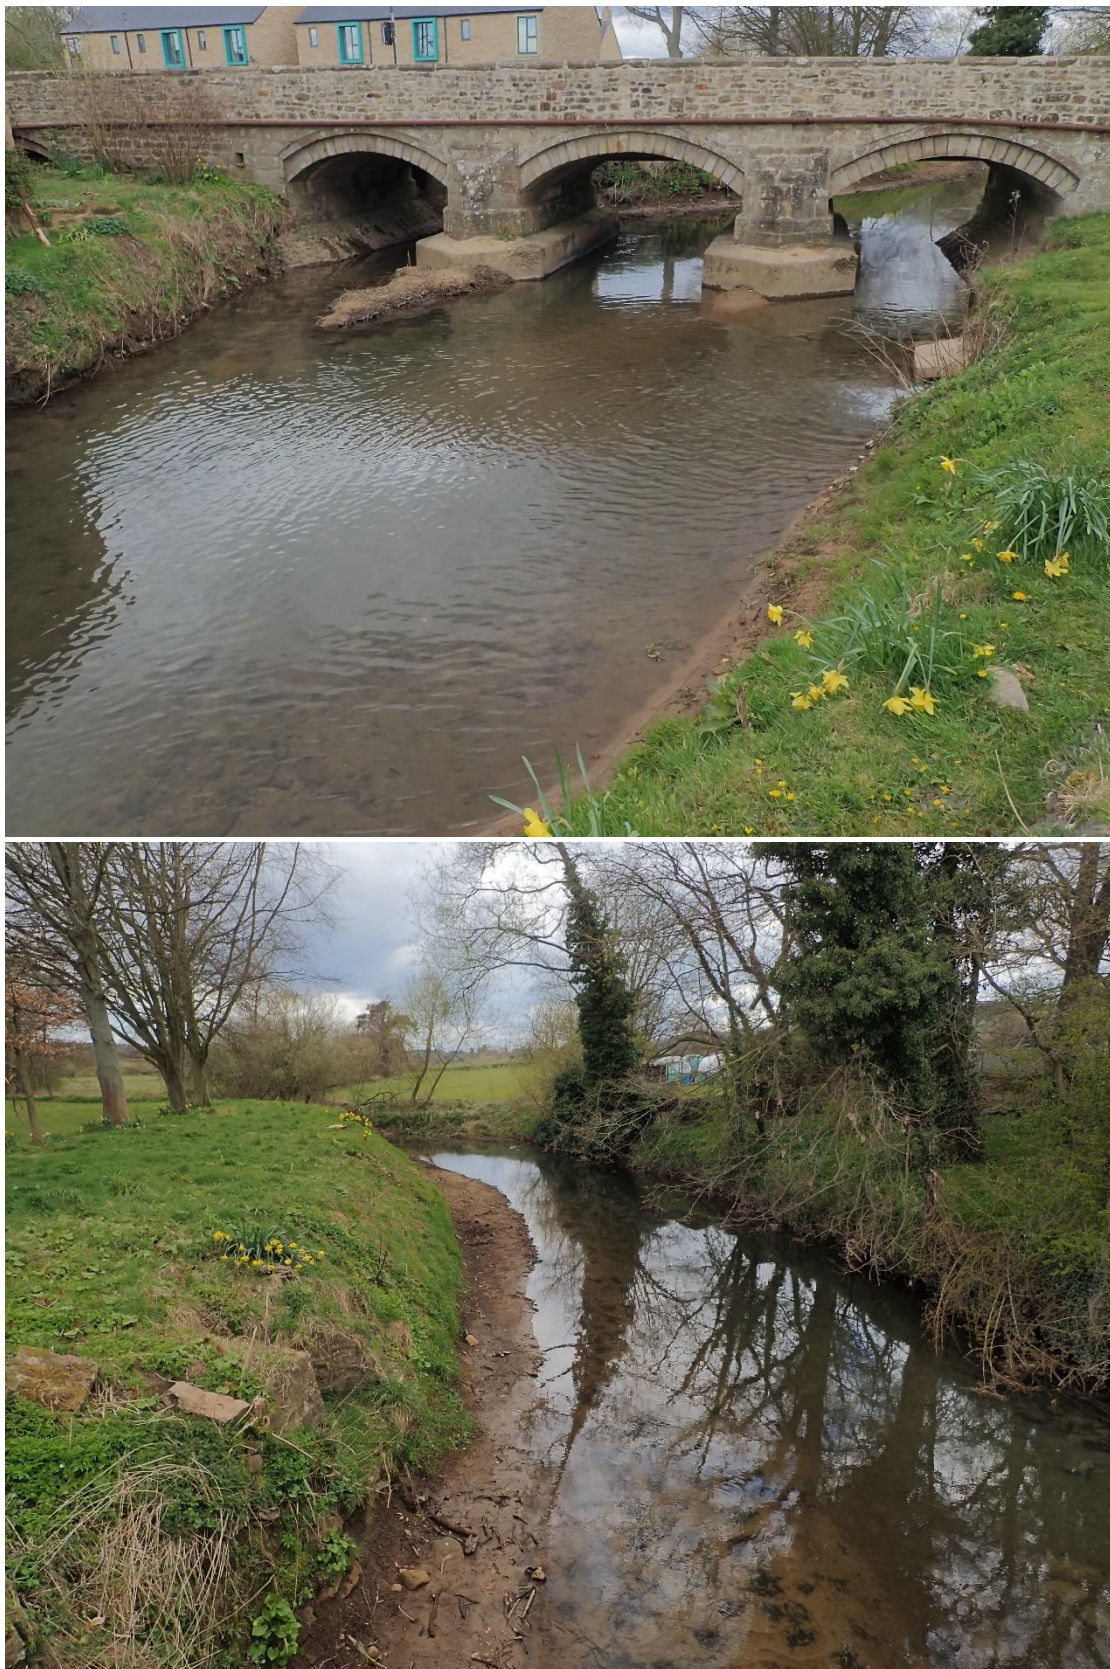
**Fig 9. Views d/s & u/s of Gilling Bridge (NZ 18326 05215) of the dredged, trapezoidal channel and the deposits of fine sediment building up in the lee of the buttresses. It was noted that further arches originally built into the bridge had been blocked presumably to allow for development. Reduction of capacity at this man-made pinchpoint clearly increases likelihood of flooding.**

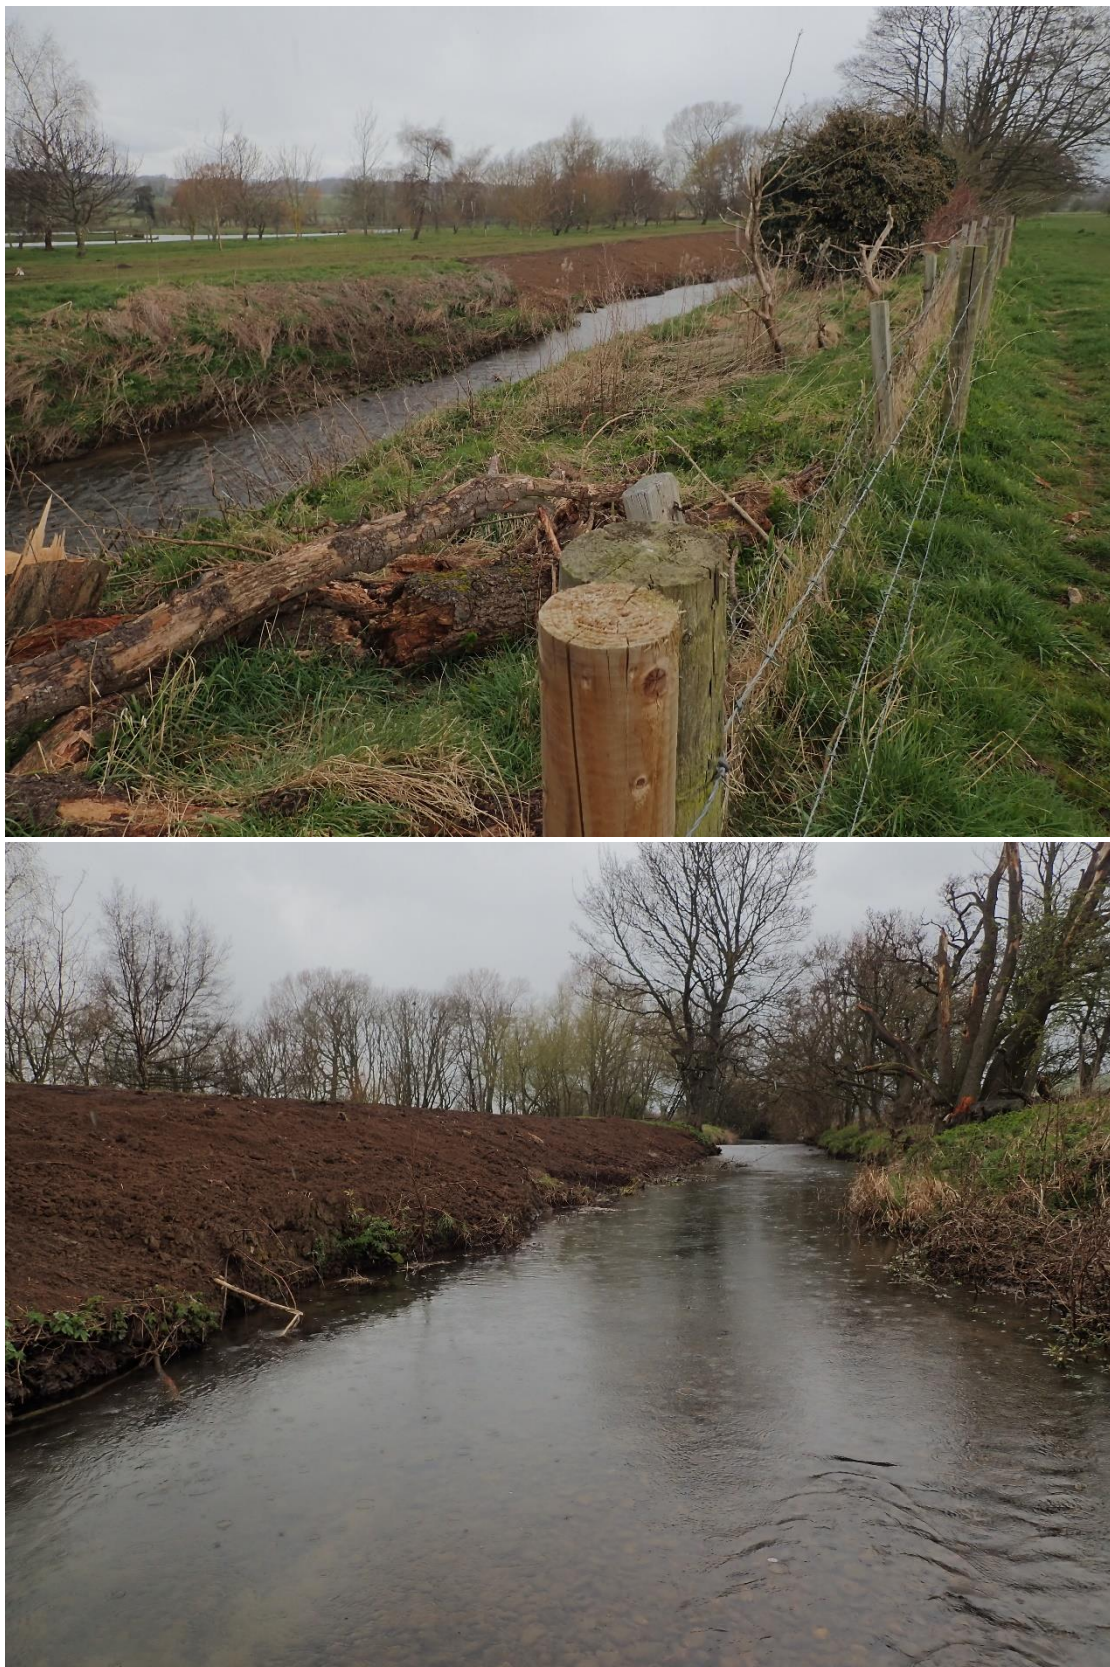
**Fig 10. At NZ 17770 05360, the d/s limit of the upper beat, the landowner on the RB had taken it upon themselves to reprofile ~120m of bank and remove all the trees, plus remove low cover from the LB. There was no evidence of mitigation procedures to trap fine sediment which was smothering the entire bed, and this was probably unsanctioned work. North Yorkshire County Council would be the relevant authority.**

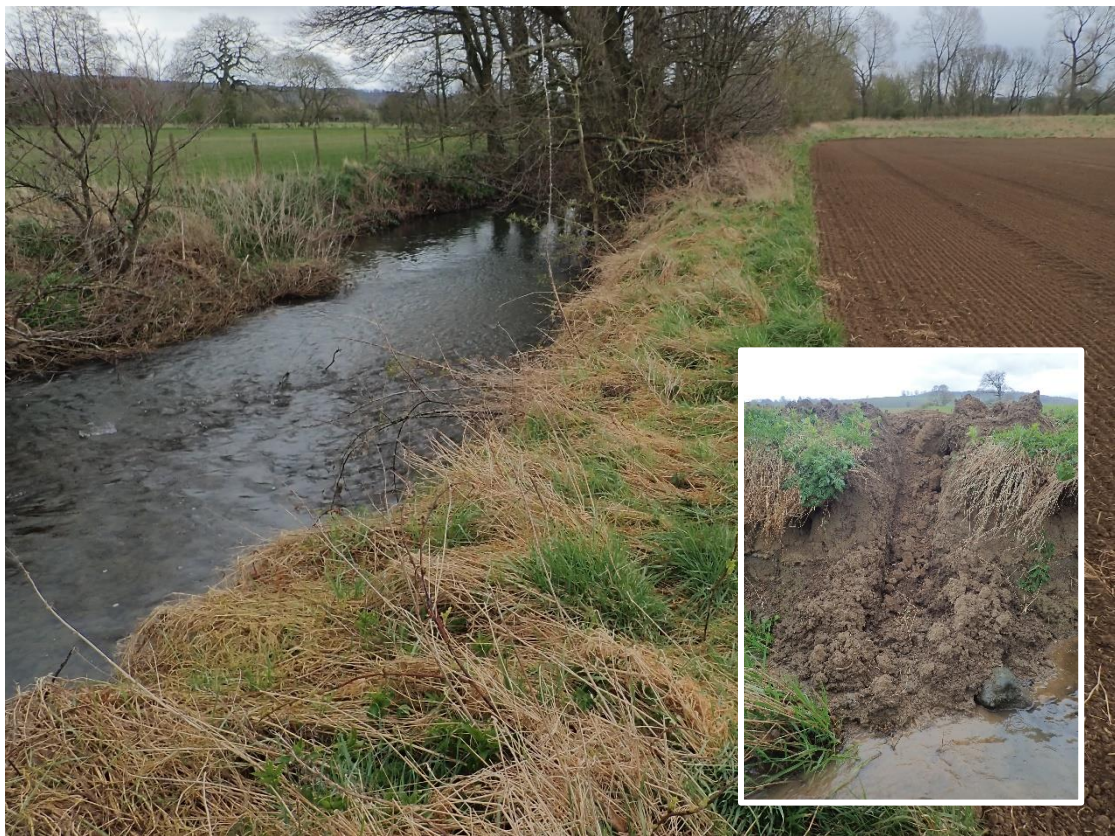
**Fig 11. Further u/s, alder cover along the majority of the channel was reasonable and there was a bare minimum of buffer zone comprising native riparian flora. However, this had been deliberately breached at various locations to drain standing water from the adjacent fields (insert), thereby introducing fine sediment directly to the channel and is a clear breach of the Farming Rules for Water.**

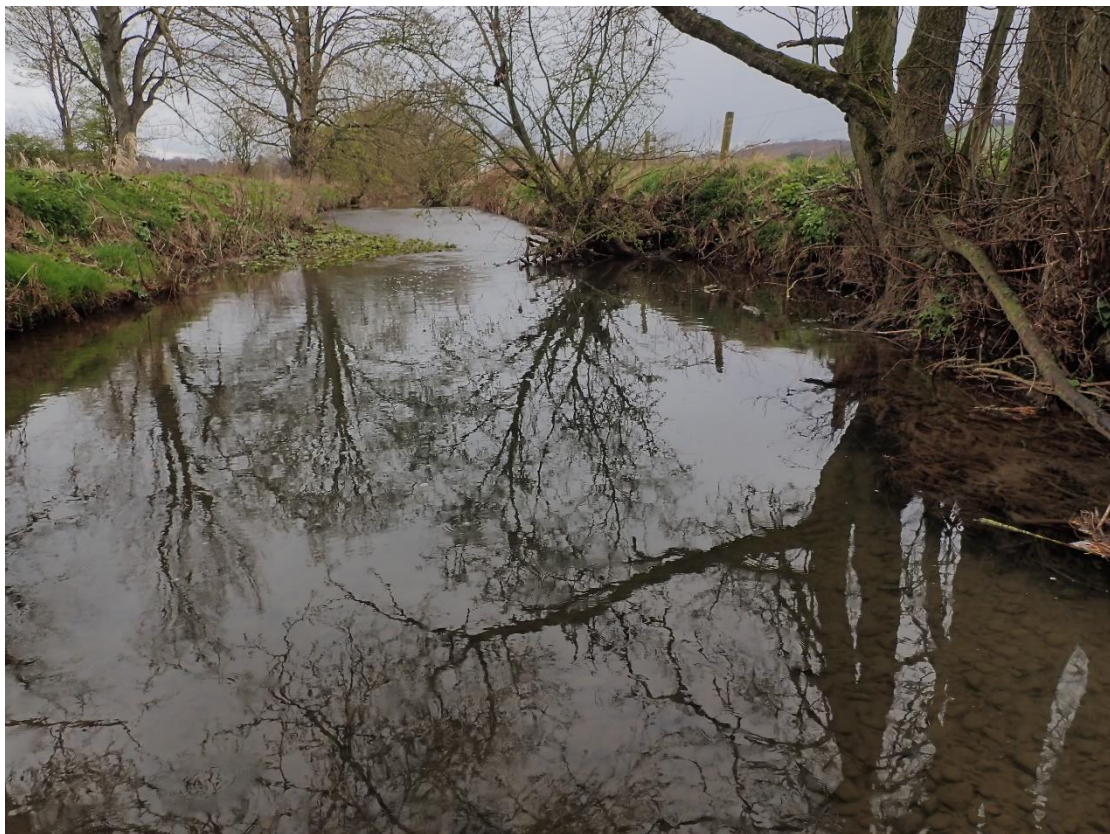
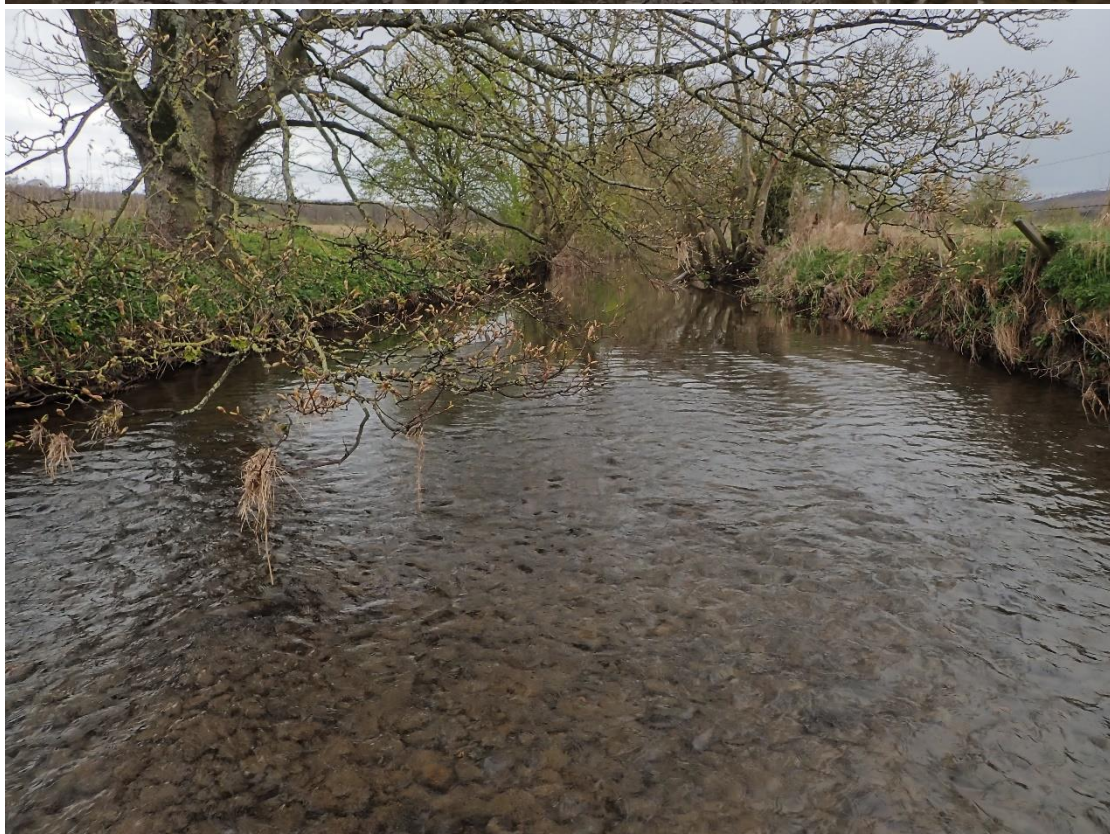
**Fig 12. Mature specimens of alder, sycamore and ash again provided the majority of physical habitat features within the straightened reaches, either as low and/or trailing branches or root balls and trailing roots within the channel. These should be retained at all costs. Note the smothering of the uniform bed with fine sediment.**

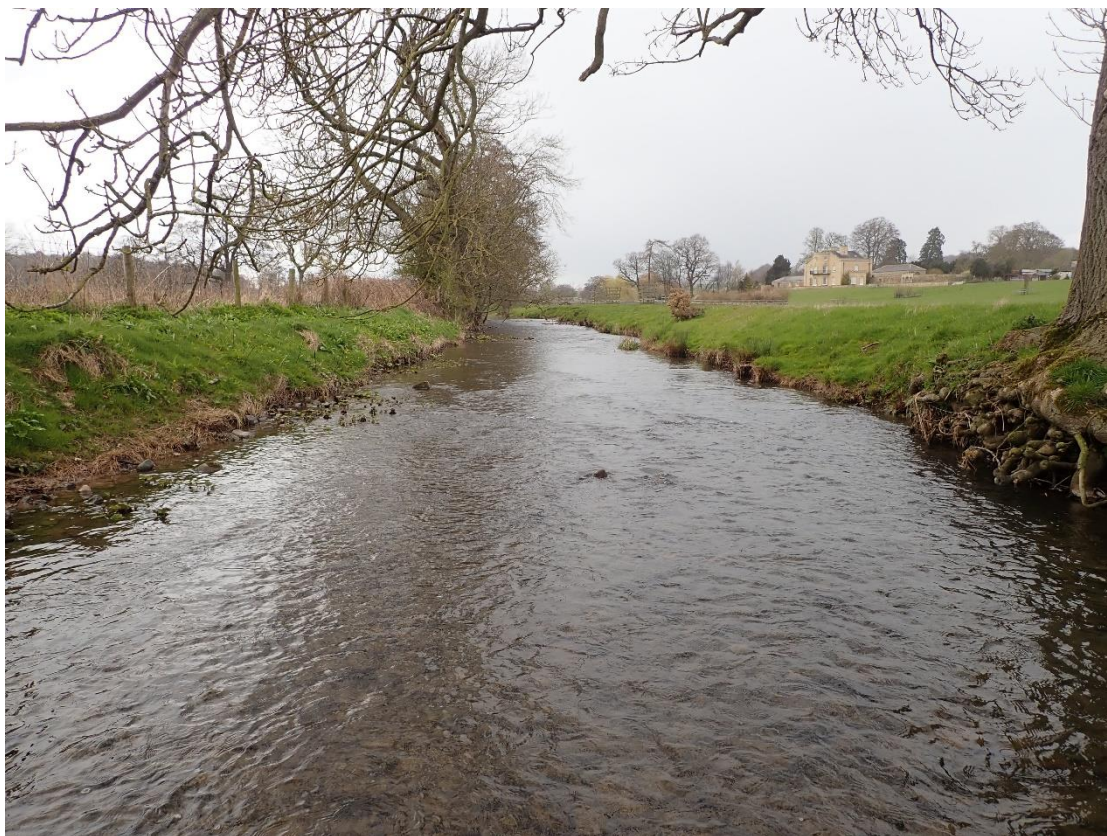
Towards the u/s limit, the LB was completely open to grazed pasture which introduced a different suite of pressures: grazing and trampling reducing the plant community and hence rooting diversity, further reducing resilience of the bank and any fringing cover. It would be beneficial to exclude livestock and provide alternative drinking to allow the (re)development of a native herbage and tree fringe.

**Fig 13. Toward the u/s limit, the LB was given over to pasture and the sward closely grazed, thereby removing any trailing cover along the bank and any chance of self-set regeneration of trees.**
