Walkover Report
Gunnerton Burn
(River Tyne Catchment)
02/02/2017

Undertaken by Gareth Pedley, Wild Trout Trust

Gunnerton Burn, Water Framework Directive Waterbody ID GB103023074880.

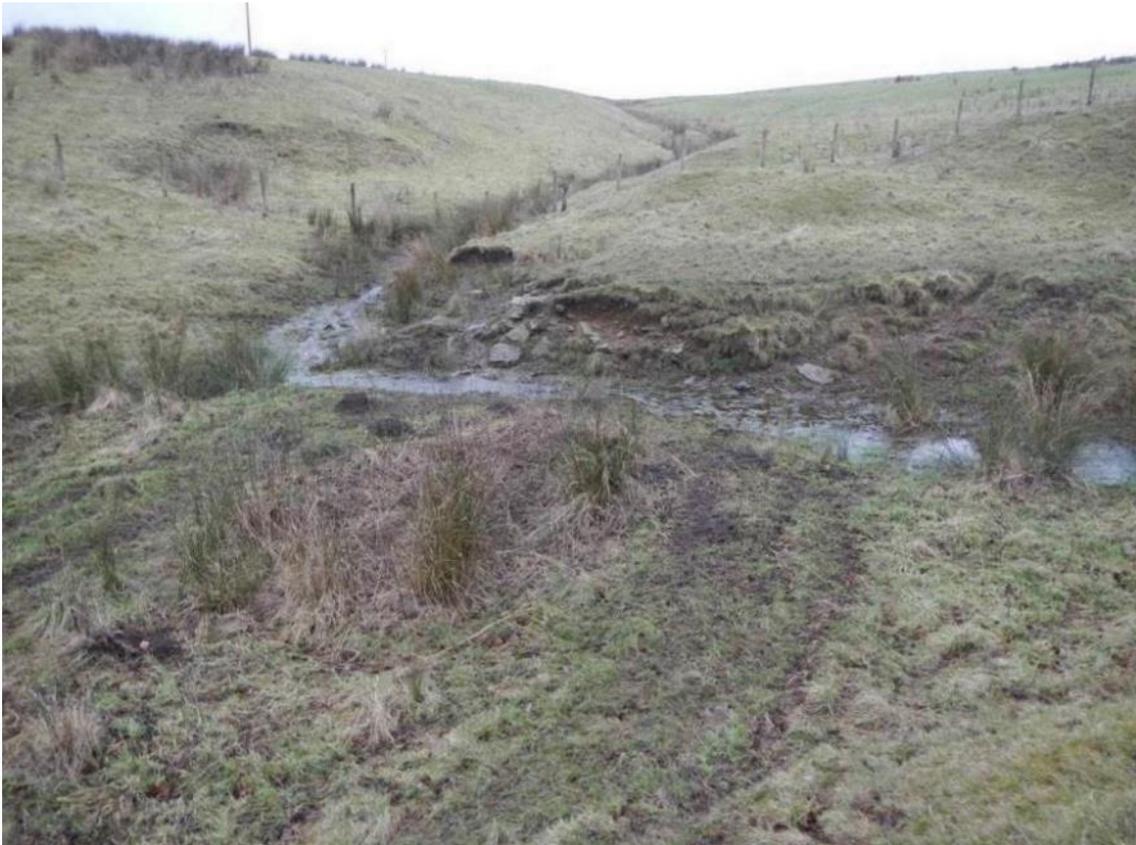
Photo DSCN5558. The Gunnerton Burn catchment was walked from Cowden Burn, Nr Middle Cowden (NY 90988 78749). At this point Cowden Burn and a small tributary confluence (to the left of shot). Both watercourses u/s of this point are small and have the potential to support juvenile salmonids and invertebrates. Owing to the watercourse sizes, the only likely remediation required would be buffer fencing to exclude livestock and reduce bank erosion/siltation and allow tree regeneration.

| Issue | Proposed action | Photos | Priority (1-3) |
|--|---|---|---|
| Livestock poaching and bank erosion (NY 90988 78749). | Buffer fence the watercourse and provide alternative watering and crossing points. Will stop excessive erosion and | DSCN5558 | 2 |

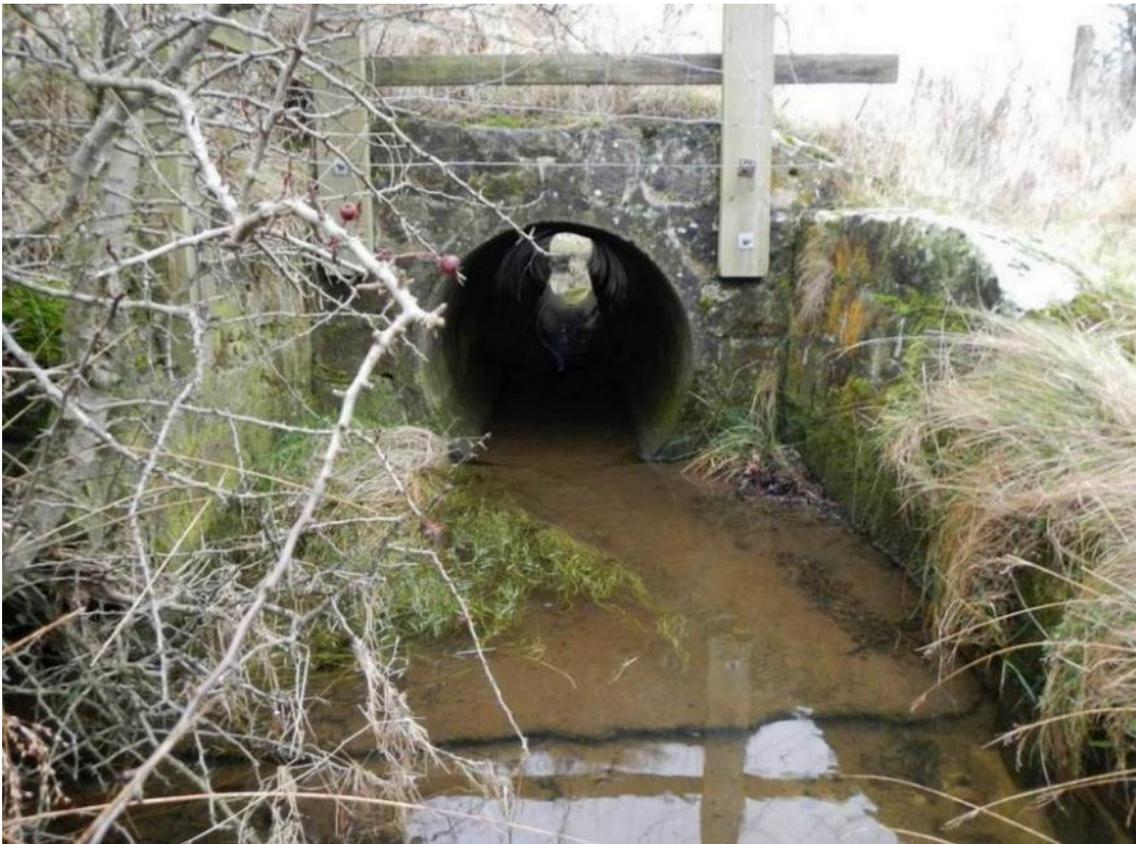
Photo DSCN5562. The road crossing near Middle Cowden poses no major obstacle to fish passage.

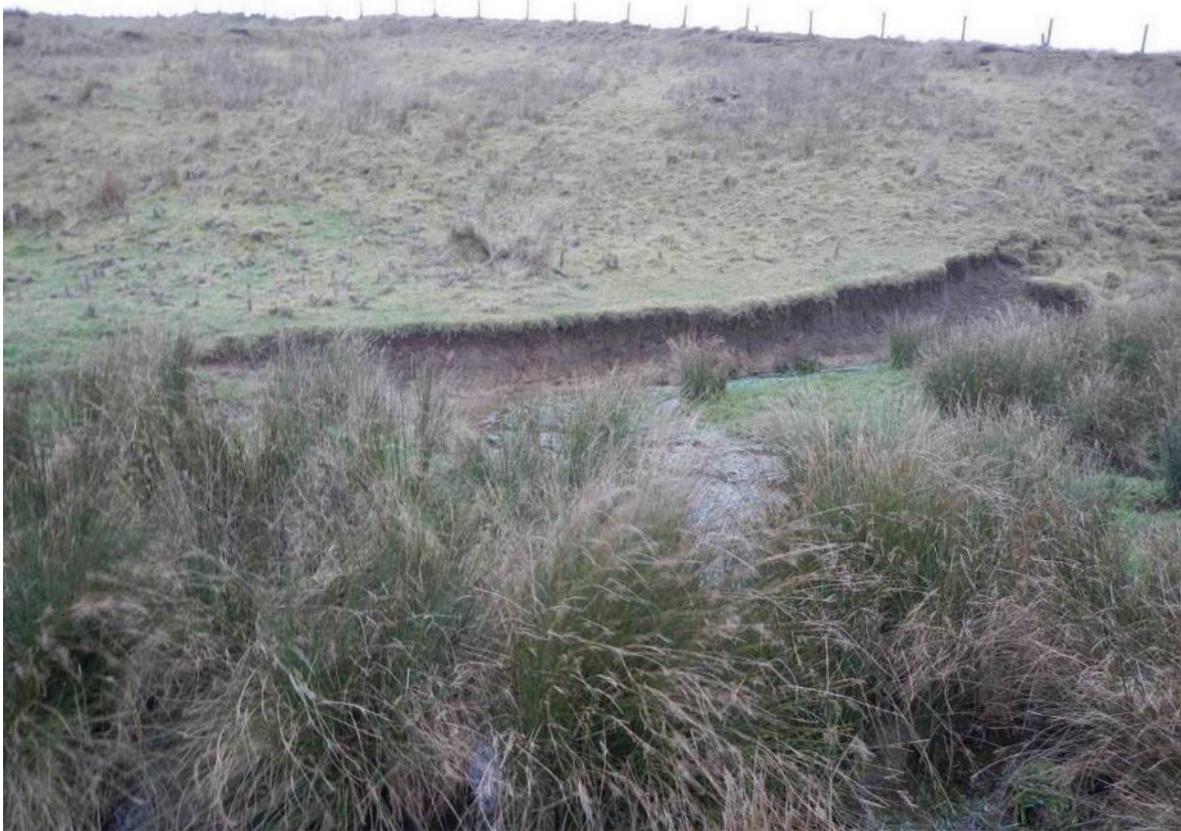
Photo DSCN5566. Land use d/s of the road, where the watercourse becomes the Gunnerton Burn, is unimproved grazing and while the intensity is relatively low, it is sufficient to be exacerbating bank erosion and preventing tree and vegetation regeneration. Consequently, the only trees observed were old and riparian habitat is sub-optimal.

| Issue | Proposed action | Photos | Priority (1-3) |
|--|---|---|---|
| Livestock poaching and bank erosion d/s of the road (NY 90994 78585 - NY 91499 77983). | Buffer fence the watercourse and provide alternative watering and crossing points. | DSCN5566 & DSCN5574 | 3 |

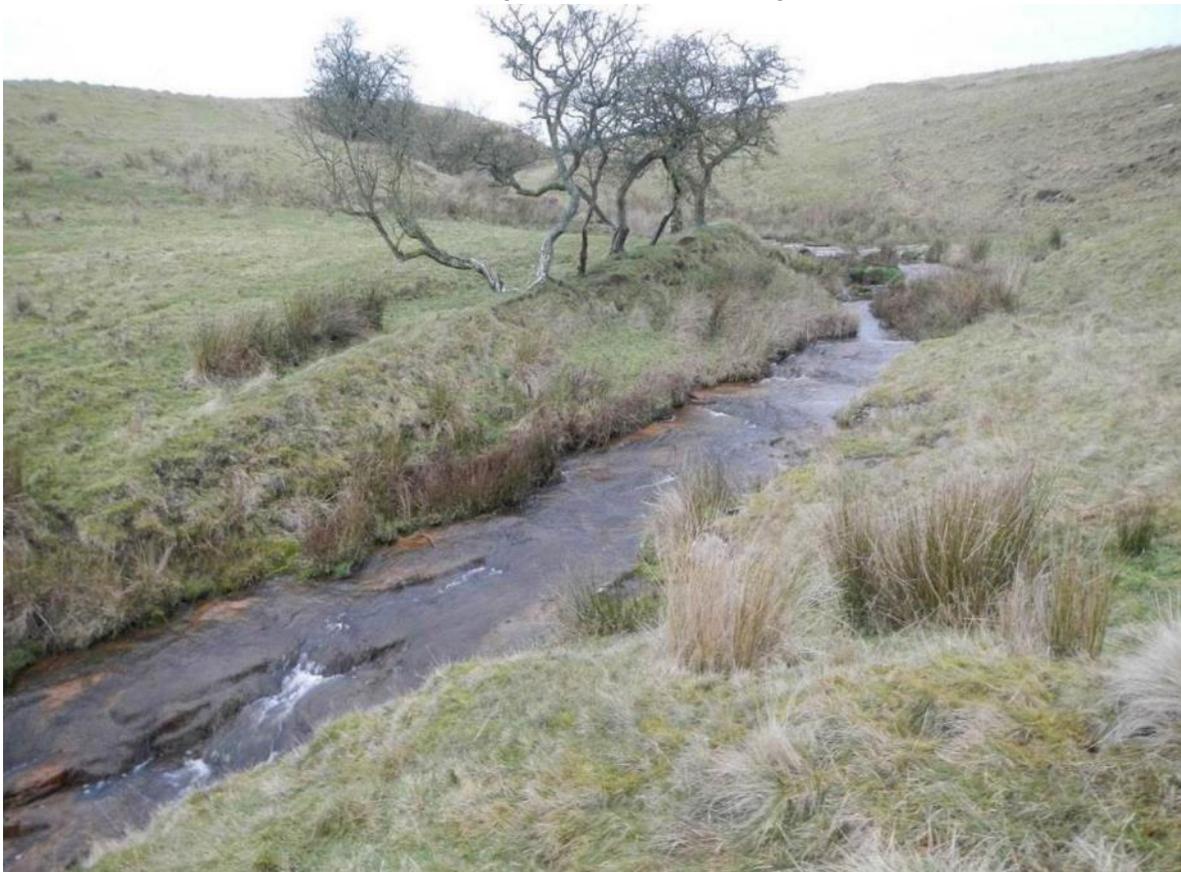
Photo DSCN5574. Bedrock outcrops along the course of the burn creating a natural, passable impediment to fish passage. The impermeable barrier of bedrock within the ground appears to be causing iron laden water to resurge, where it oxidises and precipitates out of solution. Note the old trees/shrubs and lack of regeneration and the embankment/dredged material.

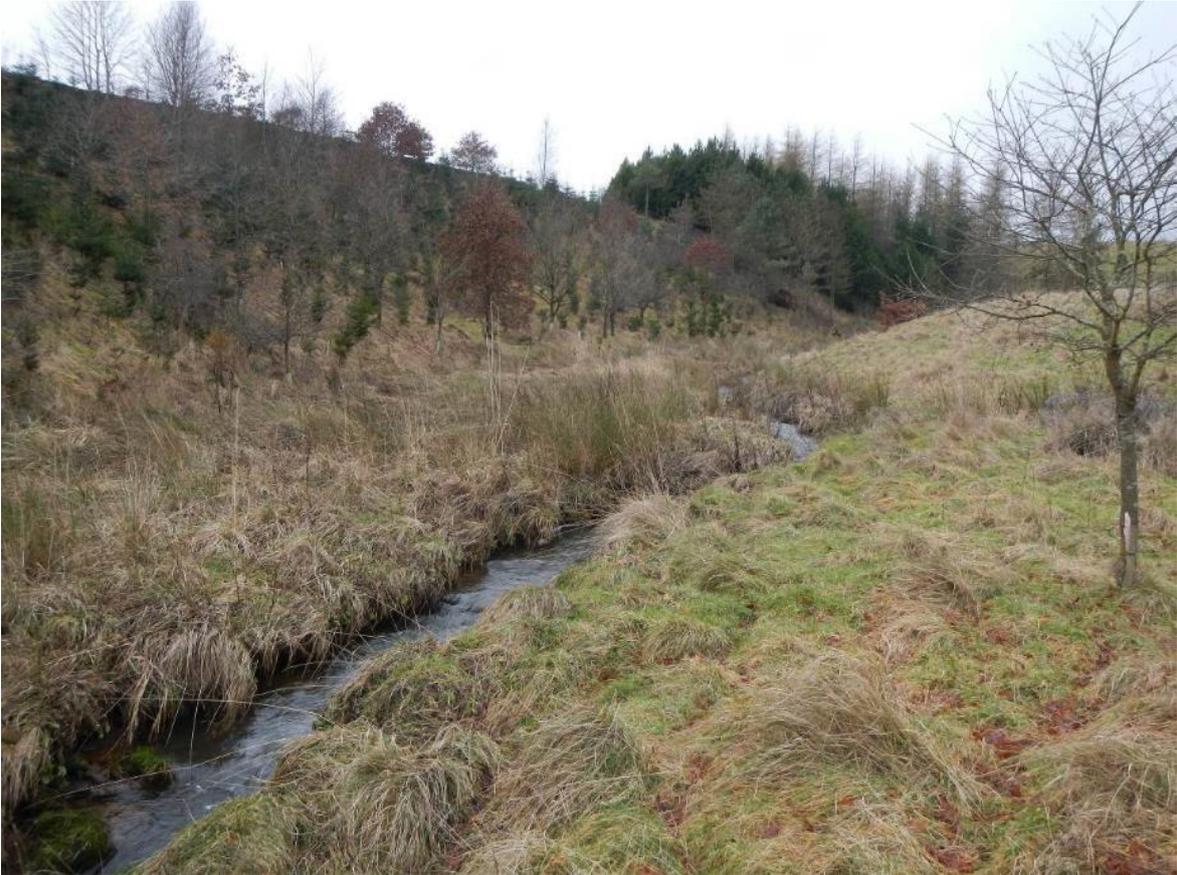
Photo DSCN558. A short section of plantation/buffer fencing (NY 91329 78211 - NY 91390 78137) d/s of the bedrock offers protection to bankside vegetation and trees. The channel in this section has been notably straightened and the habitat is therefore degraded. Possible mini restoration site.

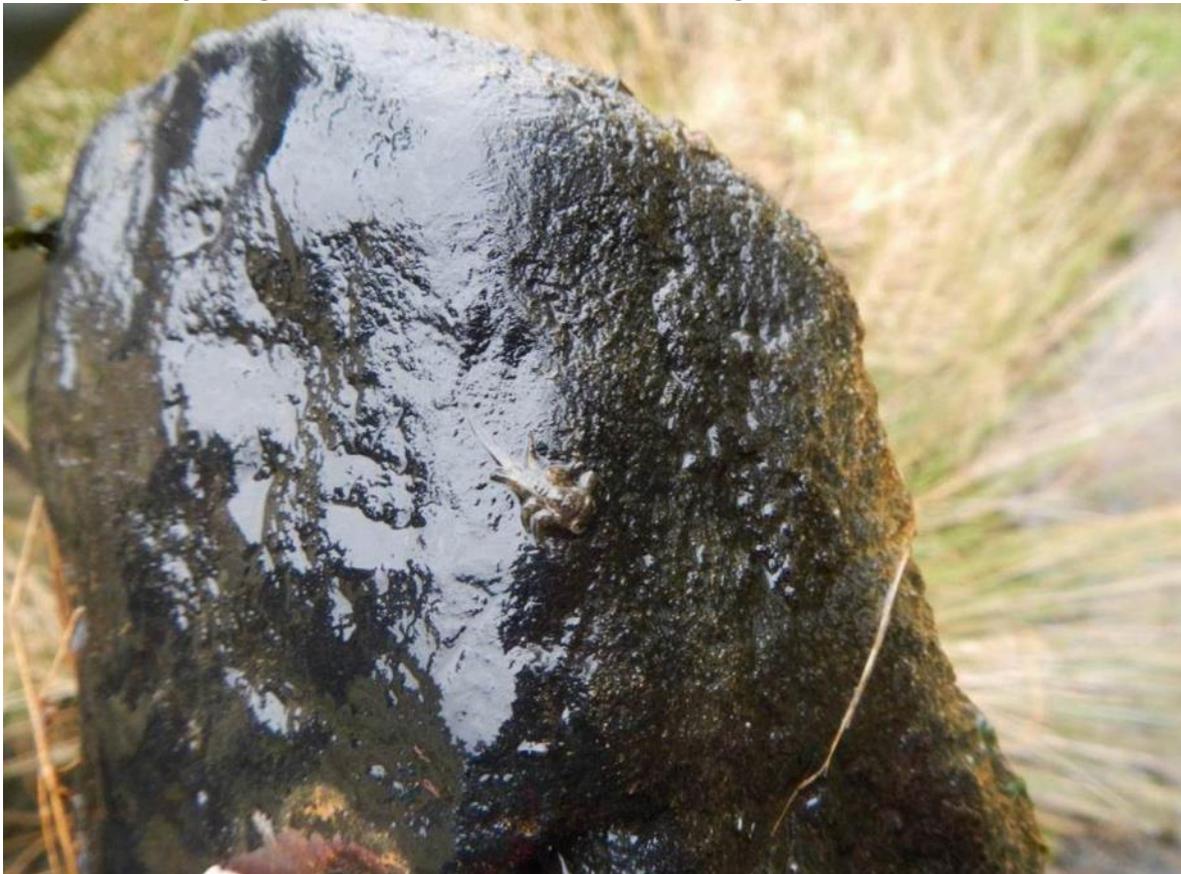
Photo DSCN55582. Despite the elevated iron within the water, relatively sensitive mayflies (Ephemeroptera) were observed through stone turning. Iron oxide deposition tends to appear worse than it is. It is often the other contaminants within mine waters (often associated with ochreous staining) that actually causes water quality issues. In this case, the naturally low occurrence of iron is unlikely to be a problem.

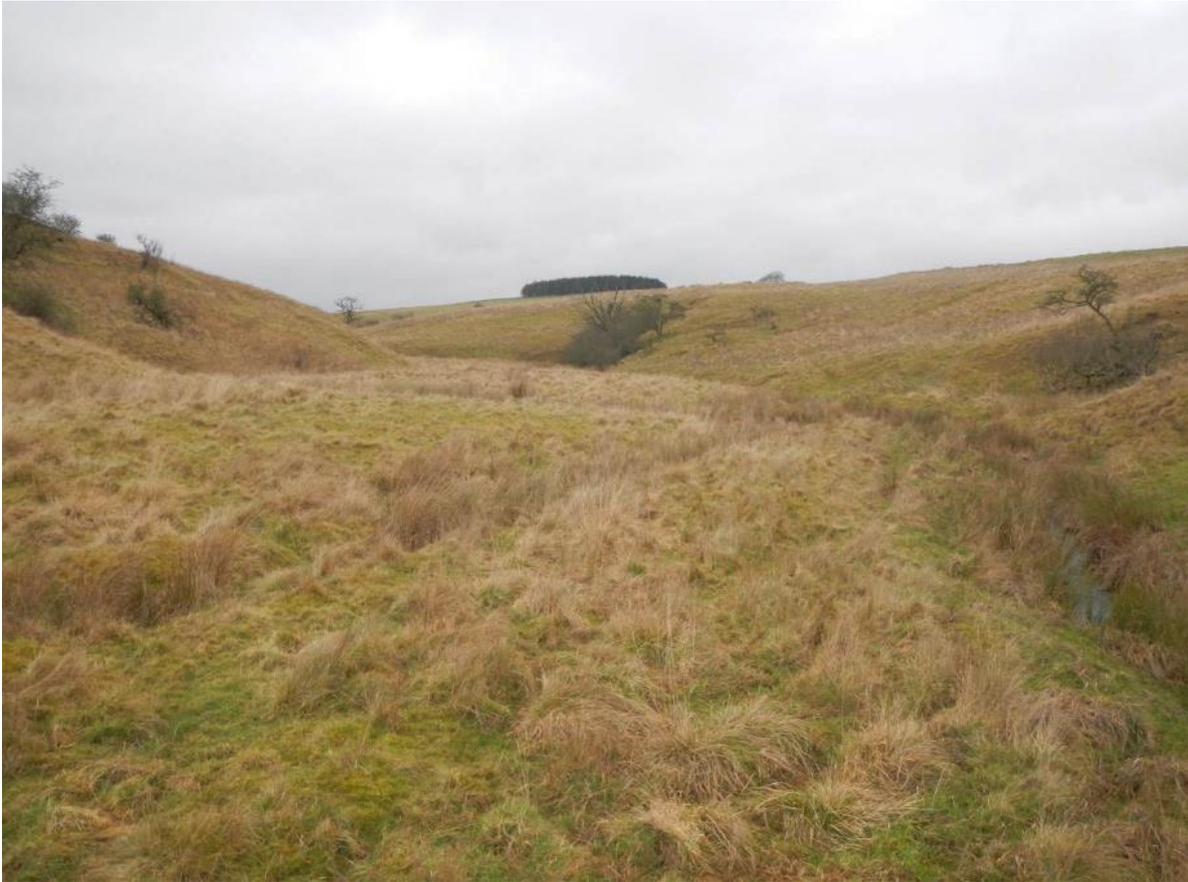
Photo DSCN5584. Obvious signs of major channel realignment were observed in several locations where the burn had been relocated to a straightened channel to the side of the floodplain (right of shot). The grazing remains relatively low intensity but still limits tree and vegetation growth.

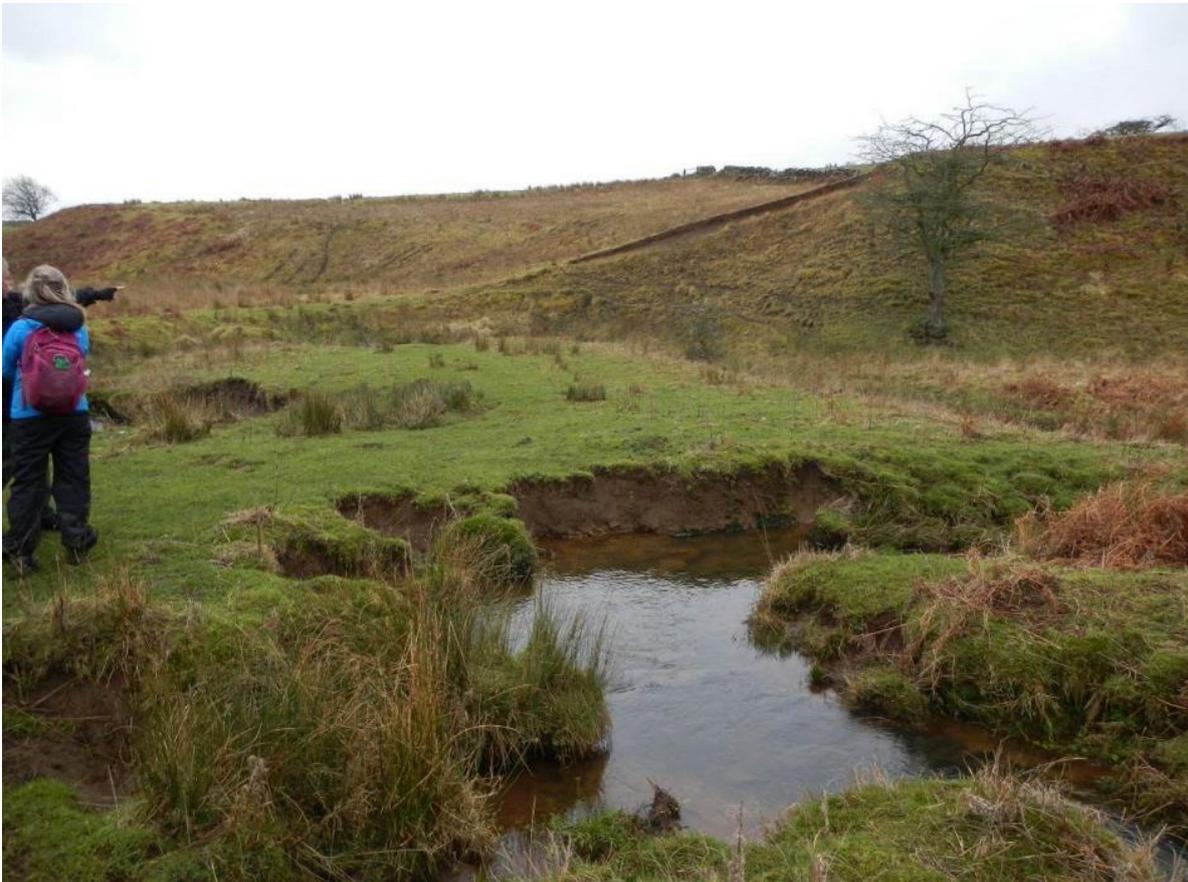
Photo DSCN5586. From NY 91499 77983 a marked increase in the intensity of grazing was noted, with a reduced sward and an associated increase of bank erosion. The channel is, however, more natural in planform, which creates the potential for notable improvement through simple fencing.

| Issue | Proposed action | Photos | Priority (1-3) |
|--|---|---|---|
| Increased grazing pressure and erosion (NY 91499 77983 - NY 91559 77632). | Buffer fence the watercourse and provide alternative watering and crossing points. | DSCN5586 | 2 |

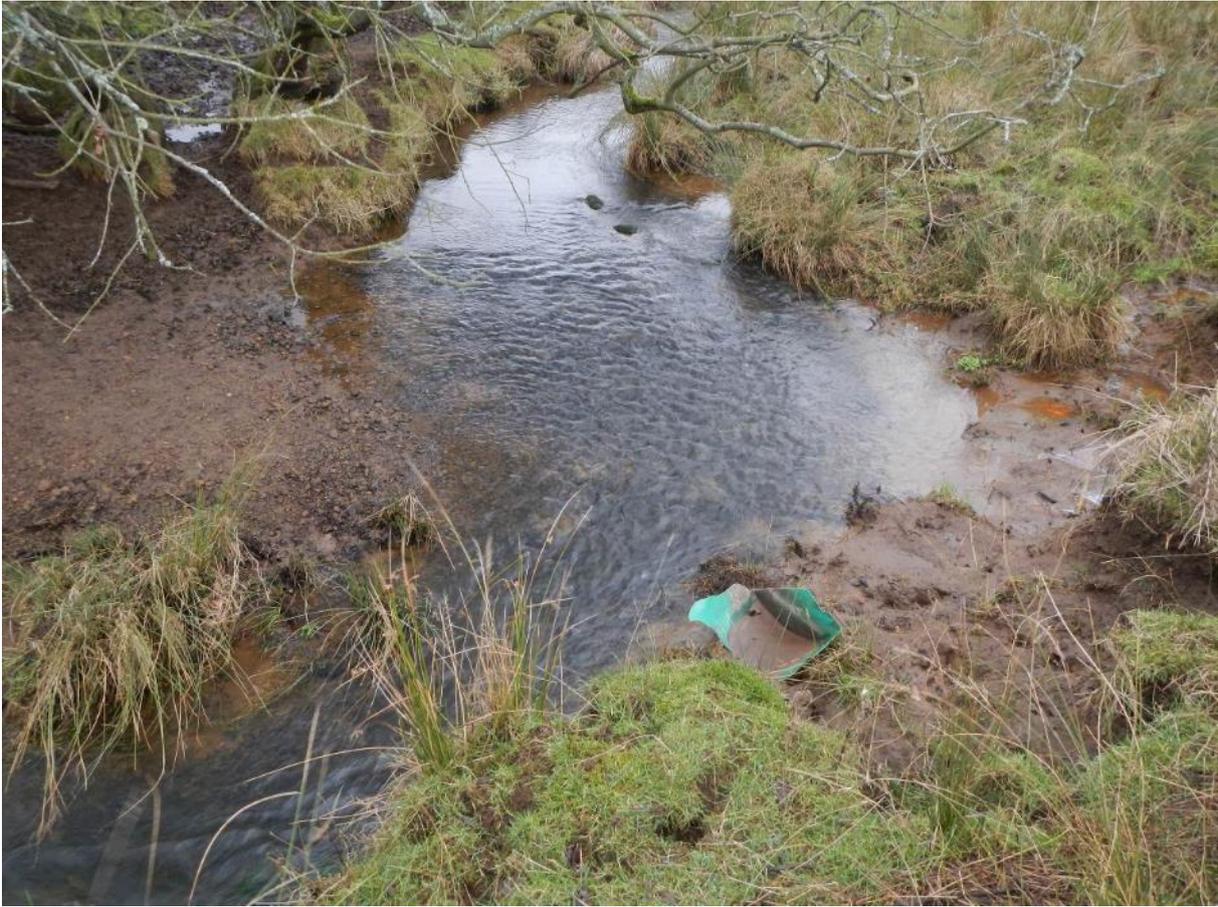
Photo DSCN5589. Some areas of substrate with good potential for salmonid spawning were observed, but fine sediment input from erosion is already having an impact upon the quality of that habitat.

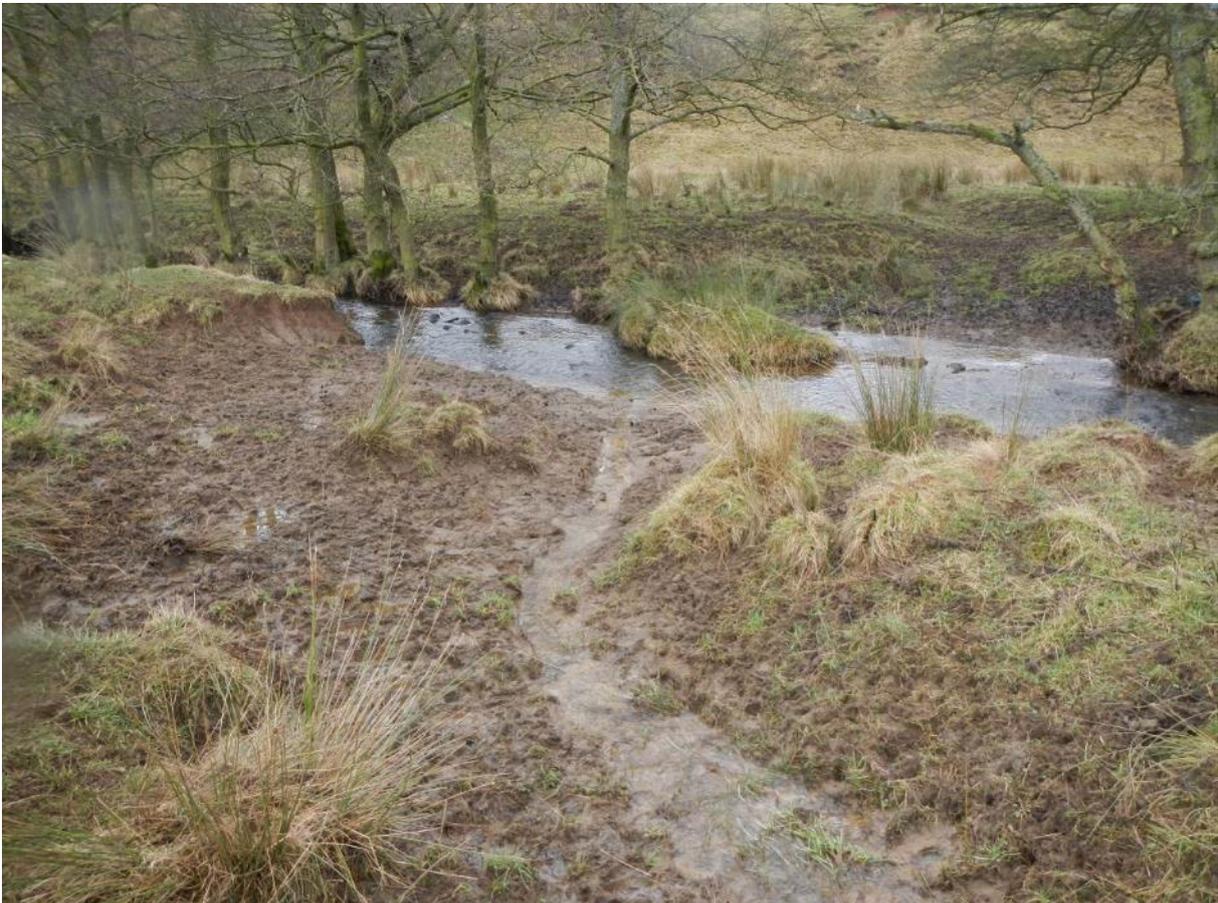
Photo DSCN5598. In the next field d/s (NY 91559 77632 - NY 91384 77292) the intensity of grazing increases further and erosion through fording and poaching become severe, with the above scene observed at three different points within a 200m section.

| Issue | Proposed action | Photos | Priority (1-3) |
|--|---|---|---|
| Major grazing and erosion issues. (NY 91559 77632 - NY 91384 77292). | Buffer fence the watercourse and provide alternative watering and crossing points. | DSCN5594, DSCN5598 & DSCN5601 | <u>1</u> |

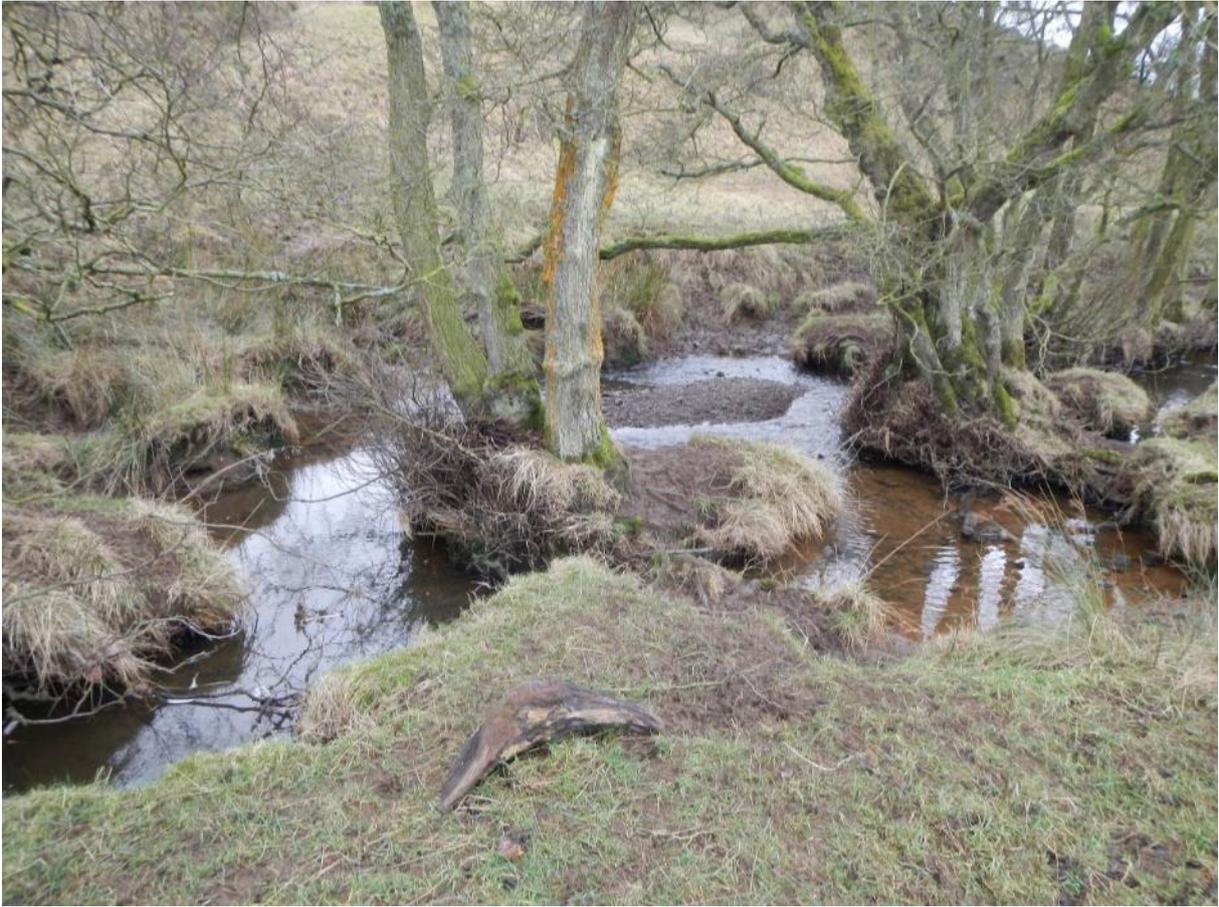
Photo DSCN5594. Erosion around the base of bankside alder trees is so severe that they are becoming completely separated from the bank in many areas.

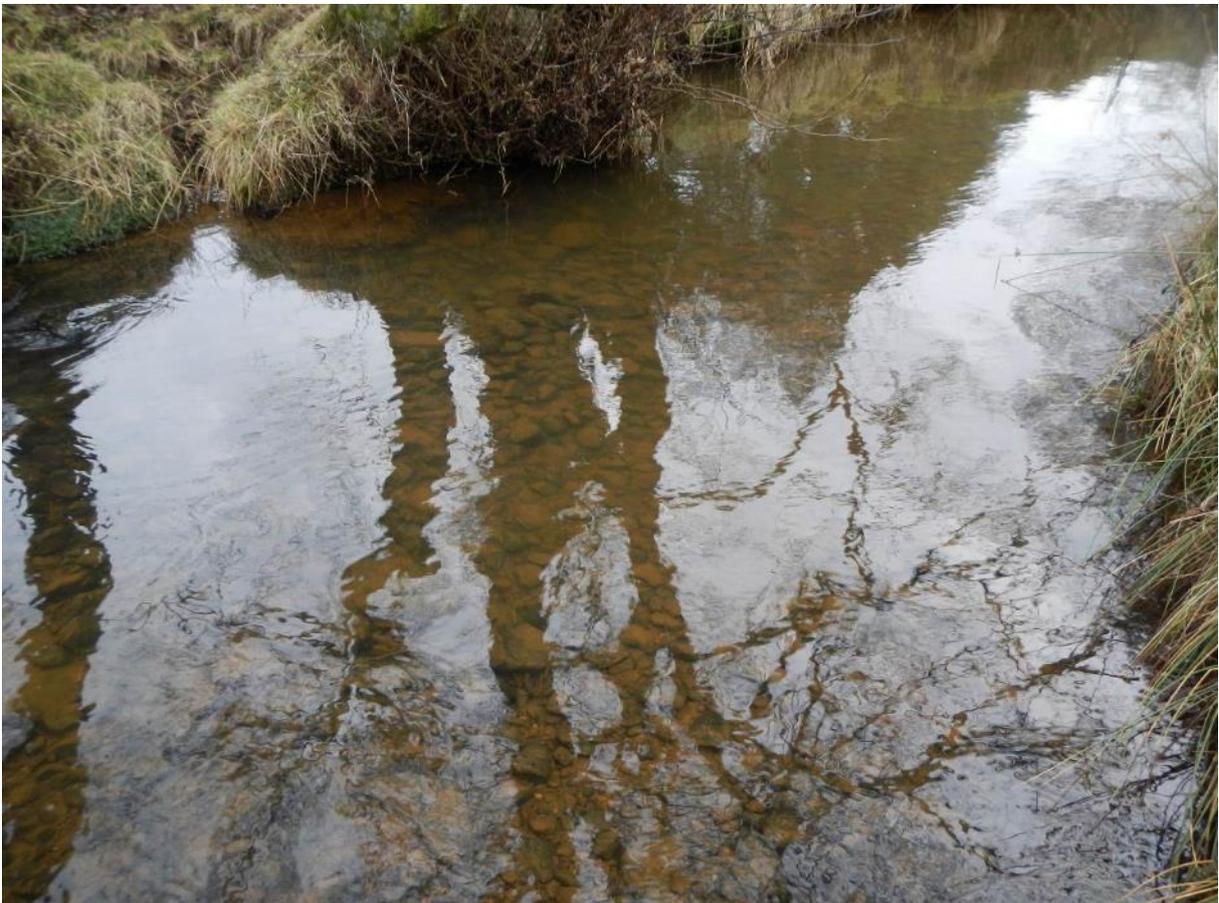
Photo DSCN5601. By this point, the consequential fine sediment is already a blatant issue on the bed of the burn.

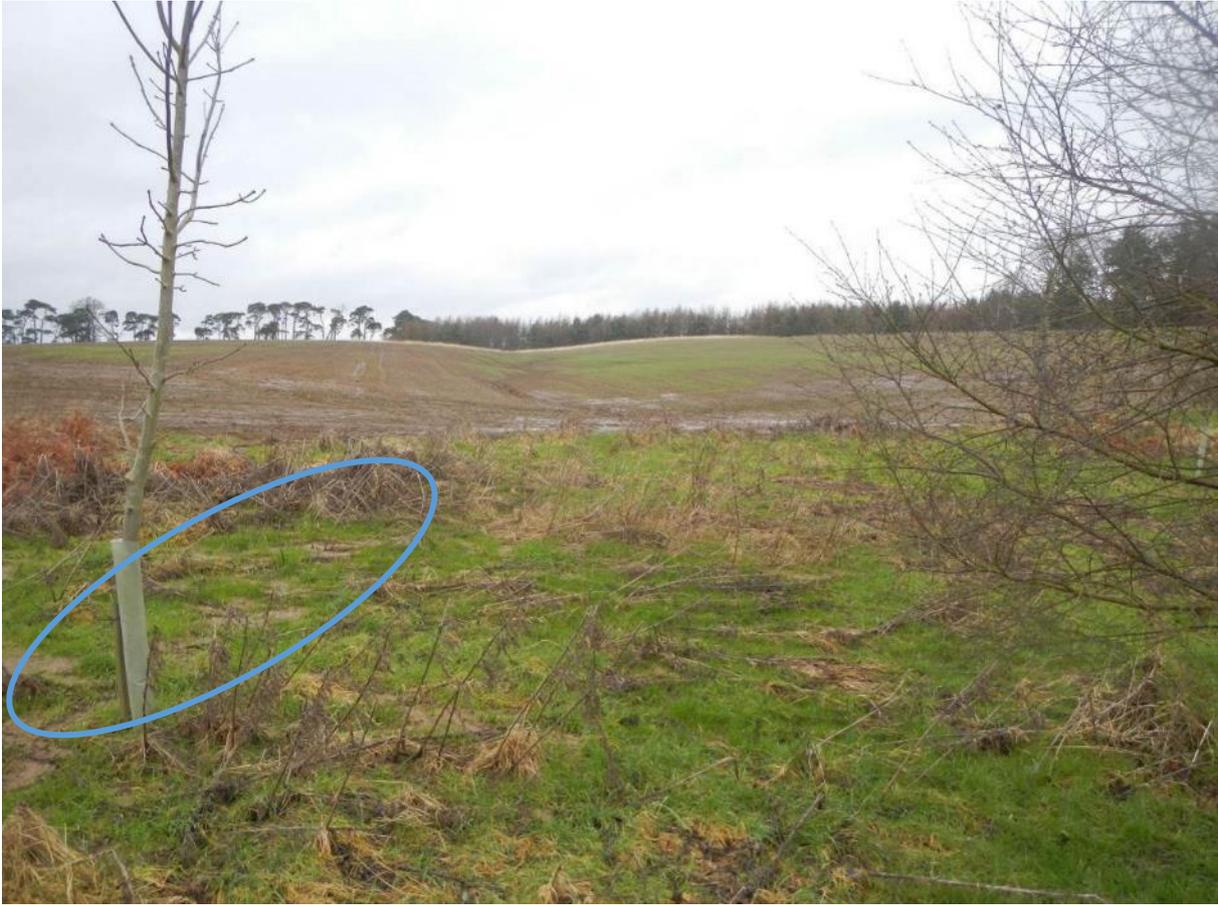
Photo DSCN5604. To compound the sedimentation issues from livestock, as soon at the land use changes and livestock are excluded, arable runoff becomes an even greater issue (NY 91308 77212). Sediment pathway straight from the field (ellipse circle).

| Issue | Proposed action | Photos | Priority (1-3) |
|--|---|---|---|
| Major issues of arable field runoff (NY 91308 77212 and NY 91279 77090) | Farm advisory visit to discuss options with farmer. Alteration to direction of tillage, buffer along gullies (rather than cultivation – temporary watercourses are effectively being cultivated). | DSCN5605, DSCN5612 & DSCN6517 | <u>1</u> |

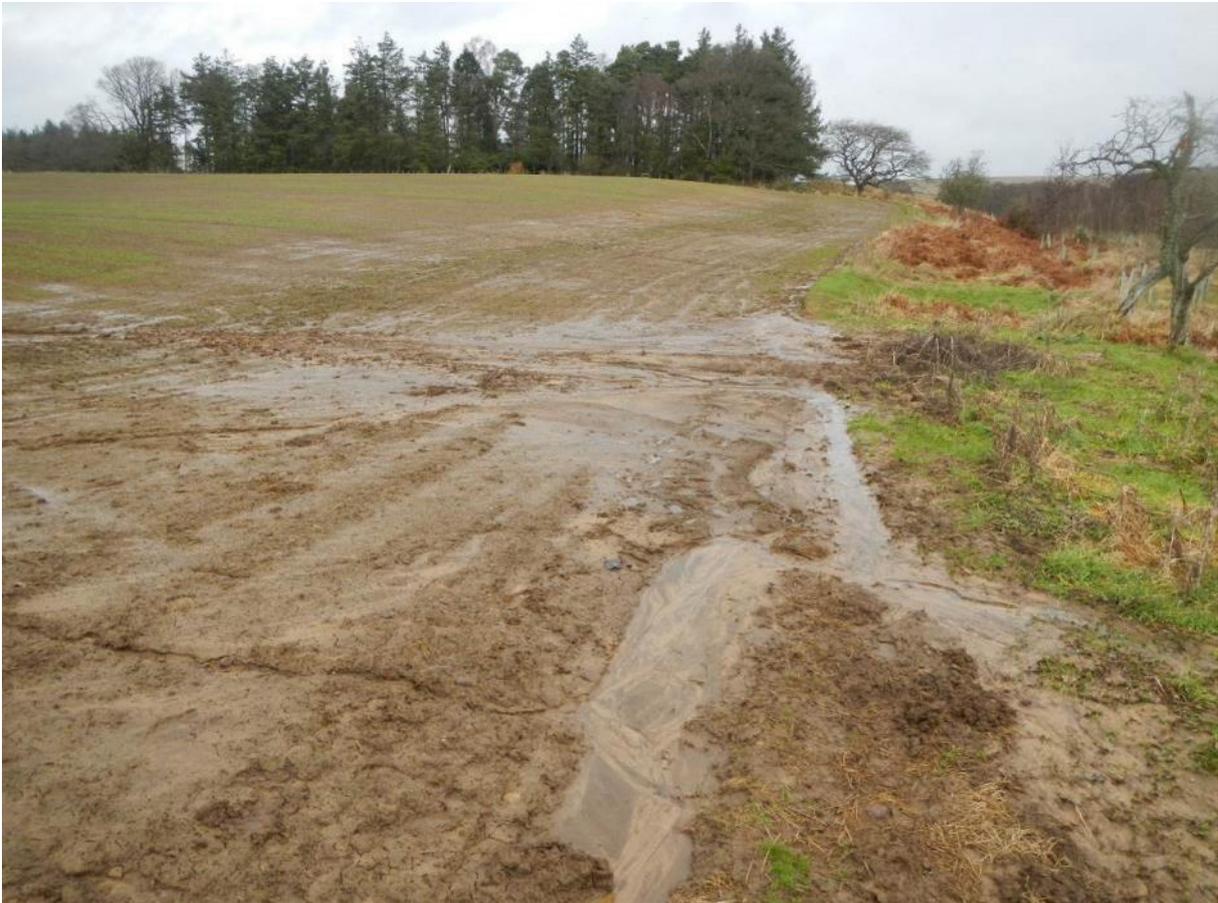
Photo DSCN5605. High volume of topsoil that has been washed off the surface of the field and to the burn during high rainfall. Some is trapped within the buffer but the volumes are clearly so high at times it is simply flowing straight through the rough vegetation.

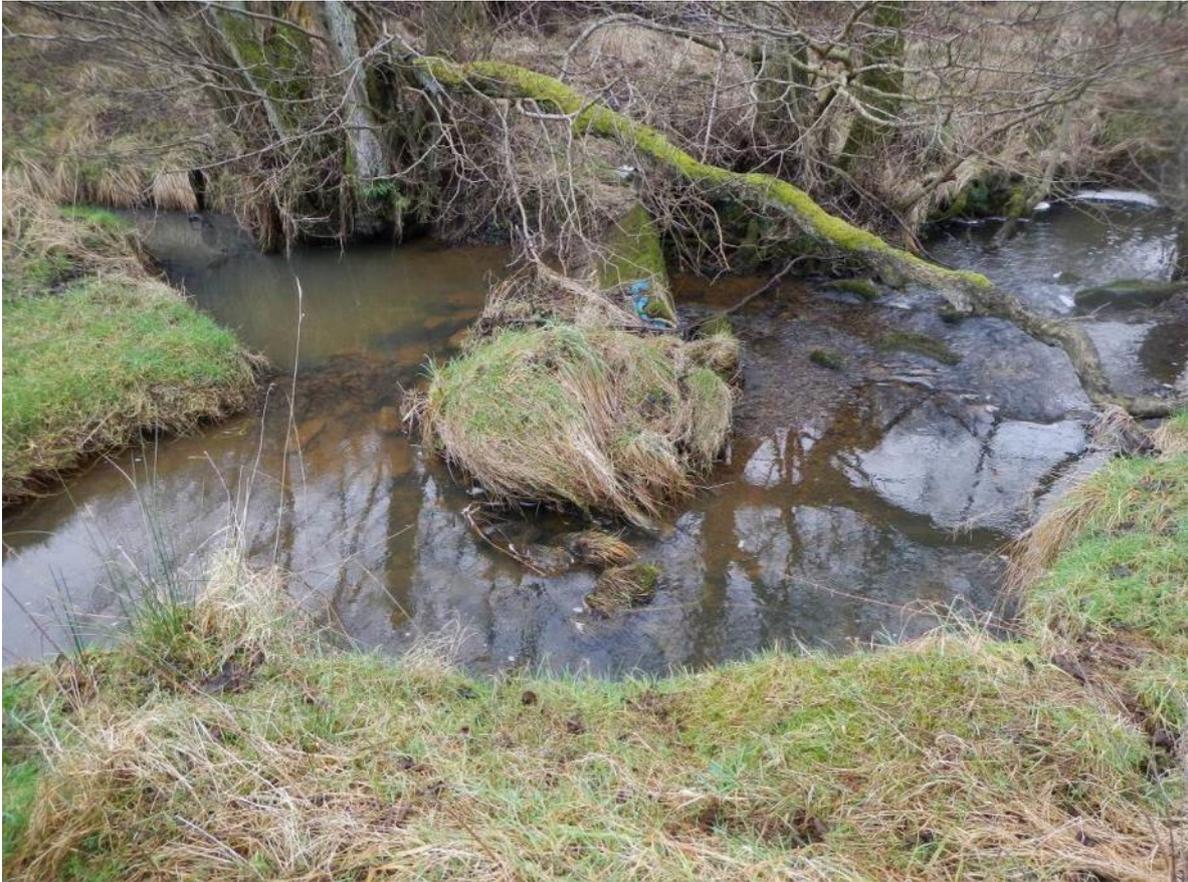
Photo DSCN55609. A disused weir has collapsed, freeing up fish passage; however, the substrate is now so degraded that invertebrate and salmonid spawning habitat is utterly compromised. Aside from the fine sediment inputs/runoff, stock exclusion has reduced erosion and improved riparian habitat quality.

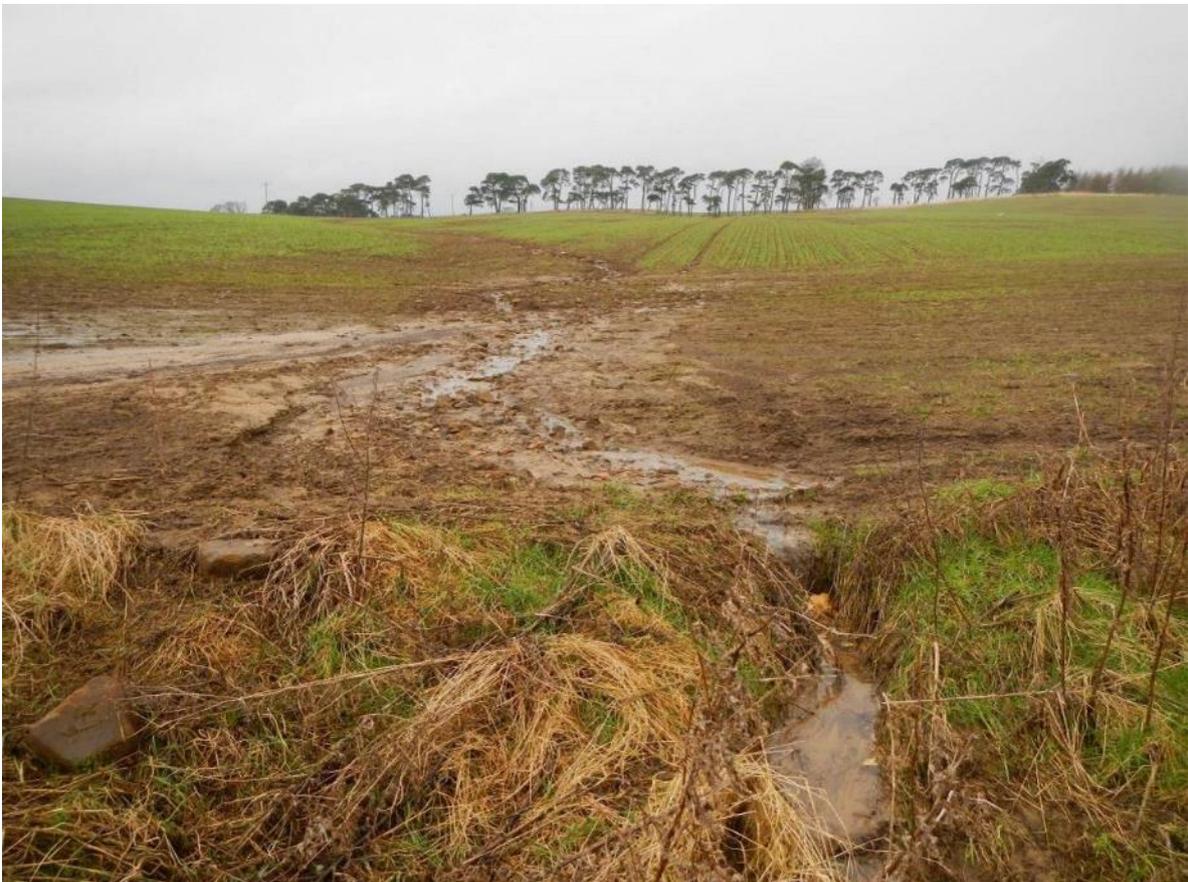
Photo DSCN5612. At NY 91279 77090 another gully that clearly also reaches the burn was also observed. Between these points another one that likely reaches the burn was also observed. These are such an issue they are clearly visible form aerial photography.

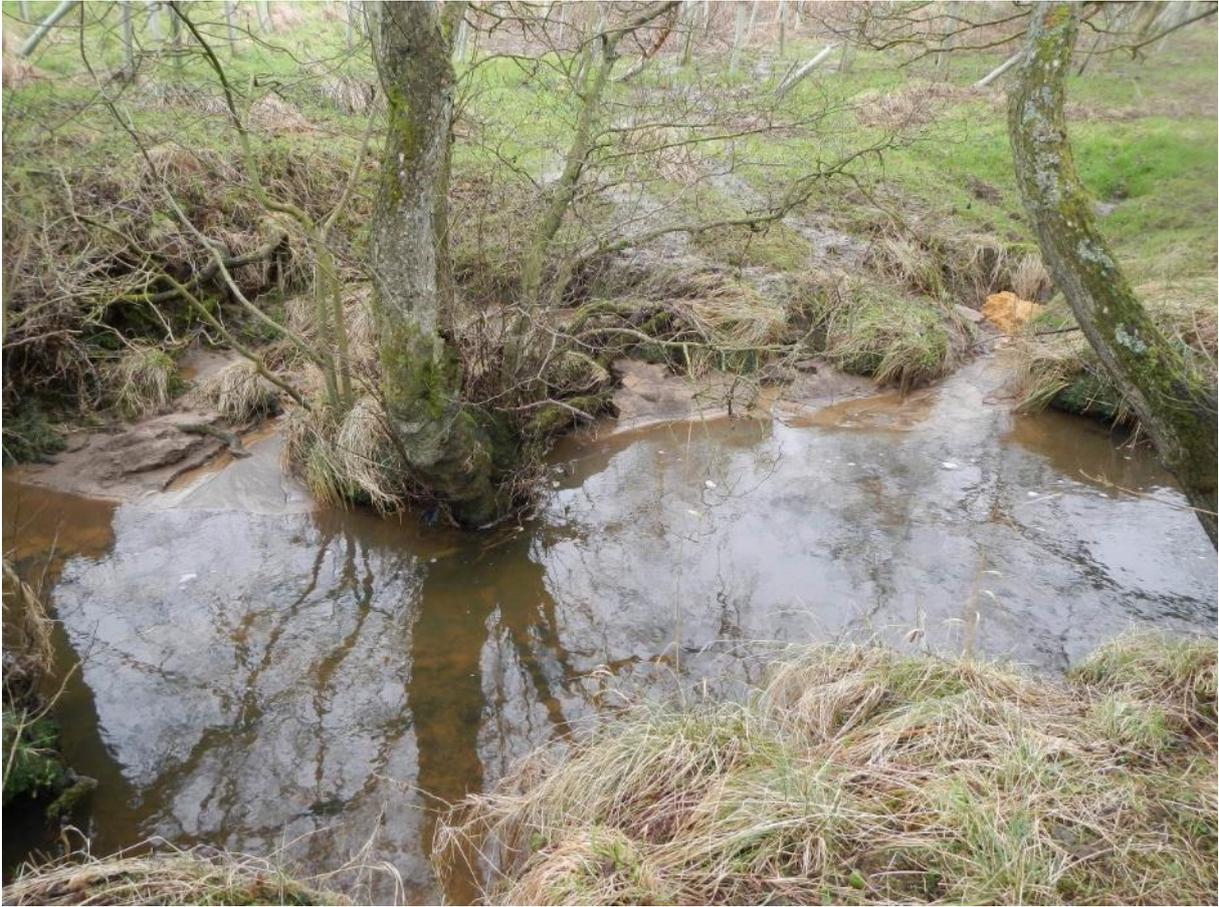
Photo DSCN5617. At the d/s, burn end of these gullies (NY 91307 77064) massive accumulations of fine sediment can be observed along the bank and across the burn bed. Again, the improved tree and vegetation cover through livestock exclusion otherwise provides improved bankside habitat.

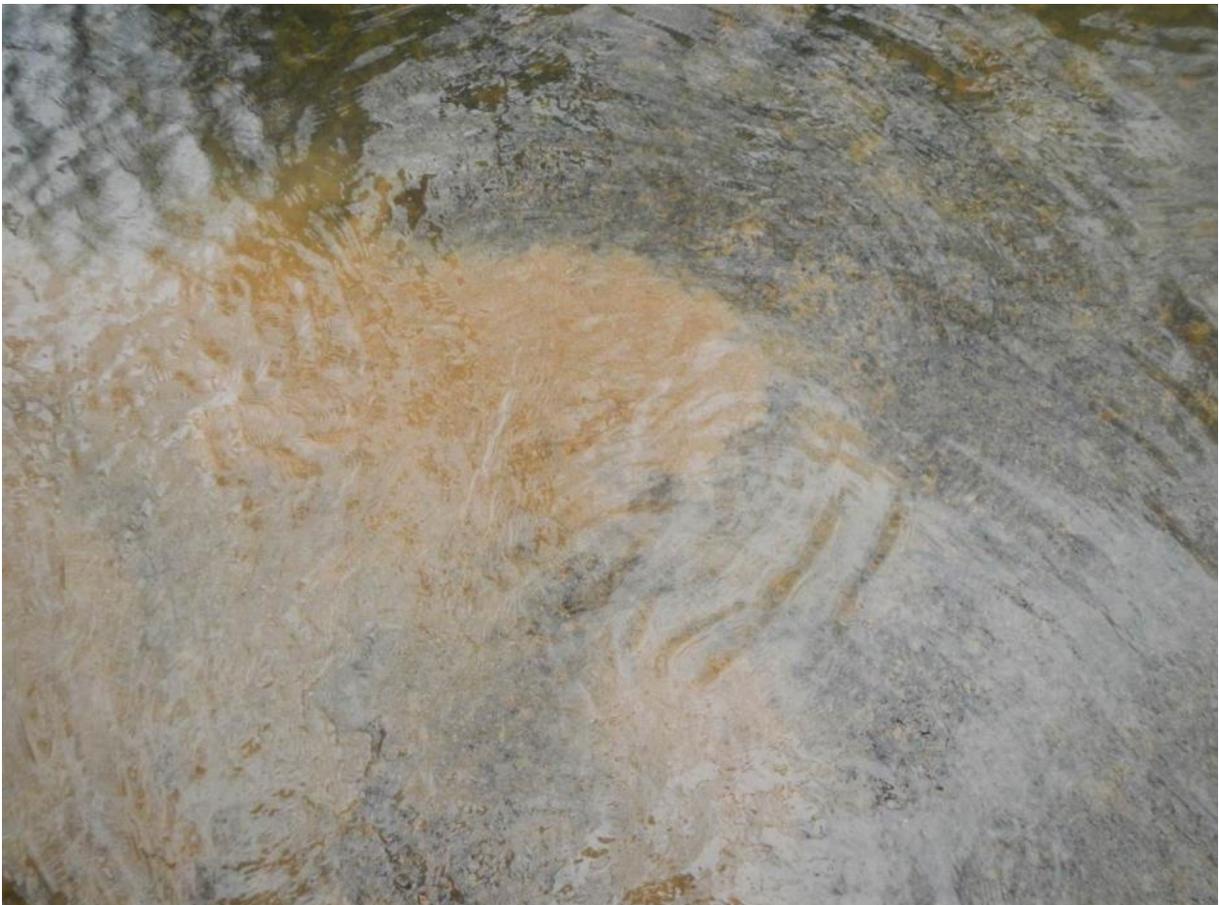
Photo DSCN5618. Even light agitation of the bed liberates plumes of fine sediment. Most of the substrate observed was degraded past the point of supporting salmonid spawning.

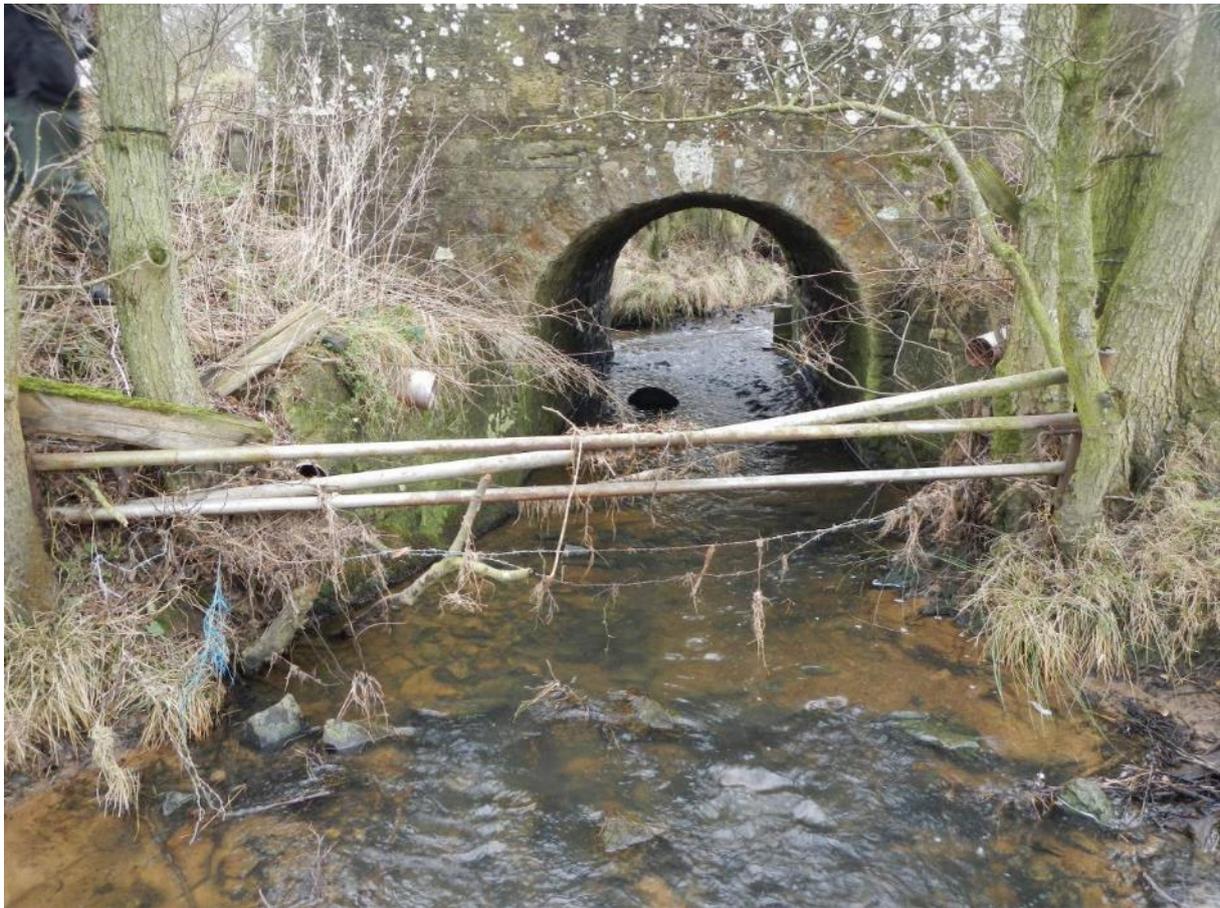
Photo DSCN5620. A road crossing/bridge at NY 91277 76932 poses no impediment to fish passage but the land use d/s of this point reverts to unrestricted sheep grazing (see DSCN5627).
