Walkover Report
Gunnerton Burn
(River Tyne Catchment)
02/02/2017

Undertaken by Gareth Pedley, Wild Trout Trust

Gunnerton Burn, Water Framework Directive Waterbody ID GB103023074880.

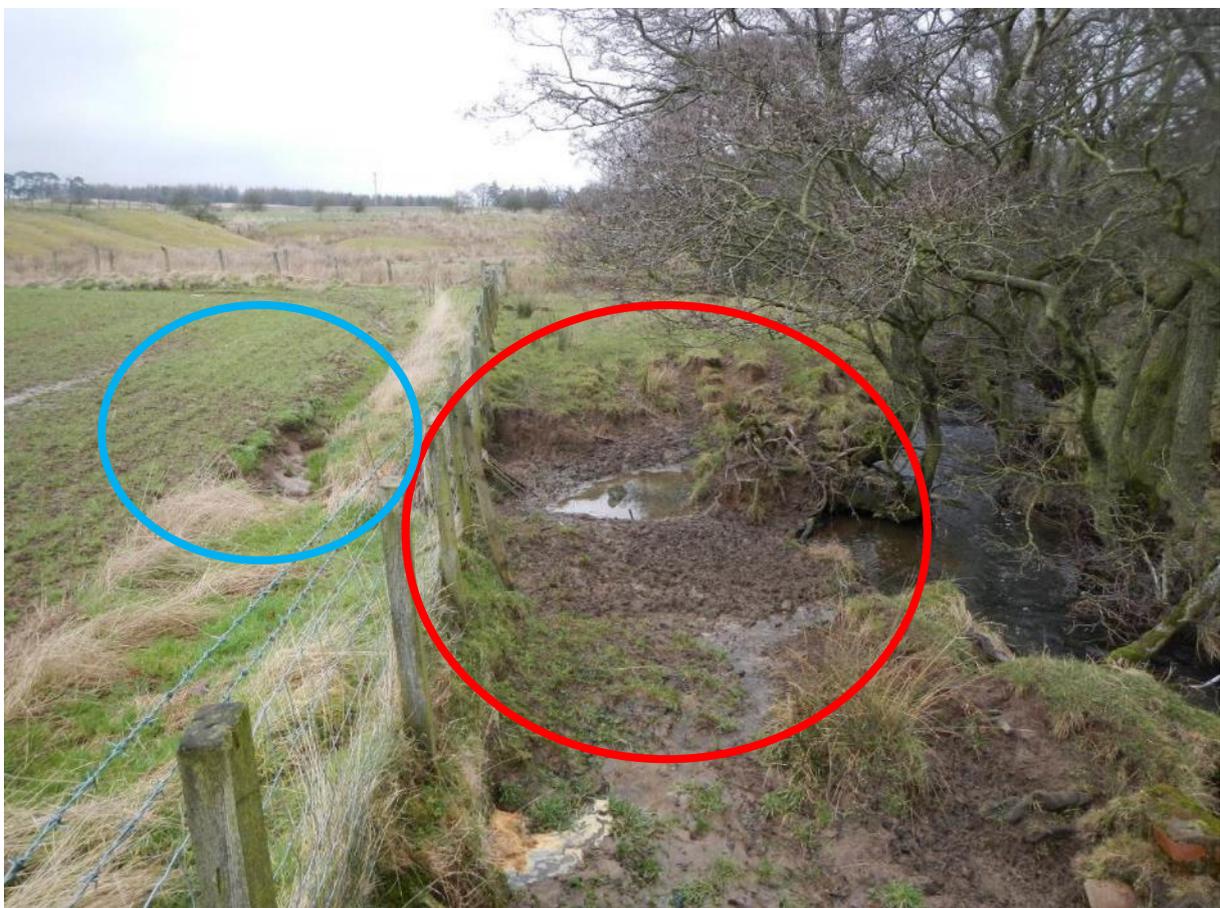
Photo DSCN5627. With the grazing comes more erosion and siltation (red circle – also see DSCN5641). Closely adjacent arable farming also contributed further runoff and fine sediment (blue circle).

| Issue | Proposed action | Photos | Priority (1-3) |
|--|---|---|---|
| Major grazing and erosion issues. (NY 91277 76932 - NY 91037 76617). | Buffer fence the watercourse and provide alternative watering and crossing points. | DSCN5627 & DSCN5628 | 1 |
| Major issues of arable field runoff at NY 91168 76776 and traversing wood/plantation (NY 90939 76694), both from same filed. | Farm advisory visit to discuss options with farmer. Alteration to direction of tillage, buffer along gullies (rather than cultivation – temporary watercourses are effectively being cultivated). | DSCN5627 & DSCN5641 | <u>1</u> |

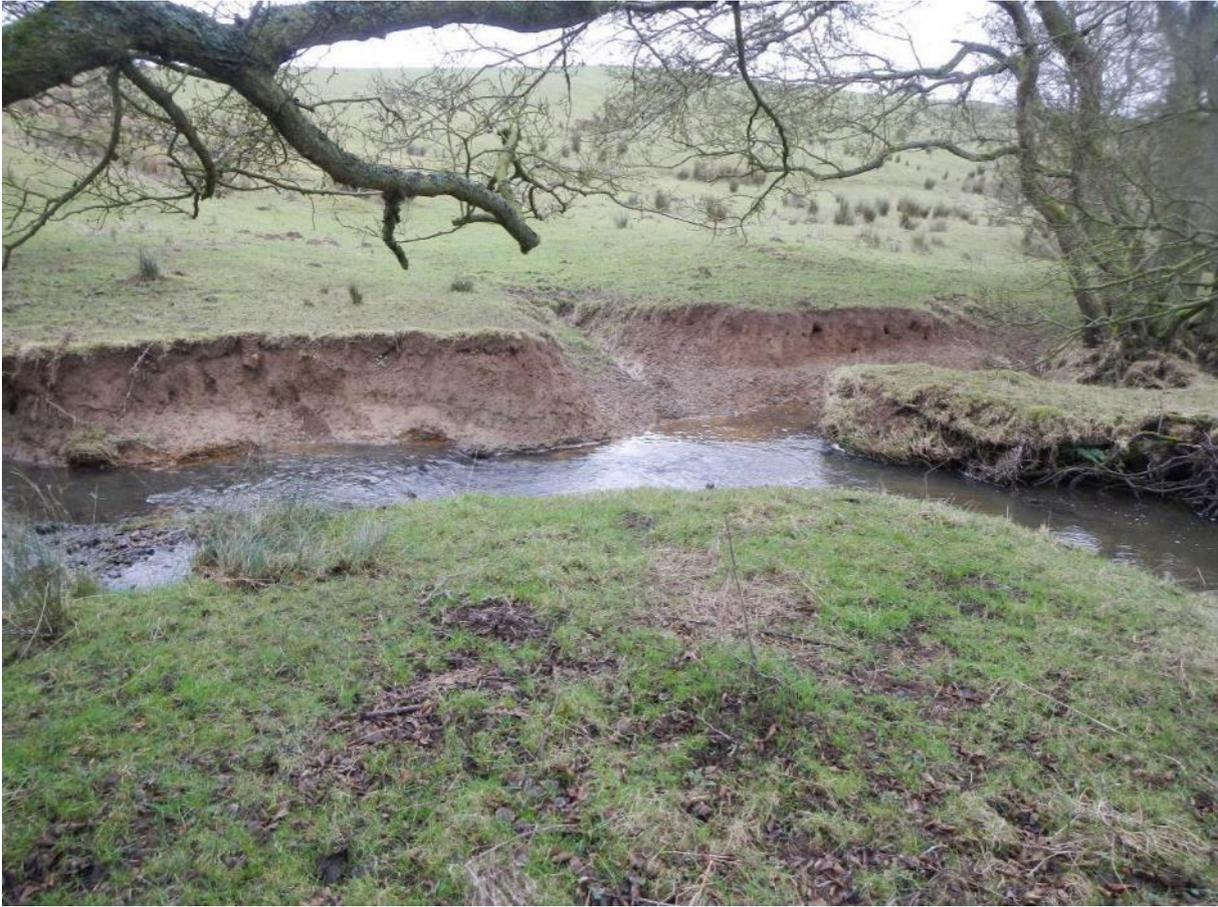
Photo DSCN5628. Bankside erosion is a continuing problem throughout the grazed field and is threatening bankside trees in many places.

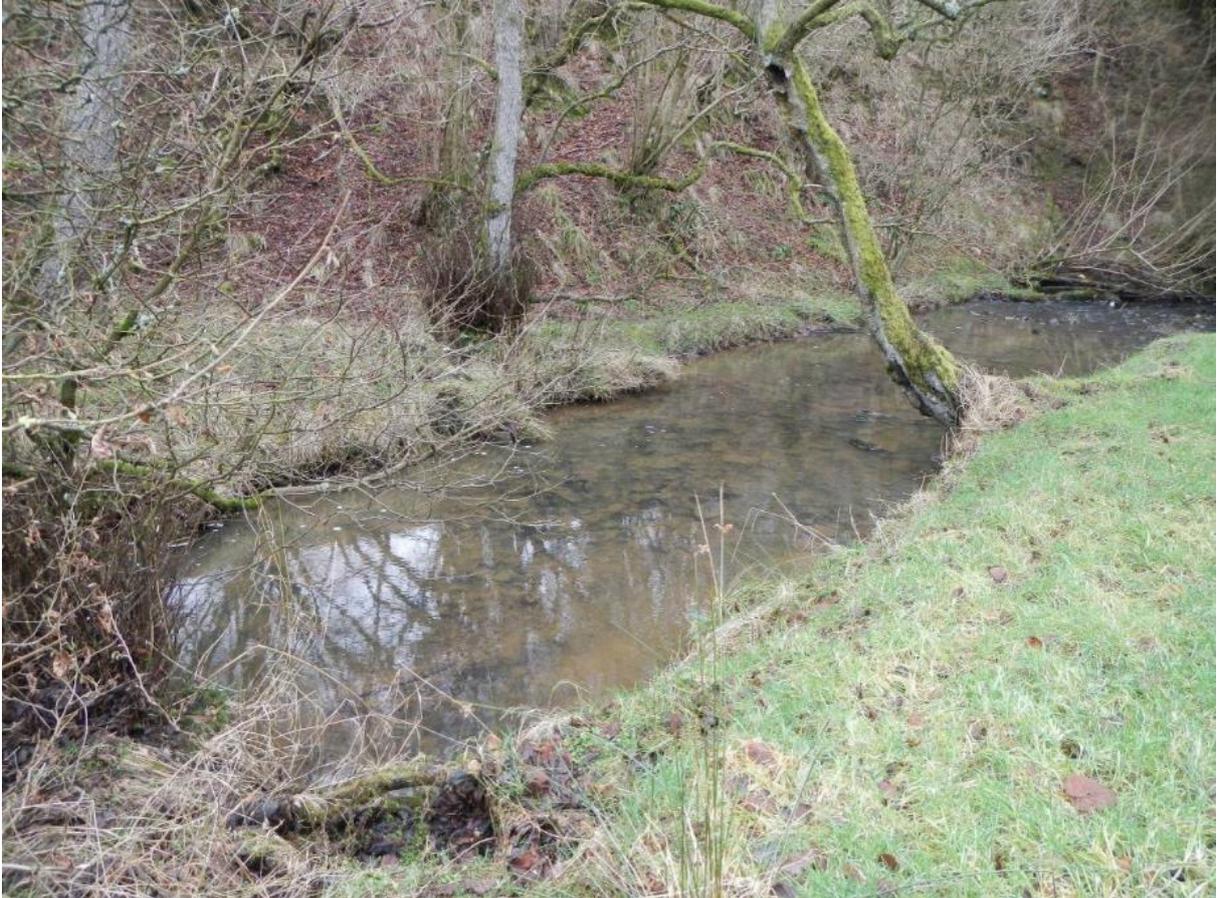
Photo DSCN5635. A small field at the d/s end of the intensive grazing is currently being grazed less intensively and a short section of improved habitat exists, just u/s of a coniferous plantation. The impact of long-term grazing upon vegetation and a lack of tree regeneration remain.

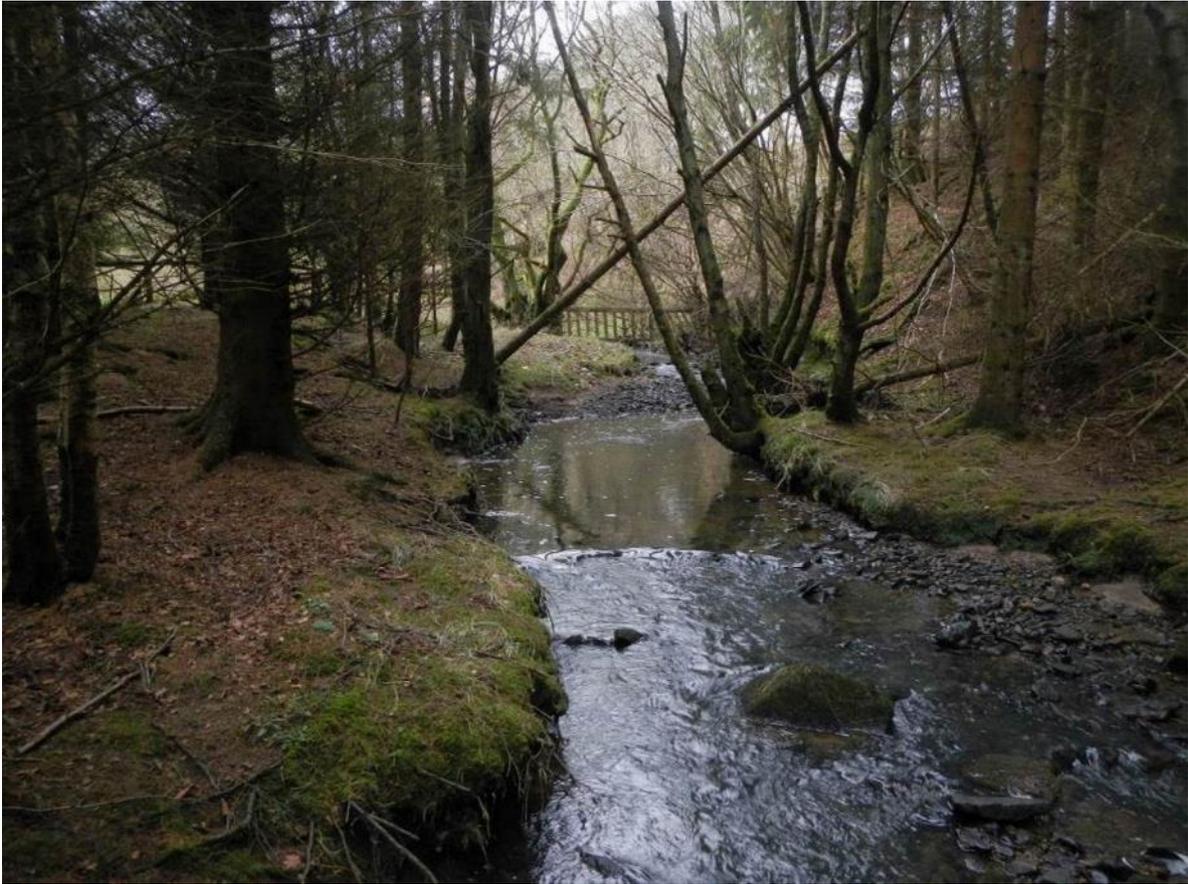
Photo DSCN5636. At NY 91037 76617 the burn enters a stock-excluded plantation and habitat improves; however, the closely planted conifers offer poorer habitat than a natural deciduous woodland and bring their own issues in terms of reduced light penetration/ground cover and impacts upon the watercourse.

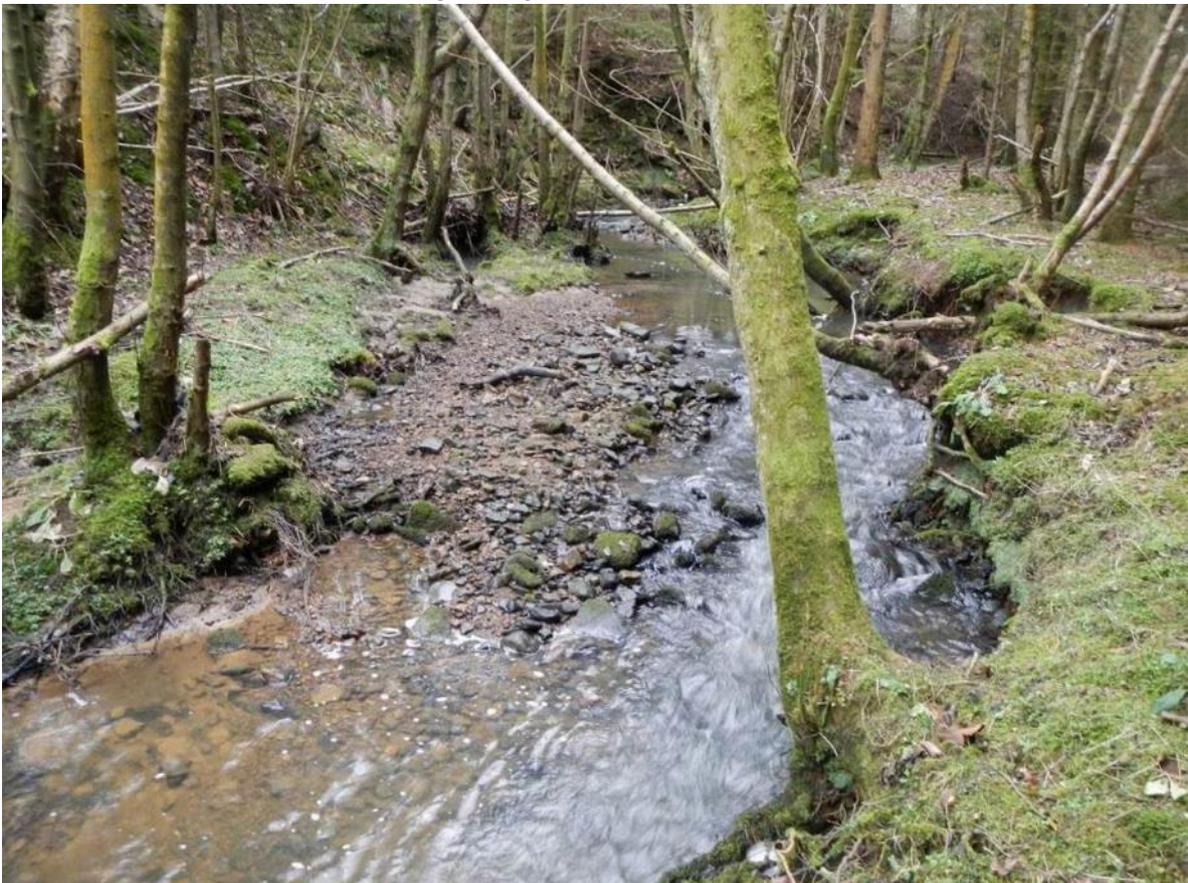
Photo DSCN5638. Bank erosion amongst the shallow rooted conifers has allowed some interesting bends and in-channel features to develop, potentially creating spawning areas if the fine sediment inputs can be curtailed.

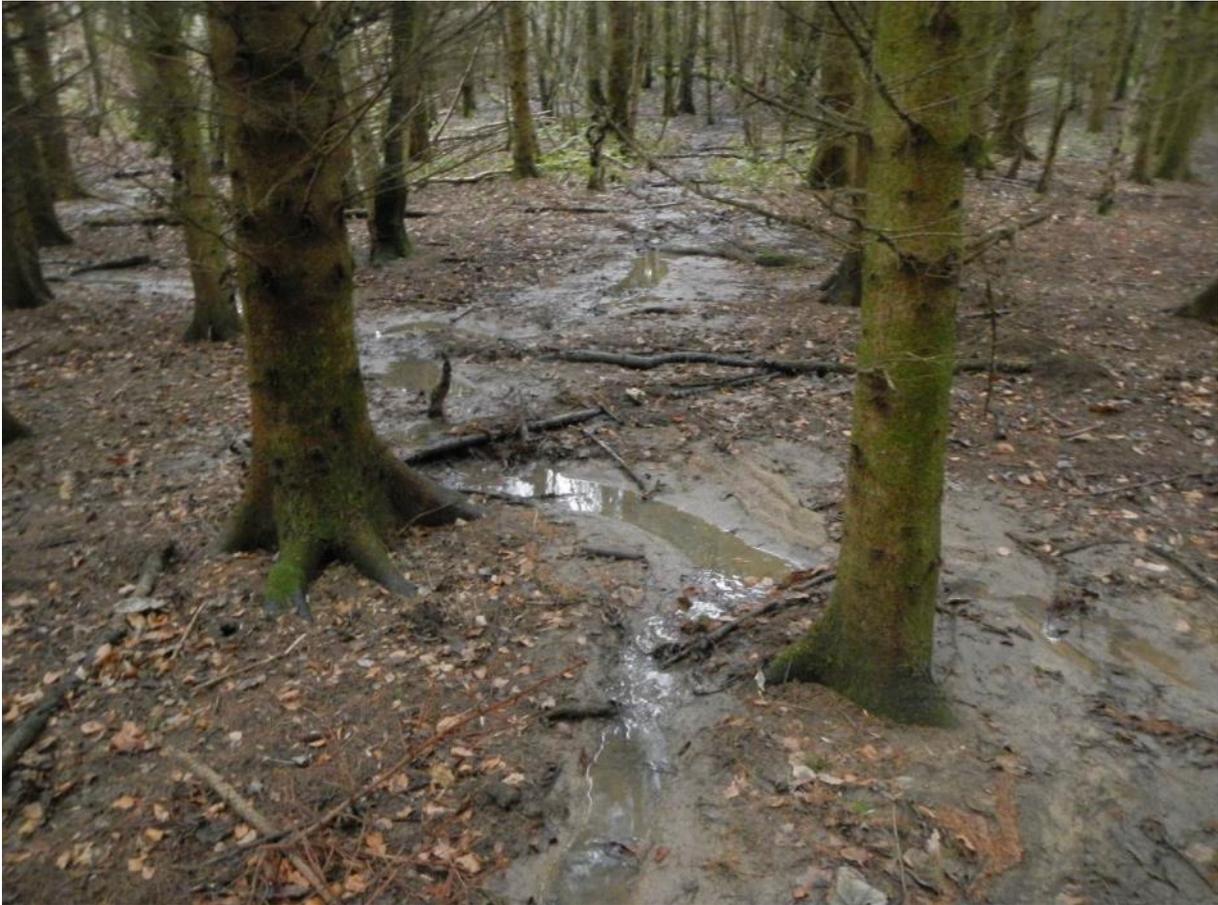
Photo DSCN5641. Land use adjacent to the plantation/wood is arable and sediment pathways were noted traversing the wood, right to the burn (appeared to be originating from a gully at NY 90939 76694 but entering the watercourse near NY 90776 76557).

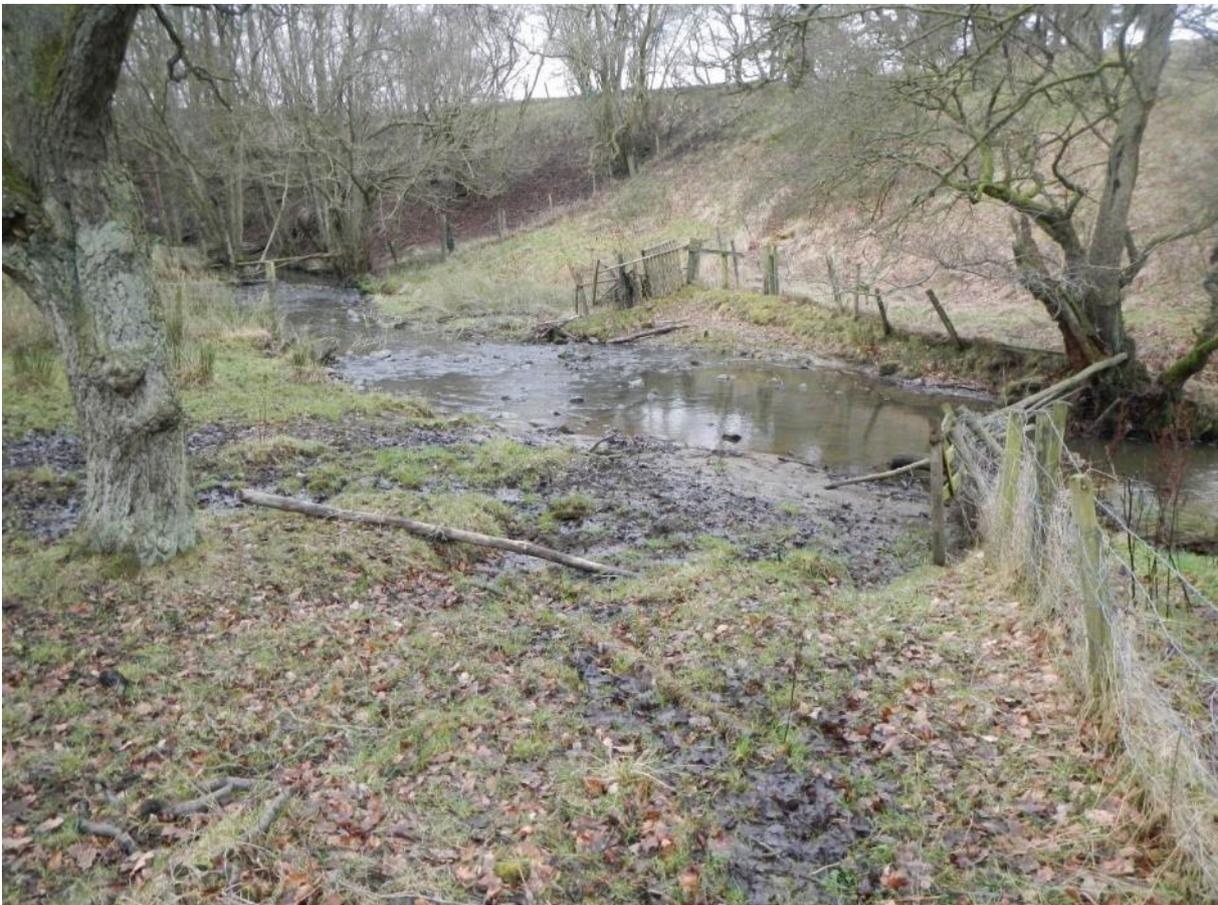
Photo DSCN5644. At a small break in the woodland (NY 90745 76473), livestock access again creates poaching and sediment issues, although not quite as severely as u/s.

| Issue | Proposed action | Photos | Priority (1-3) |
|--|---|---|---|
| Grazing pressure and poaching/erosion (NY 90745 76473). | Buffer fence the watercourse and provide alternative watering and crossing points. | DSCN5644 | 2/3 |

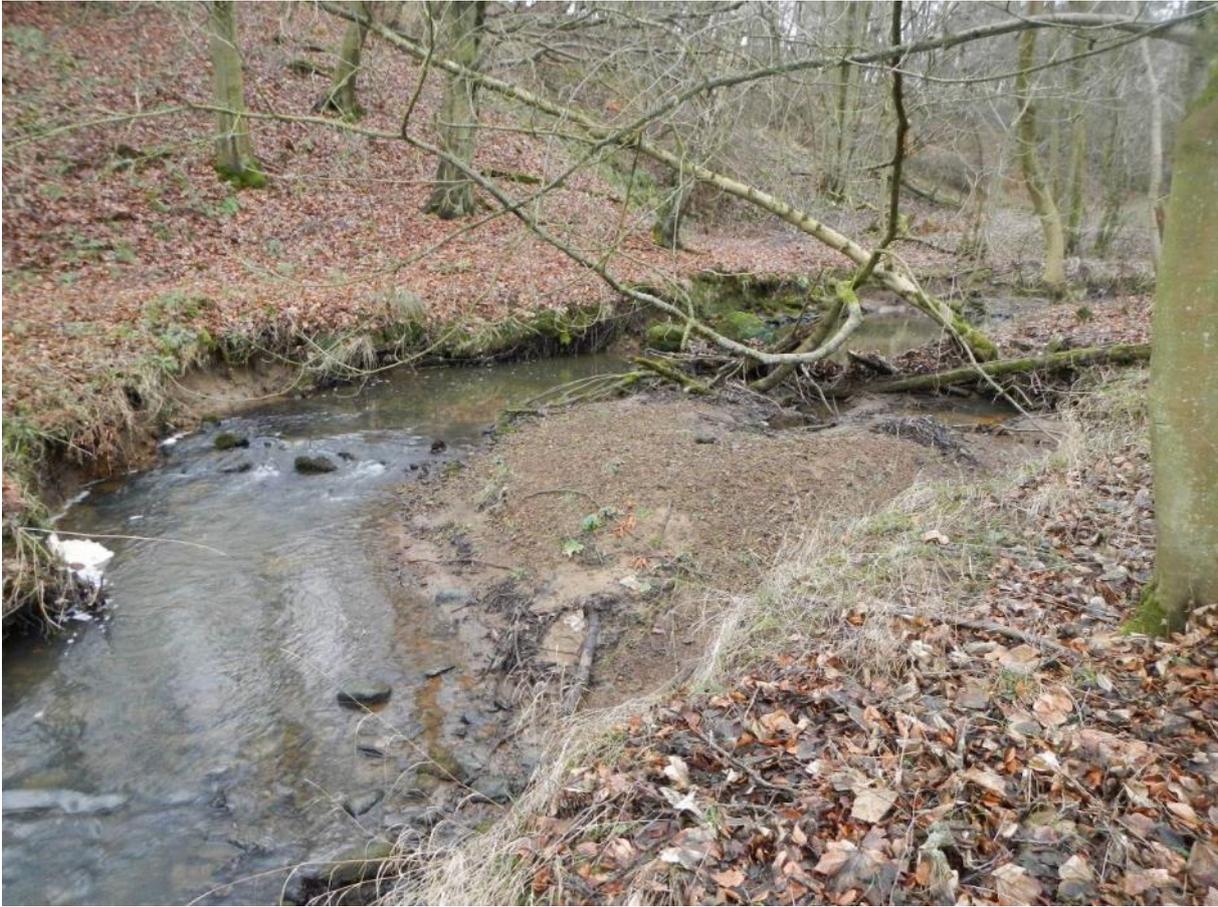
Photo DSCN5646. The next woodland d/s of the break is predominantly deciduous and provides much higher quality riparian and in-channel habitat with beneficial woody material readily input to the burn. However, even the beneficial morphological features are not sufficient to scour and sort the bed free from fine sediment.

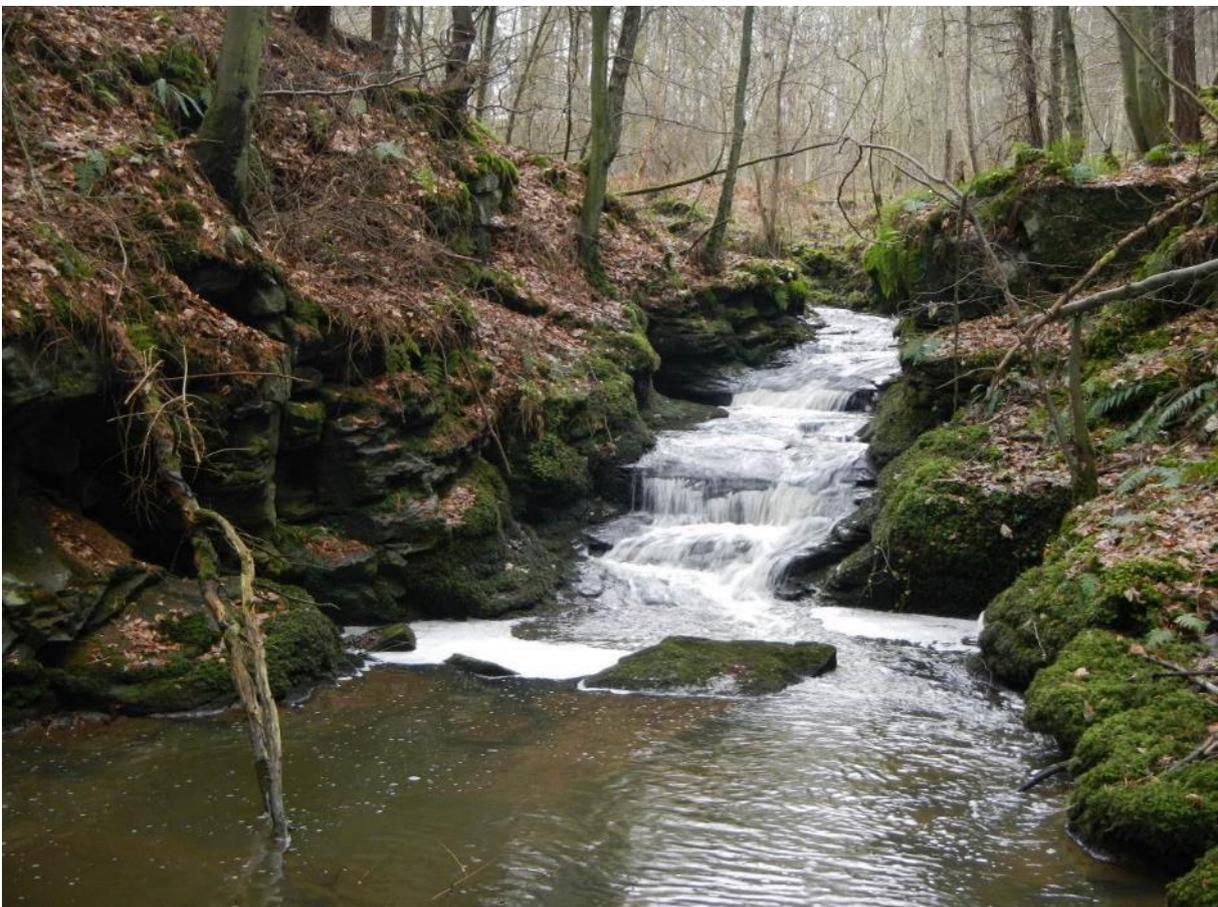
Photo DSCN5649. At NY 90932 76245 a poorly passable natural obstruction was observed. While an impediment, this bedrock structure is likely to be passable to some fish at high flows.

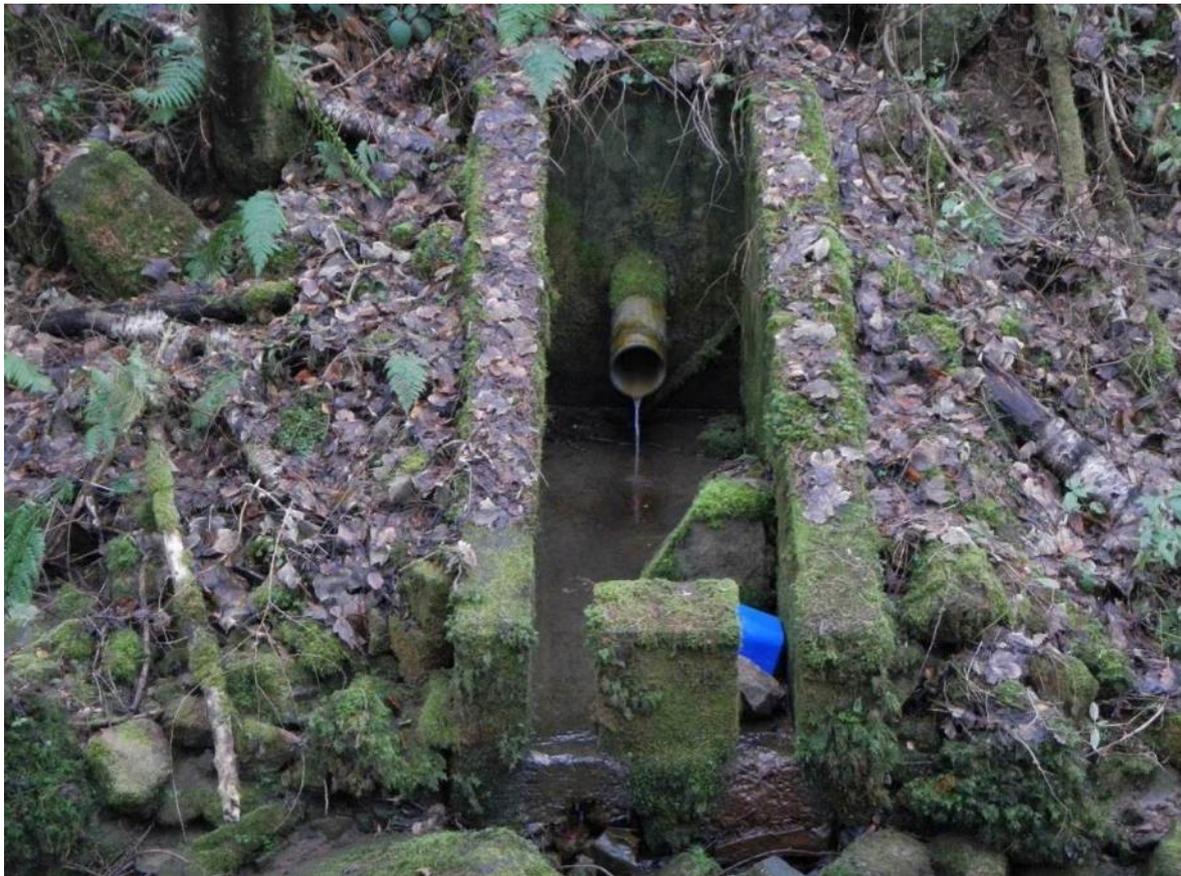
Photo DSCN5657. A pipe discharge was observed at t NY 91031 75945. Although no obvious source was observed during the walkover, inspection of aerial photography identified a series of lagoons/sewage works at the top of the adjacent hill, which may be the source. No signs of elevated sediment or nutrient (algae, excessive biofilm etc) were observed to be associated with the pipe.

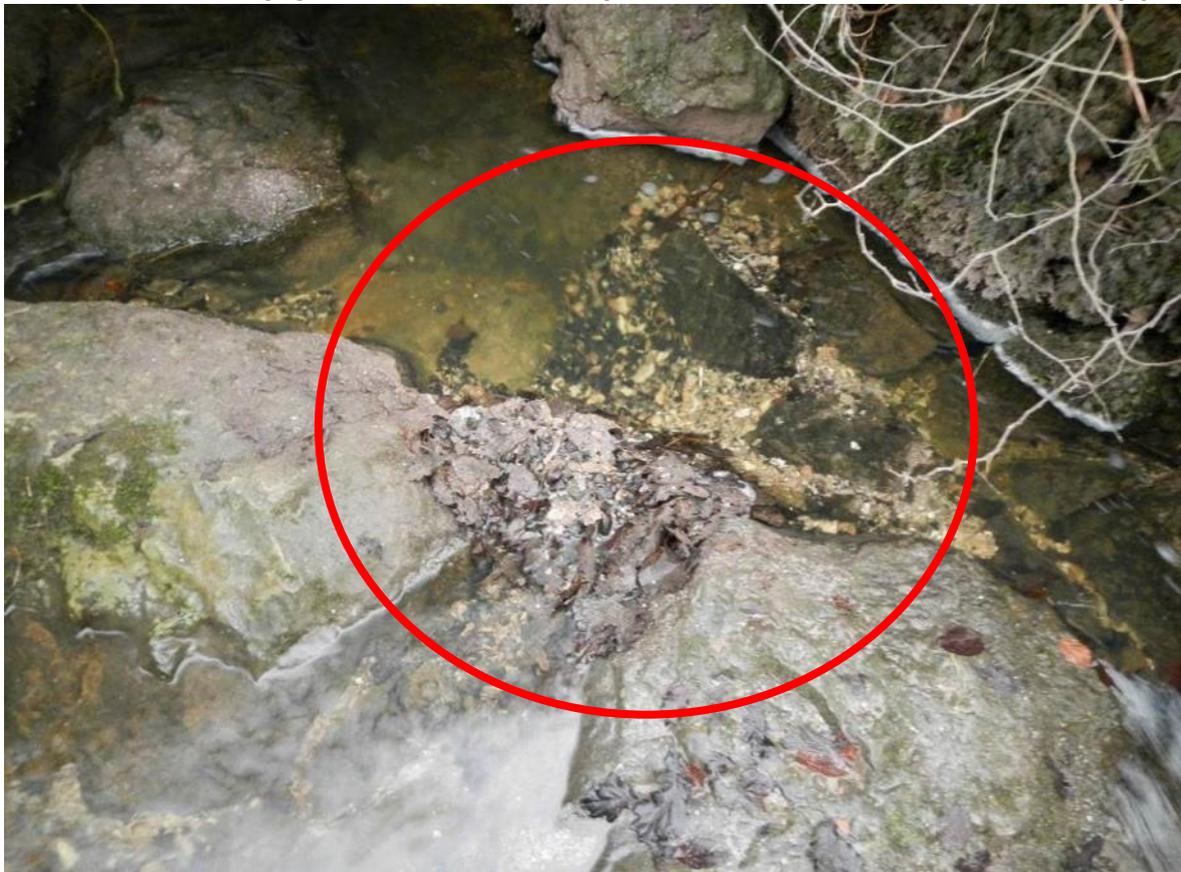
Photo DSCN5667. Typical of many peoples attitude to watercourses: That being they are a useful waste disposal mechanism. The Coal Burn tributary is obviously used as the repository for ash from the fire of the adjacent house (NY 90786 75640). While the impact is initially limited, over time the input is likely to have an impact on the ecology of the small burn.

| Fire waste disposed of in Coal Burn (NY 90786 75640) | Advise tenants to dispose of on land. | DSCN5667 | 3 |

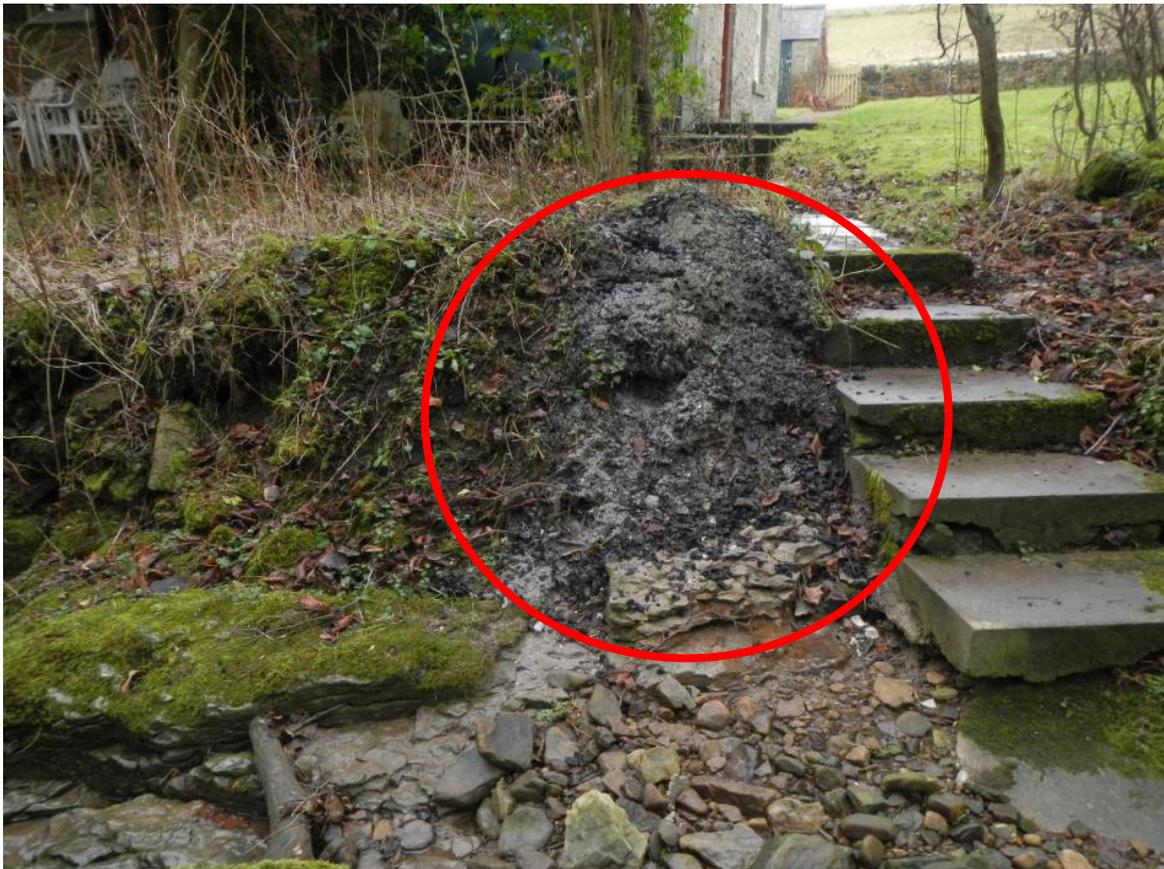
Photo DSCN5670. The next property d/s (NY 90576 75338) also uses the burn for rubbish disposal, tipping waste onto the bank, knowing full well it will be carried away on the next flood. A subsequent summer visit by EA fisheries officers noted drying up of the burn at NY 90685 75534. This creates yet another impact upon the burn, and should be investigated by the EA groundwater team but it should not inhibit much needed improvements to the sections u/s and d/s as electrofishing data indicate that this remains an important salmonid spawning tributary.

| Waste disposed of on banks of Gunnerton Burn (NY 90576 75338). | Advise tenants to dispose of on land. | DSCN5670 | 3 |

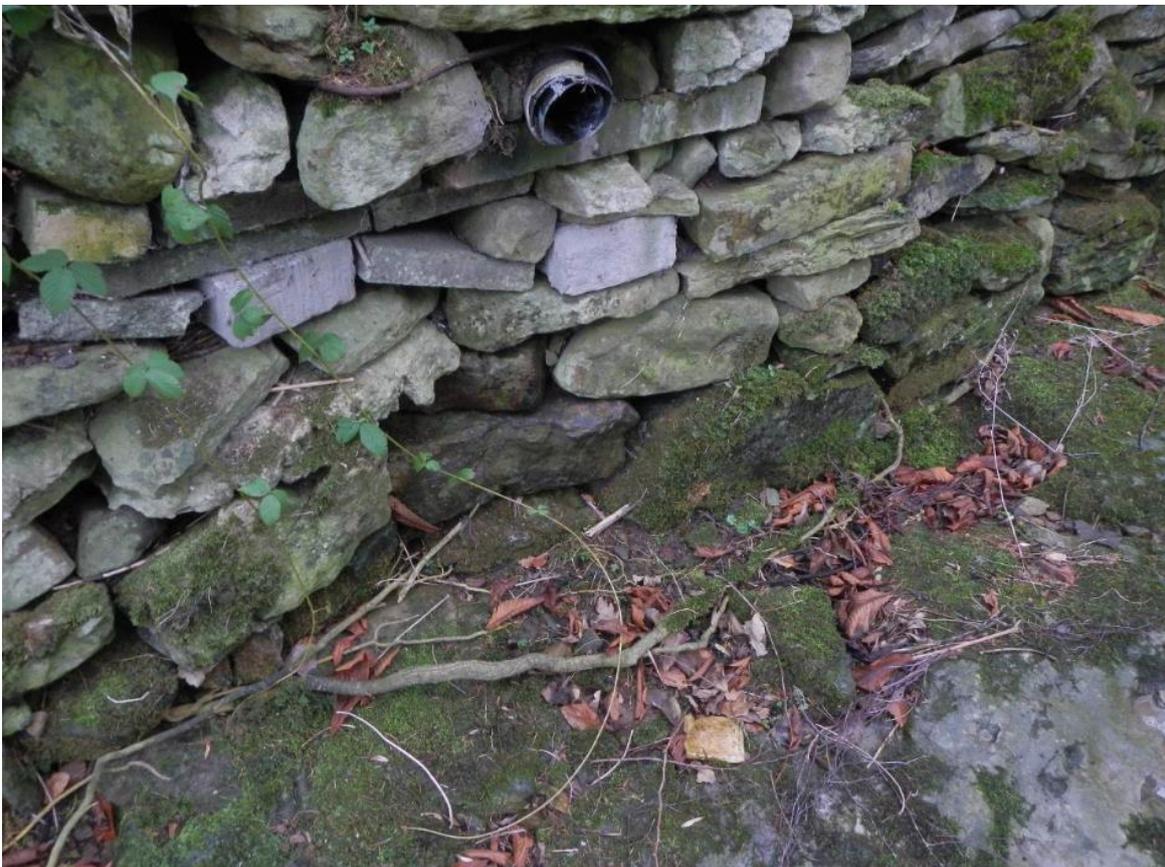
Photo DSCN5671. At the second house where the waste was being dumped on the bank (NY 90572 75328), two pipes were observed, neither appeared to be an issue on the day of the visit.

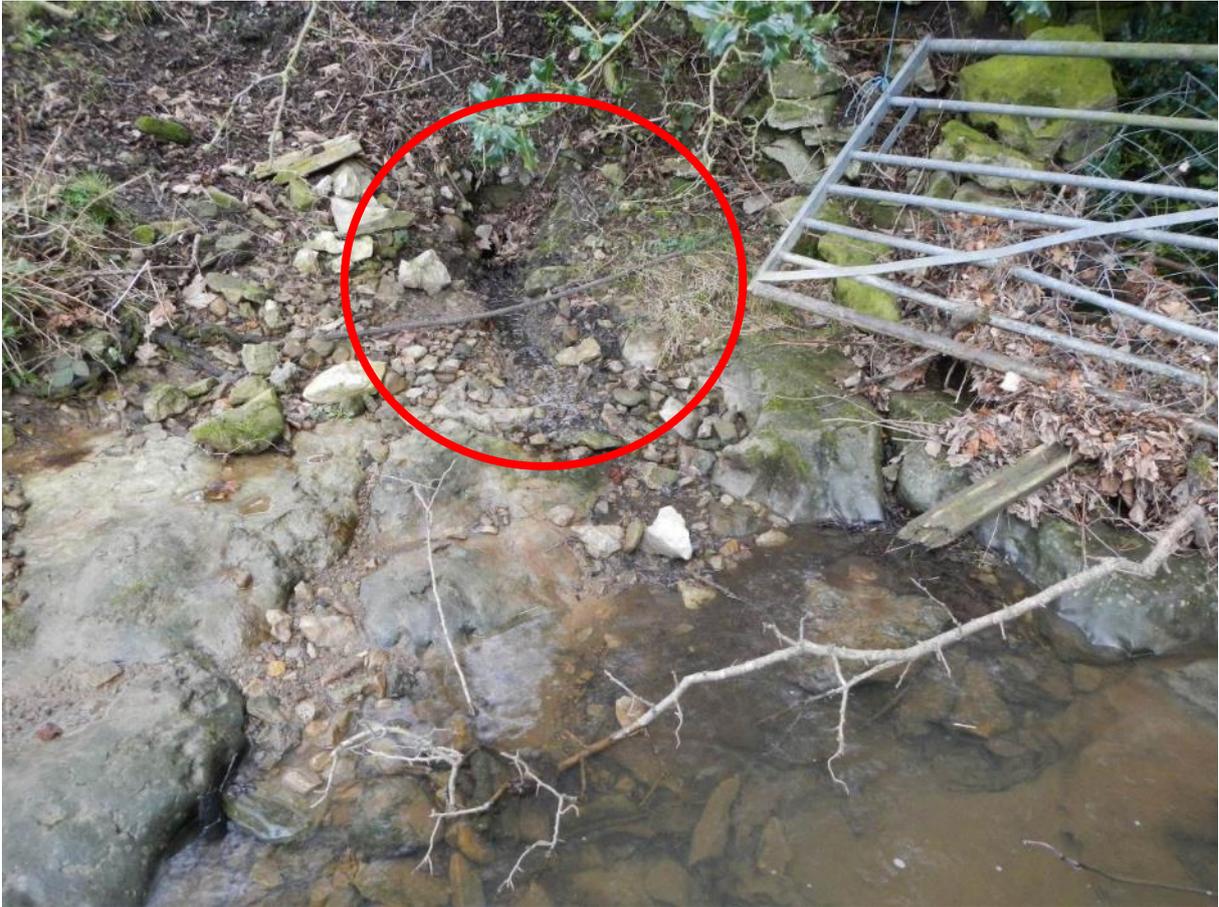
Photo DSCN5672. The discharge point of the farthest d/s of the two pipes (red circle - NY 90556 75311).

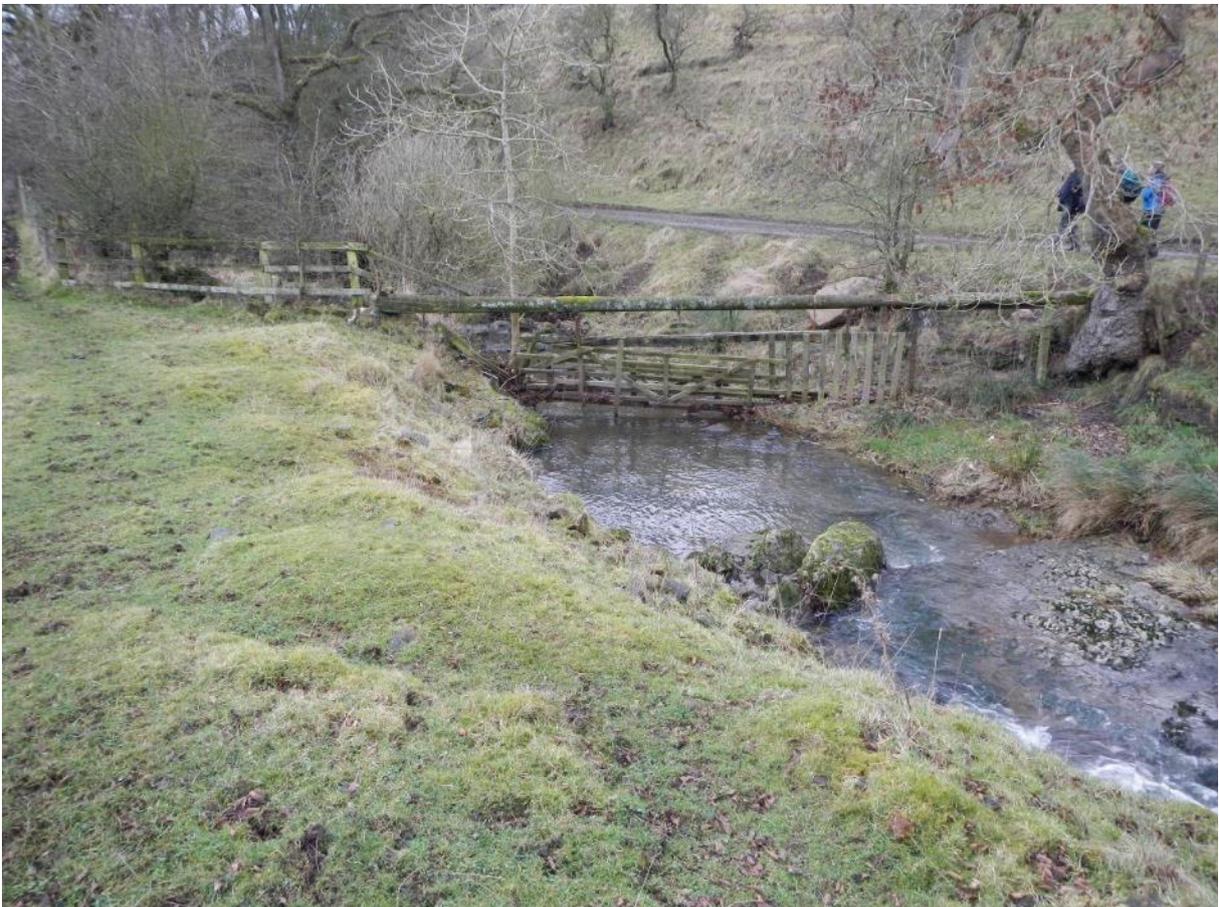
Photo DSCN5673. Buffer fencing would be beneficial for a short section of field d/s of the house, u/s of Gunnerton village (NY 90535 75294).

| Grazing pressure and loss of marginal vegetation (NY 90535 75294). | Buffer fence the watercourse and provide alternative watering point. | DSCN5673 | 3 |

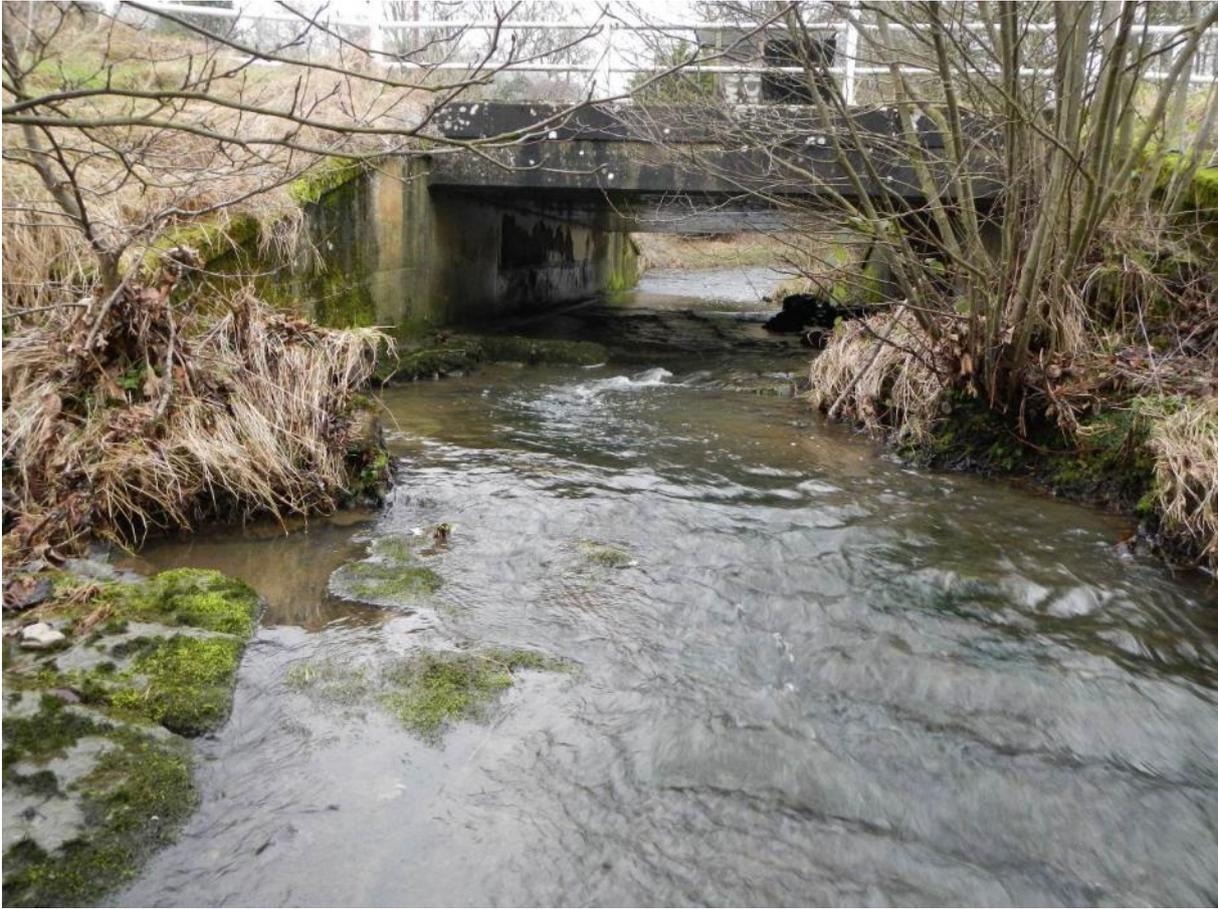
Photo DSCN5675. The road bridge in Gunnerton (NY 90516 75131) poses no real issues for fish passage, being clear span over bedrock any obstruction there is natural.

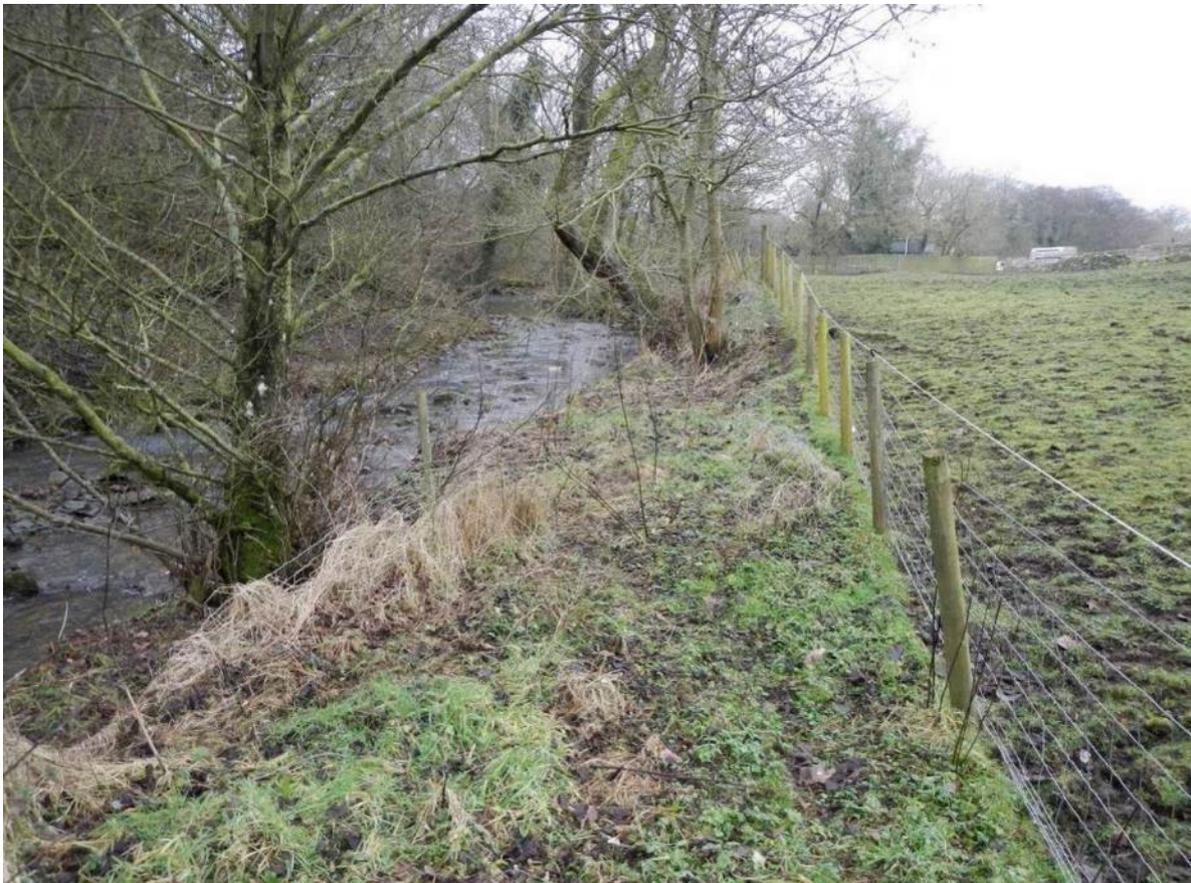
Photo DSCN5676. The first field d/s of the bridge in Gunnerton and u/s of the sewage treatment works (STW) is buffer fenced. The benefit to bankside vegetation, habitat and bank stability is clearly evident.

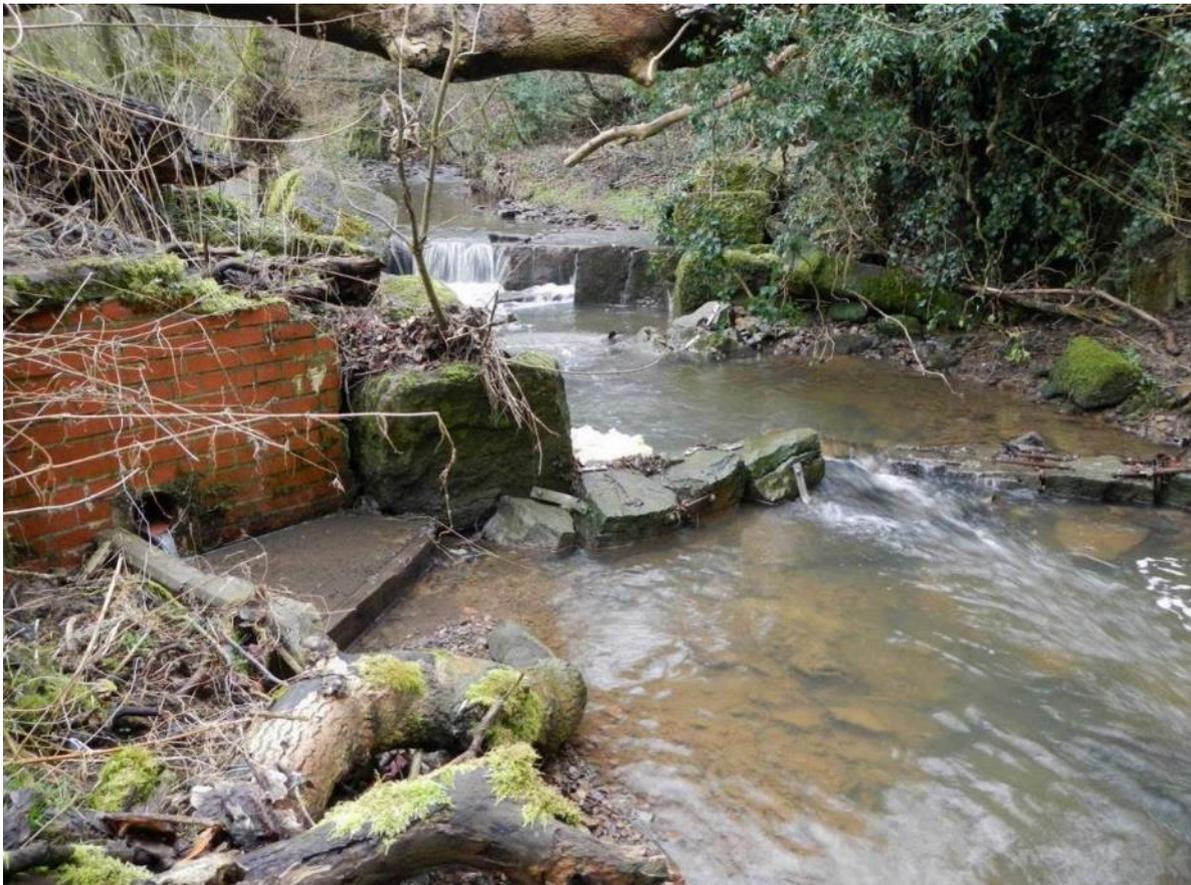
Photo DSCN5680. Alongside the sewage treatment works pre barrages have been installed to improve fish passage at a natural bedrock obstruction. Easing natural obstructions is not advisable, unlike man-made obstructions which should be removed if at all possible. No major issue was observed associated with the discharge of the STW, but note the ongoing impact of siltation.

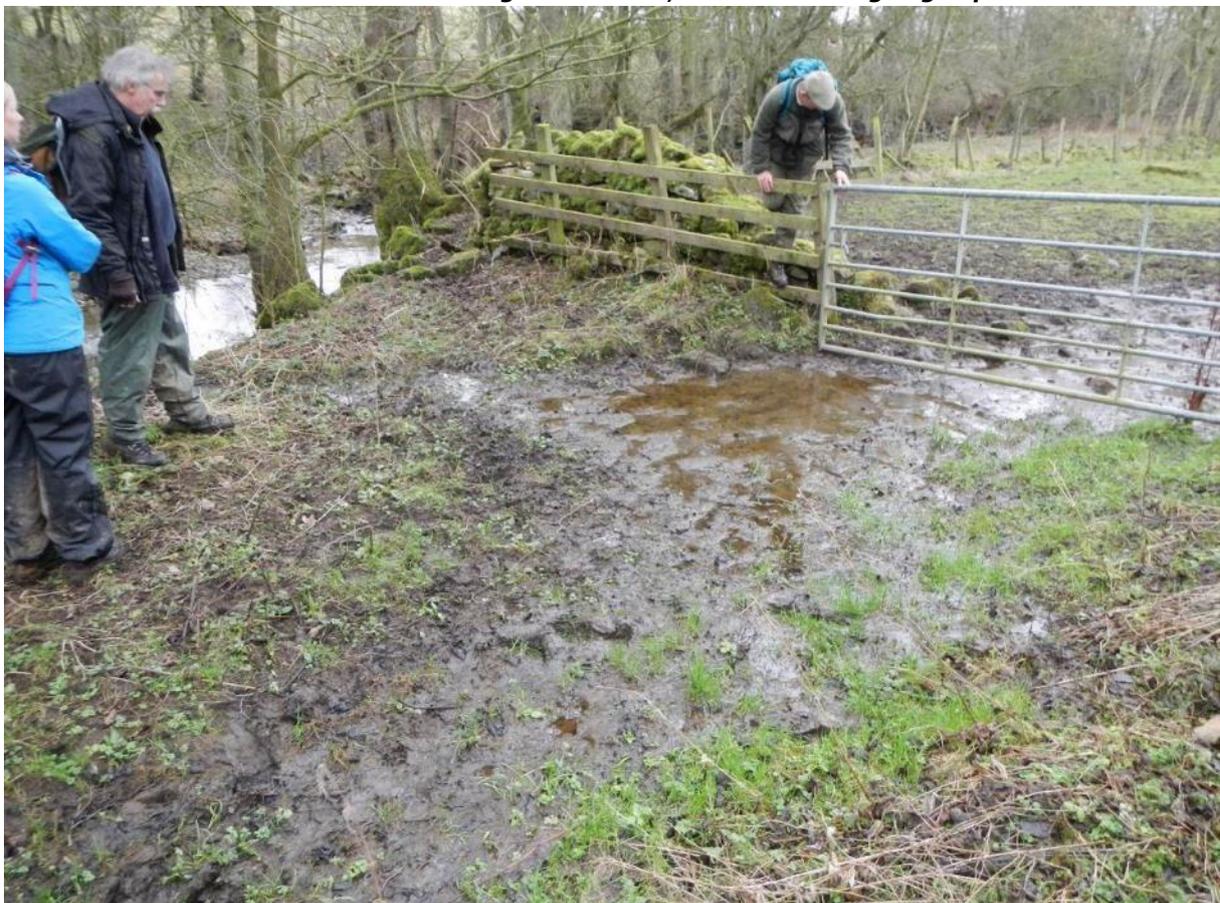
Photo DSCN5684. At NY 90323 74962, wet ground and poaching around a gateway poses another potential fine sediment input. Better drainage of the area and/or installation of hard-standing could improve the situation.

| Poaching around gateway (NY 90323 74962). | Install hard standing/improve drainage. | DSCN5684 | 3 |
