Walkover Report
Gunnerton Burn
(River Tyne Catchment)
02/02/2017

Undertaken by Gareth Pedley, Wild Trout Trust

Gunnerton Burn, Water Framework Directive Waterbody ID GB103023074880.

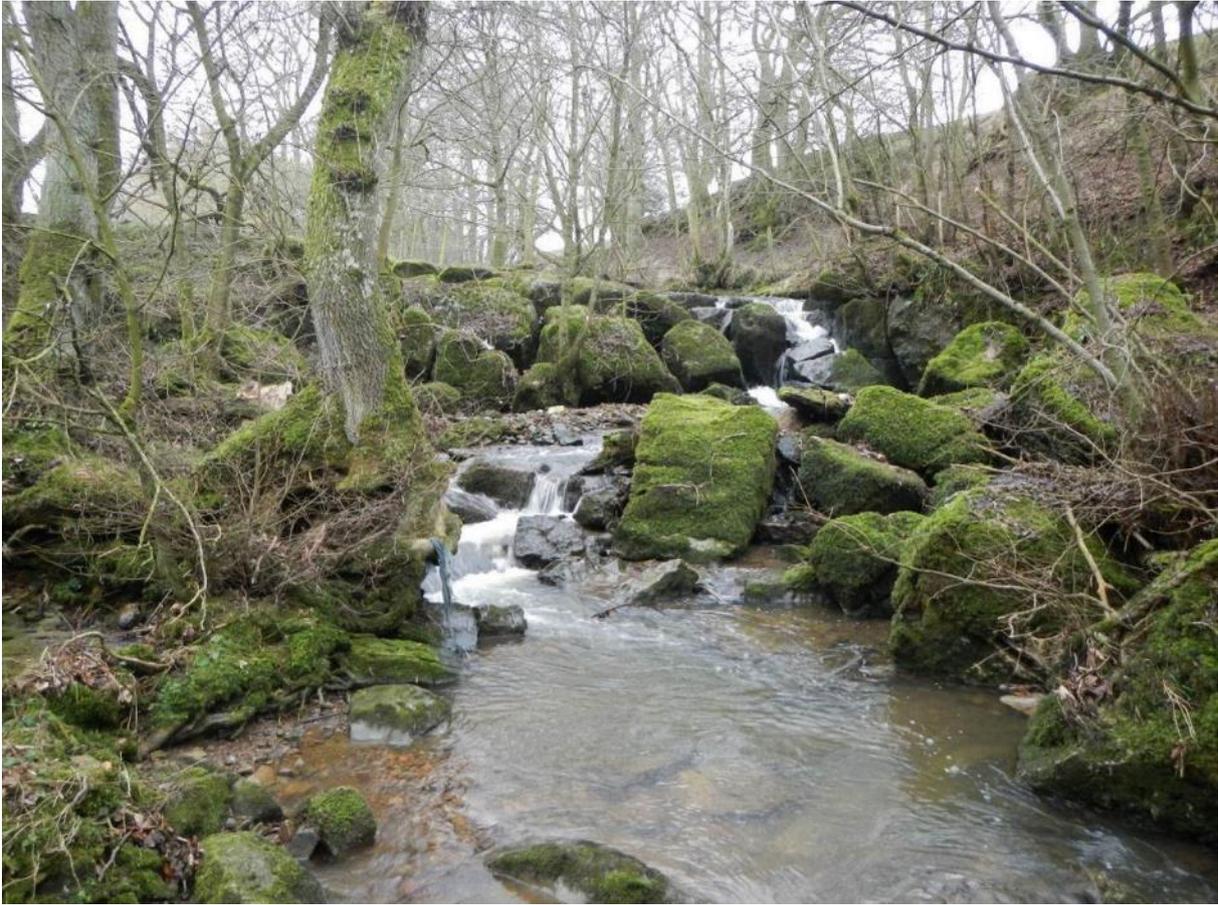
Photo DSCN5686. What appeared to be a natural rock obstruction (NY 90206 74938) will limit fish access up the burn; however, any structures known to be natural should not be altered.

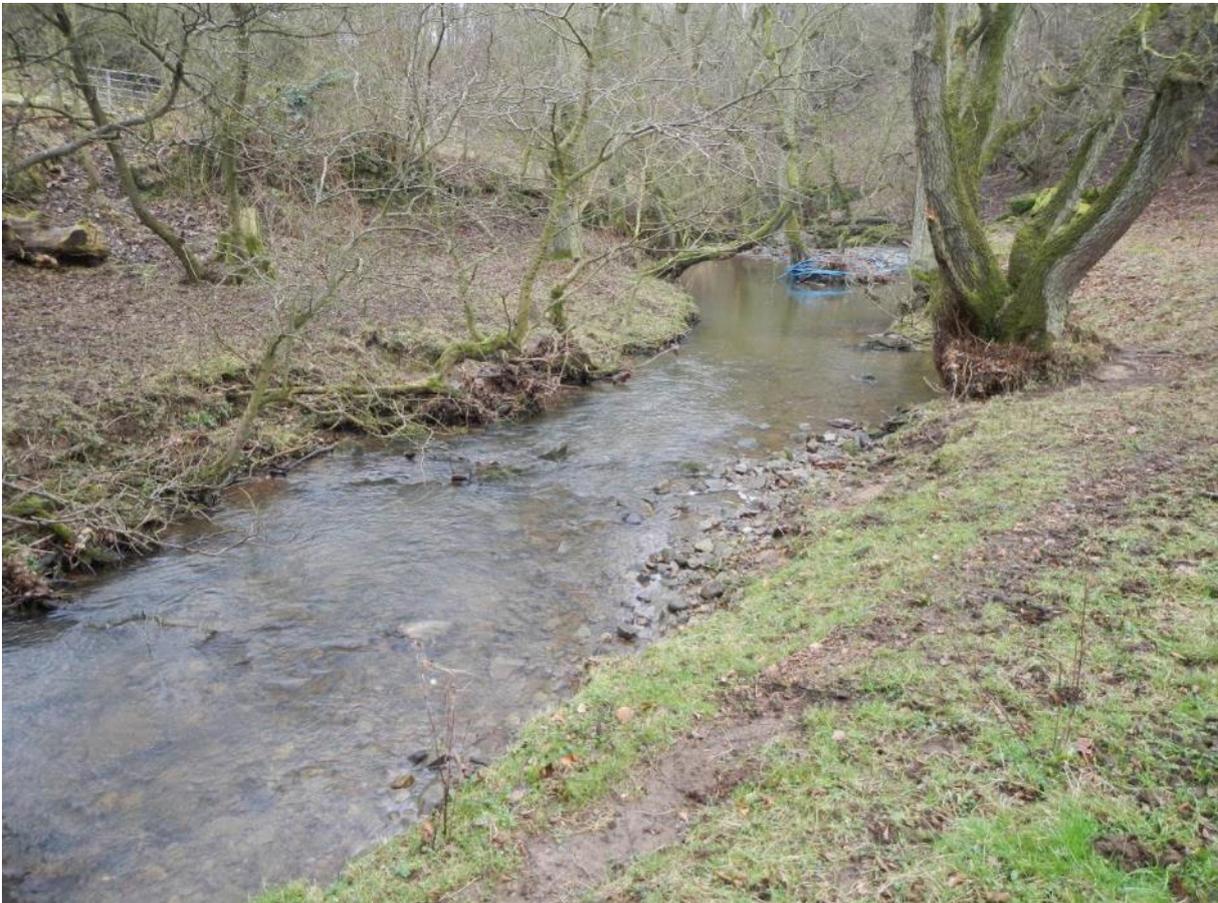
Photo DSCN5687. Livestock access to the banks in the field between the rock obstruction and the disused railway culvert is greatly limiting the quality of the riparian habitat (NY 90135 74907).

| Grazing pressure and loss of marginal vegetation (NY 90135 74907). | Buffer fence the watercourse and provide alternative watering point. | DSCN5687 | 3 |

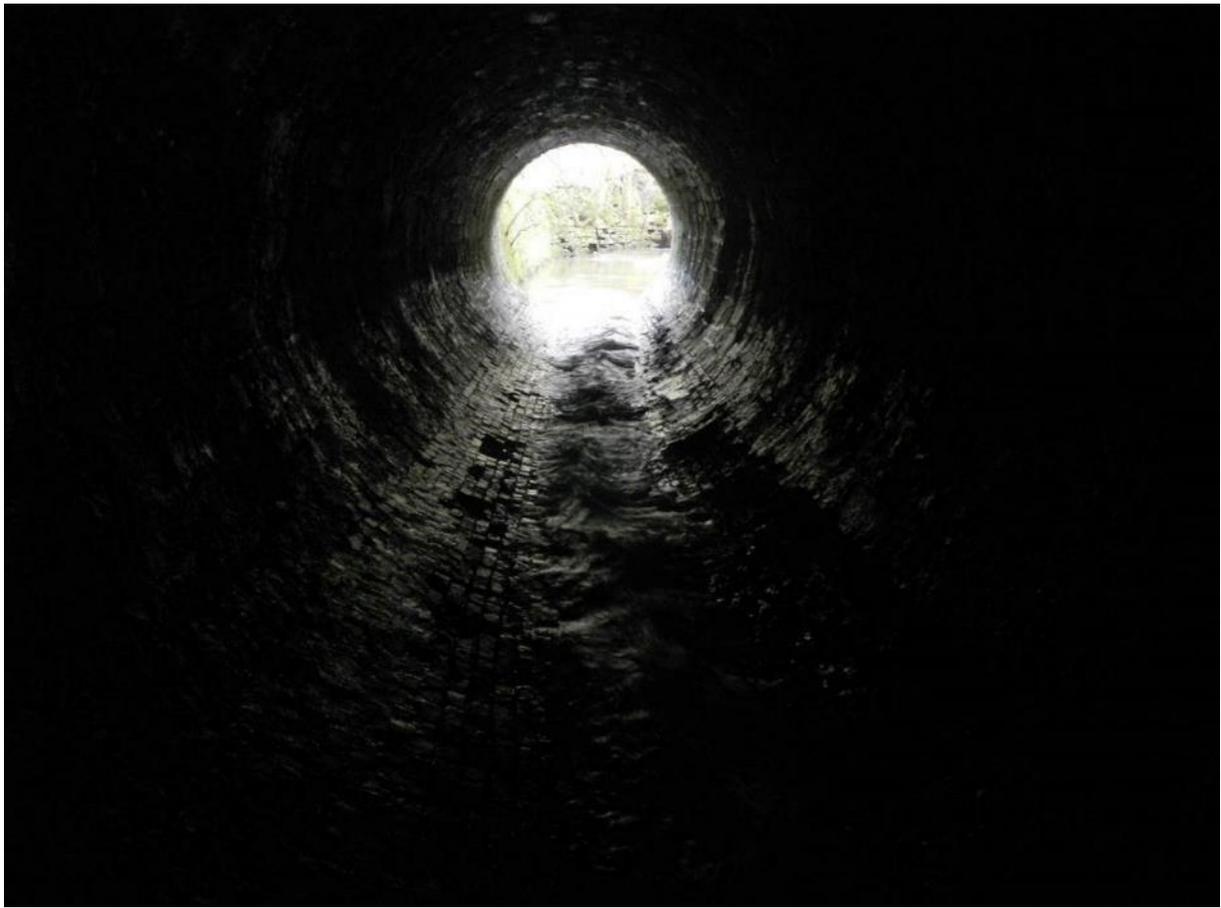
Photo DSCN5689. The railway culvert (NY 90128 74832) poses a notable obstruction to fish passage. However, it is improved somewhat by significant degradation of the culvert bed. This has created a valuable increase in roughness which dissipates the flow energy and should assist fish in ascending the burn. Installation of culvert baffles would improve the situation further.

| Fish passage issue at disused railway culvert (NY 90128 74832). | Ideally install baffles to further baffle flows and increase depth. | DSCN5689 | 2 |

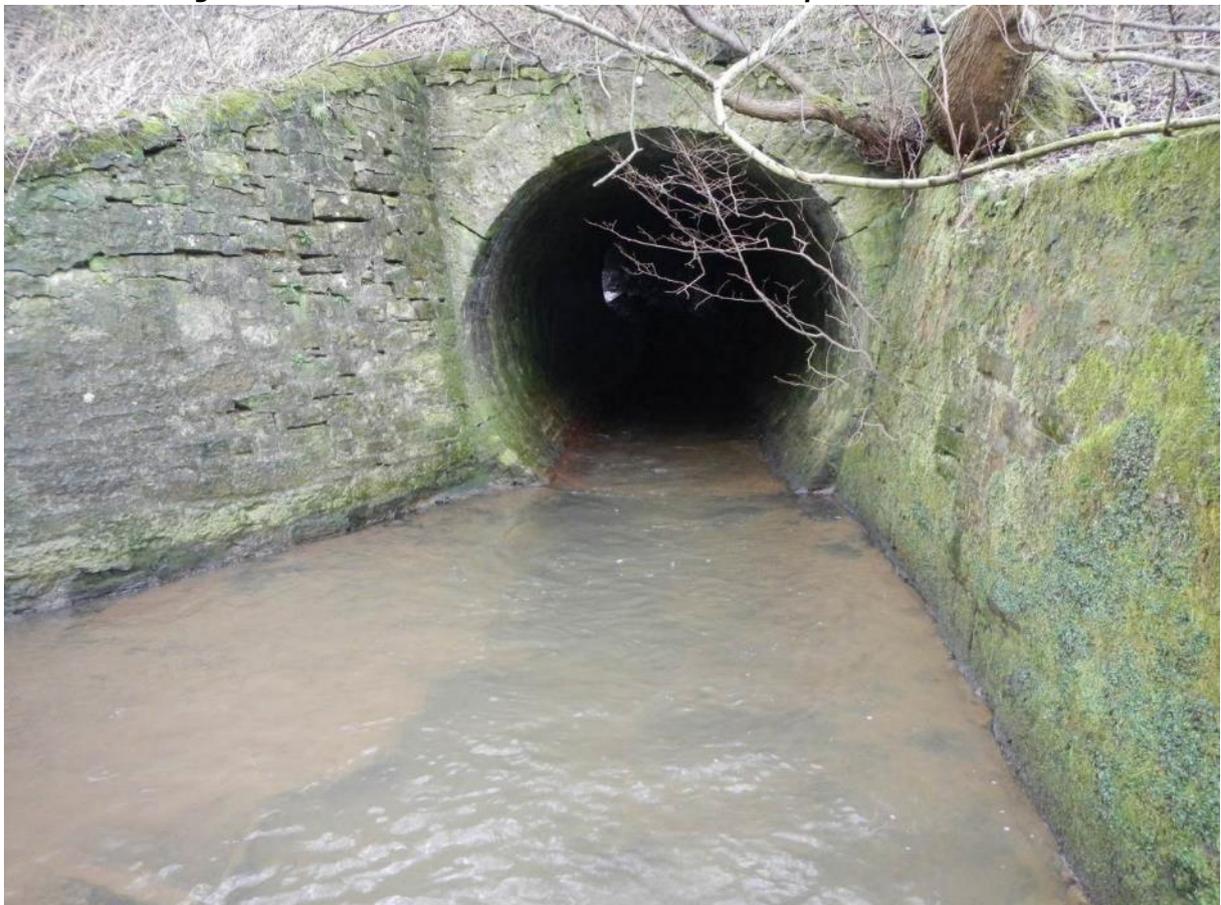
Photo DSCN5692. Access into the culvert is reasonably good as a small step d/s drowns out the entrance.

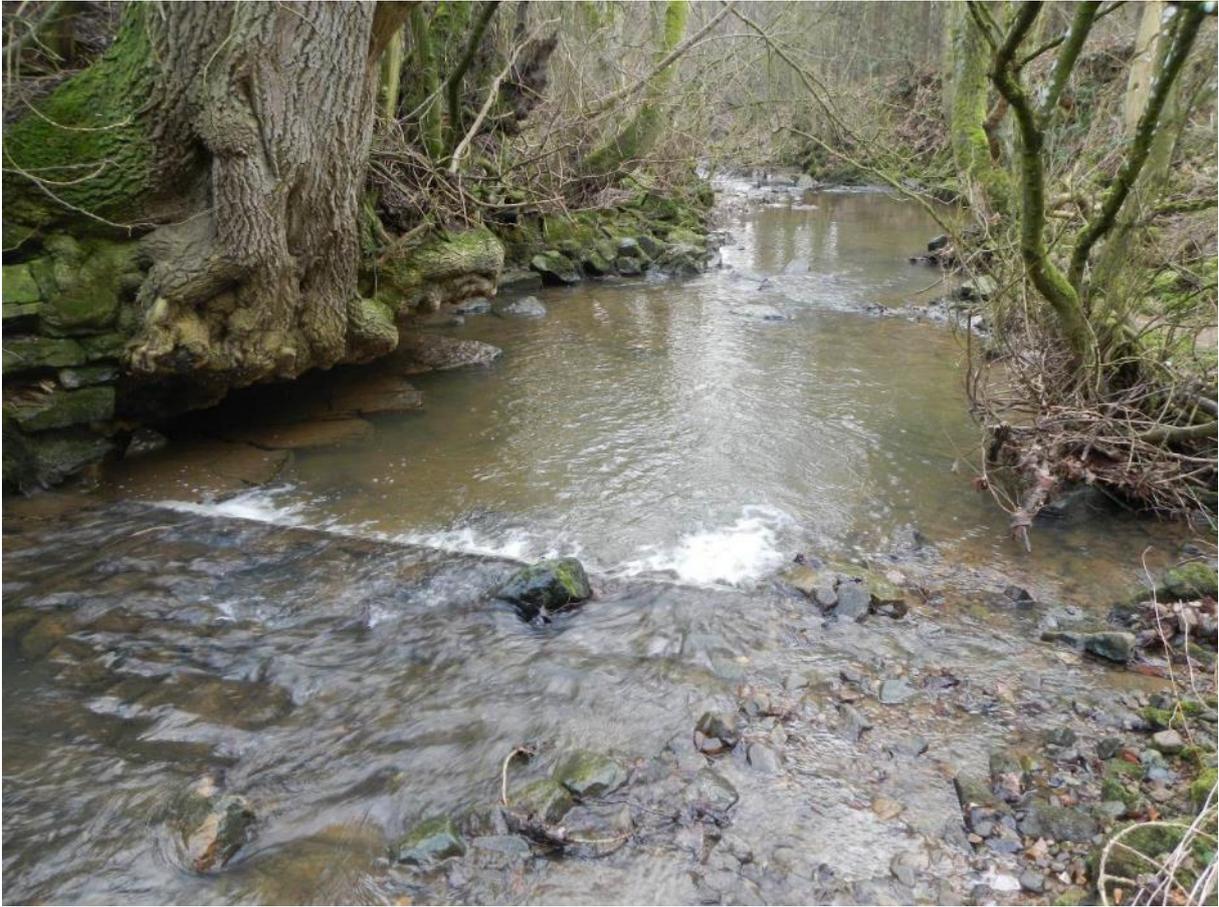
Photo DSCN5693. Small step and shallow water just d/s of the culvert – the lesser of two evils in that it improves passage into the less passable culvert by drowning out the entrance.

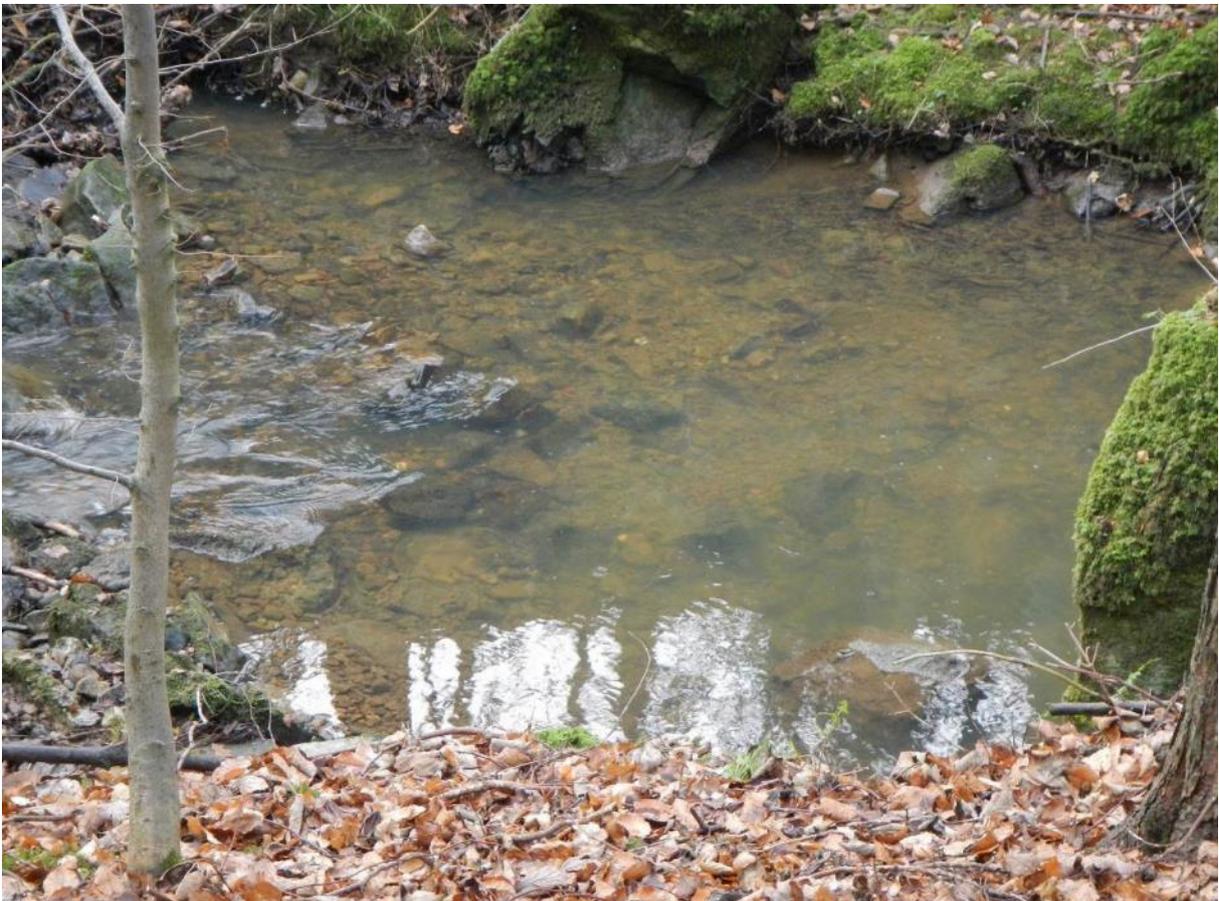
Photo DSCN5697. The fine sediment inputs u/s continue to have a major impact upon substrate habitat for the remainder of the burn, d/s to the Tyne, significantly degrading the habitat quality.

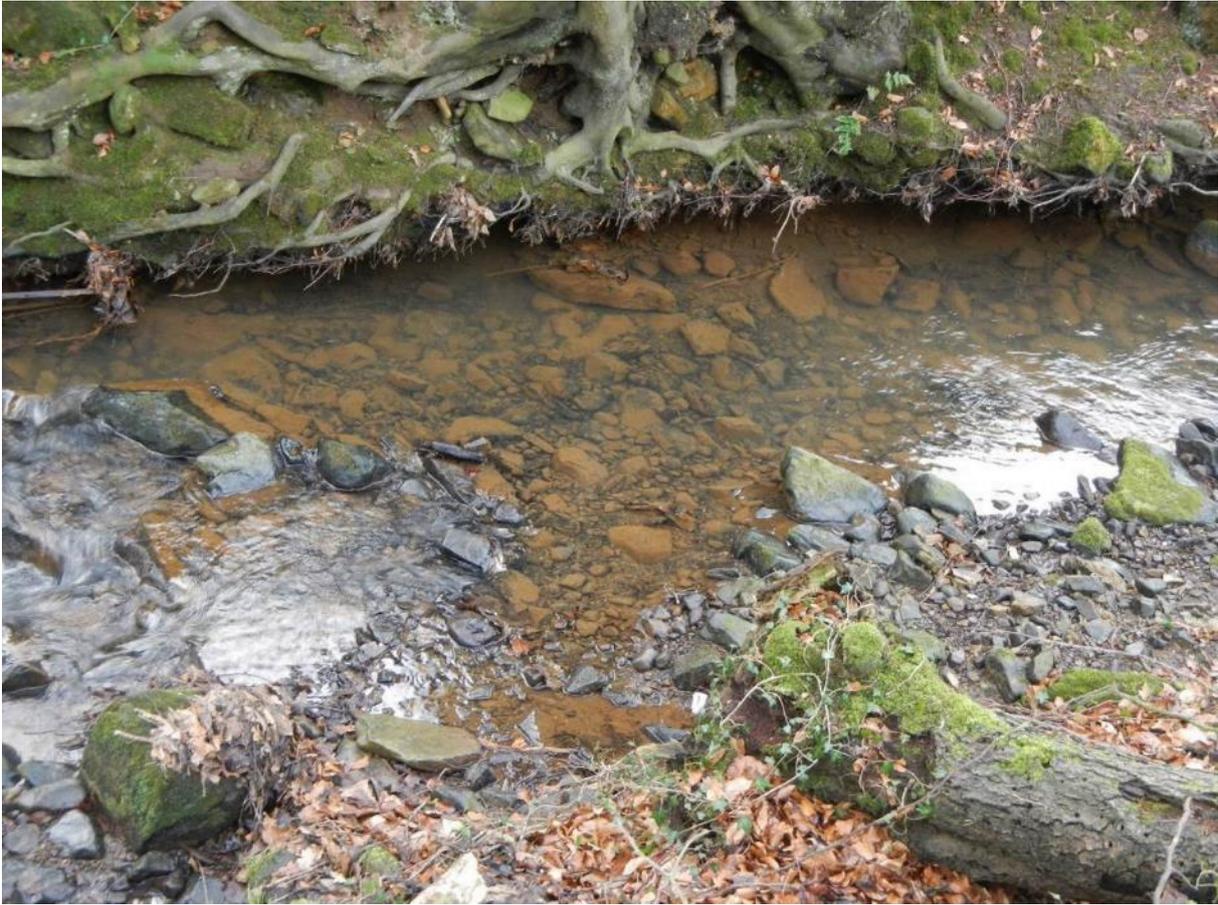
Photo DSCN5699. Mallow Burn which joins the Gunnerton Burn at NY 89864 74575 clearly also suffers similar fine sedimentation problems and requires further investigation.

| Fine sediment and balsam issues on Mallow Burn, u/s of NY 89864 74575. | Undertake further investigation to identify sources of fine sediment input and balsam. | DSCN5699 | 2 |

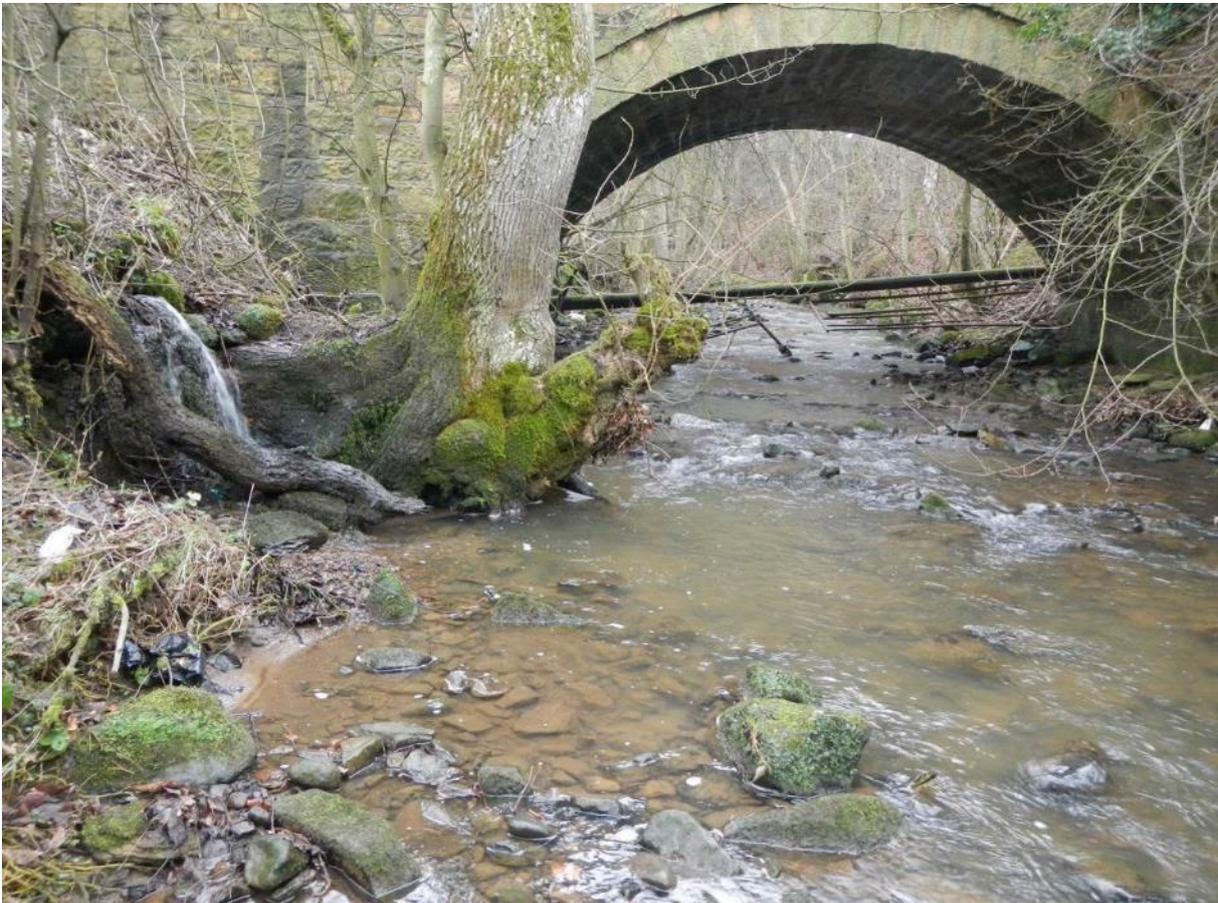
Photo DSCN5704. The road crossing of Gunnerton Burn, just d/s of Mallow Burn, poses no issues for sediment transport or fish passage.

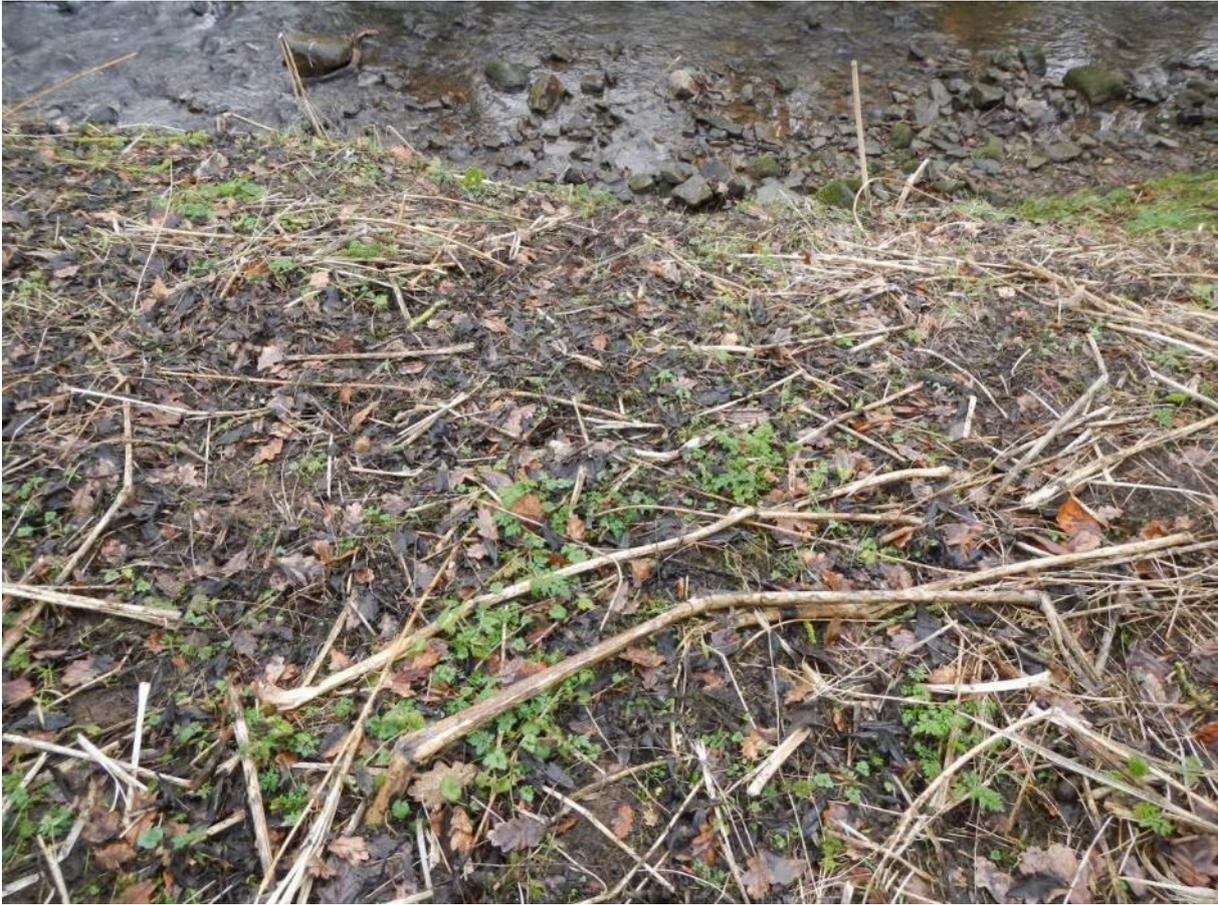
Photo DSCN5708. The section d/s of the Mallow Burn to the Tyne was the first area in which Himalayan balsam was observed on the catchment, suggesting that it may originate from the Mallow Burn – another reason to investigate it further.

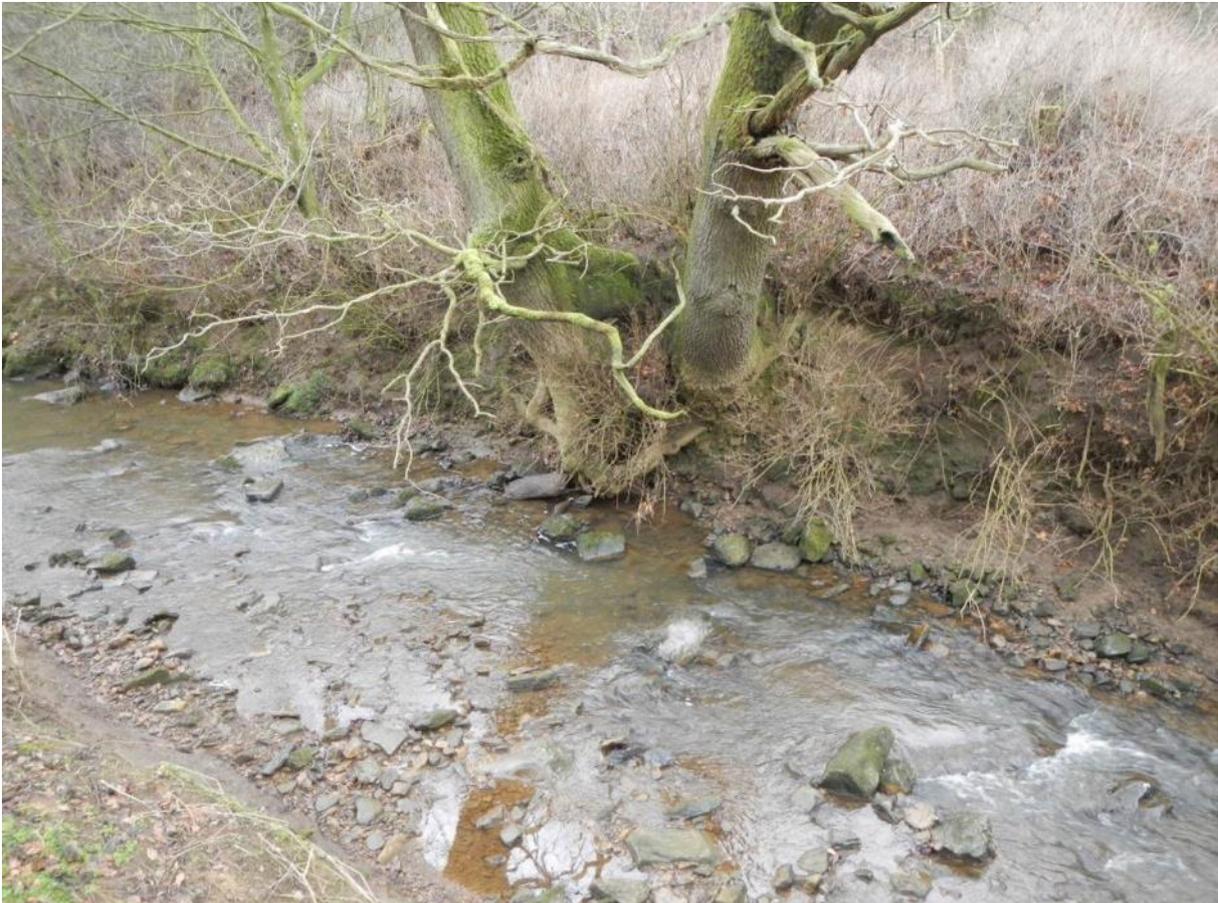
Photo DSCN5710. The incised channel along with over-shading by snowberry (Symphoricarpos alba) is leading to exacerbated bank erosion in the straight section u/s of the Tyne. Possible past channel maintenance may also be contributing.
