Walkover Report
Honeycrook Burn
(River Tyne Catchment)
21/02/2017

Undertaken by Gareth Pedley, Wild Trout Trust

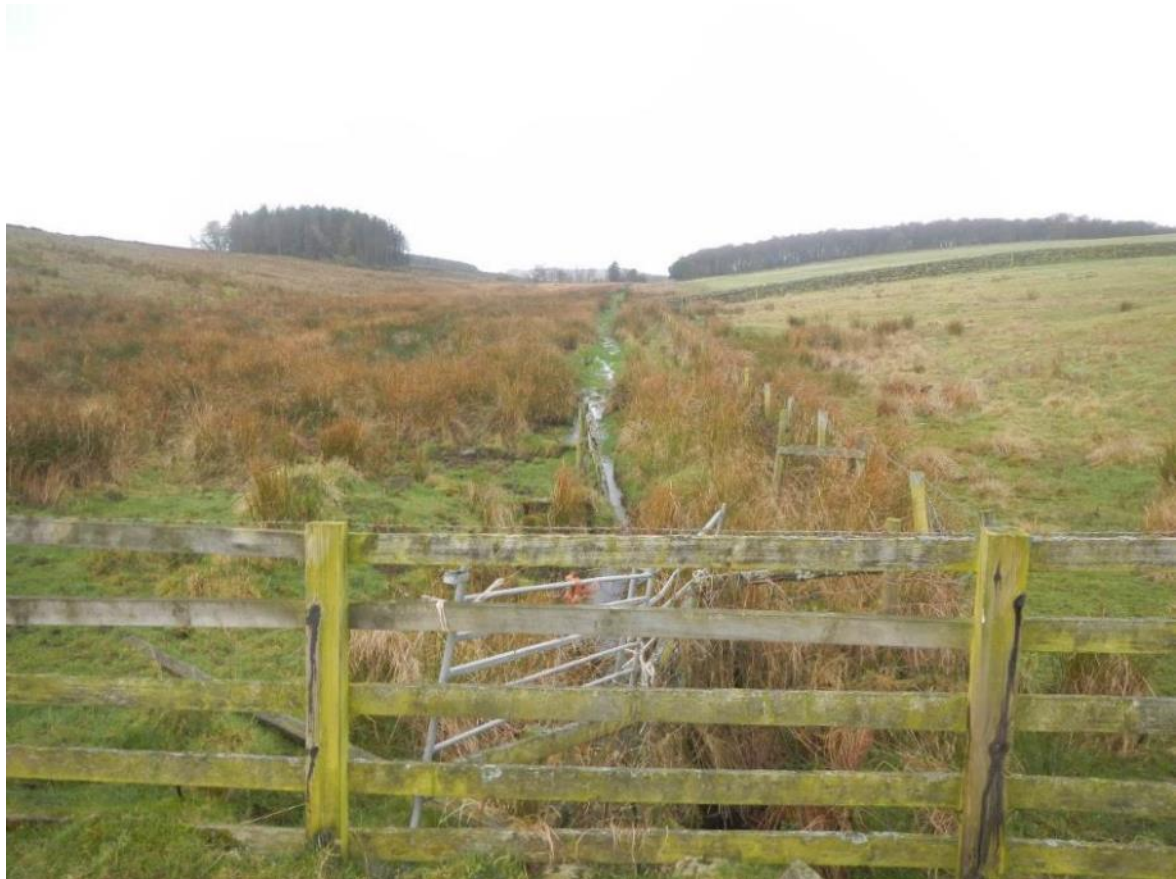
Photo DSCN6171. Looking u/s at the u/s limit of the burn inspected. At this point the burn is a small, straight ditch. It is hard to ascertain whether there would have originally been a burn at this point or just a boggy field.

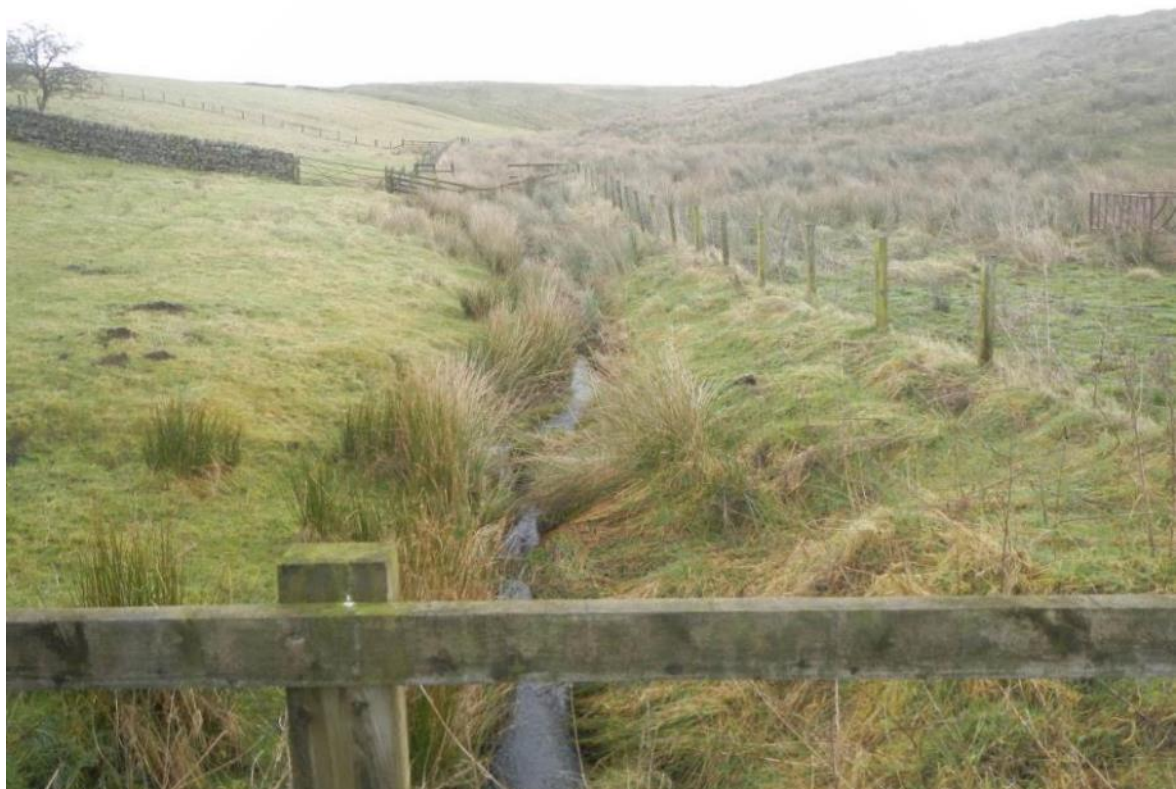
Photo DSCN6172. Looking d/s from the u/s limit. From this point d/s, the valley characteristics suggest there would have been a more defined watercourse here originally, but straightening and dredging have clearly been undertaken historically.

Issue	Proposed action	Photos	Priority (1-3)
Channel straightening/realignment from source to Joicey's Shaft disused mine. Greatest potential improvement from NY 82055 67471 - NY 82960 66661 (larger watercourse within wider floodplain).	Investigate river restoration to relocate burn to the low point of the valley, thereby improving land drainage without the requirement for regular dredging. This will also greatly improve in-channel habitat and prevent the influx of fine sediment during dredging episodes.	DSCN6178, DSCN6187 & DSCN6192	<u>1</u>
Fine sediment input/crossing point (NY 82063 67465).	Farm advisory visit to discuss options for gutters/soakaways and installation of hard standing around problem areas.	DSCN6179	2

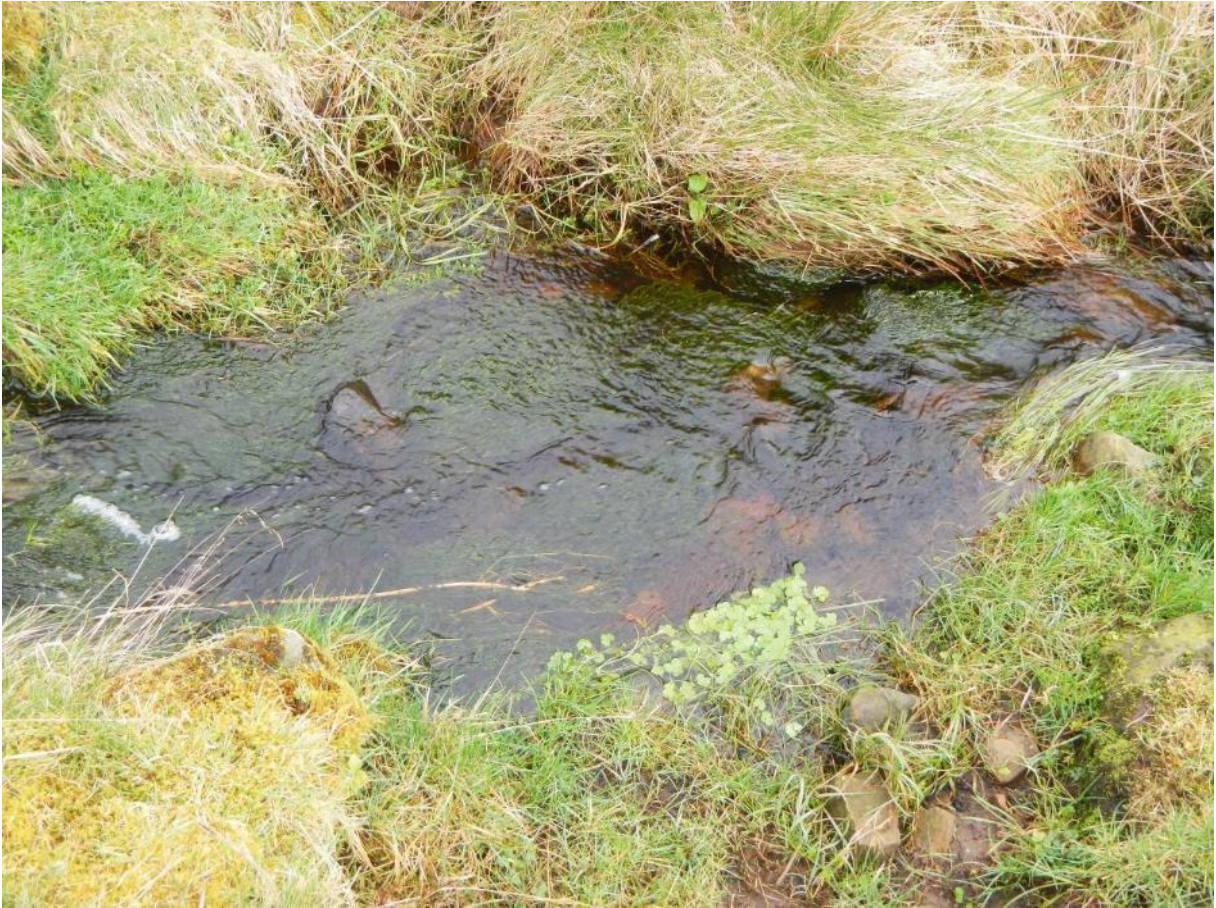
Photo DSCN6174. Although straightened, gravel and cobble substrate, along with aquatic vegetation, does provide areas reasonable quality juvenile salmonid habitat.

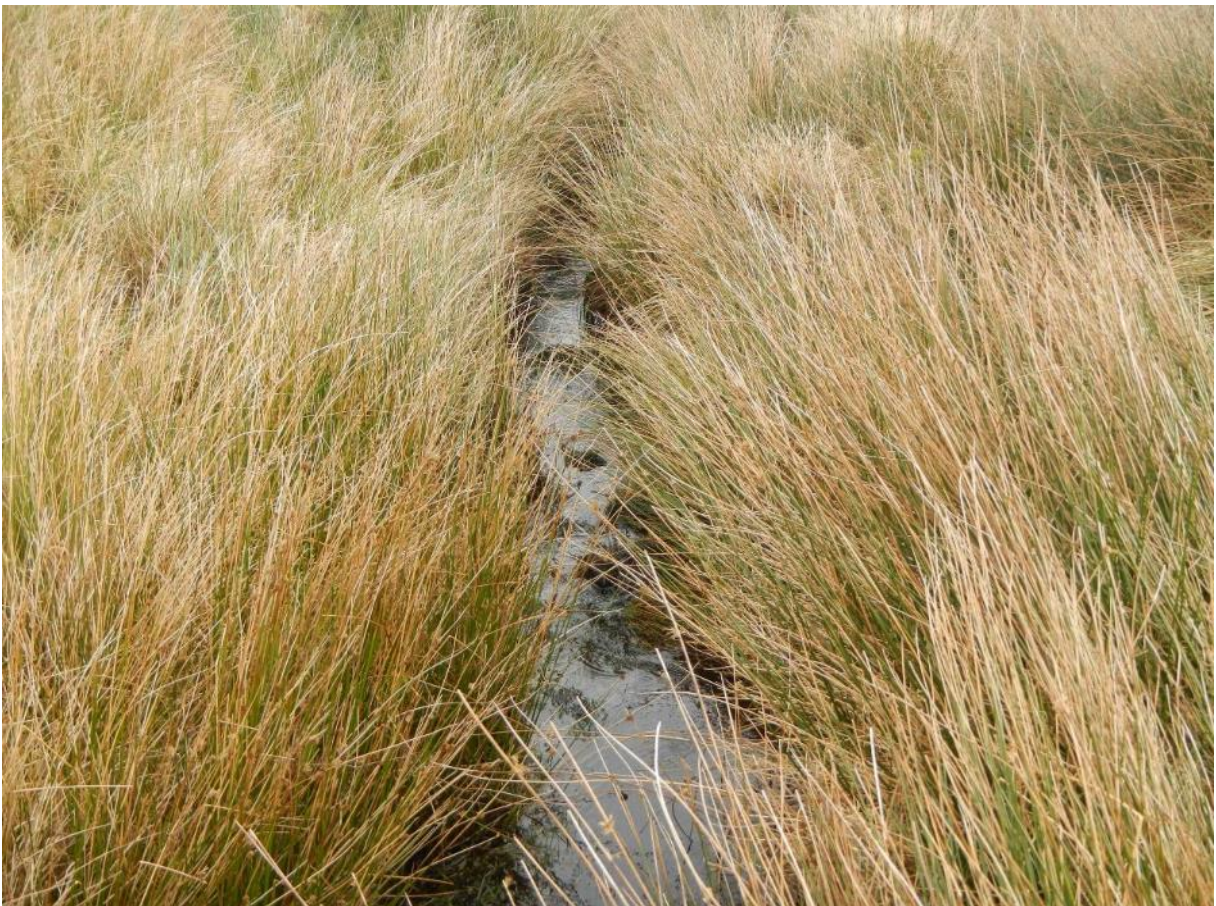
Photo DSCN6176. Grazing pressure appears to be relatively low intensity but is sufficient to limit the bankside vegetation to grasses and rushes (e.g. no herbaceous vegetation or tree regeneration).

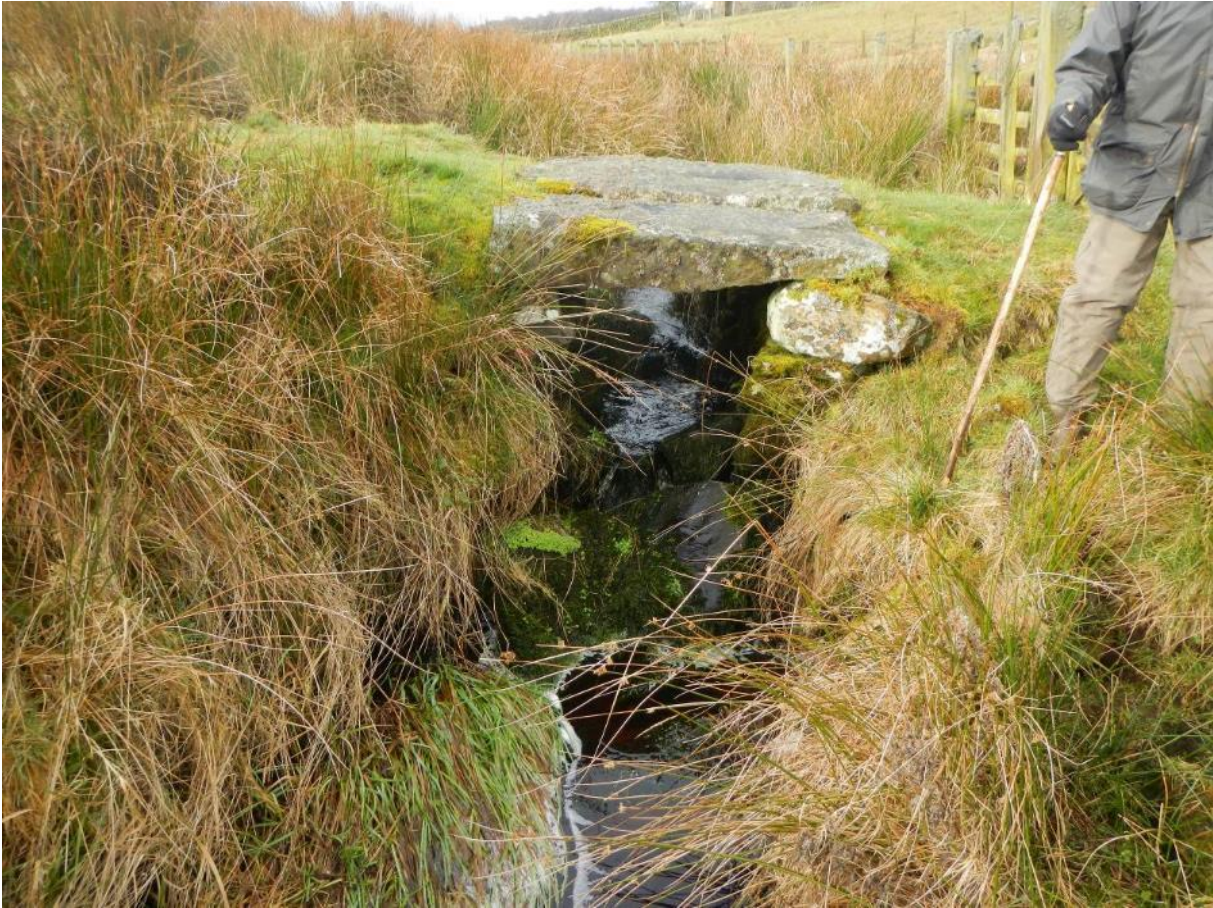
Photo DSCN6177. A small stone bridge creates a small obstruction but is relatively inconsequential.

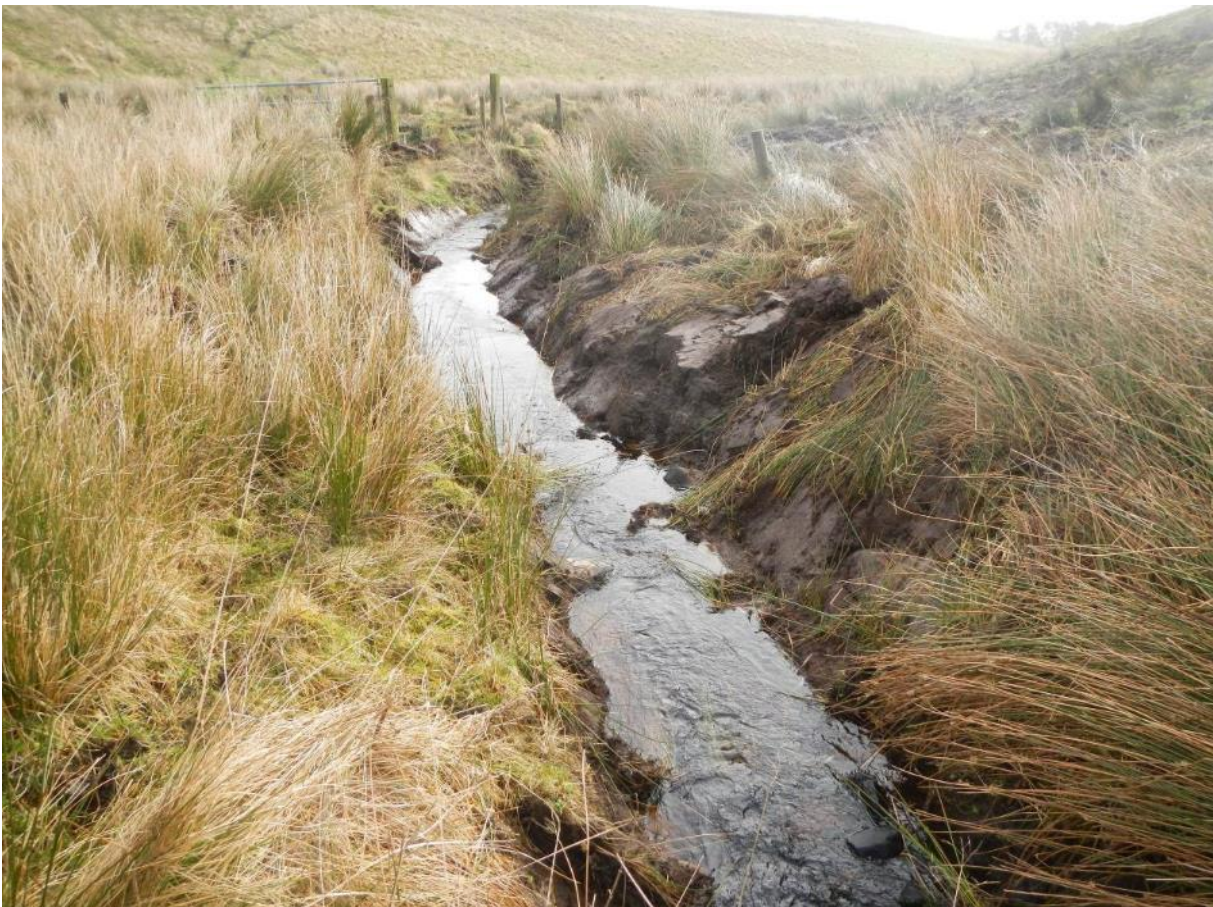
Photo DSCN6178. From NY 81914 67483 - NY 82443 66994, major recent dredging has been undertaken, greatly degrading the channel and liberating large volumes of fine sediment into the burn.

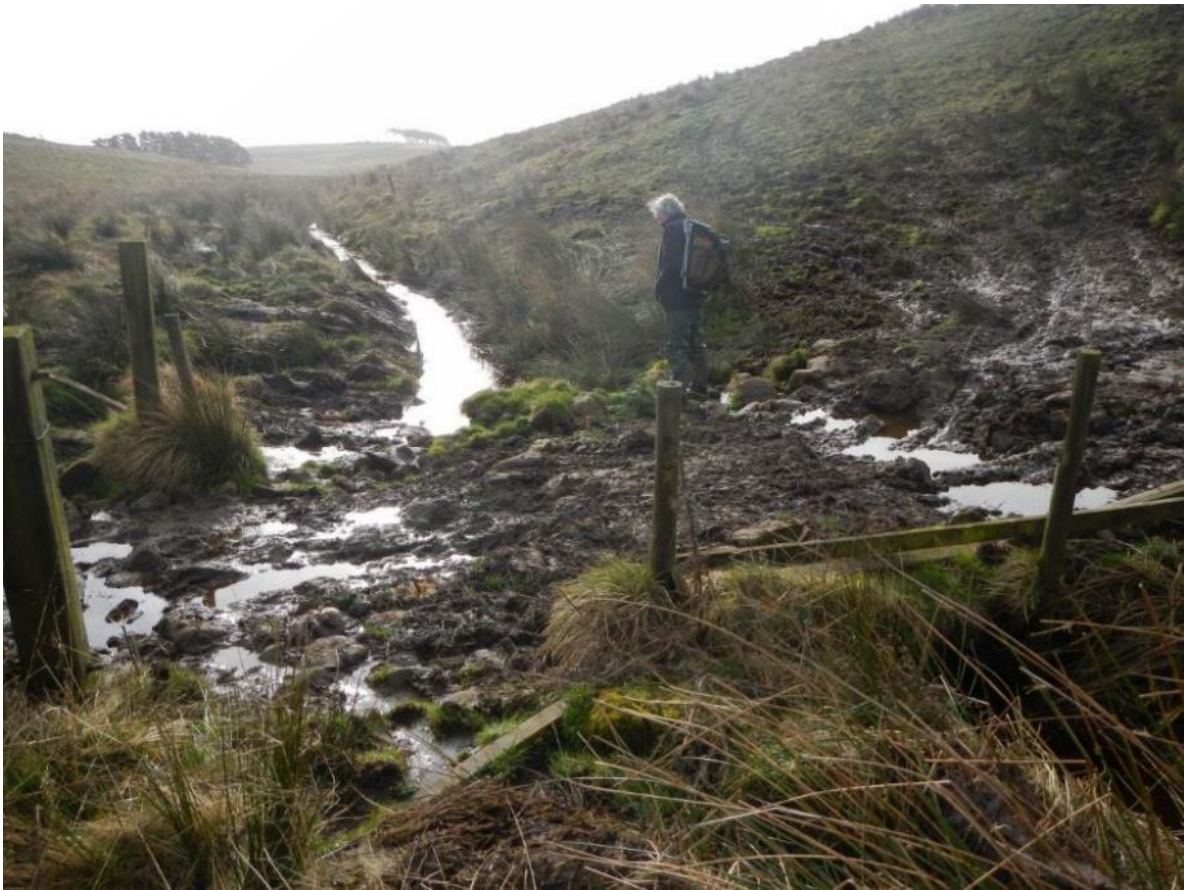
Photo DSCN6179. A crossing point (NY 82063 67465), coupled with poaching and guttering from the connecting track, creates another fine sediment input.

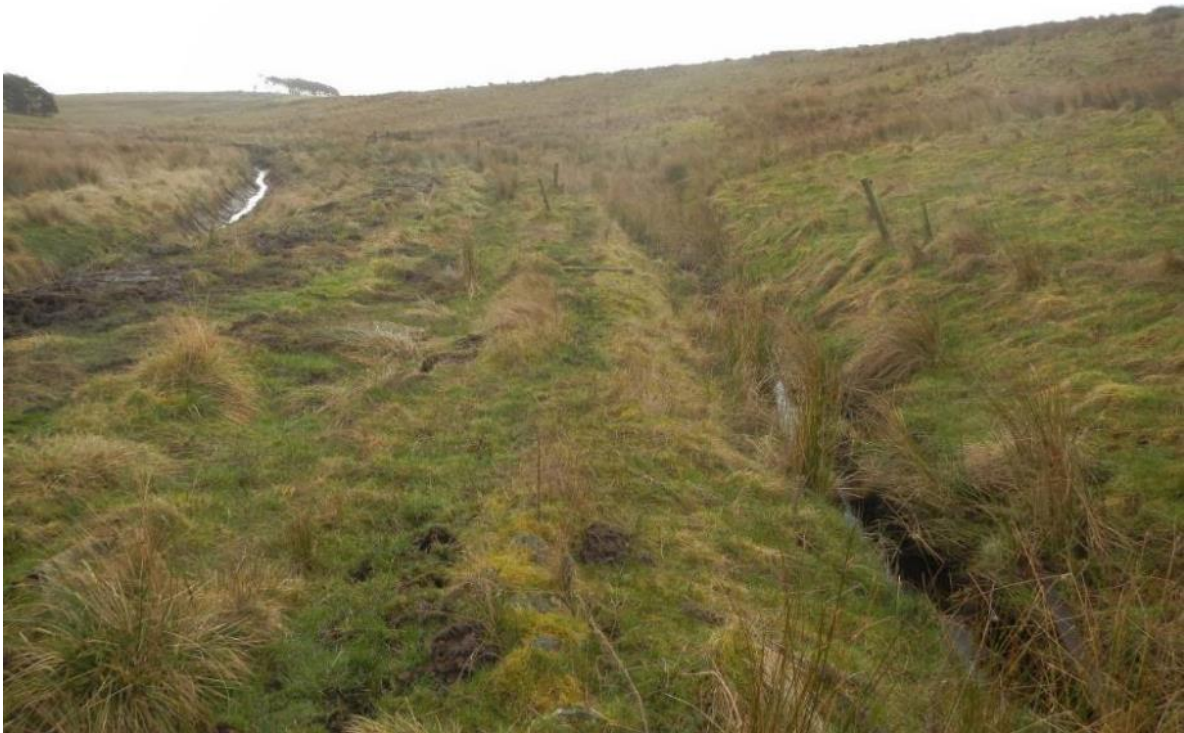
Photo DSCN6187. The current, realigned Honeycrook Burn, adjacent to the old but equally dredged and realigned/straightened channel to the left (see Plan 1). Poor land management practice that is still not achieving the desired outcome. Moving the burn to a more elevated location within the valley means that land between there and the lowest point will be wetted by seepage from the channel.

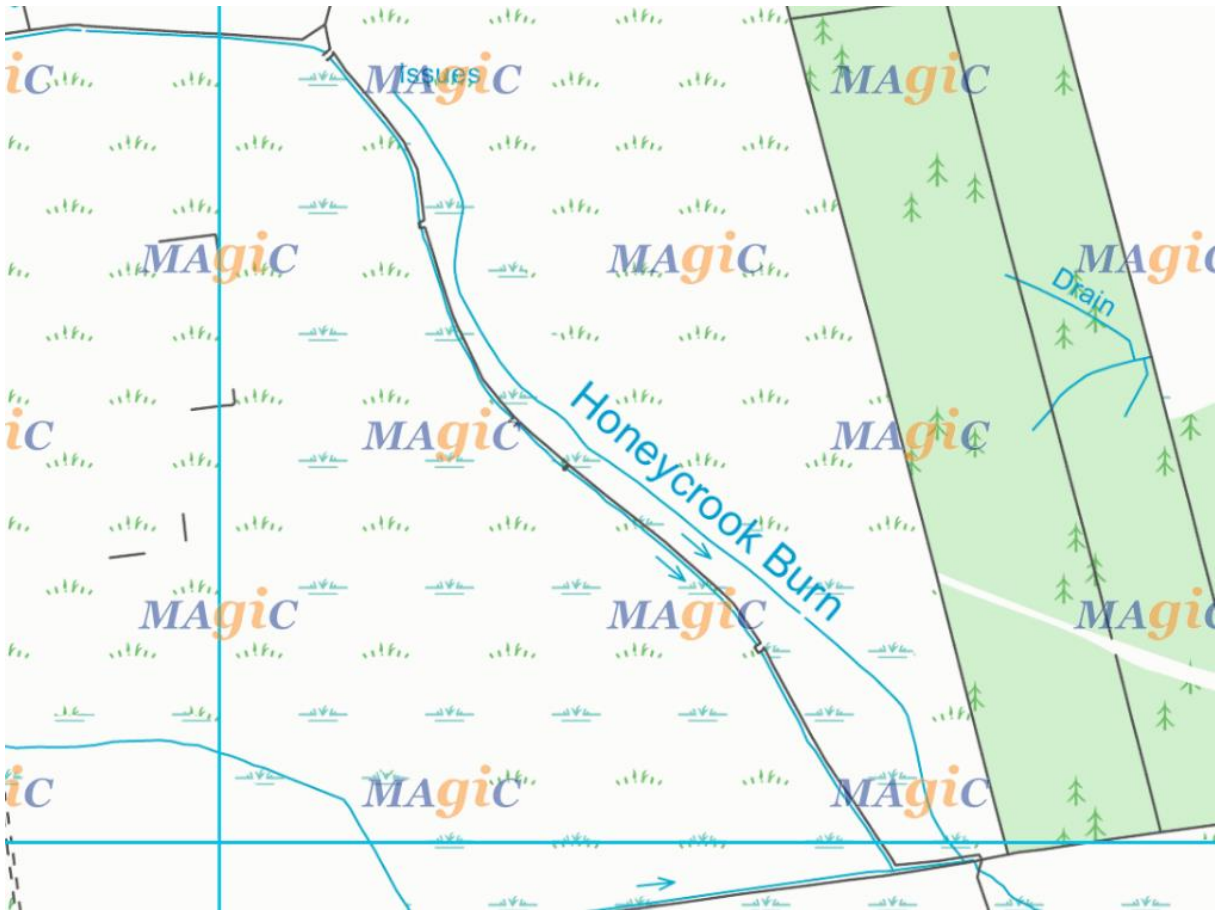
Plan 1. The past (to the right – with the name) and present channel of the upper Honeycrook Burn catchment (Map taken from <http://magic.defra.gov.uk/MagicMap.aspx>).

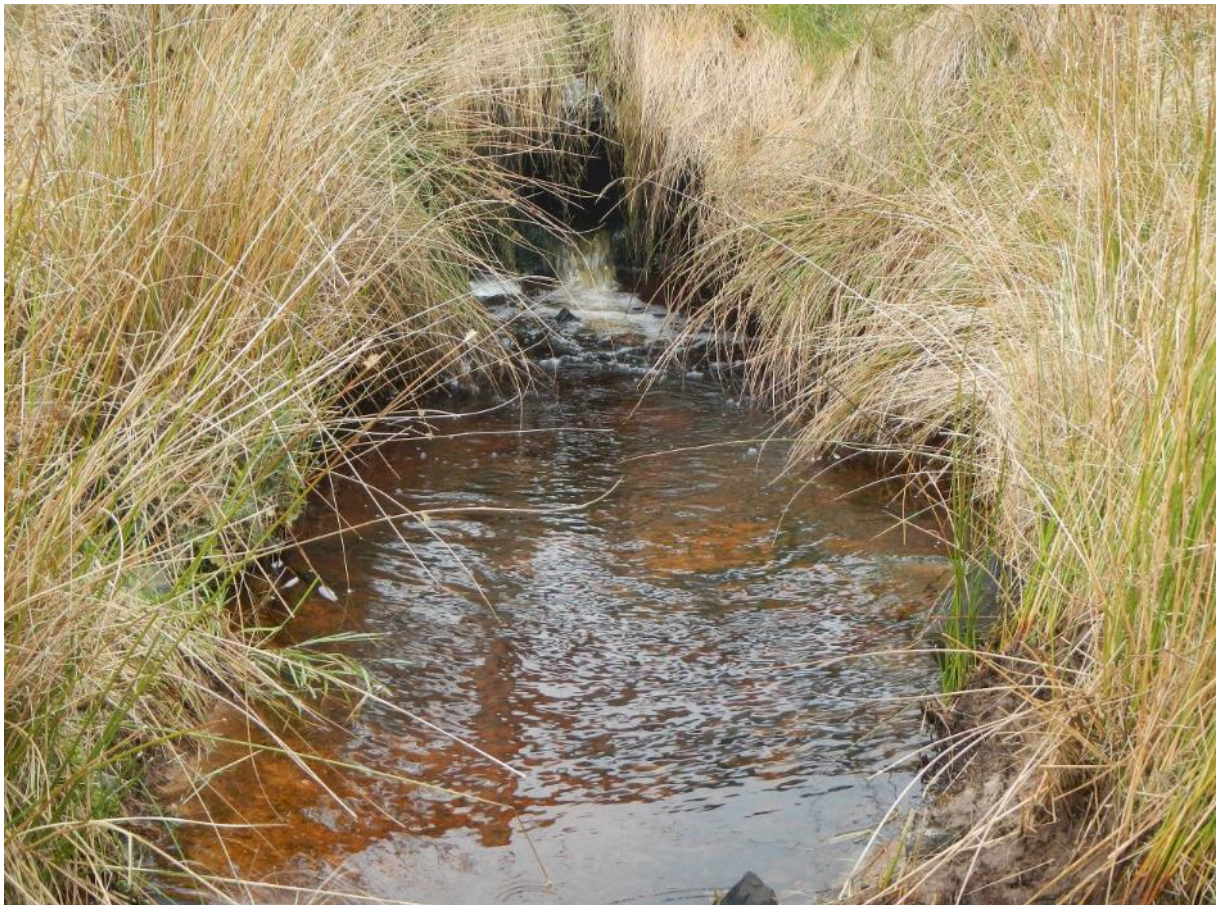
Photo DSCN6190. At NY 82172 67252, a small pipe culvert creates a minor obstruction to fish movement but could have been prevented by simply using a larger diameter, partially sunken pipe.

Obstruction to fish passage at small pipe culvert (NY 82172 67252).	Ideally replace with a larger diameter, partially sunken pipe. This is currently a low priority owing to the poor habitat available. The issue would also be rectified if river restoration is undertaken.	DSCN6190	3
Livestock access d/s of Haresby Lonning (NY 82976 66482 - NY 82990 66176).	Install buffer fencing.	DSCN6226	2
Track crossing and fine sediment input (NY 82894 66096).	Farm advice/install gutters that divert track runoff away to rough ground.	DSCN6247	3
Loss of the majority of the burn underground and very poor fish passage (impassable except in very high flows) which fragments the catchment (NY 82645 65903 - NY 82553 65846).	Further investigation is required but breaking out the underground channel to permanently adopt that route (semi-natural d/s of the underground section) would be the minimal input solution. (further restoration of that channel would also be beneficial). Simply reinstating the main channel would not provide adequate fish passage.	Plan 1, DSCN6254 & DSCN6265	1

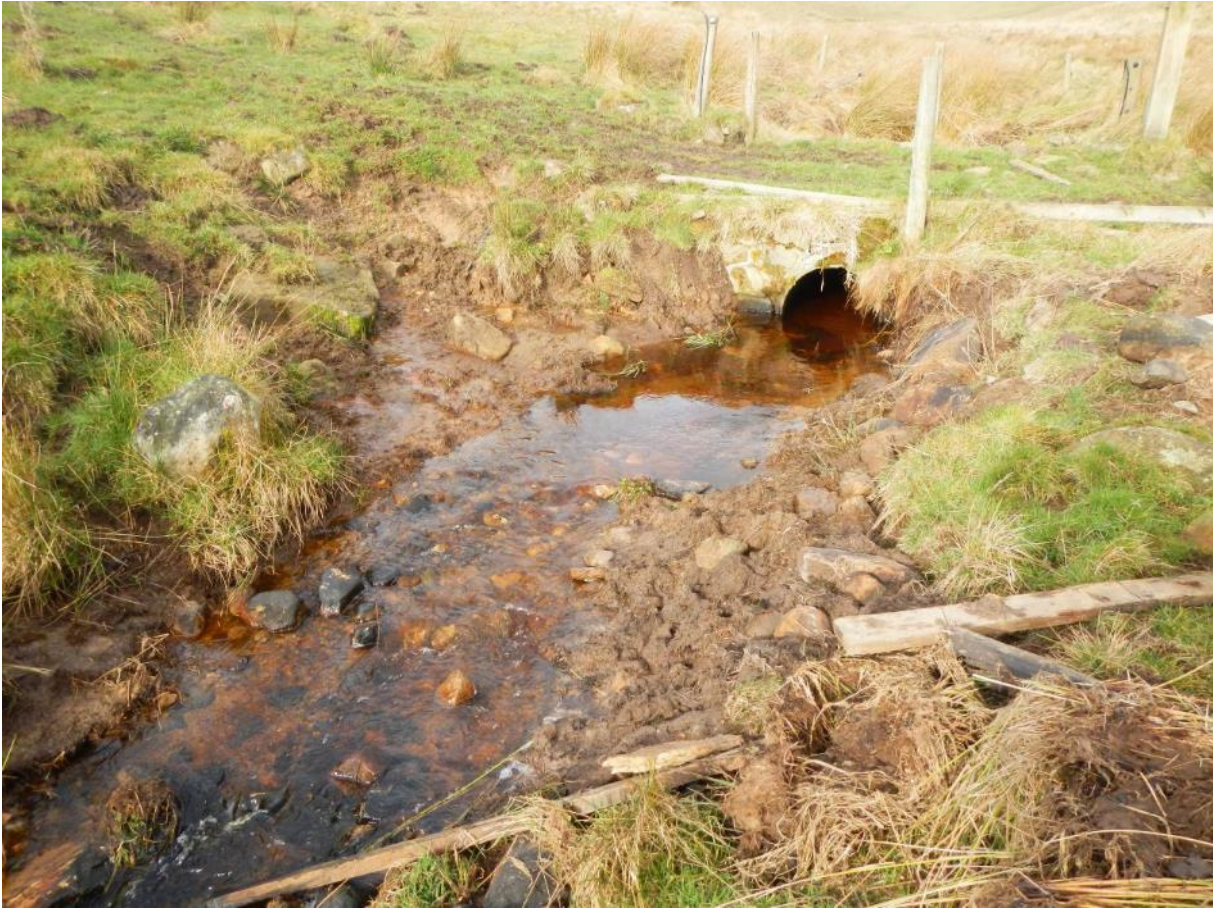
Photo DSCN6191. At NY 82318 67116, a more sympathetically installed culvert creates no obstruction. Poaching and bare bank around the culvert, however, creates a fine sediment input.

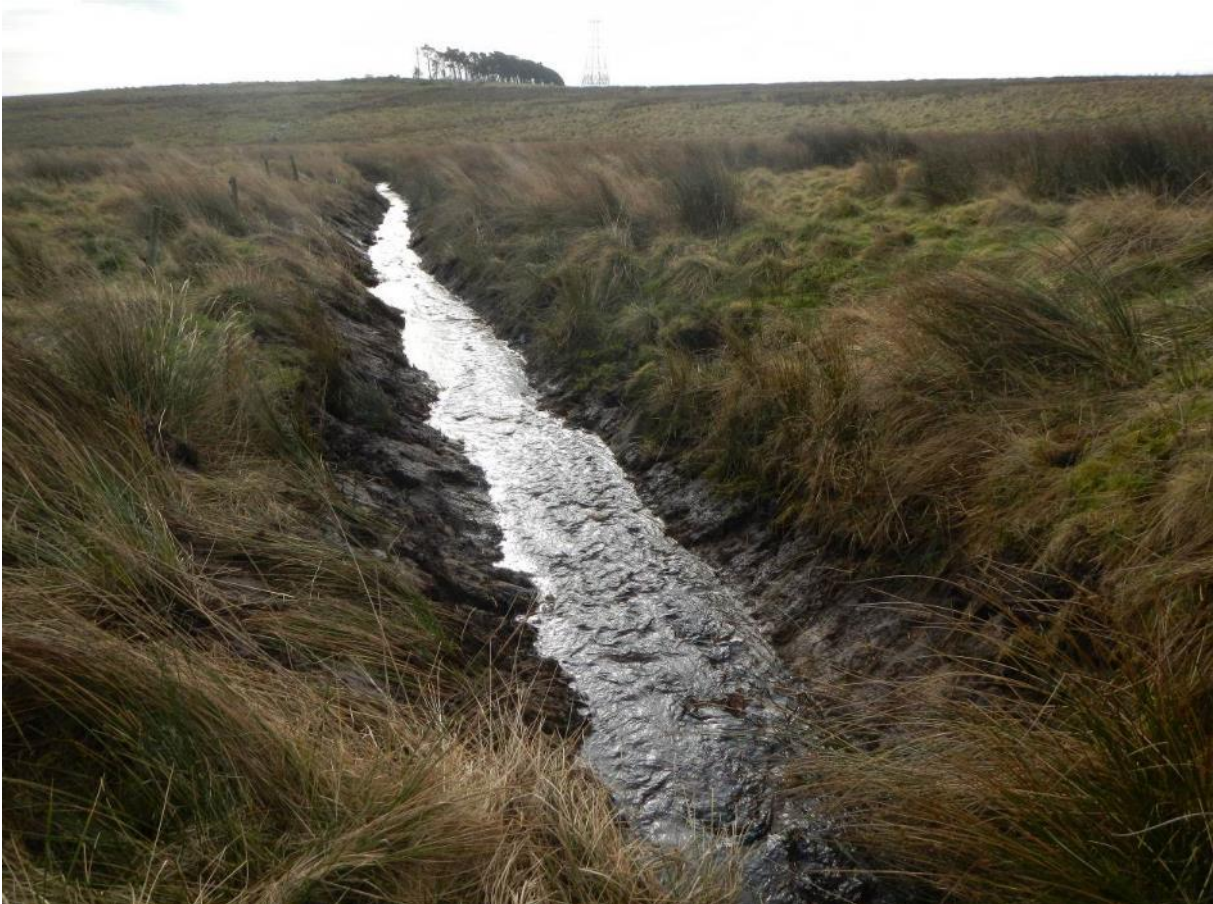
Photo DSCN6192. Further dredging of the straight channel denudes habitat and creates more fine sediment input that will impact upon habitats d/s.

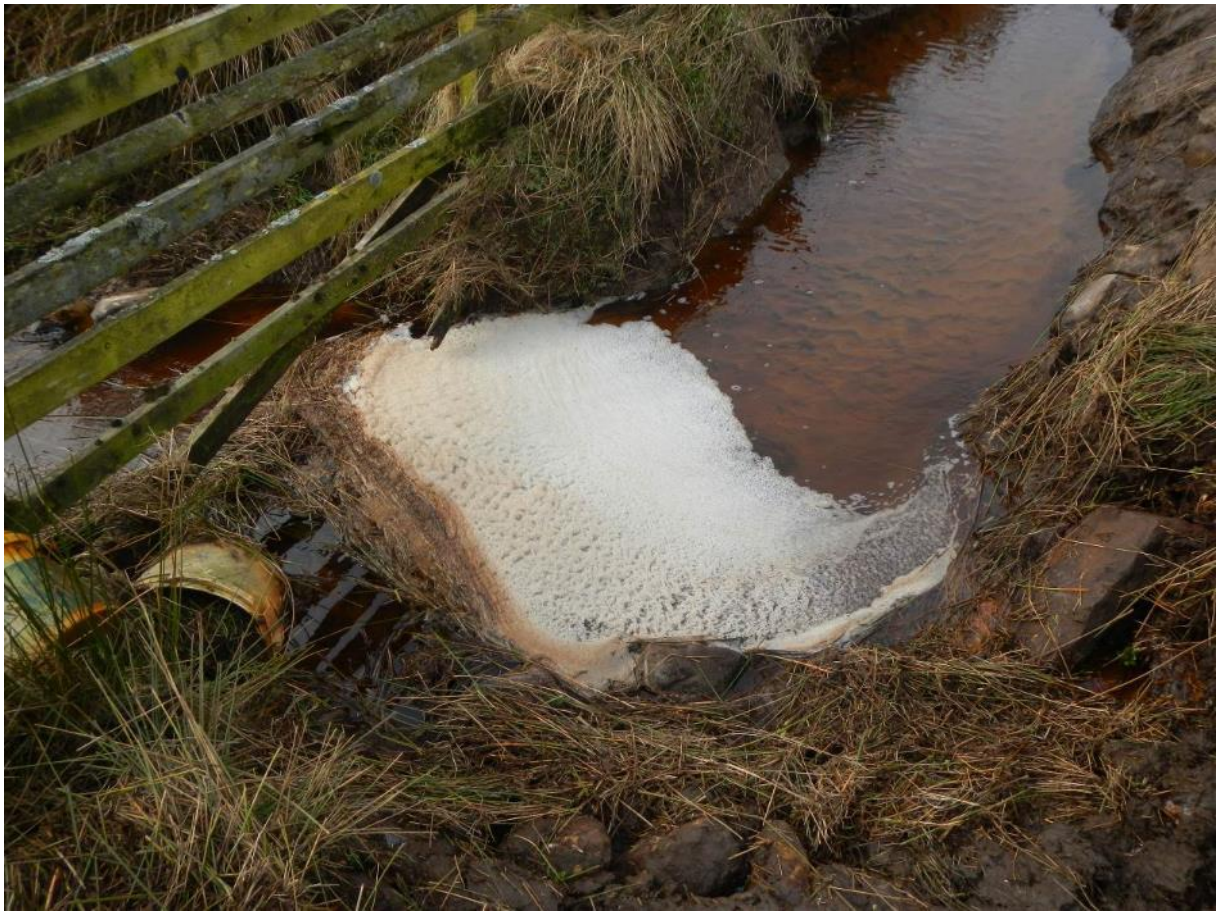
Photo DSCN6198. A perfect example of the fine sediment smothering the bed and nutrients liberated (as observed by the surface foam) by the dredging work.

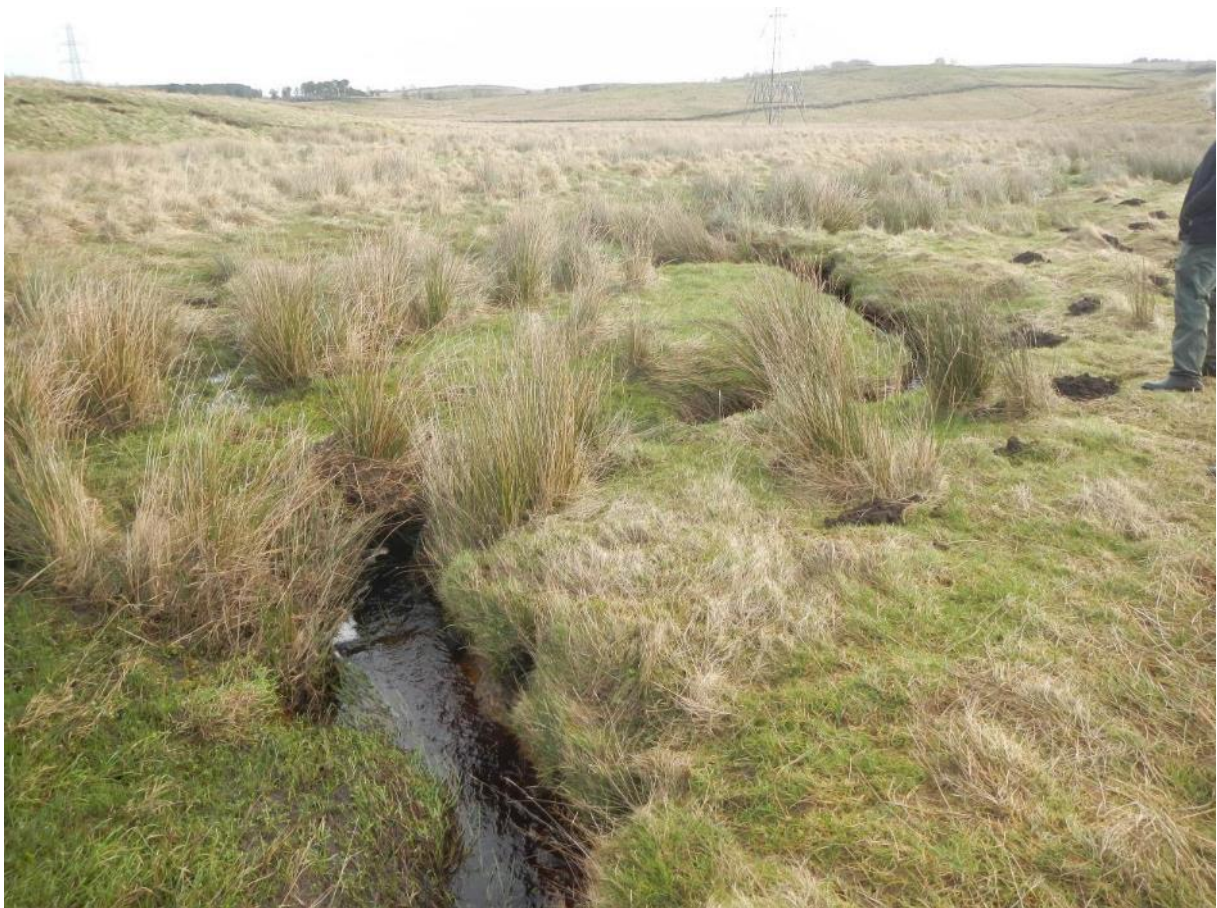
Photo DSCN6202. Further d/s, the channel has greater sinuosity but is still clearly realigned from a natural course. Habitat quality is slightly better, with greater potential to support juvenile salmonids and invertebrates but it is very far from optimal.

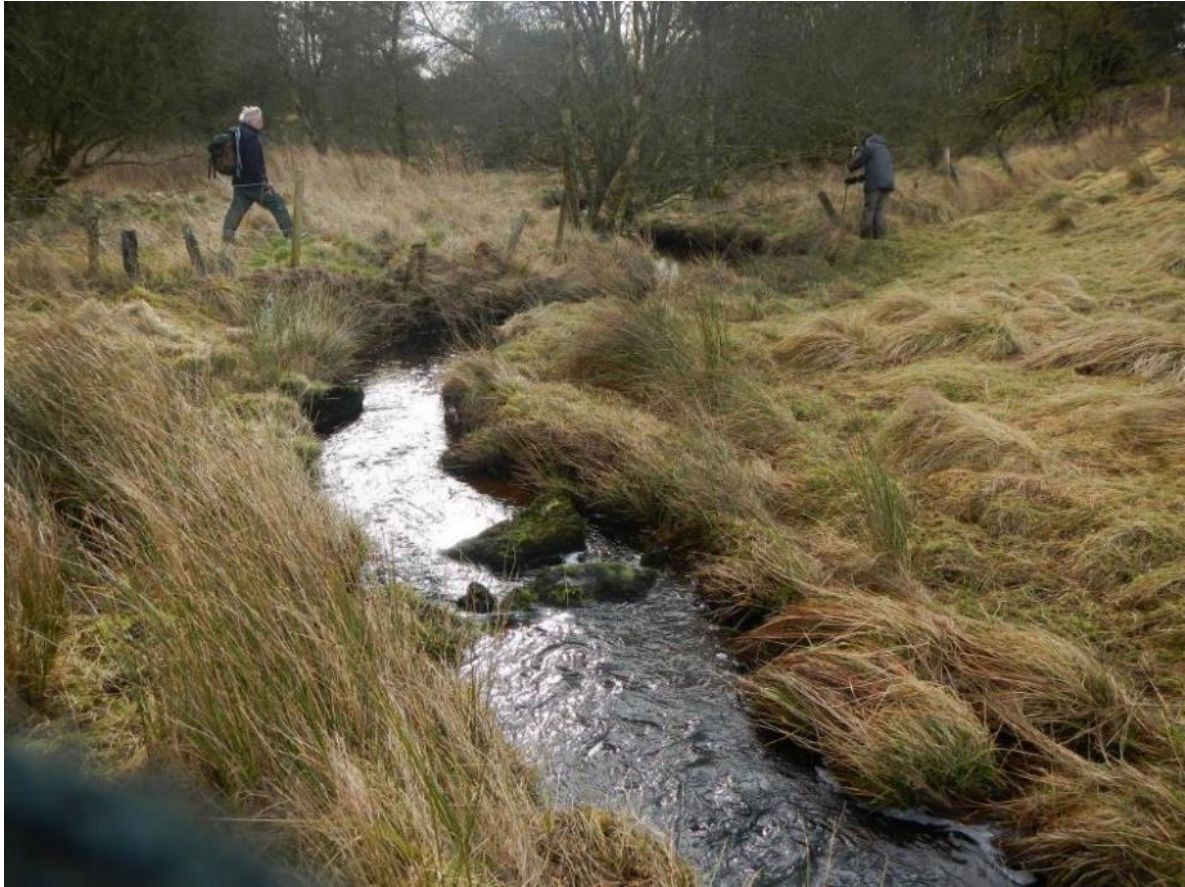
Photo DSCN6214. Further d/s the channel begins to take on a more natural (although still impacted) character. At NY 82958 66655, a stock exclusion fence demarks the start of an area of sparse woodland and historical mine working. As a result, channel planform, habitat quality (including salmonid) are all improved.

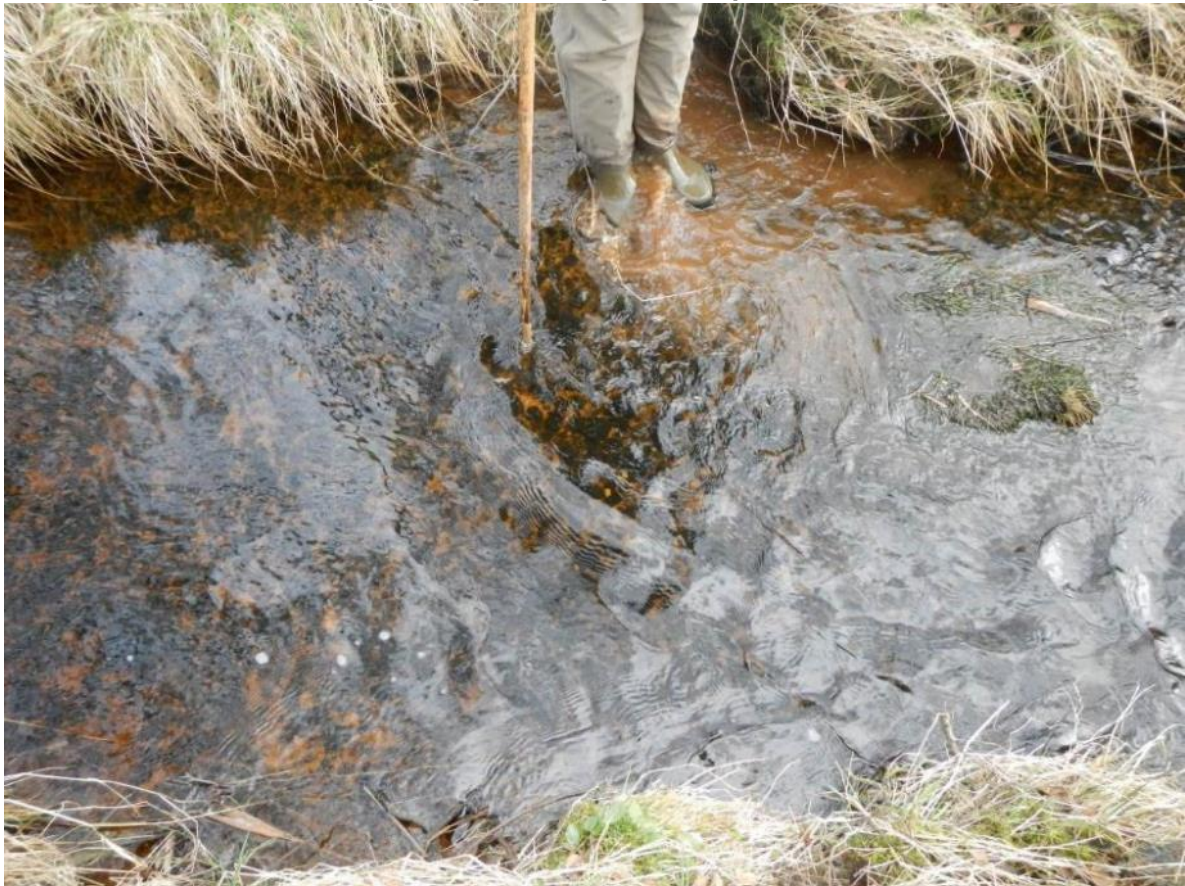
Photo DSCN6221. Although the general habitat quality improves, the substrate quality (undoubtedly impacted by the recent dredging) is poor, limiting its viability for salmonid spawning substrate or invertebrates.

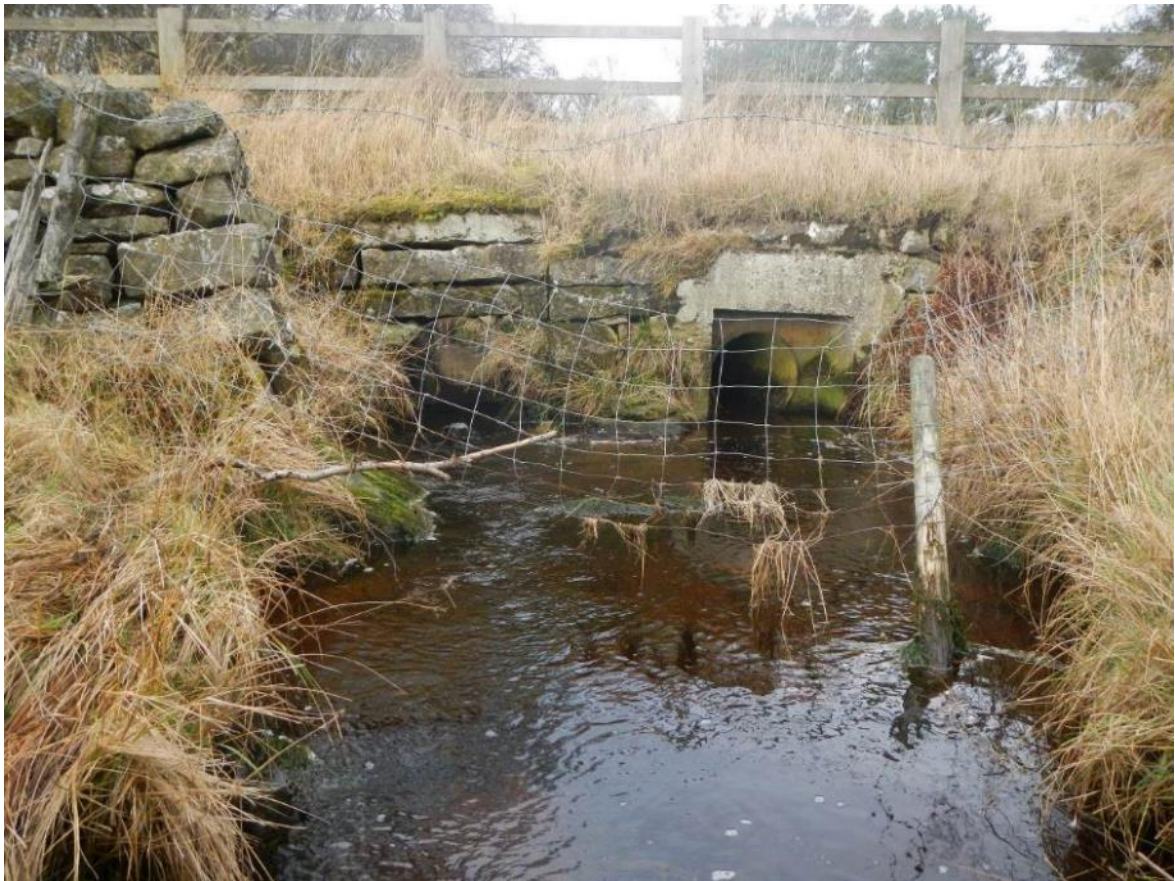
Photo DSCN6225. At NY 82976 66482, the Haresby Lonning (road) crosses the burn, where the burn is piped through two relatively small diameter pipes. While this is far from ideal, the pipes are partially sunken and fish passage at low and medium flows is unlikely to be a major problem. Fluming of high flows may cause some obstruction.

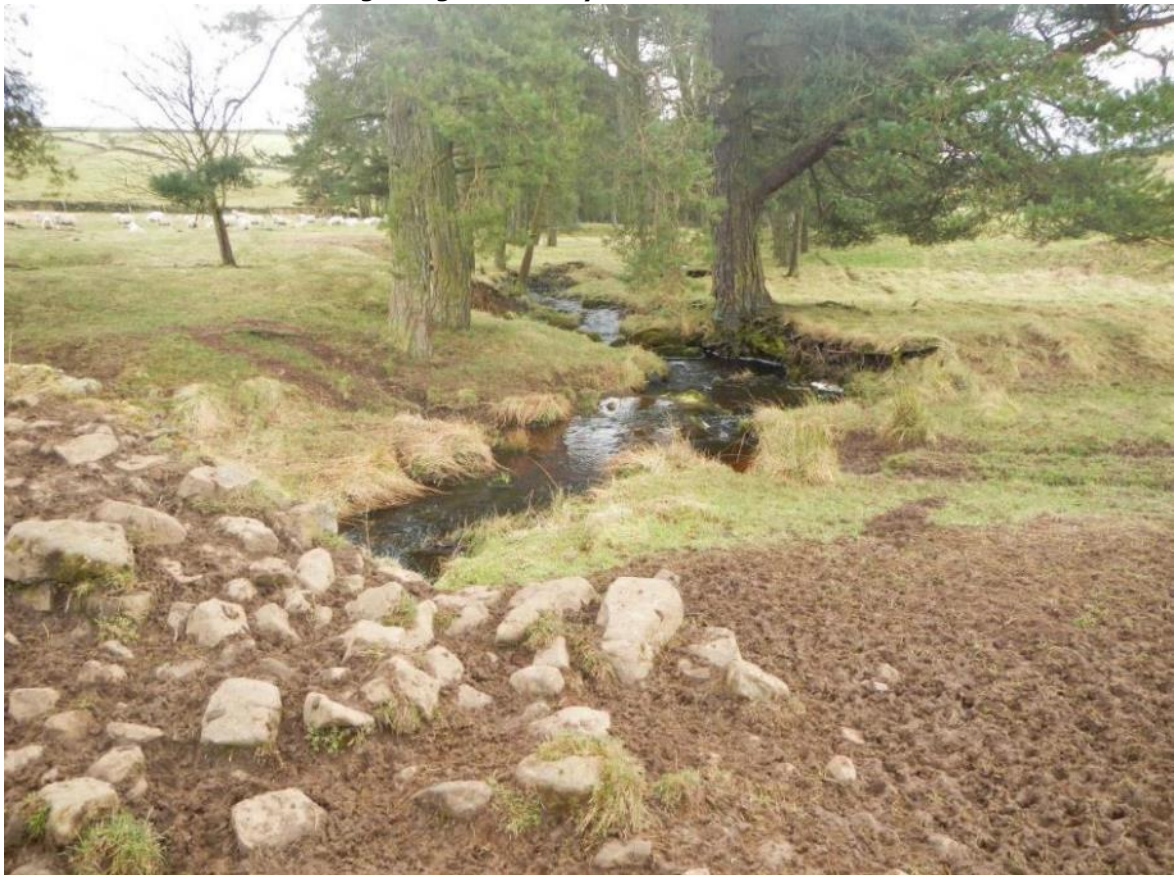
Photo DSCN6226. Although historically straightened d/s of the lonning, the channel is recovering some of its natural sinuosity, with bankside trees improving its diversity, despite being only a short distance u/s of a now defunct dam that would have originally impounded flows. Grazing also resumes d/s of the lonning.

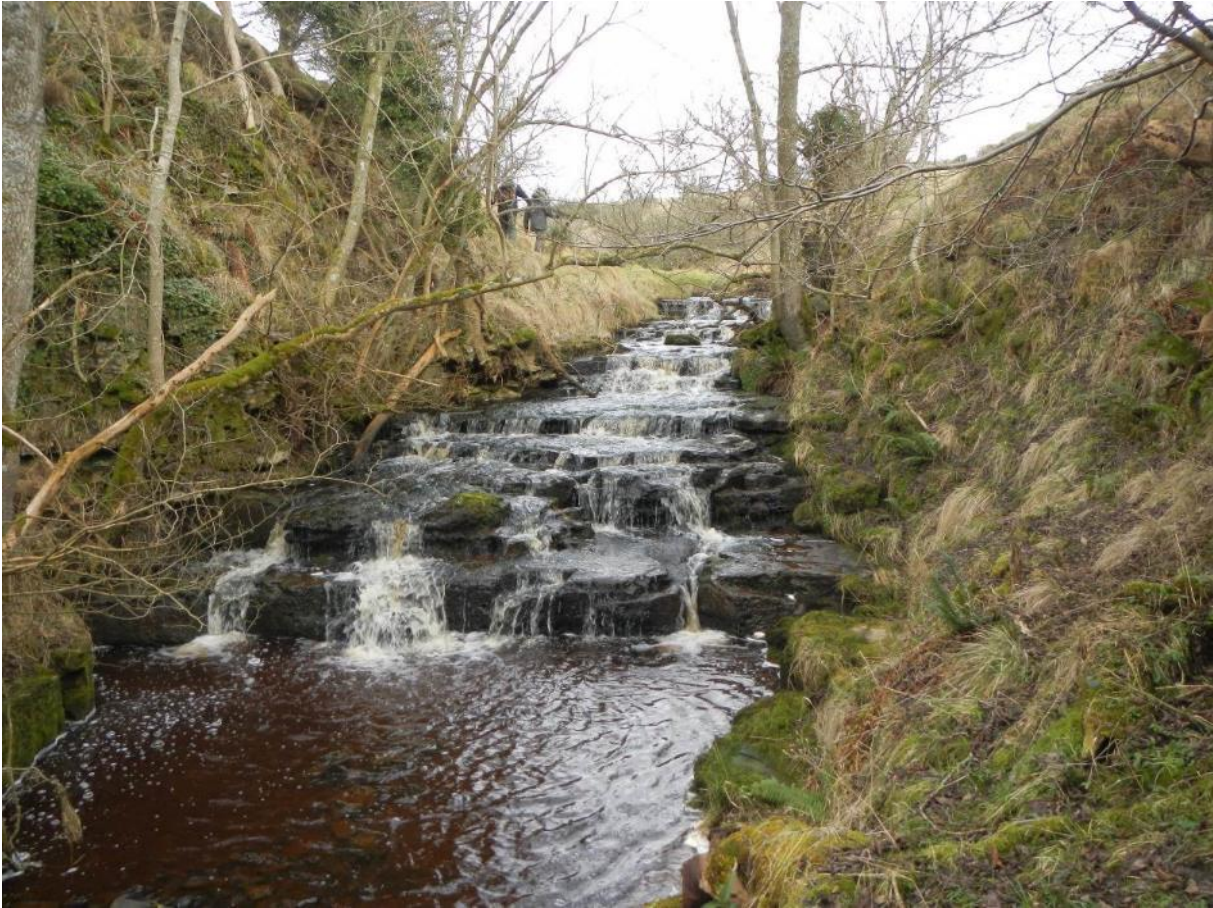
Photo DSCN6239. Further d/s from the old dam site a natural bedrock waterfall/cascade naturally inhibits fish passage (NY 83083 66180). From this point d/s the valley becomes more gorge-like and the channel steeper.

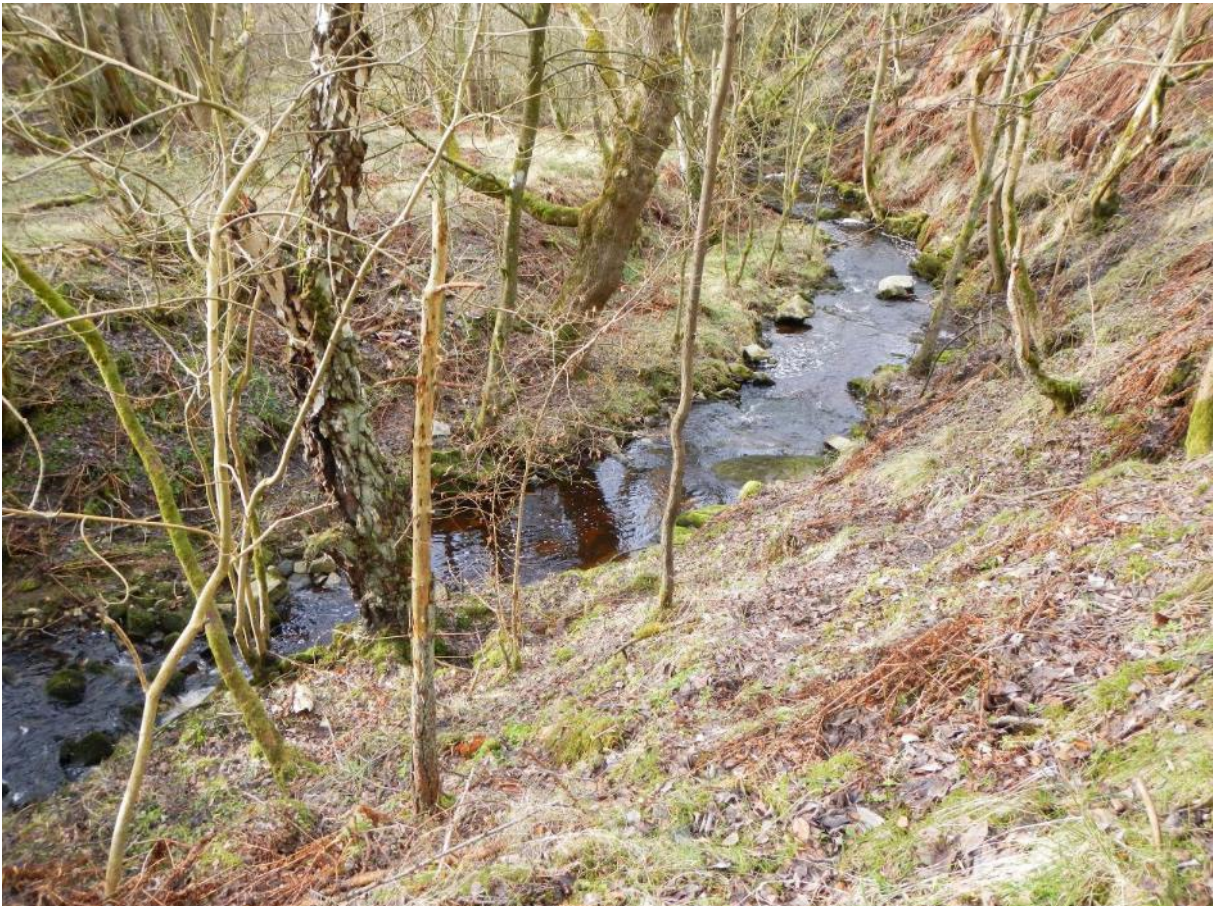
Photo DSCN6249. At NY 82990 66176, the burn enters a wooded section and the impact of the steeper gradient can be seen in the character of the burn.
