Walkover Report
Honeycrook Burn
(River Tyne Catchment)
21/02/2017

Undertaken by Gareth Pedley, Wild Trout Trust

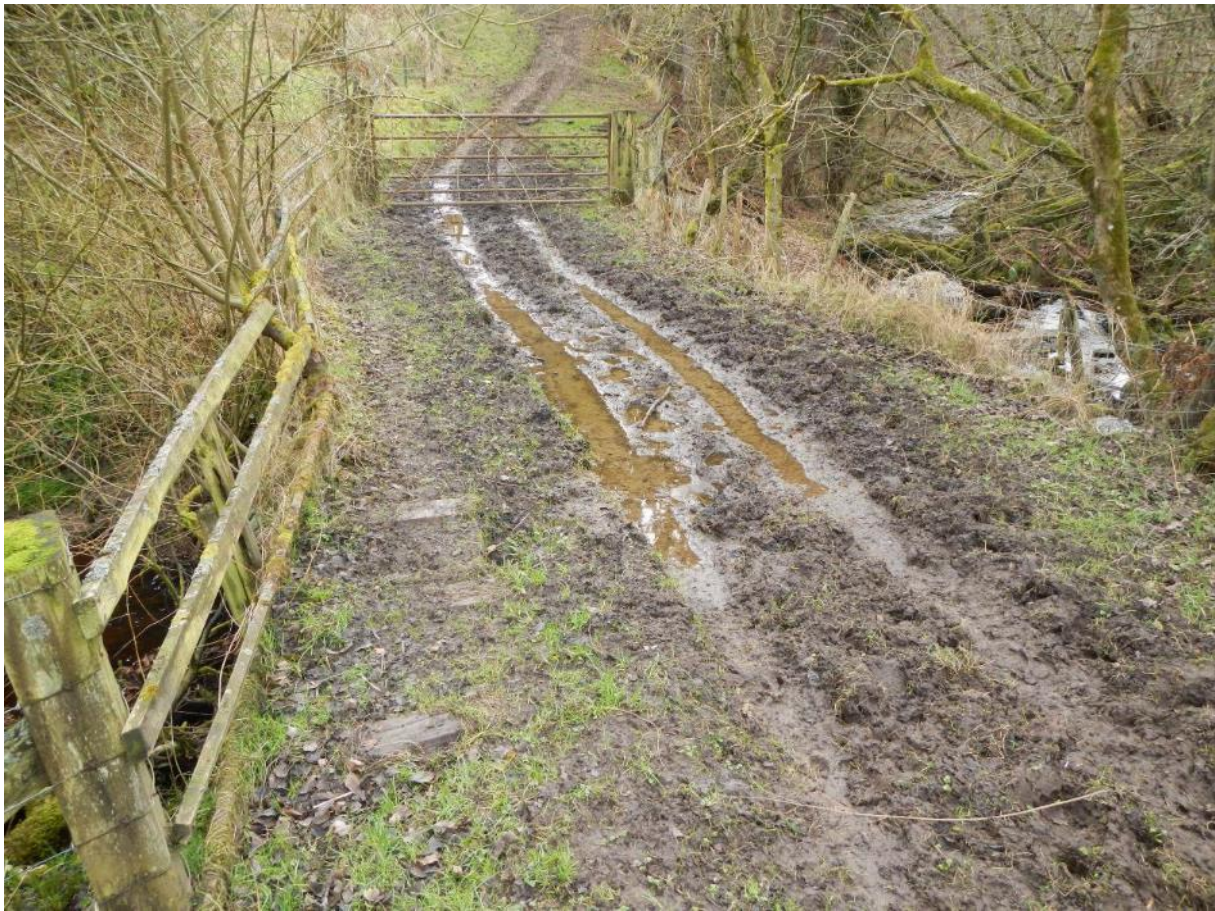
Photo DSCN6247. A track crossing at NY 82894 66096 creates another fine sediment input to the burn, with the track/wheel ruts channelling surface water and fine sediment runoff.

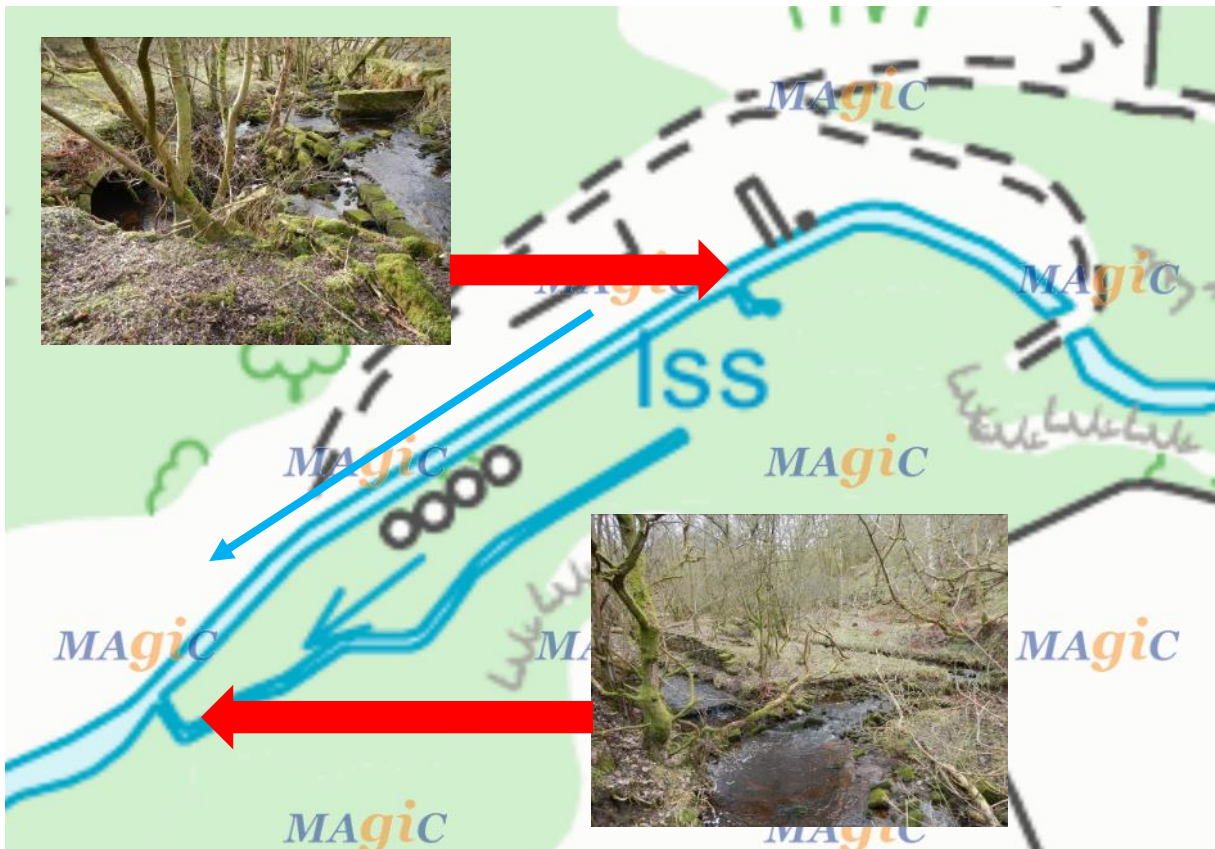
Plan 1. Within the wood, more obvious past mine workings create a major impact upon the burn. In addition to straightening/realignment the flow has historically been split between two channels: The main, straight, cobble-lined surface channel and a parallel (partially underground) channel which is fed off through the LB via a bricked culvert. Due to degradation of the channels, the majority of the flow now passes via the underground channel.

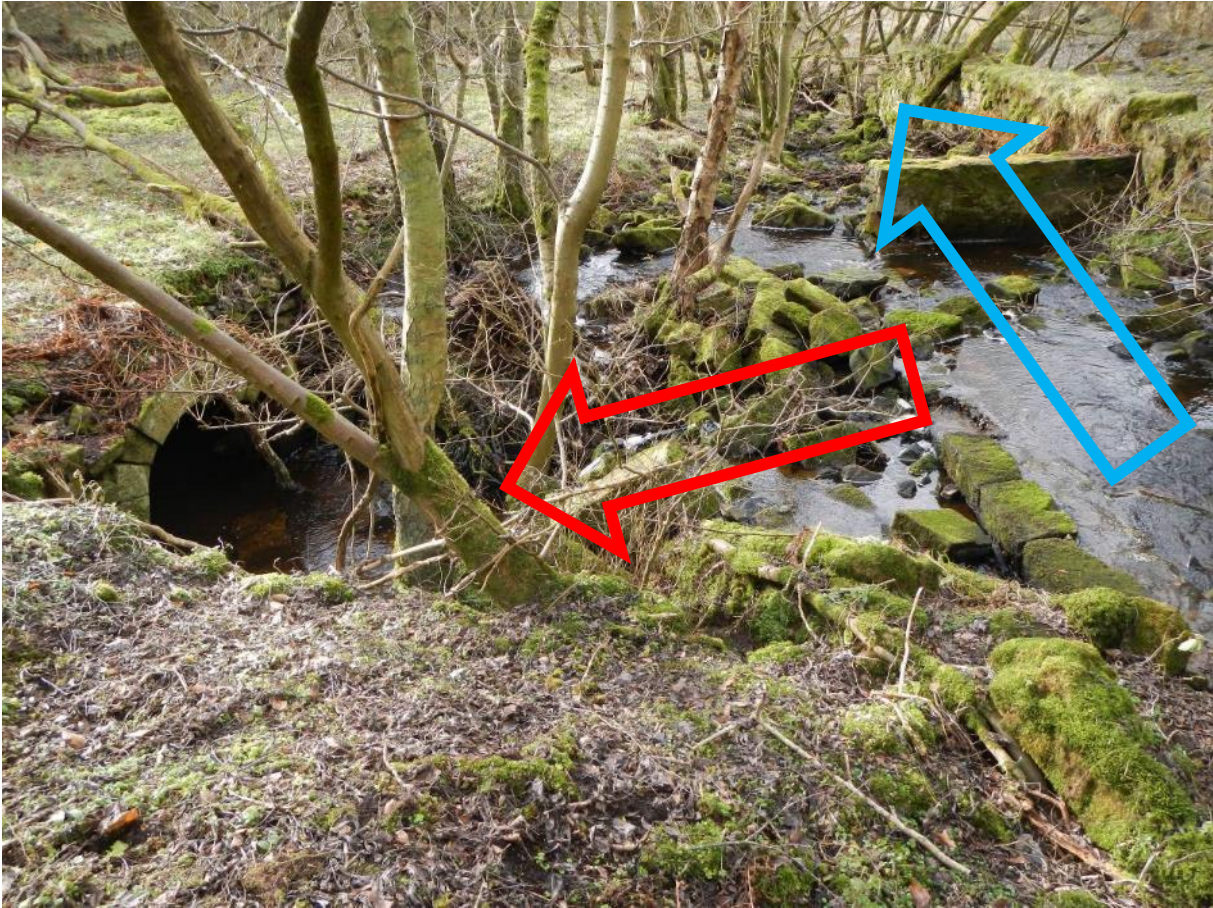
Photo DSCN6254. The offtake at NY 82645 65903, where the historical main channel (blue arrow) loses the majority of its flow to the side channel (green arrow). Neither the original main channel (concrete lined and steep) nor the current main flow channel (underground) could provide adequate fish passage. Major work is required at this site but, owing to the dilapidated nature of the structures and space available, significant improvements are likely to be easily possible.

Obstruction to fish passage at small pipe culvert (NY 82172 67252).	Ideally replace with a larger diameter, partially sunken pipe. This is currently a low priority owing to the poor habitat available. The issue would also be rectified if river restoration is undertaken.	DSCN6190	3
Livestock access d/s of Haresby Lonning (NY 82976 66482 - NY 82990 66176).	Install buffer fencing.	DSCN6226	2
Track crossing and fine sediment input (NY 82894 66096).	Farm advice/install gutters that divert track runoff away to rough ground.	DSCN6247	3
Loss of the majority of the burn underground and very poor fish passage (impassable except in very high flows) which fragments the catchment (NY 82645 65903 - NY 82553 65846).	Further investigation is required but breaking out the underground channel to permanently adopt that route (semi-natural d/s of the underground section) would be the minimal input solution. (further restoration of that channel would also be beneficial). Simply reinstating the main channel would not provide adequate fish passage.	Plan 1, DSCN6254 & DSCN6265	1

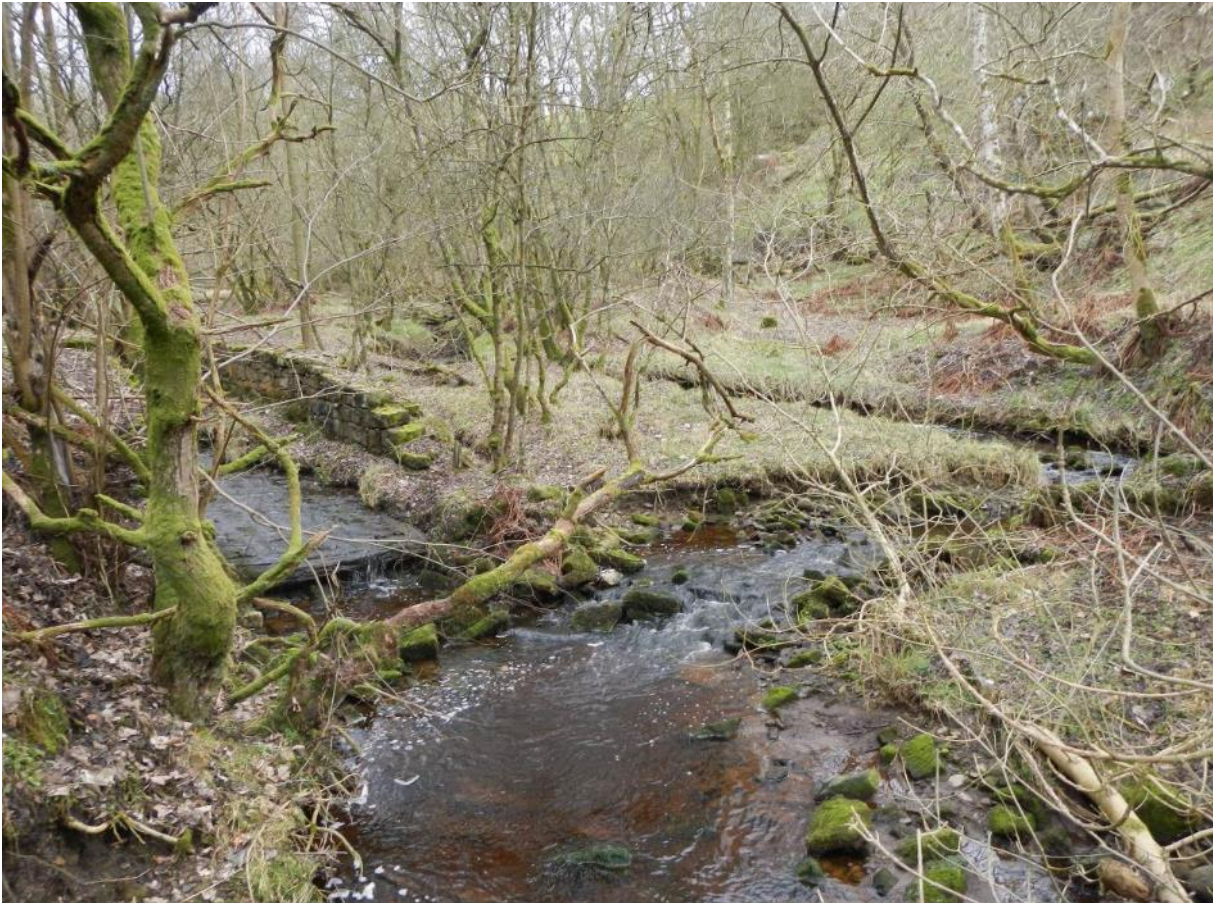
Photo DSCN6265. Looking u/s at the point eh two channels re-join (NY 82553 65846).

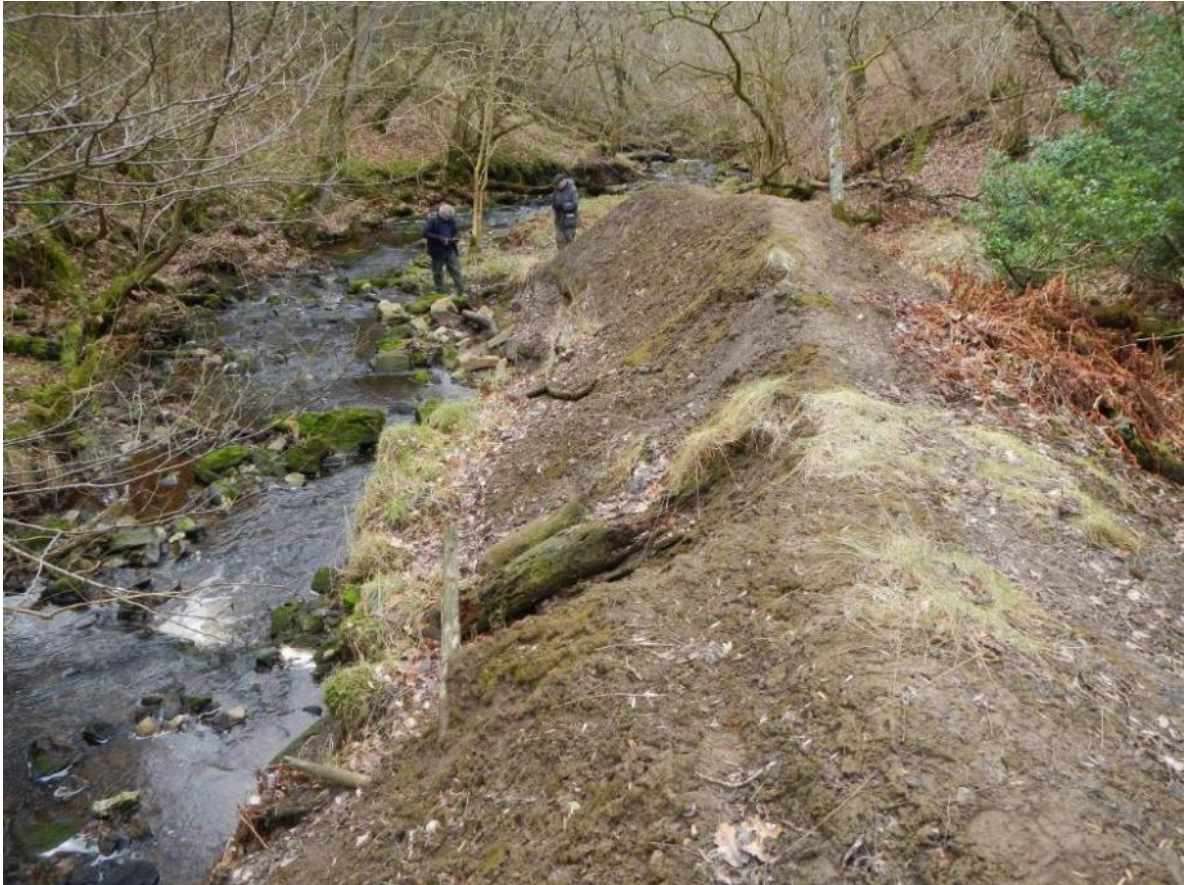
Photo DSCN6272. A short distance d/s of the mine workings (NY 82477 65812) un-vegetated mounds were observed that appeared to have recently deposited. This is, however, impossible as mature saplings prevent vehicular access, suggesting that they are old mounds of potentially contaminated material that cannot be effectively colonised by vegetation. High flows may well be sufficient to wash off any shallow rooted vegetation that tries to establish.

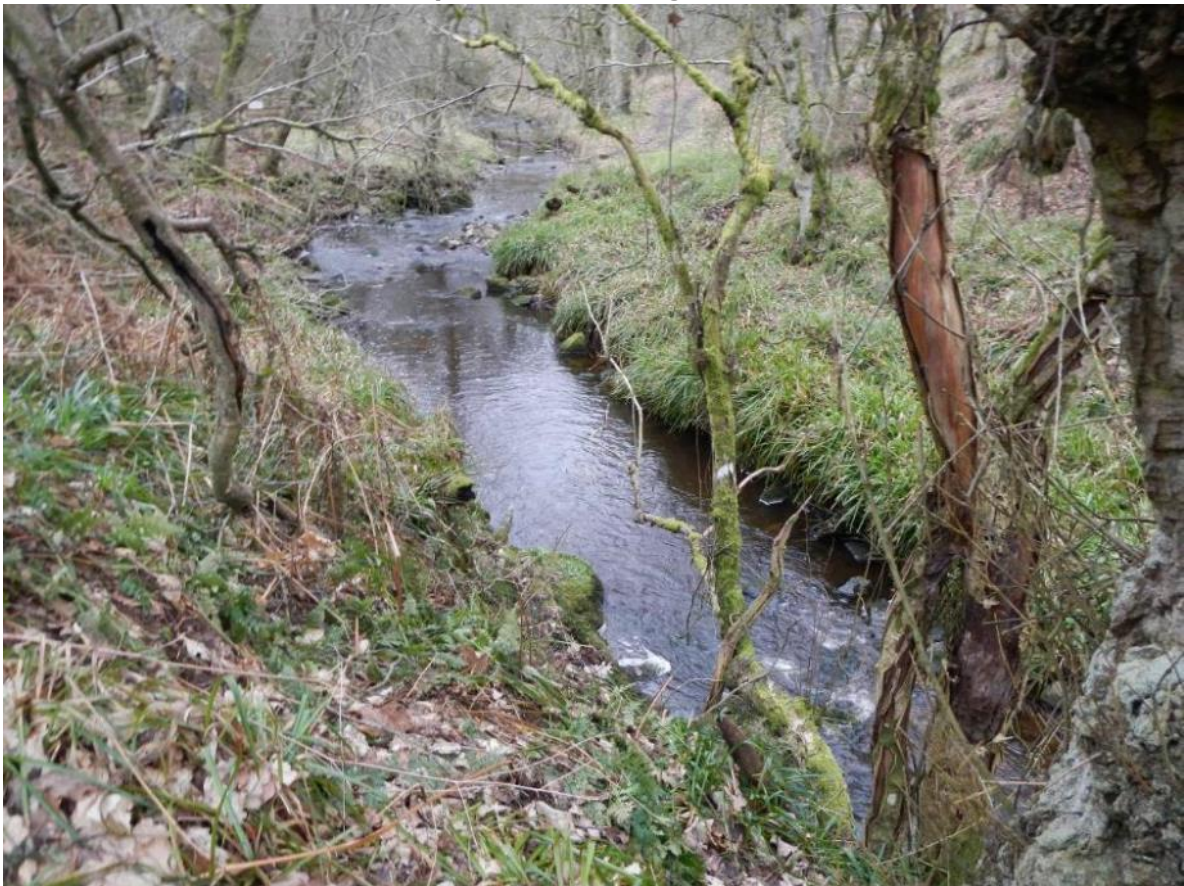
Photo DSCN6276. The valley opens slightly d/s and the channel gradient decreases, providing improved resident and juvenile salmonid habitat.

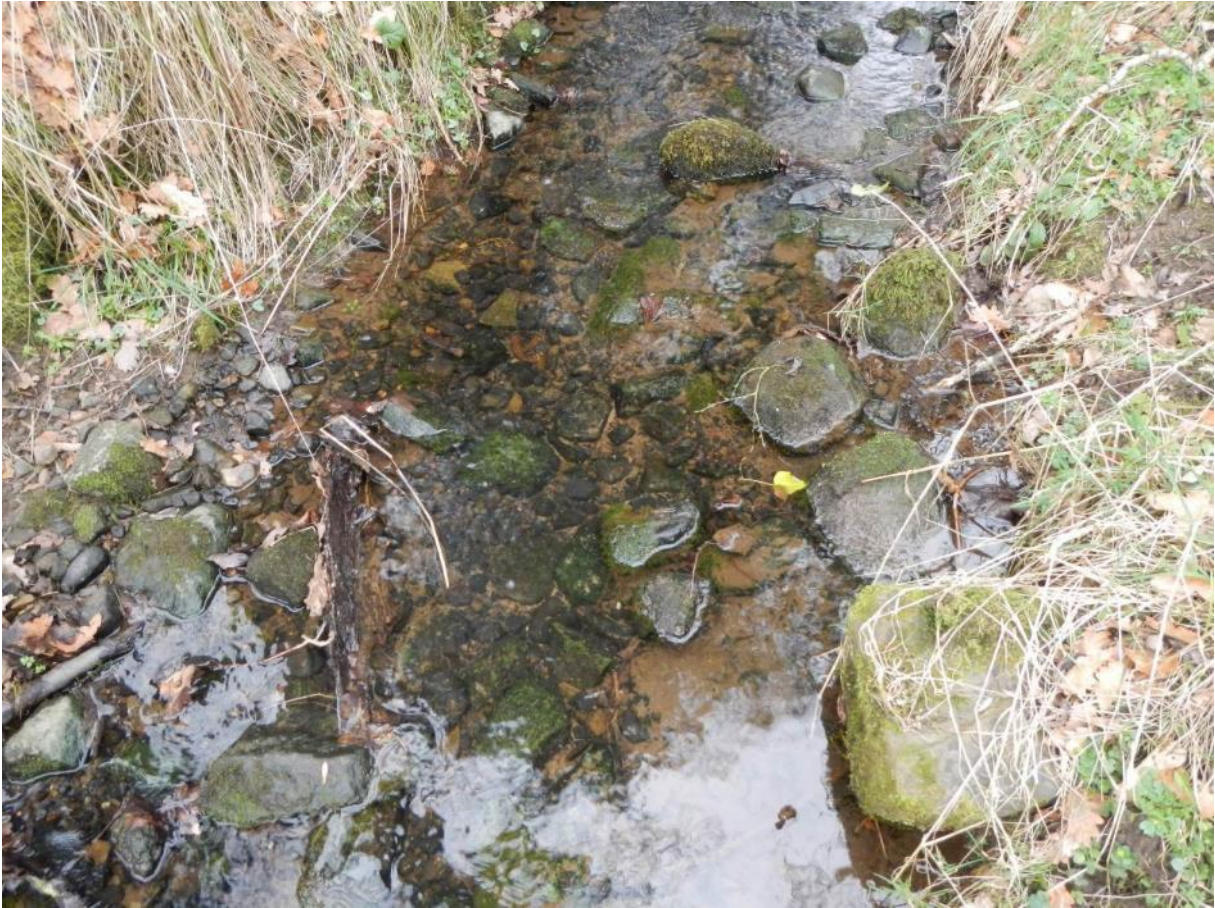
Photo DSCN6279. A small tributary entering the burn at NY 82280 65708 shows signs of increased fine sediment input that limit its value as invertebrate and salmonid habitat.

Elevated fine sediment within tributary (NY 82280 65708).	Investigate possible sources u/s. Relatively low priority owing to small size.	DSCN6279	3
Small weir within Tony's Patch Nature Reserve (NY 82239 65641) which impedes fish passage.	Remove weir to reinstate sediment transport and fish passage. A quick and easy win, possible with volunteers.	DSCN6284	1
Grazing without buffer fence – reduced vegetation and increased bank erosion (NY 82222 65425 – NY 82290 64956).	Install buffer fencing. An area of reasonable quality channel would be improved.	DSCN6303	2
Concrete/stone-lined channel with poor fish passage (NY 82229 64946 and NY 82165 64898).	Investigate purpose of reinforcement and, if possible, break out the bed to allow a natural channel to develop.	DSCN6325	1

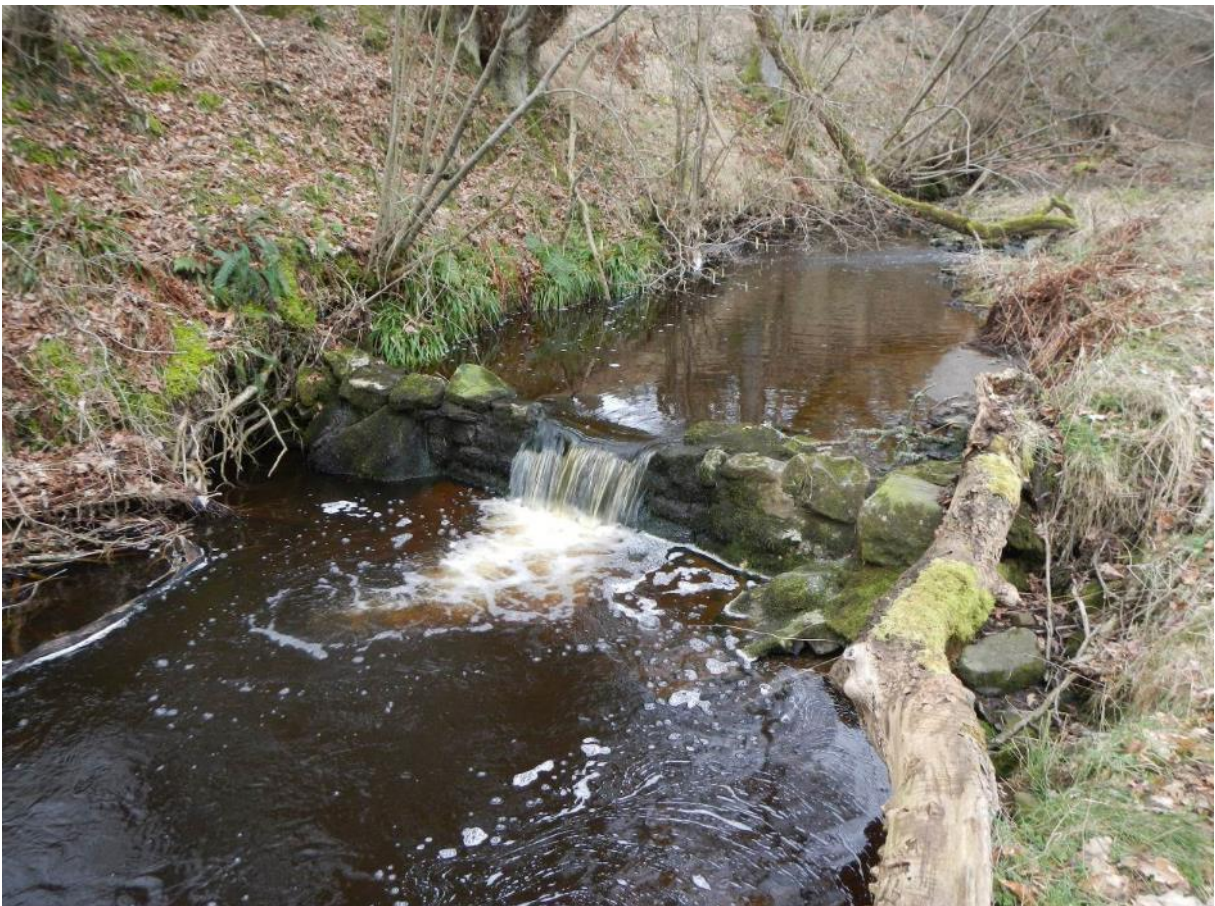
Photo DSCN. A small weir within Tony's Patch Nature Reserve (NY 82239 65641) poses an unnecessary and significant obstacle to fish passage. A small structure like this could be easily removed by a group of volunteers, to reinstate habitat quality and connectivity.

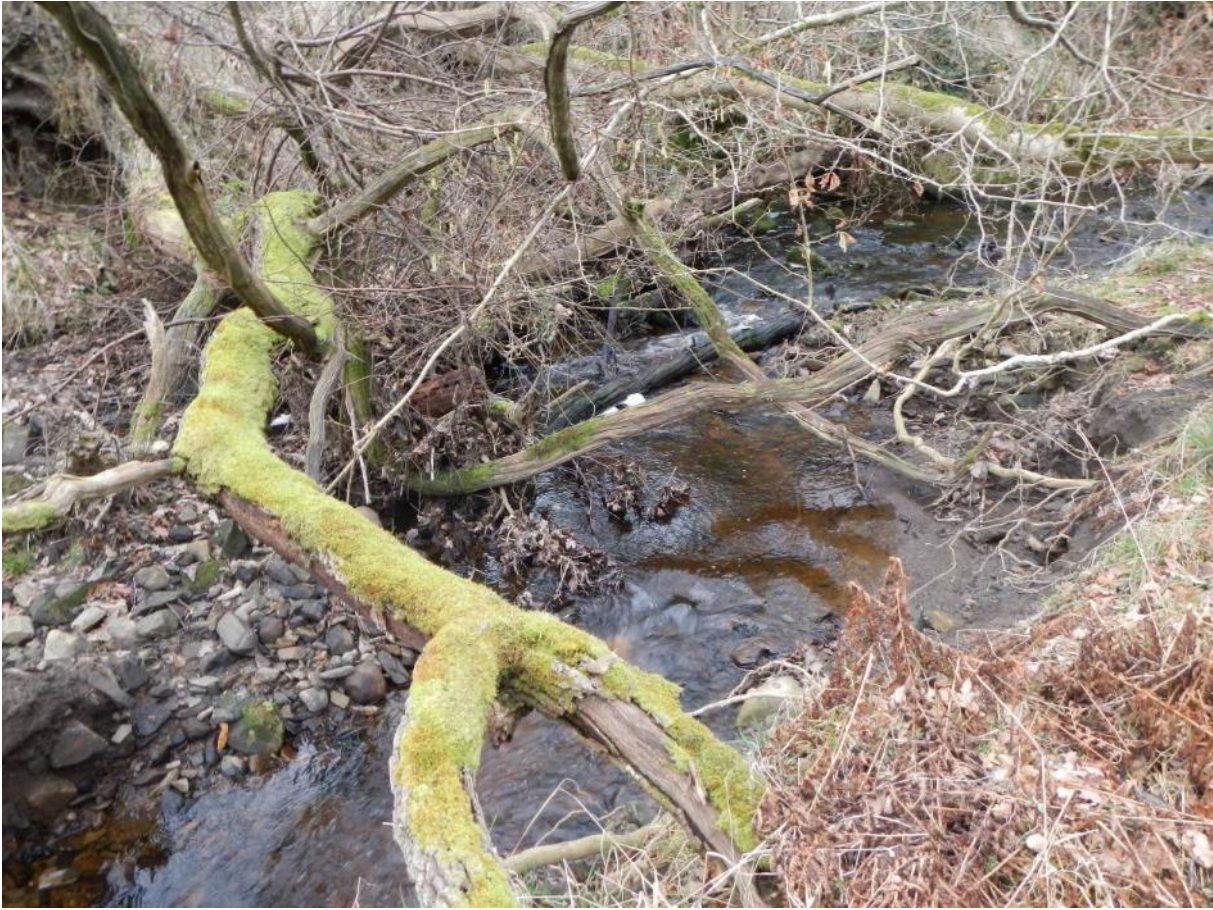
Photo DSCN6285. Natural woody material input within the nature reserve is helping to develop valuable habitat diversity.

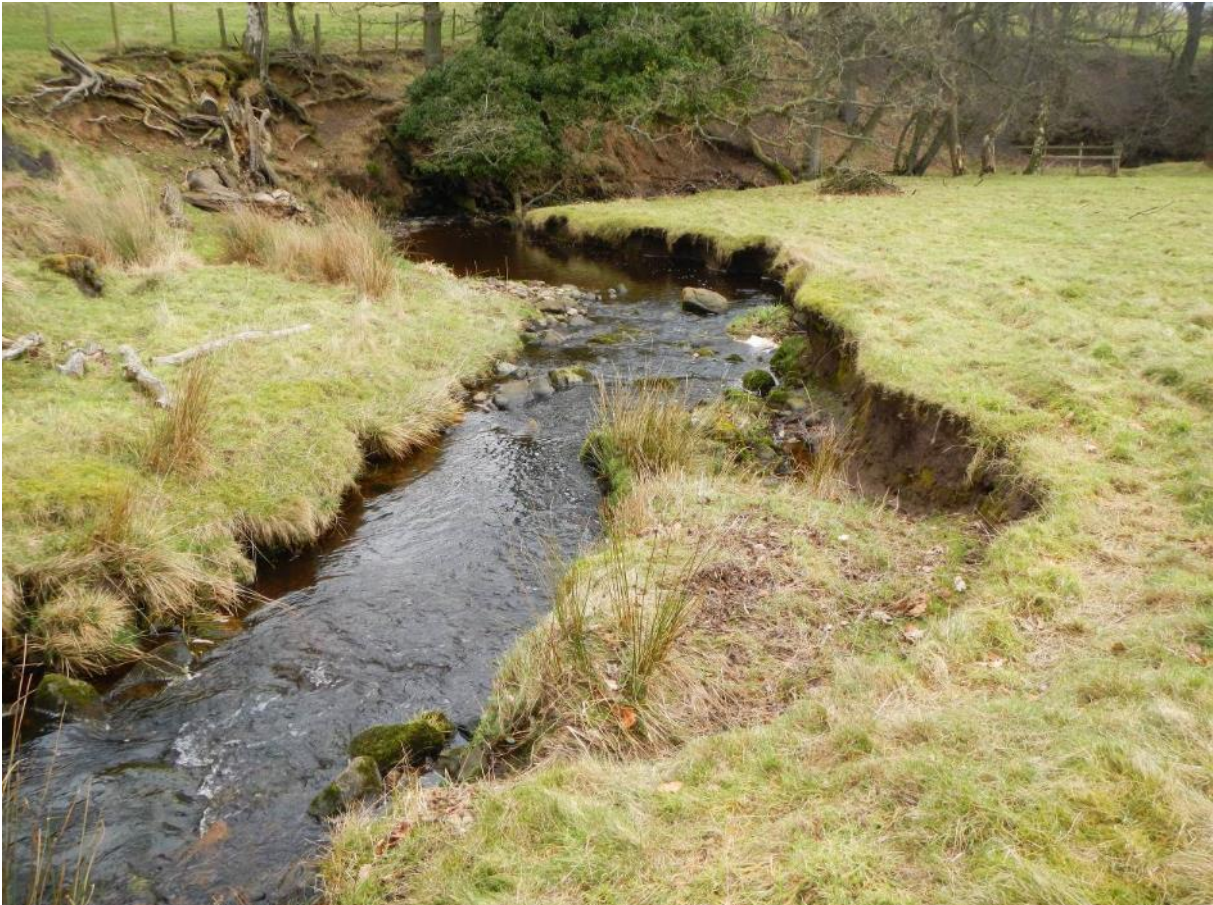
Photo DSCN6303. Grazing is undertaken in the two fields between the nature reserve wood and the next road crossing d/s (NY 82222 65425 – NY 82290 64956). Correspondingly, the riparian habitat quality decreases and bank erosion increases.

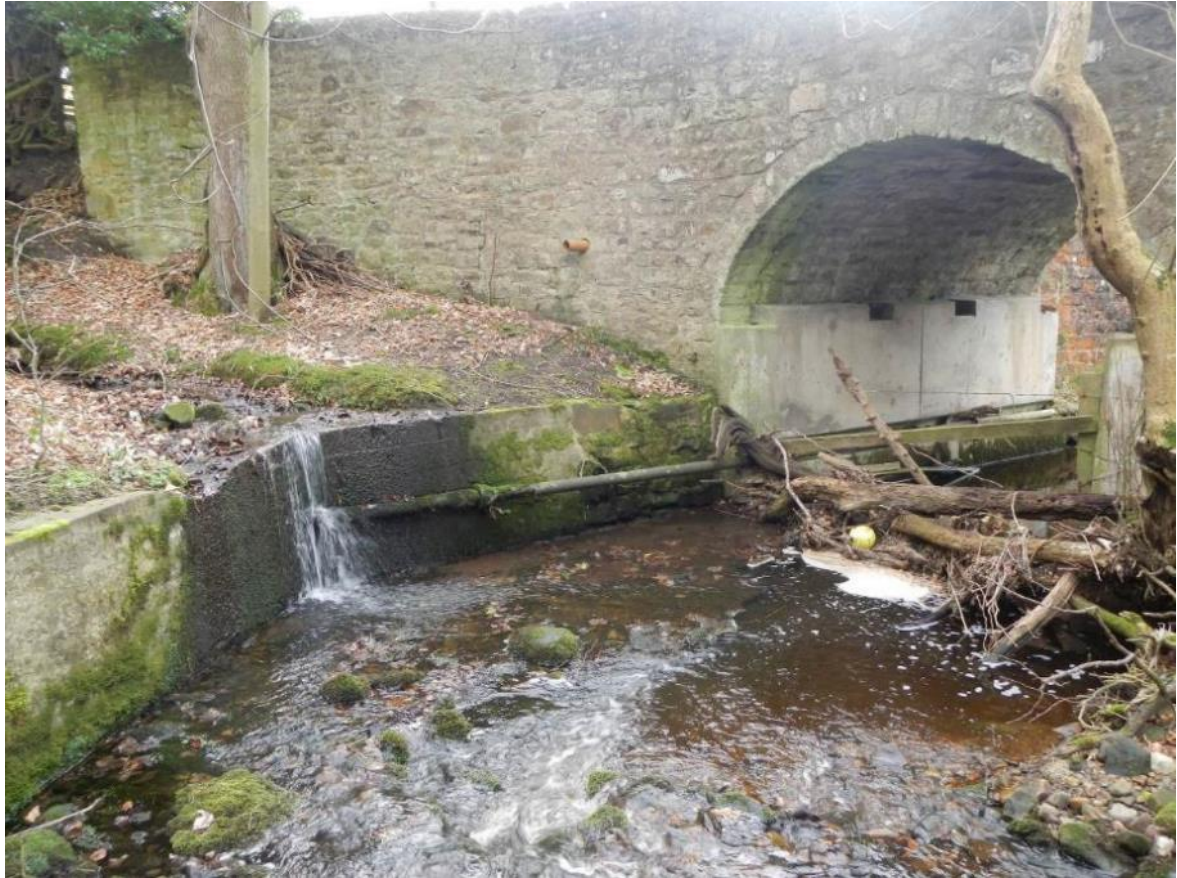
Photo DSCN6318. Although some woody material clearly accumulates against the relatively clear-span road bridge (some concrete footings), the blockage did not appear to be a major fish passage issue.

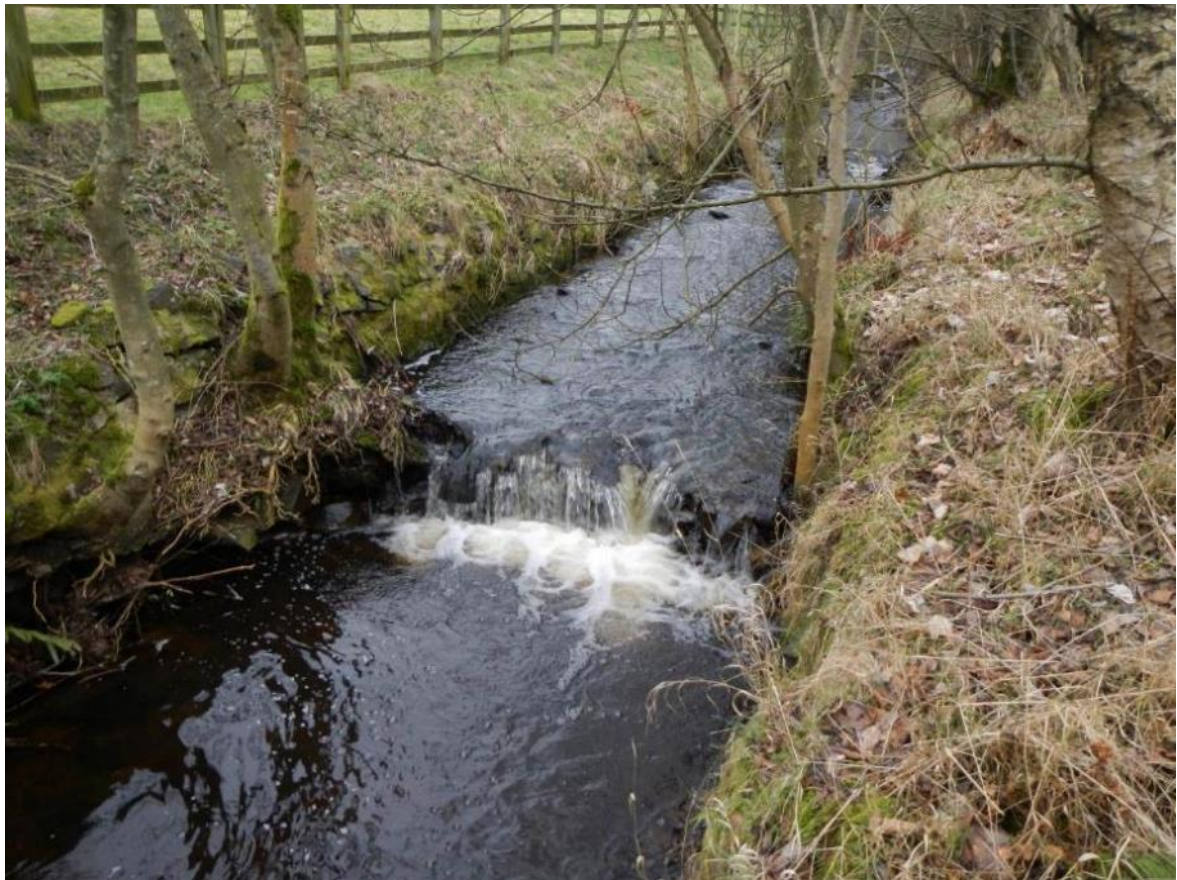
Photo DSCN6325. The burn enters a woodland d/s of the bridge and, for a short distance (NY 82229 64946 and NY 82165 64898) flows within a concrete reinforced channel, with the shallow, uniform flow creating an un-natural impediment to fish passage. The purpose of the lined channel was unclear. At the d/s end, the channel has become undercut and appears to be disintegrating, which is naturalising the channel but also creates a step which further inhibits fish passage.

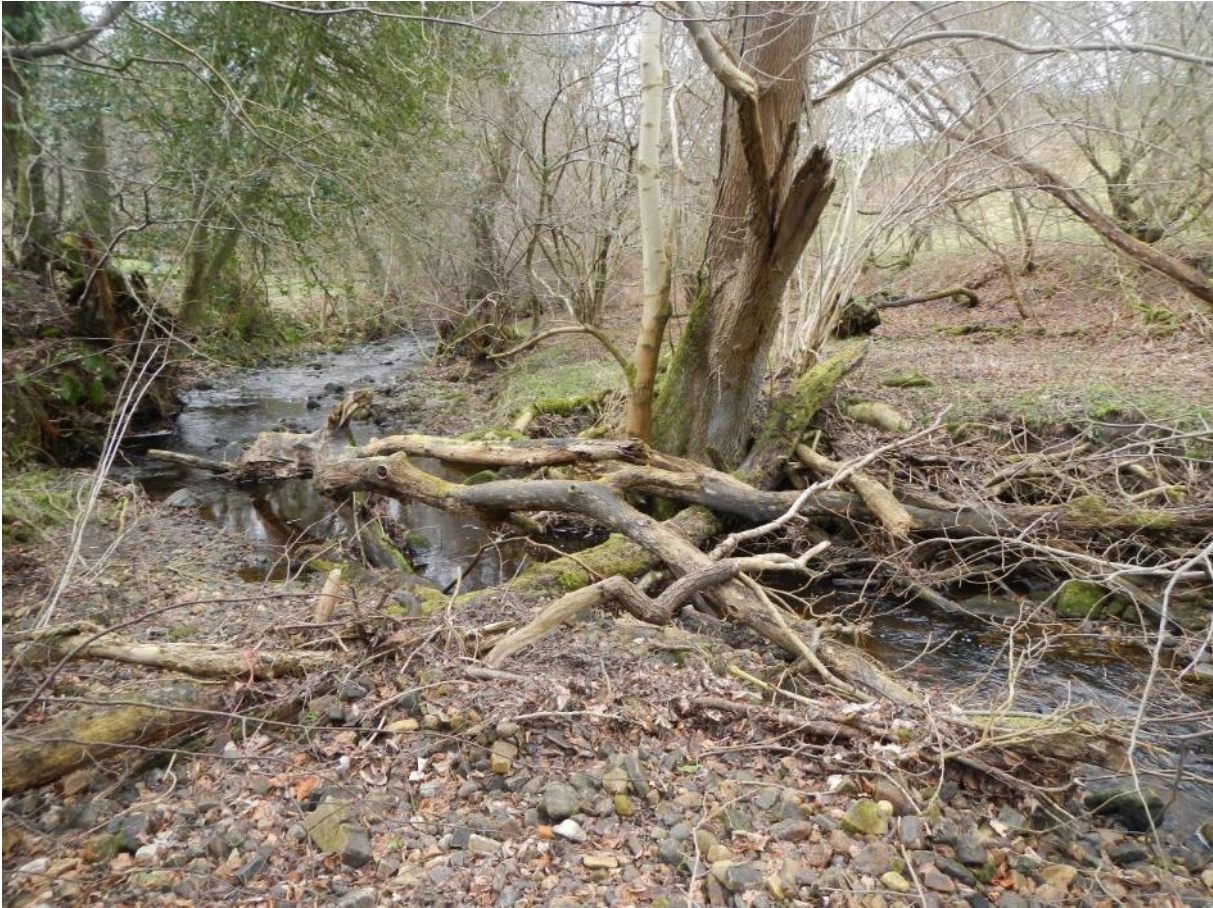
Photo DSCN6329. The habitat d/s of the concrete channel improves considerably, becoming far more natural.

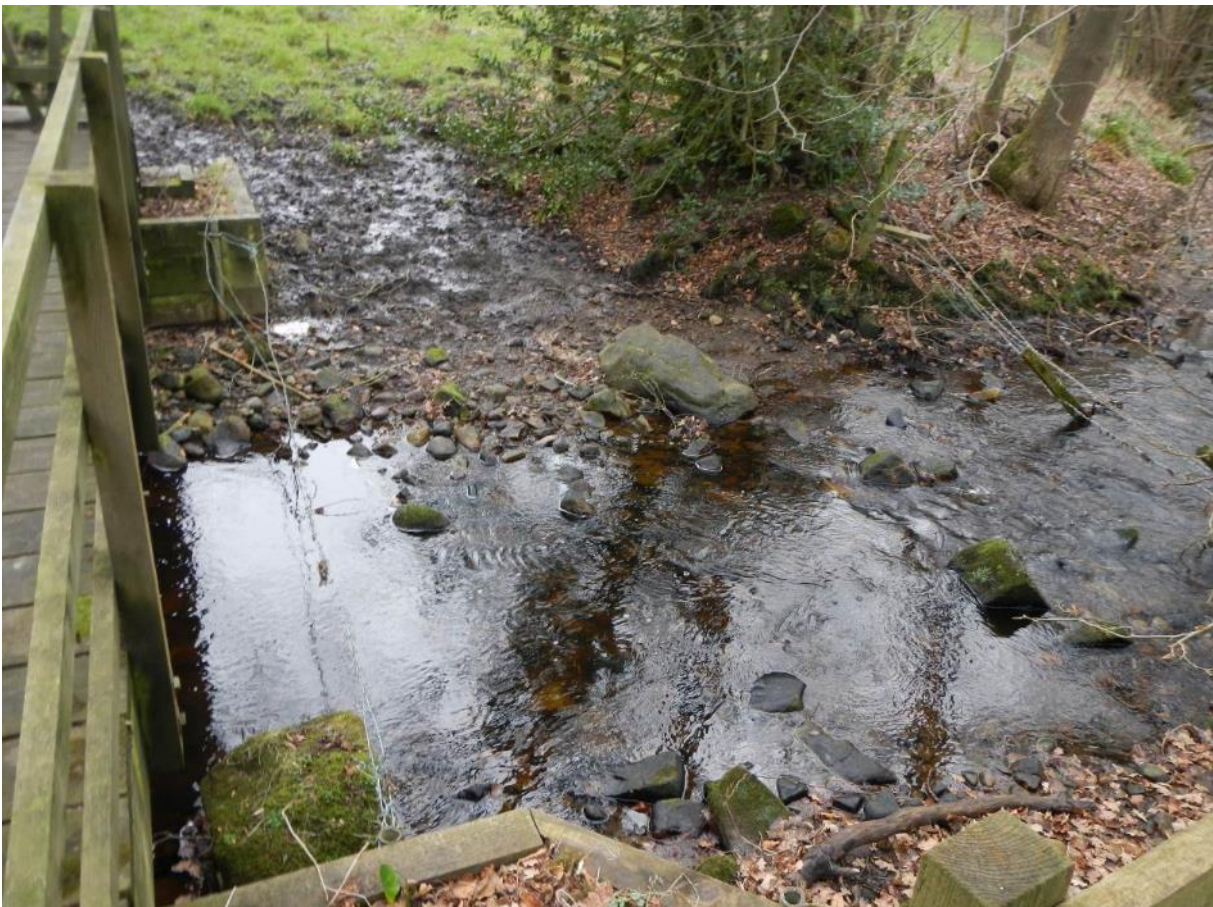
Photo DSCN6331. A small area of livestock access creates a fine sediment input by a footpath crossing (NY 82054 64891), but the area generally provides good habitat with areas of potential spawning substrate.

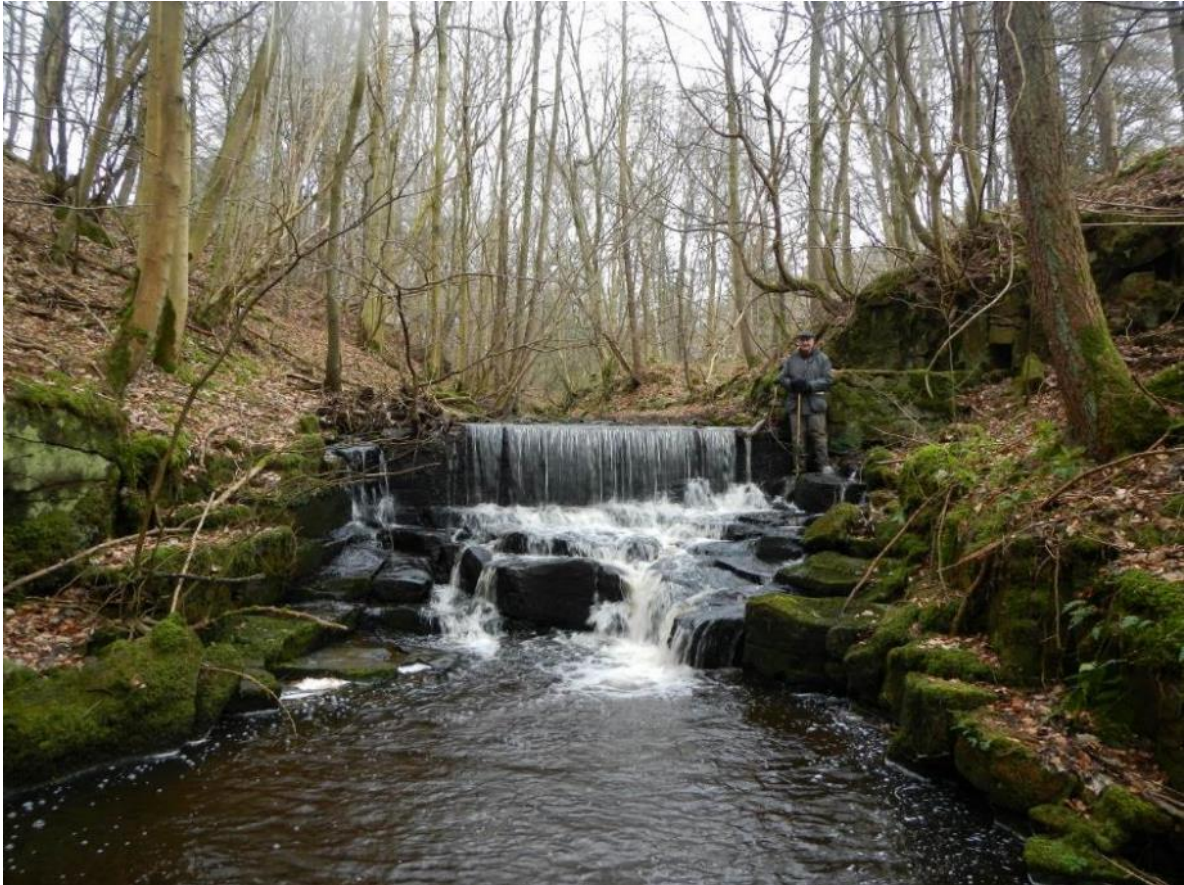
Photo DSCN6339. Further d/s, the valley becomes steeper and bedrocky. A stone weir built on top of a natural bedrock outcrop to supply a water wheel creates an impassable barrier in most flows (NY 81959 64846). This could easily be removed to return fish passability at the site to a natural state.

Weir on top of bedrock outcrop, significantly impeding fish passage (NY 81959 64846)	Remove weir. Possible to undertake with skilled/able volunteers.	DSCN6339	1
--	--	----------	---

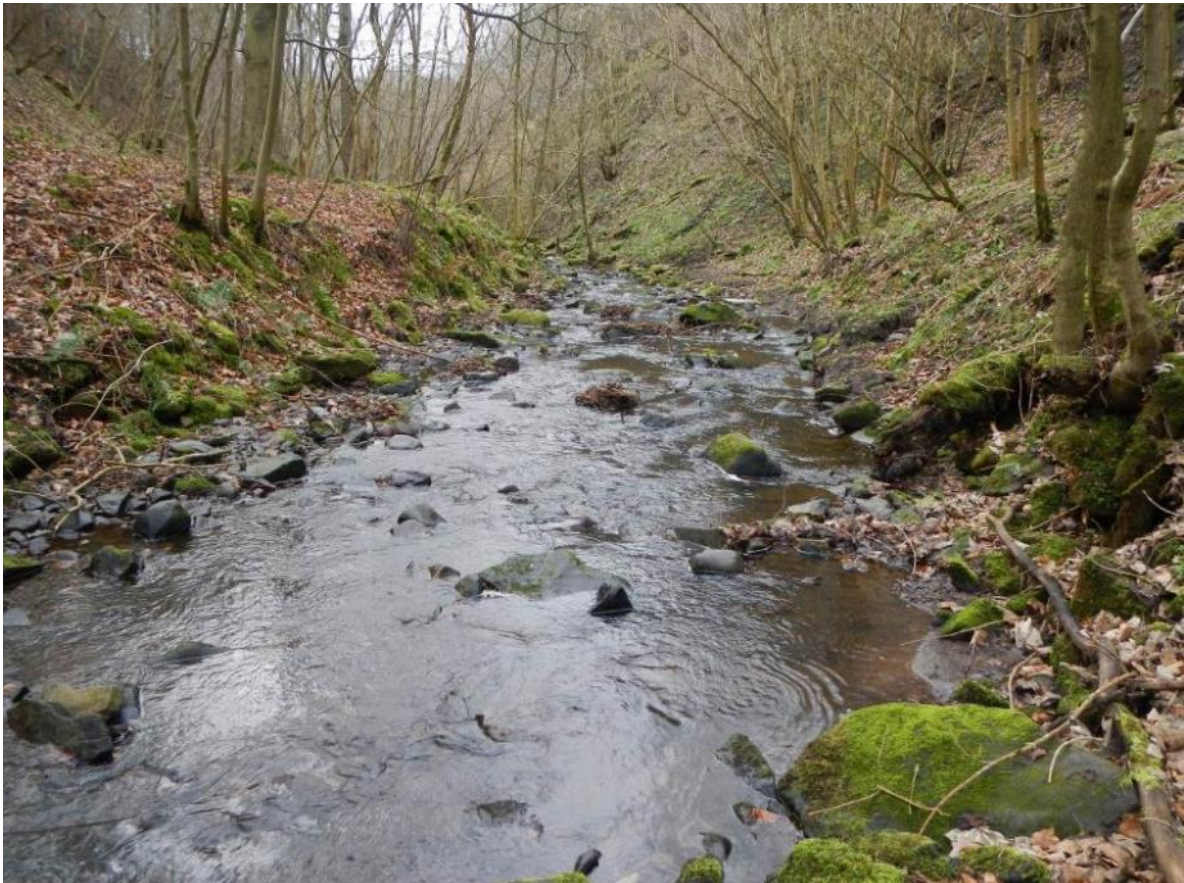
Photo DSCN6345. Although the narrow, steep-sided nature of the valley limits the formation of pools and the retention of potential spawning substrate, the habitat provided should be capable of supporting small, juvenile salmonids.

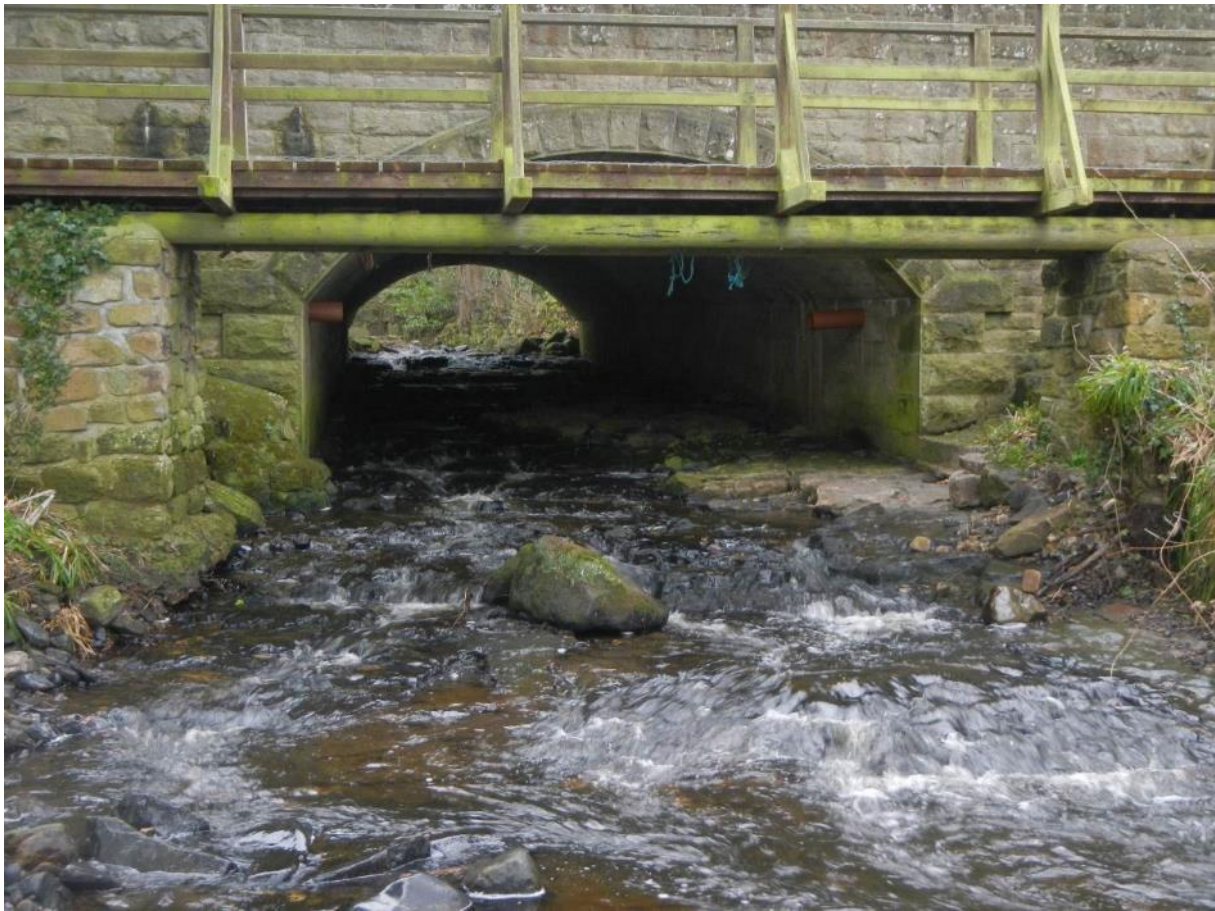
Photo DSCN6364. Being clear-span and located on bedrock, the A69 road bridge poses no significant additional issue for fish passage into the burn. As with many of the Tyne tributaries, it is naturally challenging.
