The River North Wey

Venue: Lower Neatham Mill, GU34 4NP.

Advisory Visit, 26th June 2025

By David Oakley, Conservation Officer, WTT doakley@wildtrout.org

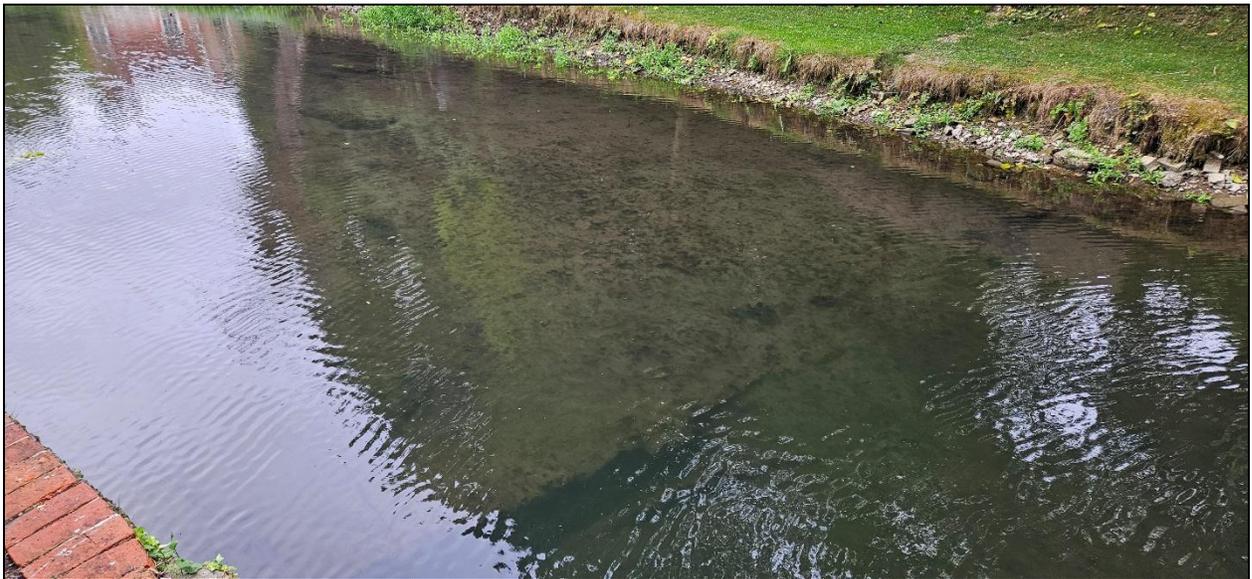
The morphology of the river in the stretch inspected was generally poor, given the mill impoundment at the d/s end. The river was not following its original (paleo) course, having been relocated to the side of the river valley to provide a head of water for the Lower Neatham Mill. This relocation results in a perched channel and impounded river with little flow. In turn the low flows have enabled the river's silt load to be deposited, clogging the river bed, and building up to deep deposits in places. See Fig 2

Fig 2, demonstrating the deep layer of silt in mill leat, NGR SU 73943 40701

Given the main channel is artificial and heavily perched, there is little which can be done to improve its morphology. The existing overhanging willow and in-stream dead wood, should be retained for its habitat value. However given the minimal flow in the channel, there is little to be gained from introducing further material in an attempt to vary the flow and diversify the river bed. Similarly, any attempts at introducing gravel to the main channel may be futile given the quantities needed to displace the silt. Also this would raise the level of the river bed creating a potential future flooding issue.

If the silt is to be removed (which would be against WTT guidance) there are a couple of methods available. Firstly, draining the leat down, allowing the silt to dry out and then digging it out and removing from site. This approach will mean the leat will need to remain dry for a considerable time, (probably requiring a coffer dam and water pump) and the use of heavy machinery. The other approach, is to slowly agitate the silt from the river bed back into suspension, through increased water flow flushing it downstream. This method would require the mill sluice to be repaired, and careful ongoing management of the sluice levels. Care should be taken not to release too much silt in one go and only at appropriate times of year, avoiding spawning times, as the silt could easily clog riffles downstream. NB it must be accepted that without taking the leat offline, silt will continue to deposit in the leat on an ongoing basis.

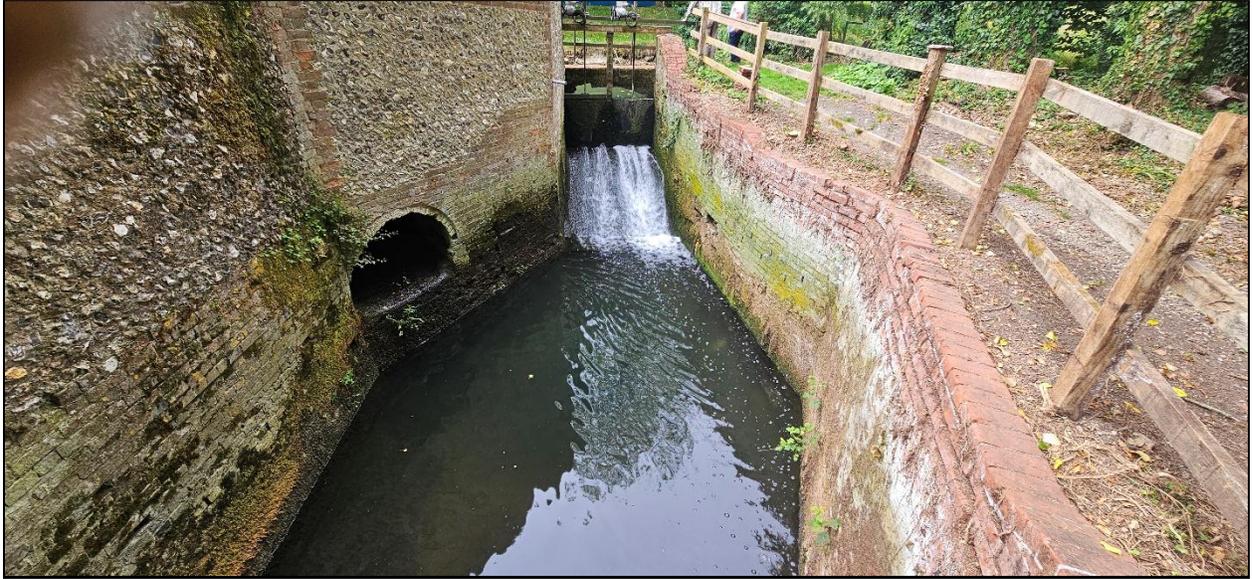
Although not measured, the head loss on the mill sluice must have been in the region of +/- 75cm, making this route an effectively complete barrier to fish migration. In addition to the main sluice there were several secondary sluices enabling further control of the flow. The main side sluice was evidently a more recent and better maintained structure. See Fig 3. The owner believed they only opened these gates in times of extreme flood to take the water pressure off the mill. Apart from the EA sluice much of the other mill infrastructure was dated and in poor repair.

Fig 3 the EA controlled sluice gates, NGR SU 73923 40701

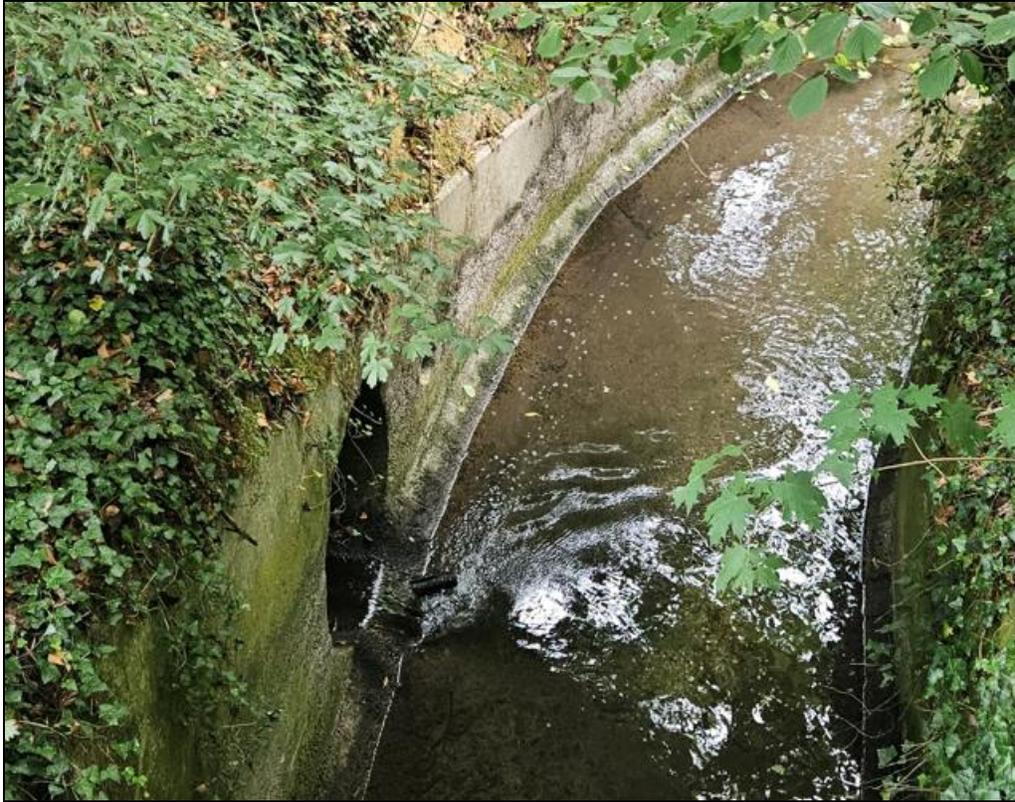
Fig 4 d/s end of the BPC. NGR SU 73957 40774

Here the stream's bed was smooth concrete, preventing the build up of any sediments and subsequent colonization by plants. The main BPC has a relatively constant and steady gradient which would enable fish passage in both directions.

With the increase in flow, the BPC may need some bank stabilization works, and there is potential in augmenting the existing gravel riffles with more stone. For the lower section of the BPC, installing a series of baffles of wood or stones on the concrete cill would create a variation in flow, aiding fish passage, and they would also enable some gravels to accumulate making a more natural environment. By creating a pinch point at the mouth of the BPC, it will speed up the flow, making it a more desirable route for the fish to follow upstream. See Fig 10

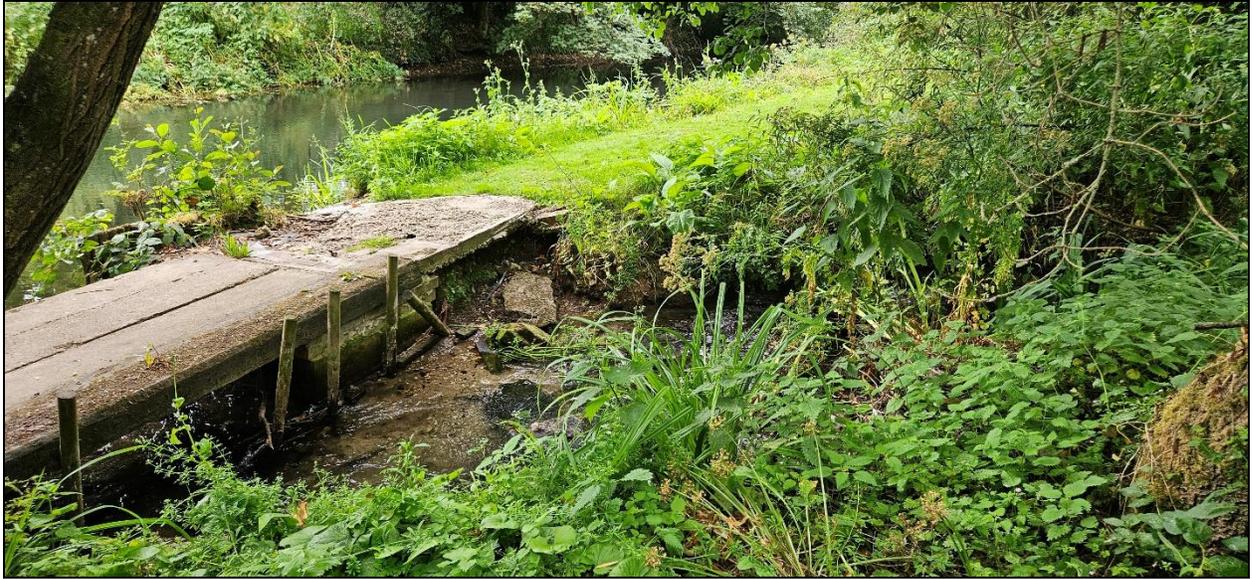
Fig 5 Take off for the BPC of a rather haphazard construction NGR SU 73907 40676

In the shorter term, the issue of impoundments hampering fish migration can be resolved in part by utilizing the existing BPC. The flow to the BPC could be improved and become more dependable by rebuilding the off take from the main channel at a slightly lower level, and at a less obtuse angle. Clearing the existing “mouth” at the off take by removing debris, and reforming it, utilising a geo-membrane held in place with large stones, always ensuring correct water levels are maintained.

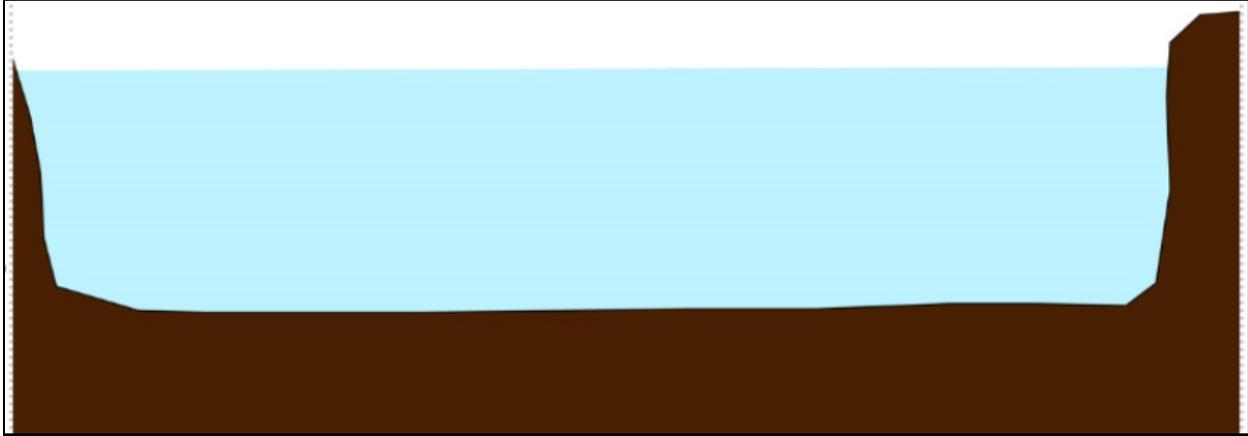
The perched and artificially created channel has steeper, deeper banks, without the usual gradual sloped banks required to allow a healthy mix of riparian plants to establish. See Diagram 1. A cross section of a naturally flowing river is shown in Diagram 2. This would be achievable if the river were to be relocated.

Dia 1 Example of an artificial channel cross section showing sheer marginal edges, restricting plant diversity and physical diversity

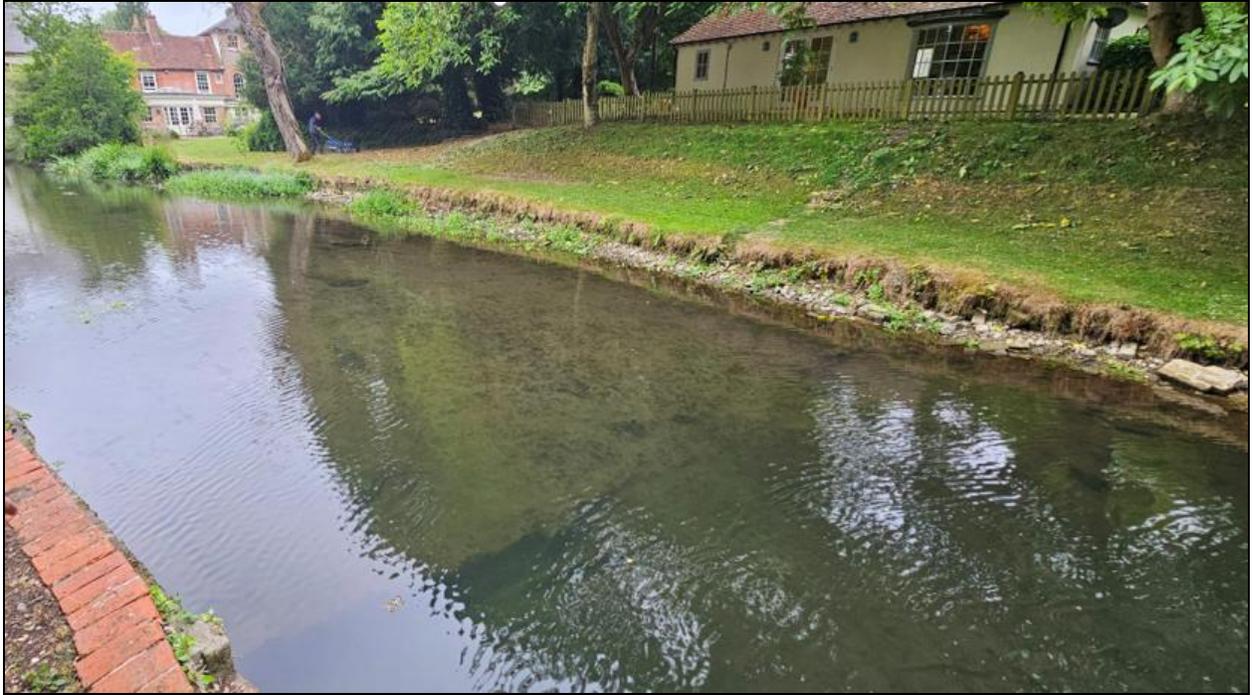
The left bank was managed by the owner and regularly mown to create a grass path alongside a narrow strip of marginal growth by the river, see front page photograph. The right bank was in different ownership. At the d/s end, opposite the mill, the whole bank formed part of a garden. It was regularly mown and any marginal growth removed. See Fig 6

Fig 6 an intensively managed right bank. NGR SU 73966 40722

Establishing wider unmown margins along the river edge, ideally 3-4m wide, is another beneficial management practice. This will encourage deeper rooting plants to colonize, further reducing erosion of the banks. The plant mix could be enriched by introducing native herbaceous species as required, but still aiming to retain a scruffy margin to both protect from erosion and provide habitat. The non native and highly invasive Signal Crayfish unfortunately is a contributing factor as it digs burrows into river banks.

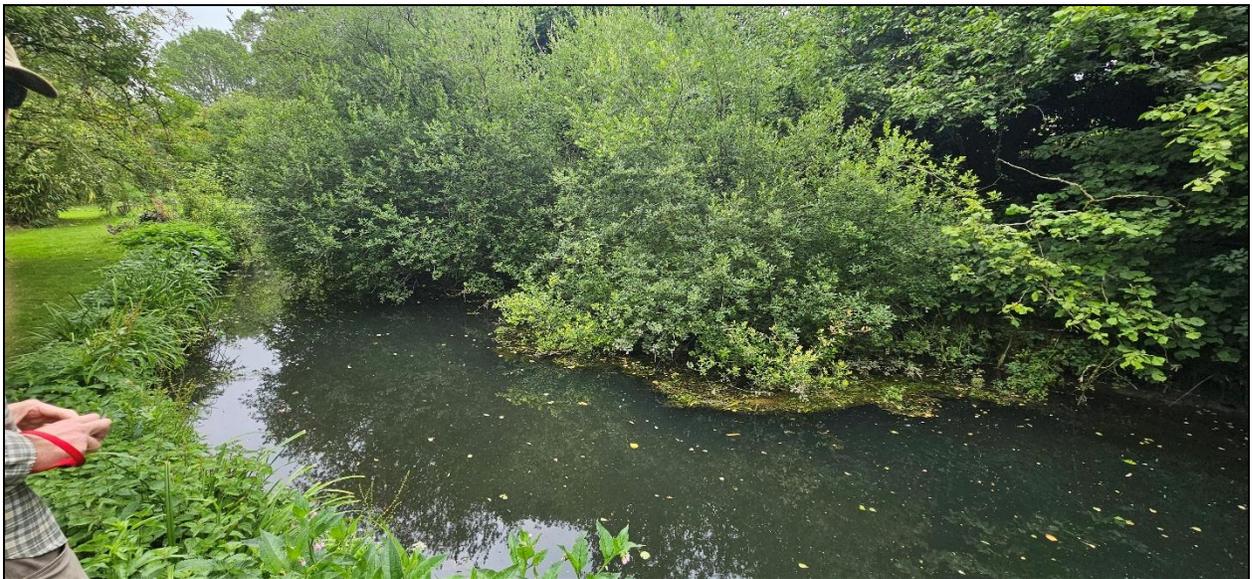
Further upstream, the ownership changes and the bank was left to grow wild, reverting from a good mix of marginal herbs, to a mix of native trees and shrubs. In places these have fallen into the river creating vital cover and habitat for fish and other creatures. Features such as these, in stream dead wood, trailing tree roots all need to be retained as essential diverse habitat, particularly vital for smaller fish and trout fry, offering protection from predators.

Fig 7 showing good quality habitat on the r/b NGR SU 73766 40565

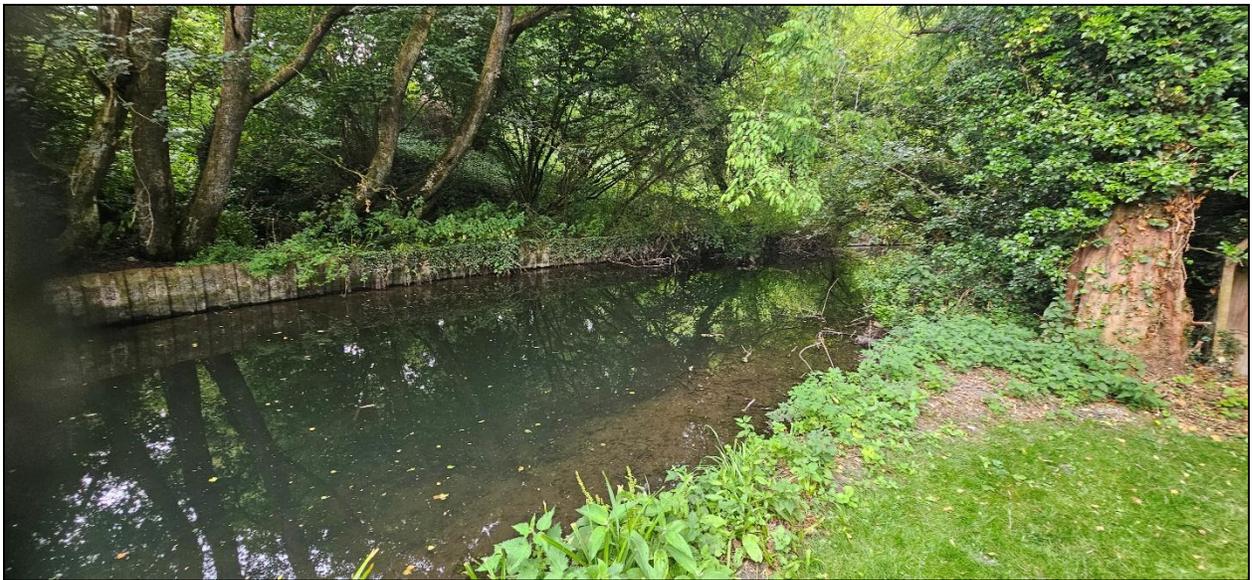
Fig 9 Start of new potential channel NGR SU 73712 40543

be cut through the adjoining land/woodland creating a more sinuous channel with gradual gradient down to below the mill, effectively bypassing all of the mill's infrastructure. (This has been achieved on other rivers, with substantial grant aid available, and the results are tremendous. See fig 8,) This ideal solution would require numerous land owning interests to join forces and agree a change in the river's route, and should be seen as a longer term aim. With the channel redirected the existing mill leat could be retained as a backwater. The new channel could start at NGR SU 73712 40543 as shown in Fig 9.

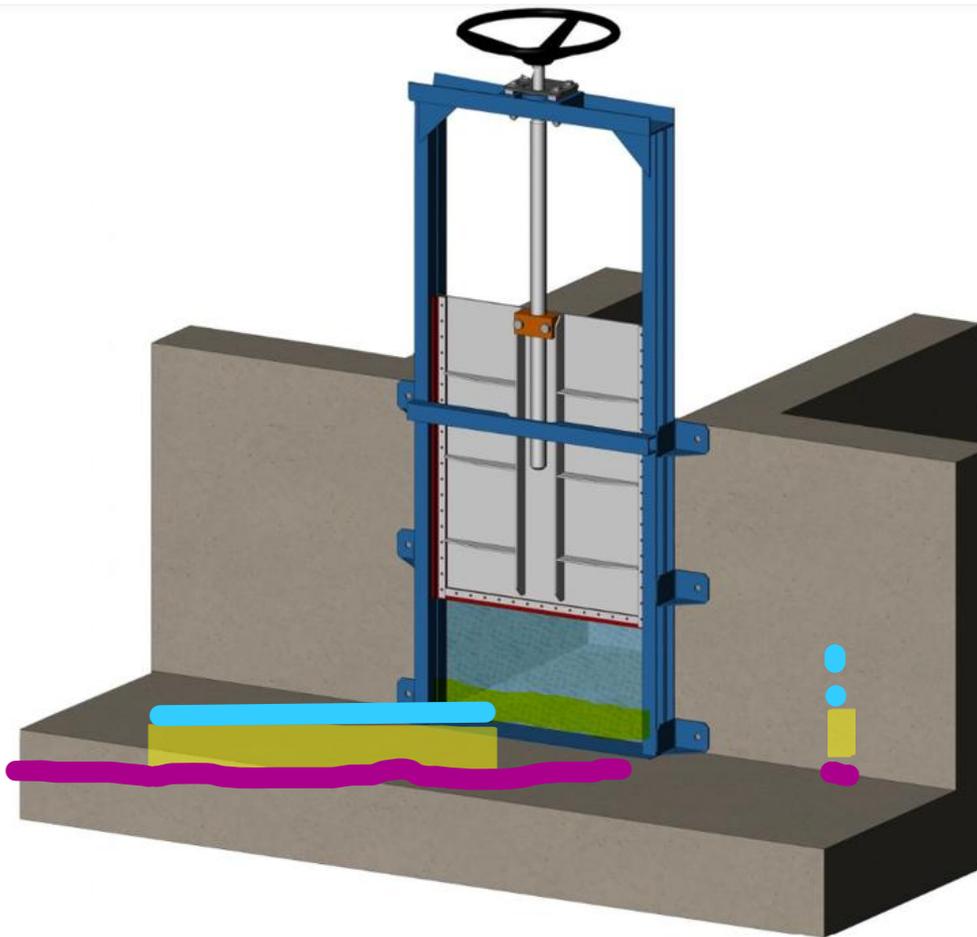
For this change in BPC depth, it is essential that the flow and levels in the main channel are controllable and measured. The main mill sluice is broken so can not effectively control the water depth. Also there is no means to determine the water level heights. Repairing the main sluice and reinstating it as a rising sluice gate see Dia 3, will enable control of the main river levels, which in turn affects the level in the BPC. With reference to Dia 3, the sluice gate is raised and lowered by turning the handle. As this is an under shot sluice system, more water is taken from the bed of the river which will in turn aid the movement of silt. The current system has effectively lost the whole of the sluice gate, and water is only retained by a fixed board shown yellow on the diagram.

Dia 3 An under shot, vertically rising, sluice gate
