**WILD TROUT TRUST**  
wildtrout.org

**River Mells and tributaries, near Frome, Somerset**

**Wild Trout Trust report following an Advisory Visit on 28-29 June 2022**

**Undertaken by Theo Pike: [tpike@wildtrout.org](mailto:tpike@wildtrout.org)**

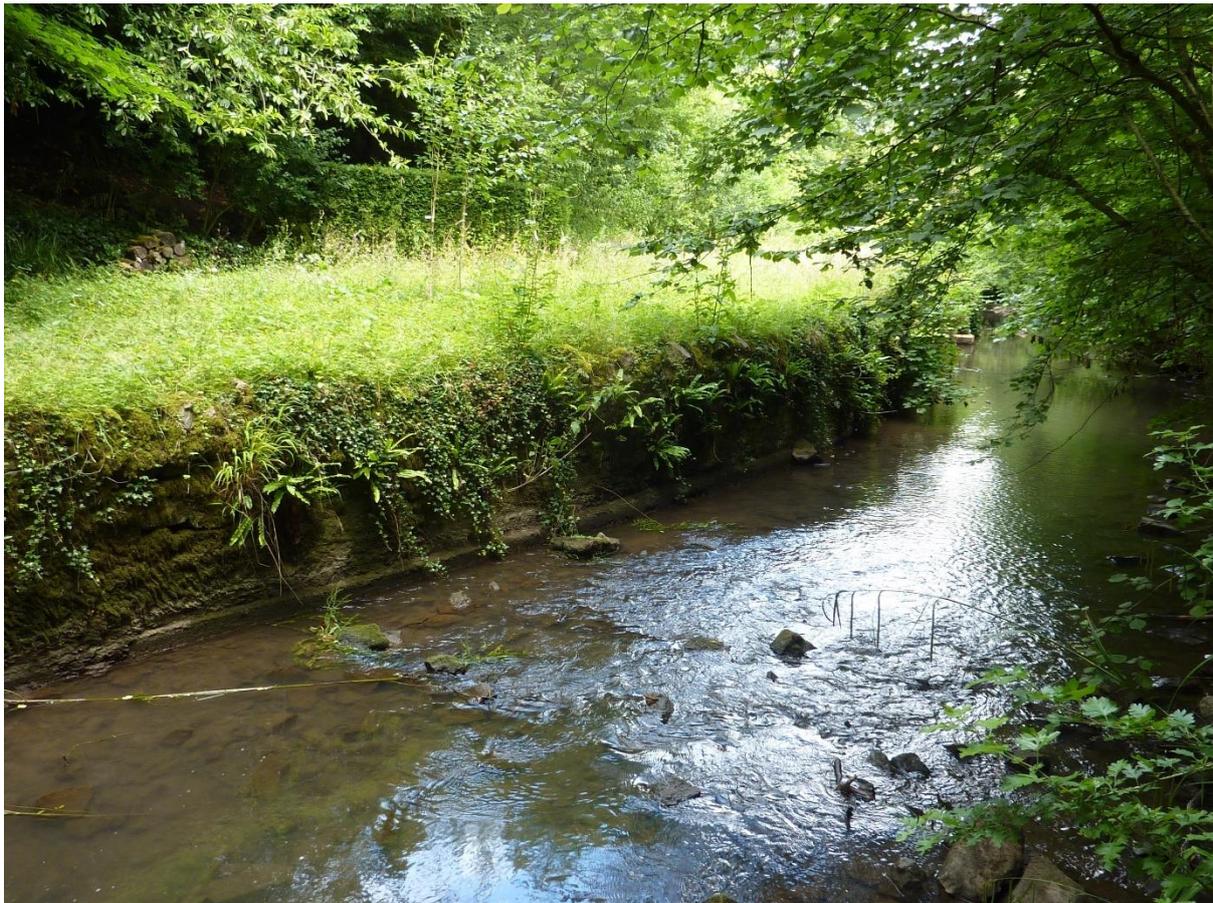
*Figure 7: The simplified channel at Great Elm could be improved by introducing boulders and LWM in order to restore the river's natural 'roughness'.*

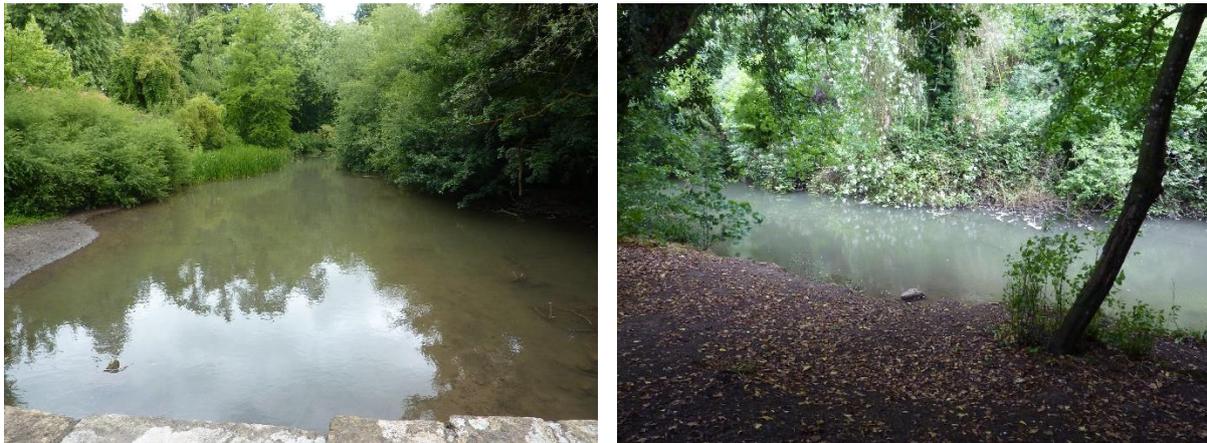
*Figure 8: Left, the heavily-silted mill pond at Great Elm; Right, the narrowing impoundment just upstream of the weir.*

A more sustainable long-term solution would be to remove or lower the weir at the downstream end, and then recreate a more natural, sinuous channel through the area of the present impoundment (which narrows almost to natural channel width as it approaches the weir, and is believed to host an anomalous population of roach). An inspiring example of this kind of solution can be found on the River Wandle in south London, where a similar silt-trap impoundment was successfully restored as a free-flowing, self-scouring channel:

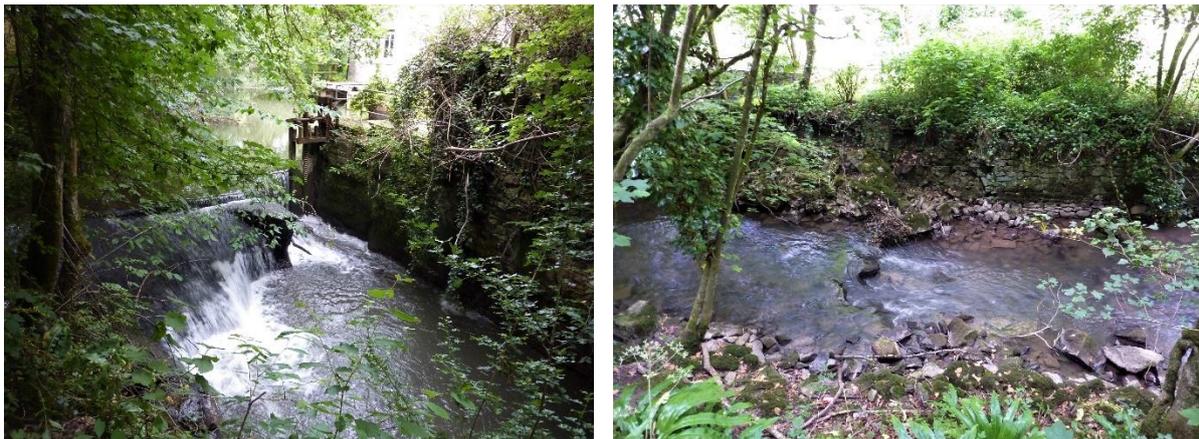
*Figure 9: Left, the impassable weir at Great Elm; Right, the collapsing LB wall just downstream of the weir.*

Viewed from downstream, the weir at Great Elm is clearly a barrier to fish passage, and is likely to be impassable to all fish in all flow conditions. As discussed above, the most sustainable option would be removing the weir completely. If this is not possible, a compromise solution could involve some reduction in height, plus installation of a rock ramp downstream to improve fish passage through this area, whilst helpfully eliminating the requirement for ongoing maintenance of a technical fish pass.

Works to install a rock ramp could also include repair of the deteriorating garden wall on the RB, just downstream of the weir: this deterioration of the retaining wall is a demonstration of the river's erosive power when deprived of its upstream sediment supply as a result of a weir (as discussed in *Channel modifications including weirs*, above).

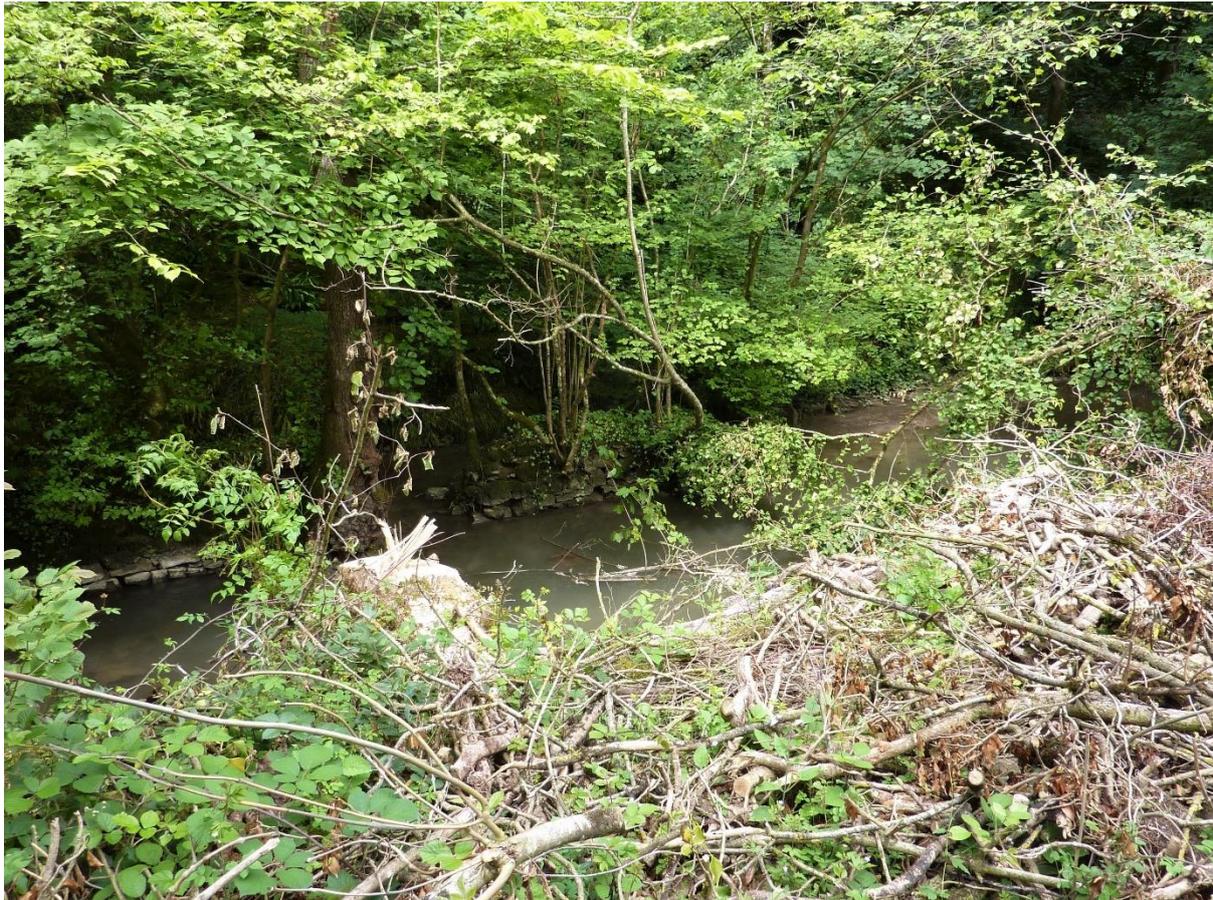
*Figure 10: Tree works related to ash dieback have skylighted the river in several areas.*

Proceeding downstream towards the railway bridge at ST 75184 49481, it was noted that recent tree works (presumably to remove trees affected by ash dieback, in dangerous proximity to a public footpath) had reduced overshading of the channel from the southerly RB. Despite the tragedy of ash dieback, this could be a beneficial first step towards re-establishing a healthier age structure of trees along this stretch of the river.

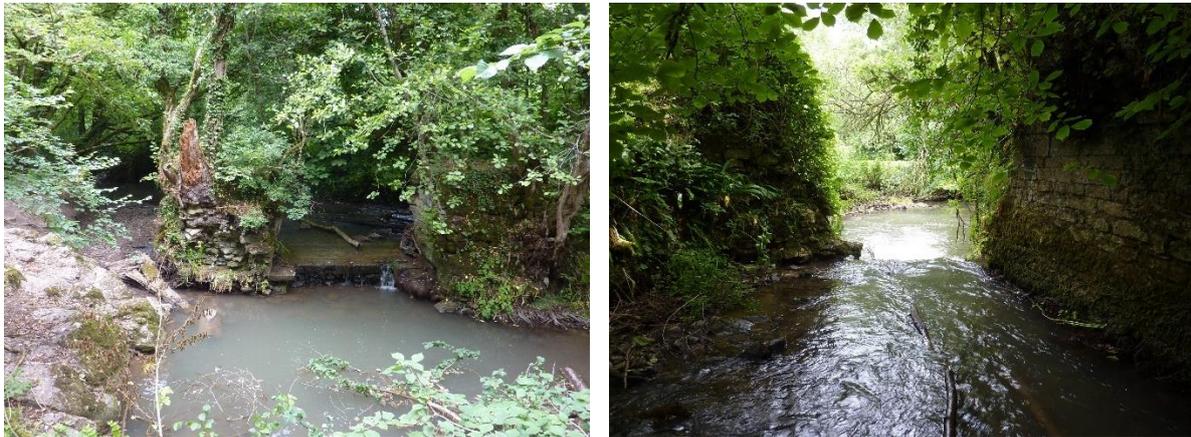
*Figure 12: Left, RB weir structures at Bedlam; Right, LB weir structures at Bedlam.*

At the time of this walkover, most of the flow was directed down the LB weir. Due to downstream movement of coarse sediment, which appeared to have created a virtual rock ramp over the sill, this weir did not appear to be a significant obstacle to fish passage. However, any such structure can still impede passage of juvenile trout, or weaker-swimming fish species, so notching or lowering the structure would be advisable for this reason. In higher flows, an additional passable channel may also be activated on the RB.

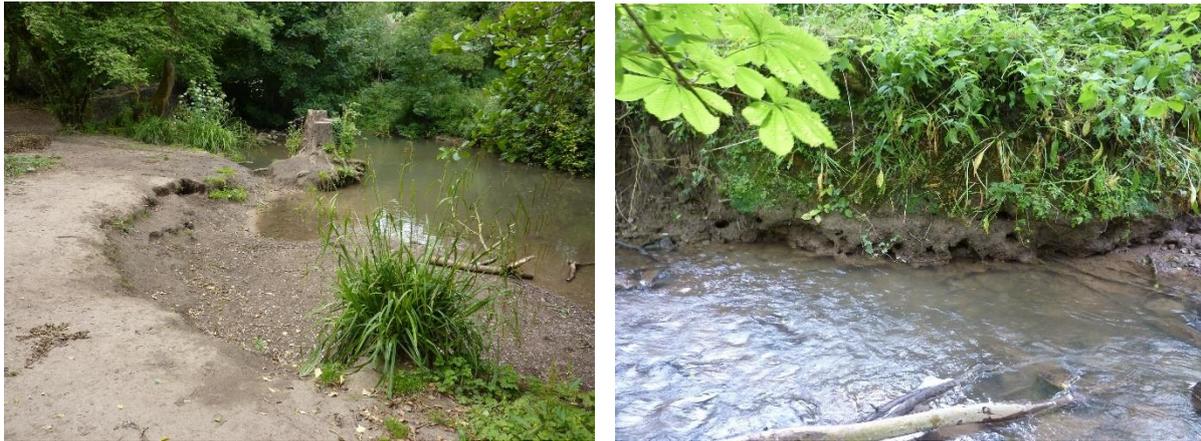
*Figure 13: Left, a severely-eroded area of bank at a popular access point; Right, signal crayfish burrows at Bedlam. Such burrows can be up to 2 metres deep, undermining river banks, and making them more vulnerable to erosion.*

Erosion can be a valuable natural process when it creates channel diversity and resupplies the river with gravel from its previous course across a floodplain - but artificially accelerating excessive bank erosion (as in this case) can cause damaging quantities of silt to be 'dumped' into a river, smothering fish eggs and habitats for many species.

Here, erosion will also have been exacerbated by the tunnelling activities of American signal crayfish, whose burrows were noted in an area of soft bankside among the mill buildings just upstream. (Ironically, the combination of hard bedrock and rock armour walls along many stretches of the Mells may actually be protecting the river from even more widespread impacts caused by this damaging INNS).

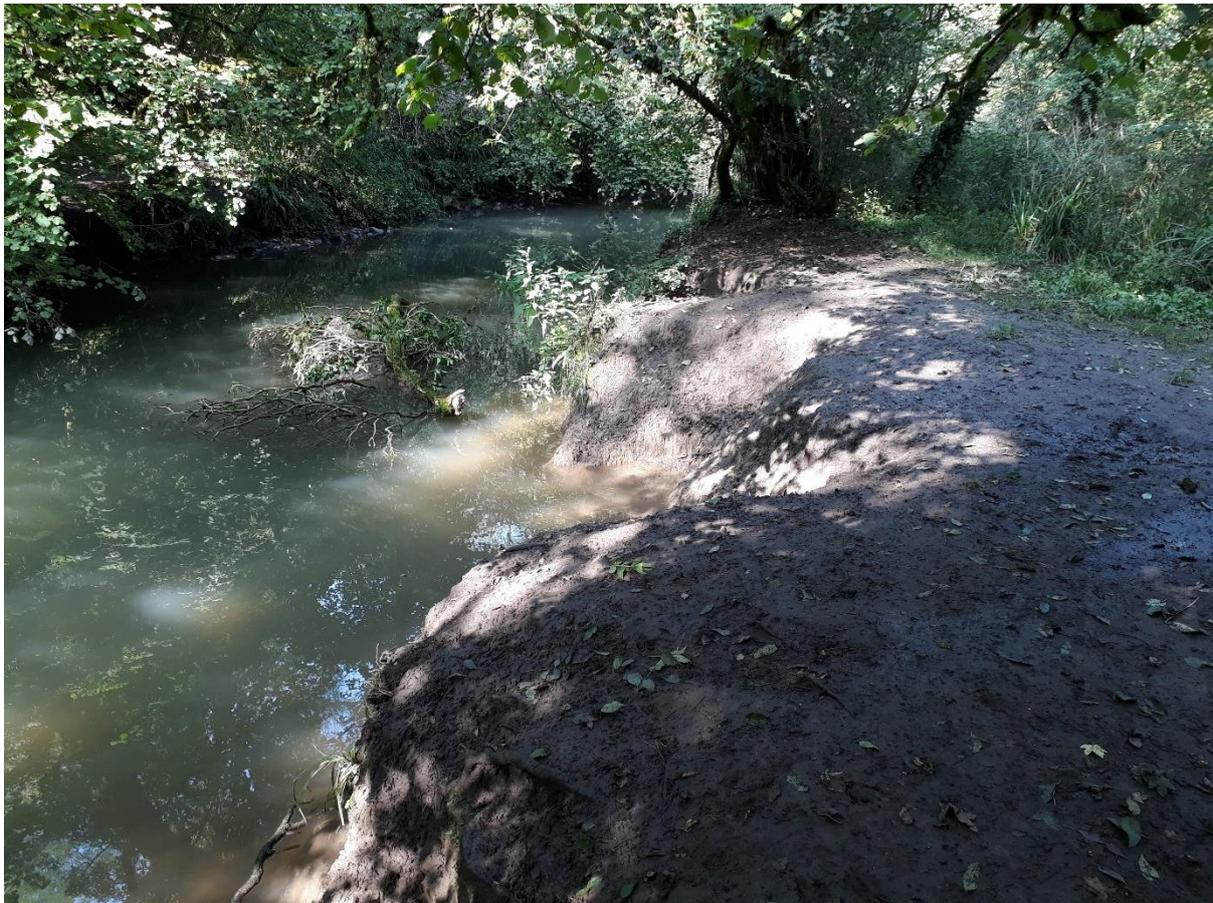
*Figure 15: Severely-eroded banks, including a 'dog slide', in Vallis Vale.*

Proceeding downstream into Vallis Vale, the public footpath crosses from the RB to the LB of the river, bypassing a short stretch of river which is privately owned and could not readily be observed – apart from noting c 30 m of new stone gabion basket revetment on the outside of the bend upstream of the footbridge at ST 75441 49372. From this point, the average depth of the channel appears to increase, and the river adheres tightly to the high south face of the gorge, while much of the LB has steep earth banks without the rock armouring which is so prominent further upstream.

At the same time, some areas of seriously eroding river bank (such as that shown in Figure 15 above) may require more immediate intervention: for instance, by packing them with brash to encourage silt deposition and reconsolidation. Planting live goat willow whips within the brashy matrix may also help to reinforce these areas for the longer term, as the whips become established and develop root systems which will help to bind the bank together. Further temporary protection could be provided by constructing dead hedges on the bank top. Stabilised banks with healthy native vegetation, instead of bare earth, will also be more capable of resisting invasion by INNS like Himalayan balsam and giant hogweed.

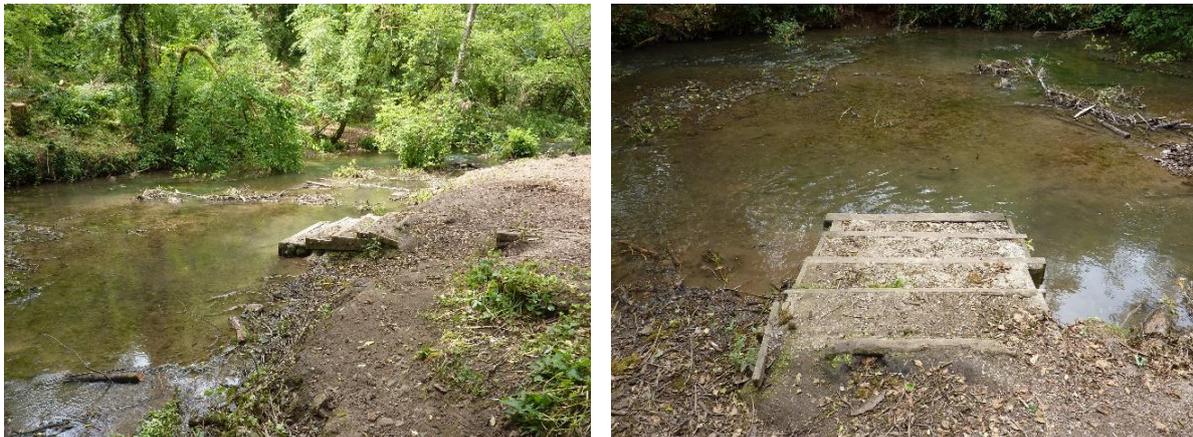
*Figure 16: Another popular dog-dipping area: the regression of the bank from the lowest step indicates how much bank has been lost, and dumped into the river as silt.*

As discussed with reference to the dog dip in Bedlam, it would be beneficial to prevent further erosion, and formalise this area as a dog dip, by restoring the bank toe with local limestone boulders, back filled with locally-derived cobbles and gravel.

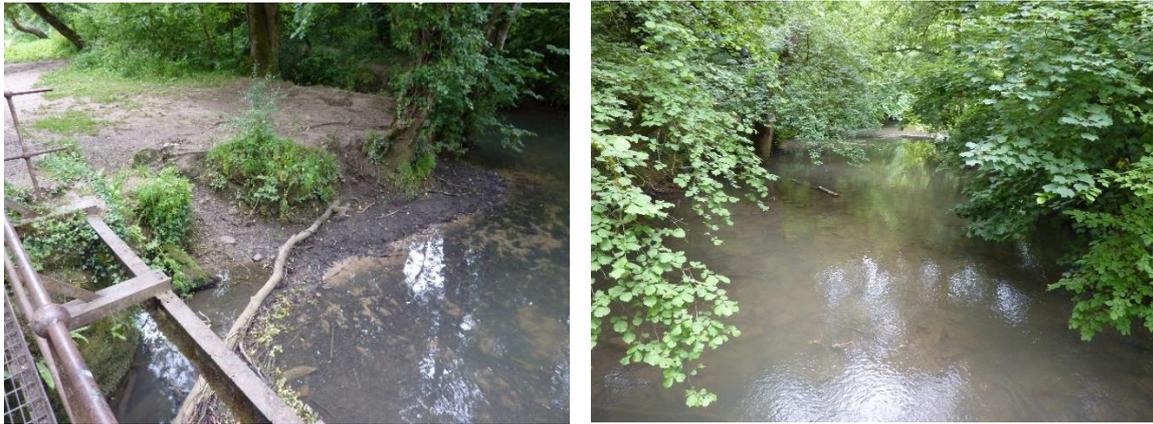
*Figure 17: Left, bank erosion around the junction of the Nunny Brook with the main River Mells; Right, looking downstream from the confluence of the Mells and Nunny Brook.*

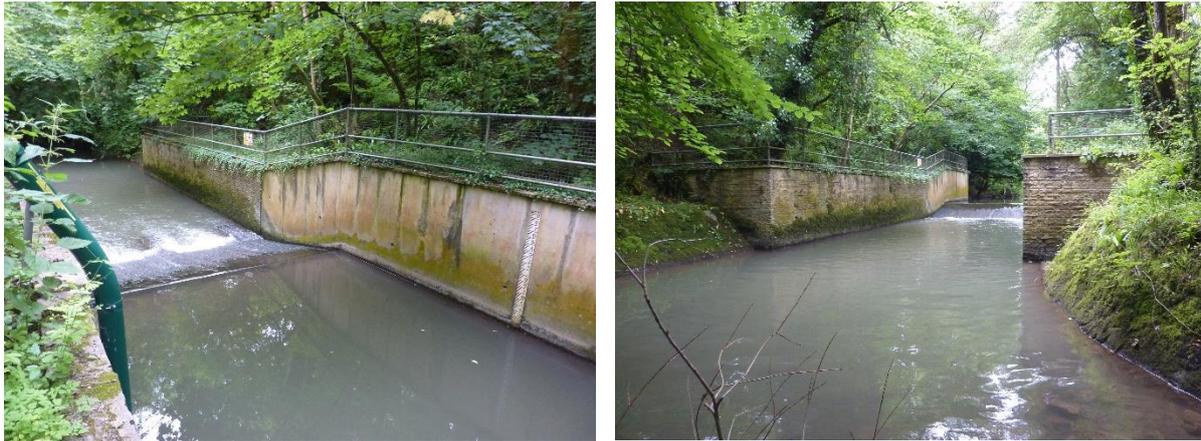
*Figure 18: Left and right: the EA gauging weir at Vallis Vale could be replaced with a non-impounding ultrasonic device.*

A short distance downstream of the straightened section shown above, the river becomes impounded for c 200m by an EA gauging weir at ST 75723 49112. While the structure of this weir is not as extreme as some of the other 'flume-type' gauging stations seen further downstream on the Frome and on other Somerset rivers, the shallow laminar flow over the smooth concrete face of the weir is still likely to present a barrier to most fish species under most flow conditions.

In the short term, options for installing an eel pass should be investigated with the EA – perhaps including low-cost baffles on the downstream face of the weir, to ease passage for as many species as possible, including trout moving upstream to spawn in the Nunney Brook. In the longer term, full replacement of this whole structure with an ultrasonic gauge could also be investigated:

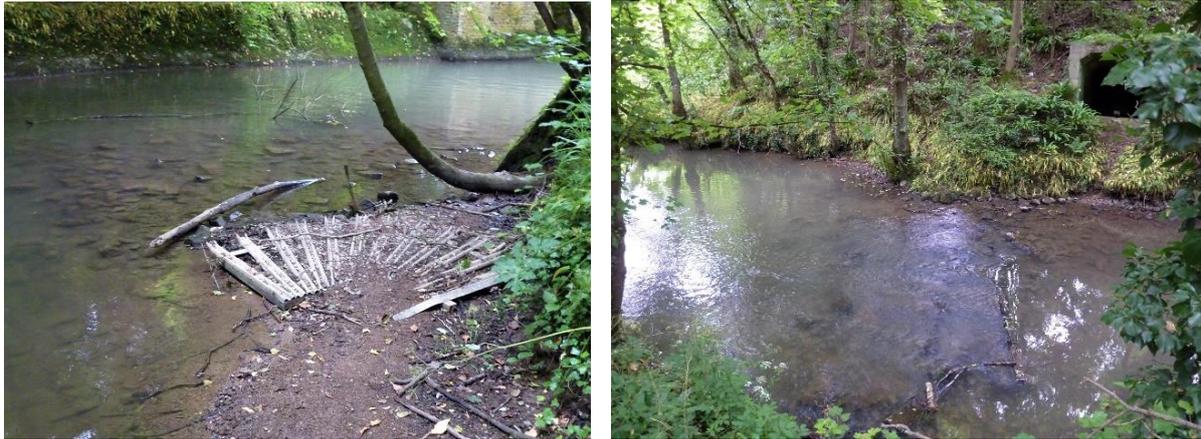
*Figure 19: Left, heavy post-industrial rubbish in the river downstream of the gauging weir; Right, the upstream end of the Hapsford mill impoundment drowns a potential spawning riffle: flows in this area are unlikely to have enough energy to keep gravels scoured free of silt.*

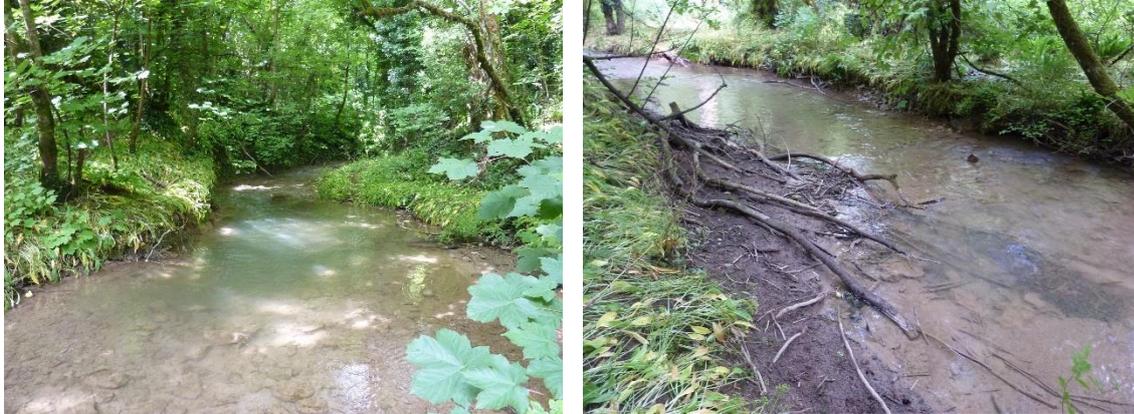
*Figure 21: Left, the Whatley Brook's sinuous channel at the upstream extent of this survey; Right, an accumulation of woody material and silt which could be formalised with stakes and additional brush.*

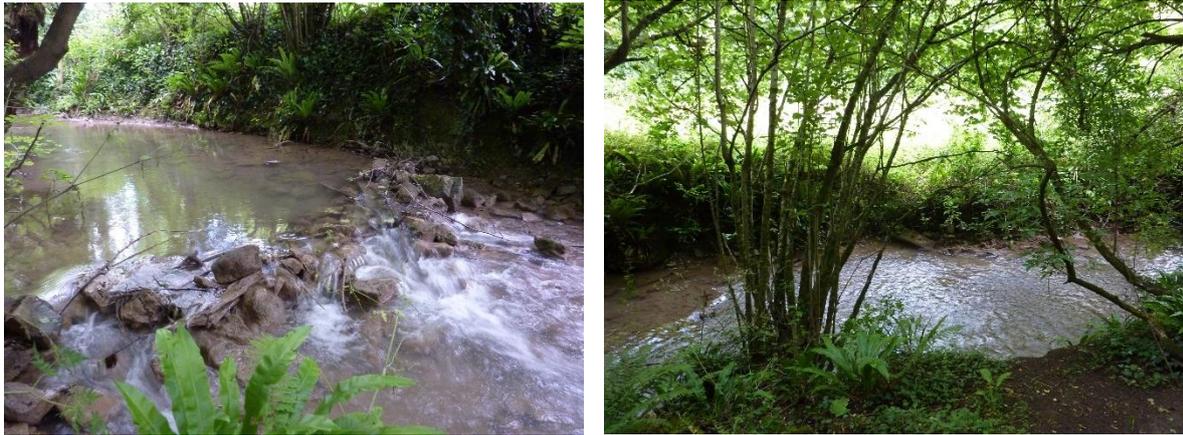
*Figure 23: Left, an informal rock cascade which may present fish passage issues in this small stream; Right, bankside hazels which could be hinged into the margins to promote mid-channel scour (and thus more ecologically useful areas of deeper water, as well as habitat for invertebrates and cover for small fish).*

Because these may act as obstructions to fish passage, especially (and ironically) in low flow conditions, it would be better to focus on increasing mid-channel scour and encouraging natural pools and pockets to develop, with sinuosity and variable depths within the stream's current planform. The presence of numerous bankside hazel coppices suggests an easy solution: hinging stems down into the margins to add immediate habitat and hydrological diversity, including refugia for juvenile trout seeking shelter from higher flows, as well as capturing silt and perhaps becoming vegetated (as discussed in relation to Figure 21 above). Increasing mid-channel scour may also assist any spawning efforts by trout – by keeping high levels of suspended sediment moving past deposits of suitable spawning gravel.

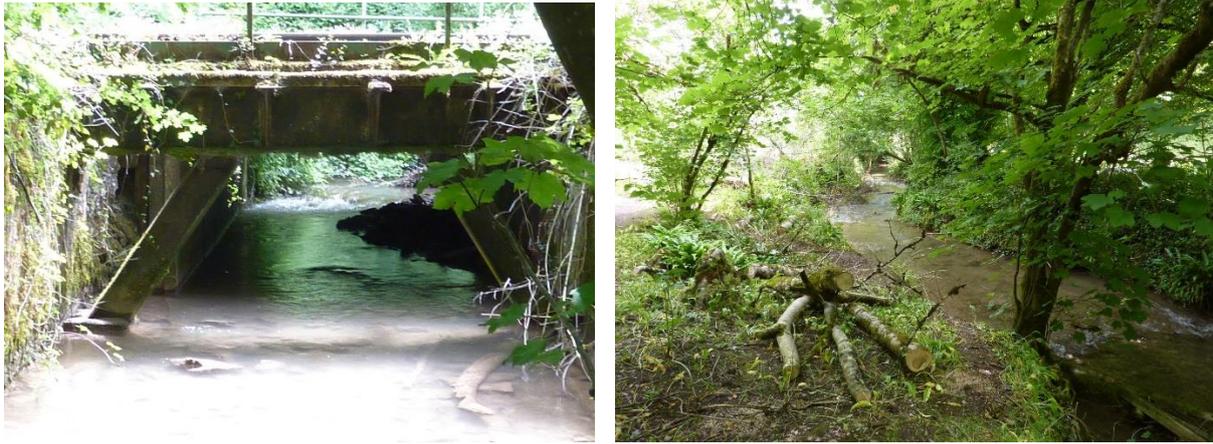
*Figure 24: Left, the box culvert under the railway line; Right, downstream of the culvert, the channel appears relatively naturalistic, with plenty of arisings from recent tree works which could be used to improve in-channel habitat.*

At the time of this walkover, quite large quantities of arisings were still present on the banks, including some large sections of trunk, and it would be valuable to reposition some of the larger sections so that they lie partly within the channel, creating hydromorphological benefits, whilst being secured at their bankside end.

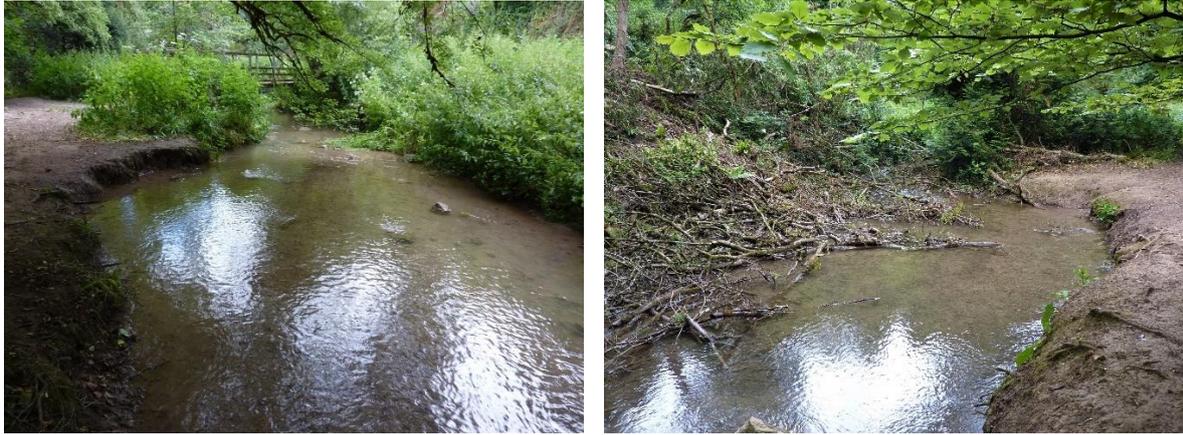
Figure 25: Two areas of severe erosion on the RB of the Whatley Brook as it approaches the confluence with the main River Mells.

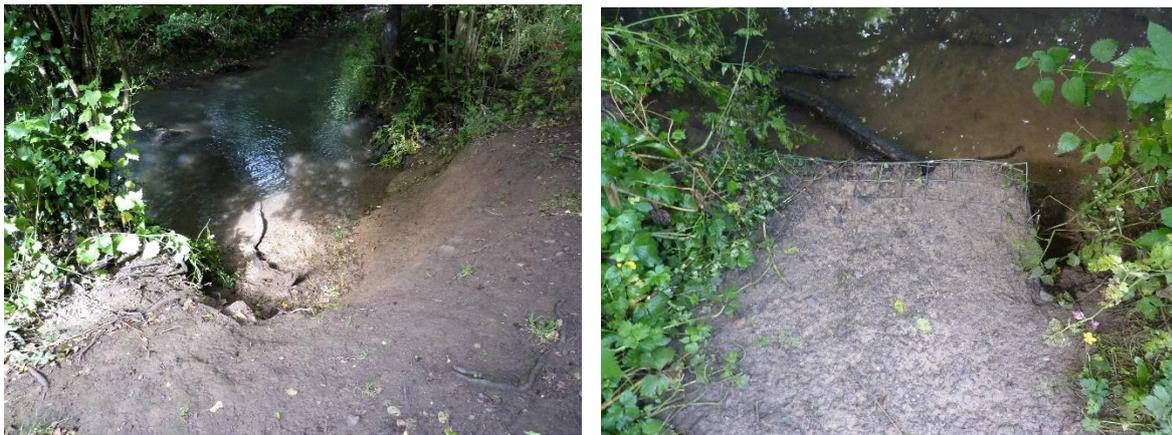
*Figure 28: Left, a typical 'dog slide' causing localised erosion along the Nunney Brook; Right, a previous attempt to repair this erosion with a gabion basket. A more natural approach would be packing the eroding area with brush, protecting the bank top with a dead hedge, and guiding dog walkers towards formalised, erosion-resistant dog dip areas.*

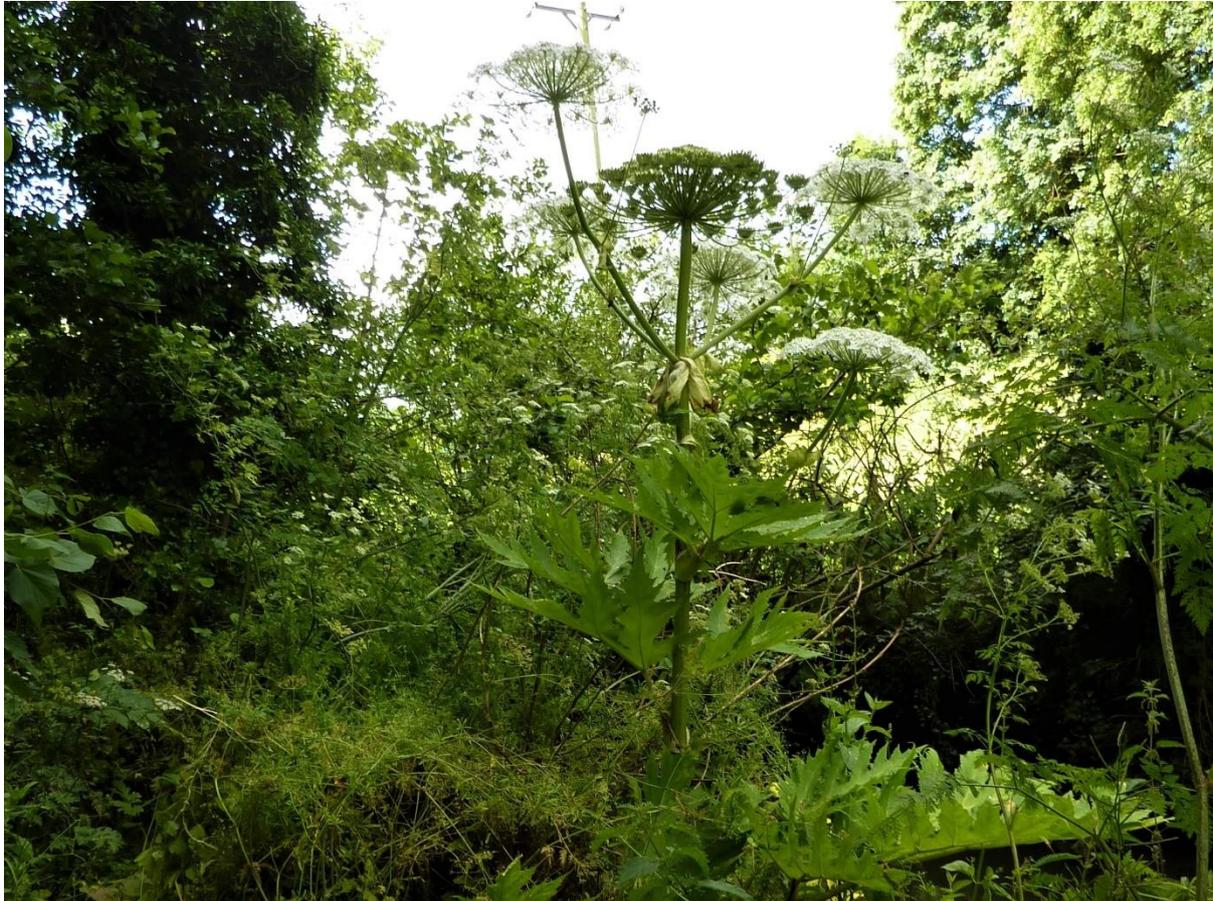
*Figure 29: Giant hogweed on the Nunney Brook.*

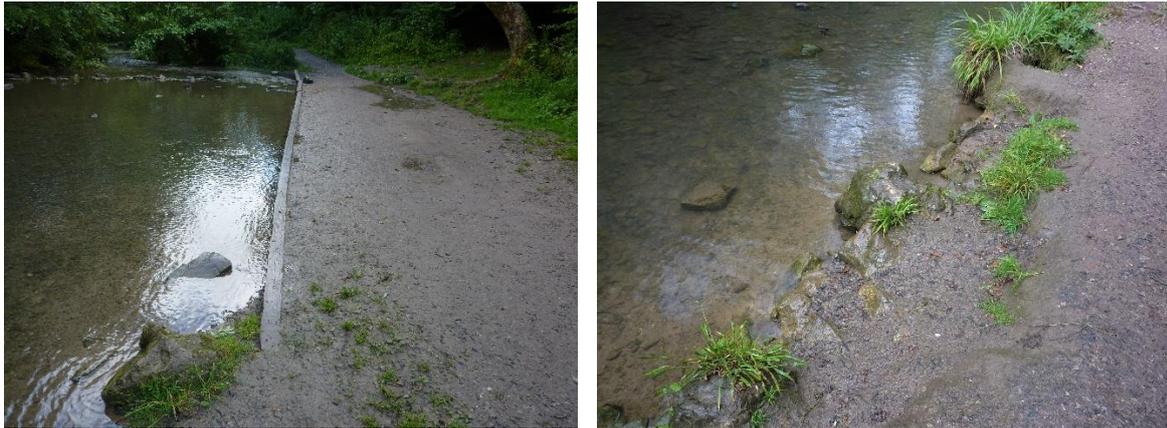
*Figure 30: Left, the toe-boarded edge of the dog dipping area on the Nunney Brook; Right, a more naturalistic boulder edge*

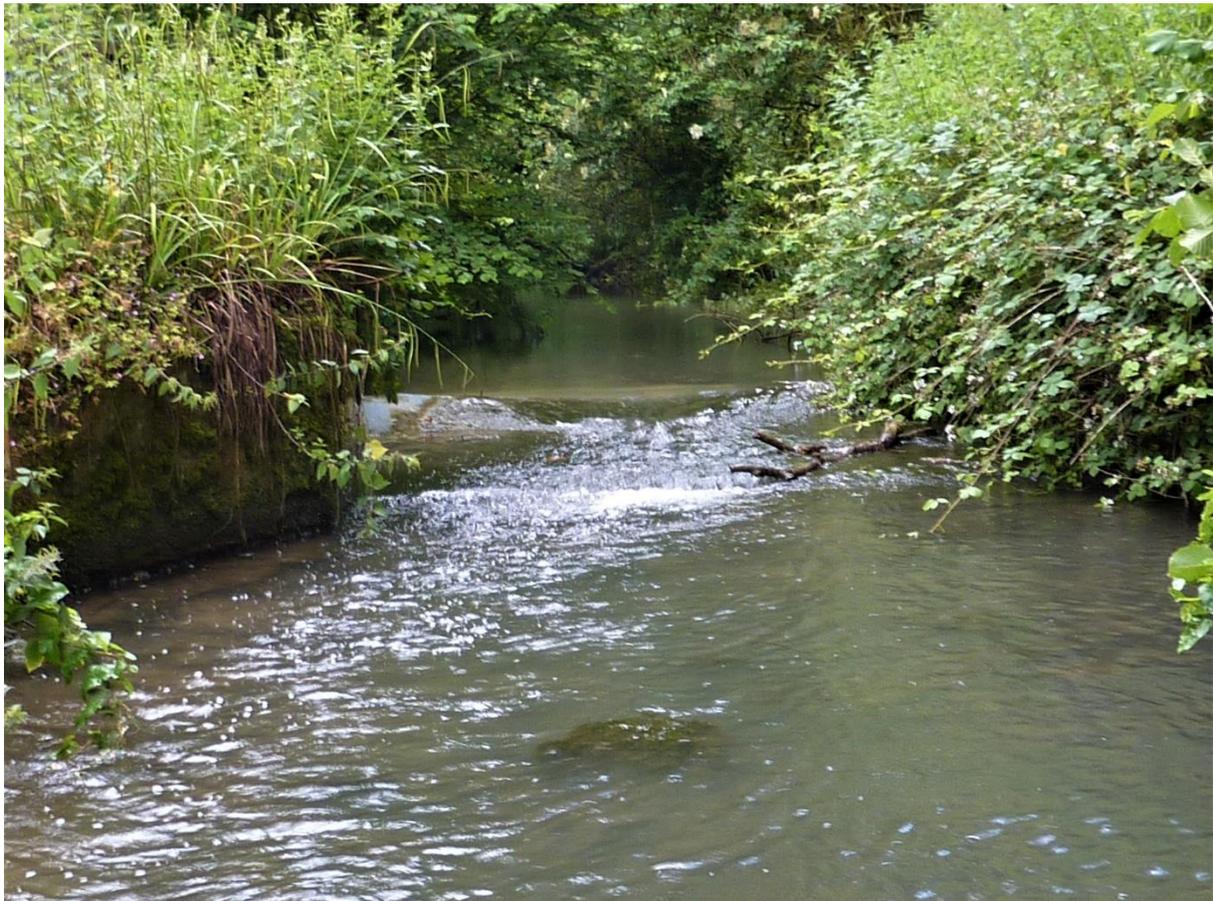
*Figure 32: The gauging weir on the Nunney Brook.*
