## WILD TROUT TRUST

### **Advisory Visit**

**River Thet, Manor Farm, Attleborough, Norfolk**

**March 2024**

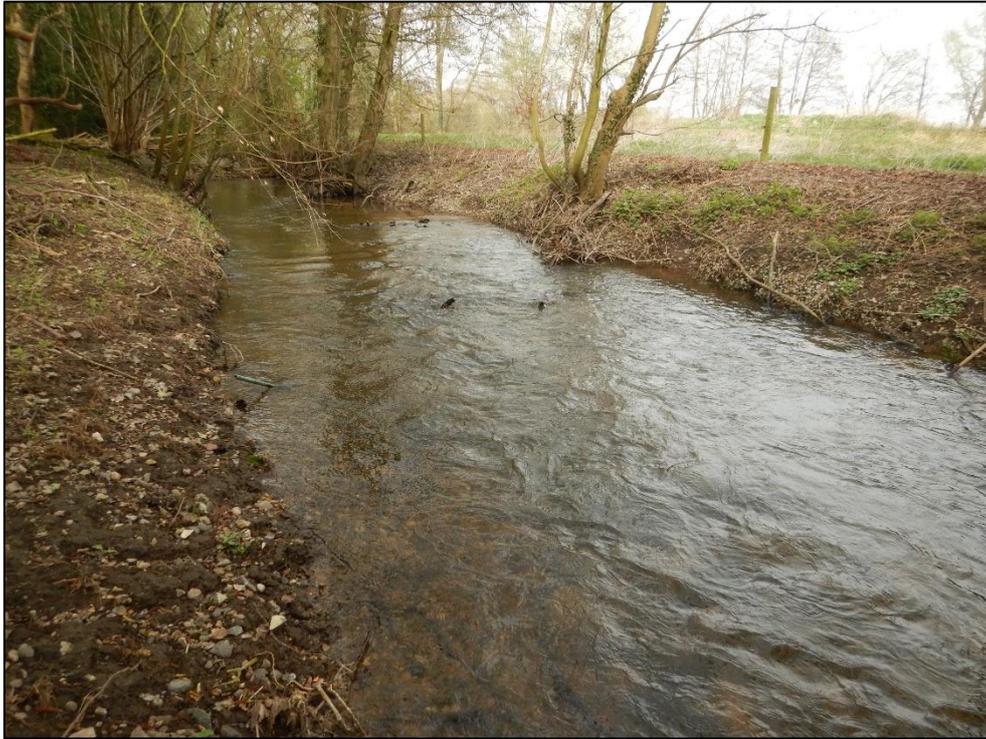
The visit started at a point where the river is realigned between two former gravel pits, consequently the river's course is straight as it flows in an easterly direction. The river is ~4m wide with a depth ~0.3m (pic 1). The flow was swift with a gravel bed exposed. In the lee of any obstruction sand and fine sediment was present. The gravel, although abundant, was generally poorly sorted, suggesting that it was not very mobile. Importantly, brown trout need clean and graded gravel (particularly in the size range 10-40mm) to spawn upon (illustration 1). With their eggs

Pic 1 – The Thet has some areas of swift flow over a gravel bed, but an abundance of fine sediment reduces its potential for productive trout spawning.

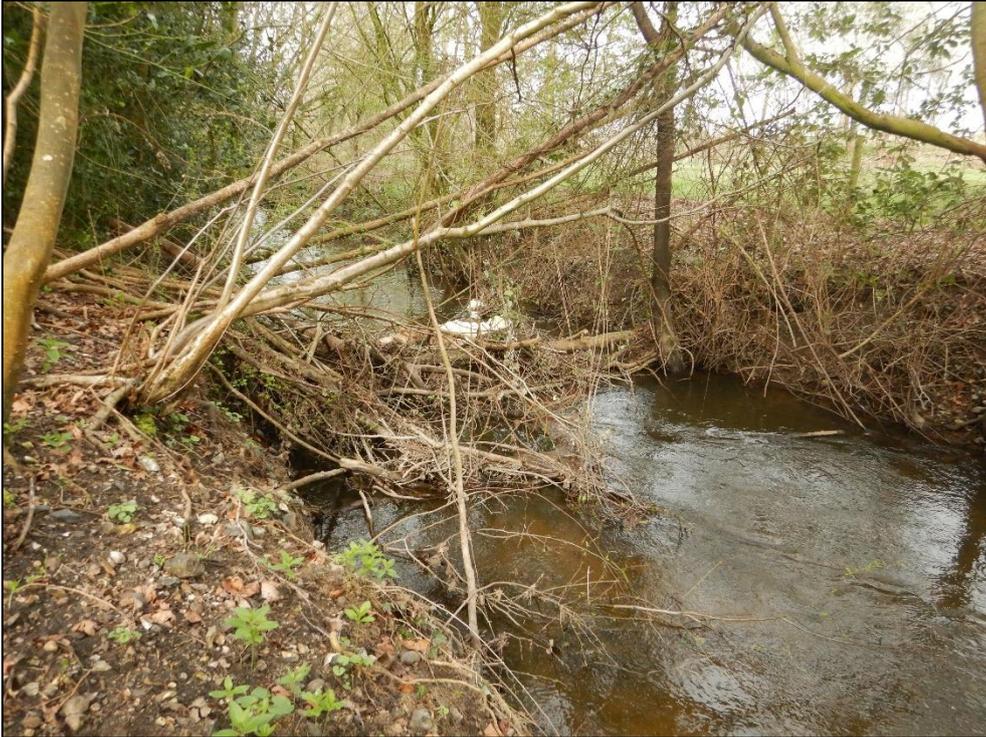
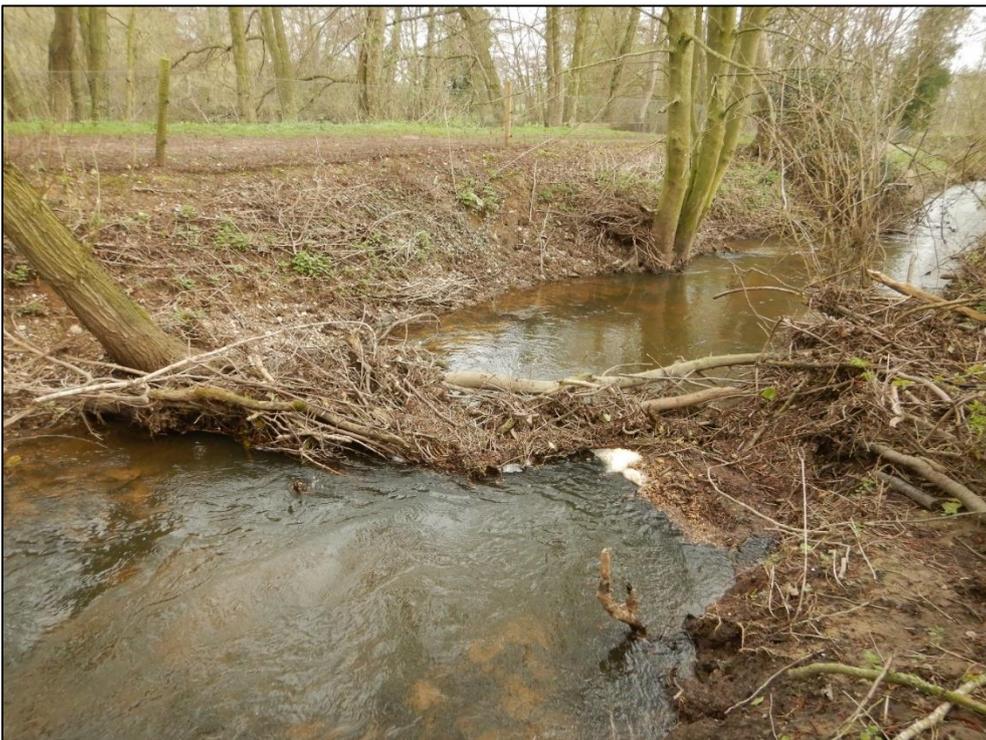
Encouragingly, the river contained natural logs jams (pics 2 & 3) and woody material. Accumulations of large woody material provide some cover and encourage silt to drop. The occurrence of fallen sticks, branches and tree limbs, together with the organic matter that they collect, may look unsightly to some but the presence of such material is of great importance within rivers. Collectively such material is referred to as Large Woody Material (LWM). LWM leads to an increase in the surface area on to which a biofilm (algae, bacteria and other microbes) can grow. In turn, the biofilm may become a source of food for invertebrates, increasing the total biomass that a river can support. LWM also provides underwater cover, offering protection for fish against otters or fish-eating birds. LWM can also provide natural flow deflection which may locally increase a river's flow velocity assisting cleansing of the gravel bed, but correspondingly slowing it elsewhere around structures. Where LWM presents no flood risk it should be retained, as it improves hydraulic roughness within the channel. Where possible, fallen trees should be retained as they fall. But where there is concern for their position, they may be secured using appropriately secure fixings.

Pic 2 – Natural log jams provide important cover for fish and aquatic invertebrates.

Pic 3 – Natural log jams also enhance flow diversity and may initiate bed scour and sediment storage.

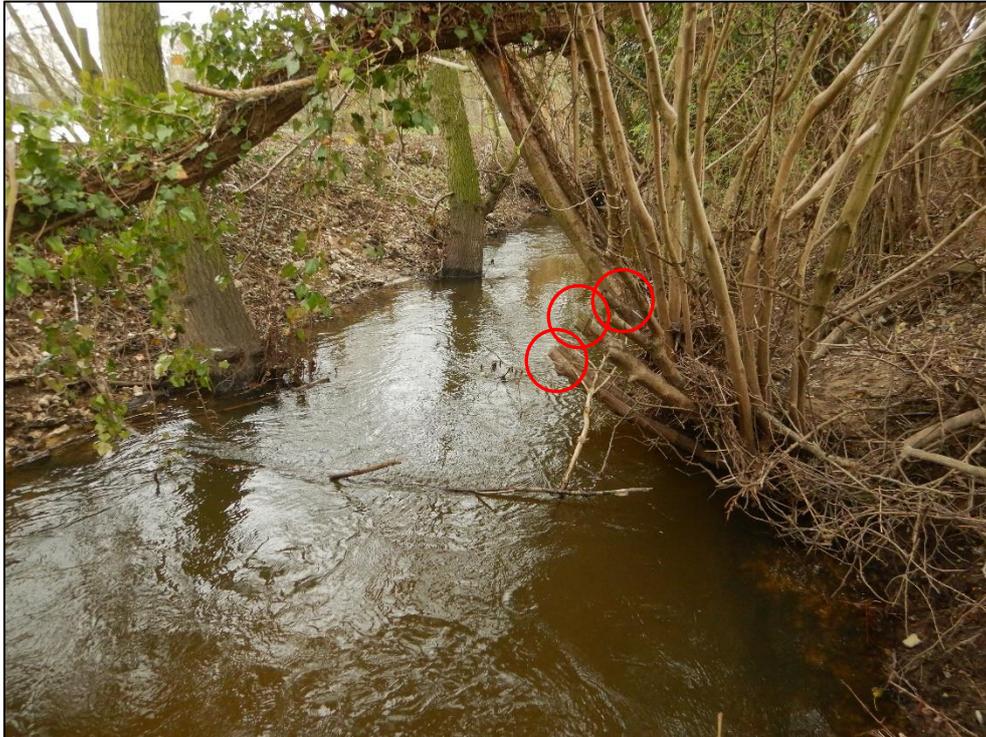
Pic 4 – Note that limbs (red circles) have been cut from the hazel, presumably to ease the passage of flow, reduce scour and meandering near to the lakes.

Some of the smaller trees, especially hazel, could be hinge-cut to increase marginal cover (pic 4). Tree-hinging is a technique favoured by the Wild Trout Trust for delivering instant woody cover at, and below, water level. Trees (large or small) are cut to produce an effect similar to hedge laying. Species such as willow and hazel respond particularly well. Laying retains a living hinge that secures the cut stem to the tree stump so structural

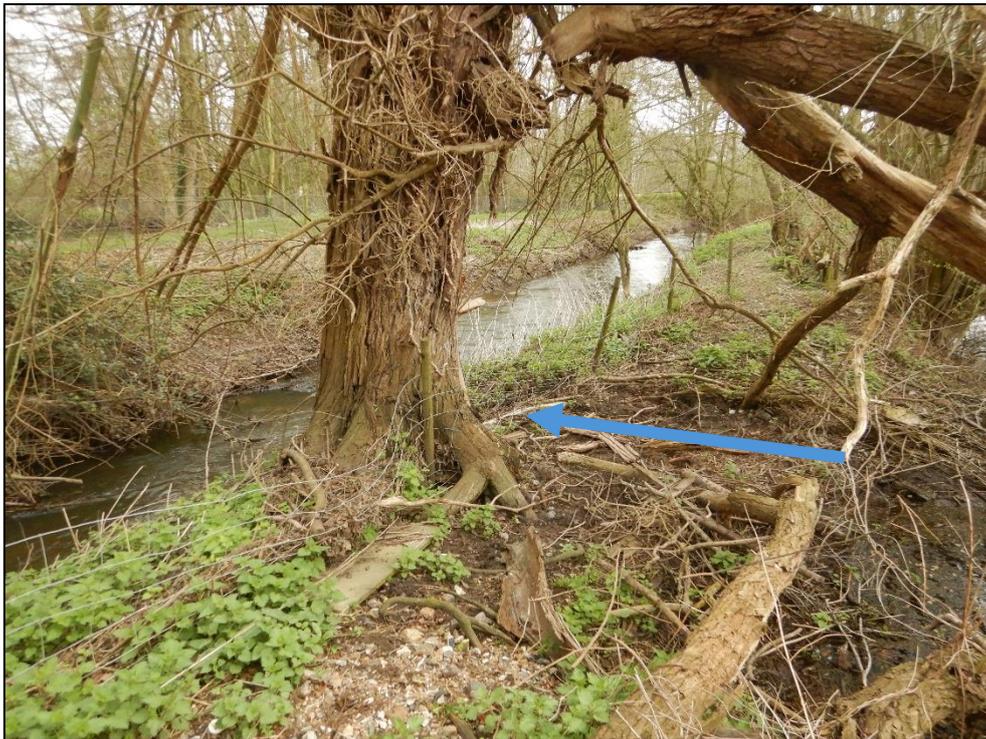
There was clear evidence of the river having flowed into and out of at least one lake during recent high-water events (pic 5). The lakes now occupy the space that would have once been the river's floodplain, and it is clear following this winter's exceptionally high flows that the river will connect to its floodplain.

Pic 5 – Water has entered the lake from the right bank, and has flowed out (blue arrow) with enough force to scour the bank top.

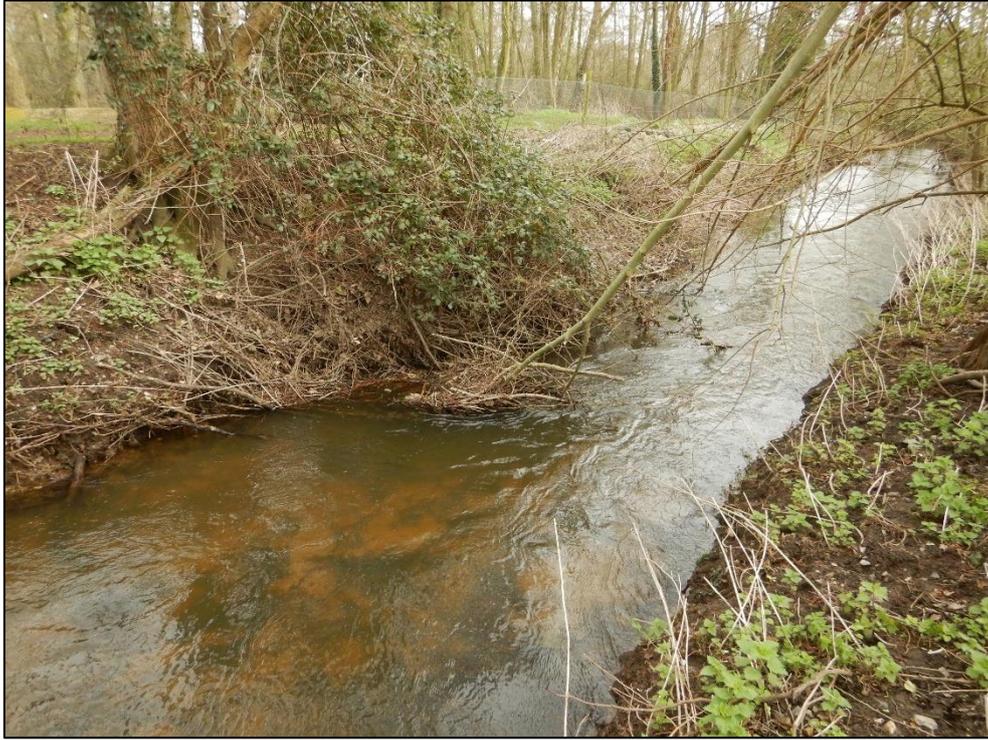
The issue of fine sediment within the river channel starts to become a major issue for the Thet at 52.507991, 0.950820 (pic 6). Sand covers the gravel bed, moving downstream in bars with only larger stones protruding. High volumes of sand (and other fine sediment) covering the entire riverbed will reduce the river's diversity by limiting the availability of ecological niches. For example, clean and sorted gravel may be present beneath the sand but it unavailable as a spawning substrate. Similarly, riverbed stones used by stone-clinging caddis and mayfly larvae will also be absent. Fine sand forms a dense, cohesive body making it less likely to be scoured in all but the

highest of flows. In addition to the river not being able to lift its fine sediment load and deposit it upon its floodplain, the river is also struggling to transport it through the system due to a lack of flow diversity; the lack of flow diversity is compounded by the river's straightness and incised form. If the river meandered, it would be better able to sort its fine sediment and deposit it on the inside of meanders, and if the channel was not so incised it would be able to deposit its fine load upon adjacent floodplains. That is simply not happening in the River Thet at this site. Past realignment and dredging has changed the river from its natural state, which can transport fine sediment, to one which is an over-capacity, depositional environment which can no longer manage, and balance its fine sediment load.

Pic 6 – Sand starts to dominate the riverbed.

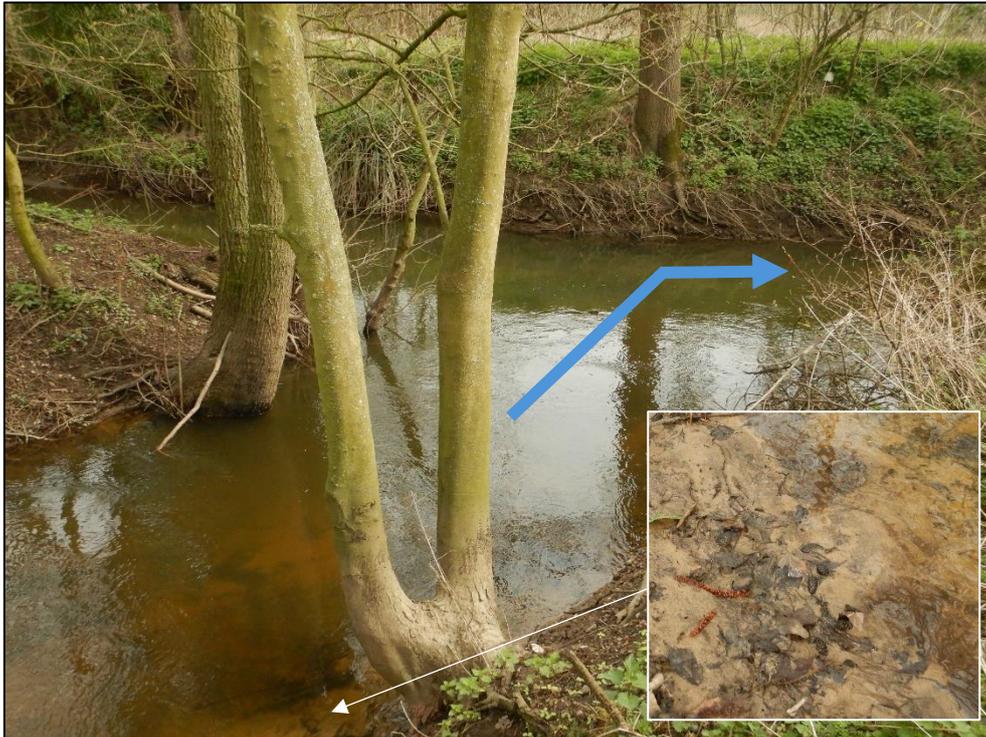
At 52.507937, 0.951396 the Thet is forced to take an unnaturally sharp 90-degree turn (pic 7) as it meets another tributary. The channel upstream continues to be dominated by sand, with some deep deposits to the margins but with none high-up the bank. It is thought that when the river is in flood, whilst its channel may fill-up, water is partially backed-up as opposed to running faster, the river's velocity near bed is probably not that high and little sediment is actually lifted and transported. Sediment is likely to be mobilised as the river drops in level. The constant movement and smothering of the bed by fine sediment will be ecologically damaging to the river's aquatic environment, especially it's invertebrate communities which are a crucial component of many food webs.

Pic 7 – The river is forced to take an unnatural 90-degree turn. The unnatural channel alignment is adversely affecting the river’s ability to transport fine sediment.

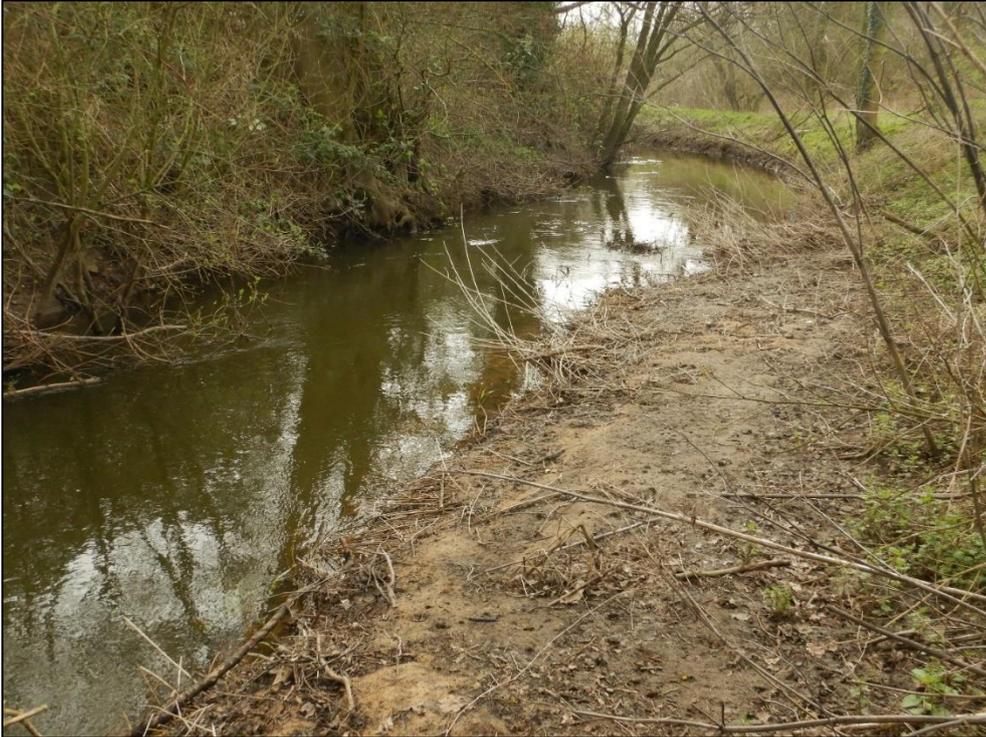
With the river now having turned to flow in a southerly direction, it is still over-burdened by sand. A right bank berm showed recent sand deposits (pic 8), it is doubtful that the feature could have taken any more. If the berm is in full sun, then the deposited sand may become fixed by vegetation growth, which in time may become stable enough to deflect flow, leading to some degree of channel movement. But the natural extent of movement is likely to be very minimal given the strongly rooted (pic 9) shrubs and trees of the left bank.

Pic 8 – A large sand deposit with potential to become a vegetated berm.

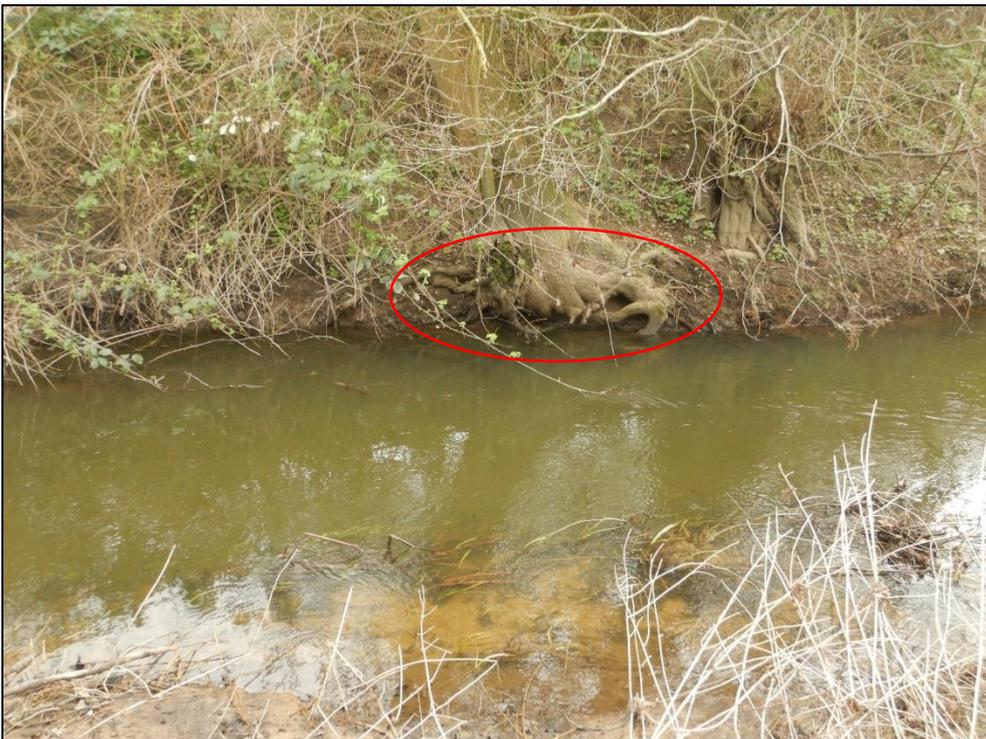
Pic 9 – Strongly rooted trees and shrubs (red oval) hold the left bank firm making it less likely to move due to lateral scour.

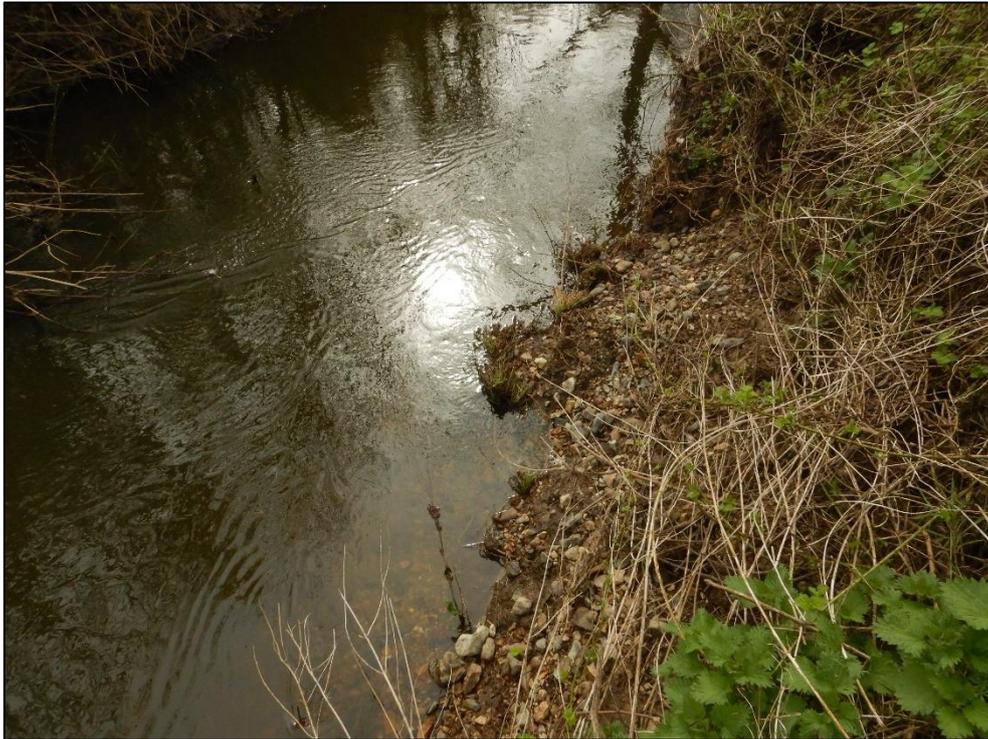
Occasionally there was evidence of active coarse sediment supply (pic 10), but the volume of gravel and stone is far from the quantity that would be required to form new gravel bars and riffles.

Pic 10 – Active coarse sediment supply, but it will not be enough to create new valuable river features.

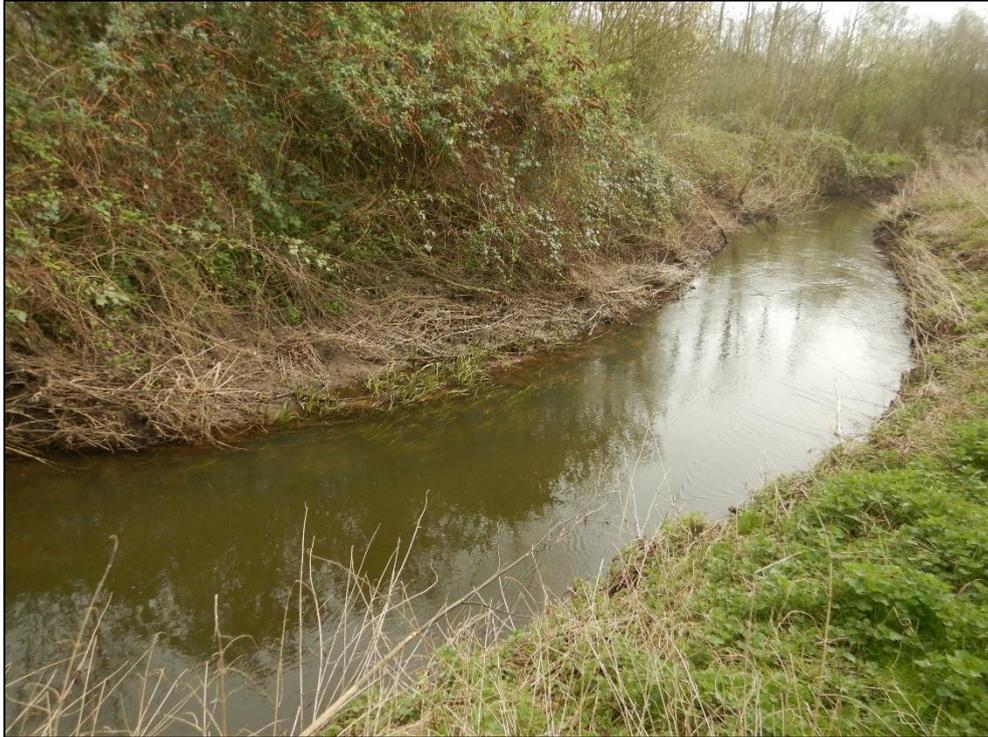
In places the water level appears to be ~4m below the ground level, the extent of channel incision is very significant. Although remaining largely straight, there are some short reaches where the channel gently meanders (pic 11) and the width increases to ~7m. Correspondingly, there are silt bars on the inside of the meanders with some marginal vegetation. Unfortunately, the vegetation appears to be predominantly bur reed. Bur reed typically grows in slow to medium paced rivers where deep silt and sand dominate. Bur reed can completely dominate open water habitats by late July, giving the impression of a choked channel. Once river managers perceive a choked channel, the thought is that something must be done to return the river to its earlier capacity and so physical removal of the plant and substrates may be called for (by dredging or heavy weed cutting) but this simply repeats the cycle of over-deepening the channel, fine sediment accumulation and colonisation by bur reed. A more considered approach is to remove the physical conditions that the plant requires for growth. That can be done by restoring the riverbed to one which is shallower, prevents the accumulation of fine sediment, and creates faster water velocities (which can prevent reeds from rooting). But in the case of the Thet, it is not just riverbed restoration that is required, but also channel realignment. Only a combination of riverbed restoration and channel realignment will achieve effective river restoration at this site.

Pic 11 – The channel has some slight meandering, just enough to allow silt to be deposited in margins.

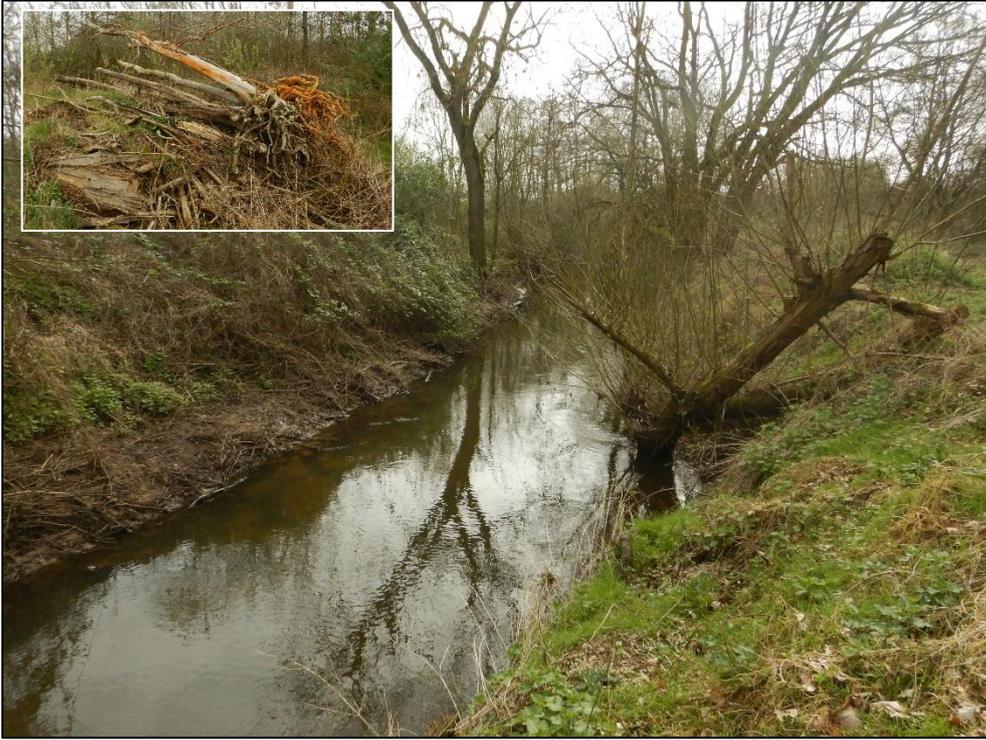
Given the tree-lined nature of the reach, it was surprising not to find fallen trees within the channel. There was evidence of past tree management and of trees having been removed from the water. Trees within rivers are a crucial component of the riverine environment. Fallen trees only need to be moved if they are causing an unacceptable flood risk or lead to habitat degradation (as can result in an unnatural realigned channel). In the setting of Swangey Fen there did not appear to be any flood risk to property and fallen trees could provide additional cover at water level. Importantly, fallen trees will initiate bed scour by retaining a head of water behind them, as water is forced down against the bed, coarse sediment may be scoured out leading to the formation of new riffles and gravel bars.

Pic 12 – Overall, the river lacks fallen trees within it. Trees have been removed from the river in the past (inset).

Oxygen Conservation should establish if the river is subject to any (annual?) maintenance regime and by whom. It might be possible to adjust the regime for the greater benefit of the river.

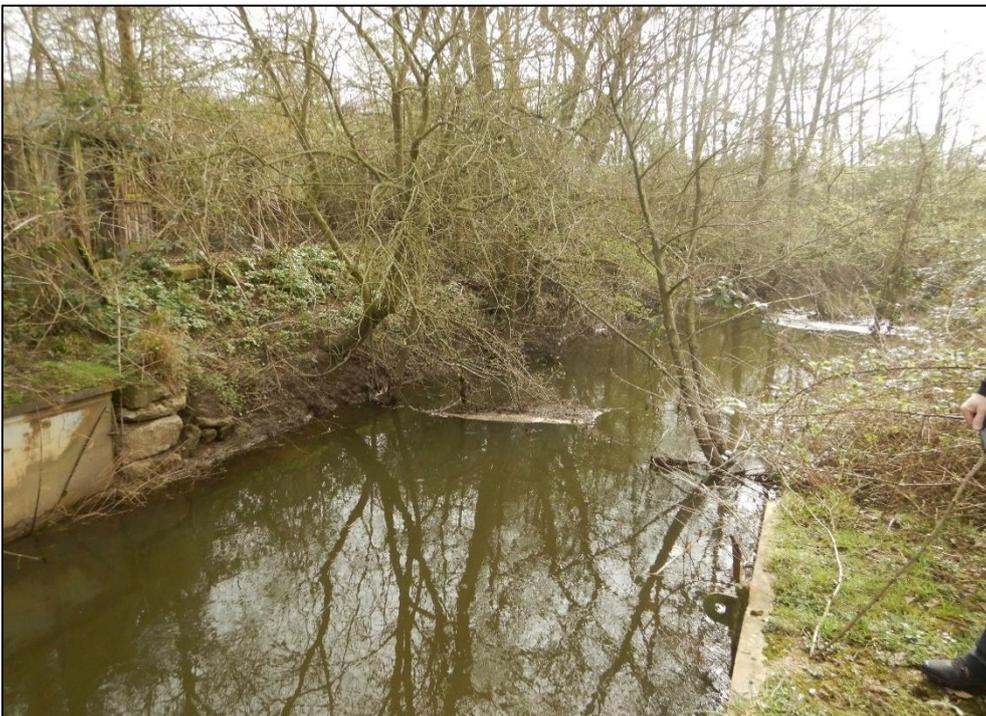
At 52.506024, 0.952194 there are the remnants of a former bridge. Beneath where the bridge deck once stood, the riverbed appeared to be shallower, indicative of a more natural bed depth (but remembering that the whole channel is considered artificial). The bridge parapets are still present, causing a channel restriction and degradation of the marginal habitat (pic 13).

Pic 13 – The retention of defunct bridge parapets results in channel degradation and a restriction to flow.

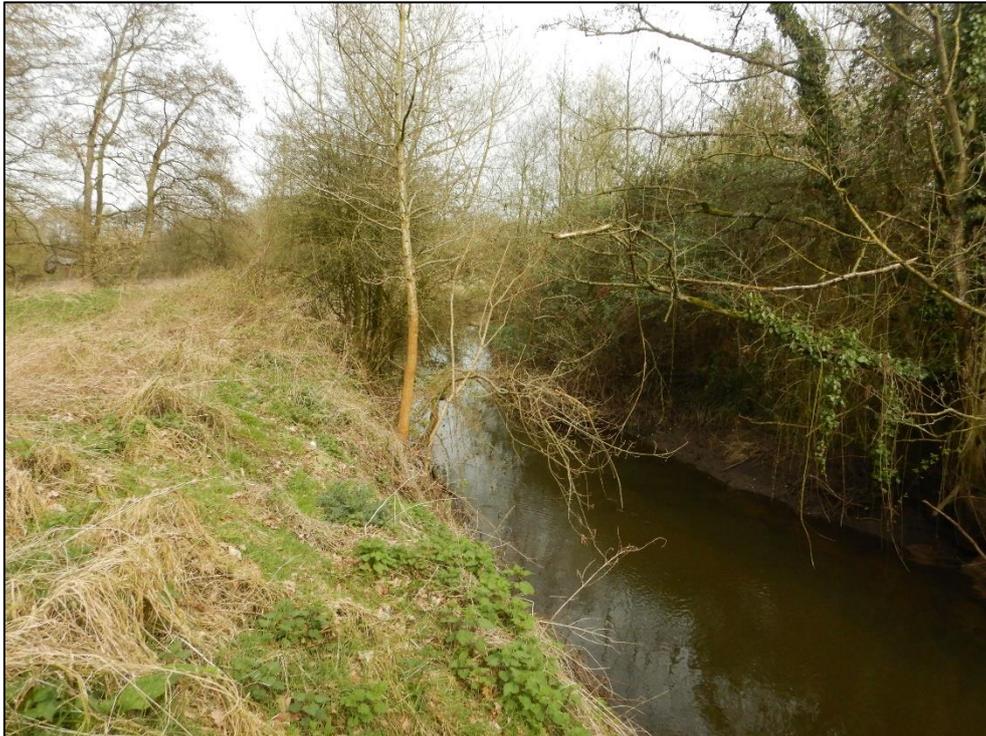
At 52.505026, 0.952150 the river is starting to be lost beneath tree canopies merging from both banks. This is allowing brambles to cover the river. Whilst shade from trees is important, with brambles engulfing the river corridor excessive shade will result. That will prevent the growth of marginal plants leading to a decline in the ecological richness of the river, its flow diversity and its ability to fix mobile sediment. Pics 14 and 15 show the process of tree and bramble dominance. Given that most trees on the true right bank appear no older than 10 years, it's a change that has probably arisen from the cessation of flail cutting which probably maintained the right bank for ease of access.

Pic 14 – Recently established ash trees have colonised the bank, bramble (and ivy with its leaves still visible) are growing out over the river using the trees for support.

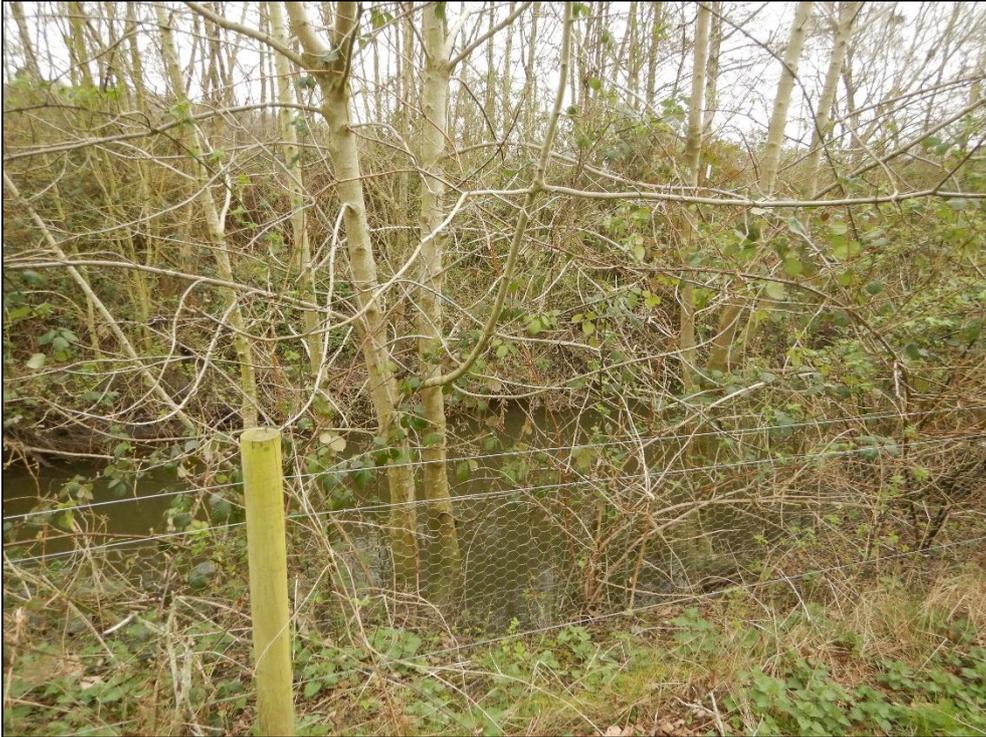
Pic 15 – A recently installed fence has protected riparian trees, but they now threaten to reduce the river’s ecological diversity through dense shade, which is further compounded as bramble grows up, and over, the low trees.

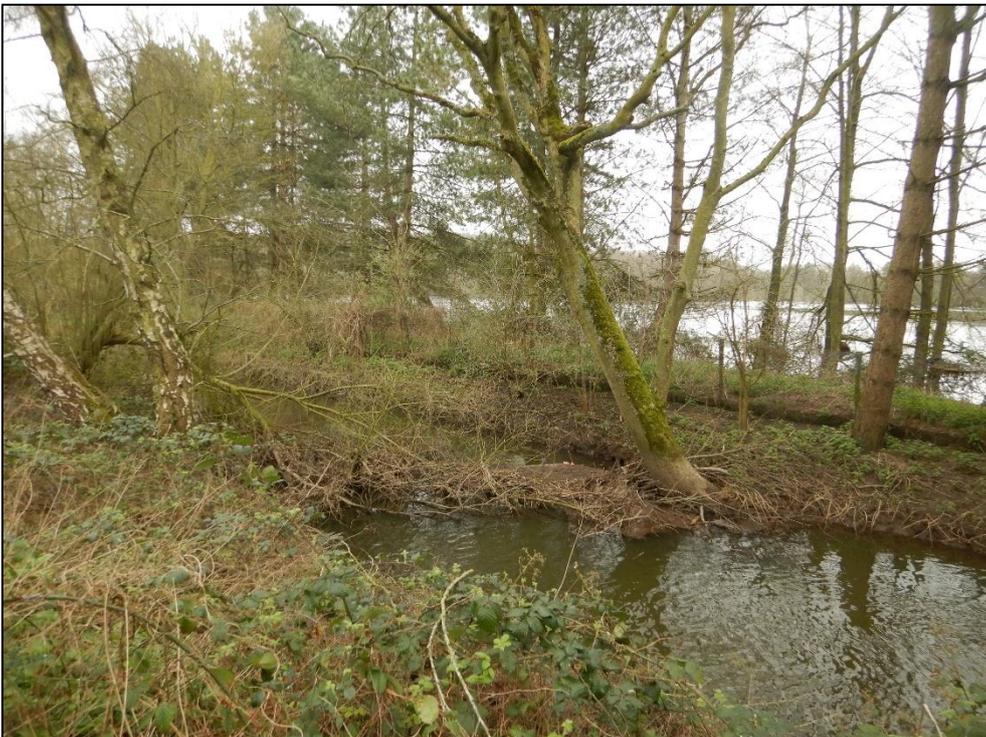
The river continued to flow in an unnaturally straight channel (pic 16) and its velocity appeared to reduce. There were occasional accumulations of woody material resulting from recent high water, but none of the accumulations were pinching the channel enough to initiate bed scour.

Pic 16 – Accumulations of woody material are not enough to initiate bed scour but still provide important cover.

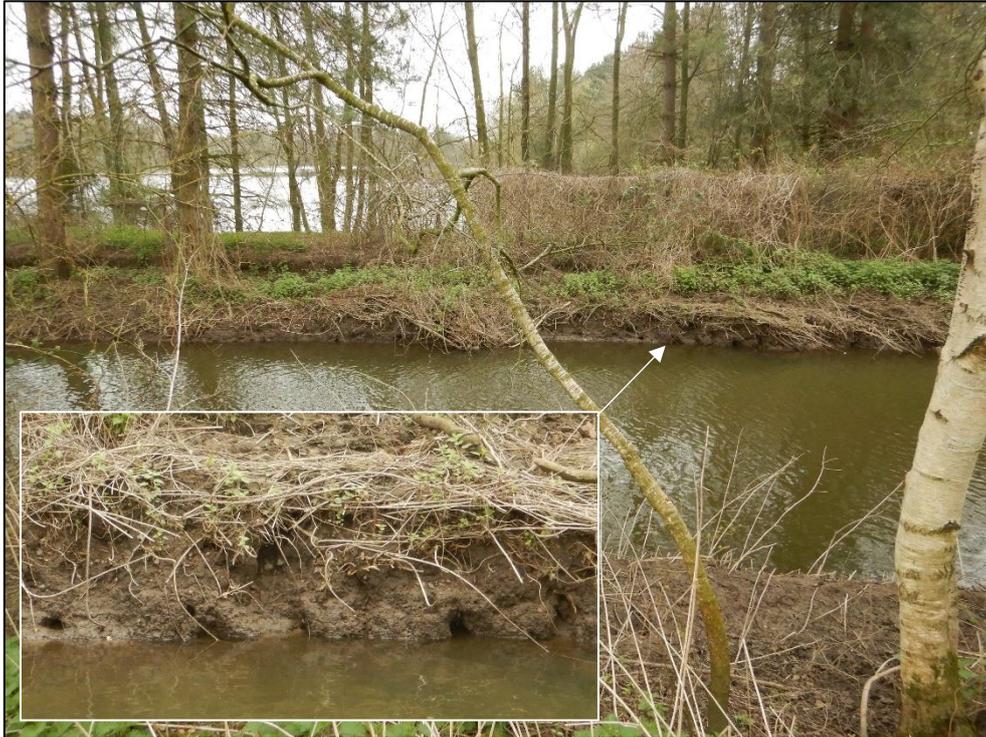
Burrows in the bank were noticed at 52.503652, 0.952194. The shape and density of them suggests signal crayfish rather than water vole (pic 17). With signal crayfish present, banks will become less stable, especially with less marginal vegetation because of shade. Bank instability will result in further fine sediment input to the river, leading to further ecological damage.

Pic 17 – Note the lack of marginal vegetation and signal crayfish burrows.

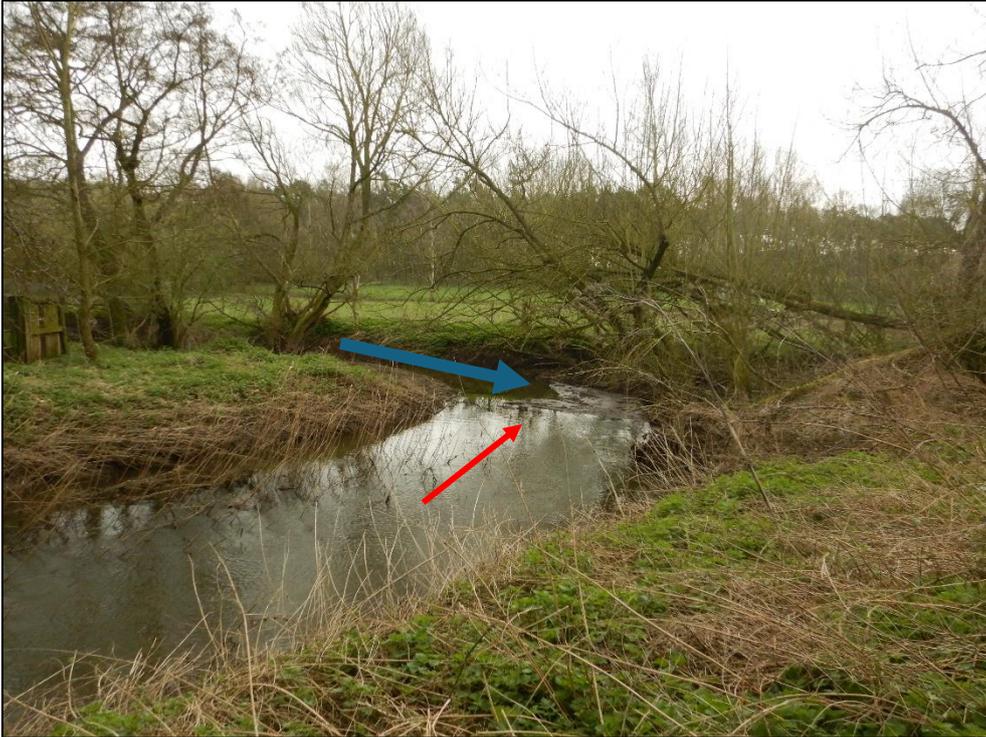
At the confluence of the Buckenham Stream the river took another 90-degree turn to head in a westerly direction (pic 18). The upper reaches of the Buckenham Stream were assessed as having good trout potential in 2021, but no fish were seen during the visit. The Thet after the confluence was notably stronger in flow and had a greater width  $\sim 8\text{m}$ . The river only needs to rise  $\sim 1.2\text{m}$  before over-topping the left bank (land outside of Oxygen Conservation's control). It is clear that flooding of left bank's low-lying land is the consequence of a flood pathway connecting to a paleochannel (pic 19).

Pic 18 – Note how the flow of the Buckenham Stream (large blue arrow) appears stronger than the Thet (small red arrow), suggesting that the Thet's flow could become backed-up when flooding occurs.

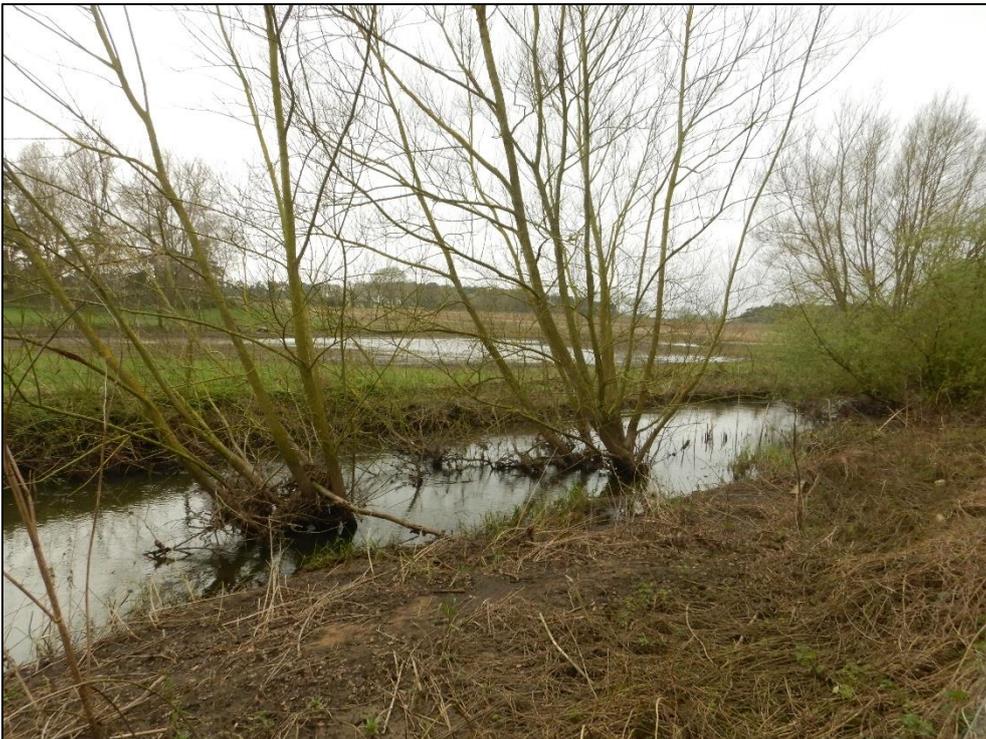
Pic 19 – Flooding of left bank's low-lying land is the consequence of a flood pathway connecting to a paleochannel.

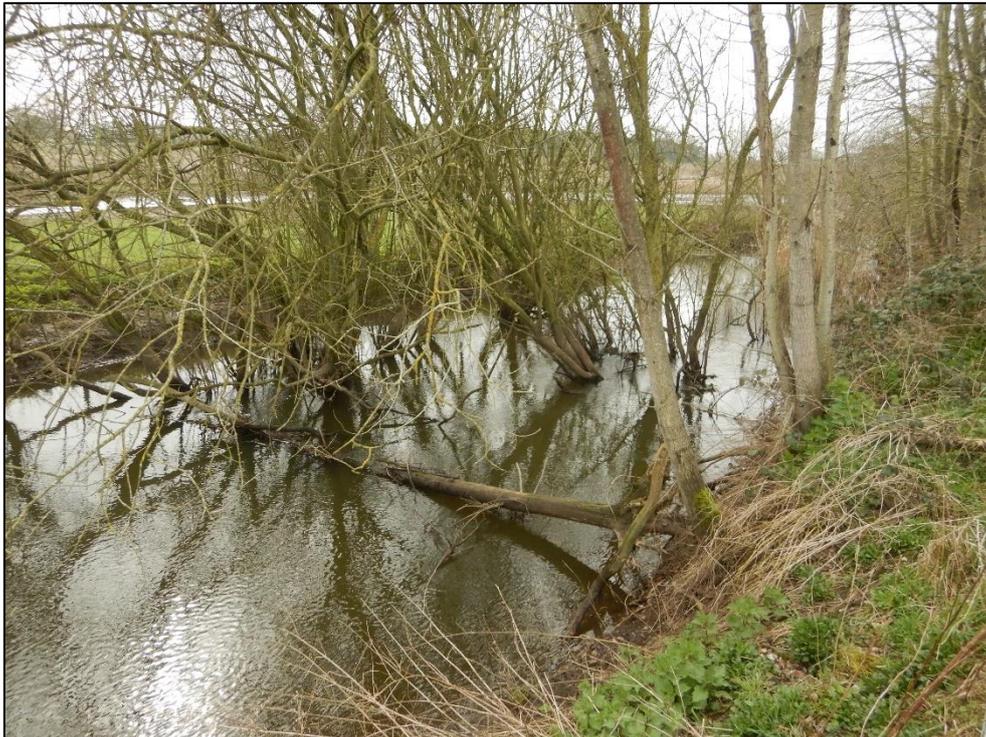
In contrast to upstream reaches, the river from this point has many willows growing within it. As the trees fall, they will cause the river to back-up, scour and re-meander, leading to significant (and importantly *unknown*) channel and landscape changes. Much good will come of the process given

Pic 20 – Willows are now growing from within the river, contrasting to the upper reach. As the trees fall, they will create flow diversity resulting in different flow pathways across the floodplain.

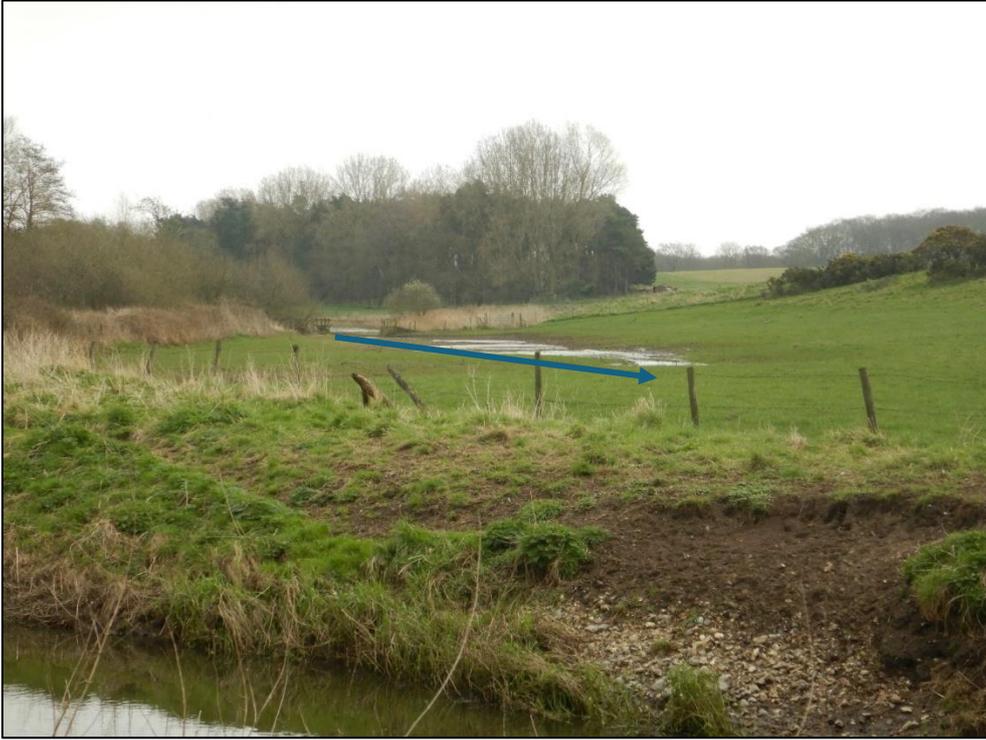
At 52.502493, 0.946609 a significant deer crossing point is present. The input of silt from the damaged banks is significant (pic 21), creating another source of fine sediment input to the river. The paleochannel started to diminish at this point but it was still apparent that a notable volume of water had moved across land to the south, creating a wide meander in the landscape until higher ground would have stopped the river's historic path, forcing it back nearer to the current channel.

Pic 20 – Note the paleochannel still present in the landscape (blue arrow). If the river was connected to it, it could provide more space for better channel alignment and the chance for natural river processes to shape the river and its valley once again. In the foreground is bank damage caused by deer, a similar extent of erosion is present on the near bank.

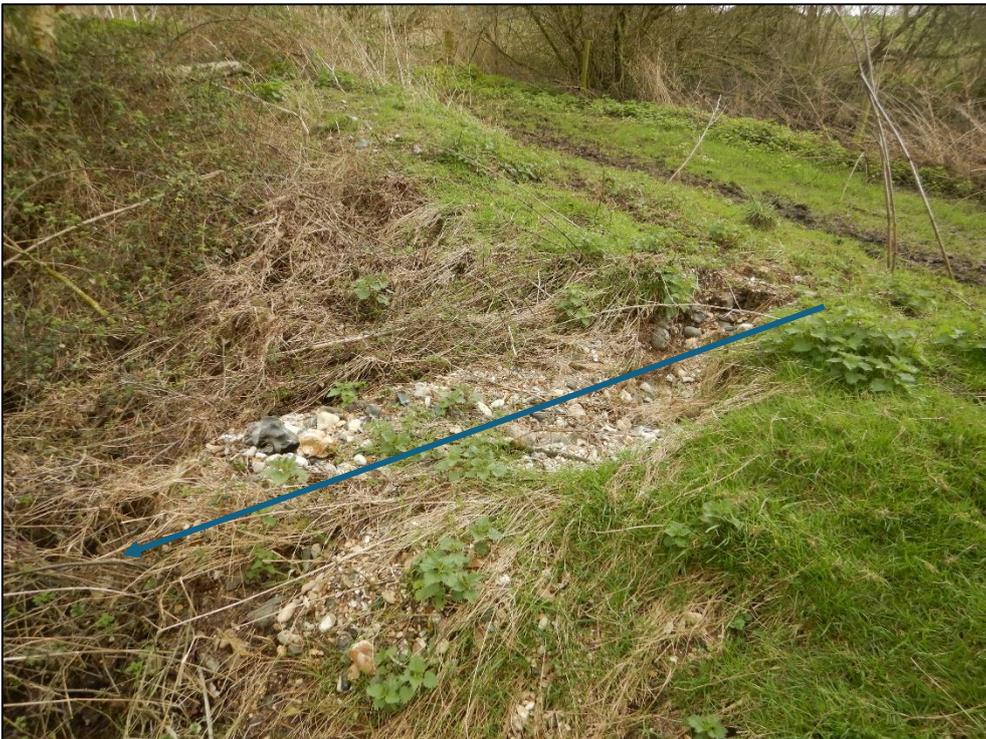
Also of significance at this point is the force of water that has entered one of the lakes (pic 21), demonstrating again that the lakes are within the active floodplain and will become inundated, possibly more frequently due to climate changes and more intense storm events.

Pic 21 – As the river has come out-of-bank it has flowed into an adjacent lake, creating a scour path. If floods become more frequent and greater in magnitude the river is more likely to flow into the lakes, and in time the lakes may actually become one with the river leading to a large swamp environment.
