Advisory Visit

River Welland at Marston Trussell, Northants

April 2024

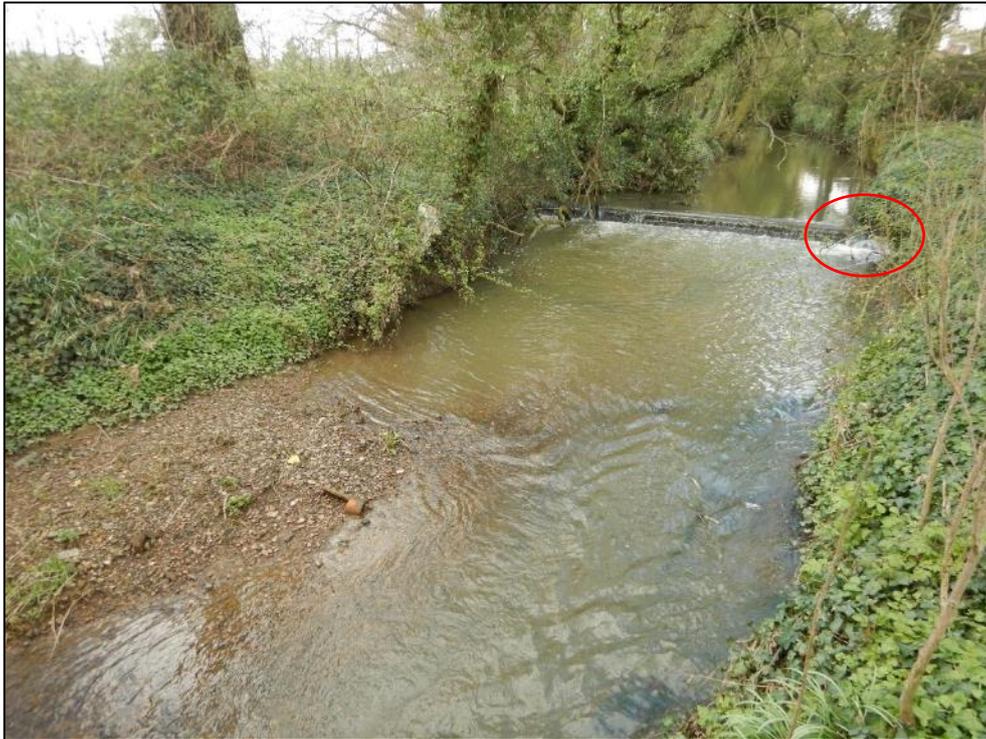
The first of many weirs was observed at 52.470529, -0.996613, and retained a head of water ~0.3m (pic 1). It was starting to fail against the true left bank resulting in an attractant flow which could ease the passage of fish over the weir. However, it is likely to be impassable in low-flow conditions.

The weir had captured gravel immediately upstream of it, eliminating any depth habitat that it once provided. Fresh gravel had been deposited downstream of the weir pool, suggesting that the weir no longer acts as a gravel trap (having been filled over time).

Upstream of the weir, the river was impounded and uniform habitat. The flow was relatively slow and open to warming by sunlight, both conditions unfavourable to trout.

Pic 1 - The first of numerous weirs. It was failing against the true left bank.

All of the 10 weirs should be removed as they serve no current purpose. If the plan for paleochannel reconnection is progressed, then some weirs may become obsolete and it may be advantageous to retain them simply for floodplain wetting. The ideal situation is one that seeks paleochannel restoration in combination with the removal of weirs to restore natural processes and free passage along the river.

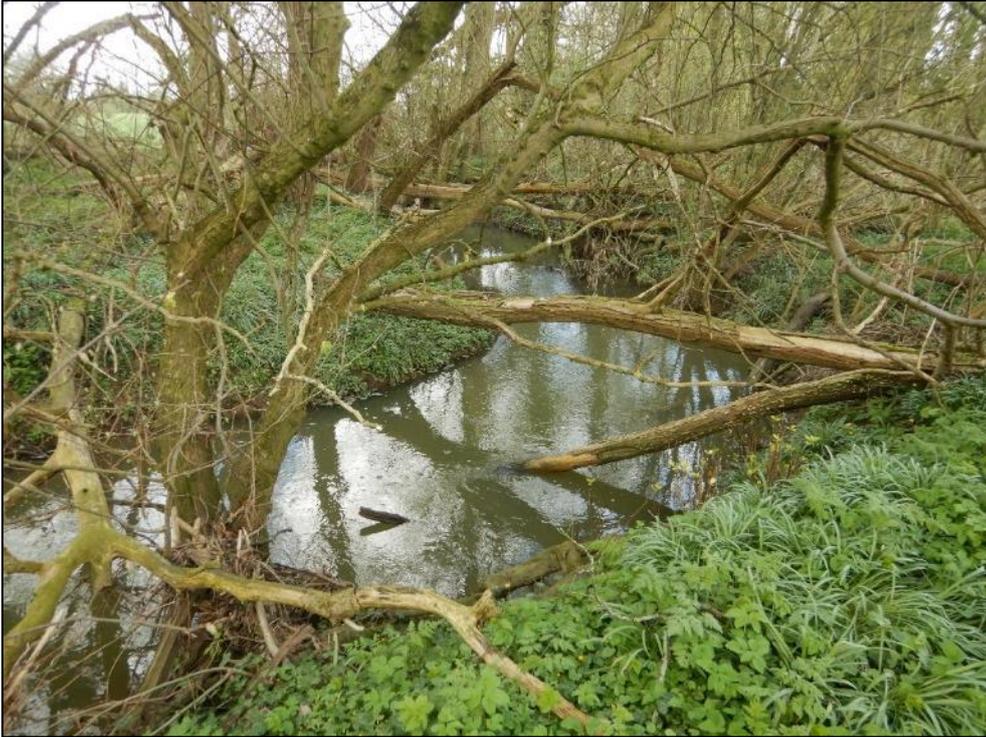
The river flowed through an area of woodland with willow the main riparian tree. Many had collapsed over the river but re-rooted (pic 2). The effect was a river peppered with multiple tree-limbs across it along a relatively short (~50m), but very interesting and ecologically valuable, length. The numerous trailing limbs will collectively act to slow the flow, presenting excellent natural flood management (NFM). Where limbs had fallen into the water, they aided gravel sorting and transport following the multiple high flow events of the recent winter. A full channel-width gravel bar was observed with well-sorted gravel which was also relatively free of fine sediment. The occurrence of sediment sorting, transport and then deposition was clear (pic 3).

Pic 2 - Excellent woody cover and NFM.

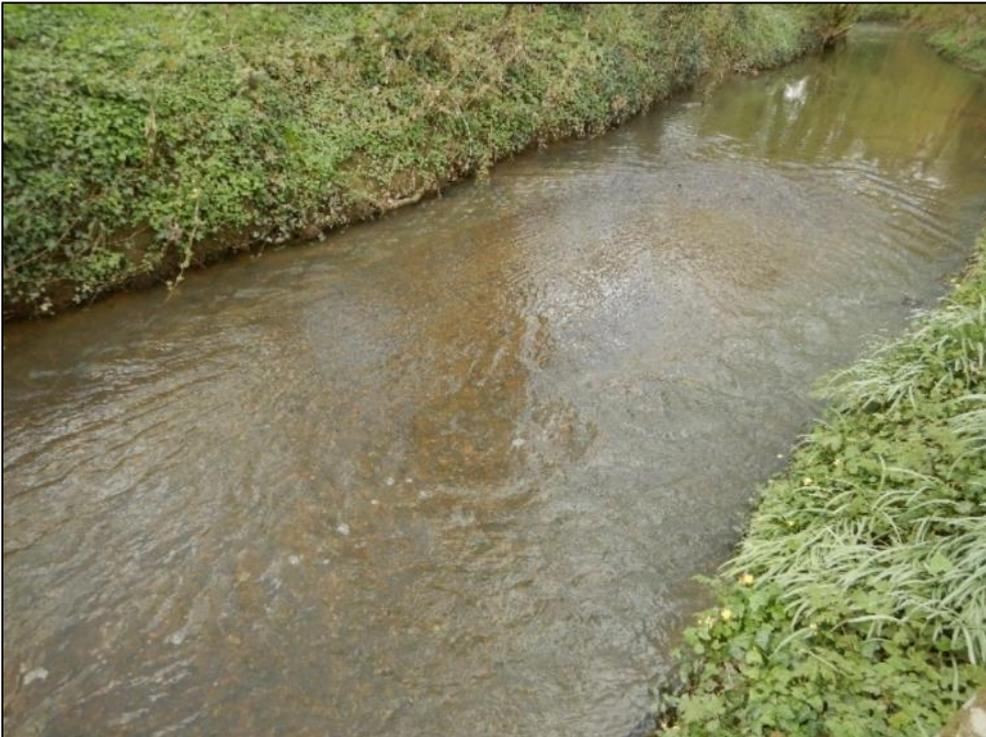
Pic 3 – Gravel deposited creating a full width gravel bar; an important habitat which should improve over time.

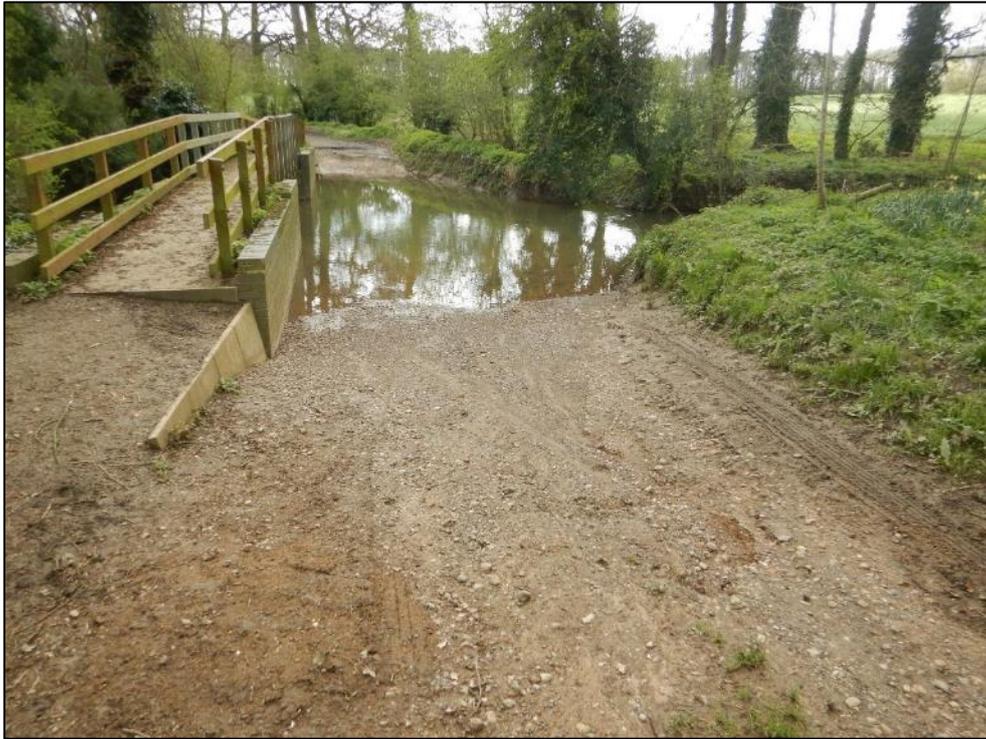
A ford was reached, and it was clear that it was a pathway for fine sediment to enter the river due to its associated unsurfaced and eroded track (pic 4). An excess of fine sediment is detrimental to river ecology. Fine particles smother gravels, blocking the interstitial spaces between gravel which may be used by aquatic invertebrates or by trout for spawning upon.

Pic 4 – The ford produced a pathway for degrading fine sediment to enter the river.

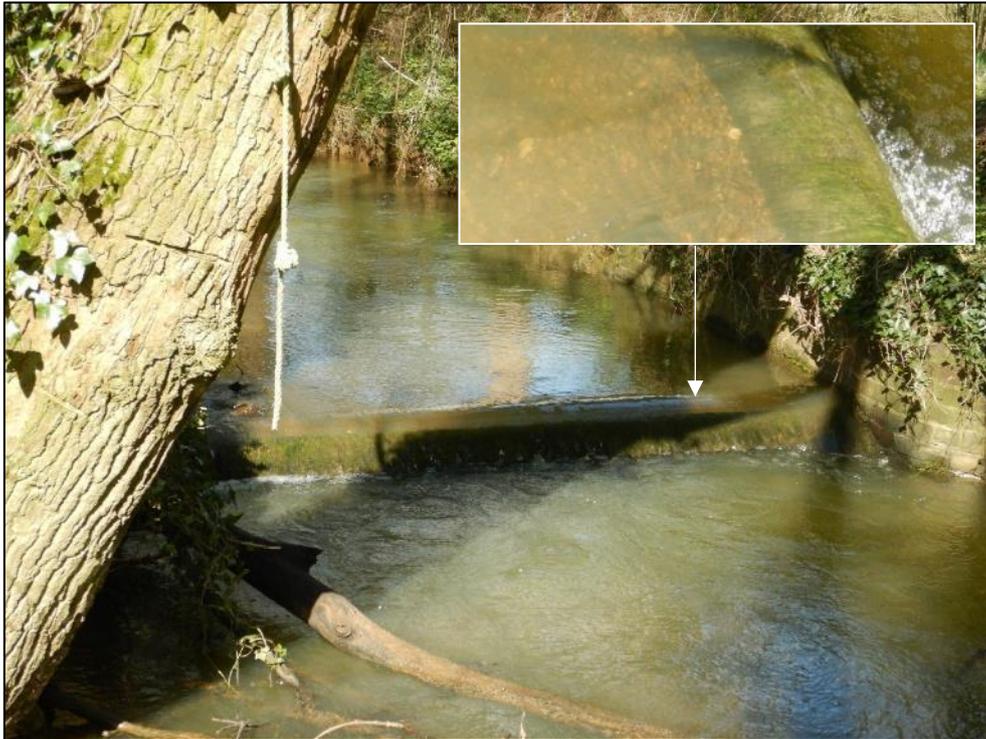
At 52.469936, -0.993867 the third weir was observed (pic 5), retaining a head of water $\sim 0.25\text{m}$; the pool habitat was inspected revealing a depth $\sim 0.75\text{m}$. Upstream of the weir gravel was again trapped, and the weir had clearly elevated flood levels causing out-of-channel flow. Connection of the river to its floodplain is important as it prevents the rapid downstream flow of water which can gather in volume to the point where it poses flood risk to communities. Slowing the flow by allowing floodplains to hold (then slowly release) and store (by encouraging infiltration) water is the right direction of travel for river restoration projects. Slowing the flow also has benefits to river ecology as high flows will push weak-swimming trout fry (recently hatched fish) and aquatic invertebrates downstream. Floodplain connection also allows fine sediment and nutrients to be deposited on land rather than within channel, and it lowers hydraulic forces within the river, reducing bank and bed erosion (which causes channel incision).

Pic 5 – With $\sim 0.75\text{m}$ depth below this weir, fish may be able to pass it. However, it presents an impoundment causing degradation of habitat upstream, whilst interrupting the natural downstream transport of gravel.

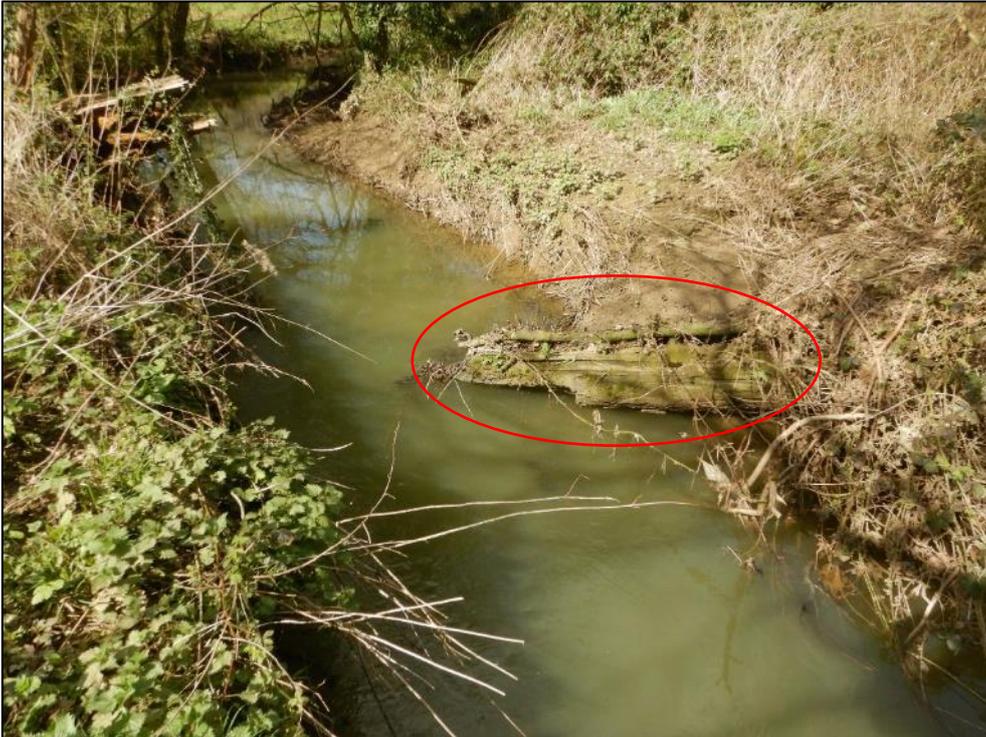
Large pieces of wood had become naturally integrated within the channel margins as years of silt had back-filled around them, leaving some pieces acting as natural flow deflectors (pic 6). Other pieces were trapping fine sediment, leading to the formation of silt bars (pic 7). The main flow pathway had an increased velocity resulting in a scoured bed with a depth $> 1.2\text{m}$. Given woody material to initiate sediment scour, transport and

Pic 6 - A natural flow deflector (red oval).

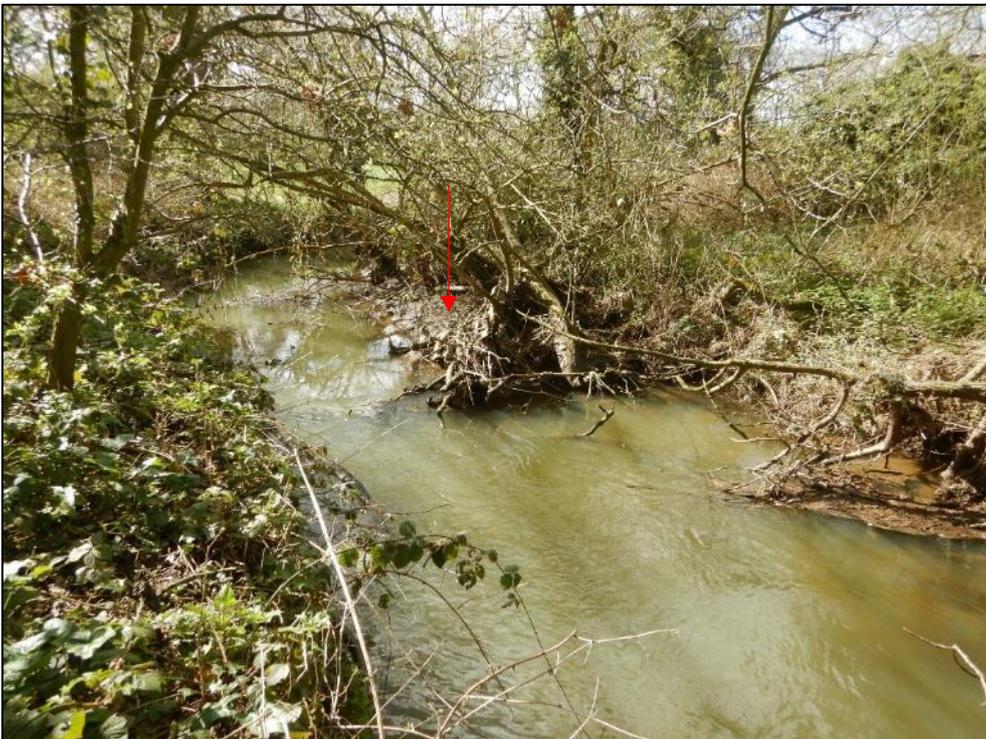
Pic 7 - Excellent LWM material trapping high volumes of fine sediment (red arrow).

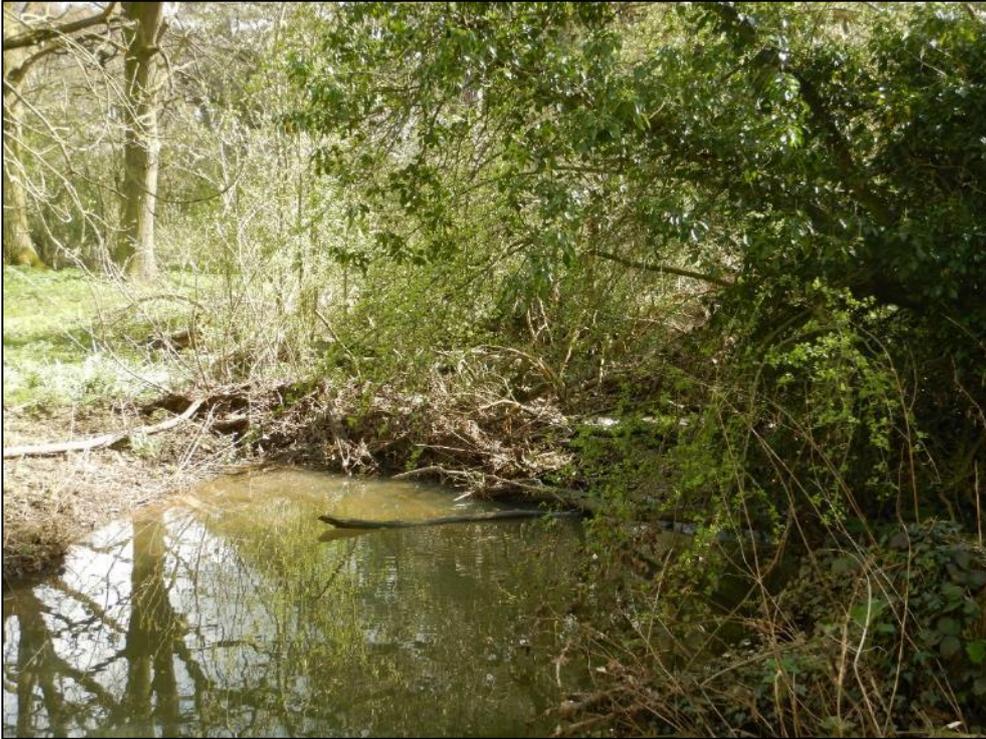
The fourth weir was observed at 52.469585, -0.991786 but it could not be assessed due to a large accumulation of woody material lodged upon it (pic

8); another problem posed by weirs as they restrict channel dimensions. Impoundment during high flows is believed to be the main cause of water on the right bank field (pic 9).

Pic 8 – LWM had accumulated against the fourth weir, causing a significant impoundment upstream.

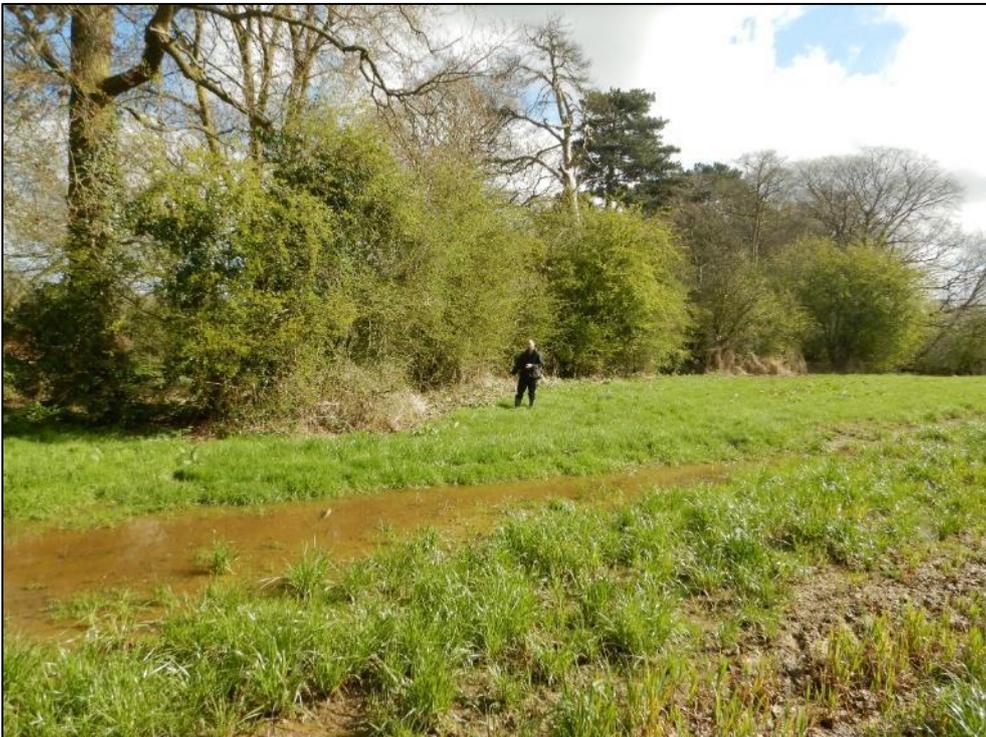
Pic 9 - Floodplain connection because of water being pushed out-of-channel by weir 4.

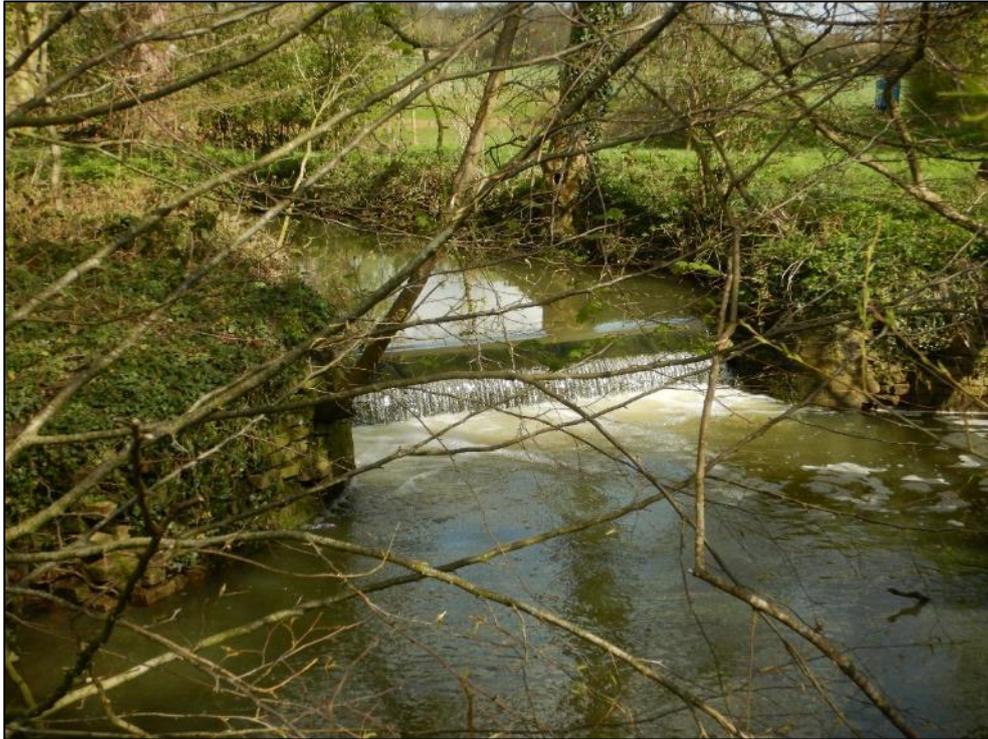
The fifth weir was observed at 52.469397, -0.991033 (pic 10). It retained a head of water $\sim 0.5\text{m}$ and was considered a barrier to fish in most flow conditions.

Pic 10 – The fifth weir created a significant upstream impoundment in normal and low flows.

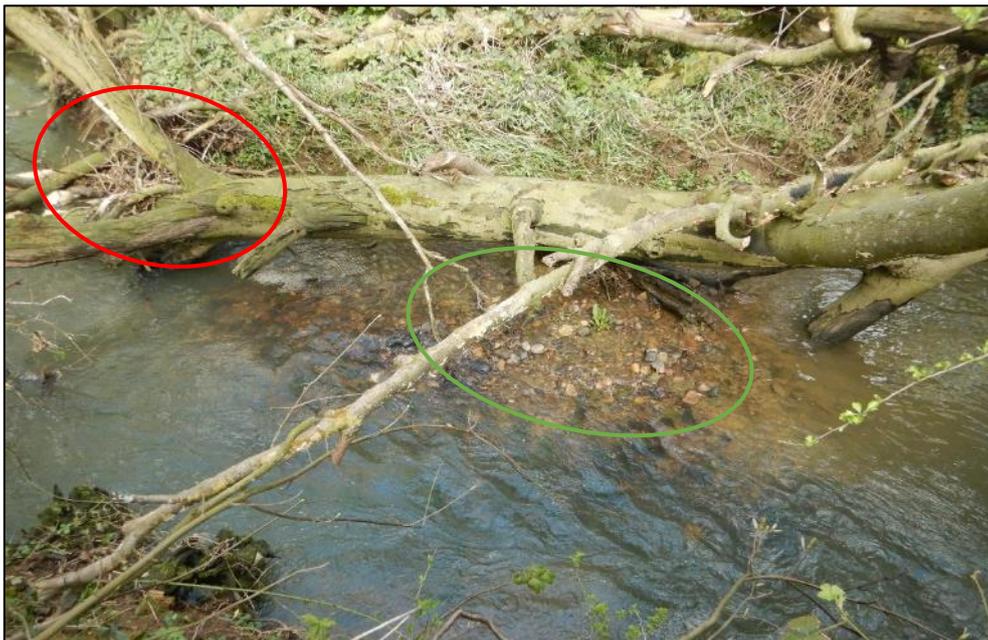
The value of fallen wood was again demonstrated as it retained a gravel point bar at a meander (pic 11). The fallen wood had also trapped flood material producing an important habitat for aquatic invertebrates such as freshwater shrimp.

Pic 11 – LWM trapped organic material (red oval) and aided the deposition and retention of gravel (green oval).

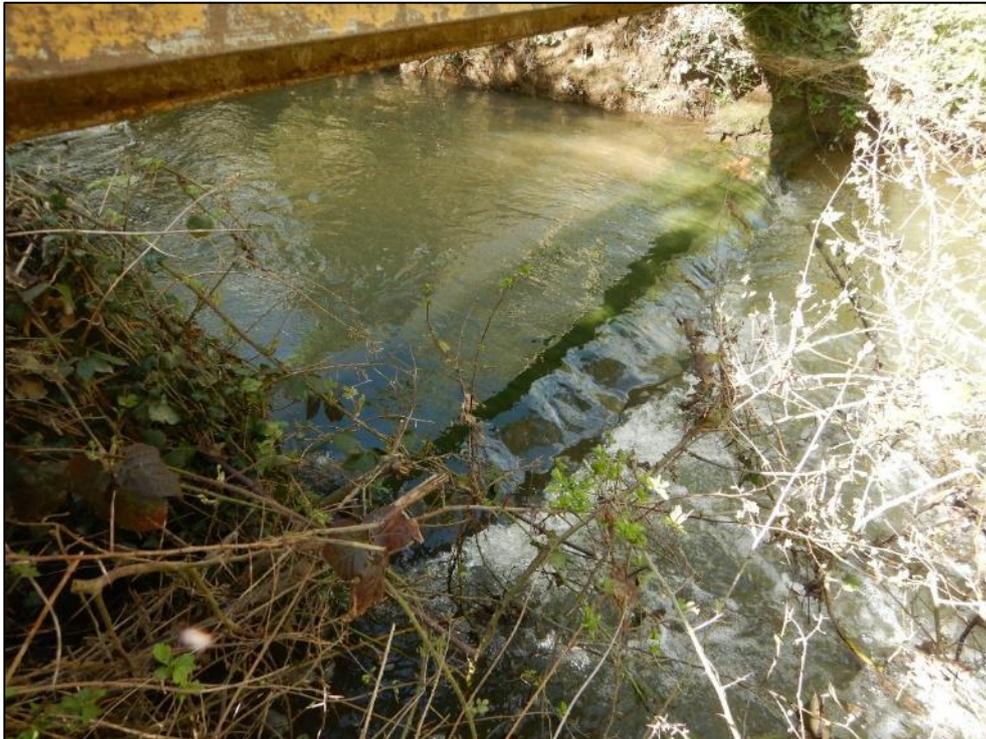
The sixth weir was observed at 52.469478, -0.990812. It retained a low head at ~0.1m but still presented an obstruction to fish passage, especially in low water or to weak swimming species such as dace.

Pic 12 - The sixth weir, small but still a barrier to fish passage.

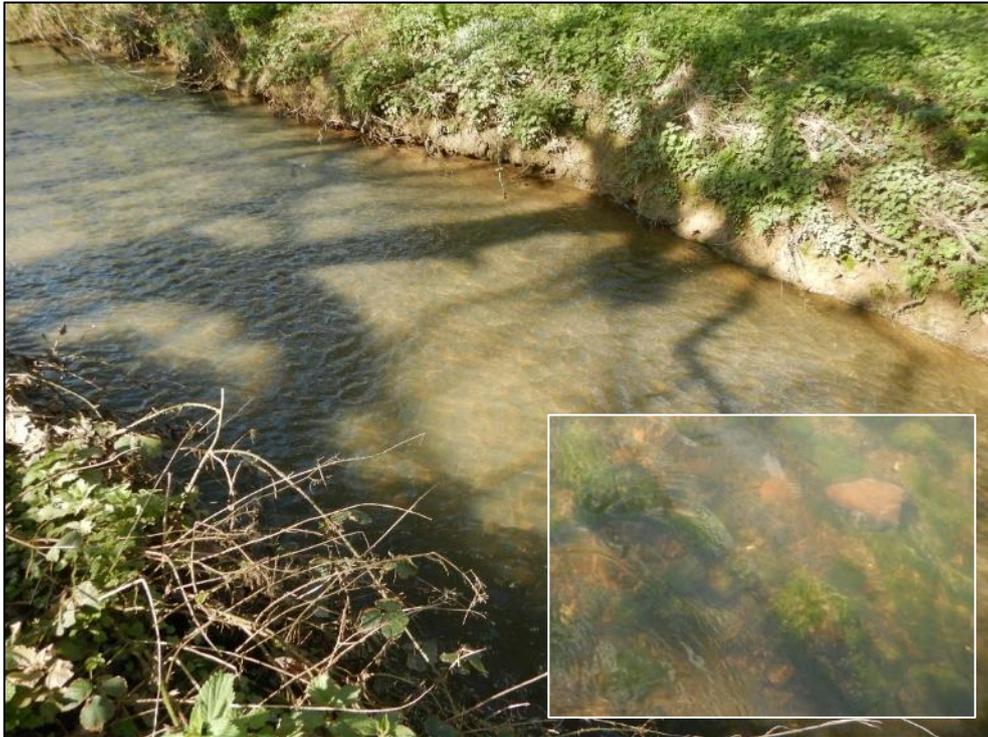
It was pleasing to observe a wide gravel dominated reach, which as water levels drop should become an important riffle (pic 13). The gravel had some compaction and contained a high proportion of fine sediment but if sites are limited, it might just be possible for trout to use it as a spawning habitat. The algae on the gravel was noted, indicating a high nutrient load.

Pic 13 – A potential riffle, but it is degraded by algae (inset picture).

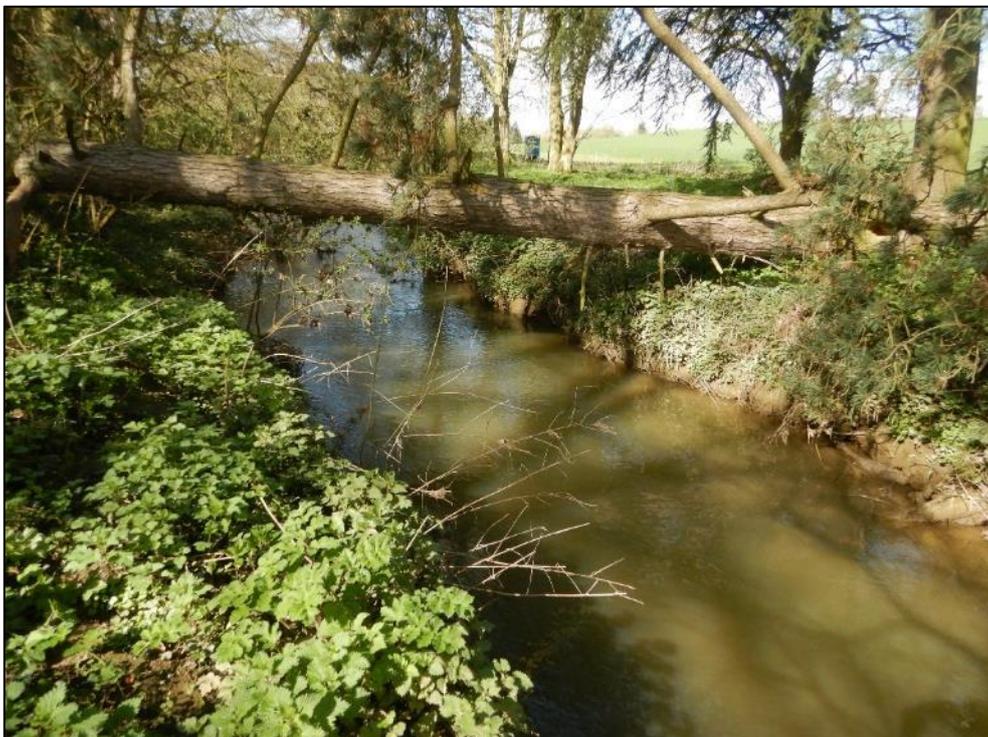
Several occurrences of trees fallen at bank top were observed (pic 14) which are important features to slow flood flows and deflect high flows downwards against the bed, initiating scour and sediment transport. Some could be manoeuvred to sit lower to the river and become more effective.

Pic 14 – Fallen trees demonstrated valuable NFM, but it could be adjusted to sit lower.

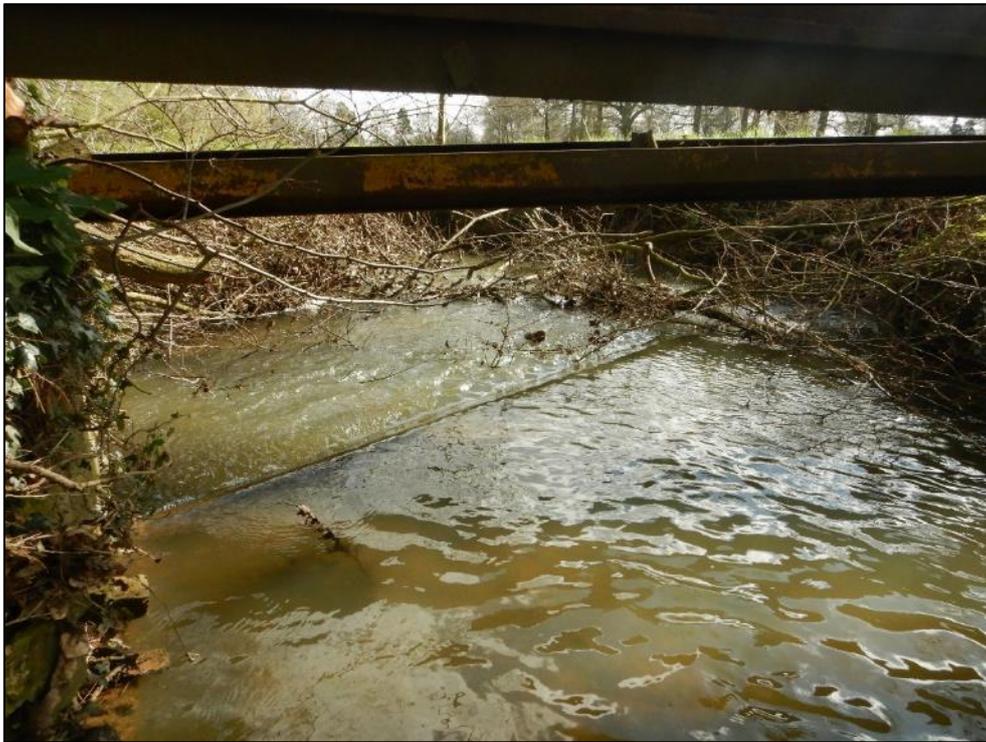
The seventh weir was observed at 52.47008667, -0.98944333 (pic 15), whilst retaining a head $\sim 0.1\text{m}$ it was considered to only present a barrier to fish movement in low water, but it would interrupt the downstream supply of gravel.

Pic 15 – The seventh weir.

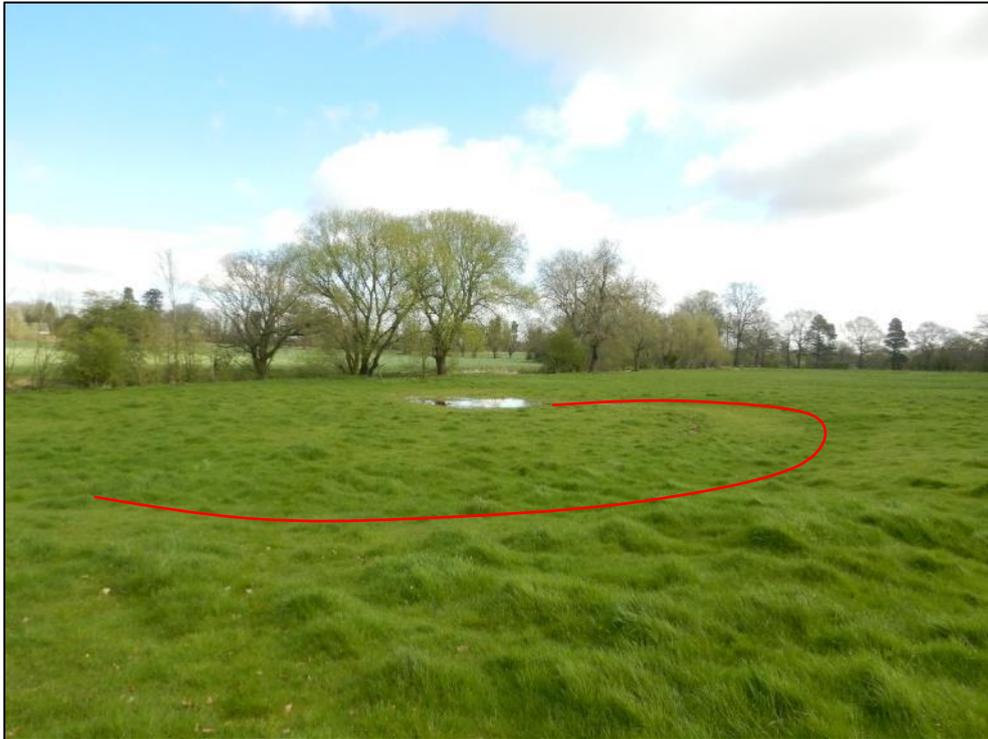
A paleochannel was observed at 52.470017, -0.989218 (pic 16). Ideally the river should be re-connected to restore lost habitats and to increase the overall length of the river, which would also aid in slowing the flow. However, the extent of channel incision requires careful consideration as to where to form the new take-off from the river. Diverting the course of the river may result in the loss of ecologically valuable parts of the current river, for long-term gain. Channel re-connection should be aspired to as the best outcome delivering protection to downstream communities against flooding and delivering valuable habitat gain.

Pic 16 – A paleochannel (red line) with potential for reconnection to the river.

Plans to reconnect paleochannels should be fully explored as a means of delivering NFM and for restoring lost habitats. But the habitat gain needs to be considered carefully against any length of ecologically valuable river that will be “cut-off” following paleochannel reconnection.

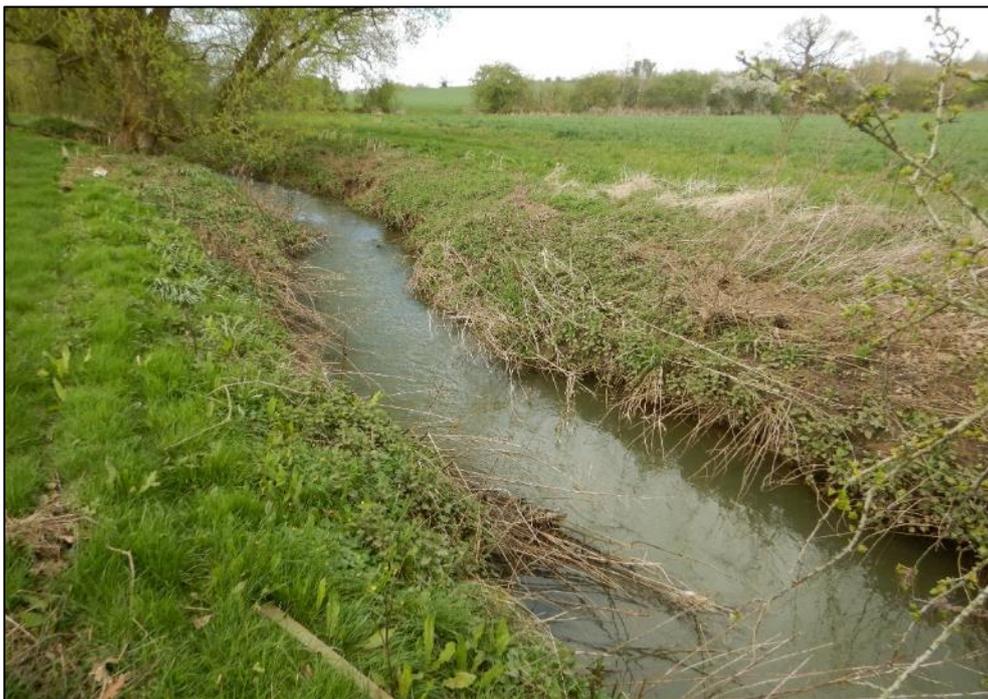
An area of open river was observed (pic 17), and with no shading from trees it had great willow herb and reed canary grass dominating the margins, providing channel narrowing to $\sim 1.5\text{m}$. The depth appeared uniform with little flow variation. The open length was not considered particularly ecologically valuable. Habitat beneath the tree canopy was considered more valuable due to the input of LWM, existing flow variation and accumulations of coarse bed substrates.

Pic 17 – A contrasting area of open channel was observed at 52.470637, -0.987978.

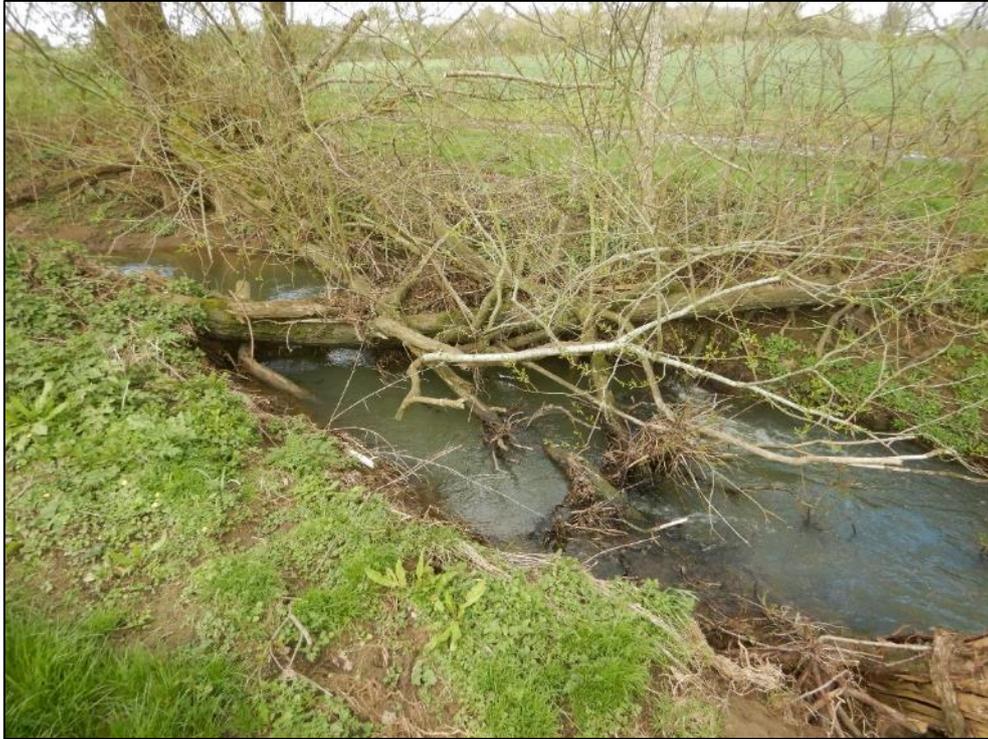
Several natural logjam “blockages” were observed (pic 18), representing important features. The accumulated woody material is vital for slowing flood flows, but appeared porous to normal flow with little impoundment upstream. The accumulated LWM constituted important habitat for both fish and aquatic invertebrates. Downstream of most of the logjams were gravel deposits resultant from scoured, sorted and transported bed substrates.

Pic 18 - Good NFM, one of a series of logjams.

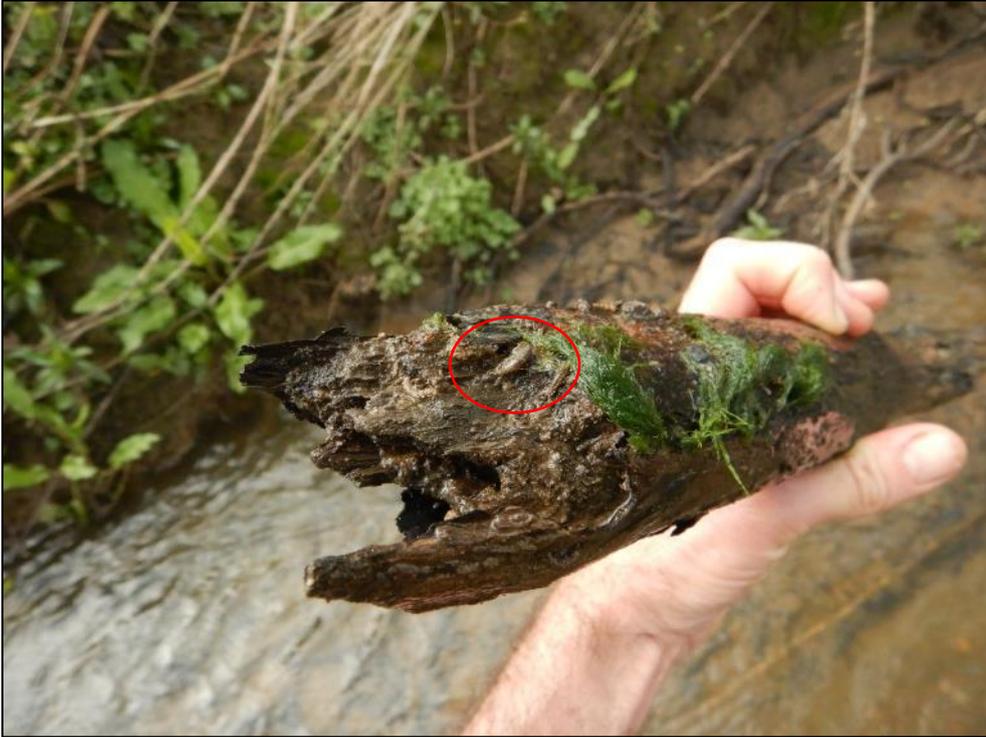
Whilst not particularly notable for most rivers, the occurrence of several freshwater shrimp (*Gammarus* sp.) on sunken wood was very encouraging (pic 19). The upper Welland is depleted of freshwater shrimp, with water quality being suspected but the actual cause not known. Freshwater shrimp are a key component of the aquatic invertebrate community, shredding organic matter as they feed, and in turn make it nutrients (and themselves) available to animals higher up the food chain. Mayfly larvae (*Baetis* sp.) and blackfly larvae (*Simulium* sp.) were also observed.

Pic 19 – Freshwater shrimp amongst LWM (red oval).

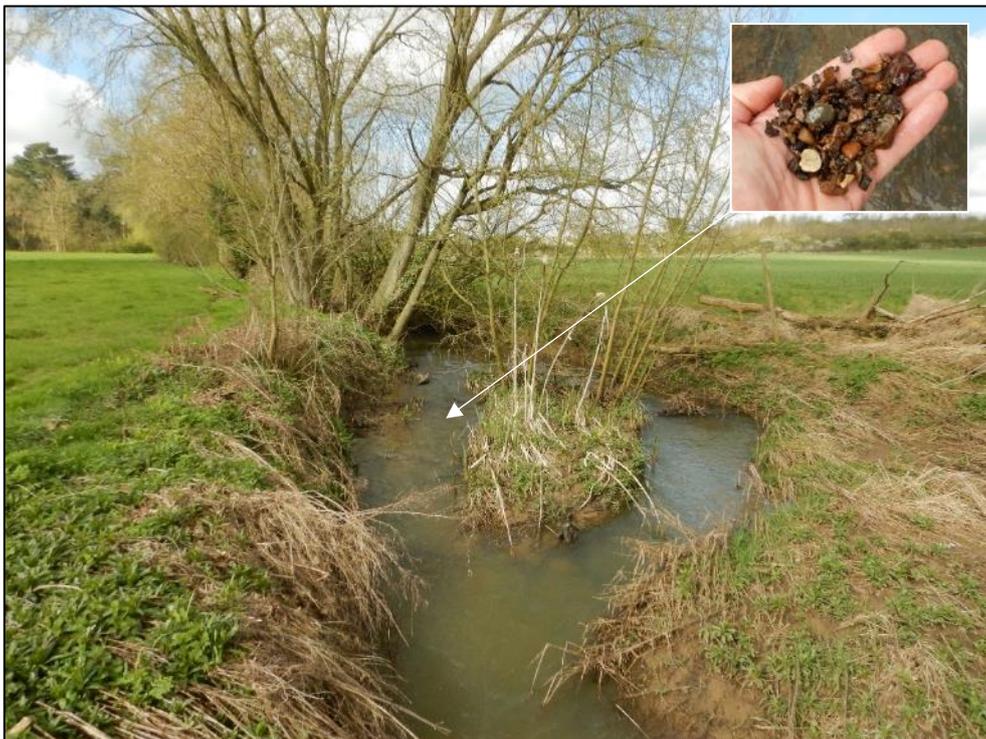
Immediately upstream of the farm access track a mid-channel island had formed (pic 20). It offered a small but interesting area of different habitat, with small runs either side having areas of cleansed gravel, potentially of use by small trout to spawn upon (pic 20, inset).

Pic 20 – An ecologically valuable mid-channel island (52.470879, -0.986650).

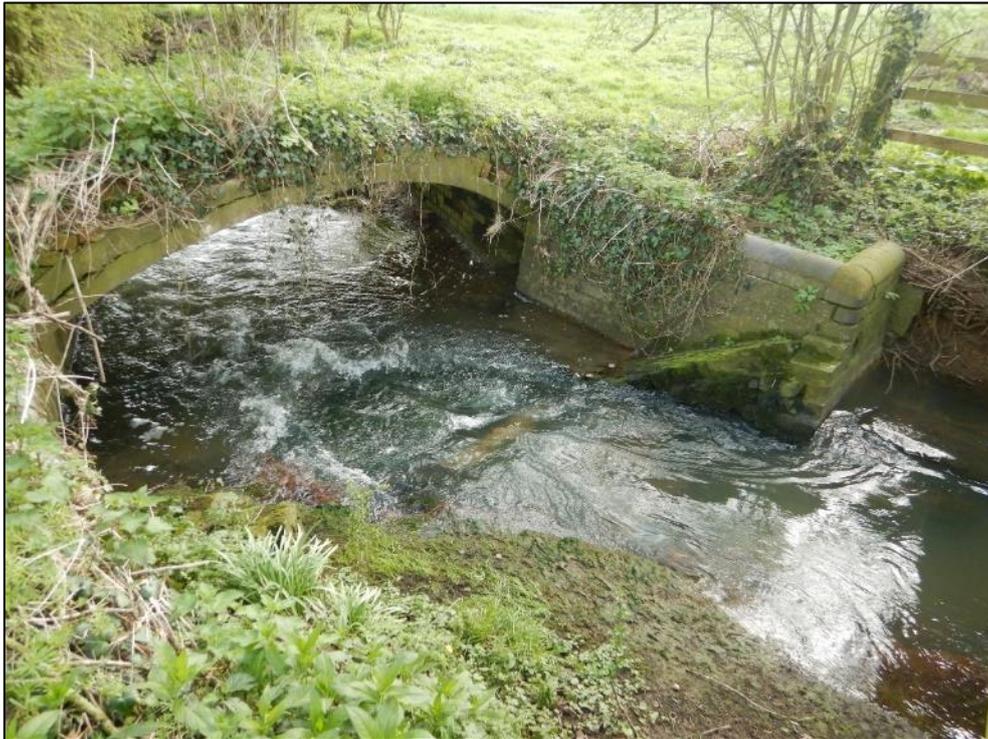
A combined bridge and weir structure (the eighth) was observed at 52.471364, -0.985543, and retained a head of water $\sim 0.3\text{m}$ (pic 21). It had a brick sill which extended for $\sim 2\text{m}$, creating a barrier to fish passage in both low and high flows, but was considered passable at the time of visit. It would also interrupt downstream sediment supply.

Pic 21 – The eighth weir structure.

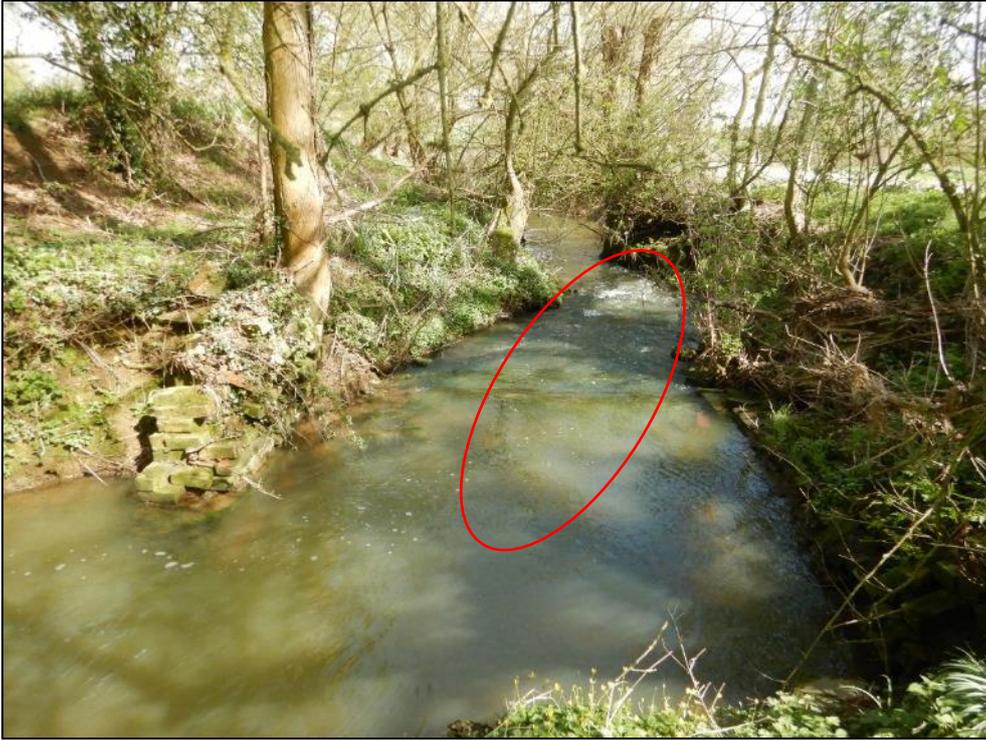
Yet another (dilapidated) weir structure (the ninth) was observed at 52.471283, -0.985321 (pic 22). Whilst the head of water retained was $>0.2\text{m}$, it had the remnants of a brick cascade which could present challenges to fish trying to swim-up its $\sim 5\text{m}$ length.

Pic 22 – The ninth structure, a long brick-lined cascade (red oval).

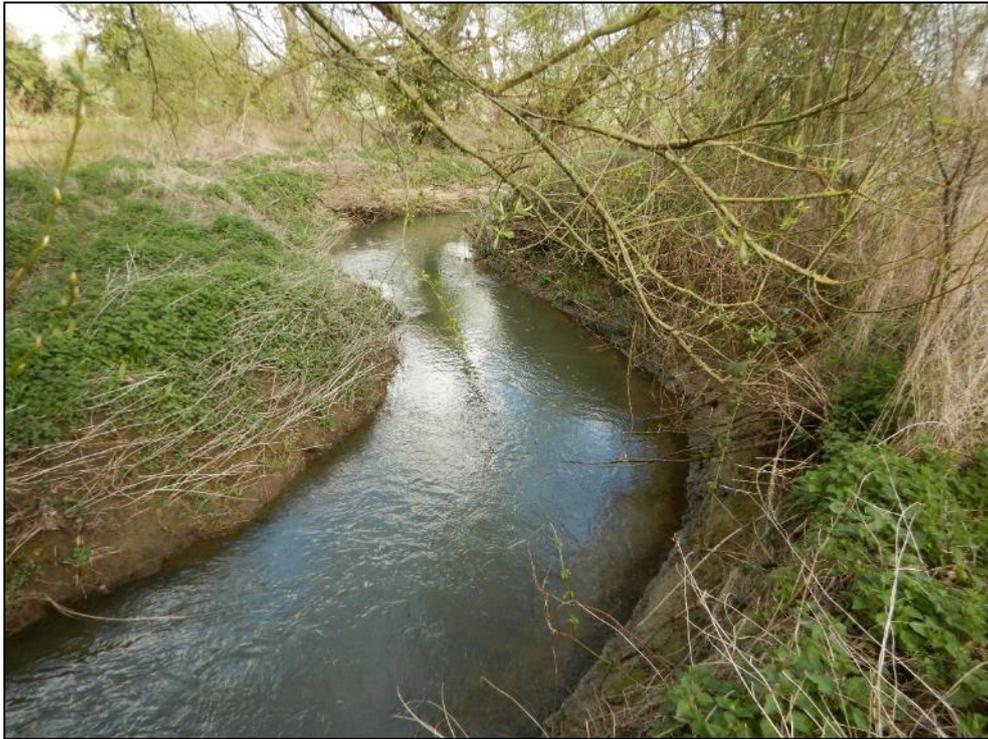
The channel was then strangely clear of fallen LWM, suggesting that it may have been removed. The channel dimensions also appeared uniform suggesting possible mechanical clearance within recent years (pic 23). If this has been the case then dialogue is needed with whoever undertook the operation to understand what the objective was, whether it was achieved, and whether an alternative approach could be considered.

Pic 23 – The channel appeared strangely devoid of LWM and had a uniform appearance (52.47142333, -0.98510000). Had it been recently maintained?

It was thought that some degree of channel management had taken place in recent years, with LWM having been removed downstream of the farm access track. Dialogue is needed with the person responsible if that were the case as the action does not appear to have given any notable flood protection gain but will have degraded river habitats.

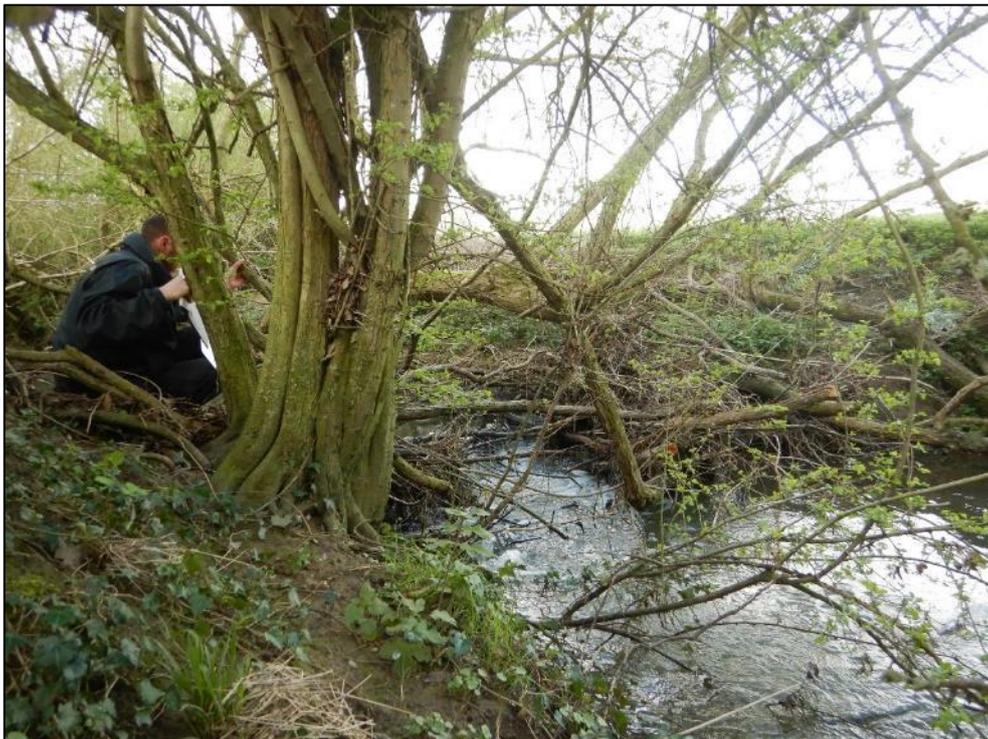
In contrast to the open areas and those with no LWM accumulations, the channel became hidden by dense shrubs, tall trees and bramble. On pushing through, more natural woody accumulations had led to temporary logjams forming (pic 24), again with much ecological value.

Pic 24 – An ecologically valuable logjam (52.47138889, -0.98357000).

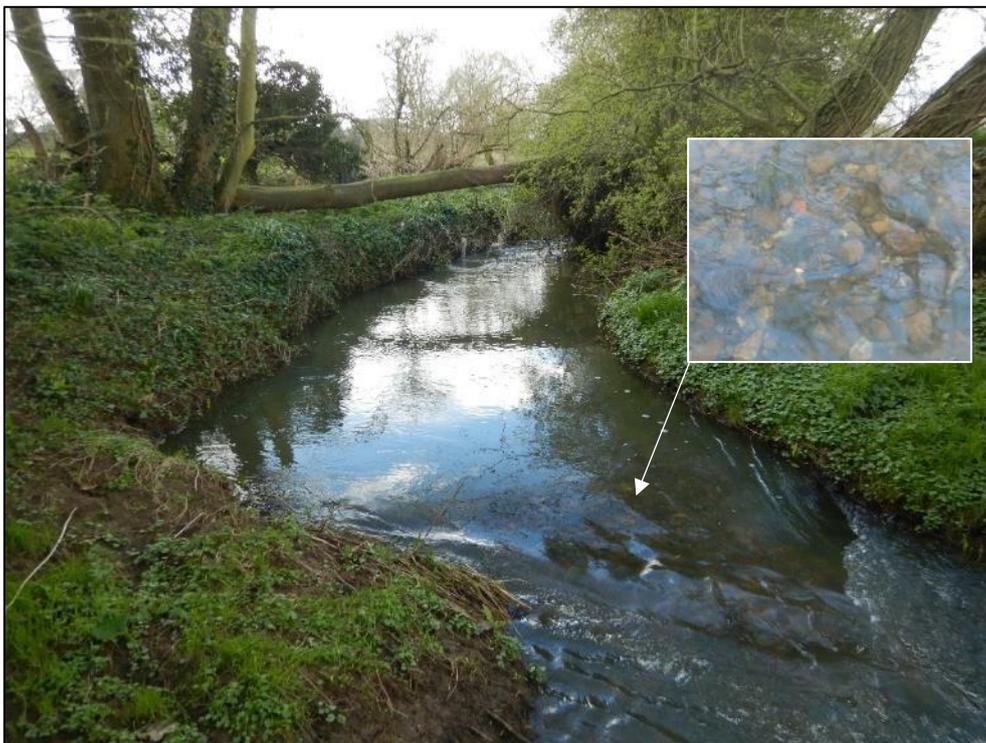
A short distance downstream the channel was partially covered by tall trees, which allowed for some light penetration resulting in better bank growth by plants. It was also evident that tree roots provided bank strength with stable near vertical banks, and tight meanders (pic 25). This allowed for gravel sorting and cleansing and once more, small areas of clean gravel suitable for trout spawning were found (pic 25, inset). Where the channel was gravel-lined it had a wide cross section at $\sim 4\text{m}$ (contrast with pic 17) leading to a shallower depth. Also of note was the lodged tree trunk at the top-of-bank. Its position on the bank would provide beneficial NFM. The open channel form did not continue for long, with young willow trees growing from within the channel a short distance downstream at 52.471607, -0.983993. Whilst the channel may look untidy, it is ecologically diverse with different flow pathways trapping gravel, and the woody features offering a wide range of ecological niches.

Pic 25 – With mature trees present the channel showed signs of stability with accumulations of clean gravel (52.47165167, -0.98285500).

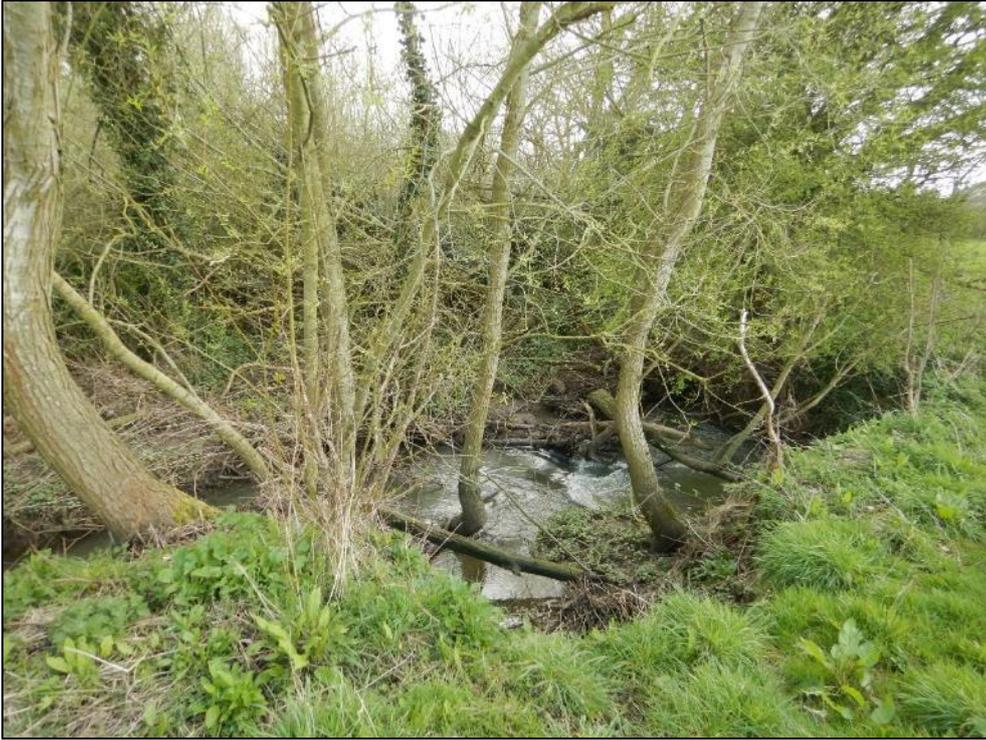
Pic 26 - Untidy rivers are ecologically diverse.
