Advisory Visit

River Welland at Marston Trussell, Northants

April 2024

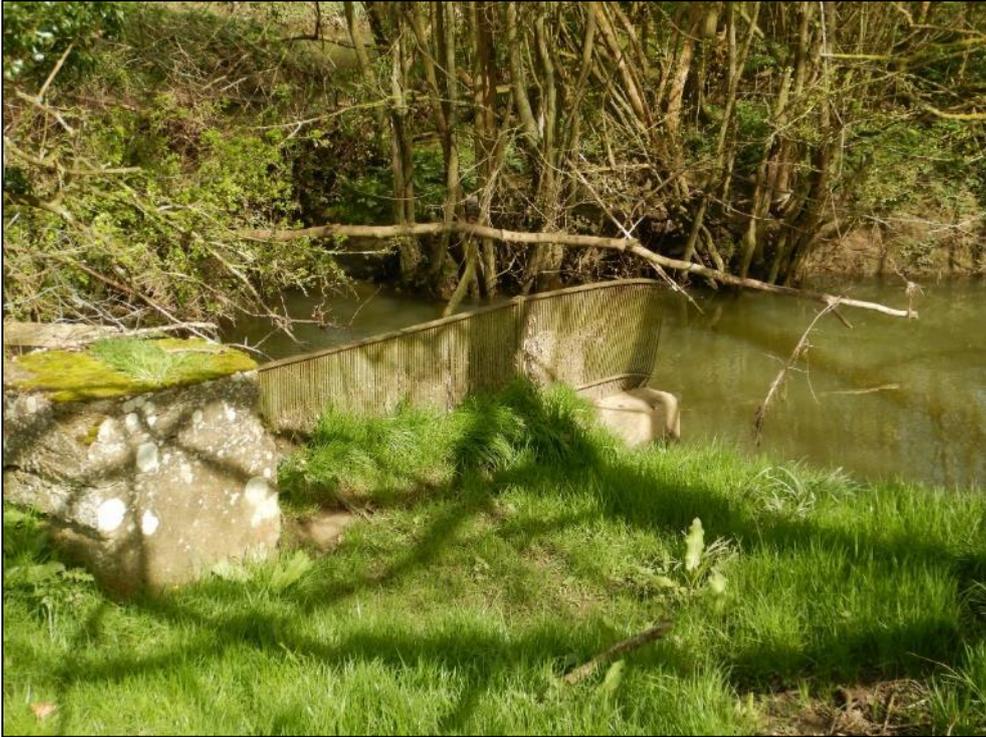
The remains of a fish-stop structure (a grille across the river to retain fish) was observed at 52.470529, -0.982222 (pic 27). Its presence shows that the river was once stocked (almost certainly with trout), and the retained fish were the quarry of anglers. No angling takes place at present. The introduction of stocked trout is almost certainly the reason for the presence of ten weirs. Rivers were historically altered to create conditions more favourable to the retention domesticated hatchery fish. Those fish would have been raised in pond environments, making them poorly suited to small, and harsh, headwater stream environments, so physical alteration of river environments was often done to accommodate them. Fortunately, that practise has gone out of favour, and it is now more widely known that wild brown trout actually require almost the complete opposite; that being free-flowing rivers without obstructions, which have naturally varying bed profiles with abundant clean gravel for spawning and a range of cover and flow types providing for all of the wild brown trout's life stages.

Pic 27 – A former fish-stop. Has the grille caused the river to take a new path?

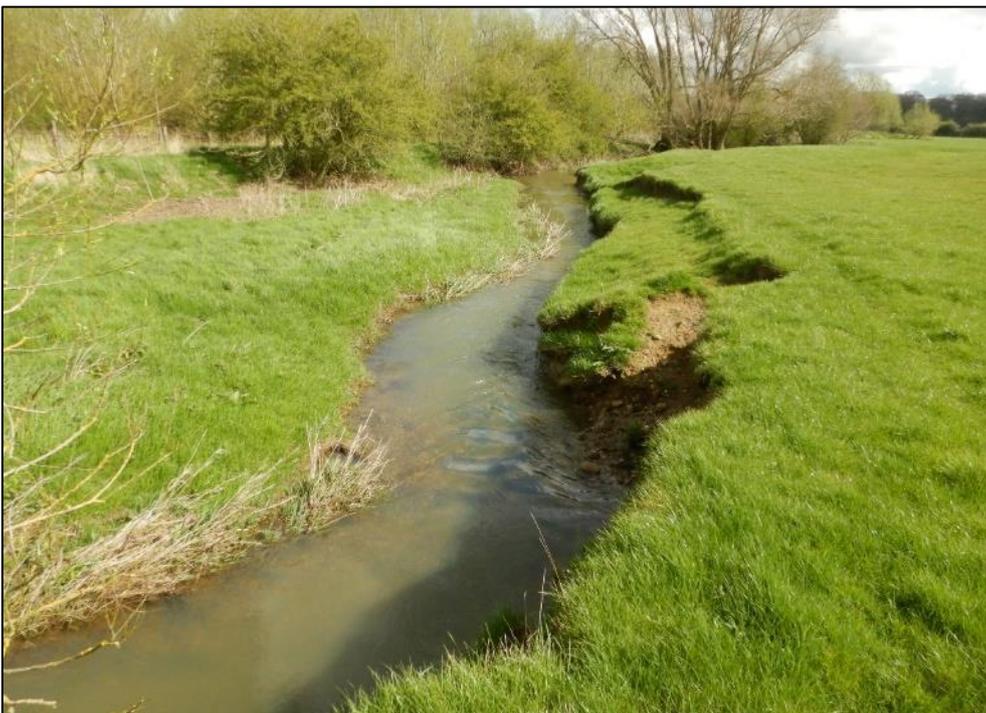
After the fish-stop the river's form changed because of land use. The right bank was subject to sheep grazing and consequently was treeless. As a result, the banks had no roots to hold them, and slumping was occurring (pic 28). To compound the situation, it appeared that in low flows sheep could ford the river and browse the left bank too.

Pic 28 – Bank slumping as a consequence of sheep grazing having removed trees.

The slumped bank section in the grazed fields has no trees upon it. If trees were present their roots would aid bank stability. Tree planting is required at the toe of slumped banks, and at the bank top (set back 2-5m to ensure the trees can set roots before they experience scour). Fencing is therefore required to protect the marginal vegetation (ideally forming an excluded buffer zone of 10m), and especially any trees planted.

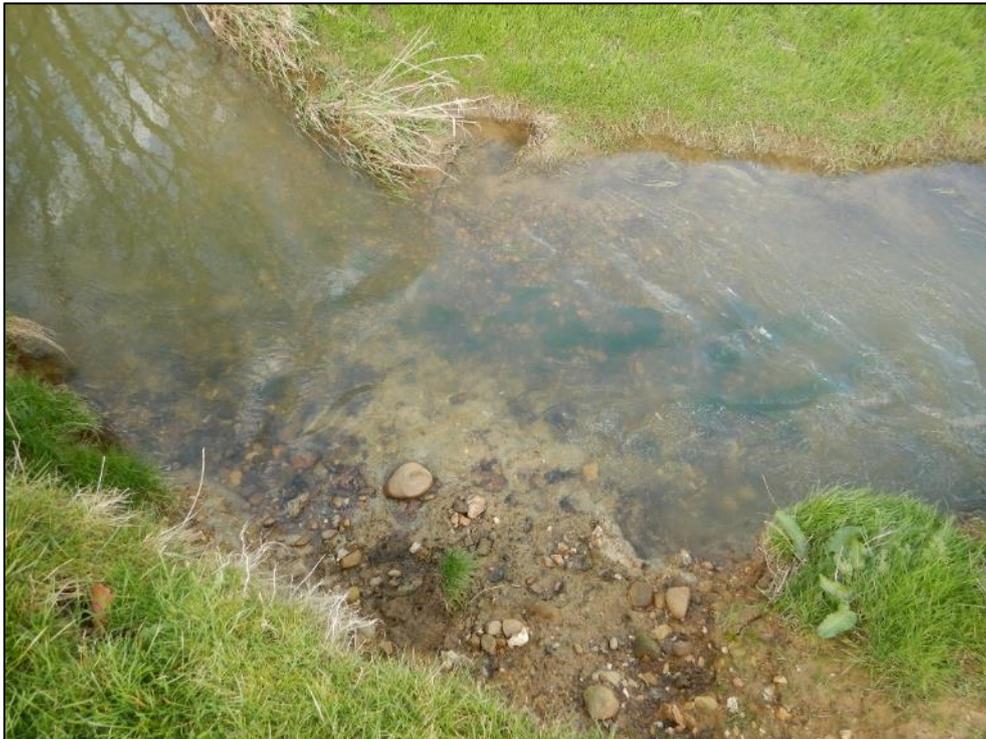
The bank slumping was inputting high volumes of fine sediment into the river, but importantly it was also introducing some coarse sediment of cobbles and gravel (pic 29).

Pic 29 – Whilst bank slumping is generally degrading, it was exposing beneficial coarse sediments.

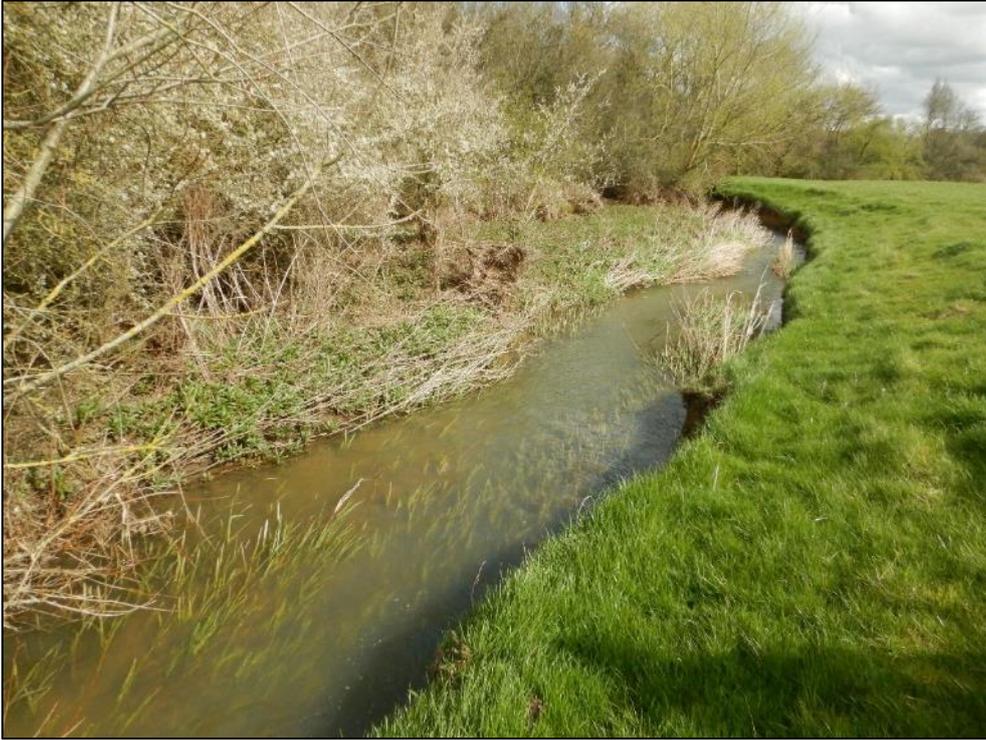
With little tree cover to control light to the channel, bur reed had found a footing in the degraded over-wide and over-deep channel (pic 30). Bur reed is often indicative of dredged channels which are now over-capacity. The plant readily colonises fine sediments, impounding summer flows whilst pushing water against the banks leading to their slow erosion and gradual widening.

Pic 30 - Bur reeds are indicative of over-capacity channels often dominated by fine sediment.

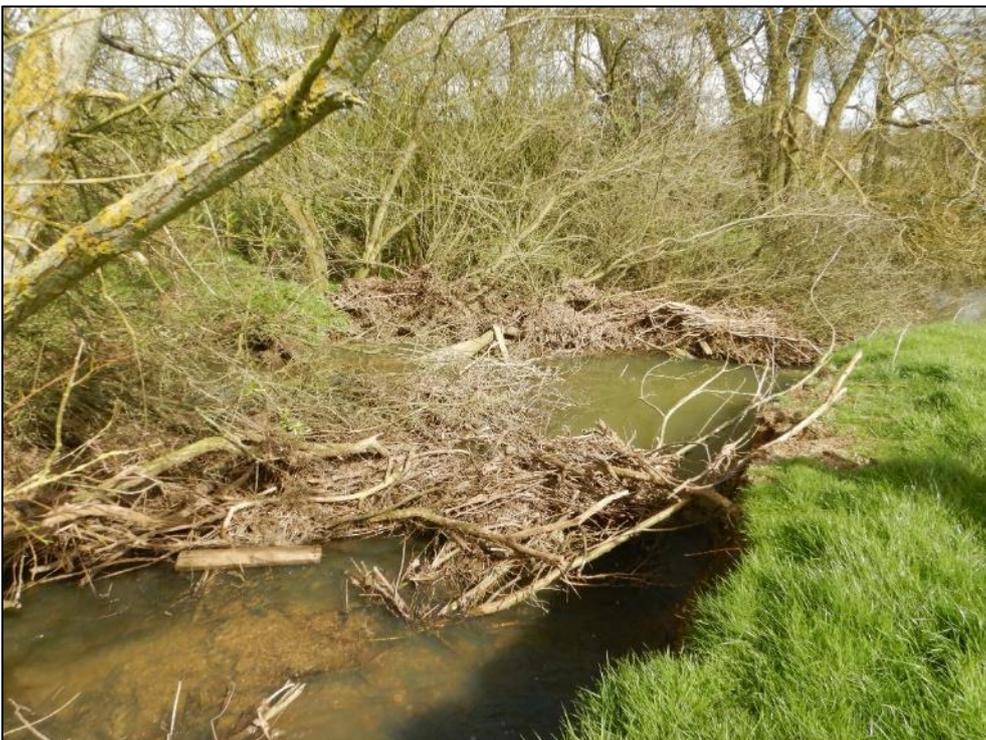
Ecologically valuable accumulations of LWM were observed at 52.47043500, -0.98022333 (pic 31), and it was apparent that the LWM was also retaining gravel in the reach, resulting in bed depth variation and flow diversity. The extensive cover given by the LWM could harbour trout. A short distance downstream and trailing trees provided excellent marginal cover for trout (pic 32), if present.

Pic 31 – Ecologically valuable woody accumulations.

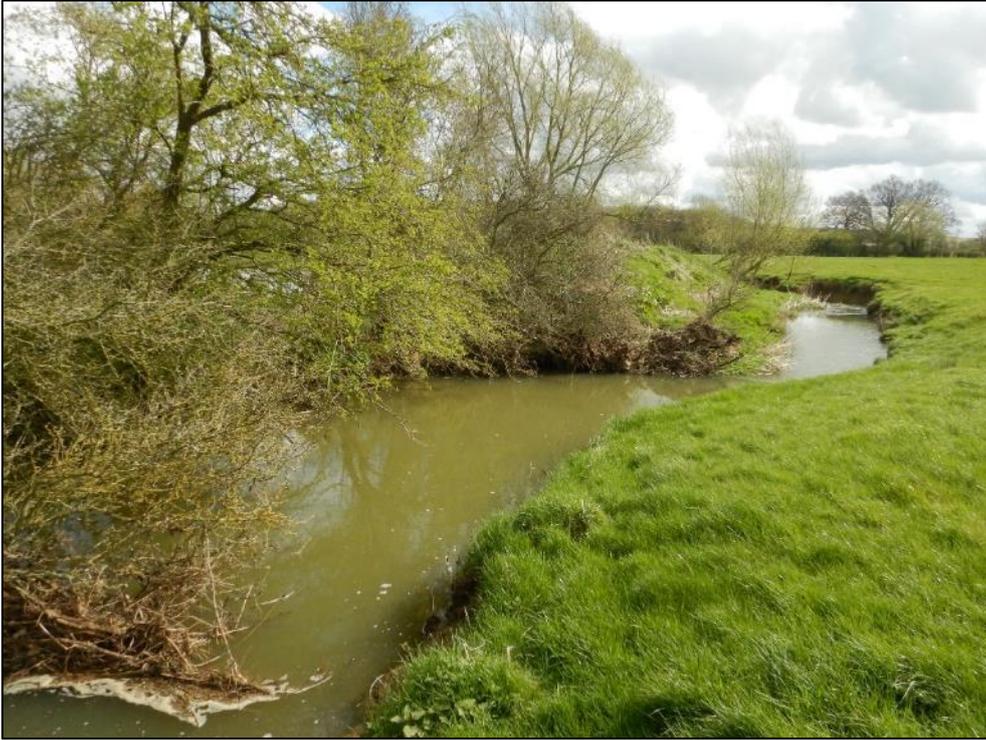
Pic 32 – Trailing tree branches offer excellent trout cover.

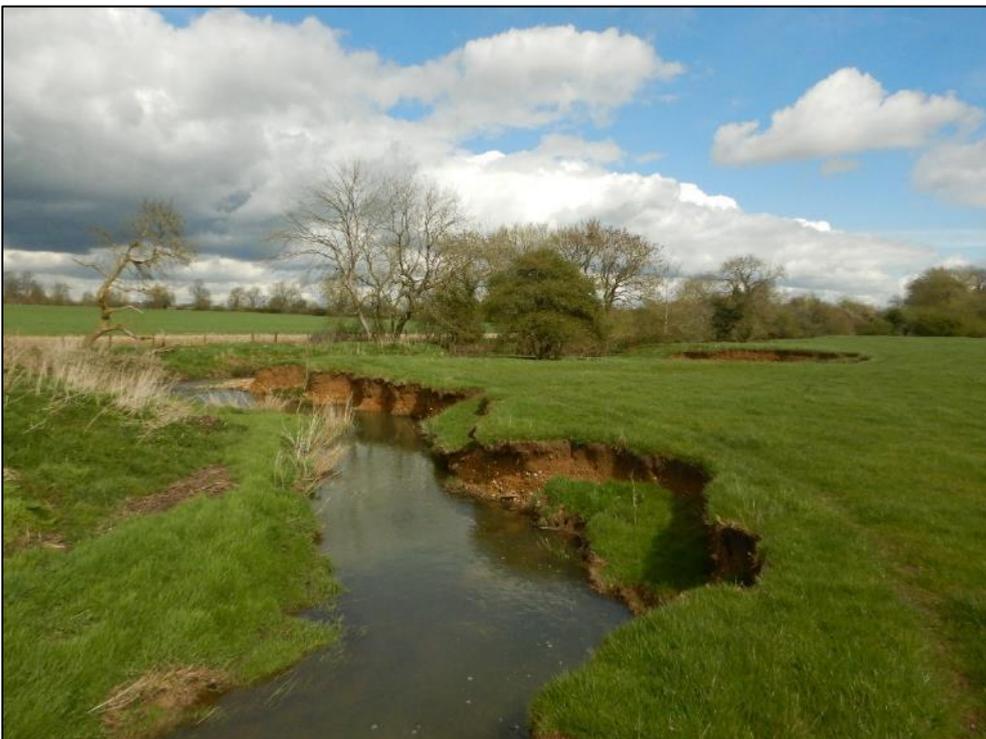
Channel instability continued throughout the sheep grazed reach (pic 33), and it is unlikely to stop until the area is extensively eroded, with bank grades reduced or until trees stabilise the margins.

Pic 33 – Channel instability occurred where trees were absent.

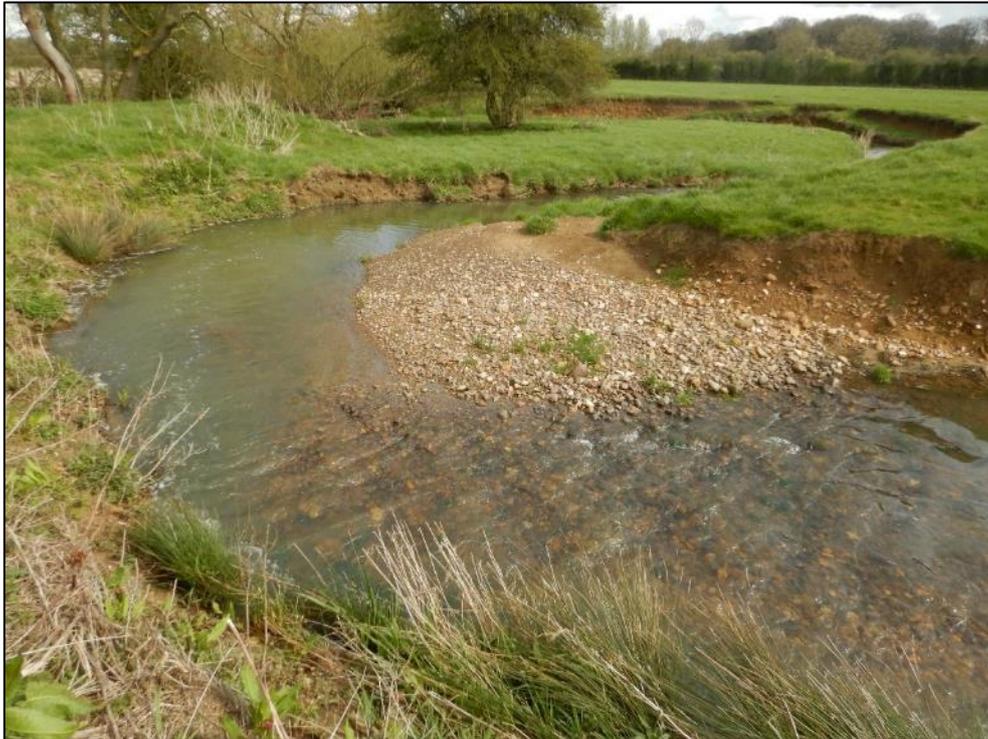
A large gravel point bar was observed at 52.47038833, -0.97897833 (pic 34). It again showed the potential of the river to restore important riverine features if supplied with gravel, given the space to adjust, and finally if enough time can be allowed and protection from grazing given, the river could stabilise its planform through the stabilising effect of tree roots.

Pic 34 – A wide, gravel abundant, meander with a point bar showing sediment transport, sorting and deposition.

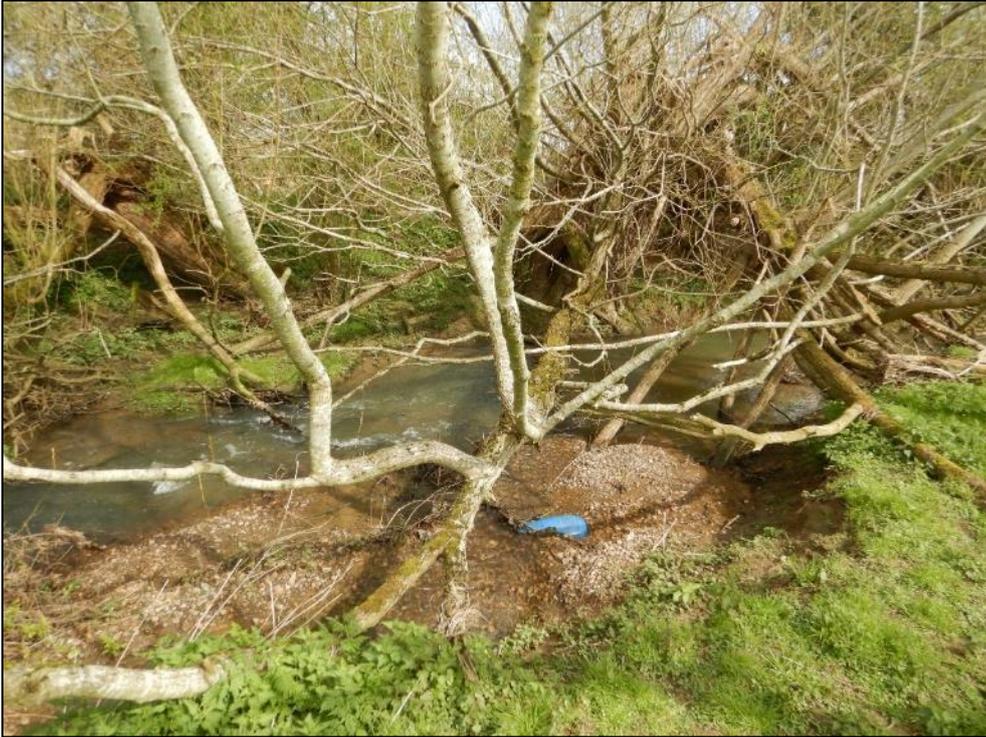
The value of a single partially collapsed tree was illustrated at 52.47105167, -0.97678833 (pic 35). With branches trailing in the water, it provided pockets of calm water, which in turn caused sediment to drop out of flow. If this tree was cleared, the gravel would continue to move through the reach to its detriment.

Pic 35 – Note how trailing tree branches have led to extensive gravel deposition.

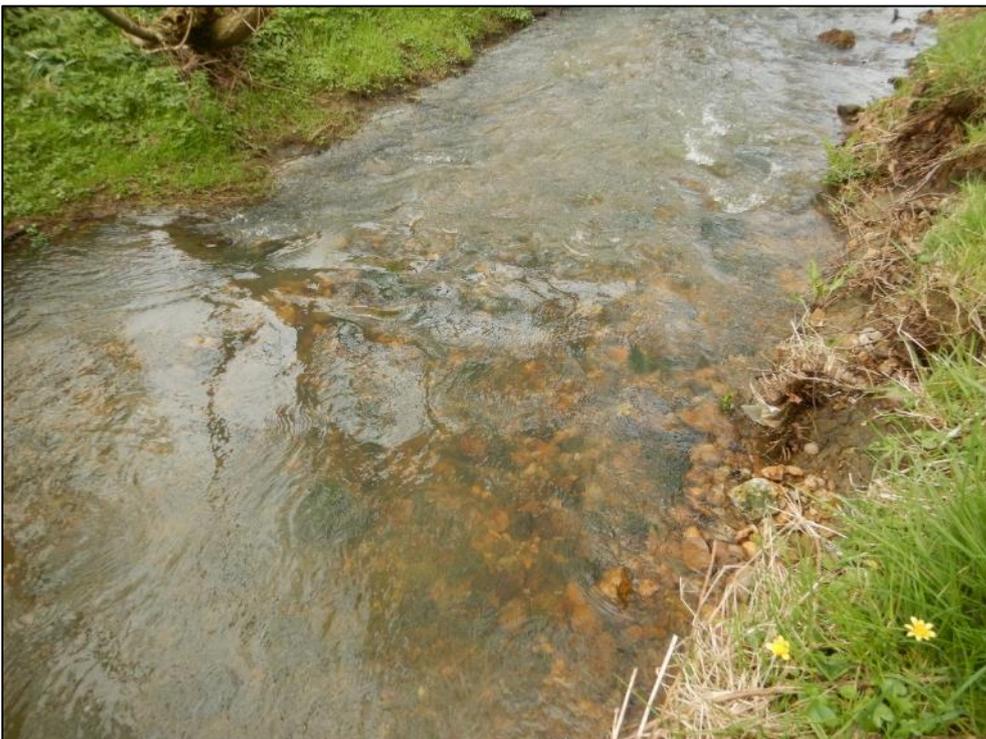
A further example of the river's capacity to restore itself given flow, coarse sediment supply and channel stability was observed at 52.47078000, - 0.97615167 (pic 36). The downstream transport of cobbles and angular stone had armoured the bed resulting in the formation of a valuable riffle, and with the left bank held strong by ash tree roots there is an emerging pool and riffle sequence as one would expect (pic 37).

Pic 36 – The supply of coarse sediment results in riffle habitat.

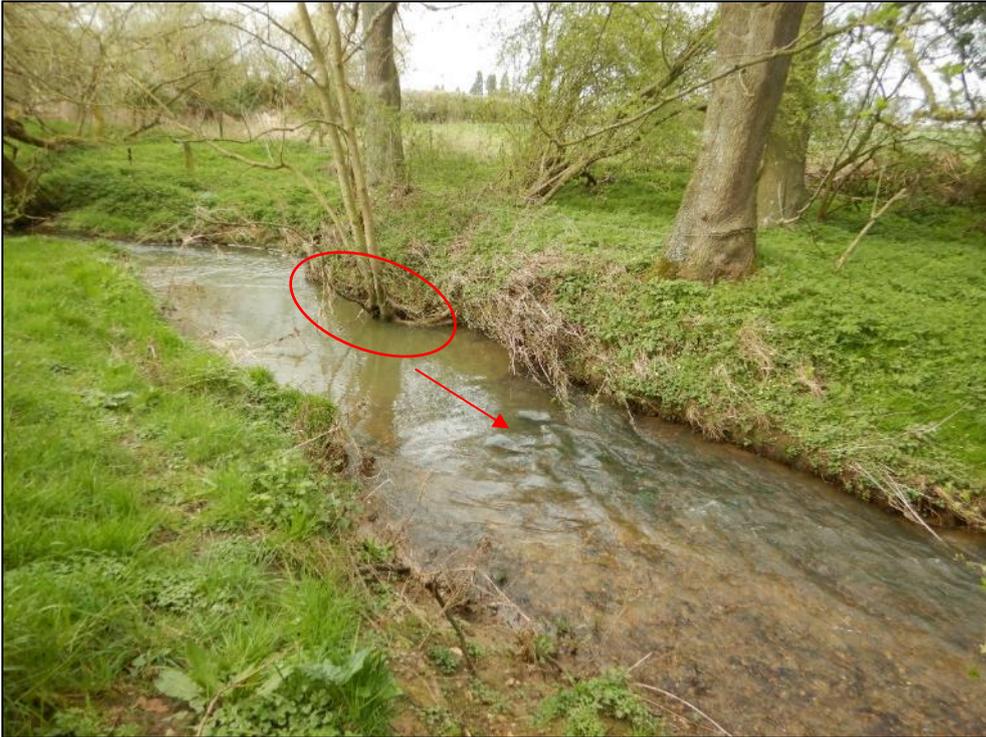
Pic 37 – With tree roots holding the bank stable an undercut will have formed (red oval), material scoured from the pool has been transported (red arrow) and deposited forming a riffle downstream.
