Advisory Visit

River Leen

"Love Your Leen", Nottingham

30/01/2026

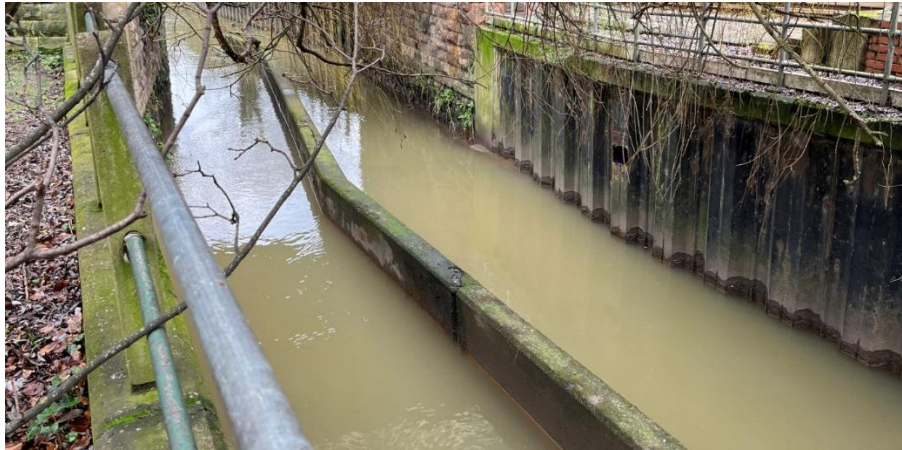
Figure 5: Central dividing wall for channel maintenance on the River Leen.

While this design feature has clear operational benefits for asset management, it creates an additional barrier within the channel and further fragments habitat. These central walls effectively create two parallel channels at each bridge or culvert location, consolidating the uniform, “box-like” channel characteristics in both. The Environment Agency have confirmed that these central walls are redundant structures and are not currently used for maintenance.

The mid-channel maintenance walls are sufficiently redundant as to be removed, assuming that alternative arrangements for future maintenance access can be agreed. Material arising from those removals could be broken up and used to diversify substrate particle size and character, turning a problematic asset into a resource for habitat improvement. The concrete or masonry from these walls, once broken into appropriately sized pieces, could provide stable substrate in areas where gravel retention is currently poor. This approach would also have the benefit of contributing to solutions for in-channel barriers while addressing substrate limitations without the need to import material from outside the catchment.

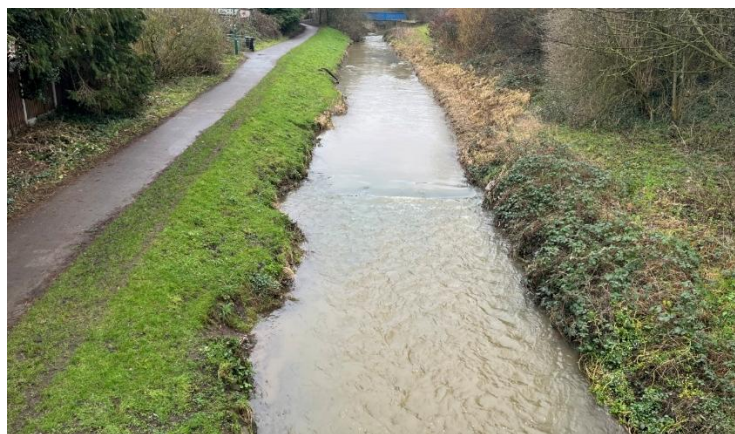
Figure 6: Upstream limit of the visit at SK54316 43872 (near Highbury Vale tram stop) straightened channel, small, submerged degrading weir.

Comments for this section, constrained on the RB by footpath, are highlighted in the original report. The removal or notching of the weir is one such intervention. Around the bend (just below the bridge used to take the image shown in Fig.4), it was suggested to explore some potential berm creation. However, during the most recent visit, the previous path of the watercourse was reported to be a series of meanders crossing what are now recreational grounds at Highbury Vale/Basford area. The old route of the river can be traced via an existing greenway path traversing from Mill Street Recreation Ground through to Mill Street/David Lane. Large willow trees are still present along this route marking the river's historic route. The meandering channel can be seen between the Highbury Vale Workhouse and Basford on the one-inch 1877 Ordnance Survey Map, sheet 126 hosted by the National Library of Scotland: <https://maps.nls.uk/view/239763862>.

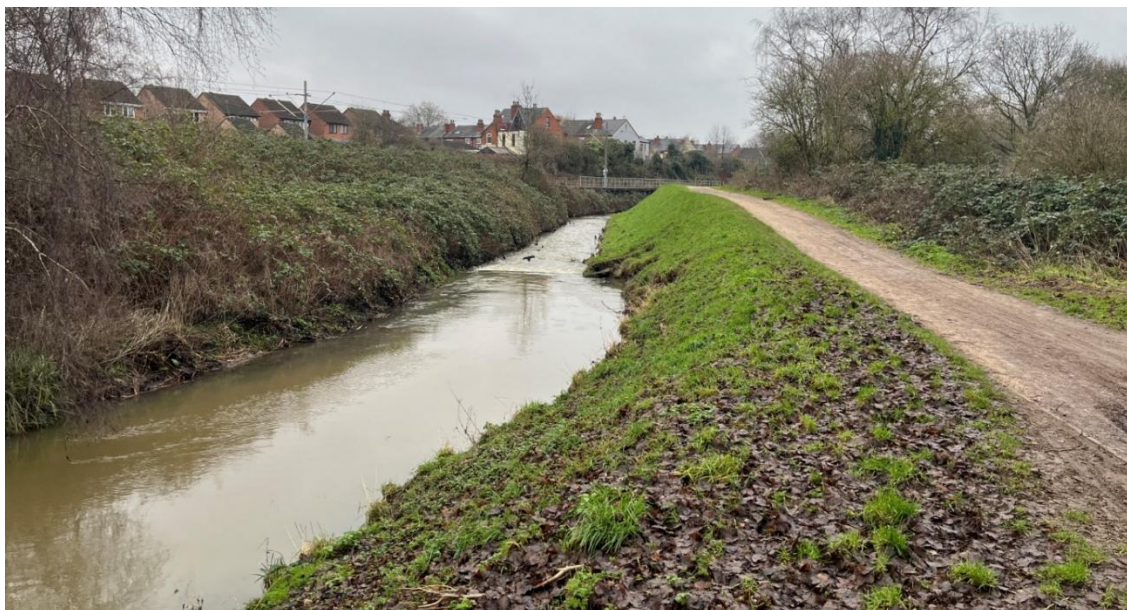
Figure 7: Section downstream of Mill Street Recreation Grounds constrained by railway infrastructure on the LB, there may be potential to re-route the footpath and create additional meanders with a lowered floodplain on the RB as part of a re-meandering scheme.

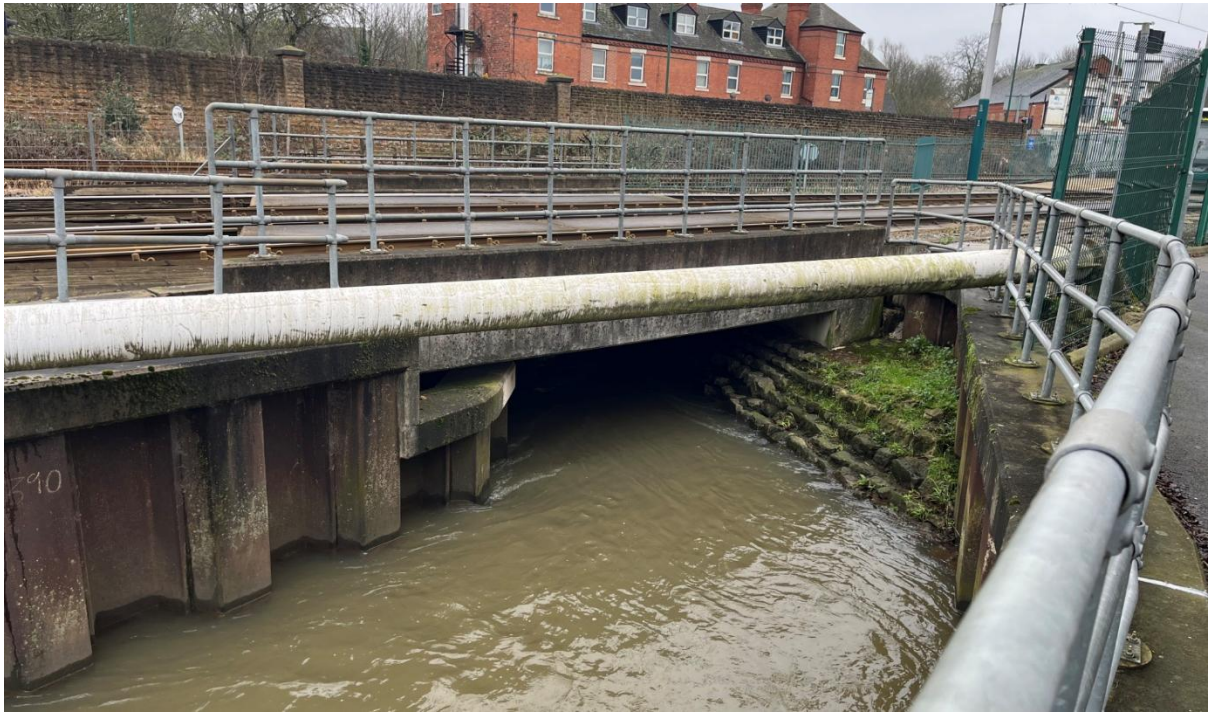
Figure 8: Hydraulic limit for the upstream reach imposed by the culvert beneath the rail infrastructure at SK54963 43420. Located near Vernon Road, upstream of Vernon Park.

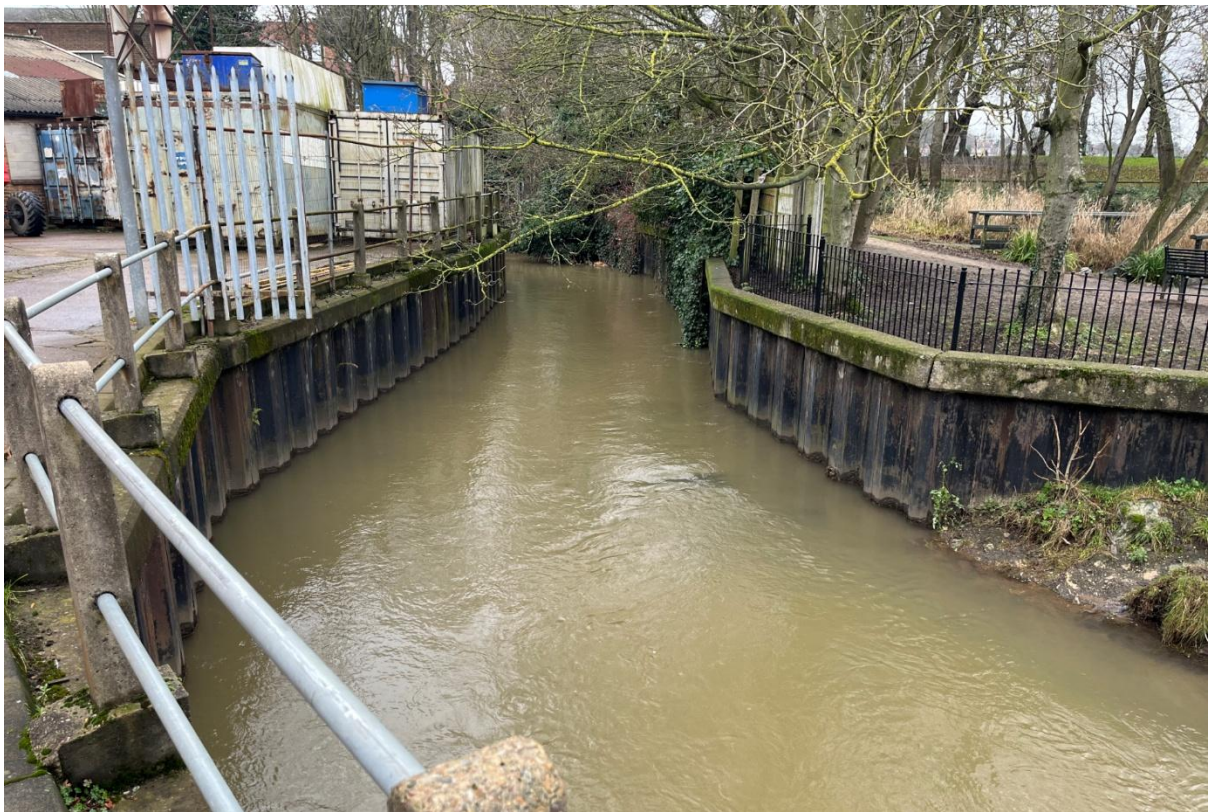
Figure 9: Sheet piling constraining channel at SK55114 43402 between factory and lake in a small park (Vernon Park) that currently suffers from antisocial drug use.

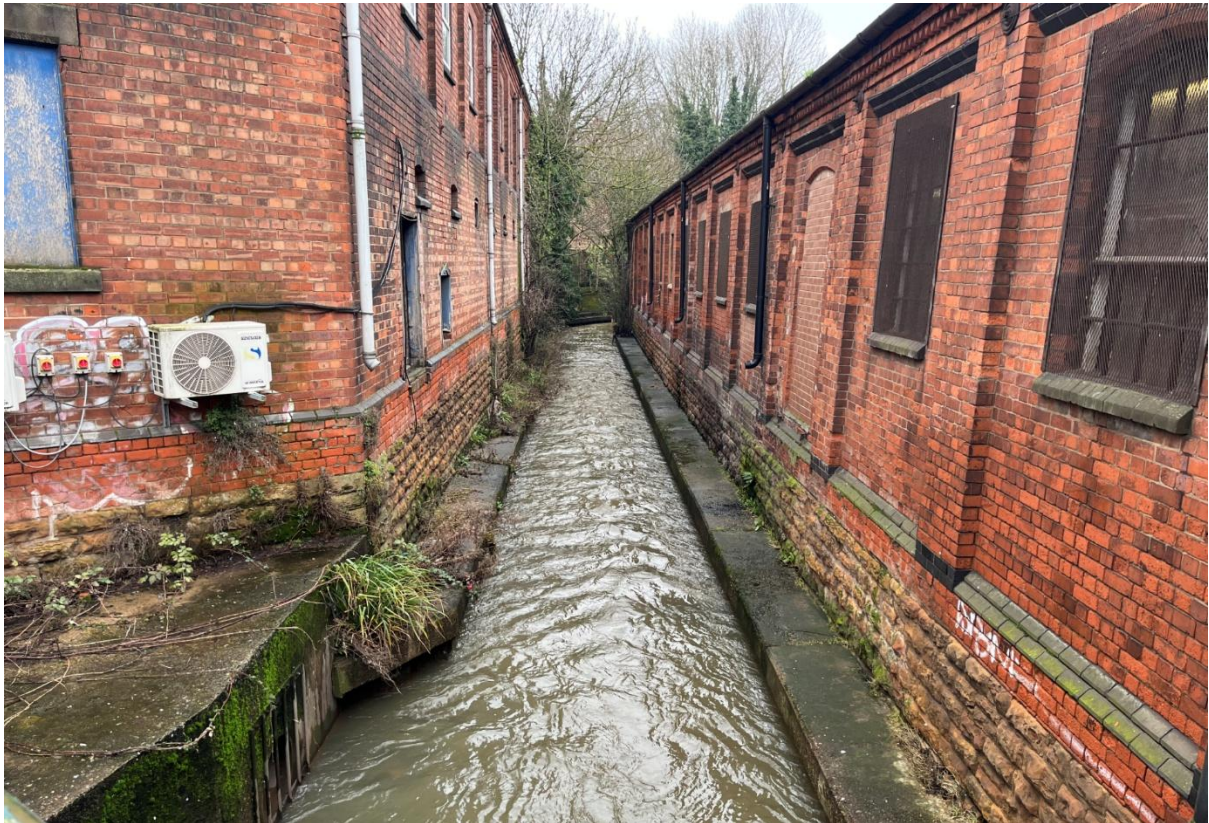
Figure 10: Constrained channel downstream of Southwark Street and feeding into the section shown in Fig. 9.

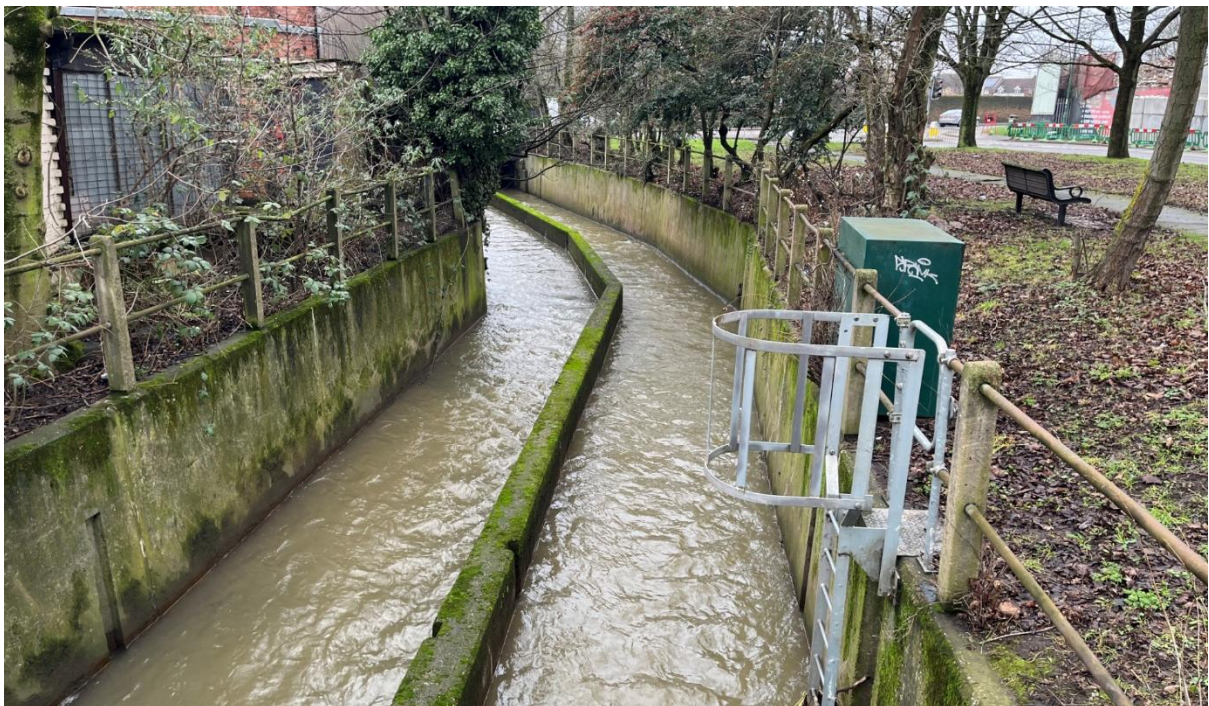
Figure 11: Typical example of central, channel-maintenance wall, plus access ladder, between factory and Vernon Park. Section between Vernon Road and Southwark Street, Basford.

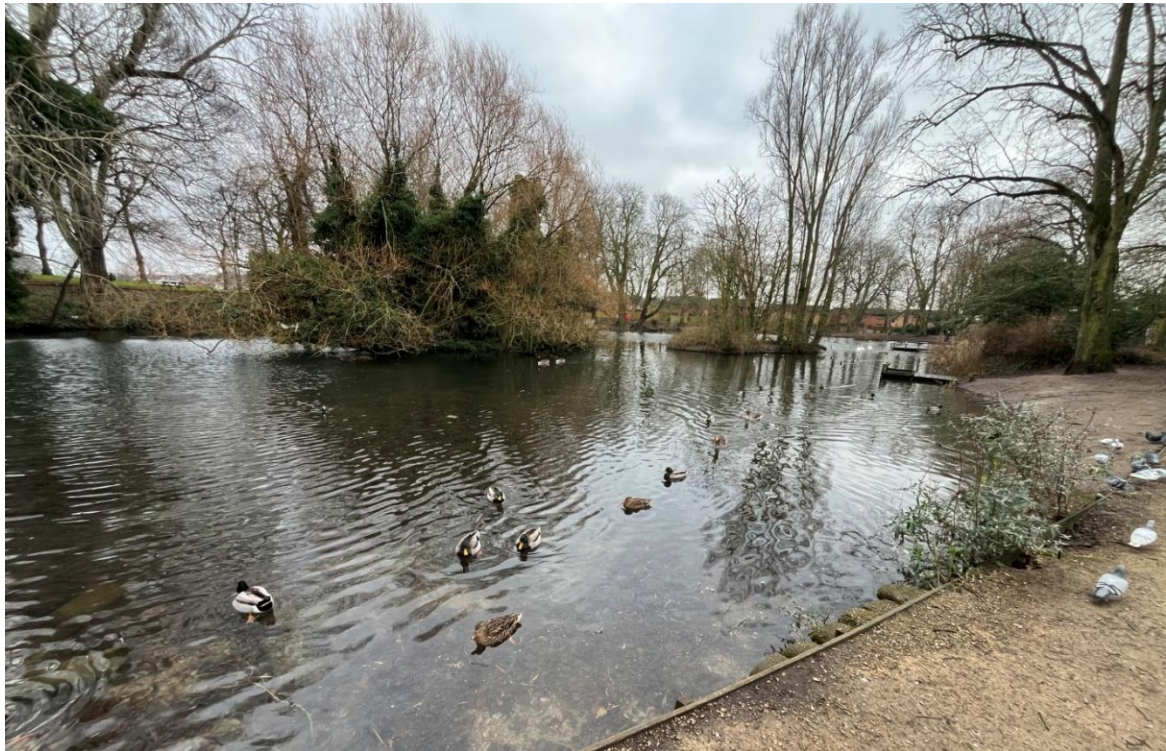
Figure 12: Vernon Park lake. The outfall from this lake is likely to contribute significant nutrient enrichment to the River Leen (including via waterfowl feeding and faecal matter). There is also likely to be an impounding structure used to divert flow through the lake from the river. There may be benefits to exploring the establishment of reedbed water treatment at the outflowing end of the lake and the associated return flow to the river. Investigating the ability to maintain lake water levels without impeding fish passage in the river would also be beneficial.

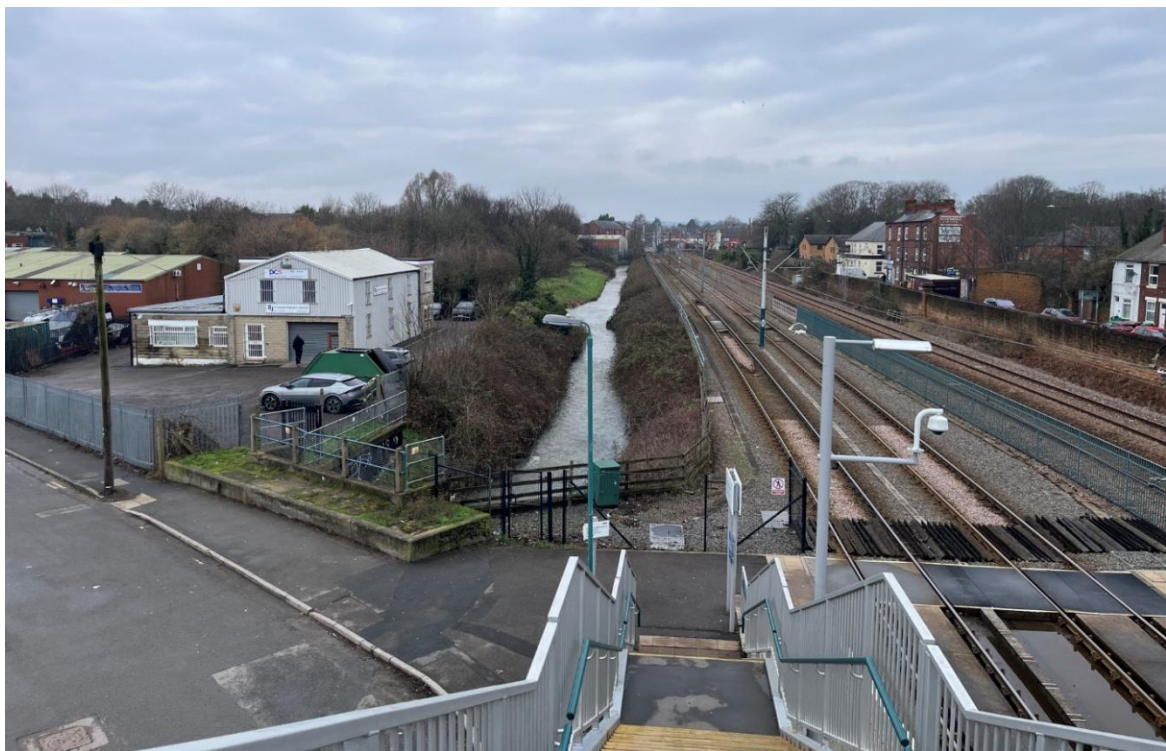
Figure 13: Illustration of straightened channel, constrained by tram/rail infrastructure along the LB at SK55237 43033. Note the slight widening of the channel, visible just above the street lighting fixture. Section part of Lincoln Street Open Space, looking upstream from Nottingham Road near Basford Tram Stop.

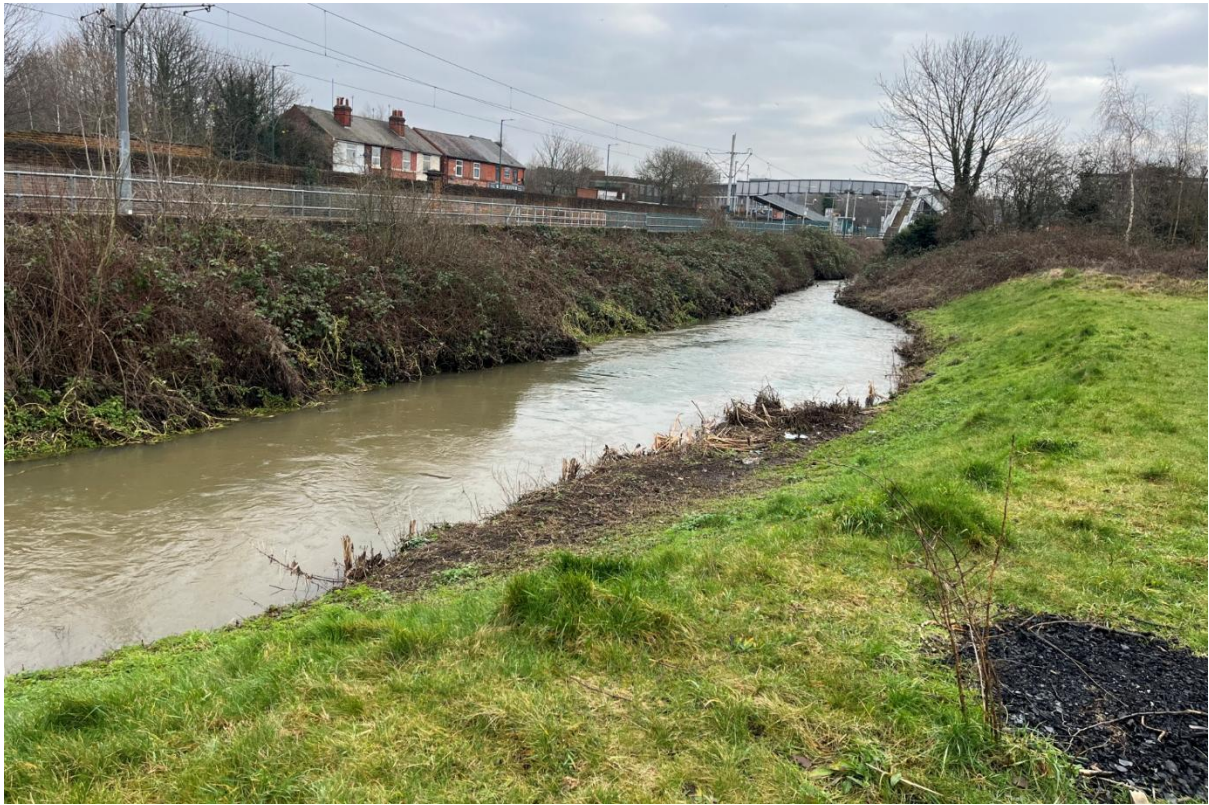
Figure 14: Lincoln Street Open Space. Widened area visible from Fig. 13, the confluence with the Day Brook enters under the tram lines from the LB. While care would be needed to avoid breaching the Sustainable Urban Drainage System (SUDS) ponds several metres outside the right hand edge of the frame, there may be opportunities to increase the degree of channel sinuosity and variation in width by altering and regrading the RB in this reach.

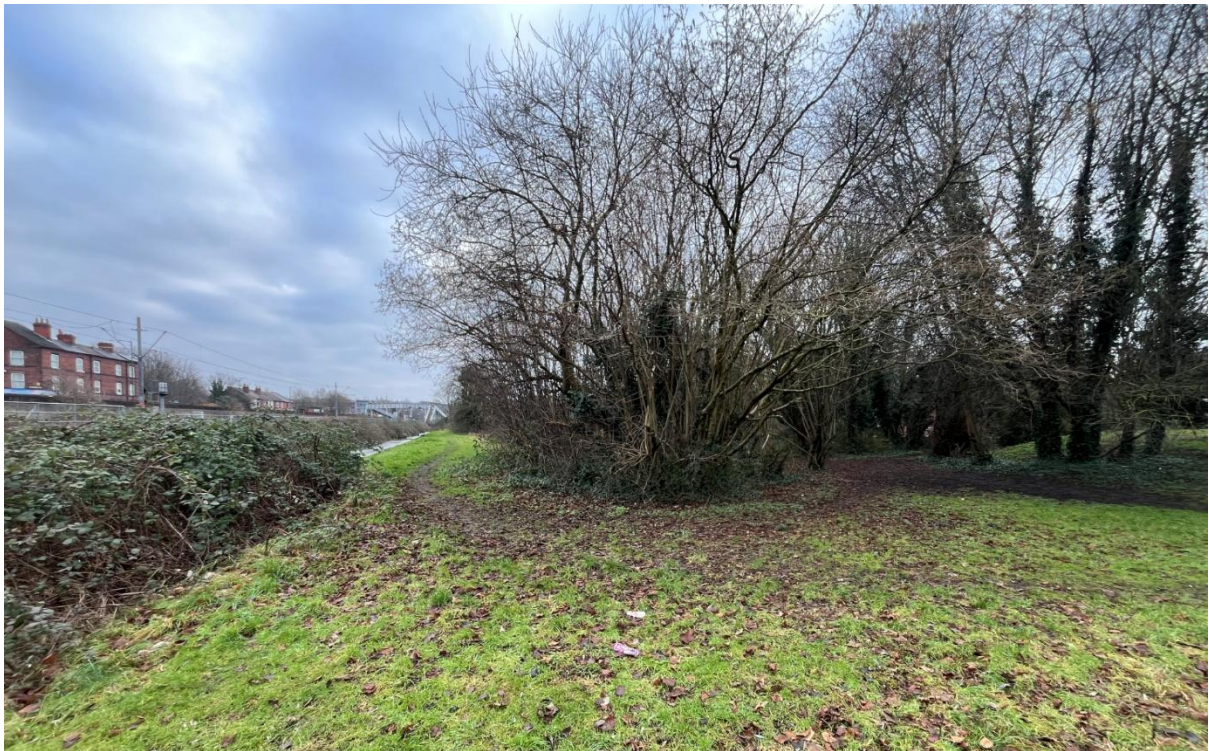
Figure 15: Lincoln Street Open Space. Indication of potential to selectively widen and re-meander the channel by cutting into and regrading the RB in the region of the confluence with the Day Brook. Additional floodwater storage could be created through such interventions.

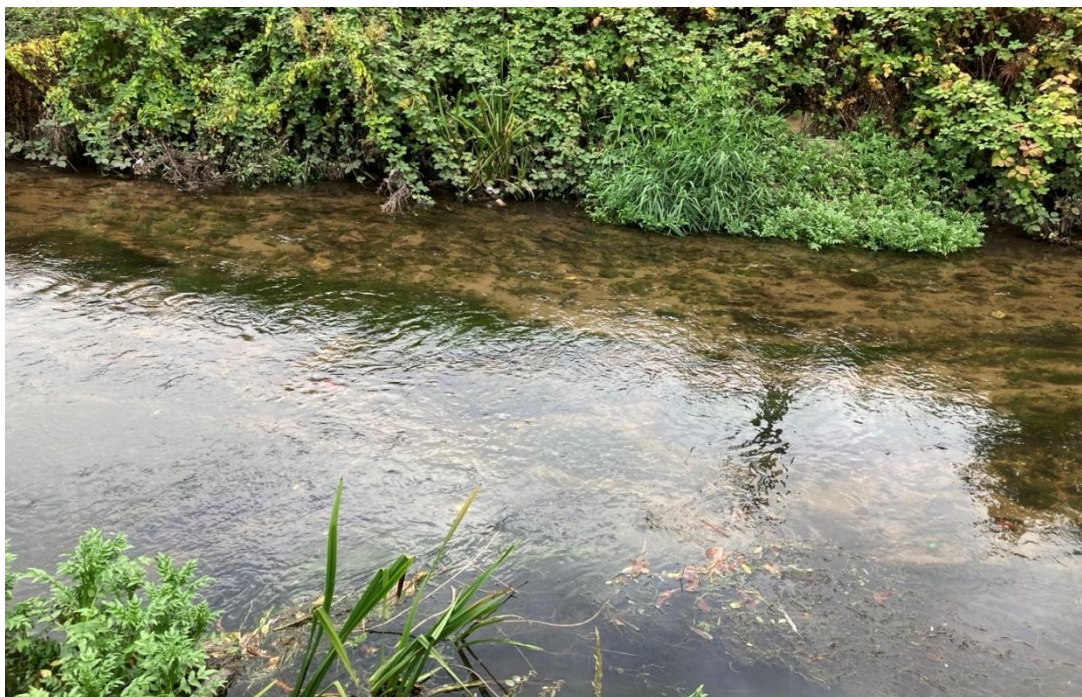
Figure 16: Lincoln Street Open Space. Photograph of the reach close to the Day Brook confluence supplied by EA in summer conditions. This shows retention of a slightly more diverse range of substrate particles and associated submerged macrophyte growth. However, the sand-sized fraction is still very prominent here and has a tendency to smother gravel and cobble particles. Significant investment in SUDS systems to tackle fine particulate matter in surface water runoff (alongside seeding of a mix of cobble and gravel substrate) would be required to create a more ecologically-valuable substrate composition.

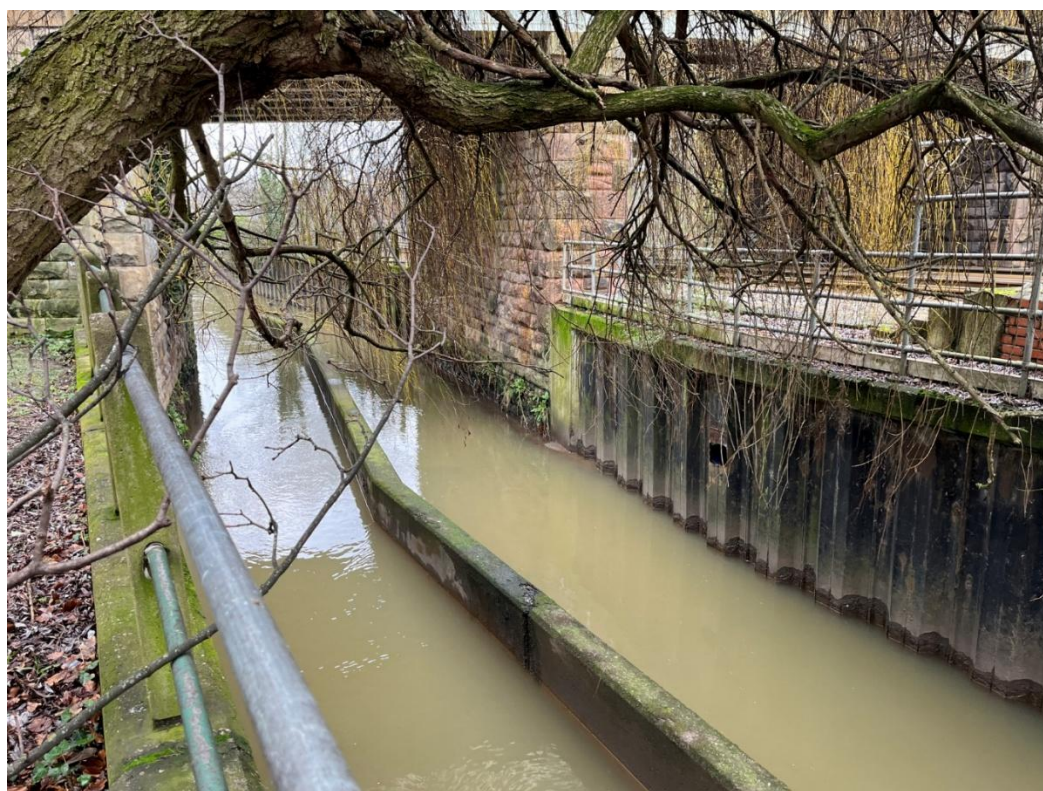
Figure 17: Another example of sheet piling on both RB and LB with a central maintenance channel divider at SK55342 42810. Section near St Leodegarius Church, Basford downstream of Church Street.

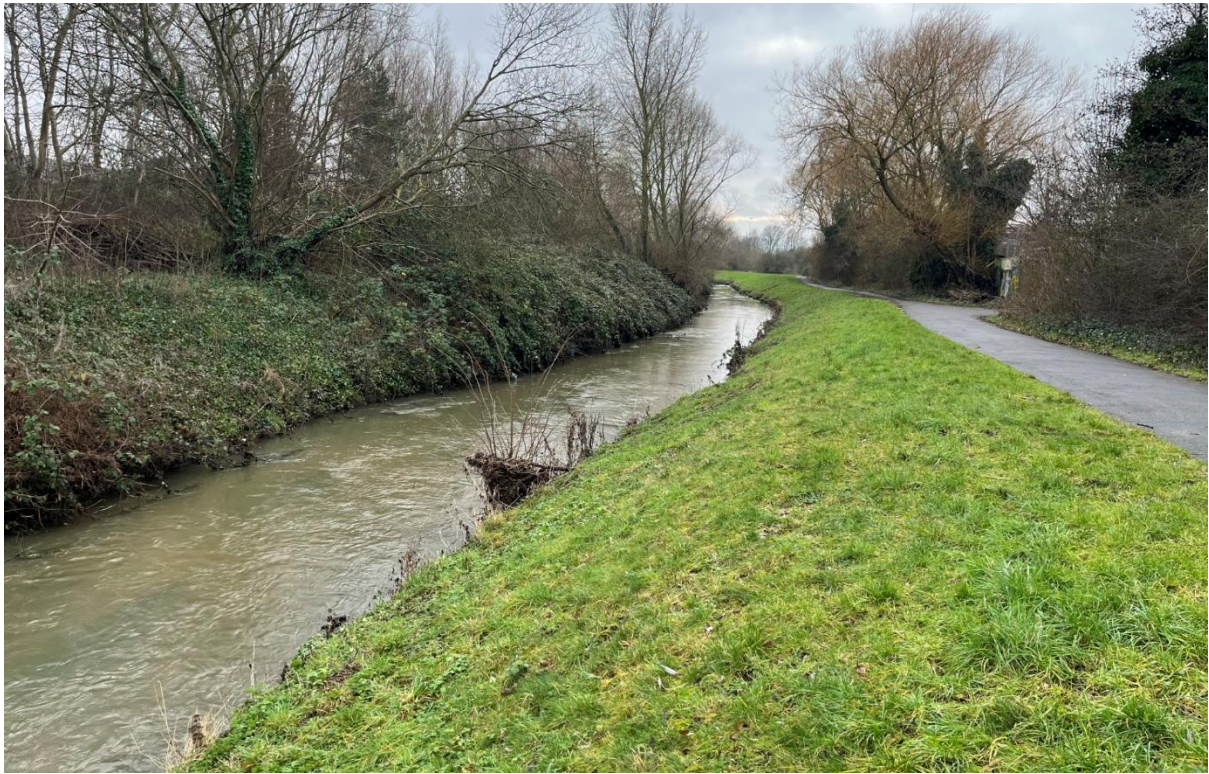
Figure 18: Reach following a greenway corridor downstream of bridge at Western Blvd. adjacent to railway lines at SK5533742620 where some potential for re-meandering and large woody material introduction along with reduced riparian mowing at the water's edge would be beneficial.

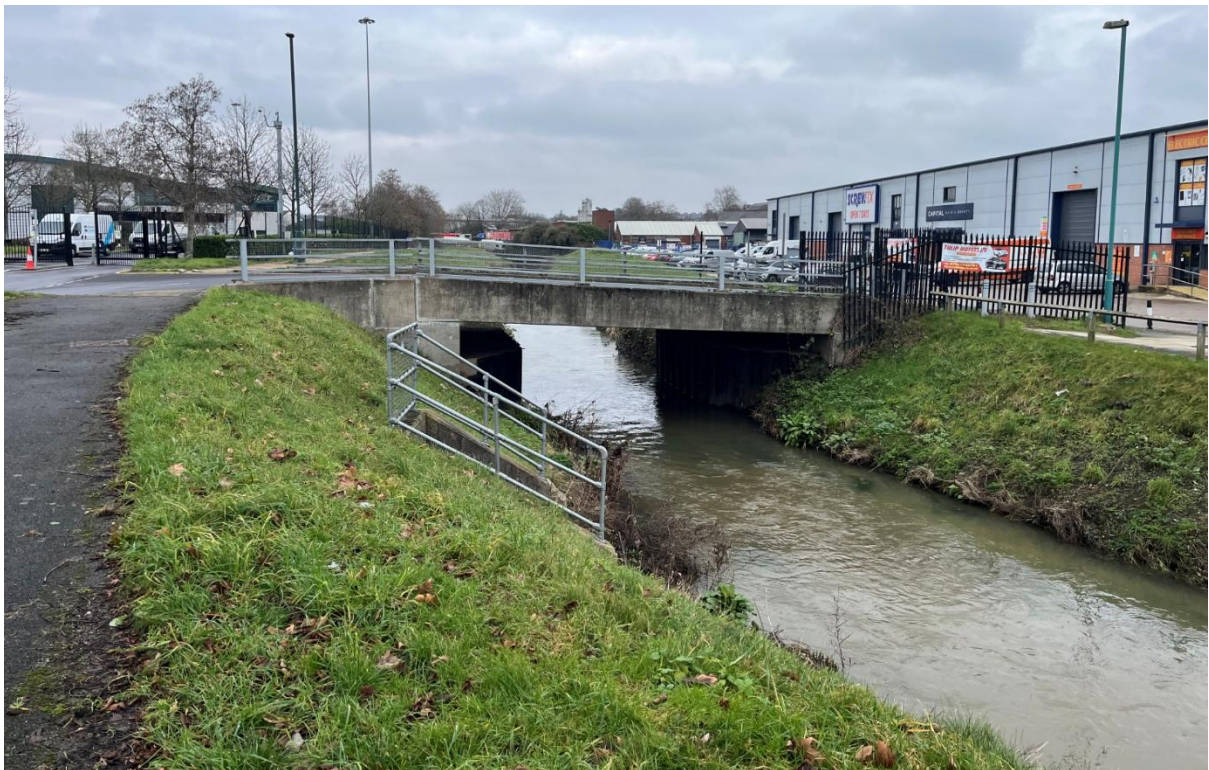
Figure 19: The hydraulic capacity of this bridge near the Wilkinson Street Tram interchange at SK55390 41999 is close to that of the bank-full height of the incised channel here. Being surrounded on all sides by transport and industrial infrastructure leaves little room for alterations to the channel form.

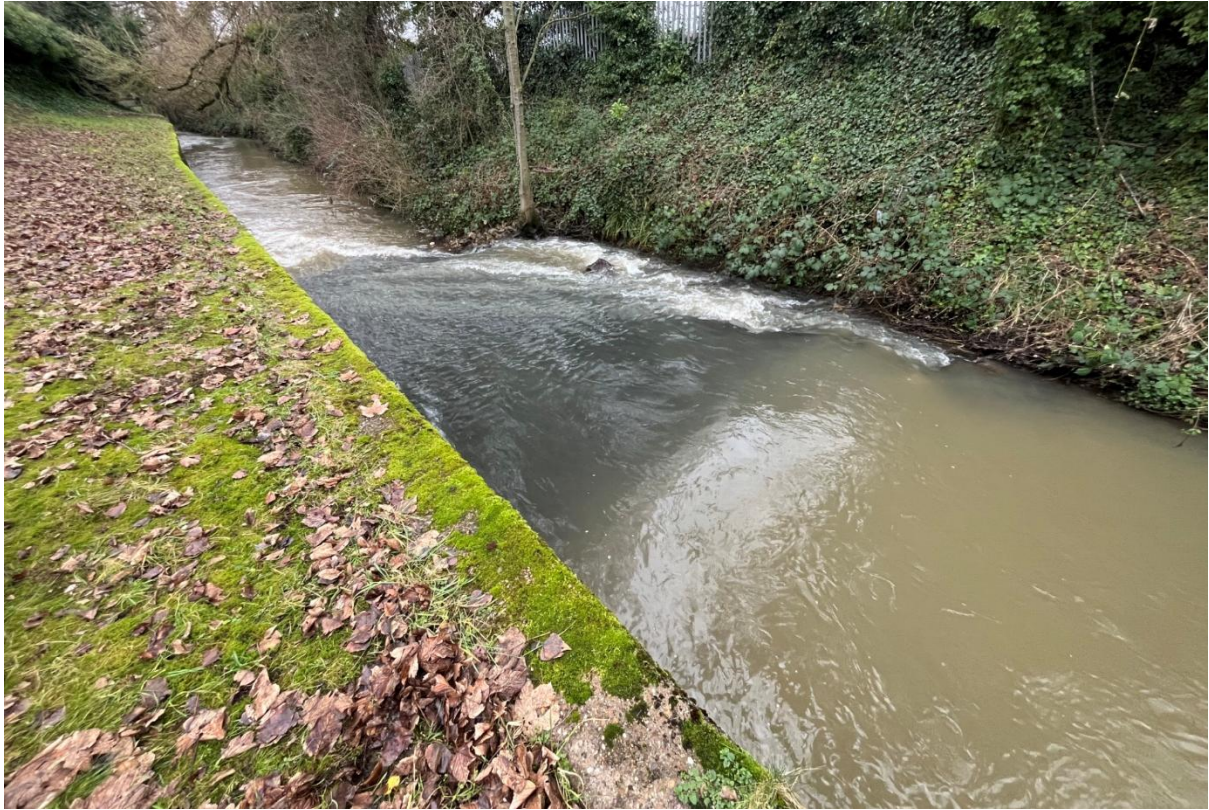
Figure 20: Weir at SK5543041796 downstream of Wilkinson Street could, as a minimum, benefit from hydraulic roughening of the smooth apron so as to create a rock-ramp style fish passage easement and improved habitat. Upstream walls are already collapsing close to the Wilkinson Road bridge, so any head-cut erosion from weir removal would need to be incorporated into the preferred option of full weir removal.

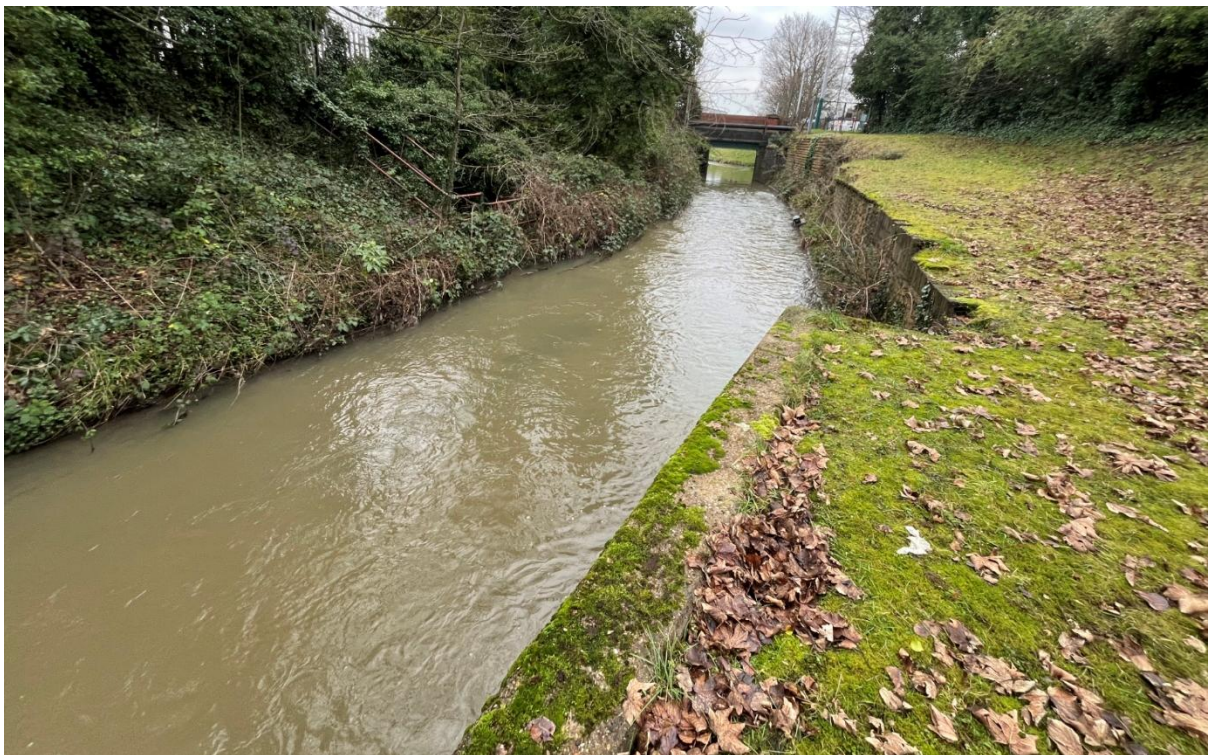
Figure 21: Facing upstream from the weir shown in Fig.20. The wall on the LB (right of frame) is beginning to collapse. Potentially the repair and mitigation of that situation could be used to argue for a weir removal along with appropriate mitigation for head-cut erosion risks to surrounding infrastructure.

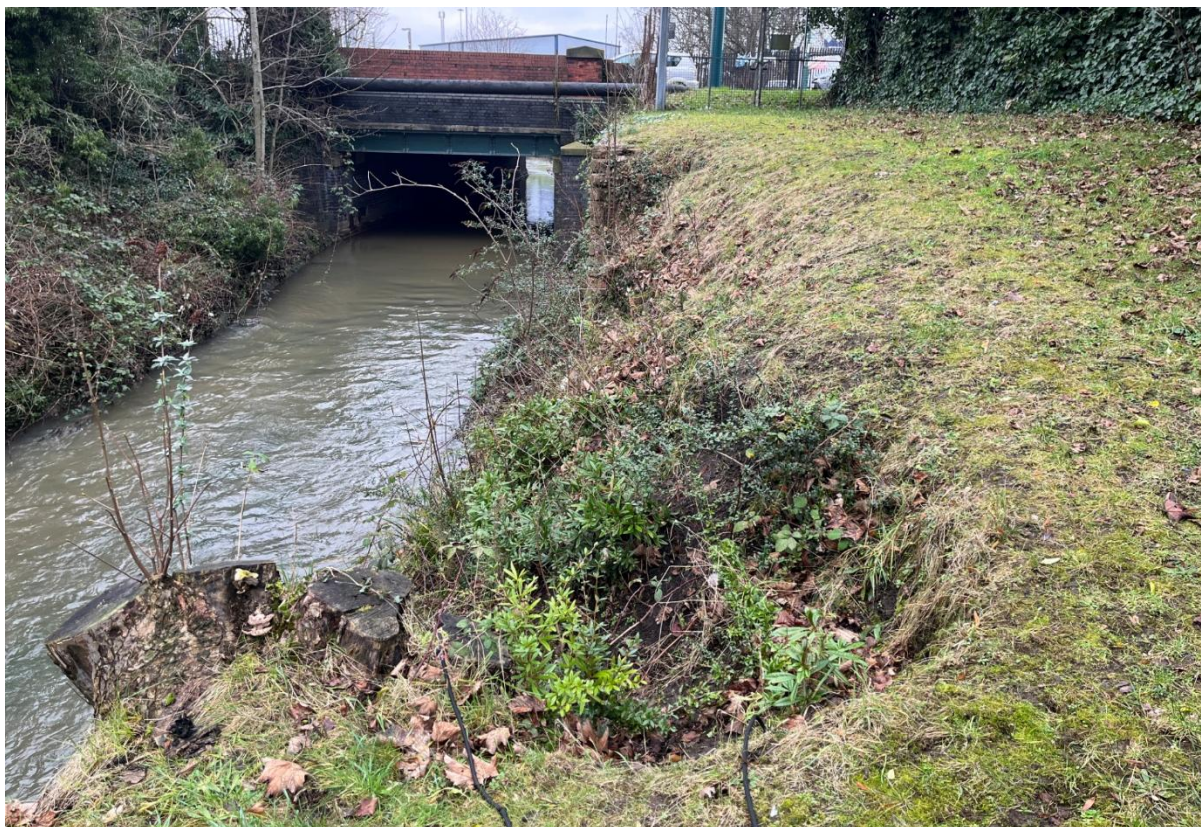
Figure 22: Detail of bank collapse upstream of weir shown in Fig.20.

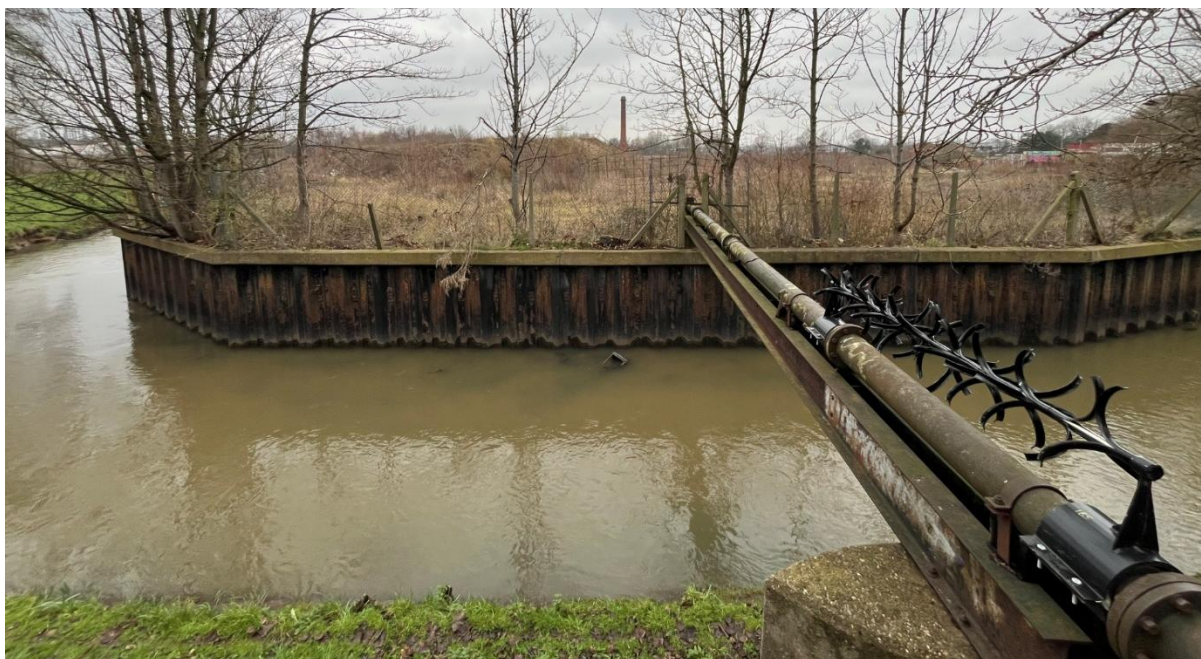
Figure 23: Sharp bend that angles the River Leen around derelict site of the former Cussons soap-manufacturing plant at SK5529741640. Getting the “Love your Leen” project involved early in any discussions over regeneration of this plot of land is strongly advised. This would greatly increase the chances of being able to divert and re-meander the channel through this parcel of land. As well as ecological benefits, the inclusion of more natural features and better floodplain connectivity would also deliver floodwater storage needed to cope with climate change.

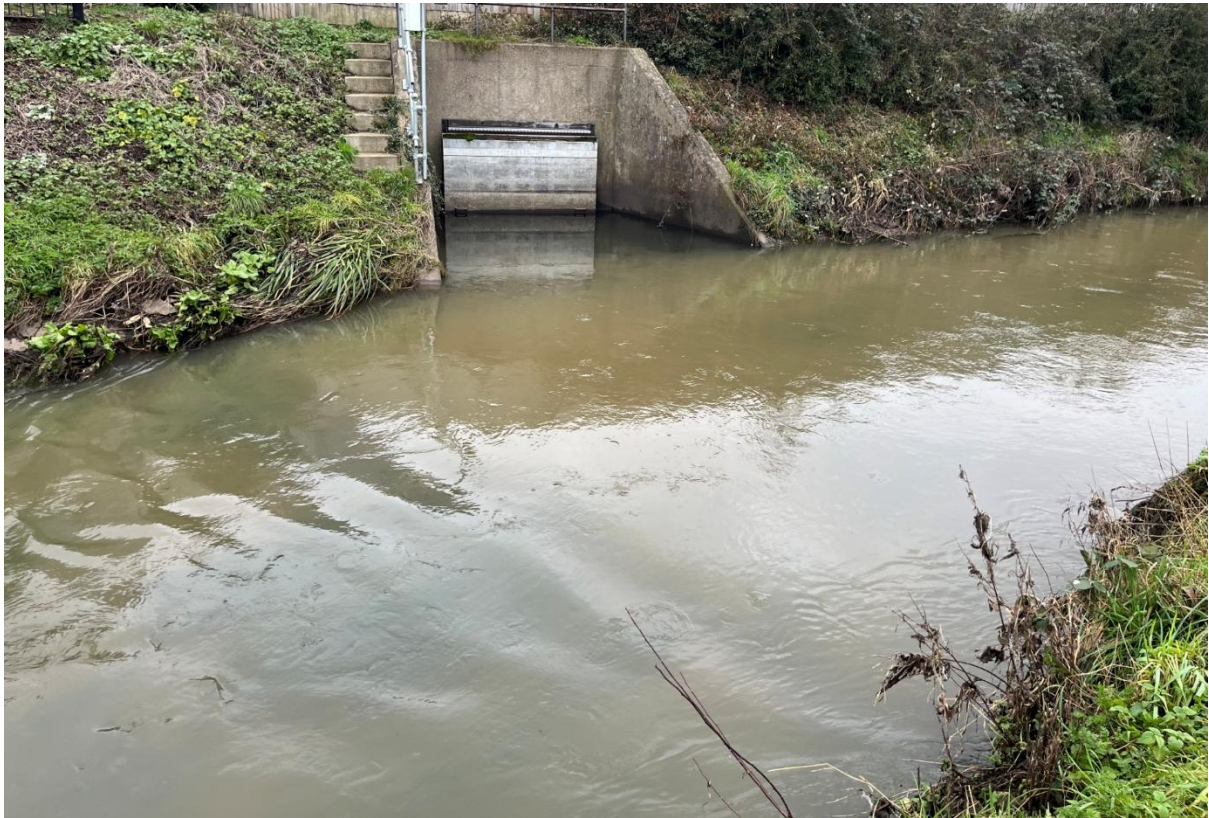
Figure 24: Apparent penstock/flow control and level gauge on outfall on the RB at SK55173 41656 as well as a submerged, low-level weir crest. Exploring the potential to remove or notch this weir is advised. The river then runs downstream through a very straight section adjacent to Bobbers Mill. The channel features grassed flood embankments on both sides and is tightly constrained by surrounding infrastructure (Figs. 25 and 26).

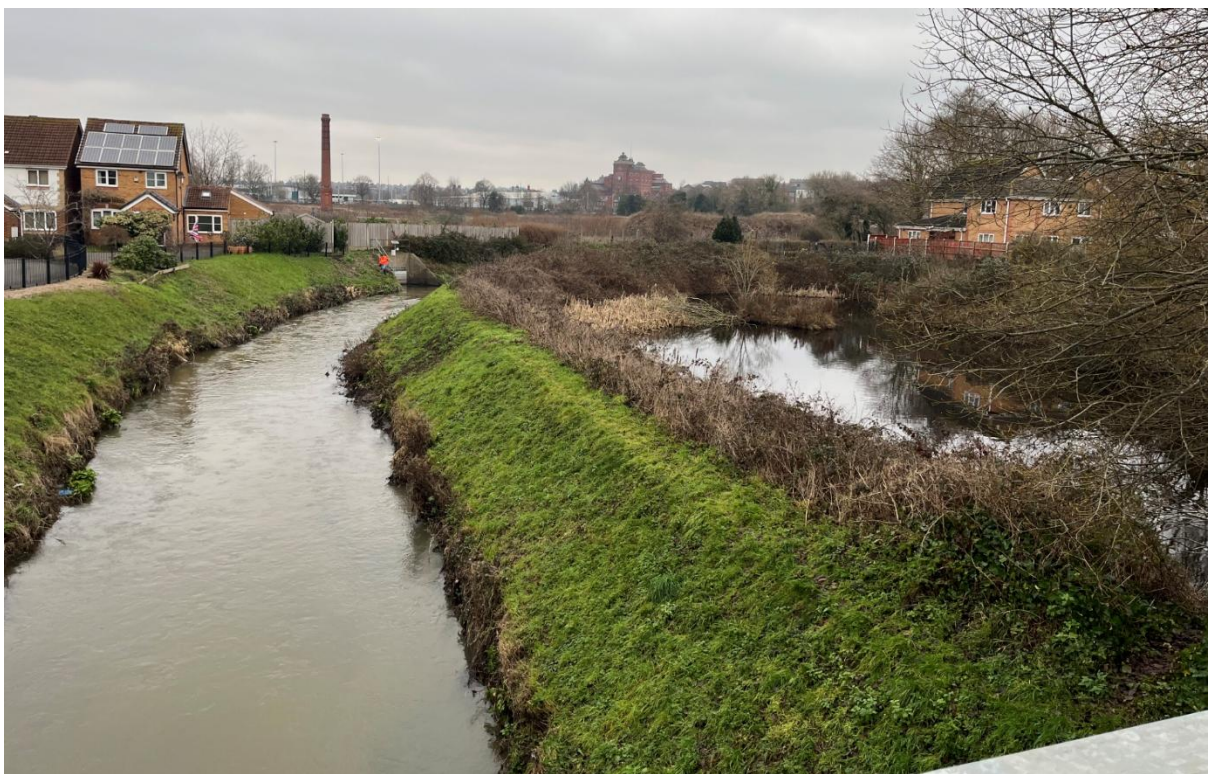
Figure 25: Facing upstream from Meadow Brown road (with steep-sided pond on LB; right of frame).

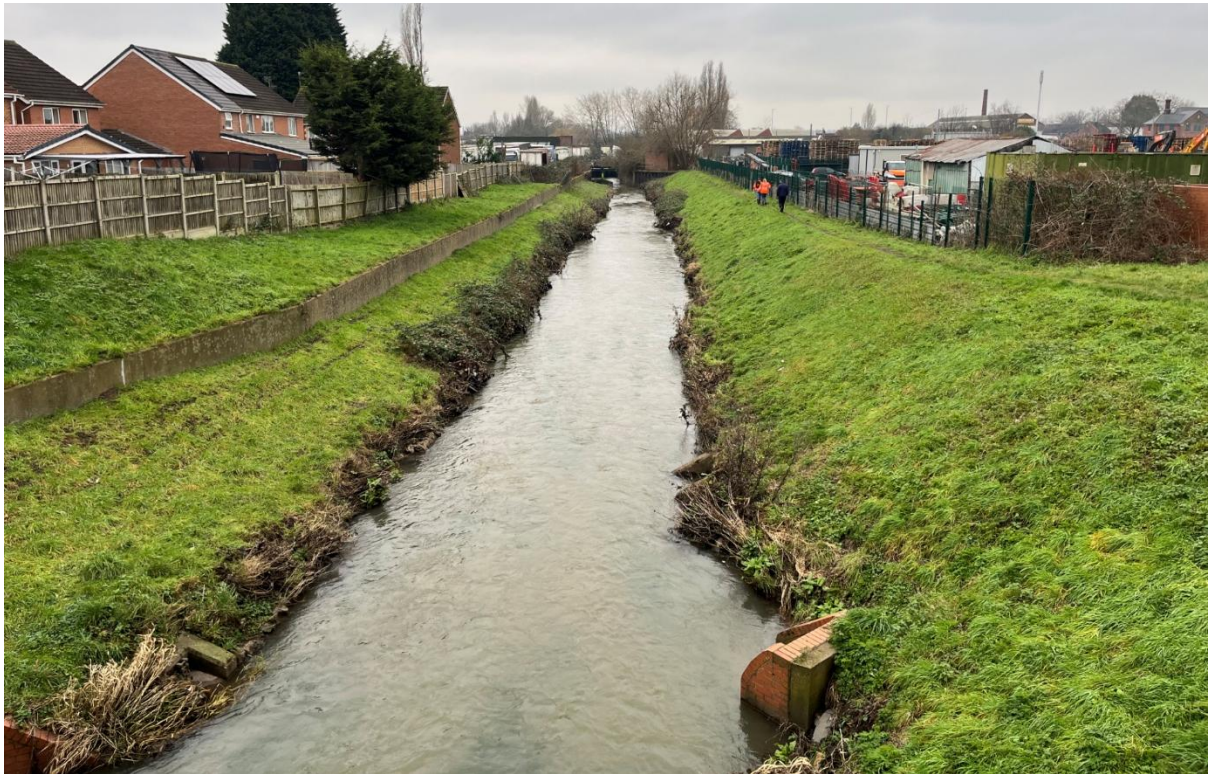
Figure 26: Facing downstream from Meadow Brown Road. Note the flood embankments and proximity to housing and business premises. In-channel large woody material, substrate-seeding and allowing riparian vegetation to grow would improve ecological potential here.

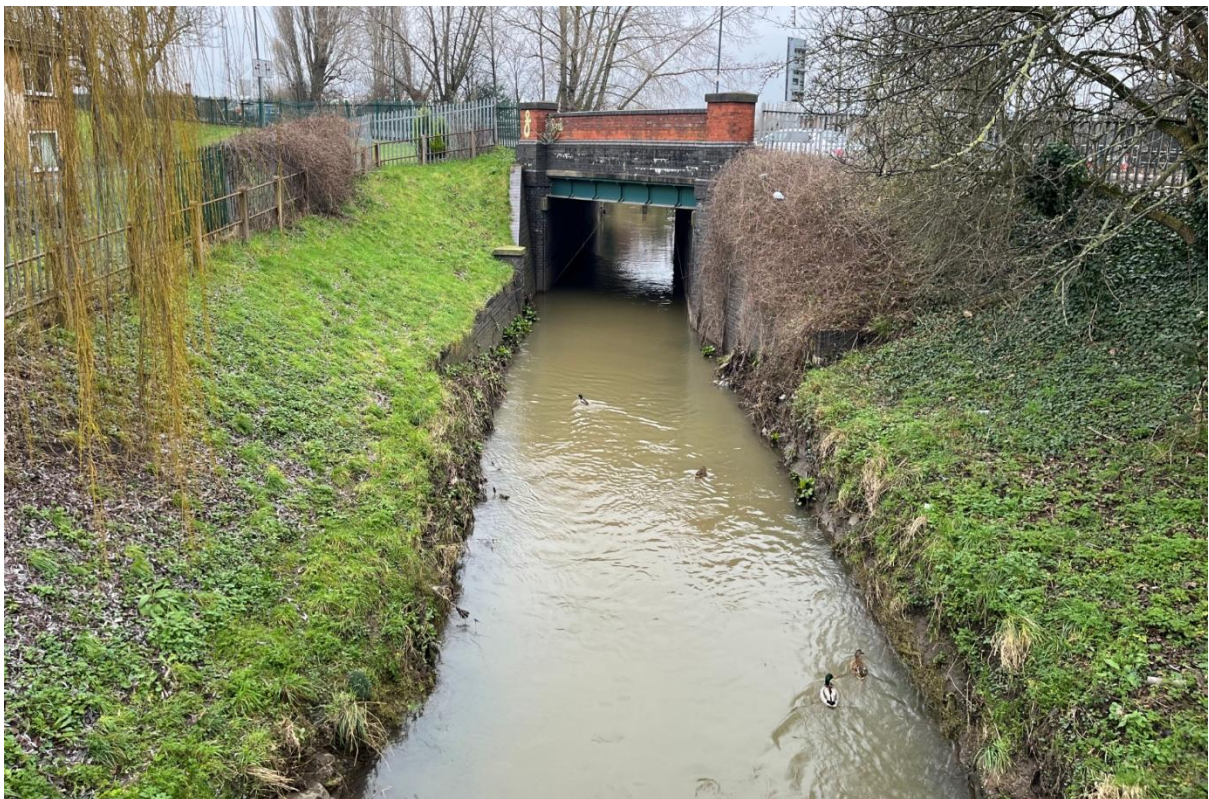
Figure 27: The channel adjacent to Poulter Close at SK5499641212 follows the typical design of straightened, artificial channel, flanked by grassed flood embankments (see also Figs 28 - 30).

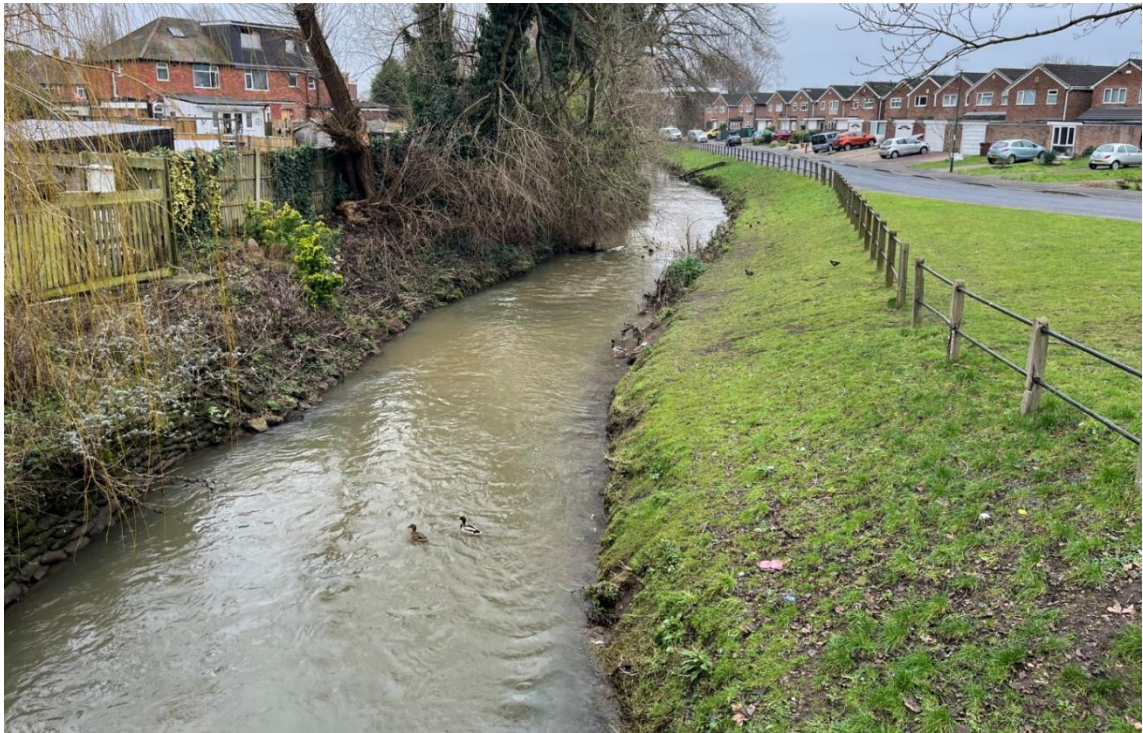
Figure 28: More extensive vegetation growth on the LB (left of frame) is providing ecological benefits to the channel. Again, substrate-seeding, in-channel woody material and greater sinuosity in the path of the river would further improve prospects for biodiversity.
