Advisory Visit

River Leen

"Love Your Leen", Nottingham

30/01/2026

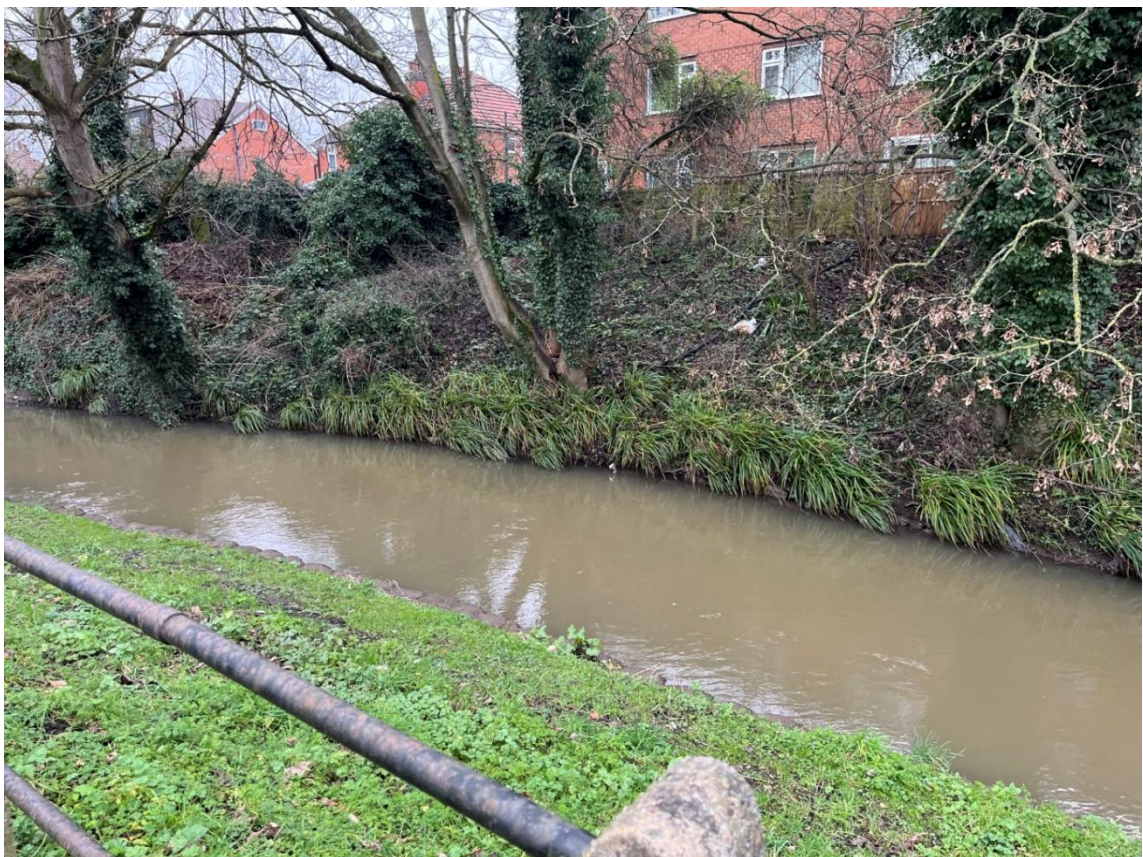
Figure 29: Far bank (LB) showing a rare example on the River Leen of riparian woodland and understory vegetation species. The low, trailing marginal vegetation will provide much-needed cover from predation and a degree of shelter from spate flows.

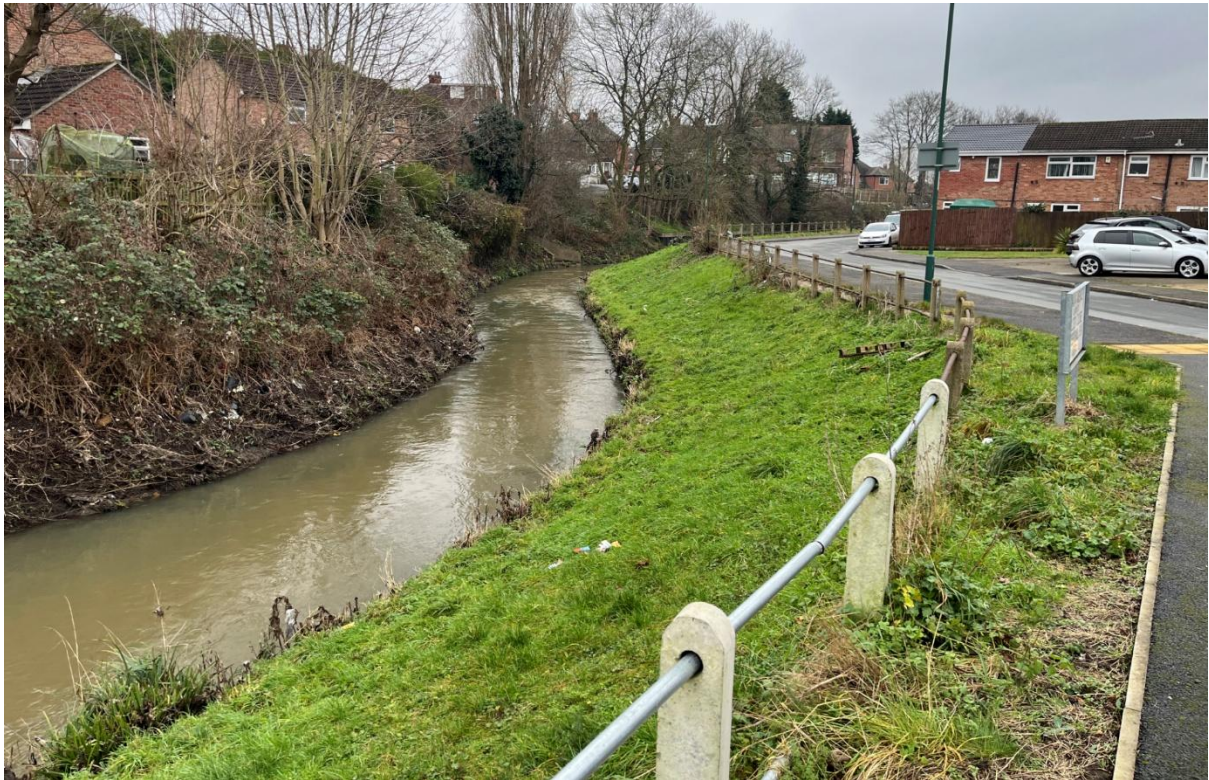
Figure 30: Contrasting vegetation-management between LB and RB, along with extreme proximity of the wetted channel to housing and road.

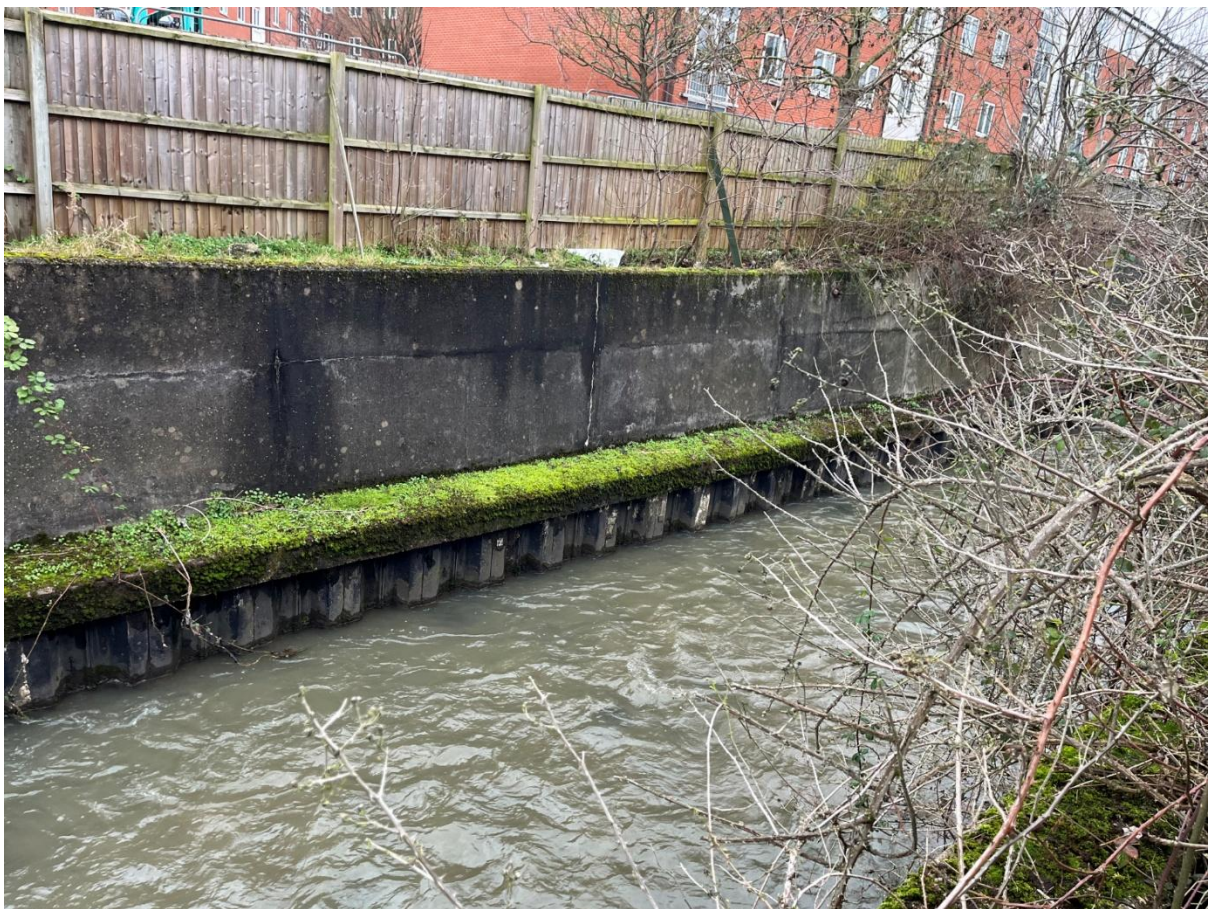
Figure 31: Constraints become even tighter in the Student Quarter of Nottingham around SK55056 40428.

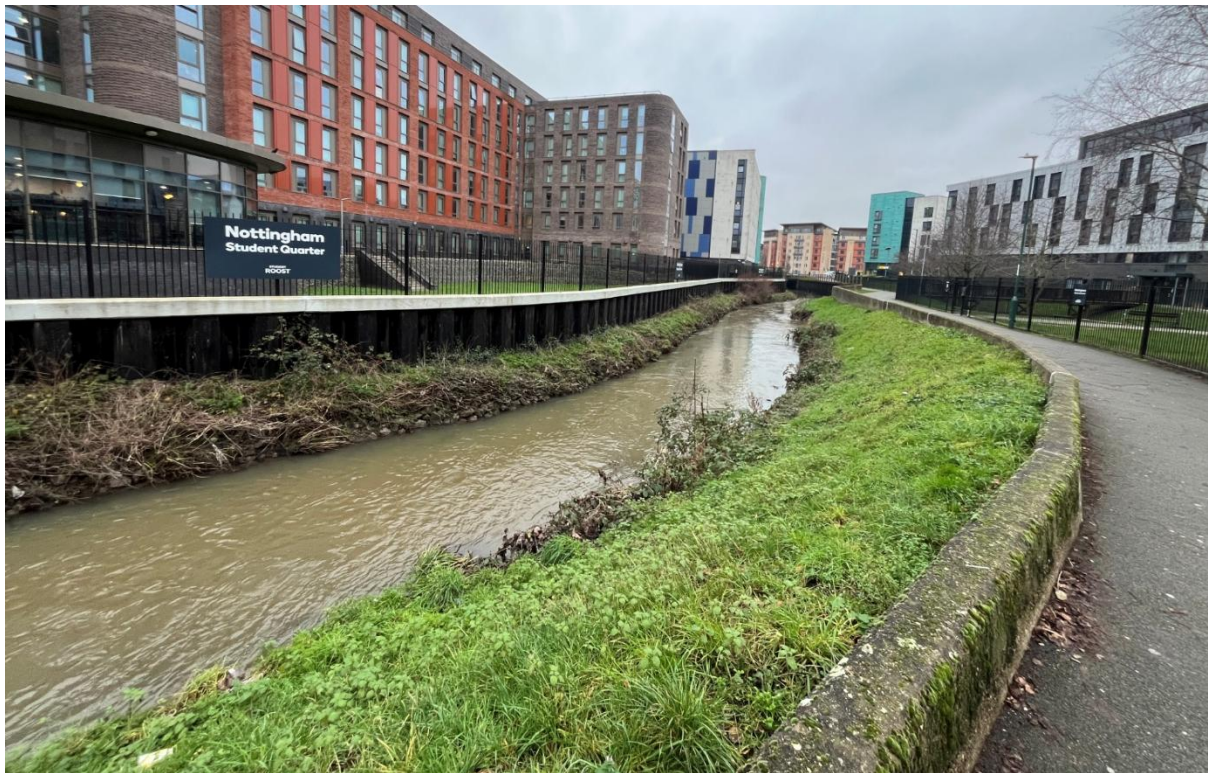
Figure 32: The degree of urban development lining the edges of the channel in these reaches presents huge challenges to river habitat improvement here. Sensitivities over flood risk do need to be balanced with a realistic assessment of the impact of allowing more structurally-diverse riparian vegetation to develop.

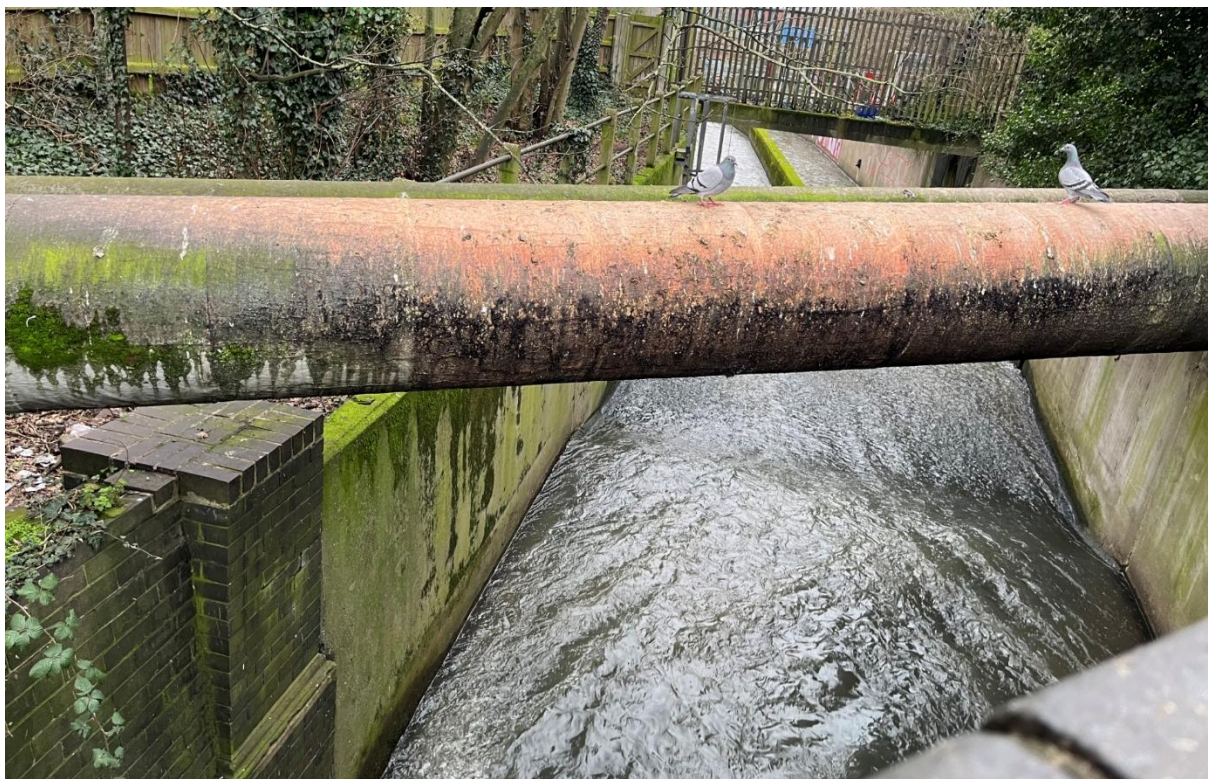
Figure 33: Weir at SK55038 40069 downstream of Wollaton Road with a smooth surface and laminar flow that creates a significant barrier to fish migration as well as substrate transport. Roughening the surface so as to promote accumulation of substrate would offer some improvement to habitat and connectivity.

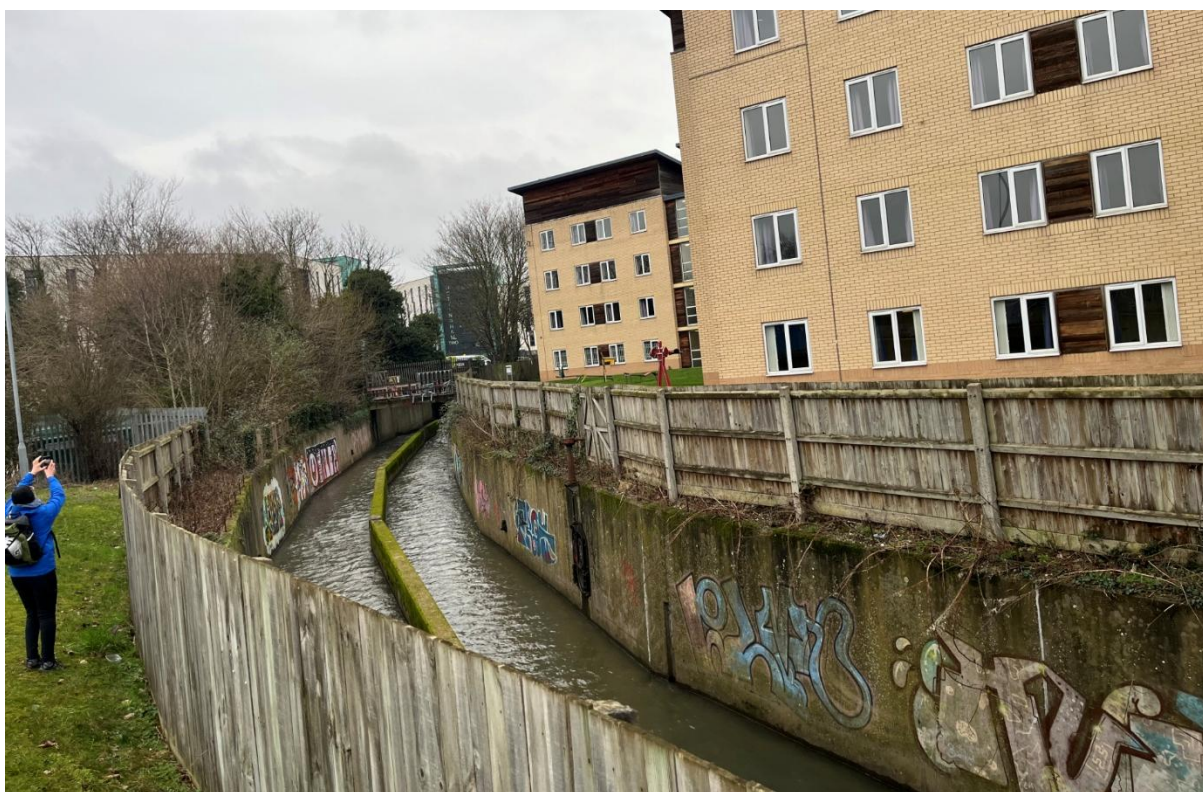
Figure 34: Central wall example at SK54933 40025 in a short, above-ground section of the Leen between Daisy Park student halls and railway line.

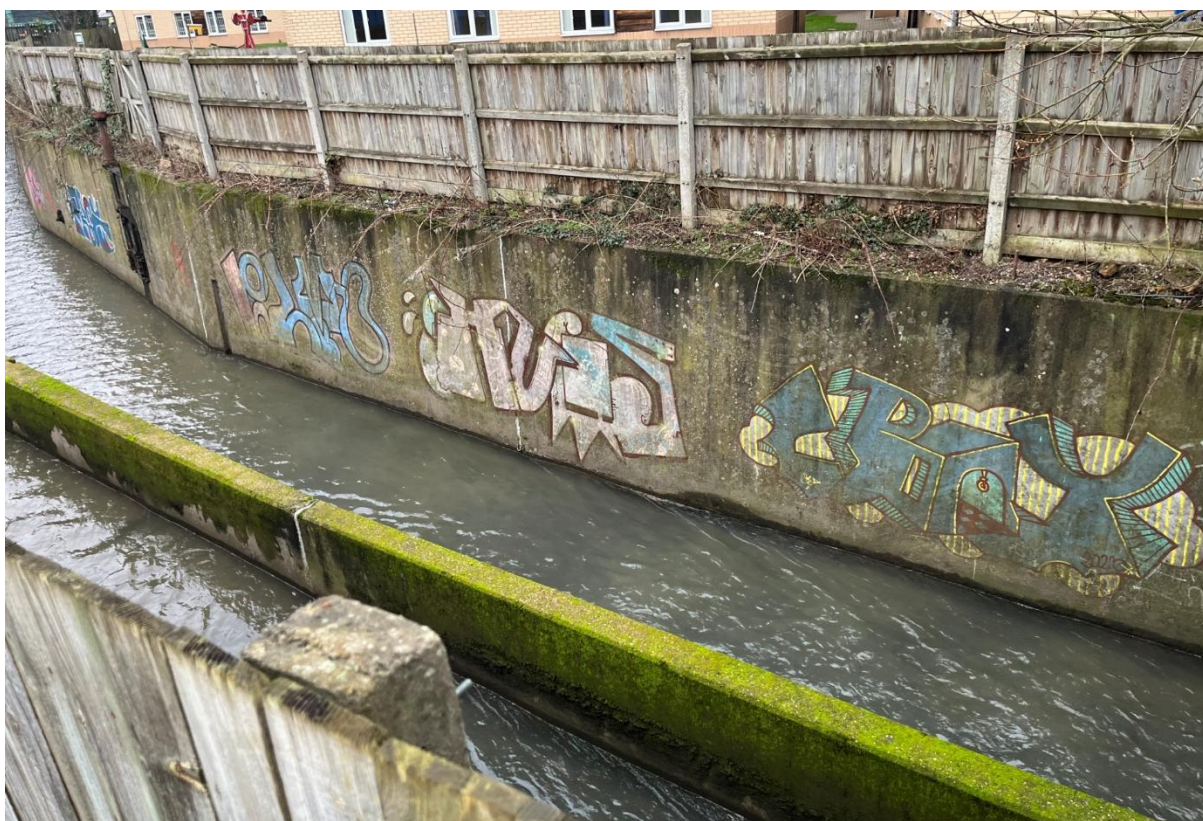
Figure 35: View of channel adjacent to Daisy Park student halls just as it passes over a small weir and into a culvert.

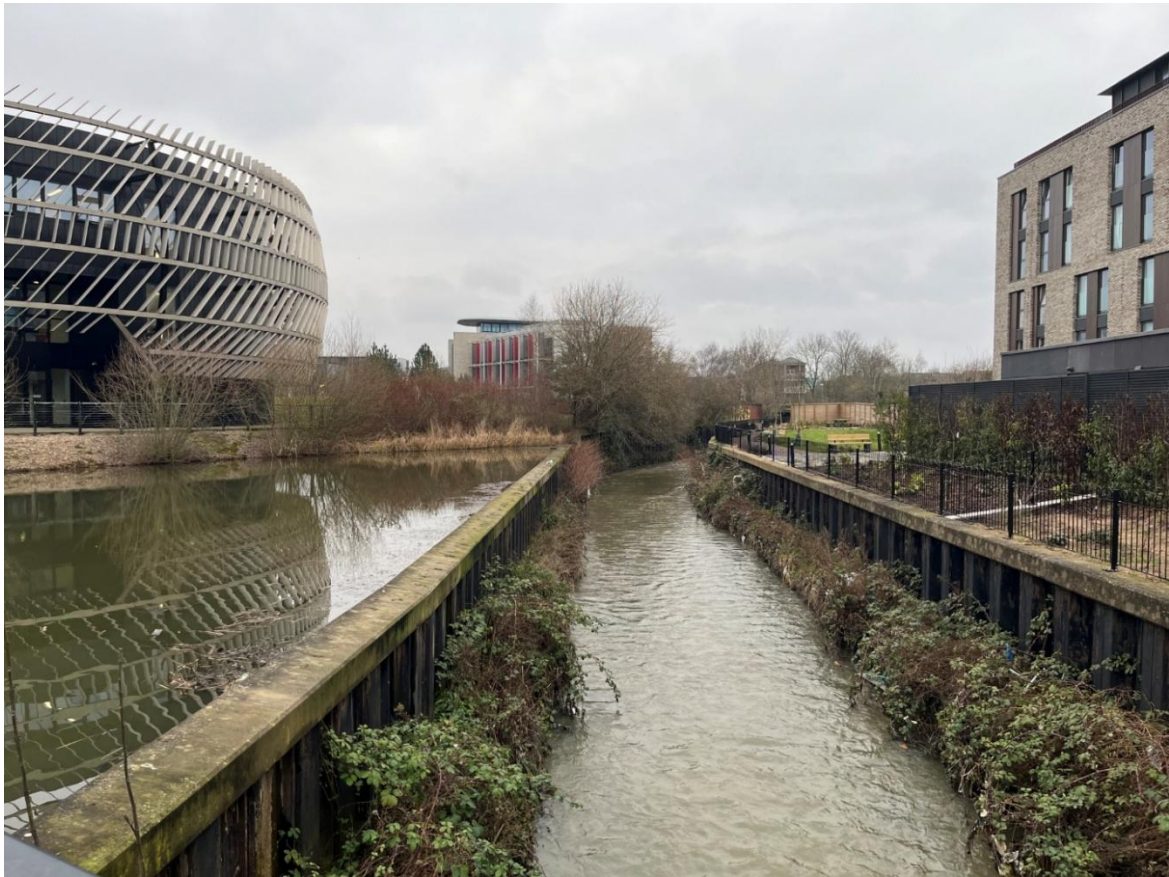
Figure 36: Elevated SuDS pond belonging to the Ingenuity Centre building (left), part of the University of Nottingham Innovation Park, adjacent to the River Leen at SK55085 39573.

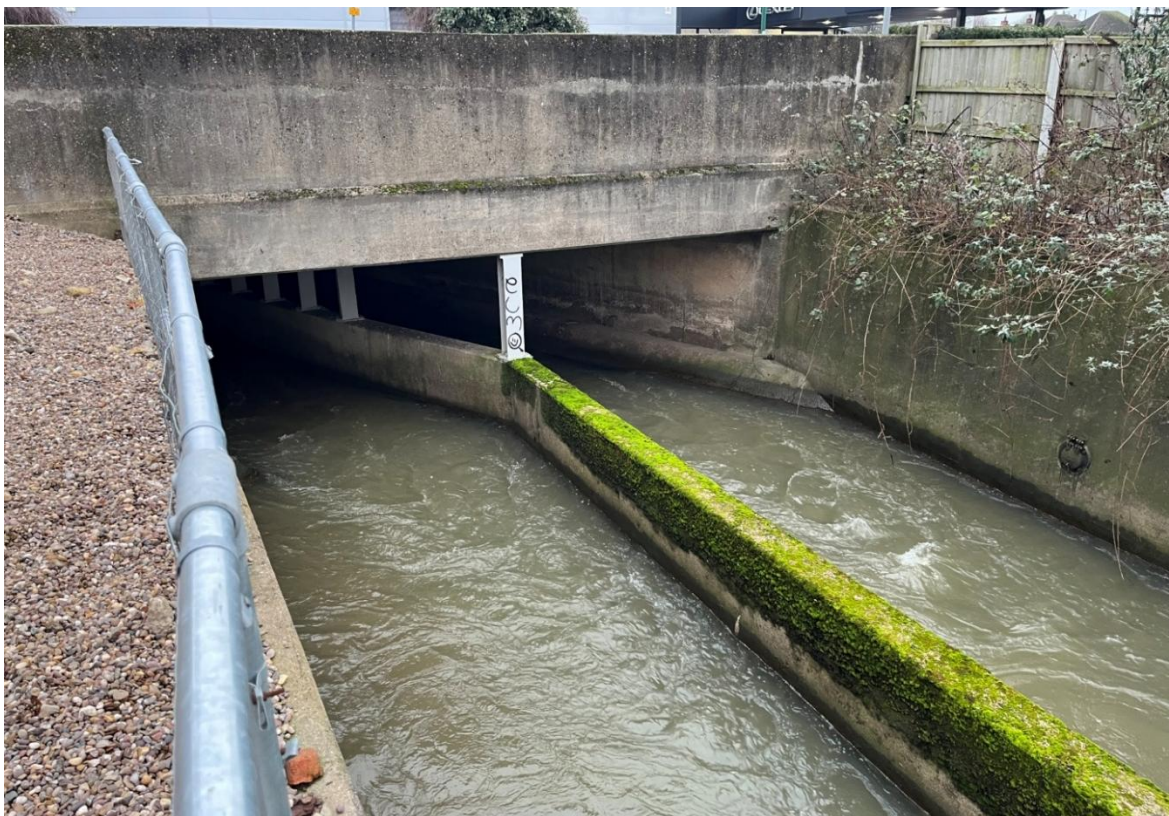
Figure 37: Culverted section emerging into completely straight concrete-walled channel with central concrete dividing wall at Triumph Road, SK55025 39327.

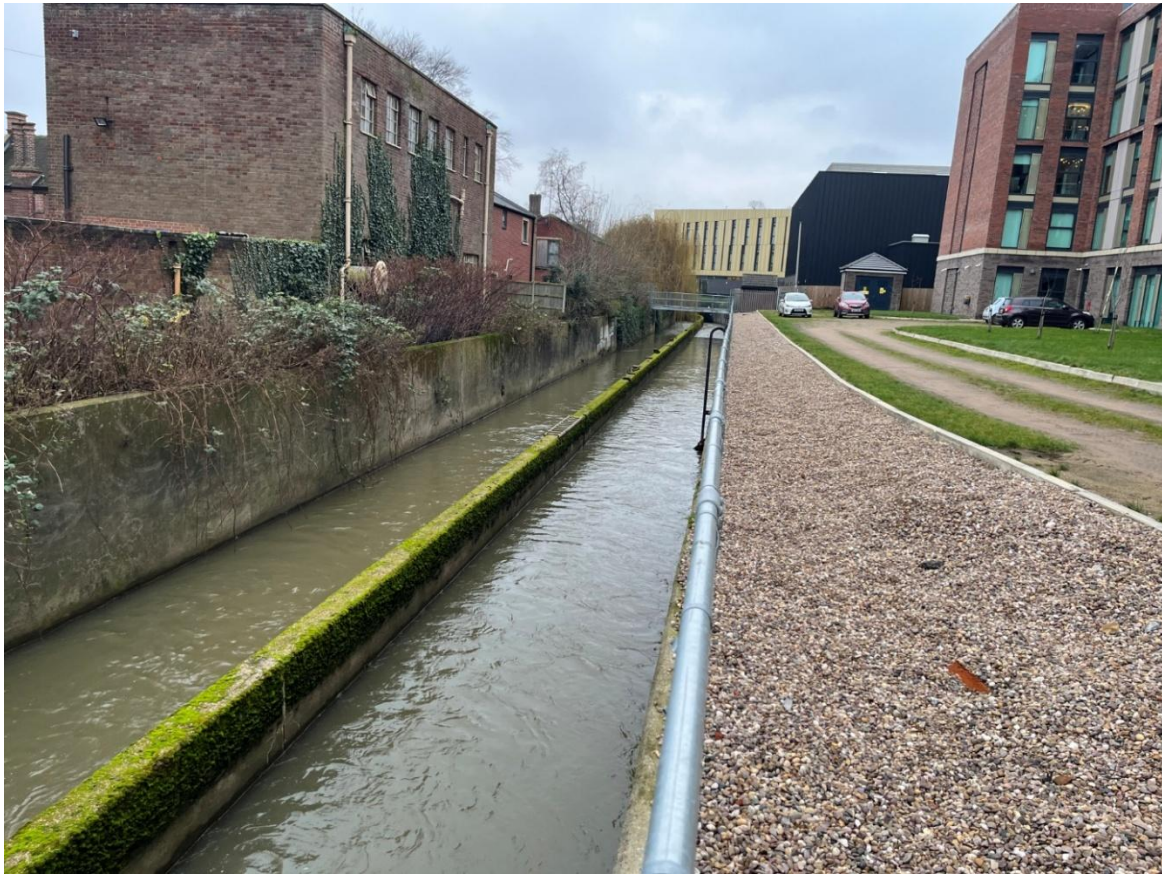
Figure 38: Section flowing from culvert under Triumph Road to emerge in front of Triumph House.

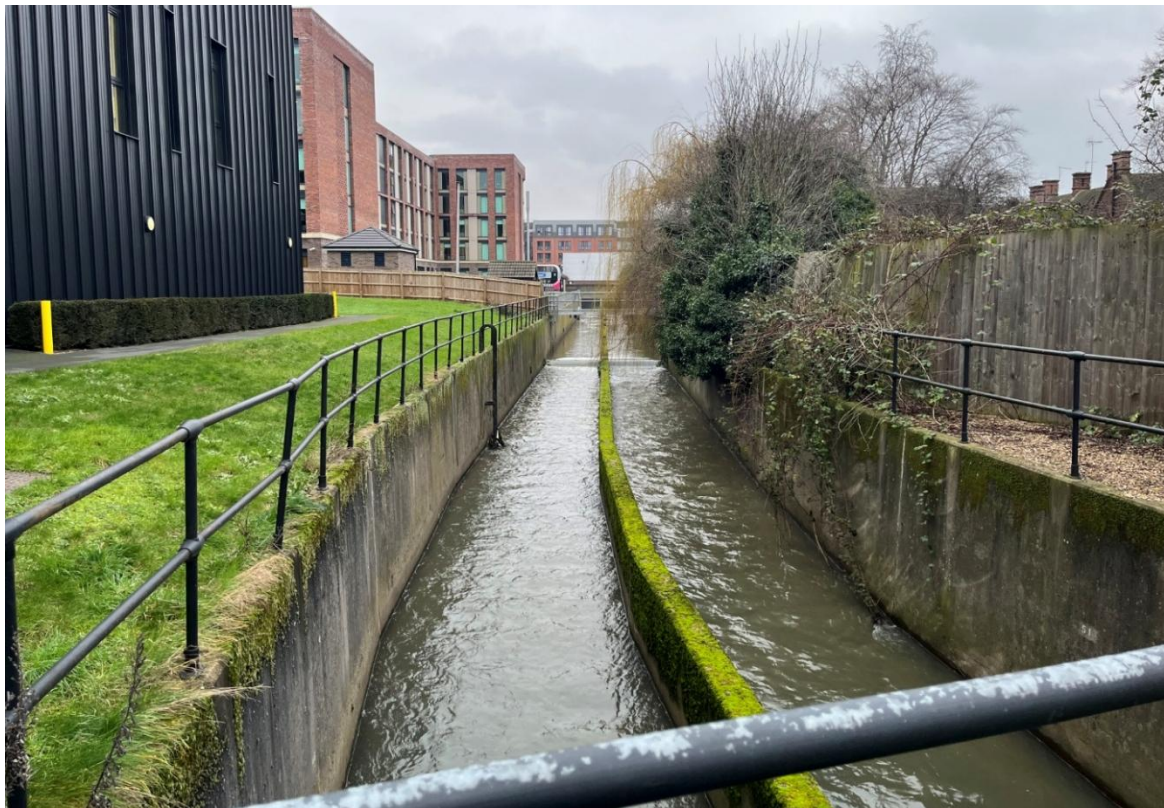
Figure 39: Standing on entrance to culvert facing upstream towards weir at adjacent to centre for aerospace manufacturing, University of Nottingham Jubilee Campus, SK54933 39242.

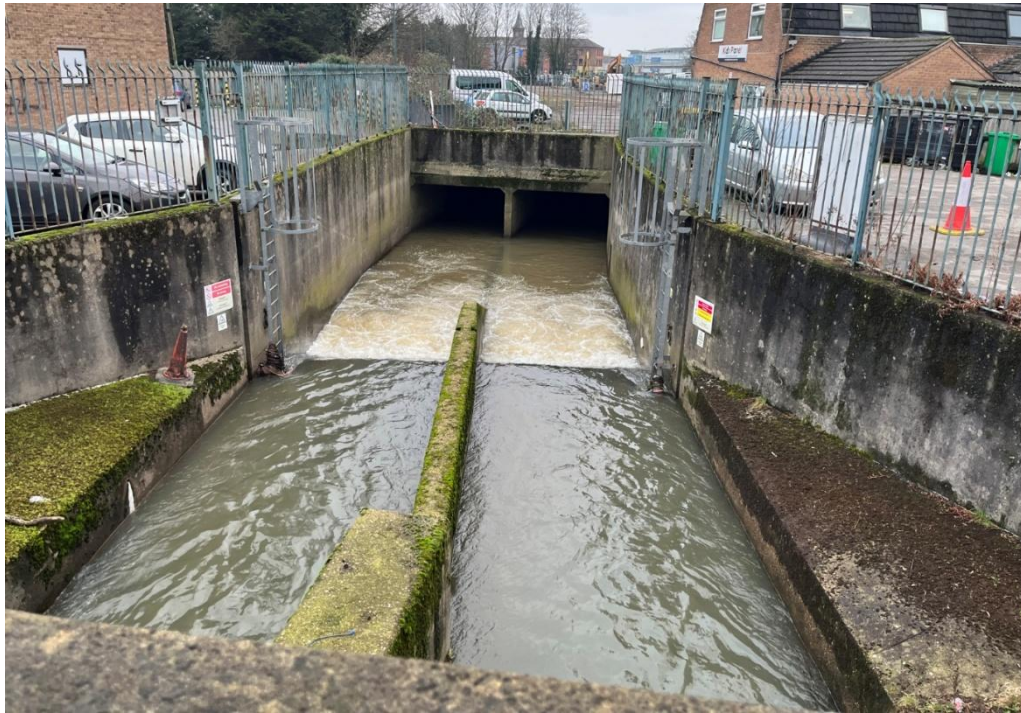
Figure 40: Very short, open section at SK54927 39200 with a weir and entering a further culvert (parallel to Hill Side). Structures photographed facing downstream while standing on the downstream end of the culvert cited for Fig. 39. Note the presence of a further, similar weir at the downstream exit of this culvert below the A6200/Derby Road at SK54932 39153.

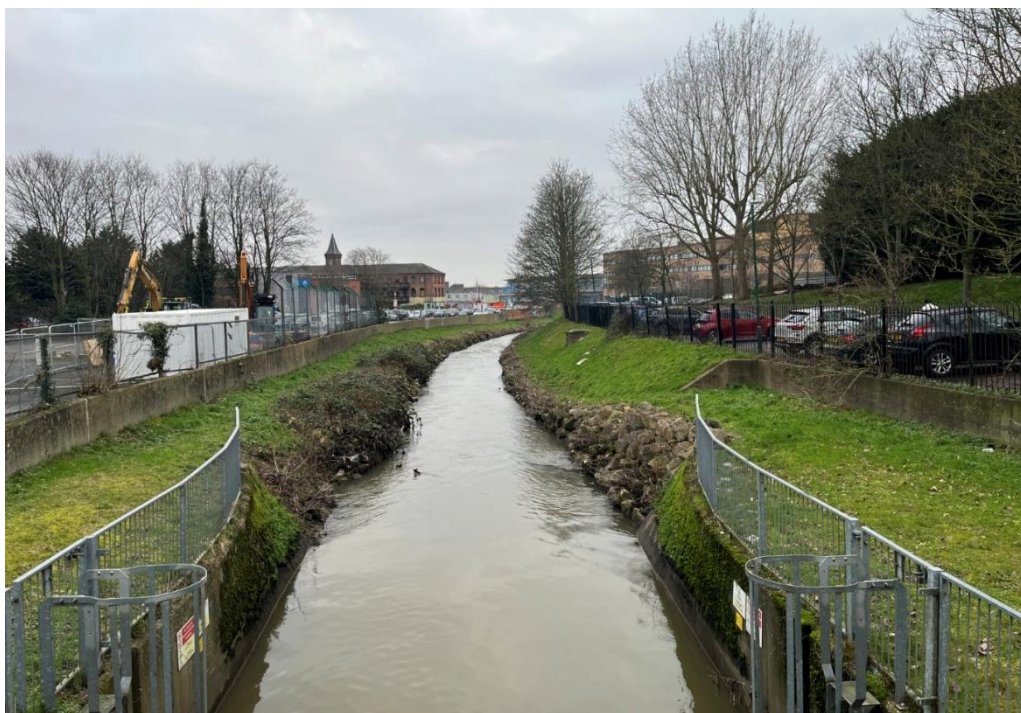
Figure 41: Emerging into area with a concrete flood wall at SK54935 39087 (LB, left of frame) that is beginning to twist and deform. Ideally, any remedial actions for the wall should include ecological improvements to the river corridor. Note the fence on the RB which creates a sense of physical segregation from river; therefore, people aren't able to enjoy and interact positively with the river. The river follows an adjacent cycle path at Hill Side. This section connects with the QMC hospital site (see section in Figure 42). This section is being considered within the River Leen Strategy with options for de-culverting and setting back the existing flood wall to create more space for river restoration, flood capacity and amenity/access improvements.

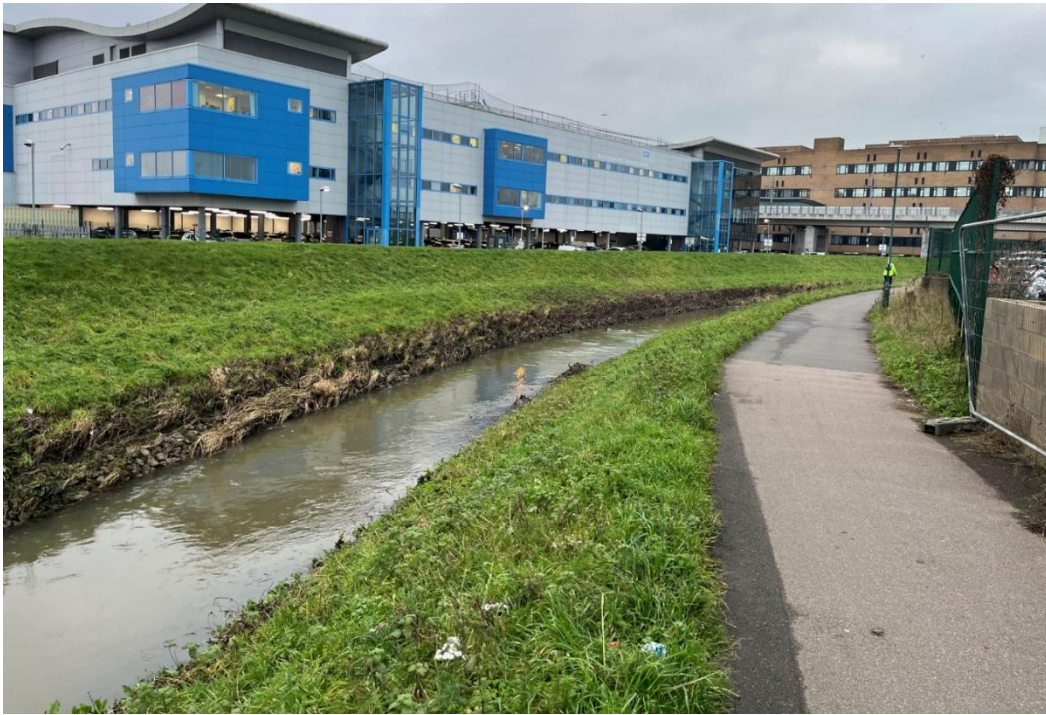
Figure 42: Just upstream of the next bridge downstream of Fig. 41 at SK55149 38644, opposite the Nottingham NHS Treatment Centre. Note a small amount of erosion on the opposite bank on the outside of the bend. The adjacent car park and degraded river corridor currently restricts the amenity value of the riverside to hospital patients and staff. Compare with Sheffield's pocket park creation at Matilda street for flood risk, public amenity and habitat improvement: <https://www.wildtrout.org/wttblog/reducing-flooding-creating-urban-oasis-and-home-wild-trout>

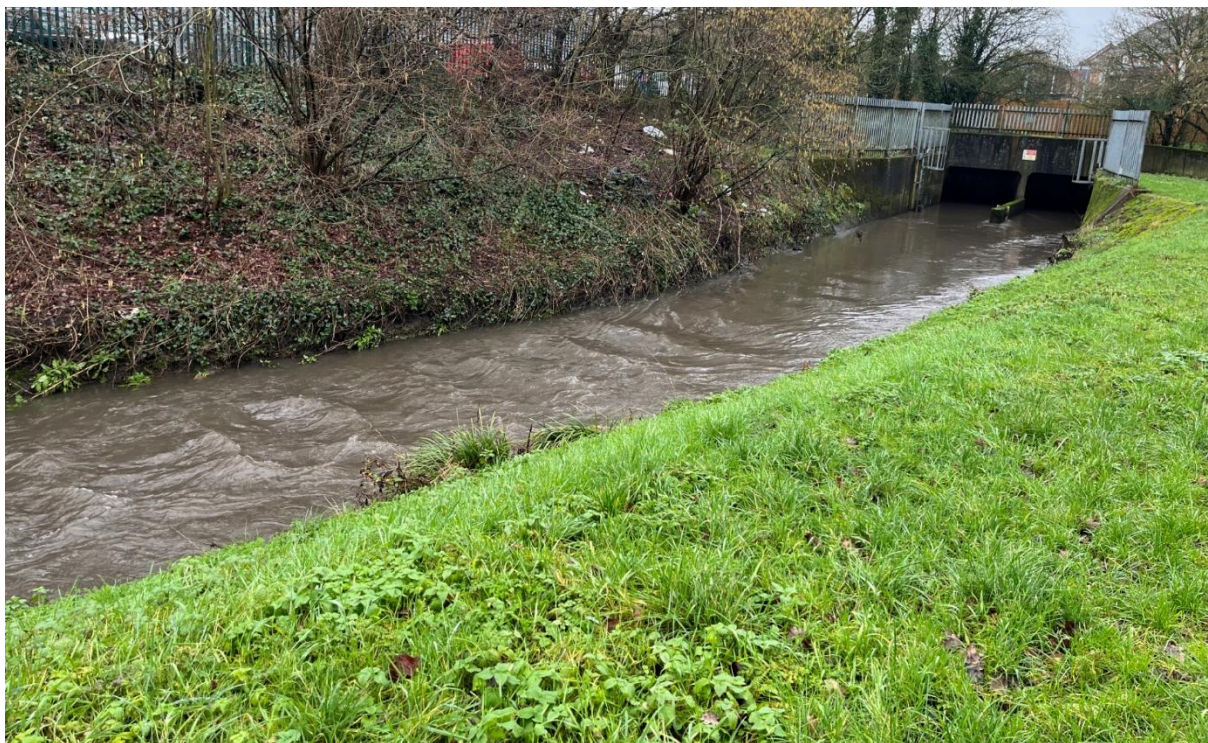
Figure 43: Emerging from Leen siphon (a structure with its own, implied flood-risk concerns) crossing under the Nottingham Beeston canal at SK55382 38600 with some slightly more structurally-diverse vegetation on the opposite bank.

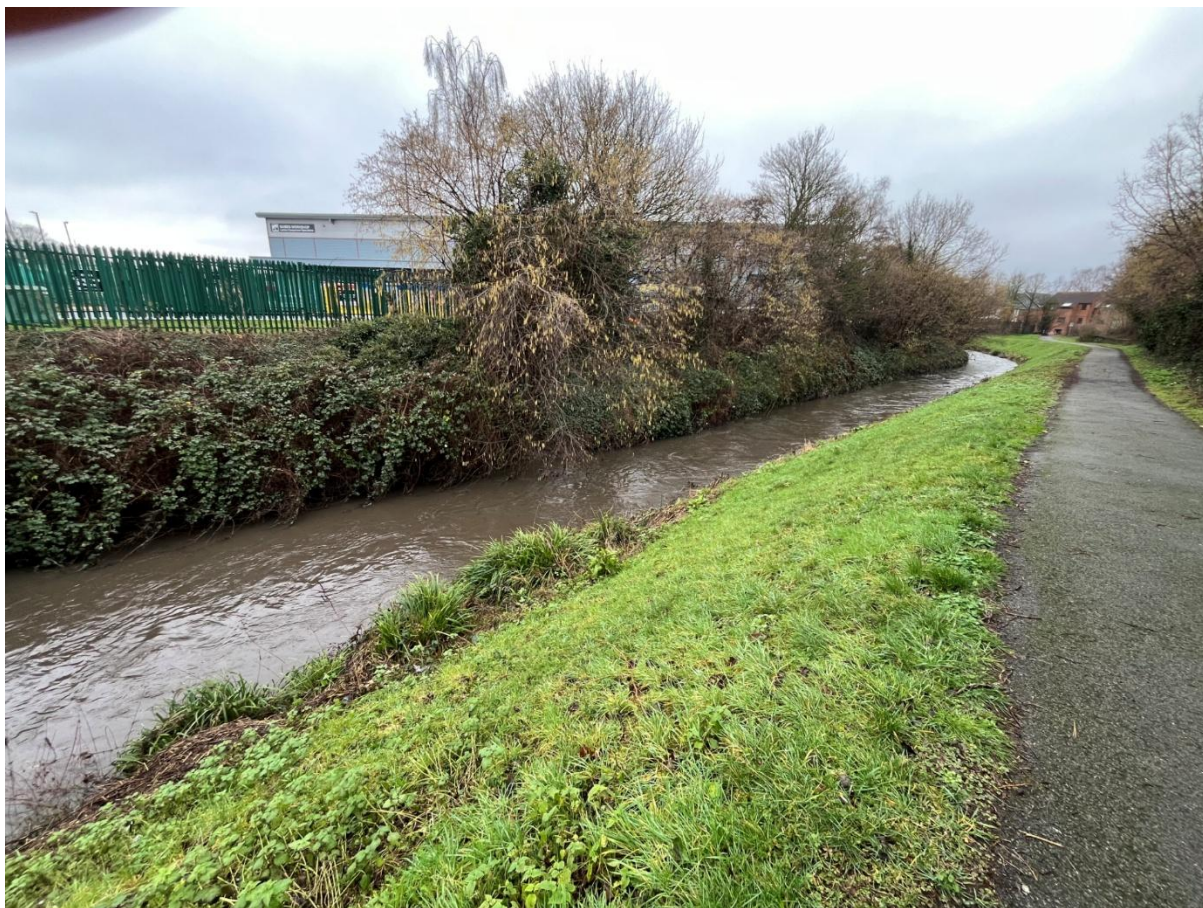
Figure 44: Left bank facing upstream just above the Willow Road bridge, Lenton area at SK55468 38520.

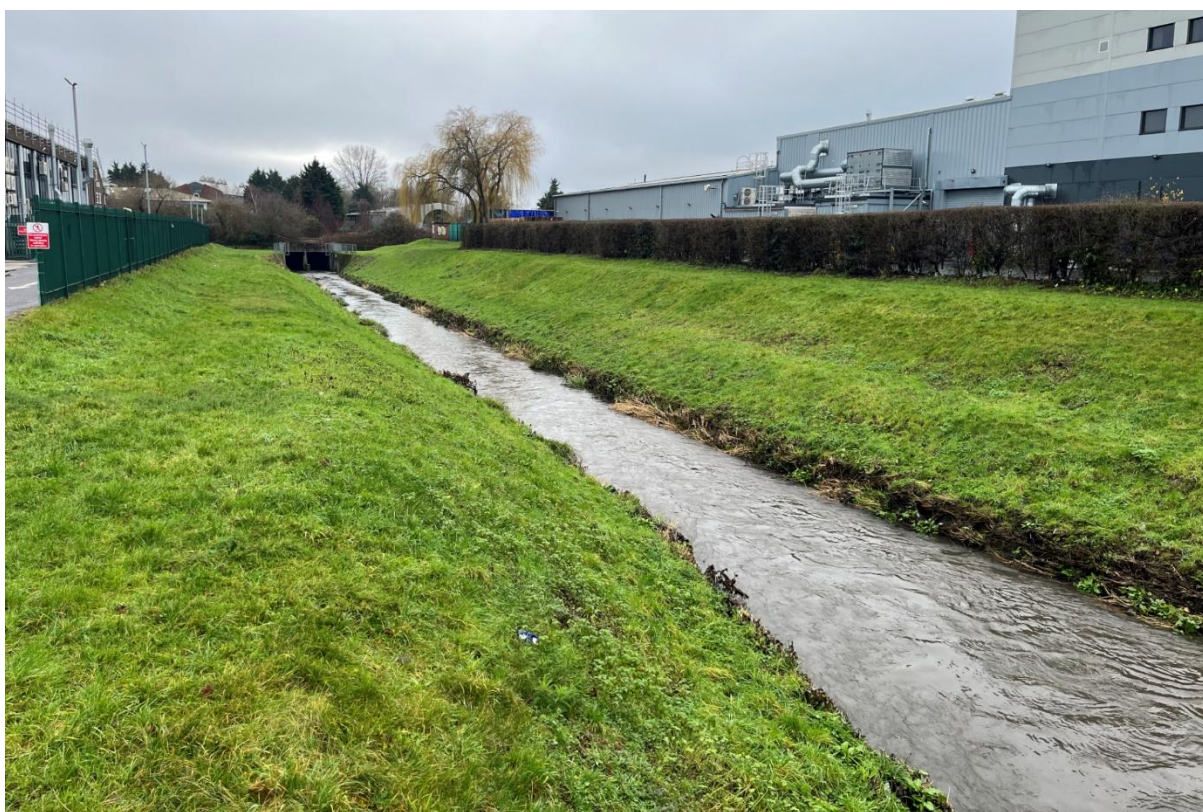
Figure 45: Below Willow Road Bridge at SK55488 38488 photographed from the LB within a formal flood defence channel. Any flooding resulting from the canal-crossing siphon appears likely to bypass these defences.

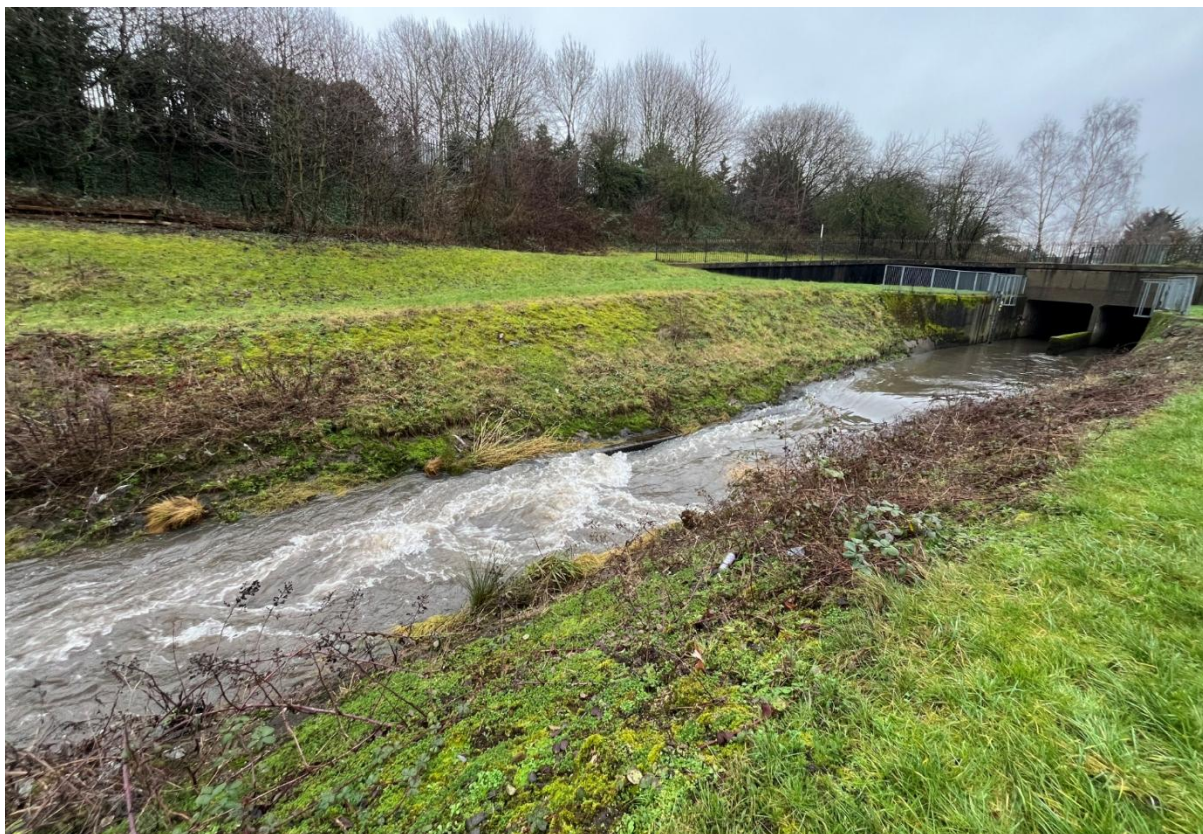
Figure 46: Weir downstream of Lenton Lane at SK55724 38374. Note hydraulic limit imposed by bridge.

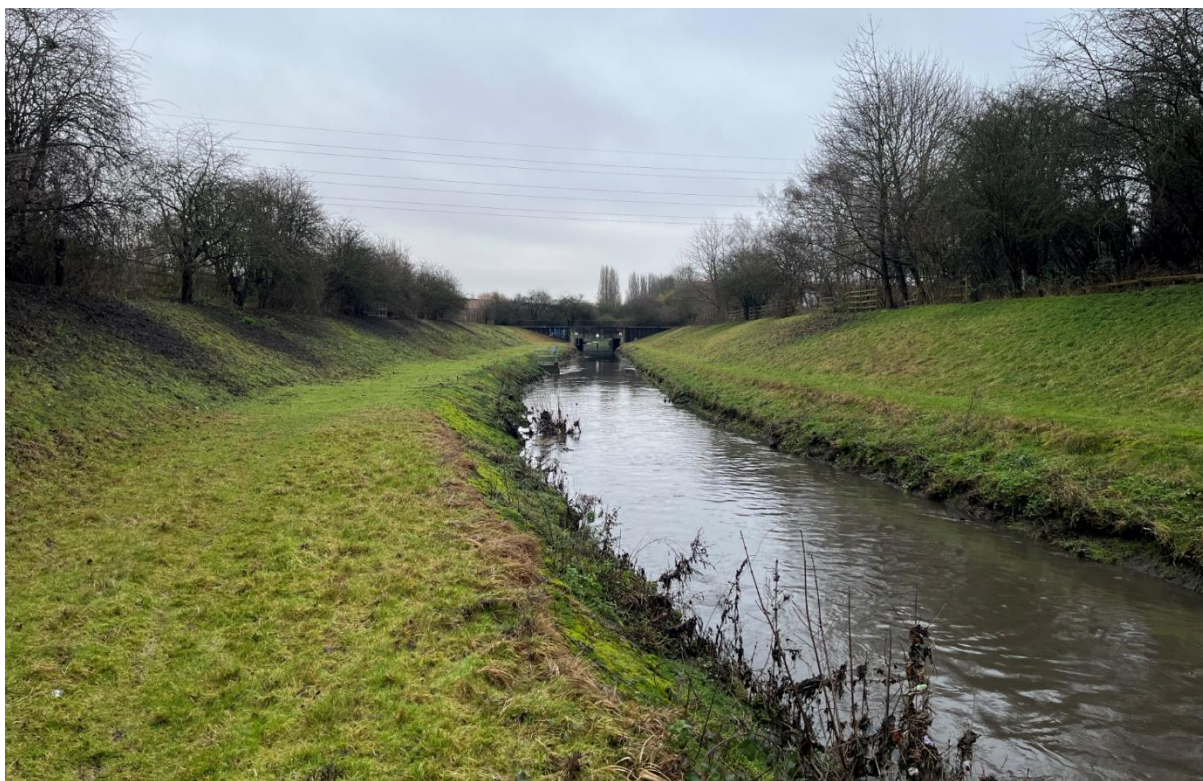
Figure 47: Facing downstream approximately 120m below Lenton Lane towards culvert. Note the significant additional floodwater capacity between the bridge upstream and culvert downstream. There is potential for re-meandering, more natural riverbed substrate introduction and in-channel large woody material here.

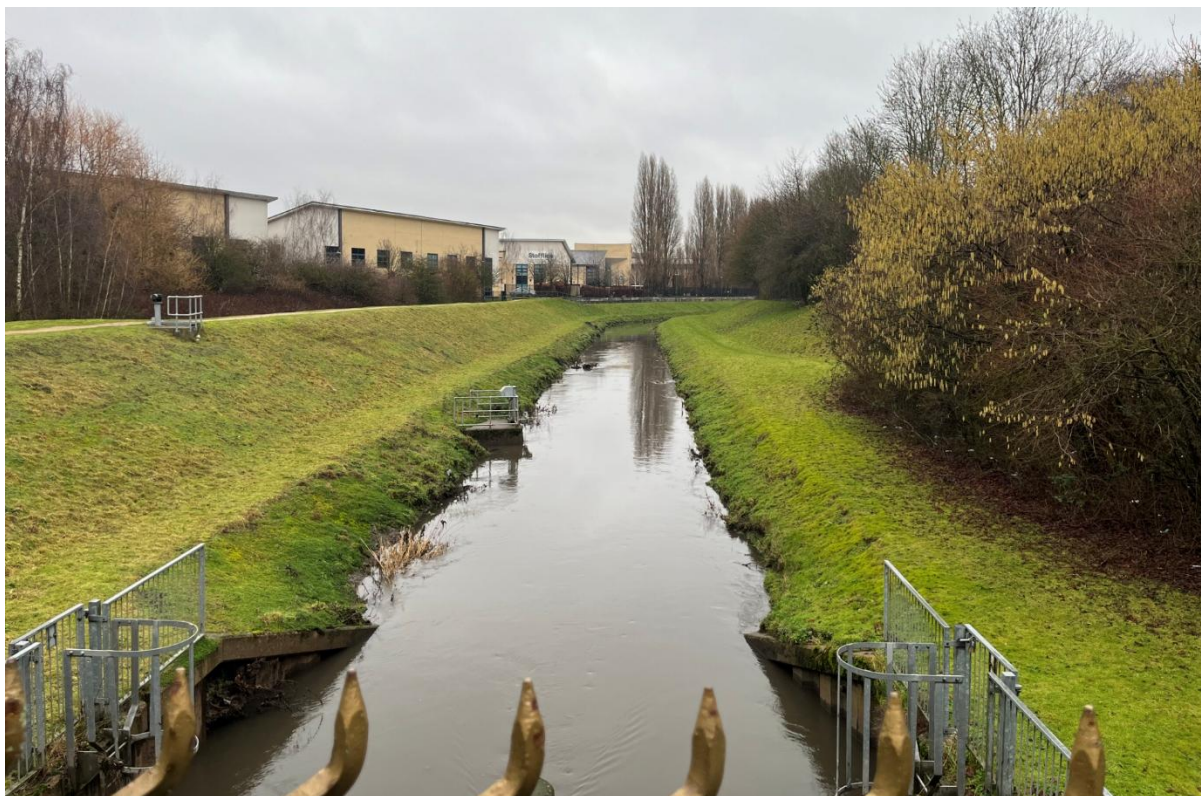
Figure 48: Facing downstream where the culvert cited in Fig. 47 ends at SK56001 38418. The Leen then enters another culvert 530m downstream of this point before its confluence with The River Trent at SK56647 38073, approximately an additional 270m downstream. This is the last open section of the Leen before it meets the River Trent.
