WILD TROUT TRUST

Pullaugh Burn and Nick Burn

Galloway Fisheries Trust

23/06/2021

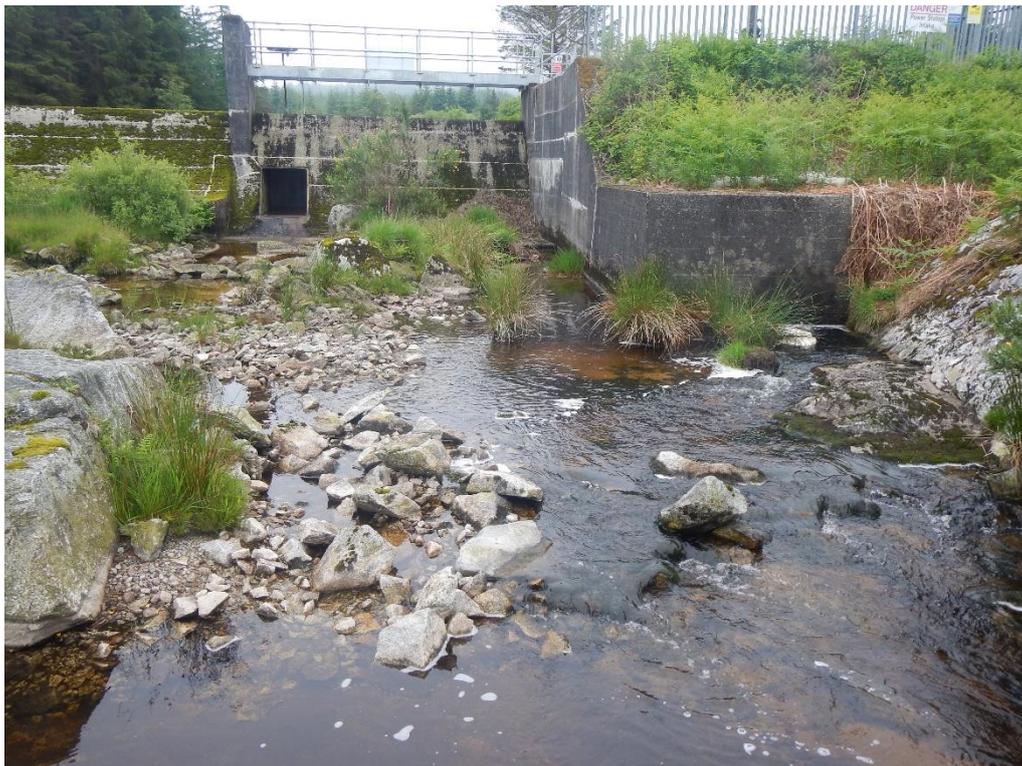
Figure 1. At the upstream limit inspected, the watercourse emerges from the Pullaugh Burn Inlet hydropower scheme (NX5442274140). The associated dam appeared to form the effective u/s limit for migratory fish passage on the burn. The structure also creates a barrier to sediment transport downstream. Any substrate removed from the intake area (which it is assumed will be required to maintain the installation) should be relocated to the d/s side of the dam, not removed permanently from the system.

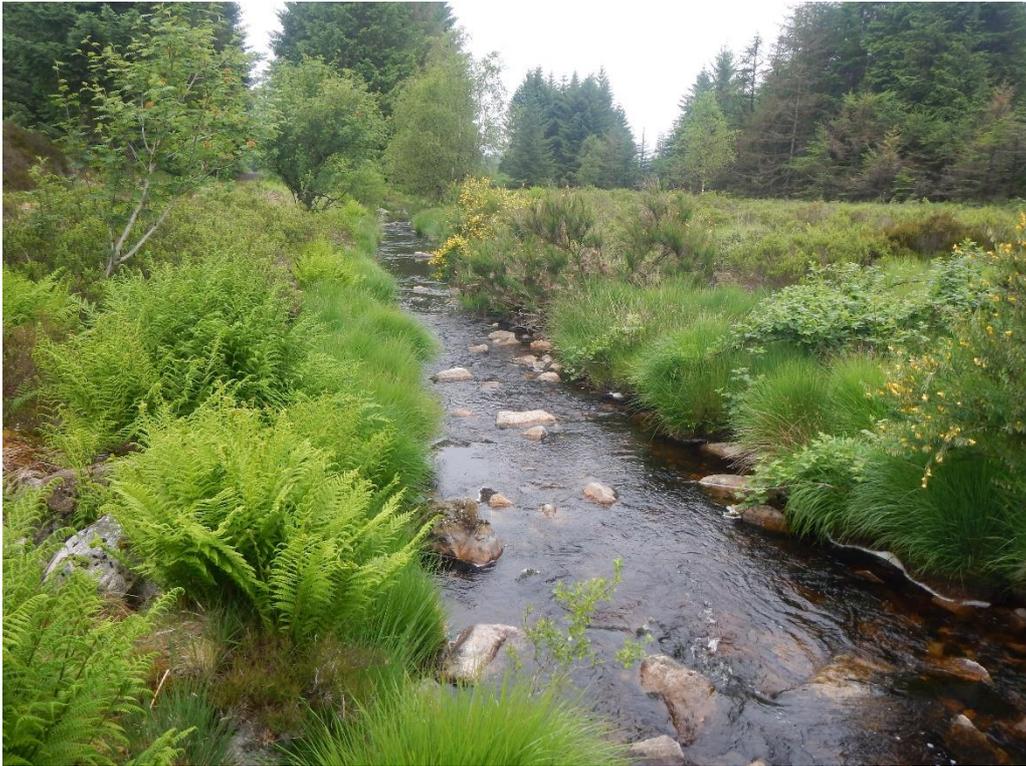
Figure 2. D/s of the dam, the burn has been straightened and flows within a steepened and incised channel. The substrate is correspondingly even coarser than would naturally occur on this relatively high gradient upland burn – an issue exacerbated by interruption of sediment supply at the dam. Consequently, the substrate comprised predominantly large cobble and boulder.

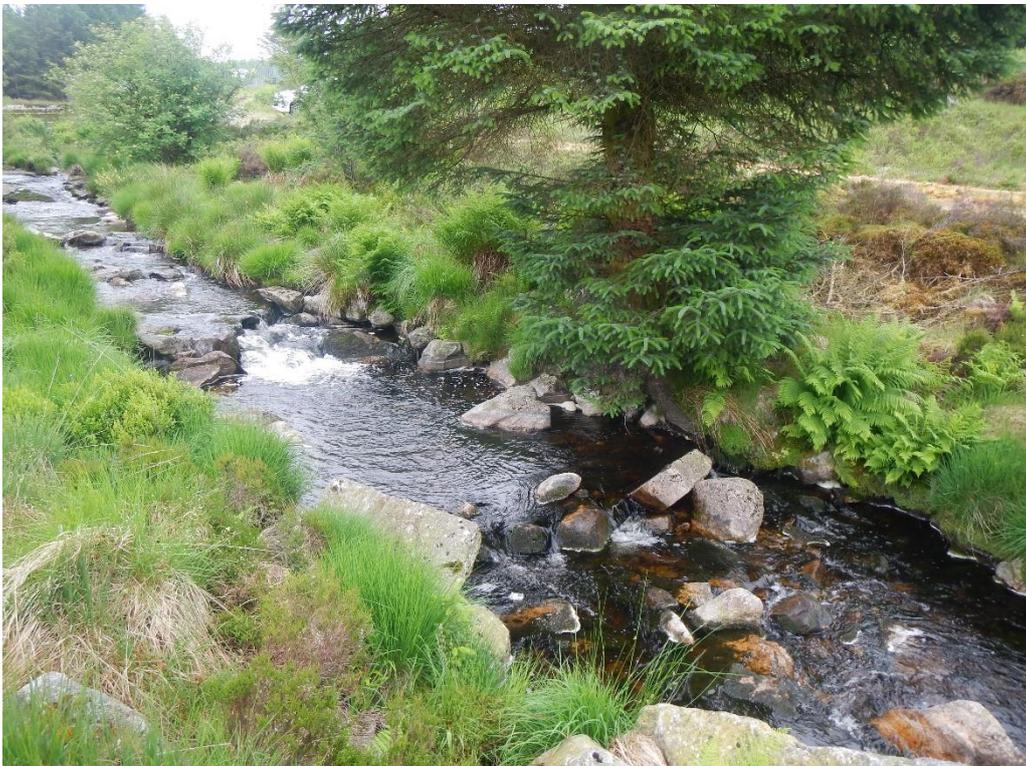
Figure 3. The straightened channel would benefit from re-meandering but, in the absence of such intervention, a lone conifer offers a potential anchor point from which to secure woody material within the channel (NX5441674199). Willows in this area (background) could also be laid into the channel which would create additional low/overhanging/trailing cover and increase flow diversity - also forcing peak flow out of channel to reduce peak flow velocities and hopefully aid gravel retention.

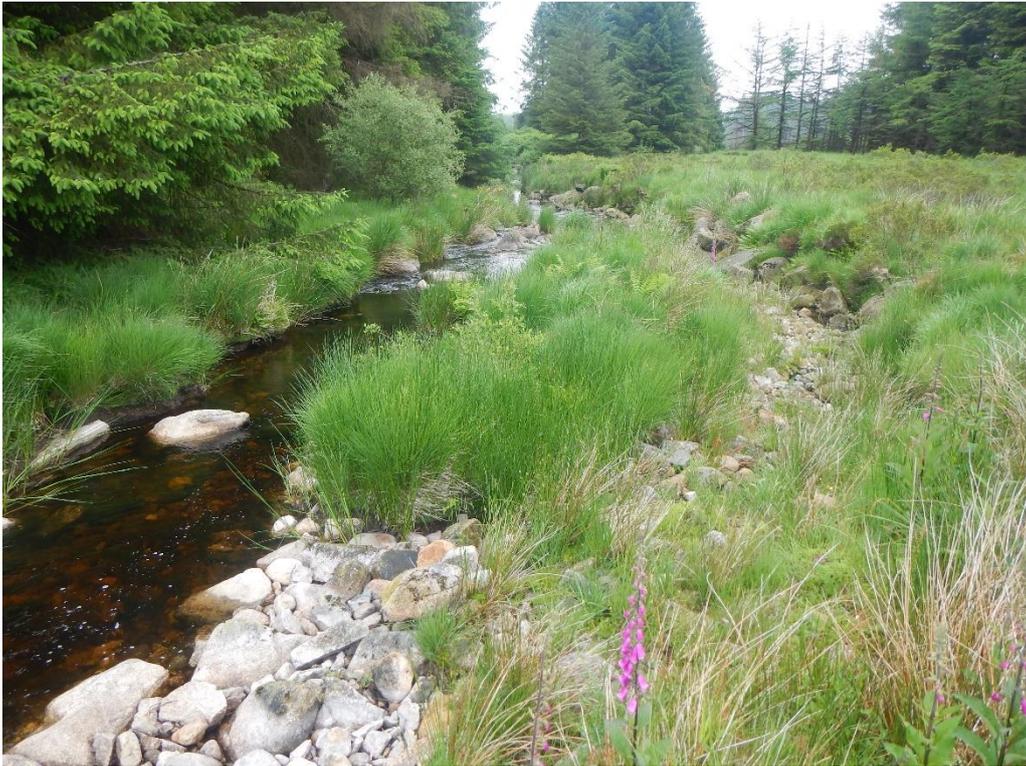
Figure 4. A small section of high-flow/paleochannel on the RB side offers a potential to encourage channel sinuosity if more flow can be diverted there from the current course (NX5440174260). A combination of redistributing bed materials (by hand/with hand tools) and increasing roughness within the current channel with coarse woody material could help to facilitate this. Also note conifer planting too close to the LB.

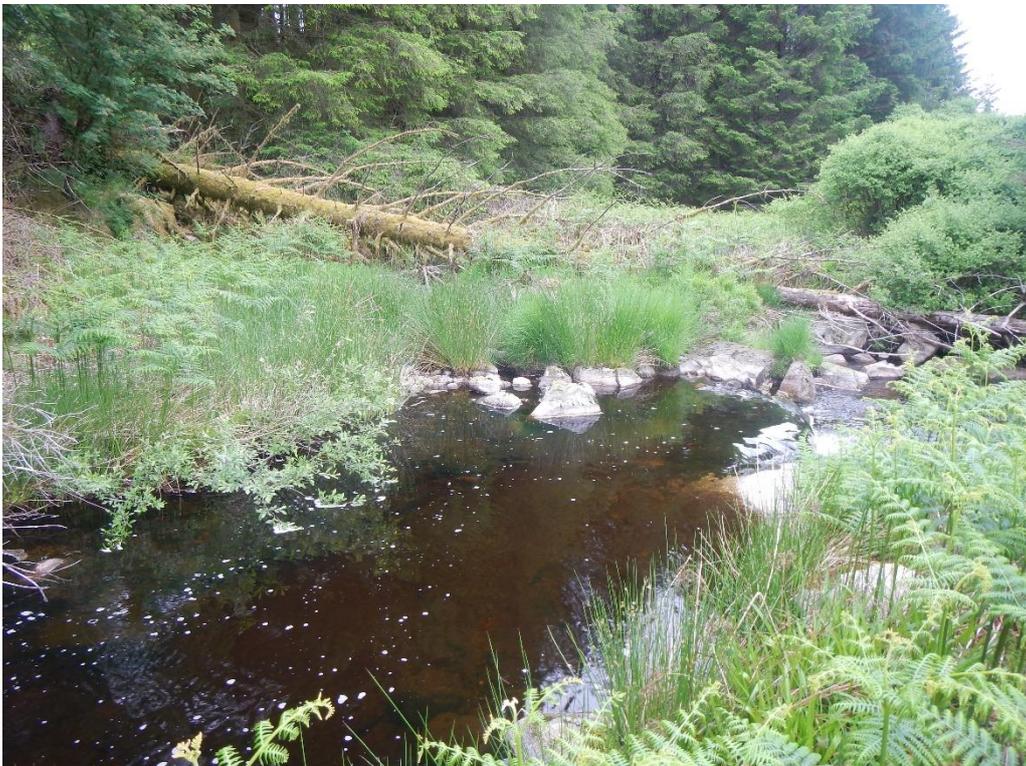
Figure 5. Low willow shrub (left of shot) developing valuable low cover over a pool. A fallen, dead conifer creates an example of larger-scale interventions that could be initiated on the burn by felling larger trees across the channel to increase the availability of coarse woody material and encourage peak flow out of bank to reduce over-scouring of the bed. This could be a particularly valuable action in the straighter/straightened sections to also encourage lateral scour and activate paleo/high-flow channels.

Longer-term, reconnecting side channels that have been bypassed by straightening and installing much larger woody material into the channel would greatly assist natural recovery. Large conifers could be felled over the channel or ideally even pushed/pulled (excavator or winch) over, with their rootball attached (replicating the occurrence in Figure 5 and Figure 23). The benefit of retaining the rootball is that it acts as an anchor and

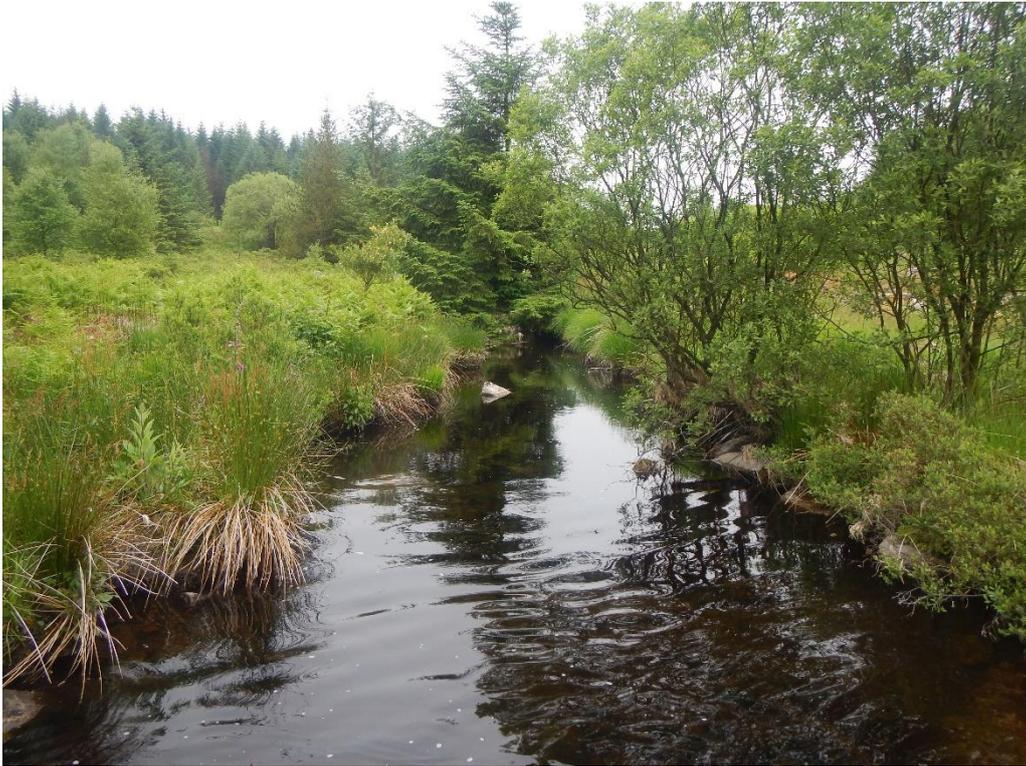
Figure 6. The occurrence of native deciduous trees along the watercourse is scarcer than desirable, but occasional bankside willow shrubs improve habitat and provide an opportunity to lay stems into the channel to increase cover. This could increase structure within the channel, breaking up the uniformity of the pool and offering natural fish refuge from predators and high flow. This minimal intervention work could be undertaken through a river-walk workshop, utilising only small hand tools.

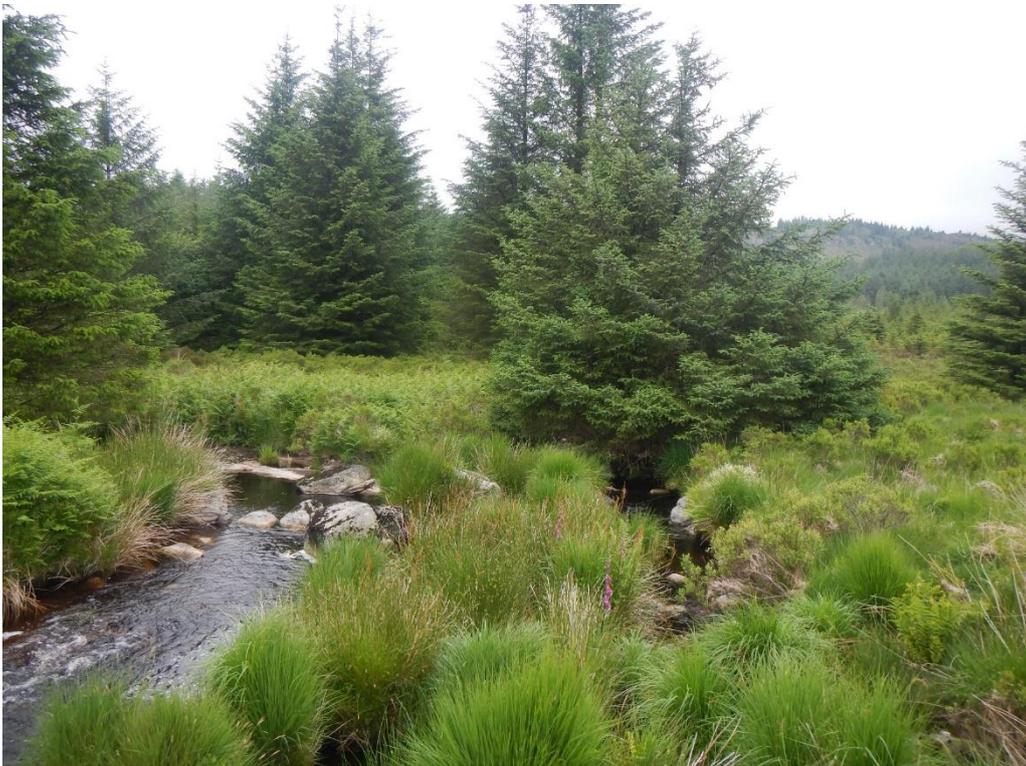
Figure 7. The main burn and side channels bifurcate at numerous points, creating a range of watercourse sizes and presenting good potential for salmonids from parr stage upward. Juvenile habitat could be improved further if the occurrence of native bankside trees and structure can be increased. Removing bankside conifers and replacing them with natural deciduous species would naturally boost/restore productivity; invertebrates falling from trees would increase the availability of food items and leaf litter would provide additional nutrients, in addition to food and shelter for invertebrates.

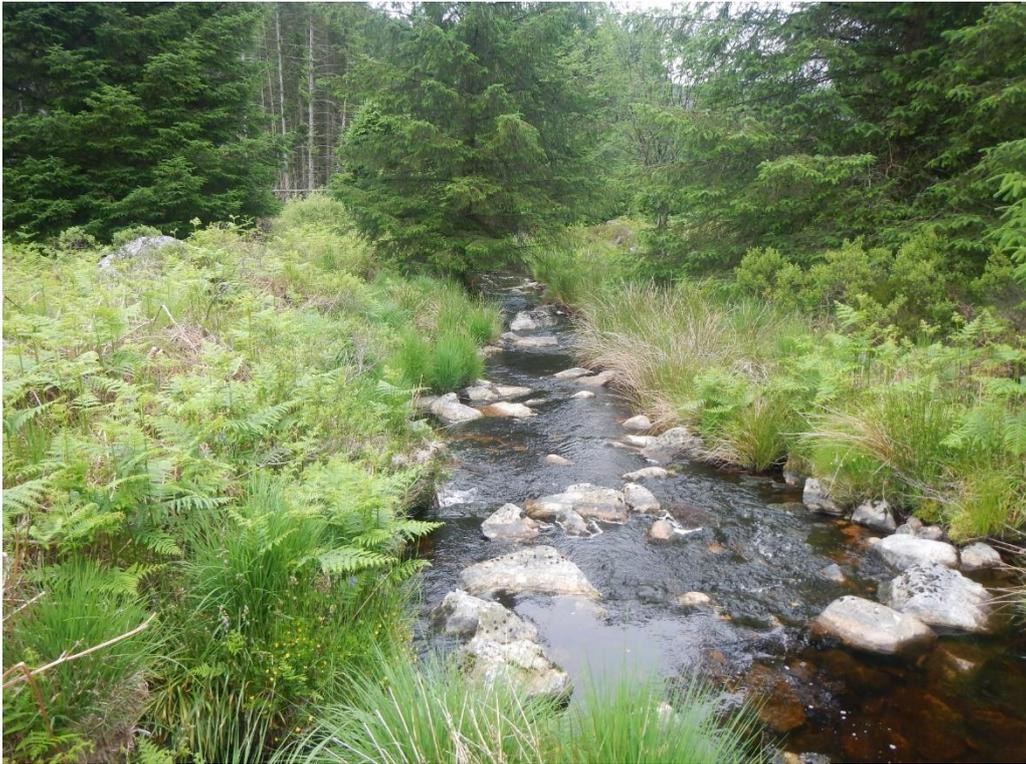
Figure 8. For most of its length, the gradient of the burn remains steep, so the gravel and cobble required for salmonid spawning is scarce. Areas of straightening exacerbate this issue by further increasing the gradient. This section of straight channel appeared to have been prioritised by diverting flow at the upstream end with large boulders (NX5450974646), at the expense of a more sinuous LB channel - reducing channel length and habitat quality. Such areas, combined with interruption of sediment supply from upstream and the lack of access to smaller headwater burns, will undoubtedly contribute to reduced fish recruitment and lower overall fish densities than should naturally occur.

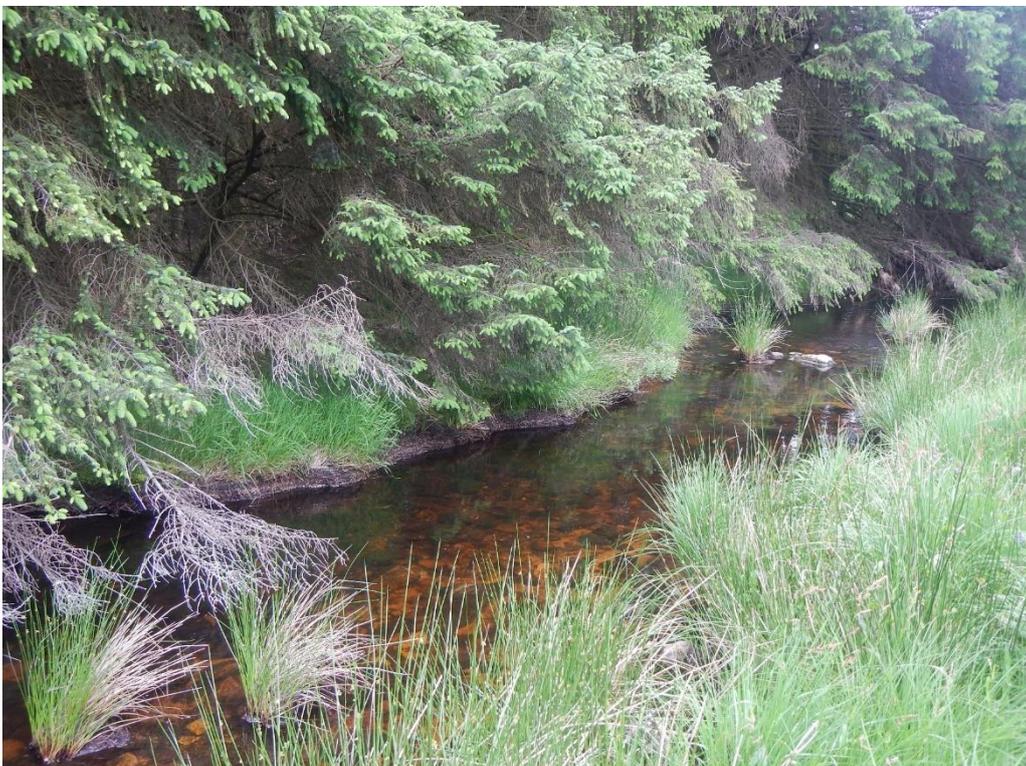
Figure 9. In the ~500m upstream of the River Dee, burn gradient reduces and areas of wider channel retain more gravel and cobble substrate. This would be the priority area for installing woody material, where the greatest benefits could be achieved (NX5460474795 - NX5490874835). Conifer planting, too close to the watercourse, has also denuded riparian habitat quality on the LB around NX5460474795.

- Install several woody material habitat structures in the ~500m u/s of the Dee to improve gravel sorting and retention (NX5460474795 - NX5490874835)
- Lay specific willows/willow limbs into the channel throughout, potentially as part of a river-walk workshop
- Ensure that any gravel removed around the Pullaugh Inlet Hydropower Dam during site maintenance is returned immediately downstream to avoid complete gravel depletion of the lower burn

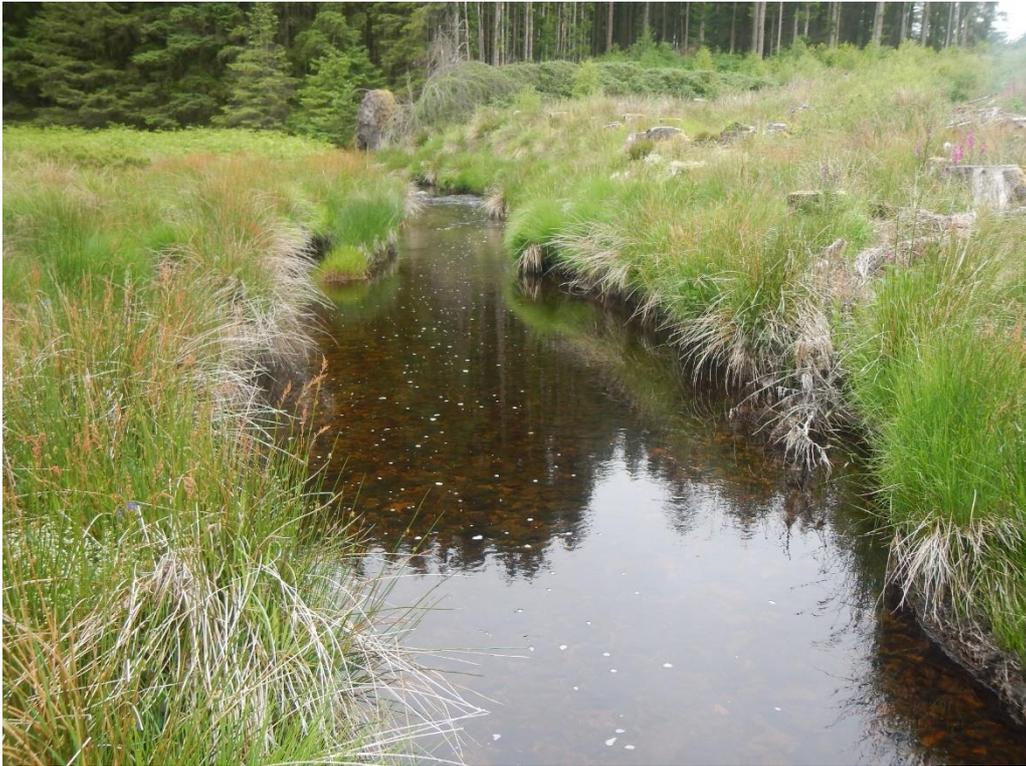
Figure 10. Clear-felling a short distance downstream could form the start of habitat improvements if complemented with replanting of a deciduous buffer (NX547087483). Installing several discrete in-channel structures could reduce peak flow velocities and improve flow diversity while still retaining areas of the existing channel capacity d/s of each structure to facilitate increased deposition. Strategically placing the structures on inside bends would also accentuate channel sinuosity (e.g. right of shot) and encourage lateral scour/increased meandering over time.

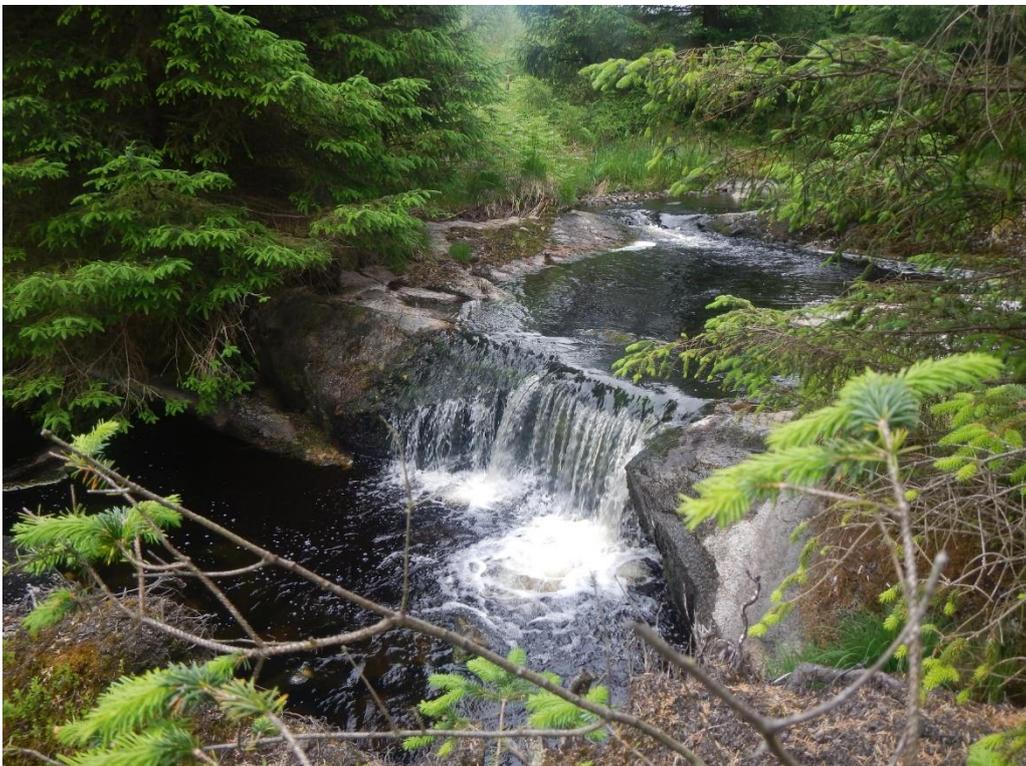
Figure 11. A natural bedrock outcrop just u/s from the confluence with the Dee limits fish access to the burn and is only passable in medium-high flow (NX5493074877). Other natural falls within the reach up to the hydro dam naturally reduce fish access but are not complete barriers. Juvenile salmonids were observed throughout the burn but appeared to be in lower numbers than would be expected - with the lack of gravel and inhibited access to tributaries further up the catchment, this is not surprising.

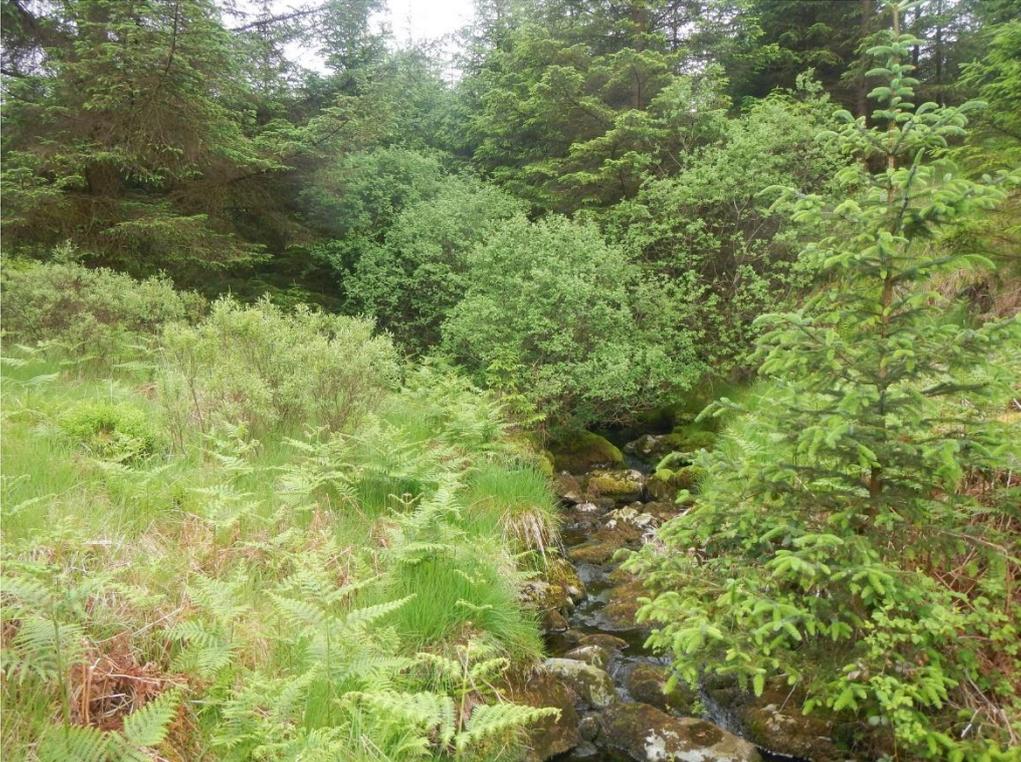
Figure 12. At the u/s limit inspected (NX5785572972), Nick Burn had minimal flow and was enclosed by a combination of deciduous and, predominantly, conifer trees. The burn u/s was poorly accessible and appeared to enter dense coniferous plantation a short distance further u/s.

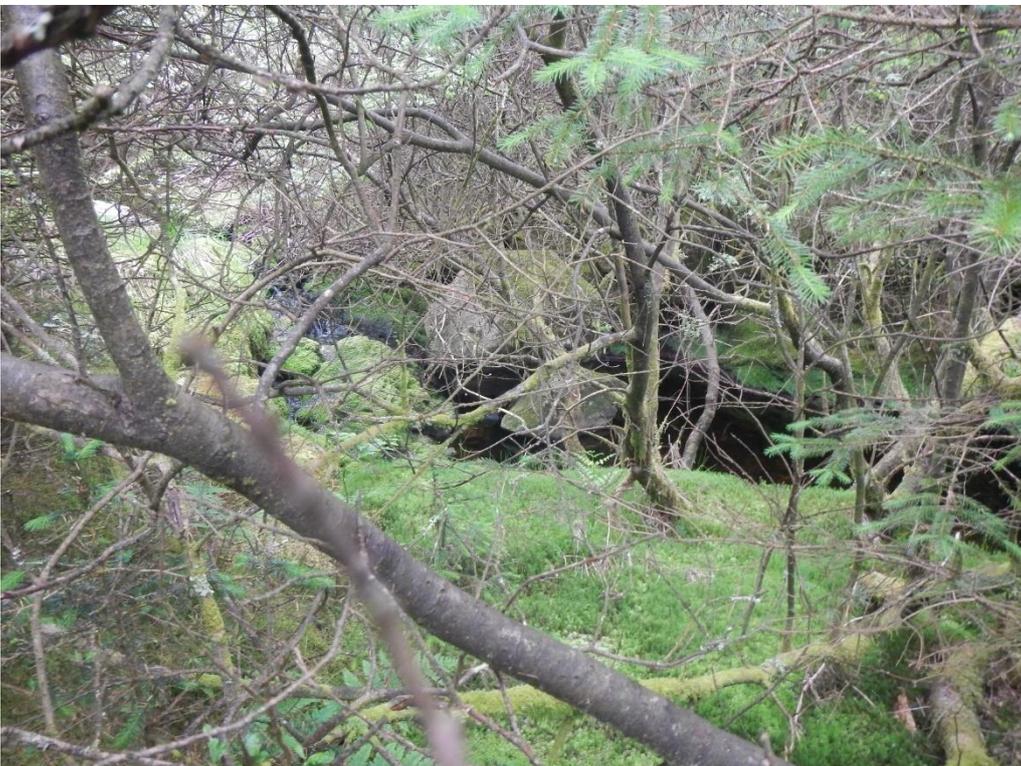
Figure 13. While the area is currently overshadowed, removal of the coniferous contingent along the burn could reinstate a far more natural light:shade regime. Some of this work could potentially be undertaken by physically able members of a workshop (under supervision), with the arisings potentially used as material for in-channel woody material.

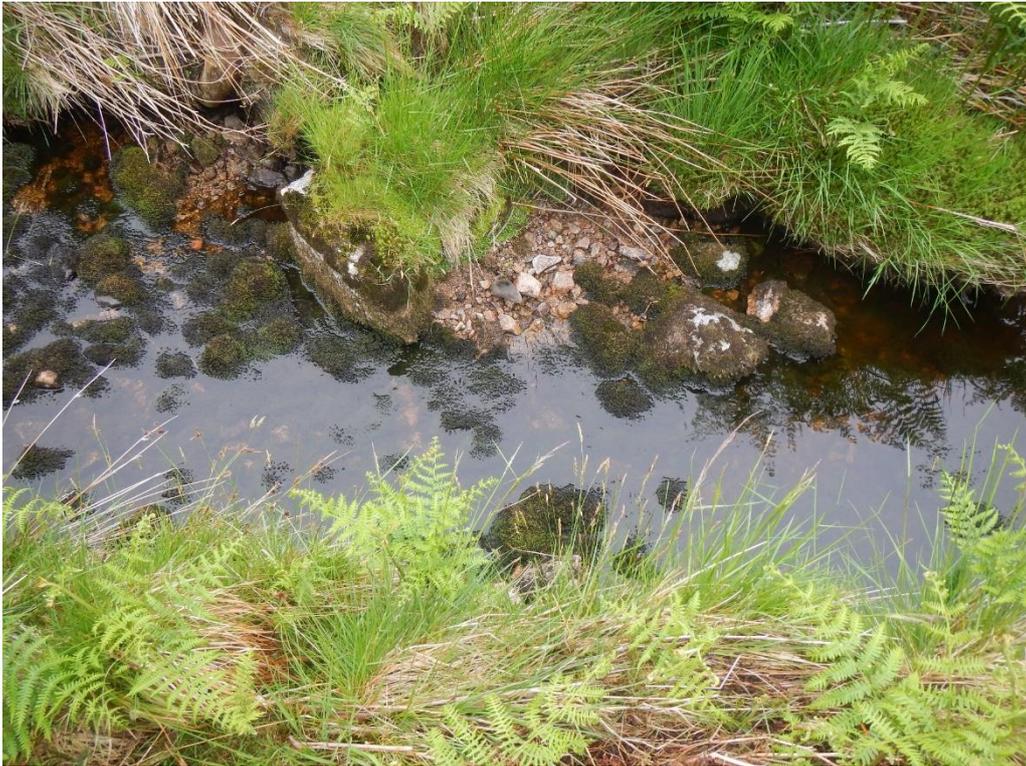
Figure 14. The minimal flow of the burn belies the clear influence of peak flows on the substrate composition, with gravel only retained in sheltered areas, behind in-channel structure like large boulders. The heavy coniferous forestry u/s (and associated drainage) will certainly contribute to more extreme flow events. Note how the immobile larger cobble and boulder substrate is covered in moss, indicating it is stable, while the smaller, more mobile gravels are largely absent from the main areas of the channel.

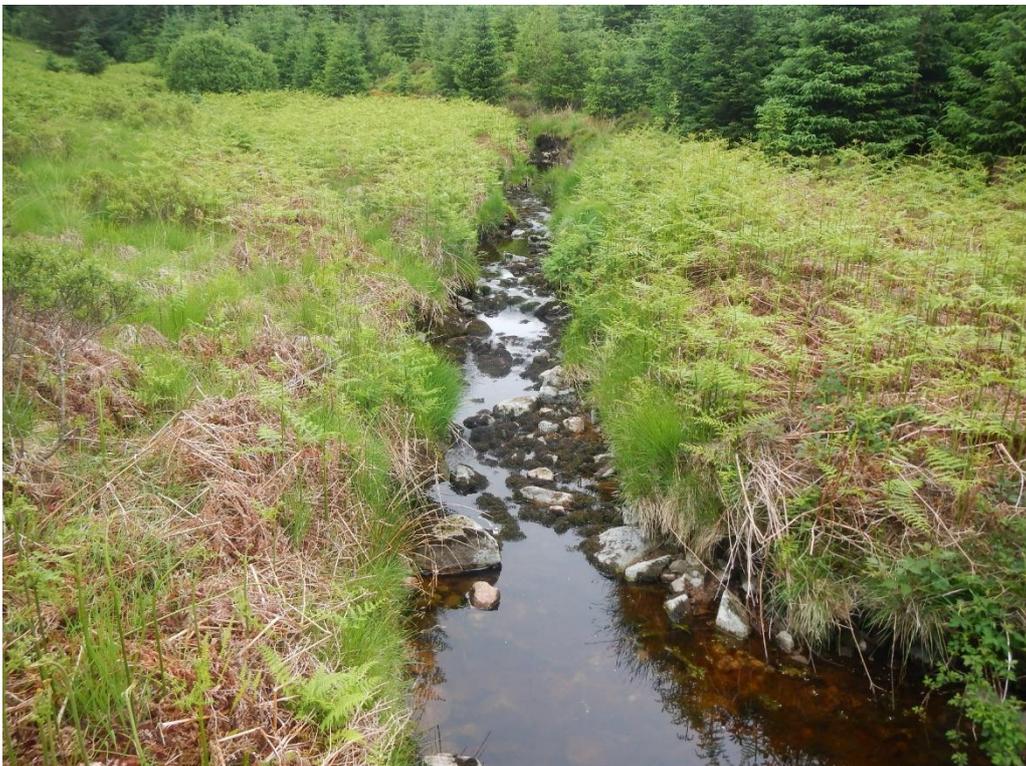
Figure 15. Looking u/s at the particularly straight channel with very low flow, and a severe lack of finer substrate.

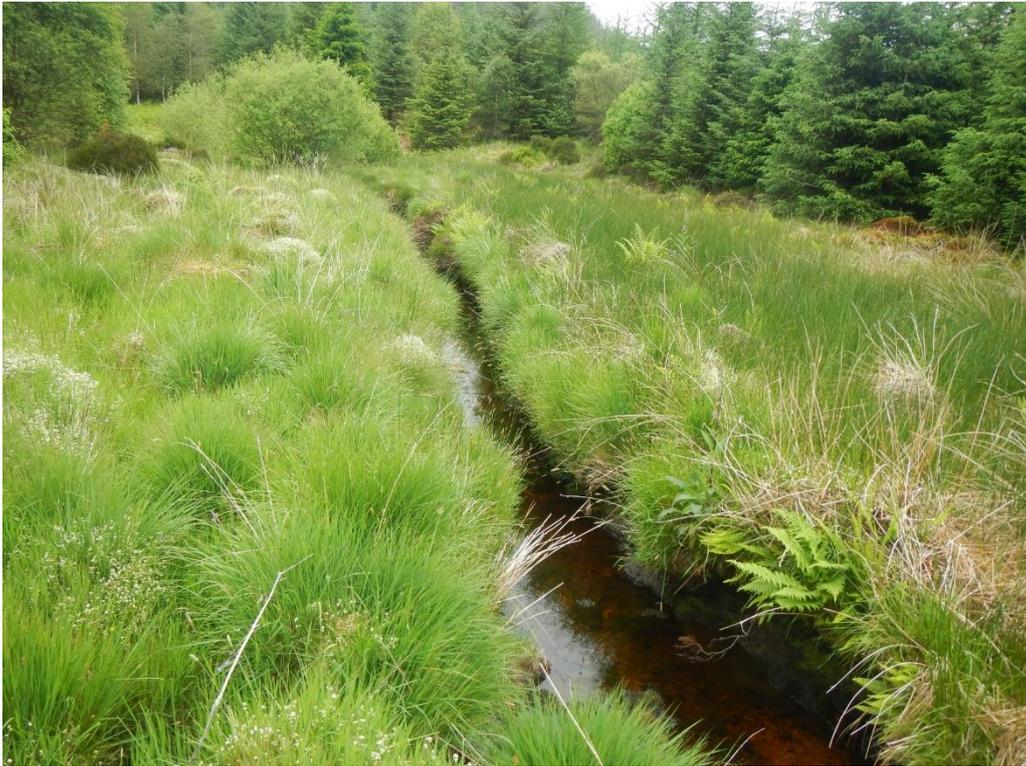
Figure 16. Several other sections are also overly straight, exacerbating the extreme flow issues with a corresponding lack of depth variability and pools. This is almost certainly a result of past channel dredging/realignment for drainage.

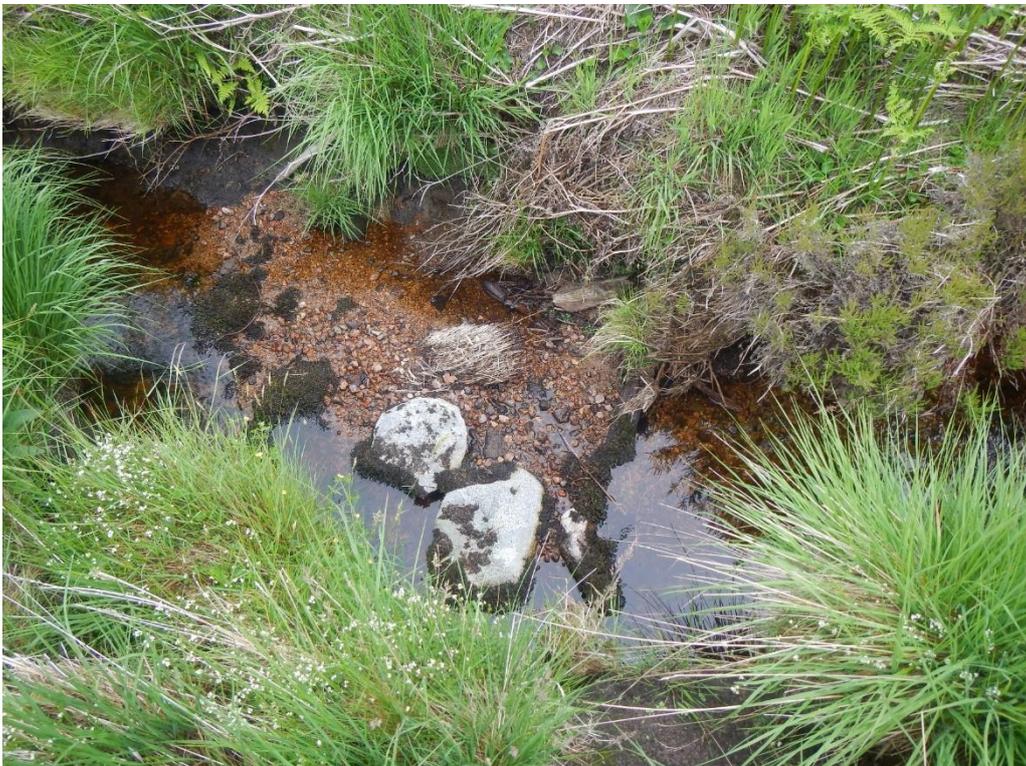
Figure 17. In the $\sim 200\text{m}$ u/s of the Dee, the burn gradient reduces, and the gravel component of the substrate increases.

- Install woody material habitat structures in the ~200m u/s of the Dee to improve gravel sorting and retention
- Remove of conifer regeneration along the burn
- Seek clearance alongside the upper burn to facilitate creation of an appropriate deciduous buffer

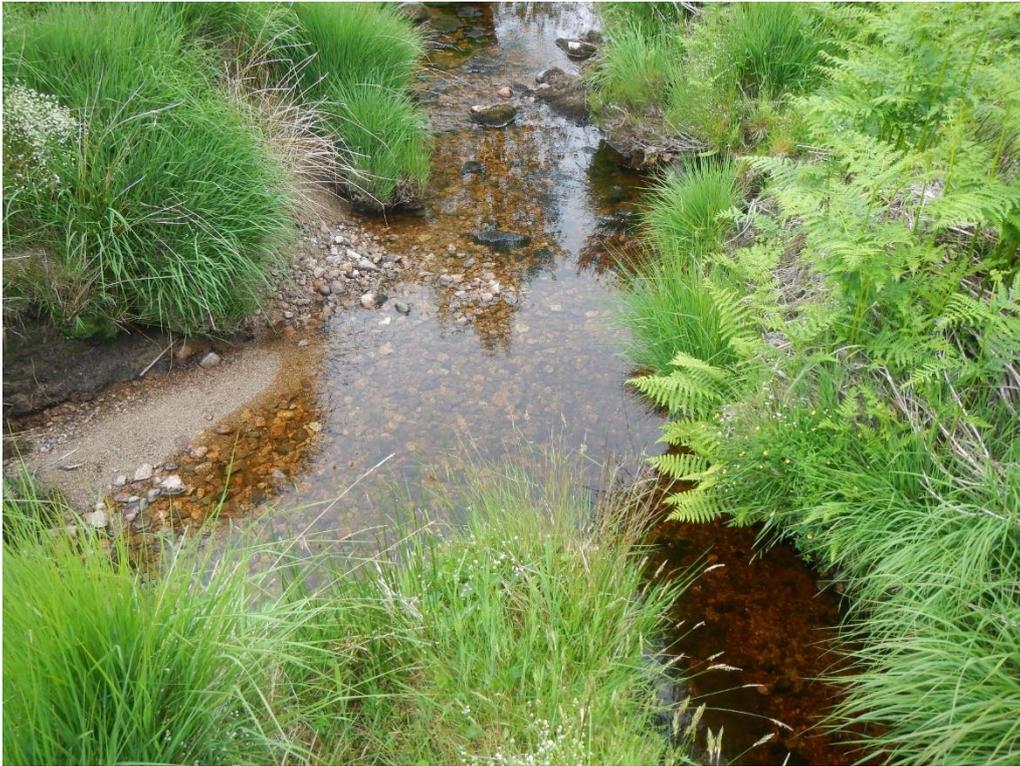
Figure 18. From the confluence with White Burn (NX5781573361), the flow and channel size increase, further contributing to the retention of gravel. This general area should therefore be the priority for any habitat work as there is currently the greatest potential for improvement. Increasing the availability of structure within the channel through the installation of woody material and bankside tree planting would be the quickest and easiest way to capitalise upon the improved flow and channel characteristics.
