Pont and Blyth Investigation

River Blyth – from Bellasis Bridge to Hartford Bridge

(Waterbody ID - GB103022077050)

Date – 23/02/12

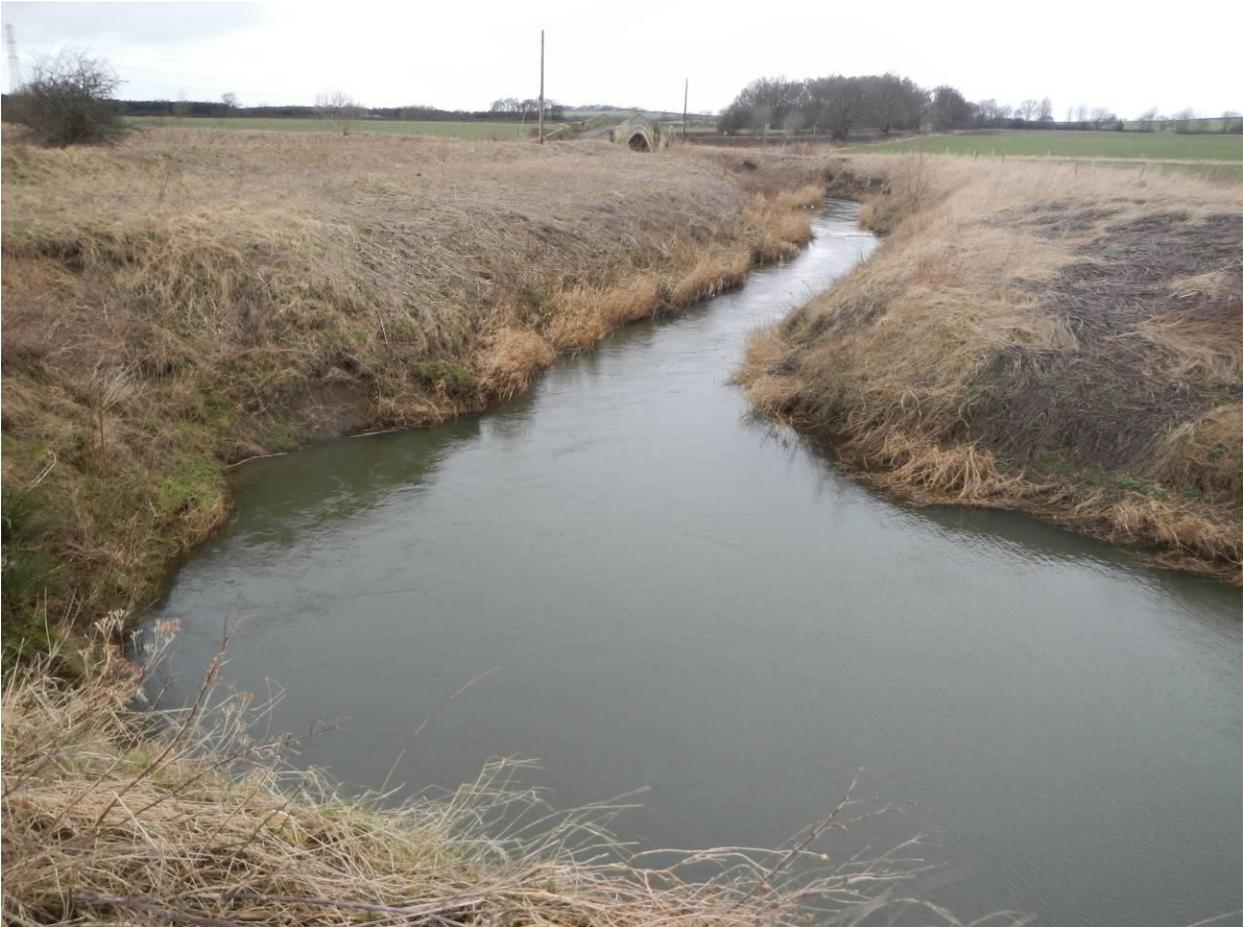
Directly below the bridge some more natural bed characteristics remain, with patches of gravel and cobble substrate and some water crowfoot (*Ranunculus sp.*) beds (Picture 1). This is likely to be the result of reduced dredging around the bridge to limit disturbance of the bridge footings. Even so, the channel is still deeply incised here (2-3m) and follows an obviously realigned course. Below, the channel reverts to lengths of more heavily dredged and straightened channel between sharp bends.

Picture 1. The River channel directly below Bellasis Bridge, where some natural substrate was present in the 20m d/s of the bridge, before the impact of deeper dredging returns. In the foreground a sharp bend has created a large pool.

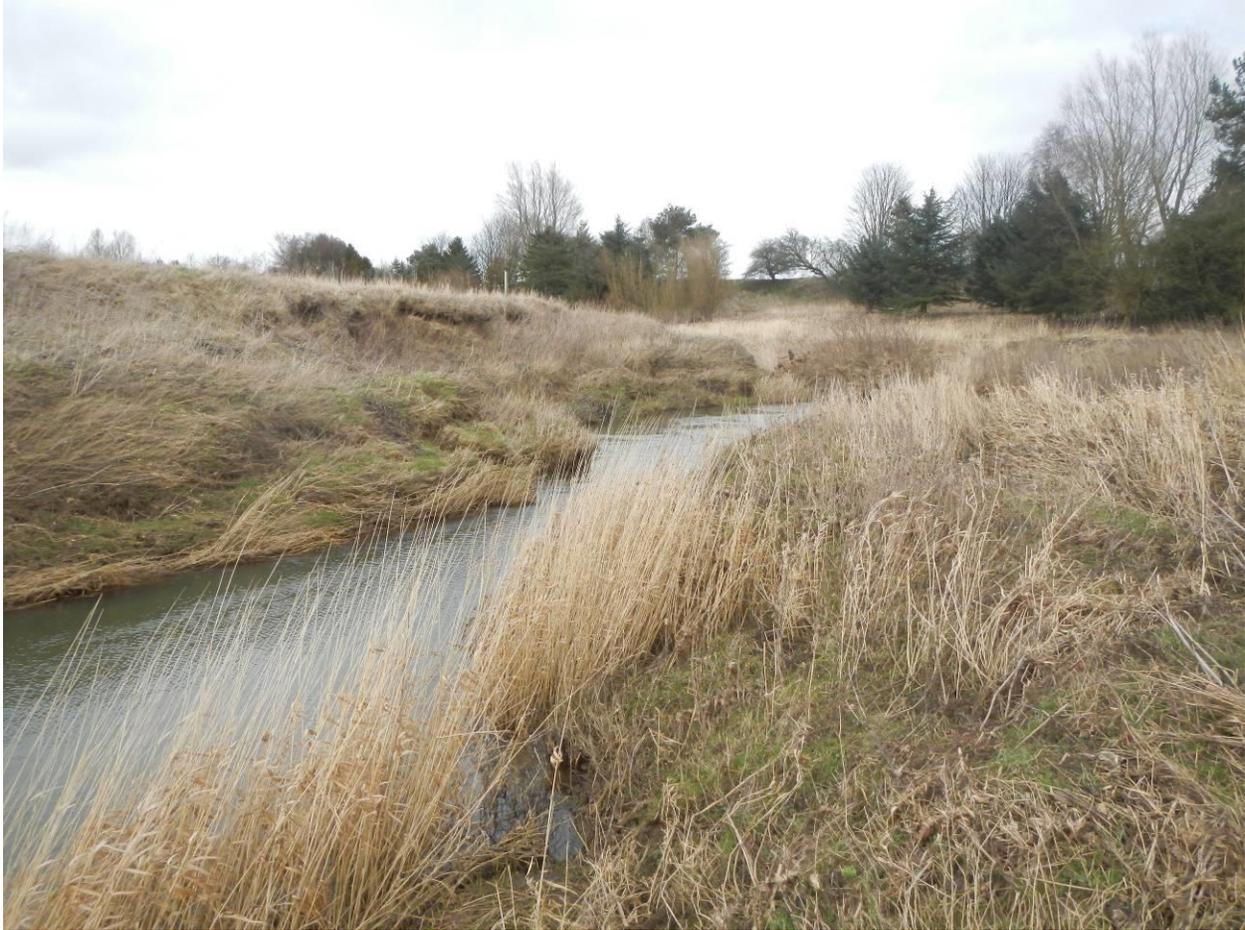
In many areas the River is attempting to re-meander, and re-grading of the over steep banks is resulting (Picture 2). Where the banks have become undercut the turf and topsoil is slumping down to the river level and forming a new bank toe. In many areas the healthy root mass provided by vegetation is holding the bank together long enough for it to become established, with further growth consolidating it into a shallower profiled channel. The process is affecting the land for a considerable distance back from the river in places (over 10m) and appears to have influenced land use in the area with large buffer strips of un-cultivated land left on either bank.

Picture 2. Natural erosion on the LB, which is leading to increased channel sinuosity. Vegetation is consolidating slumped areas of the bank and facilitating natural re-grading.

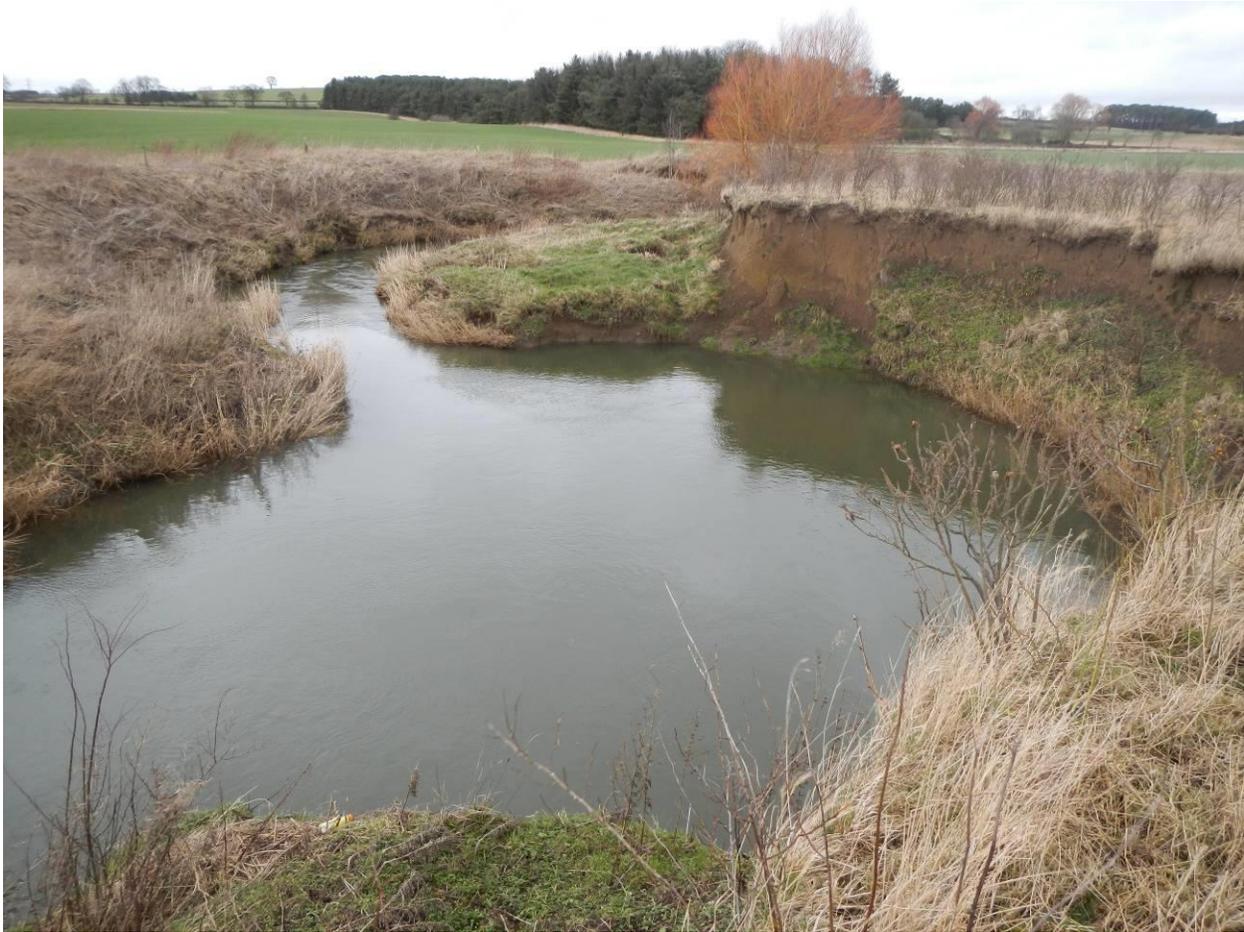
On the sharper bends, deeper water and more erosive flow is inhibiting the re-grading process and the bank material is being washed downstream. This is a common problem where a channel is deeply incised, and it could take years and significant channel movement before it stabilises (Picture 3).

This erosion is increasing siltation of the watercourse and exacerbating to existing problems of high sediment loading from upstream. However, unlike the land use issues upstream, the adjustment that is occurring on the bends will ultimately lead to a more natural watercourse when it starts to stabilise.

Picture 3. Sharp bend with a very steep bank that is unlikely to re-grade as the depth and flow mean that any slumped turf will be submerged, inhibiting growth of vegetation and allowing the earth to wash away over time (NZ1926477568).

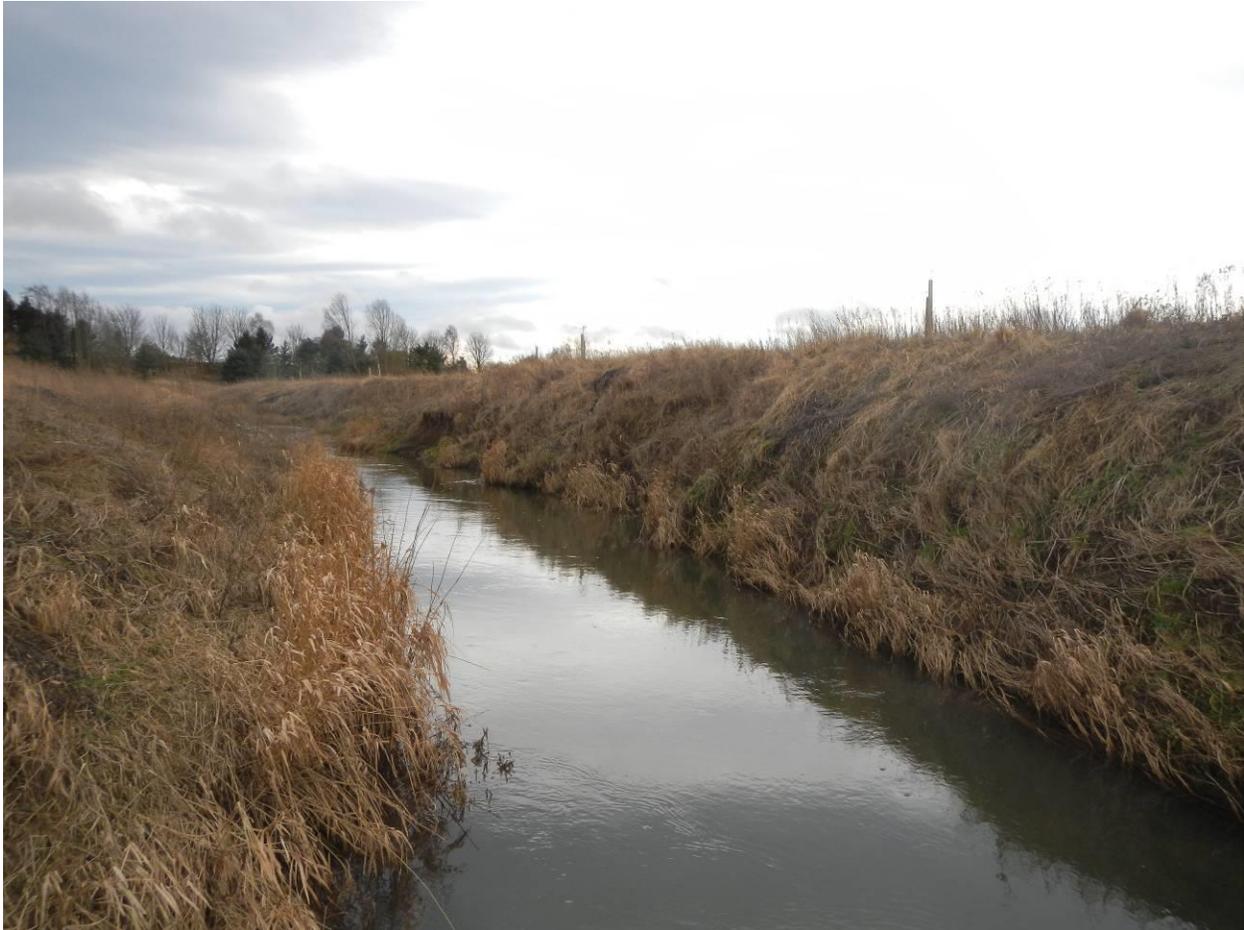
Between bends the River channel was straight for long sections but flow variation within the channel has facilitated areas of deposition, with some being colonised by emergent vegetation. Over time these will increase flow diversity within the channel, creating meanders, but at present much of the river still resembled the channel section in picture 4.

Picture 4. Very straight, uniform channel, with little habitat or flow diversity.

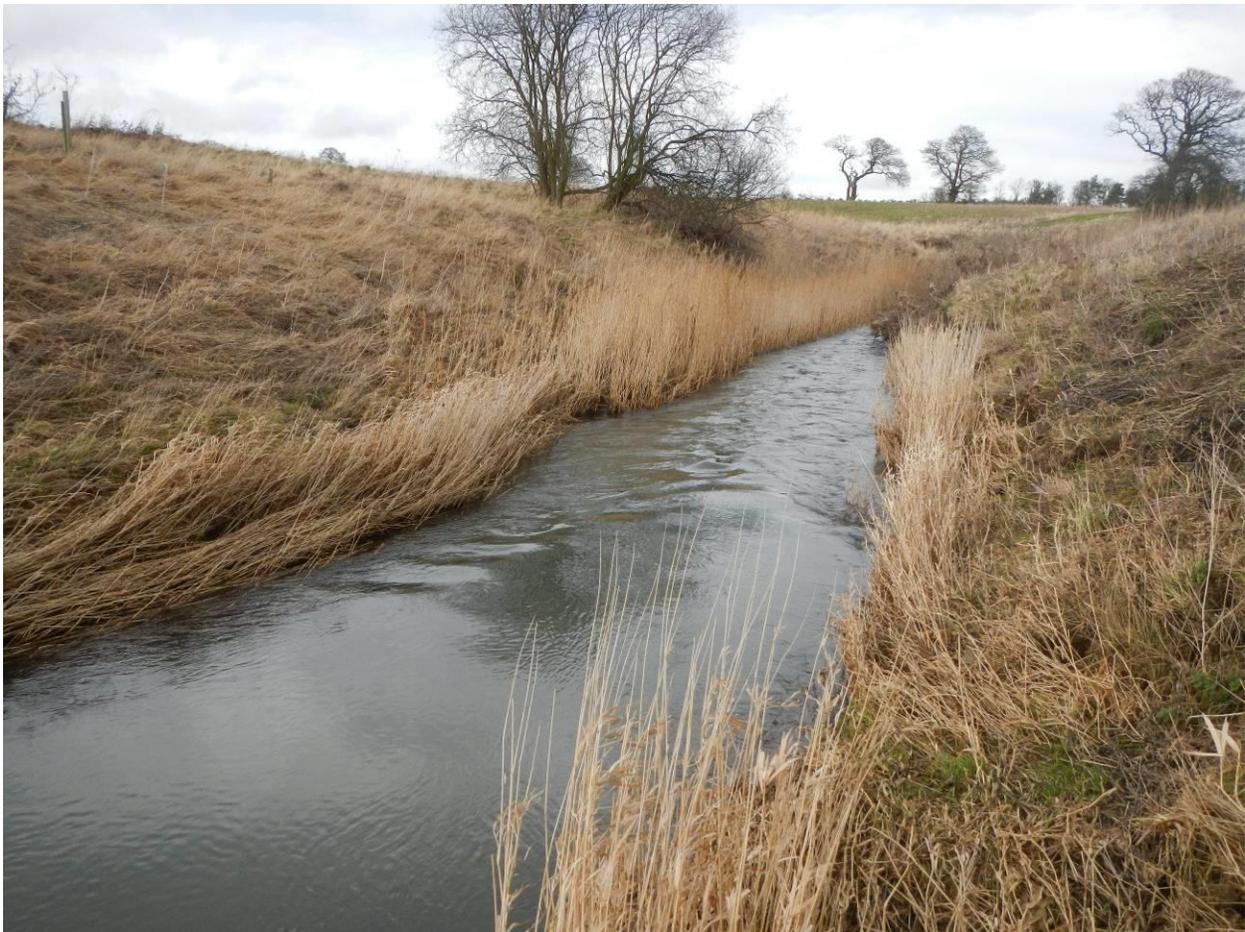
Approximately 1km below Bellasis Bridge, directly below the remains of old bridge footings, the habitat improved slightly, with the first of a series of three, cobble-bedded riffles observed (Picture 5). Again this would appear to be due to a reduction in the extent of dredging below the bridge, as the improvement only exists for around 100m downstream, after which the

channel is again heavily dredged. None of the riffles provided suitable substrate for salmonid spawning as the material was of too coarse diameter.

Picture 5. Steep and straight channel resulting in cobble and boulder substrate.

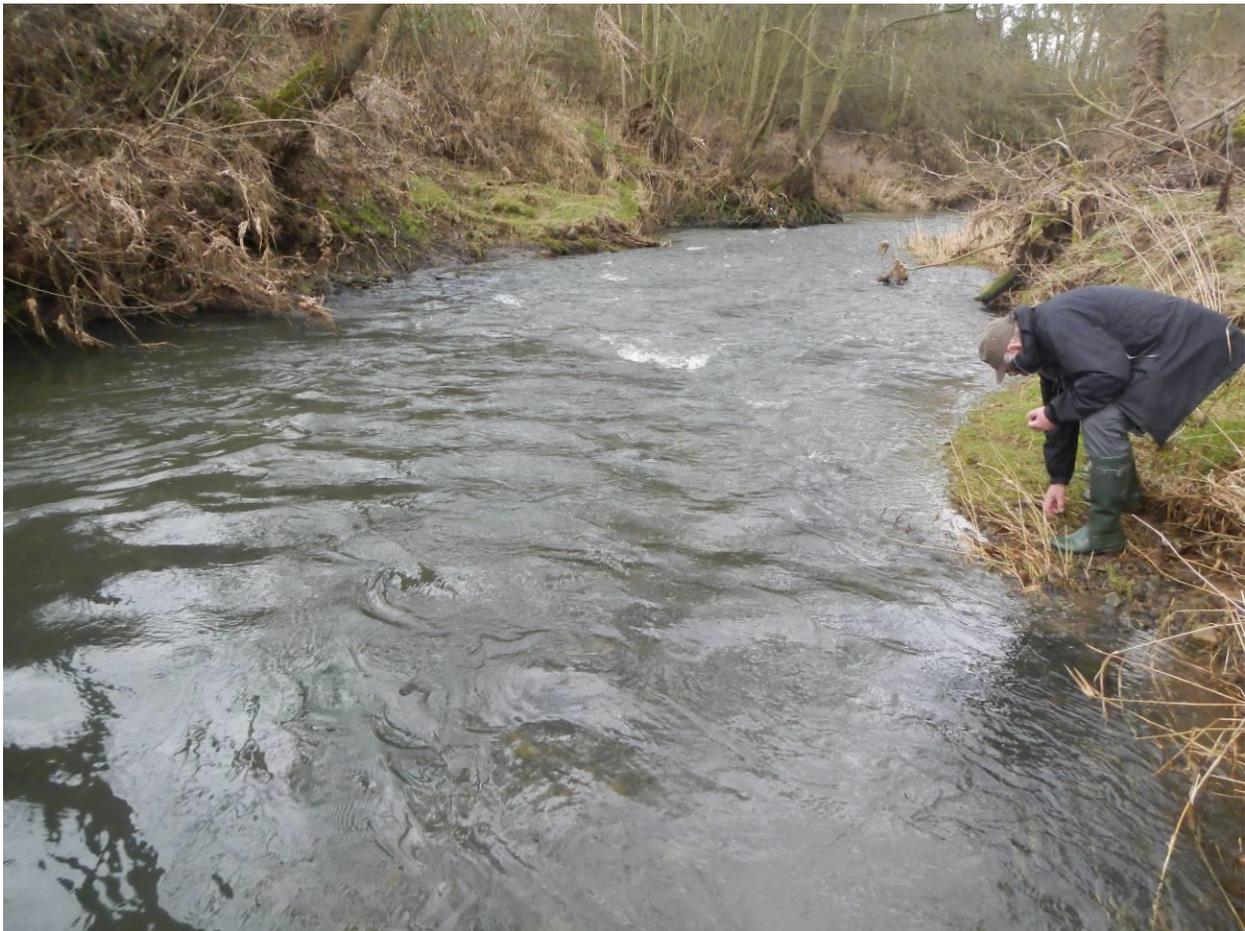
Picture 6. One of a series of more natural riffles observed (c.6-8 wide)

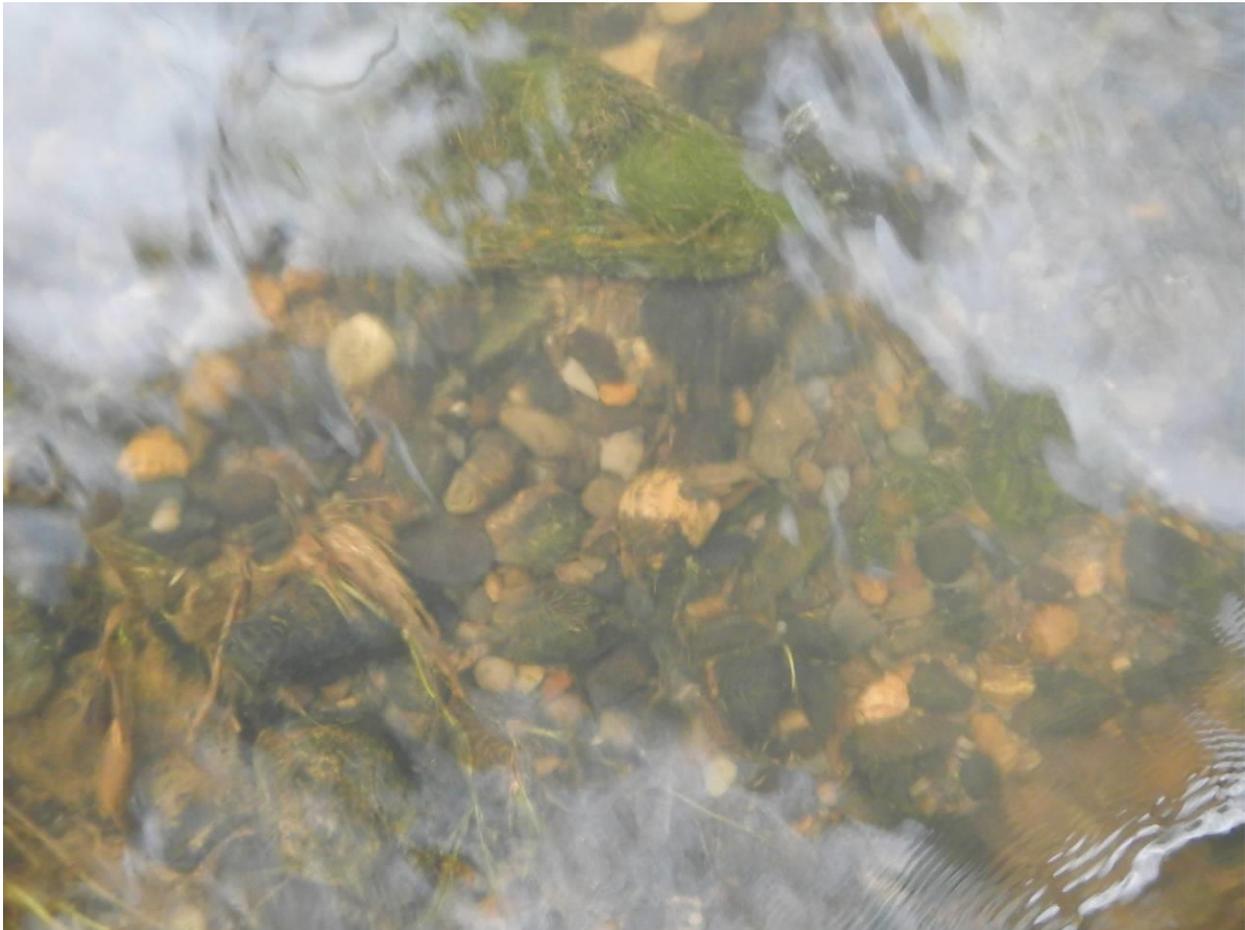
A reduction in fine sediment supply from upstream and an increase of in-channel structure from LWD and marginal trees, to increase gravel sorting, may facilitate improvement of the substrate in this area to a state capable of

supporting viable salmonid spawning. As demonstrated by the presence of suitable sized gravels in picture 7.

Picture 7. Gravel of a suitable size (5 – 50mm dia.) for spawning of small salmonids, currently compromised by a high sediment composition.

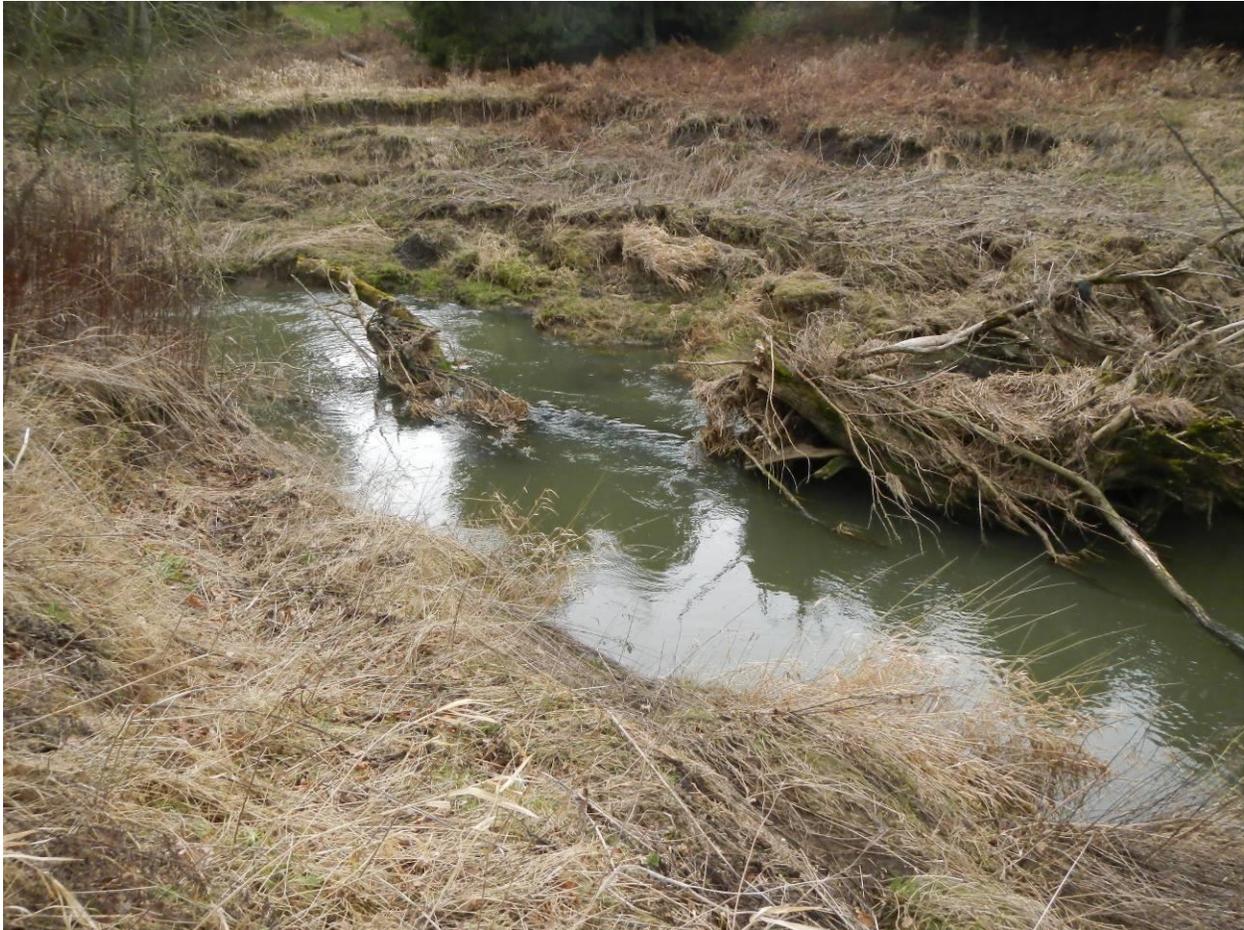
At several points throughout the next c.1.5km the river is heavily dredged, but areas of significantly improved habitat occur where woody debris within the channel and dense willow shrubs along the bank have increased in-channel structure. This has improved flow diversity and increased depth variability. While shallow riffles and gravel substrate are still scarce, these areas provide greatly enhanced juvenile and adult salmonid habitat (Picture 8).

Picture 8. A good example of beneficial LWD that has increased flow diversity and scour to create lies for a range of salmonid life stages.

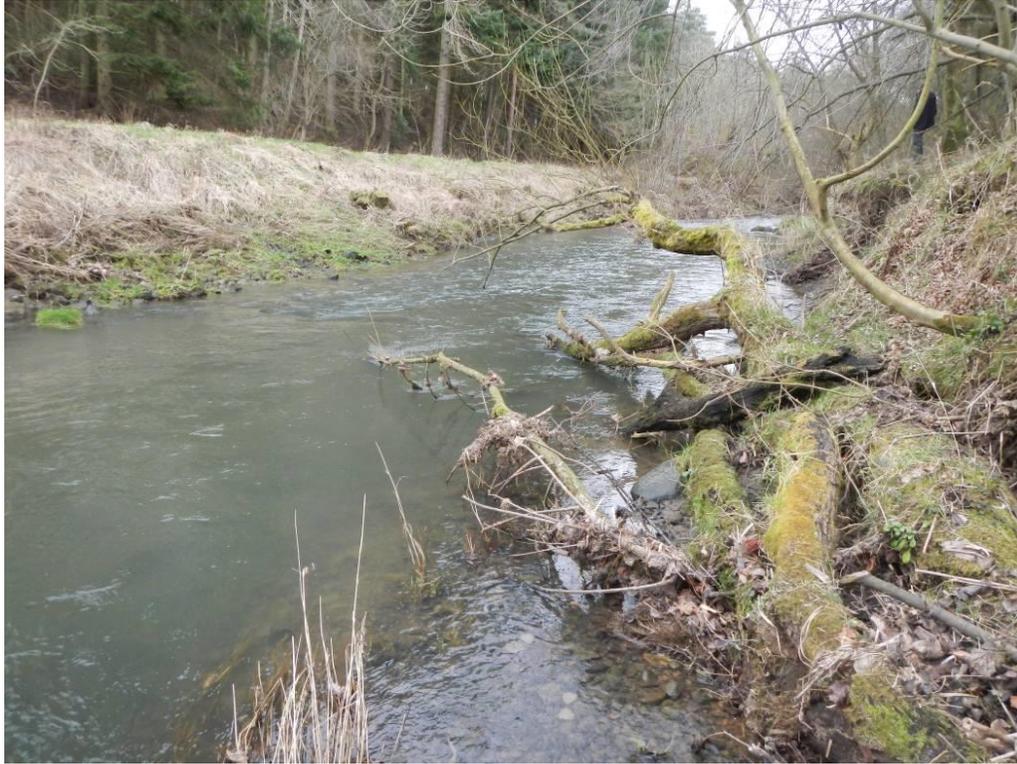
The channel also widens towards the A1, increasing to 10-15m wide in most places. These improvements in habitat quality are likely to be closely related to a reduction of dredging pressure in the area, with another significant factor improving being an increase in LWD and marginal tree cover, which enhances the already increased flow velocity and diversity, provides in-channel cover, and assists gravel retention and sorting (Pictures 9 & 10).

Picture 9. LWD providing cover and assisting deposition of sediments on the nearside bank (RB).

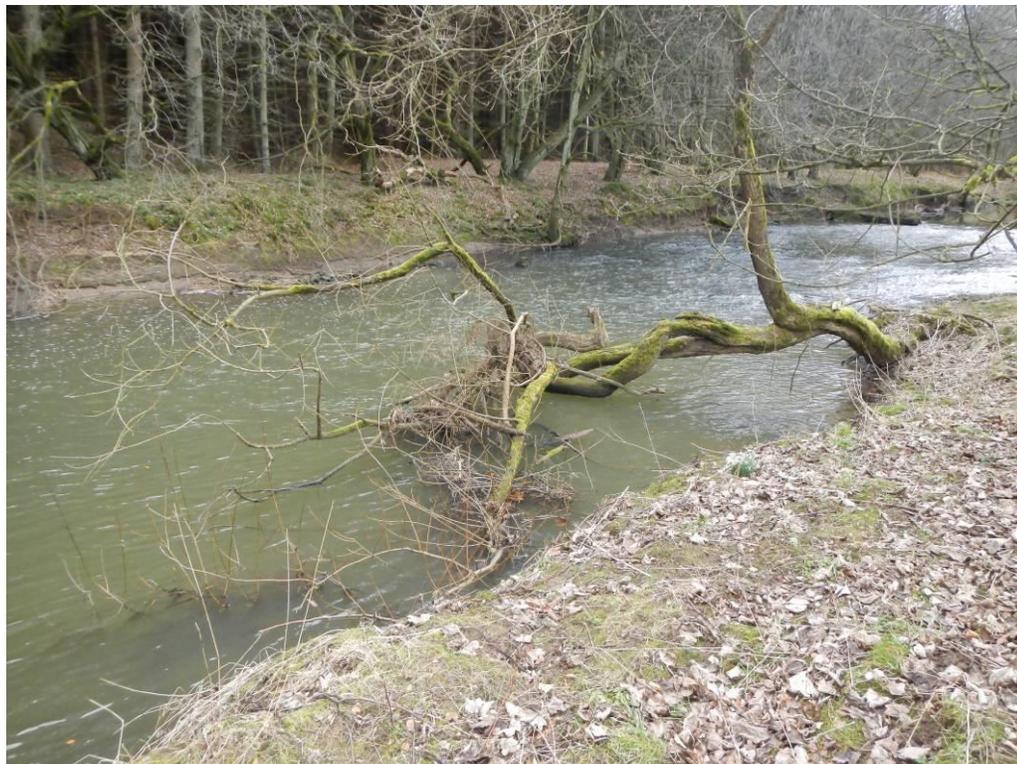
Picture 10. Overhanging willow, with trailing branches that will greatly enhance the habitat of the pool. The structure provided, and deposition it encourages, will optimise flow within the channel.

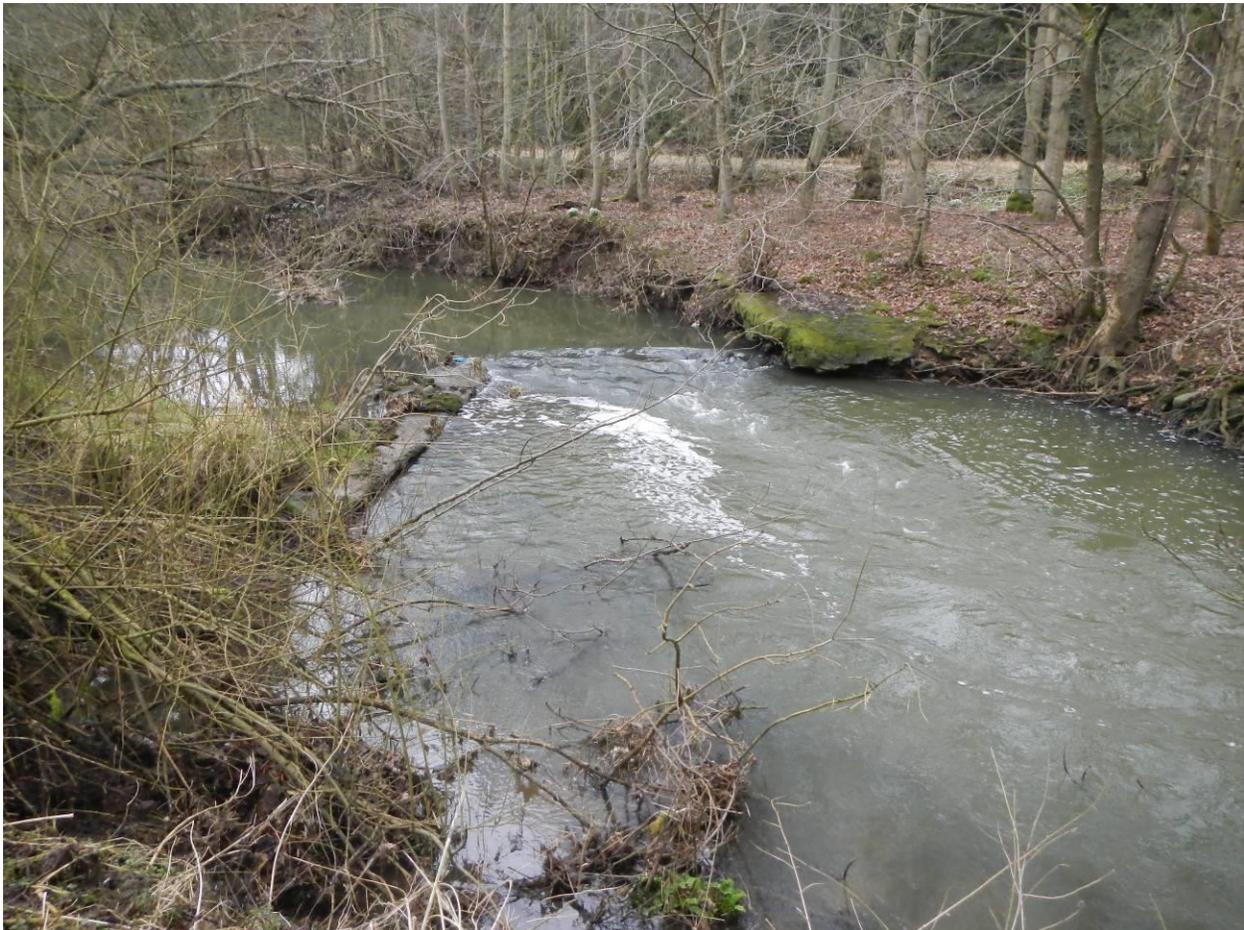
A series of weirs were also present within the section (NZ2119378472, NZ2134178395 and NZ2151178240), which although in a poor state of repair cause some impoundment to the River (Picture 11). It is recommended that these impoundments are removed down to river bed, at least in the middle third. Retention of the structure at either bank would create a pinch point to increase velocity and scouring, but it may be difficult to achieve. A more ecologically friendly option would be complete removal of the structure and tree planting, or installation of LWD in its place, on opposite banks.

This would create a similar effect, replacing some of the flow enhancement benefits downstream of the weir, without the negative impoundment. These weirs are not of a significant height to cause obstruction to fish passage, but in an area with such limited gradient, any impoundment is likely to have a significant negative impact.

Picture 11. One of the weirs that should be removed or lowered. This structure demonstrates the flow benefits of narrower pinch points. Note the river level in relation to the bank where a more natural bed is present (1.5m below the bank top) in contrast to the 3-5m of incision observed upstream.

Due to the lack of natural bed features, deep over-wide channel, and low gradient in Section 2, the weirs present, although in a very poor state of repair, are adding to the impoundment of the River. It is recommended that these impoundments are removed down to river bed level, at least in the middle third. Retention of the structure at either bank could be facilitated, creating a pinch point to increase velocity and scouring. This would also reduce the amount of materials that have to be removed. For some of the weir this process may simply be a case of removing or rearranging the cobble and boulder fill from the centre section of the weir.

If the weirs are completely removed, installation of LWD or tree planting in its place on opposite banks would help to increase velocity through the centre of the channel and replace habitat features lost through the removal.

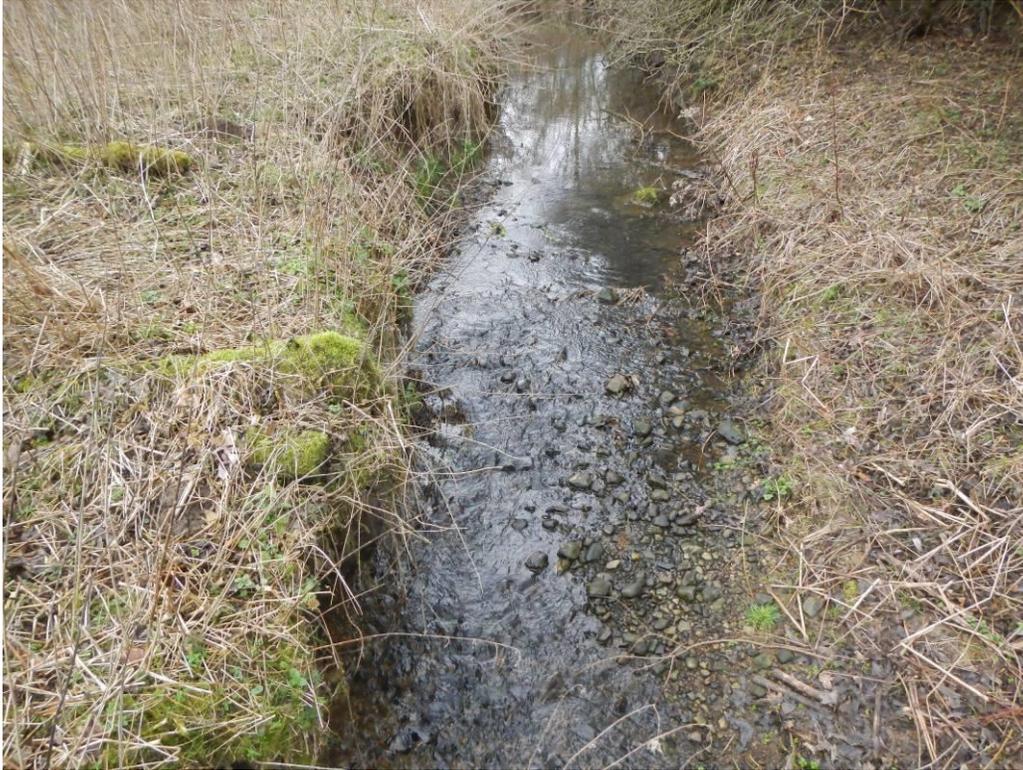
Approximately 600m upstream of the A1, the Catraw Burn (Picture 12, NZ2124878502) enters the Blyth and represents the only tributary in the section with potential as a spawning tributary. The Burn was small and carried a high silt loading, but appeared subject to little or no dredging, with a sinuous course, and coarse, salmonid spawning-sized substrate. If the sedimentation issues on the Burn could be addressed it could form an important spawning and nursery area for salmonids. This is dependant on other water quality and quantity parameters. To this end, it is suggested that the Catraw Burn be investigated further.

Picture 12. Potential spawning and juvenile nursery habitat on the Catraw Burn.

It is recommended that the Catraw Burn (NZ2124878502) is investigated further as a potential spawning tributary. Enhancement of the Burn could help to mitigate the lack of suitable spawning on the Blyth system. The Burn appeared to have potential as a spawning tributary, but the quality of the gravel was compromised by high sediment loading. It may be that periods of low flows, as are common throughout the Blyth, are exacerbating sediment deposition and may reduce the potential as a spawning tributary, but the sedimentation should also be investigated as a source to the Blyth.

Investigation into the water quality of the Burn, and the water quantity likely to be experienced throughout the spring and early summer at least, would be useful. If these parameters were suitable it may be worth installing features such as brash bundles and branches within the channel that would enhance juvenile salmonid habitat and potentially increase juvenile output.

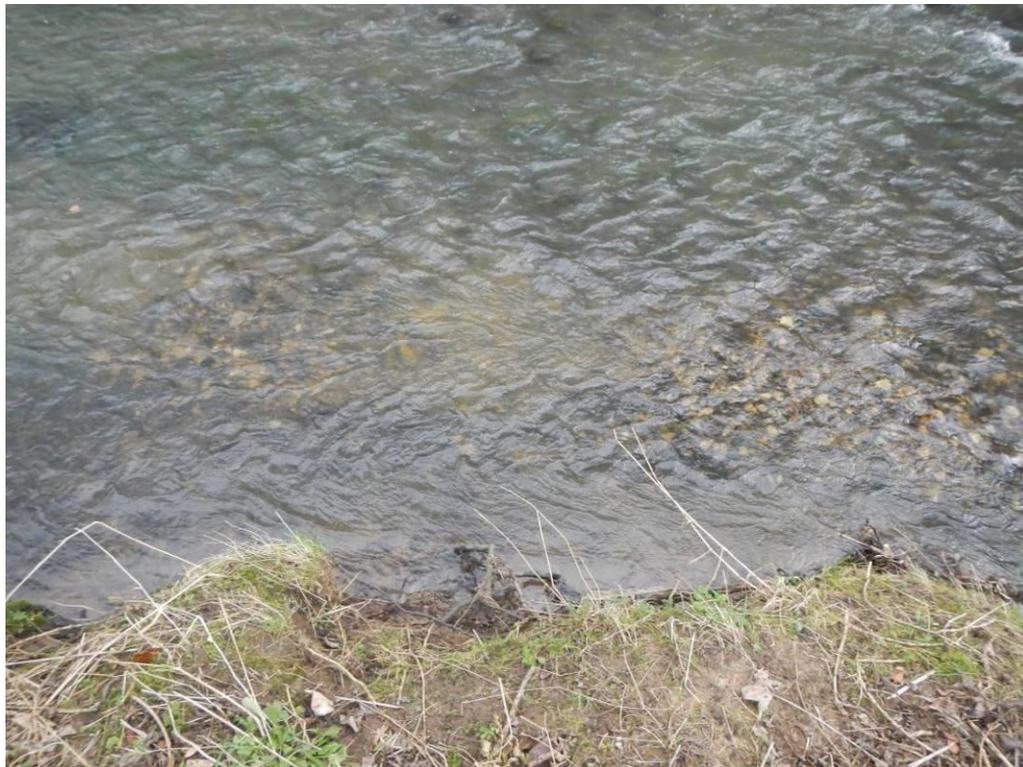
In the bottom 300m above the A1, areas of bedrock became apparent along the river bed, marking a change in character of the river, after which it became steeper, with an increasing number of riffles. Correspondingly, areas of higher quality, cleaner gravels observed (c.100m upstream of the A1 Bridge), which were of a suitable size and composition for salmonid spawning. Within this gravel were several clearer, recently disturbed areas that appeared to represent salmonid redds (Picture 13). The size and location would suggest that they were created by larger migratory salmonids, possibly sea trout.

Picture 13. One of several suspected salmonid spawning redds on the River Blyth (NZ2164078286).

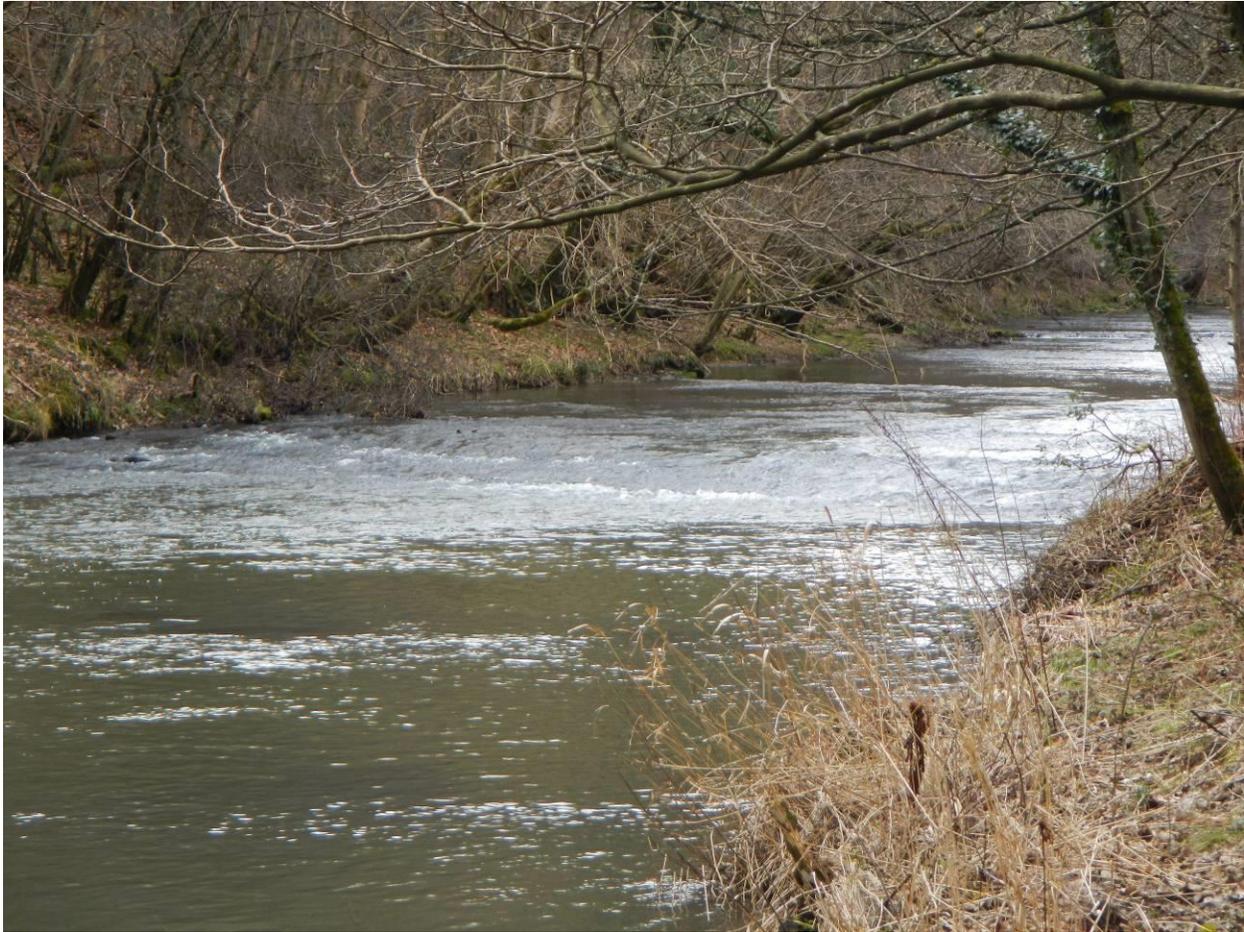
Picture 14. A natural bedrock ledge, creating some cascading in the centre of shot, with deeper pool and glide habitat in the foreground. LWD could help to diversify the habitat in reaches such as this.

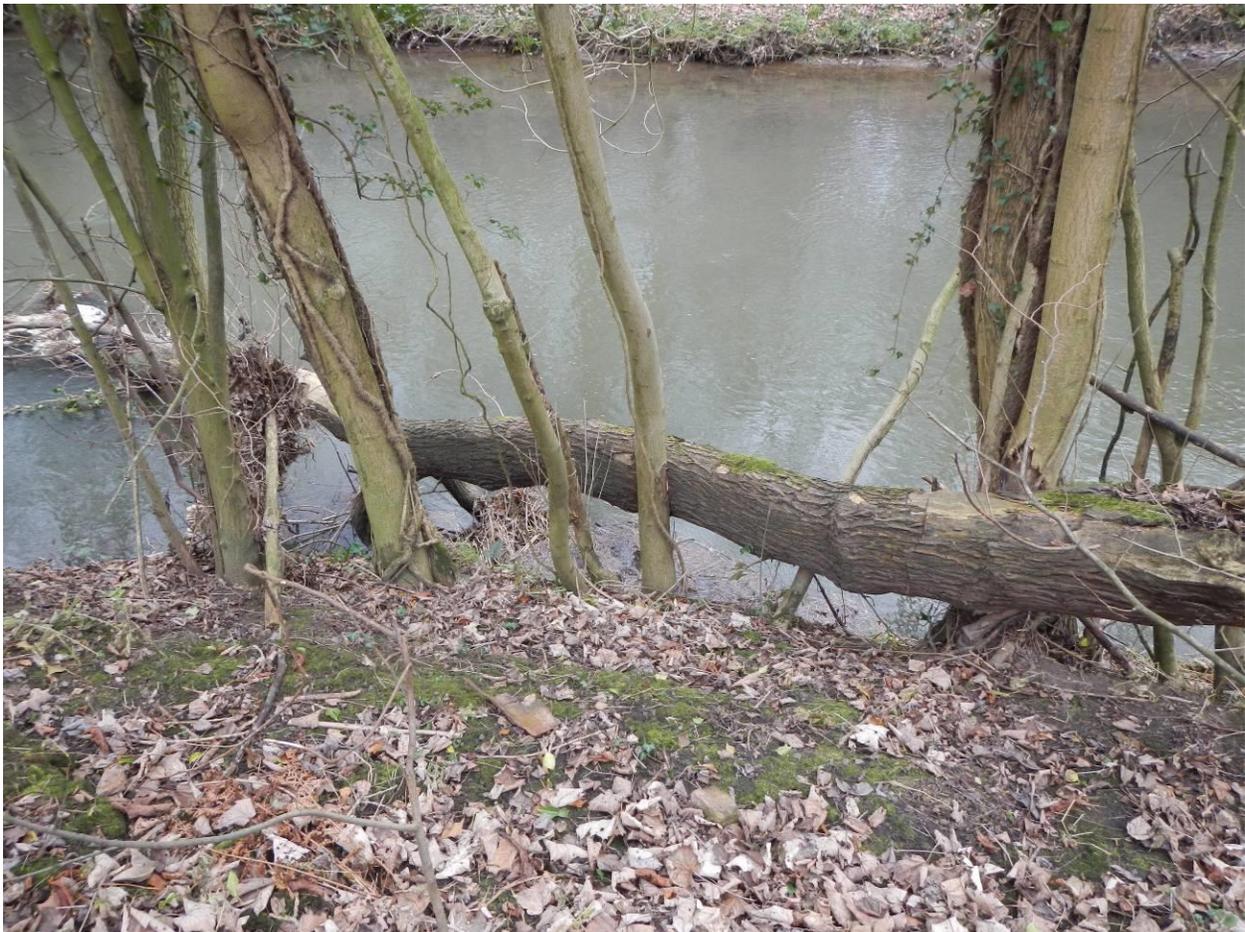
Picture 15. Fallen tree being retained in place by pressure, against other limbs.

Without the additional cover provided by trees and logs in pictures 15, 16 & 17 the habitat would be of significantly lower quality. In picture 15 the log is facilitating accumulation of other debris, providing increased cover and flow diversity. In picture 16 the wide slow nature of the river would provide little cover or diversity within the channel, but with tree cover the pool has structure and shelter for fish and invertebrates to inhabit. The shallow riffle in picture 17 would equally provide little cover or shelter from the flow, without the tree present.

With this in mind it is recommended that living trees and shrubs be retained, as they are naturally anchored in situ. Simple natural methods could also be employed to retain larger material and LWD in place, as seen in picture 15. There a tree has fallen into the River between several living trees and will be retained in place by the force of water acting on the fallen limb, which will pin it against the upright trees. In areas where flooding is a greater risk, trees and branches could be retained with steel cable, and/or posts, creating tree kickers.

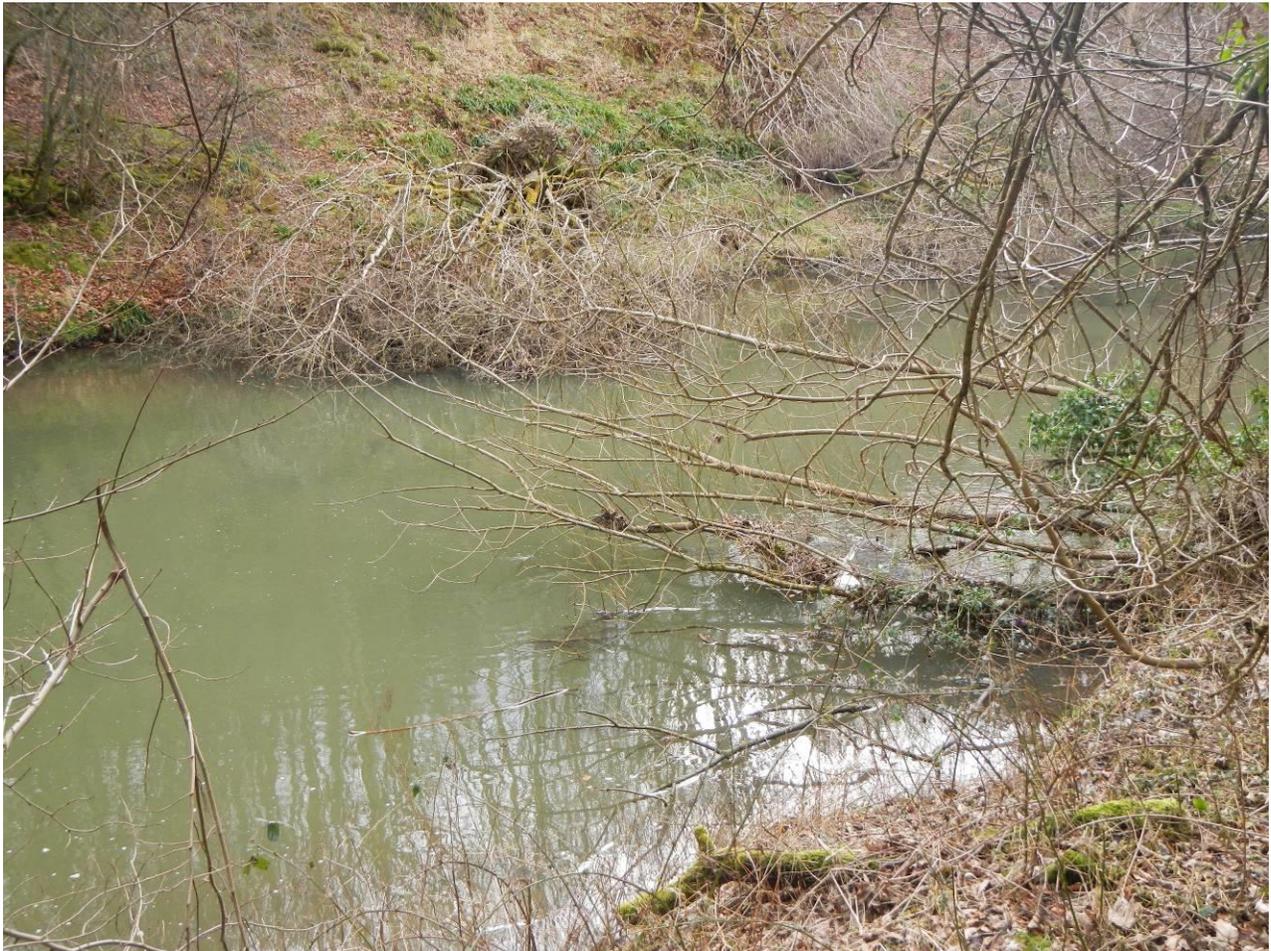
Picture 16. Valuable habitat and cover provided by tree branch structure within a uniform channel.

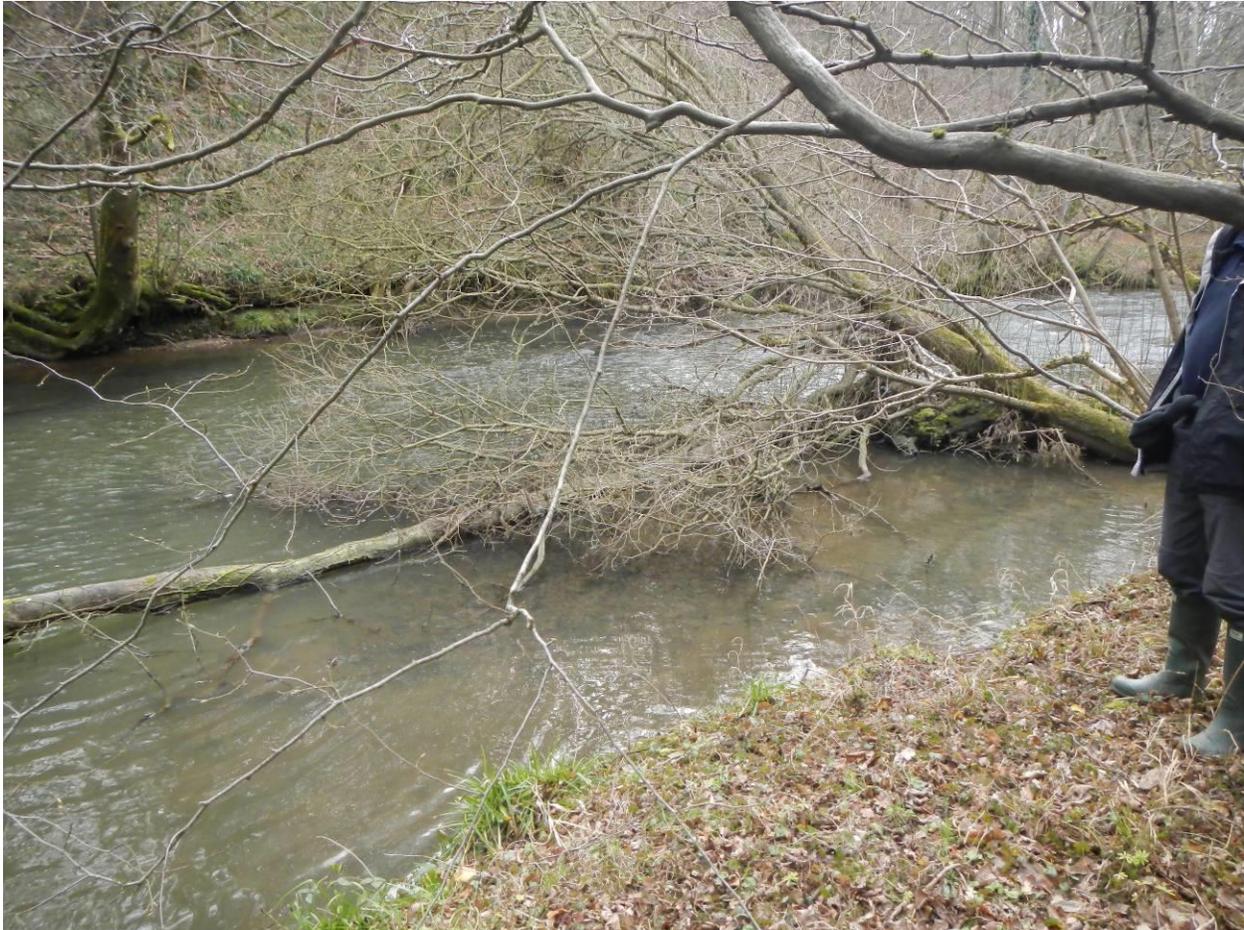
Picture 17. Aerial cover and slower fish holding water provided by an overhanging tree, with suitable fry habitat in the foreground. The structure of the tree within the channel is also optimising current velocity of the riffle.

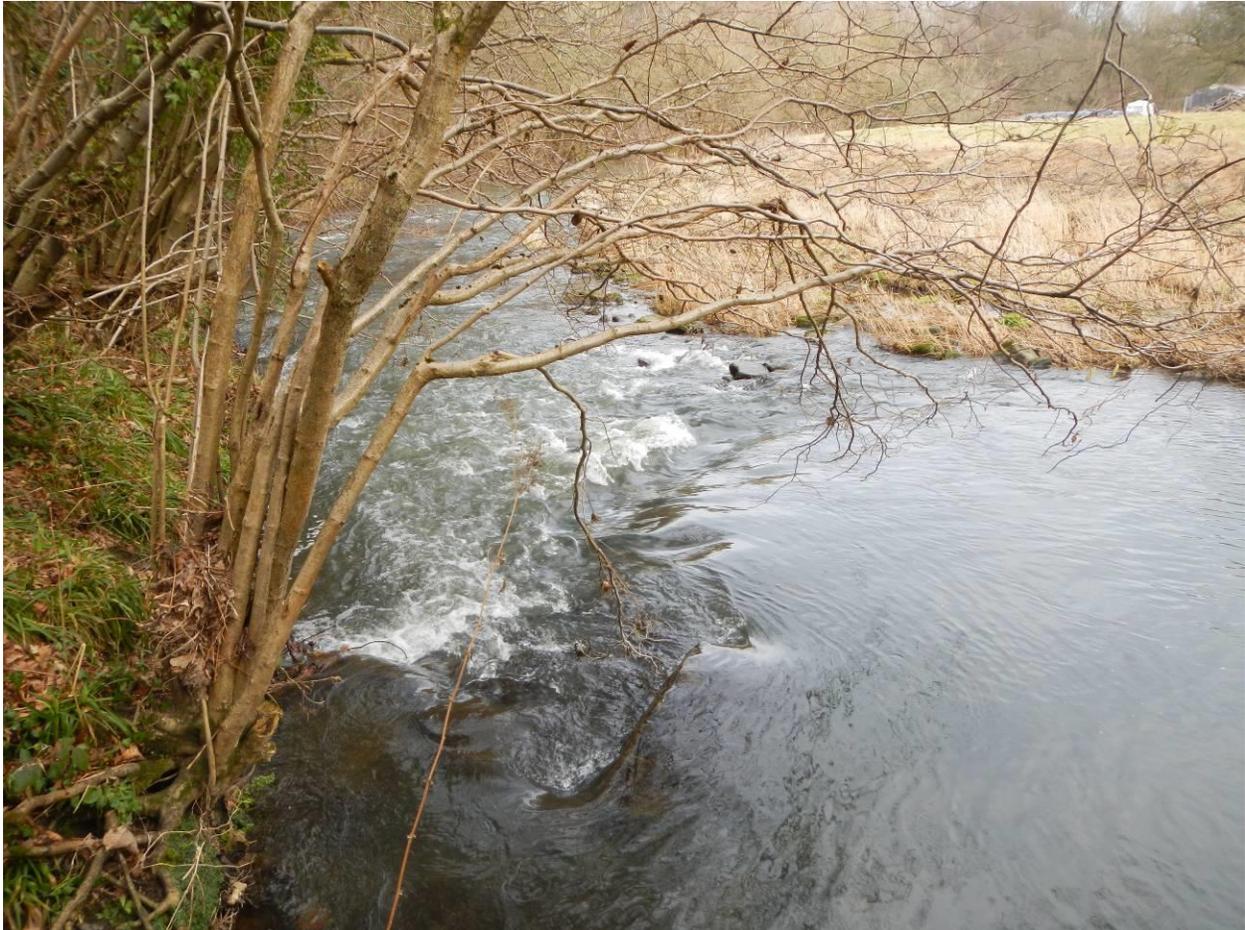
Picture 18 shows a significant channel narrowing downstream of the old weir site. The deposition, and vegetated bar created, now restricts the river to approximately half of the average width for this reach and the benefit of increased velocity at this localised pinch point can be seen.

Picture 18. Significantly restricted channel width creating enhanced flow characteristics, and habitat within the area and pool downstream.
