Pont and Blyth Investigation

River Blyth – from Bellasis Bridge to Hartford Bridge

(Waterbody ID - GB103022077050)

Date – 23/02/12

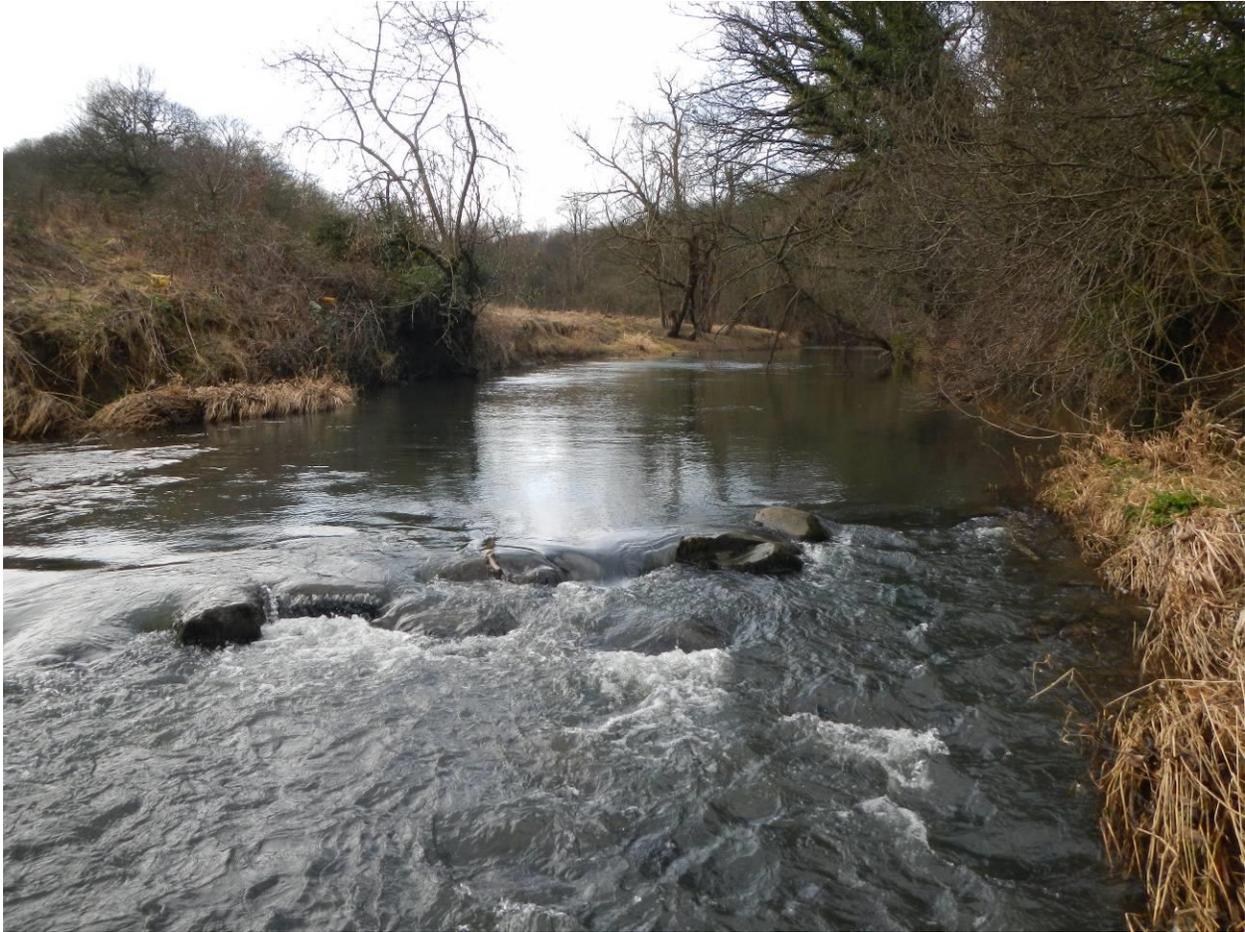
A short distance downstream of the narrowing the River again opens out into a wider channel, influenced by an area of raised bed that was possibly the site of another weir or structure (Picture 19). The minor obstruction is of no real significance, creating little impoundment in an area of reasonable gradient. At this same location a small amount of ochreous discharge was observed entering the river, but the volume was not considered to be detrimental.

Picture 19. Small area of raised cobble and boulder bed which may be the remains of a previous weir (NZ2374079751).

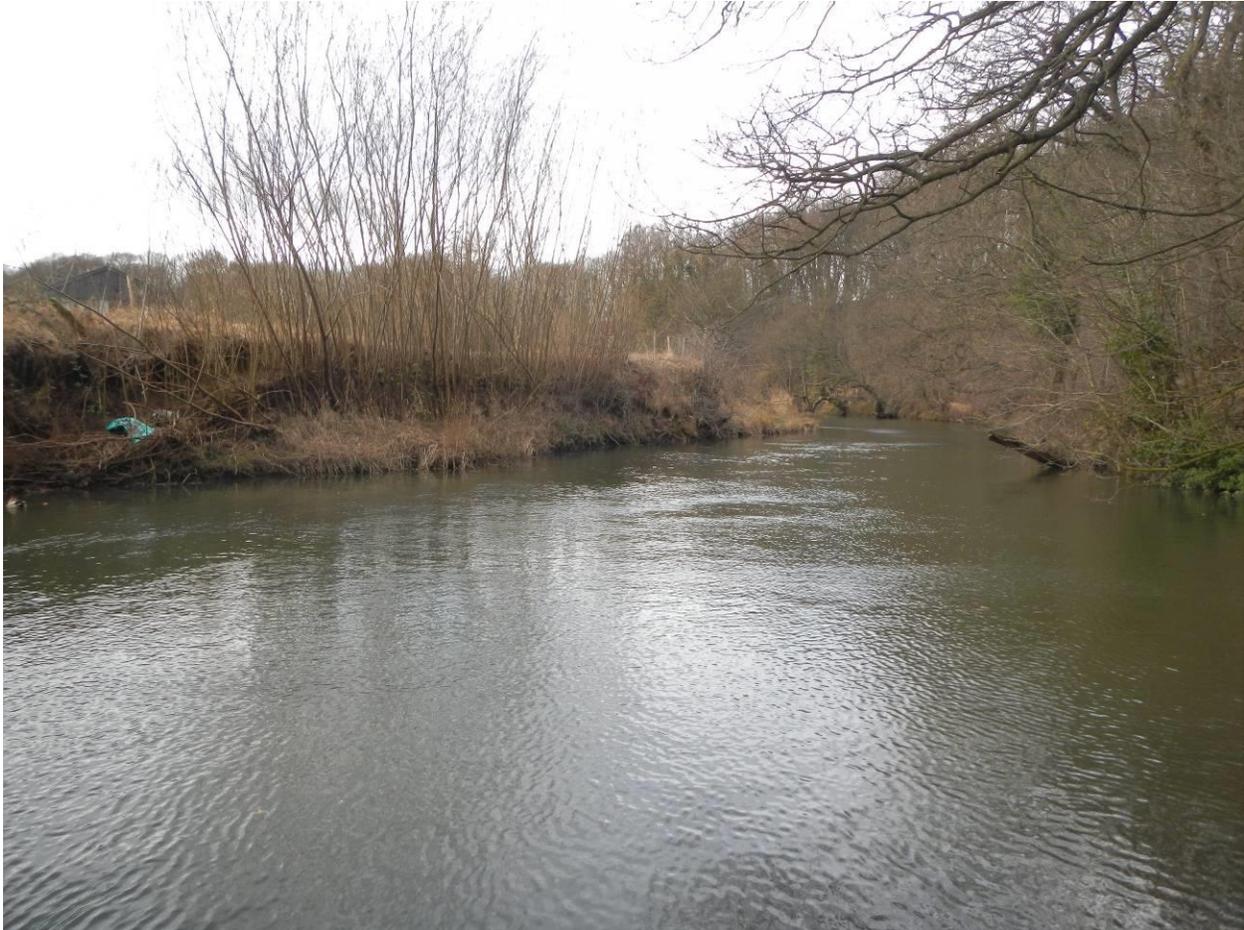
From this point downstream the river can be characterised as pool and riffle sequence for approximately 500m and represents good quality adult salmonid habitat. On the RB of the bend there was an area of healthy willow growth where spiling had been previously undertaken to reinforce and consolidate the bank (Picture 20). With the permission of the landowner, this could form a good source of willow for further planting. Habitat and protection along the bank could also be enhanced if some re-growth were laid down the bank, into the river, in a downstream direction.

Picture 20. Healthy re-growth of willow following bank revetment with living willow spiling. This could be a good source of willow for further work.

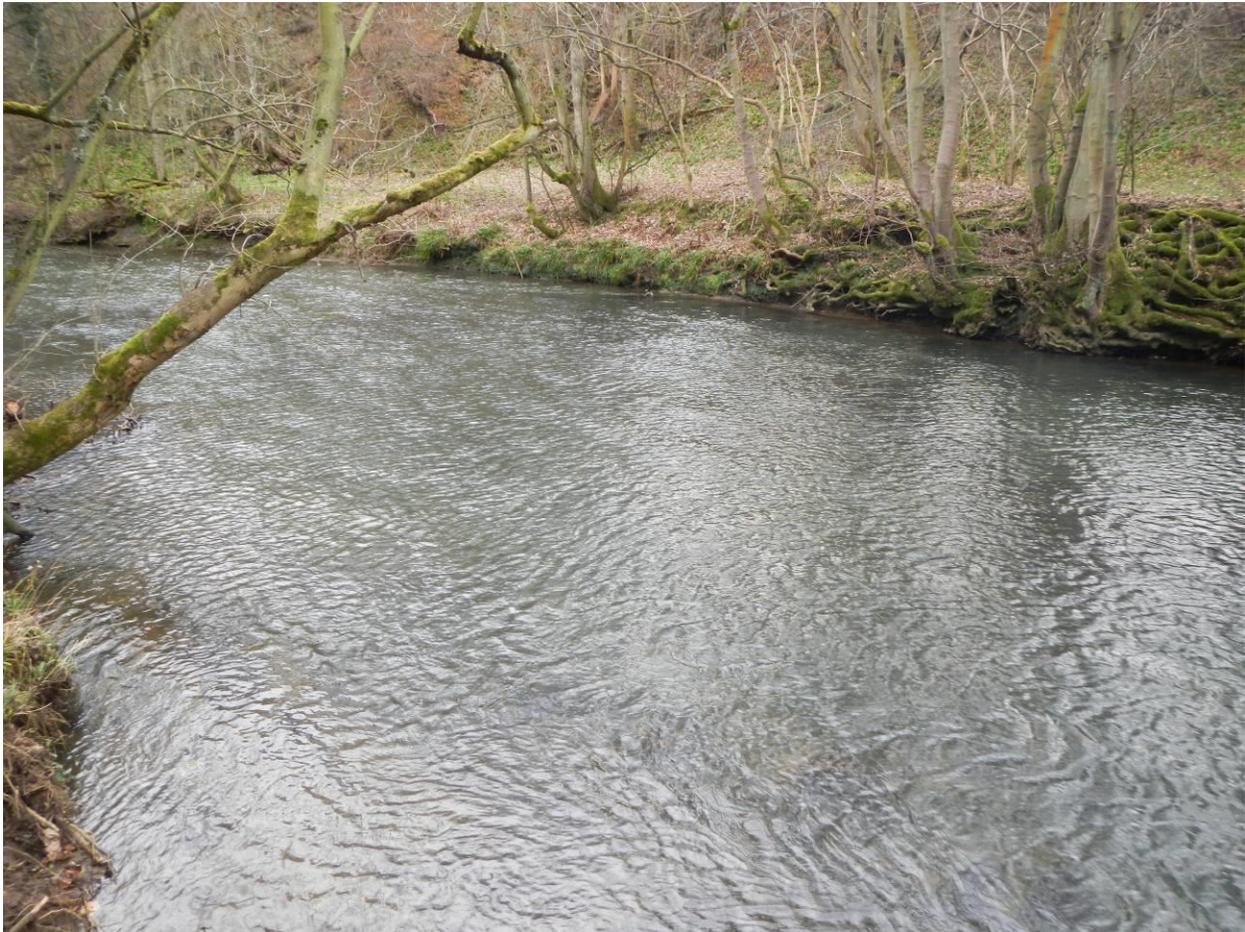
The impact of tree maintenance and removal of LWD was again obvious through this section, with significantly lifted canopy and reduced amount of low cover within the channel. This greatly reduces the quality of what would be good salmonid habitat and should be addressed by cessation of the tree pruning work.

Picture 21. General lack of low-level cover resulting from pruning and tree maintenance, which has lifted the canopy well above the water level. This could be addressed with some coppicing, additional planting, or both.

Planting with species, such as goat willow and sallow (*Salix caprea* & *S. cinerea*), hazel (*Corylus avellana*) or hawthorn (*Crataegus monogyna*), which were scarce throughout this section, would also be beneficial in

increasing low cover; as would one-off coppicing of some of the trees to encourage low-level re-growth.

Hinging could also be undertaken on species like willow, hazel and smaller alders, where already present, to give an instant increase in the available low cover. This could then be undertaken on some of the trees planted, in the future.

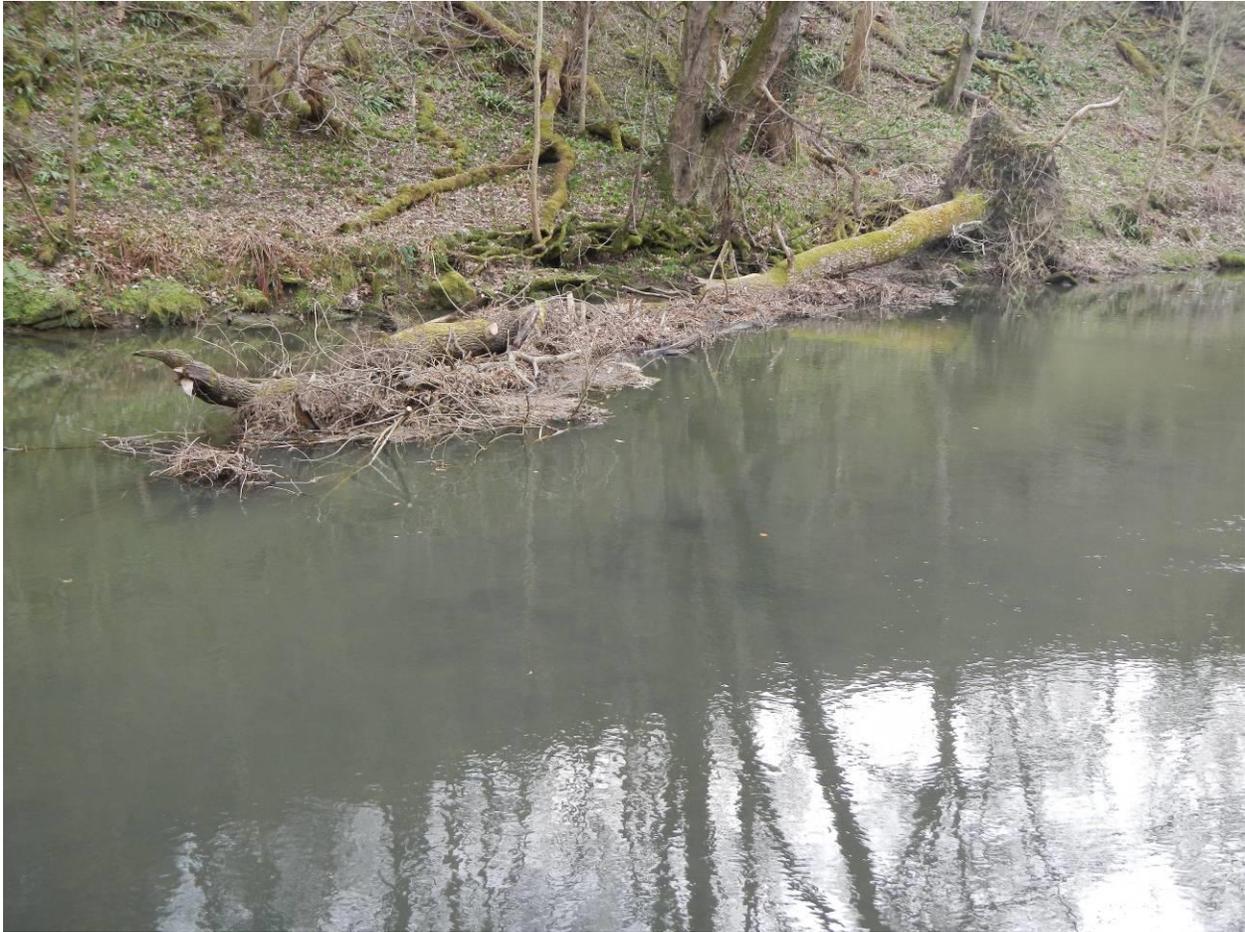
Freshly cut branches could be seen on many of the bank-side trees, and several logs and tree trunks in the area had been cut into short sections. Picture 22 shows what would be a very beneficial piece of LWD before it was cut in half. It was not possible to ascertain whether the work had been carried out by Environment Agency Operations Delivery personnel, the Council, local landowners or the angling club, but this kind of work should be avoided wherever possible to preserve habitat within the river.

Picture 22. This tree trunk would have formed beneficial structure within the river but has been cut through, halfway along the length in the picture. This would now appear to represent a greater flood risk as only the butt is anchored to the bank and the tip is likely to wash out in the next high water.

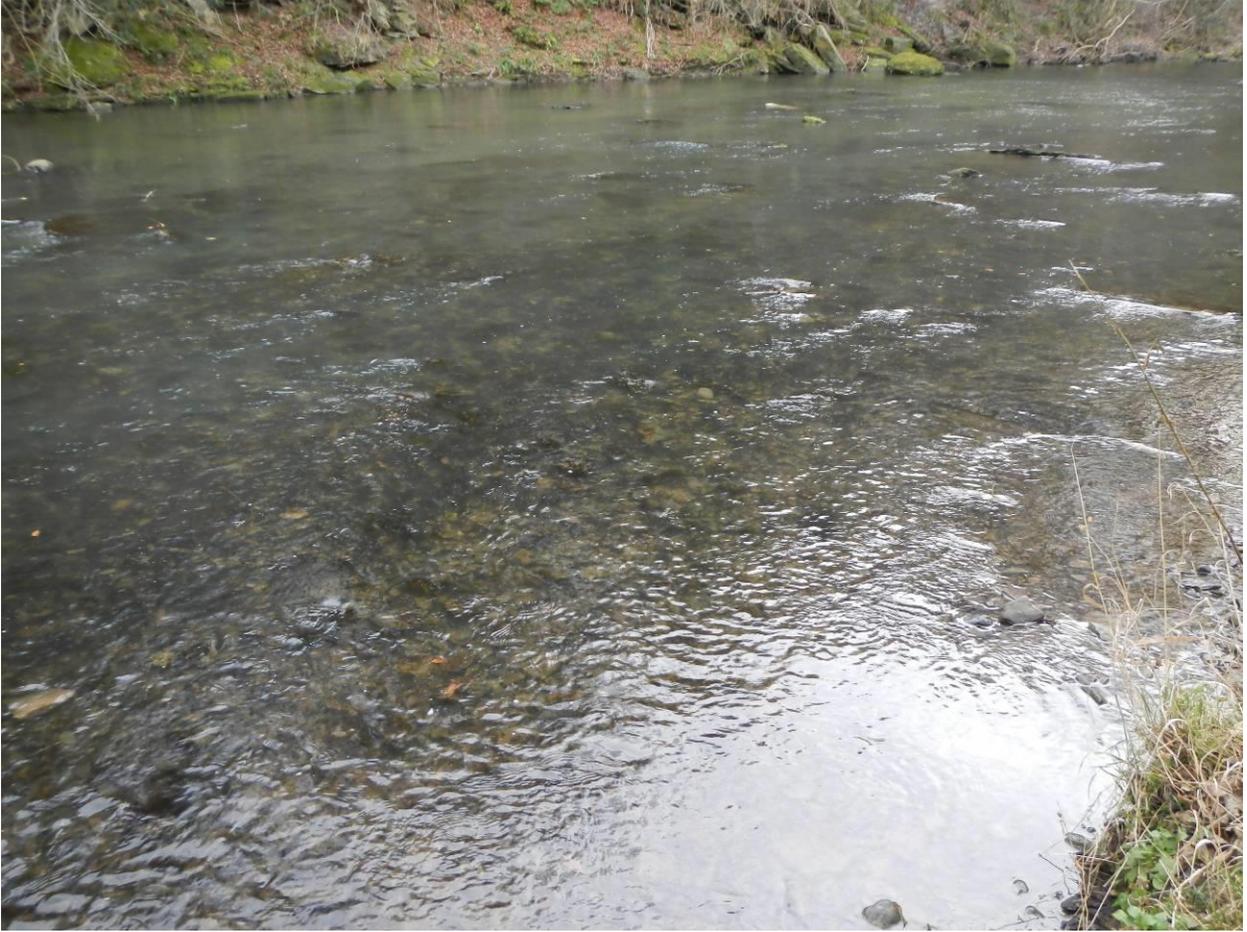
Wherever visible, the riverbed throughout the shallower sections exhibited a significant amount of brown algal growth. This suggests a high nutrient loading in the river. A fact that would be supported by issues observed in other sections of the catchment. This is something that is being investigated by the Northumberland Rural Diffuse Pollution Partnership and needs to be addressed across the whole catchment, as the notable issue observed in picture 23 is the result of a cumulative impact.

Picture 23. Significant algal growth on the riverbed.
