# WILD TROUT TRUST

**Advisory Visit**

**River Cover (Ure)**

**for Ure Dales Landscape Recovery, 2025**

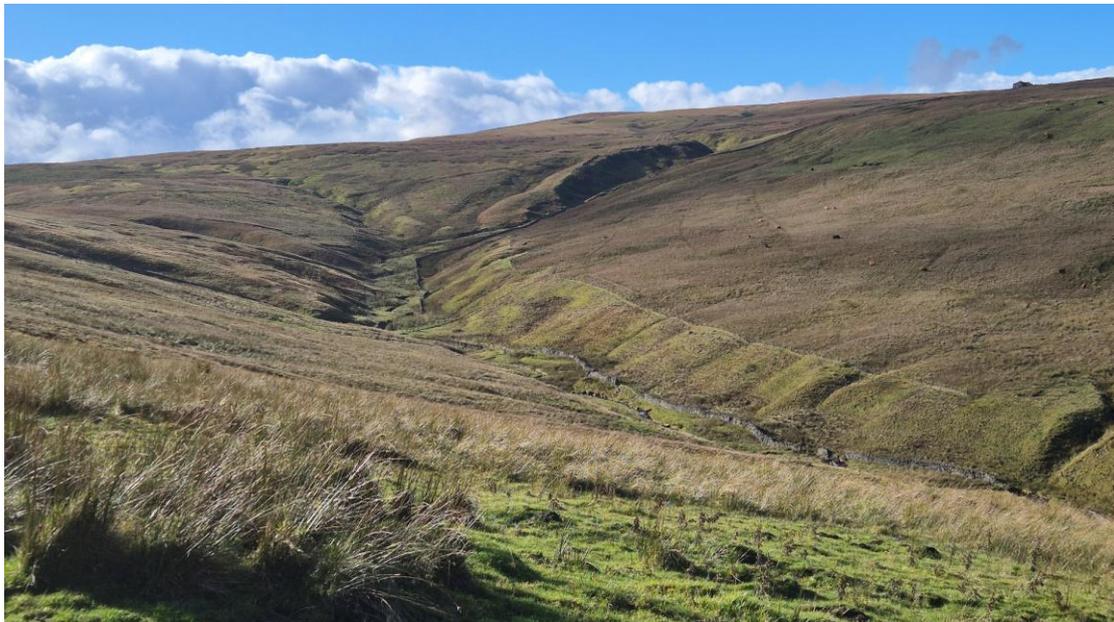
Fig 1: Looking across to West Stone Gill at 54.185684 , -2.0210821. Most u/s point viewed on the system. Difficult to see at distance but an early exclosure and planting scheme instigated by Yorks Dales RT appears to have established some woodland cover near to the channel. Indeed, the uppermost reaches of this gill, where

inaccessible to sheep, were noted in a previous WTT report as excellent examples of the floral diversity that should be present along these upland headwaters.

- Excluding livestock, particularly sheep, from the gills and narrow floodplains to allow recovery of riparian woodland in coves, and a naturally diverse herb flora, will be essential to aid recovery, boost faunal biodiversity and productivity, and mitigate for future climate.
- Some augmented planting will be necessary to kickstart recovery in a catchment that probably has an extremely poor seedbank, plus high browsing pressure from rabbit, hare, and deer.
- These planted trees will form the basis for future natural regeneration, and supply of large woody material, as well as ongoing seasonal supply of leaf litter for aquatic invertebrates.
- In time, they will also provide shade, essential for cold adapted species in a warming climate, and more resilience to bank soils, increasing channel morphological diversity.

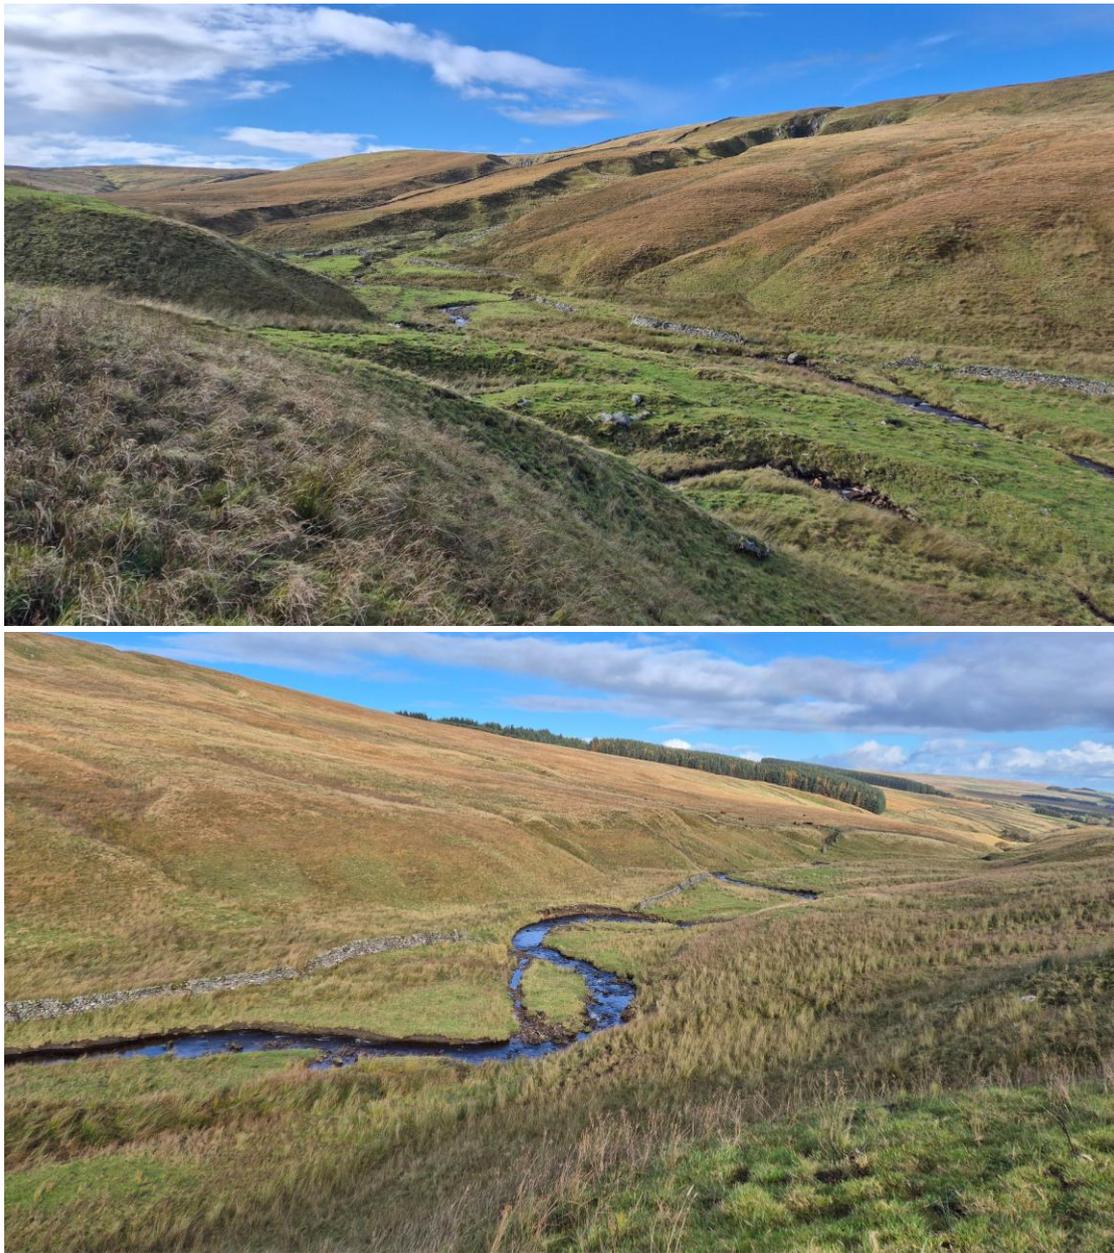
Fig 2: 54.191084 , -2.0104795 environs upper, and lower, 54.191427 , -2.0092028. Relatively high up the system but meanders evident within the narrow floodplain.

- Even up here, there was evidence of channel modification, signs of straightening and realignment to one side of the floodplain.
- The boundary wall against which the channel had been aligned in sections was clearly made from stone derived from the channel, originally contributing to incision and interfering with natural geomorphological processes.
- Grazing along the riverbanks had reduced the herb layer to short sward grass (or rush) dominance with little investment in root structure, leaving the banks susceptible to accelerated rates of erosion

- Removal of the drystone wall and return of all the stone to the channel. How it is returned depends upon the nature of the channel adjacent but could be in one or several of the following manner.

- A dispersed matrix along the bed to subtly raise bed level.
  - Clustered to one side of the channel or the other (or alternating along a straightened reach) to accentuate meanders or reinstate sinuosity.

- Clustered as a raised riffle to help reconnect paleochannels.
- Identify where paleochannels have been deliberately blocked and remove that stone to allow more frequent / earlier connection during rainfall events. Return stone to extant channel d/s as above.

- Introduce windblown whole trees (Large Woody Structure; LWS), as intact as possible ie including rootplates and lateral branches, to the floodplain and channel. The bigger the better, reducing the likelihood of movement, and clusters of trees, interlocking, with some in and some out of the channel will also induce stability.

- It should not look too contrived, rather, as if a storm had passed through and wreaked havoc.
- Placing some windblown trees across the floodplain would also restrict access to stock or wild grazers / browsers and create pockets of floral diversity. Willow whips could be pushed in amongst the crown material of such trees. If livestock pressure could be removed for at least 10y (ideally much longer), then a more targeted programme of tree planting to create riparian copses would be beneficial.

- All of the above introduced structure will make the water work over, around, or under, causing localised scour and deposition, retention and sorting of gravels important for spawning, and slowing the flow.

- There should still be an element of dynamism, ie the materials may not stay exactly where introduced, but far better to let high flow events place them naturally, and move them occasionally.

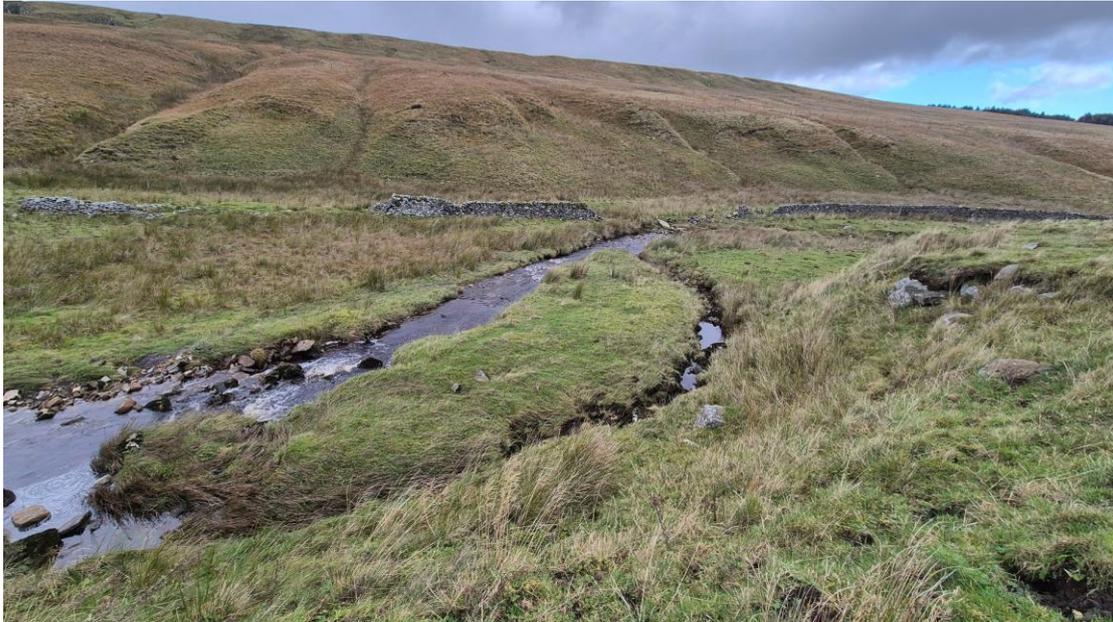
Fig 3: 54.190710 , -2.0106940. Evidence of a straighter 'D-cut' to redirect flow in a straighter course from one side of the valley to the other and reduce erosion into the valley side.

- Shorter, straighter, steeper – greater conveyance of flow and erosional power  $d/s$

- With plenty of stone available in the defunct walling adjacent, both of these channels could be bed raised to allow for better floodplain reconnection. Given the width of the floodplain here and plethora of paleochannels, it may result in a multi-threaded channel or braiding.
- Scattering trees with rootplates.

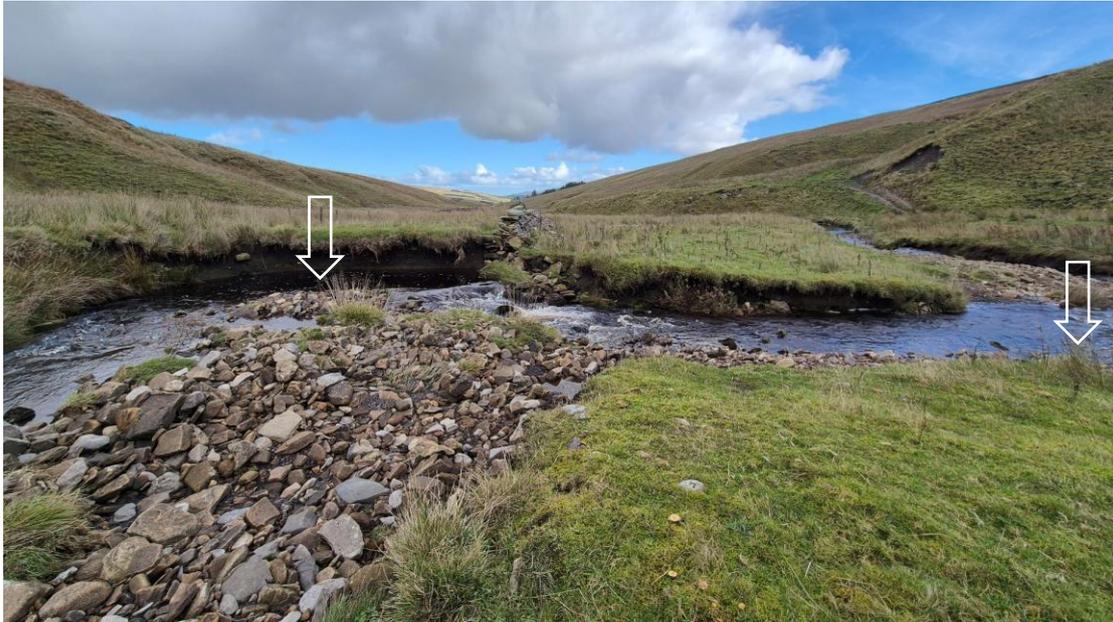
Fig 4: 54.190735 , -2.0113698. Example of the renaturalising channel allowed to meander and reinstating features such as deeper pools on the outside of bends (white arrows).

- Deeper pools are essential holding habitat for larger individual fish, especially in the absence of any other cover such as shaggy marginal vegetation, tree roots and fallen woody material.
- Hence, reinstating a more natural meandering channel and increasing the complexity and naturalness of the riparian habitat (removing grazing stressor, planting riparian trees, introducing tree fall) will be essential for recovery.

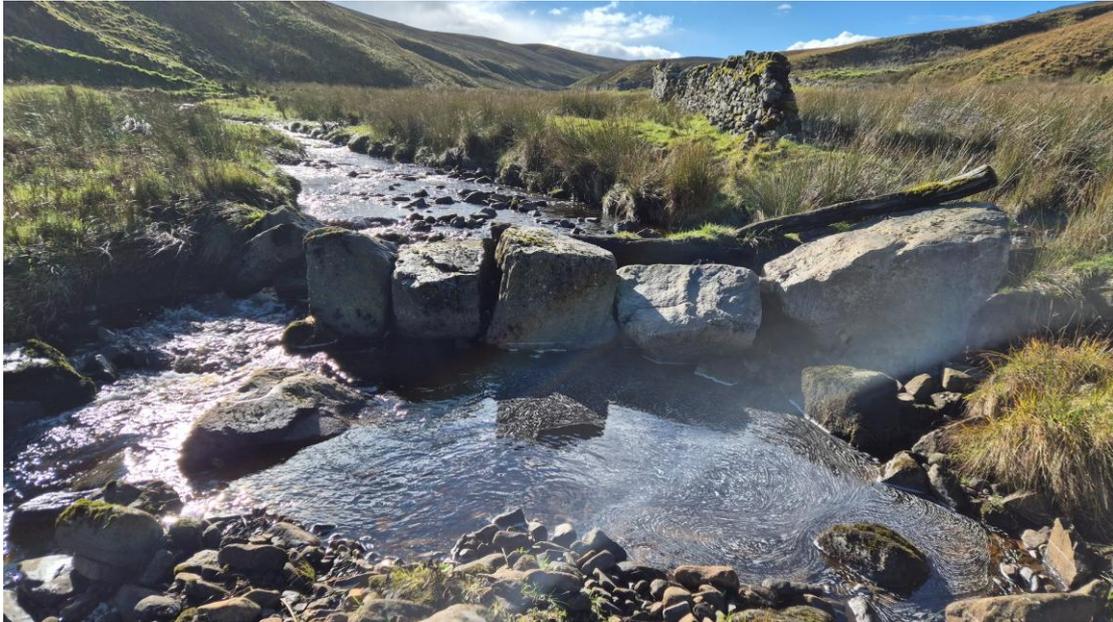
Fig 5: An attempt at creating pools by introducing boulder weirs. This was advocated by some in the early years of river restoration but would not be promoted now. With the benefit of hindsight and with increased understanding, it is better to work with natural processes to achieve more sustainable goals.

- Whilst this is a limestone catchment, and there are seams of bedrock which may form a cascade (see Fig 6), they are relatively infrequent and are not present in this reach.
- A weir angled perpendicular across the channel, even of irregular boulders, is not particularly natural.
- It may create a small pool of greater depth immediately below the structure, but it has also impounded a reach upstream which has gradually aggraded, filled with sediment, and hence robbed the channel of natural features u/s.
- Trapping sediment on the u/s side then starves the reaches d/s of smaller size fractions leading to changes in habitat niches, and potentially further channel incision.
- The impounded, infilling reach, with more sluggish flow will be shallower and more prone to warming.
- Under low flow conditions, there may be issues for free fish passage.

- Relocate the boulders to kickstart more natural processes or better reconnect paleochannels, as highlighted previously.

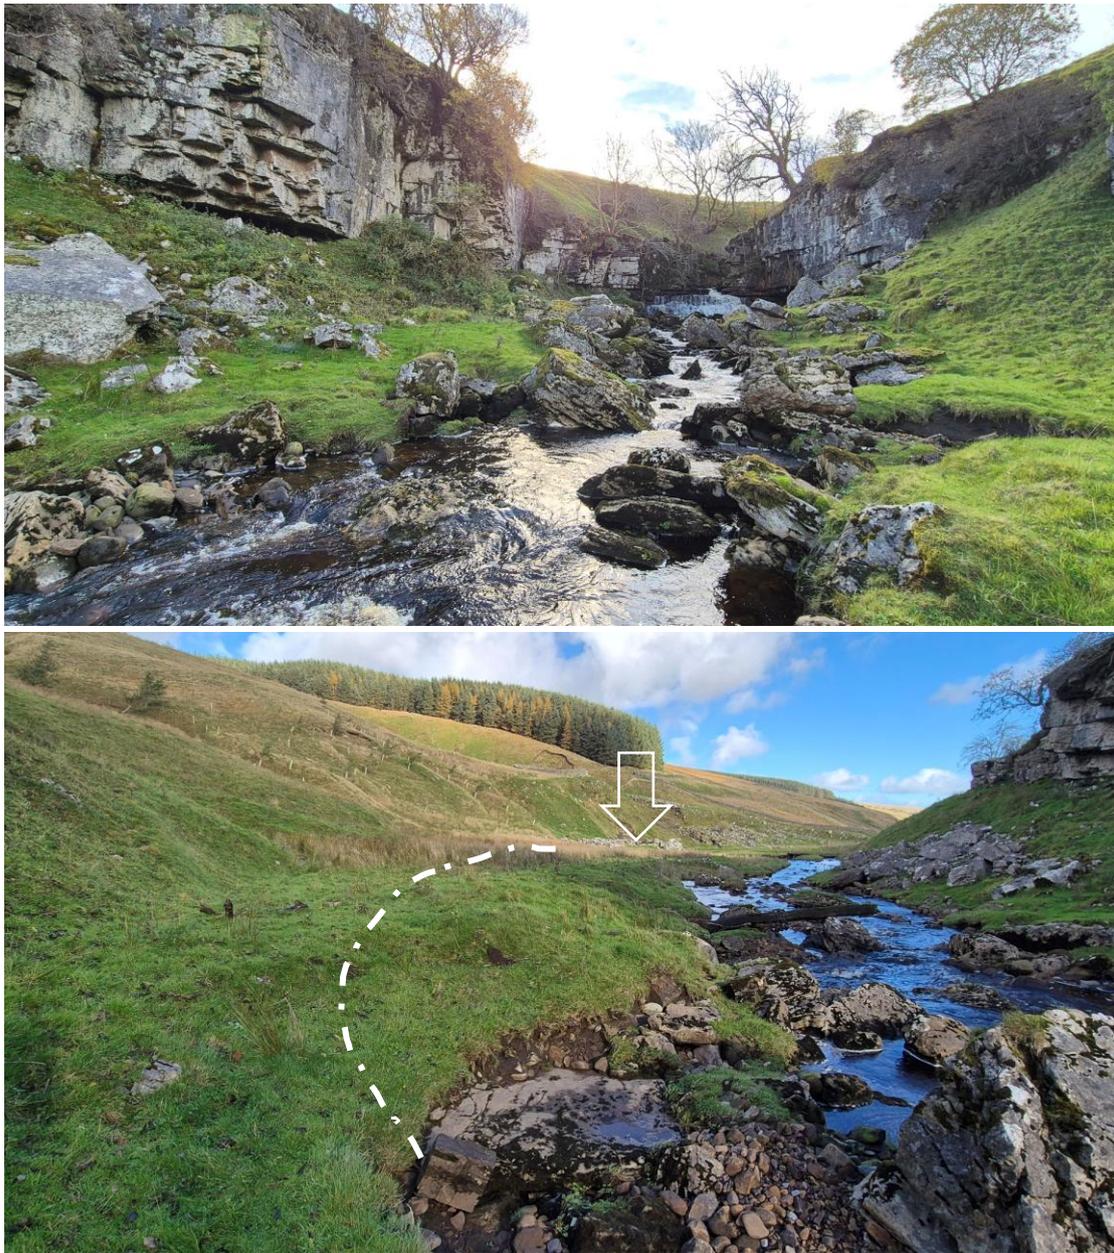
Fig 6: 54.194782 , -2.0026557. A section of limestone gorge with natural cascades which would prove challenging for fish passage. Electric-fishing surveys from ~20y ago revealed trout population(s) u/s.

- This is a natural feature and hence should not be tampered with to 'improve' fish passage. Indeed, there is value in potentially isolated and genetically distinct trout populations residing u/s.
- As the valley widened out from the falls, there was evidence of channel modification, realigning the channel away from the LHS (dashed white line) where a series of sheep folds (white arrow; see Fig 7) had been built, now dilapidated and unused. Potential to open up the head of the old channel and allow flow to return – see Fig 7.

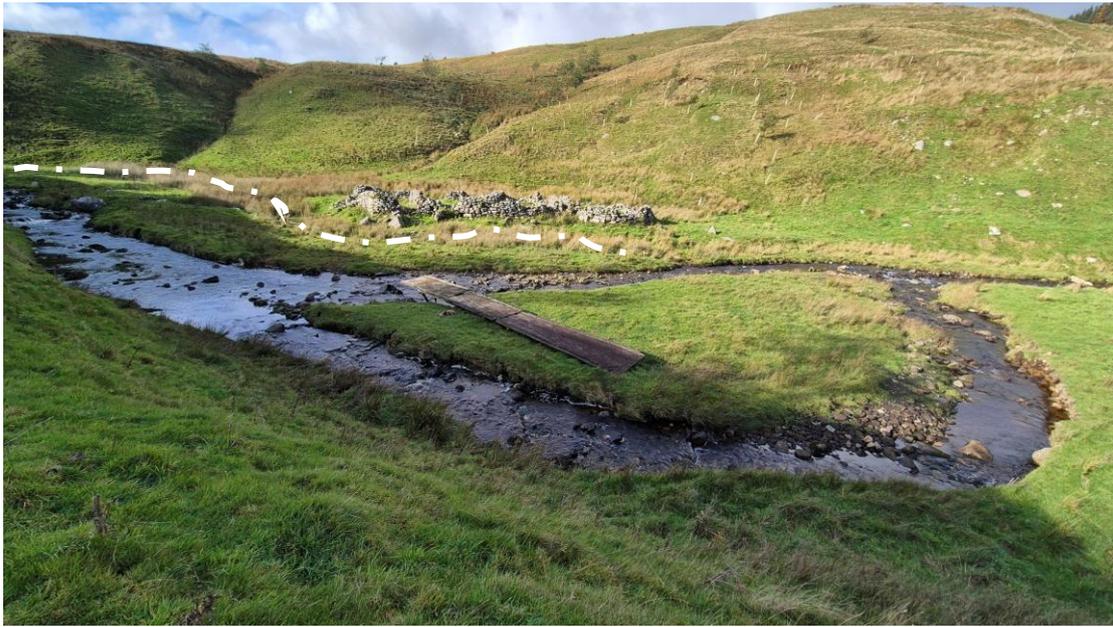
Fig 7: 54.195673 , -2.0020439 environs. Looking across to the sheep folds and the paleochannel (white dashed line) identified in Fig 6. The extant channel had been historically 'D-cut' but the current landowner reinstated access to the meander <10y ago and dispersing the flow energy across both 'arms' had allowed for greater retention of gravels in pockets that could be used for spawning.

- Positioning of sheep folds in this natural 'bowl' in the landscape was ideal to protect herds from inclement weather. Clearly, livestock still use it to shelter as the grass was heavily grazed. However, that sheltered aspect should mean that flora will bounce back readily if given the chance. It would be beneficial to augment some riparian tree cover using alder and the shrubby willow species if livestock can be excluded.
- Stone taken from the channel to build the sheep folds should be returned.
- To retain as much gravel in this location as possible (potential upper limit for spawning before the falls), multiple Large Woody Structures (LWS) created from windblown trees should be introduced.

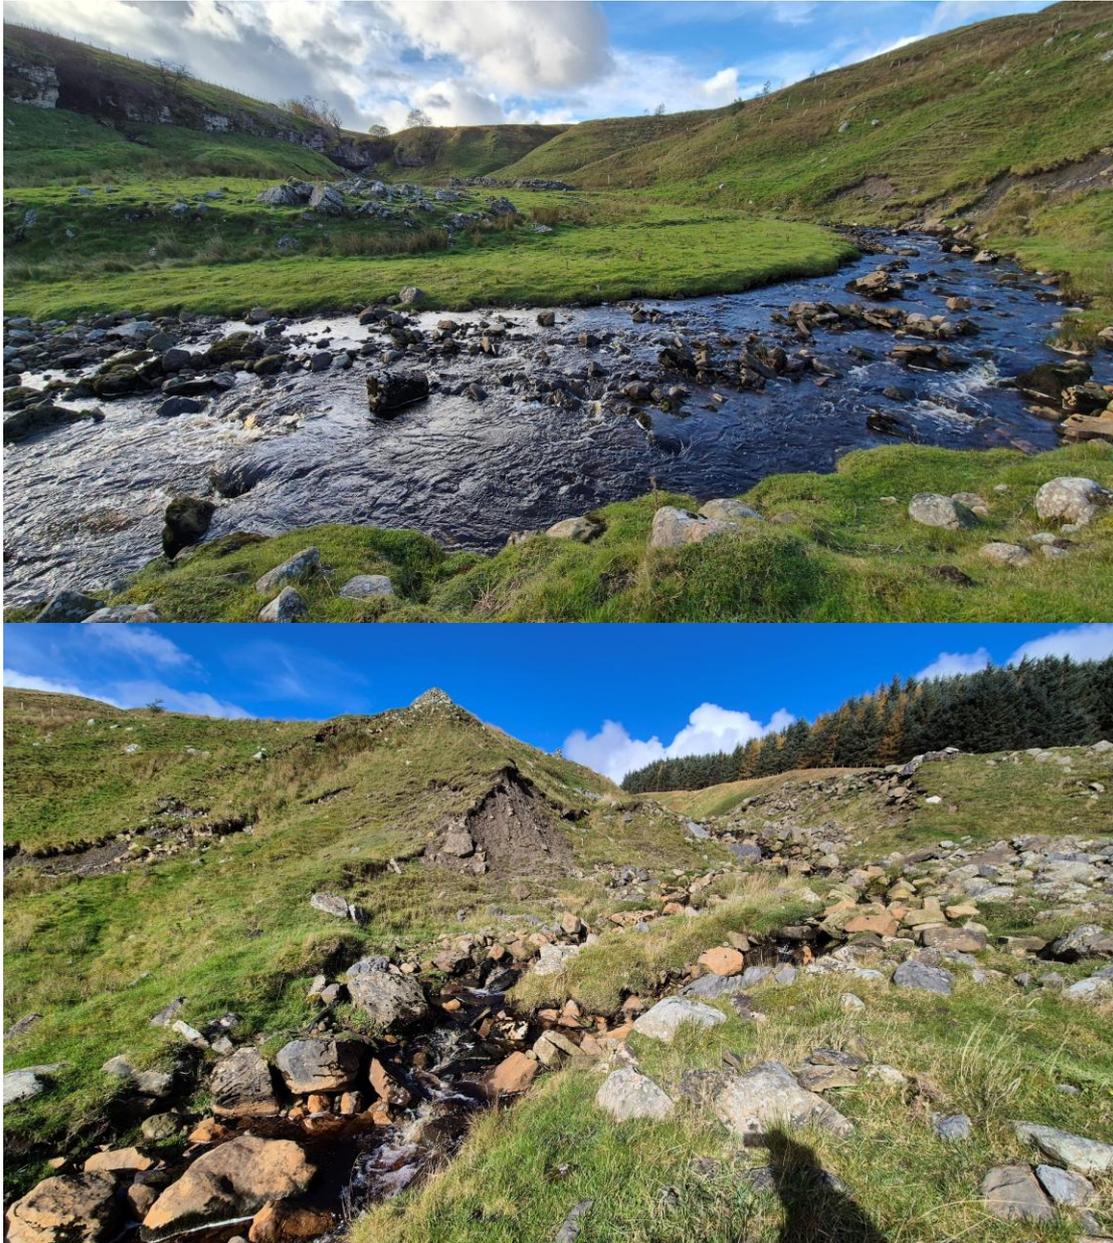
Fig 8: 54.196124 , -2.0016313 environs. Extremely large deposits of boulders both alongside the main channel (upper image) and in an alluvial fan (lower image) at the confluence of Lock Gill point to historical avulsion events. These may have been in response to destabilising human interventions like original tree clearance from the fells, drainage of the moors, and early forestry plantations. Note terracing in the valley sides adjacent to the obvious landslips in both images, caused by sheep tracking along the contours.

- Extract boulders from the piles that have not stabilised to the point of plant colonisation and return them to the channel as a dispersed matrix to reduce incision and increase hydraulic roughness.
- Exclusion of grazing will be necessary to allow the soils to stabilise and flora to recover.

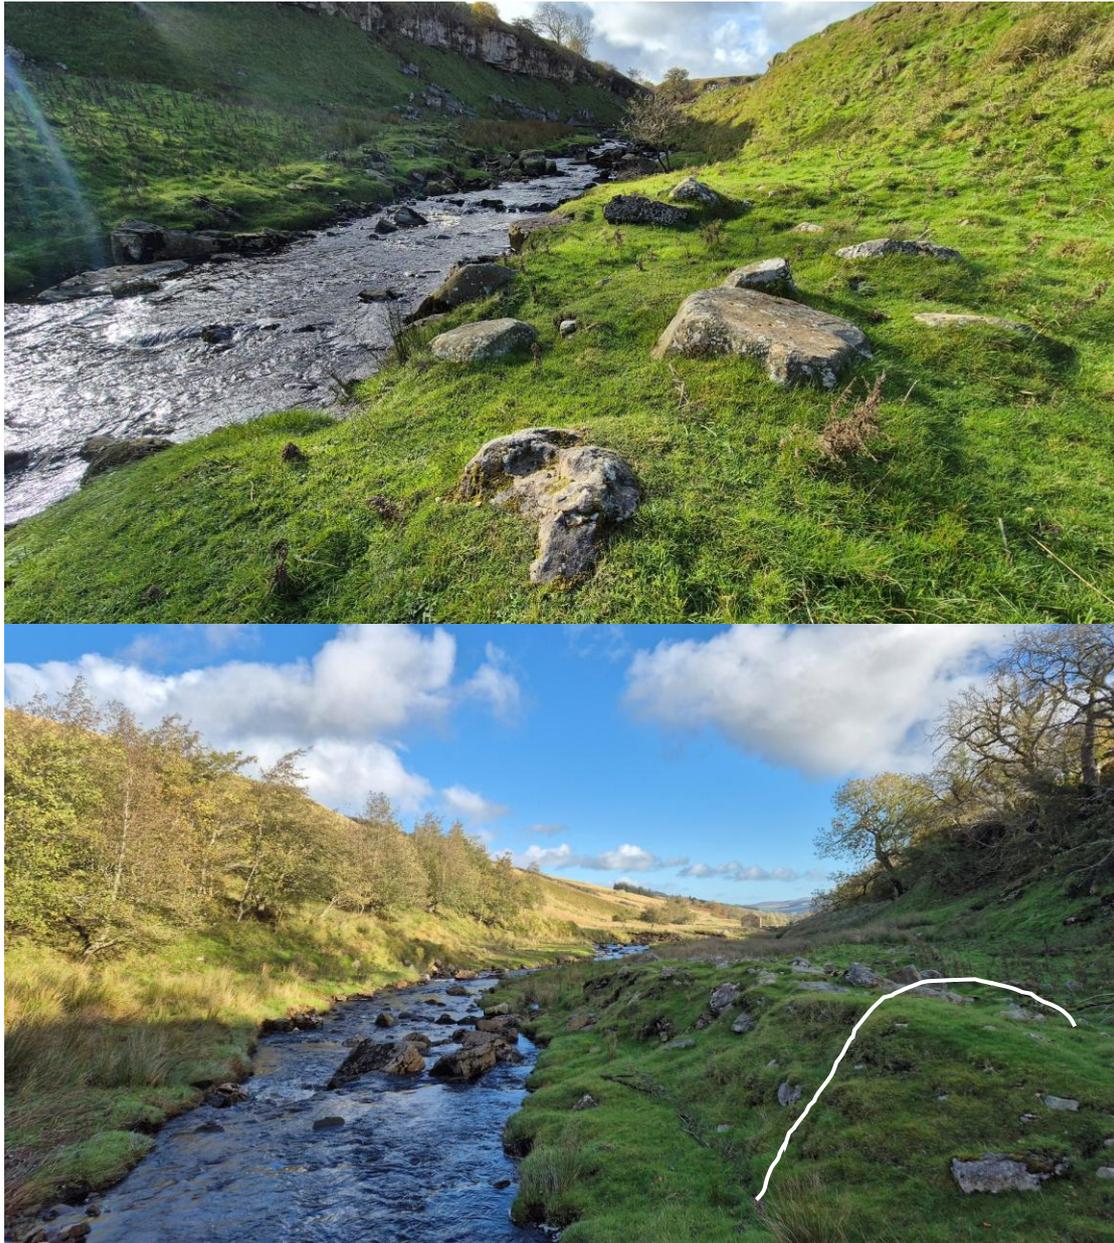
Fig 9: 54.196841 , -1.9991246 environs, looking u/s and d/s at the head of the straightened reach (which extended to 54.200912 , -1.9891137, ~950m). A small copse of alder and birch had been established on the LB (lower image)

- It appeared that large boulders had been removed from the channel (LB, upper image) or there was clear evidence of dredging spoil embanked to the RB (lower image; white line).

- Return stone to the channel to bed raise and increase sinuosity.
- Further augmented planting, or willow pegs / stakes added at high density (without guarding) and pushed into where embankment was removed from.

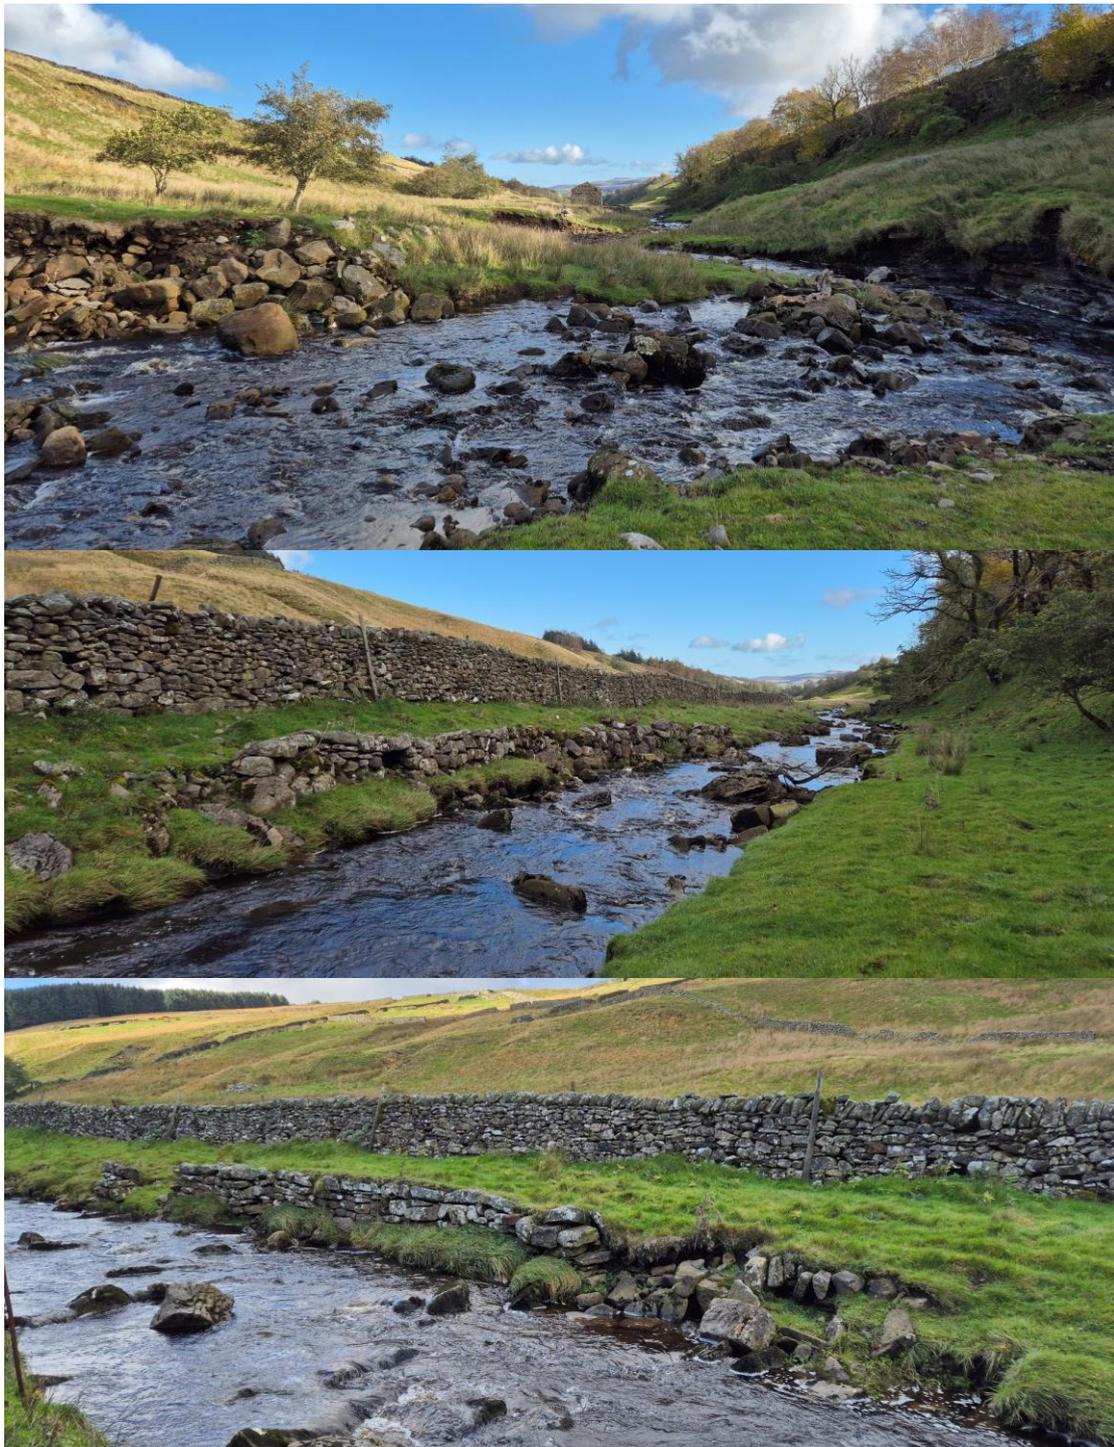
Fig 10: Upper image (54.197710 , -1.9973406) depicts one of the last renaturalising meanders at the head of the narrowest, straightest modified section. The larger boulders exposed in the LB beneath the hawthorn are part of a formalised embankment preventing the river migrating northwards. The lower two images (54.198536 , -1.9943412 environs) highlight embankment and walling of the LB and then a boundary wall set a few metres further back.

- Remove embankments and return all stone, including walling, to the channel

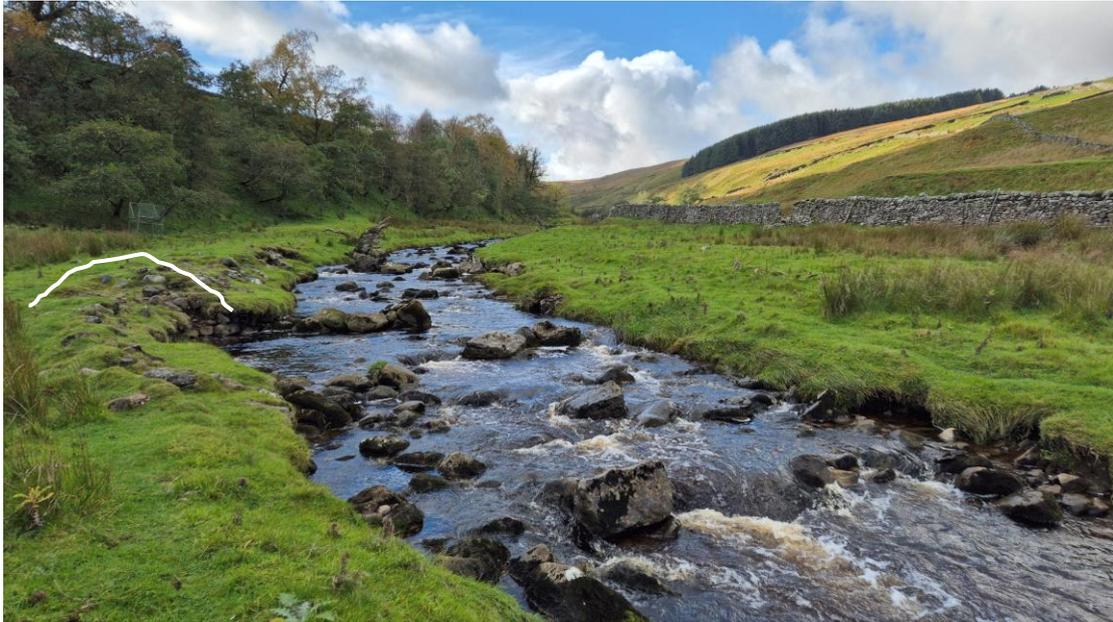
Fig 11: 54.199090 , -1.9924131. Looking back u/s to the straightened, constrained reaches highlighted in Figs 9&10. From this point down to 54.200912 , -1.9891137, the channel had been shunted first to the middle and then to the northern (LH) side of the valley and hence the embankment enabling that transition was mostly in the RB (white line).

- Removal of RB embankment to allow full access to floodplain.
- Return of the stone to the channel.
- Introduction of LWS

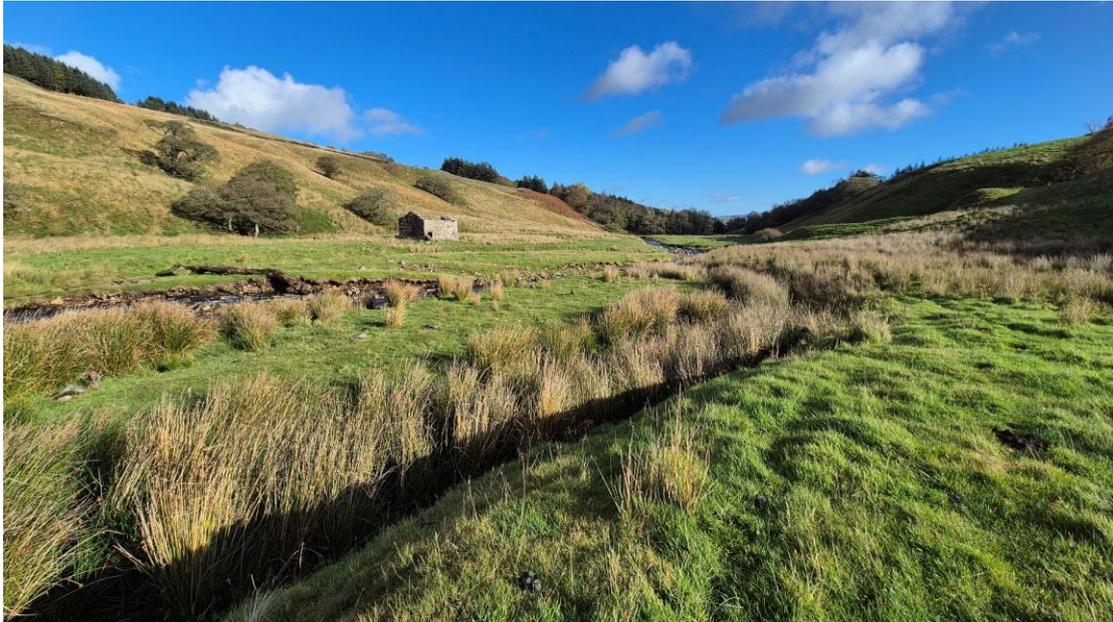
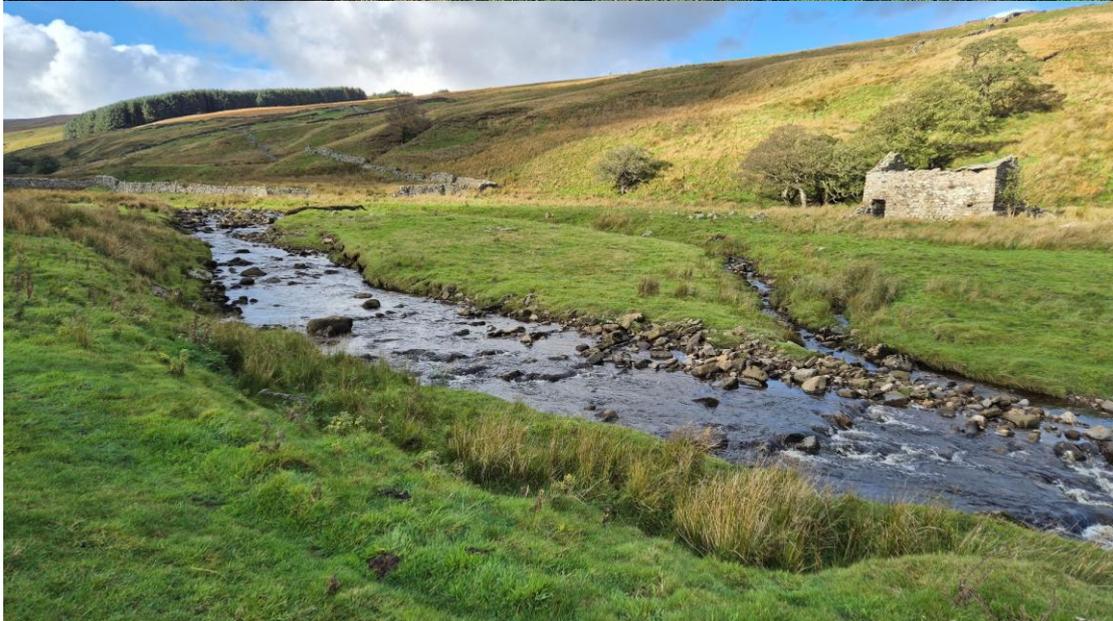
Fig 12: 54.199818 , -1.9911115. Plenty of evidence of paleochannels within the landscape to both sides of the extant, straightened channel.

- Open up access to any paleochannels that had been blocked.
- Cast any stone from paleochannels, redundant walling and embankments back into the channel to reduce incision.
- Addition of multiple LWS to push water onto floodplain earlier.

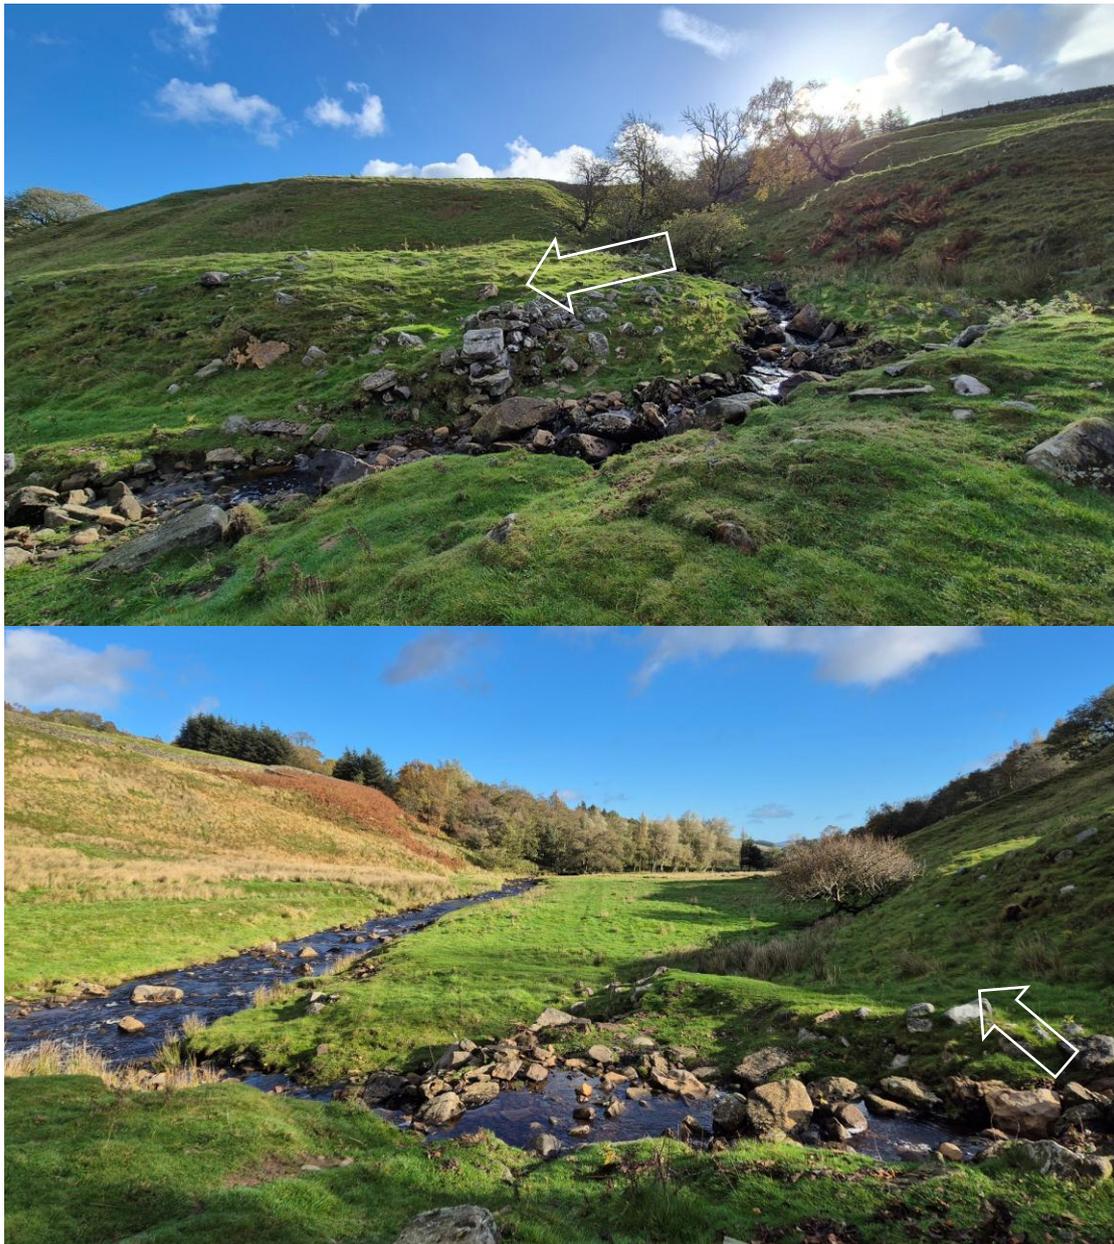
Fig 13: 54.199780 , -1.9905296. A substantial alluvial fan of large boulders as Crab Gill entered the floodplain from the south (RB) side of the valley.

- There appeared to be historic evidence of straightening of Crab Gill, perpendicular across the floodplain to the Cover, ie the shortest route possible.

- Reorganise the boulders to 'force' Crab Gill back onto what was its more natural course onto the RHS of the floodplain as indicated by the white arrows.
- Once directed toward the edge of the floodplain, allow it to form its own channel, akin to 'stage-0' restoration.

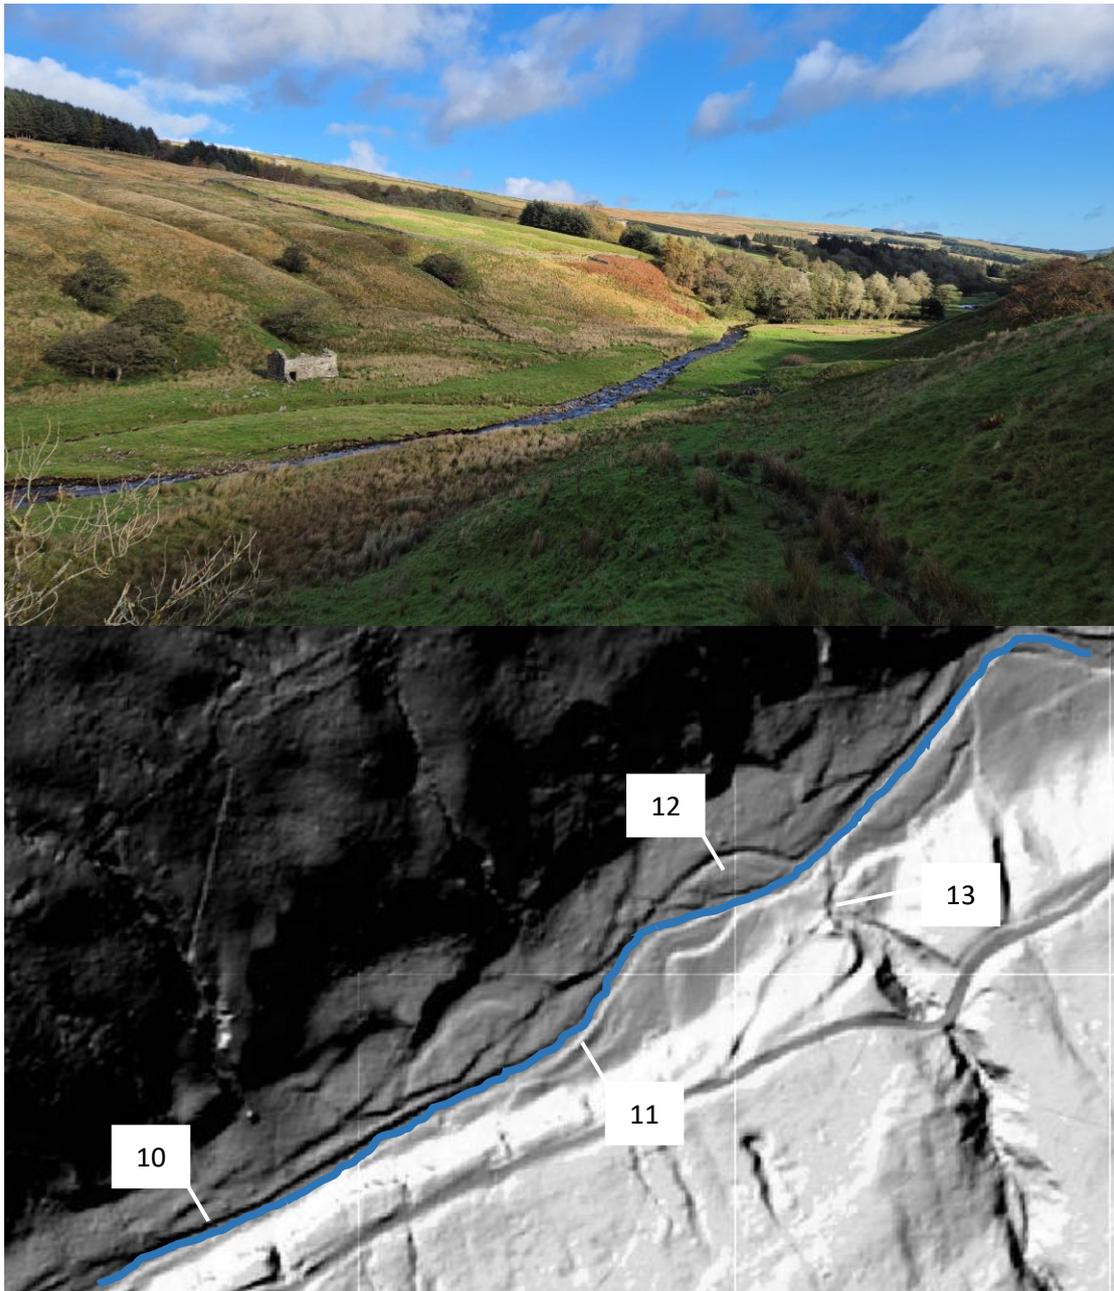
Fig 14: Taken from 54.199254 , -1.9911437, an overview of the modified, straightened channel, and the huge potential for paleochannel reconnection to either side, and a LiDAR-derived terrain model with the modified extant channel overlaid in blue.

Numbered callouts present the position of the features highlighted in Figs 10-13.

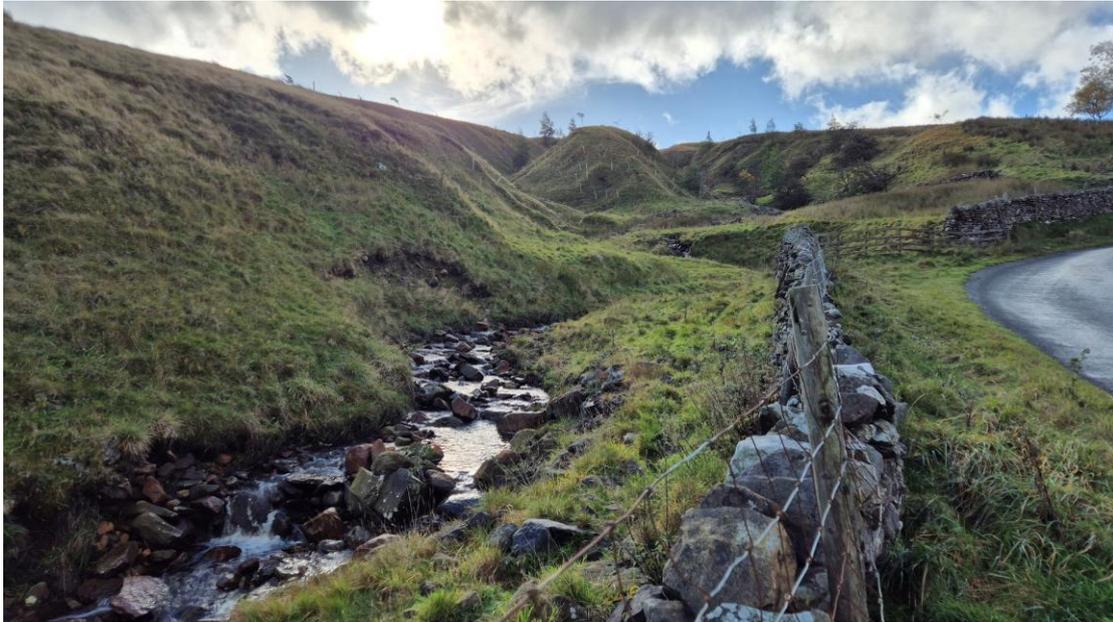
Fig 15: 54.202934 , -1.9822502 Burn Gill had been incorporated into a planting scheme in the past and a number of trees had established.

- Like most of the steep, narrow gills, the sides offered little in the way of quality grazing but livestock still accessed it and exacerbated erosion and slippage by tracking and grazing.
- Flows would naturally be flashy or even ephemeral but accentuated further because of unfettered grazing.

- Ungrazed, shaggy herbage and tree cover would help to slow flows during spates, but also to keep water cool during summer low flow conditions.
- Hence, revisit and bolster planting scheme, and where easily accessible like here, adjacent to the road, there is a fantastic opportunity to roughen up the habitat even further with addition of windblown trees and crowns or rootplates.
- The steepness and flow regime of many of these gills may be too extreme for consistent use by fish (although ideally, they should be surveyed to check), but naturally fish-free channels are even better for macroinvertebrate production and supply d/s via drift and emergence.

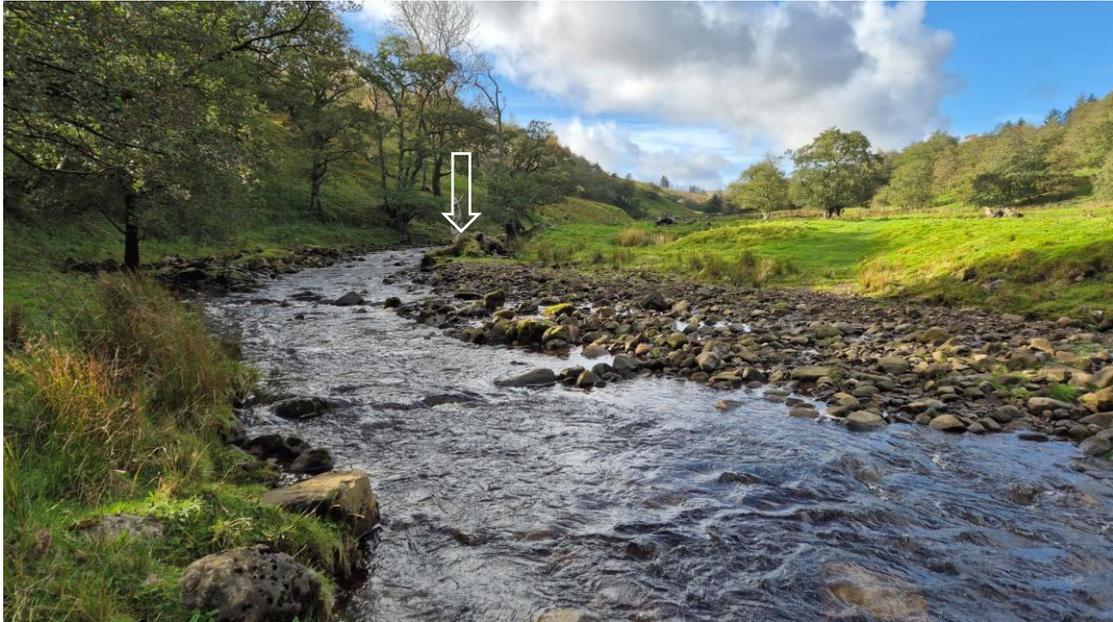
Fig 16: 54.202934 , -1.9822502. Looking u/s at the remarkable influence of one fallen ash (highlighted by the white arrow), responsible for a substantial proportion of the deposition bar d/s on the LB.

- Livestock access was probably hindering the colonisation of parts of the deposition bar by pioneer plants which would help to stabilise it.
- Only mature (and failing) trees near to the riverbank because of stock browsing; no natural regeneration to succeed those mature specimens in time.

- Failing trees such as ash with *Chalara* could be proactively pulled over or felled and lodged / tethered as LWS.
- Preventing access to the riparian strip to allow native herb understorey and natural regeneration of trees.

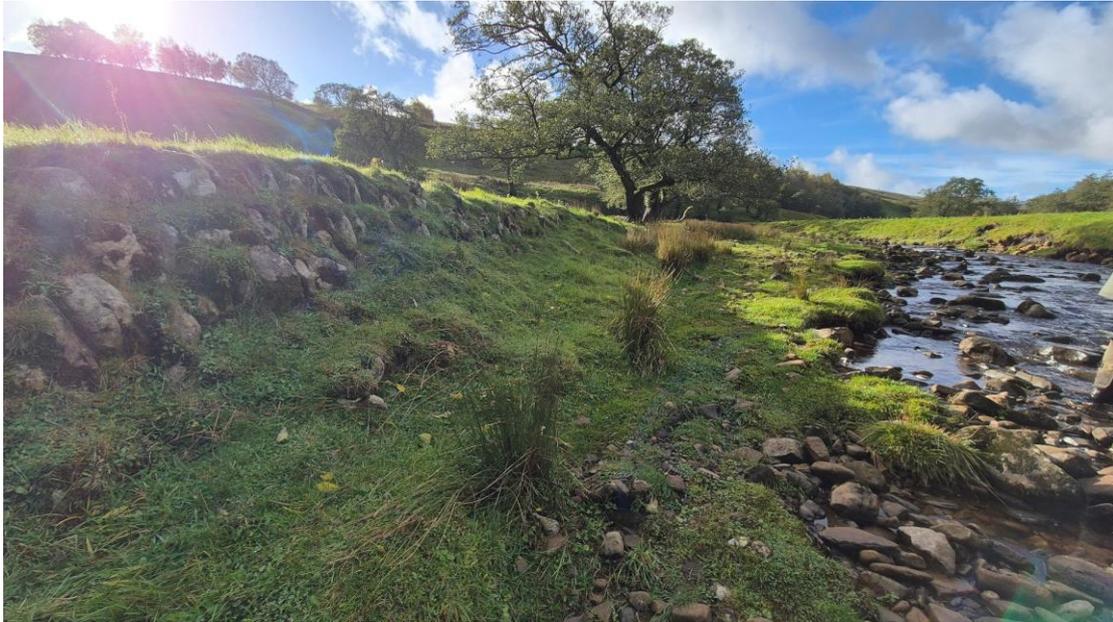
Fig 17: 54.202866 , -1.9843519. Another substantial embankment of boulder and cobble removed from the channel. It is also likely that the head of a paleochannel was blocked in this section of RB – see Fig 18 for the visible path of the paleochannel.

- In conjunction with reinstatement of the paleochannel (overleaf), cast all stone back into the extant channel to constrict and bed-raise, helping to reactivate the paleochannel.
