# WILD TROUT TRUST

**Advisory Visit**

**River Cover (Ure)**

**for Ure Dales Landscape Recovery, 2025**

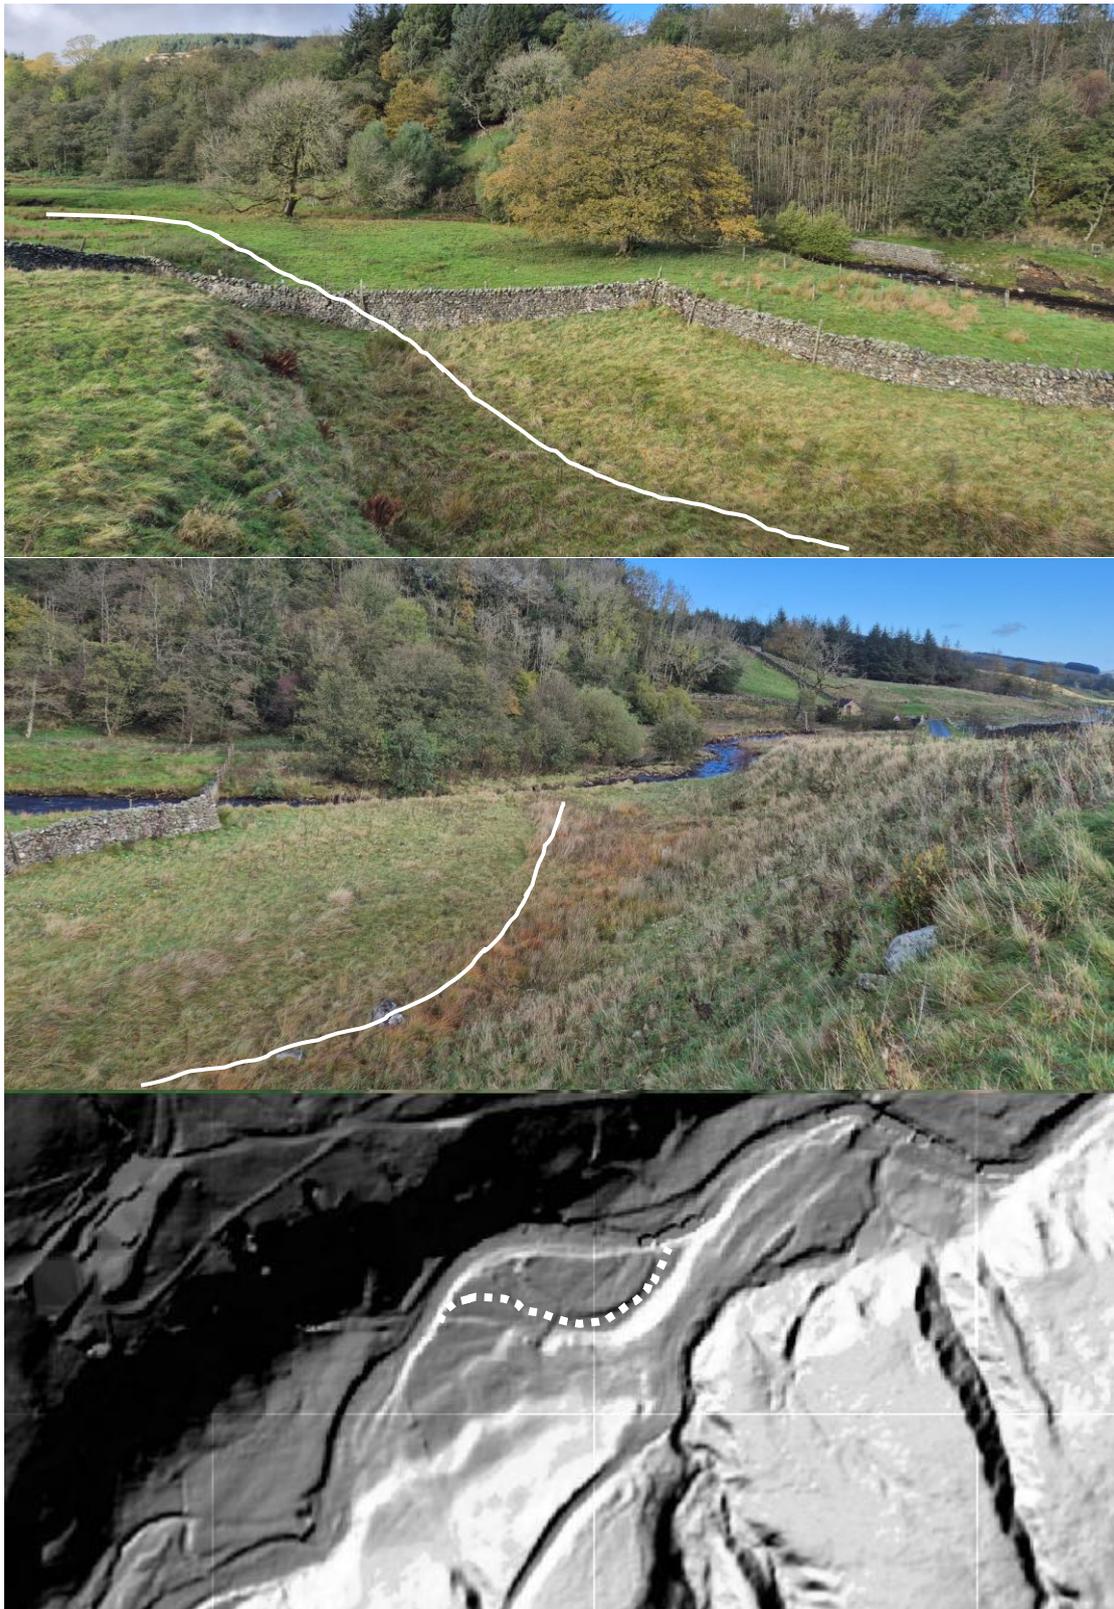
Fig 18: 54.203056 , -1.9830543. Photographs with accentuating white lines and LiDAR-derived terrain model of the paleochannel.

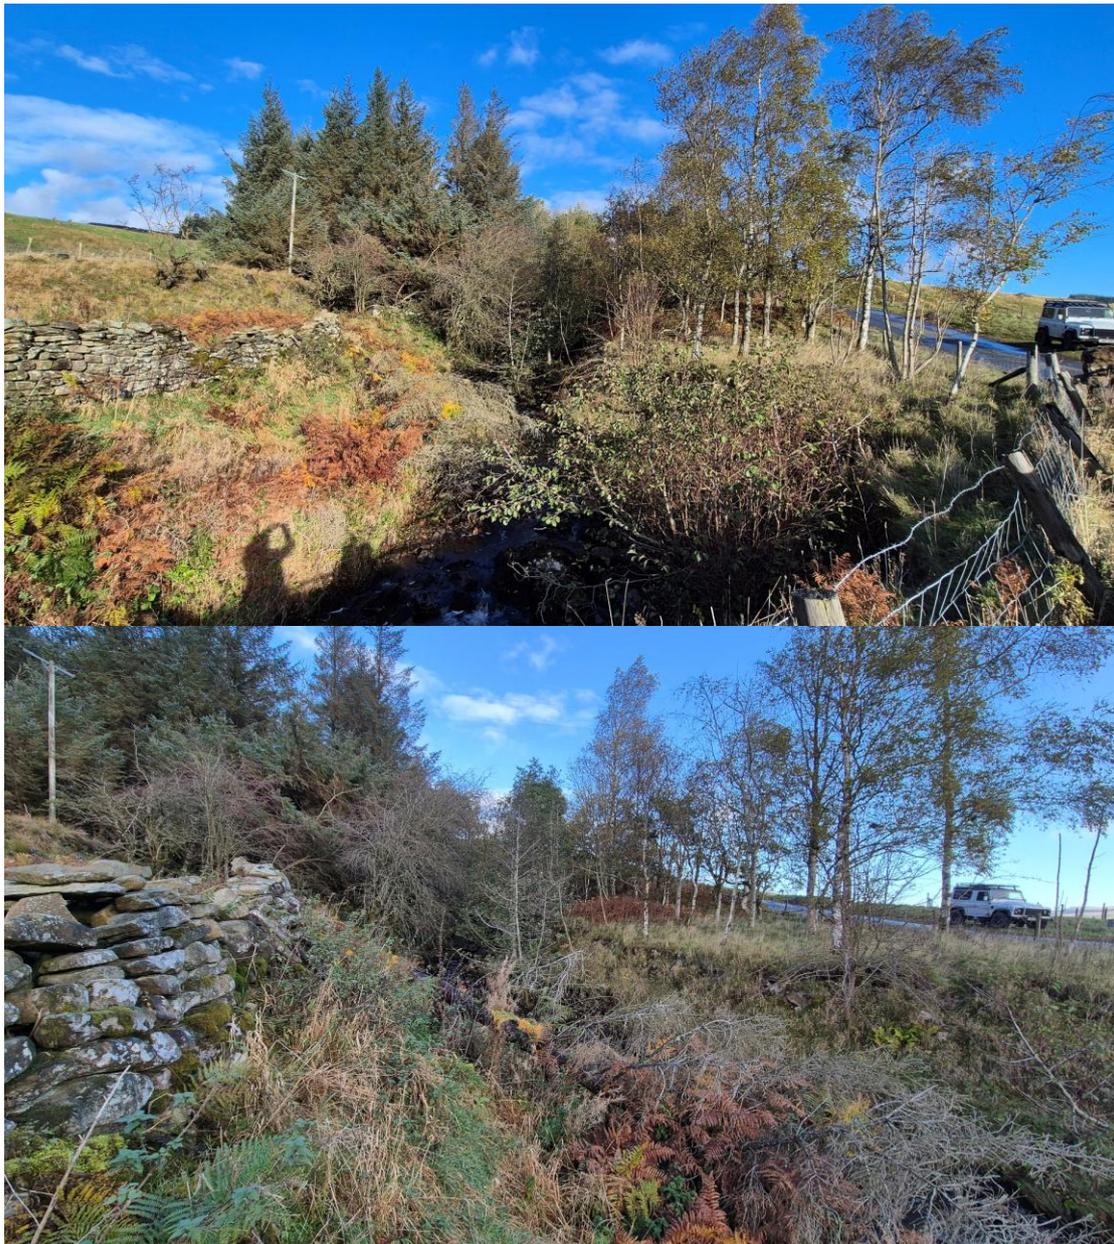
Fig 19: 54.204405 , -1.9795118. Compared to many of the tributaries, West Gill appeared to have been protected from livestock for longer, in part because it had also been used for forestry plantation. Hence, there was much better-established tree cover shrouding the channel.

- Given the steep nature of the valley sides, any future harvesting of timber could result in fine sediment ingress to the beck.

- Selective use of individual trees for habitat restoration elsewhere, rather than blanket felling of the remaining plantation trees. For example, the crown (~60% of one tree) had been left *in situ* in the lower image and was doing a fantastic job of performing Natural Flood Management.

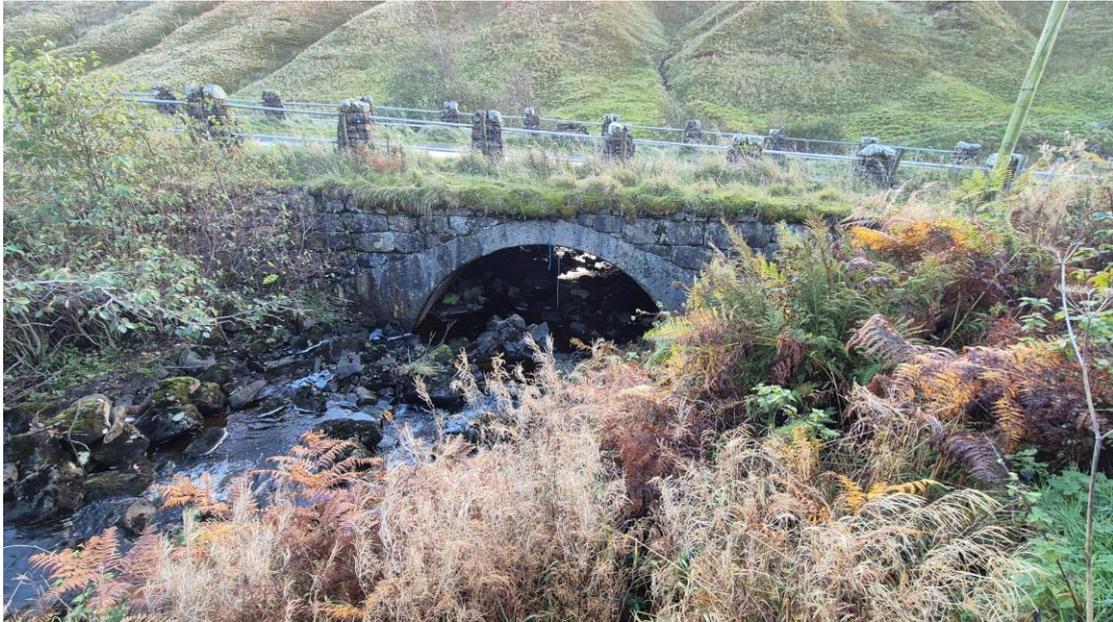
Fig 20: 54.204288 , -1.9794127. The road bridge over West Gill contained a natural bed throughout and hence caused no issues for fish passage. Historically, there was evidence of cobble, rock, and boulder build-up at the bridge which had been dredged out and placed on the bank on the u/s side (right of shot).

- Given the tree cover along West Gill now, there is less likely to be an event which would cause sediment to build up in such volumes. However, if it does occur, then it would be less detrimental to the geomorphology of the channel to return any removed sediment to the d/s side of the bridge and let it disperse naturally. Watching brief.

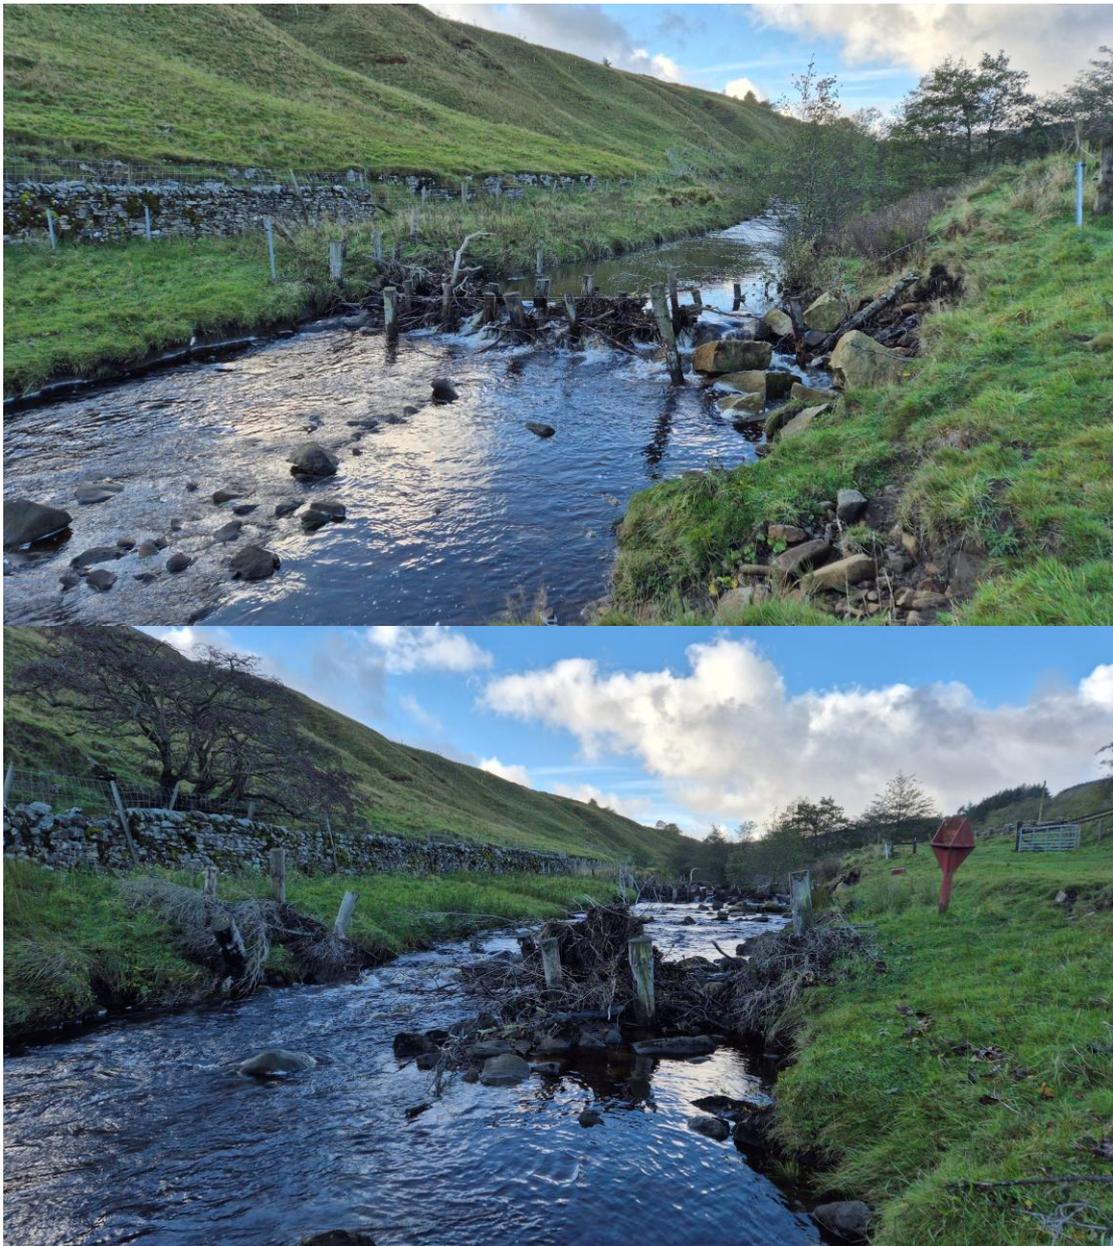
Fig 21: 54.204264 , -1.9787090. Looking u/s at a couple of 'beaver analogue dams' or 'pole assisted log structures' installed with the best of intentions to create a holding pool for bigger fish. The uppermost one still reasonably intact, but the lower one was blown-out to the RB.

- While at least the upper one had achieved what a beaver analogue dam should do, ie impound water to a certain extent, it wasn't the most natural looking of structures, using plantation tree trunks as a line of posts between which brush and boulders had been placed.
- The channel was artificially straightened and confined already throughout this reach which probably contributed to the failure of the second. However, damming the channel simply maintains those artificial features and exacerbates their issues further.

- Beavers need to constantly maintain their dams, so such analogues need constant work too.

- For a more sustainable approach, let beavers do beavery things. However, it is unlikely that beavers would find much of the Cover suitable in its current state.
- Better to get the channel and the riparian zone restored back to a more functional character first and then use LWS as advocated previously to accentuate features such as deeper pools which should then maintain themselves.

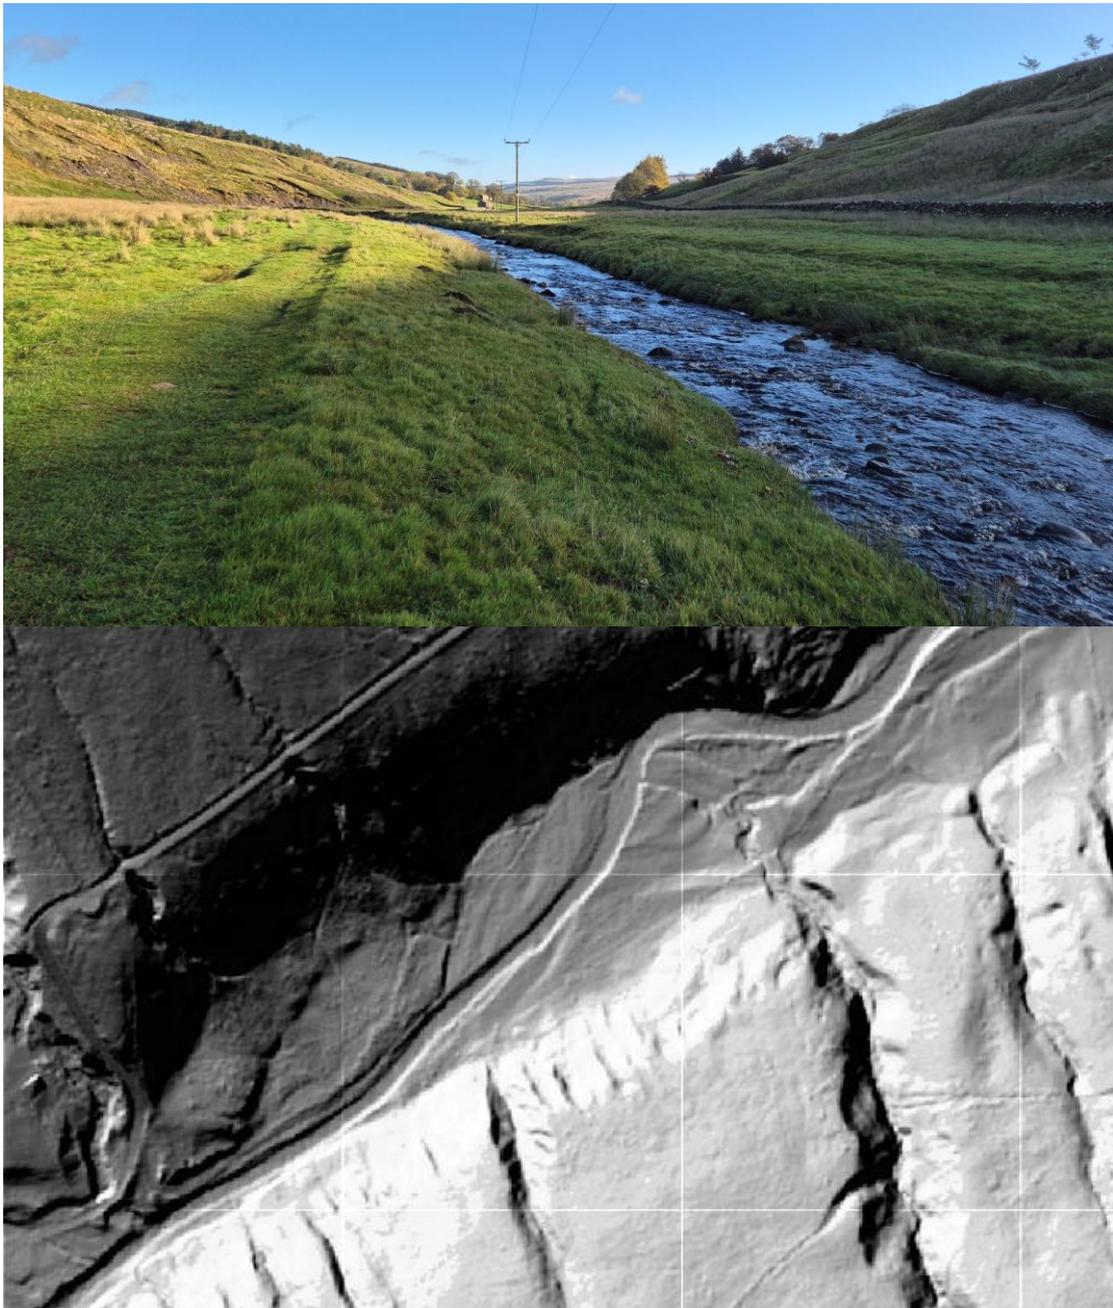
Fig 22: 54.205238 , -1.9766736. Suspiciously long, straight reach with embankment of stone and a consistent slope, certainly along the

LB. The LiDAR-derived terrain model clearly shows multiple meandering paleochannels etched into the floodplain.

- Rework both banks where there was clear embankment, and especially where the LiDAR revealed paleochannels might cross the extant channel.
- Separate alluvial material from soil and sod and return stone to the channel. Bank lowering and bed-raising in combination to reconnect the channel better with its floodplain and reinstate a more meandering form.
- Scatter LWS within the restored channel and floodplain.

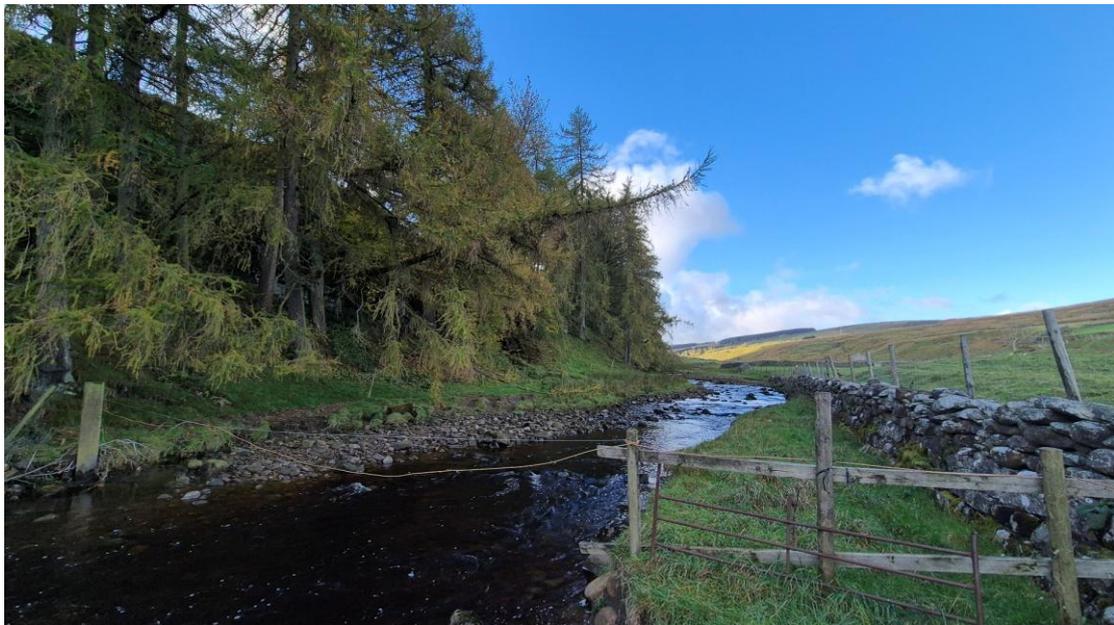
Fig 23: 54.207692 , -1.9672404 A small plantation of mature larch and possibly some other conifers on the RB, with the channel pinned to that side of the valley. A boundary wall and watergating restricted stock movement along a very narrow strip of LB, exacerbating the stressors of grazing and trampling.

- Ideally, the wall boundary and any embankment within the LB should be removed to allow the channel to re-engage with the floodplain – NB this may be an ownership boundary.
- Certainly, scope to use the failing trees for habitat improvements, either pulled over or felled and lodged / tethered *in situ* or d/s.
- Ideally exclude stock from this small parcel of woodland to re-invigorate some more diverse deciduous tree cover.

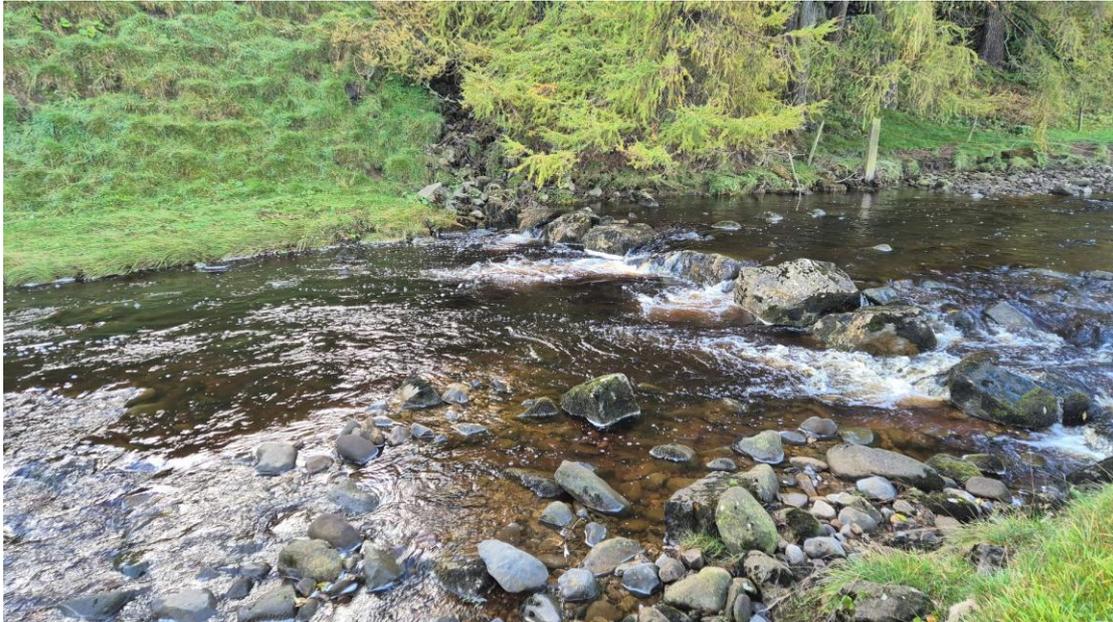
Fig 24: 54.207692 , -1.9672404. A boulder weir at the d/s end of the small plantation (Fig 23).

- Again, put in with the best intentions to create a pool via down scour on the d/s, actually, within the confines of the straightened, dysfunctional channel, any benefit of the short pool was being offset by the aggrading of sediment u/s of the weir, and maintenance of artificially consistent channel proportions.
- Little cover associated with the short pool. The bankside vegetation had been reduced to short sward grass, and the tree cover u/s was larch.

- In conjunction with channel restoration measures, it would be better to relocate 40% of these boulders from one side to the other as a low berm and hence accentuate sinuosity, or use them to bed-raise elsewhere to help reactivate paleochannel reconnection.

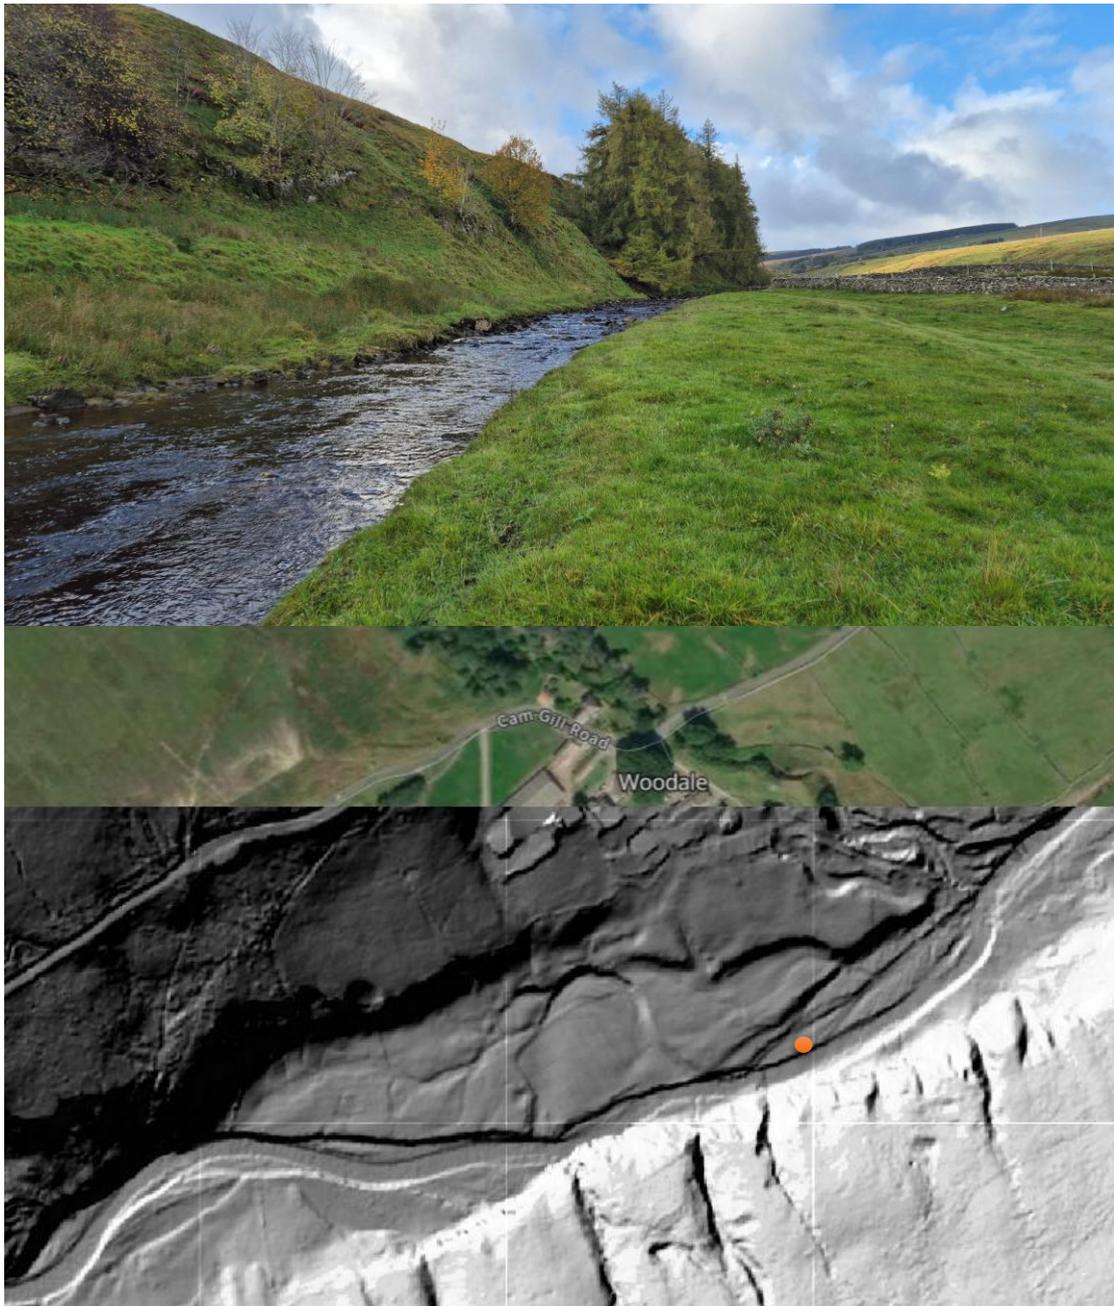
Fig 25: 54.208000 , -1.9660551. Looking u/s at the plantation with the channel pinned to the southern side of the valley by an embankment; the position of the photographer is marked by the red dot on the LiDAR image, and the freely meandering paleochannels within the floodplain to the north are very obvious.

- Removal of any revetment and embanking material and return of stone to the channel, scattering of LWS from the plantation within the channel and floodplain.
- Ideally pepper with willow and alder whips to kickstart riparian tree cover.

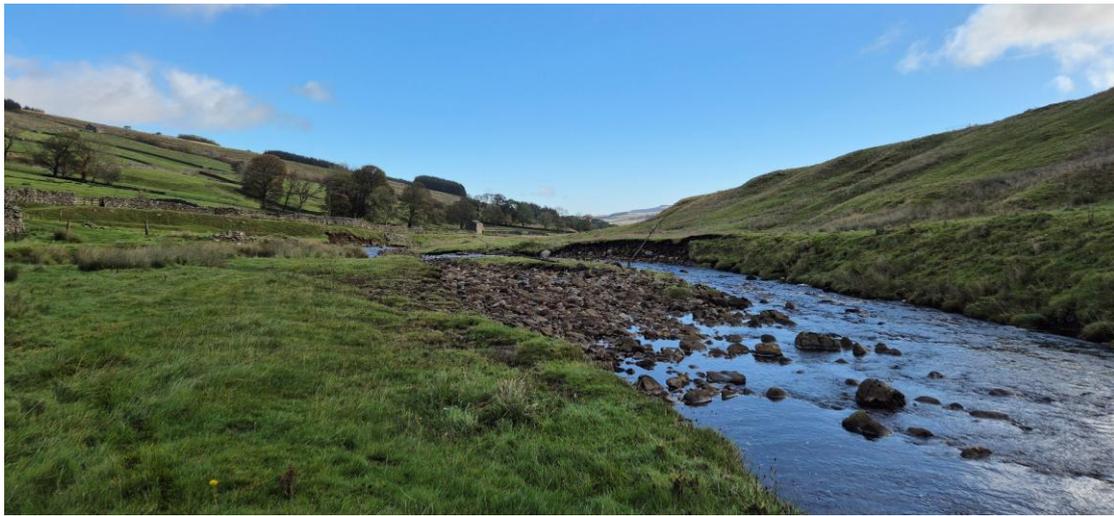
Fig 26: 54.208000 , -1.9660551. Looking d/s at the tail end of the long, straightened reach that had been pinned to the southern (RH) side of the valley, and to where it was beginning to interact with the alluvial fan of deposition from Fall Gill from the northern (LH) side; Fig 27.

- The vertical eroding RB in the distance was caused by the modifications to the channel u/s, delivering water too quickly to that point.
- Highly exposed channel with shallow water, prone to warming.

- Explore opening up some of the paleochannels to the LB and restrict grazing further.

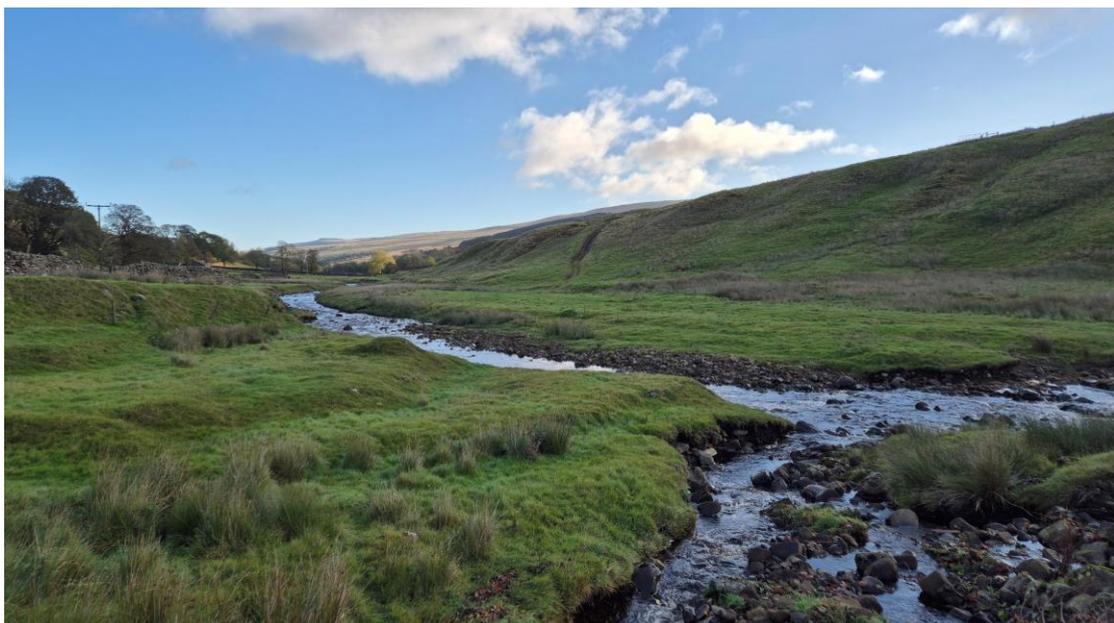
Fig 27: 54.208659 , -1.9650862 – confluence of Fall Gill (foreground) with the Cover; the furthest d/s observation point again highlighting how exposed and incised the channel is.
