River Don Walkover
(River Tyne Catchment)
29th & 30th November 2016

Undertaken by Gareth Pedley, Wild Trout Trust

1.0 Introduction

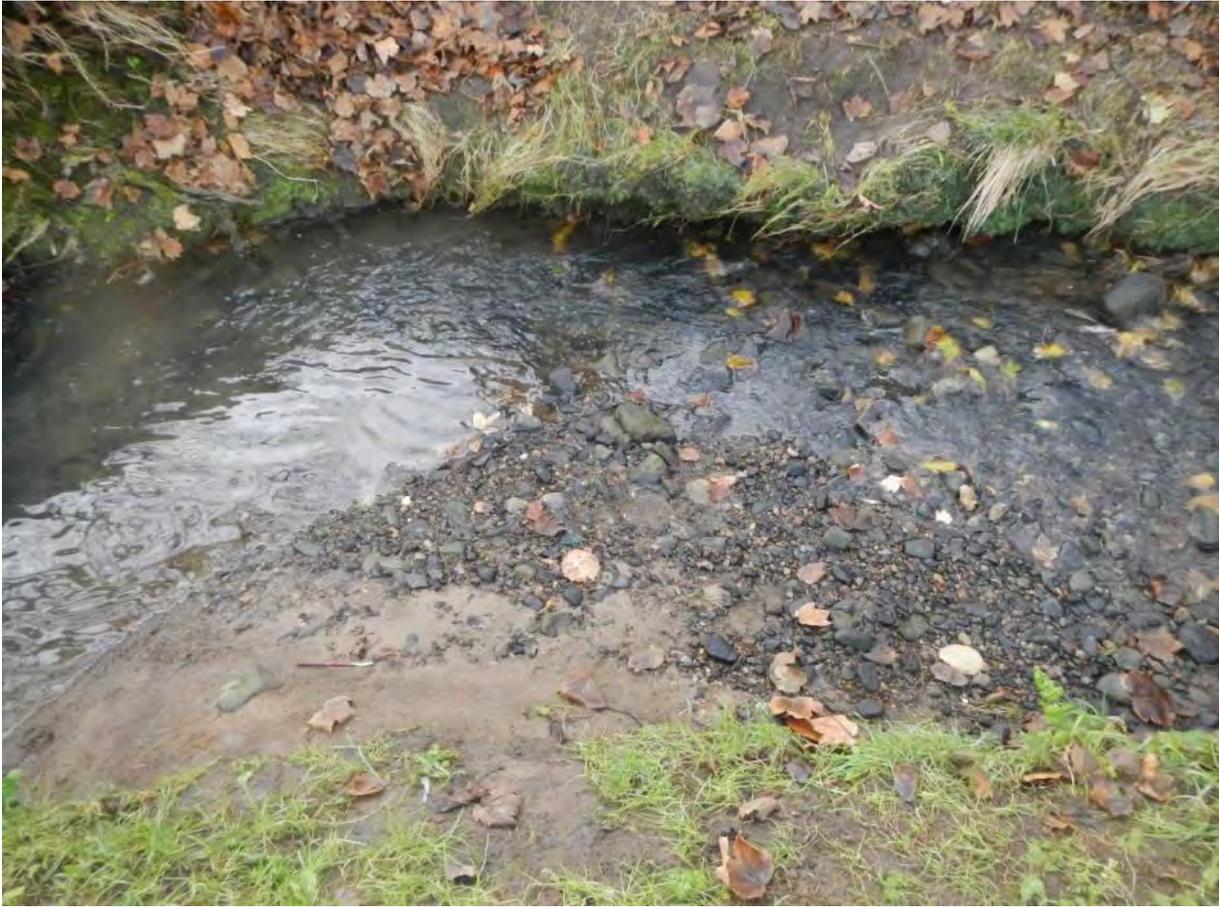
Where bends remain, greater depth variation and substrate sorting were observed (Photo DSCN4980), providing a greater range and quality of habitat. In areas of higher habitat quality, ephemerals were found (Photo DSCN4981). In other areas, the channel appears to have been excavated down to the underlying boulder clay, with the resulting uniform width/depth channel compounding the fine sediment and degraded habitat issues (Photo DSCN4986). While some of the substrate in this area is capable of providing good invertebrate and salmonid spawning habitat, the inputs of fine sediment u/s and reduced bed sorting within the modified channel greatly reduce its ecological quality.

Photo DSCN4980. Where bends remain, greater depth and substrate diversity are present, although these features are not as abundant or structured as would be expected on a more natural channel.

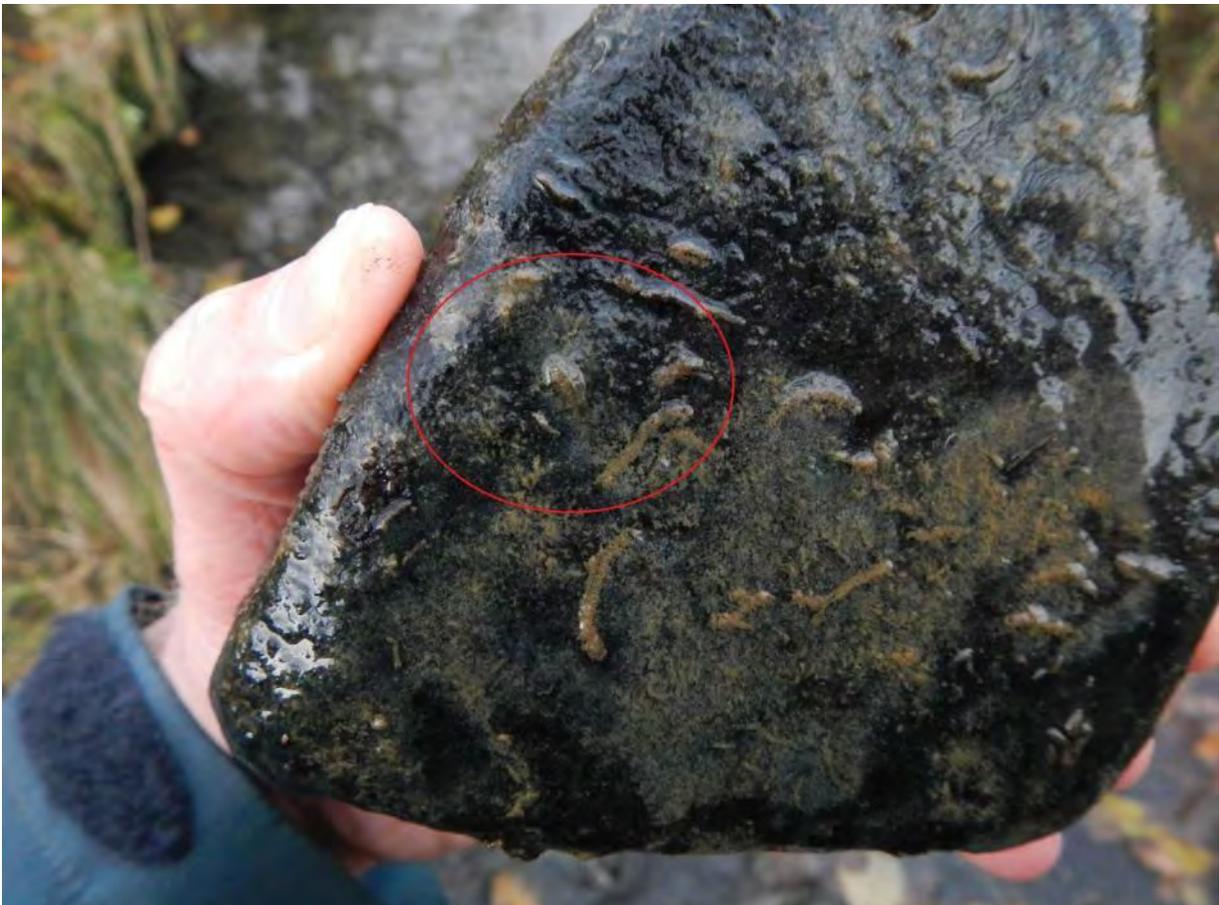
Photo DSCN4981. Ephemeropterans were observed within the golf course at low densities. Also note the fine sediment accumulation on the biofilm.

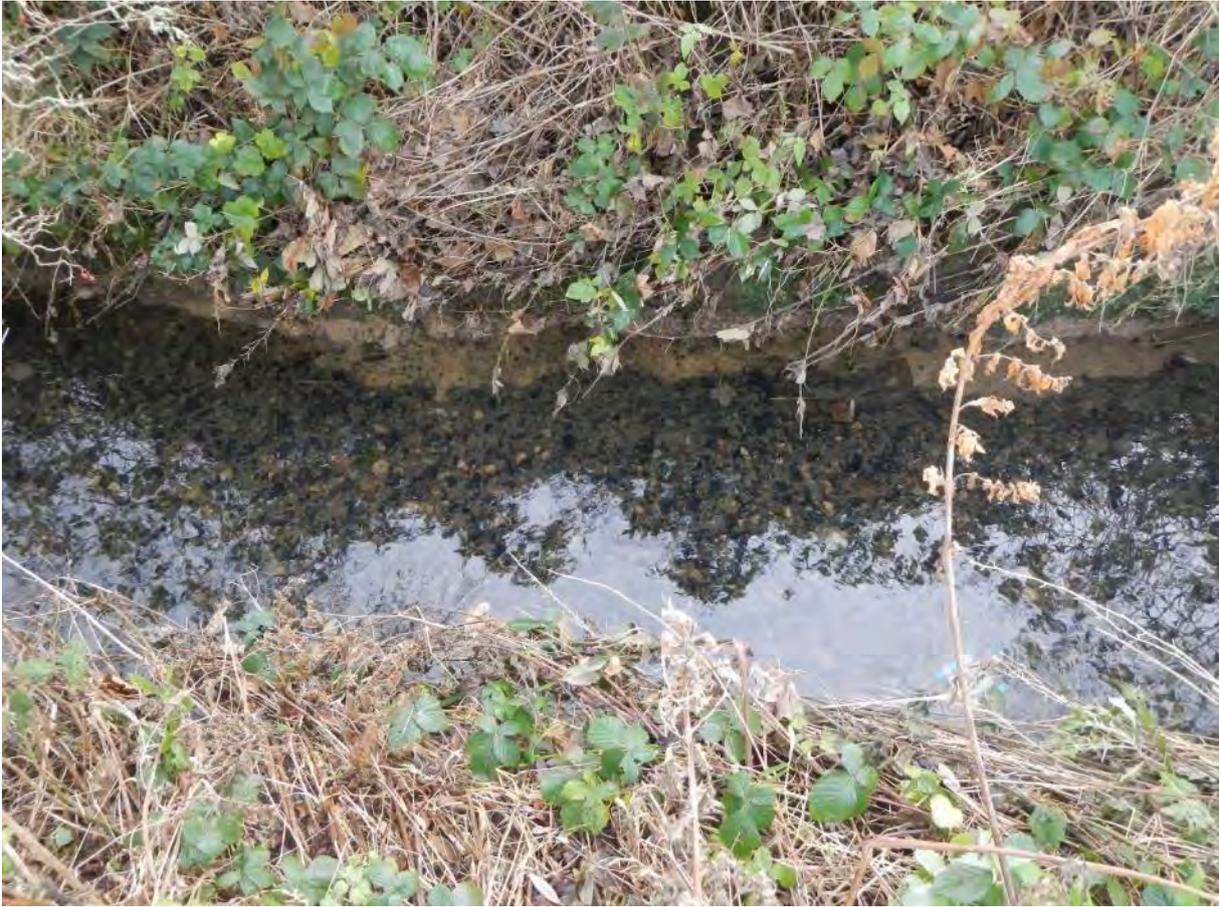
Photo DSCN4986. Straightened, uniform capacity channel sunken into the underlying boulder clay. Note the lack of sediment sorting, high loading of fine sediment and resulting poor habitat quality.

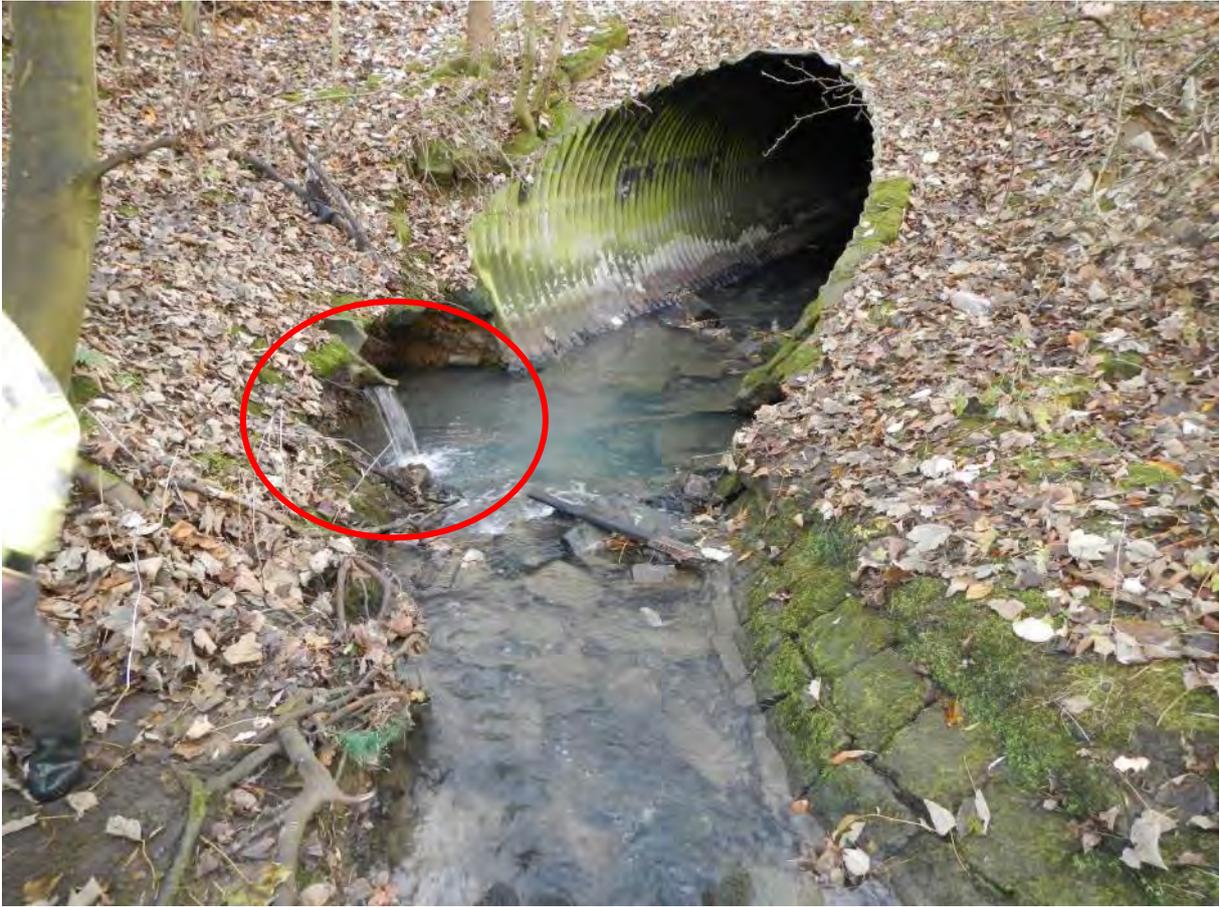
At the d/s extent of the golf course the river enters the A195 culvert, which is not considered to be an obstruction to fish passage. At the u/s side, a pipe was observed to be discharging discoloured water (Photo DSCN4989). Immediately d/s of the culvert another large culvert joins the channel but was not discharging at the time (Photo DSCN4991). Detailed invertebrate surveying was not undertaken but further stone turning failed to identify ephemeroptera (or much else) for some distance d/s of the culverts. Further investigation of the quality of both potential discharges and the local invertebrate populations would be beneficial.

Photo DSCN4989. A195 culvert. No fish passage issues, but a notably discoloured water discharge immediately u/s of the culvert (NZ 30348 59922).

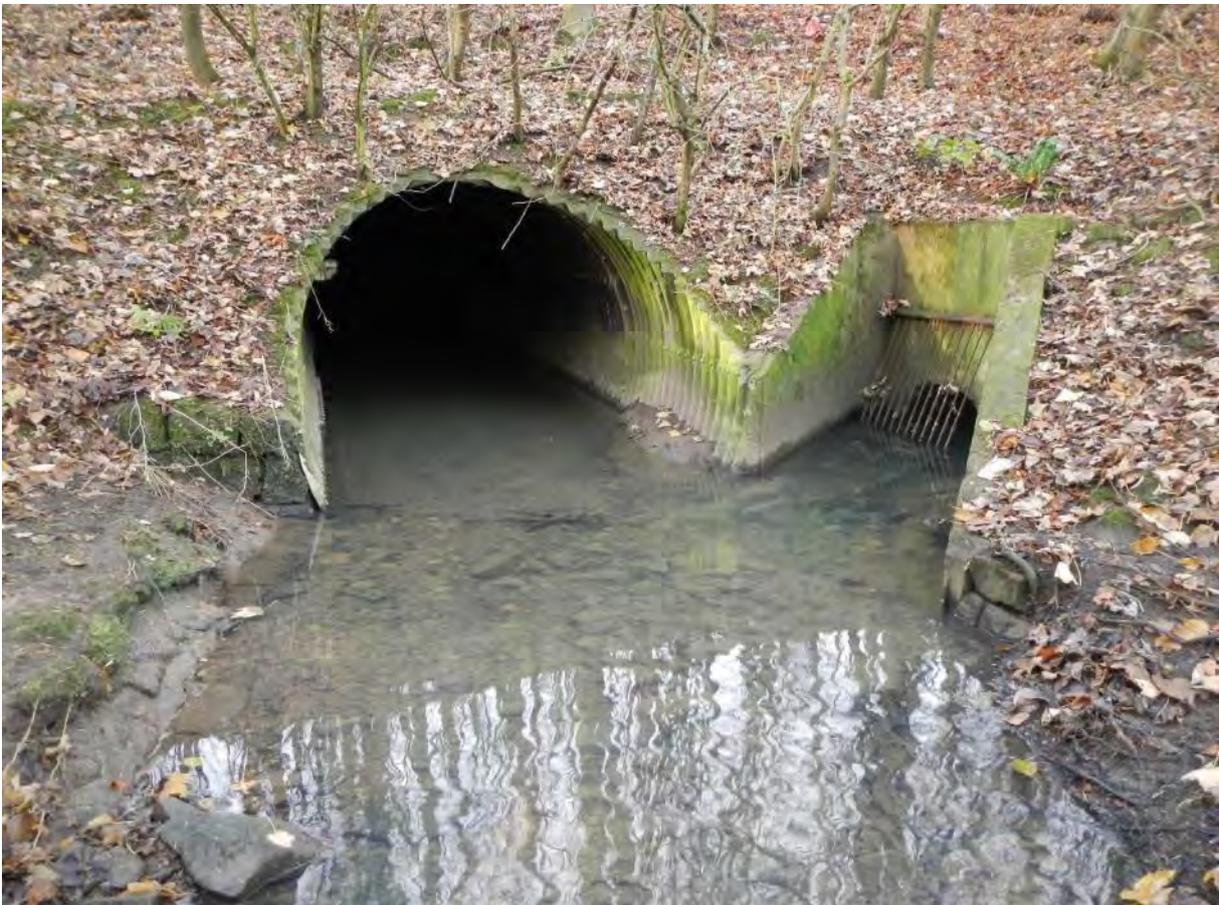
Photo DSCN4991. The d/s end of the A195 culvert with an additional culvert on the LB (right of shot). No issues with fish passage at this location although no ephemerals were identified by stone-turning in the channel for some distance d/s.

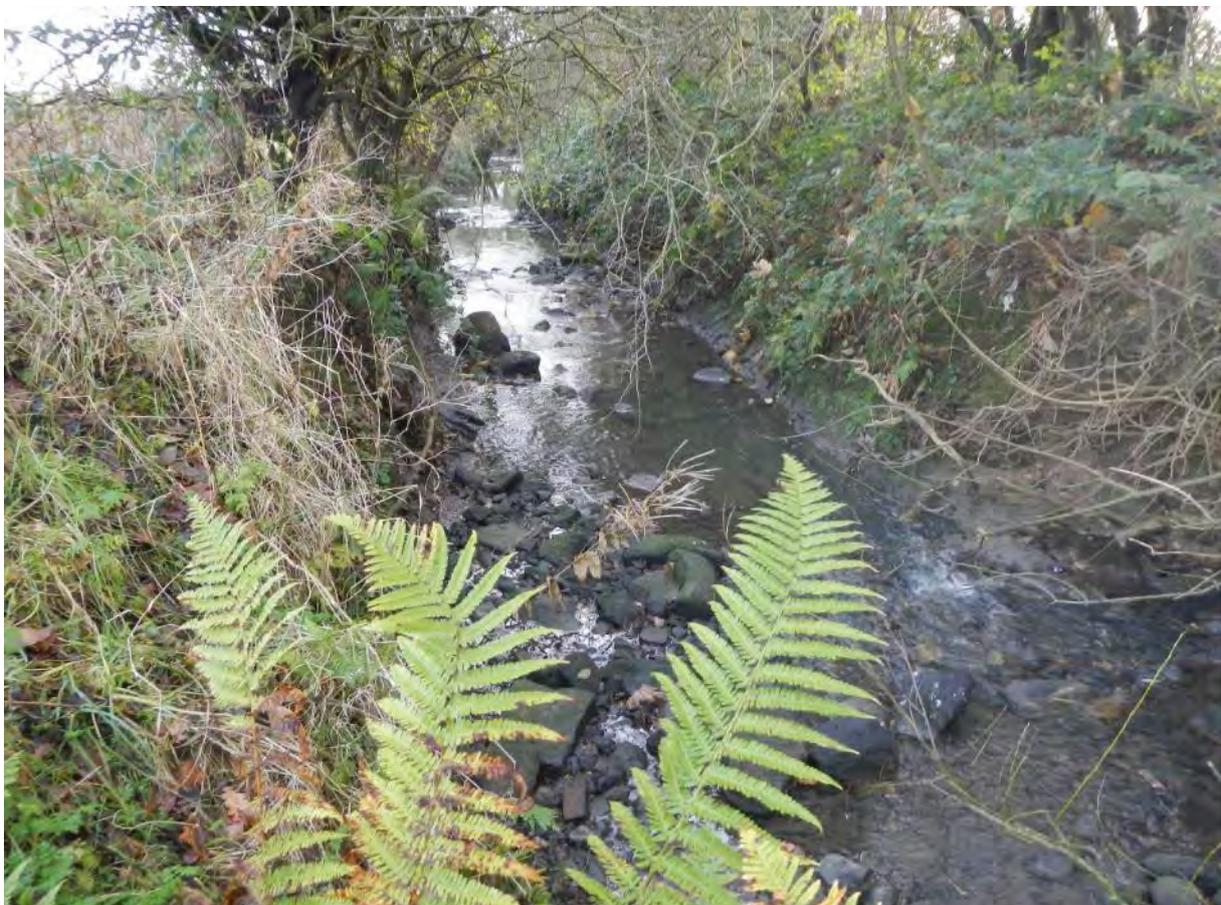
Major channel realignment and re-sectioning continues d/s of the A195 culvert, where there is a general lack of gravel and depth variation, with predominantly coarse cobble substrate remaining (Photo DSCN4997); almost certainly a result of bed scouring at high flows within the straightened, incised channel. The result is degraded salmonid habitat, with long sections only capable of supporting fry habitat and younger parr (e.g. no spawning, older juvenile or adult habitat). The issues with channel incision and high flows will also make it a particularly hostile place for juvenile fish in high flows and have also led to a major logjam/debris dam to become established in one area which inhibits fish passage (Photo DSCN5004). Areas of the substrate could potentially support larger migratory salmonid spawning, but the lack of sorting and fine sediment issues greatly degrade that habitat (probably below viability).

Photo DSCN4997. Straightened, uniform and incised channel, lacking in finer gravel substrate and depth variability.

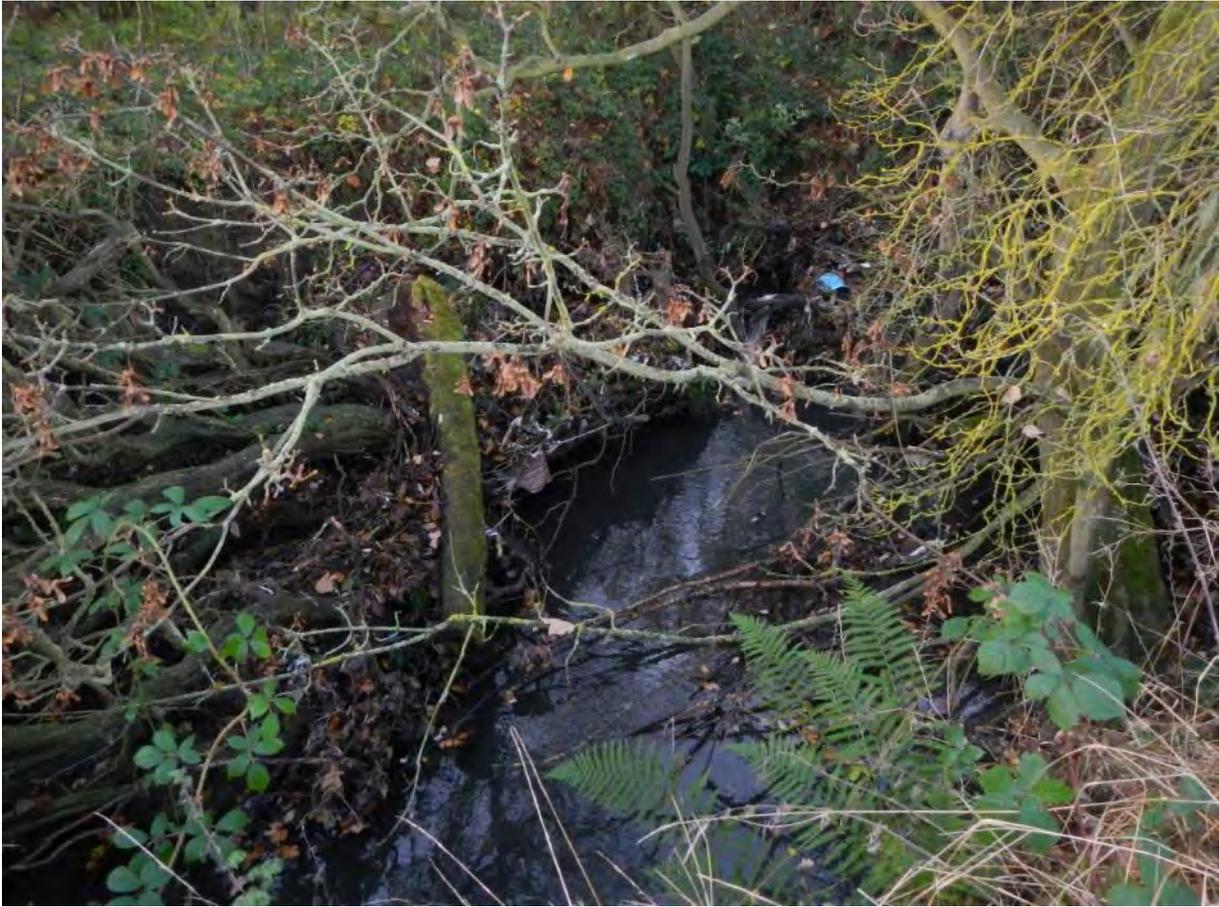
Photo DSCN5004. The deeply incised, trapezoidal channel has led to woody material becoming lodged and causing a more significant obstruction than is likely to occur on a more naturally profiled channel. With the extent of debris now trapped, this is likely to obstruct fish passage.

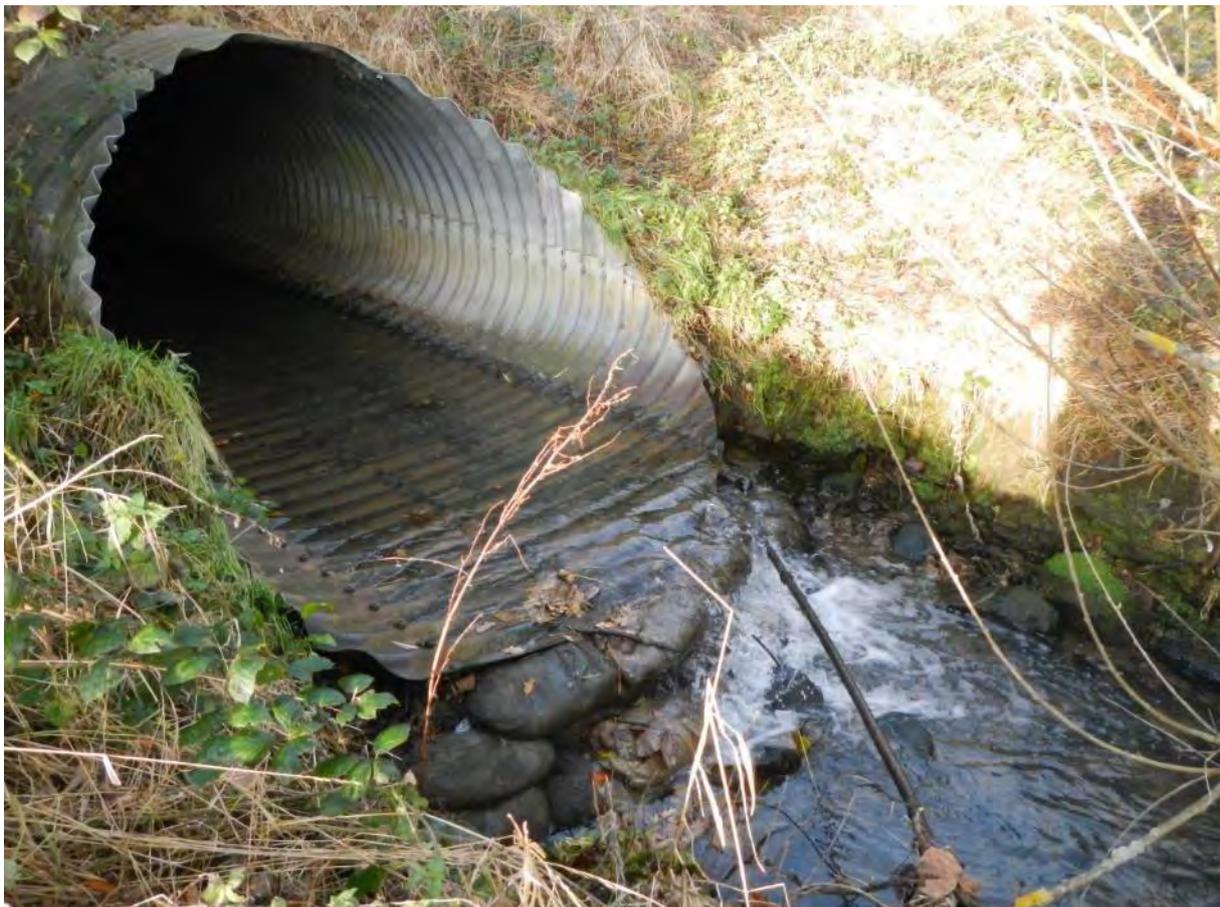
The stepped d/s entrance to the culvert, and shallow water within, create a major issue for fish passage and inhibit access to the higher quality habitat from d/s (Photo DSCN5035). A further river crossing/culvert creates a lesser issue a short distance further downstream (Photo DSCN5039).

Photo DSCN5035. Railway (disused) culvert (NZ 31523 59644).

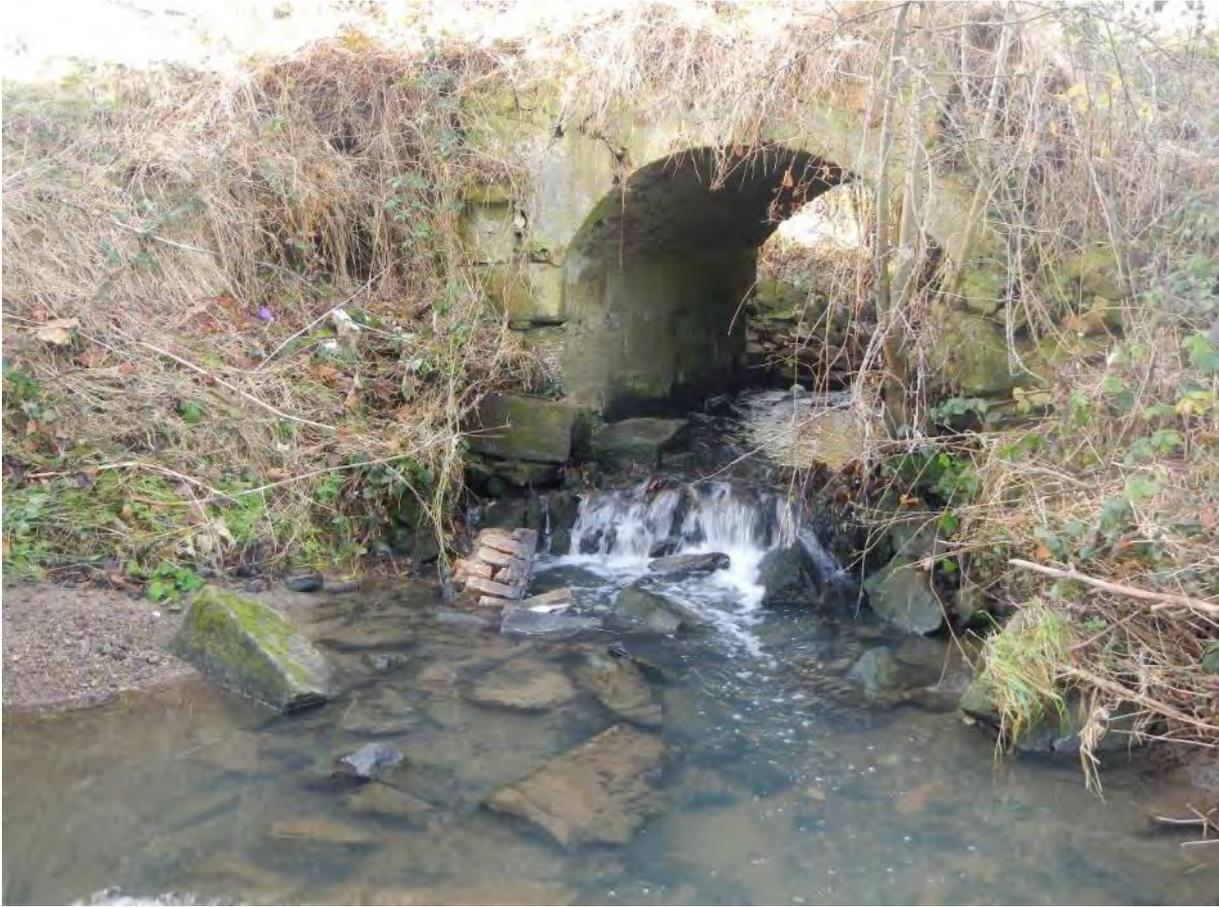
Photo DSCN5039. Another perched culvert and issue for fish passage (NZ 31637 59635).

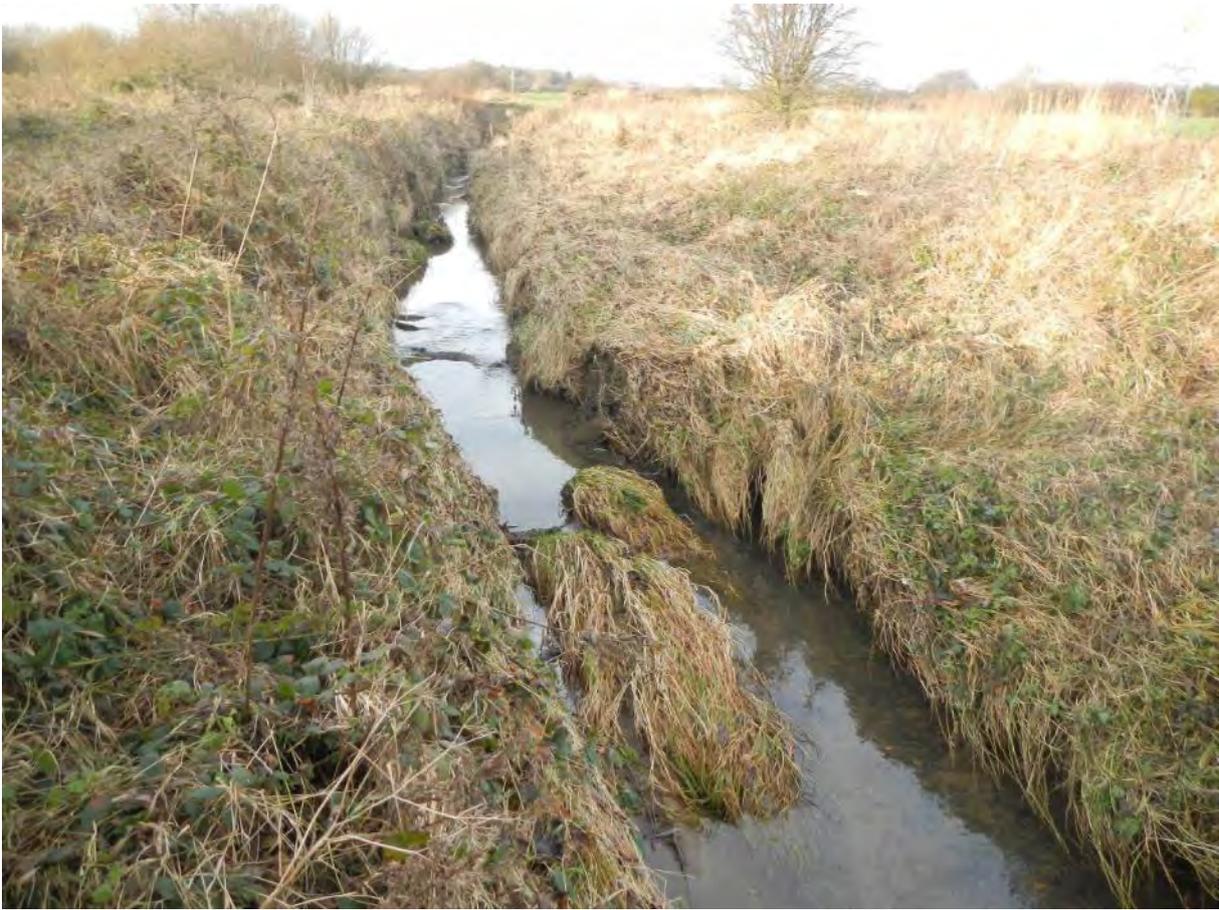
Photo DSCN5052. Slumping banks and sediment deposition are part of the natural channel recovery but the increased fine sediment input to the channel is compounding the habitat issues. Undercut banks and trailing vegetation provide some improvement to salmonid habitat.

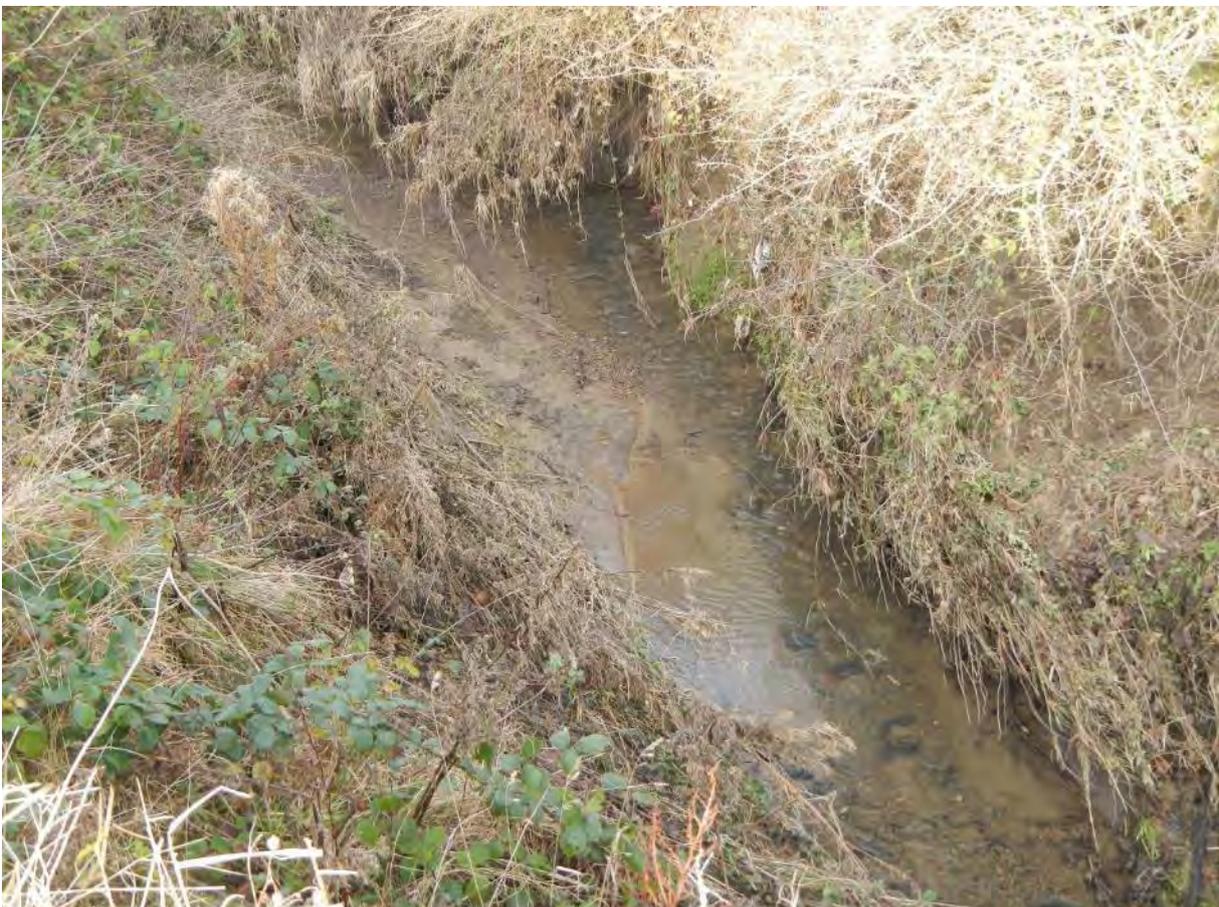
Deeper areas and overhanging vegetation improve habitat for salmonids somewhat, but the lack of natural bends and deeper pools is severely limiting. Finer gravel is retained in areas but remains compromised by fines and a lack of sorting; an issue compounded by the areas of bank slumping and fine sediment input (Photo DSCN5074).

Photo DSCN5074. Areas where beneficial coarse gravel and cobble substrate are retained are degraded by finer material.

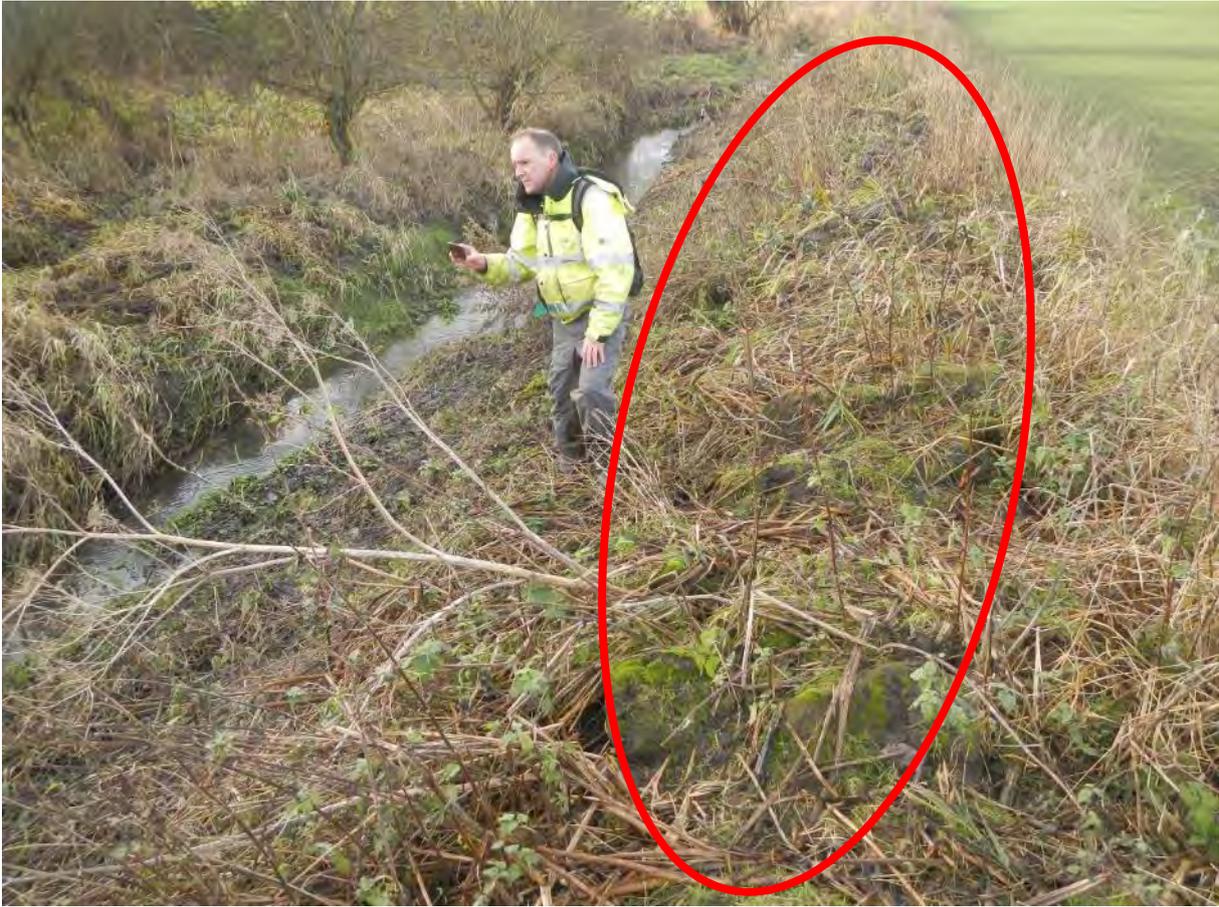
Although less incised, recent dredging of the tributary is clearly inhibiting its natural recovery (Photo DSCN5089). Fine sediment input And a lack of bed sorting is clearly an issue in what could, potentially, recover or be restored to much higher quality salmonid habitat (Photo DSCN5093).

Photo DSCN5089. Straightened but less incised tributary with signs of recent dredging along the bank top (red ellipse).

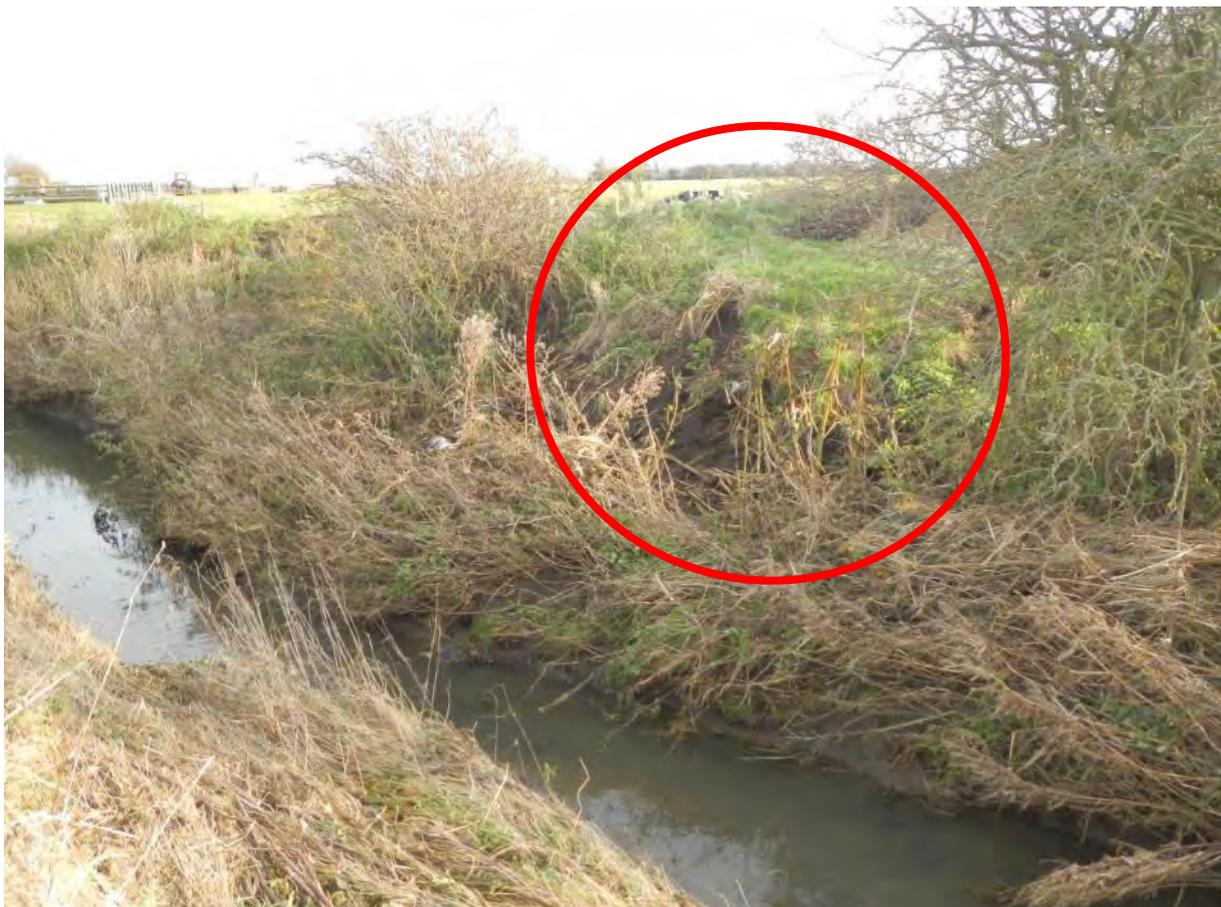
Photo DSCN5099. The channel around Hylton Bridge Farm, u/s to the tributary has been subjected to even greater dredging impact. Also note the manure pile/midden (red circle), some of which will be washed into the channel at high flows.

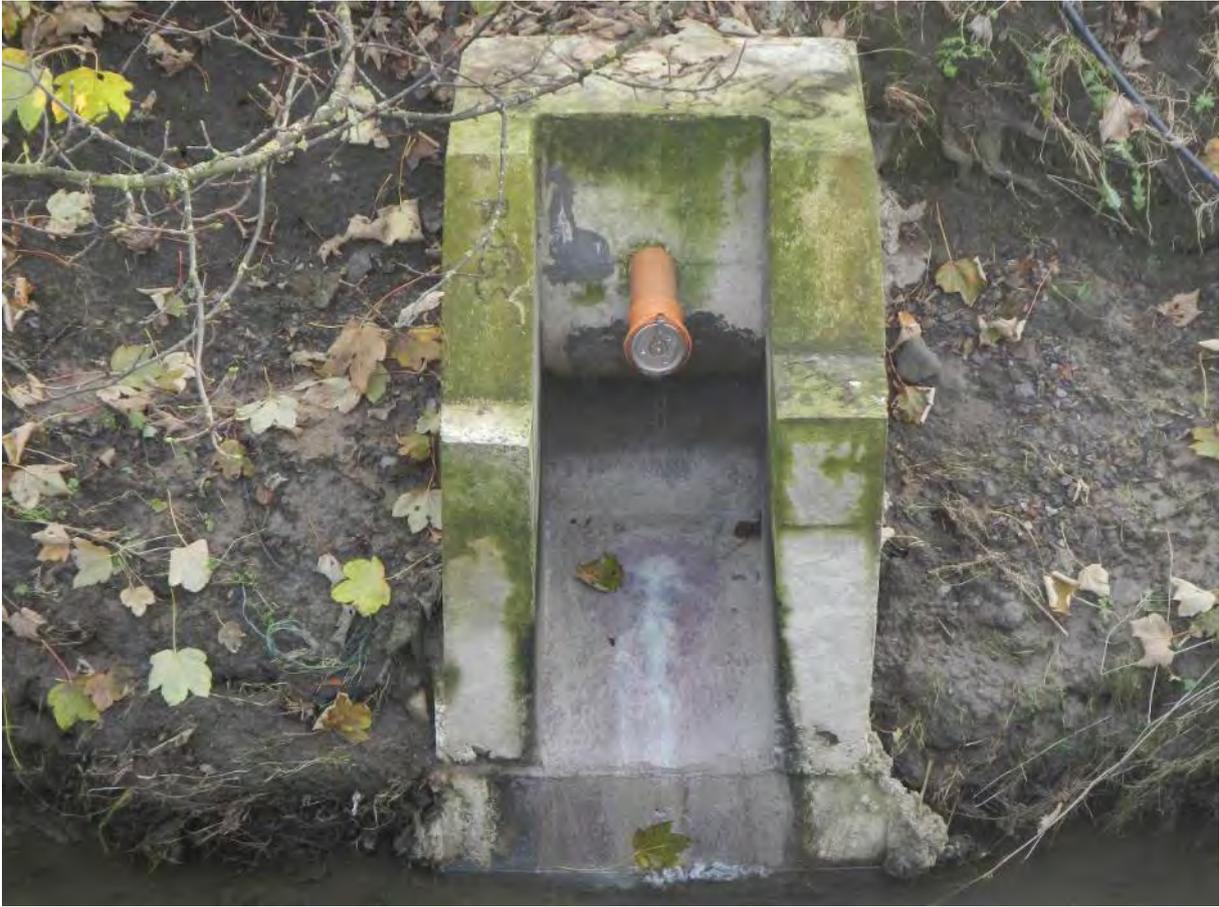
Photo DSCN5105. Suspected septic tank discharge with sewage fungus.

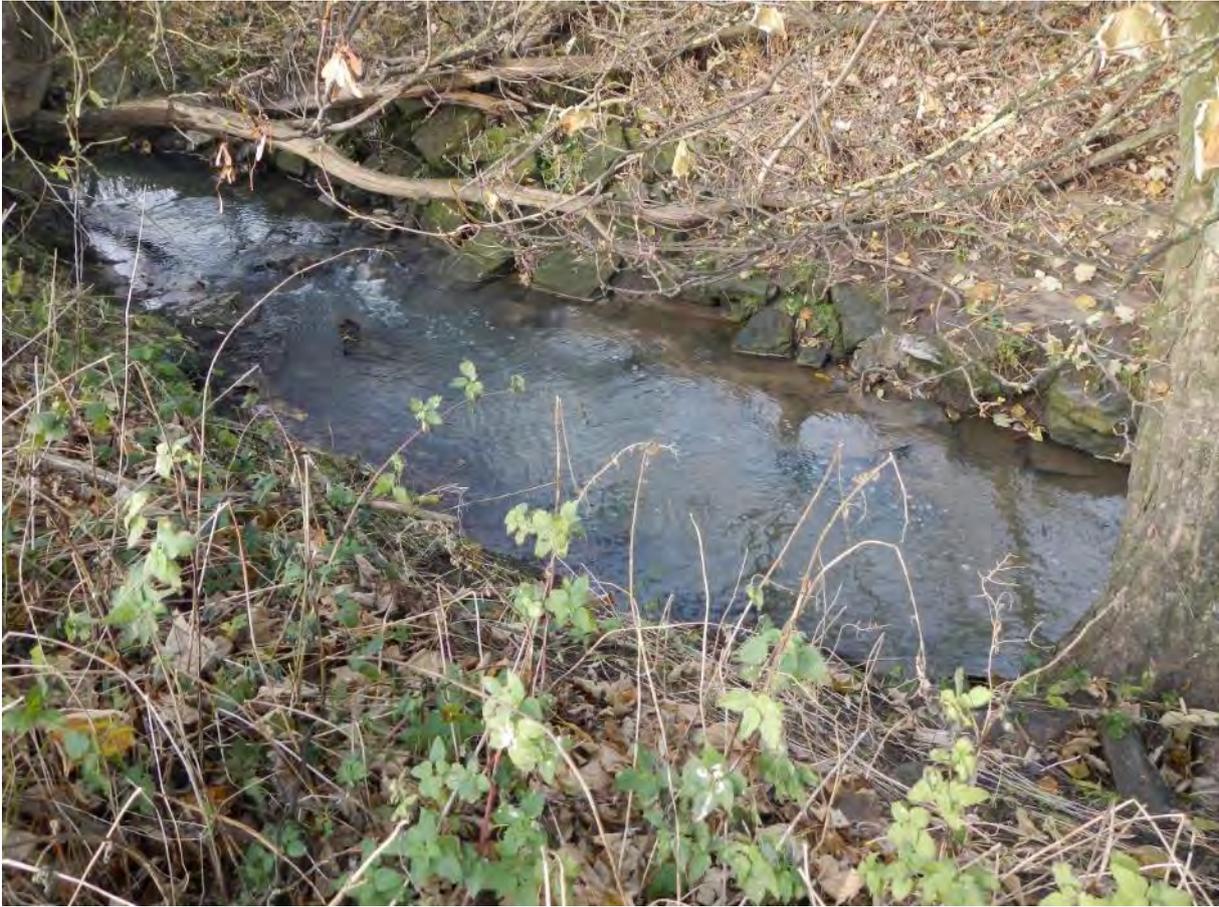
Photo DSCN5115. Collapsed riprap bank protection provides coarser substrate features and artificially enhances the degraded habitat of the area with some flow diversity.

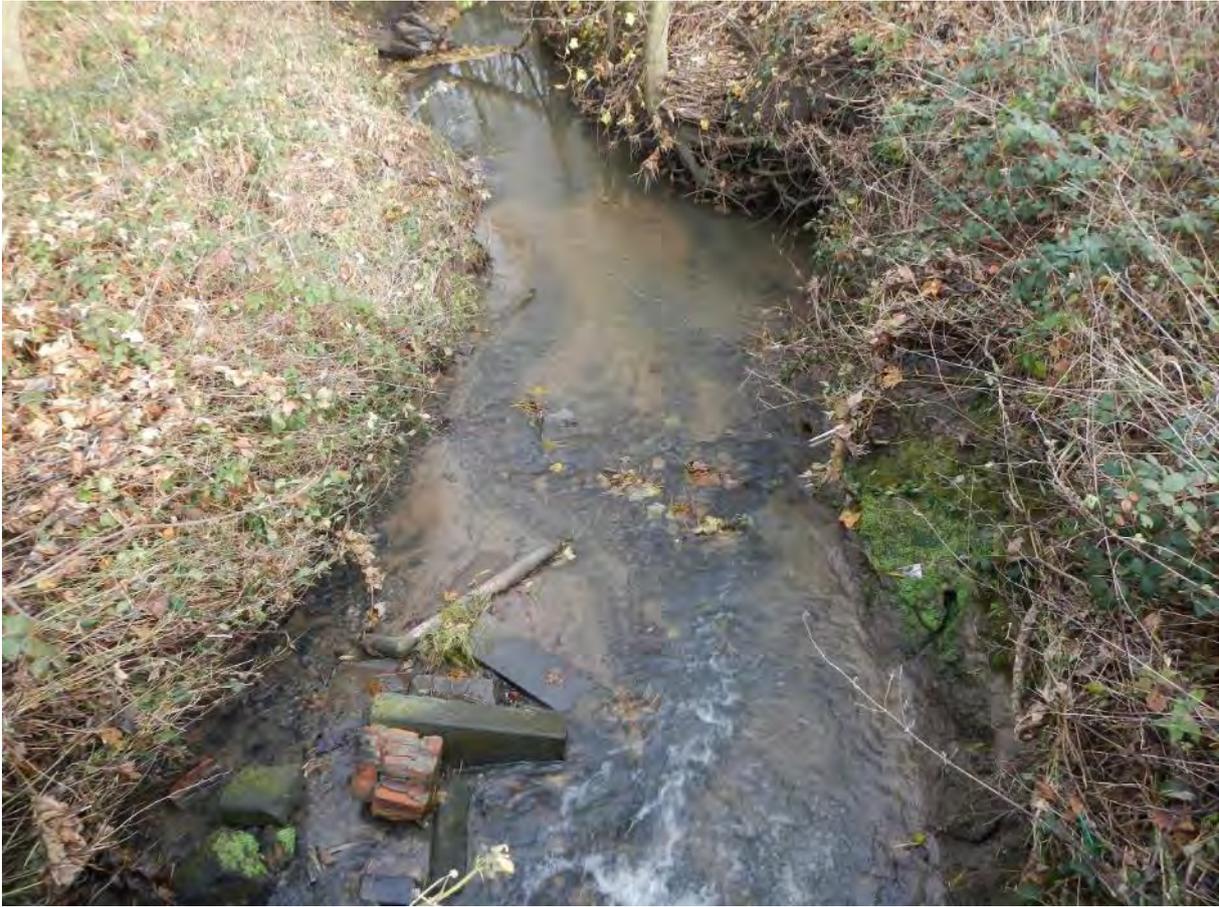
Some flow diversity was evident at the start of Reach 3, particularly around in-channel structures such as trees and bridge footings (Photo DSCN5121), but the channel remains a relatively uniform width for long sections (Photo DSCN5127). A lack of silt-free, sorted gravel precludes salmonid spawning and limits the diversity/quality of invertebrate habitat. Some habitat capable of supporting older juvenile and adult salmonids was observed.

Photo DSCN5121. Around a small access bridge, some beneficial features exist; however, the channel is generally of a uniform width and depth for long sections.

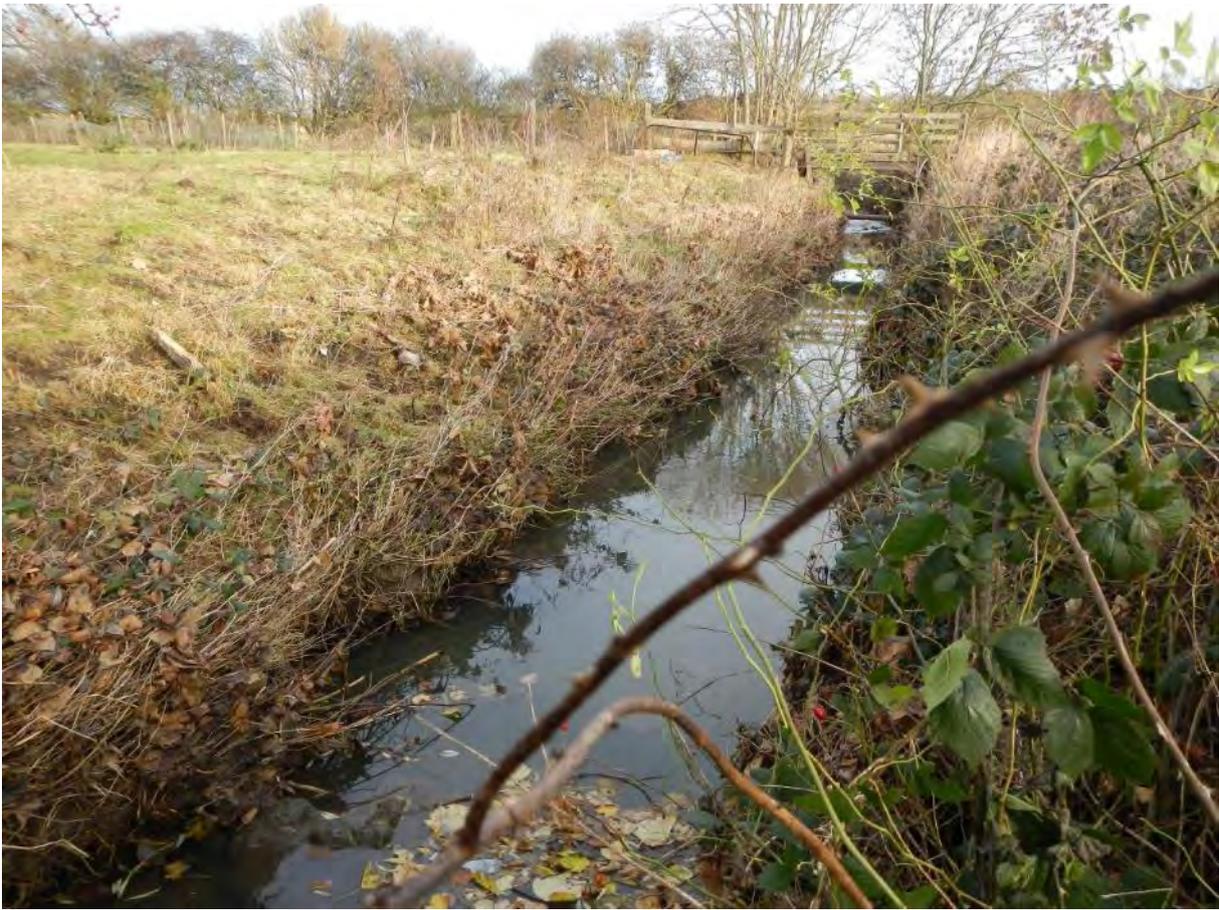
Immediately u/s of the A19 culvert the channel is straight and significantly lacking features or flow diversity (Photo DSCN5127). Neither end of the A19 culvert appeared to pose an issue but the structure should be investigated for fish passability (Photo DSCN5130). Evidence of spawning immediately d/s of the culvert may suggest a barrier within it; however, the spawning activity could just be a result of the coarser material there raising the bed, accelerating flow and mimicking a natural gravel bed (appears to be aggregate associated with the road)(Photo DSCN5132). This was the only potential spawning site observed for medium/large salmonids in the area.

Photo DSCN5127. The area u/s of the A19 suffers from significant straightening/re-sectioning.

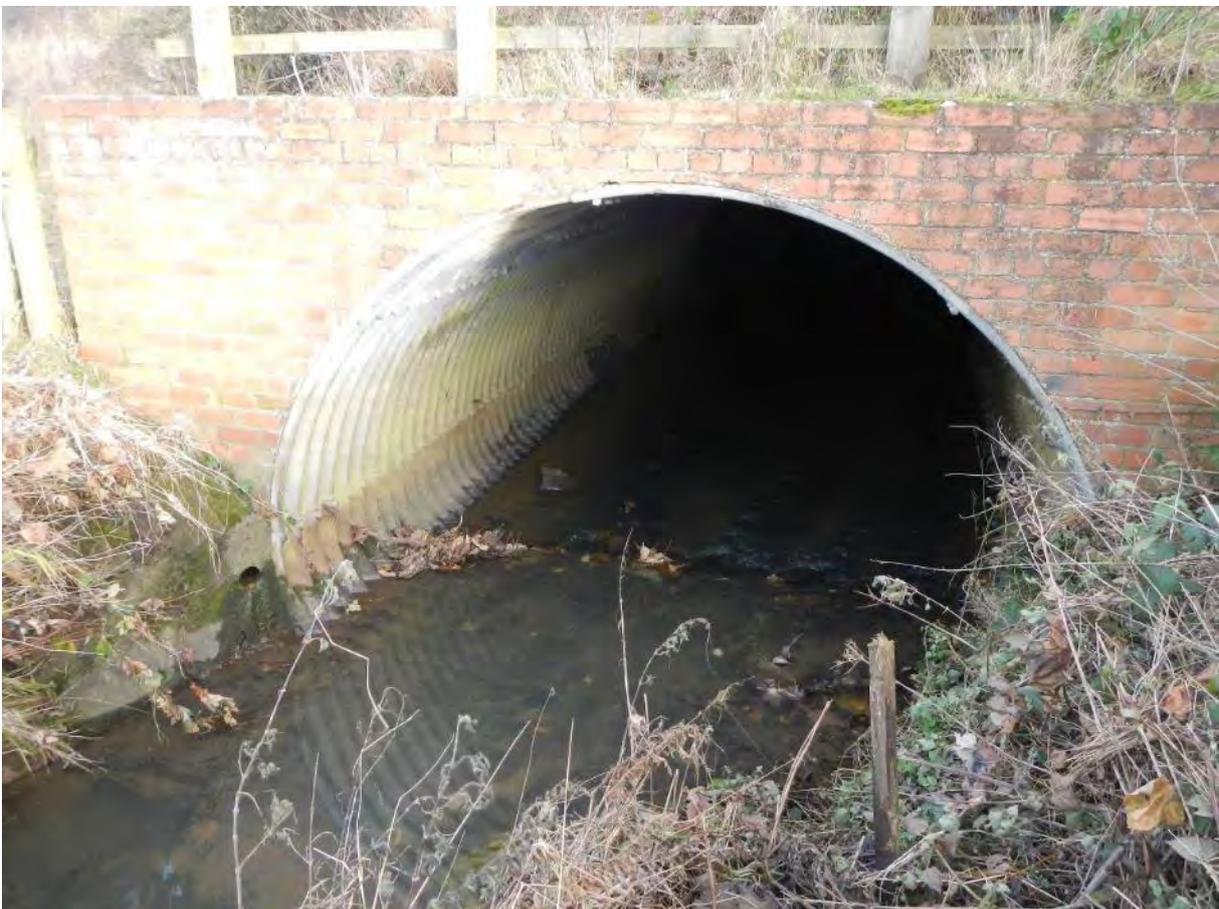
Photo DSCN5130. The A19 culvert appears passable but it should be investigated as it was not possible to see right through – spawning immediately d/s could suggest an issue.

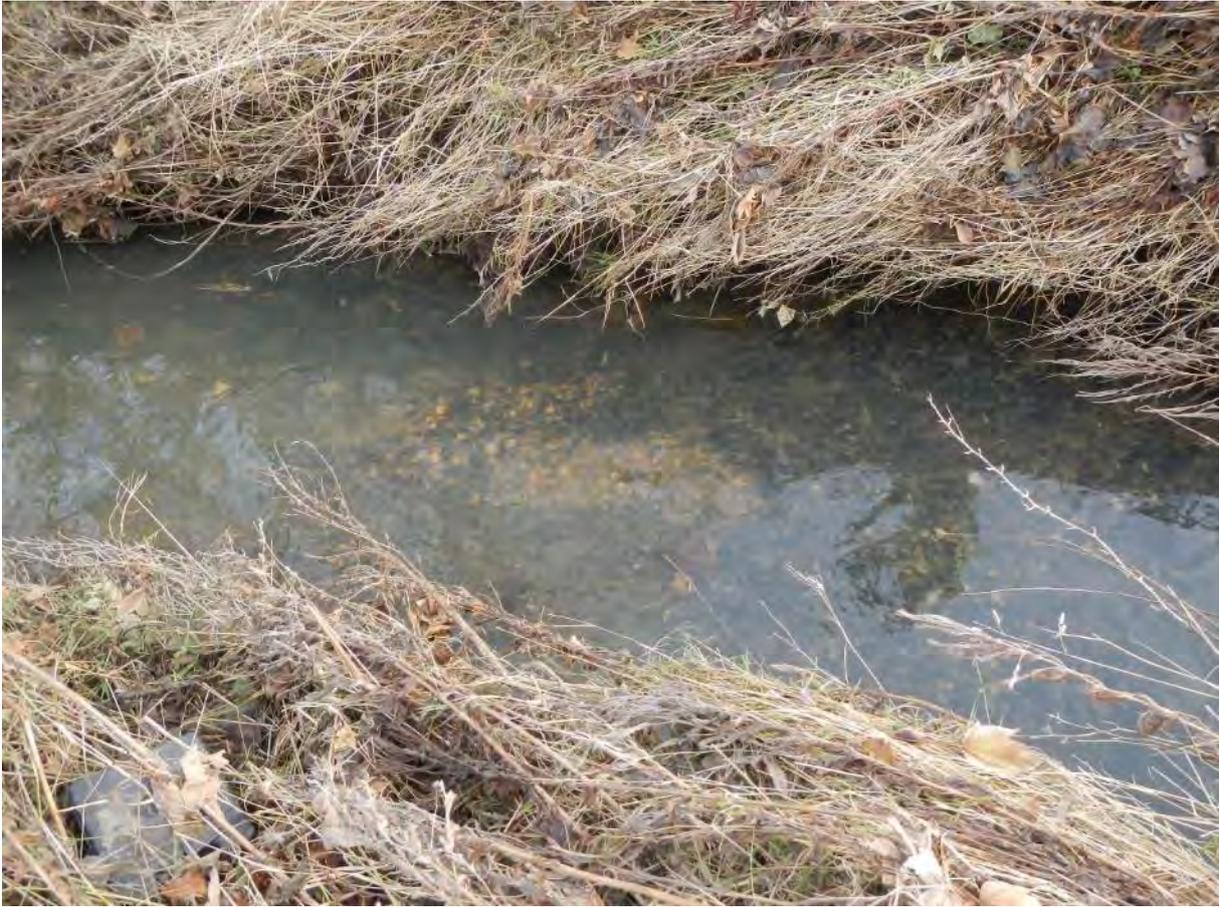
Photo DSCN5132. A salmonid redd on the only area of suitable, coarse (fine sediment free) substrate observed. The material appeared to be artificial, possibly washed out of the culvert structure.
