River Don Walkover
(River Tyne Catchment)
29th & 30th November 2016

Undertaken by Gareth Pedley, Wild Trout Trust

1.0 Introduction

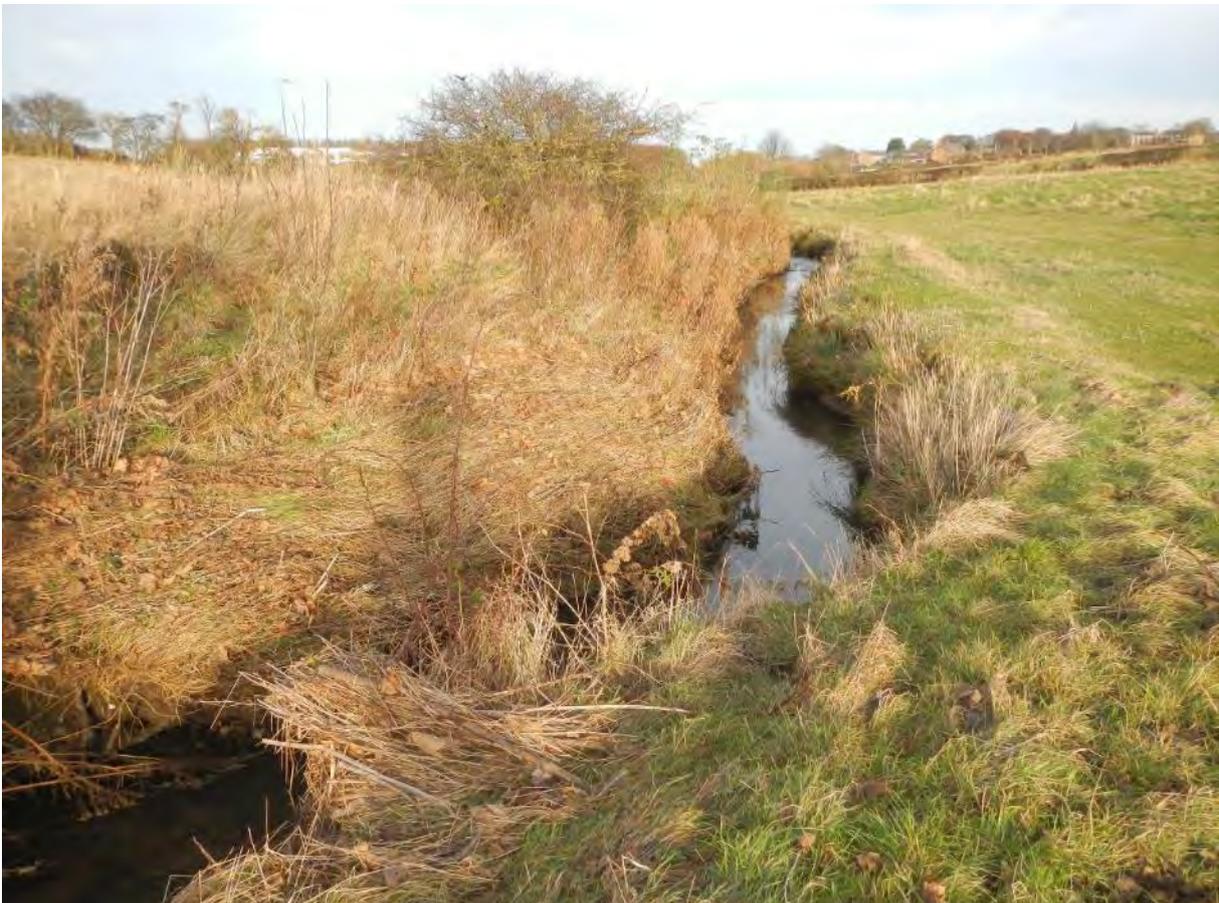
Photo DSCN5169. The slightly increased sinuosity of the rest of Reach 4 offers some habitat improvement, with occasional deeper areas but a greatly reduced occurrence of pool and riffle features limits the habitat potential.

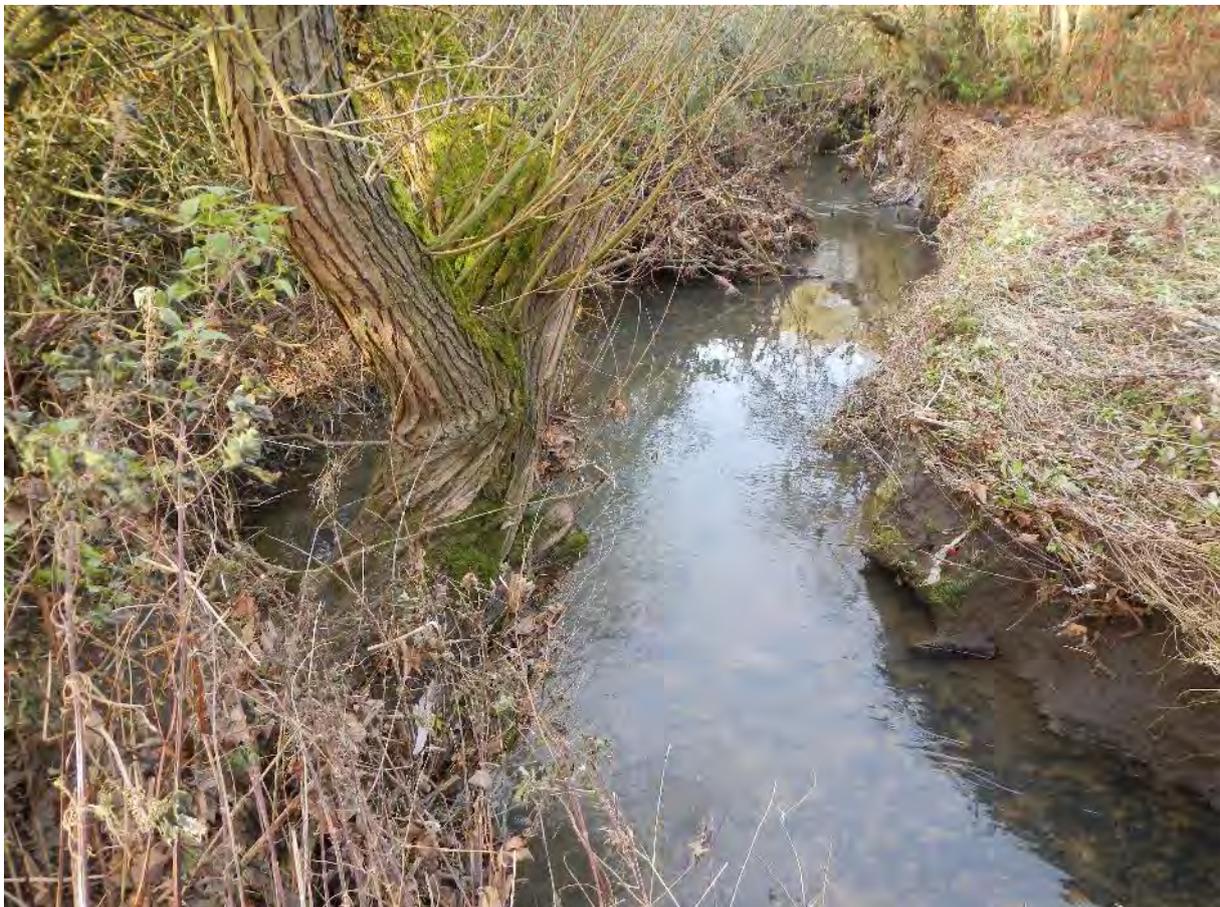
Photo DSCN5180. Habitat towards the upper limit of Reach 3b, a short distance d/s of the A184.

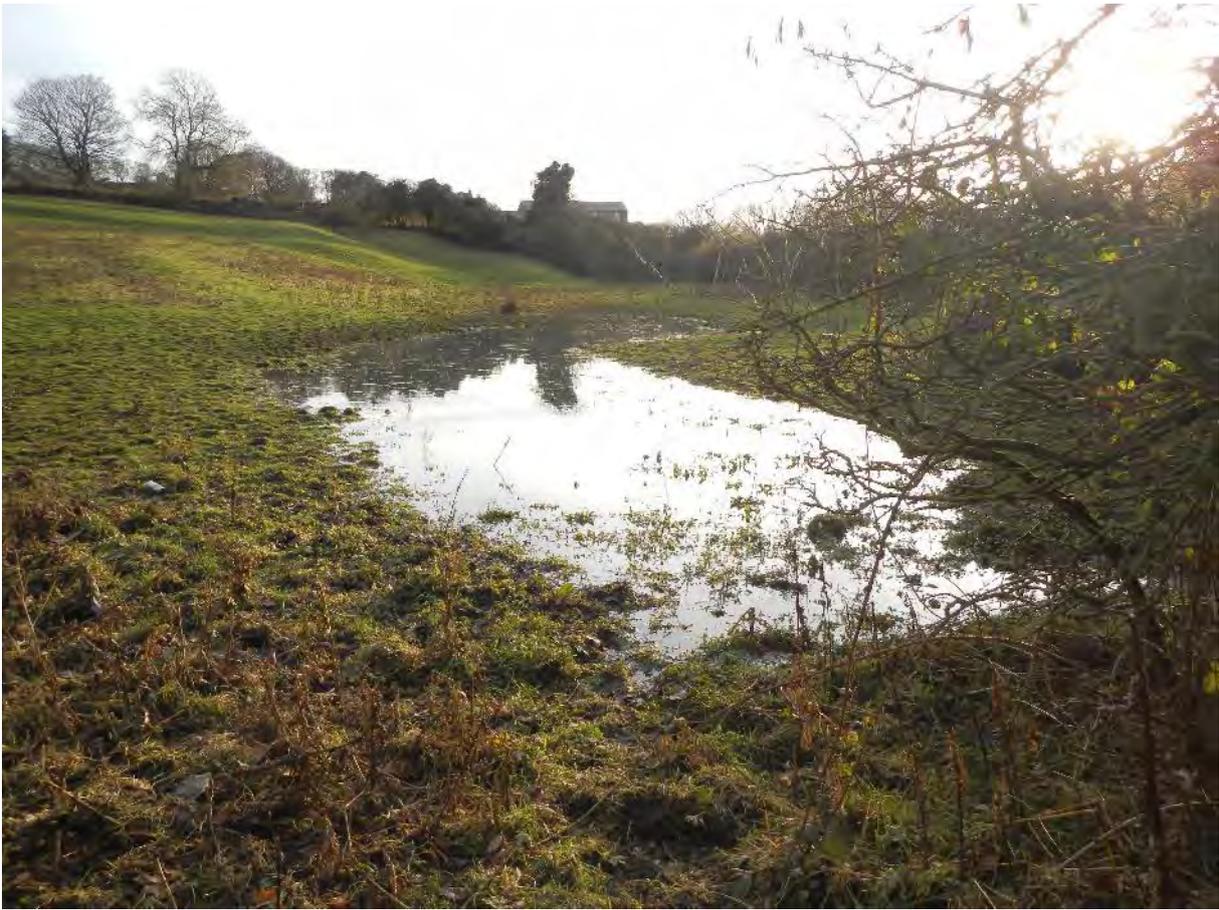
Photo DSCN5184. Obvious signs of the pre-realignment paleo channel as a low, more sinuous wetted area of the field.

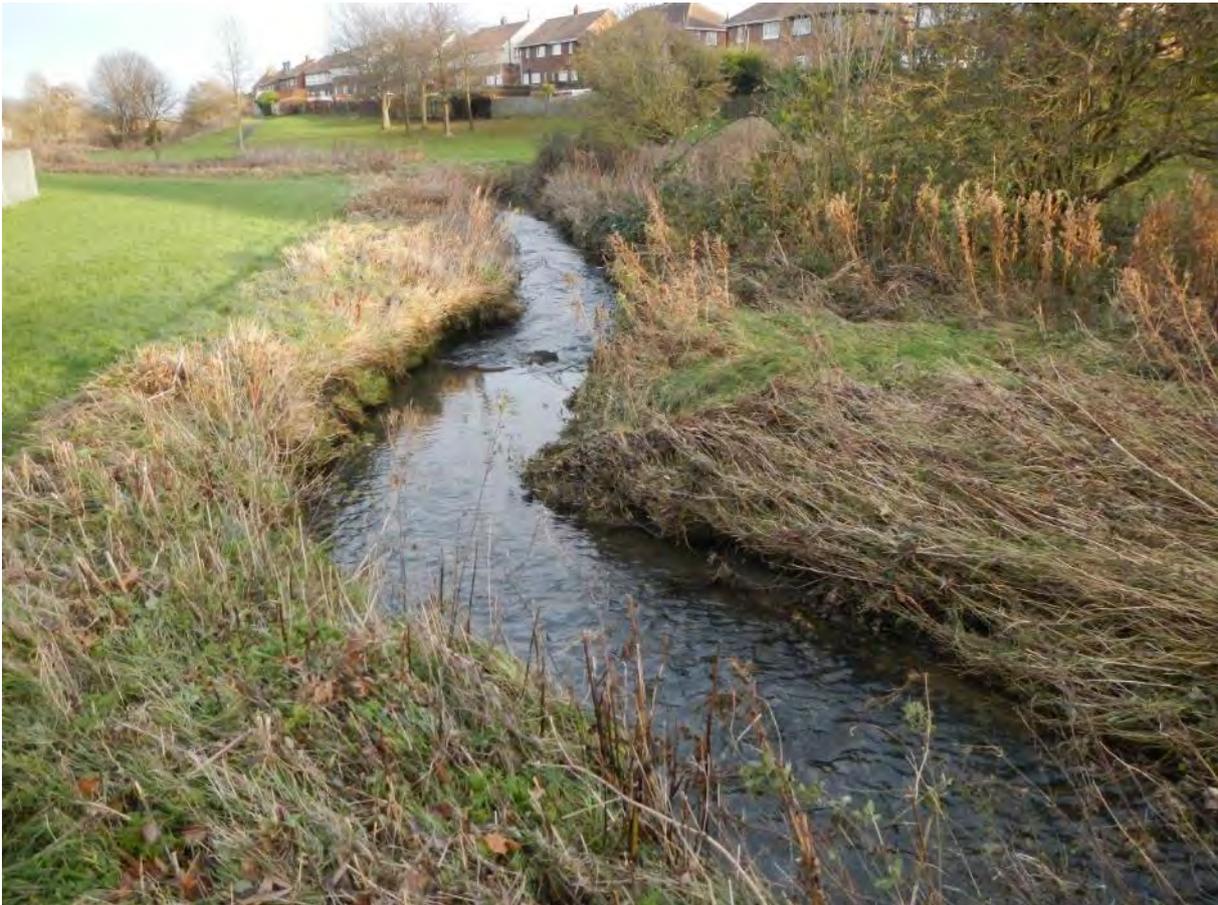
Photo DSCN5196. A more discernible pool and riffle sequence was observed in many areas of Reach 3b, despite evidence of past realignment.

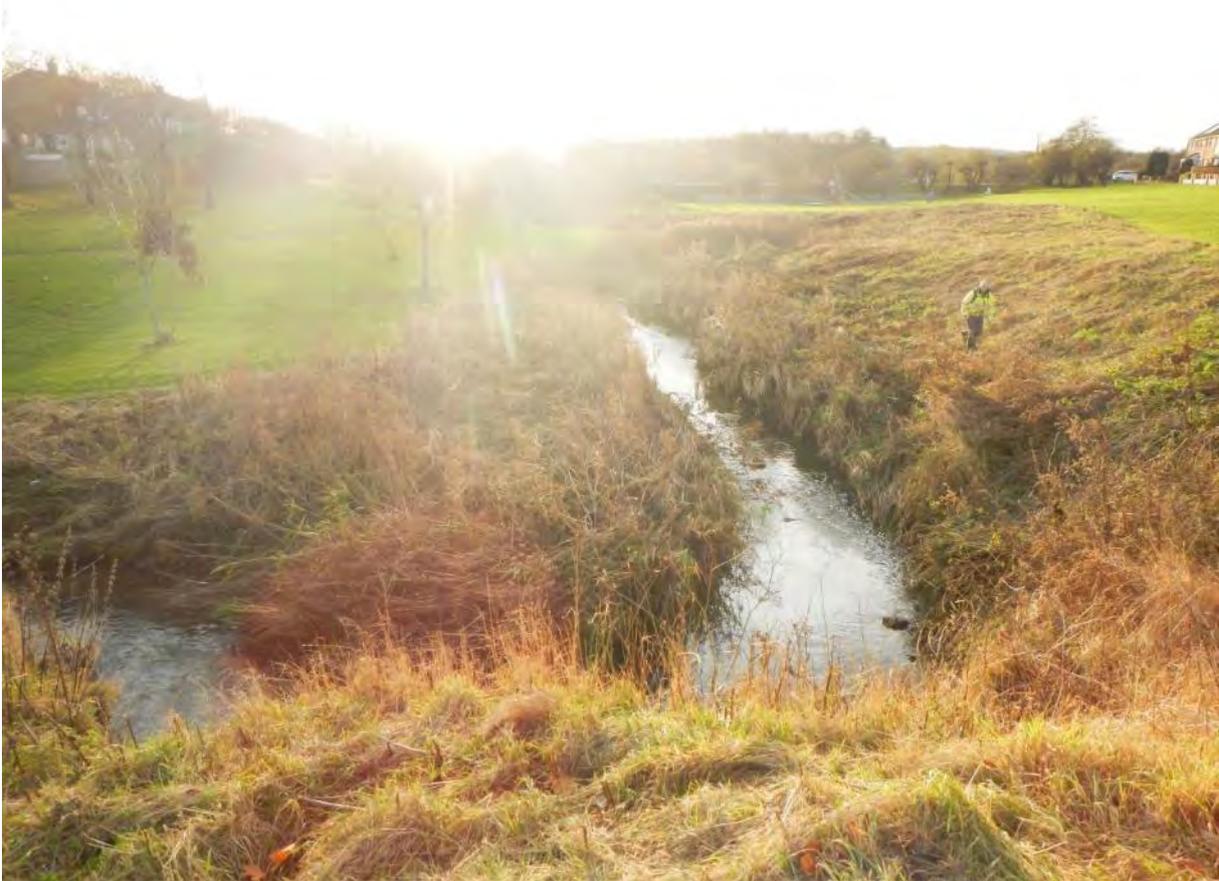
Photo DSCN5201. Where sharper bends remain, they provide valuable deeper water pool habitat, adjacent to shallower riffle areas. An important combination for salmonid and invertebrate habitat.

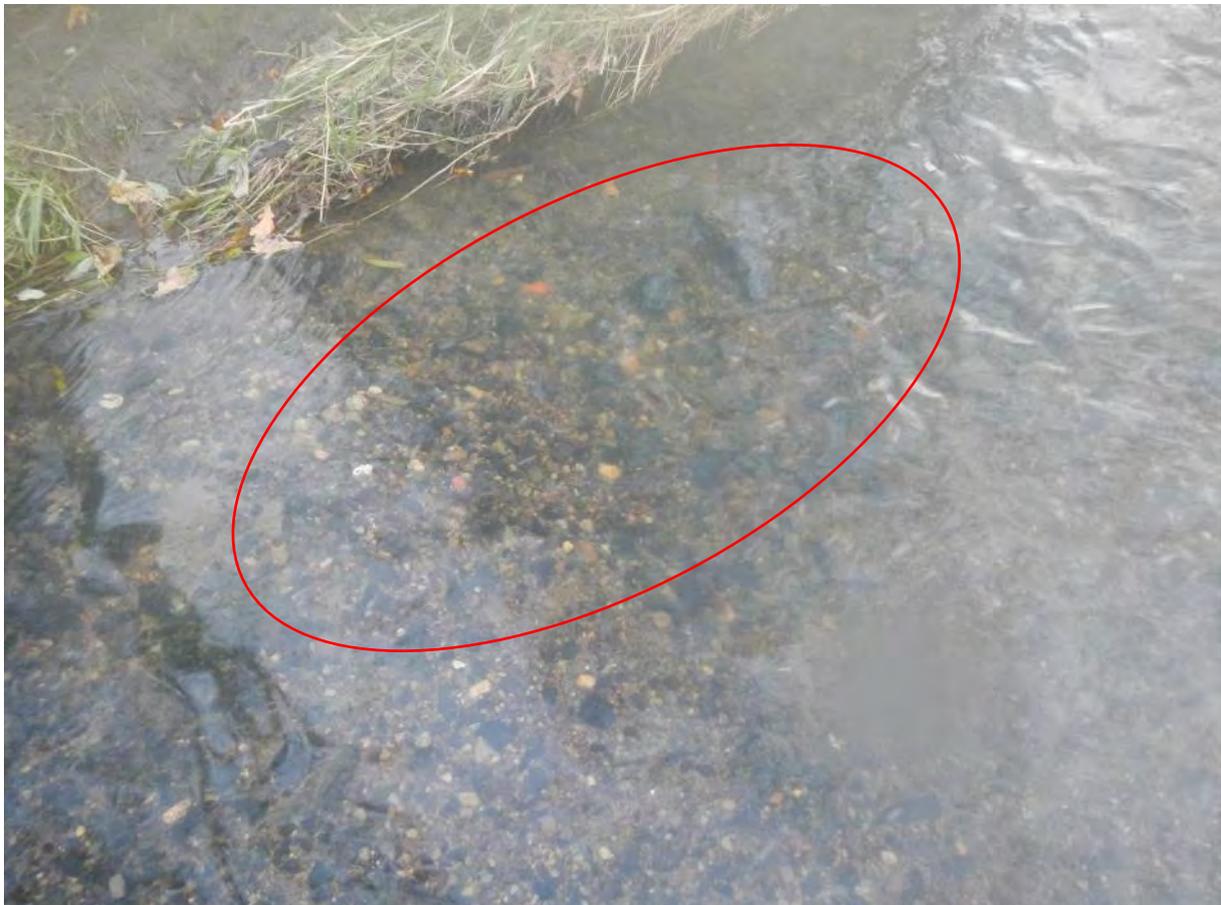
Photo DSCN5254. The redd at which the trout (Photo DSCN5244) was first observed. The composition of the gravel is sub-optimal for spawning but about as good as it gets for small resident trout on the Don.

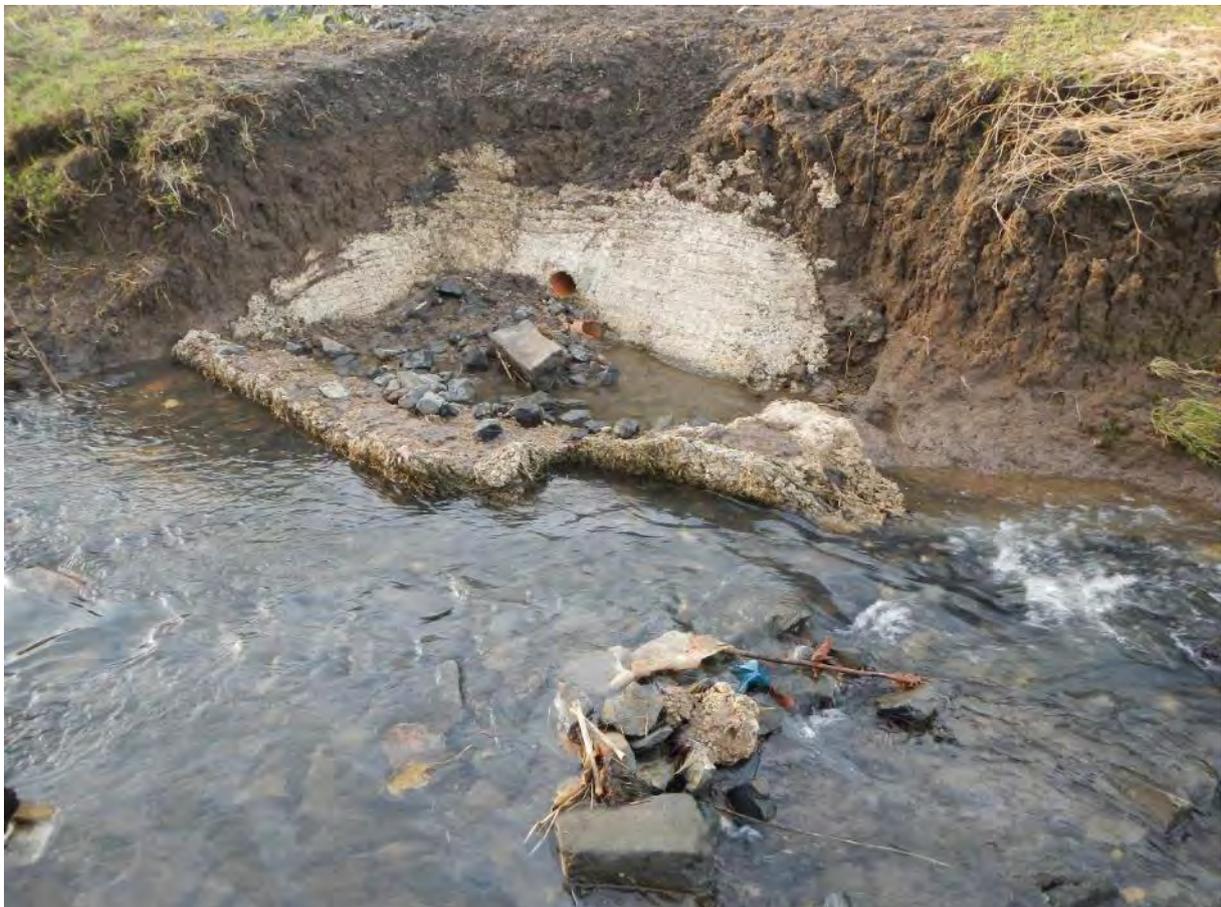
Four additional impacts were observed within the reach: a very unsympathetically installed outfall (Photo DSCN5202); a grey water outfall (pollution) and revetted bank (Photos DSCN5258 & DSCN5260); and a weir/possible pipe crossing around the mid-point of the reach, u/s of the New Road crossing (Photo DSCN4806) which impounds flow, interrupts sediment transport and inhibits fish passage. The actual road culvert poses no barrier for sediment or fish.

Photo DSCN5202. Very unsympathetically installed outfall that is also likely to have created a minor pollution (NZ 34964 61438). This area will now be subject to severe scouring and erosion at high flows.

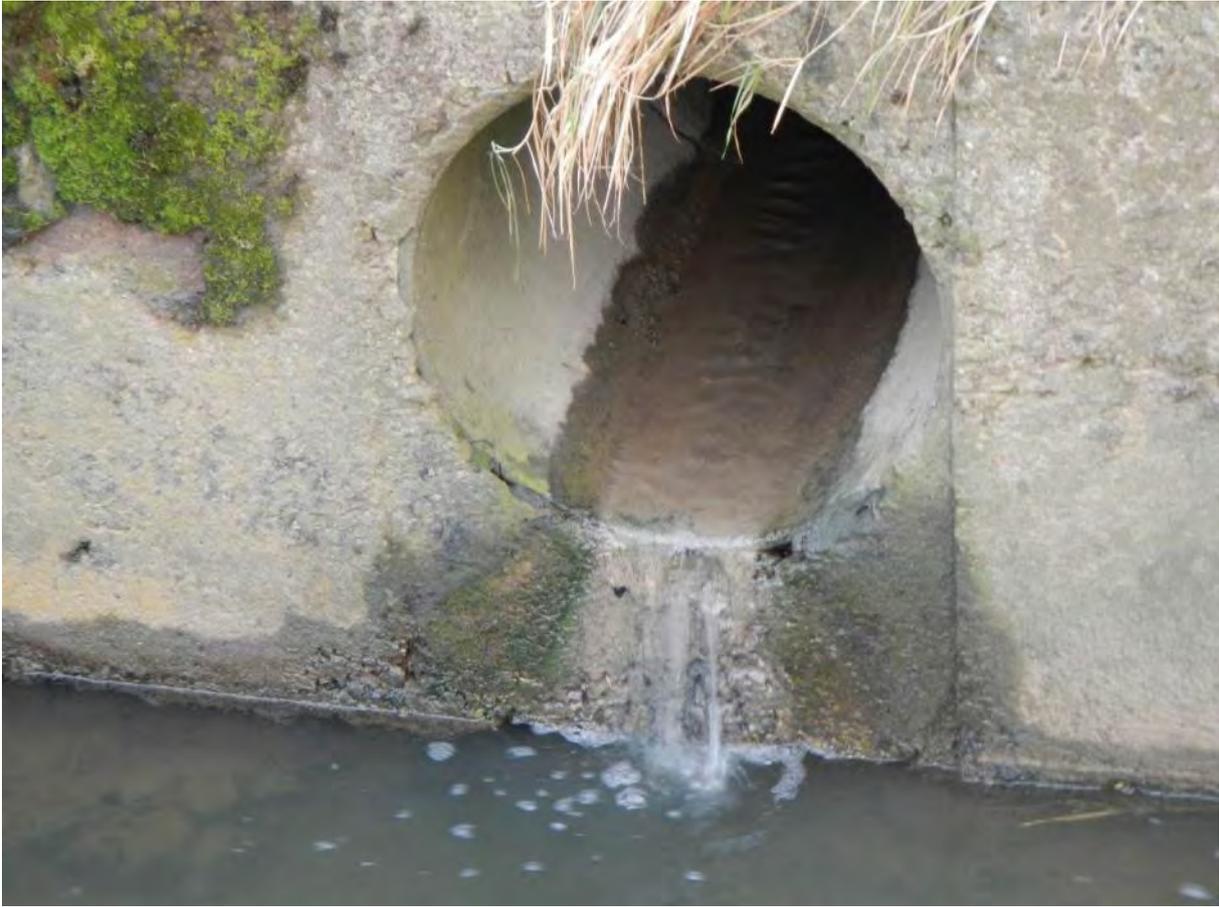
Photos DSCN5258. Grey water discharge/pollution (NZ 35738 61798).

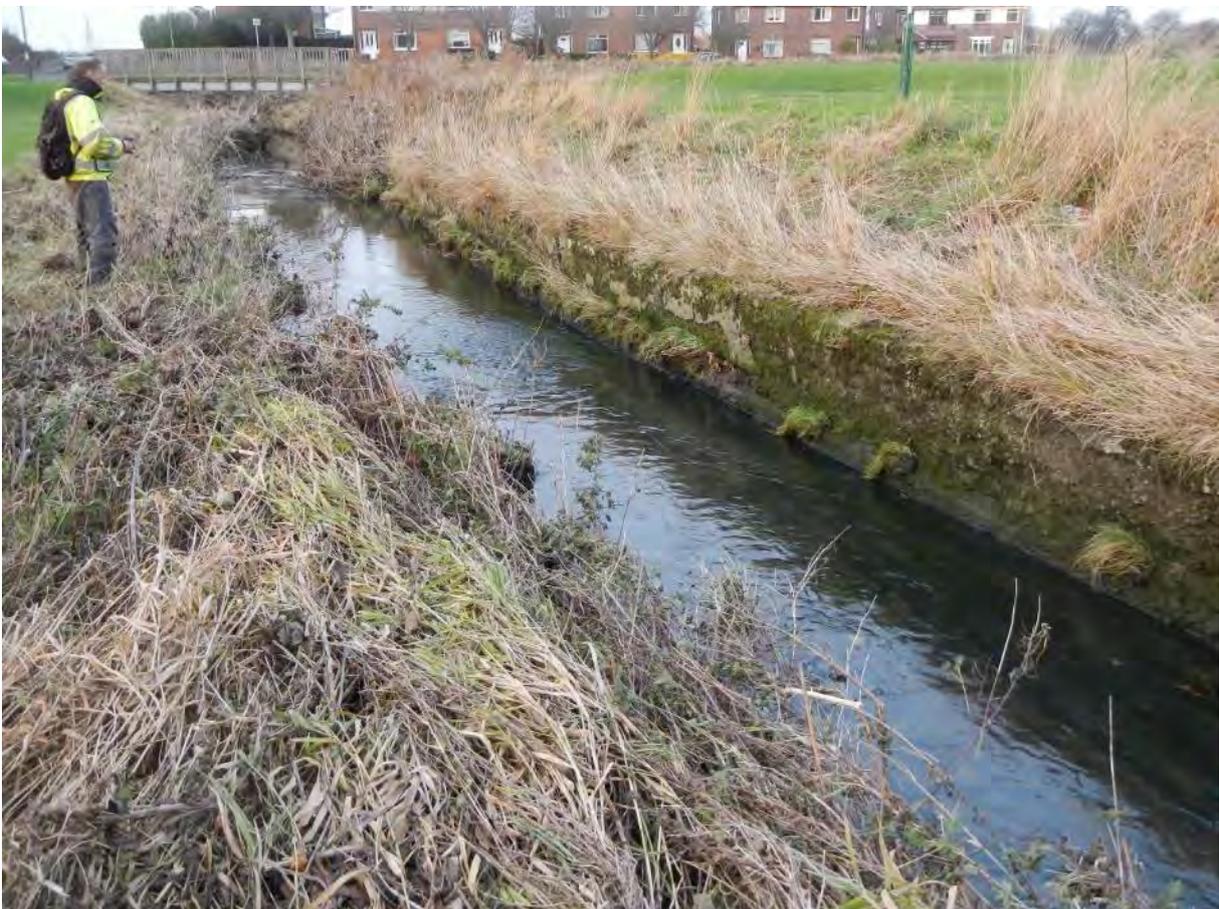
Photo DSCN5260. An area of concrete walling/bank revetment degrades the riparian habitat quality.

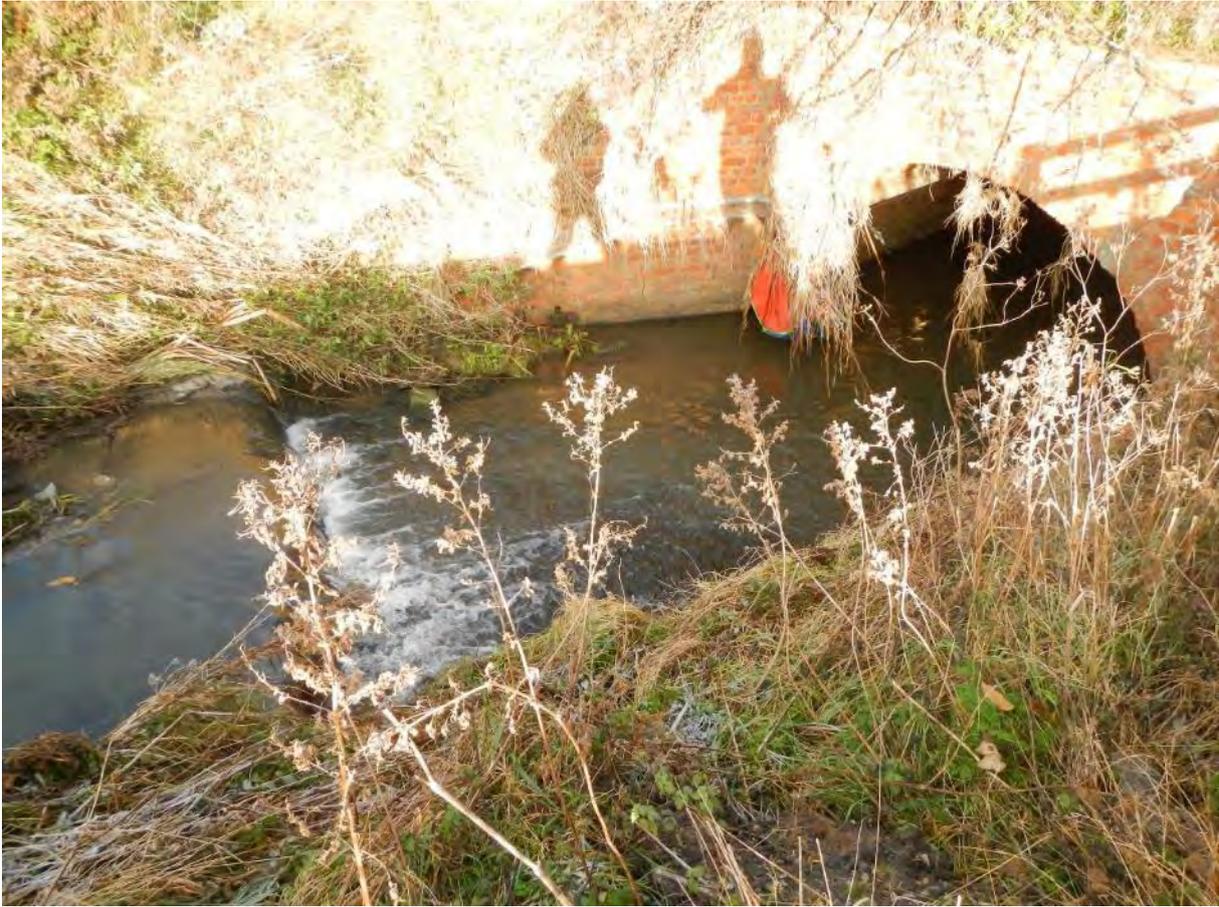
Photo DSCN4806. A weir/possible pipe crossing immediately u/s of New Road (NZ 35812 61959) impounds the river u/s, inhibiting fish passage and sediment transport.

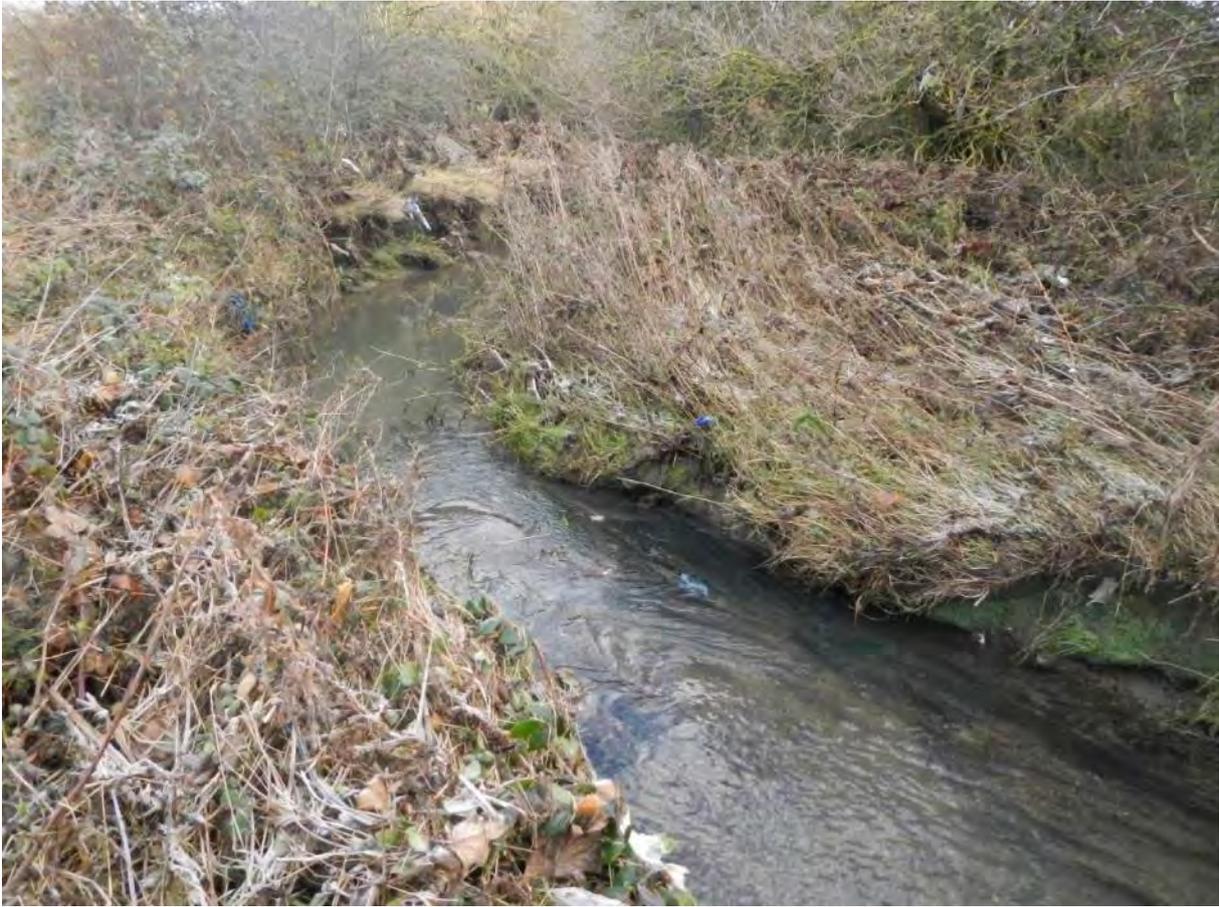
Photo DSCN4809. The channel d/s of New Road retains some bends but is straightened, incised and of uniform dimensions for long sections. The resulting substrate and general habitat quality is poor.

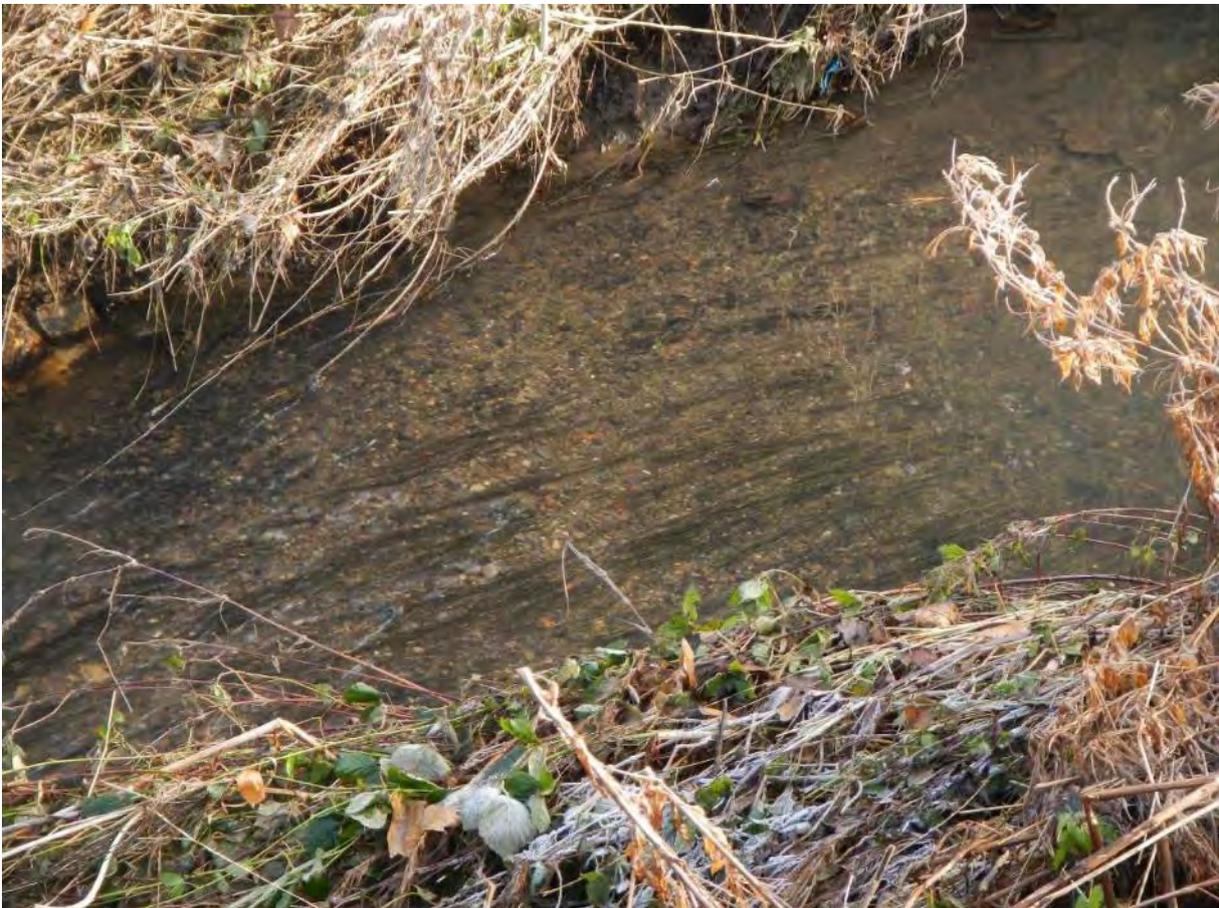
Photo DSCN4816. Gravel lift and potential small salmonid spawning substrate severely compromised by fine sediment and a lack of sorting.

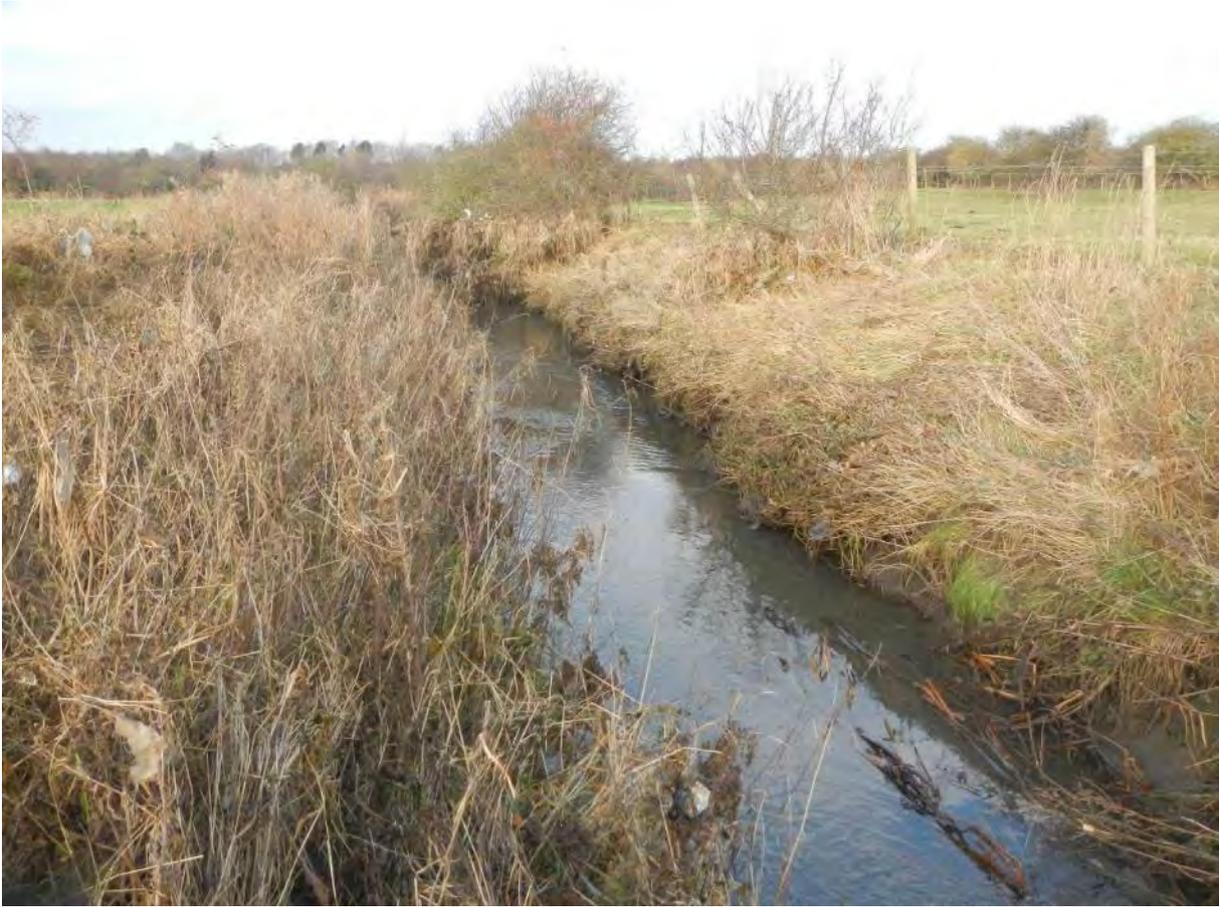
Photo DSCN4820. Put simply, the most heavily dredged and realigned sections do not provide salmonid habitat.

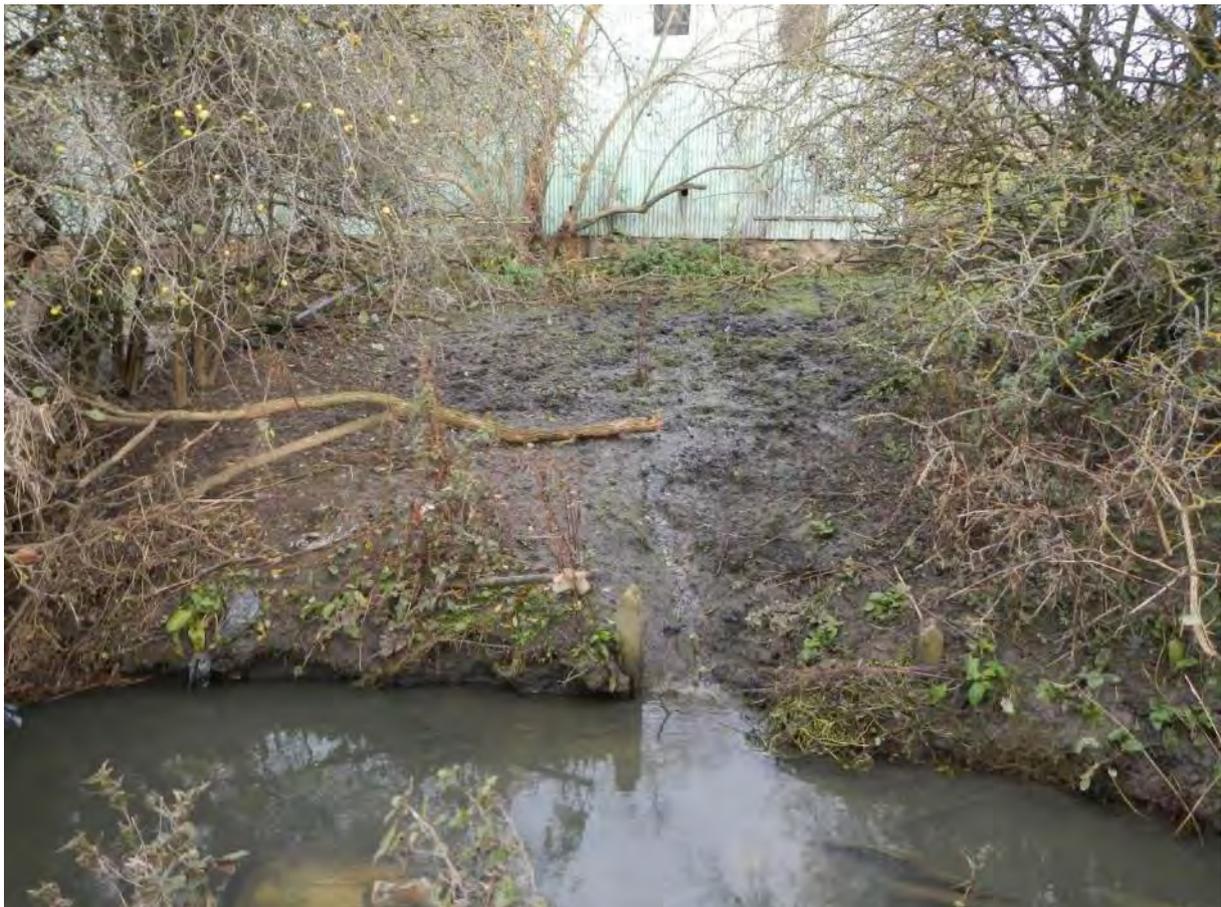
At Newton Garth Farm, habitat quality is further degraded by a lack of buffer fencing and livestock (horse) access to banks (Photo DSCN4831), where further fine sediment inputs result (Photo DSCN4836). Adjacent to the farm, a pipe crossing creates a potential impediment to fish passage and increased flood risk (Photo DSCN4835).

Photo DSCN4831. Around Newton Garth Farm a lack of vegetated buffer allows livestock access to the river bank, denuding it of vital vegetation.

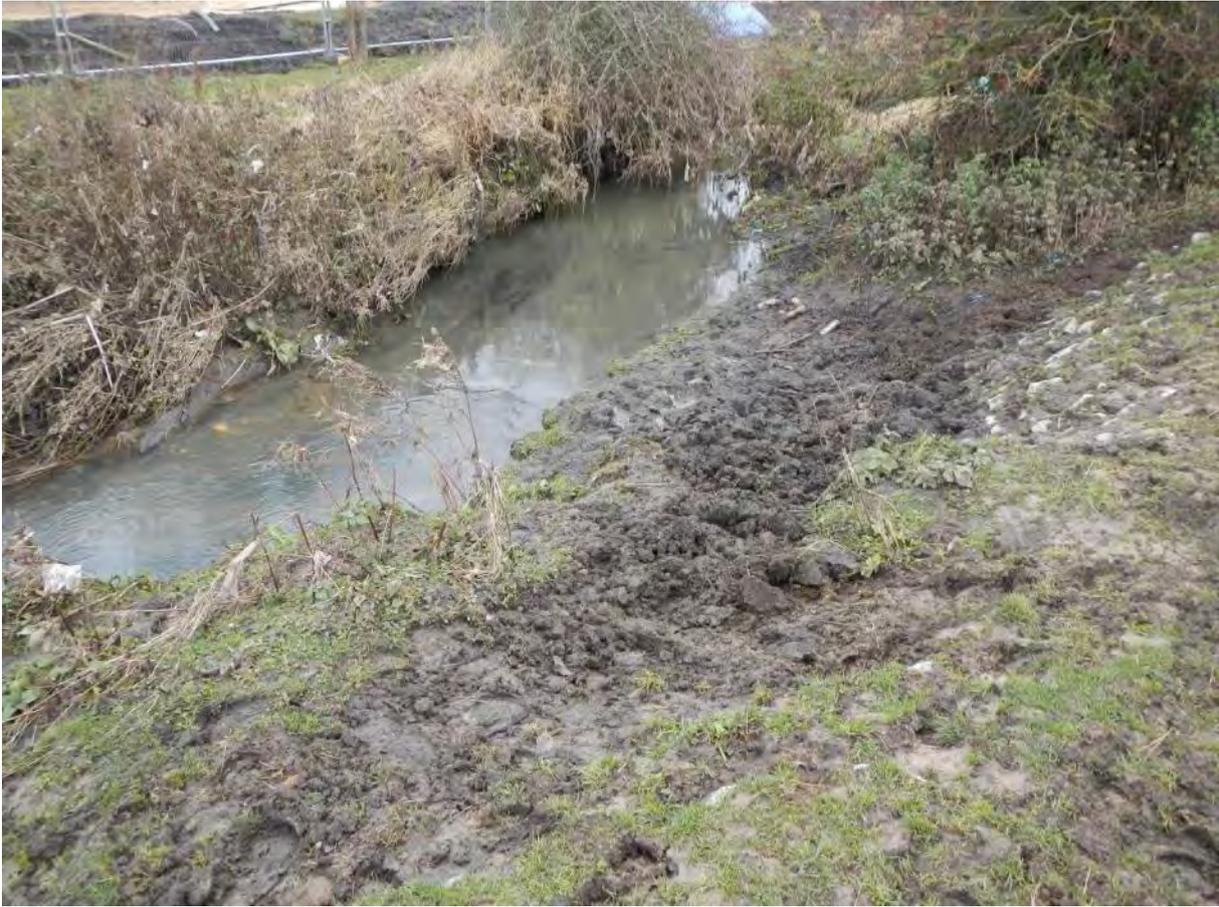
Photo DSCN4836. Livestock trampling and poaching is resulting in further fine sediment input to the river.

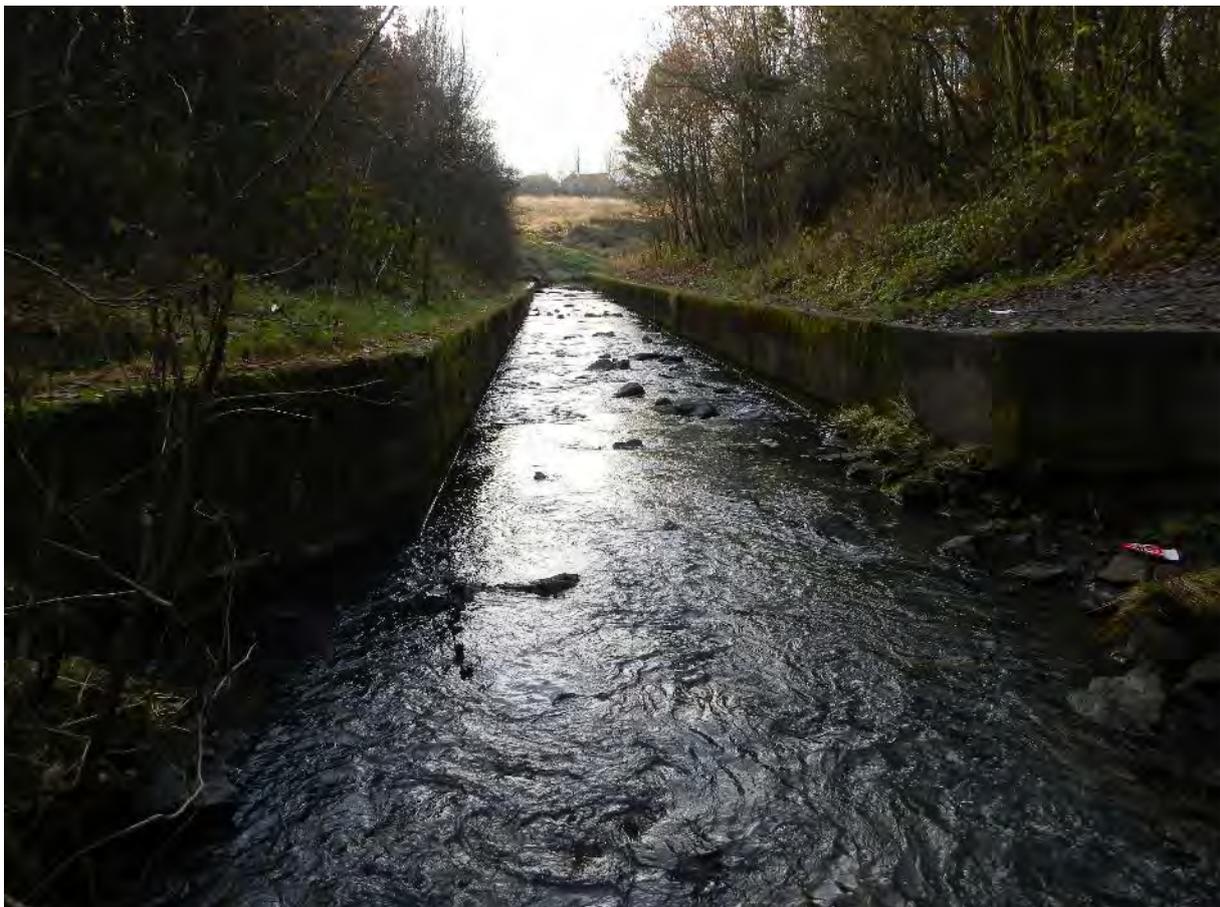
Towards the d/s end of Reach 3a, the adjacent land use changes (possibly along the outskirts of a historical mining area) and, aside from a significantly straightened and concrete-lined section (Photo DSCN4855), the form and habitat quality of the river improves. An old weir-like structure has degraded, now posing no issue to fish passage (DSCN4863), and the habitat quality d/s (including substrate diversity) improves somewhat. This may again be due to a lesser extent of straightening, dredging and re-dredging in comparison to agricultural areas.

Photo DSCN4855. Straightened, concrete-lined channel.

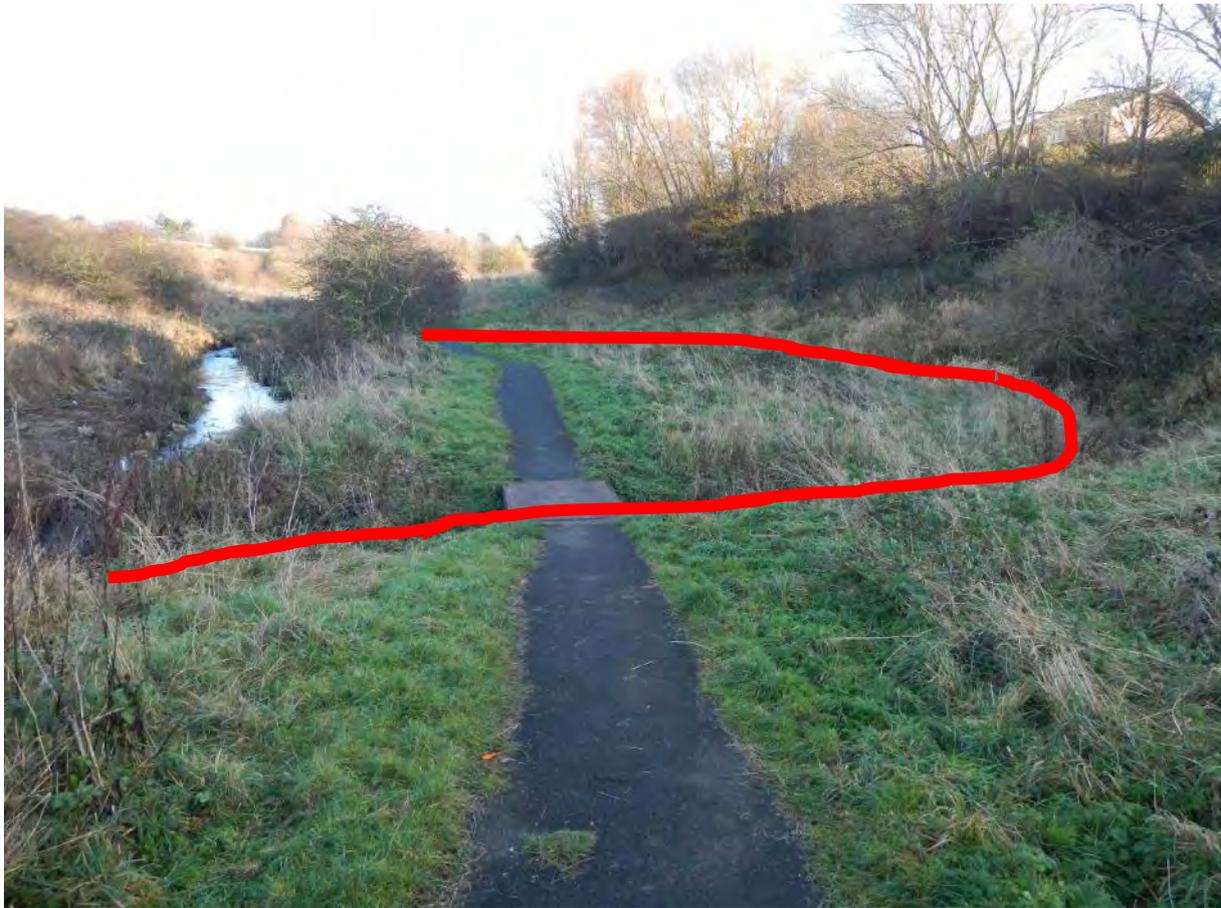
Photo DSCN4868. Obvious signs of straightening - the red line depicts a past, naturally more sinuous channel.

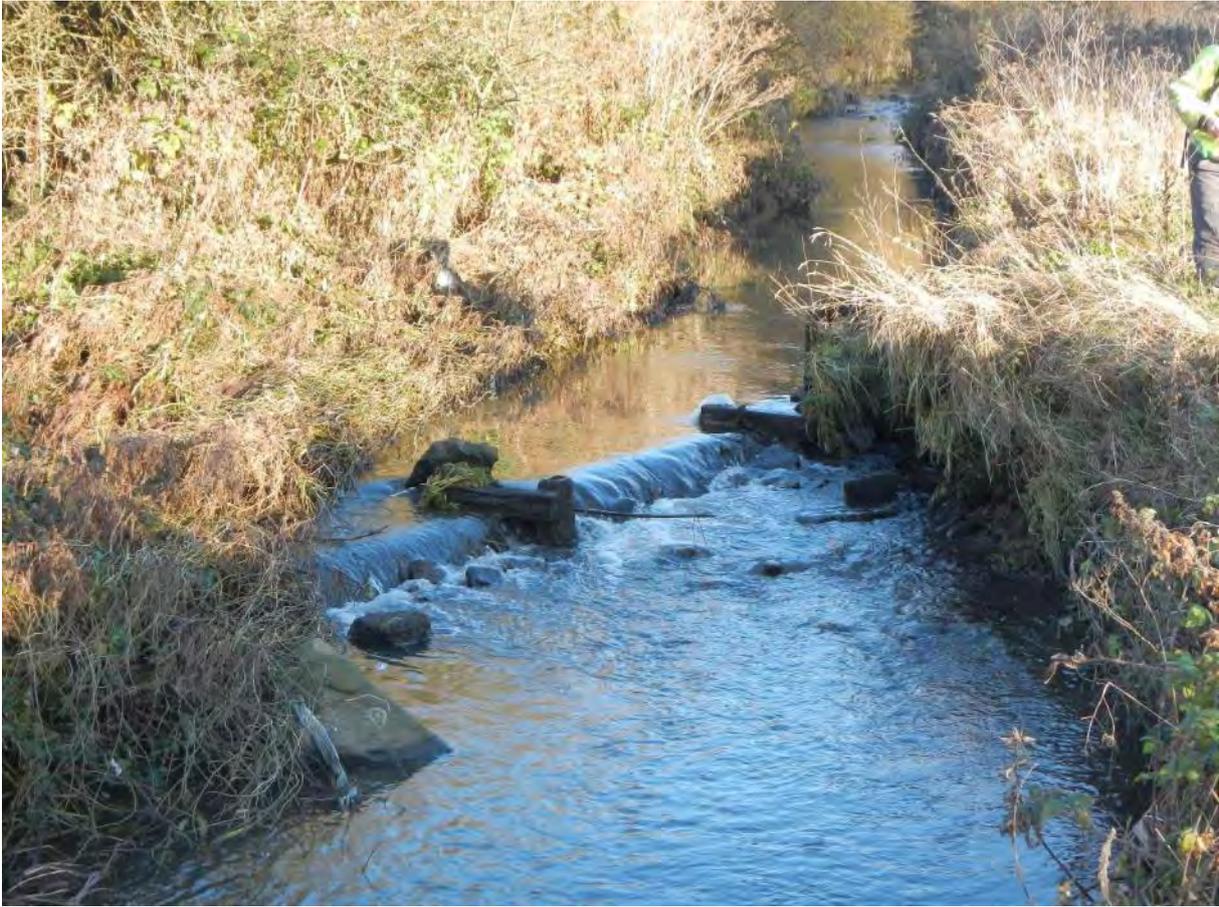
Photo DSCN4871. Small impoundment and minor issue for sediment and fish passage.

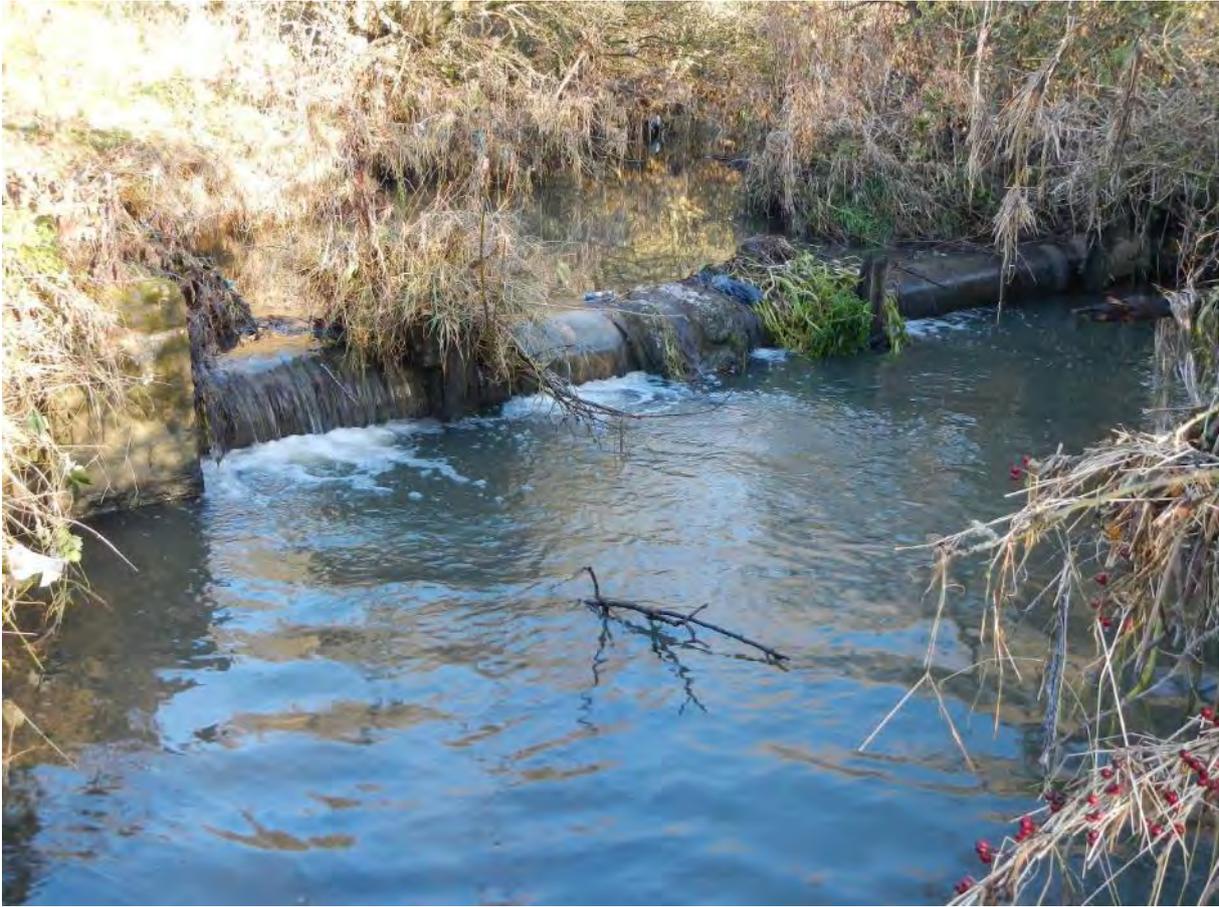
Photo DSCN4875. Small impoundment posing a slightly greater issue for sediment and fish passage.

Issue	Proposed action	Photo	Priority (1-3)
Channel modification	Investigate options for river restoration on rough ground u/s of Metro line. Low-ish priority as channel is moderate condition and service checks may eliminate this area owing to pipe network.	DSCN4871	2
Barrier to fish movement	Install easements at pipe crossings. Structures relatively passable, so only moderate priority.	DSCN4875	2/3

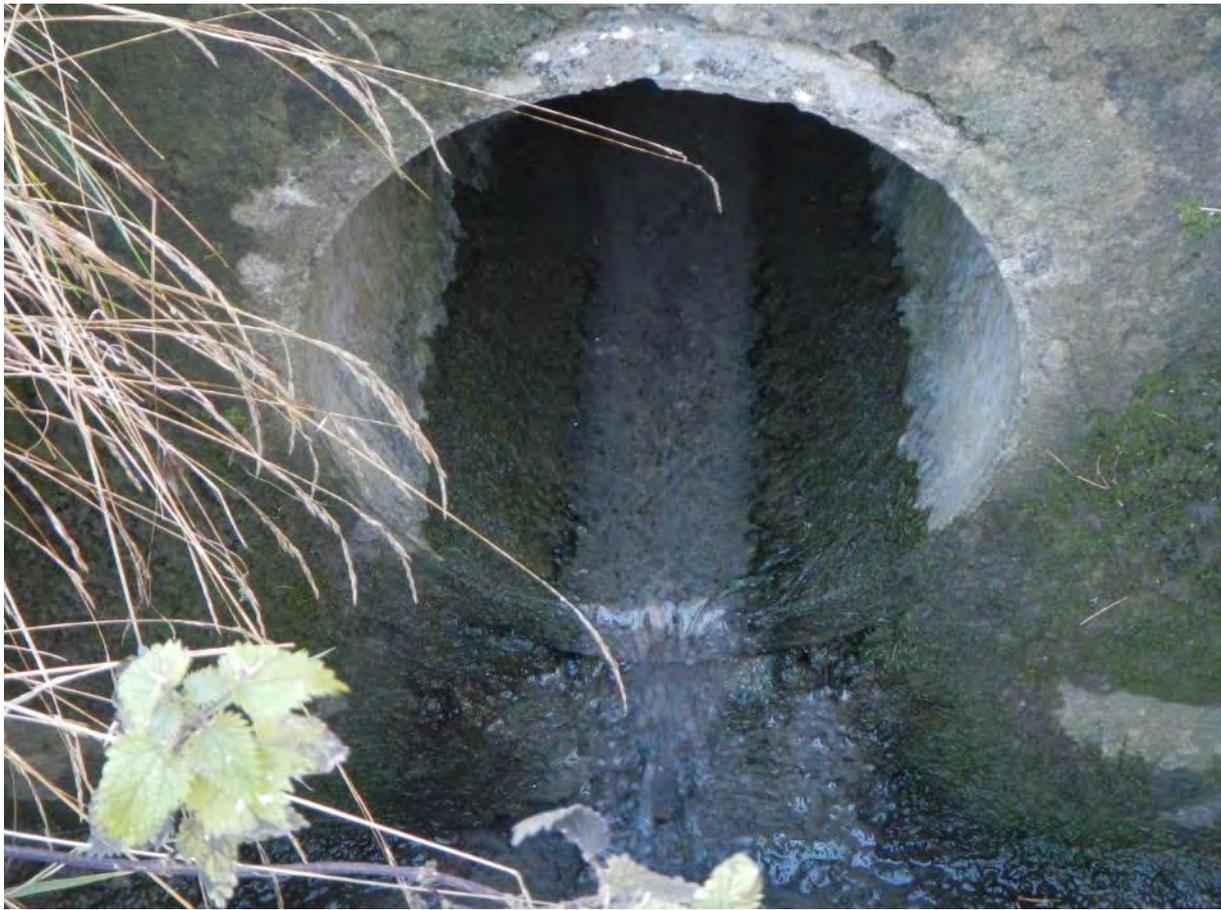
Photo DSCN4879. Grey water discharge and sewage fungus just u/s of culvert (NZ 34251 62786).
