River Don Walkover
(River Tyne Catchment)
29th & 30th November 2016

Undertaken by Gareth Pedley, Wild Trout Trust

1.0 Introduction

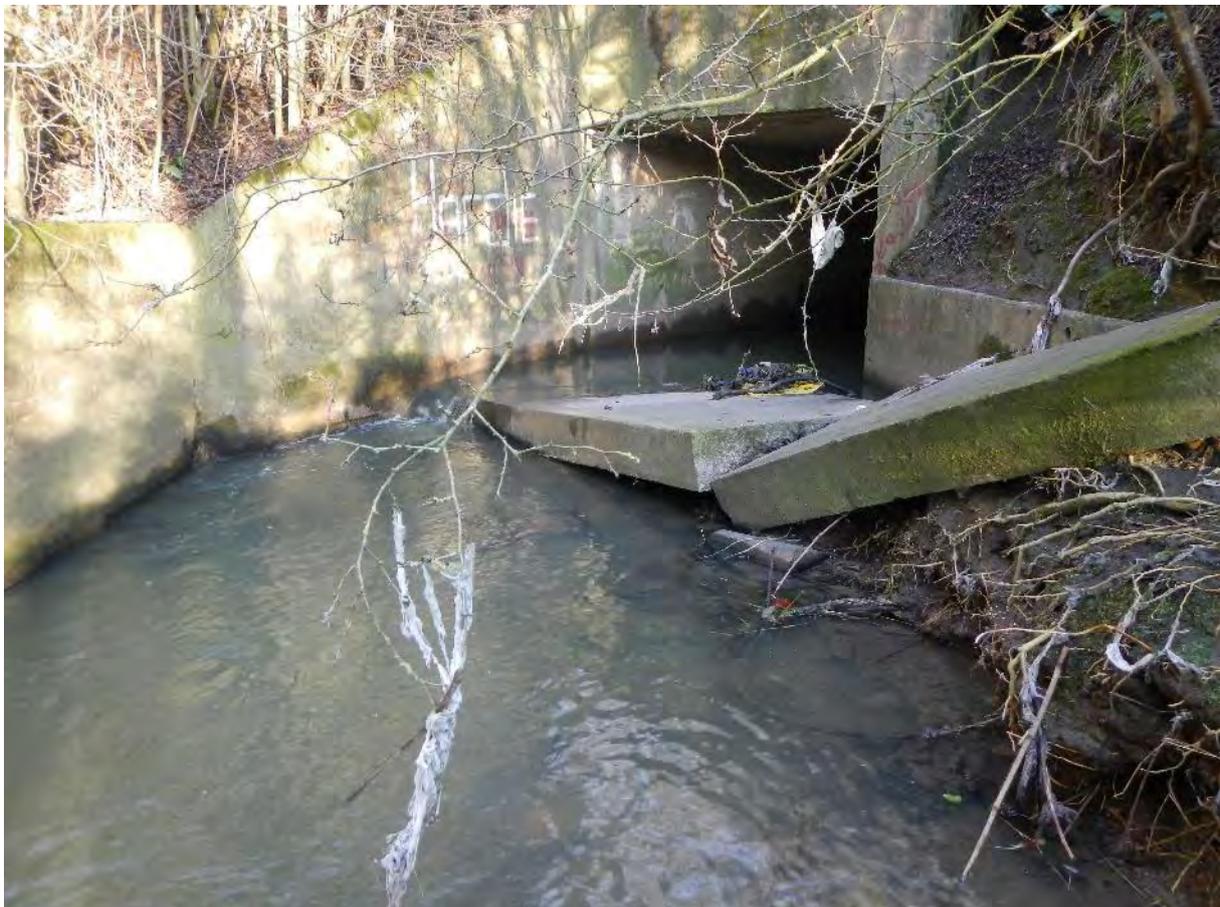
Photo DSCN4890. Collapsed side-wall that creates another obstacle but appears to be acting as a pre-barrage to the weir u/s of the culvert, making its retention beneficial in the short-term.

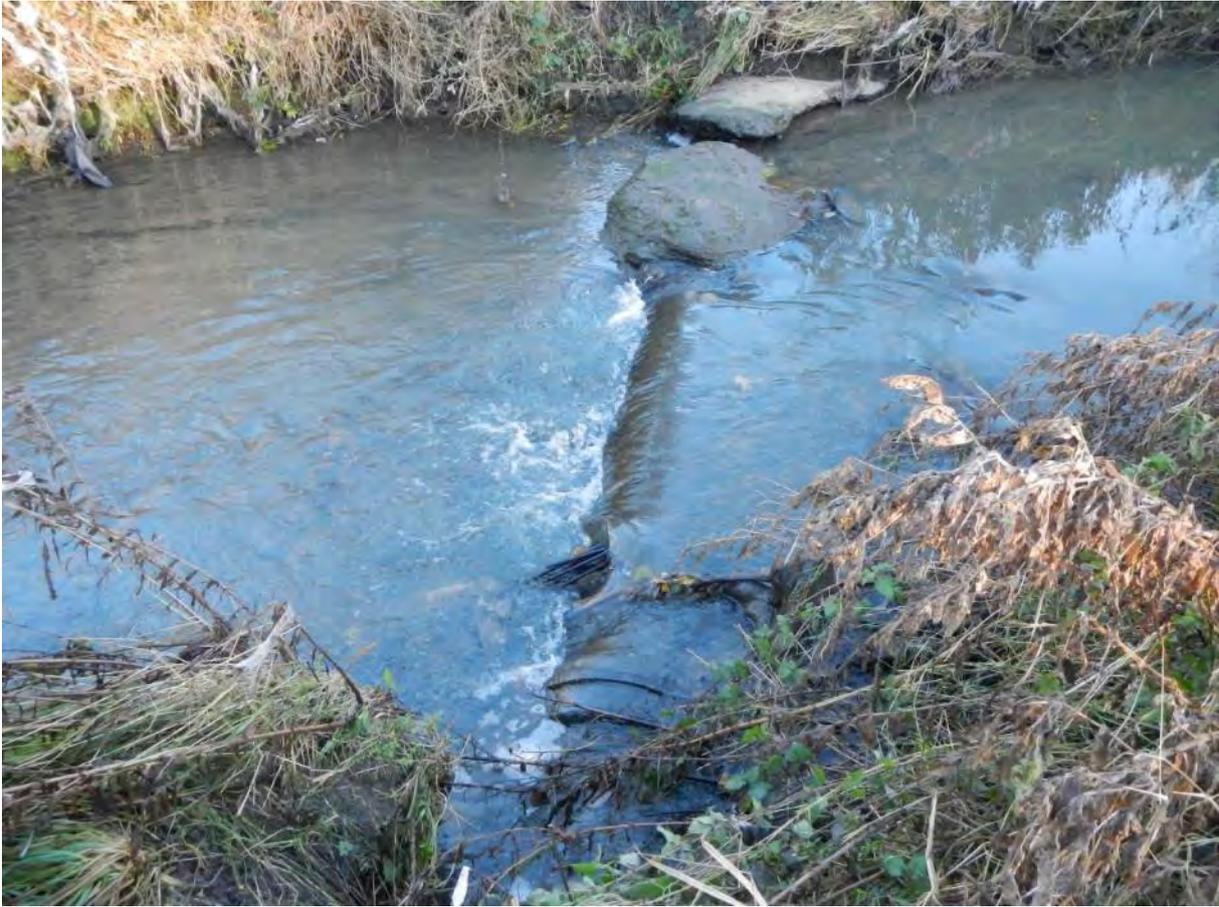
Photo DSCN4895. Minor obstruction created by another pipe crossing.

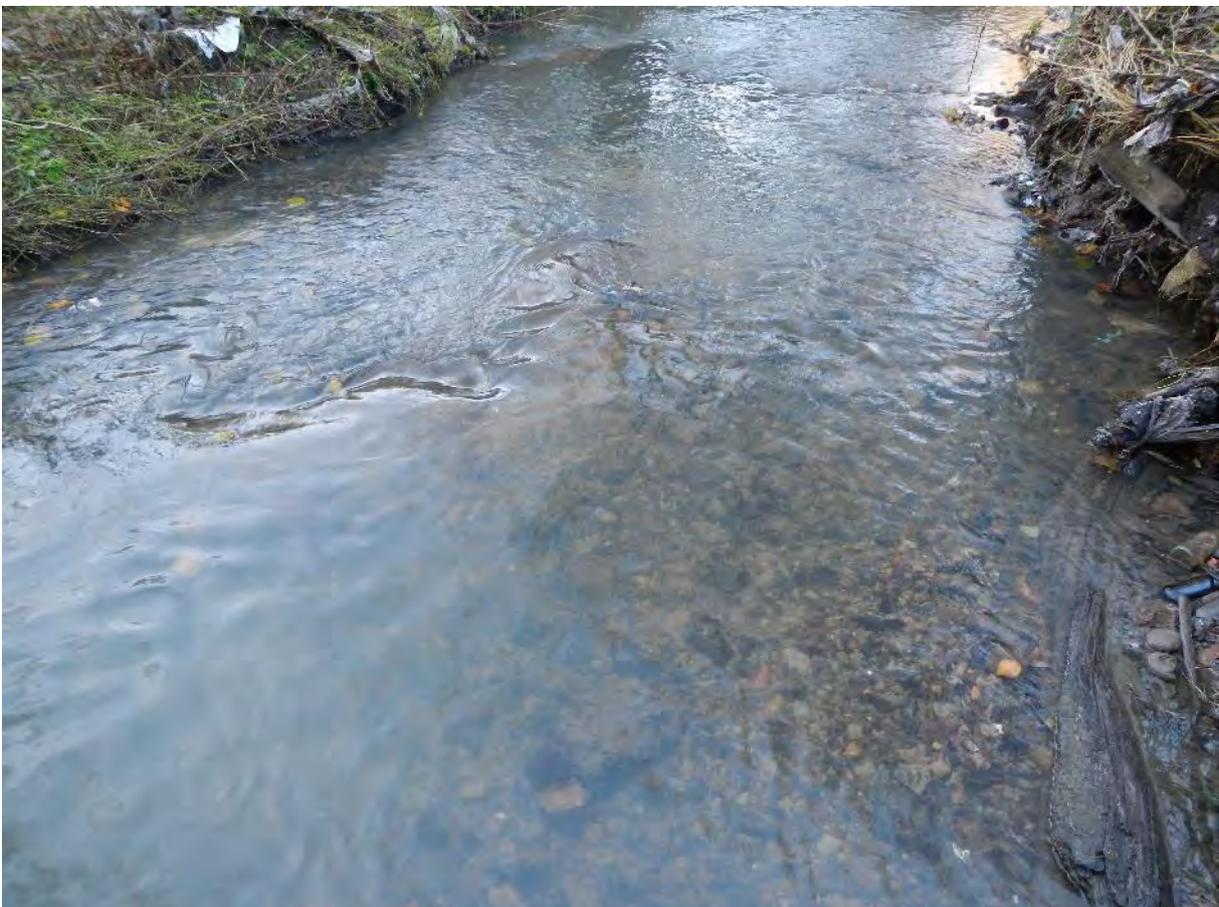
Photo DSCN4893. Even where the basic characteristics for salmonid spawning habitat are present, the fine sediment loading of the substrate is likely to preclude its use.

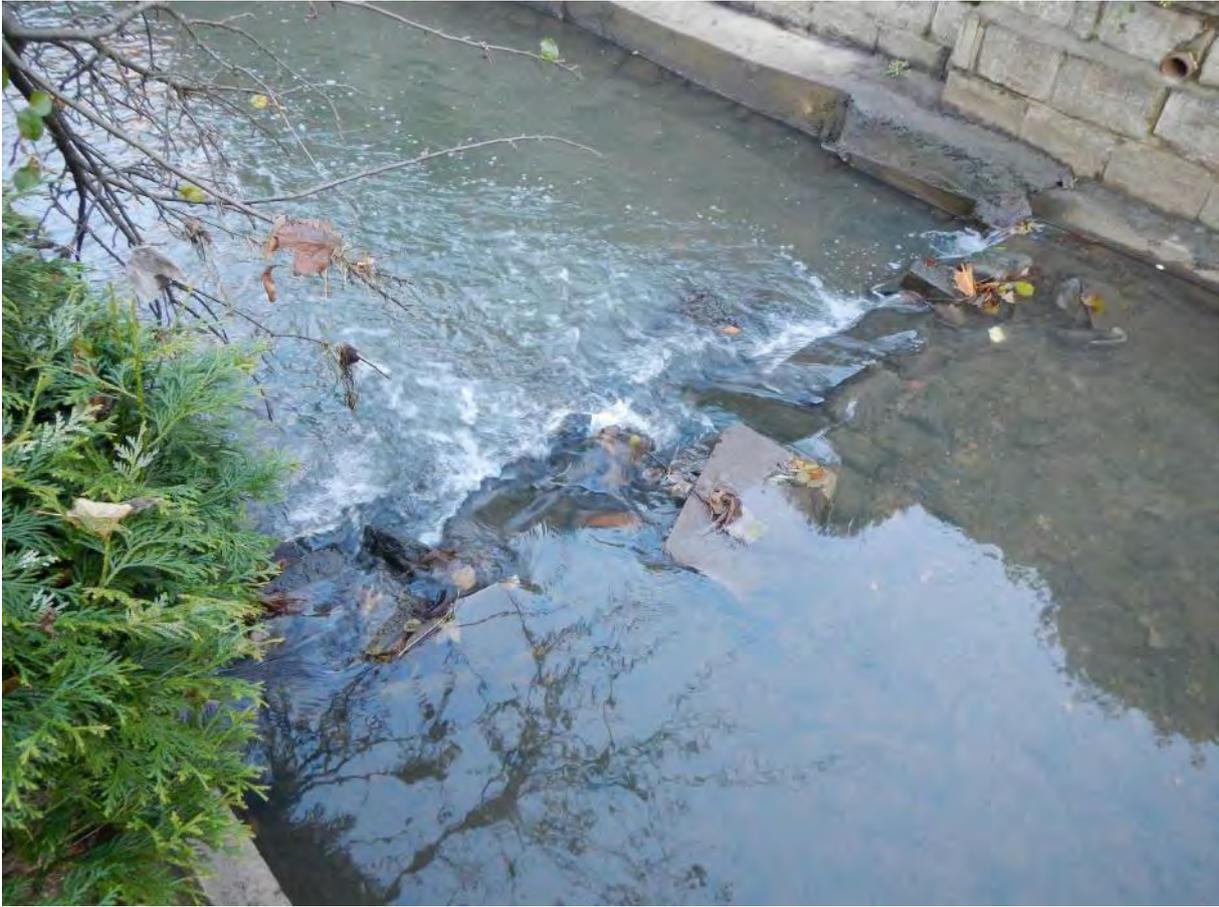
Photo DSCN4906. Small stone weir which is reasonably passable but should be removed.

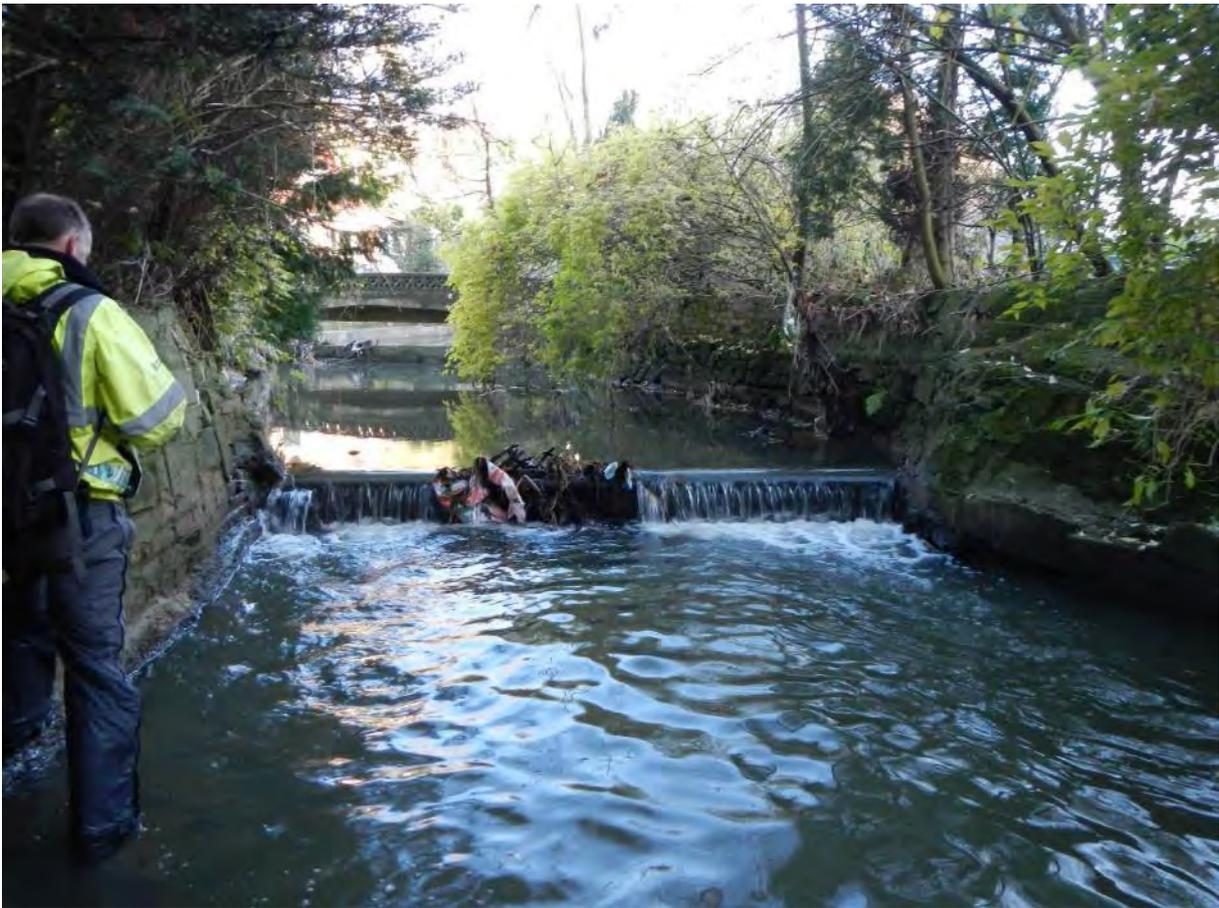
Photo DSCN4909. Pipe crossing with relatively shallow water on the d/s side creates an issue for fish passage at low-medium flows and is probably a significant barrier to eels (further inspection required).

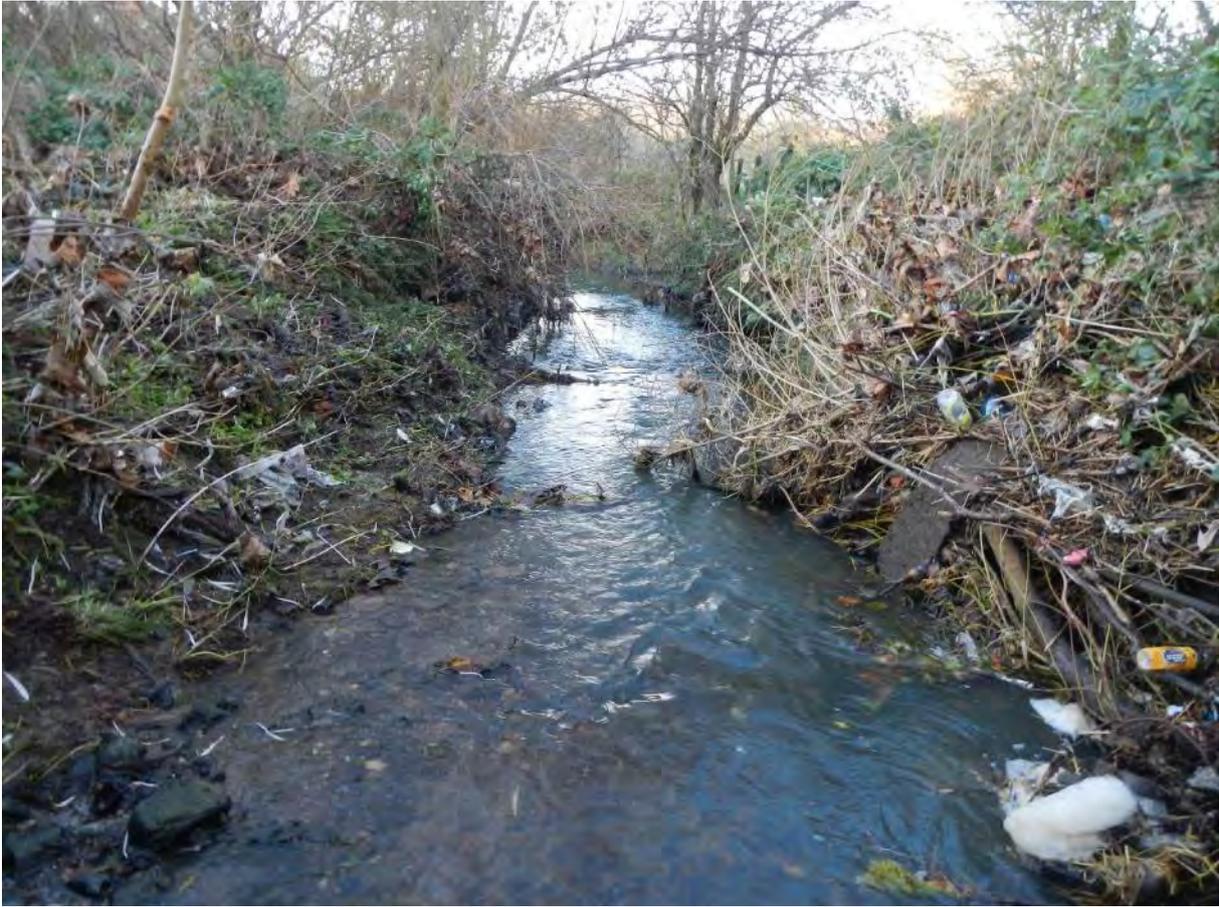
Photo DSCN4914. Overhanging and trailing cover provide some improvement to fish habitat but the bed material is choked with fines, even where flow is of higher velocity.

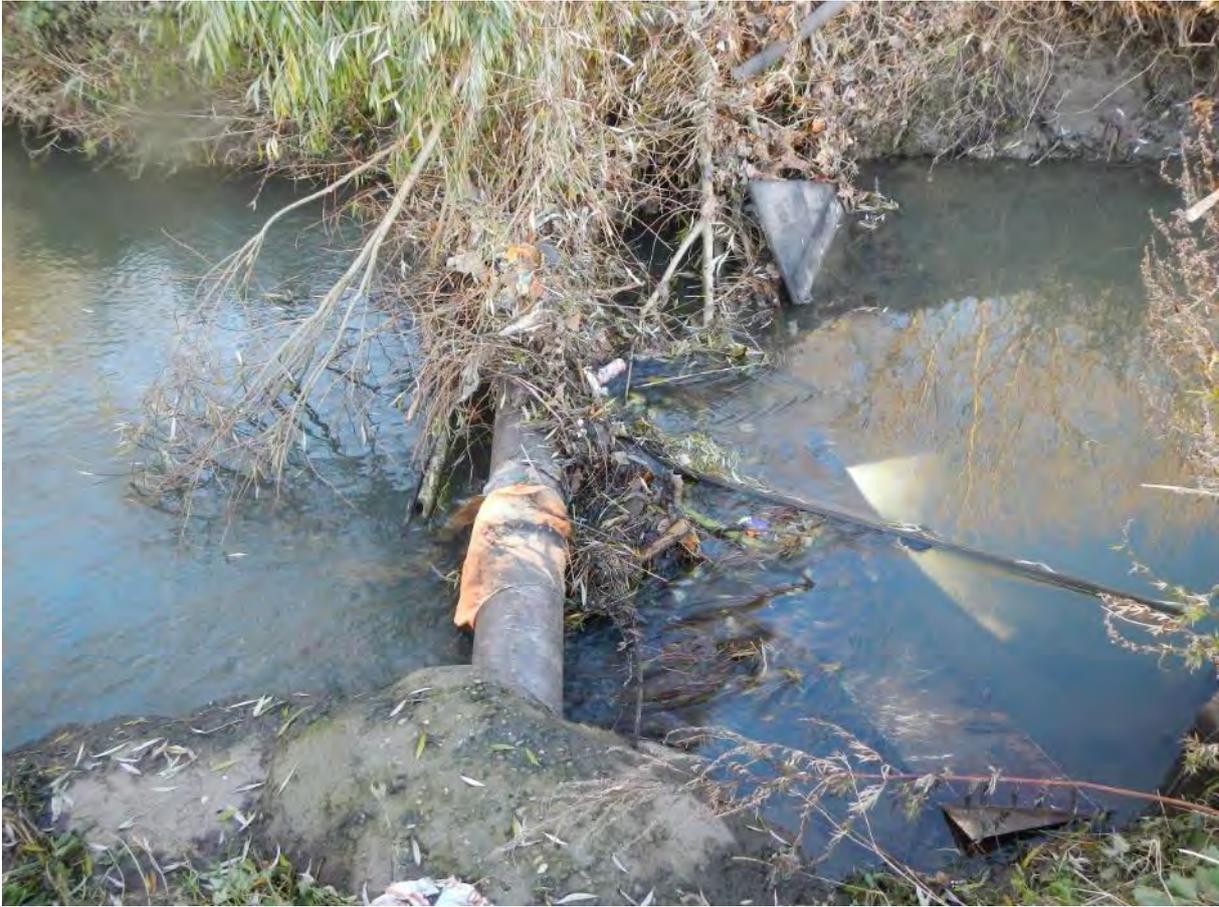
Photo DSCN4923. Pipe crossing partially blocked with flood debris. This is unlikely to pose an issue to fish passage unless it becomes completely blocked. Note that even though partially blocked, the constriction is barely sufficient to create flow diversity within the over-capacity channel.

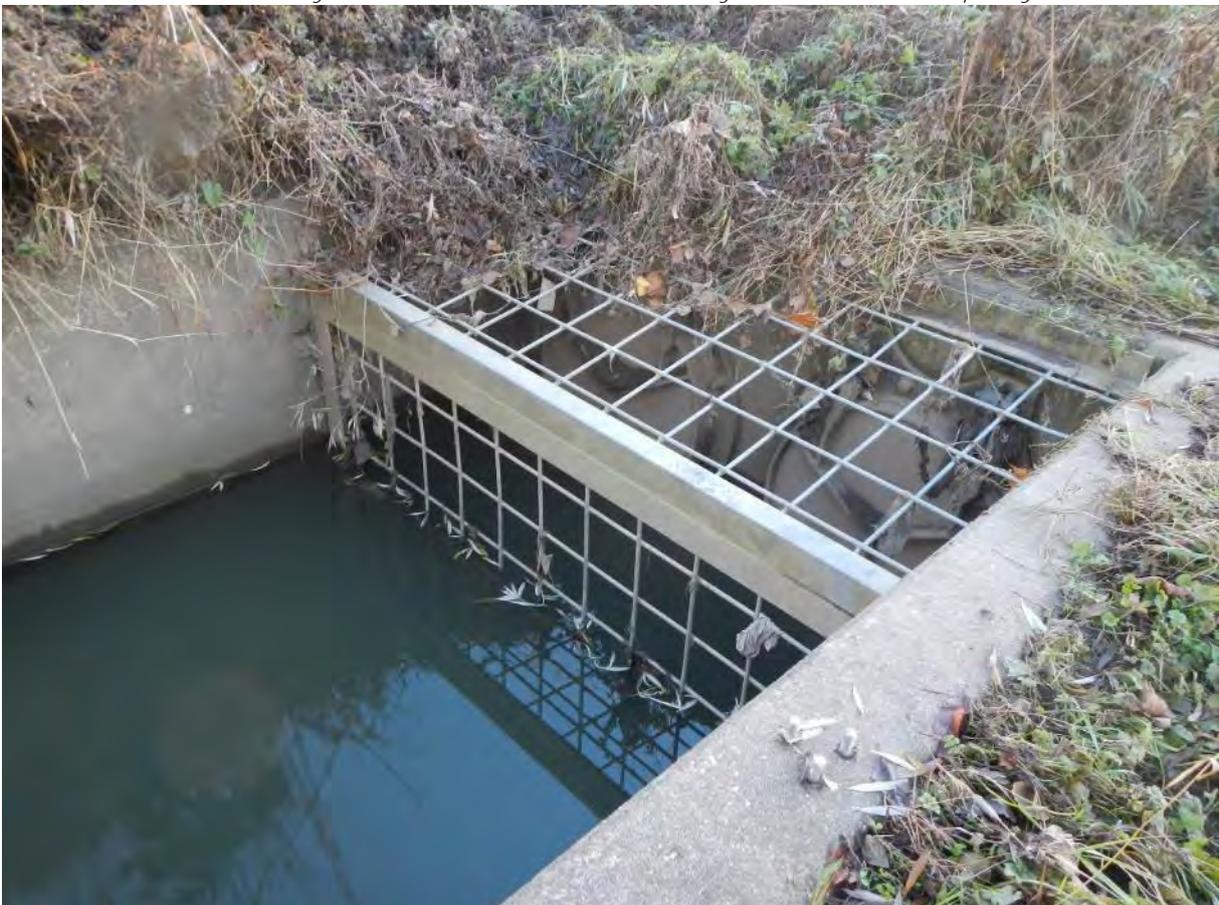
Photo DSCN4924). Large double flap valve which appears to be a CSO by the sewage litter observed on the screen. Any sewage discharge into such a low flow river section is likely to pose water quality issues.

Issue	Proposed action	Photo	Priority (1-3)
CSO discharge / litter	Investigate (NWL) why sewage litter / unscreened waste is being discharged to a watercourse.	DSCN4924	1
Channel modification u/s end of Reach 1	Investigate options for river restoration. Severely degraded channel (not suitable for salmonids) with great potential for restoration on community land.	DSCN4926	2
Barrier to fish passage	Remove concrete bag weir.	DSCN4947	1
Invasive species	Investigate source of Japanese knotweed on Monkton burn and treat with herbicide	DSCN4944	1/2
Barrier to fish movement pipe crossing and weir.	Investigate / service checks for structures. If not live, remove. Possibly improve weir passability if not removed.	DSCN4950 & DSCN4952	2
CSO discharge / litter	Investigate with NWL why sewage litter / unscreened waste is being discharged to a watercourse.	DSCN4956	1
Barrier to fish movement	Investigate / service checks for structures. If not live remove. If live, notch/baffle/nappe.	DSCN4957	2

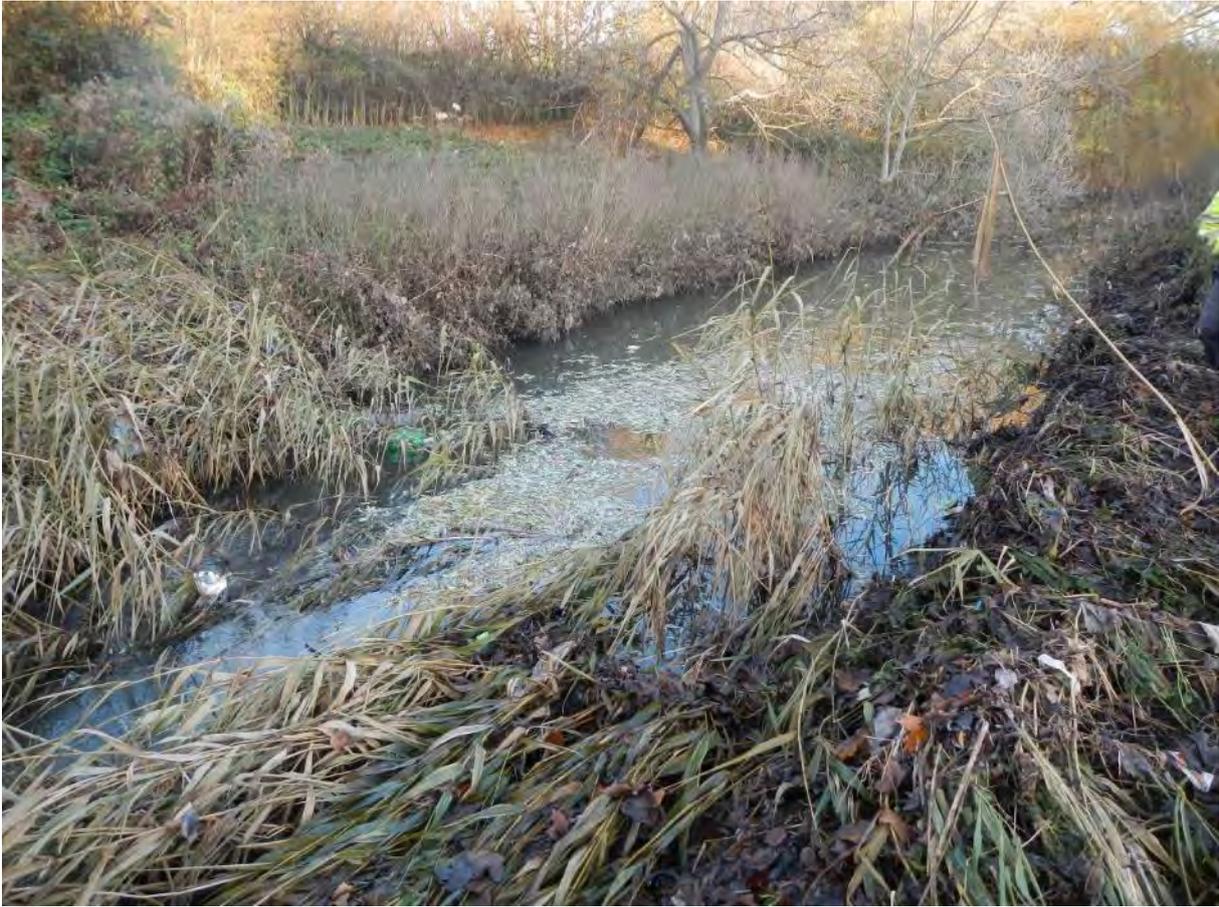
Photo DSCN 4929. In the widest sections flow velocity is so low that emergent vegetation has encroached across most of the channel (probably assisted by uniform sediment deposition). Some areas are barely recognisable as a river.

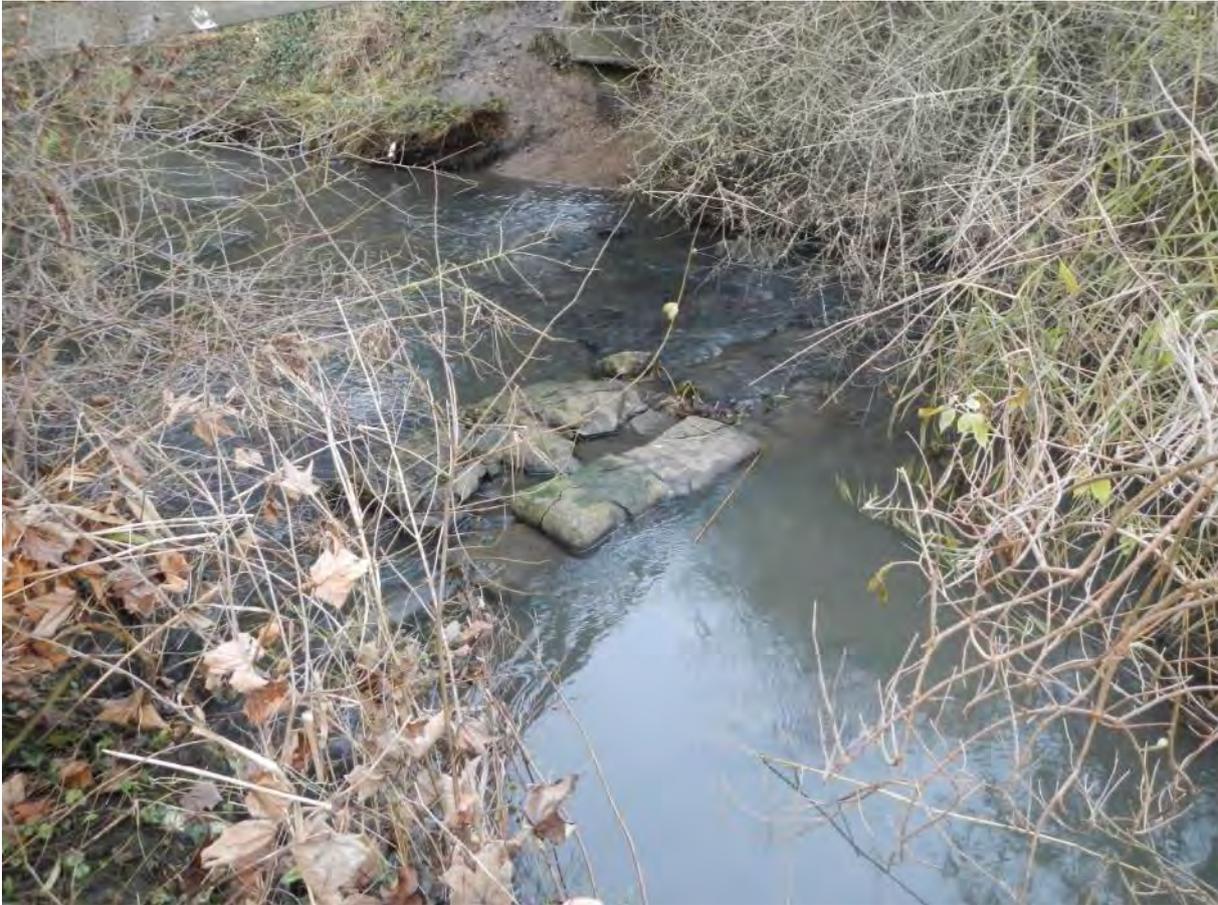
Photo DSCN4947. Small impoundment caused by a concrete bag weir. This is passable but the flow characteristics upstream would be improved by its removal.

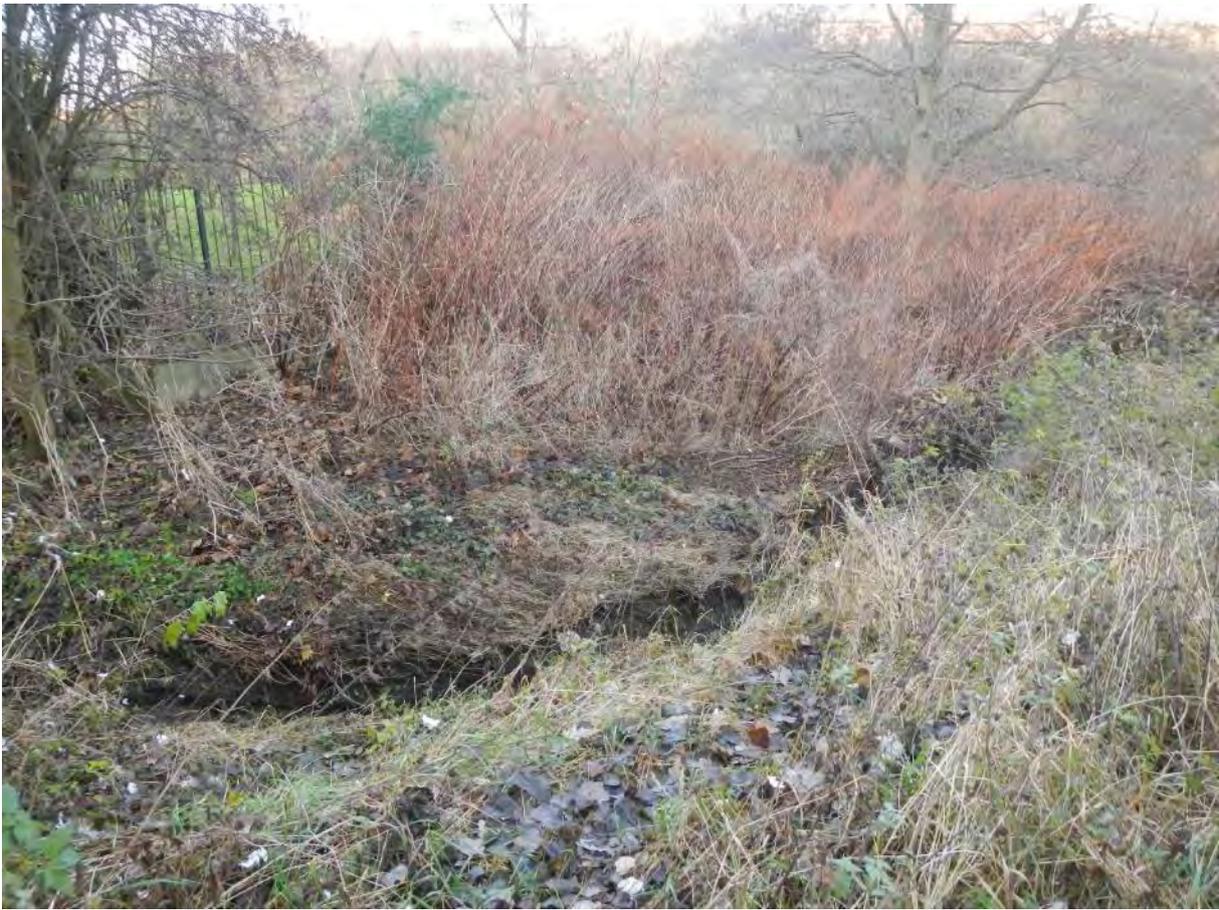
A short distance d/s, Monkton Burn joins the Don and provides the source of Japanese knotweed (*Fallopia japonica*) on the river (Photo DSCN4944). A fixed bed cross-section/possible pipe crossing (Photo DSCN4950) and weir pose a small issue to fish passage and should ideally be removed. **However, if the upper structure is an active pipe crossing that can't be removed**, the weir may actually improve fish passage somewhat by creating a pre-barrage, with access via the broken/collapsed RB side (Photo DSCN4952). On the d/s side of the weir areas of slightly improved habitat were observed but channel straightening limits their value (Photo DSCN4953). Between the weir and Cemetery Road d/s, another large flap valve with sewage litter (Photo DSCN4956) and a small weir/possible pipe crossing (Photo DSCN4957) were noted.

Photo DSCN4944. Monkton Burn – the source of Japanese knotweed on the Don.

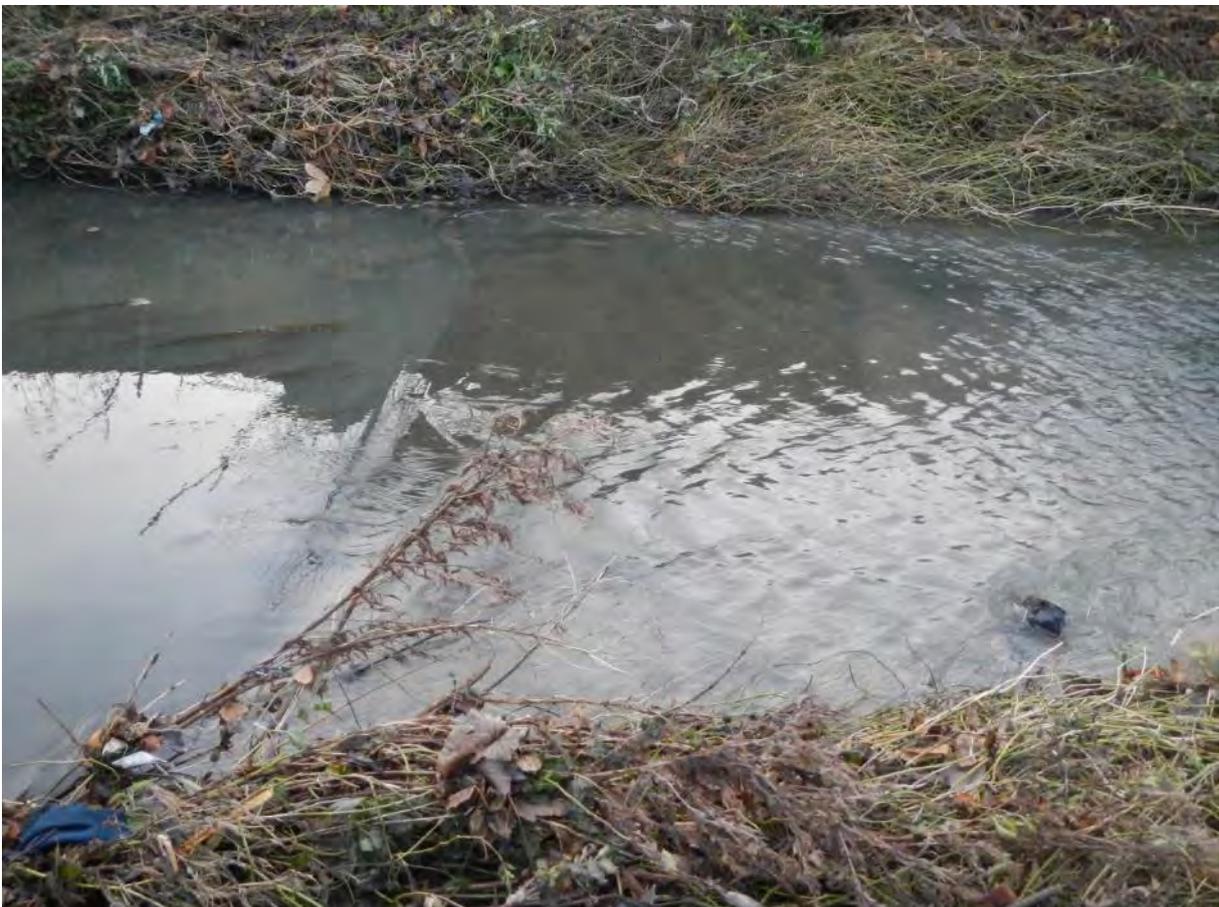
Photo DSCN4950. A fixed, concrete bed cross-section, possibly protection of a pipe crossing. If that is not the case or the pipe is disused the structure should be removed.

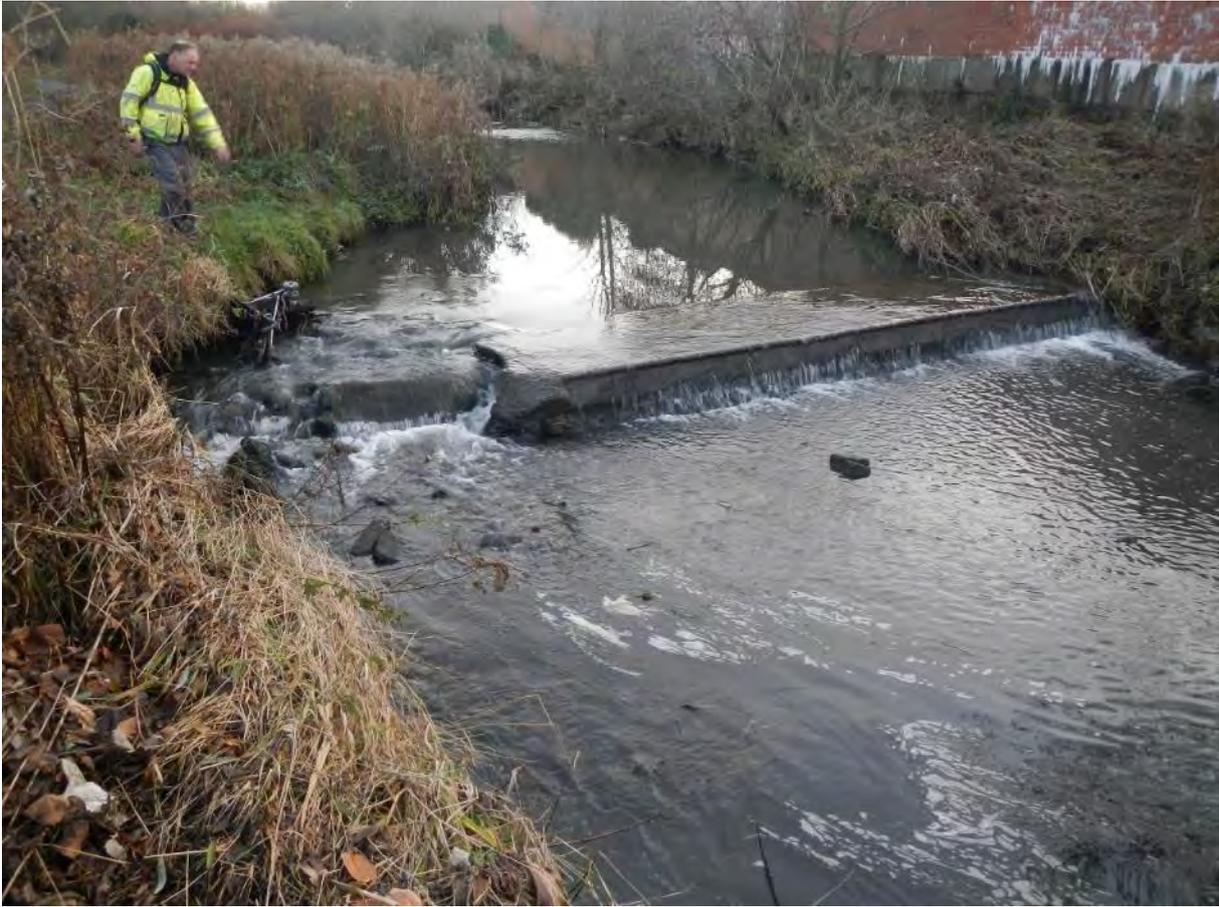
Photo DSCN4952. Weir, possible other pipe crossing. This currently provides some pre-barraging for the u/s weir but, ideally, both structures should be removed if possible.

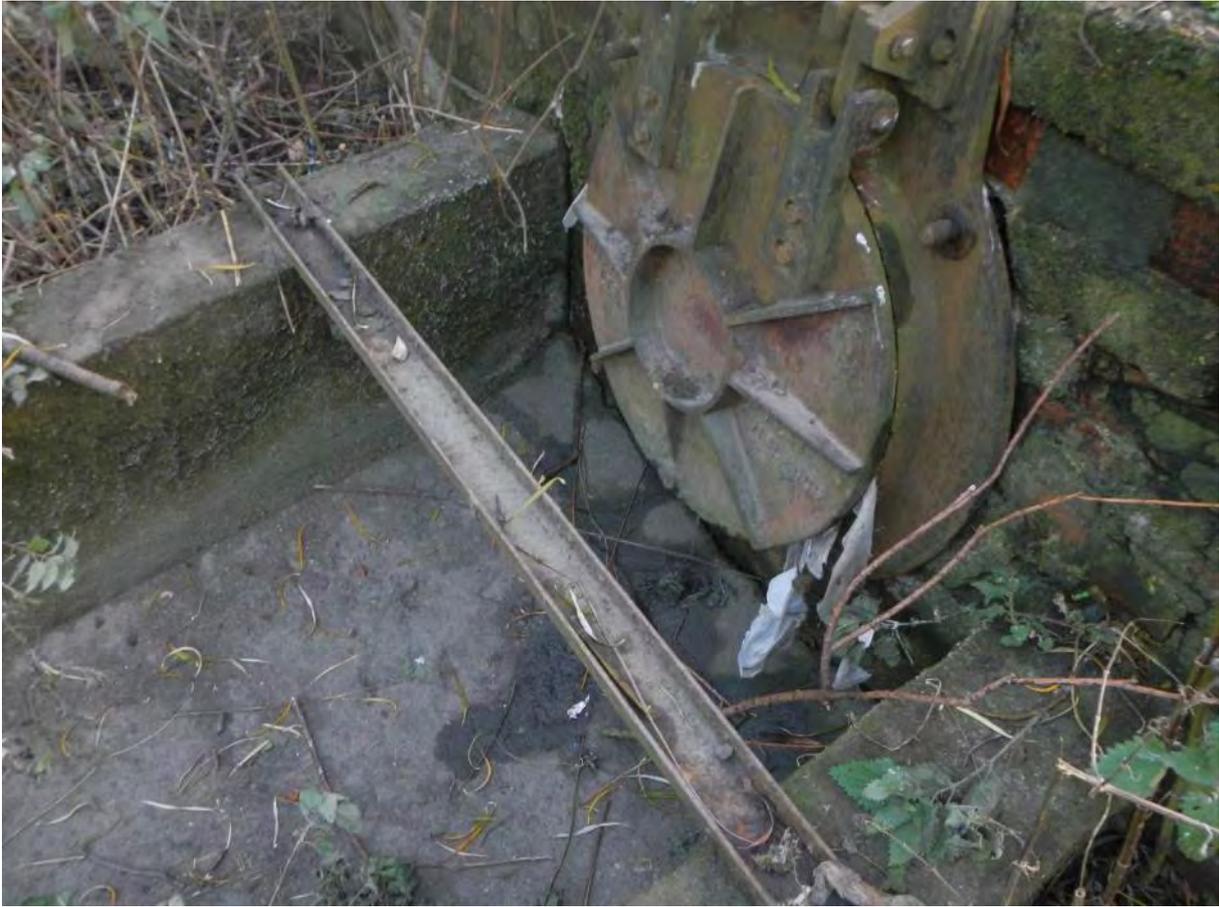
Photo DSCN4956. A large flap valve/CSO with sewage litter (NZ 33063 64320).

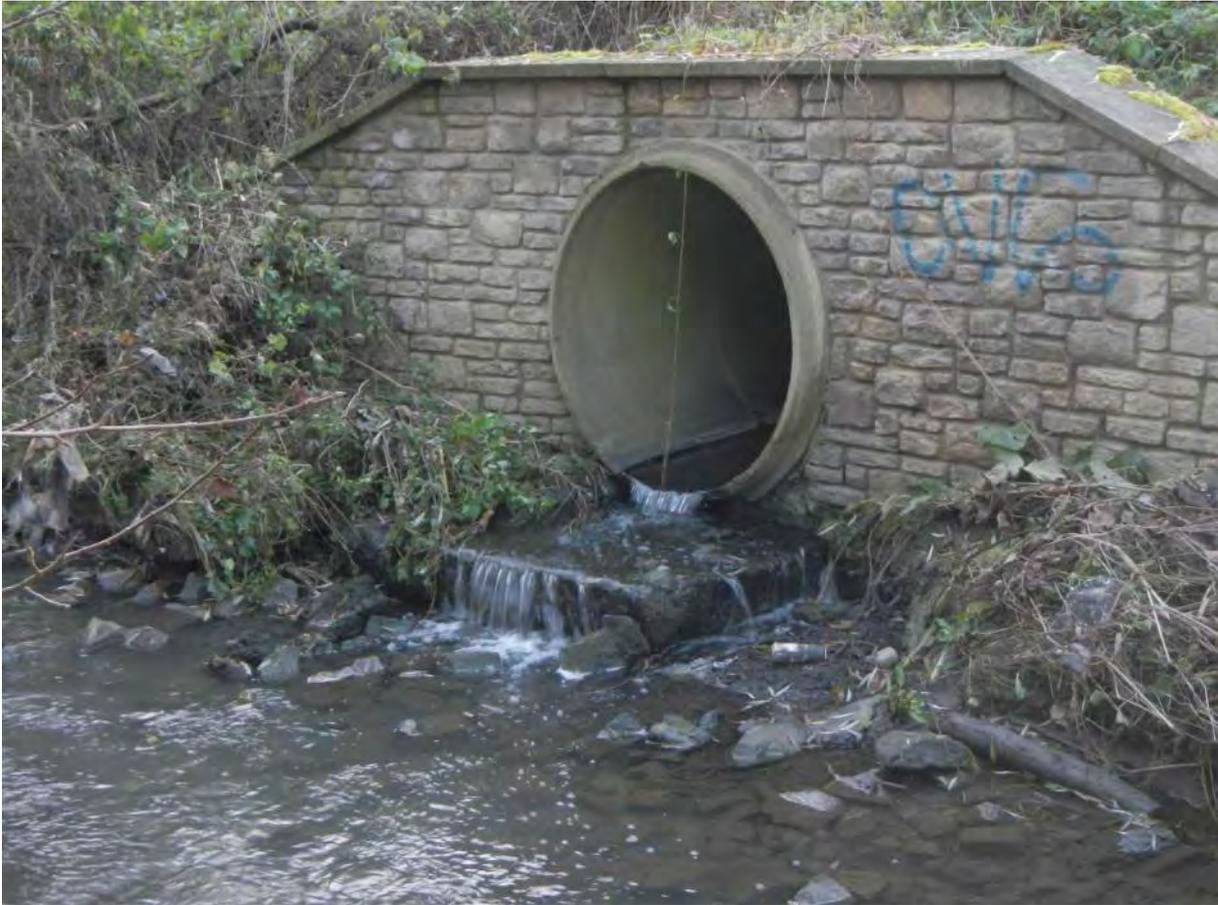
Immediately u/s of the Cemetery Road culvert, Bede's Burn joins the river via a culvert perched well above the river bed level, making it poorly passable to fish (Photo DSCN4959). However, subsequent inspection of aerial photography would suggest that the burn culverted for much of its length and likely to be of minimal habitat value.

Photo DSCN4959. Bede's Burn discharging to the River Don via a poorly passable, perched culvert.
Owing to the extent of modification, this tributary is likely to provide minimal habitat value anyway.

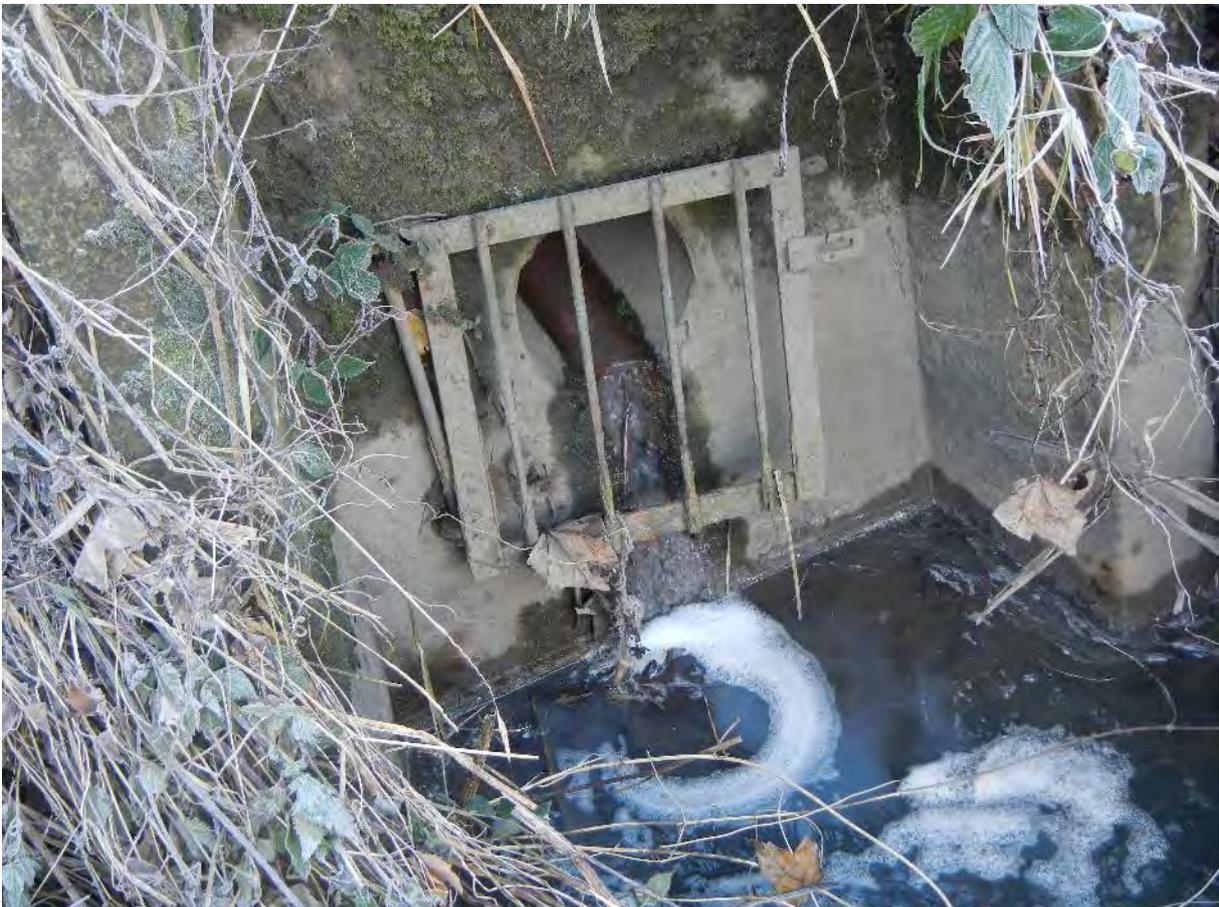
Photo DSCN4805. Suspected wrong connection draining straight into the river (NZ 33353 64608).

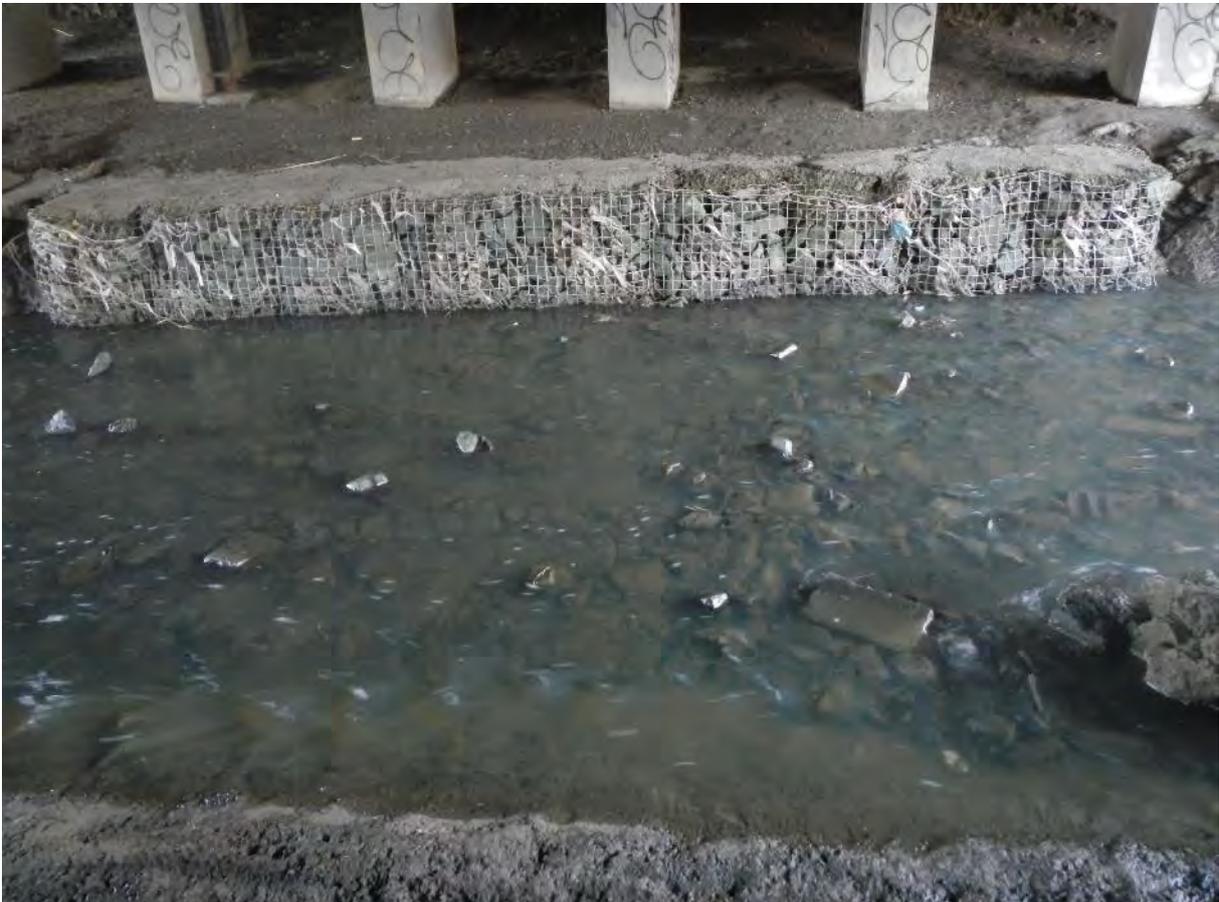
Photo DSCN4803. Around and under the A19, wider areas of channel where the gradient remains provide some coarser substrate habitat but the fine sediment and poor water quality is clearly visible.
