WILD TROUT TRUST

**River Esk Walkover (lower)**

(West Cumbria)

5/02/2021

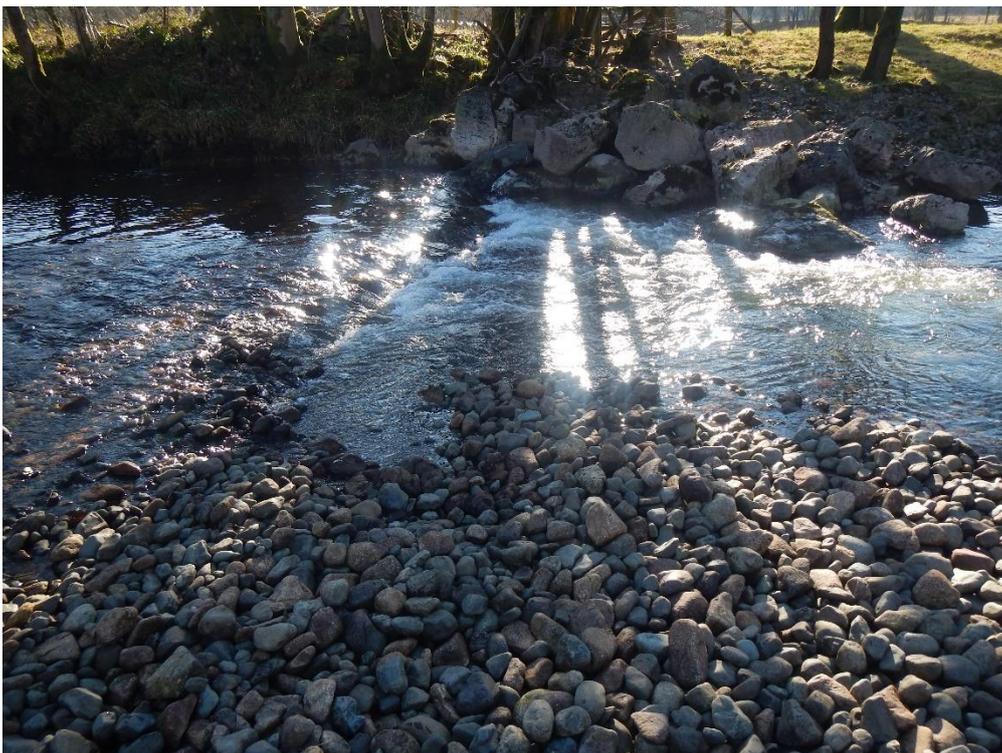
**Figure 1** The lower section of the Esk, from Black Dub to Donald's Pool, has been significantly straightened but also has numerous man-made weirs and flow deflectors installed. These provide some flow variability but create a range of unintended consequences. Here the structure is impeding natural sediment transport between pools and disrupting the flow into Black Dub (SD 13518 97997). It would be far better to allow natural shallower riffle features to form between the pools.

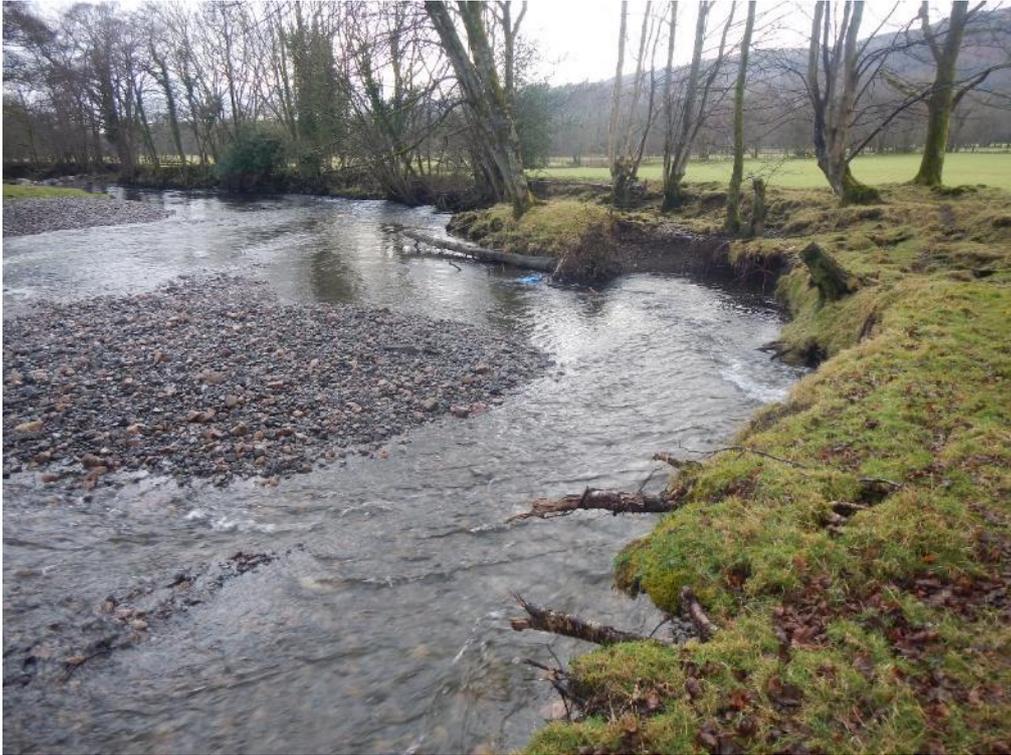
**Figure 2.** Sheep grazing is contributing to bank instability at Black Dub (note the lack of vegetation) and will hinder attempts to restabilise it (SD 13513 98017). Flow disruption caused by the structure upstream (**Figure 1**) is also contributing to the gravel bar within the channel, forcing flow into the bank. The top of a fallen tree in the river has been cut, reducing its habitat value and diminishing the bank protection it could provide. It is far better to leave fallen trees intact; the rootball acts as an anchor and the diffuse canopy dissipates flow (often turning an area of erosion into an area of deposition).

Livestock should be excluded from the riverbank around Black Dub, to allow a diverse strip of riparian vegetation to develop. This would improve bank stability and manage the existing erosion but also create a range of benefits to biodiversity, including provision of additional habitat for invertebrates, thereby improving the ecology of the river and providing more food for fish.

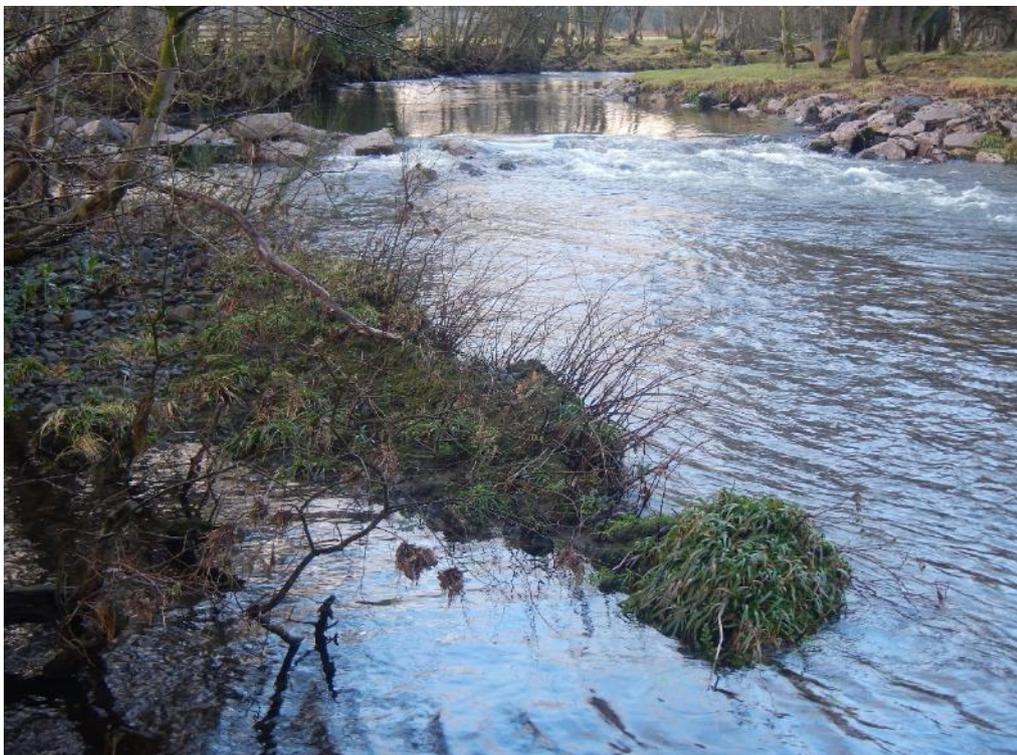
**Figure 3** A weir at the downstream end further interrupts the transport of bed material, leading to shallowing of the pool (SD 13458 97955). It also focusses flow into the centre of the channel when a healthy river flow should be allowed to naturally move back and forth from one outside bend to the other as it progresses downstream – it should not be constrained in the centre of the channel.

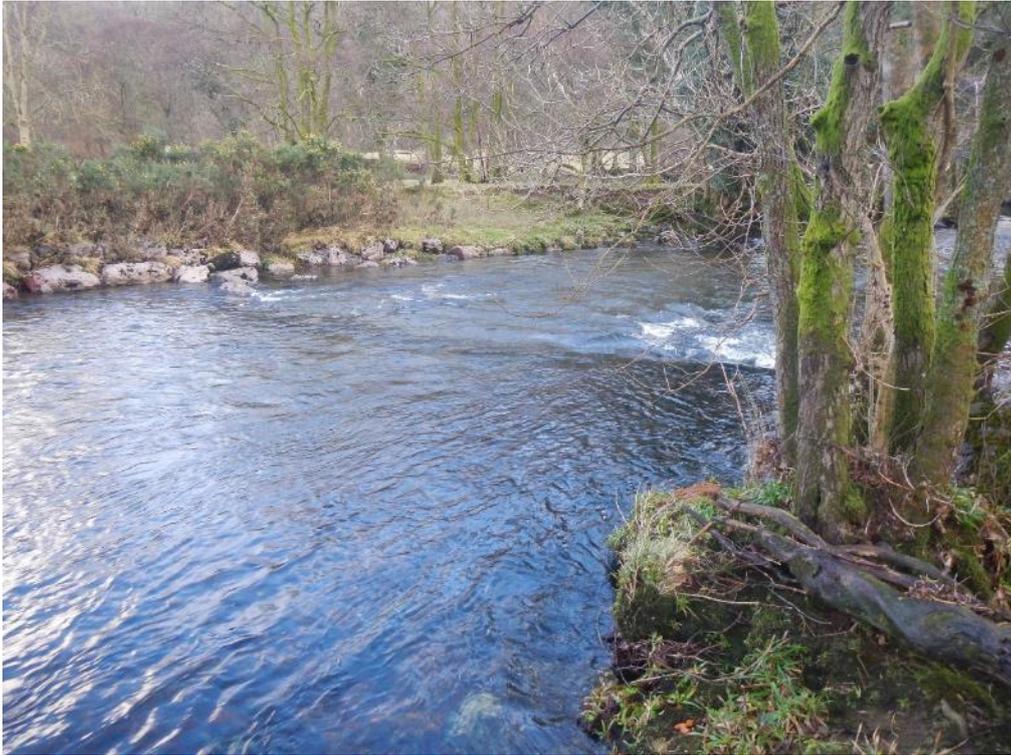
**Figure 4** Another rock weir structure a short distance downstream creates less of a problem for sediment transport but still detrimentally locks the bed in place and unnaturally constrains flow to the centre of the channel (SD 13449 97911).

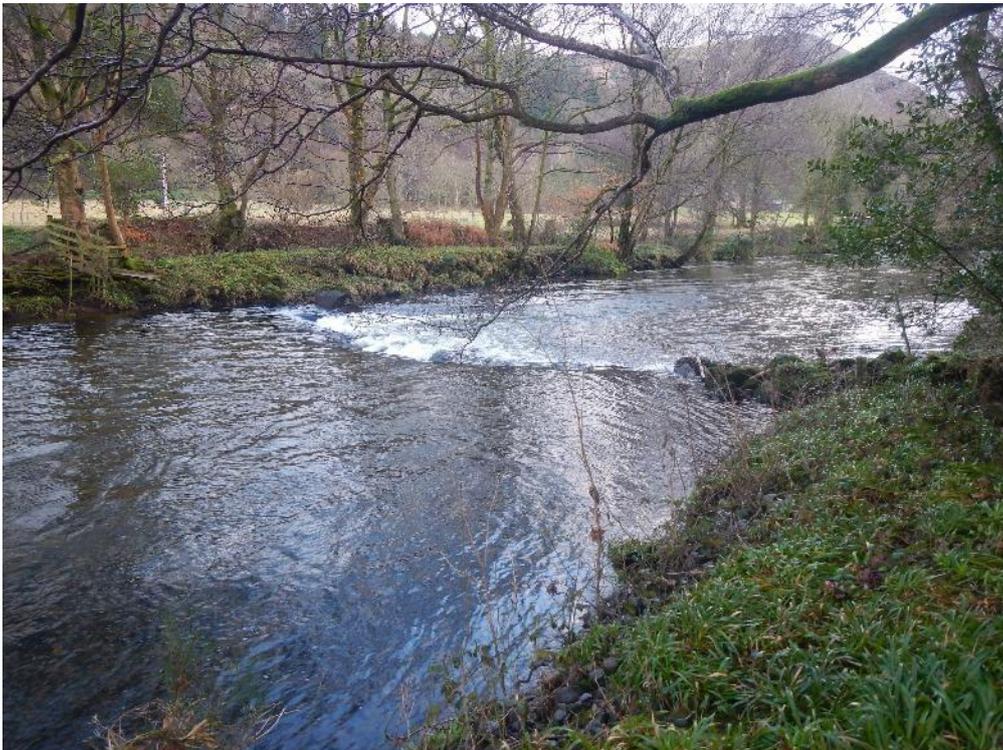
**Figure 5** Impounded water upstream of the next weir structure (SD 13430 97858). Between pools there should naturally be shallower depositional areas of gravel/cobble and riffled water that provide vital habitat for a range of invertebrates and juvenile fish. Instead, that valuable habitat has been degraded in an attempt to artificially create depth. Depth created by an impoundment will always diminish over time as bed material is trapped upstream (see **Figure 6**). Again, the weir focusses flow to the centre of the channel, disrupting the flow approaching the next natural pool downstream.

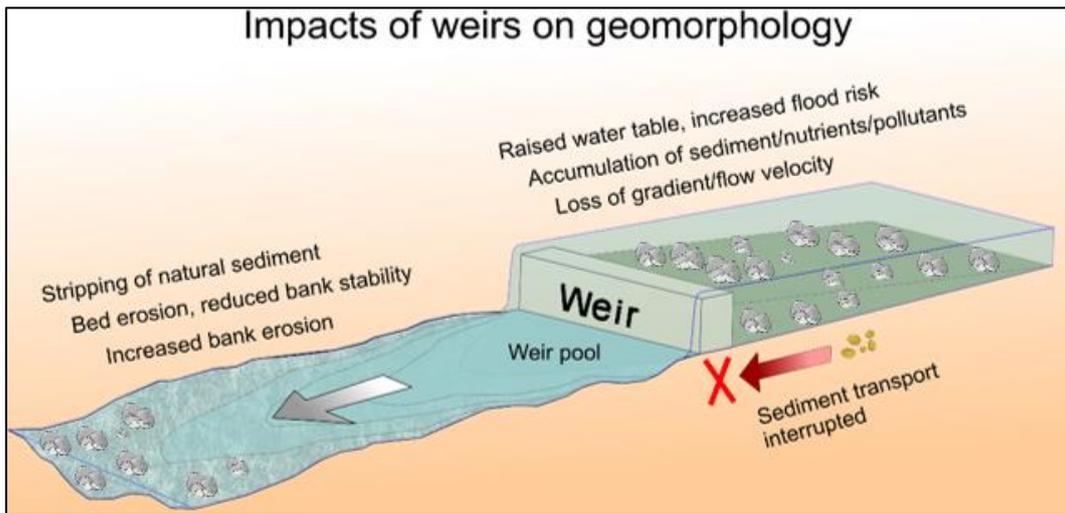
**Figure 6** Shows how deeper water created by weirs is only temporary and any depth created is at the expense of flow diversity. The de-energised flow upstream deposits sediment, reducing depth over time as the pool fills up with bed material. Eventually the pool becomes, shallow enough to have sufficient flow energy to transport additional bed material past the weir, but that process remains more erratic than would occur without the weir. Weirs also create negative impacts upon habitat upstream through reduced flow diversity. That is why it is always preferable that pool depth is created and maintained naturally through scour, avoiding full width obstructions like weirs. Moreover, when installed at an existing pool, the reduced gradient upstream (and reduced flow energy) resulting from the raised weir means that the pool is likely to end up even smaller/shallower than before the weir was installed.

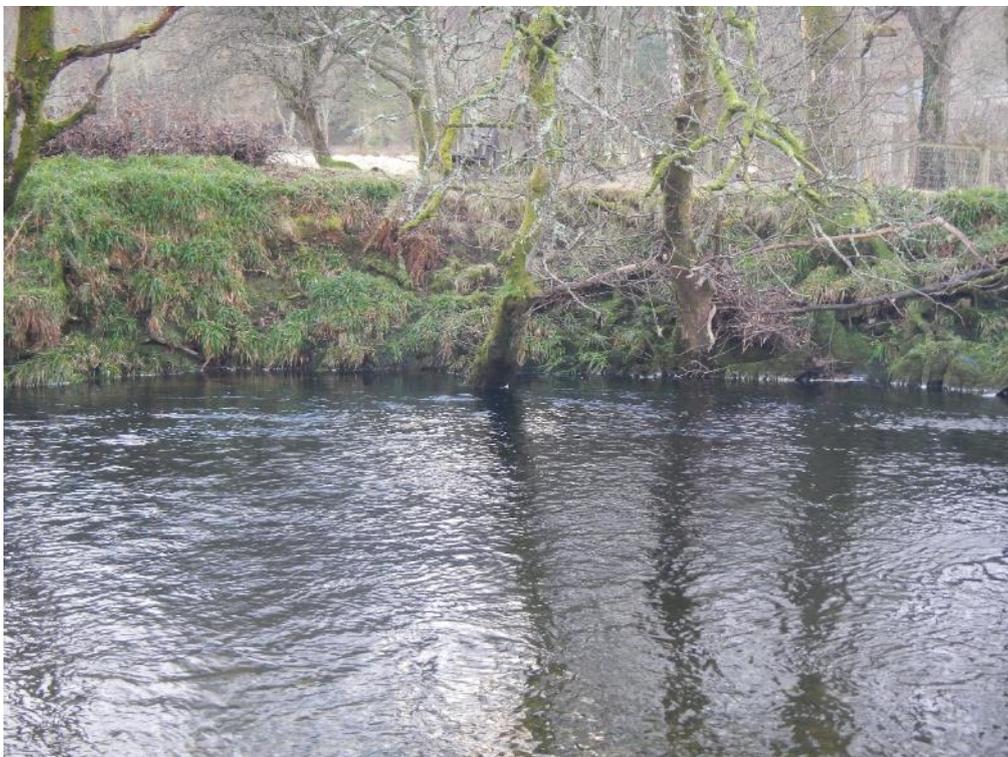
**Figure 7** Being at a bend, the deep water at Knott End Dub is more naturally maintained by flow and bed scour around the outside bend. Overhanging trees provide valuable shade and additional cover which should be retained – a classic sea trout lie.

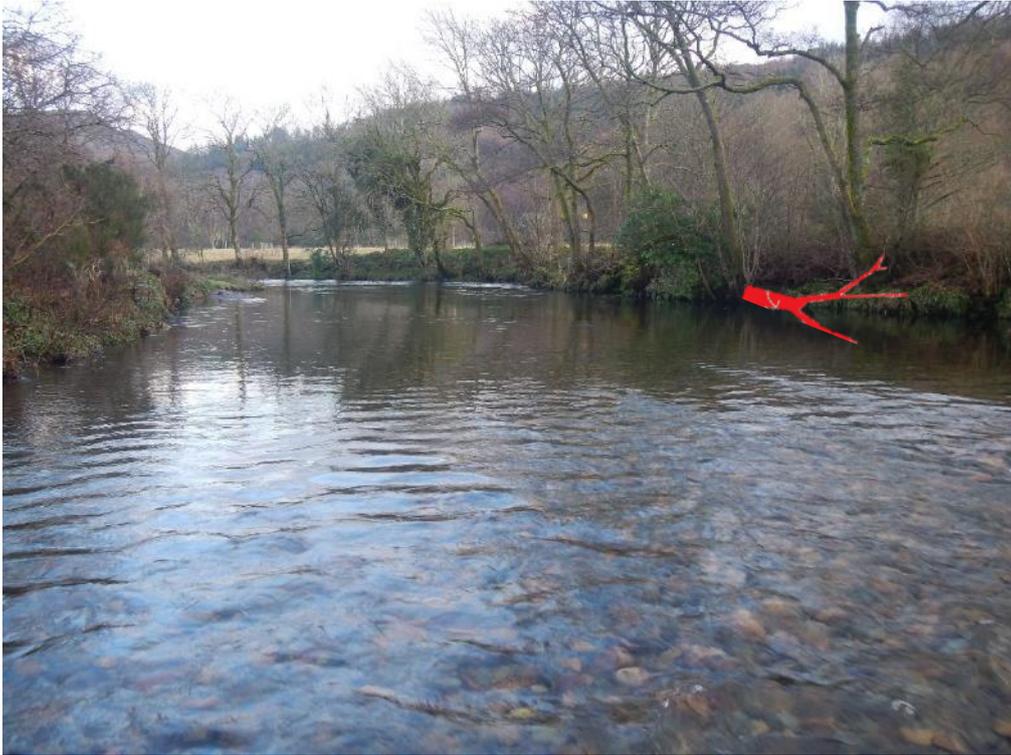
**Figure 8** Looking back upstream at Knott End Dub (SD 13364 97800), the trees on the LB (right of shot) provide valuable cover, but a history of pruning and natural sloughing has left them lacking low branches. Coppicing one or two trees to use as lodged woody material and laying a small shrub along the bankline (red outline) could help to redress the lack of cover and increase the fish-holding potential of the pool. Planting a couple of goat willow whips in the open sections could also help.

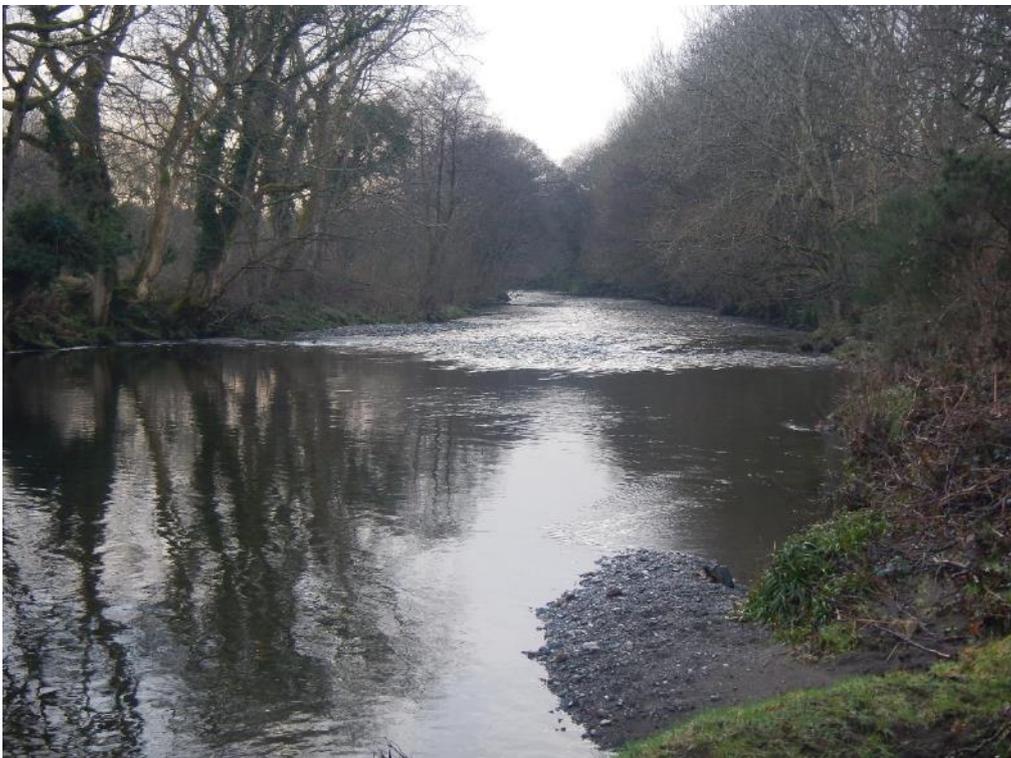
**Figure 9** Deflectors (possibly with a full width structure beneath) disrupt the tail of the pool and what would otherwise be a better potential salmonid (particularly salmon and sea trout) spawning area (SD 13343 97792). Deflectors along the RB in the shallow riffle further downstream prevent the predominant flow running tightly along the base roots of the trees (where it would be of greatest benefit), effectively straightening/smoothing out the bend.

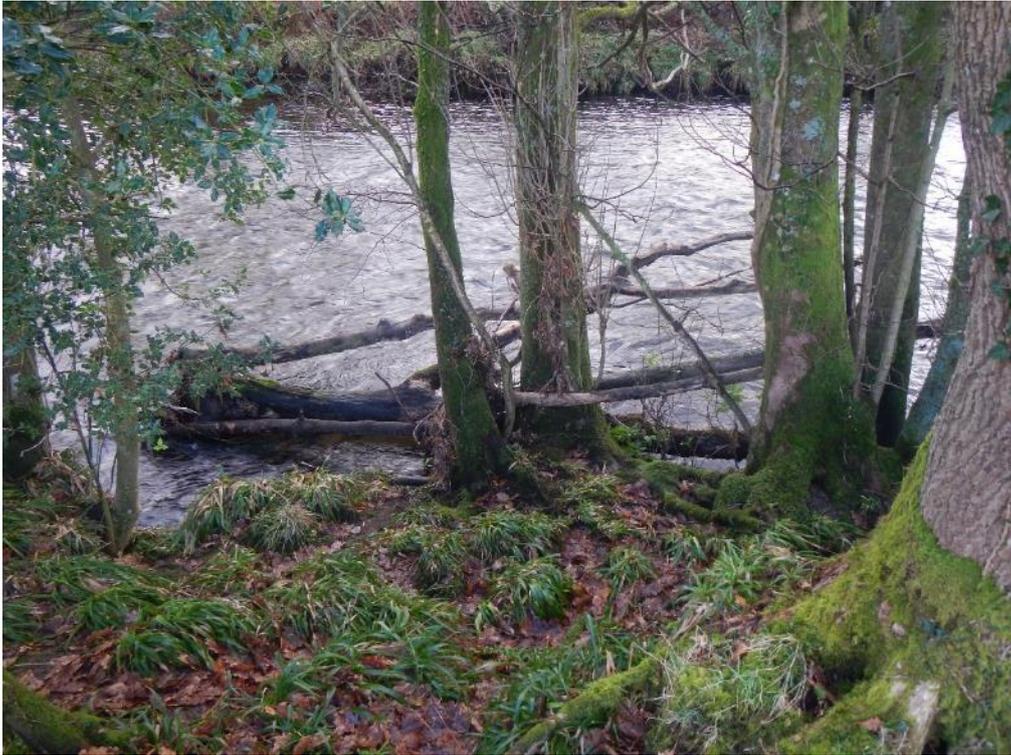
**Figure 10** In the faster water area downstream: a perfect example of naturally lodged large woody material (LWM). This could be replicated in other areas to increase flow diversity, drive improvements in the bed morphology and provide cover for fish (see **Recommendations**).

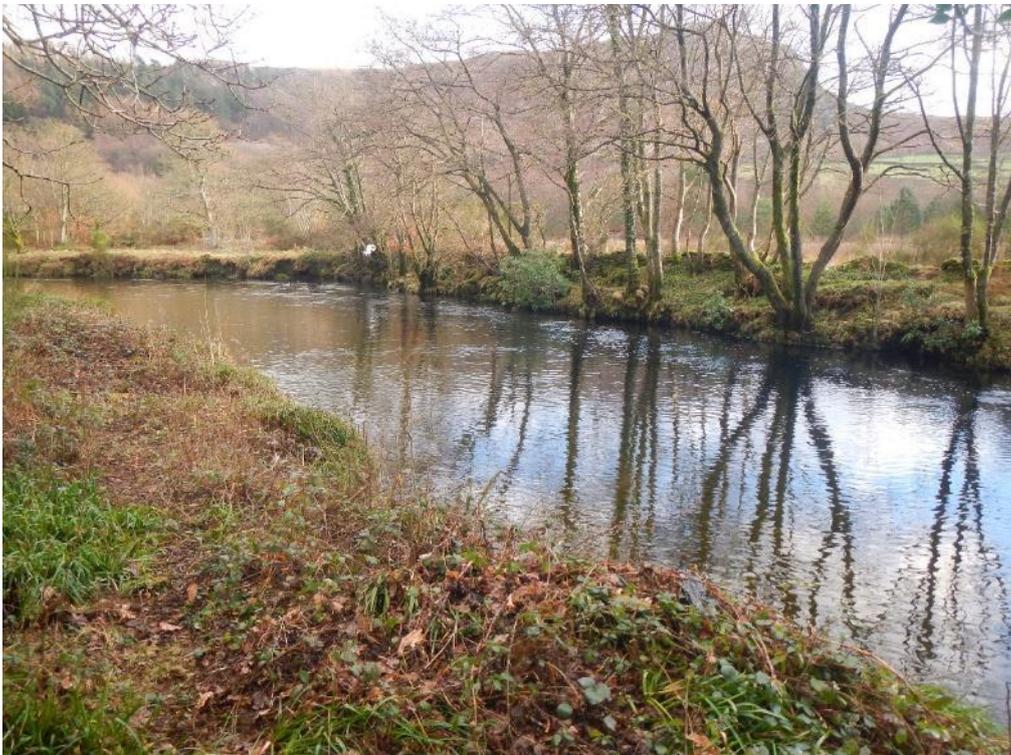
**Figure 11** Although trees are present around the outside bend of Hazel Dub, there is a scarcity of low branches. While this kind of clearance was once the aim of many angling club work parties to ease casting, greater understanding of fish habitat proves this to be highly counterproductive, reducing the numbers of fish an area is likely to hold. Moreover, an open pool with reduced flow diversity and fewer features is less interesting to fish and easier for predators like cormorants to exploit. Selectively coppicing one or two trees could beneficially reinvigorate low-level branch growth (see **Recommendations**).

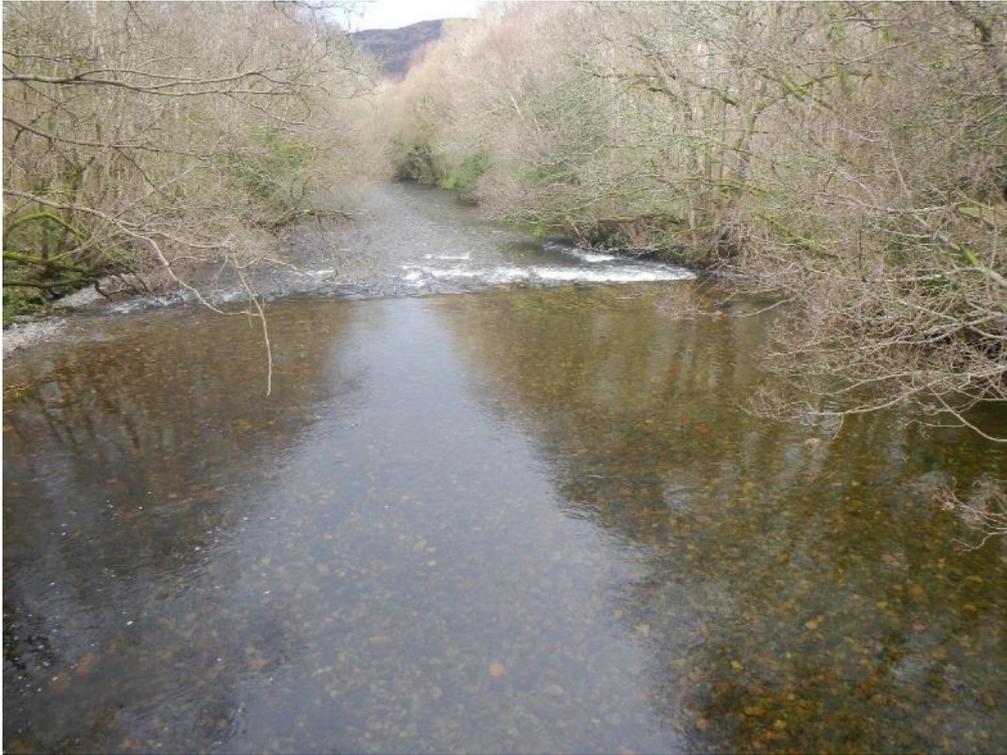
**Figure 12** A weir (associated with flow gauging) at the tail of the pool creates a minor obstruction and would ideally be replaced by a stand-alone ultrasonic flow gauging, without a weir, to allow completely natural movement of fish and sediment (SD 13068 97799). However, considering the number of more damaging gauging structures nationally, this is low priority. Even in the impounded area, the substrate is relatively coarse, hinting that the high energy of peak flows within the uniform channel, which is incapable of retaining smaller gravel.

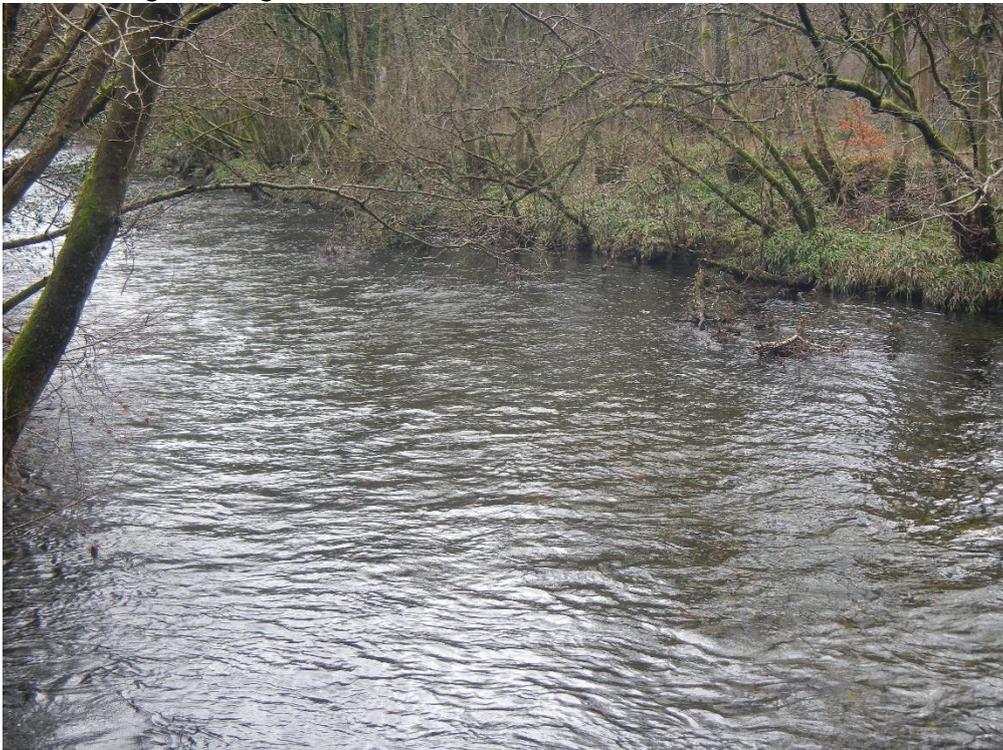
**Figure 13** Much of this reach has been straightened (SD 13064 97805 - SD 12732 97949), with a notable loss of pools and deeper water. Some of the river's paleochannels (old course) are still visible within the woodland and options for restoring them should be investigated. Even allowing adjustment of the riverbanks would be a great improvement on the uniform channel. The occurrence of low and trailing cover increases, and the available habitat is gradually improving as a result, becoming more likely to hold fish. However, the channel remains uniform in depth and width.

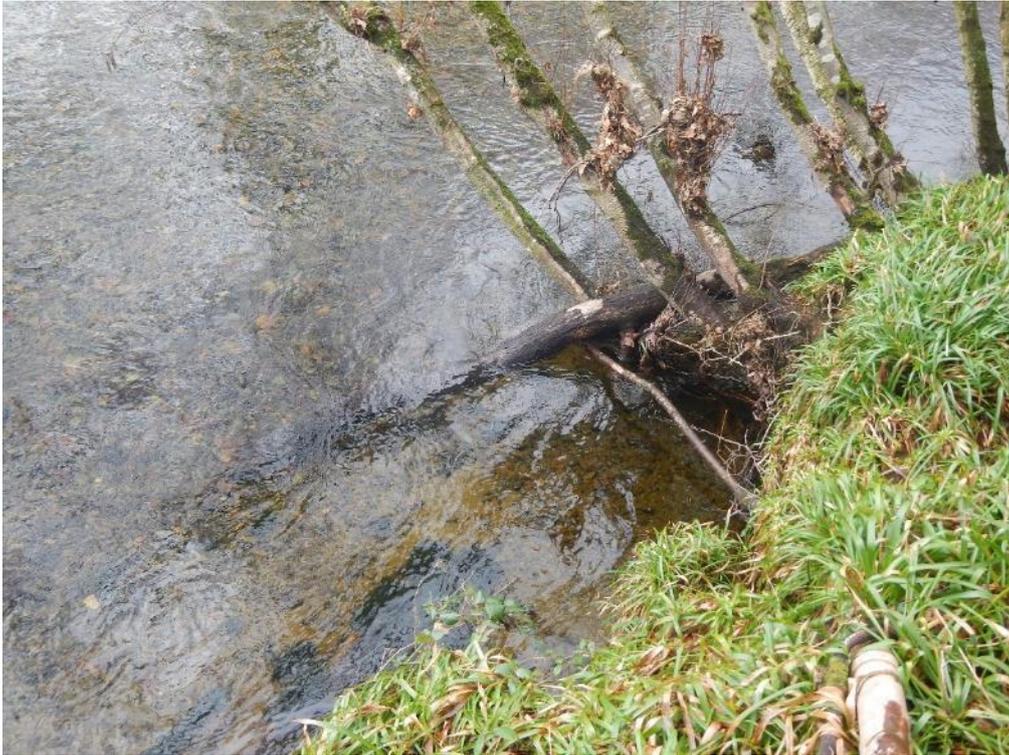
**Figure 16** More examples of naturally lodged woody material within this reach. The scour associated with this lodged branch has created a small pocket of deeper water, a good demonstration of how increased flow diversity can create fish-holding features. Replicating this feature with larger material could create larger features and help to move the flow around within the channel. Numerous options for installing woody material in the channel were observed between Hazel Dub and Donald's pool.

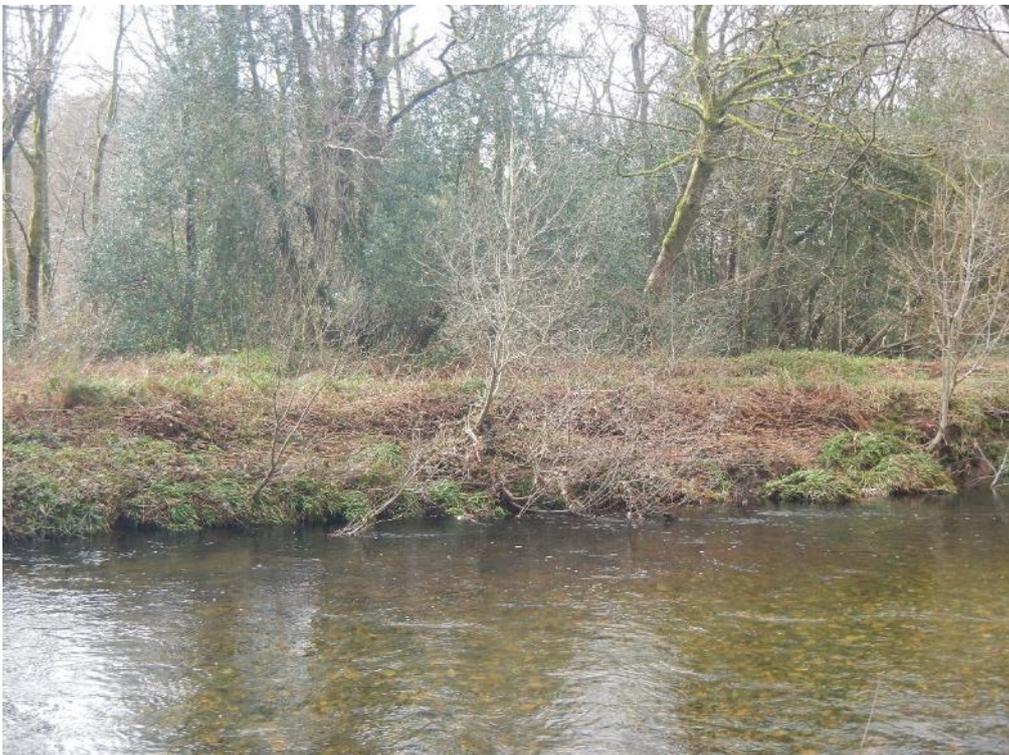
**Figure 17** At a slight bend in the channel, the natural creation of depth along the outside of the bend (although far less than on a natural, more sinuous meander) provides some habitat improvement. The overhanging/trailing trees further improve the habitat of the area and should be preserved. Planting to create additional overhanging cover would be beneficial (see **Recommendations**).

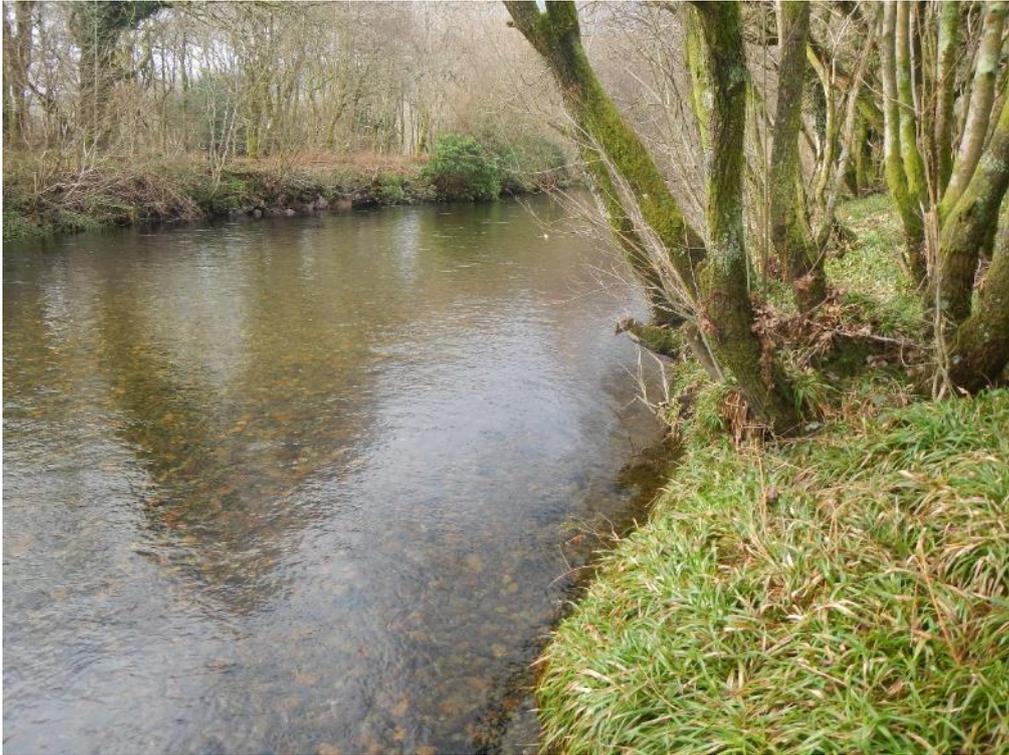
**Figure 18** Where groups of tree trunks occur (in this case mainly alder), they create ideal locations for installing lodged woody material (see **Recommendations**). The ideal locations and size/extent of any structure would be dictated by existing in-channel structures. The aim is to maximise the sinuosity of flow while not overcrowding the channel (which could lead to one structure counteracting the next).

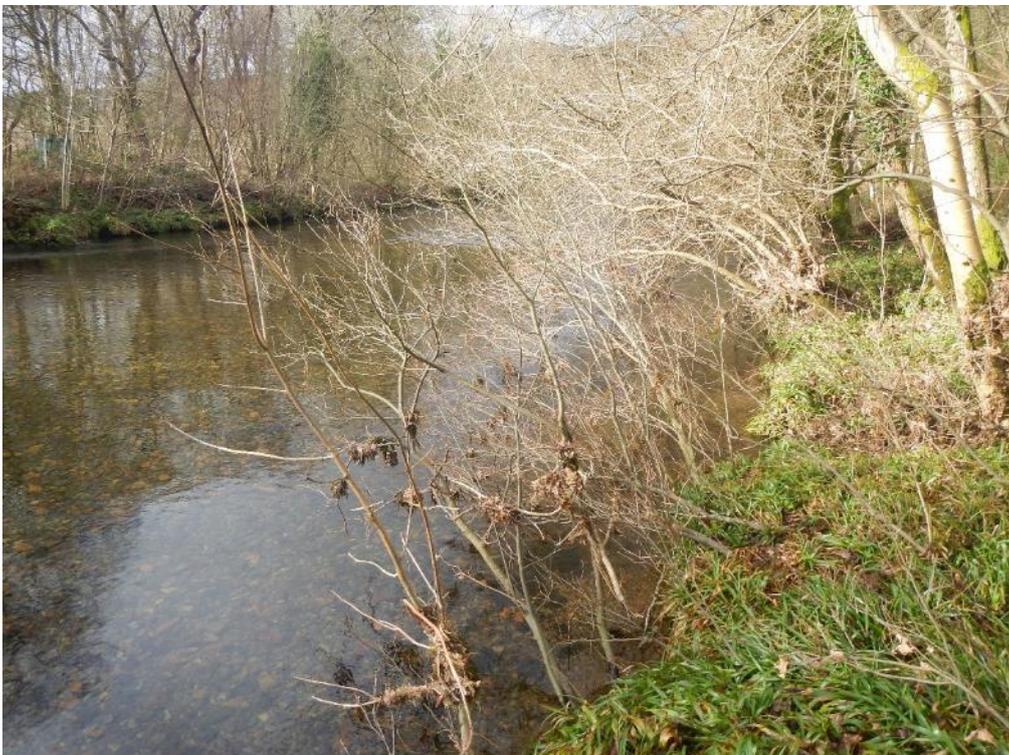
**Figure 19** In the area, around Cropple Howe, the fenced woodland is allowing tree regeneration to occur. Particularly notable is the presence of young willows which, owing to their palatability, are often the first tree species to be lost through sheep grazing (as has occurred elsewhere). Some of the larger/more mature trunks could be laid (similar to hedge laying) further into the channel to increase flow diversity (see **Recommendations**).

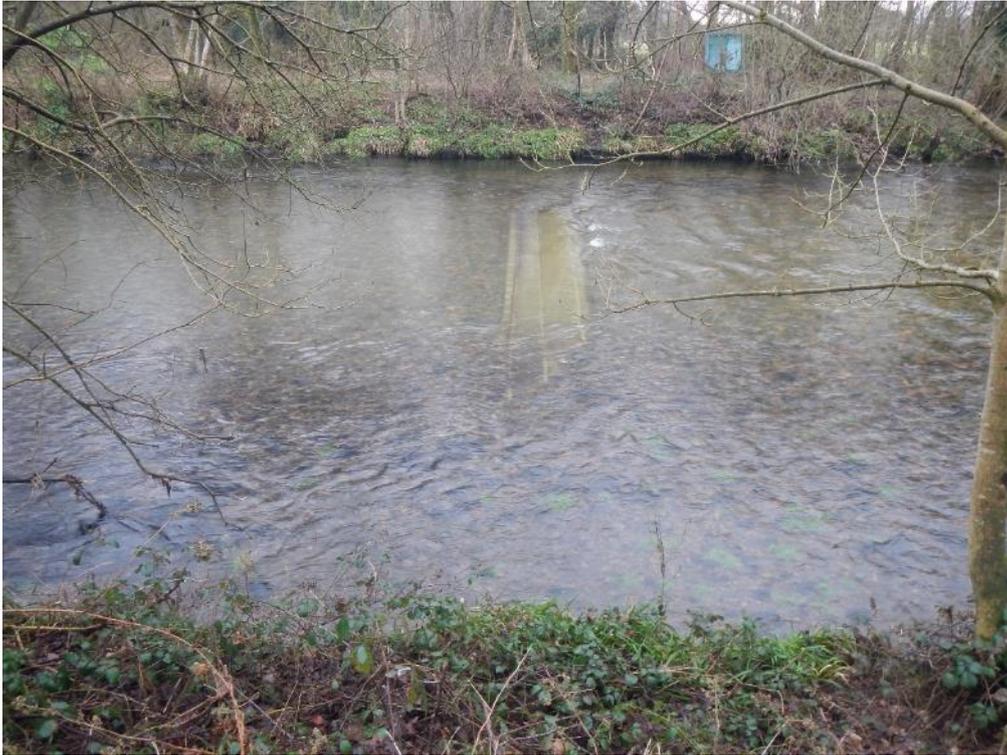
**Figure 20** The remains of a resistivity fish counter at The Flatts (SD 12811 979050). While it does not create a major barrier to fish or sediment, a fixed cross section in the riverbed reduces its ability to adjust and remain free from fine sediment/silt. The level bed cross-section also distributes flow across the channel, encouraging uniformity of the bed up and downstream. The best solution would be to remove the structure, allowing natural flow patterns and sediment transport to re-establish.

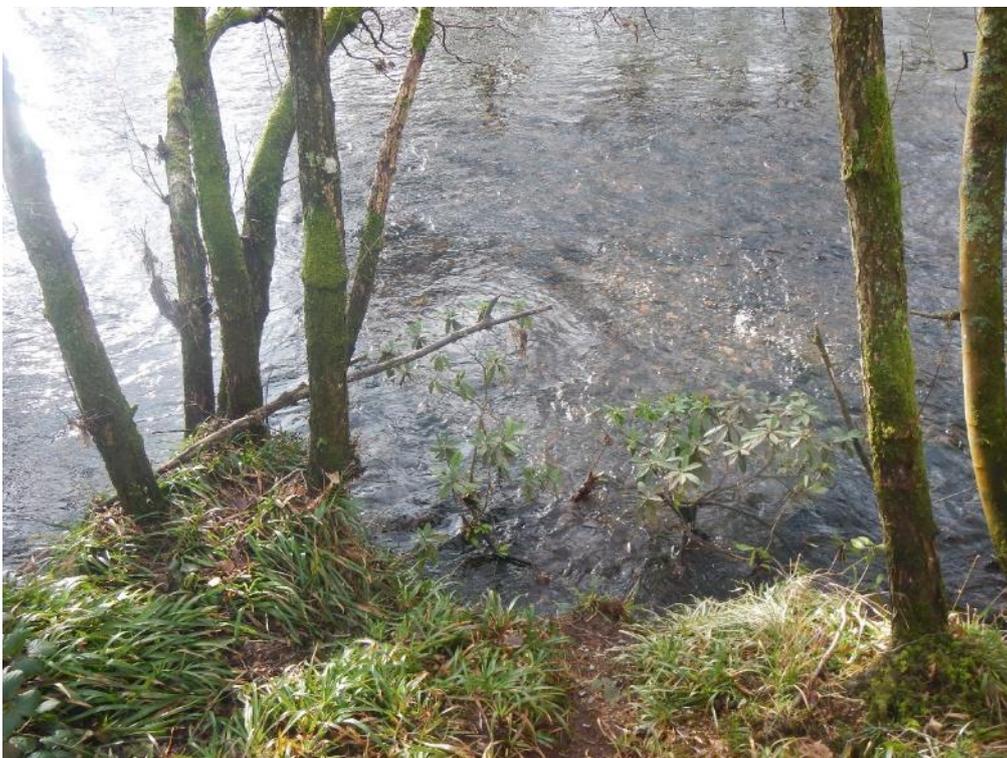
**Figure 21** Downstream of other trailing branches, smaller gravel is deposited in the river margin and what is suspected to be the remains of a redd was observed. This is not the ideal location for a redd (and was partially exposed at lower flow on 12<sup>th</sup> Feb). However, it demonstrates the value of increasing flow diversity within the channel and the lack of suitability for spawning within other areas.

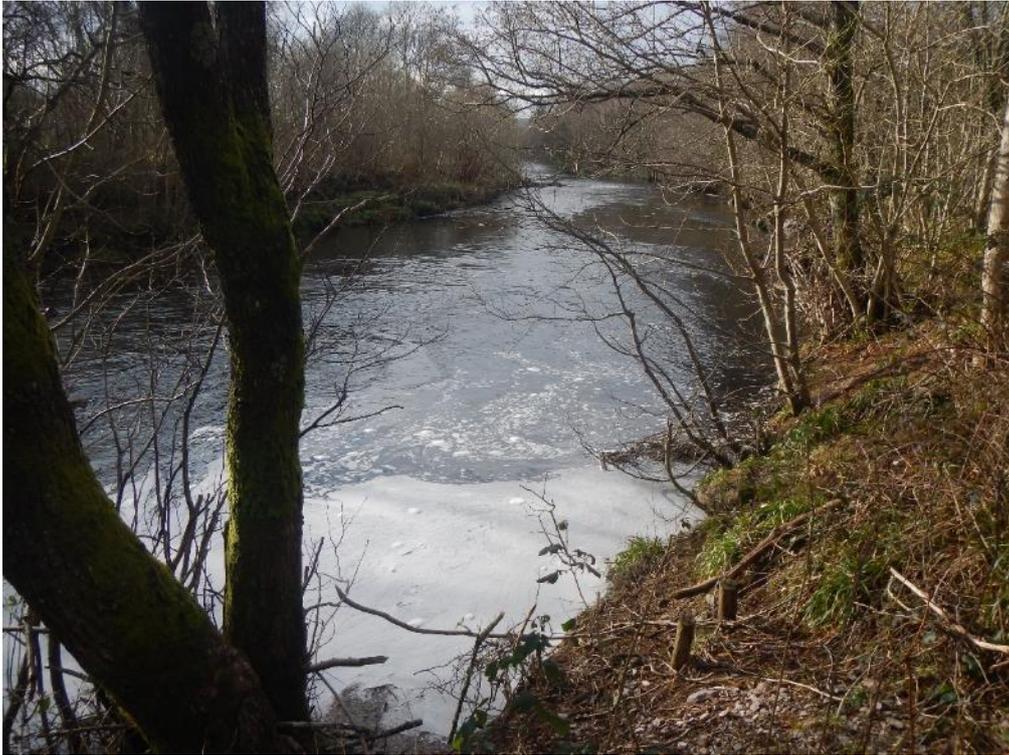
**Figure 22** The bend at Buttress Pool helps to maintain depth, although the channel is still significantly realigned and restationed here. The river course pass through the woodland, further into the right bank, with one or more sizeable bends and several smaller meanders. This constitutes a significant loss of habitat length and quality in the area.

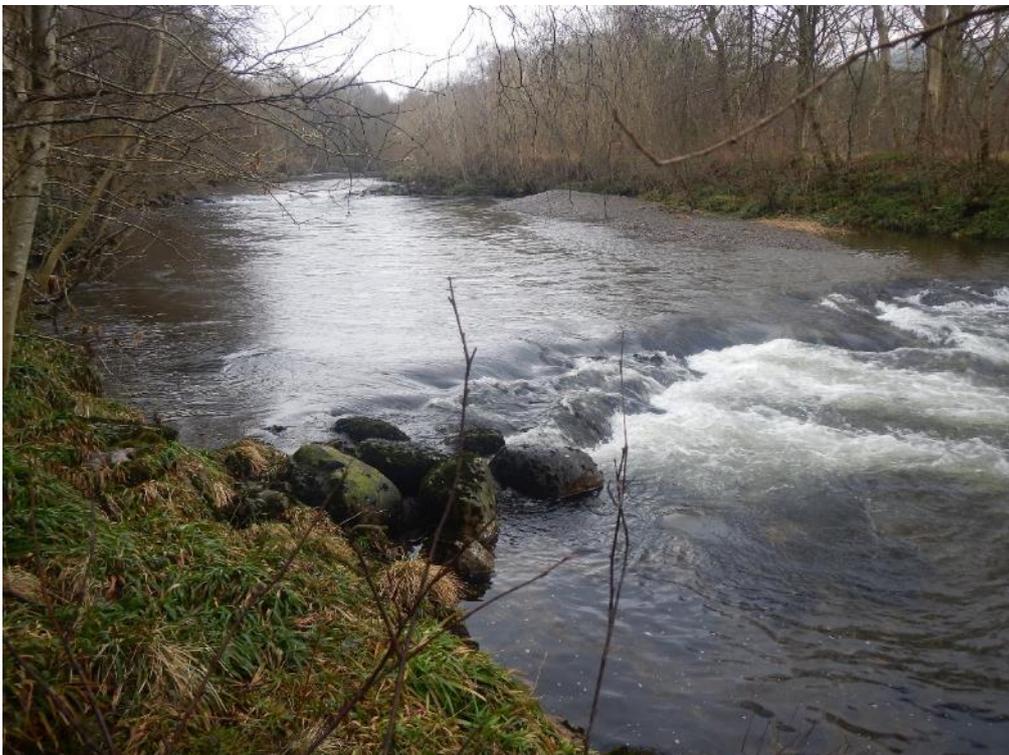
**Figure 23** Two weirs have been installed downstream of Buttress Pool (SD 12649 97917 & SD 12617 97889). These structures rob the pool upstream of flow energy, focussing it immediately downstream of each weir. As a result, you get a short deep pool that is less valuable to fish or angling, as the de-energised pool tail fills with depositional material. When that is coupled with unnatural funnelling of flow to the channel centre (creating dead areas at either side downstream), and additional weirs downstream which impound flow, the issues are compounded (see **Figure 24**).

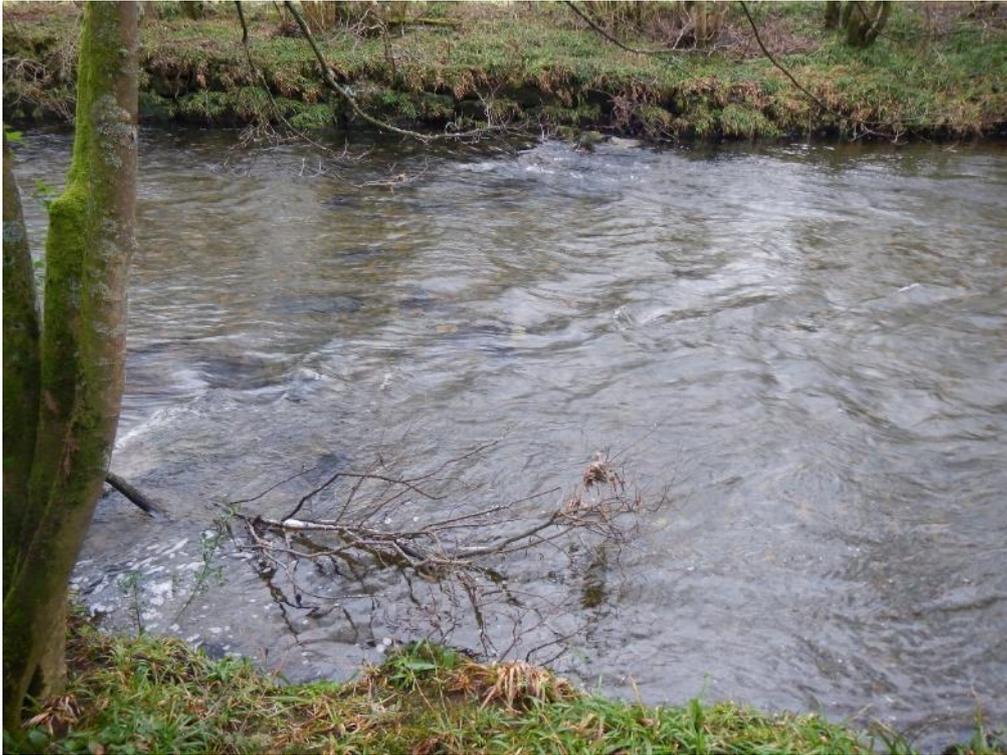
**Figure 26** The next set of paired deflectors downstream funnel flow down the centre of the channel. A better outcome would be to deflect the flow from one bank side to the other (SD 12581 97866). Flow deflectors can have a role within a modified channel such as this, but better habitat would be achieved with partial width, offset structures; these create a more sinuous flow route down the river and self-maintaining depth. Further Improvements could be achieved by installing lodged woody material, which complements offset single deflectors far better than paired deflectors. Ideally at least one side of this deflector should be removed.

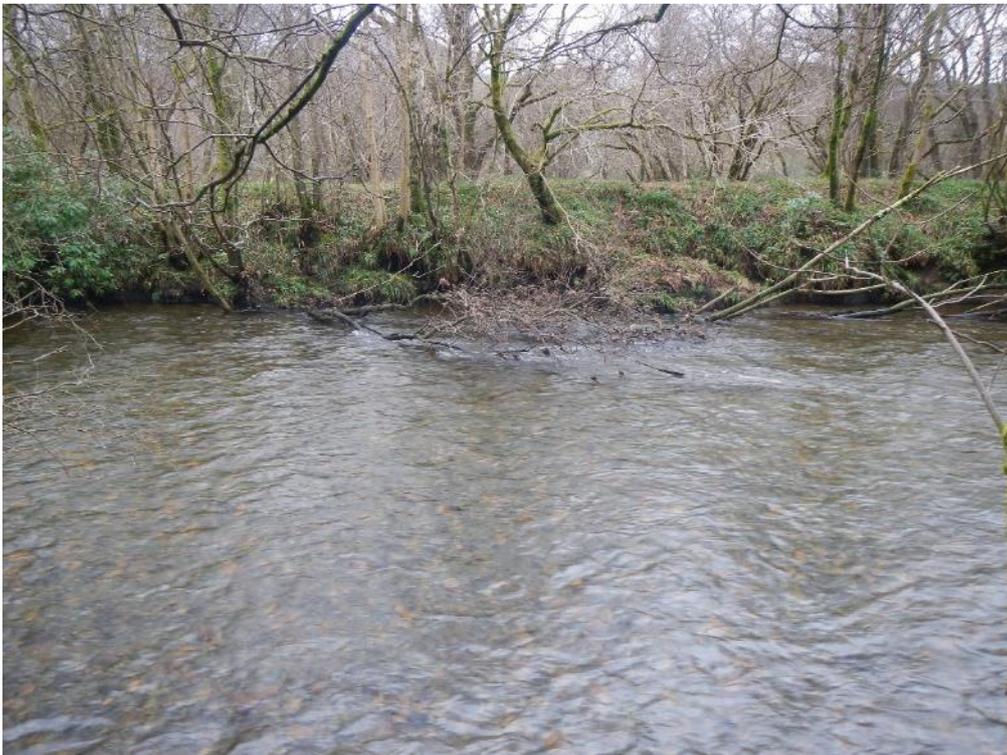
**Figure 27** Bankside willows continue to provide natural improvements and material that could be consolidated with additional material to create more influential flow deflection structures.

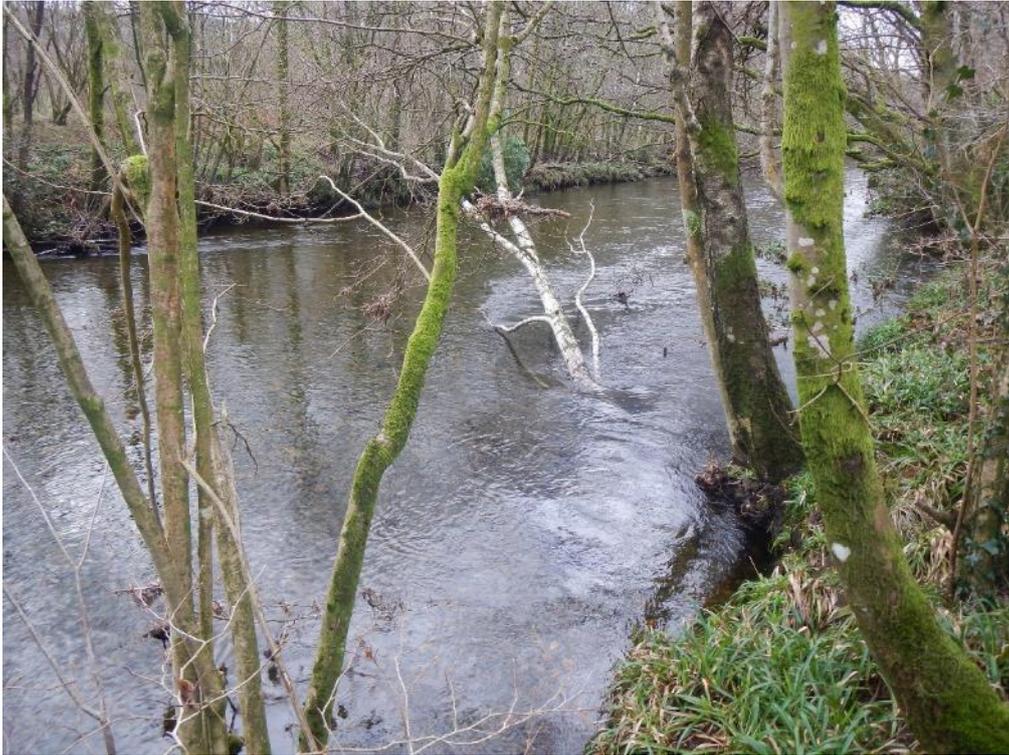
**Figure 28** A partially submerged (at high flows) birch tree offers another potential anchor for a deflector (SD 12406 97744).

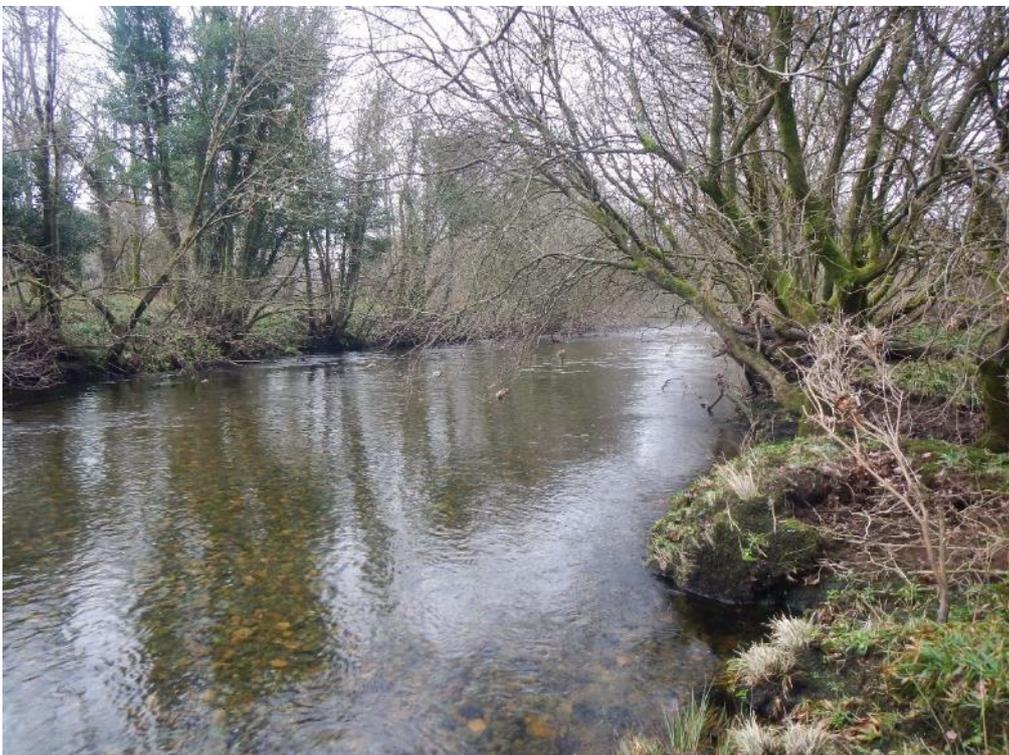
**Figure 29** At the outlet from the largest lost paleochannel, there is great potential for laying willows into the channel from the RB to diversify flow and trap gravel. This would then push more of the flow over to the far bank, creating more scour and depth there (SD 12320 97672).

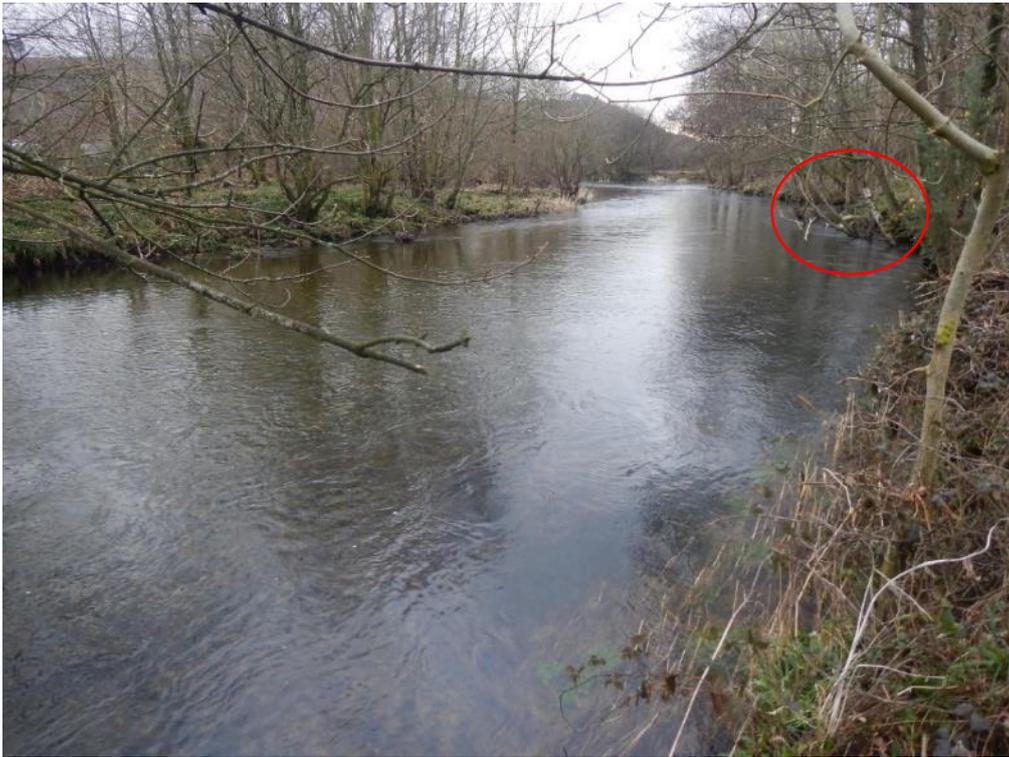
**Figure 30** The deflector on the outside bank (red circle) is counterproductive, effectively straightening out the flow pathway around the bend.
