WILD TROUT TRUST

**River Esk Walkover (lower)**

(West Cumbria)

5/02/2021

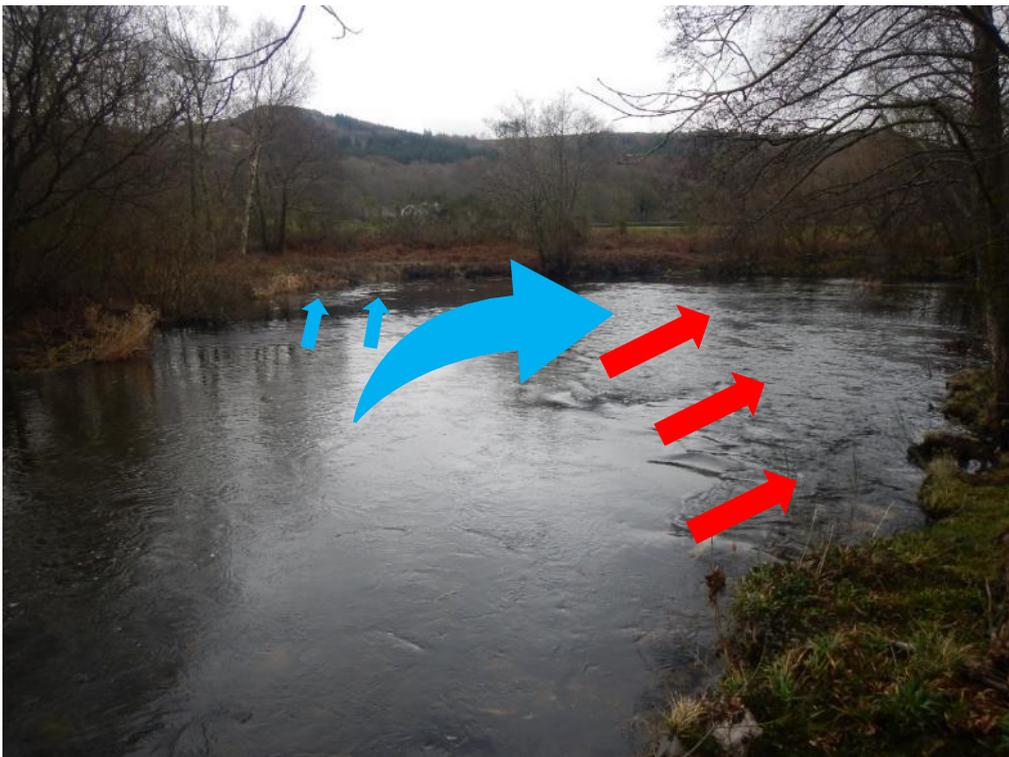
**Figure 31** The Downstream extent of the walkover was Donald's Pool (SD 12234 97538). With minimal sediment storage in the confined and straightened ~1200m of channel upstream (other than trapped by the weirs), large volumes of bed material are deposited here after each flood, this being the first large pool. The situation is made worse by the boulder structure at the upstream end. This effectively acts as a downstream deflector to any flow overtopping it, encouraging that flow to fan outward, with some cutting the bend (red arrows). However, the structure is also deflecting sediment, which gets funnelled down the centre. Without the structure, the predominant flow should just pass around the outside of the bend (blue arrow) where it would maintain the pool that adjusts, depending upon the flow and sediment received. Instead, the flow dynamics of the pool here are severely disrupted.

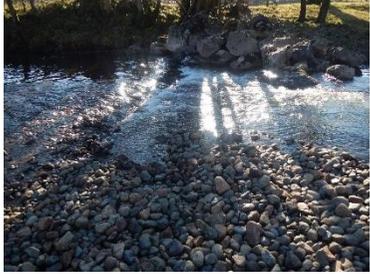
Observation	Photo (If required)	Priority (1-3)	Location	Proposed action
Boulder structures upstream and downstream of Black Dub

<p style="text-align: center;"><b>Figure 1</b></p>	2	SD 13343 97792	Removal or modification of these structures to reinstate natural pools and riffles.
Overgrazing/bank destabilisation (RB)

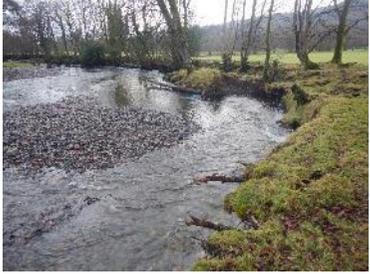
<p style="text-align: center;"><b>Figure 2</b></p>	2	SD 13513 98017	Install appropriate buffer fencing. This is given a priority 2, as the impact is mainly on the landowner/tenant. The river channel/habitat would benefit through development of the bend. Fallen trees should be left intact.

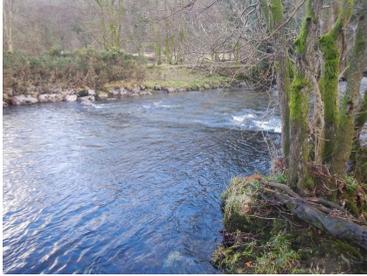
<p>Two boulder structures upstream between Black Dub and Knott end Dub</p>

<p><b>Figure 4</b></p>	<p>2</p>	<p>SD 13449 97911 &amp; SD 13430 97858</p>	<p>Removal or modification of these structures to reinstate natural pools and riffles.</p>
<p>Potential habitat improvement (LB)</p>

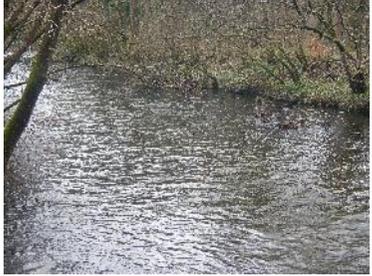
<p>More potential river restoration(s)</p>

<p><b>Figure 13</b></p>	<p>1/2</p>	<p>SD 13064 97805 - SD 12202 97533</p>	<ol style="list-style-type: none"> <li>1. Investigate options to restore paleo-channels.</li> <li>2. As a minimum, seek to establish more flow diversity with in-channel structure through tree laying and lodged woody material.</li> </ol>
<p>Potential habitat improvement (RB)</p>

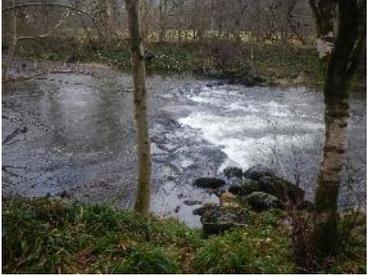
<p>2 weirs, impounding flow</p>

<p><b>Figure 23</b></p>	<p>2</p>	<p>SD 12649 97917 &amp; SD 12617 97889</p>	<p>Removal or modification of these structures to reinstate natural pools and riffles.</p>
<p>Paired deflectors inhibiting the development of beneficial habitat features.</p>

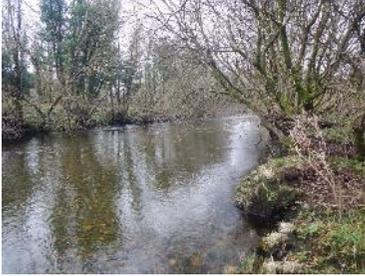
<p>Potential habitat improvement</p>

<p><b>Figure 29</b></p>	<p>2</p>	<p>SD 12320 97672</p>	<p>Ideal location for tree laying and lodged woody material.</p>
<p>Counterproductive structures in-channel</p>
