WILD TROUT TRUST

**River Irt**

Bertol Angling Club

01/10/2020

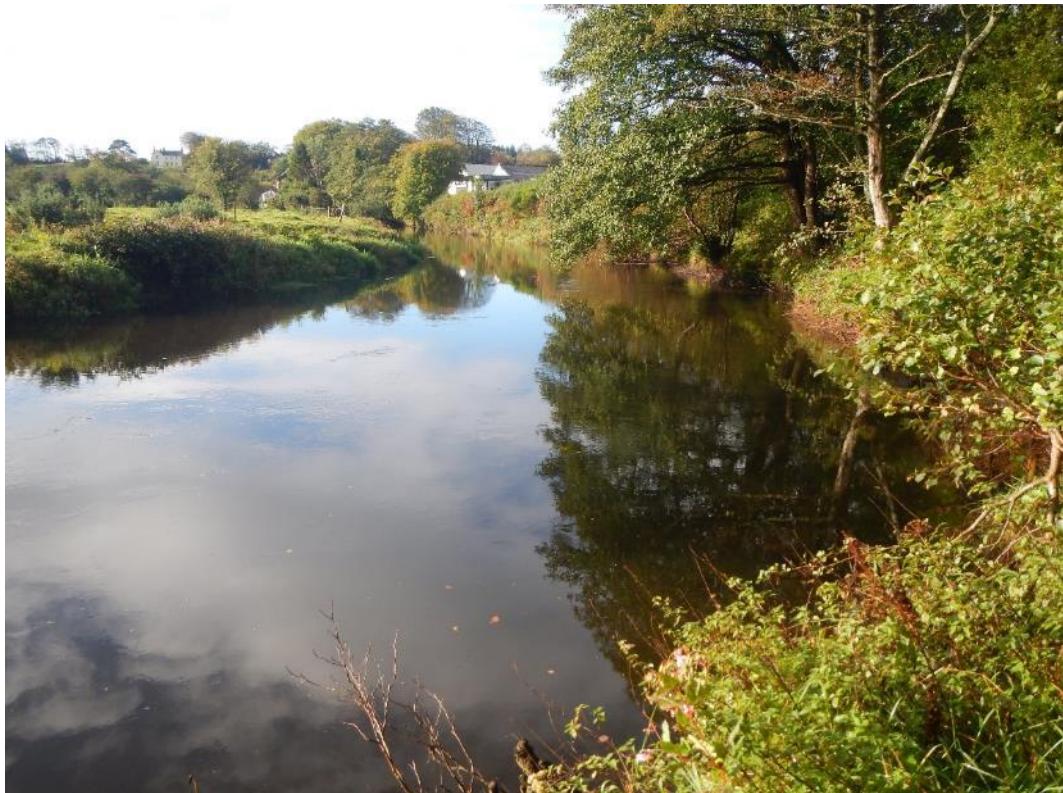
Figure 1. At the downstream end of the beat, a deep pool provides ideal cover and holding water for migratory salmonids. Overhanging bankside trees and vegetation add to cover availability in the river margins, particularly on the RB.

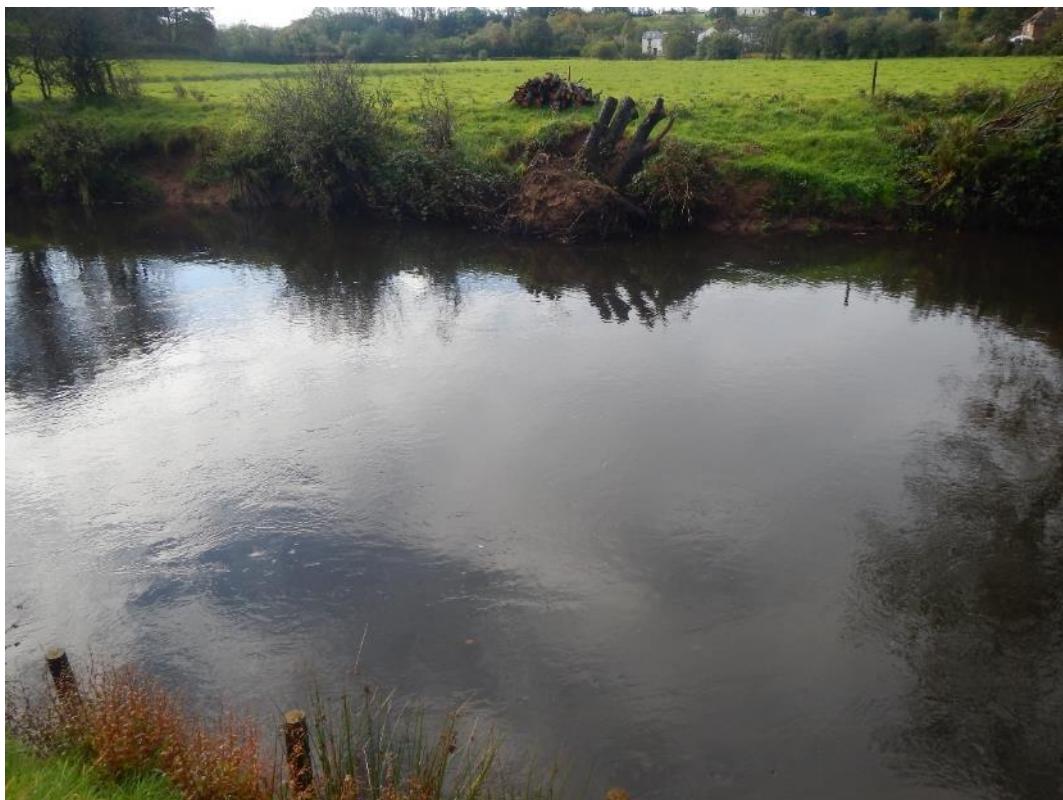
Figure 2. Tree clearance on the LB has reduced the availability of cover along the bank and in-channel, with a toppled tree cut to a pollard and pulled back to the bank. Wherever possible, retaining fallen trees where they fall in the channel, with minimal pruning or maintenance, and allowing them to naturally adjust is the best course of action. This will facilitate increased flow diversity and the sculpting of new bed features, in addition to providing in-channel cover, which will benefit invertebrates, fish and anglers alike.

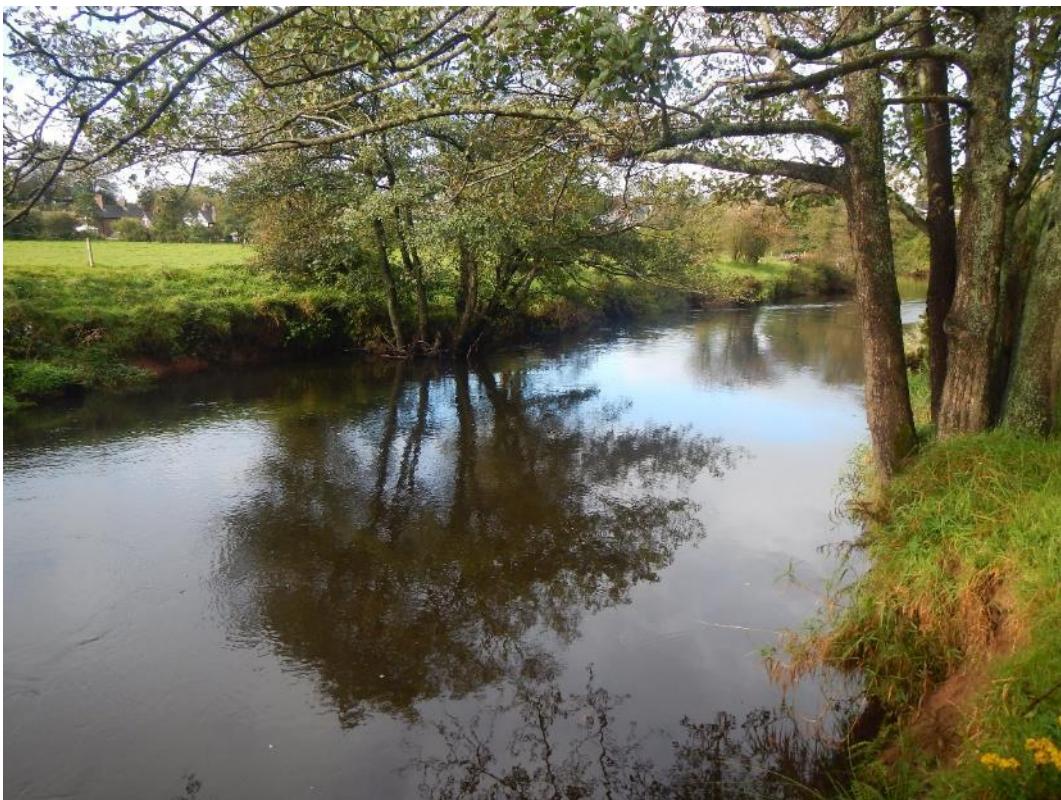
Figure 3. A similar scenario applies to pruning. Often undertaken to improve casting access, the loss of low and trailing branches is detrimental to habitat quality and the fish-holding potential of an area. Note how open and lacking cover this scene is owing to historic low-level pruning, despite the presence of bankside trees. Selective coppicing is now required to encourage low regrowth – pruning has reduced habitat quality and created more work!

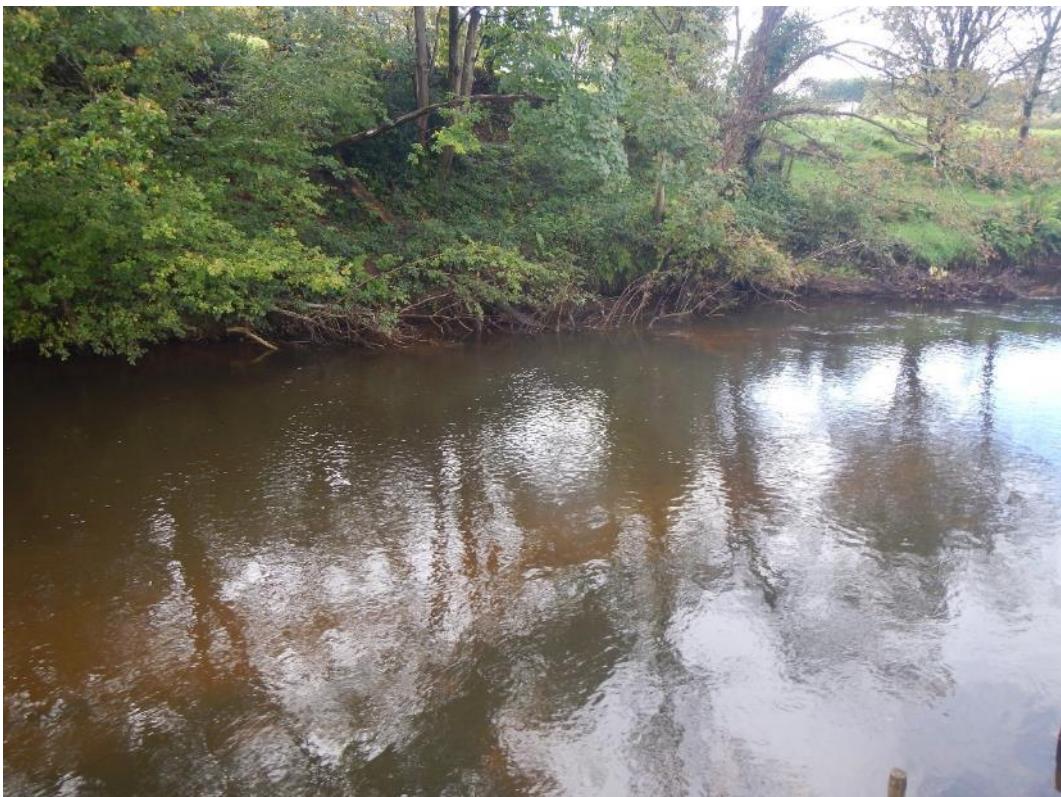
Figure 4. In contrast to the overly cleared/managed areas, the well-treed LB upstream supports high quality low cover and woody material, both naturally retained and introduced. This diversity provides important refuge areas for fish to shelter from high flows and predators – it also creates excellent fish-holding features to cast to. Very few rivers now support the extent of woody material structure and overhanging trees they should do naturally, and this is reflected in elevated predation rates by piscivorous birds.

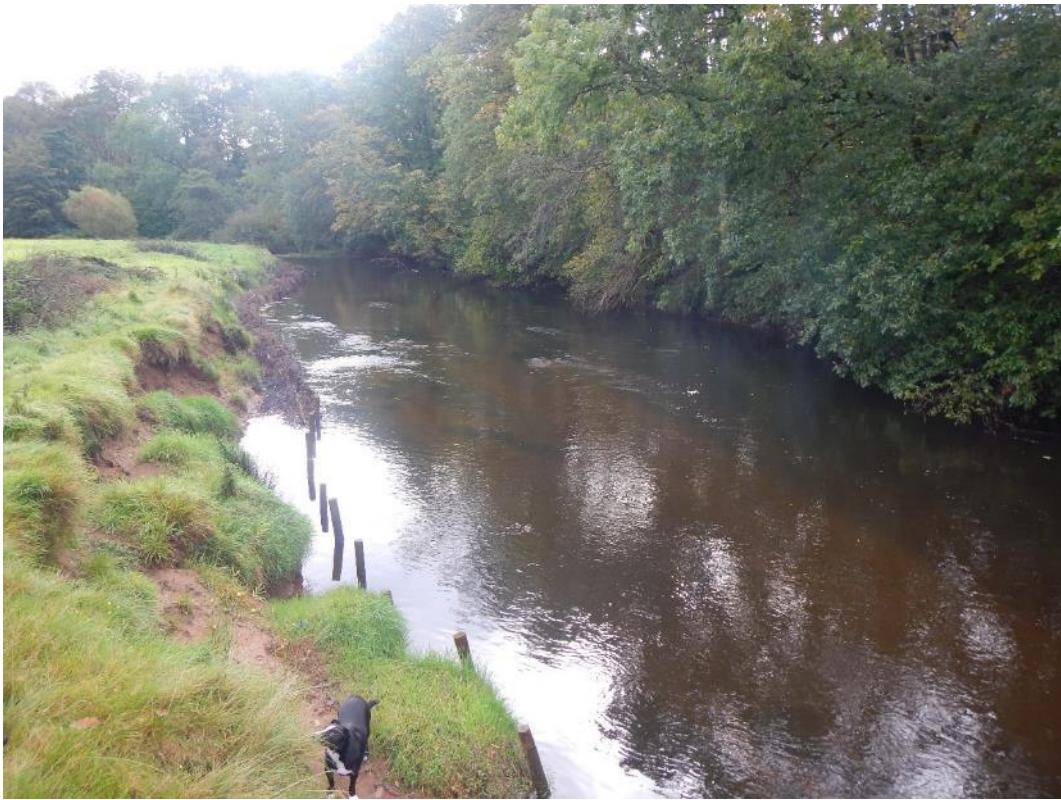
Figure 5. High quality, natural, low-level cover along the far LB, in contrast to the grazed, denuded and destabilised RB (left of shot), with a lack of vegetation diversity and obvious erosion issues (SD 08144 99828). Simple livestock exclusion would solve this issue on an area of bank that would not be eroding naturally. Note the lack of trees and tree regeneration owing to the grazing which left unchecked, can ultimately lead to a complete loss of trees over time and even greater erosion.

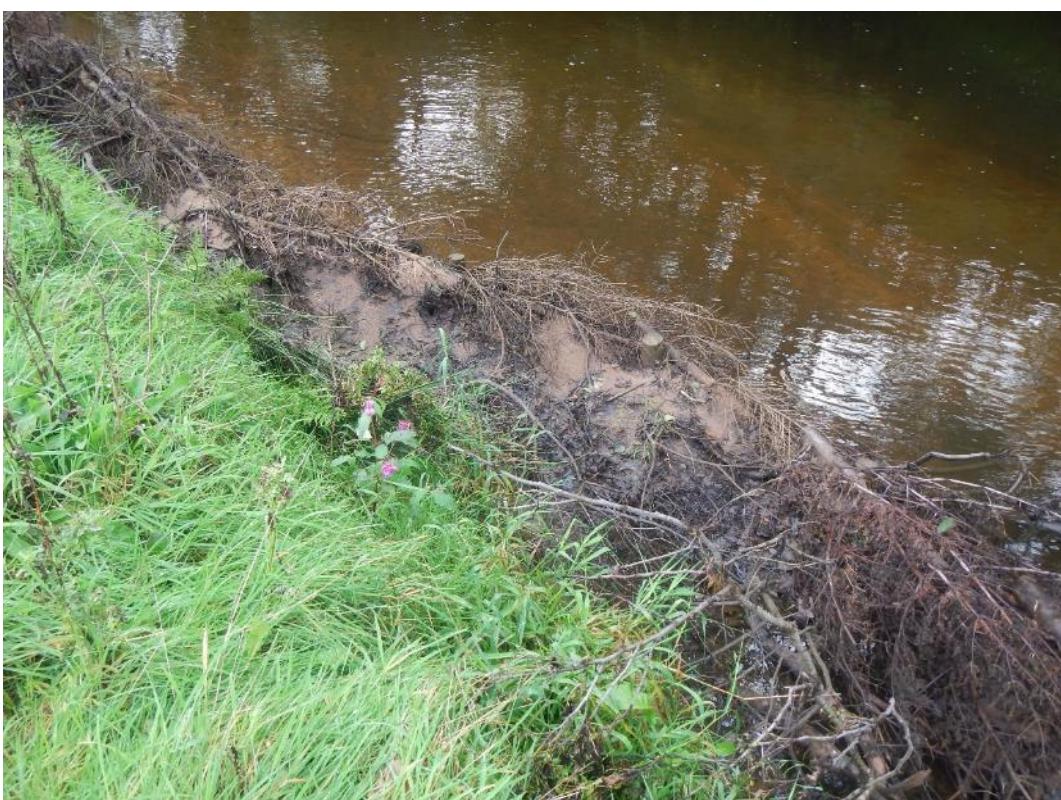
Figure 6. In the absence of agreement to buffer fence the watercourse, the brash bank protection installed is working well to trap fine sediment and consolidate the lower bank. However, this only likely to be a short-term fix unless livestock can be excluded to allow the banks to properly revegetate and become consolidated.

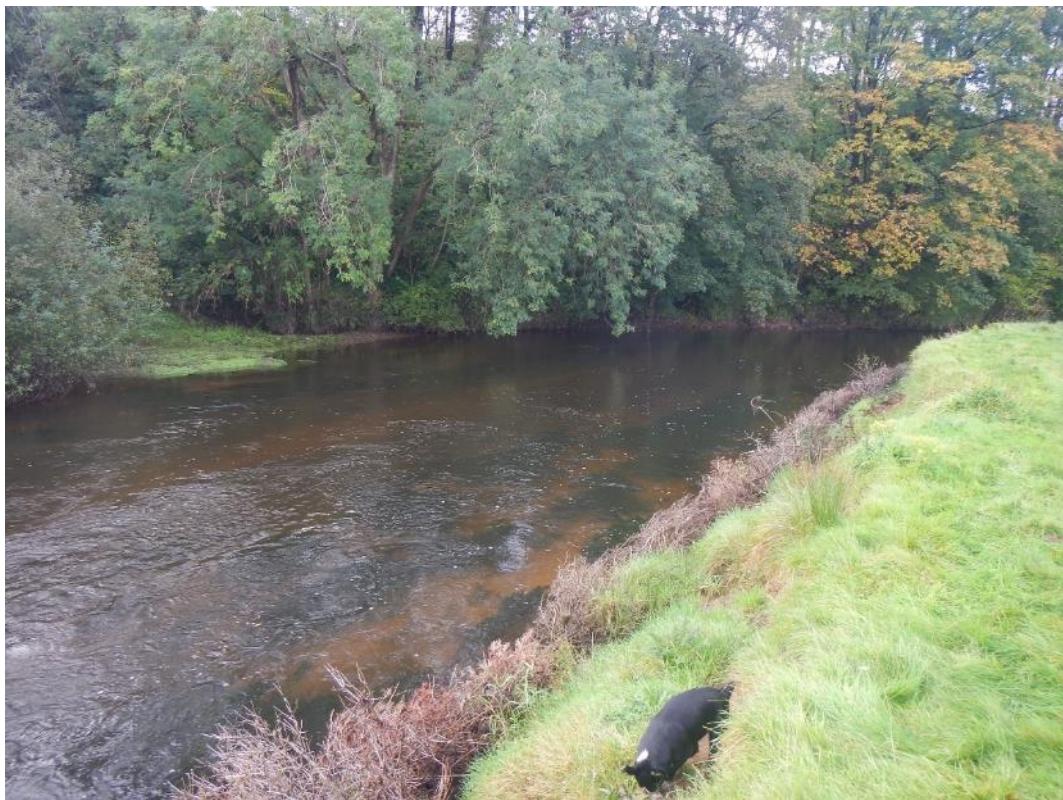
Figure 7. Erosion on the inside of the bend has widened the channel sufficiently to reduce flow velocities such that they now have insufficient energy to scour and maintain the pool. Correspondingly, a significant known pool is now reduced in depth. Again, consolidating the bank with more diverse vegetation would help to rectify this issue over time.

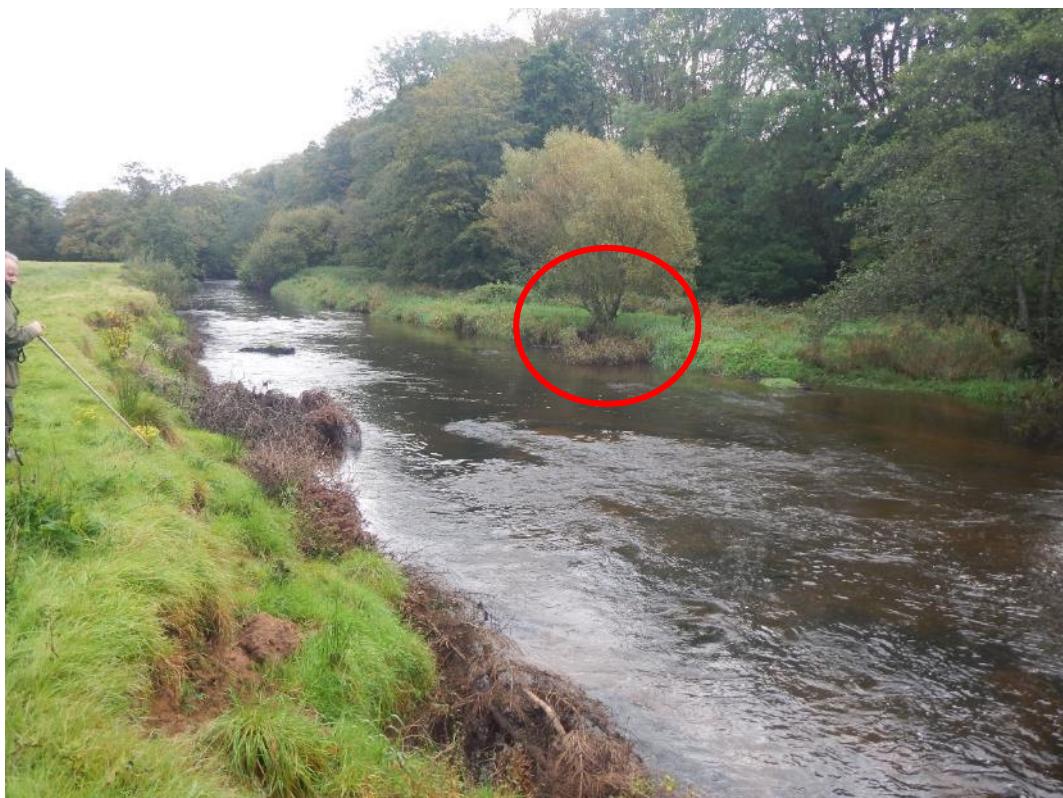
Figure 8. The brash bank protection continues for an extended length upstream and while it is beneficial in stabilising the bank and reducing fine sediment input, it should not be required. The lower branches of a willow on the far bank have been laid into the channel to provide valuable low and trailing cover (red circle). Ideally, more of the tree could have been laid into the channel, but with the present unstable state of the opposite LB, this is likely to have increased erosion. Further laying would be beneficial once the bank is stabilised.

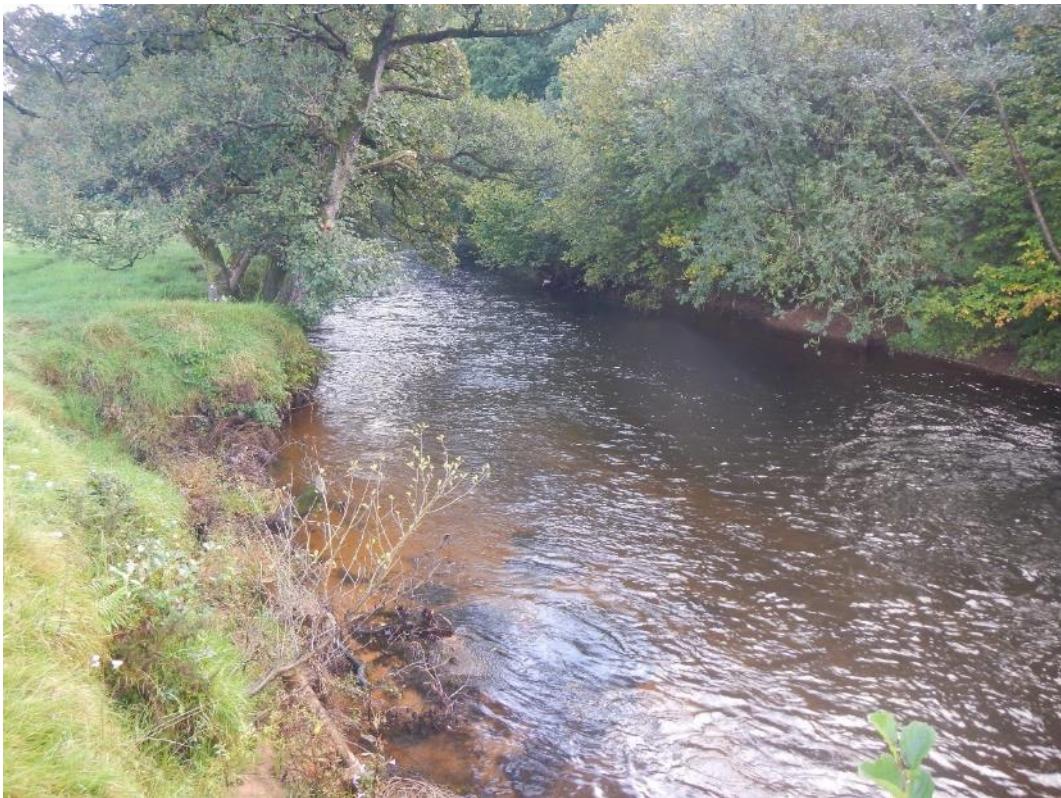
Figure 9. Where the occasional tree remains, the benefit on bank stability is immediately apparent, with a much narrower channel and deeper, fish-holding run present. Note the small saplings in the foreground struggling to take a hold, out of the reach of livestock.

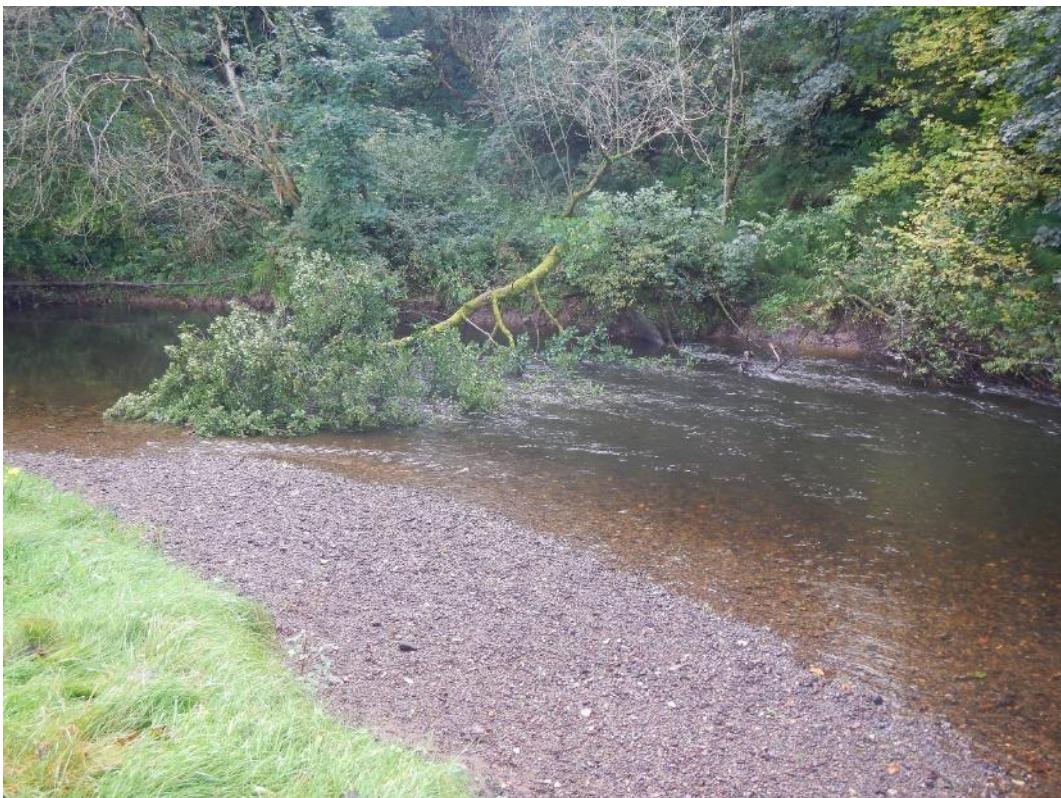
Figure 10. A leaning tree on the outside of a bend upstream has been hinged into the river and now provides in-channel structure. A case could be made for allowing such trees to naturally topple into the river as they may have a greater chance of remaining in situ, but any such woody material in the channel is beneficial. It is hoped that the trunk will remain in place, with subsequent high flows driving beneficial scour into the bed to clean and sort the substrate into valuable spawning habitat. The tree may swing round under the pressure of high flows, to end up lying more parallel to the bank, but will still provide valuable cover.

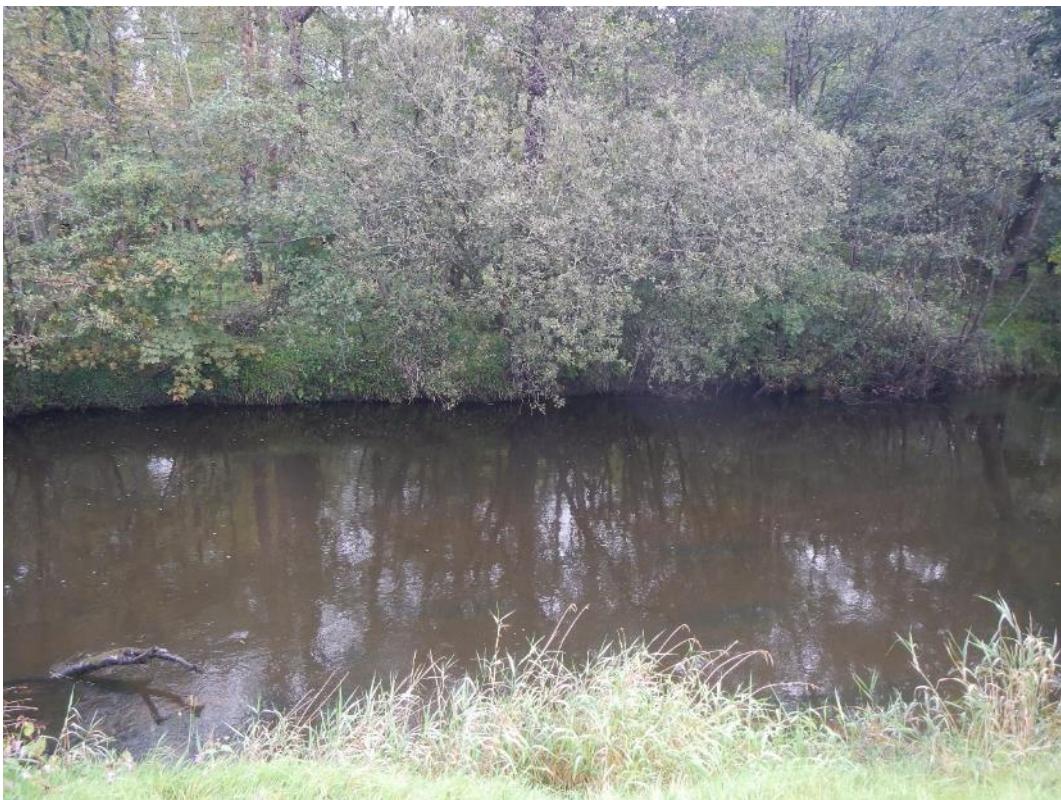
Figure 11. Further round the bend, the channel is relatively uniform, lacking structure and flow diversity. Laying some of the bankside willows down into the channel could increase flow diversity and provide valuable fish-holding/refuge. Alternatively (or in addition), woody material could be lodged between or against the bankside trees (see recommendations).

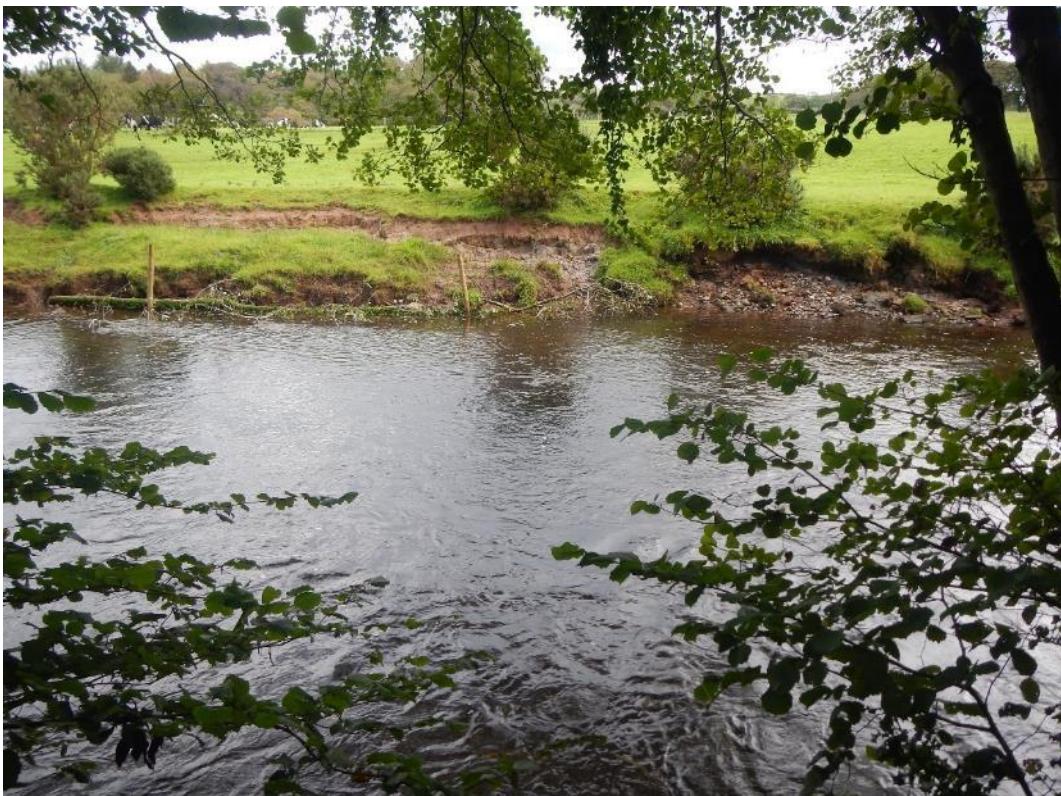
Figure 12. Upstream of the wooded LB section, further livestock access and bank erosion issues were observed (NY 08336 00129). Again, these could be easily addressed through fencing that would also benefit the landowner/tenant without the need for costly and time-consuming bank protection that could ultimately lead to homogenisation of the habitat. Too much of any one thing (or habitat type) can ultimately be a bad thing.

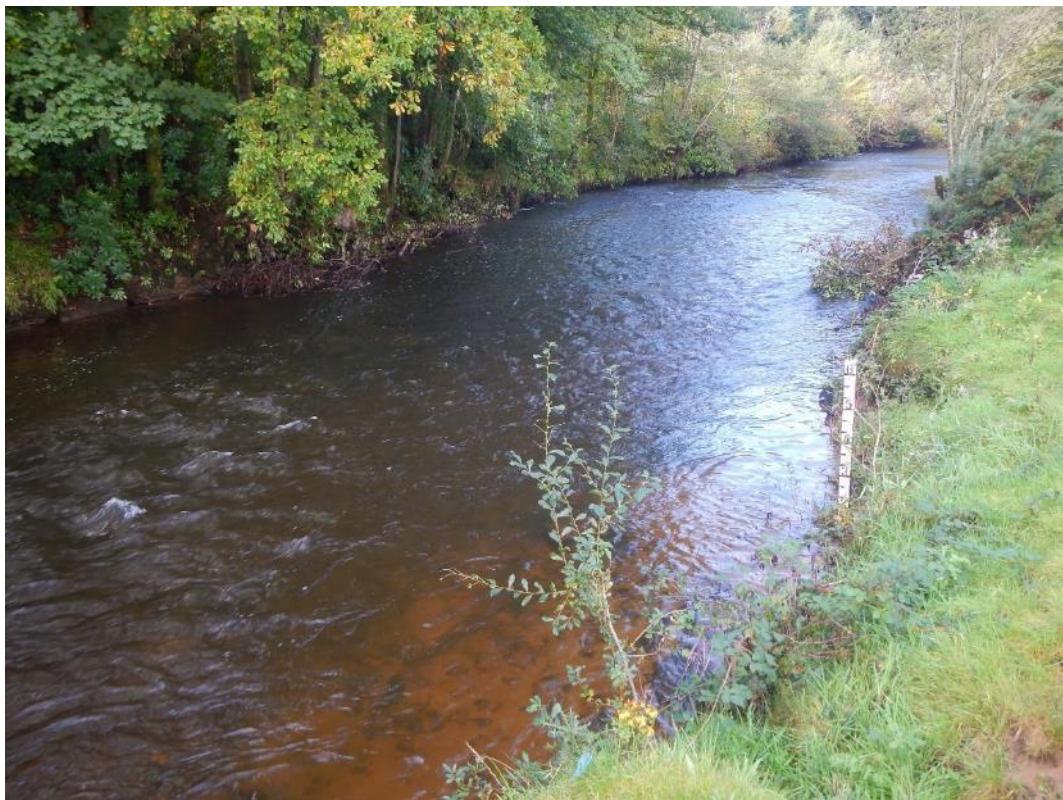
Figure 13. Upstream of the bridge (NY 08287 00141), the area has been cleared of low branches in response to a trunk falling into the channel and fear of the same occurring with other trees. Trees falling into the channel is a highly beneficial, natural occurrence and should be promoted wherever possible. The shallow gravelly areas provide potential spawning habitat, but the lack of cover leaves fish vulnerable and less likely to remain here long. More cover could really improve this area for adult and emerging juvenile fish.

The tree lined bank in this area (Figure 13. Upstream of the bridge (NY 08287 00141), the area has been cleared of low branches in response to a trunk falling into the channel and fear of the same occurring with other trees. Trees falling into the channel is a highly beneficial, natural occurrence and should be promoted wherever possible. The shallow gravelly areas provide potential spawning habitat, but the lack of cover leaves fish vulnerable and less likely to remain here long. More cover could really improve this area for adult and emerging juvenile fish.) is well consolidated with tree root matrices and is unlikely to become significantly destabilised even if the odd tree does fall in. It is therefore usually beneficial to seek advice before undertaking major tree management that could negatively impact upon habitat quality. Retaining one of the trunks within the river margin has helped to provide some in-channel structure here, but a lack of low and trailing branches is still evident.

To counteract the canopy lifting, the ideal solution would be to rotationally coppice some of the trees, thereby reinstating a more diverse canopy and encouraging low-level regrowth. Coppicing should always be undertaken sparingly, with only one in every four or five trees treated in a year, and usually no more than half of the total number being coppiced. This should promote a natural level of light and shade, avoiding the uniform regrowth and overshading that can occur as multiple coppiced stools regrow at the same time.

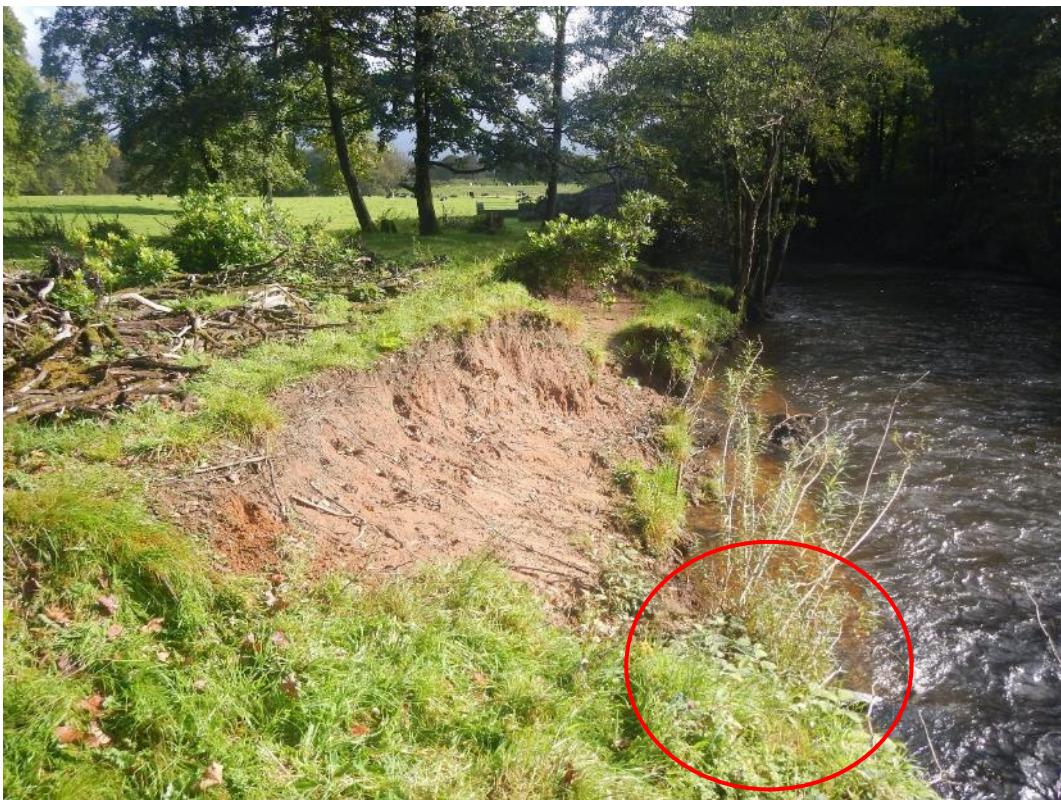
Figure 14. Further erosion issues where the physical damage of cattle hooves is all too apparent. Japanese knotweed (visible in the foreground – red circle) exacerbates the issue and should be treated with herbicide by a licenced operative (NY 08199 00155).

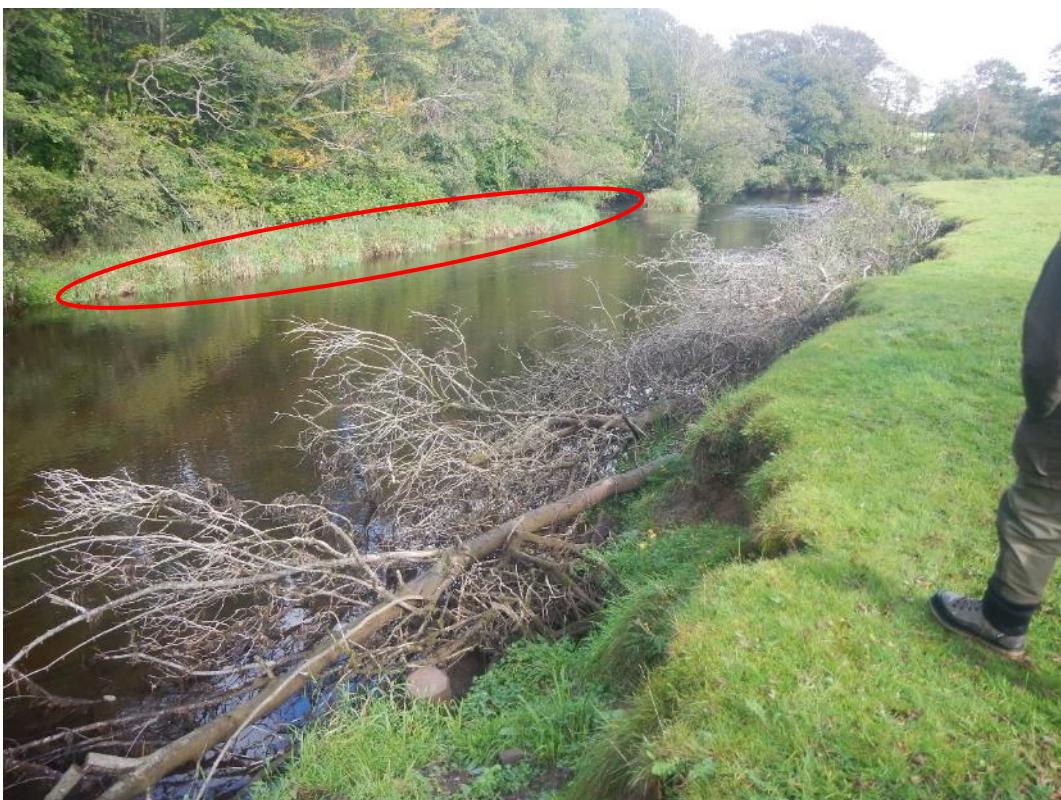
Figure 15. More, somewhat beneficial, brash bank protection. The technique employed here is exactly the right one for protecting riverbanks but again, simply should not be required on a section of bank, which would naturally stabilise if livestock were excluded. The technique is working effectively to protect the bank and trap fine sediment in high flows but it is not a long-term solution to the grazing issue. Planting two or three goat willow whips into the far bank could provide valuable fish-holding areas as they grow over the channel (red ellipse).

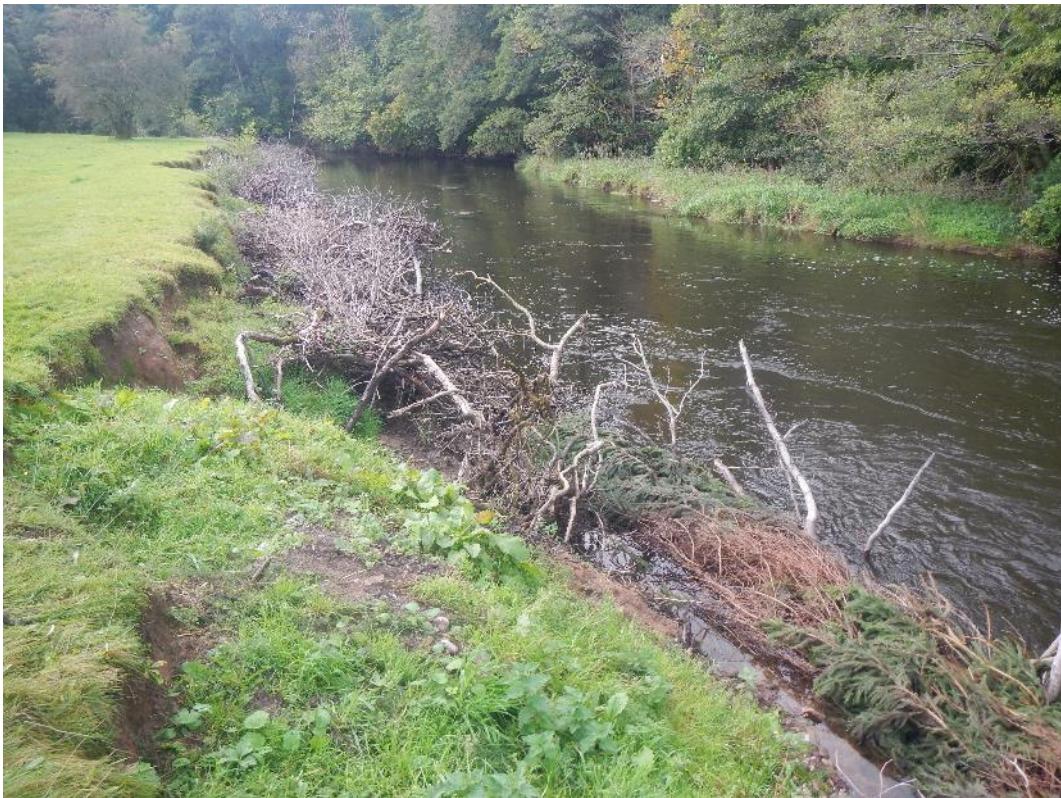
Figure 16. Looking downstream at the same reach (NY 08209 00305). One of many examples where earth (including farm waste) has been dumped along the river, usually in erosion voids and behind bank protection. Dumping any waste material on the bank is inappropriate and most likely in breach of regulations; even appropriate backfilling requires a permit. Artificially dictating the river width for long sections is not advisable, it would be better to allow natural bank adjustment and reinstatement through stock exclusion.

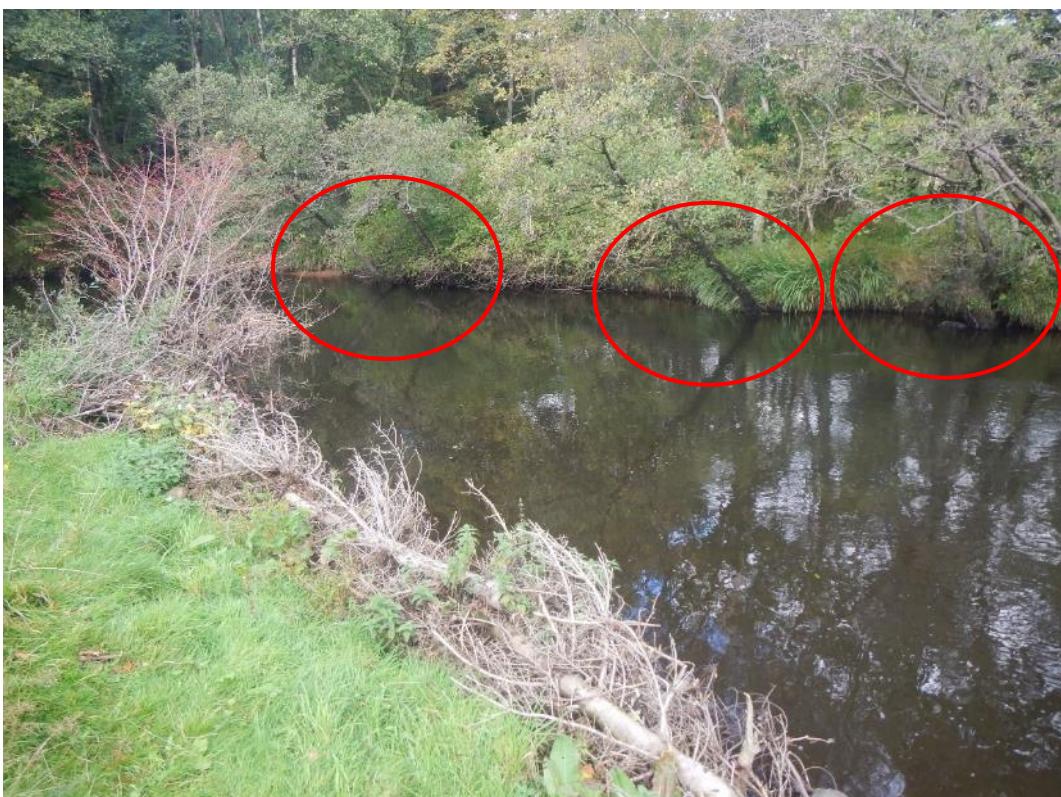
Figure 17. More evidence of past pruning of low-level branches. Some low regrowth has occurred, but it is rare for trees to put significant effort into replacing branches below their own canopy as they would just over-shade themselves. As such, judicious coppicing of the affected trees could be used to encourage the required low regrowth and gradually rectify the issue over several years.

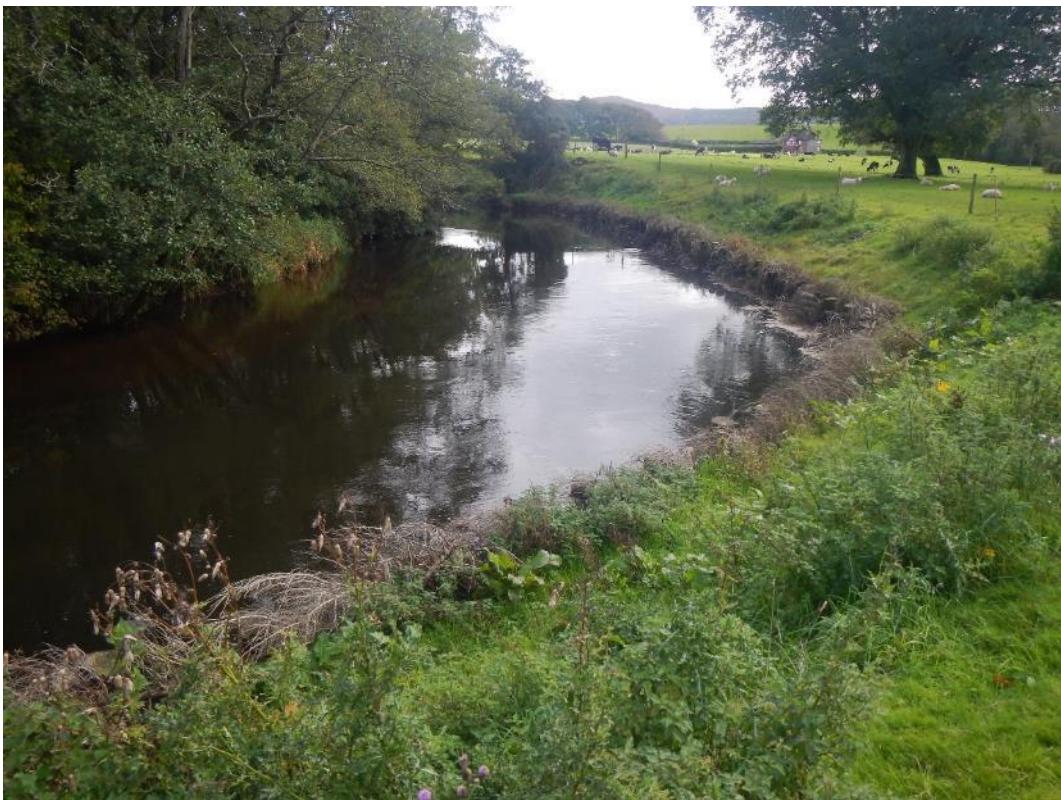
Figure 18. More bank protection, in a short section where at least cattle have been excluded, reducing the physical damage to the banks. However, note the lack of tree regeneration and low species diversity resulting from sheep browsing. Without full livestock exclusion to allow tree regeneration, the benefits gained in stabilising the bank will be lost over time as the brash protection degrades.

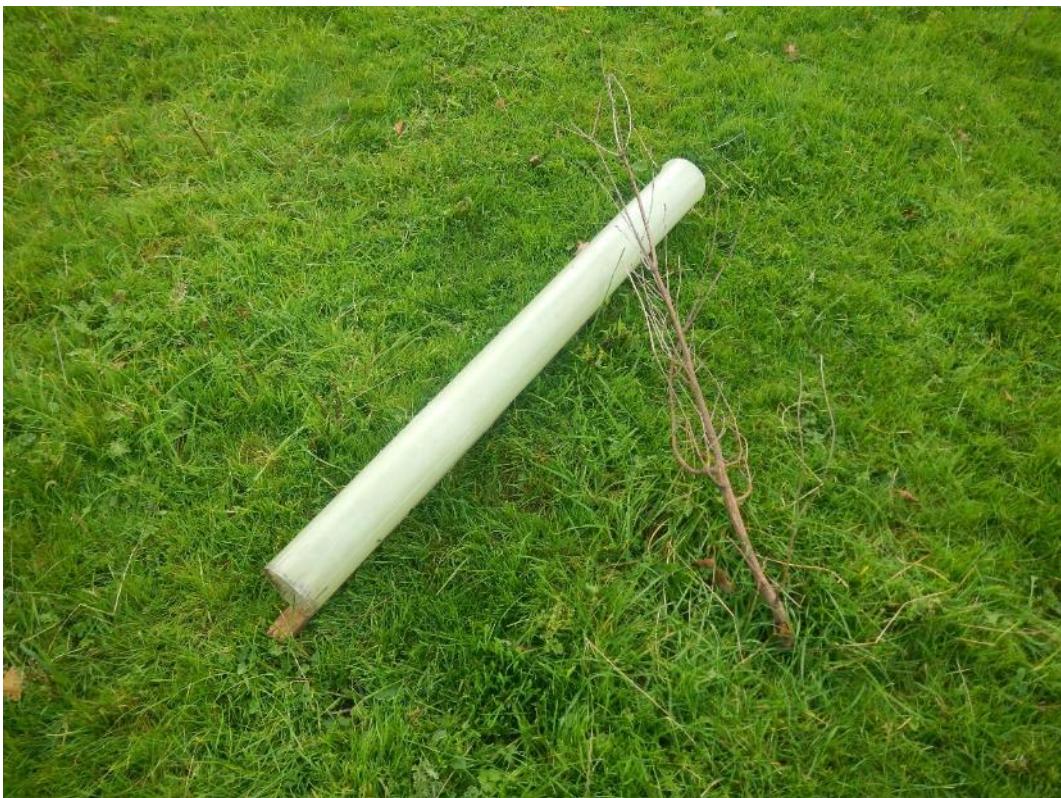
Figure 19. Evidence of the livestock issues: one of many dead saplings within the breast-wire buffer strip that have been killed by sheep browsing. Sheep will often preferentially browse trees and saplings over grass if they are allowed access.

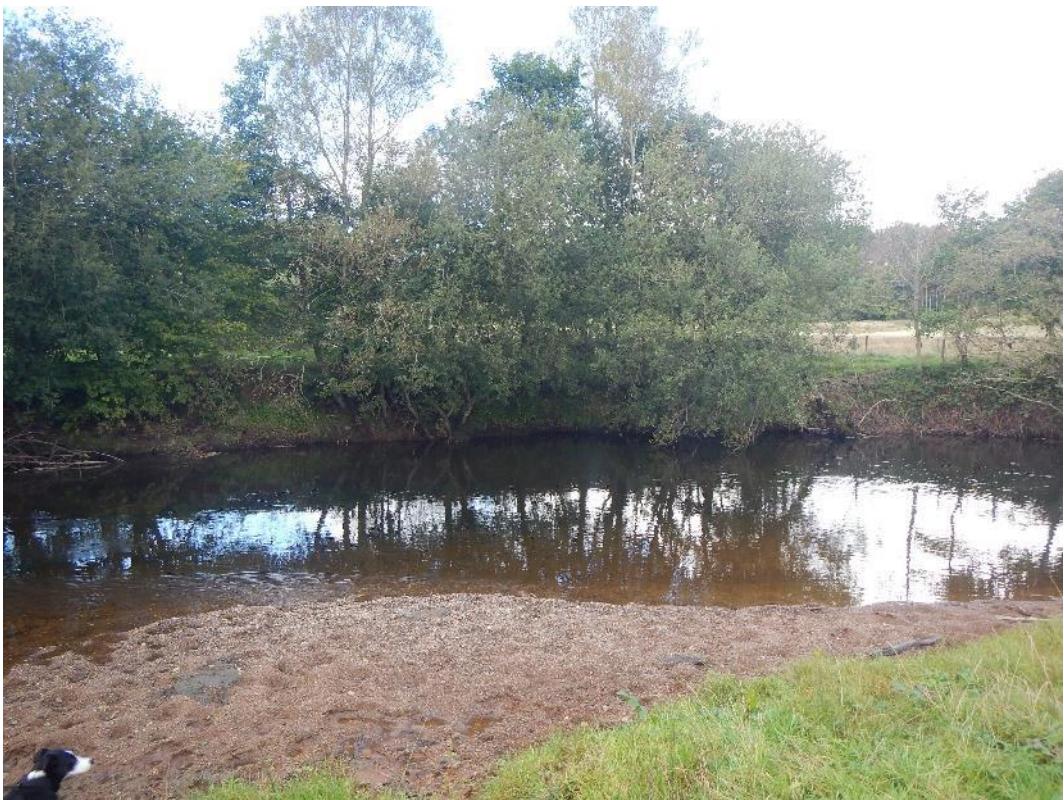
Figure 20. Signs of gravel having been extracted from the channel were also observed (NY 08227 00329 & NY 08380 00285), with farm machinery access tracks into the watercourse visible on Google Maps (Figure 21). Even aside from the immediate ecological issues of the dredging (particularly the likely impact upon protected freshwater pearl mussels), the interruption of sediment supply down the river has the potential to destabilise the riverbanks and increase erosion rates up and downstream, which could be contributing to the issues observed.

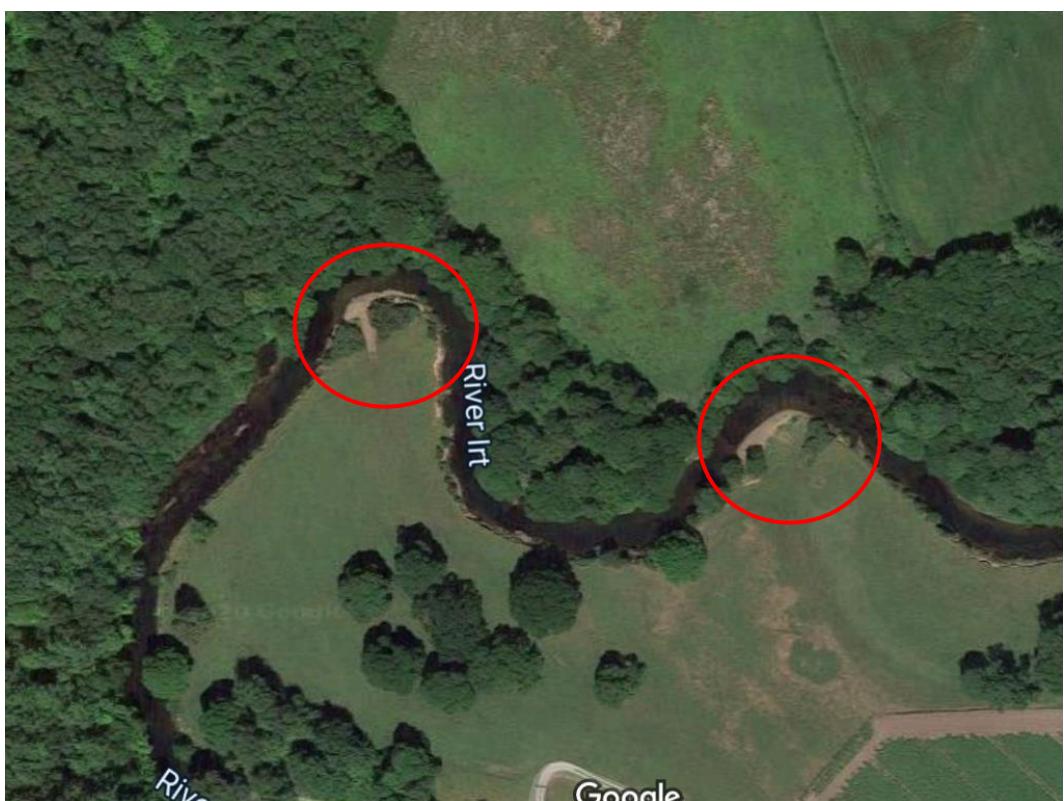
Figure 21. Aerial photography on Google maps clearly showing signs of farm machinery regularly accessing the watercourse (red circles).

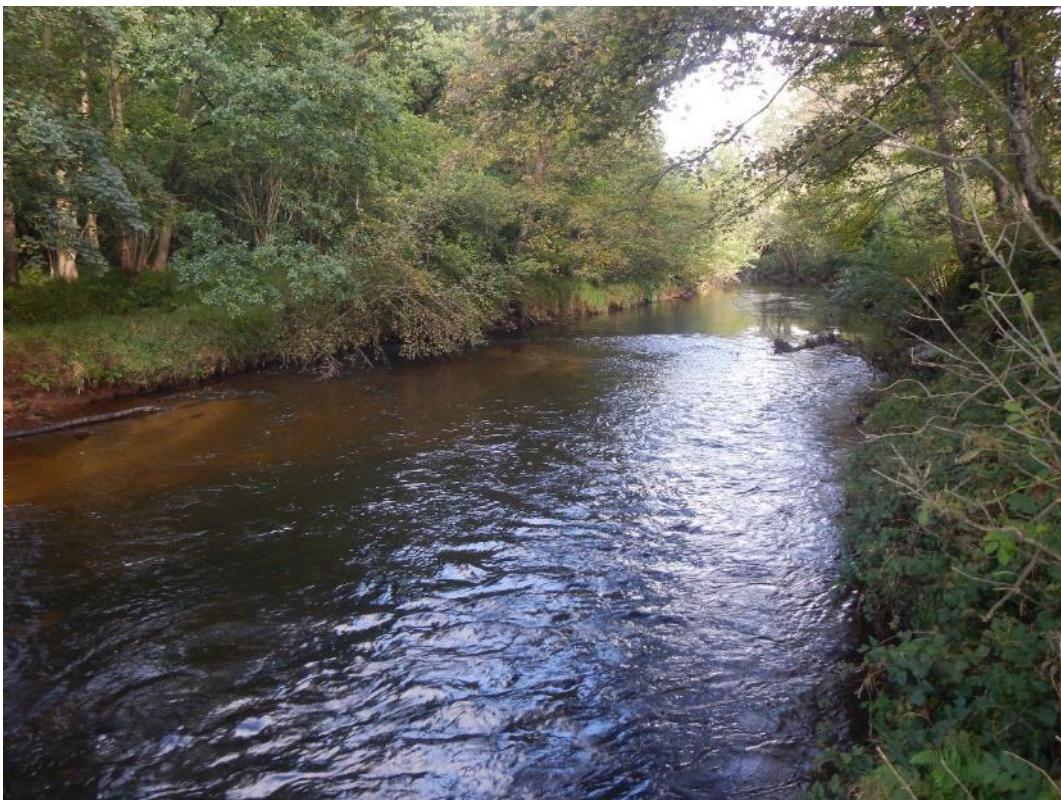
Figure 22. At the next wooded section on the LB, more potential high-quality spawning habitat was observed. Fish are likely to spawn in this area but would benefit from more trees/branches providing cover within the channel. It would be worth engaging with the landowners to gain agreement for habitat improvement work here.

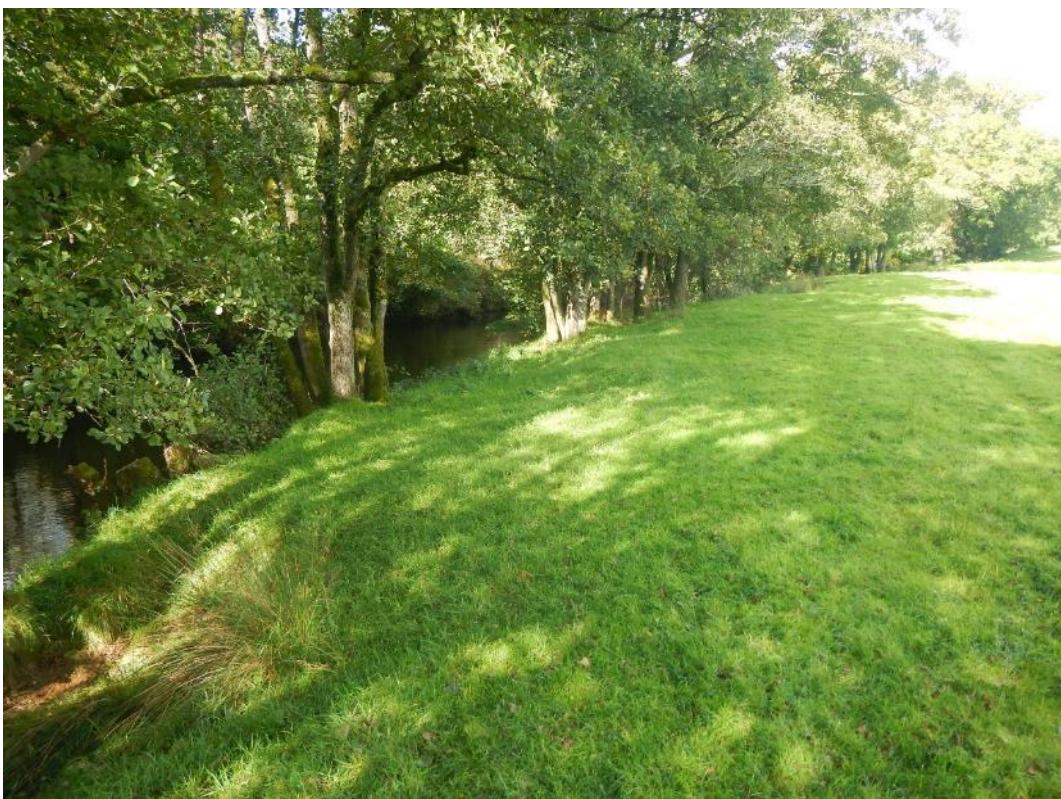
Figure 23. Upstream of the wood, grazing pressure appears to reduce, and an increased number of trees offer greater bank protection. However, note the lack of vegetation diversity, understory or tree regeneration that still occurs, even with lower intensity sheep grazing. This is why livestock exclusion for riverbanks is always preferable. The near monoculture of alders is also a potential concern as alder disease (*Phytophthora alni*) could have a severe impact. Maximising natural species diversity is always beneficial.
